## **APPENDIX C – GEOLOGY AND GEOMORPHOLOGY**

## GEOLOGY AND GEOMORPHOLOGY REPORT FOR THE CATHERINE CREEK TRIBUTARY ASSESSMENT – GRANDE RONDE RIVER BASIN Tributary Habitat Program, Oregon

February 2012

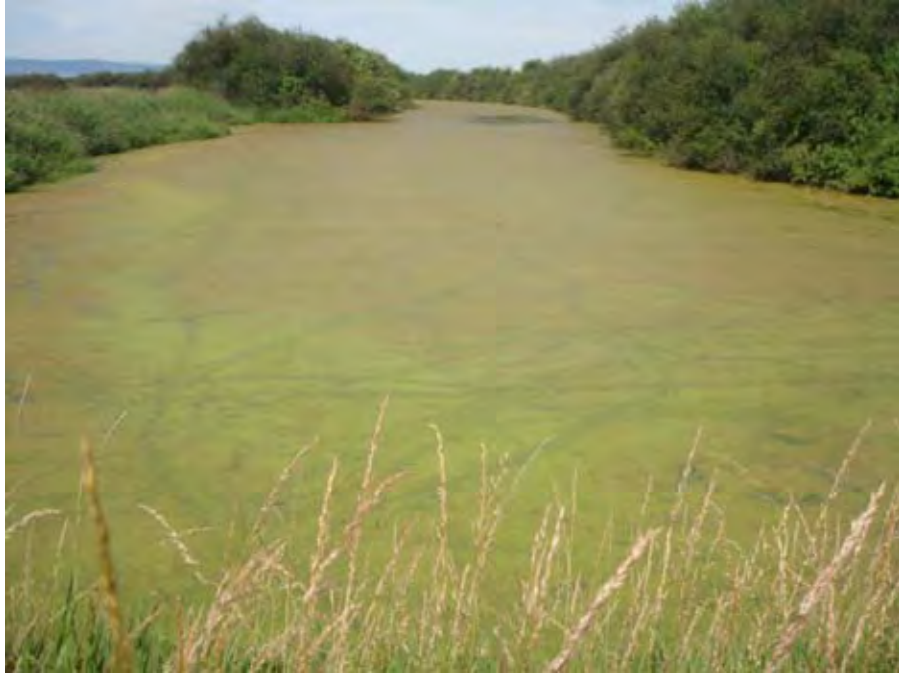
**Photograph 51. View looking west at algae covered oxbow lake (cut-off meander) near river mile 13.62. Reach 1 – Catherine Creek, Grande Ronde Subbasin, Oregon – Bureau of Reclamation Photograph by D. Stelma, July 10, 2010.**

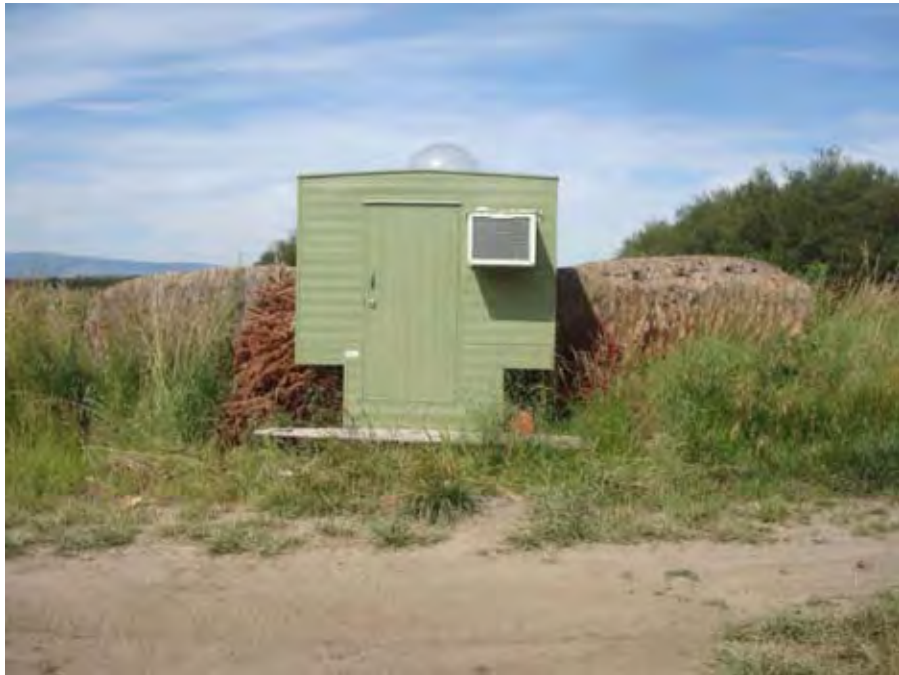
**Photograph 52. Pump house on west side of Catherine Creek near river mile 13.62. Reach 1 – Catherine Creek, Grande Ronde Subbasin, Oregon – Bureau of Reclamation Photograph by D. Stelma, July 10, 2010.**

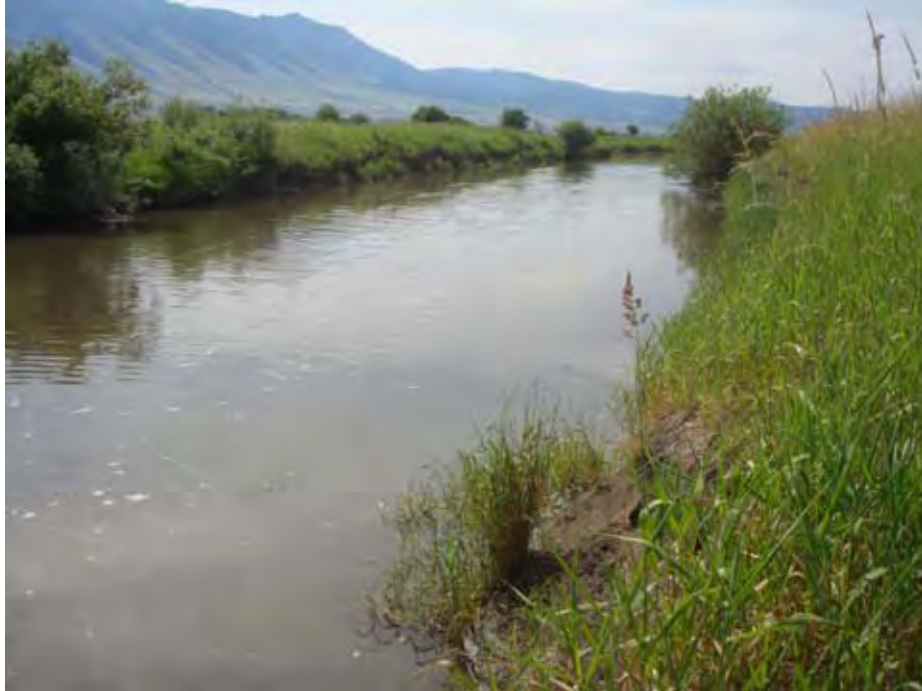
**Photograph 53. View looking upstream at Catherine Creek channel near river mile 13.60. Reach 1 – Catherine Creek, Grande Ronde Subbasin, Oregon – Bureau of Reclamation Photograph by D. Stelma, July 10, 2010.**

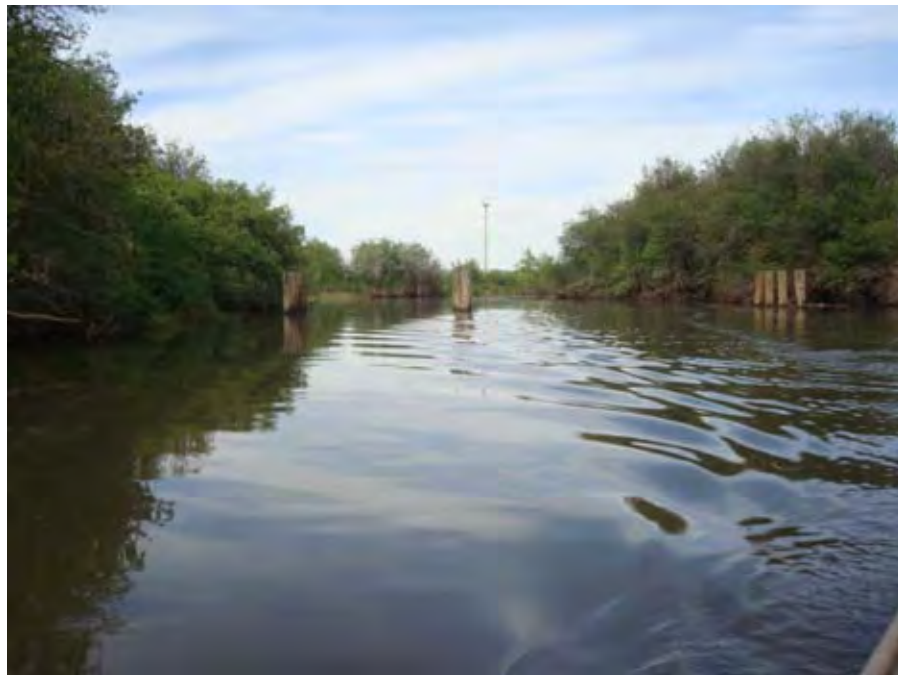
**Photograph 54. View looking downstream at abandoned bridge piers exposed in the Catherine Creek channel upstream of Elmer Dam near river mile 13.24. Reach 1 – Catherine Creek, Grande Ronde Subbasin, Oregon – Bureau of Reclamation Photograph by D. Stelma, July 10, 2010.**

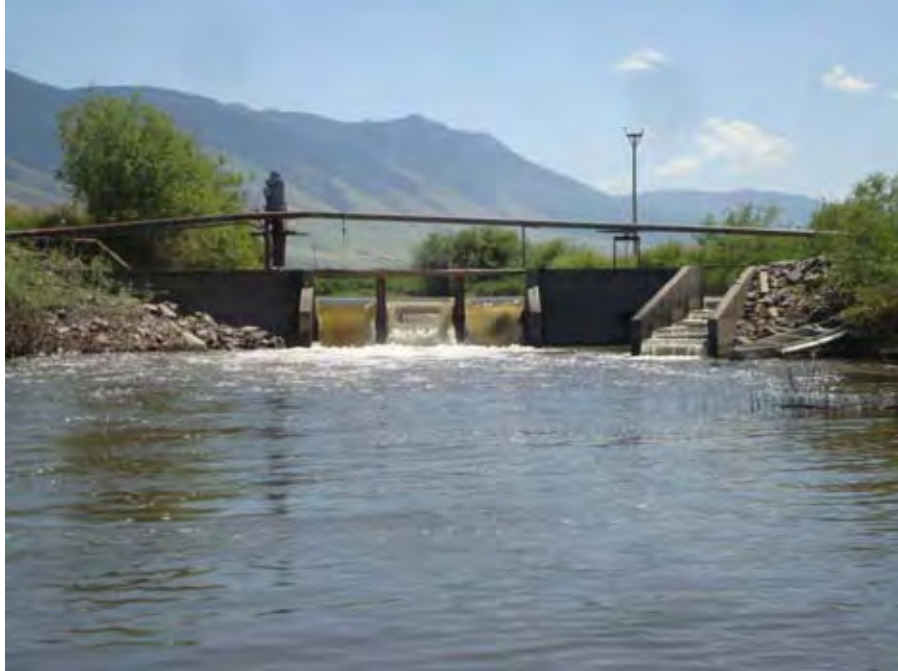
**Photograph 55. View looking upstream at Elmer Dam near river mile 13.13. Reach 1 – Catherine Creek, Grande Ronde Subbasin, Oregon – Bureau of Reclamation Photograph by D. Stelma, July 9, 2010.**

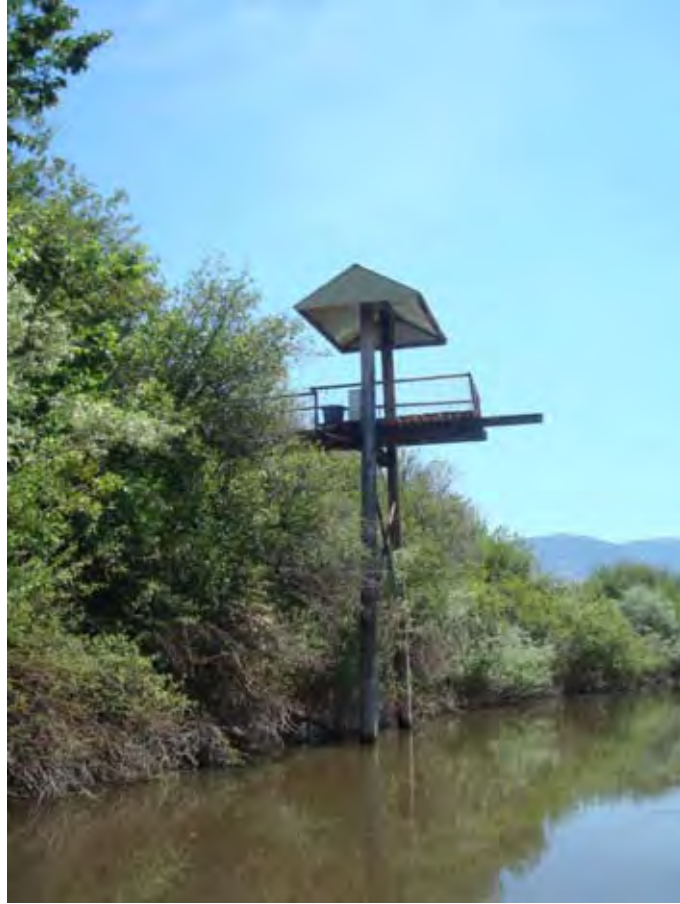
**Photograph 56. View looking upstream at observation deck on east bank of Catherine Creek downstream of Elmer Dam near river mile 13.13. Reach 1 – Catherine Creek, Grande Ronde Subbasin, Oregon – Bureau of Reclamation Photograph by D. Stelma, July 9, 2010.**

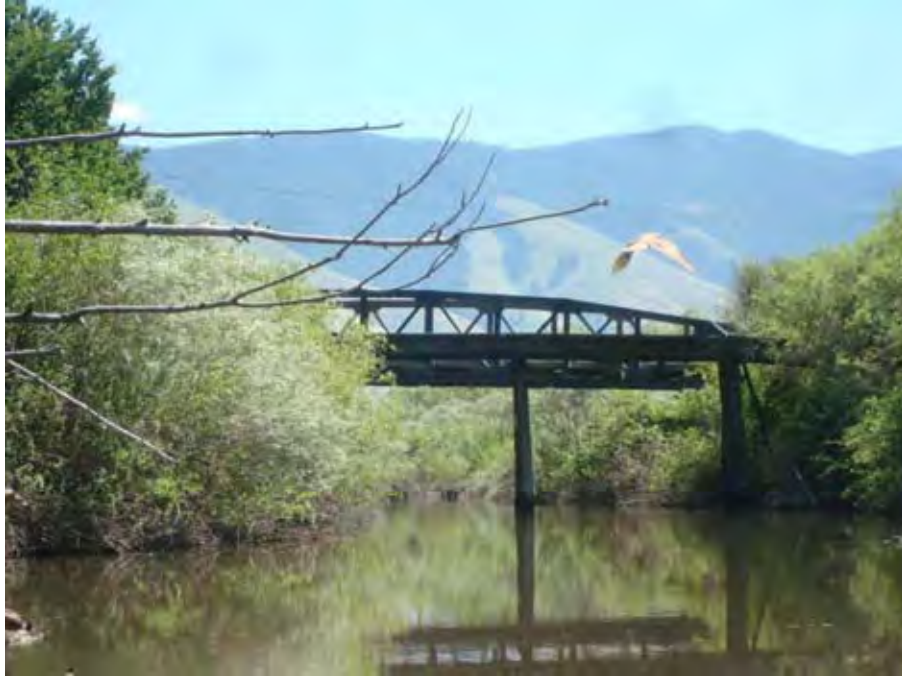
**Photograph 57. View looking upstream at farm access road bridge across Catherin Creek downstream of Elmer Dam near river mile 12.95. Reach 1 – Catherine Creek, Grande Ronde Subbasin, Oregon – Bureau of Reclamation Photograph by D. Stelma, July 9, 2010.**

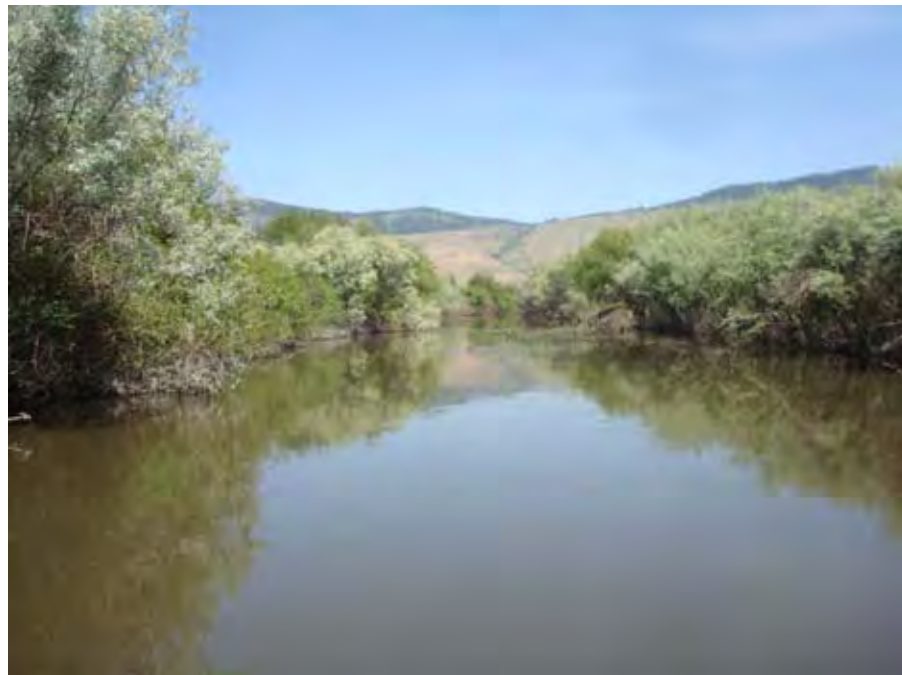
**Photograph 58. View looking upstream at Catherine Creek channel near river mile 12.65. Reach 1 – Catherine Creek, Grande Ronde Subbasin, Oregon – Bureau of Reclamation Photograph by D. Stelma, July 9, 2010.**

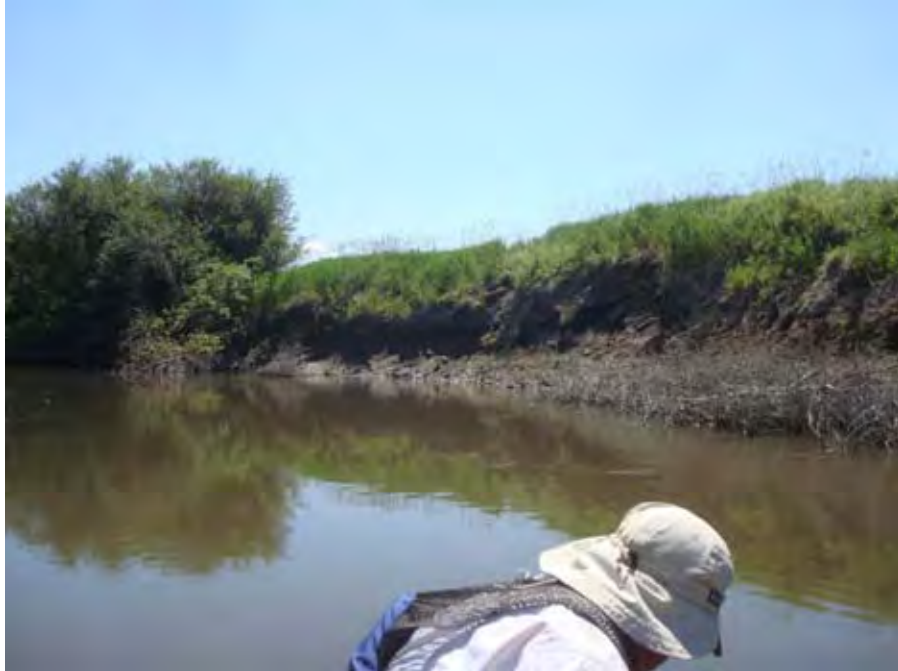
**Photograph 59. View looking upstream at left bank, exposed fine-grained alluvium along an under-cut stream bank near river mile 12.55. Reach 1 – Catherine Creek, Grande Ronde Subbasin, Oregon – Bureau of Reclamation Photograph by D. Stelma, July 9, 2010.**

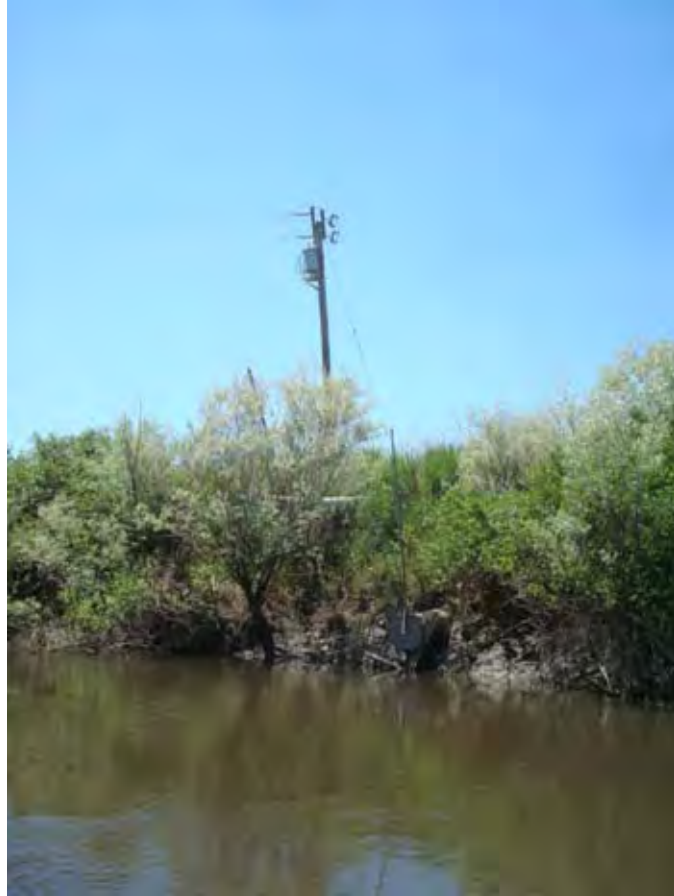
**Photograph 60. View looking upstream toward the left bank at CMP drain pipe with slide-gate near river mile 12.50. Reach 1 – Catherine Creek, Grande Ronde Subbasin, Oregon – Bureau of Reclamation Photograph by D. Stelma, July 9, 2010.**

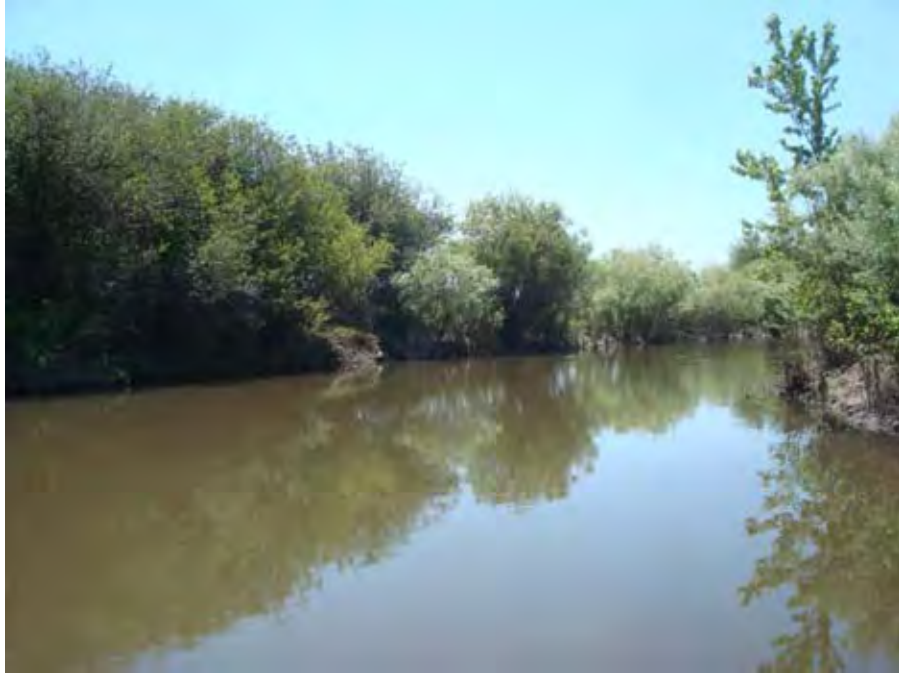
**Photograph 61. View looking upstream at Catherine Creek channel near river mile 12.30. Reach 1 – Catherine Creek, Grande Ronde Subbasin, Oregon – Bureau of Reclamation Photograph by D. Stelma, July 9, 2010.**

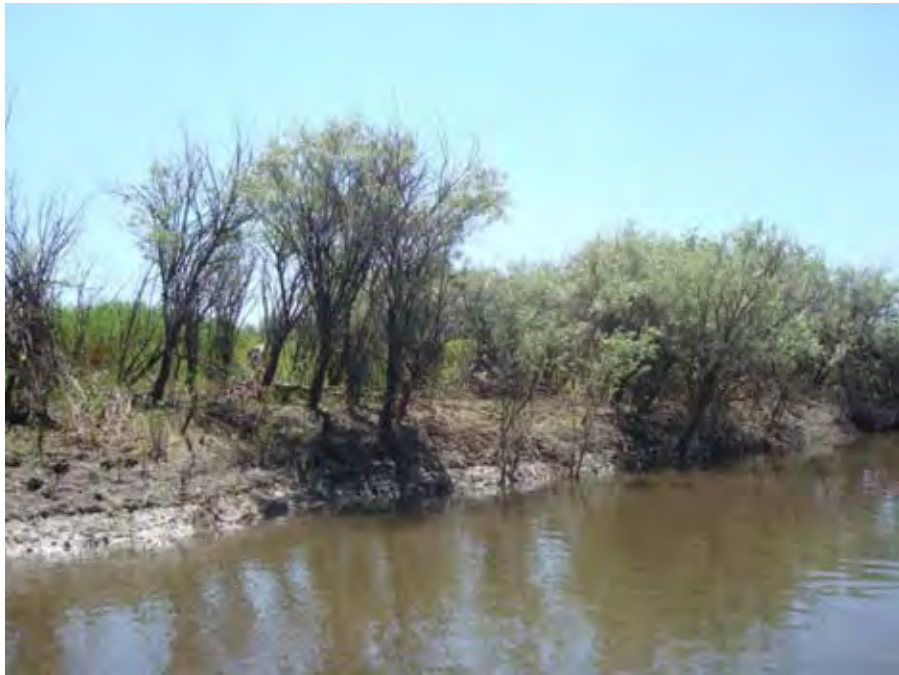
**Photograph 62. View looking downstream at vegetation (European Willow) and fine-grained alluvium exposed on the left bank of Catherine Creek near river mile 11.90. Reach 1 – Catherine Creek, Grande Ronde Subbasin, Oregon – Bureau of Reclamation Photograph by D. Stelma, July 9, 2010.**

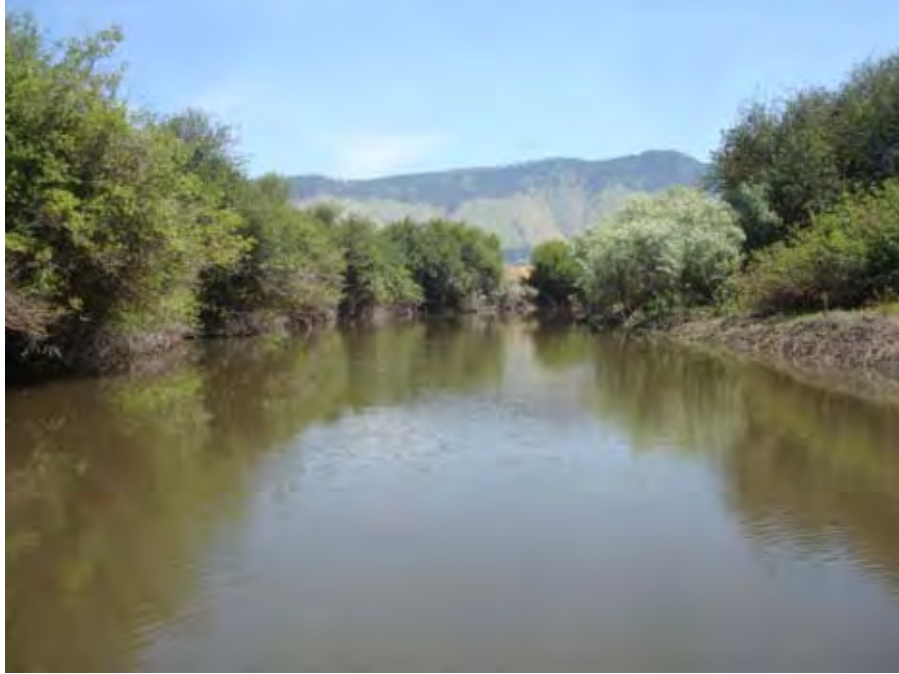
**Photograph 63. View looking upstream at Catherine Creek channel near river mile 11.80. Reach 1 – Catherine Creek, Grande Ronde Subbasin, Oregon – Bureau of Reclamation Photograph by D. Stelma, July 9, 2010.**

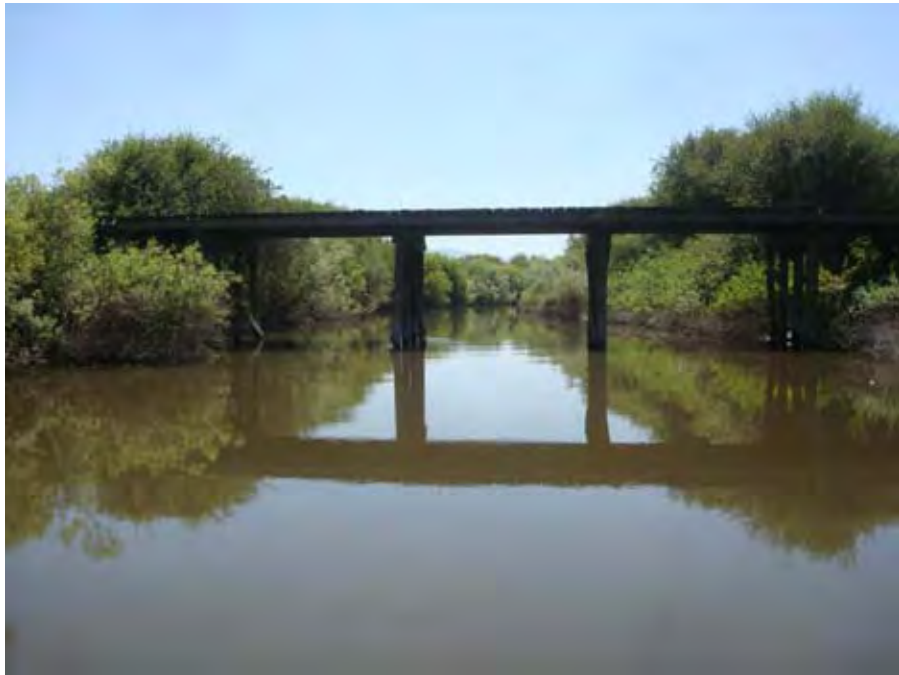
**Photograph 64. View looking upstream at farm access road bridge crossing Catherine Creek near river mile 11.30. Reach 1 – Catherine Creek, Grande Ronde Subbasin, Oregon – Bureau of Reclamation Photograph by D. Stelma, July 9, 2010.**

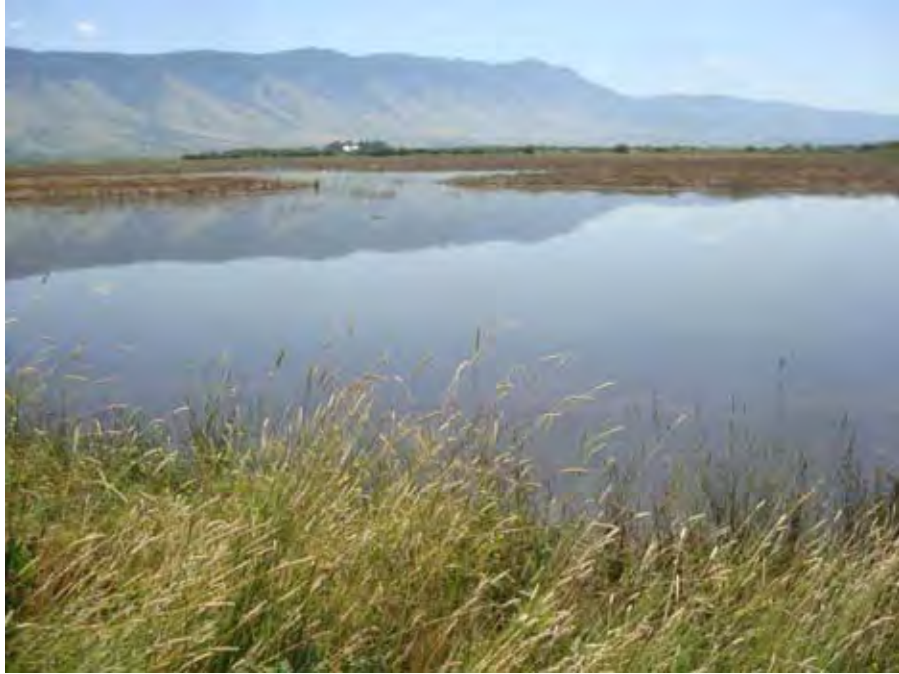
**Photograph 65. View looking east at wetland area behind levee on the inside curve of Catherine Creek oxbow (Mt. Fanny in background) near river mile 11.05. Reach 1 – Catherine Creek, Grande Ronde Subbasin, Oregon – Bureau of Reclamation Photograph by D. Stelma, July 9, 2010.**

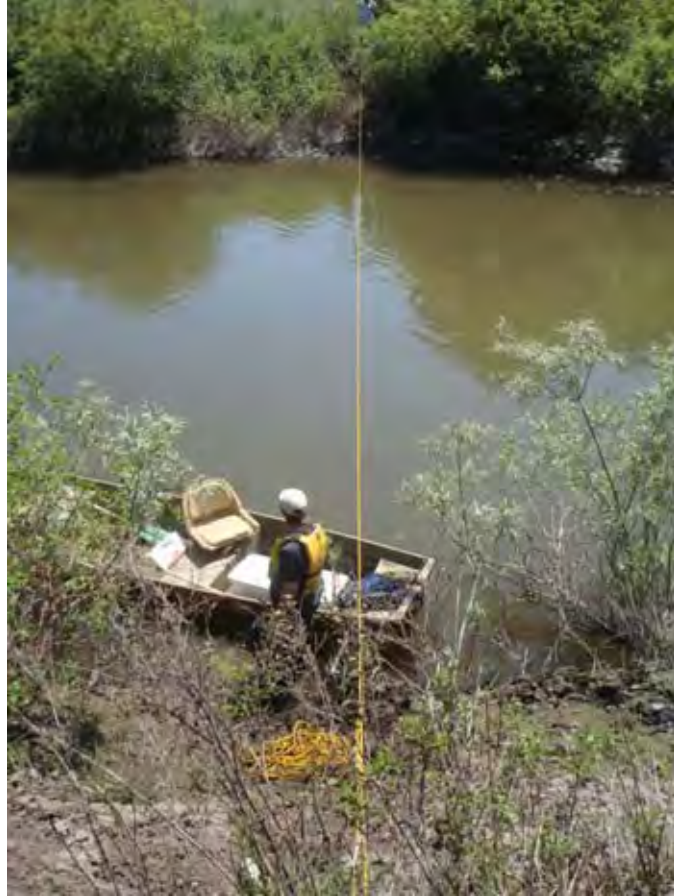
**Photograph 66. View looking from the right bank toward the left bank at profile site near river mile 10.50. Reach 1 – Catherine Creek, Grande Ronde Subbasin, Oregon – Bureau of Reclamation Photograph by D. Stelma, July 9, 2010.**

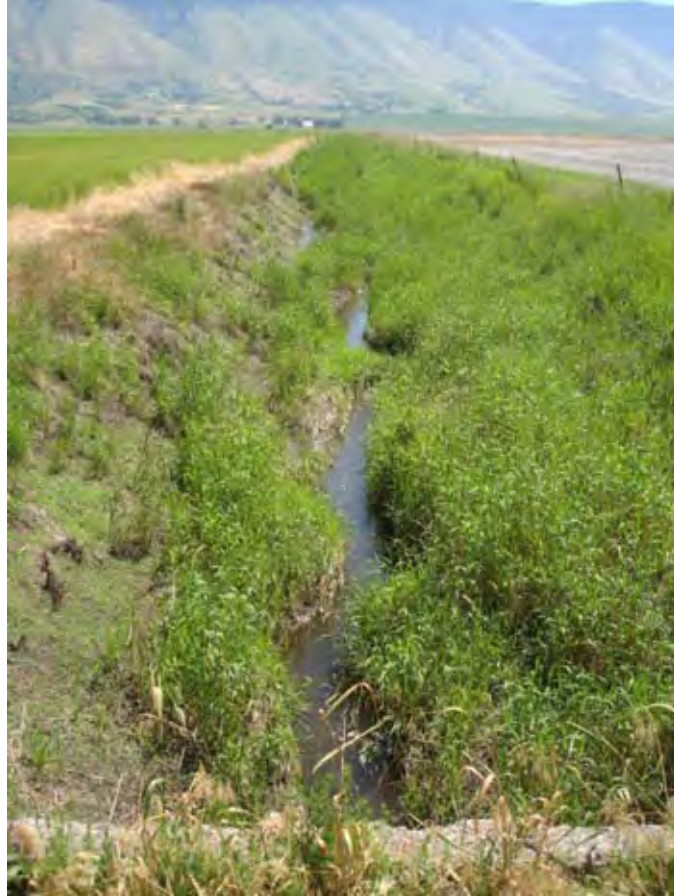
**Photograph 67. View looking east (upstream) at man-made drainage ditch near river mile 10.19. Reach 1 – Catherine Creek, Grande Ronde Subbasin, Oregon – Bureau of Reclamation Photograph by D. Stelma, July 9, 2010.**

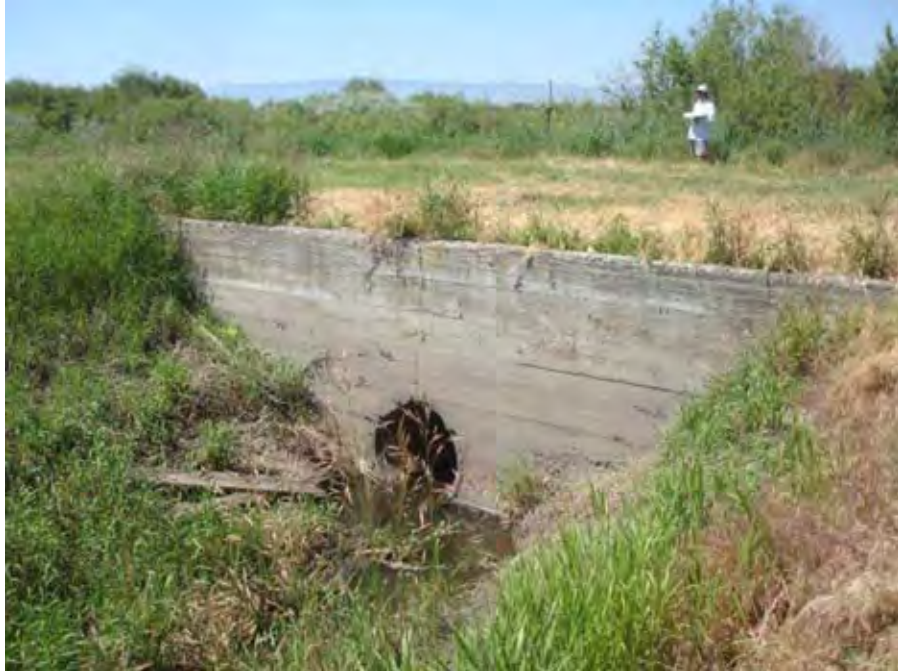
**Photograph 68. View looking at bridge and discharge pipe at mouth of man-made drainage ditch, Catherine Creek is on the other side of the road near river mile 10.19. Reach 1 – Catherine Creek, Grande Ronde Subbasin, Oregon – Bureau of Reclamation Photograph by D. Stelma, July 9, 2010.**

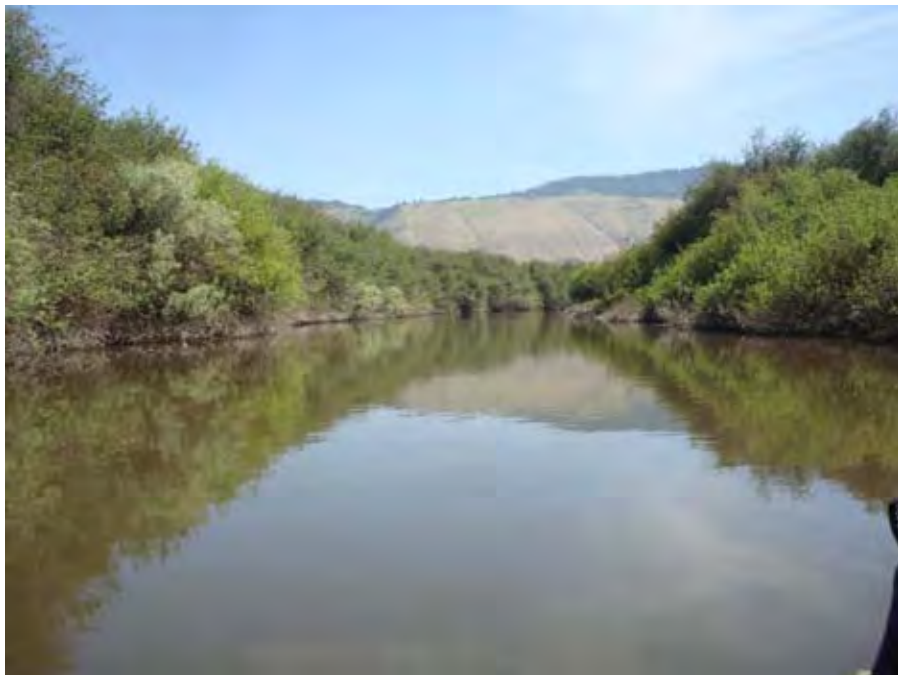
**Photograph 69. View looking downstream at Catherine Creek channel near river mile 9.55. Reach 1 – Catherine Creek, Grande Ronde Subbasin, Oregon – Bureau of Reclamation Photograph by D. Stelma, July 9, 2010.**

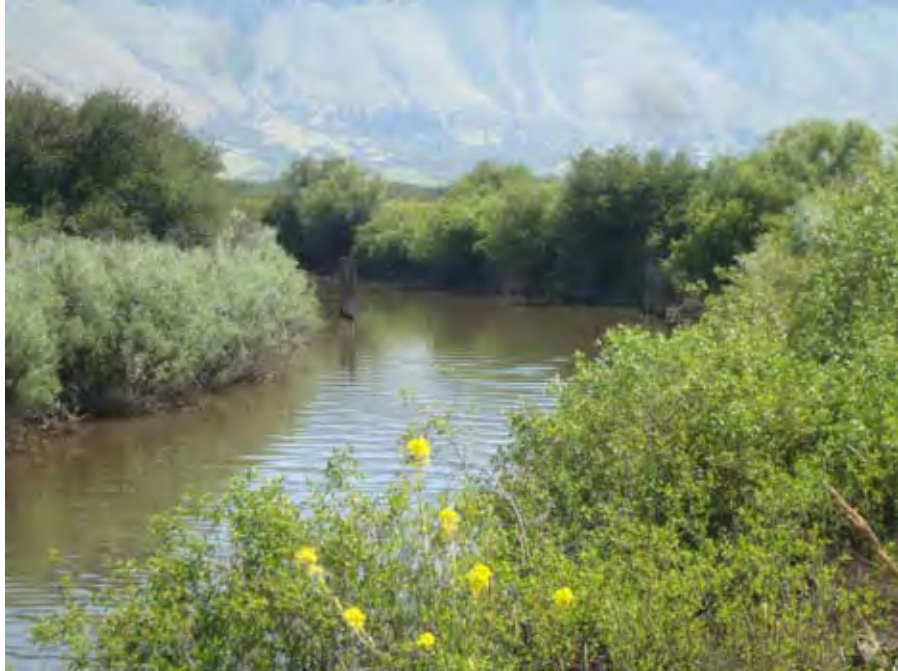
**Photograph 70. View looking southeastward (upstream) at abandoned bridge piers within the Catherine Creek channel near river mile 9.03. Reach 1 – Catherine Creek, Grande Ronde Subbasin, Oregon – Bureau of Reclamation Photograph by D. Stelma, July 9, 2010.**

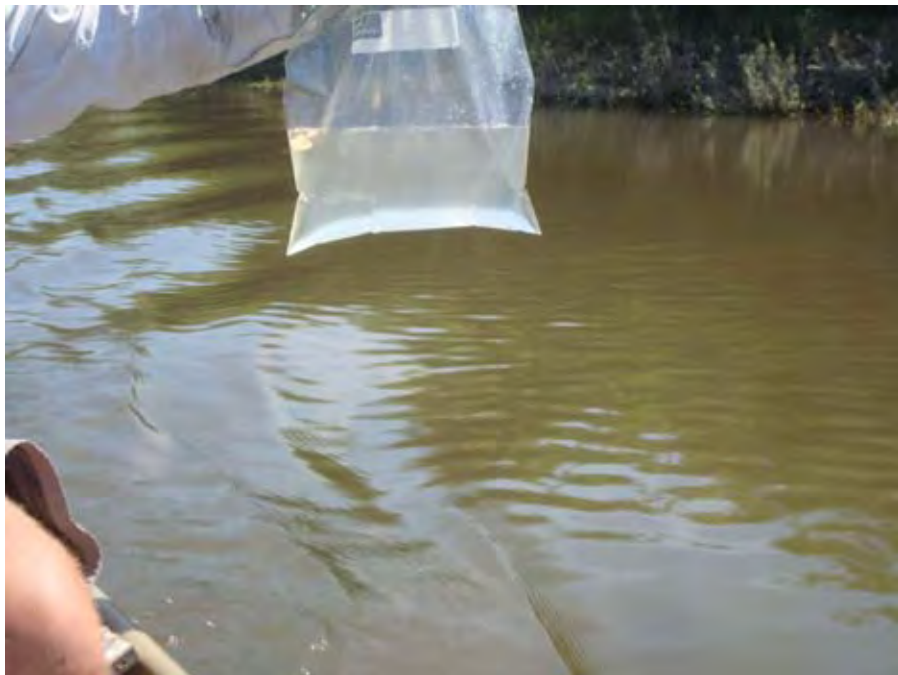
**Photograph 71. View looking of Catherine Creek water sample, note less discoloration of sample than appears in stream near river mile 8.89. Reach 1 – Catherine Creek, Grande Ronde Subbasin, Oregon – Bureau of Reclamation Photograph by D. Stelma, July 9, 2010.**

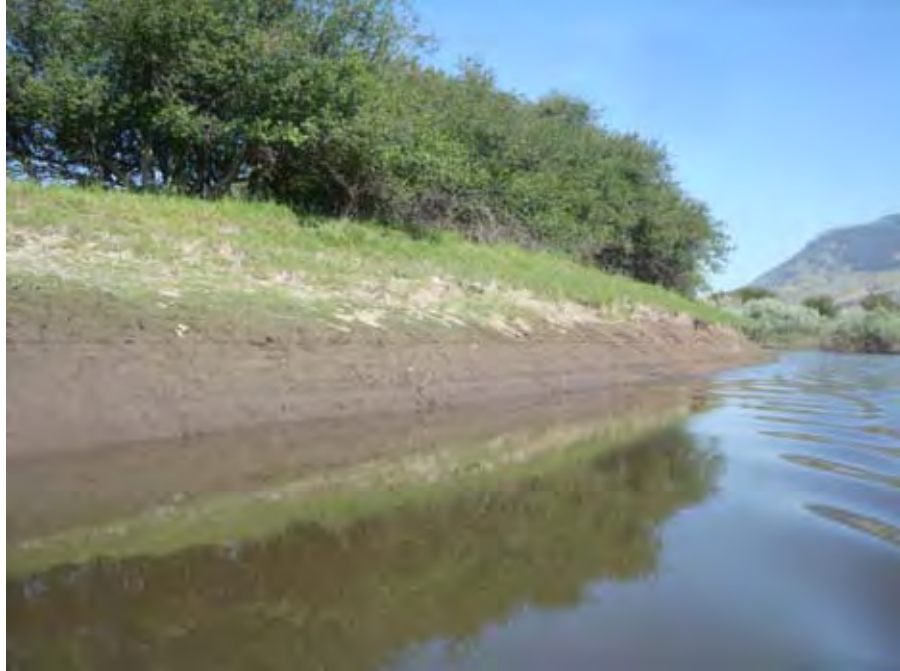
**Photograph 72. View looking northeastward (downstream) at left bank of Catherine Creek through artificial channel area between oxbows near river mile 8.49. Reach 1 – Catherine Creek, Grande Ronde Subbasin, Oregon – Bureau of Reclamation Photograph by D. Stelma, July 9, 2010.**

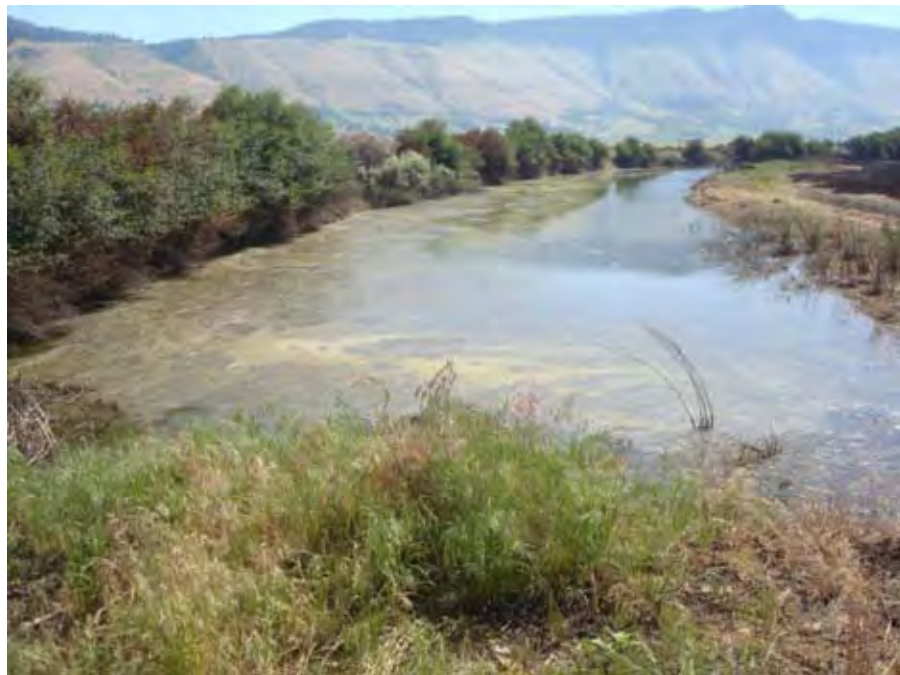
**Photograph 73. View looking east at oxbow lake (cutoff meander), note weed-covered levee in foreground near river mile 8.45. Reach 1 – Catherine Creek, Grande Ronde Subbasin, Oregon – Bureau of Reclamation Photograph by D. Stelma, July 9, 2010.**

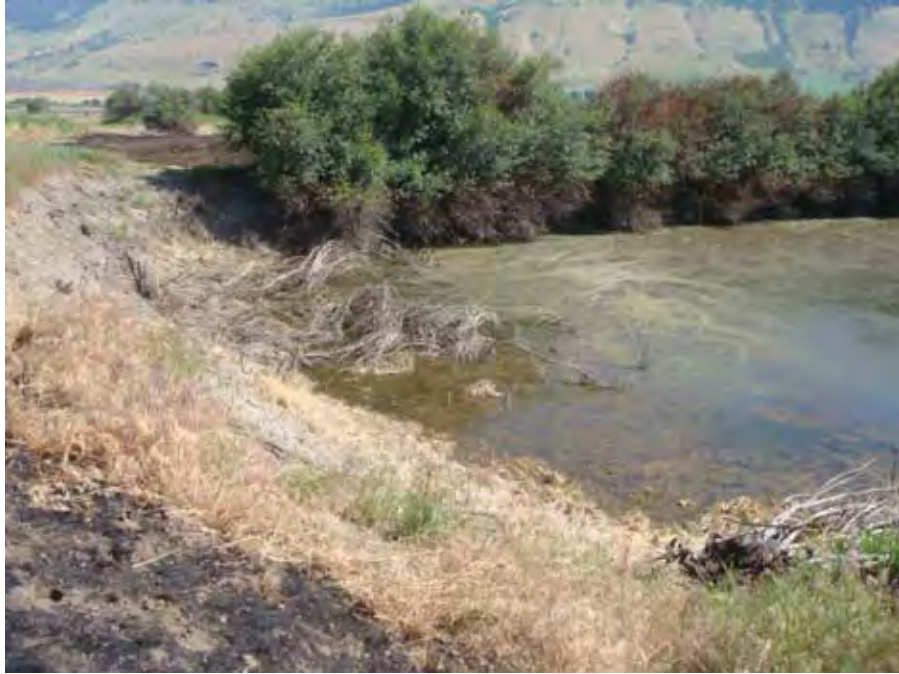
**Photograph 74. View looking northeastward (downstream) at levee (left) and oxbow lake (right) near river mile 8.45. Reach 1 – Catherine Creek, Grande Ronde Subbasin, Oregon – Bureau of Reclamation Photograph by D. Stelma, July 9, 2010.**

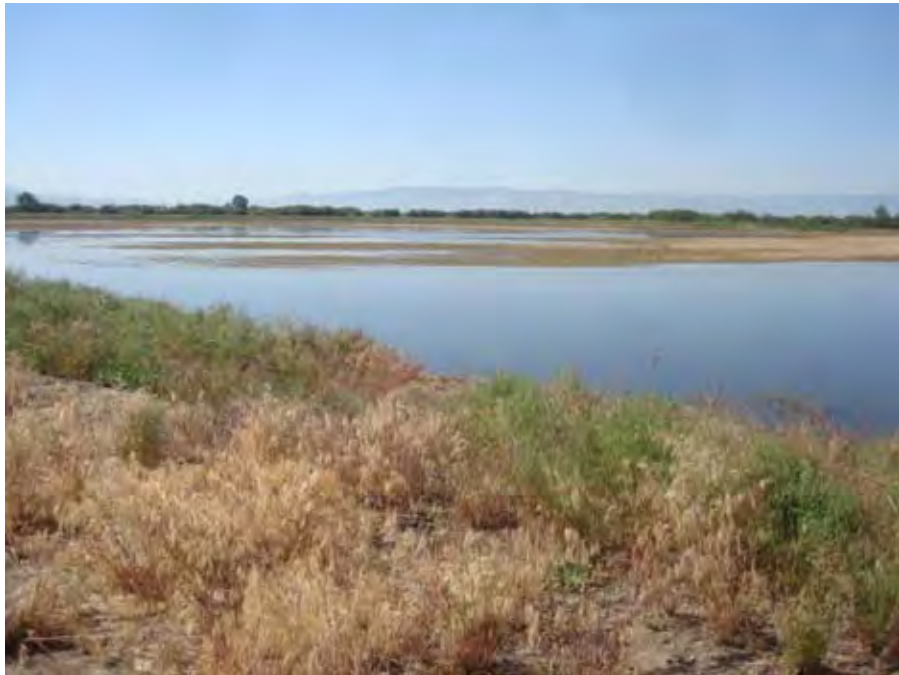
**Photograph 75. View looking of flooded area between oxbow lake lakes near river mile 8.45. Reach 1 – Catherine Creek, Grande Ronde Subbasin, Oregon – Bureau of Reclamation Photograph by D. Stelma, July 9, 2010.**

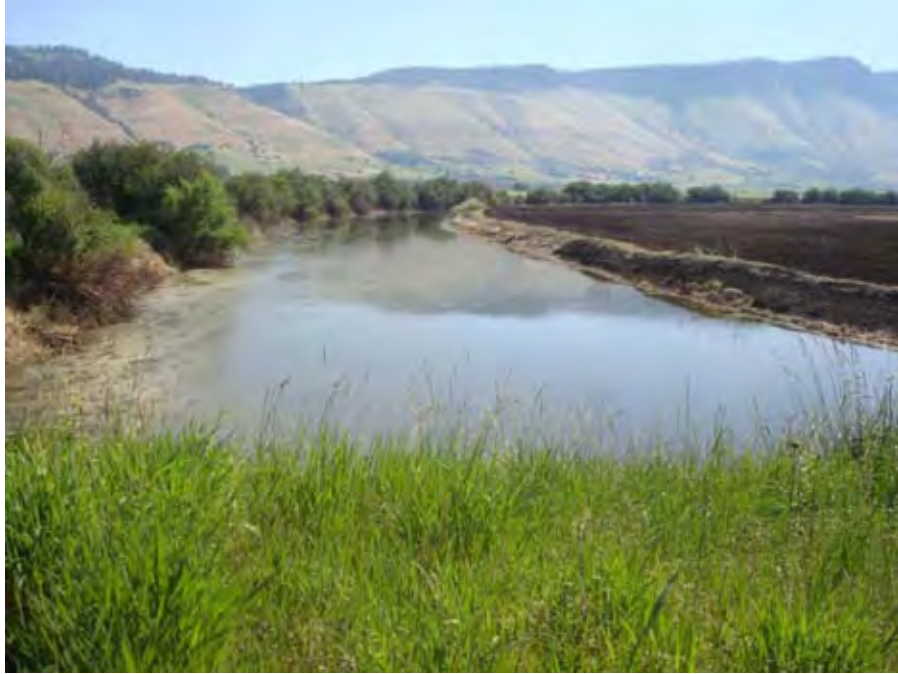
**Photograph 76. View looking east at oxbow lake (cutoff meander), note grass-covered levee in foreground near river mile 7.80. Reach 1 – Catherine Creek, Grande Ronde Subbasin, Oregon – Bureau of Reclamation Photograph by D. Stelma, July 9, 2010.**

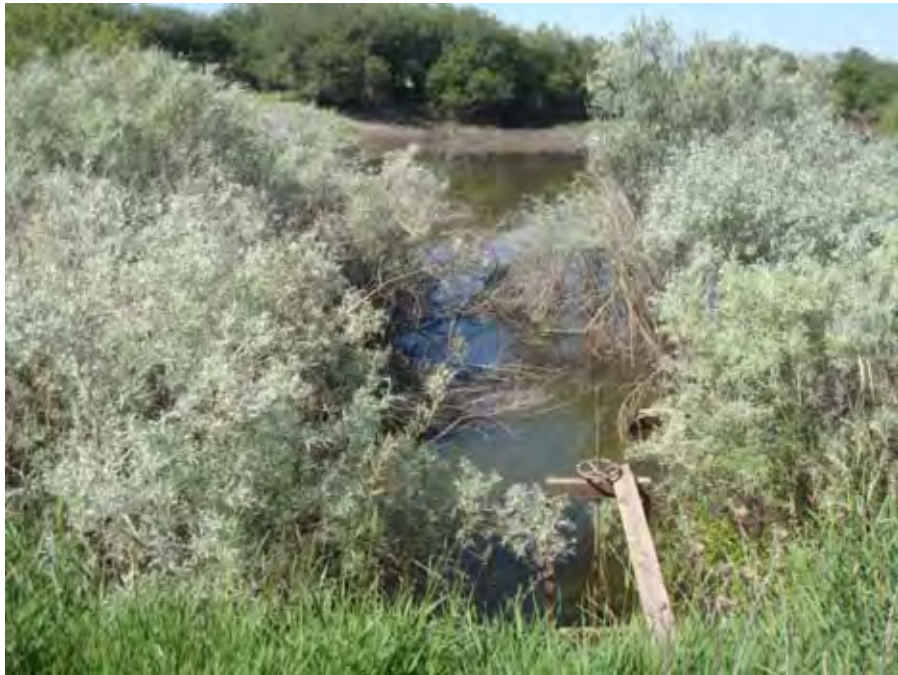
**Photograph 77. View looking west at oxbow lake discharge headgate and Catherine Creek in background near river mile 7.80. Reach 1 – Catherine Creek, Grande Ronde Subbasin, Oregon – Bureau of Reclamation Photograph by D. Stelma, July 9, 2010.**

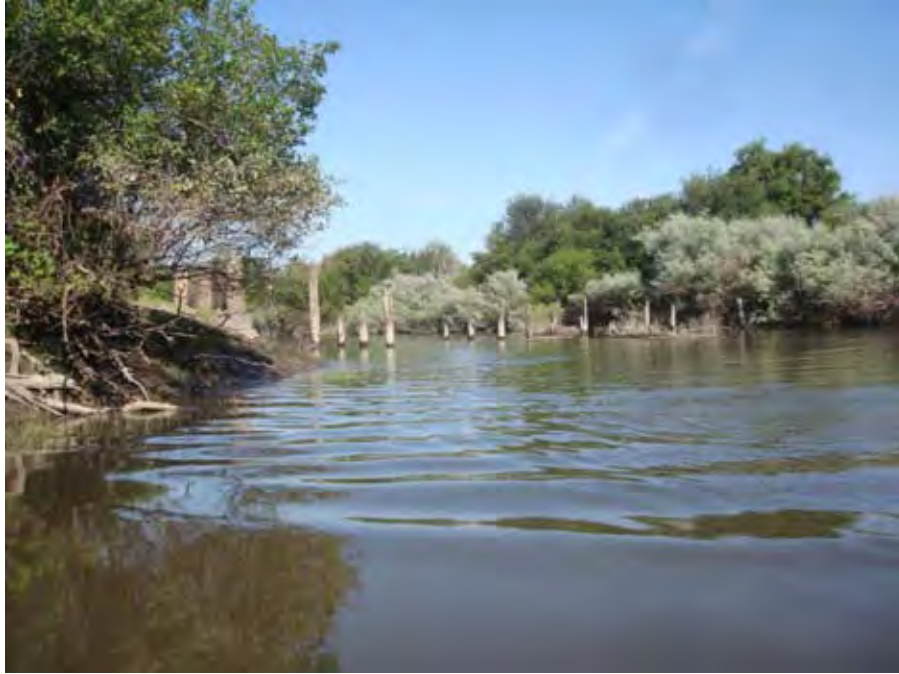
**Photograph 79. View looking downstream at abandoned bridge piers near river mile 7.60. Reach 1 – Catherine Creek, Grande Ronde Subbasin, Oregon – Bureau of Reclamation Photograph by D. Stelma, July 9, 2010.**

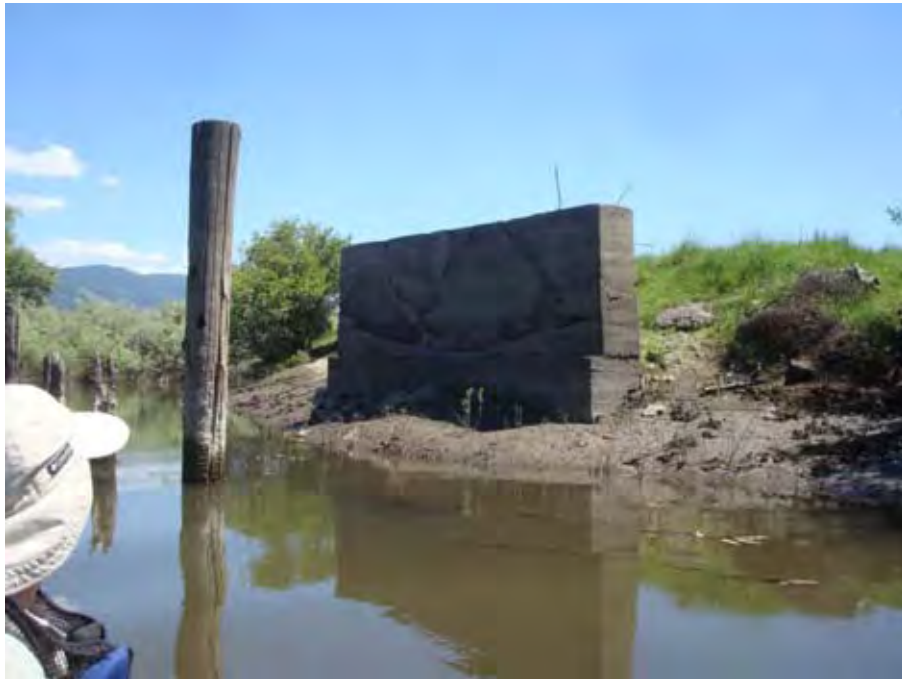
**Photograph 80. View looking upstream at abandoned concrete bridge abutment near river mile 7.60. Reach 1 – Catherine Creek, Grande Ronde Subbasin, Oregon – Bureau of Reclamation Photograph by D. Stelma, July 7, 2010.**

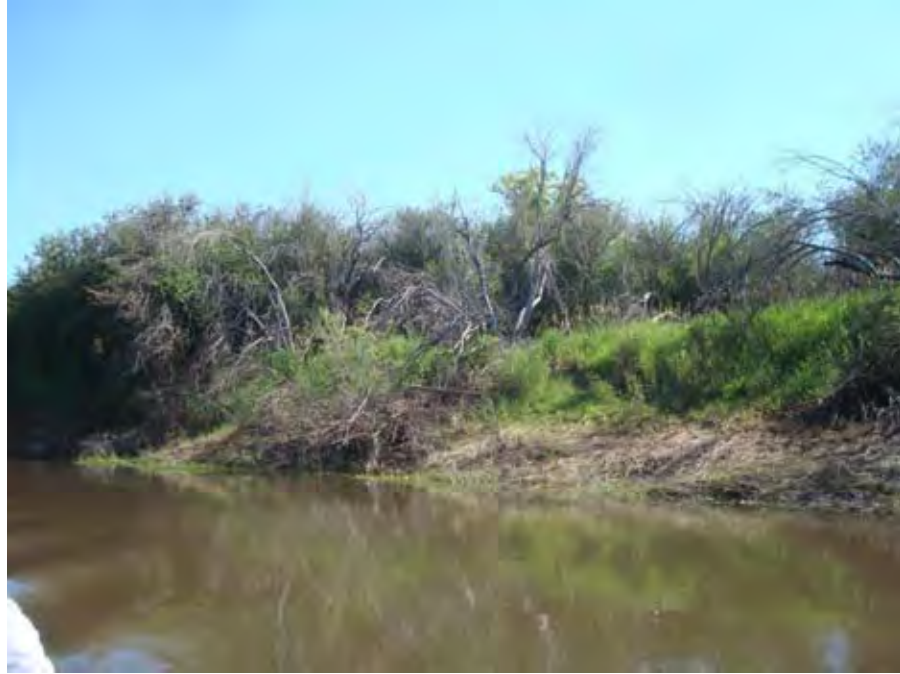
**Photograph 81. View looking downstream toward the left bank of Catherine Creek in burned forest area near river mile 7.20. Reach 1 – Catherine Creek, Grande Ronde Subbasin, Oregon – Bureau of Reclamation Photograph by D. Stelma, July 9, 2010.**

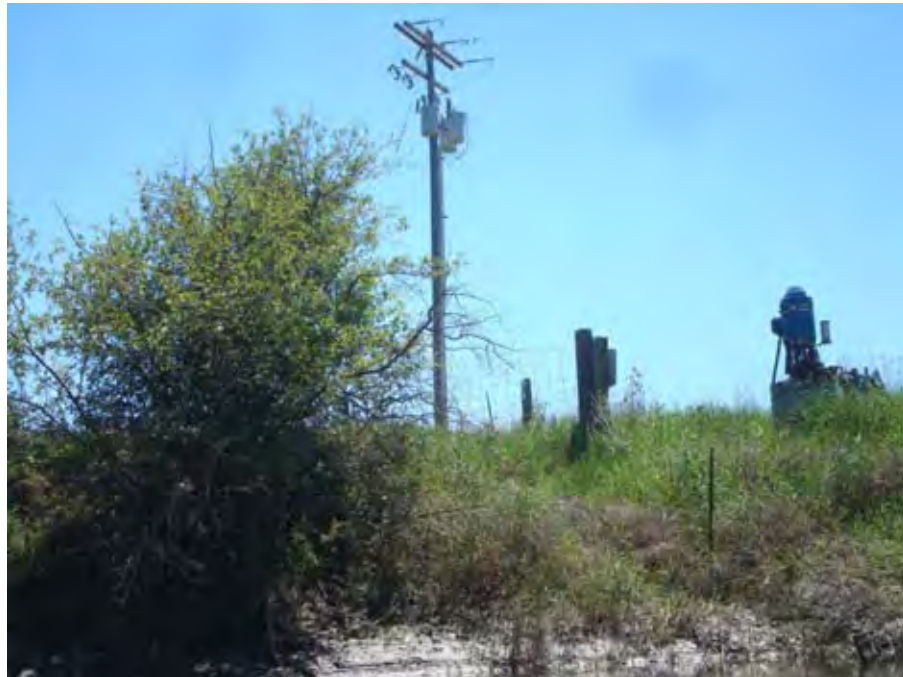
**Photograph 82. View looking upstream and west at pumping plant on the east bank of Catherine Creek, intake is submerged in creek bed near river mile 7.20. Reach 1 – Catherine Creek, Grande Ronde Subbasin, Oregon – Bureau of Reclamation Photograph by D. Stelma, July 7, 2010.**

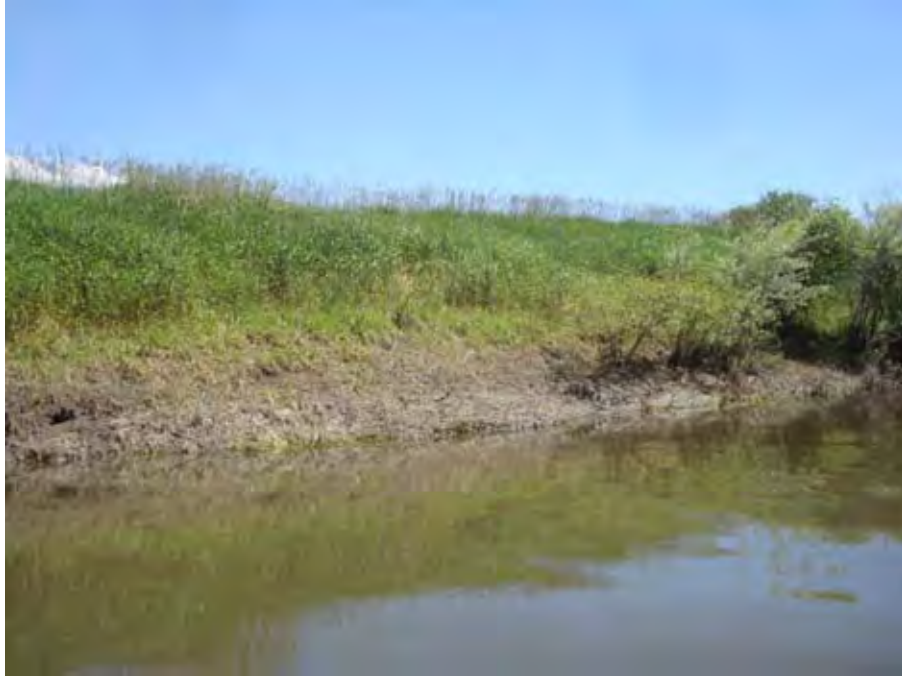
**Photograph 83. View of fine-grained (silt and clay) sediments along the bank of Catherine Creek with a mix of willows and hay-grass near river mile 6.90. Reach 1 – Catherine Creek, Grande Ronde Subbasin, Oregon – Bureau of Reclamation Photograph by D. Stelma, July 7, 2010.**

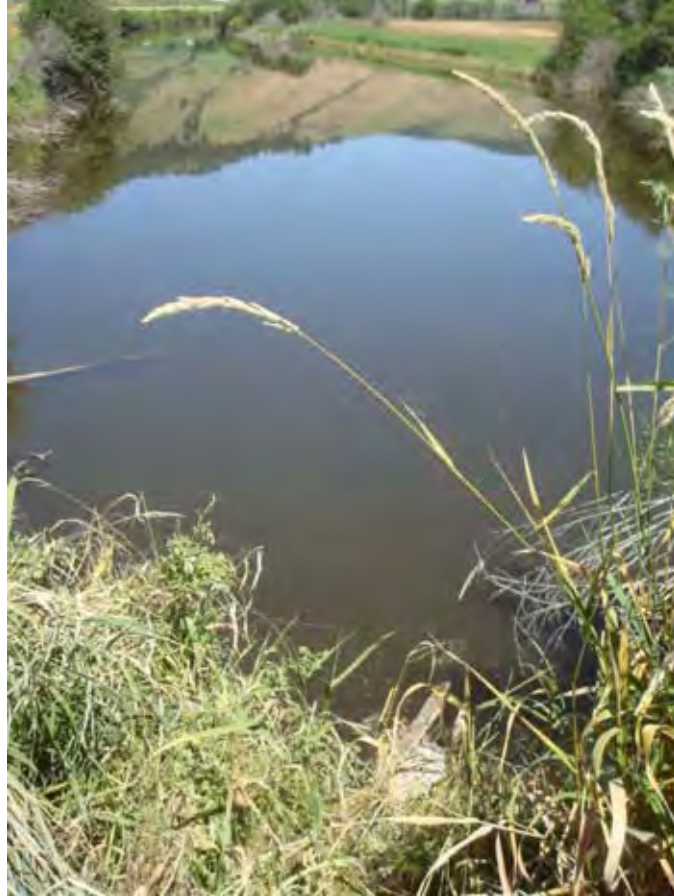
**Photograph 84. View of cutoff meander (oxbow lake) and gravity drainage pipe to Catherine Creek near river mile 6.60. Reach 1 – Catherine Creek, Grande Ronde Subbasin, Oregon – Bureau of Reclamation Photograph by D. Stelma, July 7, 2010.**

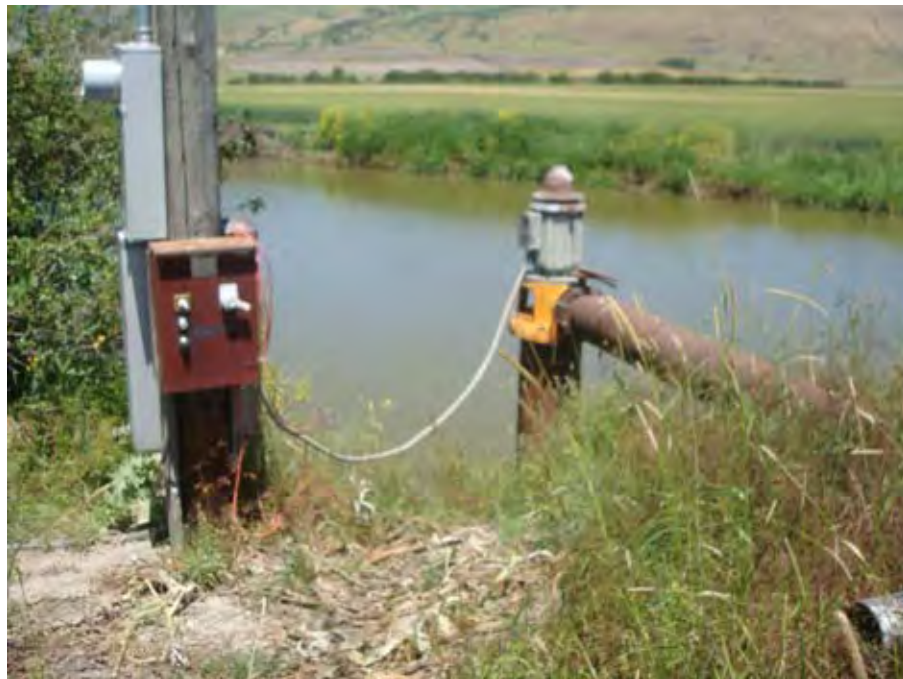
**Photograph 86. Looking northeastward at cutoff meander pond and discharge pump near river mile 5.70. Reach 1 – Catherine Creek, Grande Ronde Subbasin, Oregon – Bureau of Reclamation Photograph by D. Stelma, July 7, 2010.**
