## **APPENDIX C – GEOLOGY AND GEOMORPHOLOGY**

## GEOLOGY AND GEOMORPHOLOGY REPORT FOR THE CATHERINE CREEK TRIBUTARY ASSESSMENT – GRANDE RONDE RIVER BASIN Tributary Habitat Program, Oregon

February 2012

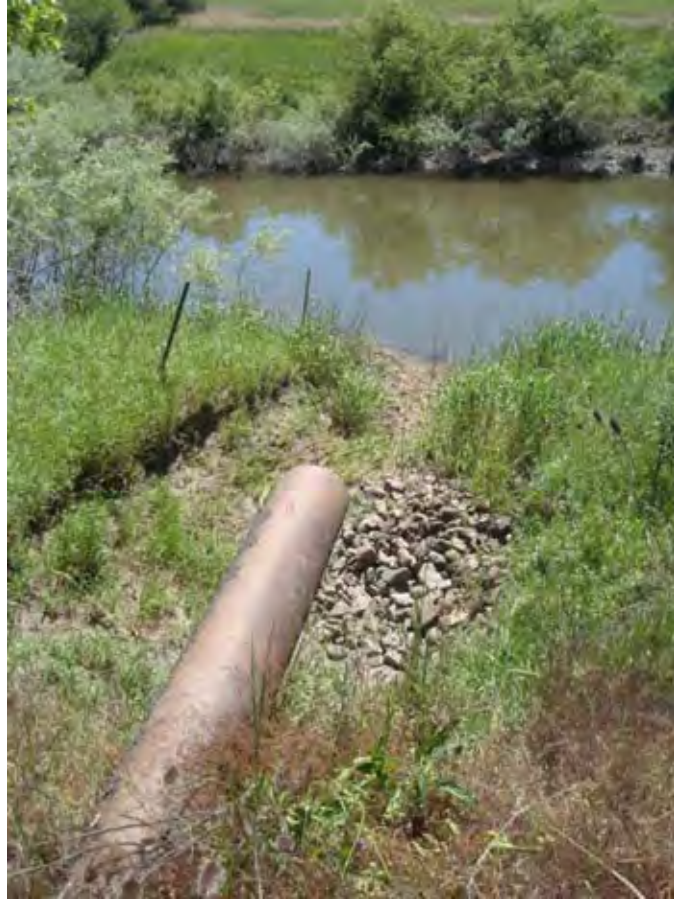
**Photograph 87. View of meander pond discharge pipe and rock erosion protection with Catherine Creek in background near river mile 5.70. Reach 1 – Catherine Creek, Grande Ronde Subbasin, Oregon – Bureau of Reclamation Photograph by D. Stelma, July 7, 2010.**

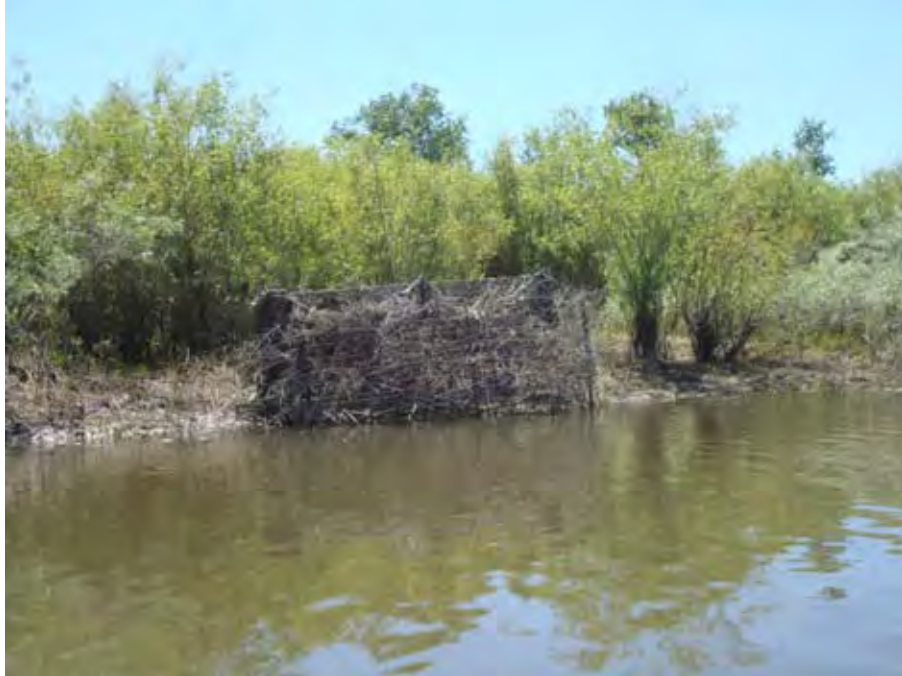
**Photograph 90. Duck blind located on the left bank of Catherine Creek near river mile 4.70. Reach 1 – Catherine Creek, Grande Ronde Subbasin, Oregon – Bureau of Reclamation Photograph by D. Stelma, July 7, 2010.**

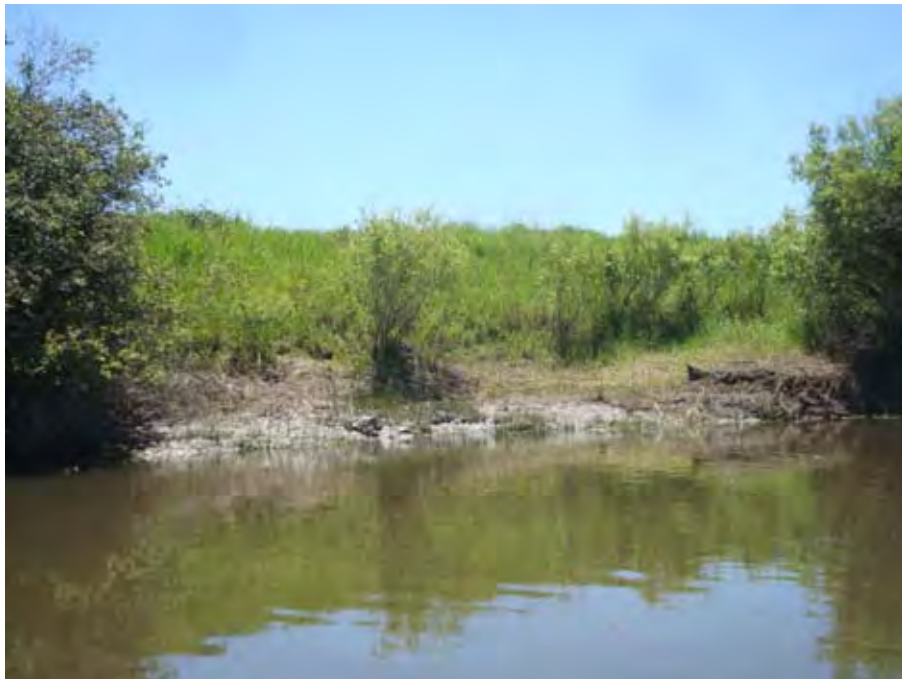
**Photograph 91. View looking at grass covered levee and fine-grained alluvial soil (Qal2) along the right bank of Catherine Creek near river mile 4.40. Reach 1 – Catherine Creek, Grande Ronde Subbasin, Oregon – Bureau of Reclamation Photograph by D. Stelma, July 7, 2010.**

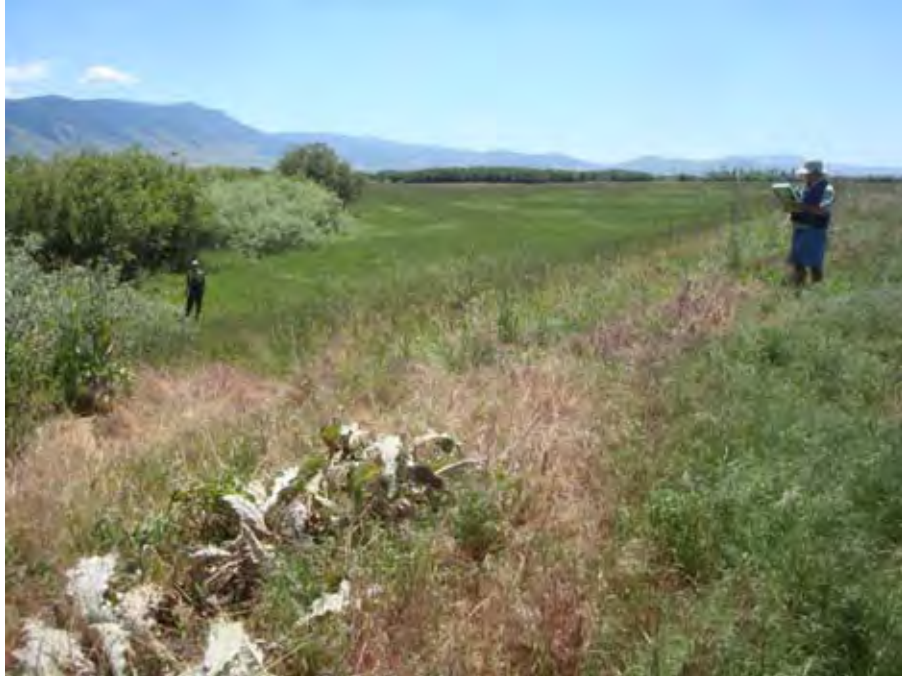
**Photograph 92. View looking upstream at fine-grained alluvium (Qal1) surface in background and grass covered levee (L) in foreground, Catherine Creek is immediately to the left of the willow trees on the left side of the photograph near river mile 3.95. Reach 1 – Catherine Creek, Grande Ronde Subbasin, Oregon – Bureau of Reclamation Photograph by D. Stelma, July 7, 2010.**

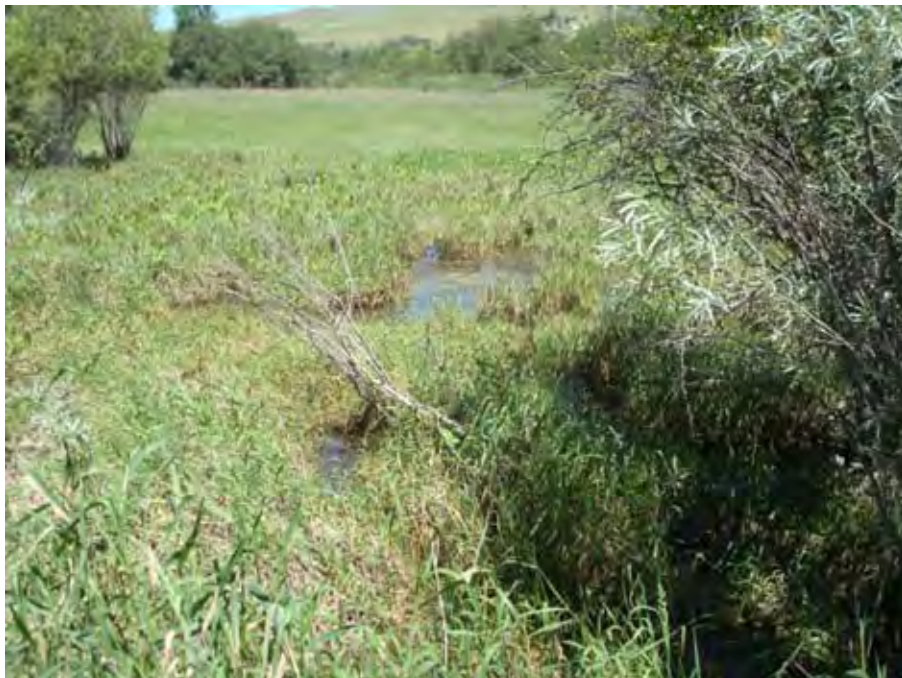
**Photograph 93. View of standing water (swamp) beyond the right bank of Catherine Creek near river mile 3.60. Reach 1 – Catherine Creek, Grande Ronde Subbasin, Oregon – Bureau of Reclamation Photograph by D. Stelma, July 7, 2010.**

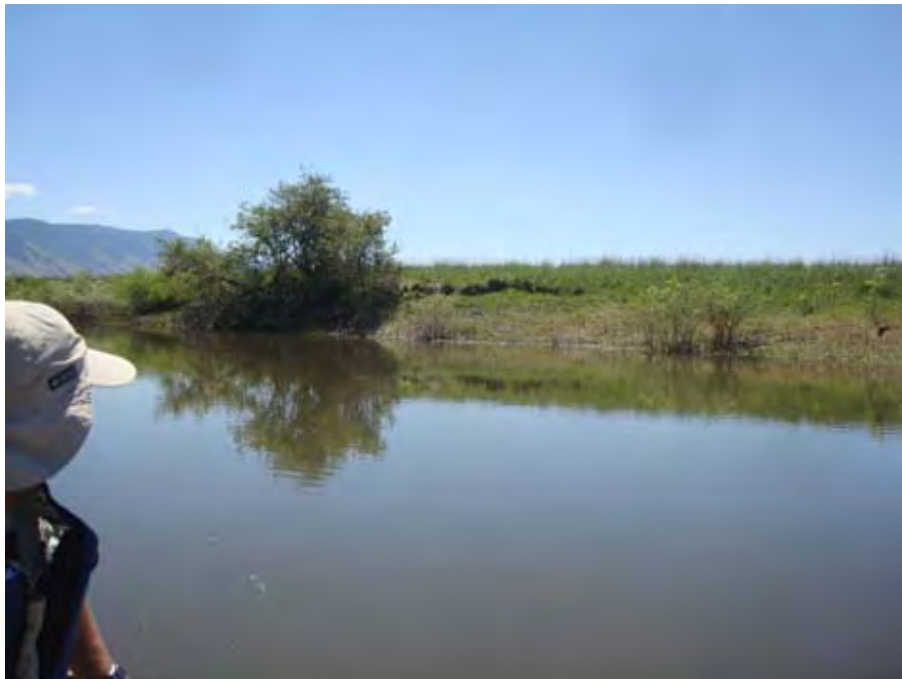
**Photograph 95. View of slumping fine-grained alluvial soil (Qal2) on the outer side a meander on the left bank of Catherine Creek near river mile 3.15. Reach 1 – Catherine Creek, Grande Ronde Subbasin, Oregon – Bureau of Reclamation Photograph by D. Stelma, July 7, 2010.**

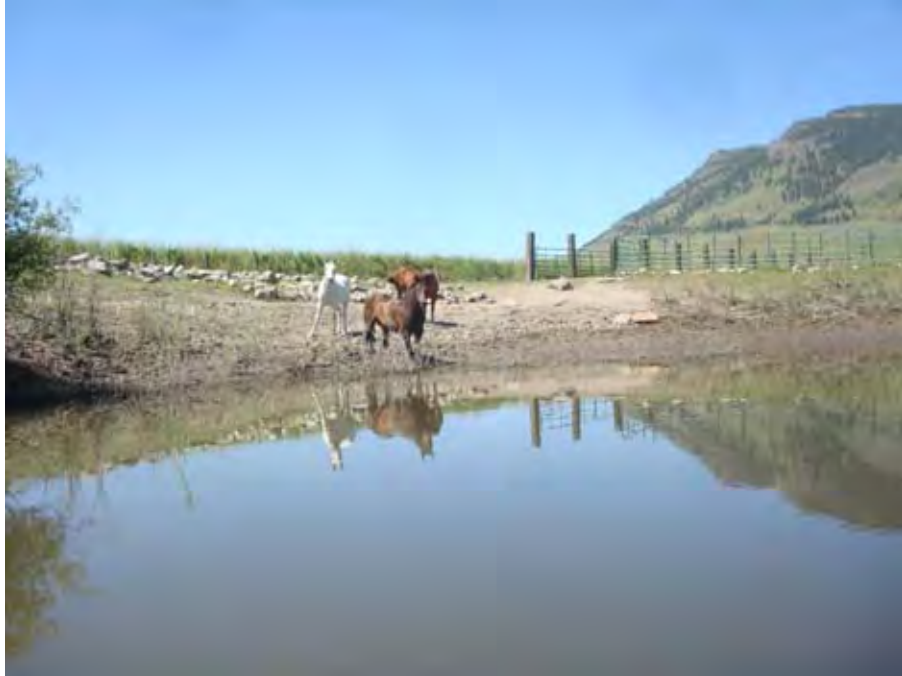
**Photograph 96. View looking at fine-grained alluvial soil (Qal1), scattered riprap, horses and a corral on the outer side of a meander on the right bank of Catherine Creek near river mile 2.95. Reach 1 – Catherine Creek, Grande Ronde Subbasin, Oregon – Bureau of Reclamation Photograph by D. Stelma, July 7, 2010.**

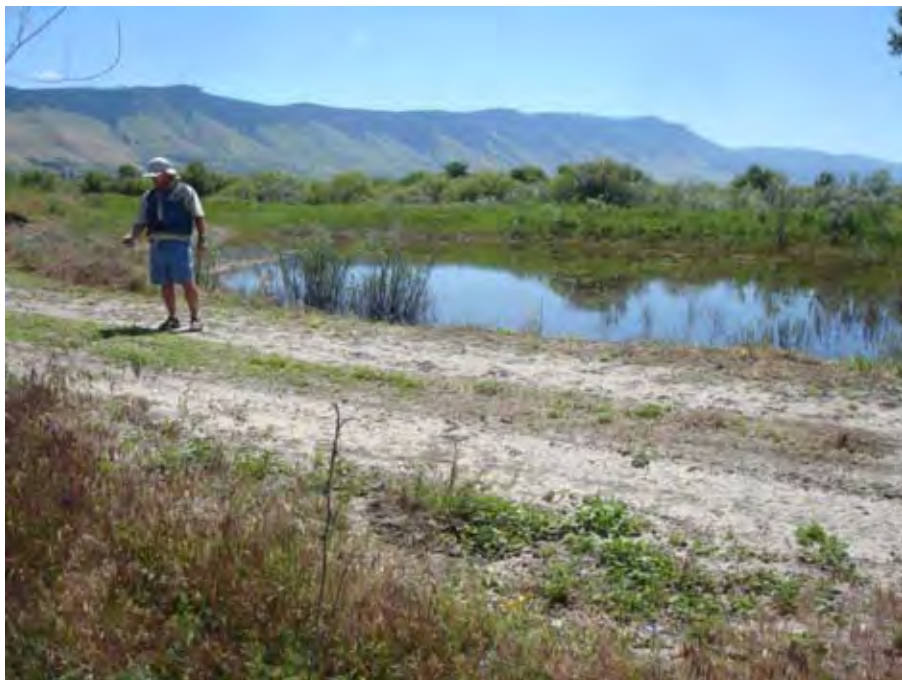
**Photograph 97. View looking southeast the crest of a levee and standing water behind levee along the left bank of Catherine Creek near river mile 2.25. Reach 1 – Catherine Creek, Grande Ronde Subbasin, Oregon – Bureau of Reclamation Photograph by D. Stelma, July 7, 2010.**

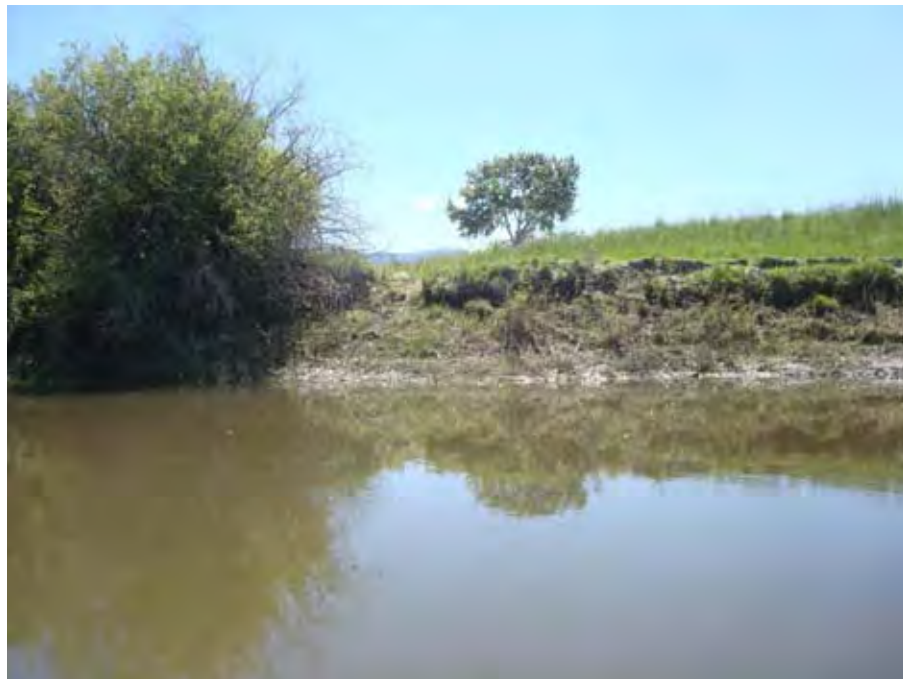
**Photograph 101. View looking at grass covered levee in background, and slumping fine-grained alluvial soil (Qal2) along the left bank of Catherine Creek near river mile 1.09. Reach 1 – Catherine Creek, Grande Ronde Subbasin, Oregon – Bureau of Reclamation Photograph by D. Stelma, July 7, 2010.**

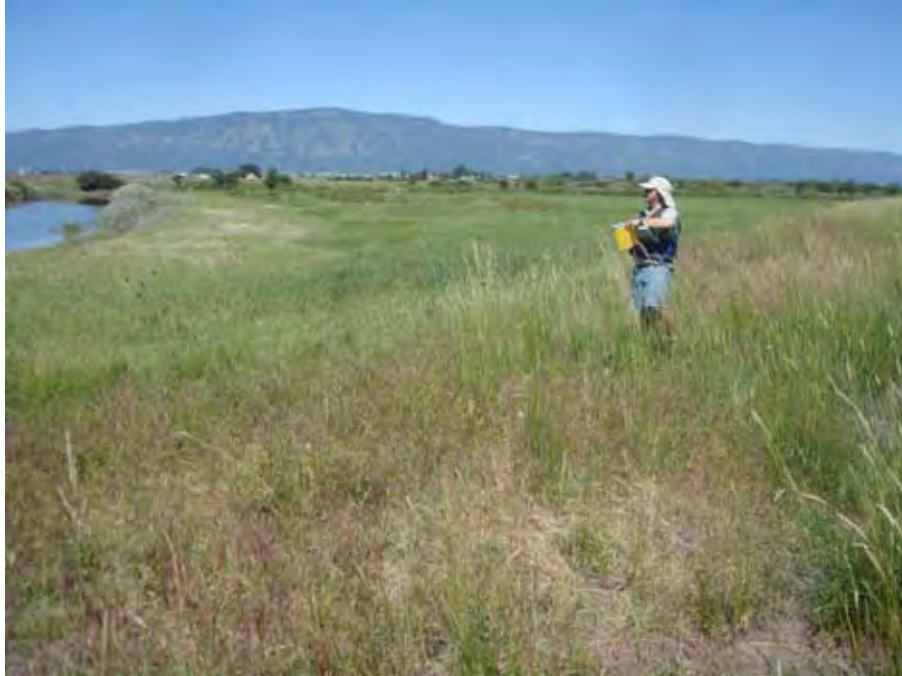
**Photograph 102. View looking downstream at fine-grained alluvium (Qal2) surface in background and grass covered levee in foreground, Catherine Creek is in upper left with Mount Emily on the horizon near river mile 1.00. Reach 1 – Catherine Creek, Grande Ronde Subbasin, Oregon – Bureau of Reclamation Photograph by D. Stelma, July 7, 2010.**

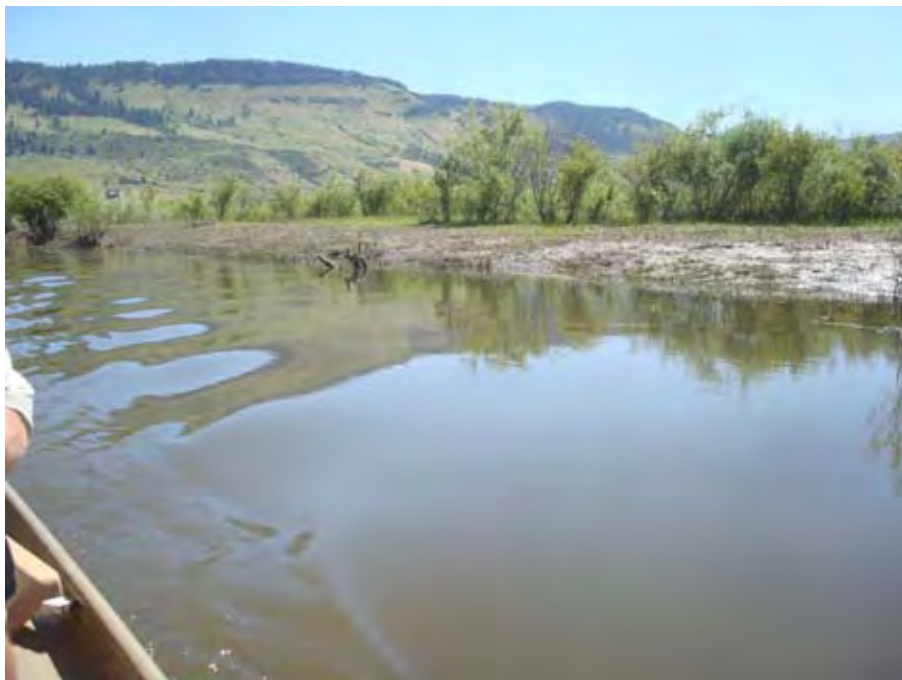
**Photograph 103. View looking downstream at fine-grained alluvial soil (Qal1) exposed along the inner bank of a meander on the right bank of Catherine Creek near river mile 0.75. Reach 1 – Catherine Creek, Grande Ronde Subbasin, Oregon – Bureau of Reclamation Photograph by D. Stelma, July 7, 2010.**

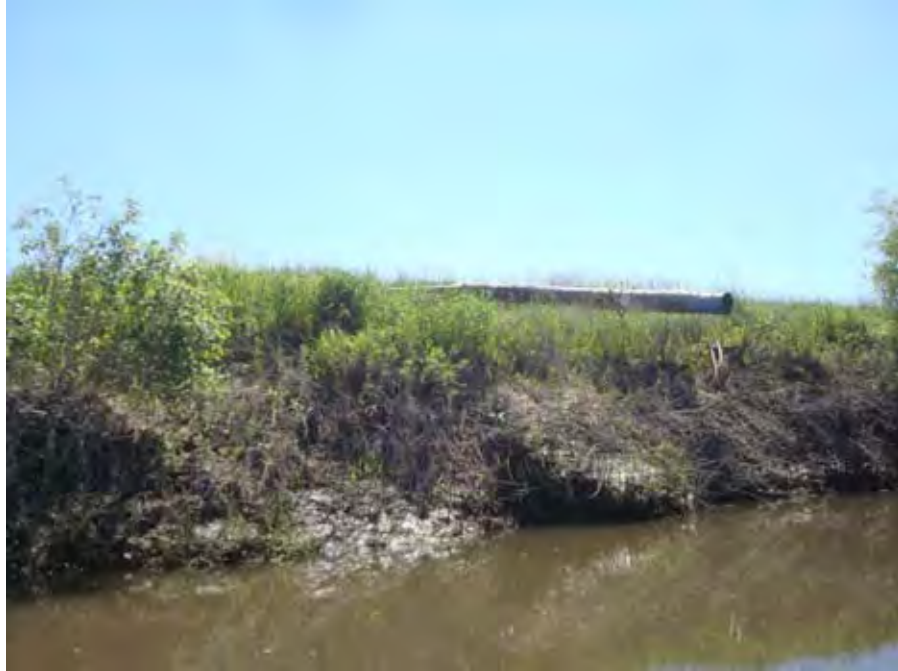
**Photograph 104. View looking upstream at field/levee drain discharge pipe on right (east) bank of Catherine Creek (foreground) near river mile 0.47. Reach 1 – Catherine Creek, Grand Ronde Subbasin, Oregon – Bureau of Reclamation Photograph by D. Stelma, July 8, 2010.**

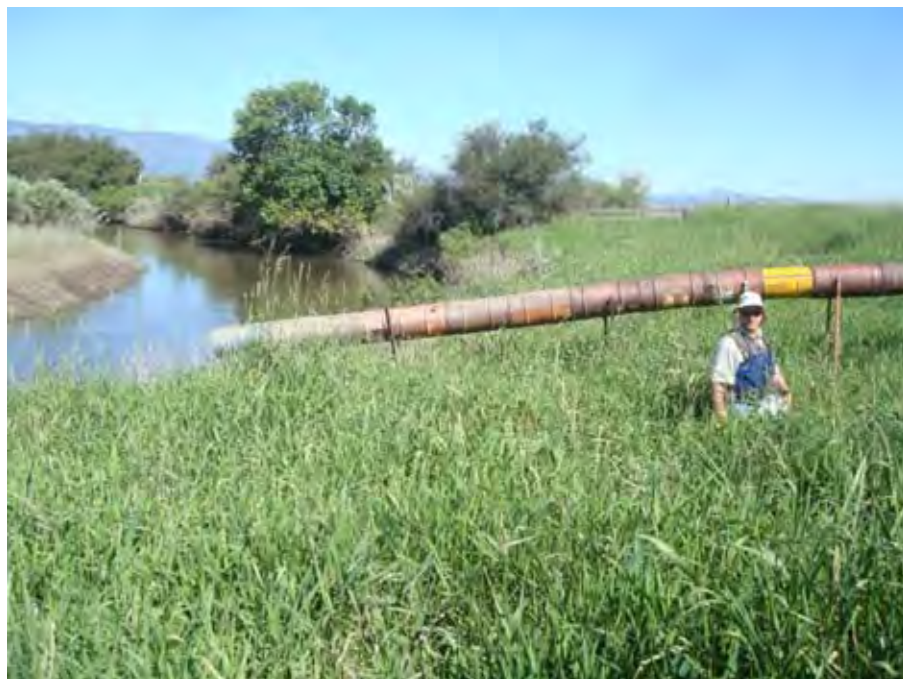
**Photograph 105. View looking downstream at fabricated-barrel discharge pipe used to drain water from behind a levee along the right bank of Catherine Creek near river mile 0.47. Reach 1 – Catherine Creek, Grande Ronde Subbasin, Oregon – Bureau of Reclamation Photograph by D. Stelma, July 7, 2010.**

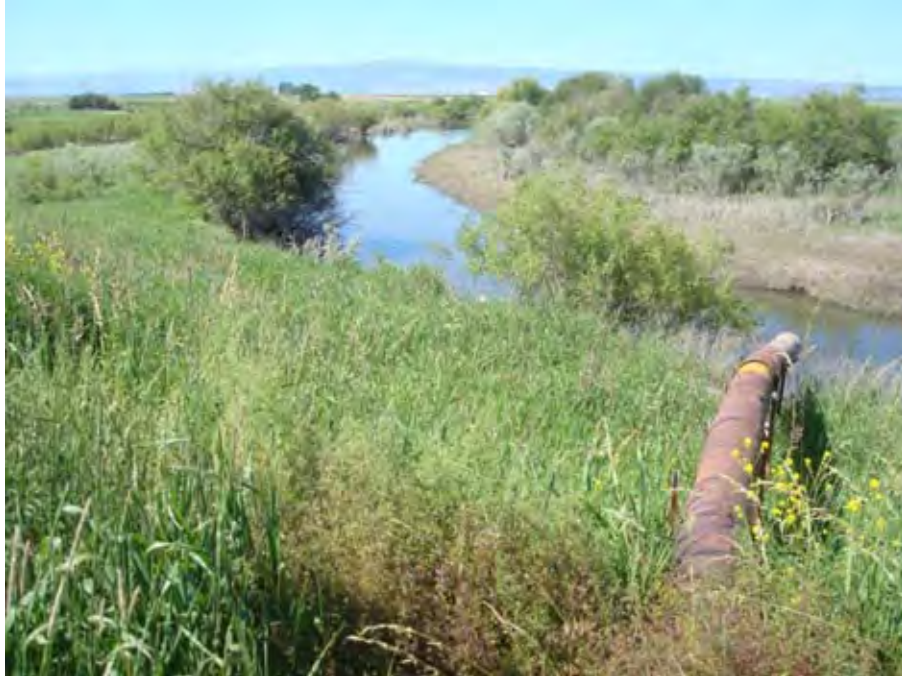
**Photograph 106. View looking upstream from the crest of the levee at fabricated-barrel discharge pipe used to drain water from behind the levee, Catherine Creek in the background near river mile 0.47. Reach 1 – Catherine Creek, Grande Ronde Subbasin, Oregon – Bureau of Reclamation Photograph by D. Stelma, July 7, 2010.**

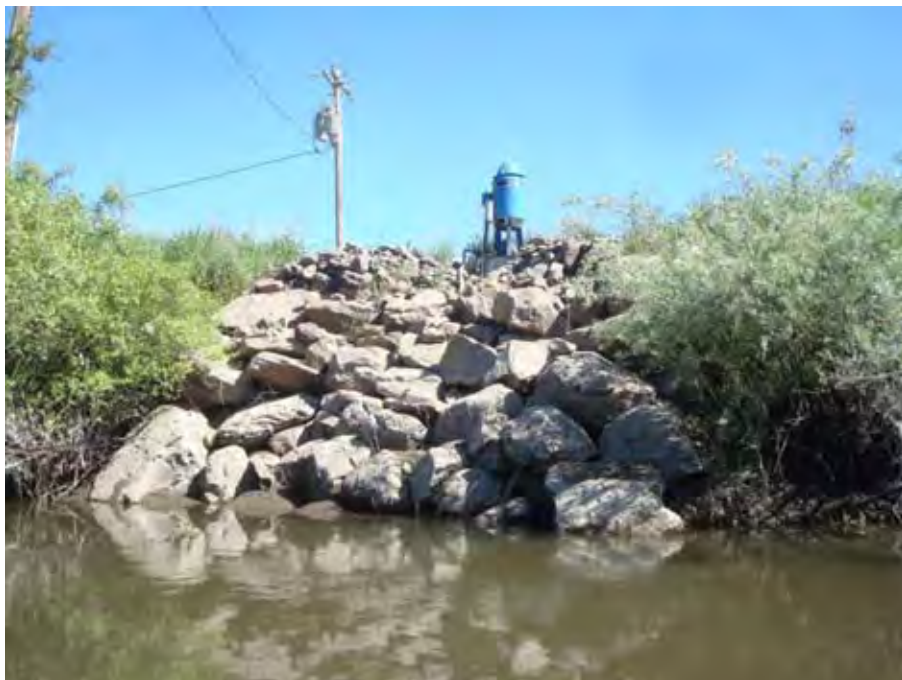
**Photograph 107. View looking at pumping station on the right bank of Catherine Creek near river mile 0.40. Reach 1 – Catherine Creek, Grande Ronde Subbasin, Oregon – Bureau of Reclamation Photograph by D. Stelma, July 7, 2010.**

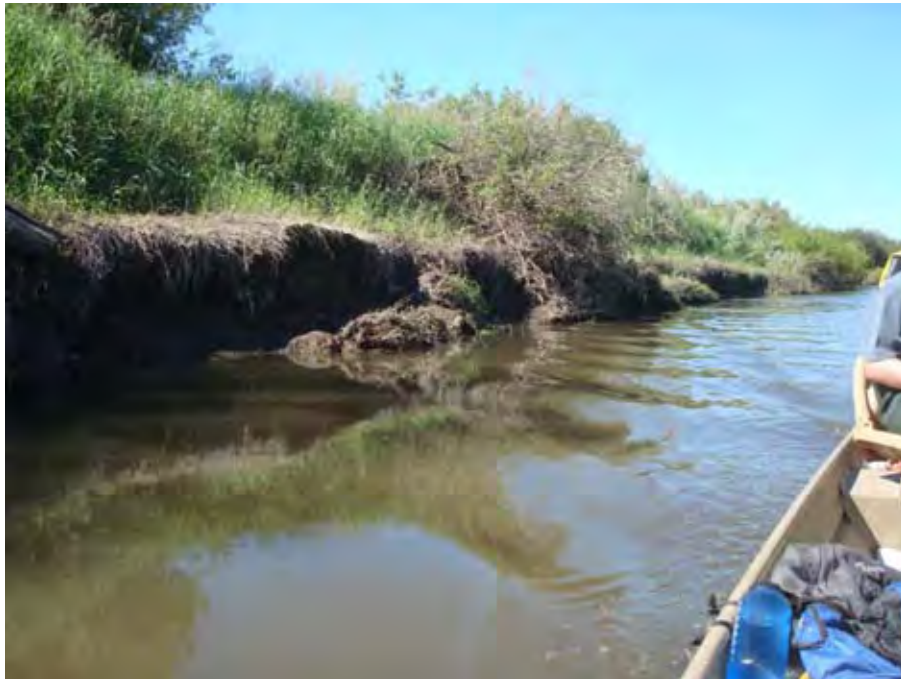
**Photograph 109. View looking downstream at grass covered levee, and slumping fine-grained alluvial soil (Qal2) along the left bank of Catherine Creek near river mile 0.03. Reach 1 – Catherine Creek, Grande Ronde Subbasin, Oregon – Bureau of Reclamation Photograph by D. Stelma, July 7, 2010.**

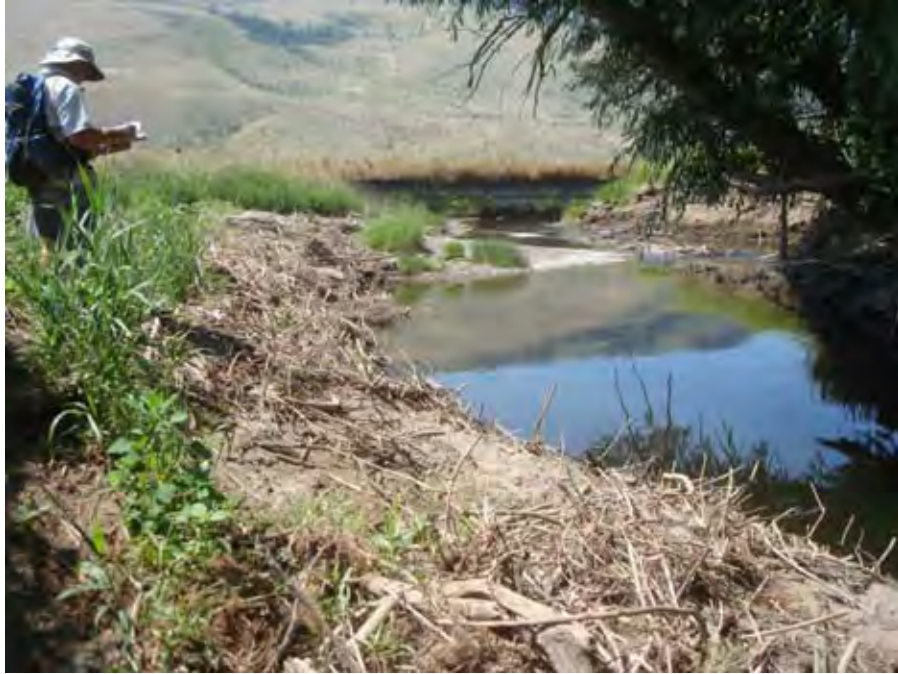
**Photograph 2. View looking downstream at wood debris on the left bank of Catherine Creek near river mile 37.14. Reach 2 – Catherine Creek, Grande Ronde Subbasin, Oregon – Bureau of Reclamation Photograph by D. Stelma, August 3, 2010.**

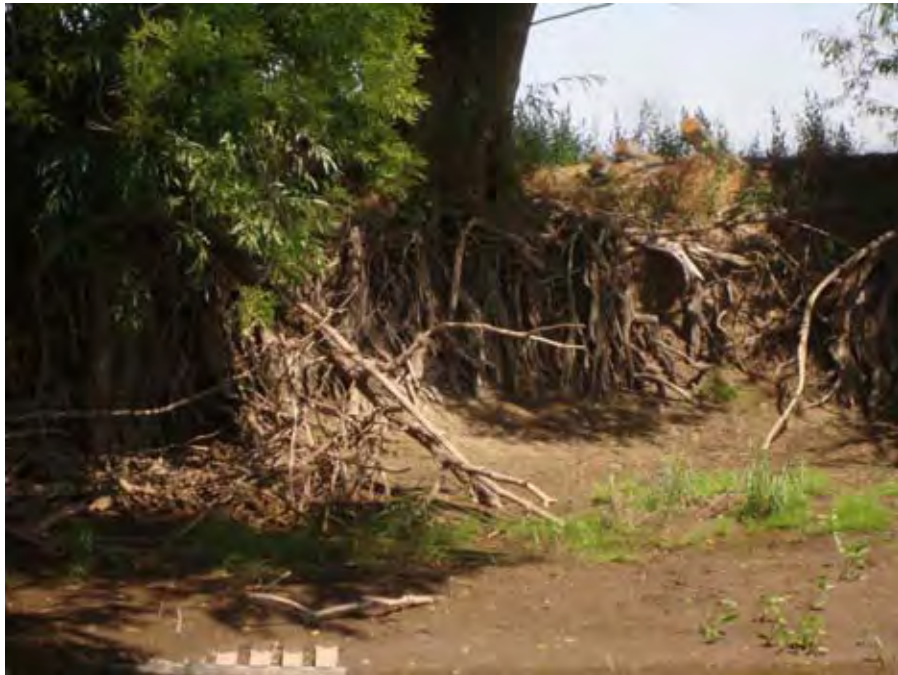
**Photograph 3. View looking at under-cut and exposed tree roots on the right bank of Catherine Creek near river mile 37.14. Reach 2 – Catherine Creek, Grande Ronde Subbasin, Oregon – Bureau of Reclamation Photograph by D. Stelma, August 3, 2010.**

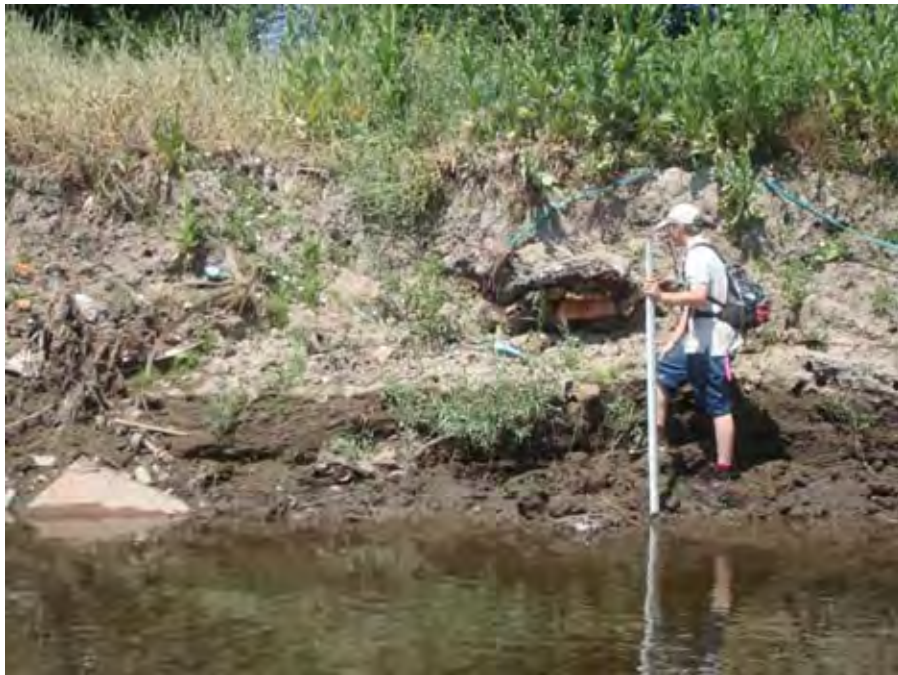
**Photograph 4. View looking at fine-grained sediments exposed on the left bank of Catherine Creek near river mile 37.10. Reach 2 – Catherine Creek, Grande Ronde Subbasin, Oregon – Bureau of Reclamation Photograph by D. Stelma, August 3, 2010.**

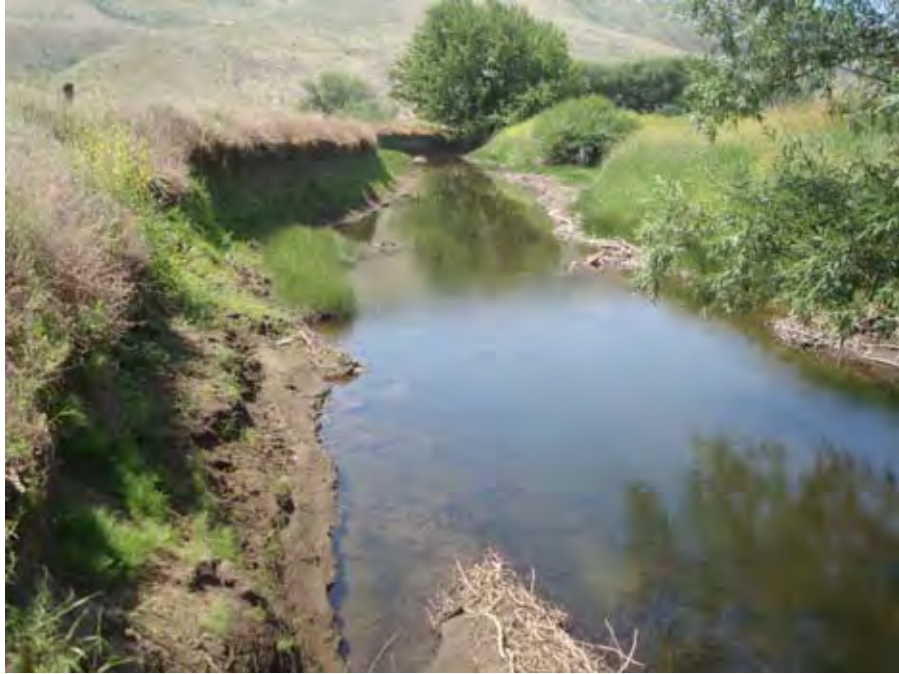
**Photograph 5. View looking at partially buried garbage exposed in the right bank of Catherine Creek near river mile 37.05. Reach 2 – Catherine Creek, Grande Ronde Subbasin, Oregon – Bureau of Reclamation Photograph by D. Stelma, August 3, 2010.**

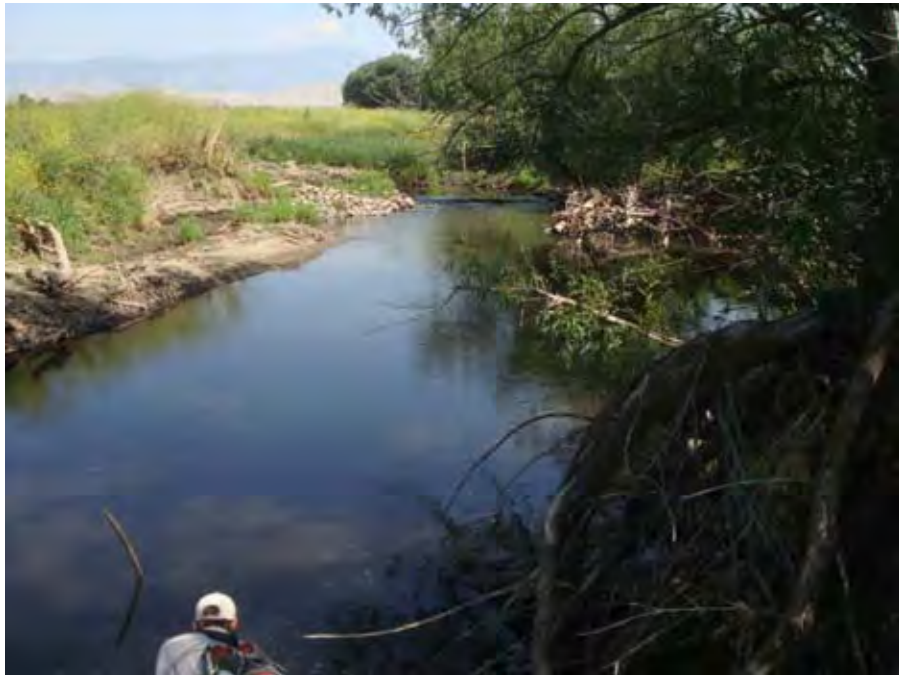
**Photograph 6. View looking downstream at the Catherine Creek channel near river mile 37.04. Reach 2 – Catherine Creek, Grande Ronde Subbasin, Oregon – Bureau of Reclamation Photograph by D. Stelma, August 3, 2010.**

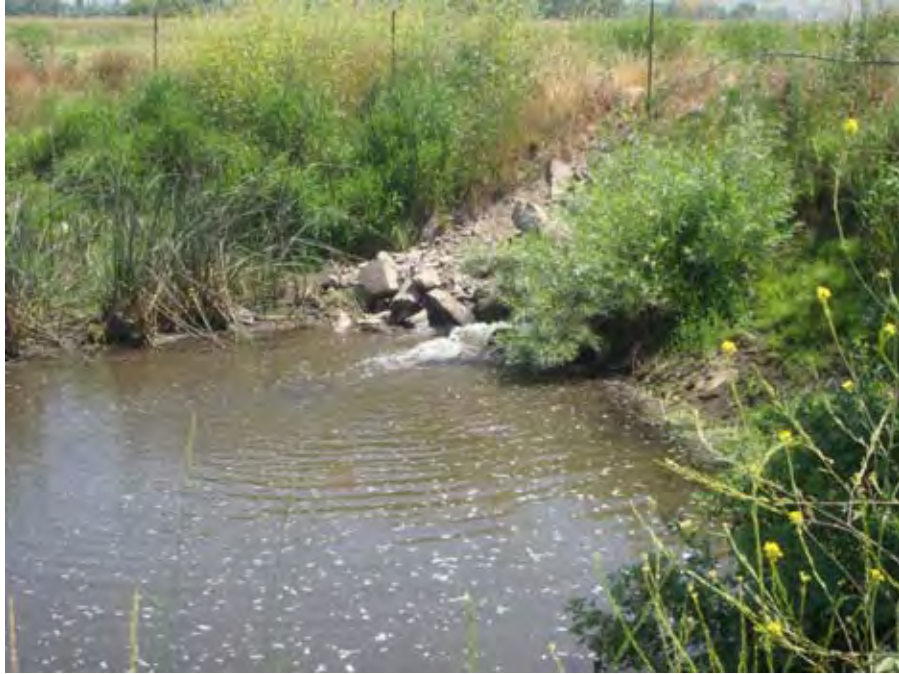
**Photograph 7. View looking upstream at Catherine Creek channel at the mouth of Pyles Creek near river mile 36.89. Reach 2 – Catherine Creek, Grande Ronde Subbasin, Oregon – Bureau of Reclamation Photograph by D. Stelma, August 3, 2010.**

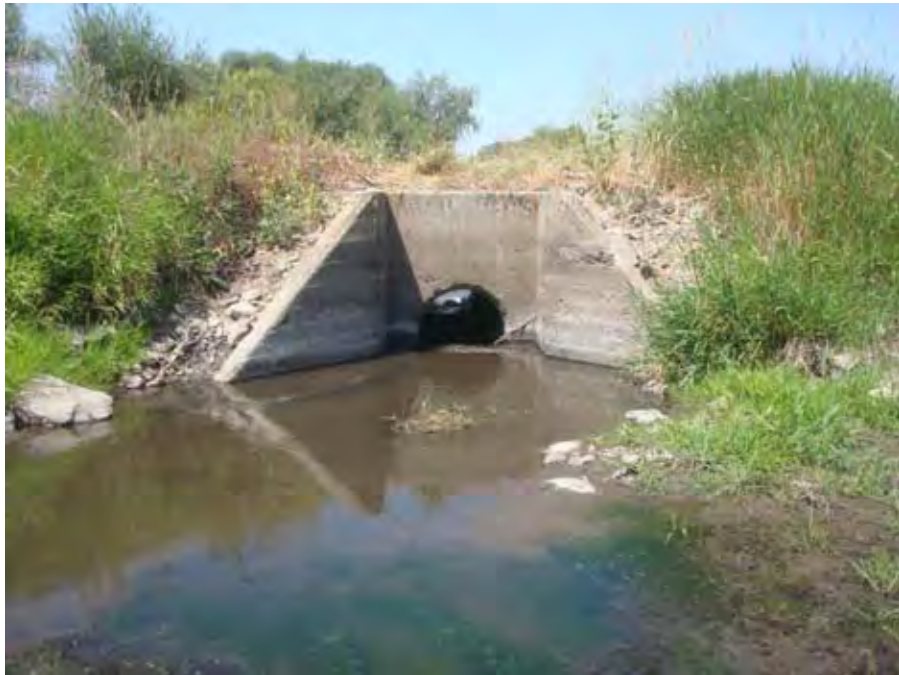
**Photograph 8. Pyles Creek discharge from culvert near the confluence with Catherine Creek near river mile 36.89. Reach 2 – Catherine Creek, Grande Ronde Subbasin, Oregon – Bureau of Reclamation Photograph by D. Stelma, August 3, 2010.**

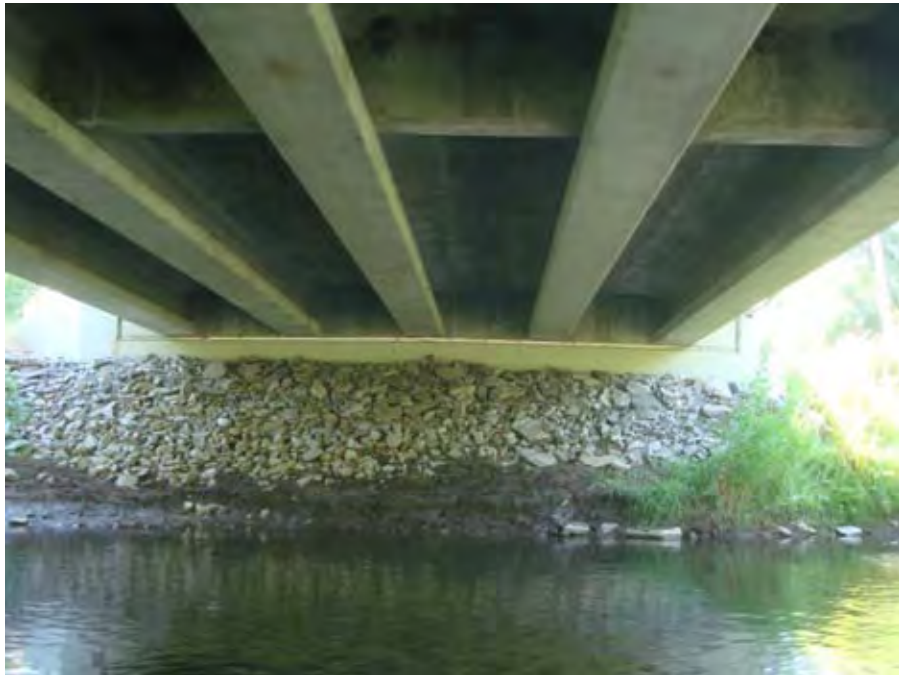
**Photograph 11. View looking downstream at Miller Lane Bridge at river mile 36.48. Reach 2 – Catherine Creek, Grande Ronde Subbasin, Oregon – Bureau of Reclamation Photograph by R. McAfee, July 31, 2010.**

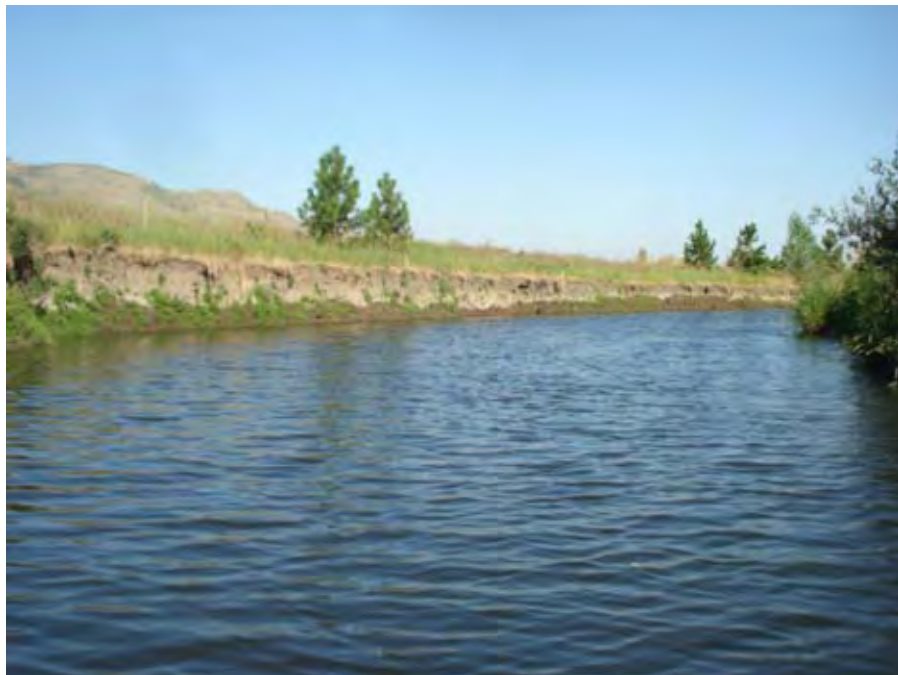
**Photograph 13. View looking downstream at a section of the left bank that is nearly vertical near river mile 36.35. Note the predominantly grass vegetation along the top of the bank. Reach 2 – Catherine Creek, Grande Ronde Subbasin, Oregon – Bureau of Reclamation Photograph by R. McAfee, July 31, 2010.**

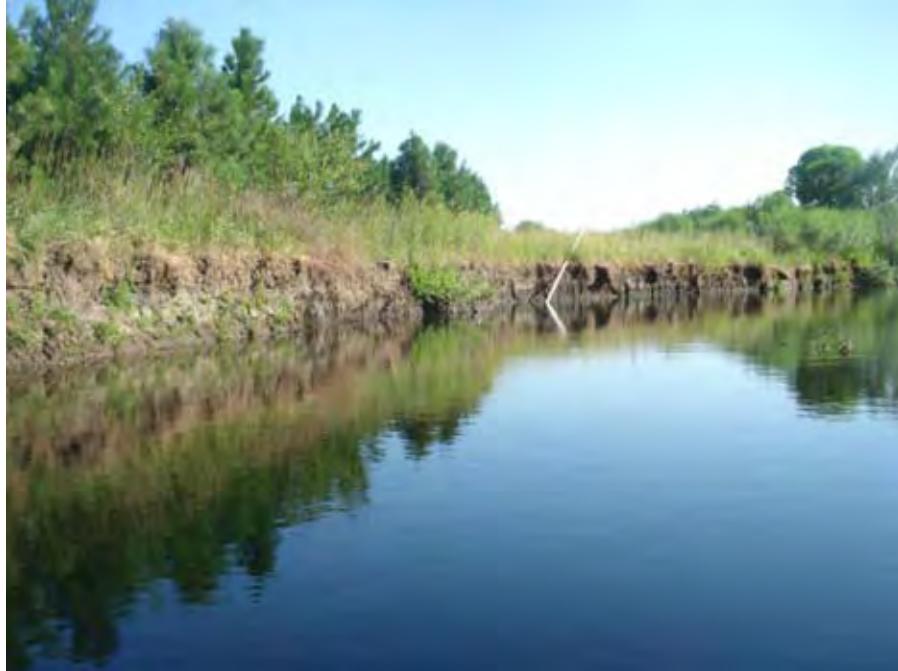
**Photograph 14. View looking downstream at a section of the left bank that is nearly vertical near river mile 36.25. Note the predominantly grass vegetation. Reach 2 – Catherine Creek, Grande Ronde Subbasin, Oregon – Bureau of Reclamation Photograph by R. McAfee, July 31, 2010.**

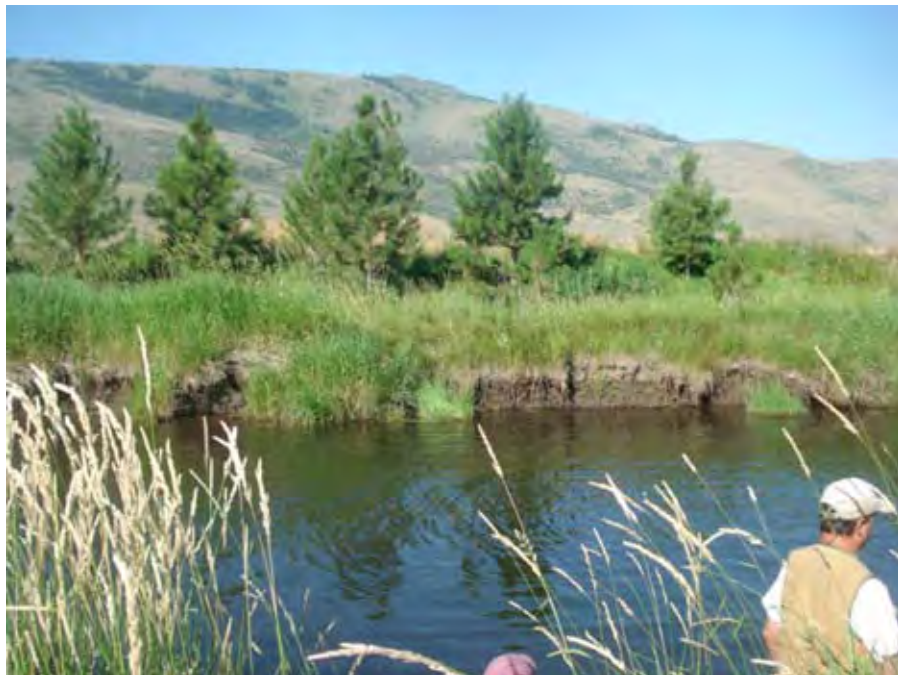
**Photograph 15. View looking downstream at a section of the left bank that is nearly vertical near river mile 36.04. Note the predominantly grass vegetation. Reach 2 – Catherine Creek, Grande Ronde Subbasin, Oregon – Bureau of Reclamation Photograph by R. McAfee, July 31, 2010.**

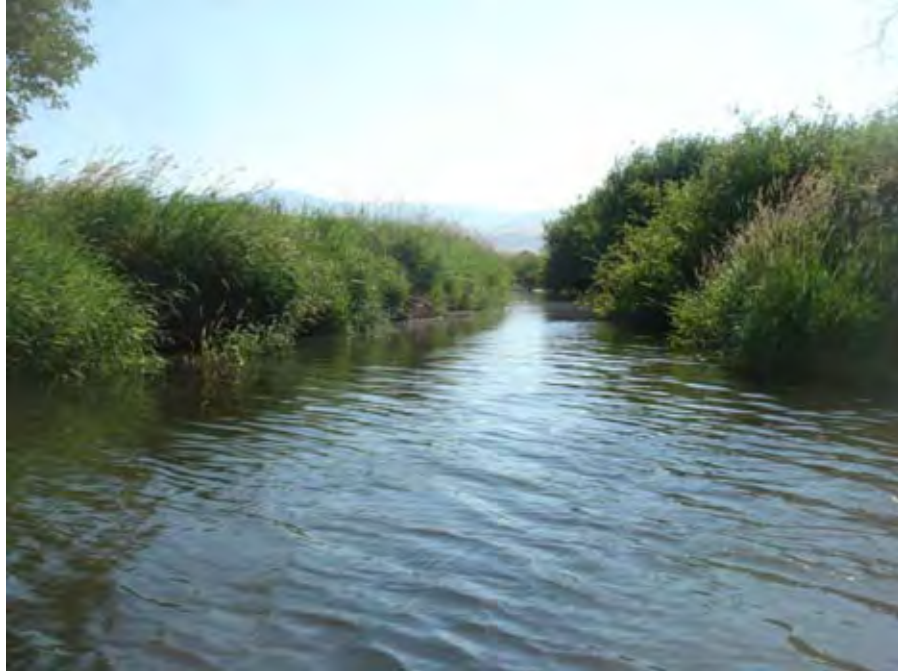
**Photograph 16. View from the right to left at the site of profile P-R2-7, at river mile 35.91. Reach 2 – Catherine Creek, Grande Ronde Subbasin, Oregon – Bureau of Reclamation Photograph by R. McAfee, July 31, 2010.**

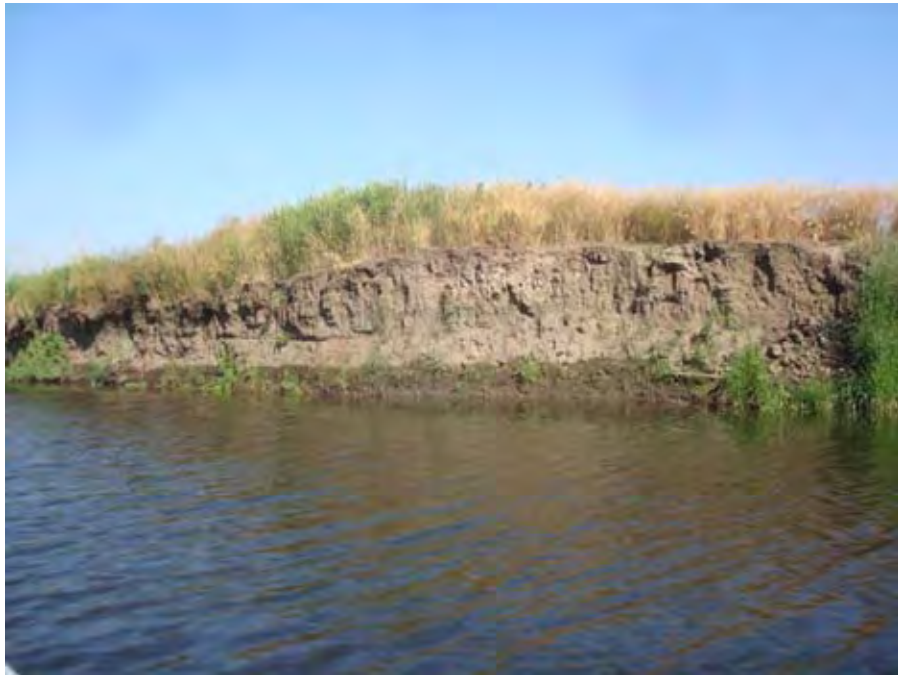
**Photograph 17. View from Catherine Creek looking at the entrance of Little Creek from the east, along the right bank near river mile 35.87. Reach 2 – Catherine Creek, Grande Ronde Subbasin, Oregon – Bureau of Reclamation Photograph by R. McAfee, July 31, 2010.**

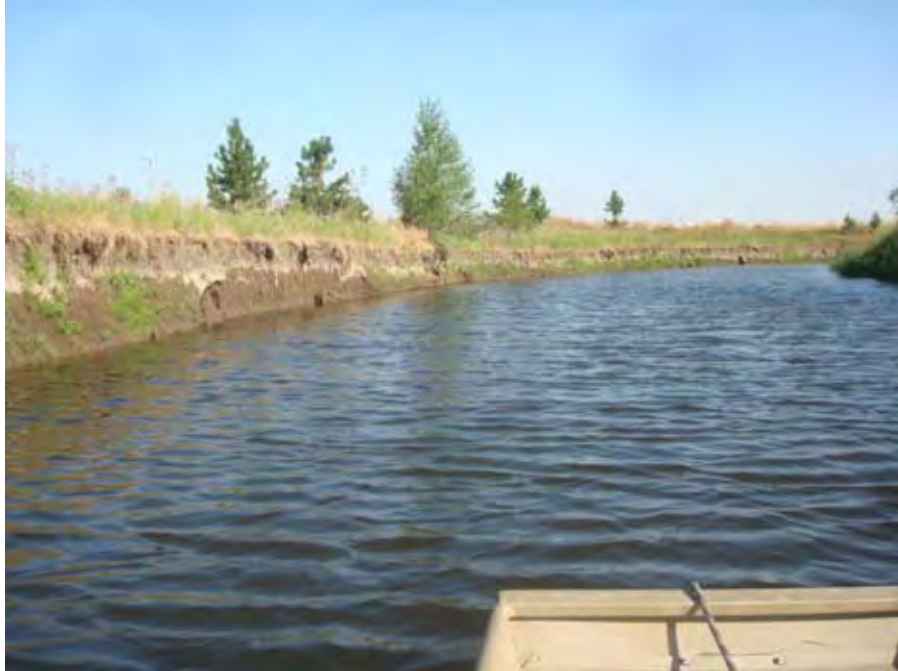
**Photograph 18. View of topsoil exposed on the right (east) bank of Catherine Creek near river mile 35.80. Reach 2 – Catherine Creek, Grande Ronde Subbasin, Oregon – Bureau of Reclamation Photograph by D. Stelma, July 31, 2010.**

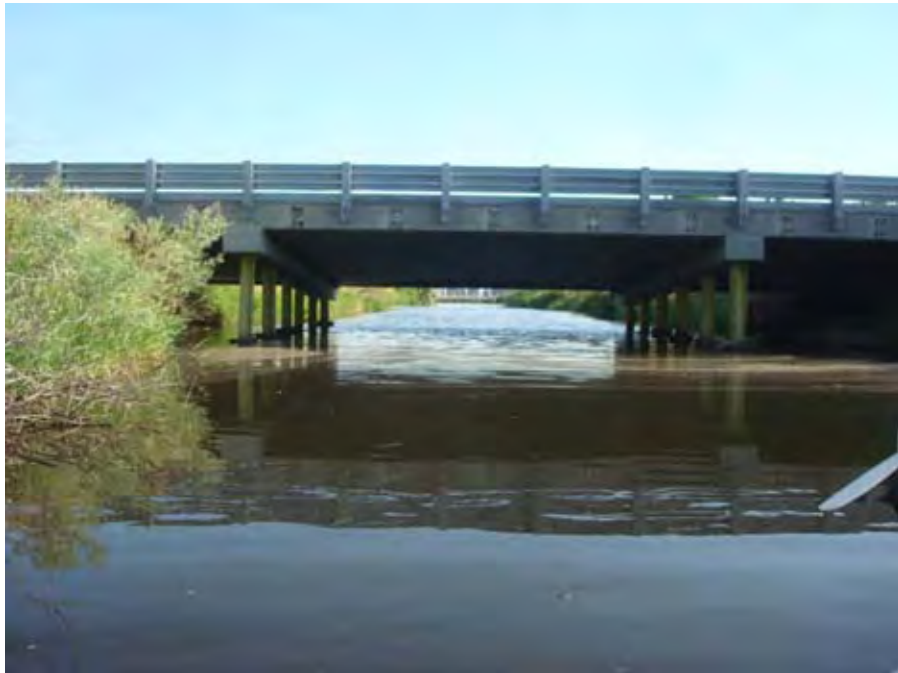
**Photograph 21. View from the left bank to the right at location of profile P-R2-8 at river mile 35.31. Reach 2 – Catherine Creek, Grande Ronde Subbasin, Oregon – Bureau of Reclamation Photograph by R. McAfee, July 31, 2010.**

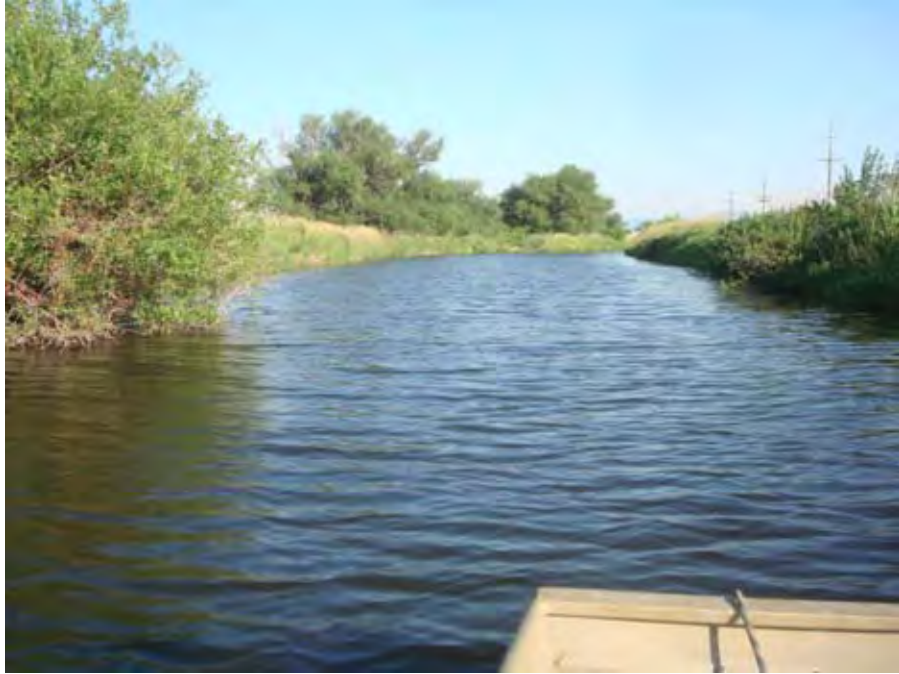
**Photograph 22. View looking downstream at the Oregon State Highway 203 Bridge near river mile 35.30. Reach 2 – Catherine Creek, Grande Ronde Subbasin, Oregon – Bureau of Reclamation Photograph by D. Stelma, July 31, 2010.**

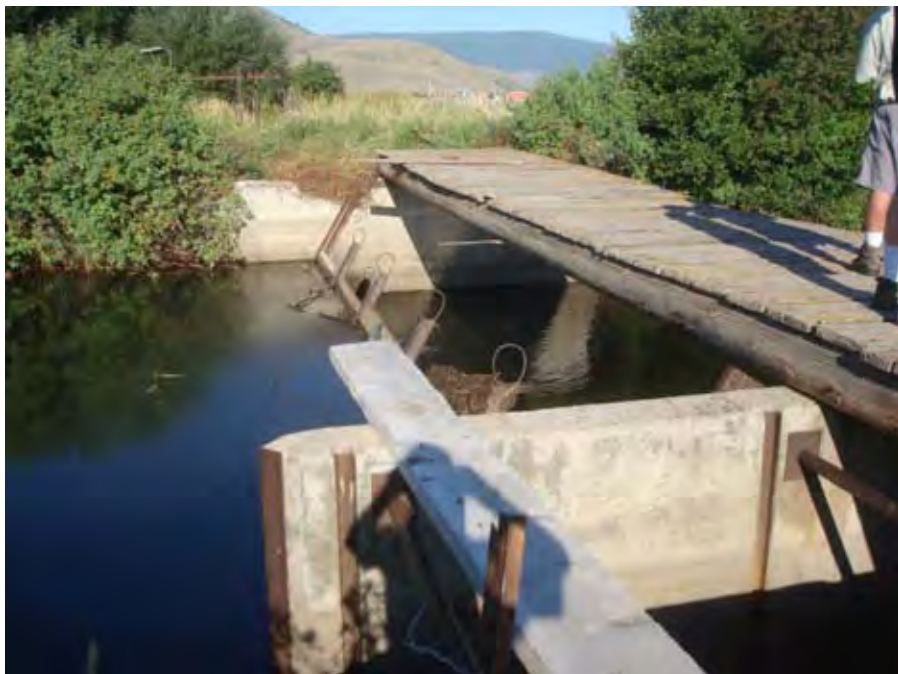
**Photograph 25. View looking downstream at the upstream side of Upper Davis Dam, note (lower) Davis Dam tail water in background near river mile 34.99. Reach 2 – Catherine Creek, Grande Ronde Subbasin, Oregon – Bureau of Reclamation Photograph by D. Stelma, July 31, 2010.**
