## **APPENDIX C – GEOLOGY AND GEOMORPHOLOGY**

## GEOLOGY AND GEOMORPHOLOGY REPORT FOR THE CATHERINE CREEK TRIBUTARY ASSESSMENT – GRANDE RONDE RIVER BASIN Tributary Habitat Program, Oregon

February 2012

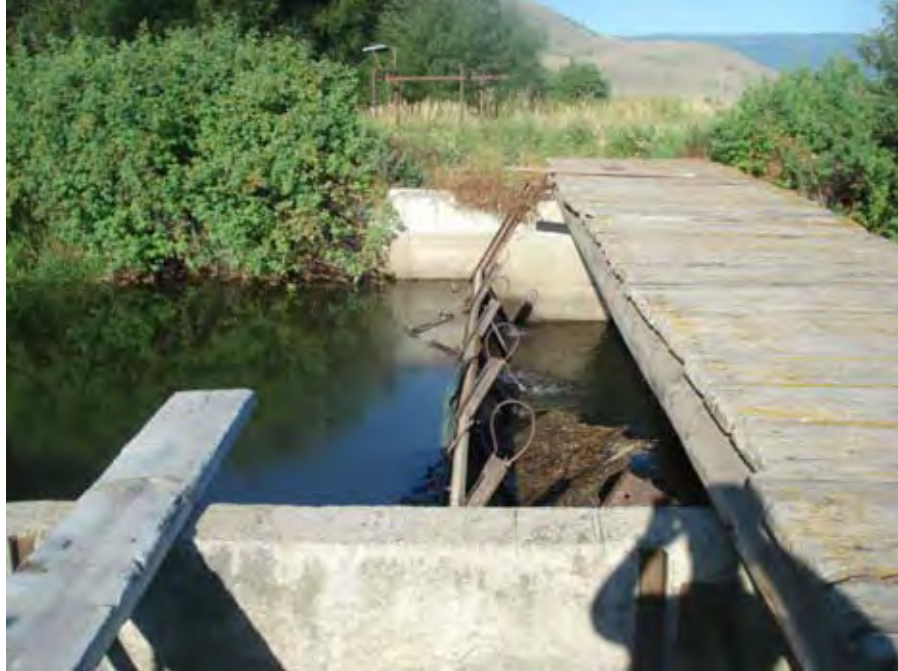
**Photograph 26. View looking from right to left at the upstream side of Upper Davis Dam near river mile 34.98. Reach 2 – Catherine Creek, Grande Ronde Subbasin, Oregon – Bureau of Reclamation Photograph by D. Stelma, August 1, 2010.**

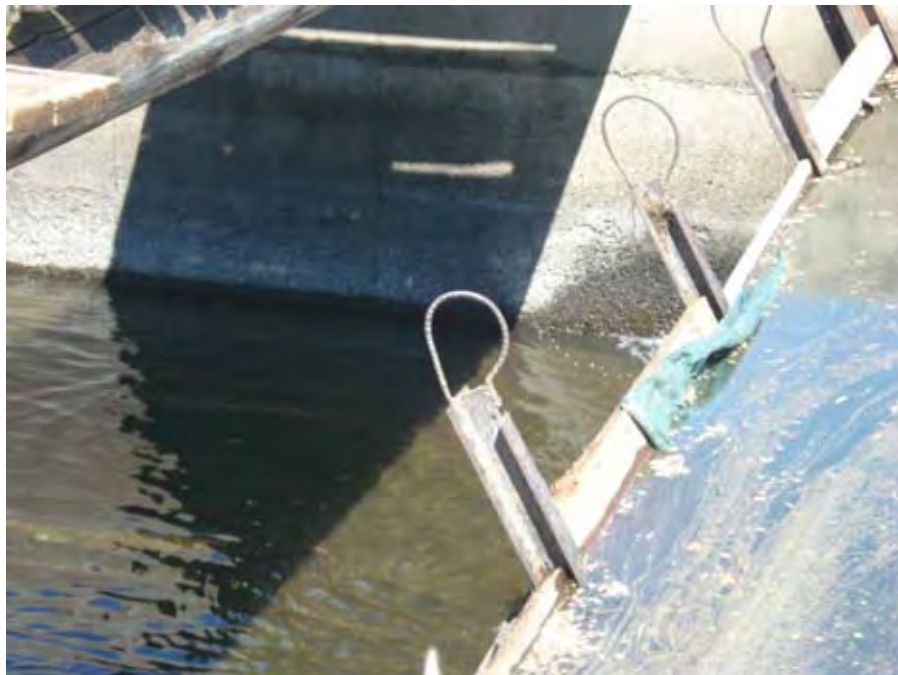
**Photograph 27. View of water backed up at Upper Davis Dam at river mile 34.98. Reach 2 – Catherine Creek, Grande Ronde Subbasin, Oregon – Bureau of Reclamation Photograph by R. McAfee, August 1, 2010.**

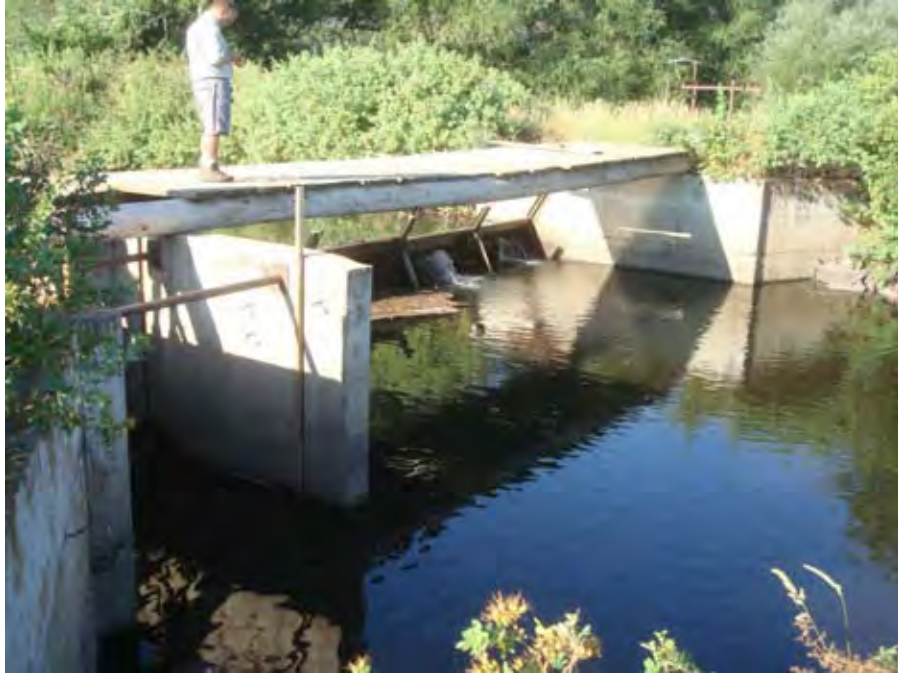
**Photograph 28. View from the left bank of the checked-up water level upstream of Upper Davis Dam near river mile 34.98. Reach 2 – Catherine Creek, Grande Ronde Subbasin, Oregon – Bureau of Reclamation Photograph by R. McAfee, July 27, 2010.**

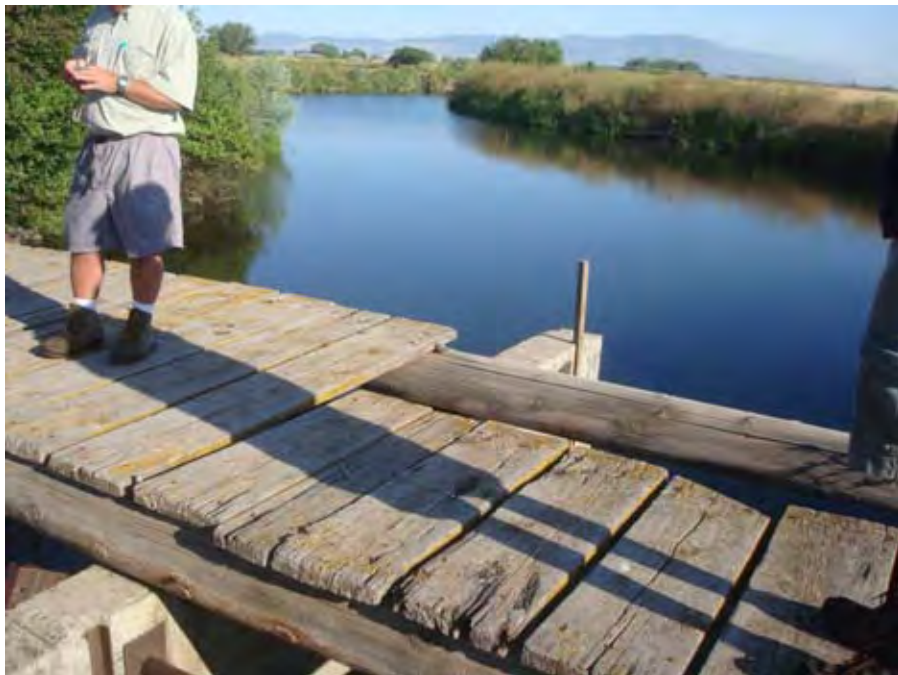
**Photograph 29. View looking from right to left at the downstream side of Upper Davis Dam, note (lower) Davis Dam tail water level approximately 2- to 3-feet below gates near river mile 34.98. Reach 2 – Catherine Creek, Grande Ronde Subbasin, Oregon – Bureau of Reclamation Photograph by D. Stelma, August 1, 2010.**

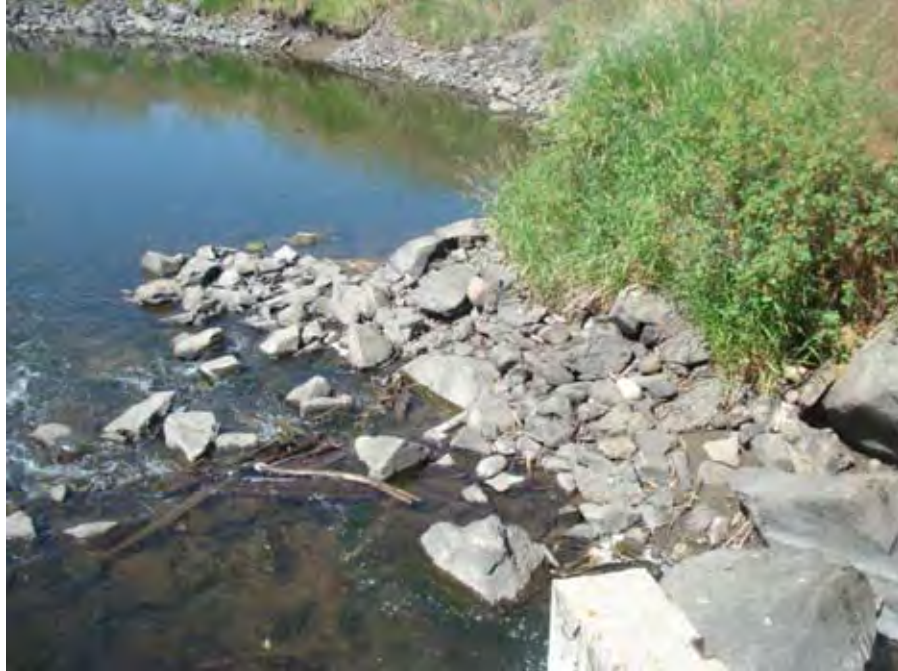
**Photograph 30. View looking downstream from the crest of Upper Davis Dam near river mile 34.98, note (lower) Davis Dam tail water in background. Reach 2 – Catherine Creek, Grande Ronde Subbasin, Oregon – Bureau of Reclamation Photograph by D. Stelma, August 1, 2010.**

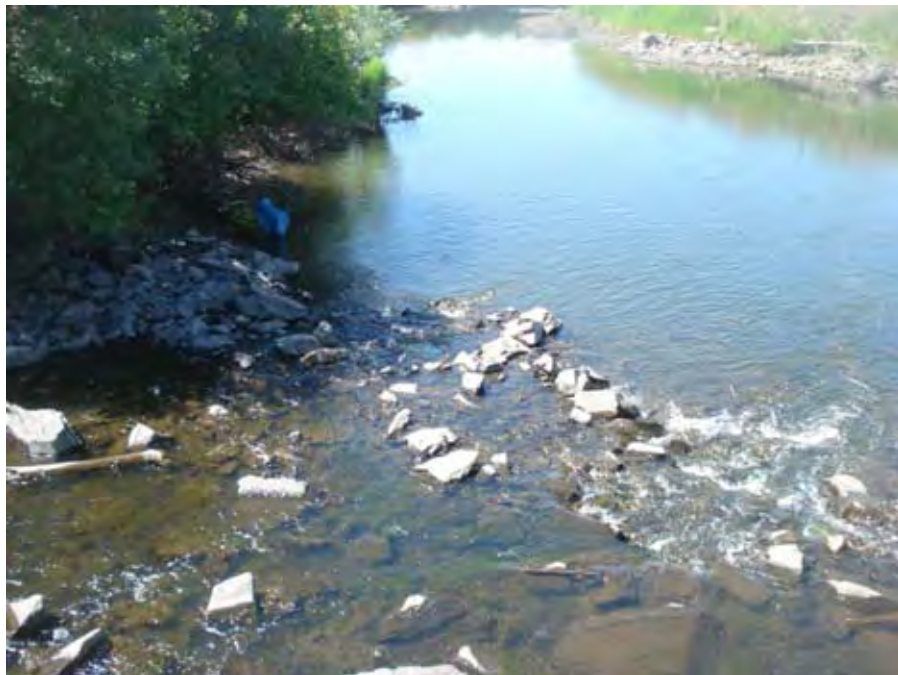
**Photograph 31. View looking downstream from Upper Davis Dam at the riprap across the bottom of the channel and along the right bank near river mile 34.98. Reach 2 – Catherine Creek, Grande Ronde Subbasin, Oregon – Bureau of Reclamation Photograph by R. McAfee, July 27, 2010.**

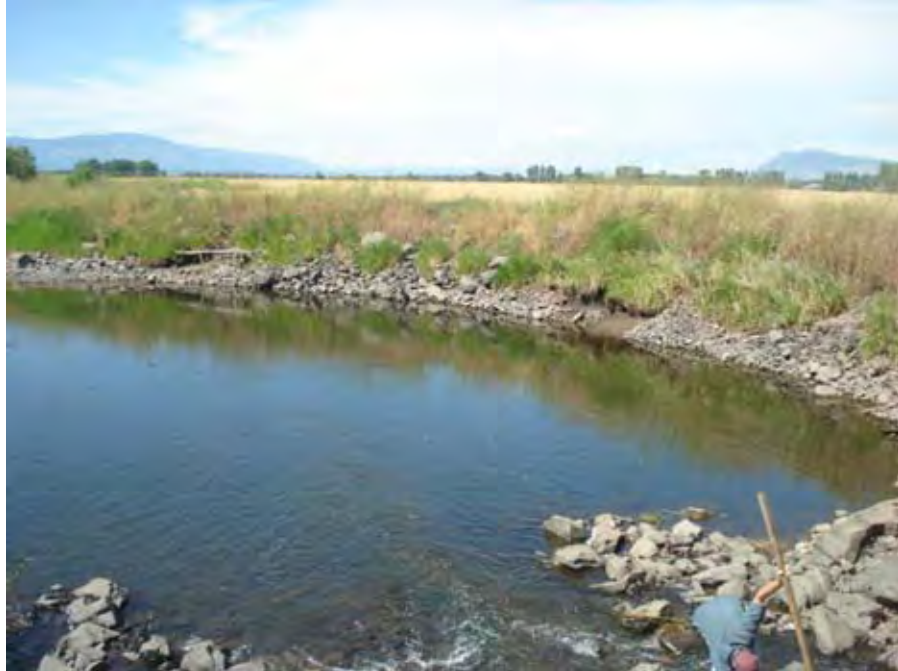
**Photograph 32. View looking downstream from Upper Davis Dam at the riprap across the bottom of the channel and along the left bank near river mile 34.98. Reach 2 – Catherine Creek, Grande Ronde Subbasin, Oregon – Bureau of Reclamation Photograph by R. McAfee, July 27, 2010.**

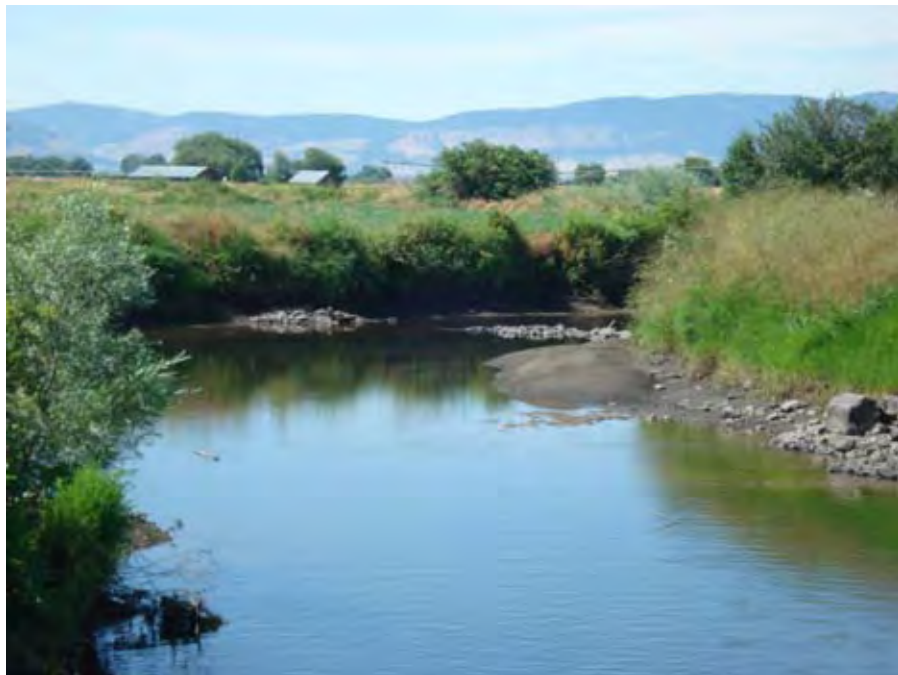
**Photograph 33. View looking downstream from Upper Davis Dam at the riprap across the bottom of the channel and along the right bank near river mile 34.98. Reach 2 – Catherine Creek, Grande Ronde Subbasin, Oregon – Bureau of Reclamation Photograph by R. McAfee, July 27, 2010.**

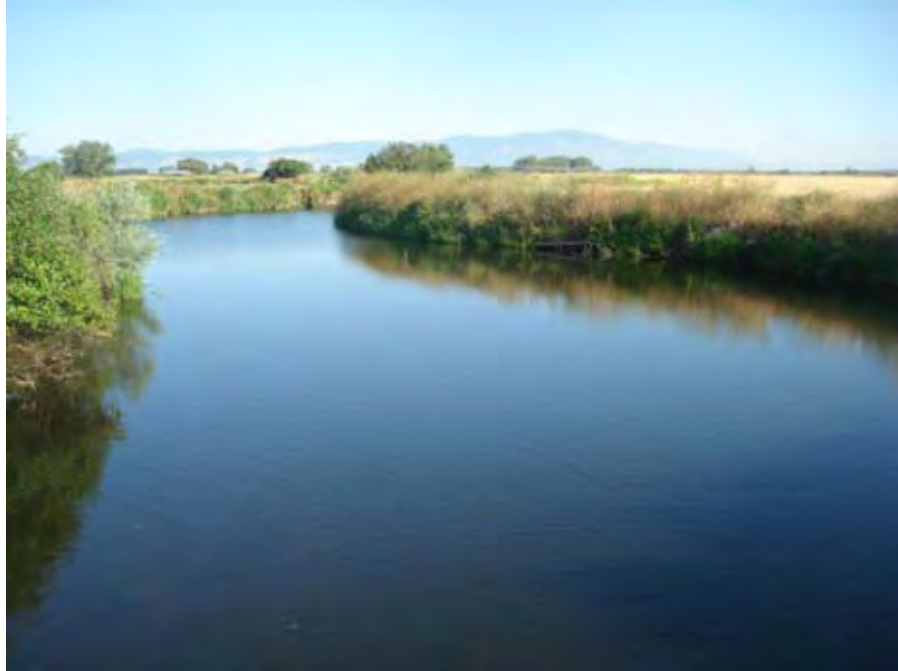
**Photograph 34. View looking downstream from Upper Davis Dam at sand deposition along the right bank and a crude rock structures along the left bank and in the channel near river mile 34.98. Reach 2 – Catherine Creek, Grande Ronde Subbasin, Oregon – Bureau of Reclamation Photograph by R. McAfee, July 27, 2010.**

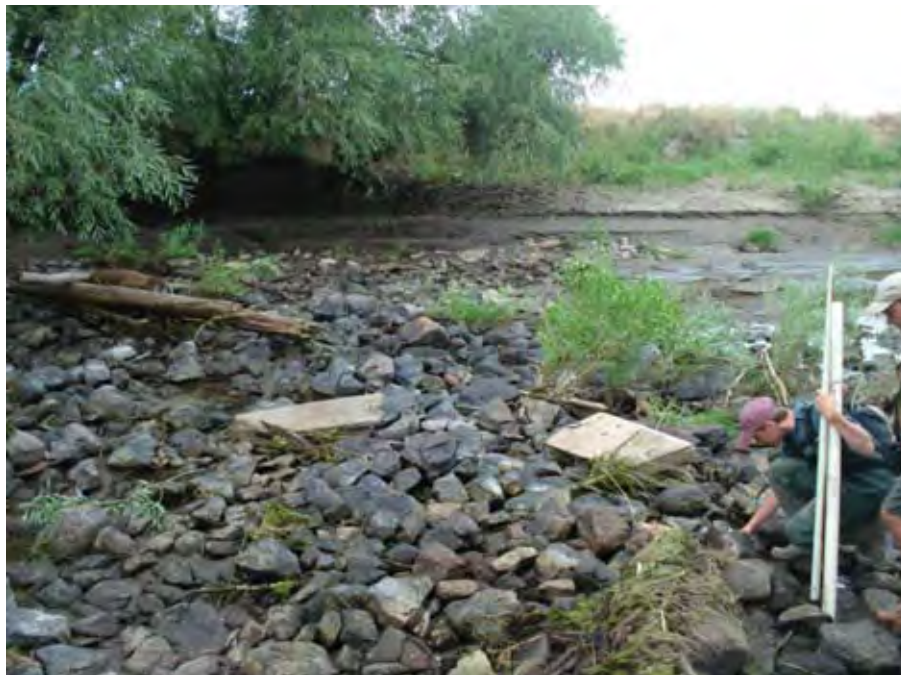
**Photograph 39. View looking upstream from the crest of Davis Dam near river mile 34.40. Reach 2 – Catherine Creek, Grande Ronde Subbasin, Oregon– Bureau of Reclamation Photograph by D. Stelma, July 27, 2010.**

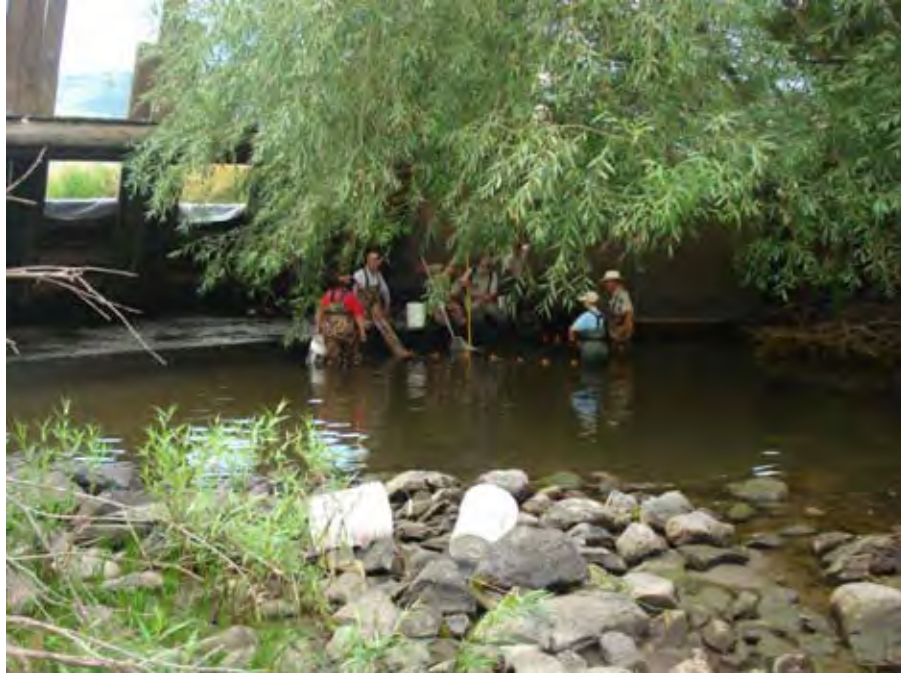
**Photograph 40. View from the right bank looking downstream at 8-to-12 inch placed riprap directly downstream of Lower Davis Dam at river mile 34.40. Reach 2 – Catherine Creek, Grande Ronde Subbasin, Oregon – Bureau of Reclamation Photograph by R. McAfee, July 27, 2010.**

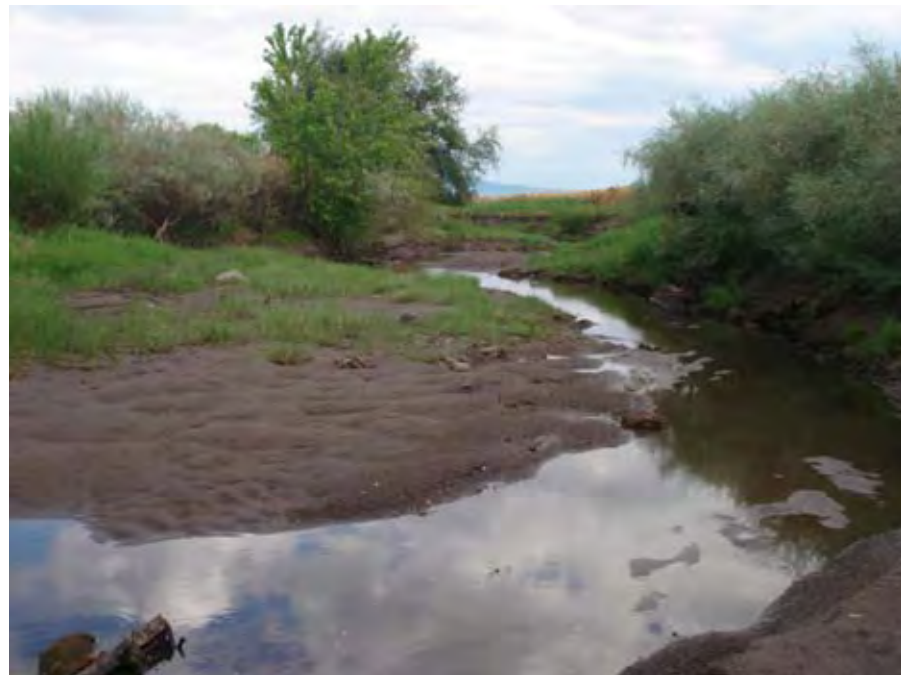
**Photograph 41. View from the right bank looking upstream at a plunge pool located on the downstream side of Lower Davis Dam near river mile 34.40. Reach 2 – Catherine Creek, Grande Ronde Subbasin, Oregon – Bureau of Reclamation Photograph by R. McAfee, July 27 2010.**

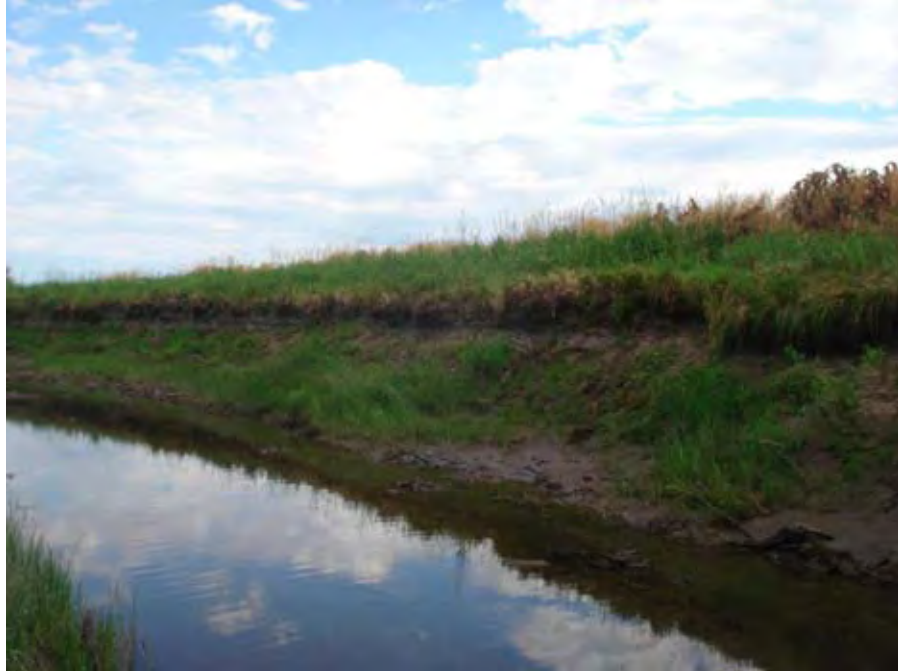
**Photograph 42. View from the right bank looking downstream at low flow conditions near river mile 34.39. Note the sand substrate and the meander thalweg. Reach 2 – Catherine Creek, Grande Ronde Subbasin, Oregon – Bureau of Reclamation Photograph by R. McAfee, July 27 2010.**

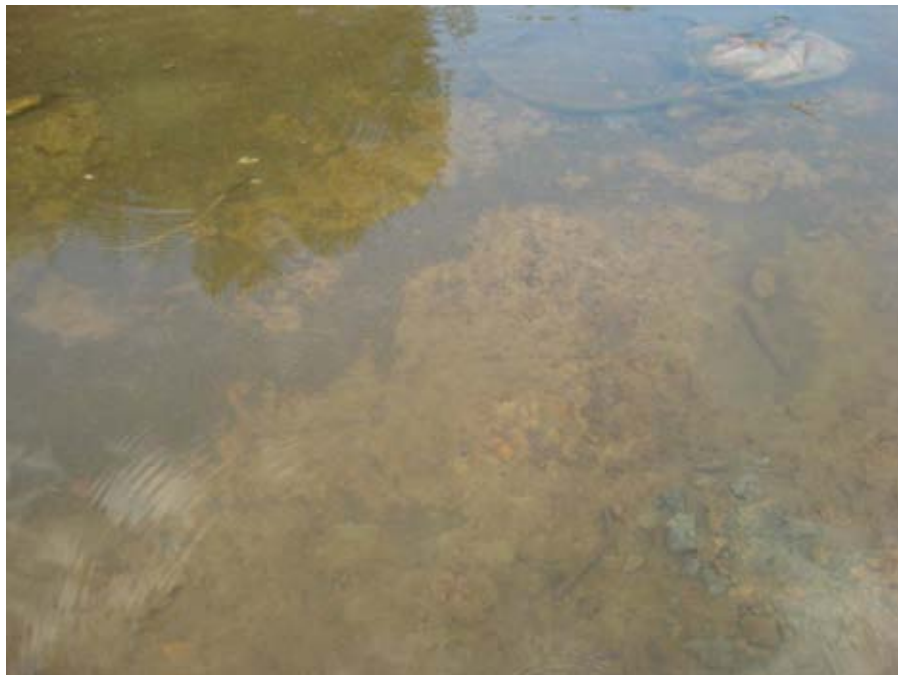
**Photograph 44. View of a very firm indurated silty sand comprising the channel bottom and acting as grade control near river mile 34.31. Reach 2 – Catherine Creek, Grande Ronde Subbasin, Oregon – Bureau of Reclamation Photograph by R. McAfee, July 27 2010.**

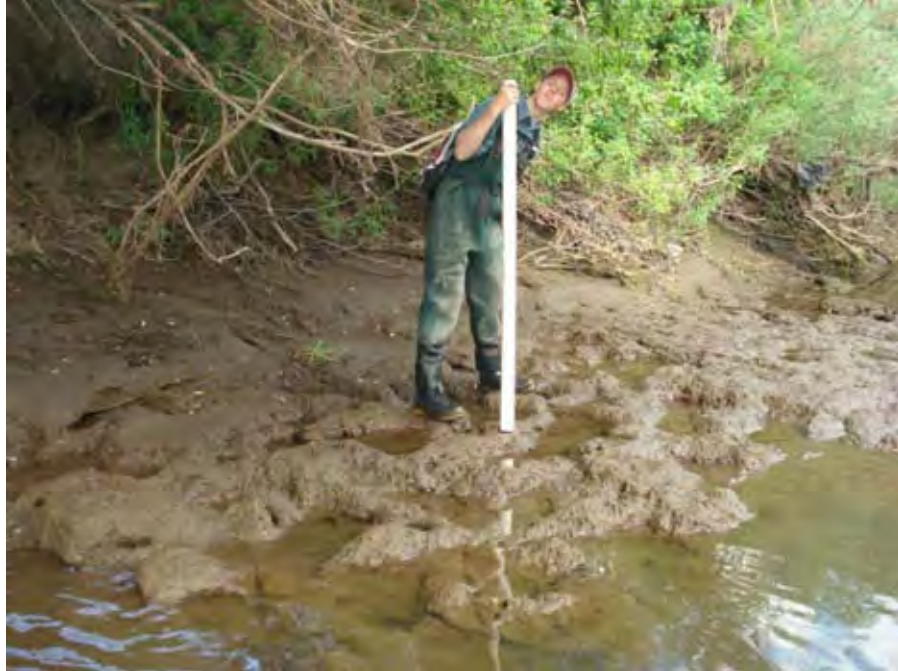
**Photograph 45. View of a very firm, indurated silty sand that comprises the channel bottom and bank toe near river mile 34.26. Reach 2 – Catherine Creek, Grande Ronde Subbasin, Oregon – Bureau of Reclamation Photograph by R. McAfee, July 27 2010.**

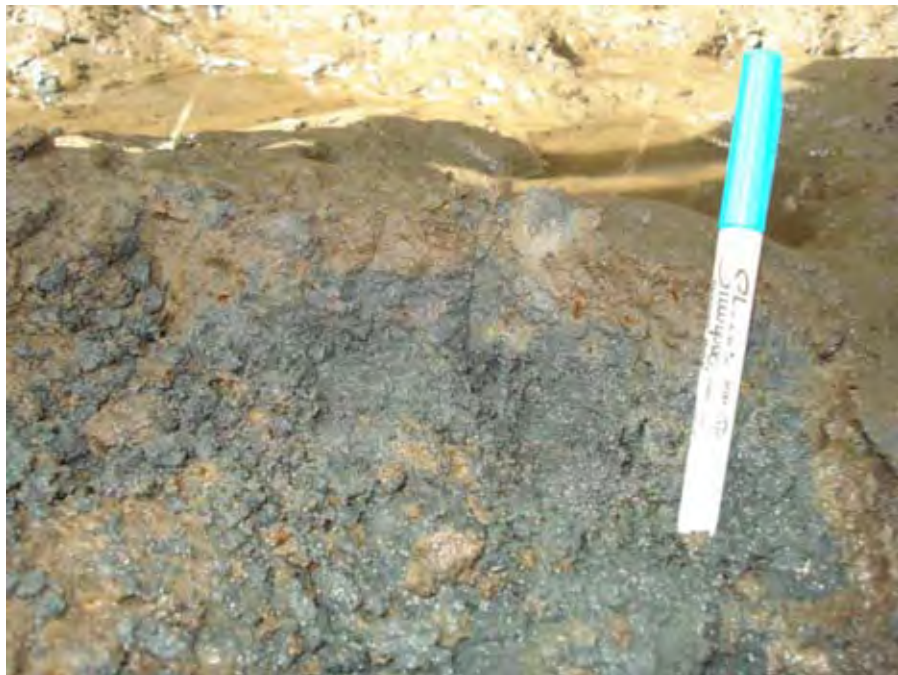
**Photograph 46. A close-up view of the firm indurated silty sand that comprises the channel bottom and bank toe and acts as local vertical control and lateral migration control near river mile 34.26. Note the brown oxidation layer and the gray core. Reach 2 – Catherine Creek, Grande Ronde Subbasin, Oregon – Bureau of Reclamation photograph by R. McAfee, July 27, 2010.**

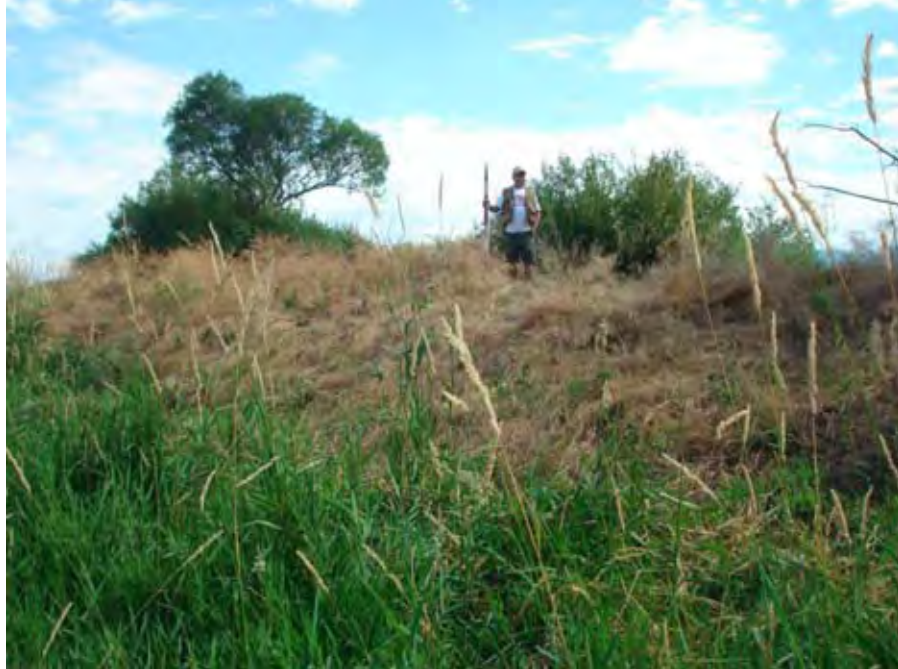
**Photograph 47. A view to the northeast showing the backside of a levee placed along the left bank of Catherine Creek near river mile 34.26. Reach 2 – Catherine Creek, Grande Ronde Subbasin, Oregon – Bureau of Reclamation Photograph by R. McAfee, July 27, 2010.**

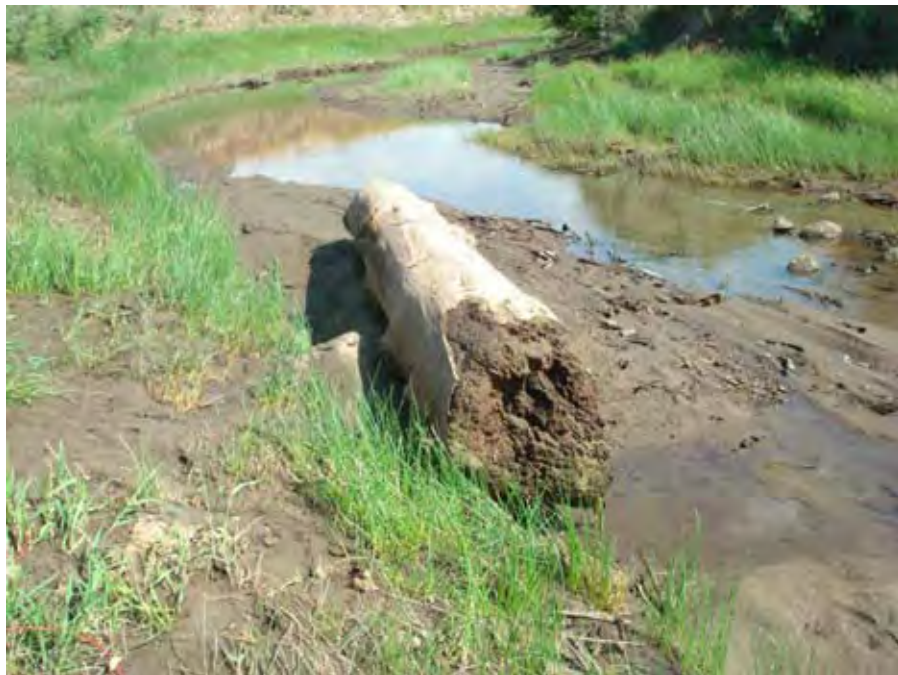
**Photograph 48. A view showing one of the few pieces of woody debris in reach 2, located near river mile 34.20. Reach 2 – Catherine Creek, Grande Ronde Subbasin, Oregon – Bureau of Reclamation Photograph by R. McAfee, July 27, 2010.**

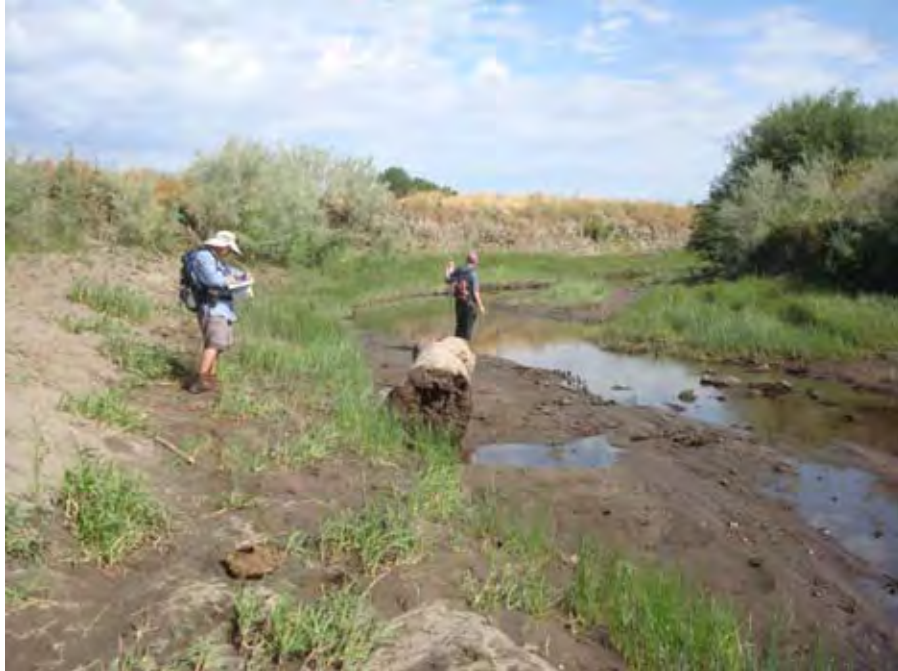
**Photograph 49** View looking downstream at Catherine Creek near the upper end of the artificial straight section near river mile 34.20. Reach 2 – Catherine Creek, Grande Ronde Subbasin, Oregon – Bureau of Reclamation Photograph by D. Stelma, July 27, 2010.

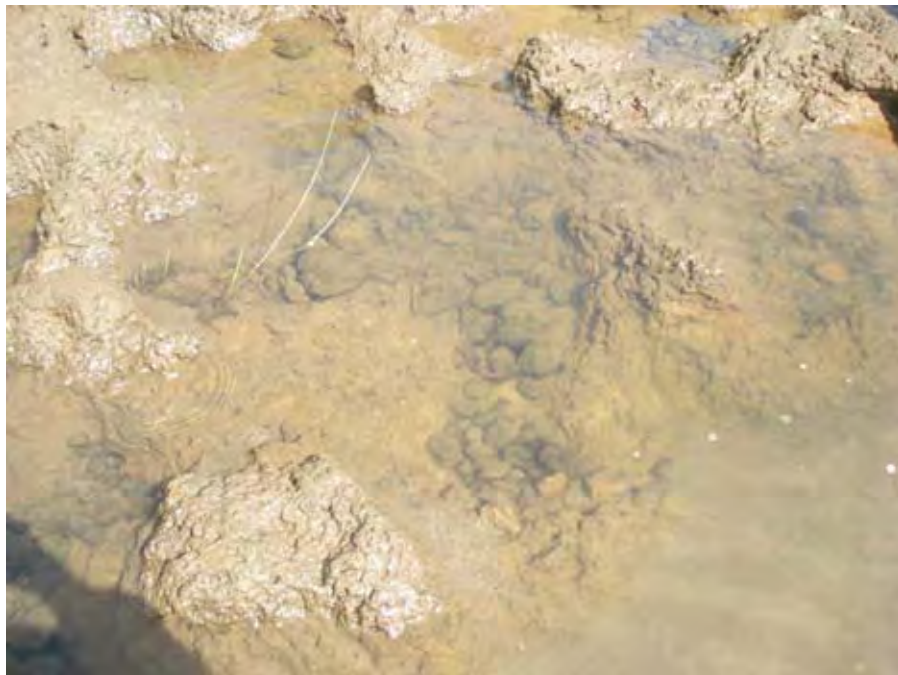
**Photograph 50.** View of a very firm, indurated silty sand that comprises the channel bottom and bank toe near river mile 34.15. Note the basalt gravels that overly the material. Reach 2 – Catherine Creek, Grande Ronde Subbasin, Oregon – Bureau of Reclamation Photograph by R. McAfee, July 27, 2010.

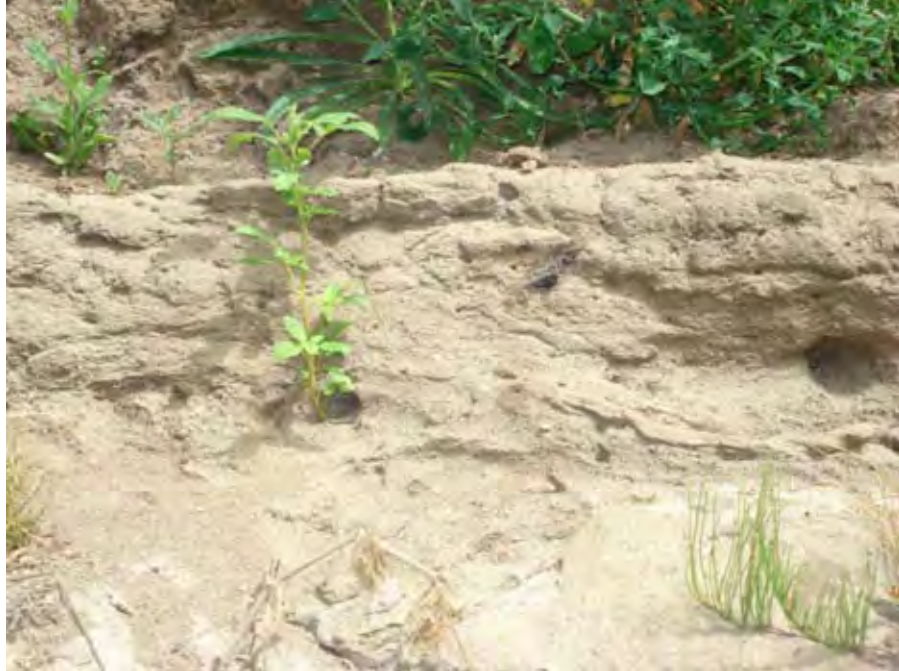
**Photograph 51. View of relatively clean sands with cross bedding features interbedded with silts and clays along the left bank near river mile 34.05. Reach 2 – Catherine Creek, Grande Ronde Subbasin, Oregon – Bureau of Reclamation Photograph by R. McAfee, July 27, 2010.**

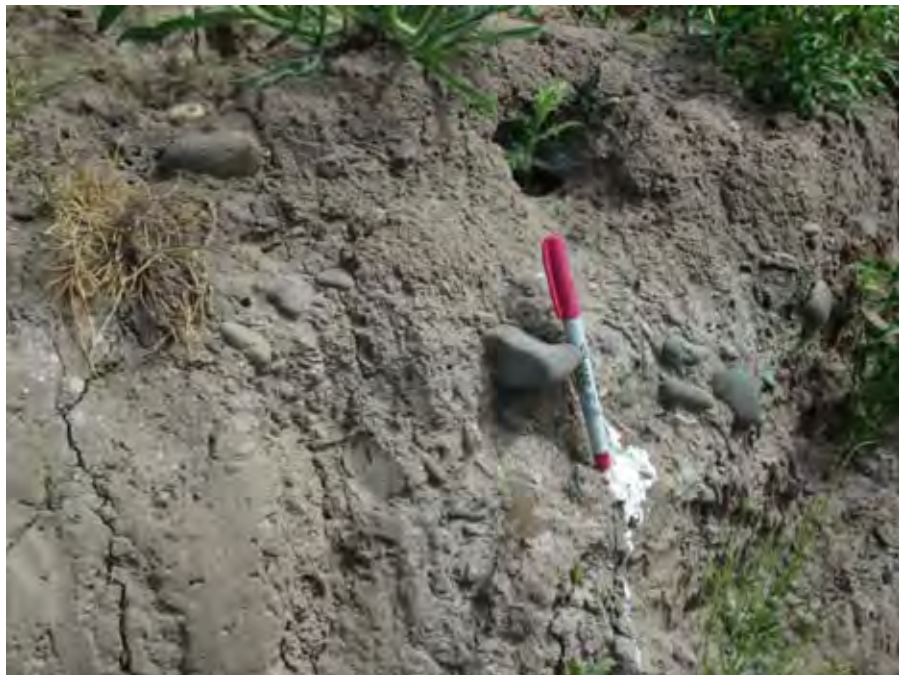
**Photograph 52. View of interbedded silty sands and clays with gravels along the left bank near river mile 34.05. Reach 2 – Catherine Creek, Grande Ronde Subbasin, Oregon – Bureau of Reclamation Photograph by R. McAfee, July 27, 2010.**

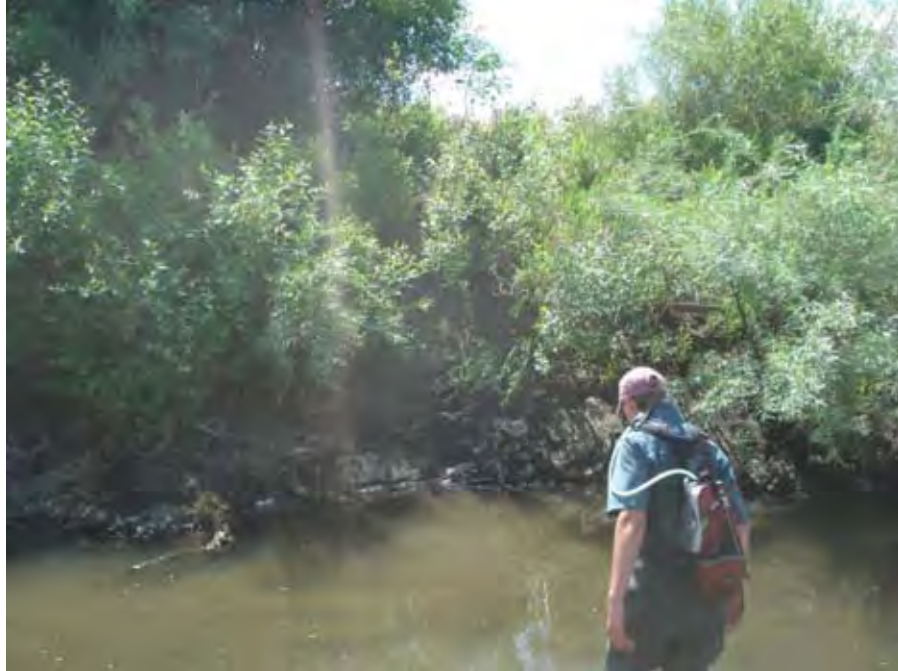
**Photograph 53. View from the left bank to the right at location of profile P-R2-1, located near river mile 34.05. Note the grass, willow, shrub-sapling and small diameter vegetation. Reach 2 – Catherine Creek, Grande Ronde Subbasin, Oregon – Bureau of Reclamation Photograph by R. McAfee, July 27, 2010.**

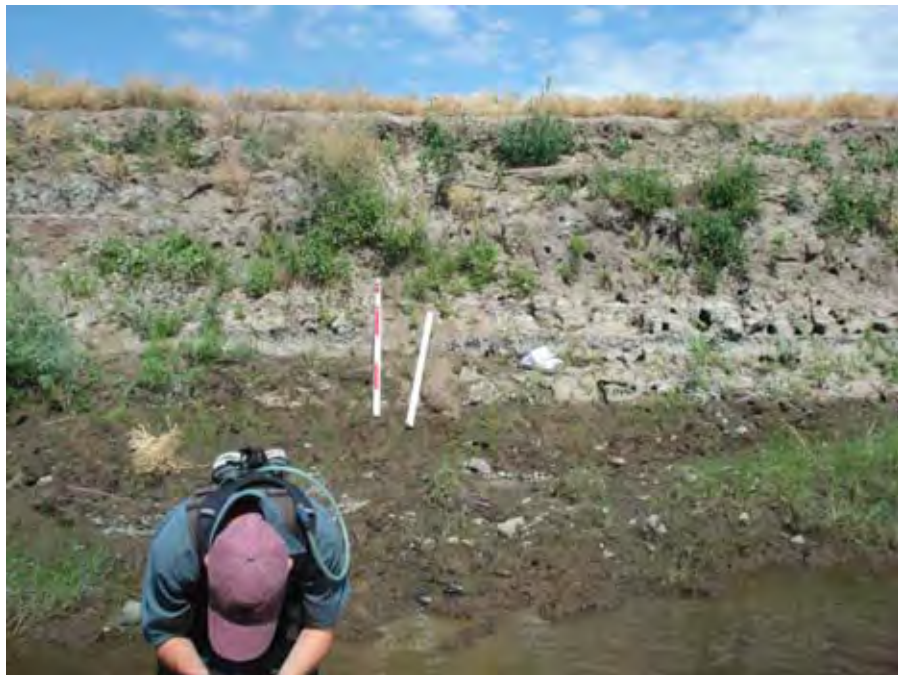
**Photograph 54. View of the left bank at location of profile P-R2-1, located near river mile 34.05. Note the lack of vegetation. Reach 2 – Bureau of Reclamation Photograph by R. McAfee, July 27, 2010.**

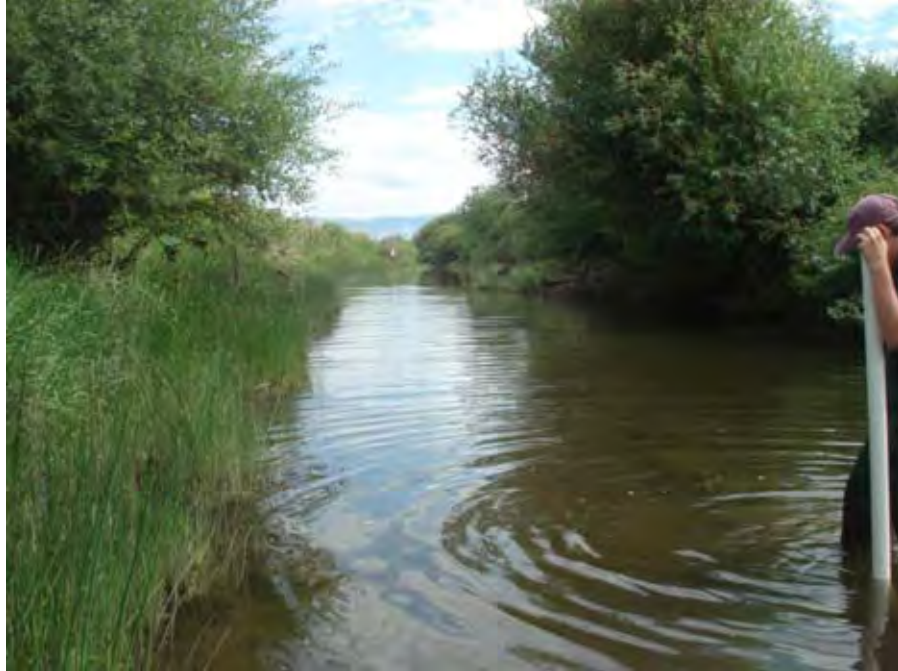
**Photograph 55. View looking downstream at a section with very low water velocities and mixed vegetation along both banks near river mile 33.98. Reach 2 – Catherine Creek, Grande Ronde Subbasin, Oregon – Bureau of Reclamation Photograph by R. McAfee, July 27, 2010.**

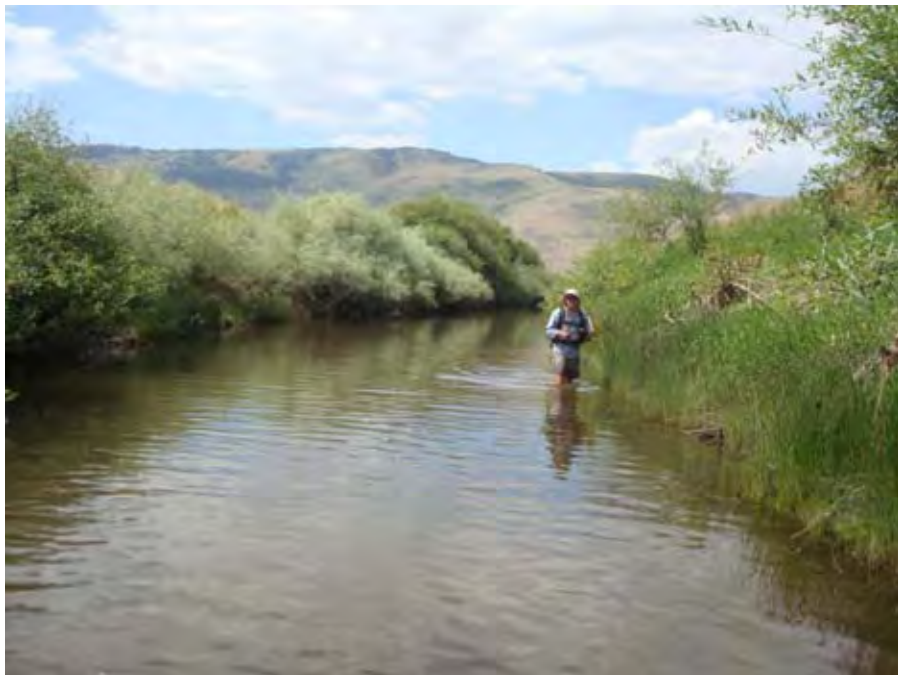
**Photograph 56. View looking downstream at Catherine Creek channel near river mile 33.95. Reach 2 – Catherine Creek, Grande Ronde Subbasin, Oregon – Bureau of Reclamation Photograph by D. Stelma, July 27, 2010.**

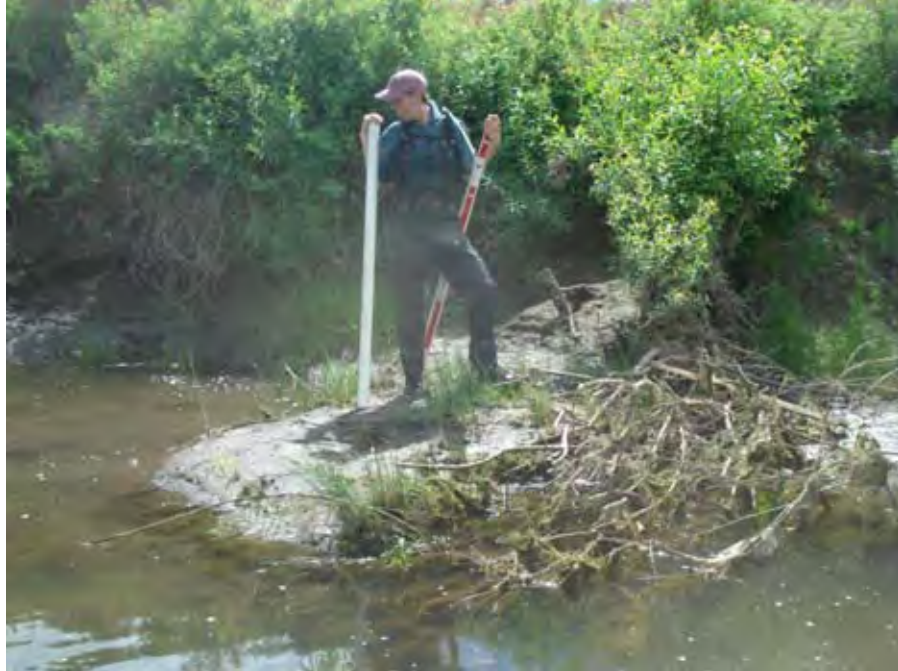
**Photograph 57. View of small brush debris and the resulting sand deposition directly downstream near river mile 33.91. Reach 2 – Catherine Creek, Grande Ronde Subbasin, Oregon – Bureau of Reclamation Photograph by R. McAfee, July 27, 2010.**

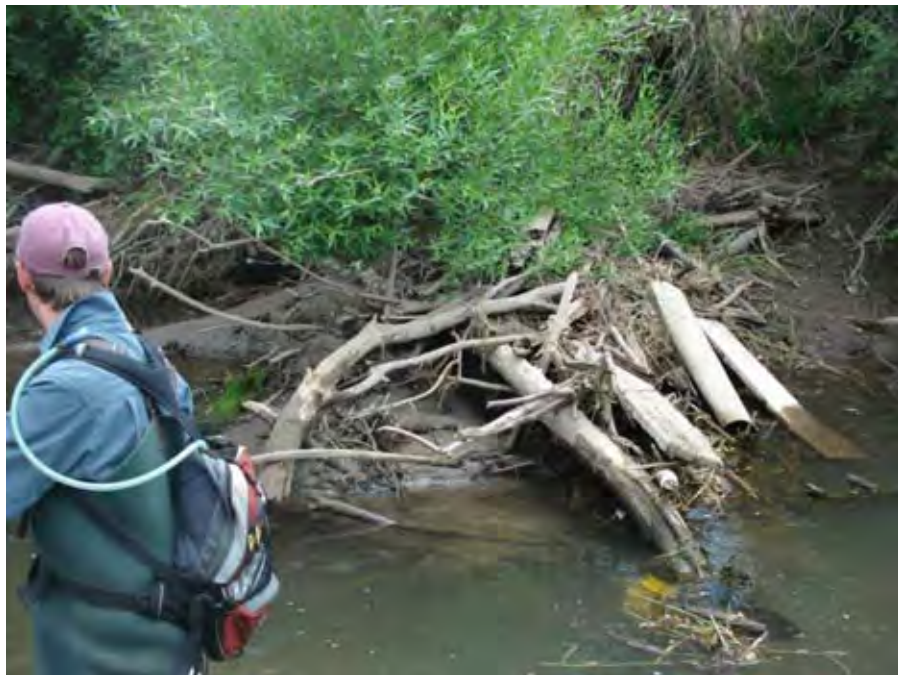
**Photograph 58. View of a small brush and wood debris and the resulting sand deposition directly downstream near river mile 33.89. Reach 2 – Catherine Creek, Grande Ronde Subbasin, Oregon – Bureau of Reclamation Photograph by R. McAfee, July 27, 2010.**

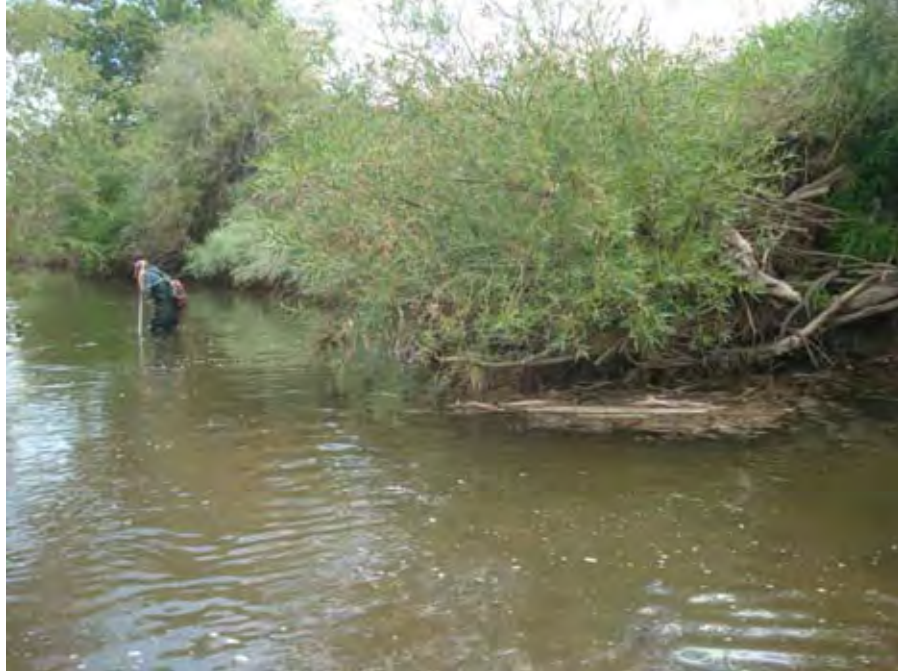
**Photograph 59. View of a small brush along the left bank with local scour downstream near river mile 33.89. Reach 2 – Catherine Creek, Grande Ronde Subbasin, Oregon – Bureau of Reclamation Photograph by R. McAfee, July 27, 2010.**

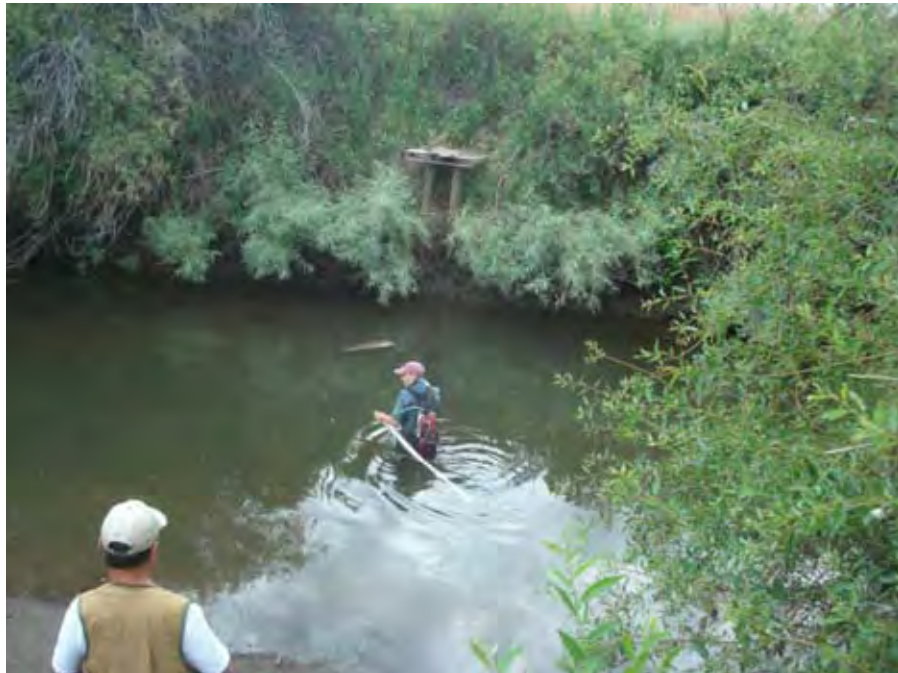
**Photograph 60. View from left bank to the right showing local scour in the channel bottom and a 'diving board' along the right bank near river mile 33.89. Reach 2 – Catherine Creek, Grande Ronde Subbasin, Oregon – Bureau of Reclamation Photograph by R. McAfee, July 27, 2010.**

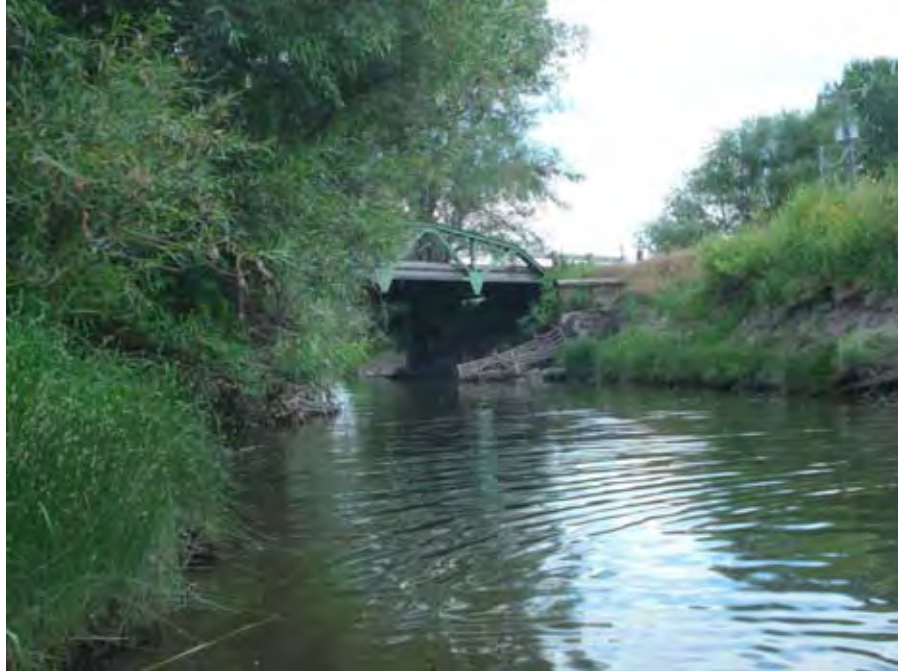
**Photograph 61. View from left bank looking downstream at the Woodruff Lane Bridge near river mile 33.85. Reach 2 – Catherine Creek, Grande Ronde Subbasin, Oregon – Bureau of Reclamation Photograph by R. McAfee, July 27, 2010.**

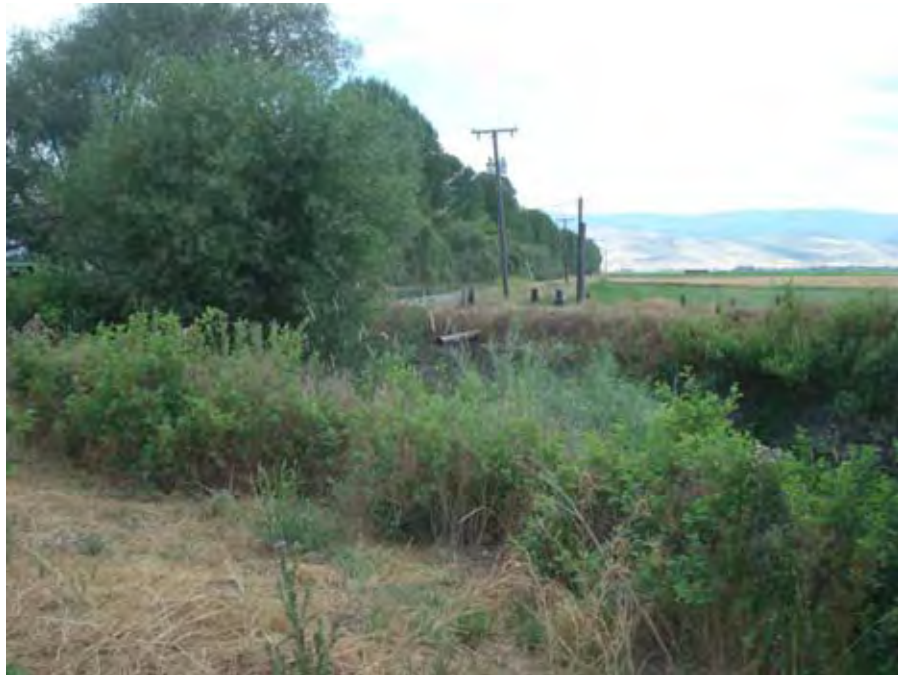
**Photograph 62. View from the top of the left bank looking downstream at a floodwater pump and return upstream the Woodruff Lane Bridge near river mile 33.85. Reach 2 – Catherine Creek, Grande Ronde Subbasin, Oregon – Bureau of Reclamation Photograph by R. McAfee, July 27, 2010.**

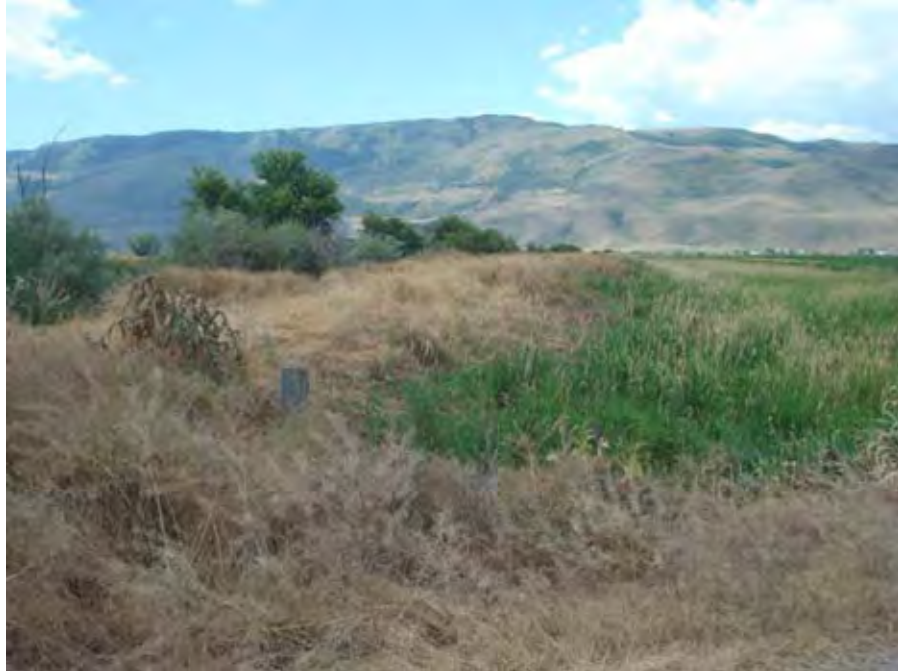
**Photograph 63. View from Woodruff Lane looking down a levee along the right bank near river mile 33.84. Reach 2 – Catherine Creek, Grande Ronde Subbasin, Oregon – Bureau of Reclamation Photograph by R. McAfee, July 27, 2010.**

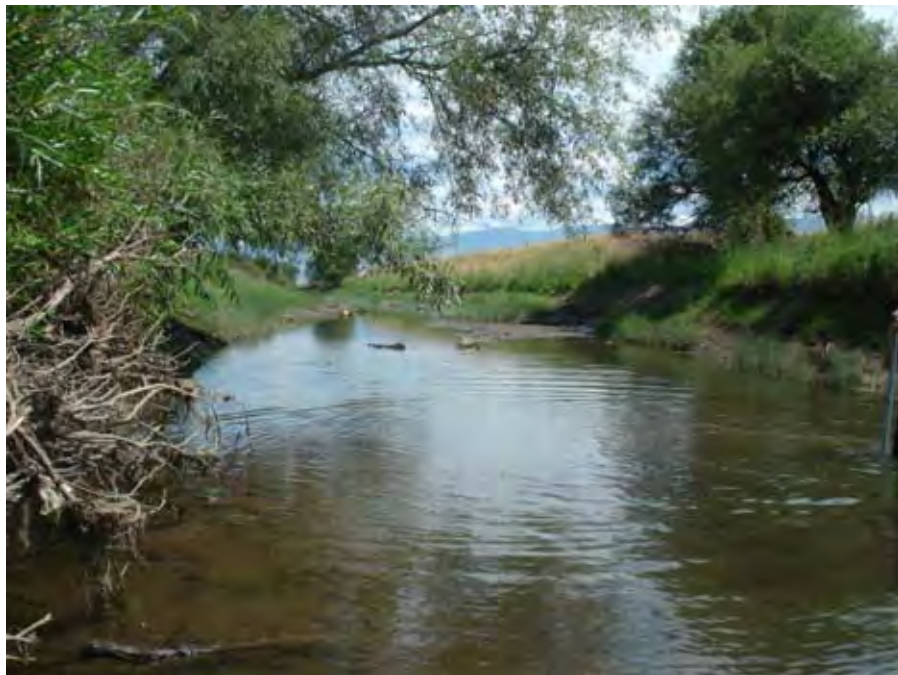
**Photograph 64. View looking downstream at the first occurrence of small alternating lateral sand bars as a result of local scour at the Woodruff Lane Bridge near river mile 33.84. Reach 2 – Catherine Creek, Grande Ronde Subbasin, Oregon – Bureau of Reclamation Photograph by R. McAfee, July 27, 2010.**
