## **APPENDIX C – GEOLOGY AND GEOMORPHOLOGY**

## GEOLOGY AND GEOMORPHOLOGY REPORT FOR THE CATHERINE CREEK TRIBUTARY ASSESSMENT – GRANDE RONDE RIVER BASIN Tributary Habitat Program, Oregon

February 2012

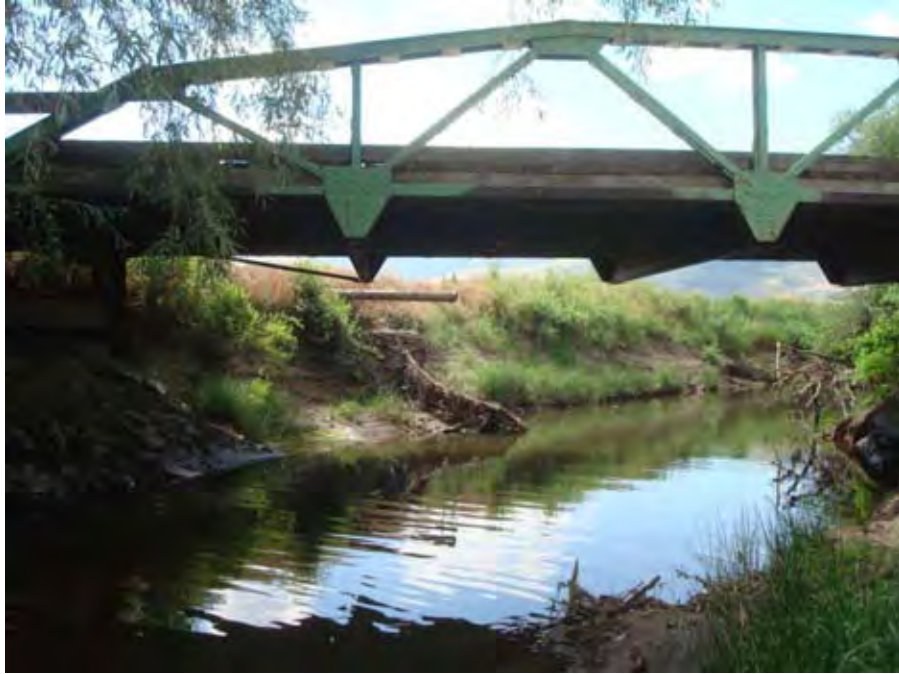
**Photograph 65. View looking downstream at the Woodruff Lane Bridge near river mile 33.84. Reach 2 – Catherine Creek, Grande Ronde Subbasin, Oregon – Bureau of Reclamation  
Photograph by D. Stelma, July 27, 2010.**

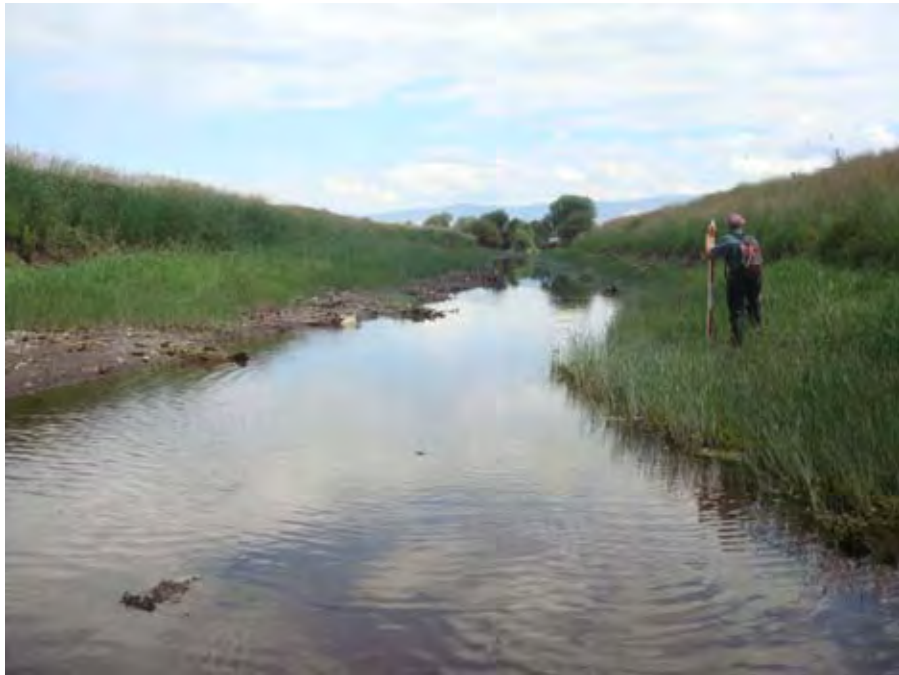
**Photograph 66. View looking downstream at Catherine Creek through the long straight artificial channel section, note silty sand and sand silt bed deposits near river mile 33.80. Reach 2 – Catherine Creek, Grande Ronde Subbasin, Oregon – Bureau of Reclamation  
Photograph by D. Stelma, July 27, 2010.**

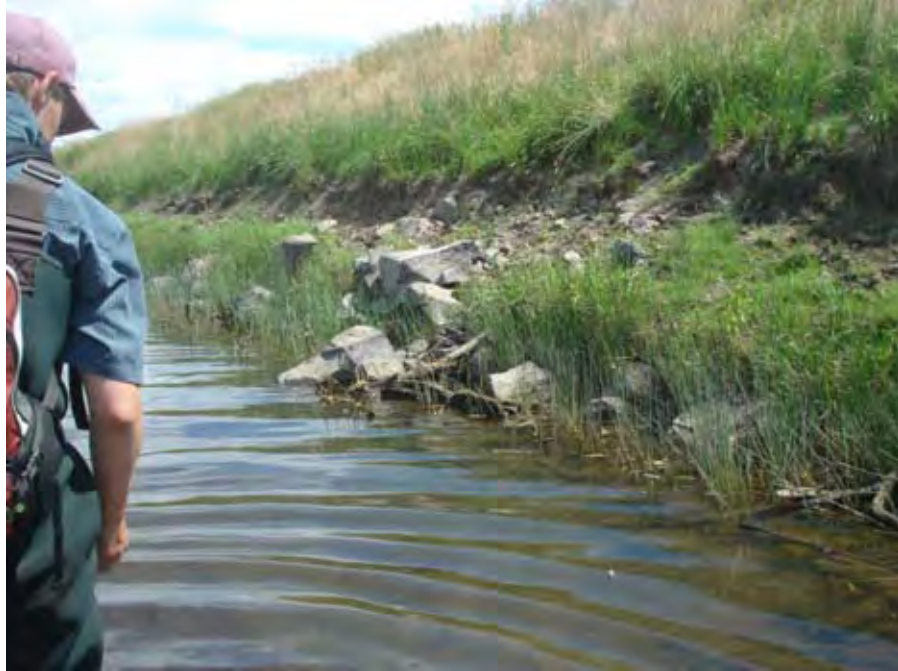
**Photograph 67. View looking downstream at a small section of riprap along the right bank near river mile 33.78. Reach 2 – Catherine Creek, Grande Ronde Subbasin, Oregon – Bureau of Reclamation Photograph by R. McAfee, July 27, 2010.**

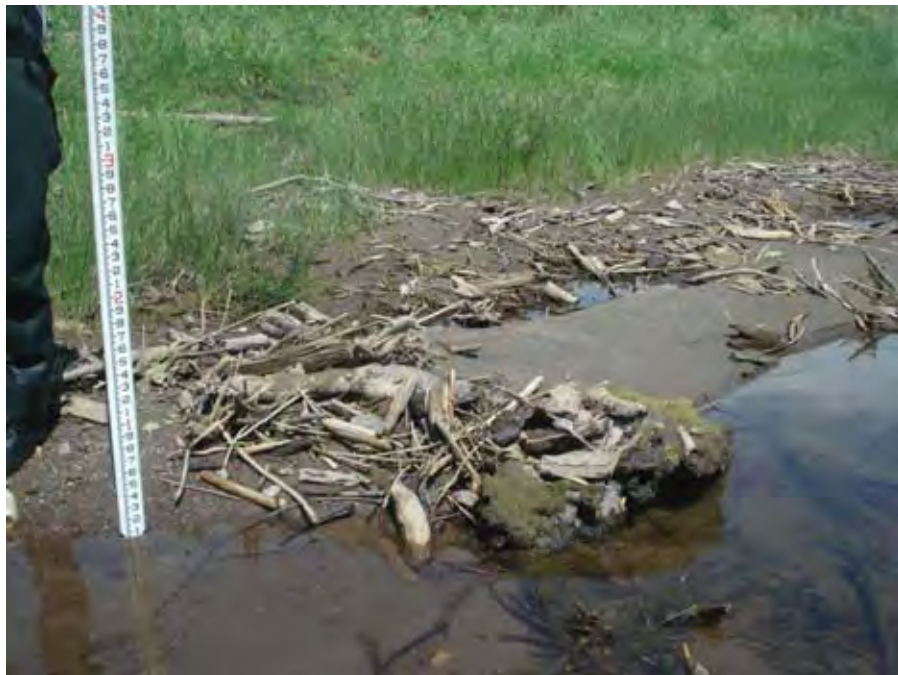
**Photograph 68. View of an example of how small roughness elements can promote local deposition near river mile 33.78. Reach 2 – Catherine Creek, Grande Ronde Subbasin, Oregon – Bureau of Reclamation Photograph by R. McAfee, July 27, 2010.**

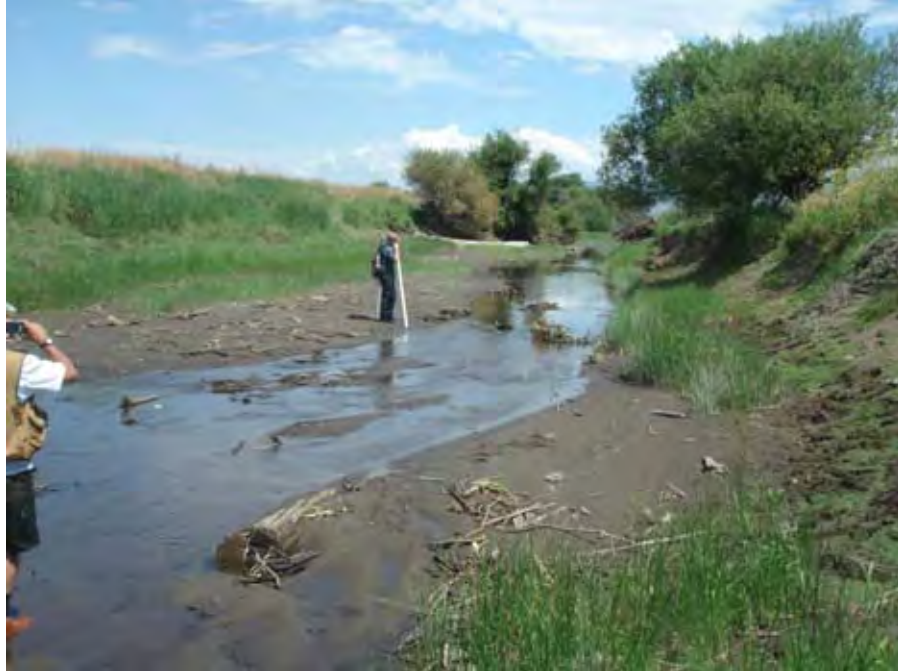
**Photograph 69. View from the right bank of a local area of deposition, with a low-flow riffle and small bars in the wetted width near river mile 33.70. Reach 2 – Catherine Creek, Grande Ronde Subbasin, Oregon – Bureau of Reclamation Photograph by R. McAfee, July 27, 2010.**

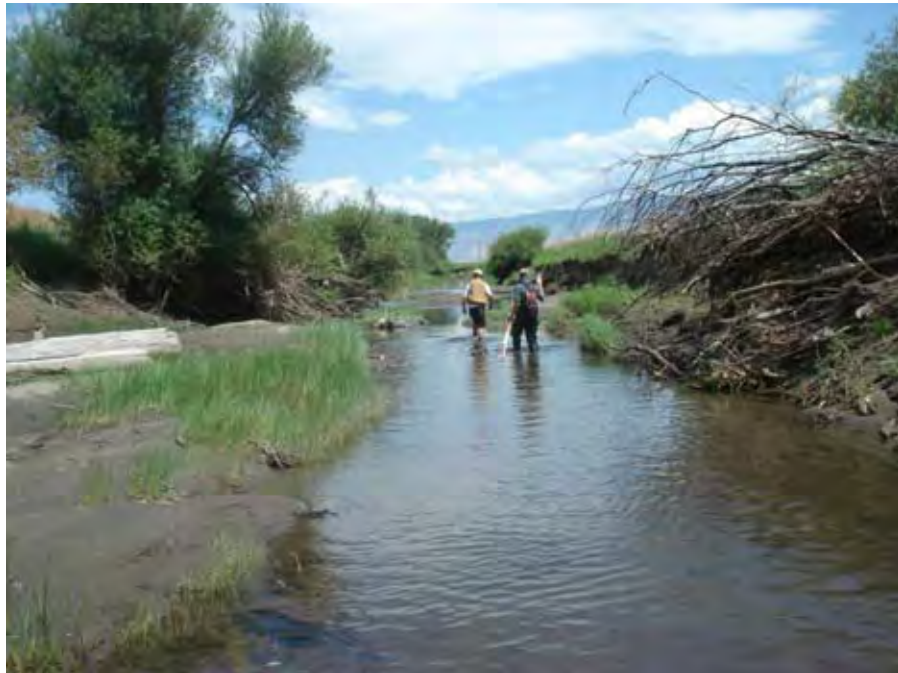
**Photograph 70. View looking downstream of woody debris along the banks and a large lateral bar along the left bank with vegetation beginning to establish near river mile 33.65. Reach 2 – Catherine Creek, Grande Ronde Subbasin, Oregon – Bureau of Reclamation Photograph by R. McAfee, July 27, 2010.**

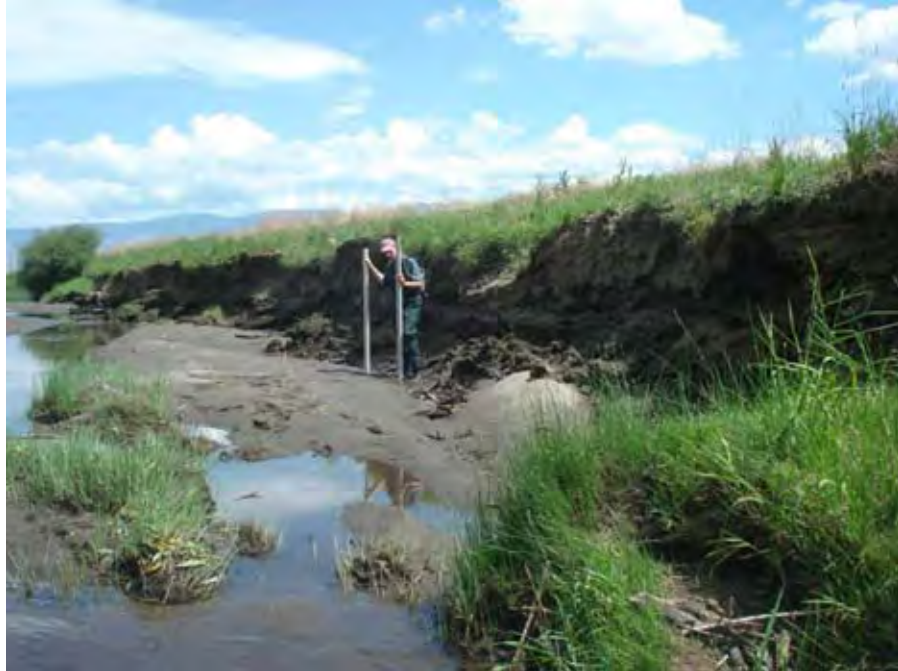
**Photograph 71. View looking downstream along an eroding section of the right bank. The bank has about 6 feet of vertical face that is contributing sand, silt and clay sized material near river mile 33.65. Reach 2 – Catherine Creek, Grande Ronde Subbasin, Oregon – Bureau of Reclamation Photograph by R. McAfee, July 27, 2010.**

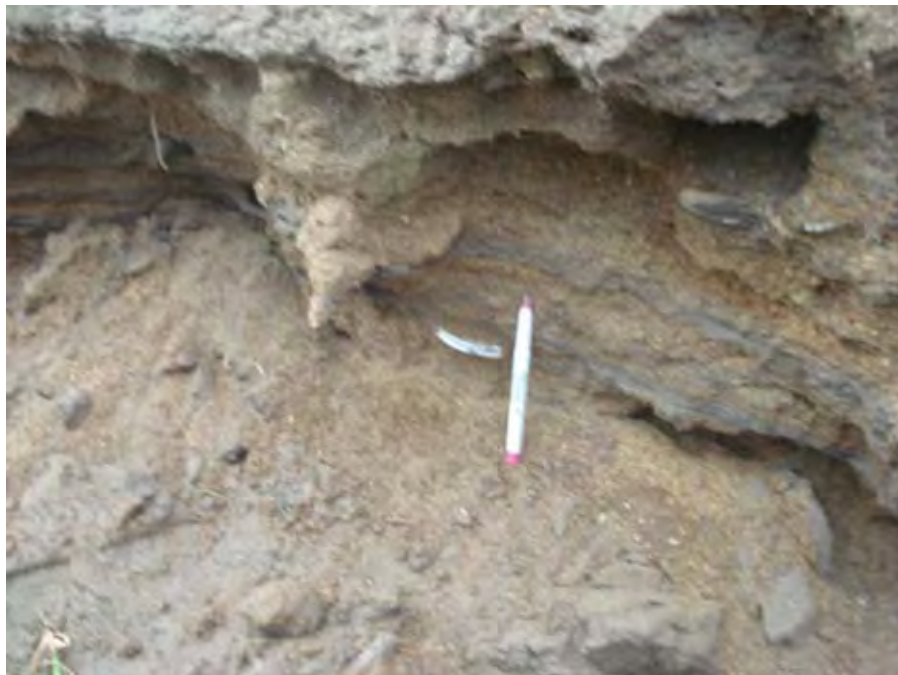
**Photograph 72. A close-up view of the left bank material comprised of silt and clay inter-bedded with sand near river mile 33.65. Note the plastic cup lid to the left of the pen. Reach 2 – Catherine Creek, Grande Ronde Subbasin, Oregon – Bureau of Reclamation Photograph by R. McAfee, July 27, 2010.**

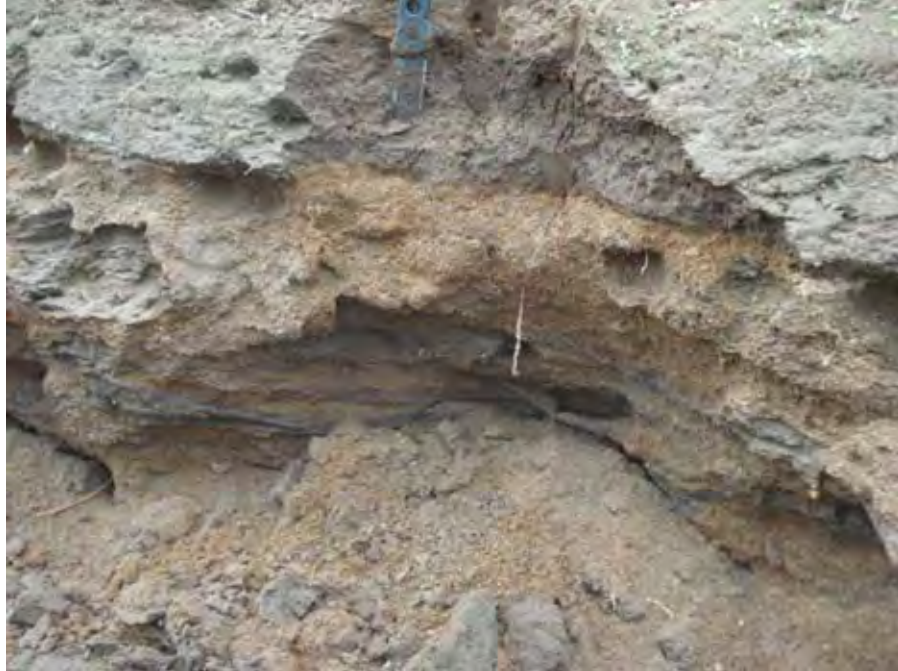
**Photograph 73. A close-up view of the left bank material comprised of silt and clay interbedded with sand near river mile 33.65. Reach 2 – Catherine Creek, Grande Ronde Subbasin, Oregon – Bureau of Reclamation Photograph by R. McAfee, July 27, 2010.**

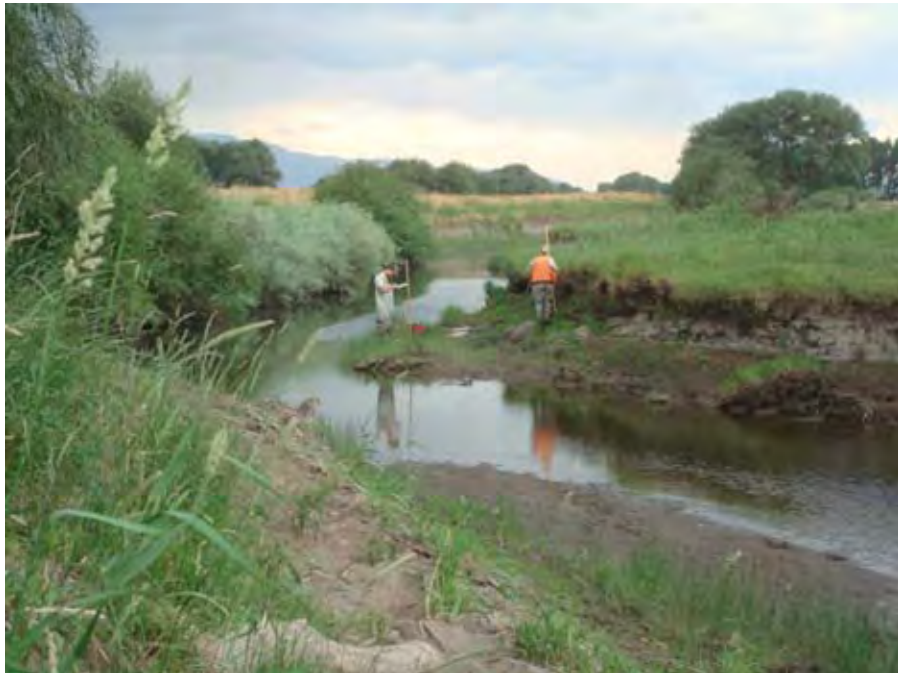
**Photograph 74. View looking downstream at the Catherine Creek channel and ODFW biological survey crew near river mile 33.63. Reach 2 – Catherine Creek, Grande Ronde Subbasin, Oregon – Bureau of Reclamation Photograph by D. Stelma, July 27, 2010.**

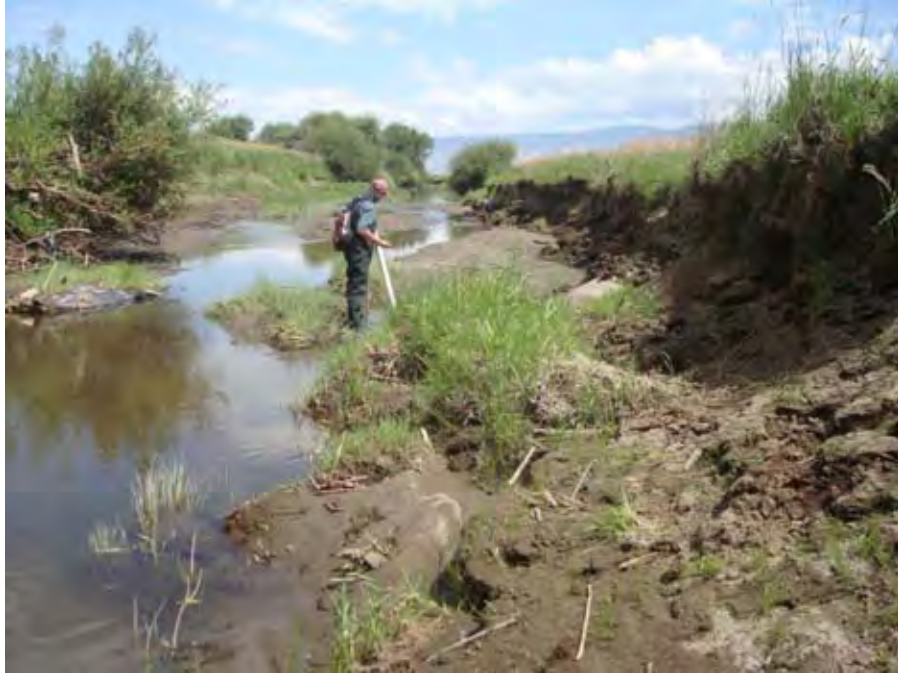
**Photograph 75. View looking downstream at Catherine Creek channel near river mile 33.63, note sloughing off right bank. Reach 2 – Catherine Creek, Grande Ronde Subbasin, Oregon – Bureau of Reclamation Photograph by D. Stelma, July 27, 2010.**

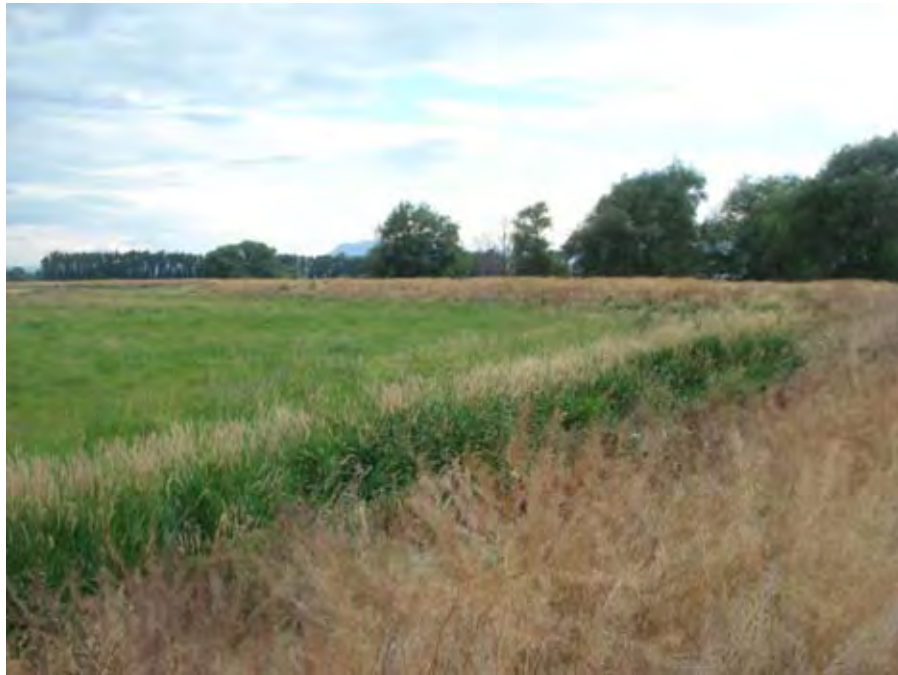
**Photograph 76. A view looking to the north of the back side of a levee that runs along the left bank near river mile 33.59. Reach 2 – Catherine Creek, Grande Ronde Subbasin, Oregon – Bureau of Reclamation Photograph by R. McAfee, July 27, 2010.**

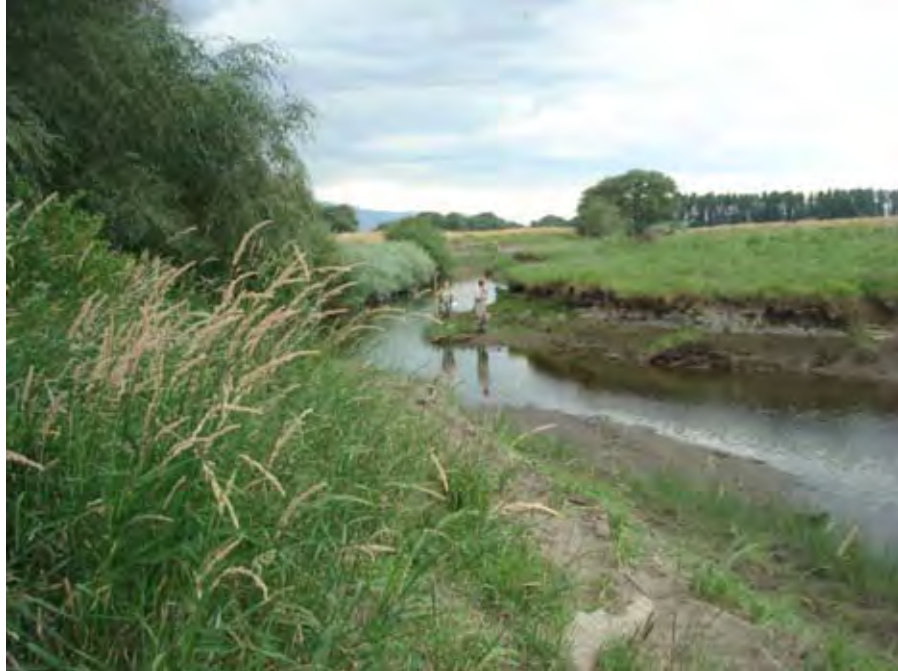
**Photograph 77. View looking to the north of the right floodplain, and a section of erosion along the right bank near river mile 33.50. Reach 2 – Catherine Creek, Grande Ronde Subbasin, Oregon – Bureau of Reclamation Photograph by R. McAfee, July 27, 2010.**

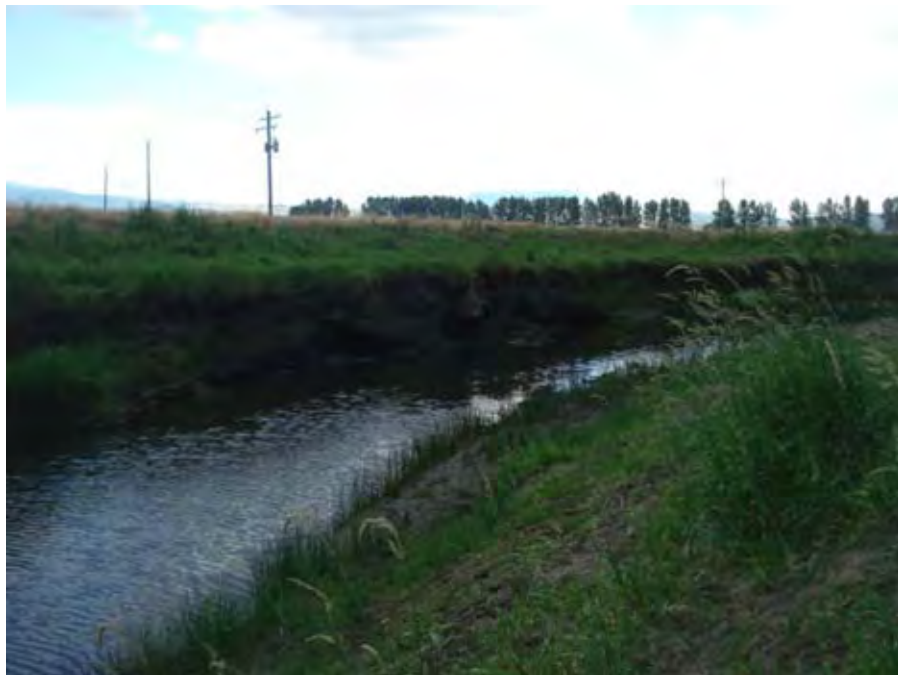
**Photograph 78. View to the south, looking upstream at an eroding grass-covered right bank on the outside of a meander bend near river mile 33.50. Reach 2 – Catherine Creek, Grande Ronde Subbasin, Oregon – Bureau of Reclamation Photograph by R. McAfee, July 27, 2010.**

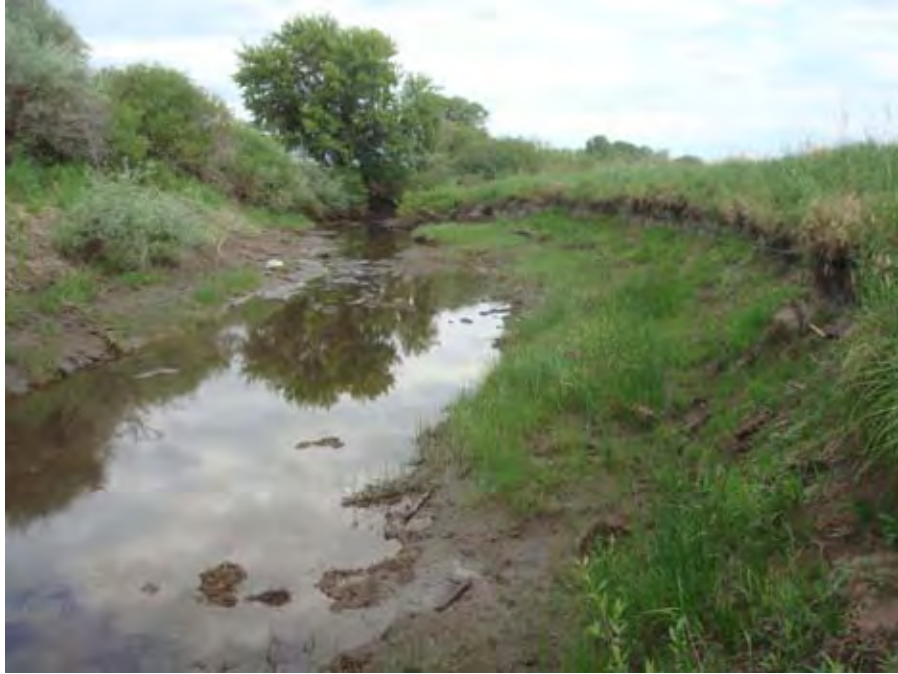
**Photograph 79. View looking downstream at Catherine Creek channel near river mile 33.28. Reach 2 – Catherine Creek, Grande Ronde Subbasin, Oregon – Bureau of Reclamation Photograph by D. Stelma, July 27, 2010.**

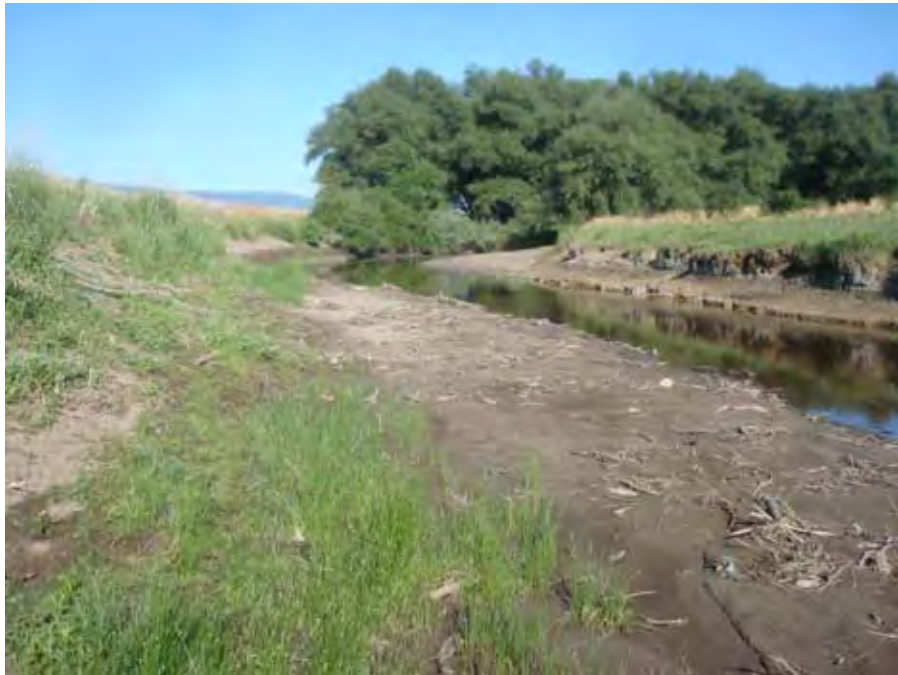
**Photograph 80. View looking downstream at the Catherine Creek channel and profile location, note fine-grained alluvium (tan dense silt) forming the bed and lower banks of the creek near river mile 33.22. Reach 2 – Catherine Creek, Grande Ronde Subbasin, Oregon – Bureau of Reclamation Photograph by D. Stelma, August 1, 2010.**

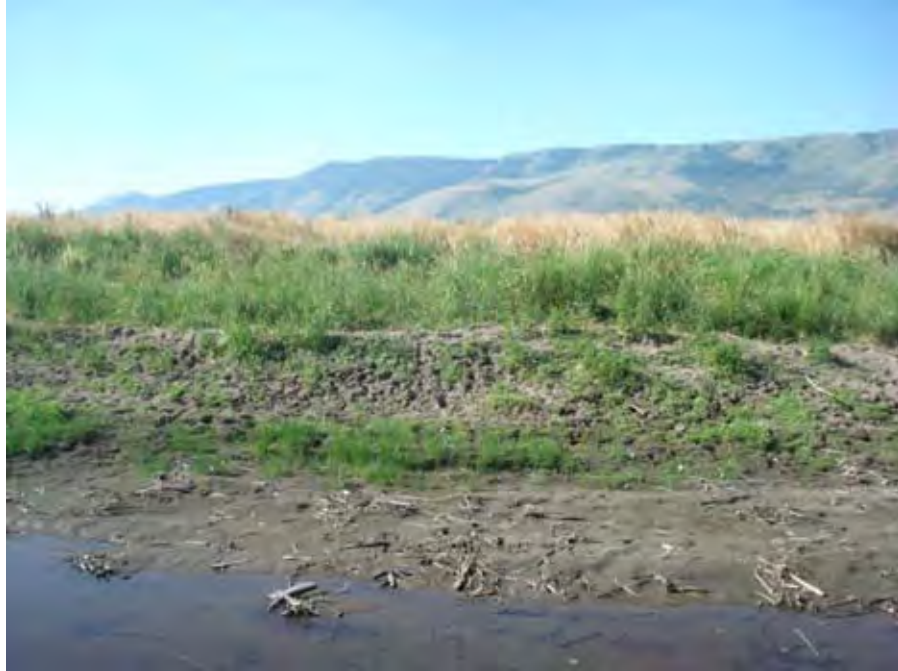
**Photograph 81. View looking at the left bank and levee in the back ground at the location of profile P-R2-9 at river mile 33.22. Reach 2 – Catherine Creek, Grande Ronde Subbasin, Oregon – Bureau of Reclamation Photograph by R. McAfee, August 1, 2010.**

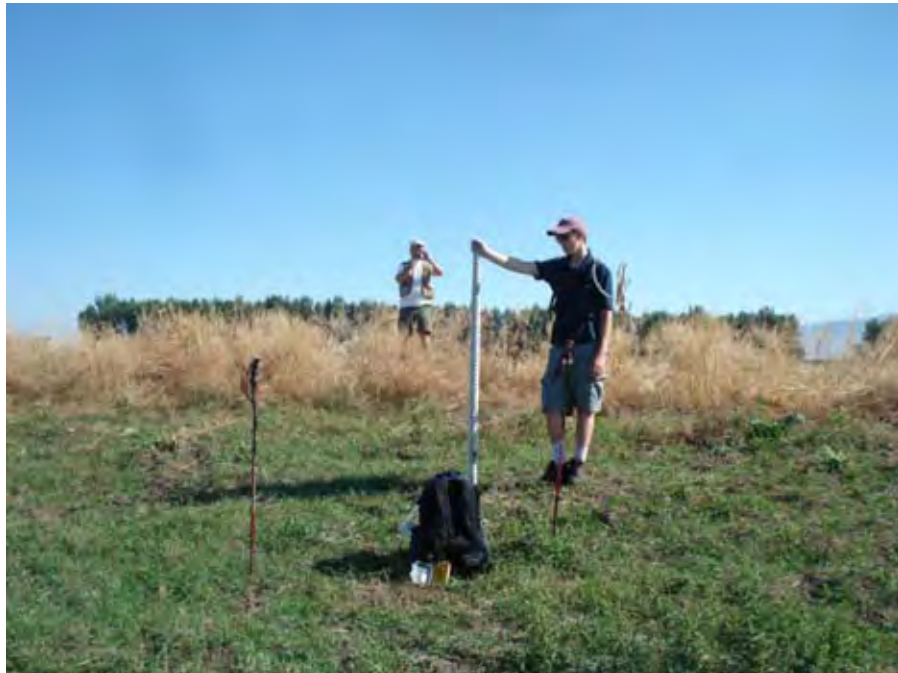
**Photograph 82. View looking at the right bank and levee in the back ground at the location of profile P-R2-9 at river mile 33.22. Reach 2 – Catherine Creek, Grande Ronde Subbasin, Oregon – Bureau of Reclamation Photograph by R. McAfee, August 1, 2010.**

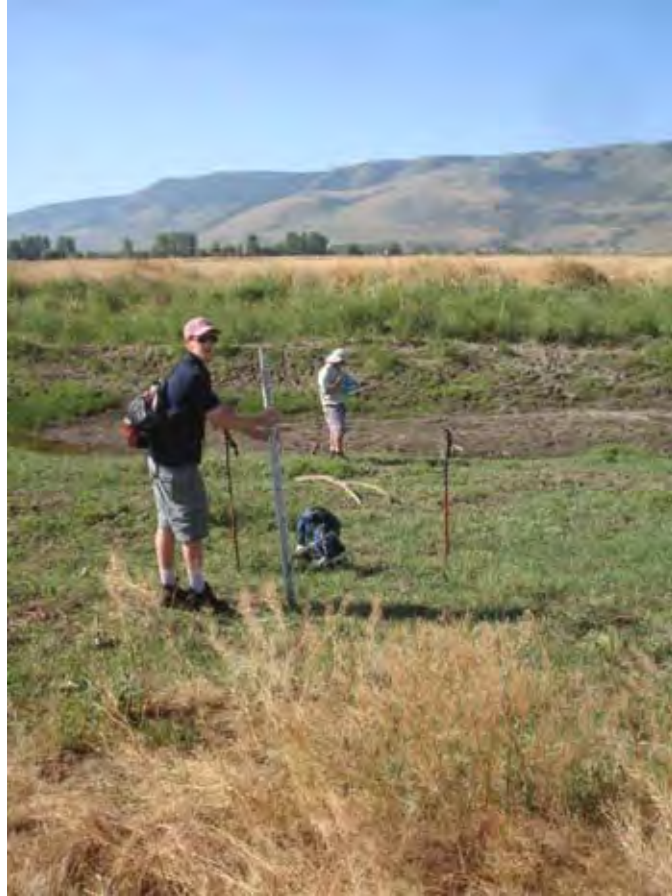
**Photograph 83. View looking from right to left across the Catherine Creek channel, profile location near river mile 33.22. Reach 2 – Catherine Creek, Grande Ronde Subbasin, Oregon – Bureau of Reclamation Photograph by D. Stelma, August 1, 2010.**

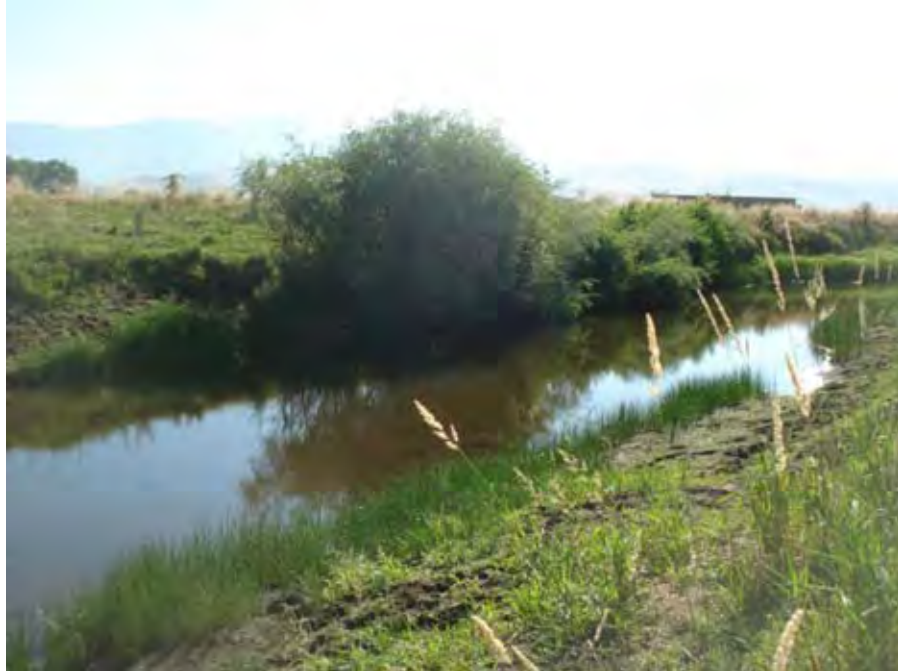
**Photograph 84. View looking upstream of banks that show signs of trampling near river mile 33.20. Note the mostly grassy vegetation along the banks. Reach 2 – Catherine Creek, Grande Ronde Subbasin, Oregon – Bureau of Reclamation Photograph by R. McAfee, August 1, 2010.**

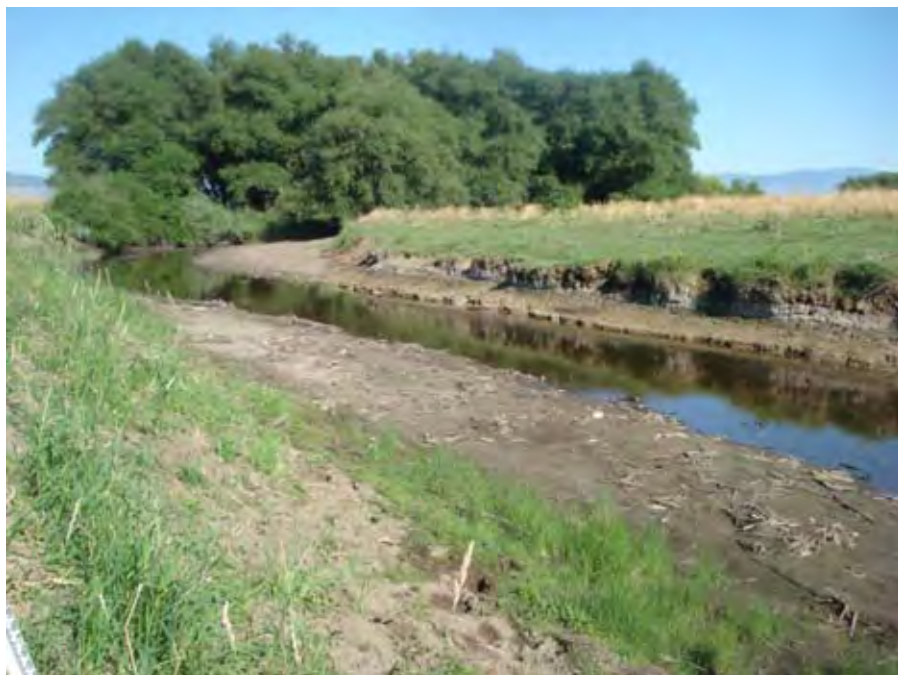
**Photograph 85. View looking downstream at alternating bar formation, evidence of trampling along both banks and a dense firm sedimentary layer at the water edge along the right bank at river mile 33.20. Reach 2 – Catherine Creek, Grande Ronde Subbasin, Oregon – Bureau of Reclamation Photograph by R. McAfee, August 1, 2010.**

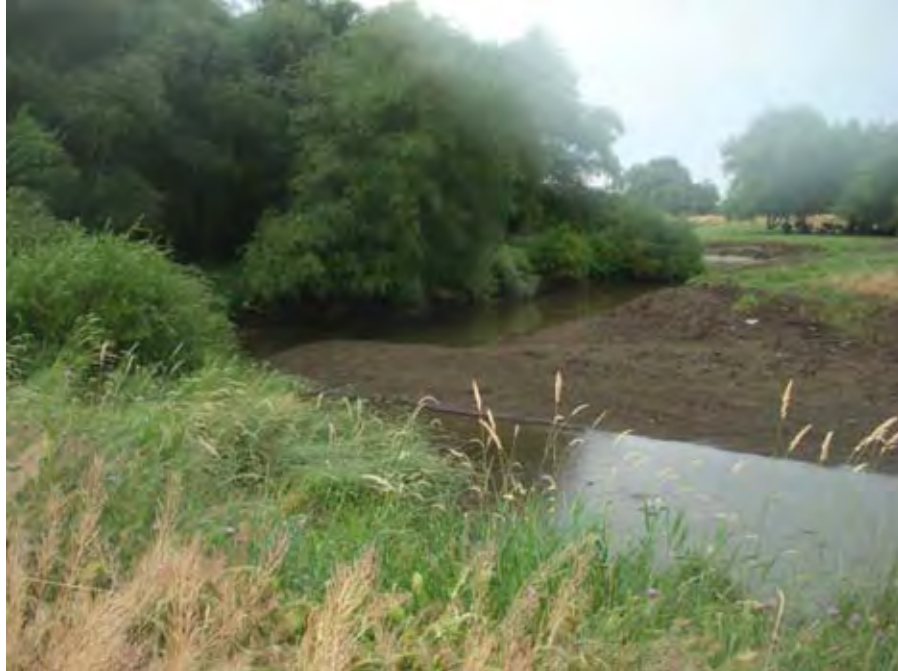
**Photograph 86. View from the left bank looking downstream at a point sand bar that acts as a hydraulic control near river mile 33.18. Reach 2 – Catherine Creek, Grande Ronde Subbasin, Oregon – Bureau of Reclamation Photograph by R. McAfee, July 27, 2010.**

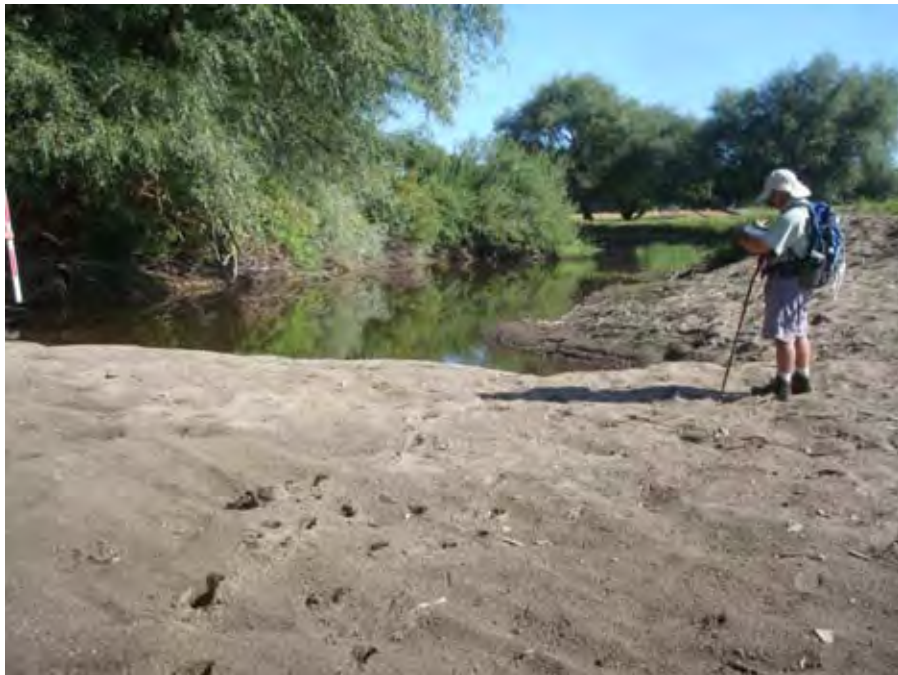
**Photograph 87. View looking downstream at large sandbar on the right bank (inside bend) of Catherine Creek near river mile 33.18. Reach 2 – Catherine Creek, Grande Ronde Subbasin, Oregon – Bureau of Reclamation Photograph by D. Stelma, August 1, 2010.**

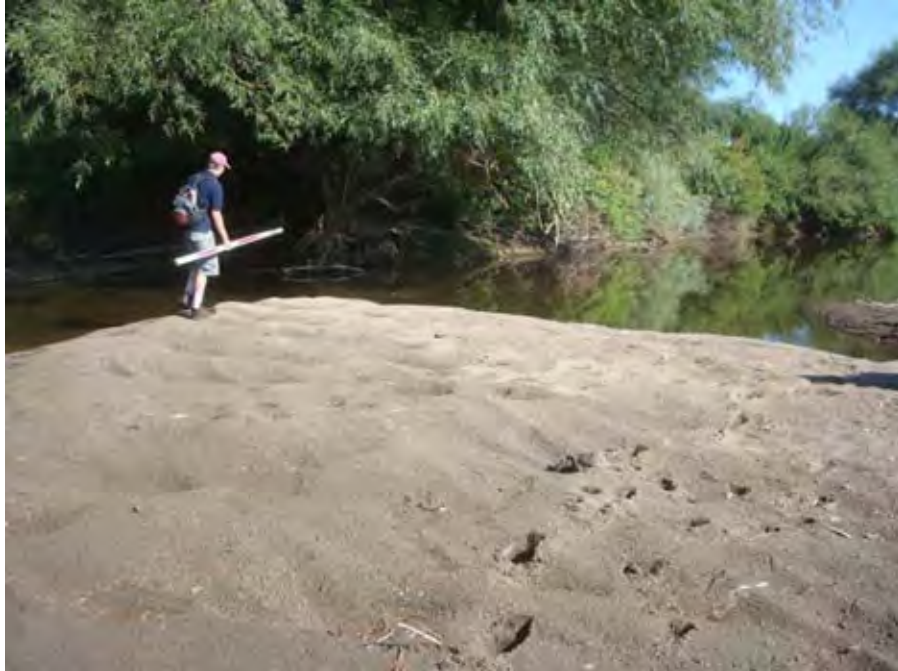
**Photograph 88. View looking downstream at large sandbar on the right bank (inside bend) of Catherine Creek near river mile 33.18. Reach 2 – Catherine Creek, Grande Ronde Subbasin, Oregon – Bureau of Reclamation Photograph by D. Stelma, August 1, 2010.**

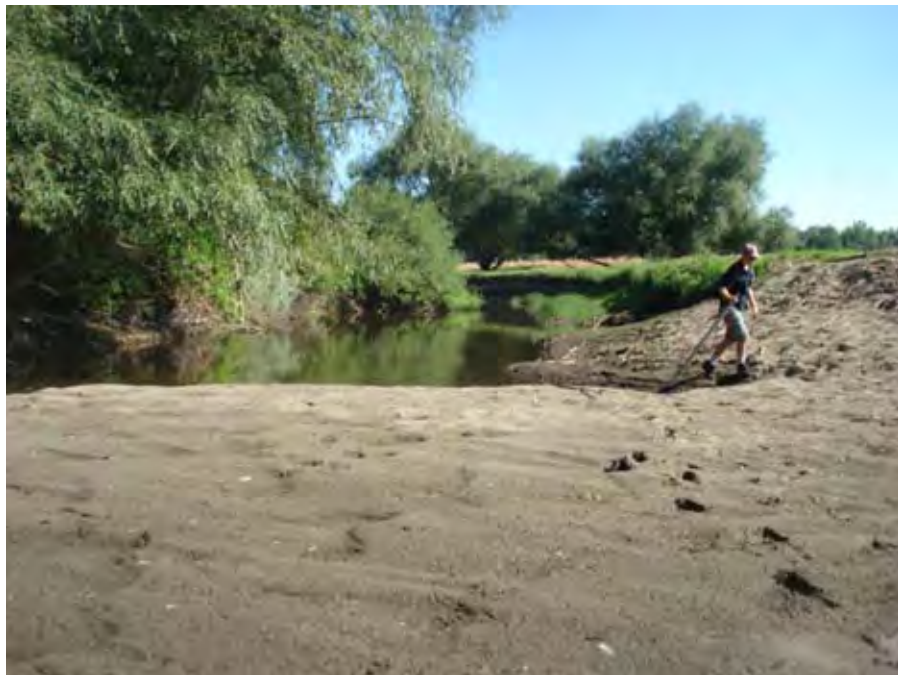
**Photograph 89. View looking downstream at a large bar along the right bank in the foreground near river mile 33.18. The right bank exhibits slumping and becomes vertical in the back ground. Reach 2 – Catherine Creek, Grande Ronde Subbasin, Oregon – Bureau of Reclamation Photograph by R. McAfee, August 1, 2010.**

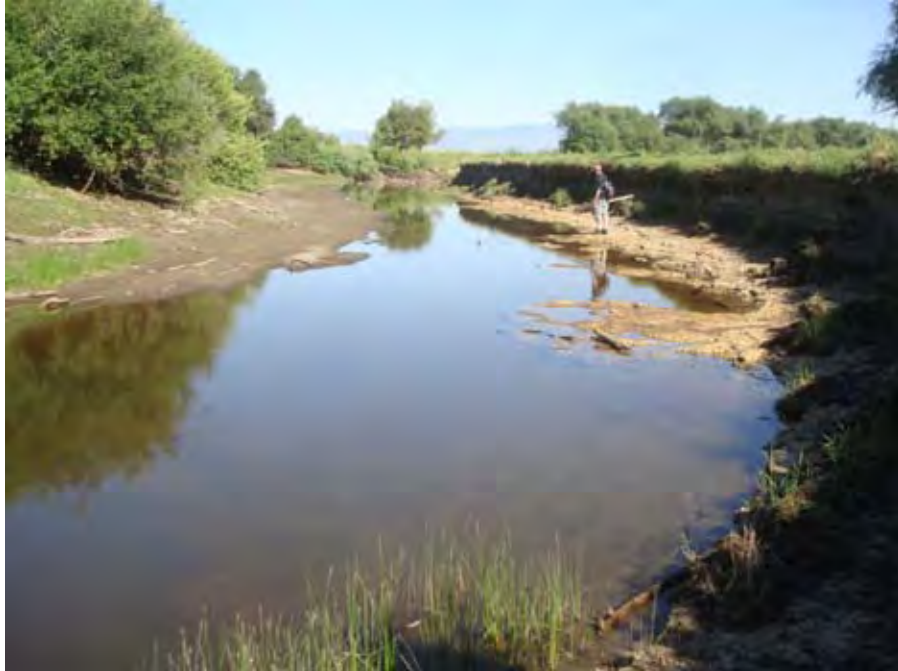
**Photograph 90. View looking downstream at the Catherine Creek channel, note fine-grained alluvium (tan dense silt) forming the bed of the creek near river mile 33.14. Reach 2 – Catherine Creek, Grande Ronde Subbasin, Oregon – Bureau of Reclamation Photograph by D. Stelma, August 1, 2010.**

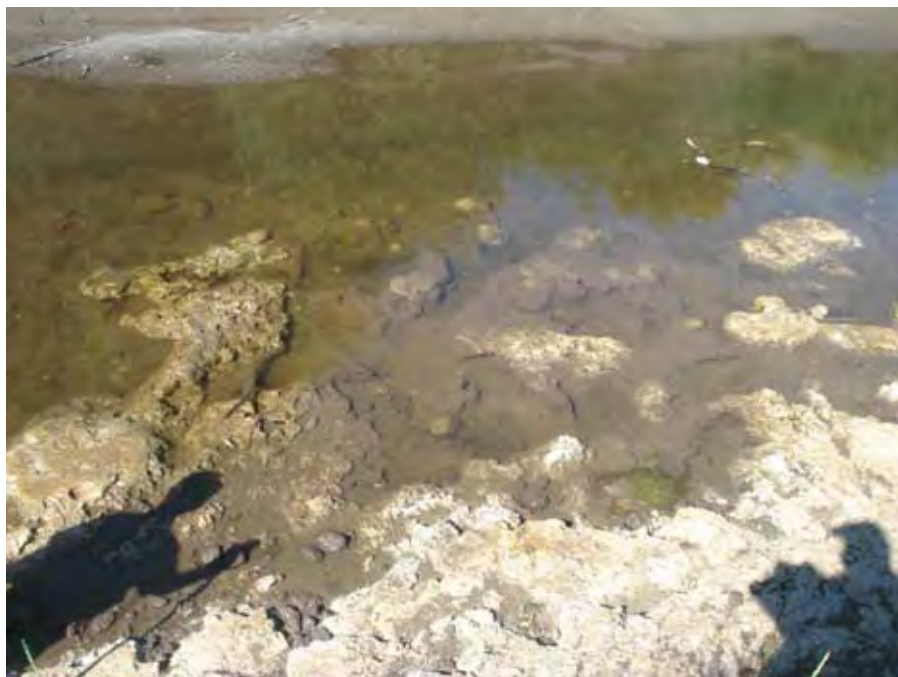
**Photograph 91. A close up view of the firm silty material that is erosion resistant, and visible along the toe of the right bank near river mile 33.03. Note the karst-type topography resulting from local ball milling by gravels visible in the lower left of the photograph. Reach 2 – Catherine Creek, Grande Ronde Subbasin, Oregon – Bureau of Reclamation Photograph by R. McAfee, August 1, 2010.**

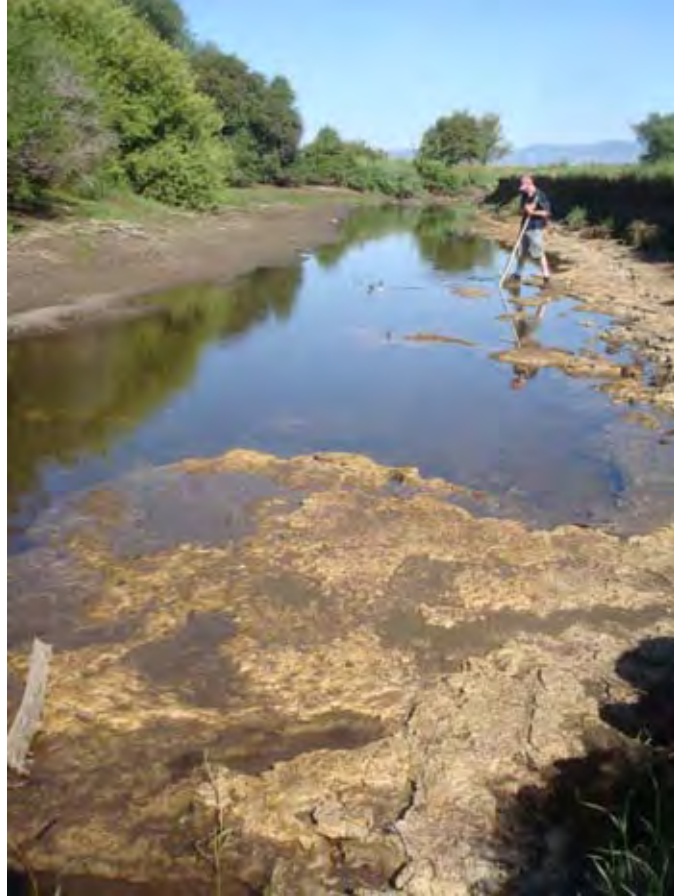
**Photograph 92. View looking downstream at the Catherine Creek channel near river mile 33.00, note fine-grained alluvium (tan dense silt) forming the bed of the creek. Reach 2 – Catherine Creek, Grande Ronde Subbasin, Oregon – Bureau of Reclamation Photograph by D. Stelma, August 1, 2010.**

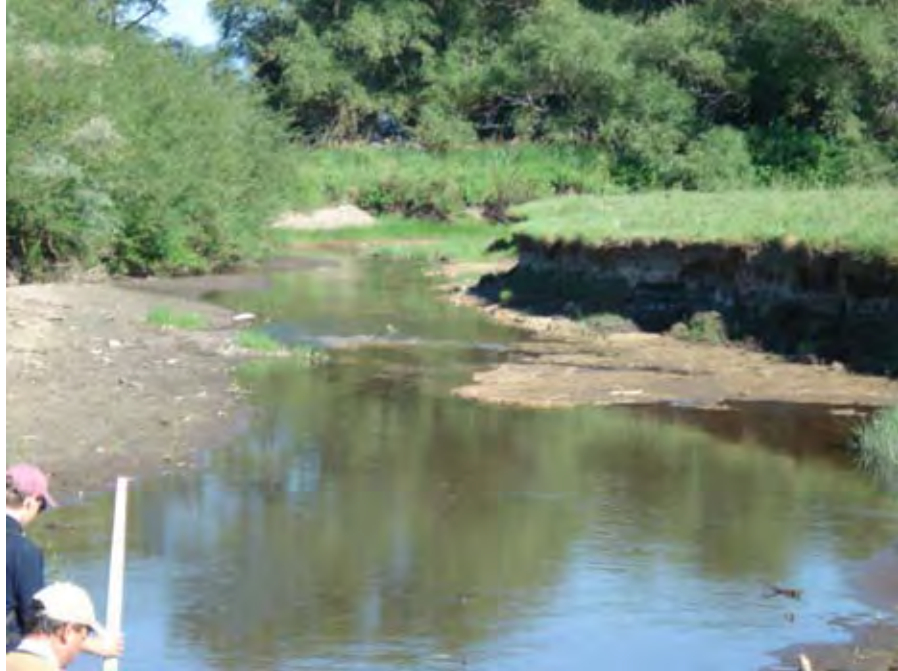
**Photograph 93. View looking downstream of sand along the left bank and the firm silty material that is erosion resistant in the channel bottom and along the toe of the right bank near river mile 32.96. Reach 2 – Catherine Creek, Grande Ronde Subbasin, Oregon – Bureau of Reclamation Photograph by R. McAfee, August 1, 2010.**

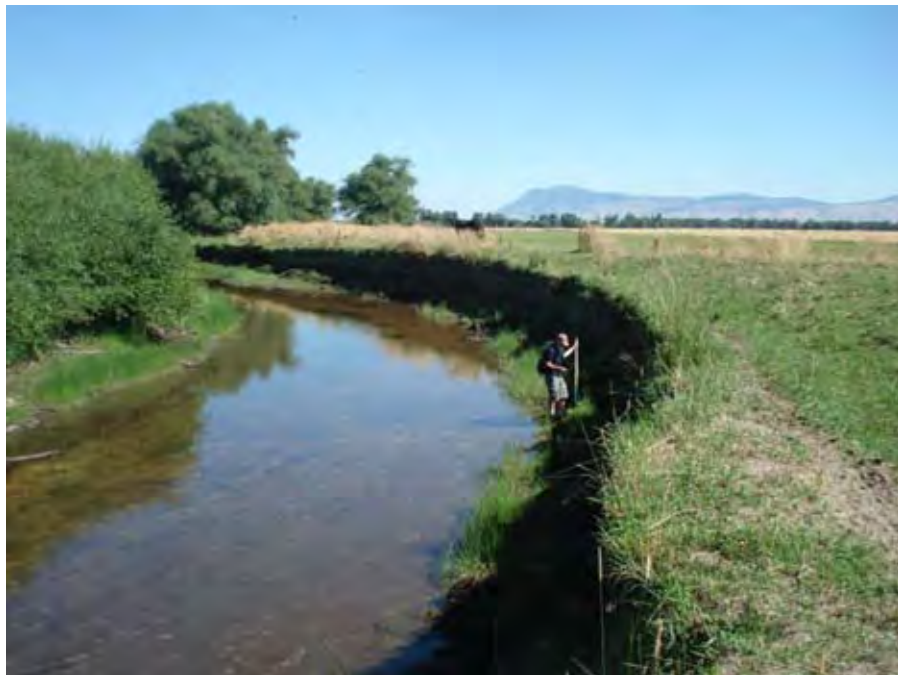
**Photograph 94. View of a section of the right bank that is near vertical, with banks slumps at the toe near river mile 32.90. Note the firm, silty material that is erosion resistant in the channel. Reach 2 – Catherine Creek, Grande Ronde Subbasin, Oregon – Bureau of Reclamation Photograph by R. McAfee, August 1, 2010.**

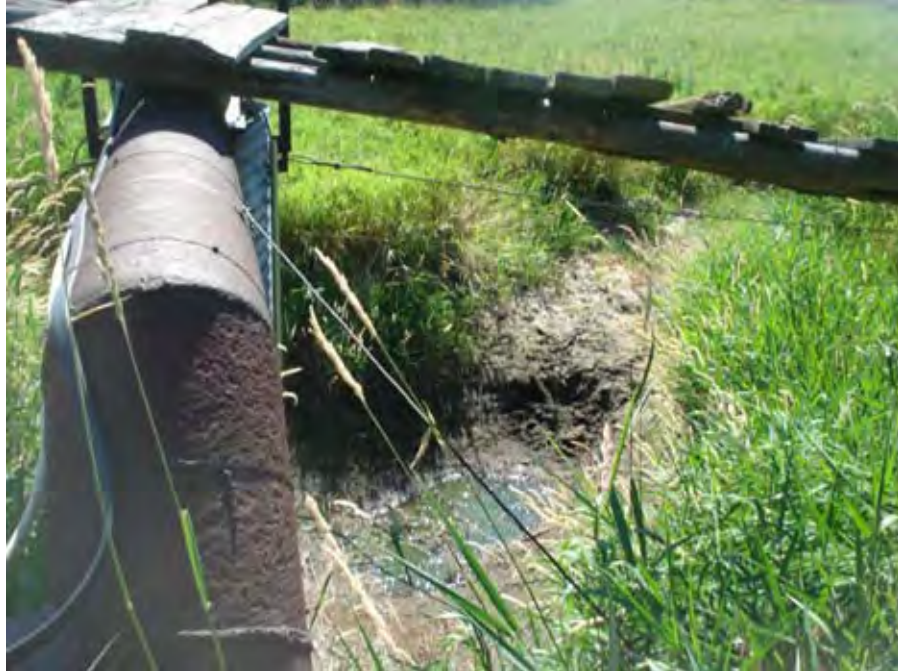
**Photograph 95. View of a pump with an excavated sump on the outside of a levee set back from the right bank near river mile 32.88. Reach 2 – Catherine Creek, Grande Ronde Subbasin, Oregon – Bureau of Reclamation Photograph by R. McAfee, August 1, 2010.**

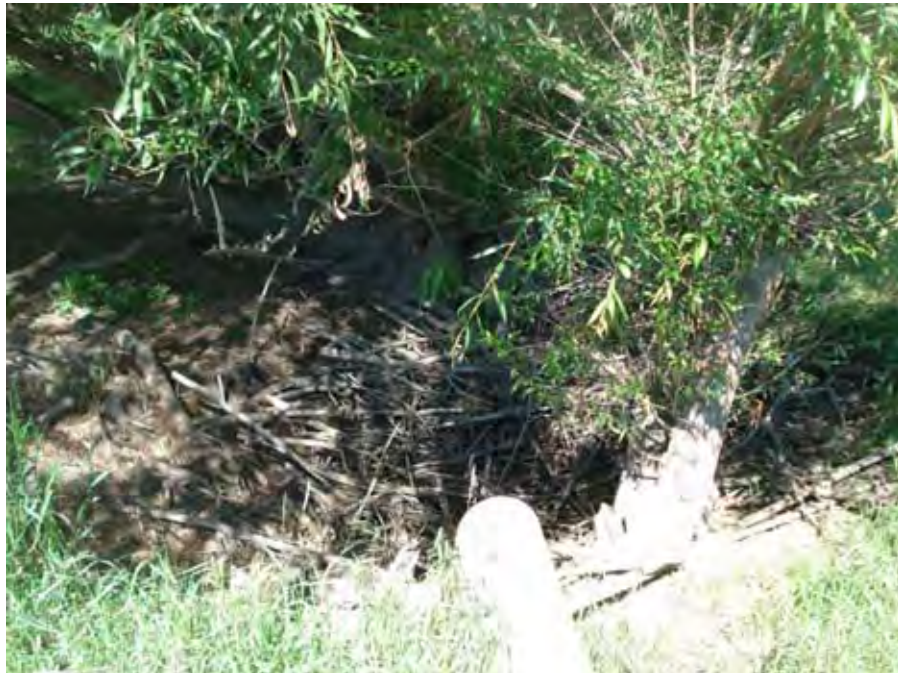
**Photograph 96. View of a pump discharge on the inside of a levee set back from the right bank near river mile 32.88. Reach 2 – Catherine Creek, Grande Ronde Subbasin, Oregon – Bureau of Reclamation Photograph by R. McAfee, August 1, 2010.**

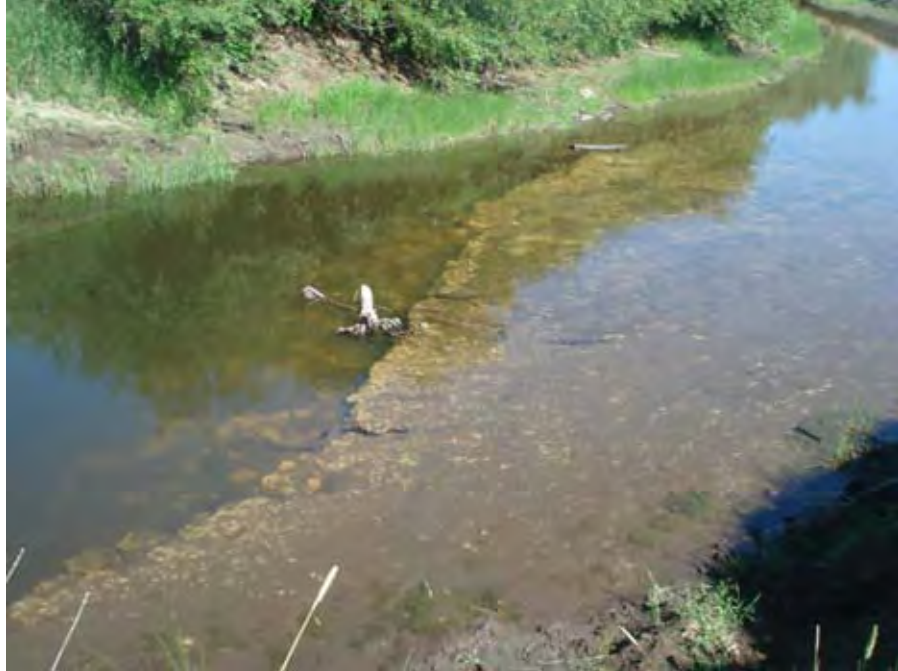
**Photograph 97. View from the right bank looking across the channel to the left at location of profile P-R2-10, near river mile 32.85 material that is erosion resistant in the channel. Reach 2 – Catherine Creek, Grande Ronde Subbasin, Oregon – Bureau of Reclamation Photograph by R. McAfee, August 1, 2010.**
