## **APPENDIX C – GEOLOGY AND GEOMORPHOLOGY**

## GEOLOGY AND GEOMORPHOLOGY REPORT FOR THE CATHERINE CREEK TRIBUTARY ASSESSMENT – GRANDE RONDE RIVER BASIN Tributary Habitat Program, Oregon

February 2012

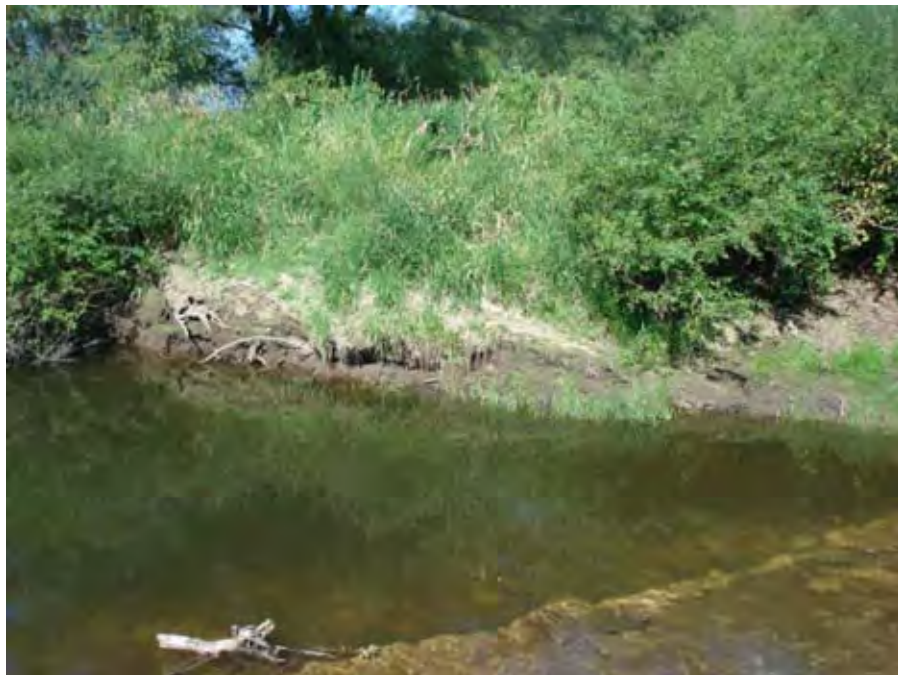
**Photograph 98. View from the right bank looking across the channel to the left at location of profile P-R2-10, near river mile 32.85 material that is erosion resistant in the channel. Reach 2 – Catherine Creek, Grande Ronde Subbasin, Oregon – Bureau of Reclamation Photograph by R. McAfee, August 1, 2010.**

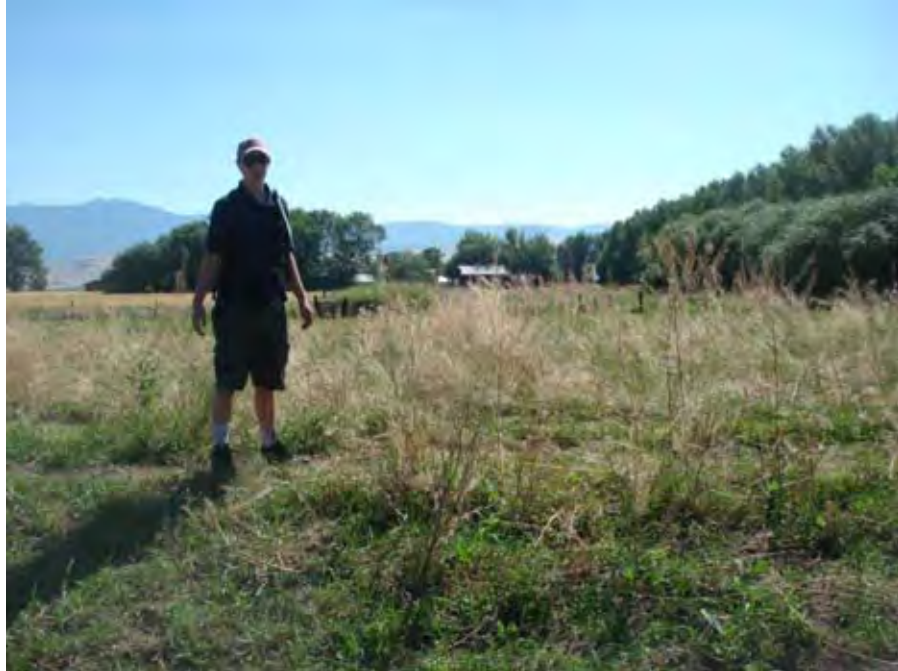
**Photograph 99. View from the right bank looking to the east of a levee in the right floodplain at material that is erosion resistant in the channel near river mile 32.85. Reach 2 – Catherine Creek, Grande Ronde Subbasin, Oregon – Bureau of Reclamation Photograph by R. McAfee, August 1, 2010.**

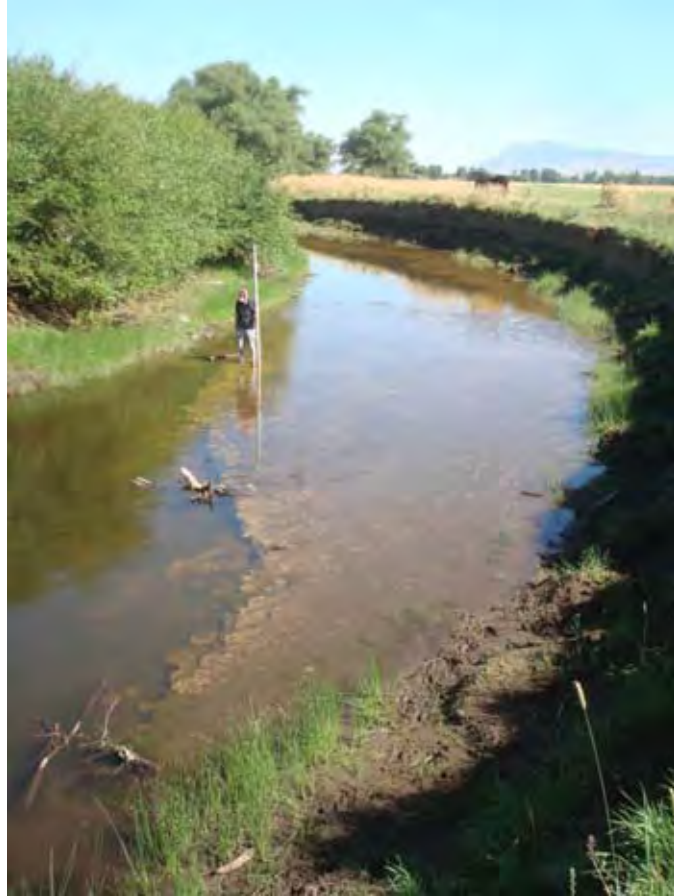
**Photograph 100. View looking downstream at the Catherine Creek channel and profile location near river mile 32.85, note fine-grained alluvium (tan dense silt) forming the bed of the creek. Reach 2 – Catherine Creek, Grande Ronde Subbasin, Oregon – Bureau of Reclamation Photograph by D. Stelma, August 1, 2010.**

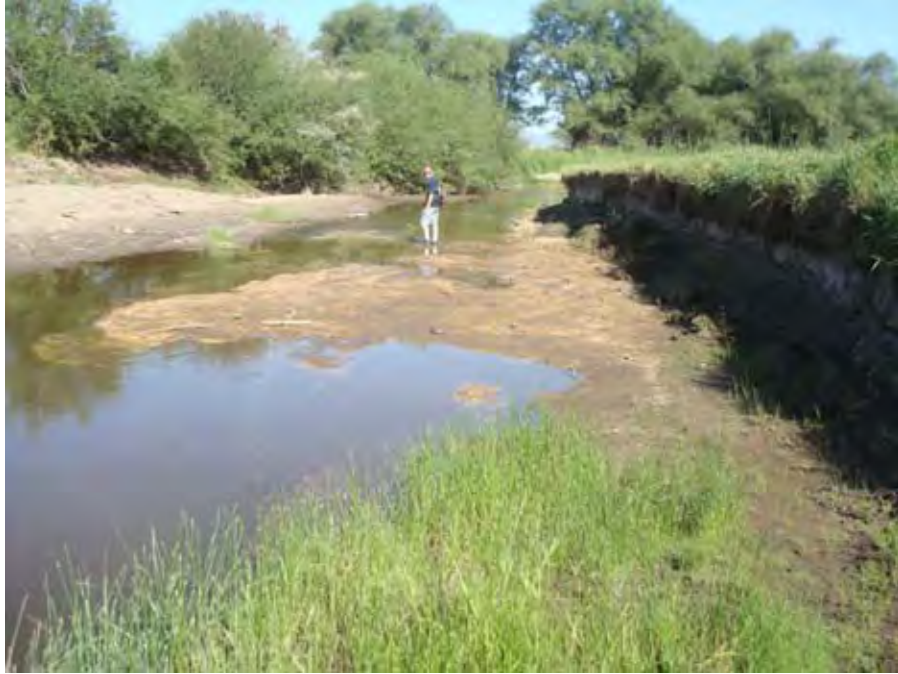
**Photograph 101. View looking downstream at the Catherine Creek channel near river mile 32.84, note fine-grained alluvium (tan dense silt) forming the bed of the creek. Reach 2 – Catherine Creek, Grande Ronde Subbasin, Oregon – Bureau of Reclamation Photograph by D. Stelma, August 1, 2010.**

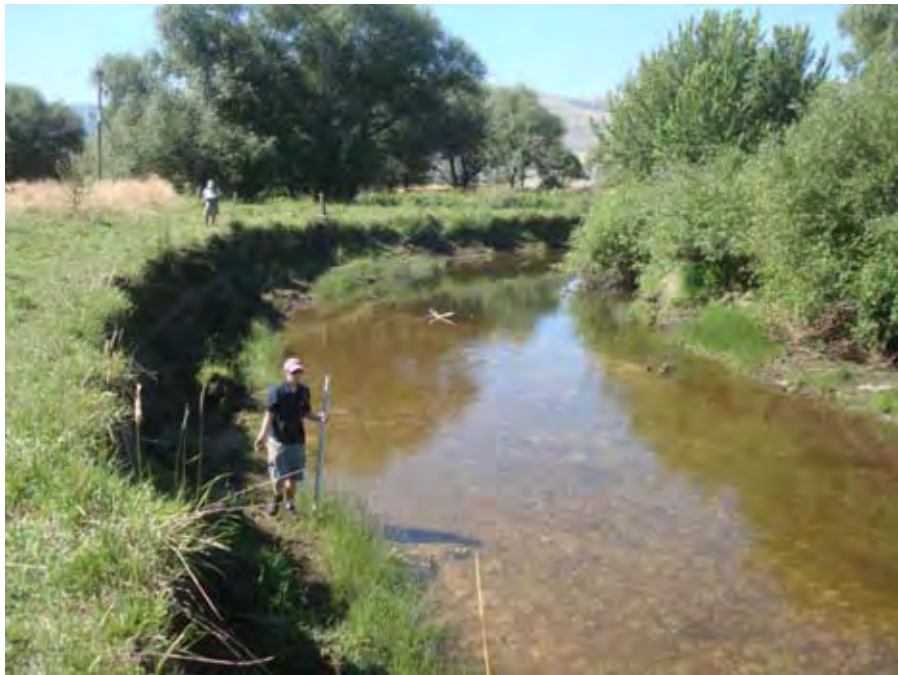
**Photograph 102. View looking upstream at the Catherine Creek channel near river mile 32.83, note fine-grained alluvium (tan dense silt) forming the bed of the creek. Reach 2 – Catherine Creek, Grande Ronde Subbasin, Oregon – Bureau of Reclamation Photograph by D. Stelma, August 1, 2010.**

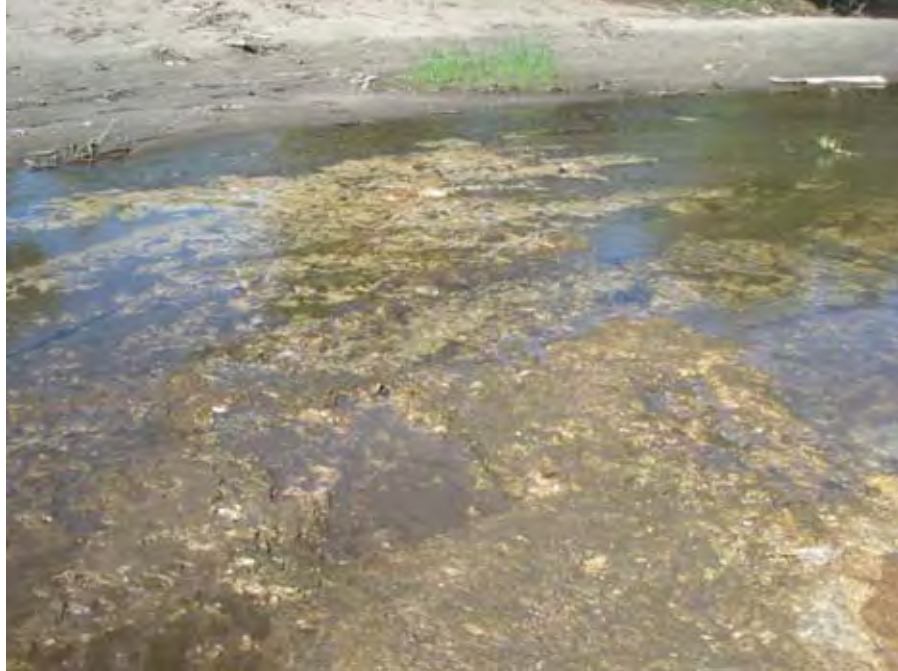
**Photograph 103. View of the firm, silty material that is erosion resistant in the channel bottom and along the toe of the right bank near river mile 32.81. Reach 2 – Catherine Creek, Grande Ronde Subbasin, Oregon – Bureau of Reclamation Photograph by R. McAfee, August 1, 2010.**

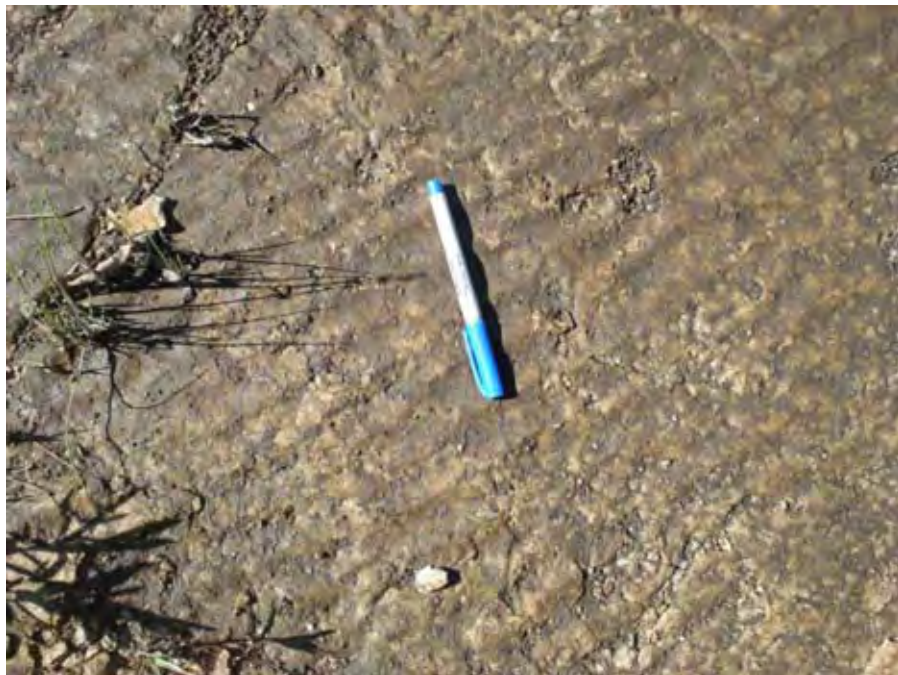
**Photograph 104. A close up view of ripple marks in the surface of the firm, silty material that is erosion resistant in the channel bottom and along the toe of the right bank near river mile 32.81. Reach 2 – Catherine Creek, Grande Ronde Subbasin, Oregon – Bureau of Reclamation Photograph by R. McAfee, August 1, 2010.**

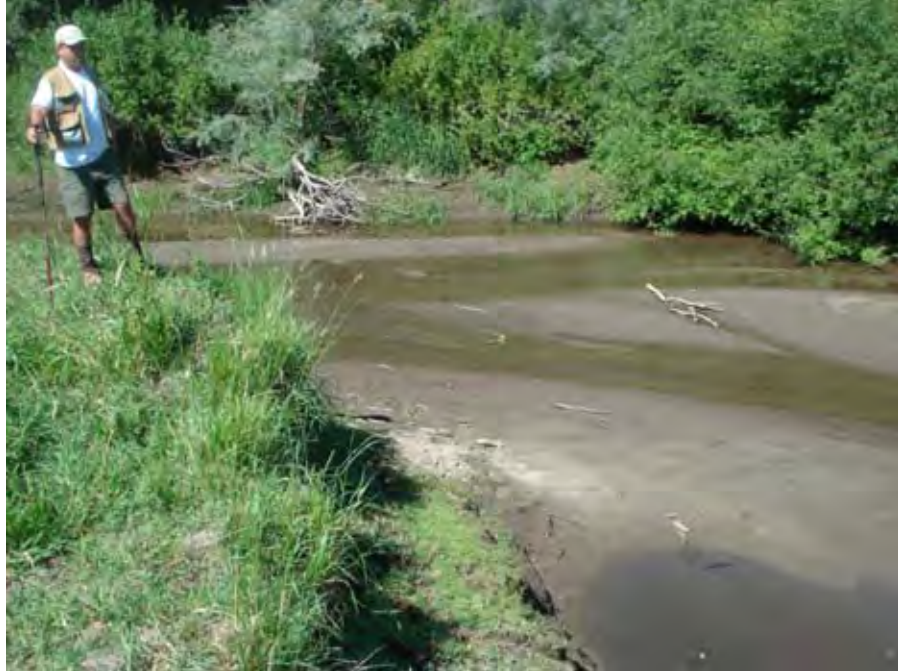
**Photograph 105. View from the right bank looking across the channel to the left at location of deposition of sand-sized material and 'braided flow' near river mile 32.75. Reach 2 – Catherine Creek, Grande Ronde Subbasin, Oregon – Bureau of Reclamation Photograph by R. McAfee, August 1, 2010.**

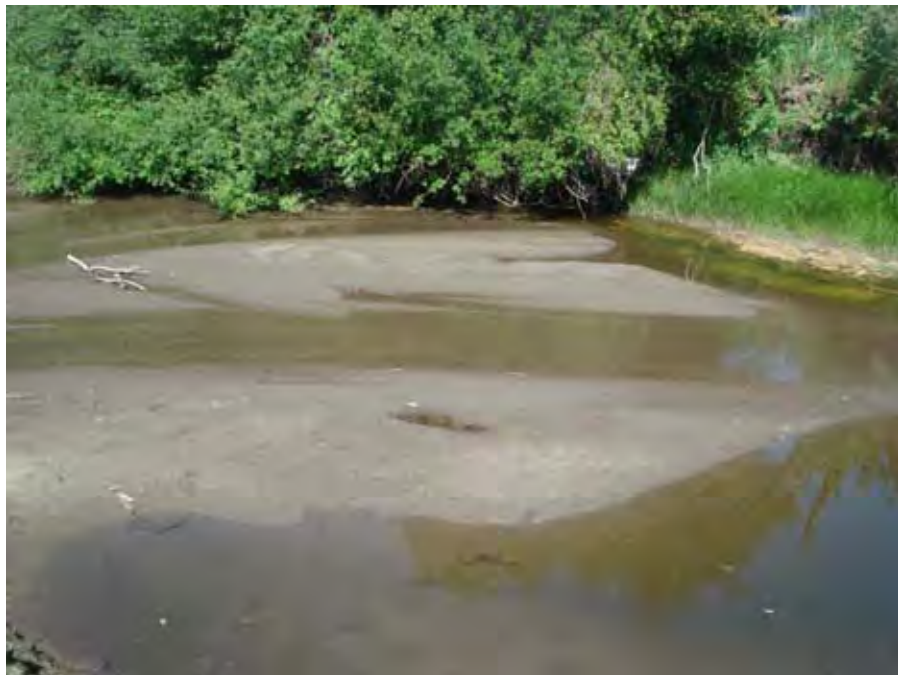
**Photograph 106. View from the right bank looking across the channel to the left at location of deposition of sand-sized material and 'braided flow' near river mile 32.75. Reach 2 – Catherine Creek, Grande Ronde Subbasin, Oregon – Bureau of Reclamation Photograph by R. McAfee, August 1, 2010.**

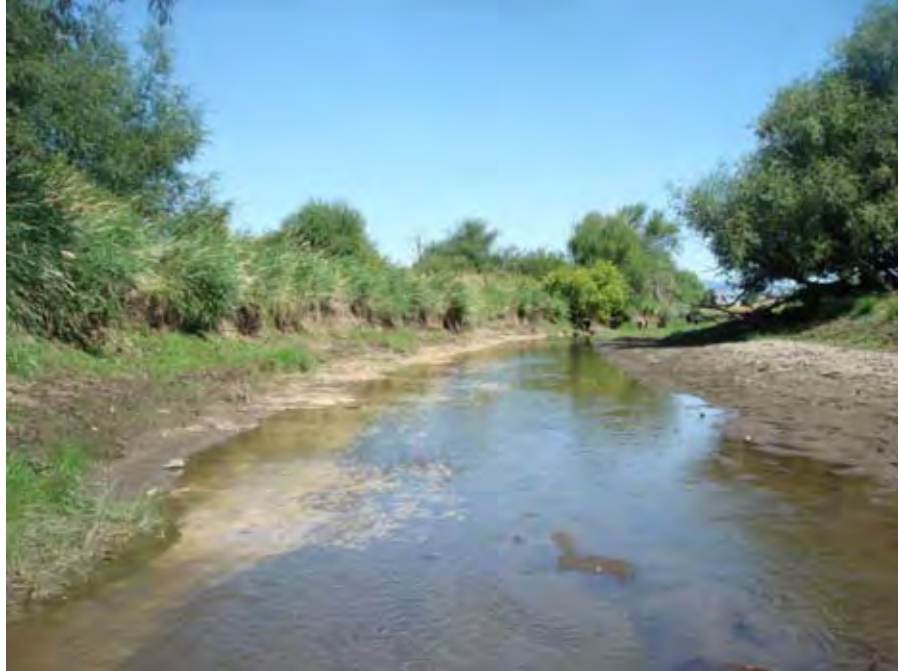
**Photograph 107. View looking downstream at gently sloped to vertical (left) banks, sand sized bed material and a dense, light tan erosion resistant material along the left bank toe near river mile 32.54. Reach 2 – Catherine Creek, Grande Ronde Subbasin, Oregon – Bureau of Reclamation Photograph by R. McAfee, August 1, 2010.**

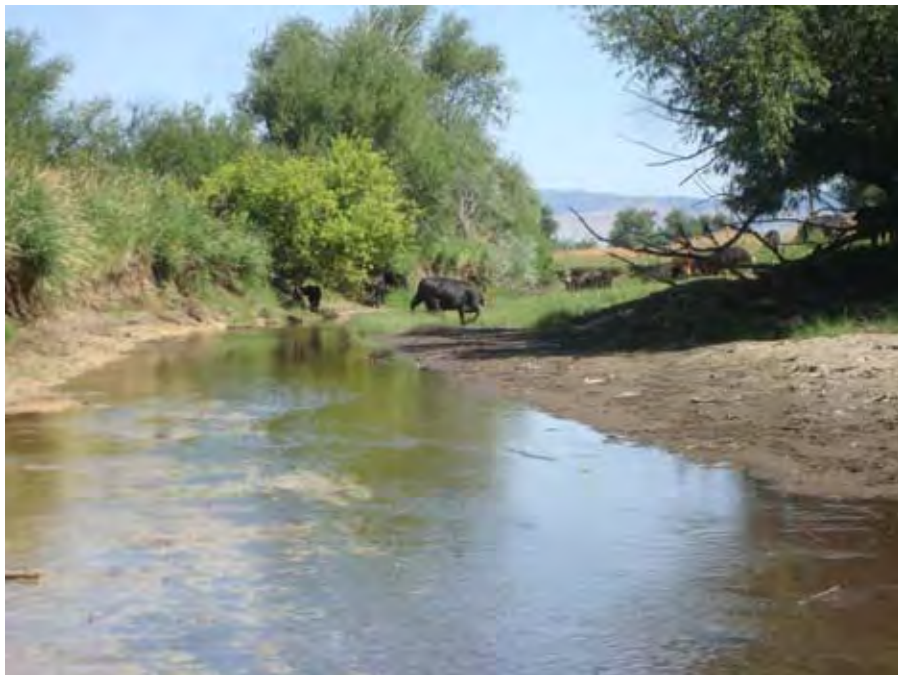
**Photograph 108. View looking downstream at the Catherine Creek channel near river mile 32.53, note cattle in stream. Reach 2 – Catherine Creek, Grande Ronde Subbasin, Oregon – Bureau of Reclamation Photograph by D. Stelma, August 1, 2010.**

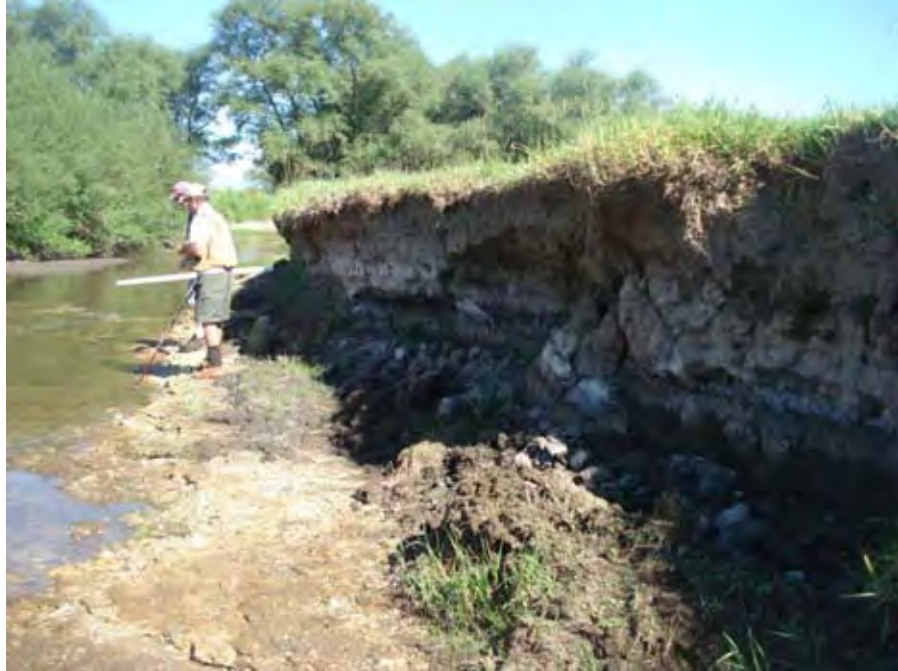
**Photograph 109. View along the right bank showing active bank erosion and the firm, silty material that is erosion resistant in the channel bottom and along the toe of the right bank near river mile 32.50. Reach 2 – Catherine Creek, Grande Ronde Subbasin, Oregon – Bureau of Reclamation Photograph by R. McAfee, August 1, 2010.**

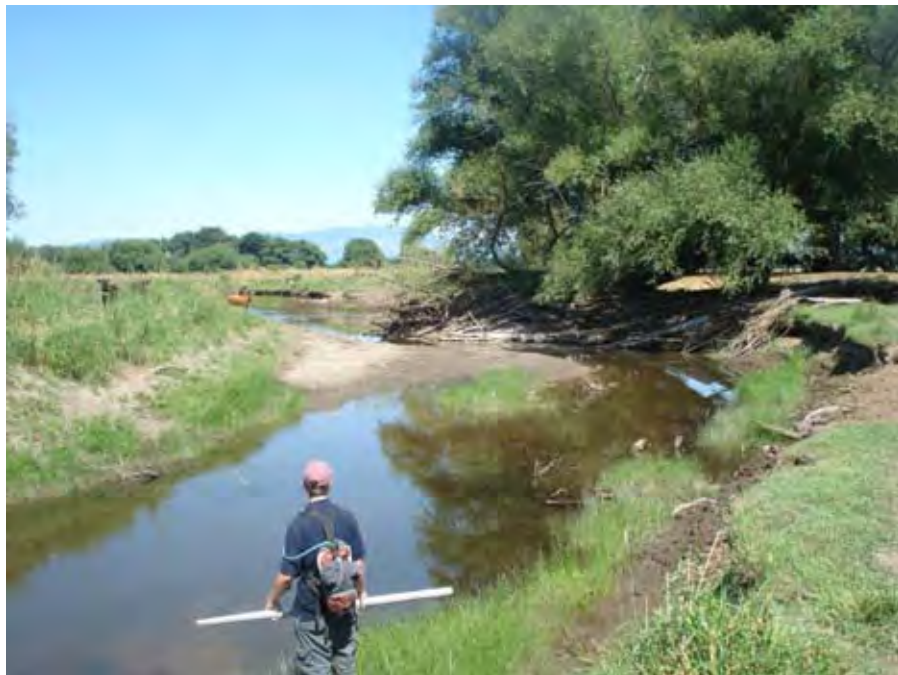
**Photograph 110. View looking downstream at an over-flow site along the right bank near river mile 32.30. Reach 2 – Catherine Creek, Grande Ronde Subbasin, Oregon – Bureau of Reclamation Photograph by R. McAfee, August 1, 2010.**

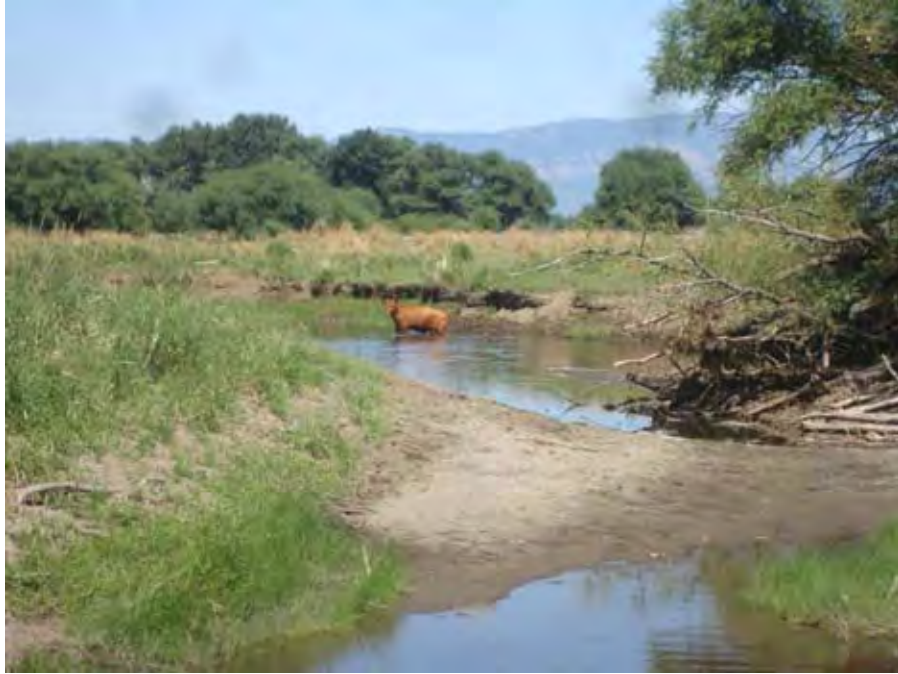
**Photograph 111. View looking downstream at the Catherine Creek channel near river mile 32.30, note cattle in stream. Reach 2 – Catherine Creek, Grande Ronde Subbasin, Oregon – Bureau of Reclamation Photograph by D. Stelma, August 1, 2010.**

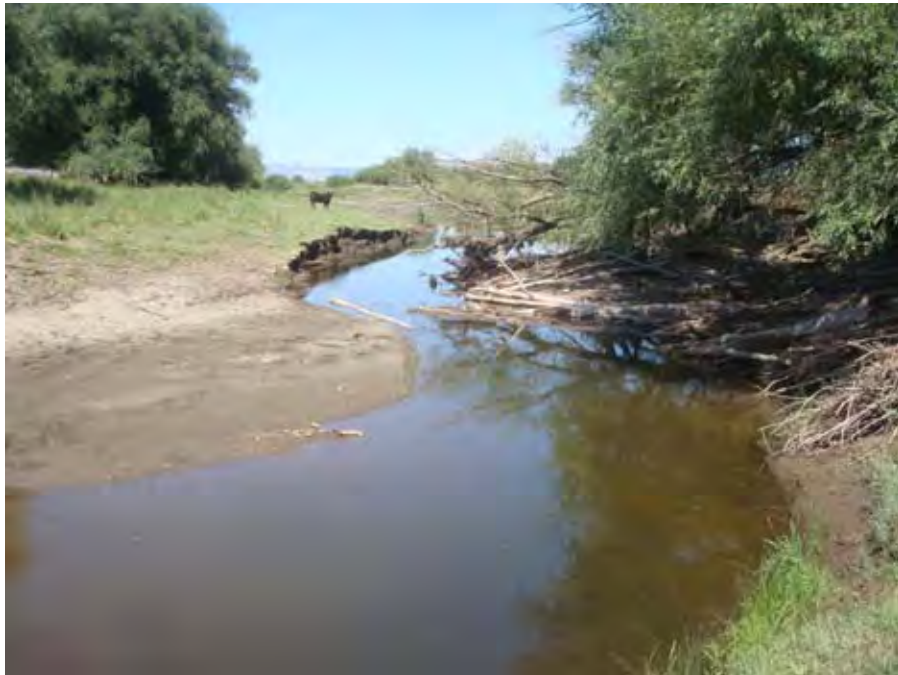
**Photograph 112. View looking downstream at the Catherine Creek channel near river mile 32.30, note cattle on stream bank. Reach 2 – Catherine Creek, Grande Ronde Subbasin, Oregon – Bureau of Reclamation Photograph by D. Stelma, August 1, 2010.**

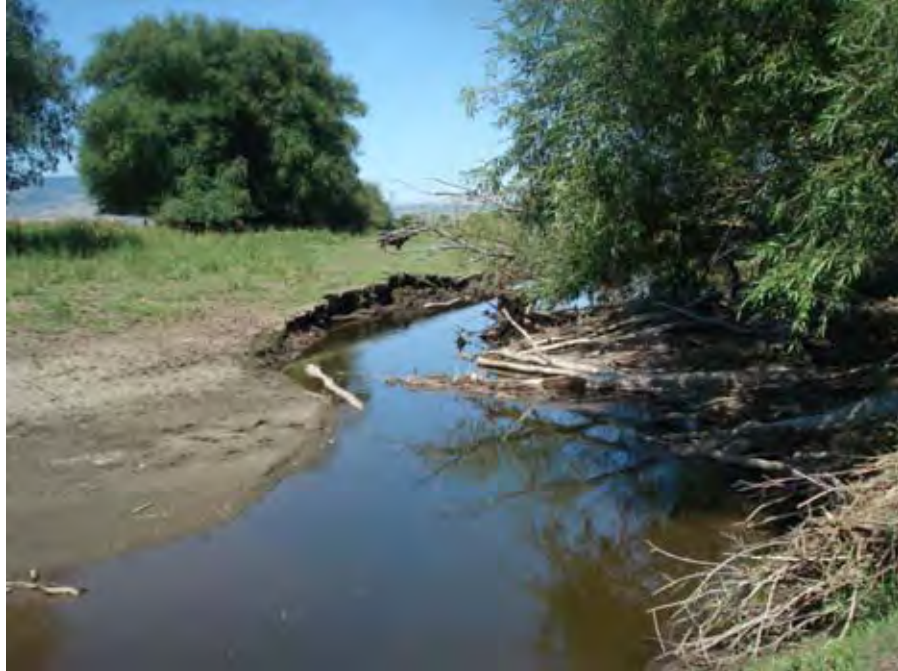
**Photograph 113. View from the right bank looking downstream at scour along the left bank associated with wood accumulation along the right bank near river mile RM 32.30. Reach 2 – Catherine Creek, Grande Ronde Subbasin, Oregon – Bureau of Reclamation Photograph by R. McAfee, August 1, 2010.**

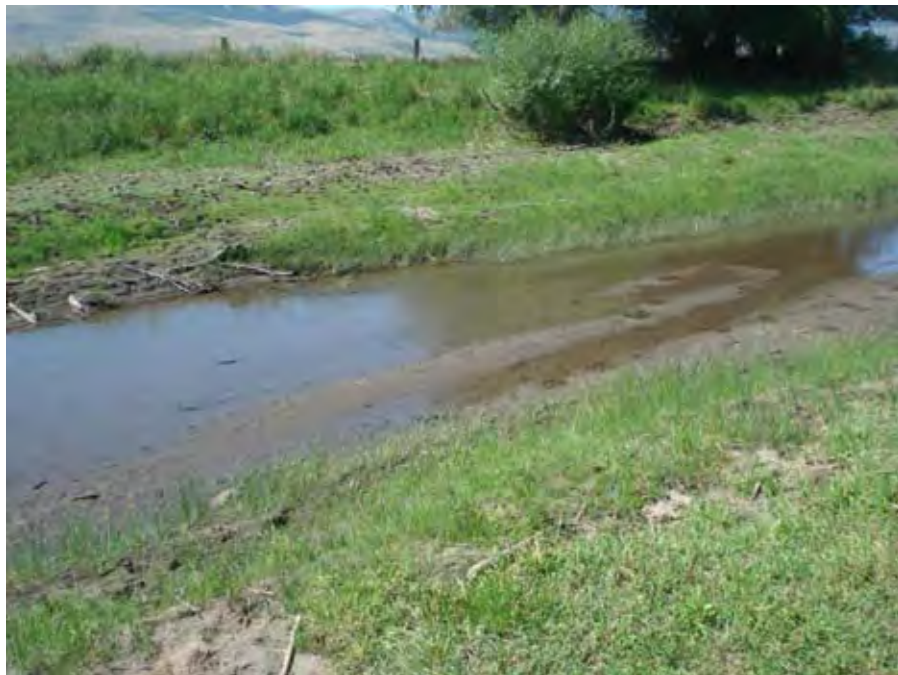
**Photograph 114. View from the right bank looking at a section of deposition of sand sized material near river mile 32.14. Reach 2 – Catherine Creek, Grande Ronde Subbasin, Oregon – Bureau of Reclamation Photograph by R. McAfee, August 1, 2010.**

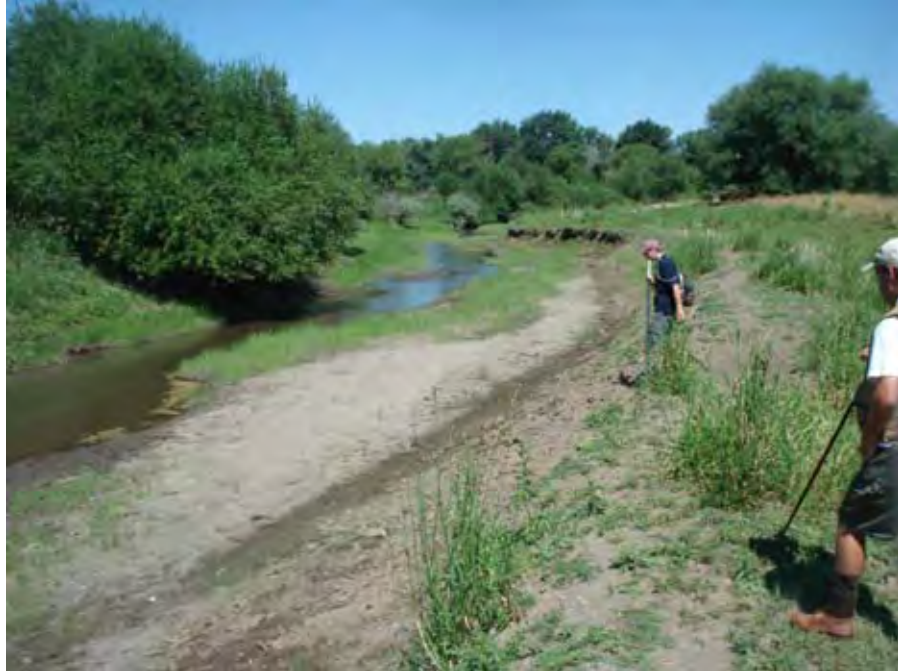
**Photograph 115. View from the right bank looking downstream at sandbar with vegetation along the toe of both banks near river mile 32.10. Reach 2 – Catherine Creek, Grande Ronde Subbasin, Oregon – Bureau of Reclamation Photograph by R. McAfee, August 1, 2010.**

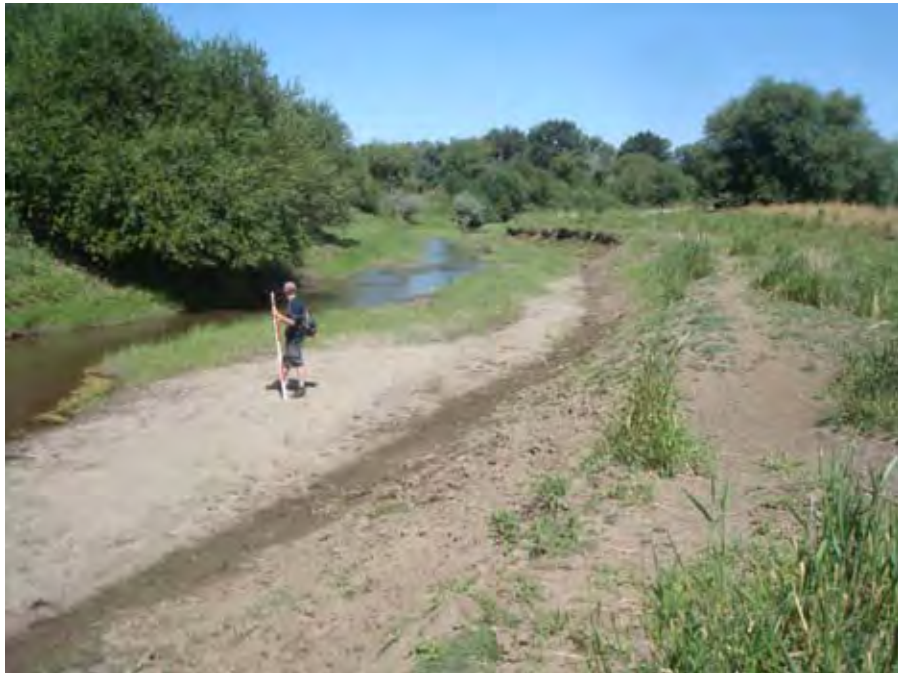
**Photograph 116. View looking downstream at the Catherine Creek channel near river mile 32.10, note sandy bed deposits. Reach 2 – Catherine Creek, Grande Ronde Subbasin, Oregon – Bureau of Reclamation Photograph by D. Stelma, August 1, 2010**

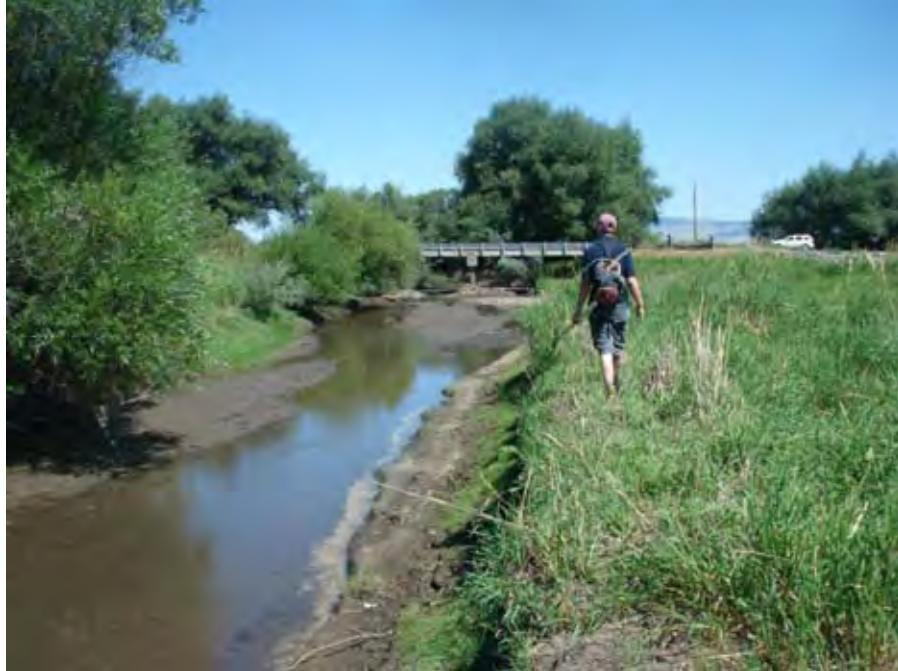
**Photograph 117. View from the right bank looking downstream at sandbar development along the toe of both banks near river mile 32.00. Reach 2 – Catherine Creek, Grande Ronde Subbasin, Oregon – Bureau of Reclamation Photograph by R. McAfee, August 1, 2010.**

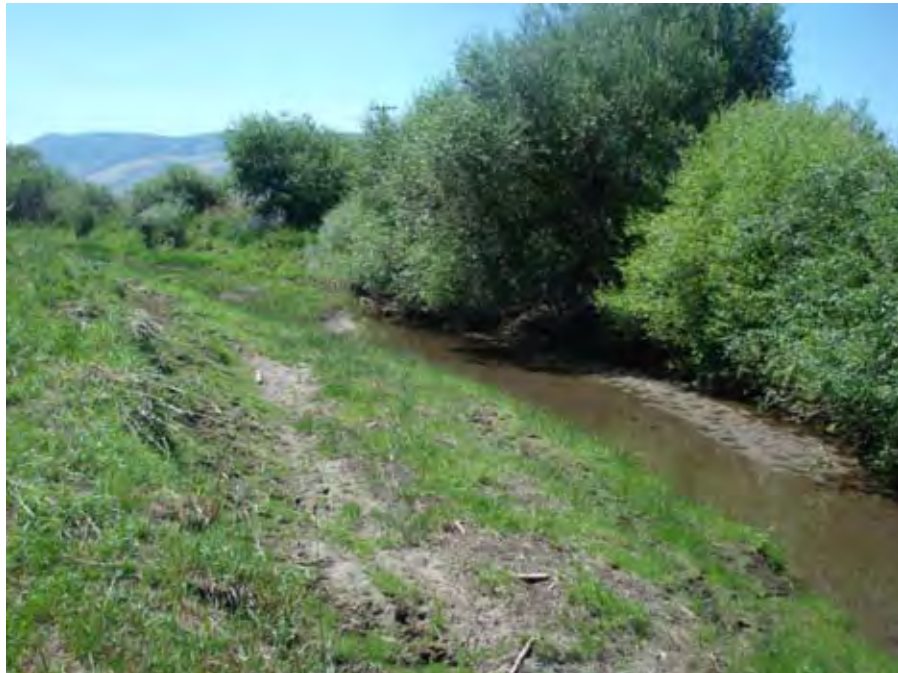
**Photograph 118. View from the right bank looking upstream at sandbar development along the toe of both banks near river mile 32.00. Reach 2 – Catherine Creek, Grande Ronde Subbasin, Oregon – Bureau of Reclamation Photograph by R. McAfee, August 1, 2010.**

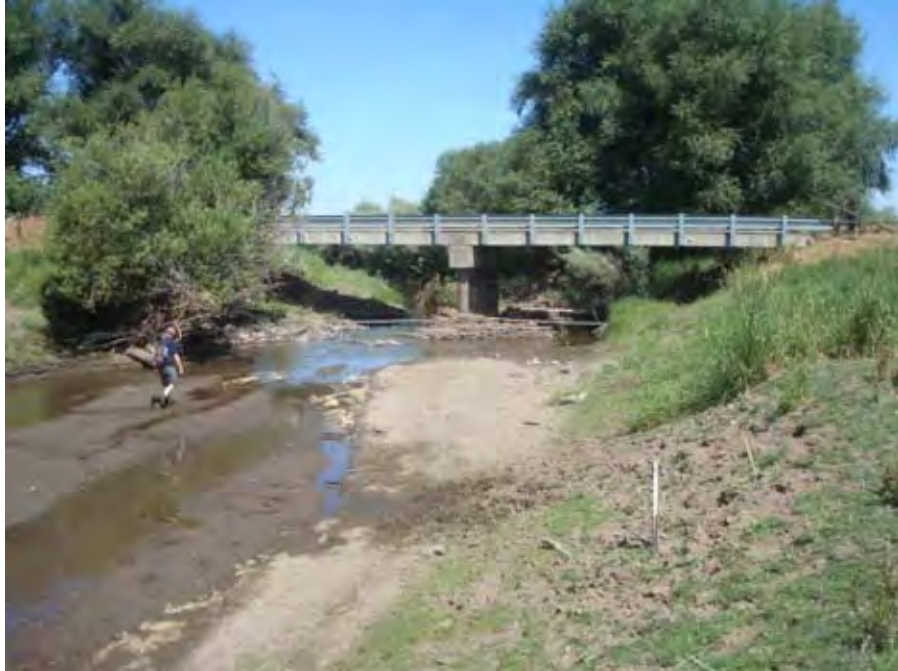
**Photograph 119. View looking downstream at the Wilkinson Lane Bridge near river mile 32.00. Reach 2 – Catherine Creek, Grande Ronde Subbasin, Oregon – Bureau of Reclamation Photograph by D. Stelma, August 1, 2010.**

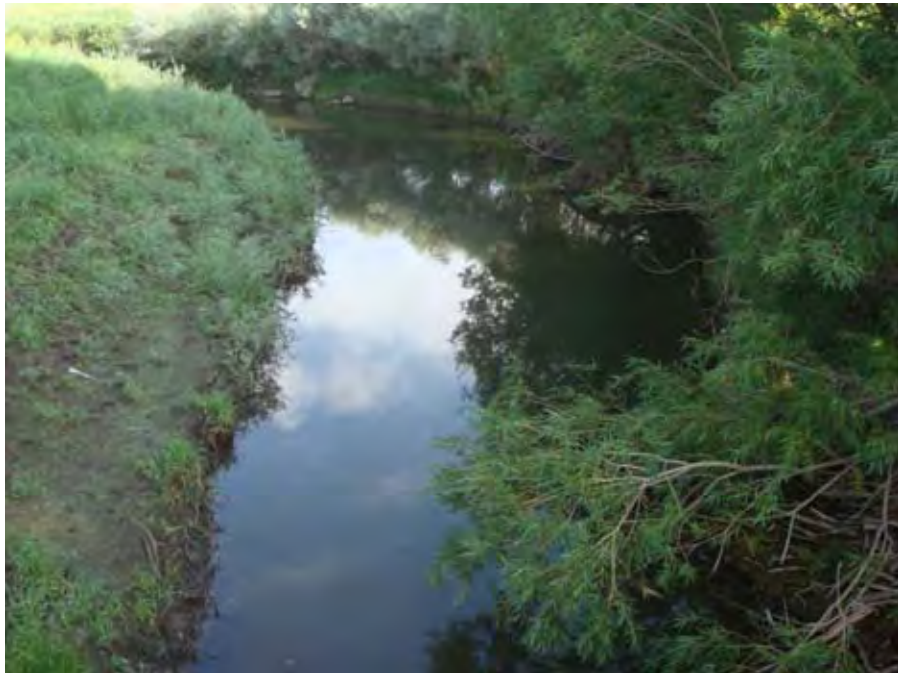
**Photograph 120. View from the Wilkinson Lane Bridge looking downstream at the Catherine Creek channel near river mile 31.95. Reach 2 – Catherine Creek, Grande Ronde Subbasin, Oregon – Bureau of Reclamation Photograph by D. Stelma, July 28, 2010.**

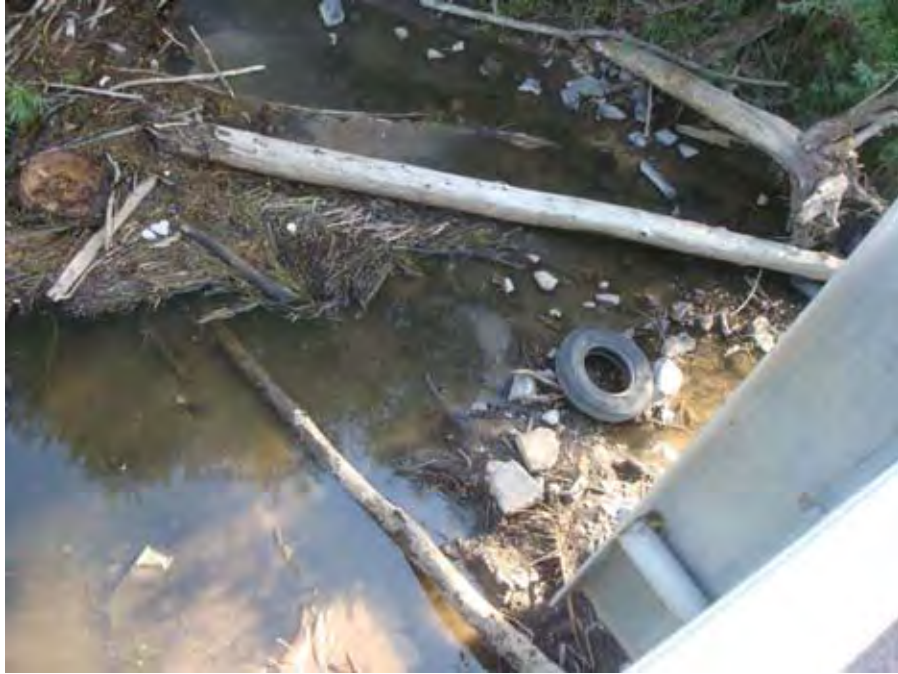
**Photograph 121. View of Catherine Creek from the Wilkinson Lane Bridge near river mile 31.95. Reach 2 – Catherine Creek, Grande Ronde Subbasin, Oregon – Bureau of Reclamation Photograph by D. Stelma, July 28, 2010.**

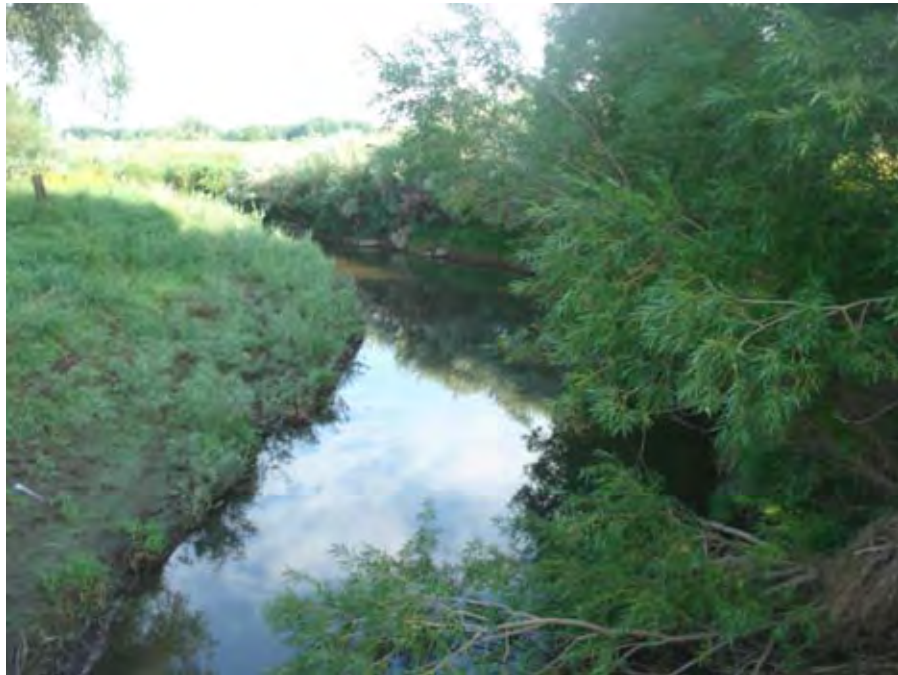
**Photograph 122. View looking downstream from Wilkinson Bridge of grass/shrub vegetation along the left bank, and sapling-pole vegetation and random riprap along the right bank near river mile 31.95. Reach 2 – Catherine Creek, Grande Ronde Subbasin, Oregon – Bureau of Reclamation Photograph by R. McAfee, July 28, 2010.**

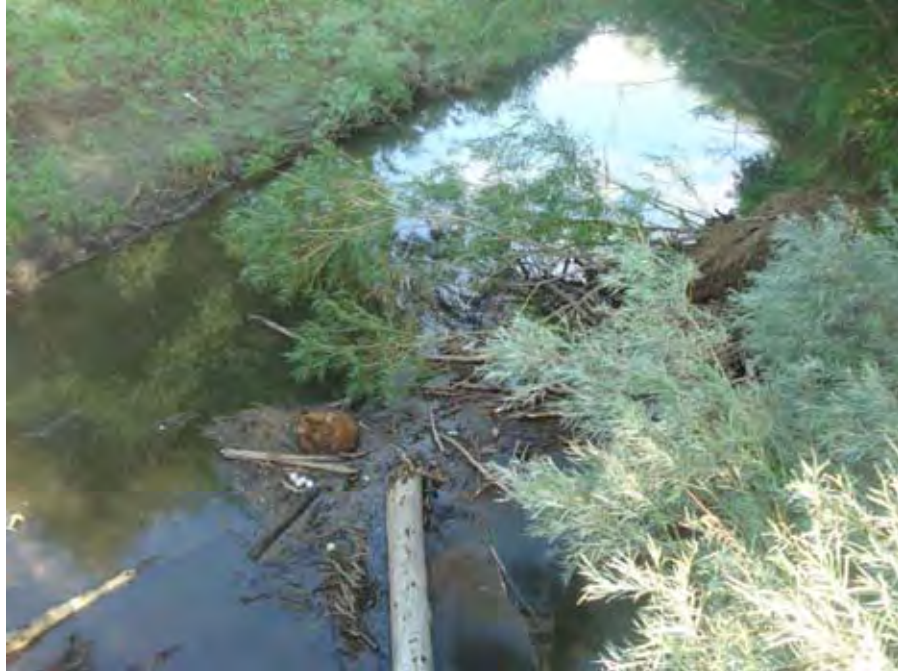
**Photograph 123. A view looking downstream from Wilkinson Bridge at debris collecting in front of the sapling-pole vegetation along the right bank near river mile 31.95. Reach 2 – Catherine Creek, Grande Ronde Subbasin, Oregon – Bureau of Reclamation Photograph by R. McAfee, July 28, 2010.**

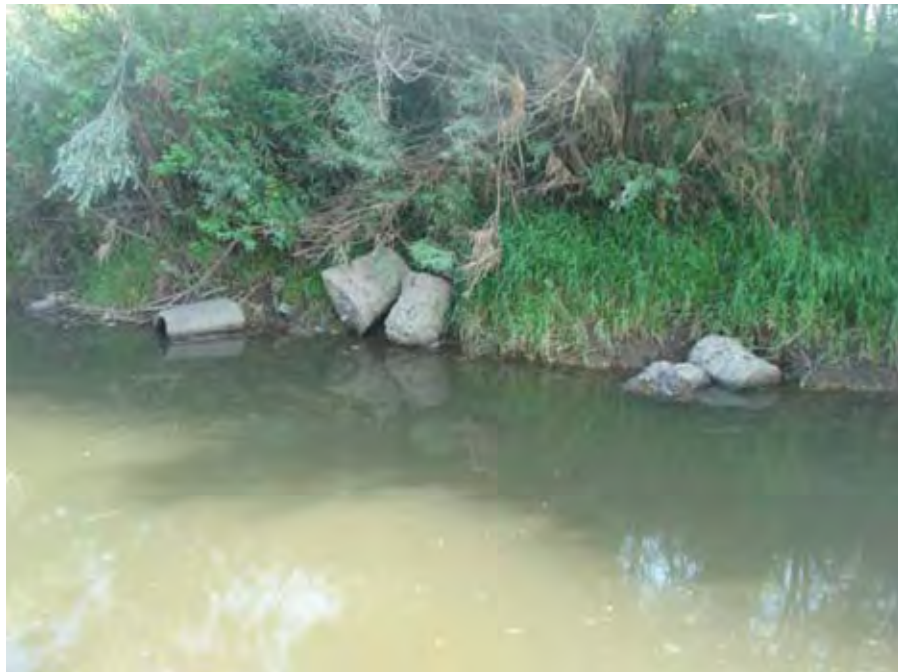
**Photograph 124. View looking downstream from the left bank to the right at random concrete blocks along the toe of the right bank near river mile 31.94. Reach 2 – Catherine Creek, Grande Ronde Subbasin, Oregon – Bureau of Reclamation Photograph by R. McAfee, July 28, 2010.**

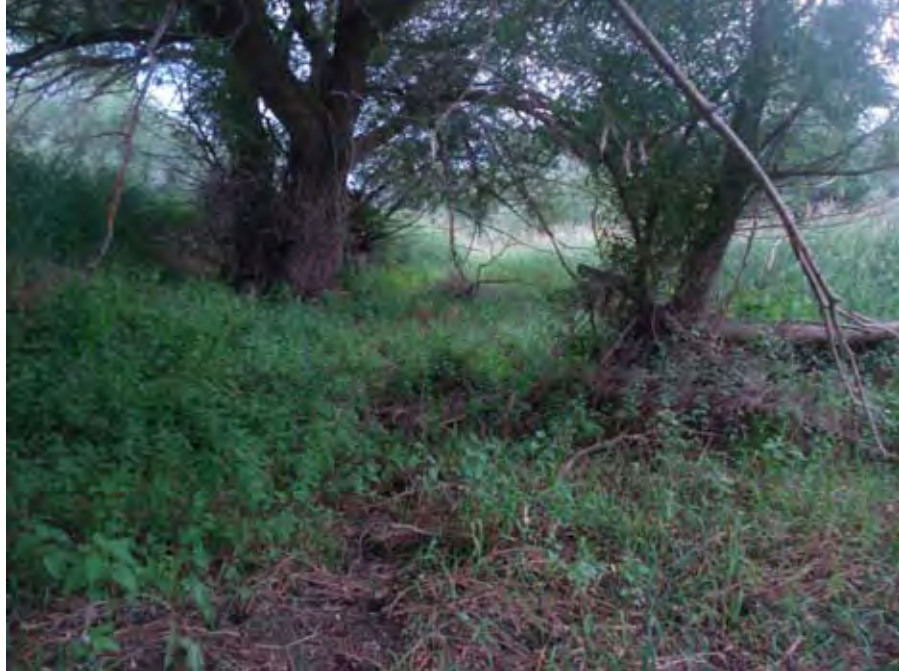
**Photograph 125. View from the right bank looking upstream at an overflow channel in the right floodplain near river mile 31.89. Reach 2 – Catherine Creek, Grande Ronde Subbasin, Oregon – Bureau of Reclamation Photograph by R. McAfee, July 28, 2010.**

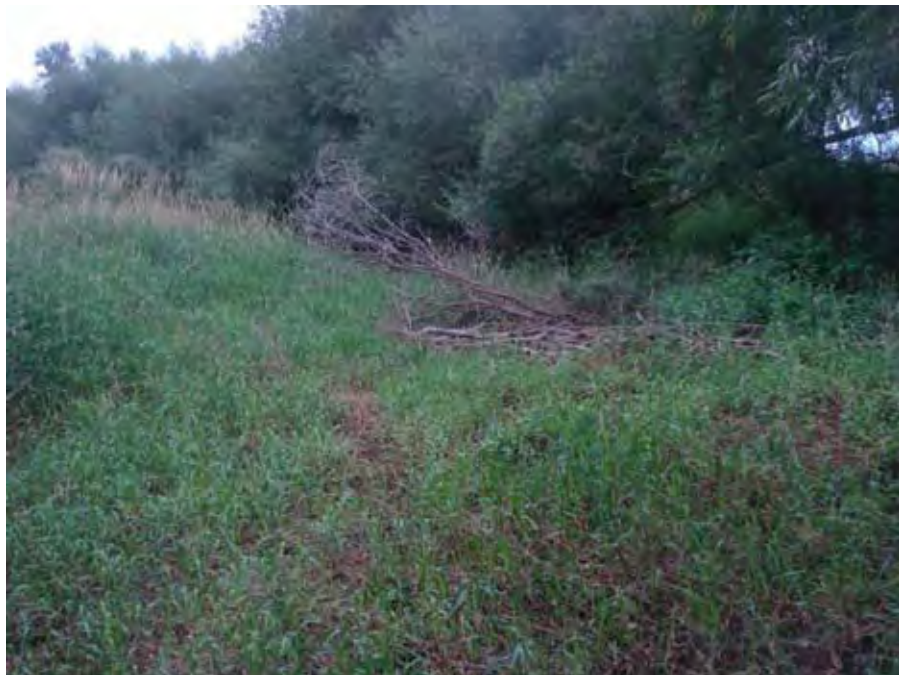
**Photograph 126. View from the right bank looking downstream an overflow channel in the right floodplain at river mile 31.89. Reach 2 – Catherine Creek, Grande Ronde Subbasin, Oregon – Bureau of Reclamation Photograph by R. McAfee, July 28, 2010.**

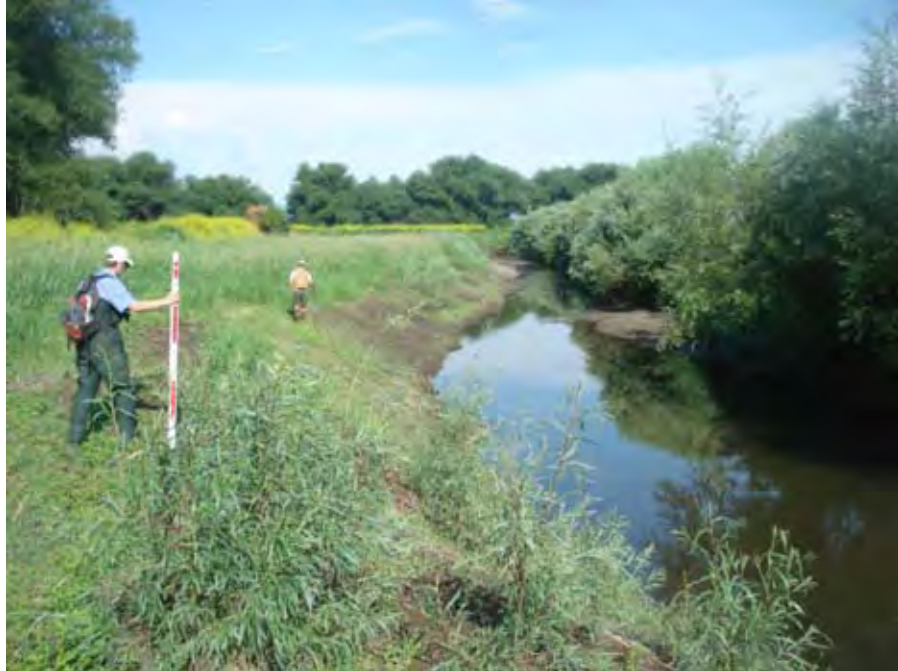
**Photograph 127. View looking downstream from the left bank at predominantly grass vegetation along the top of the left bank, willow and small tree vegetation along the right, and alternating sand bar deposits in the channel near river mile 31.88. Reach 2 – Catherine Creek, Grande Ronde Subbasin, Oregon – Bureau of Reclamation Photograph by R. McAfee, July 28, 2010.**

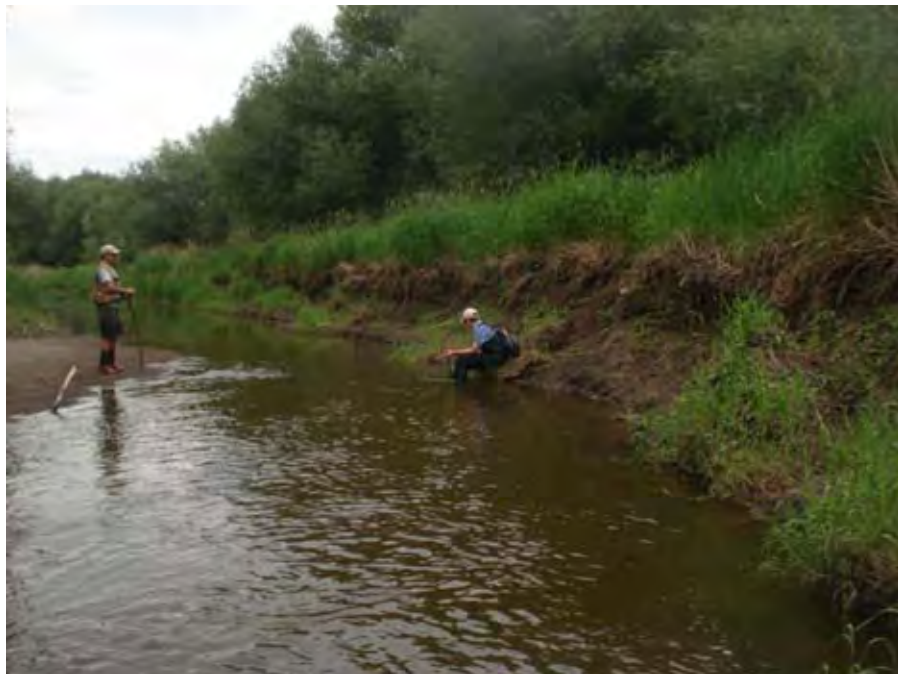
**Photograph 128. A view from the right bank looking downstream at slumping along a predominantly grass vegetated right bank and sand bed-load in the main channel near river mile 31.87. Reach 2 – Catherine Creek, Grande Ronde Subbasin, Oregon – Bureau of Reclamation Photograph by R. McAfee, July 28, 2010.**

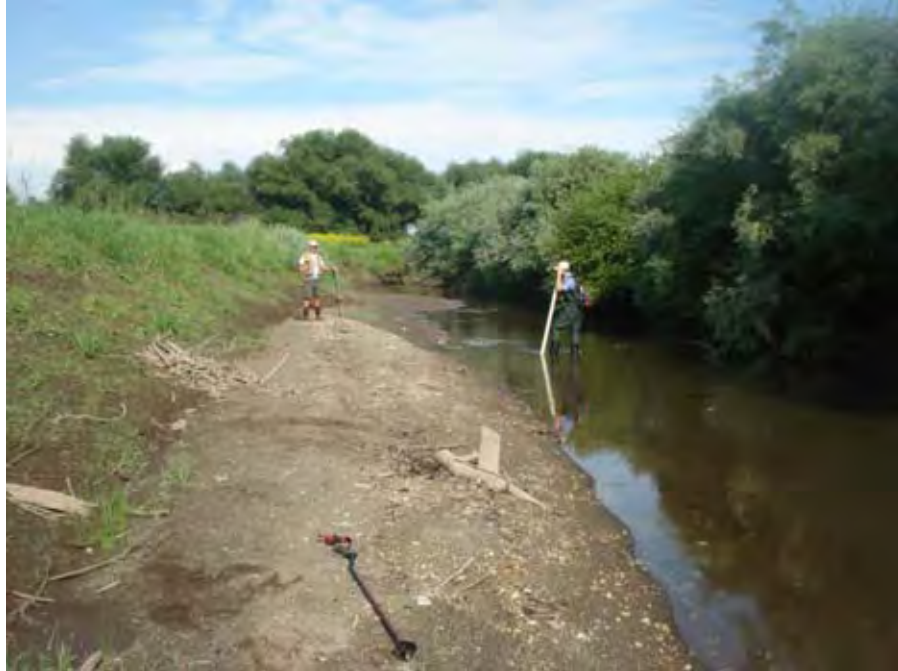
**Photograph 129. View looking downstream from the left bank at predominantly grass vegetation along the top of the left bank, willow and small tree vegetation along the right, and recently deposited sand bar along the toe of the left bank near river mile 31.85. Reach 2 – Catherine Creek, Grande Ronde Subbasin, Oregon – Bureau of Reclamation Photograph by R. McAfee, July 28, 2010.**

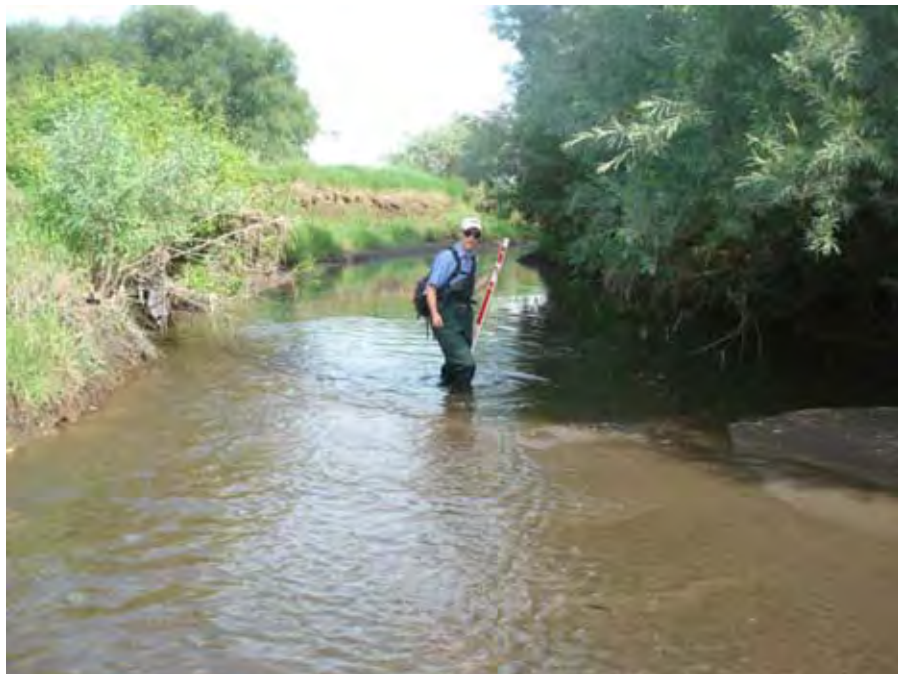
**Photograph 130. View looking downstream at a low flow riffle to pool sequence near river mile 31.80. Reach 2 – Catherine Creek, Grande Ronde Subbasin, Oregon – Bureau of Reclamation Photograph by R. McAfee, July 28, 2010.**
