## **APPENDIX C – GEOLOGY AND GEOMORPHOLOGY**

## GEOLOGY AND GEOMORPHOLOGY REPORT FOR THE CATHERINE CREEK TRIBUTARY ASSESSMENT – GRANDE RONDE RIVER BASIN Tributary Habitat Program, Oregon

February 2012

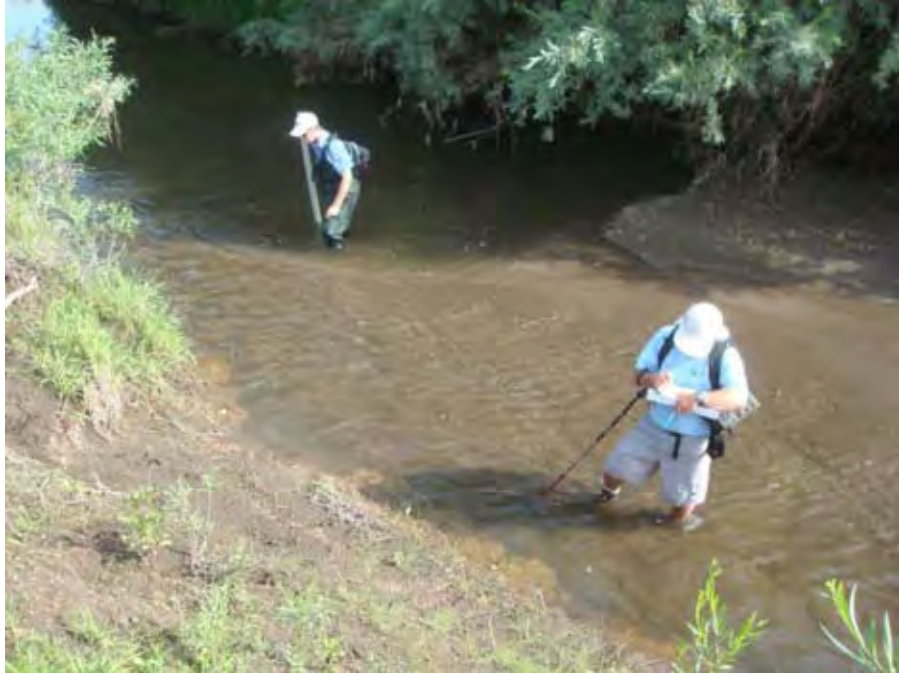
**Photograph 131. View of sandy bed material in Catherine Creek channel near river mile 31.80. Reach 2 – Catherine Creek, Grande Ronde Subbasin, Oregon – Bureau of Reclamation Photograph by D. Stelma, July 28, 2010.**

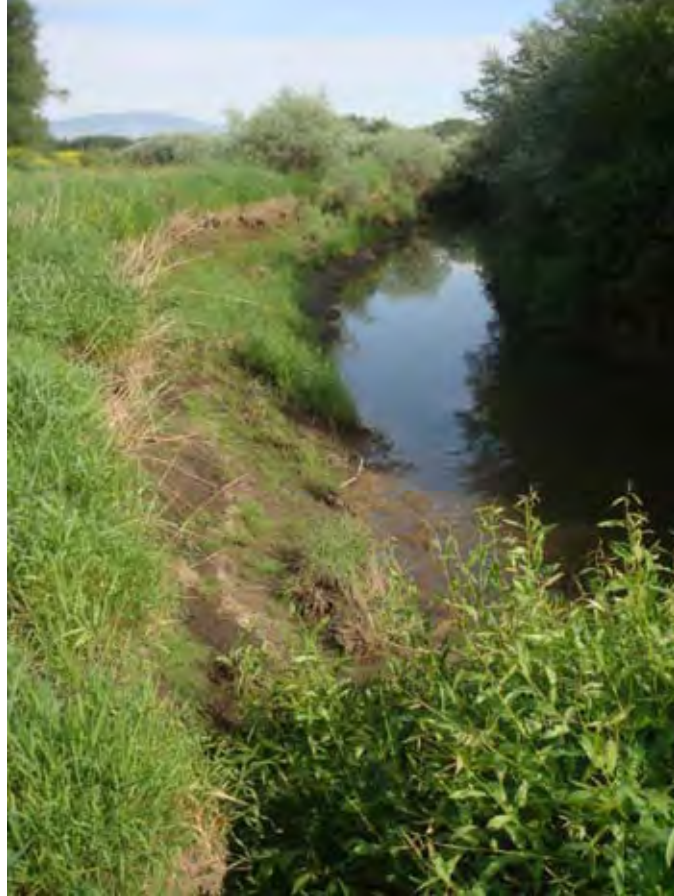
**Photograph 132. View looking downstream at Catherine Creek Channel near river mile 31.79. Reach 2 – Catherine Creek, Grande Ronde Subbasin, Oregon – Bureau of Reclamation Photograph by D. Stelma, July 28, 2010.**

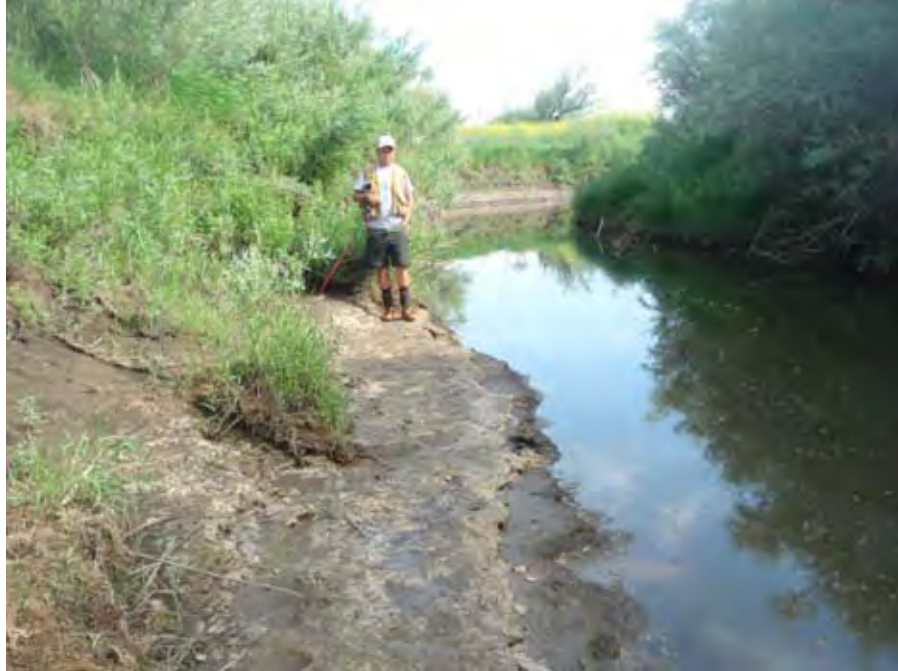
**Photograph 133. View looking downstream at a hard, indurated fine grained material that is erosion resistant along the toe of the left bank near river mile 31.69. The channel has incised through this material. Reach 2 – Catherine Creek, Grande Ronde Subbasin, Oregon – Bureau of Reclamation Photograph by R. McAfee, July 28, 2010.**

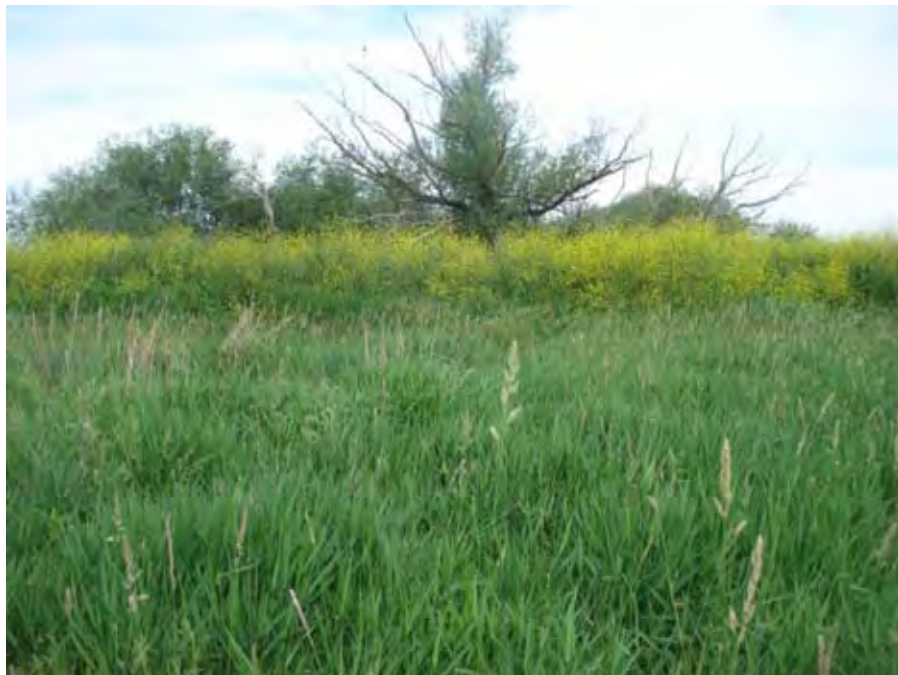
**Photograph 134. View from the top of the left bank looking to the northwest of grass vegetation and a levee near river mile 31.68. Reach 2 – Catherine Creek, Grande Ronde Subbasin, Oregon – Bureau of Reclamation Photograph by R. McAfee, July 28, 2010.**

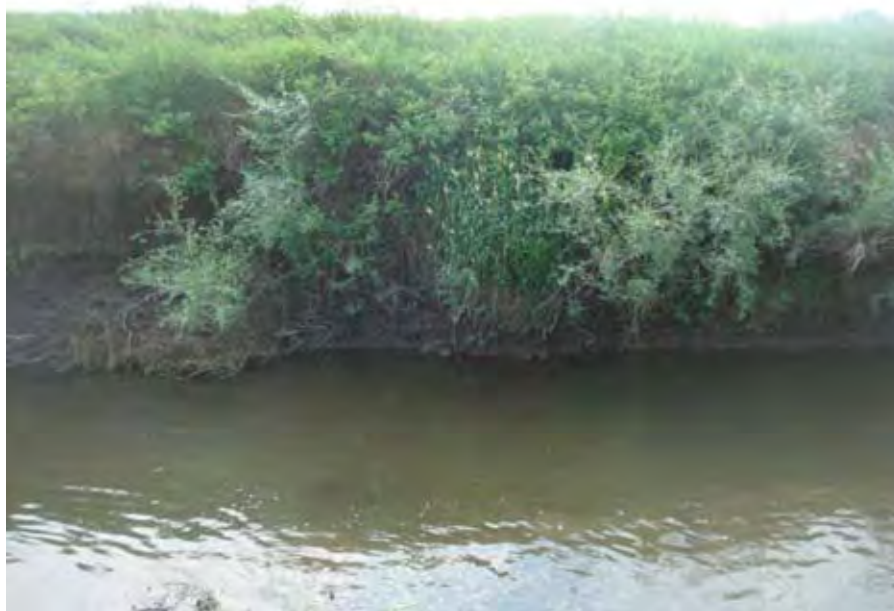
**Photograph 135. View from the top of the left bank to the right bank. The vegetation is grass/shrub and willow near river mile 31.66. Note the exposed soil sections that are a source of fine sediment. Reach 2 – Catherine Creek, Grande Ronde Subbasin, Oregon – Bureau of Reclamation Photograph by R. McAfee, July 28, 2010.**

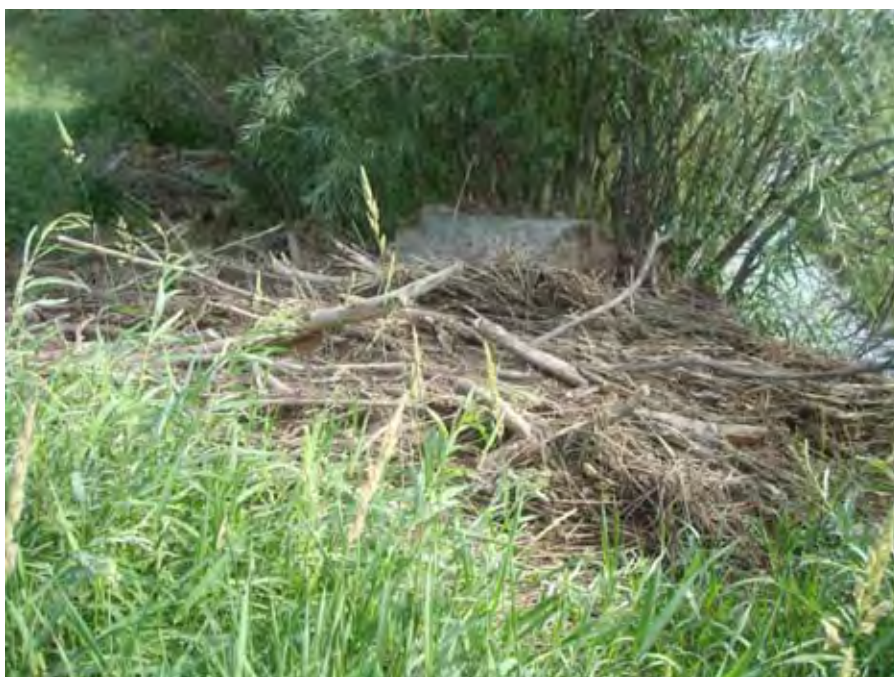
**Photograph 136. Wood debris on upper left bank near river mile 31.65, Catherine Creek visible through willows on the right side of the photo. Reach 2 – Catherine Creek, Grande Ronde Subbasin, Oregon – Bureau of Reclamation Photograph by D. Stelma, July 28, 2010.**

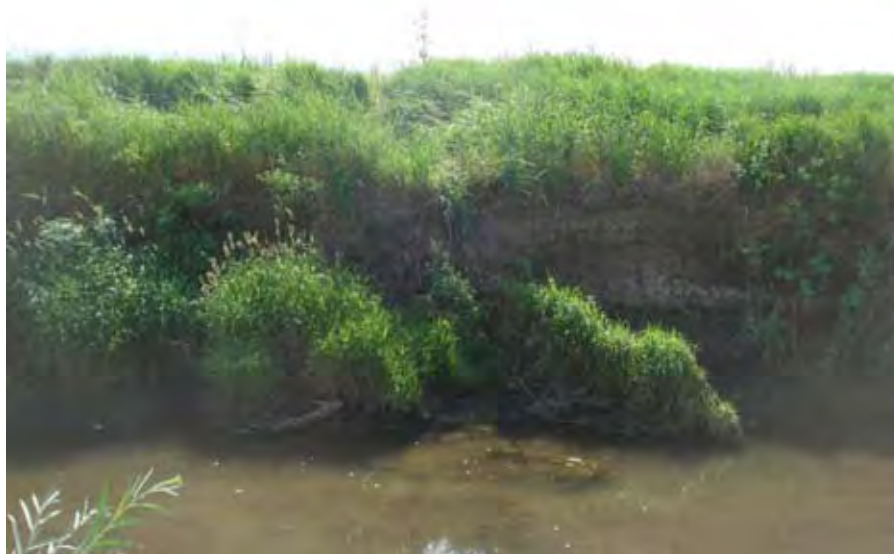
**Photograph 137. View from the top of the left bank to the right bank at location of profile P-R2-2 at river mile 31.63. The vegetation is grass/shrub and willow. Note the exposed soil sections and visible slumping indicating fine sediment input. Reach 2 – Catherine Creek, Grande Ronde Subbasin, Oregon – Bureau of Reclamation Photograph by R. McAfee, July 28, 2010.**

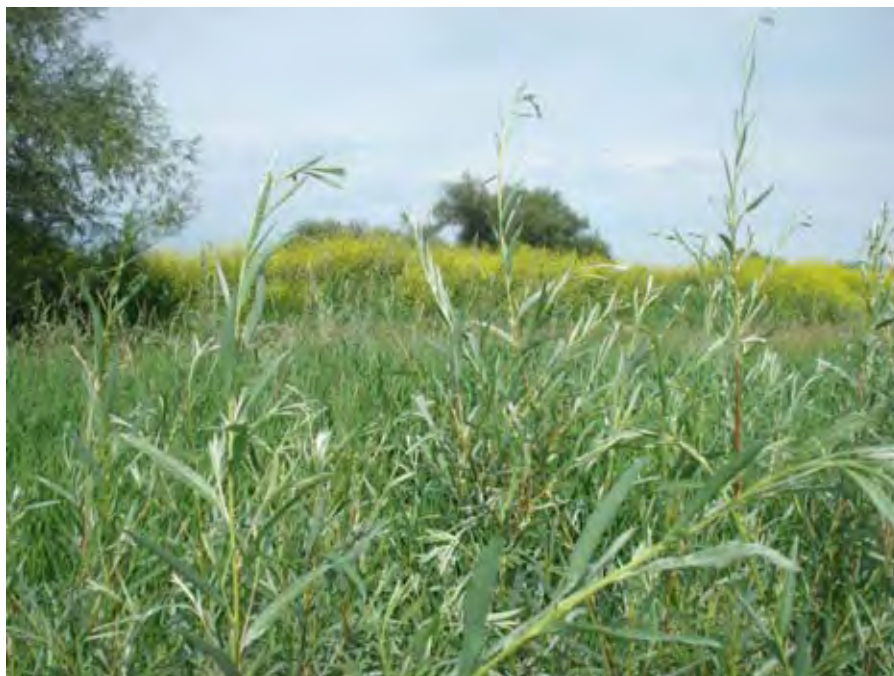
**Photograph 138. View from the top of the left bank to a levee set back to the northwest at the location of profile P-R2-2 at river mile 31.63. The vegetation is grass/shrub and willow. Reach 2 – Catherine Creek, Grande Ronde Subbasin, Oregon – Bureau of Reclamation Photograph by R. McAfee, July 28, 2010.**

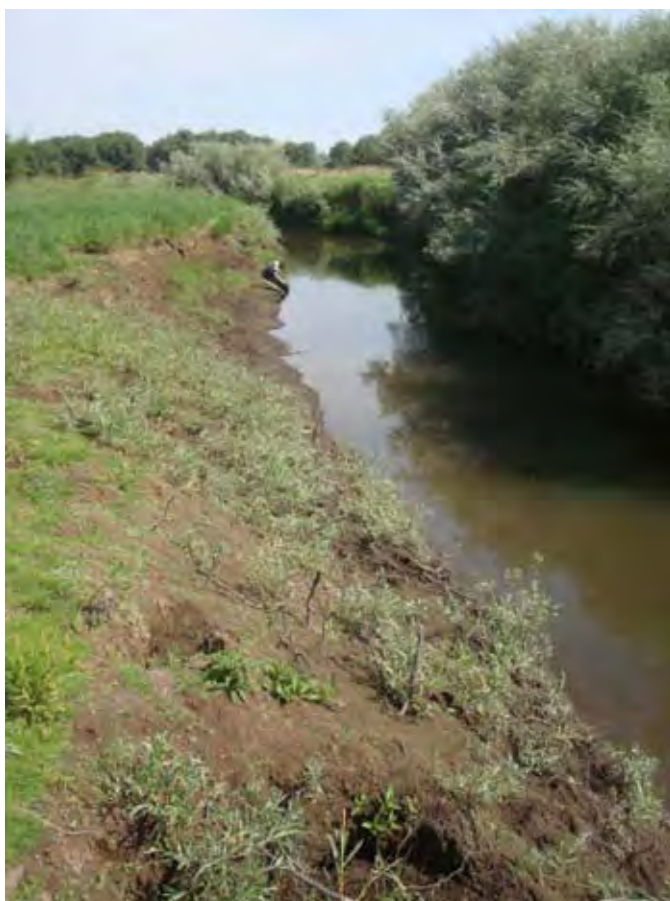
**Photograph 139. View looking downstream at Catherine Creek Channel near river mile 31.52. Reach 2 – Catherine Creek, Grande Ronde Subbasin, Oregon – Bureau of Reclamation Photograph by D. Stelma, July 28, 2010.**

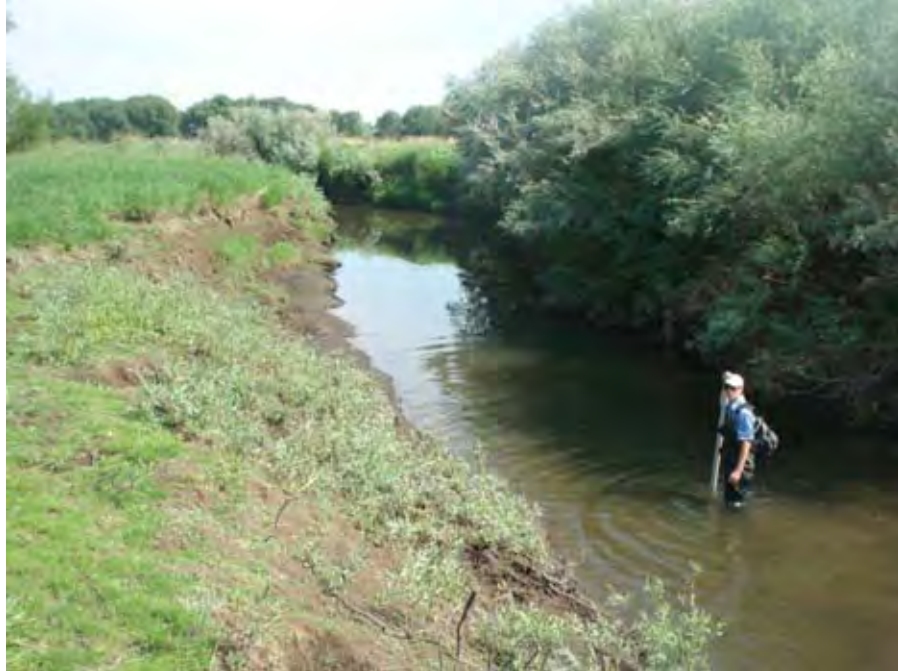
**Photograph 140. View from the top of the left bank looking downstream at grass/shrub with patches of small to medium tree vegetation along the right bank and bare bank, grass shrub on the left near river mile 31.51. Reach 2 – Catherine Creek, Grande Ronde Subbasin, Oregon – Bureau of Reclamation Photograph by R. McAfee, July 28, 2010.**

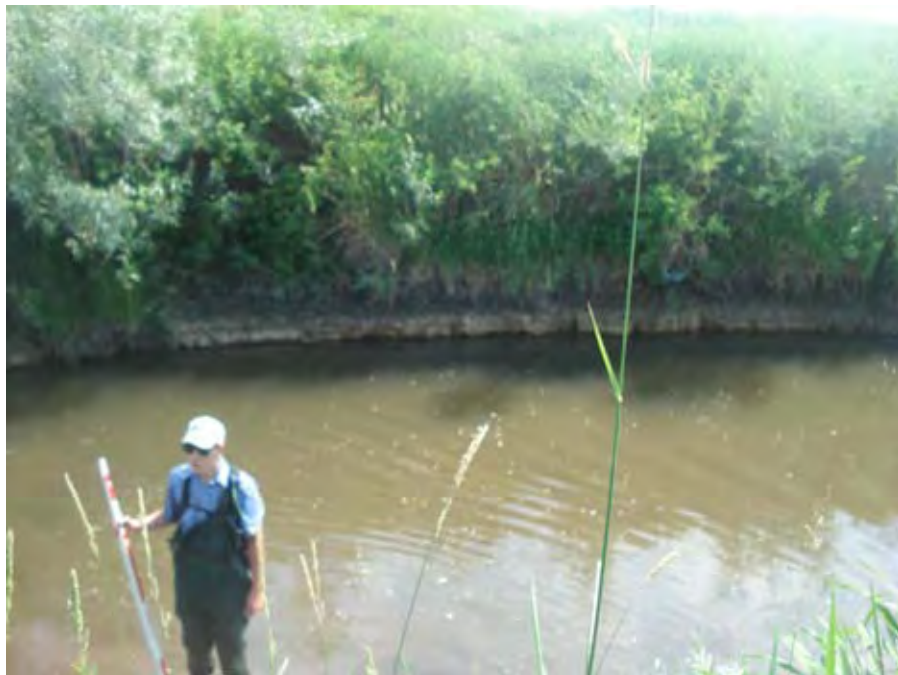
**Photograph 141. View from the top of the left bank looking to the right bank at an exposure of the hard, firm fine grained material at river mile 31.50. Reach 2 – Catherine Creek, Grande Ronde Subbasin, Oregon – Bureau of Reclamation Photograph by R. McAfee, July 28, 2010.**

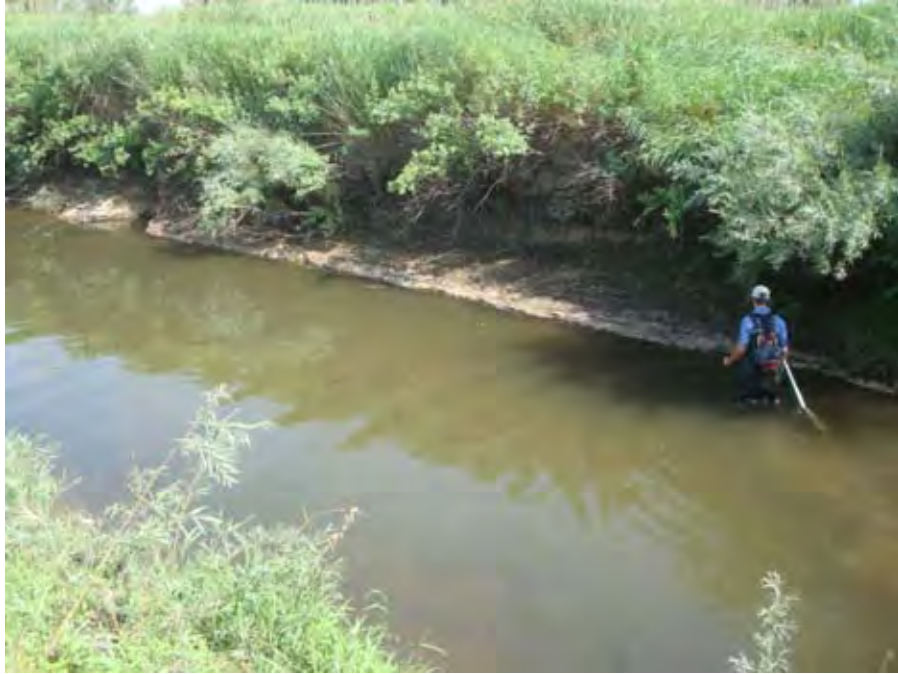
**Photograph 142. View of fine-grained alluvium (tan dense silt) exposed on the right bank of Catherine Creek near river mile 31.50. Reach 2 – Catherine Creek, Grande Ronde Subbasin, Oregon – Bureau of Reclamation Photograph by D. Stelma, July 28, 2010.**

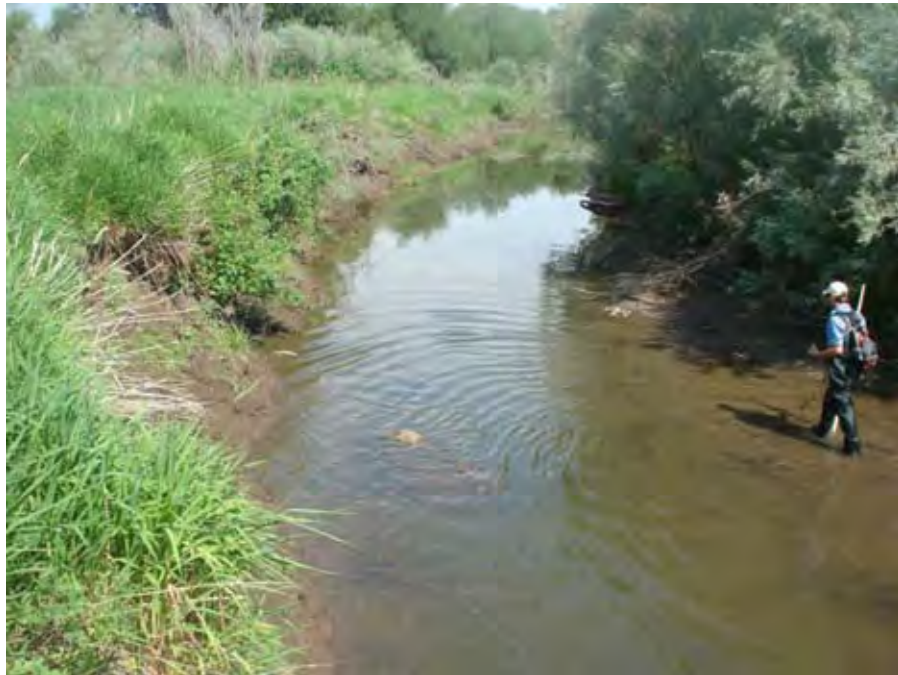
**Photograph 143. View from the top of the left bank looking downstream of small tree vegetation along the right bank and grass/shrub along the left near river mile 31.42. Reach 2 – Catherine Creek, Grande Ronde Subbasin, Oregon – Bureau of Reclamation Photograph by R. McAfee, July 28, 2010.**

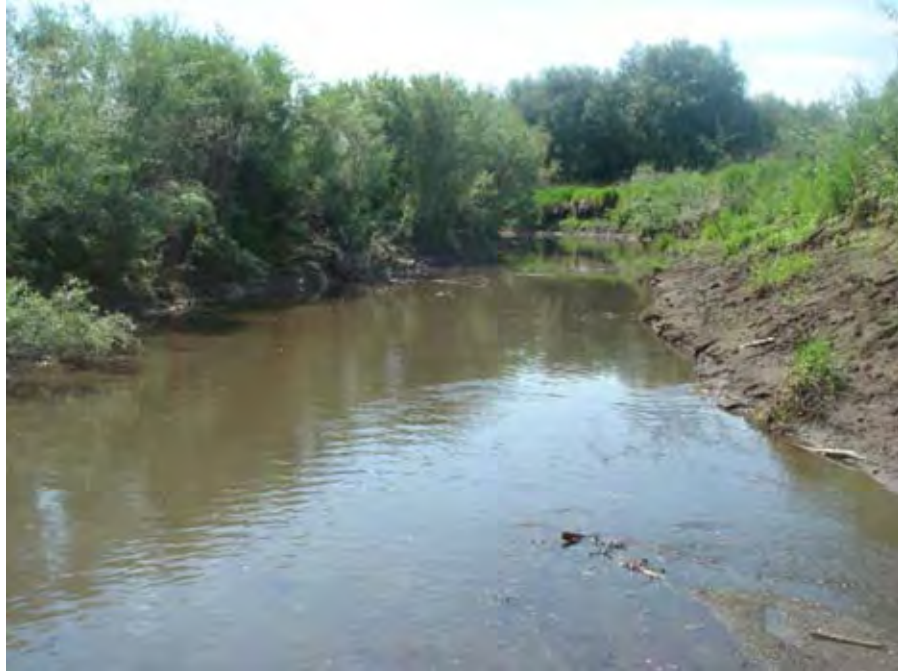
**Photograph 144. View looking upstream at small tree vegetation along the right bank and grass/shrub along the left at the Ladd Marsh input at river mile 31.40. Reach 2 – Catherine Creek, Grande Ronde Subbasin, Oregon – Bureau of Reclamation Photograph by R. McAfee, July 28, 2010.**

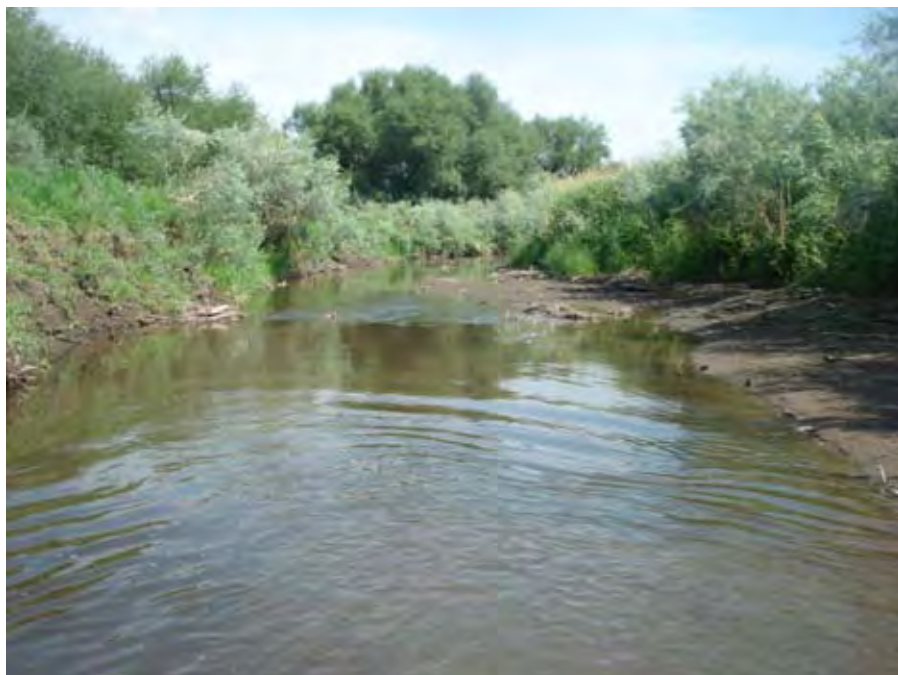
**Photograph 145. View looking downstream at sandbars along the right bank of Catherine Creek, directly downstream of the Ladd marsh input at river mile 31.40. Reach 2 – Catherine Creek, Grande Ronde Subbasin, Oregon – Bureau of Reclamation Photograph by R. McAfee, July 28, 2010.**

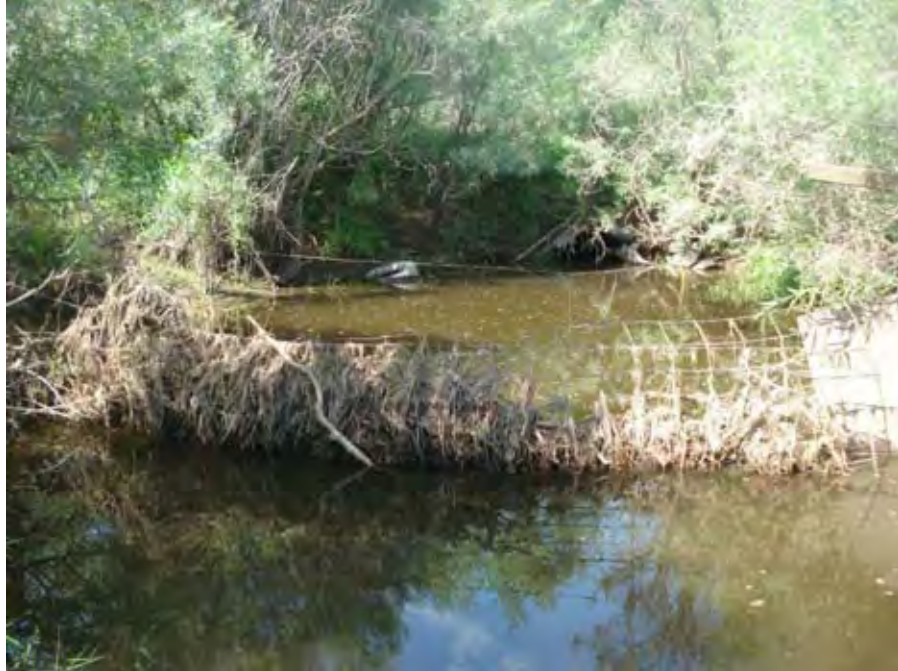
**Photograph 146. View of a fence across the Ladd Marsh input 100 feet off of the main channel of Catherine Creek near river mile 31.40. Reach 2 – Catherine Creek, Grande Ronde Subbasin, Oregon – Bureau of Reclamation Photograph by R. McAfee, July 28, 2010.**

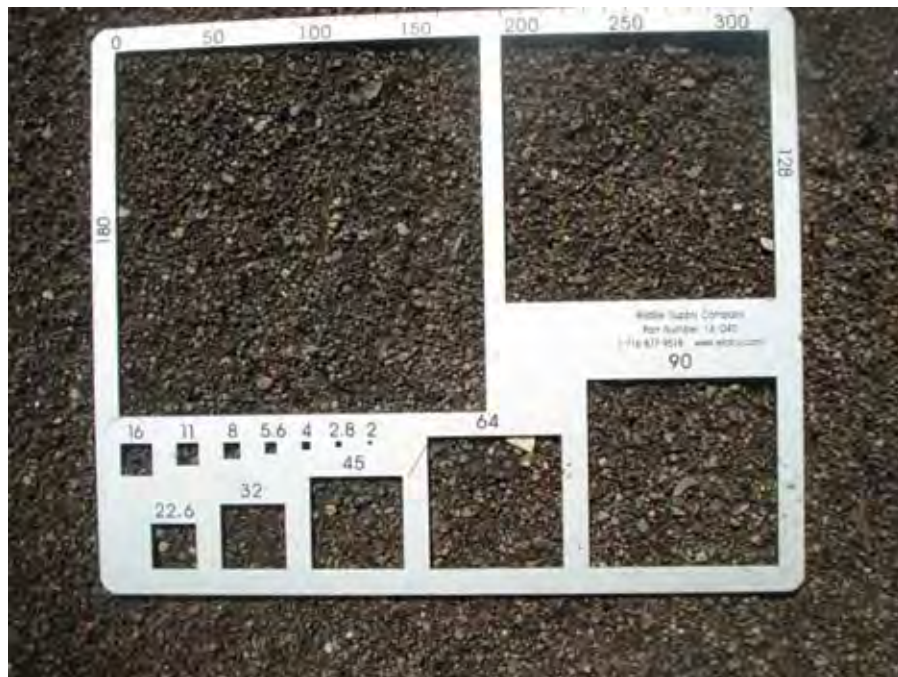
**Photograph 147. A close-up view of the coarse-to-fine sand that comprises the bars in Catherine Creek, at the Ladd marsh input at river mile 31.40. Reach 2 – Catherine Creek, Grande Ronde Subbasin, Oregon – Bureau of Reclamation Photograph by R. McAfee, July 28, 2010.**

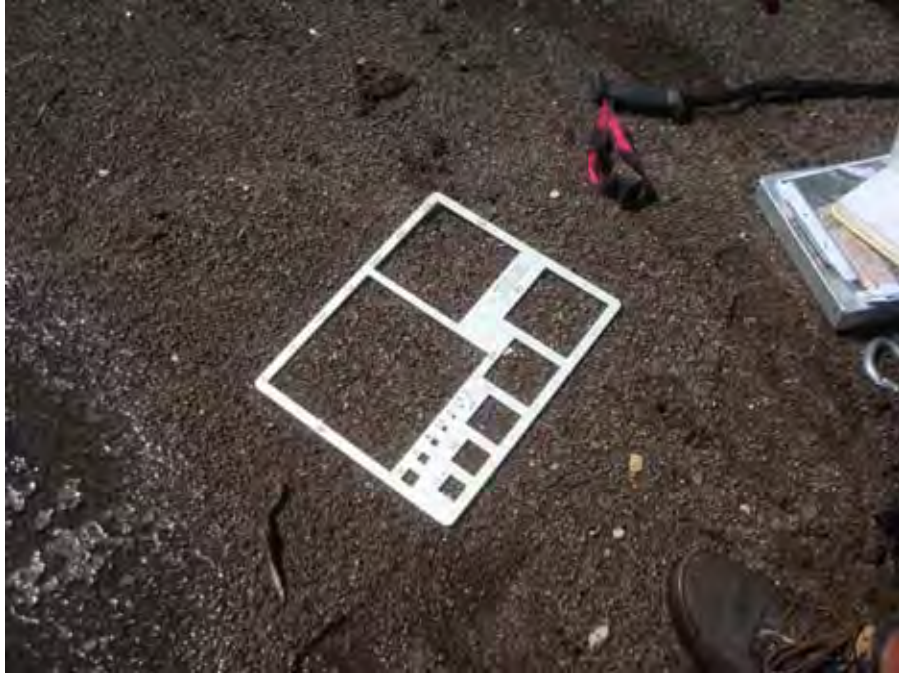
**Photograph 148. Close-up of sandbar deposits at the mouth of Ladd Creek near river mile 31.40. Reach 2 – Catherine Creek, Grande Ronde Subbasin, Oregon – Bureau of Reclamation Photograph by D. Stelma, July 28, 2010.**

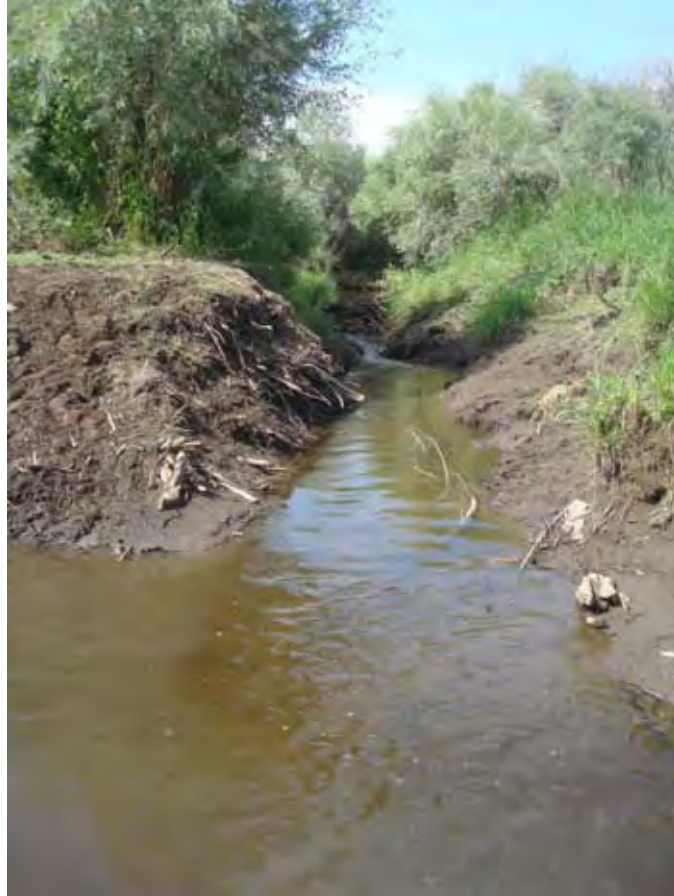
**Photograph 149. View looking westward at Ladd Creek entering Catherine Creek near river mile 31.39. Note beaver dam in Ladd Creek channel (background). Reach 2 – Catherine Creek, Grande Ronde Subbasin, Oregon – Bureau of Reclamation Photograph by D. Stelma, July 28, 2010.**

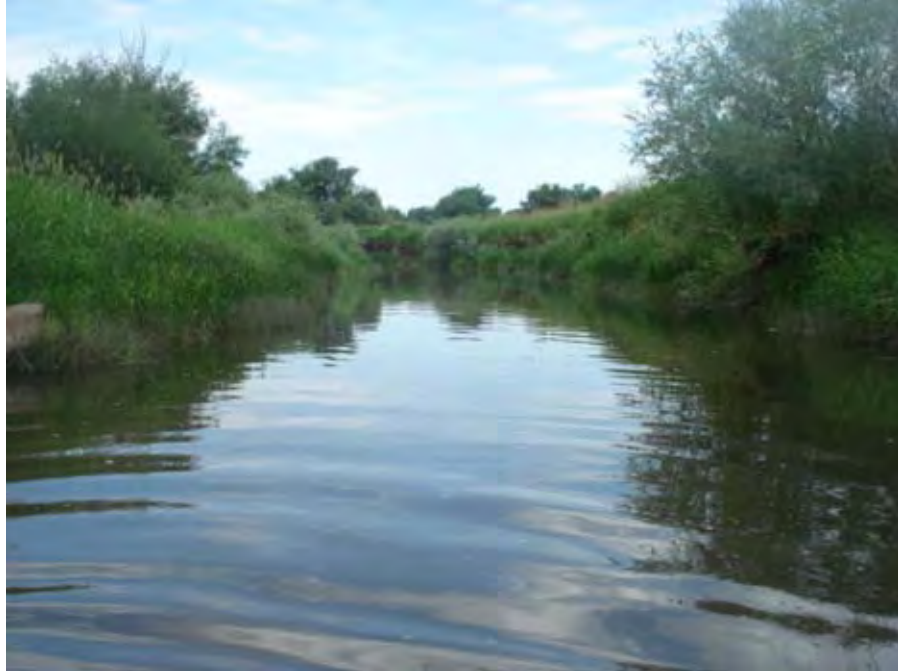
**Photograph 150. View looking downstream at a section with very slow velocity, 2' of depth and predominantly grass/shrub vegetation along both banks, at river mile 31.29. Reach 2 – Catherine Creek, Grande Ronde Subbasin, Oregon – Bureau of Reclamation Photograph by R. McAfee, July 28, 2010.**

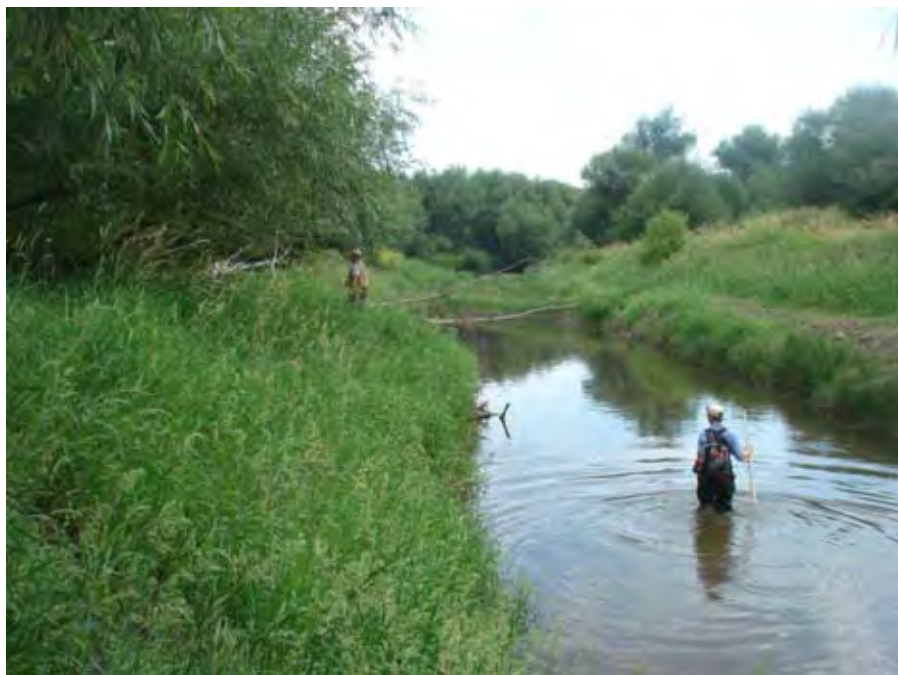
**Photograph 151. View from the left bank looking downstream at a section with very slow velocity, 2' of depth and predominantly grass/shrub vegetation along both banks, at river mile 31.27. Reach 2 – Catherine Creek, Grande Ronde Subbasin, Oregon – Bureau of Reclamation Photograph by R. McAfee, July 28, 2010.**

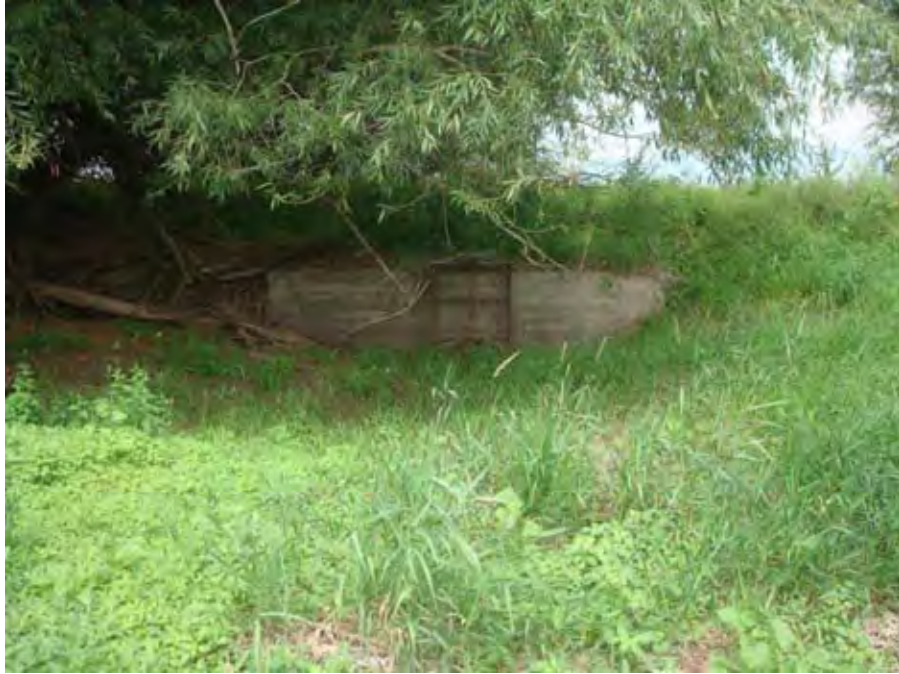
**Photograph 152. View looking at drain slide-gate on the left bank of Catherine Creek near river mile 31.18. Reach 2 – Catherine Creek, Grande Ronde Subbasin, Oregon – Bureau of Reclamation Photograph by D. Stelma, July 28, 2010.**

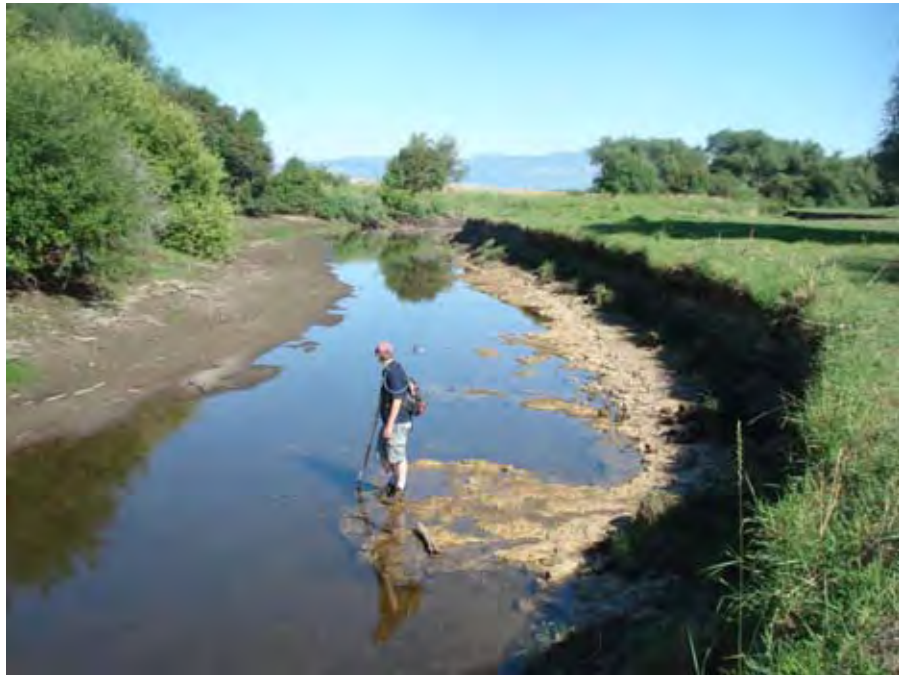
**Photograph 153. View looking downstream from the top of the right bank near river mile 31.14. The channel bottom is comprised of a dense, firm silty material that is erosion resistant, and visible along the toe of the right bank. Reach 2 – Catherine Creek, Grande Ronde Subbasin, Oregon – Bureau of Reclamation Photograph by R. McAfee, August 1, 2010.**

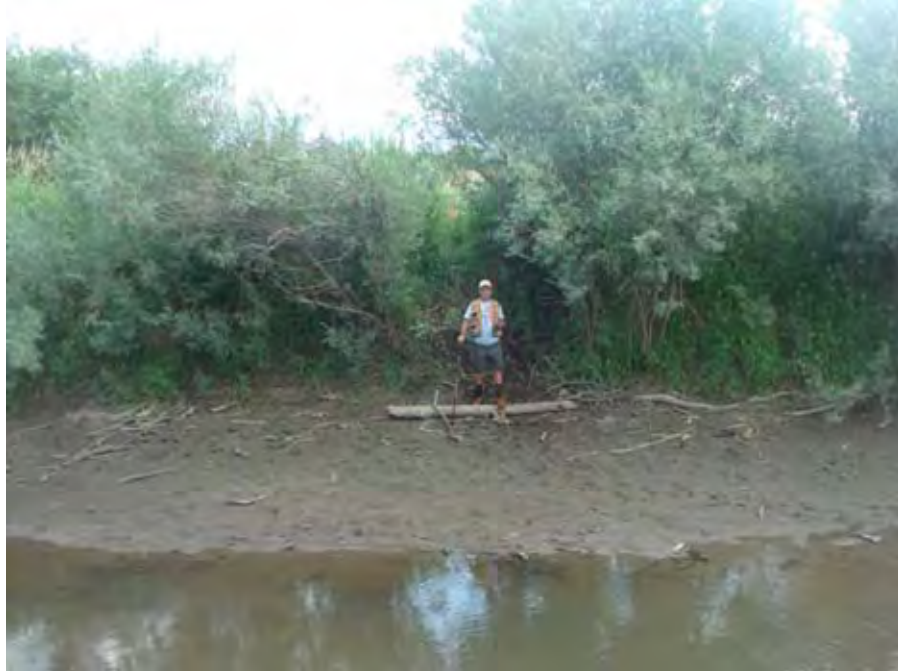
**Photograph 154. View from the left bank to the right at location of profile P-R2-3 at river mile 31.09. Reach 2 – Catherine Creek, Grande Ronde Subbasin, Oregon – Bureau of Reclamation Photograph by R. McAfee, July 28, 2010.**

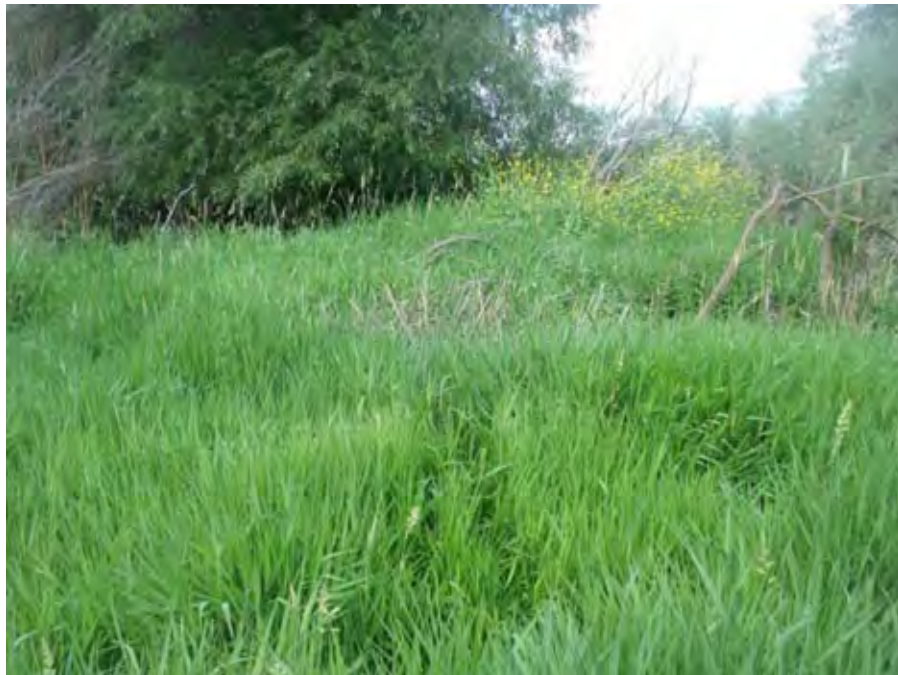
**Photograph 155. View from the edge of the left bank to the back to a small terrace in the left flood plain at location of profile P-R2-3 at river mile 31.09. Reach 2 – Catherine Creek, Grande Ronde Subbasin, Oregon – Bureau of Reclamation Photograph by R. McAfee, July 28, 2010.**

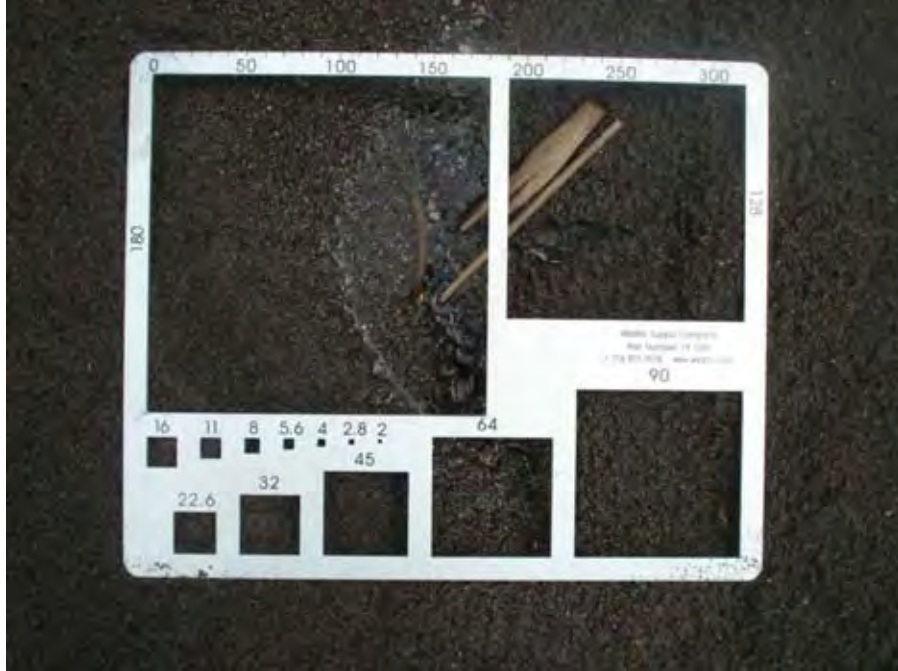
**Photograph 156. A view of the fine sand-sized material along the right bank near river mile 31.08. Reach 2 – Catherine Creek, Grande Ronde Subbasin, Oregon – Bureau of Reclamation Photograph by R. McAfee, July 28, 2010.**

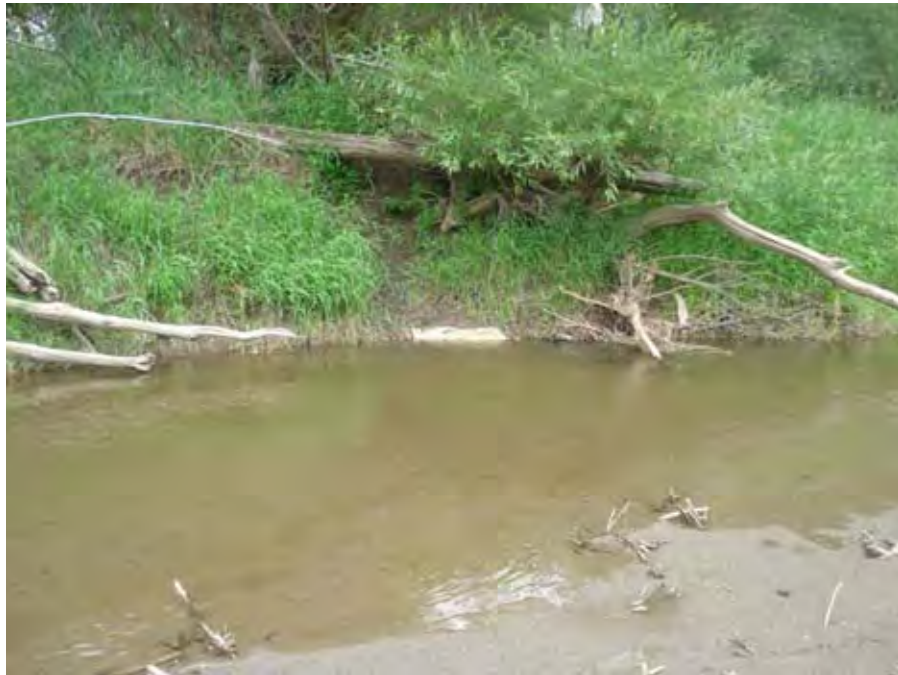
**Photograph 157. A view from the right bank to left showing an exposure of the hard, firm fine grained material that is erosion resistant at the toe of the left bank, and fine sand bed load in the active channel near river mile 31.08. Reach 2 – Catherine Creek, Grande Ronde Subbasin, Oregon – Bureau of Reclamation Photograph by R. McAfee, July 28, 2010.**

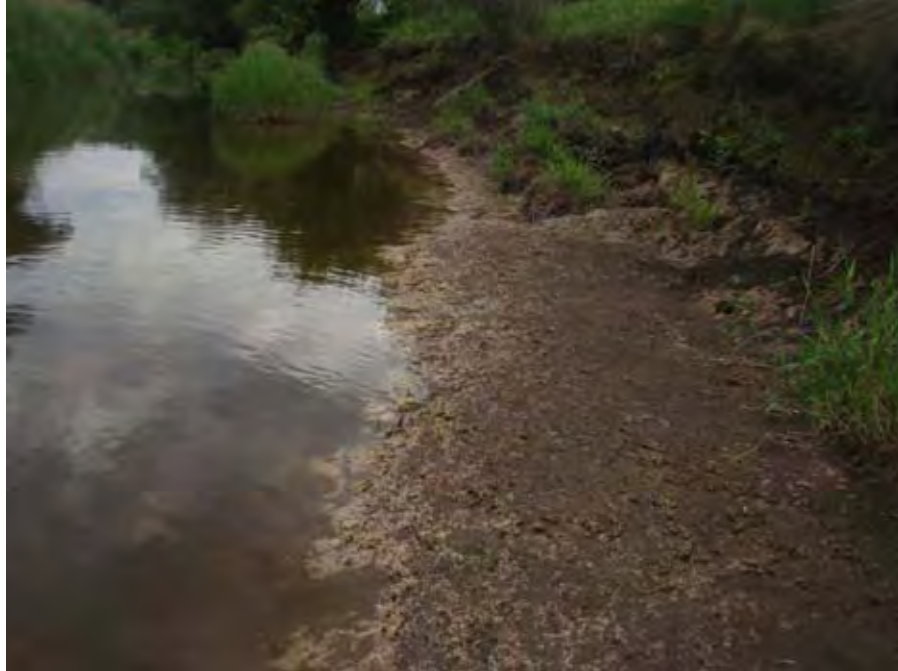
**Photograph 158. A view from the right bank looking downstream at an exposure of the hard, firm fine grained material that is erosion resistant at the toe of the right bank on the outside of a meander bend at river mile 31.00, and bank slumping just downstream. Reach 2 – Catherine Creek, Grande Ronde Subbasin, Oregon – Bureau of Reclamation Photograph by R. McAfee, July 28, 2010.**

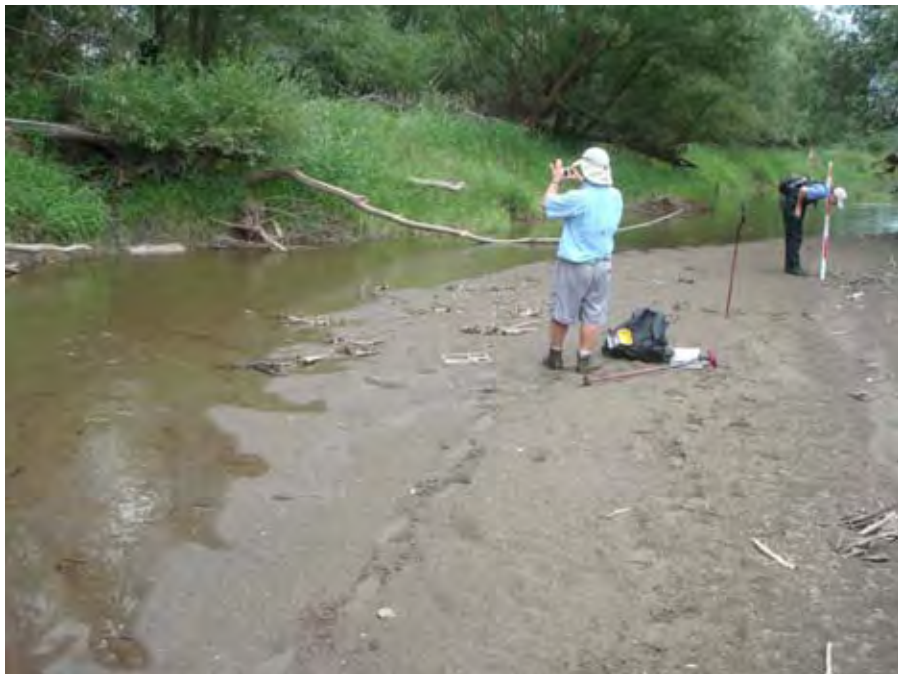
**Photograph 159. View looking downstream at sandbar (medium sand) on the right (east) side of Catherine Creek near river mile 30.89. Reach 2 – Catherine Creek, Grande Ronde Subbasin, Oregon – Bureau of Reclamation Photograph by D. Stelma, July 28, 2010.**

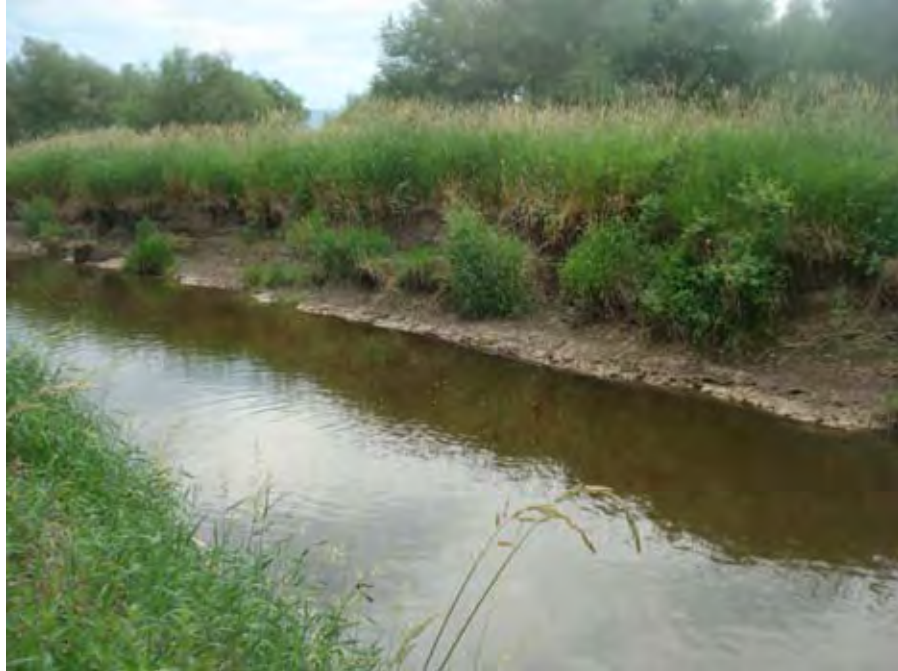
**Photograph 160. View from the right bank looking upstream at slumping along the predominantly grass vegetated left bank, hard fine grained material at the toe of the bank and sand bed-load in the main channel near river mile 30.88. Reach 2 – Catherine Creek, Grande Ronde Subbasin, Oregon – Bureau of Reclamation Photograph by R. McAfee, July 28, 2010.**

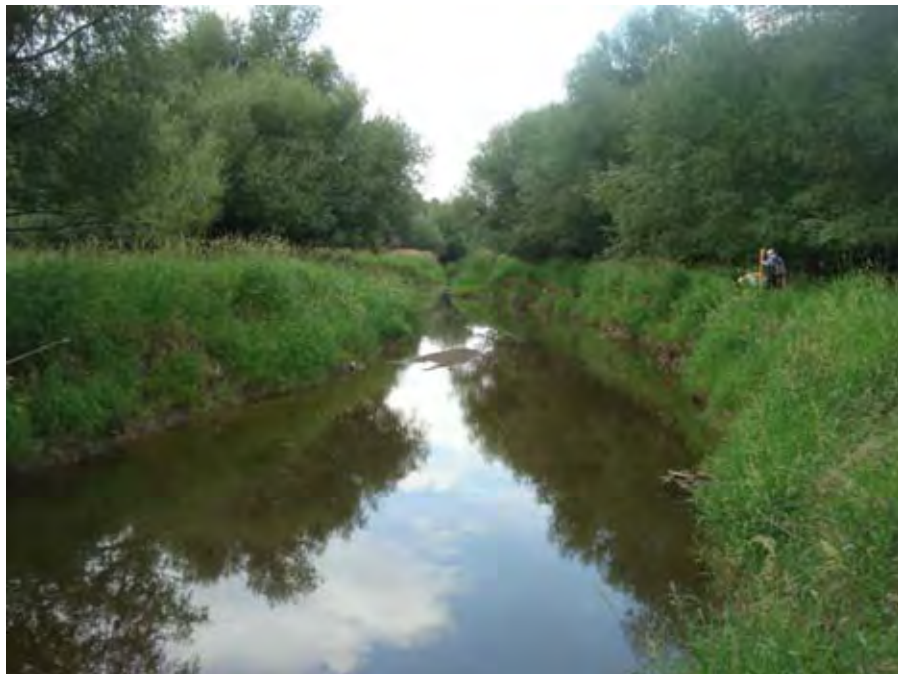
**Photograph 161. View from the right bank looking downstream at predominantly grass vegetated banks and sand bed-load in the main channel that forms small point bars at lower flow conditions near river mile 30.86. Reach 2 – Catherine Creek, Grande Ronde Subbasin, Oregon – Bureau of Reclamation Photograph by R. McAfee, July 28, 2010.**

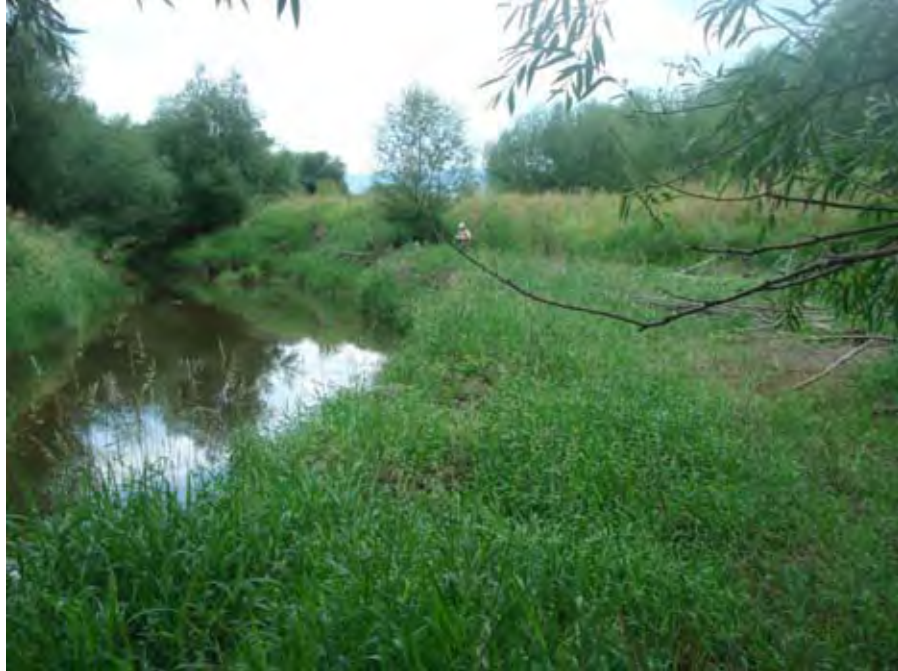
**Photograph 162. View from the top of the right bank looking downstream at an overflow channel return in the right floodplain at river mile 30.64. Reach 2 – Catherine Creek, Grande Ronde Subbasin, Oregon – Bureau of Reclamation Photograph by R. McAfee, July 28, 2010.**

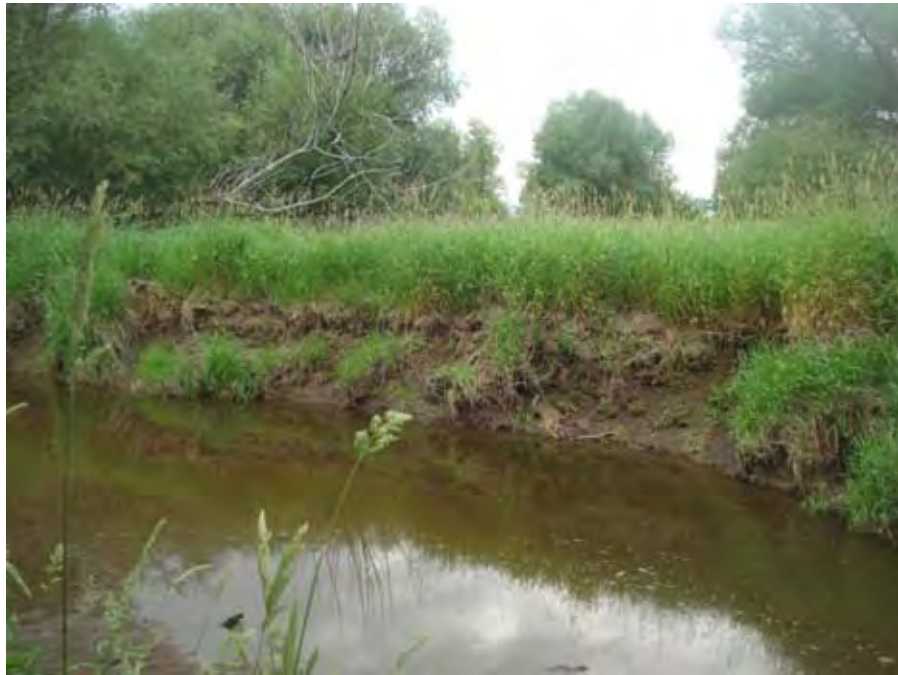
**Photograph 163. View from the top of the right bank looking upstream at a grass vegetated left bank at river mile 30.64. Slumping and exposed sediment/soil indicates local fine sediment input. Reach 2 – Catherine Creek, Grande Ronde Subbasin, Oregon – Bureau of Reclamation Photograph by R. McAfee, July 28, 2010.**
