## **APPENDIX C – GEOLOGY AND GEOMORPHOLOGY**

## GEOLOGY AND GEOMORPHOLOGY REPORT FOR THE CATHERINE CREEK TRIBUTARY ASSESSMENT – GRANDE RONDE RIVER BASIN Tributary Habitat Program, Oregon

February 2012

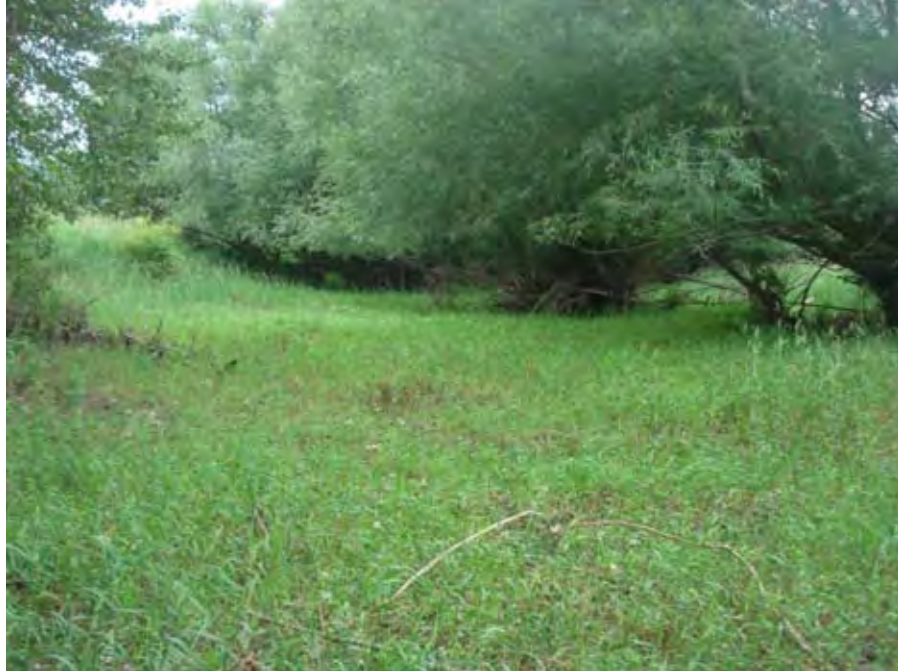
**Photograph 164. View from the top of the right bank looking upstream at an overflow channel in the right floodplain at river mile 30.61. Reach 2 – Catherine Creek, Grande Ronde Subbasin, Oregon – Bureau of Reclamation Photograph by R. McAfee, July 28, 2010.**

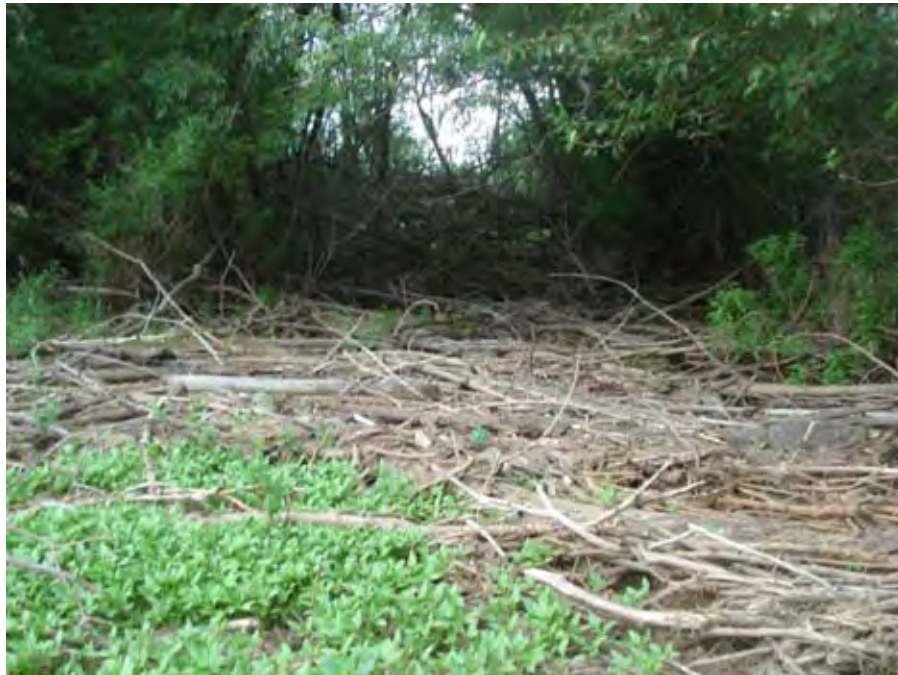
**Photograph 165. View from the top of the right bank looking downstream at woody debris accumulation in an overflow channel in the right floodplain at river mile 30.61. Reach 2 – Catherine Creek, Grande Ronde Subbasin, Oregon – Bureau of Reclamation Photograph by R. McAfee, July 28, 2010.**

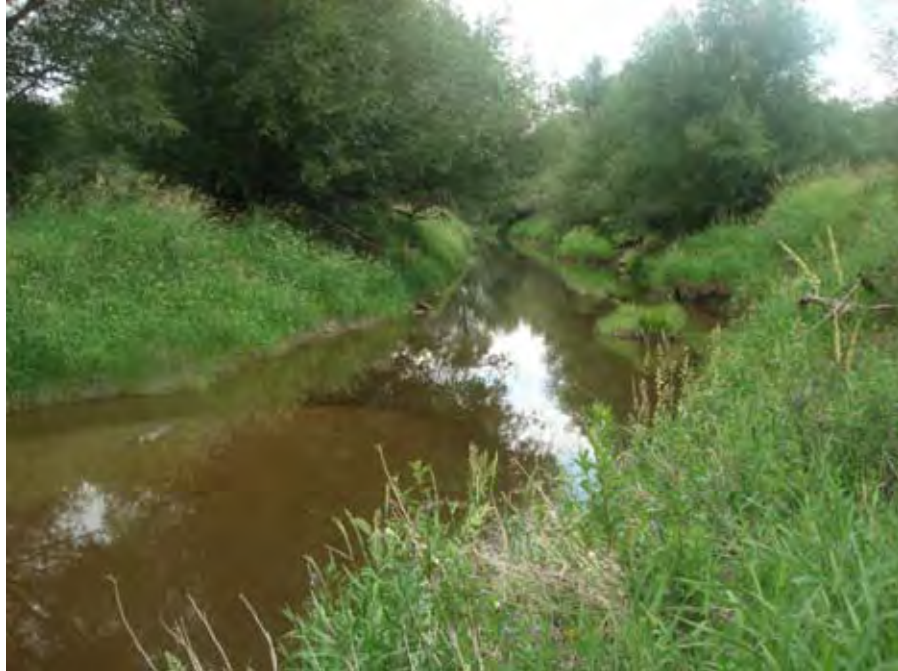
**Photograph 166. View from the top of the right bank looking downstream at a grass vegetated bank with slumping at river mile 30.60. Bed load is comprised of sand sized sediment that is visible in a delta-like pulse. Reach 2 – Catherine Creek, Grande Ronde Subbasin, Oregon – Bureau of Reclamation Photograph by R. McAfee, July 28, 2010.**

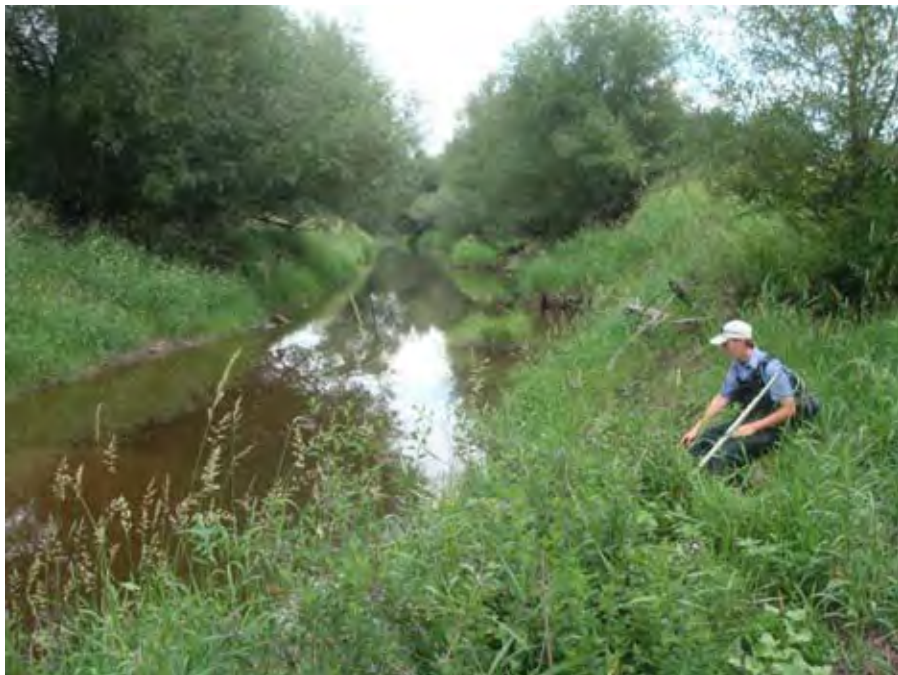
**Photograph 167. View looking downstream at Catherine Creek Channel, over-grown levee at right of photo near river mile 30.52. Reach 2 – Catherine Creek, Grande Ronde Subbasin, Oregon – Bureau of Reclamation Photograph by D. Stelma, July 28, 2010.**

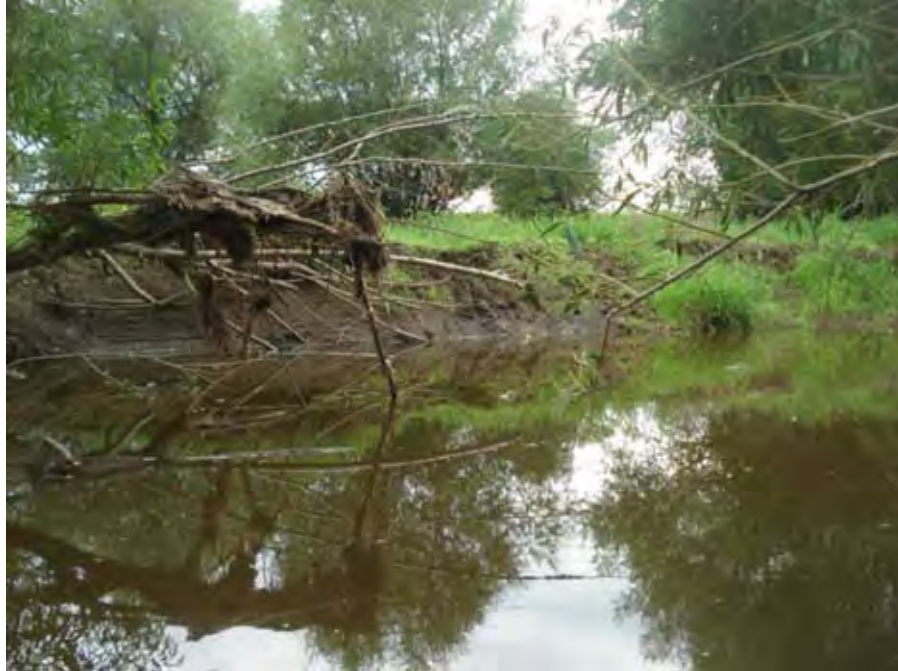
**Photograph 168. View from the right bank to the left at a grass vegetated bank with slumping at river mile 30.49. Exposed sediment/soil indicates local fine sediment input. Reach 2 – Catherine Creek, Grande Ronde Subbasin, Oregon – Bureau of Reclamation Photograph by R. McAfee, July 28, 2010.**

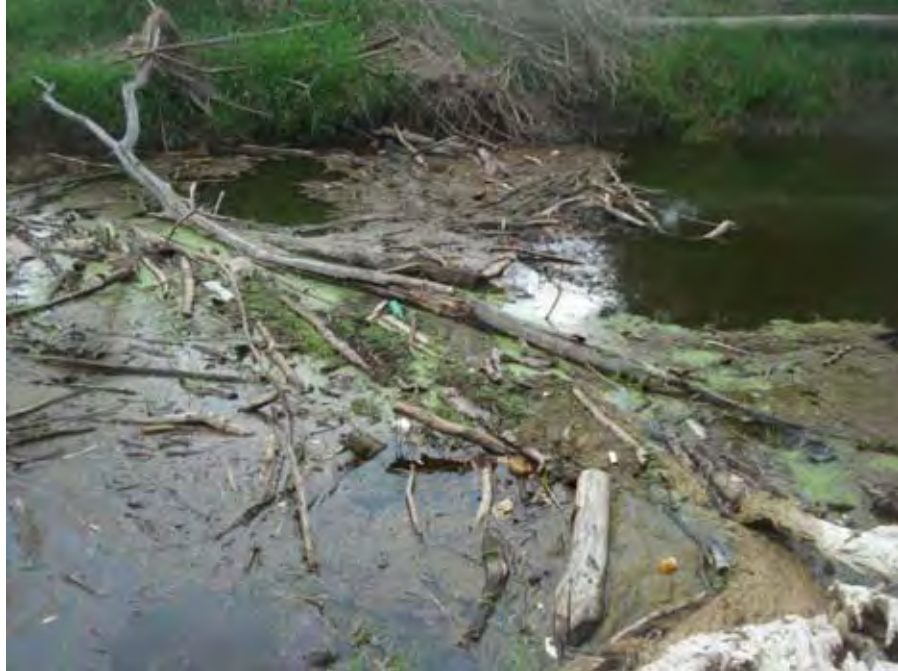
**Photograph 170. View from the right bank looking a debris accumulation on the surface near river mile 30.43. Reach 2 – Catherine Creek, Grande Ronde Subbasin, Oregon – Bureau of Reclamation Photograph by R. McAfee, July 28, 2010.**

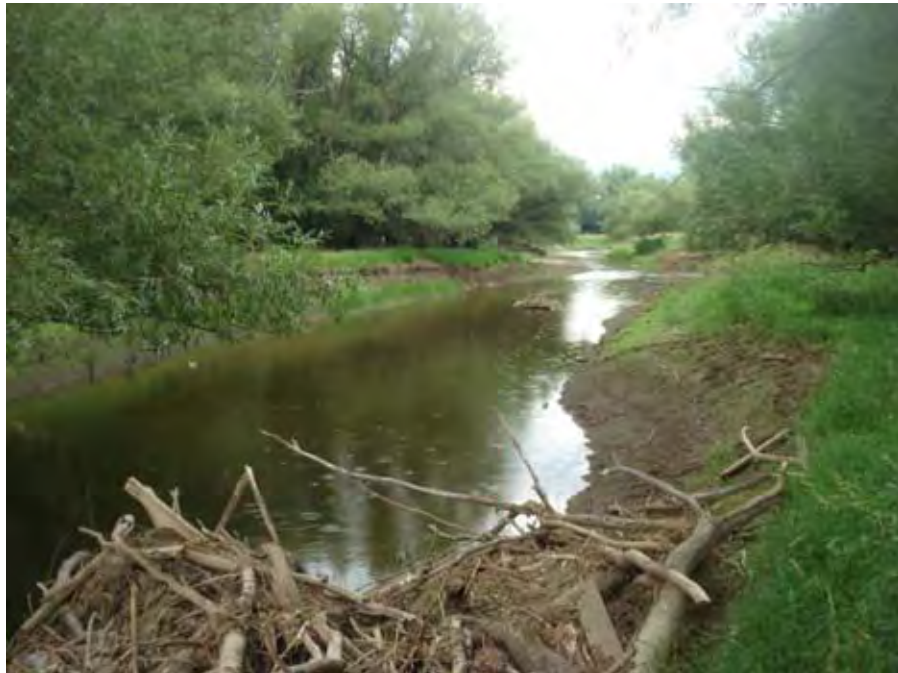
**Photograph 171. View from the right bank looking downstream at mostly denuded banks and a debris accumulation along the right bank near river mile 30.43. Reach 2 – Catherine Creek, Grande Ronde Subbasin, Oregon – Bureau of Reclamation Photograph by R. McAfee, July 28, 2010.**

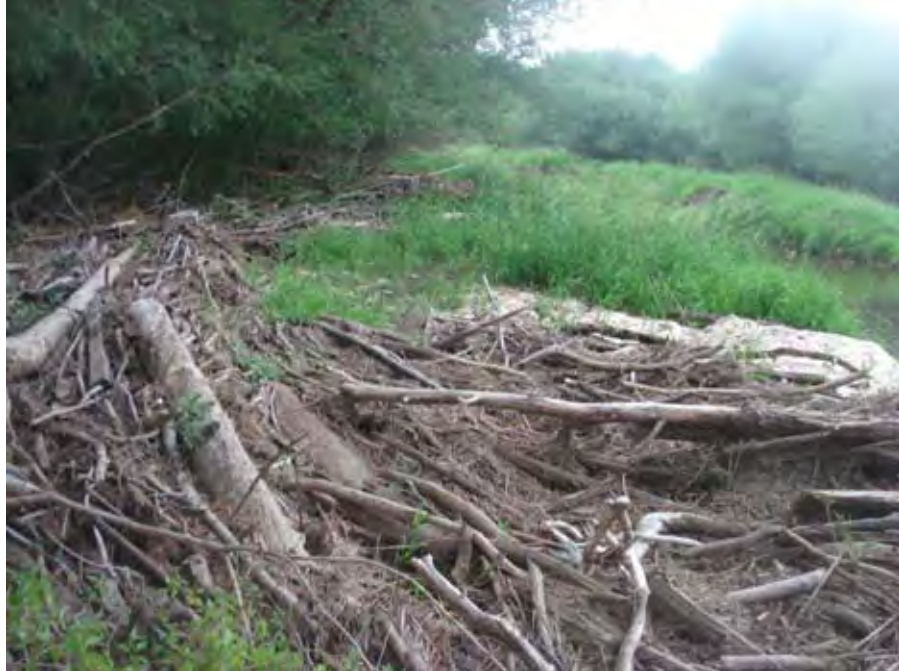
**Photograph 172. View from the right bank looking upstream at debris accumulation along the right bank near river mile 30.43. Reach 2 – Catherine Creek, Grande Ronde Subbasin, Oregon – Bureau of Reclamation Photograph by R. McAfee, July 28, 2010.**

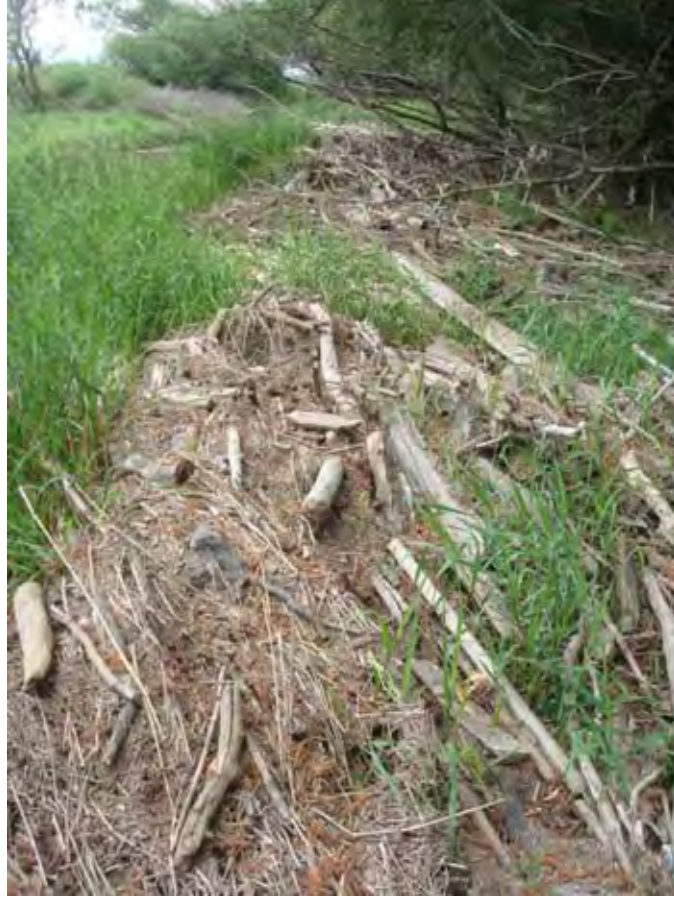
**Photograph 173. View of wood debris on upper right bank of Catherine Creek channel near river mile 30.42. Reach 2 – Catherine Creek, Grande Ronde Subbasin, Oregon – Bureau of Reclamation Photograph by D. Stelma, July 28, 2010.**

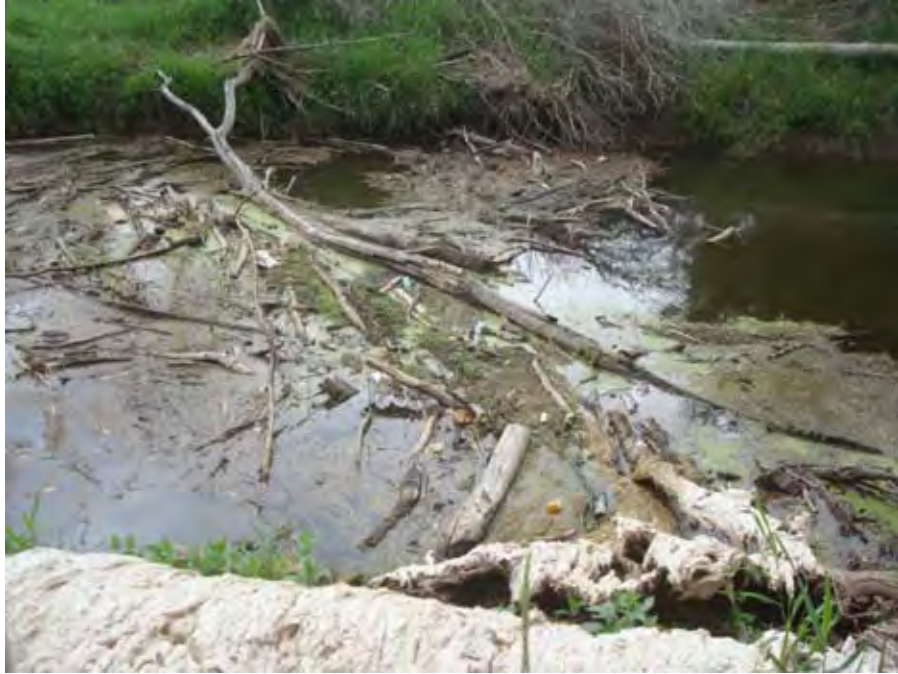
**Photograph 174. View looking from right to left at wood debris accumulation in the Catherine Creek channel near river mile 30.40. Reach 2 – Catherine Creek, Grande Ronde Subbasin, Oregon – Bureau of Reclamation Photograph by D. Stelma, July 28, 2010.**

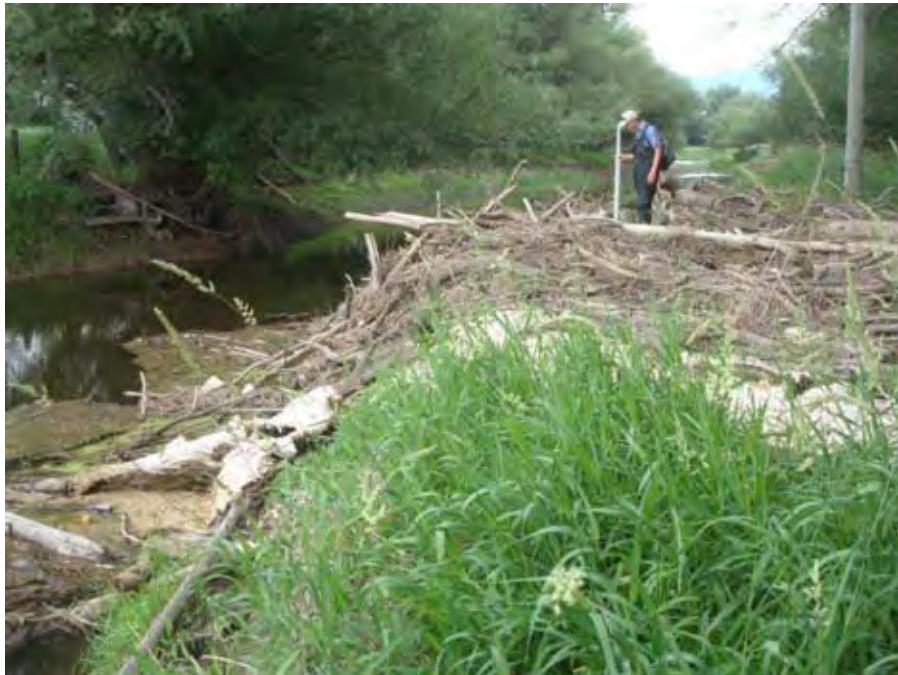
**Photograph 175. View looking downstream at wood debris on upper right bank of Catherine Creek near river mile 30.40. Reach 2 – Catherine Creek, Grande Ronde Subbasin, Oregon – Bureau of Reclamation Photograph by D. Stelma, July 28, 2010.**

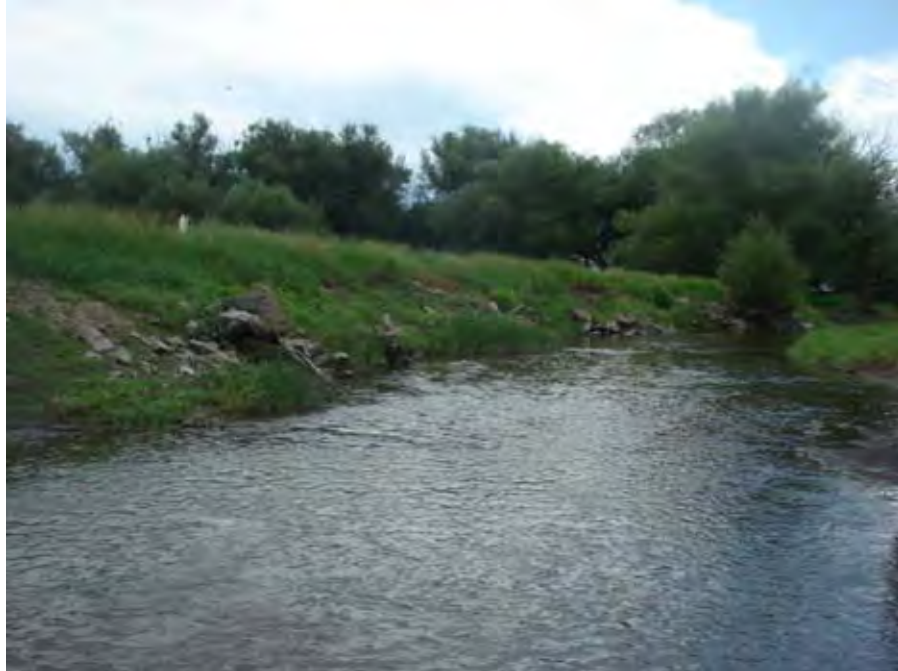
**Photograph 179. A close-up view of a buried log and riprap structure along the left bank at river mile 30.30. Reach 2 – Catherine Creek, Grande Ronde Subbasin, Oregon – Bureau of Reclamation Photograph by R. McAfee, July 28, 2010.**

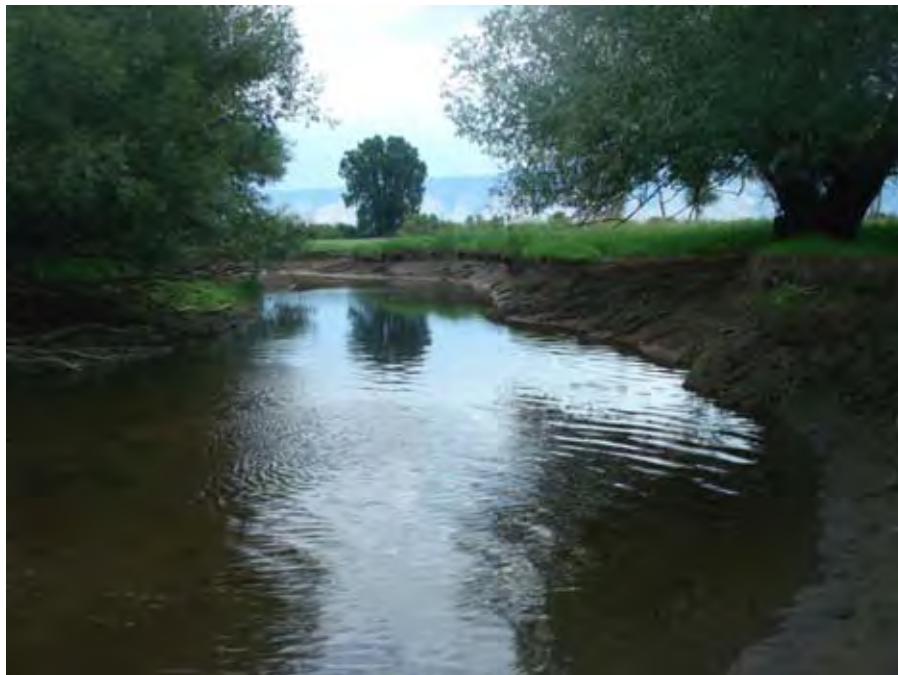
**Photograph 182. View looking downstream at the right bank. This section of the bank is grass vegetated, and the lighter material at the toe of the bank is a hard, fine-grained material that is resistant to erosion. Note the woody debris accumulation along the left bank near river mile 30.24. Reach 2 – Catherine Creek, Grande Ronde Subbasin, Oregon – Bureau of Reclamation Photograph by R. McAfee, July 28, 2010.**

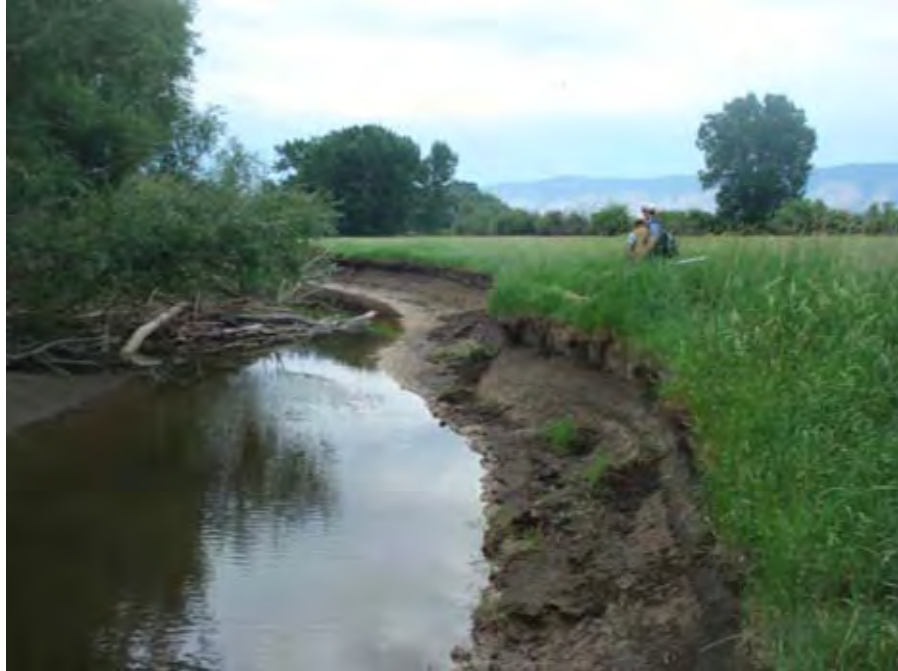
**Photograph 183. View looking at the woody debris accumulation along the left bank at river mile 30.22. Reach 2 – Catherine Creek, Grande Ronde Subbasin, Oregon – Bureau of Reclamation Photograph by R. McAfee, July 28, 2010.**

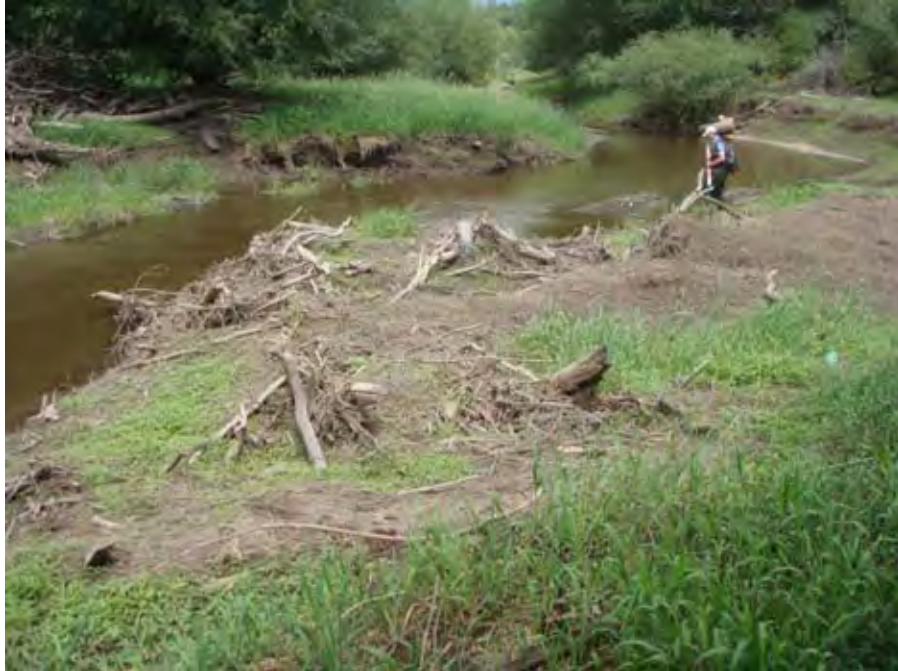
**Photograph 193. View looking upstream at fallen tree and wood debris within the Catherine Creek channel near river mile 29.98. Reach 2 – Catherine Creek, Grande Ronde Subbasin, Oregon – Bureau of Reclamation Photograph by D. Stelma, July 28, 2010.**

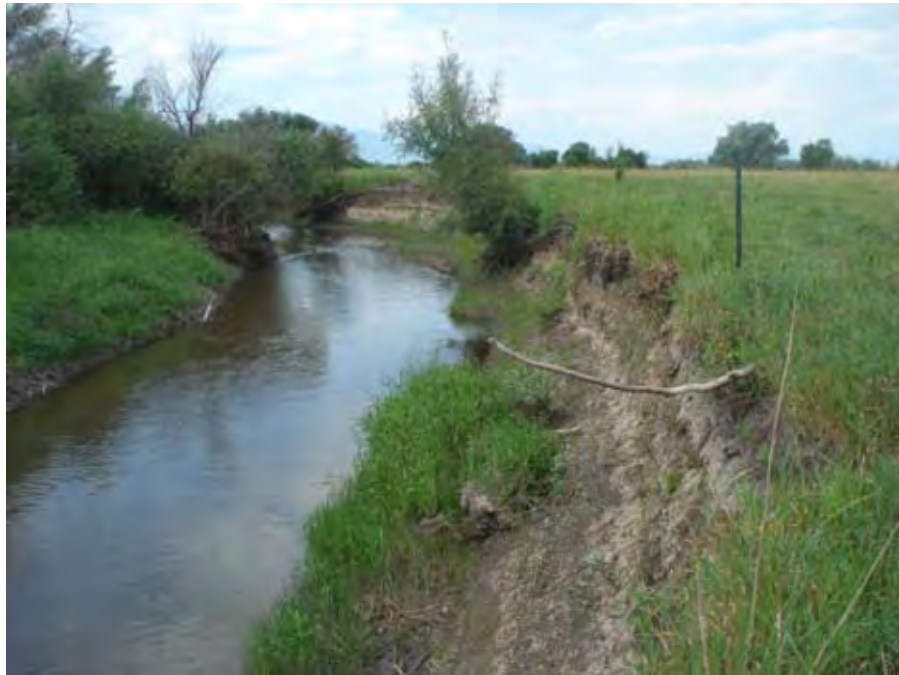
**Photograph 200. View looking north at the mouth McAlister Slough, Catherine Creek in foreground near river mile 29.38. Reach 2 – Catherine Creek, Grande Ronde Subbasin, Oregon – Bureau of Reclamation Photograph by D. Stelma, July 28, 2010.**

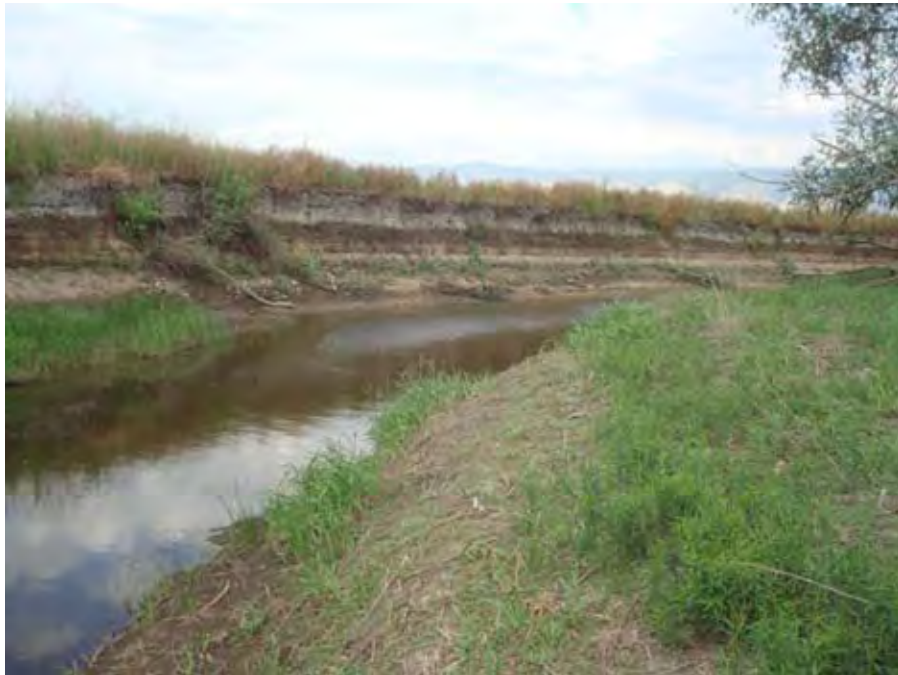
**Photograph 202.** View from the right bank looking slightly downstream at an inlet to an irrigation/stock pond along the left bank at river mile 29.37. Reach 2 – Catherine Creek, Grande Ronde Subbasin, Oregon – Bureau of Reclamation Photograph by R. McAfee, July 28, 2010.

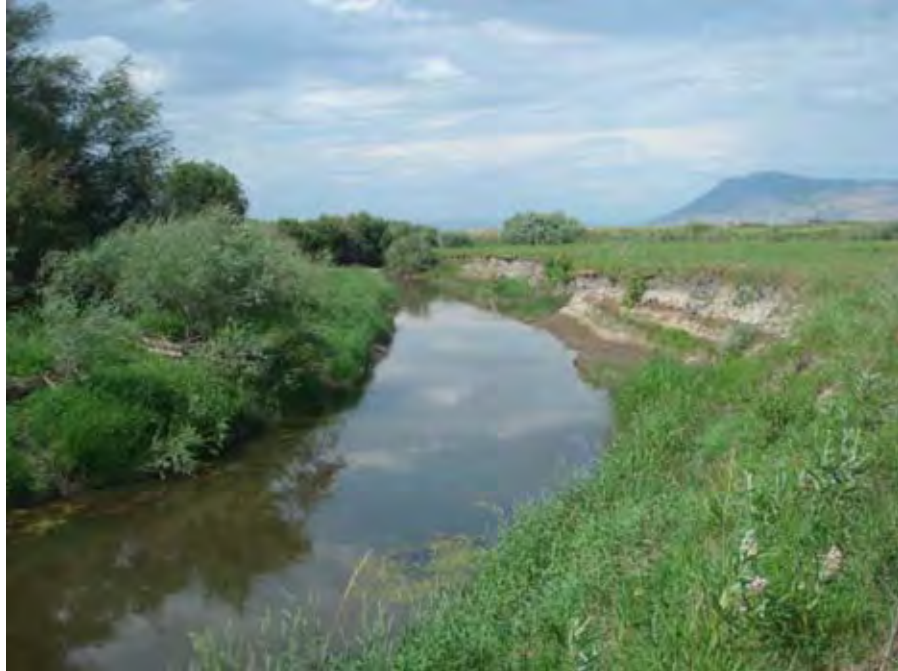
**Photograph 204. View from the right bank looking downstream at the exposed stratigraphic sequence consists of clayey-silty-sand overlain by hard fine-grained material and then topsoil near river mile 29.15. Note the predominantly grass vegetation along both banks. Reach 2 – Catherine Creek, Grande Ronde Subbasin, Oregon – Bureau of Reclamation Photograph by R. McAfee, July 28, 2010.**

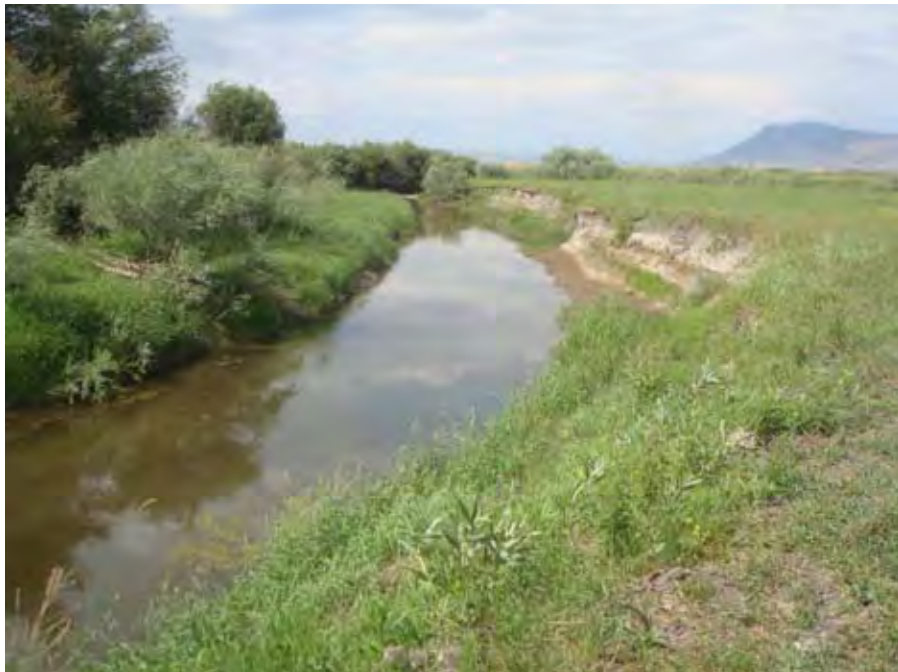
**Photograph 205. View looking downstream at fine-grained alluvial sediments exposed along the right (east) bank of Catherine Creek (Mt Harris at upper right of photo) near river mile 29.15. Reach 2 – Catherine Creek, Grande Ronde Subbasin, Oregon – Bureau of Reclamation Photograph by D. Stelma, July 28, 2010.**

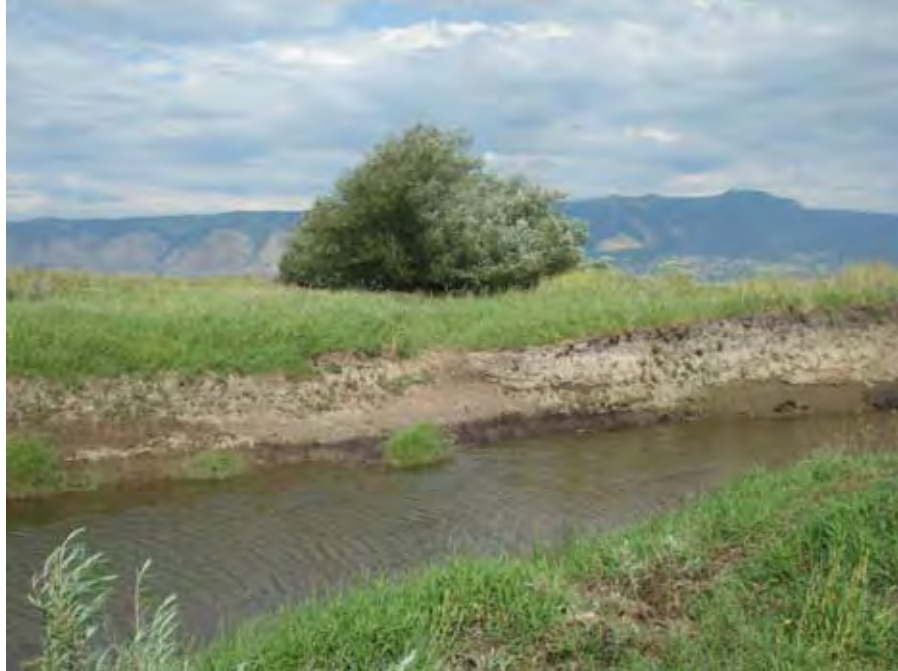
**Photograph 206. View from the right bank looking across to the subtle overflow inlet on the left bank at river mile 29.05. The inlet fills the storage pond that was the historic Grande Ronde river channel. Reach 2 – Catherine Creek, Grande Ronde Subbasin, Oregon – Bureau of Reclamation Photograph by R. McAfee, July 28, 2010.**

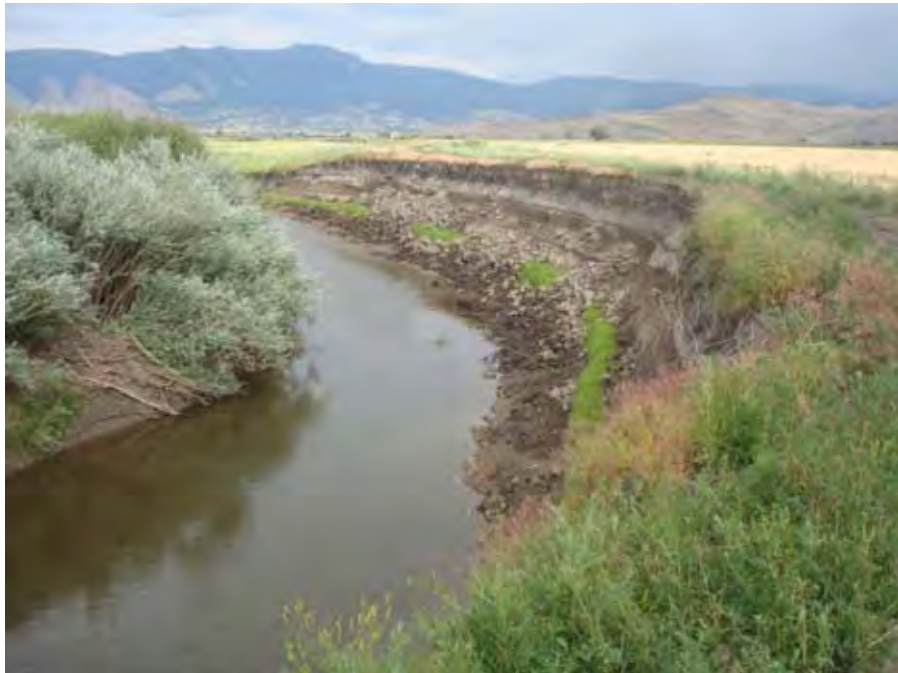
**Photograph 210. View looking downstream at fine-grained alluvial sediments exposed along the right (south) bank of Catherine Creek near river mile 27.98. Reach 2 – Catherine Creek, Grande Ronde Subbasin, Oregon – Bureau of Reclamation Photograph by D. Stelma, July 29, 2010.**

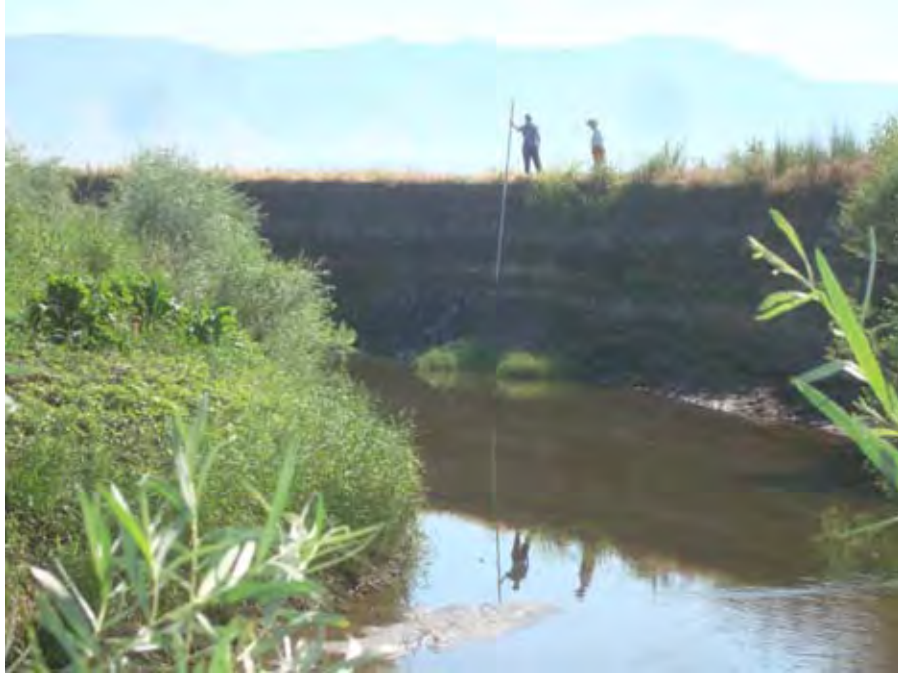
**Photograph 211. View looking upstream at fine-grained alluvial sediments exposed along the left (north) bank of Catherine Creek near river mile 27.98. Reach 2 – Catherine Creek, Grande Ronde Subbasin, Oregon – Bureau of Reclamation Photograph by D. Stelma, July 29, 2010.**

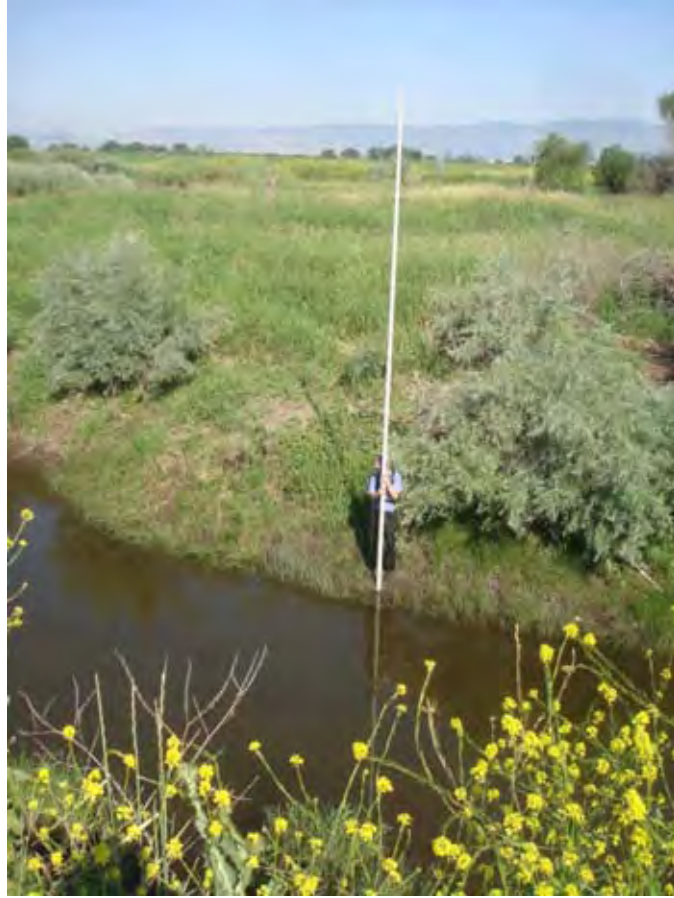
**Photograph 213. View from the right bank looking downstream at a grass/willow vegetated banks, and a thinly bedded clayey-silty sand material along the toe of the right bank and in the wetted channel at river mile 27.94. Reach 2 – Catherine Creek, Grande Ronde Subbasin, Oregon – Bureau of Reclamation Photograph by R. McAfee, July 29, 2010.**

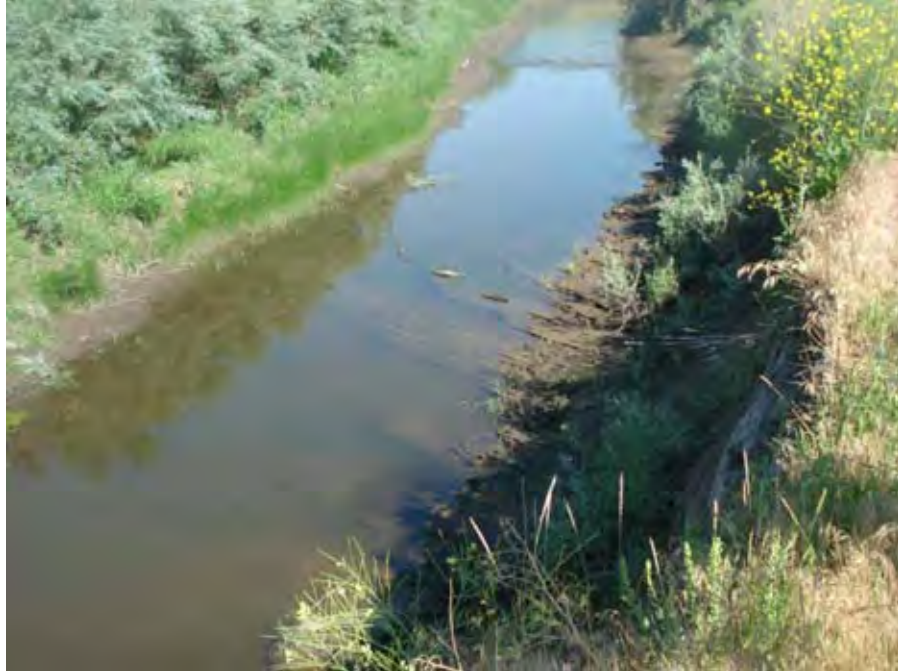
**Photograph 214. A close-up view of the thinly bedded clayey-silty sand, material along the toe of the right bank and in the wetted channel at river mile 27.94 . Reach 2 – Catherine Creek, Grande Ronde Subbasin, Oregon – Bureau of Reclamation Photograph by R. McAfee, July 29, 2010.**

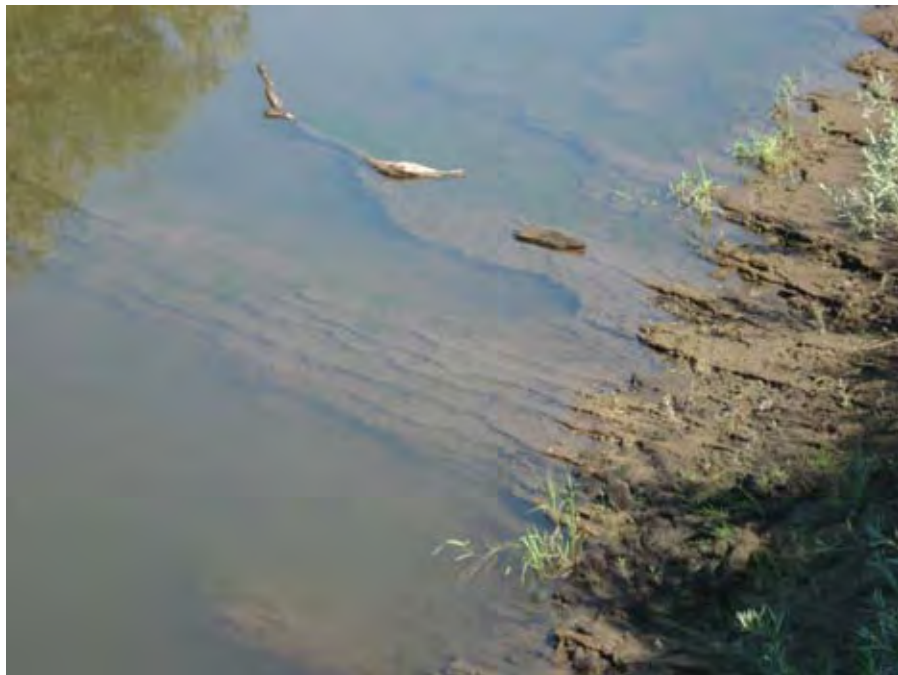
**Photograph 215. View from the right bank to the left showing a vertical denuded face and the typical stratigraphy comprised of topsoil over hard, indurated fine-grained material and well-to-poorly indurated silty-clayey sands near river mile 27.86. Reach 2 – Catherine Creek, Grande Ronde Subbasin, Oregon – Bureau of Reclamation Photograph by R. McAfee, July 29, 2010.**

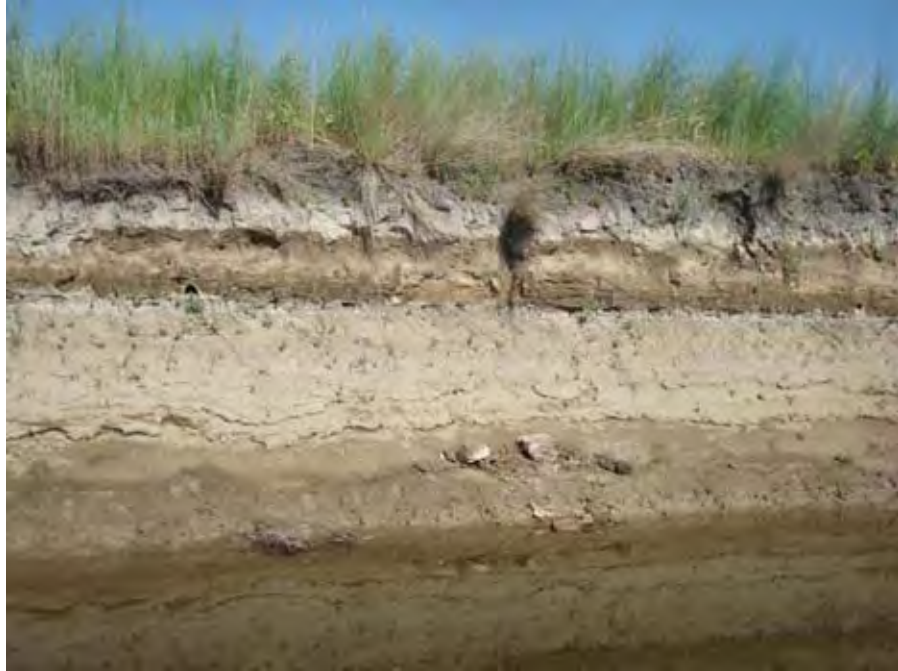
**Photograph 216. View looking at fine-grained fluvial lacustrine sediments exposed along the left (north) bank of Catherine Creek near river mile 27.85. Reach 2 – Catherine Creek, Grande Ronde Subbasin, Oregon – Bureau of Reclamation Photograph by D. Stelma, July 29, 2010.**

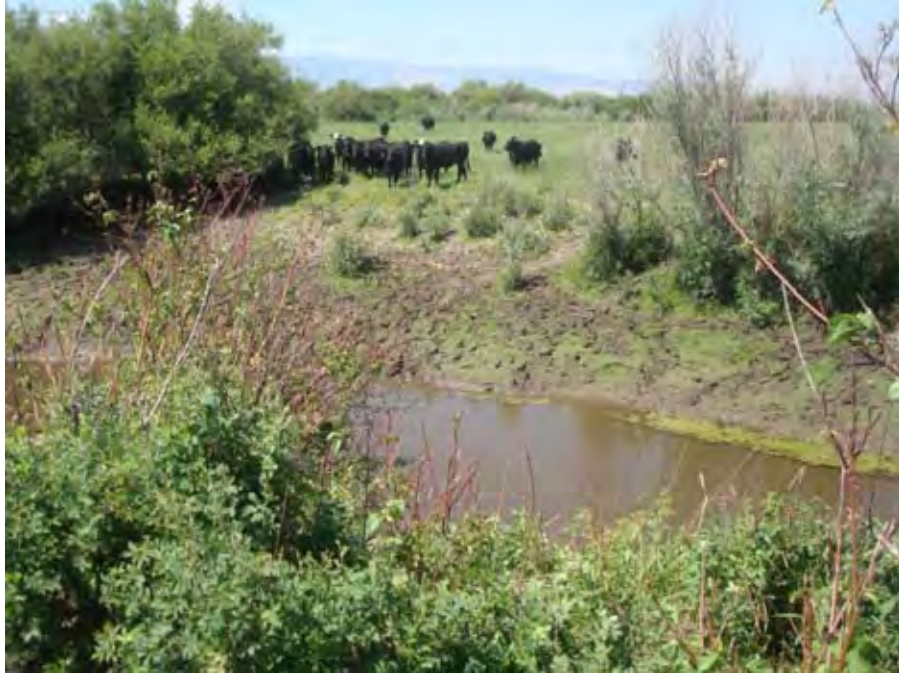
**Photograph 219. Views looking south at side drainage channel discharge gate and ditch near river mile 27.72. Reach 2 – Catherine Creek, Grande Ronde Subbasin, Oregon – Bureau of Reclamation Photograph by D. Stelma, July 29, 2010.**

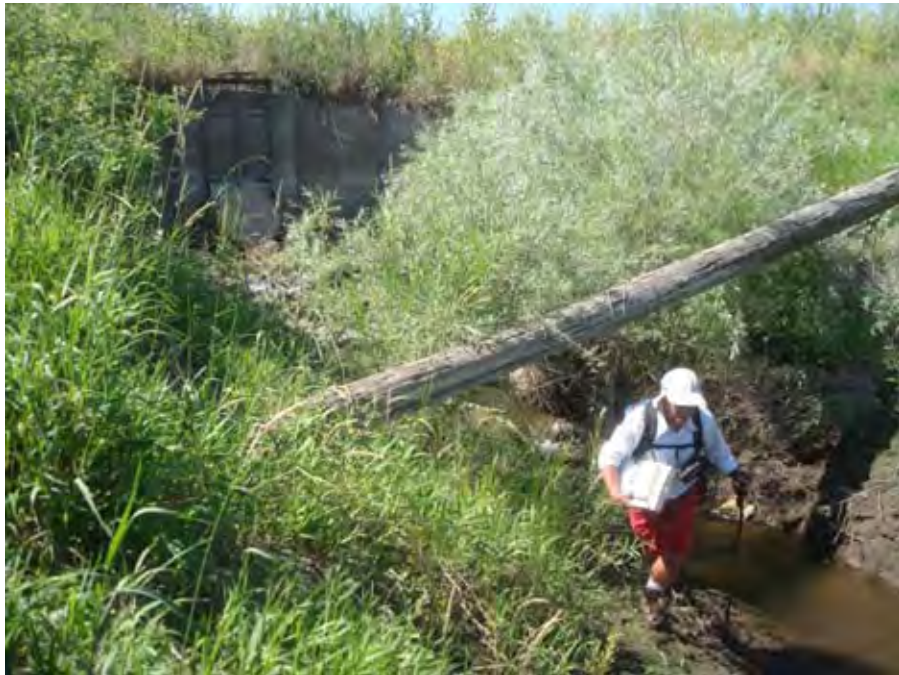
**Photograph 220. Views looking north at side drainage channel discharge, and pumps on north side of Catherine Creek near river mile 27.72. Reach 2 – Catherine Creek, Grande Ronde Subbasin, Oregon – Bureau of Reclamation Photograph by D. Stelma, July 29, 2010.**

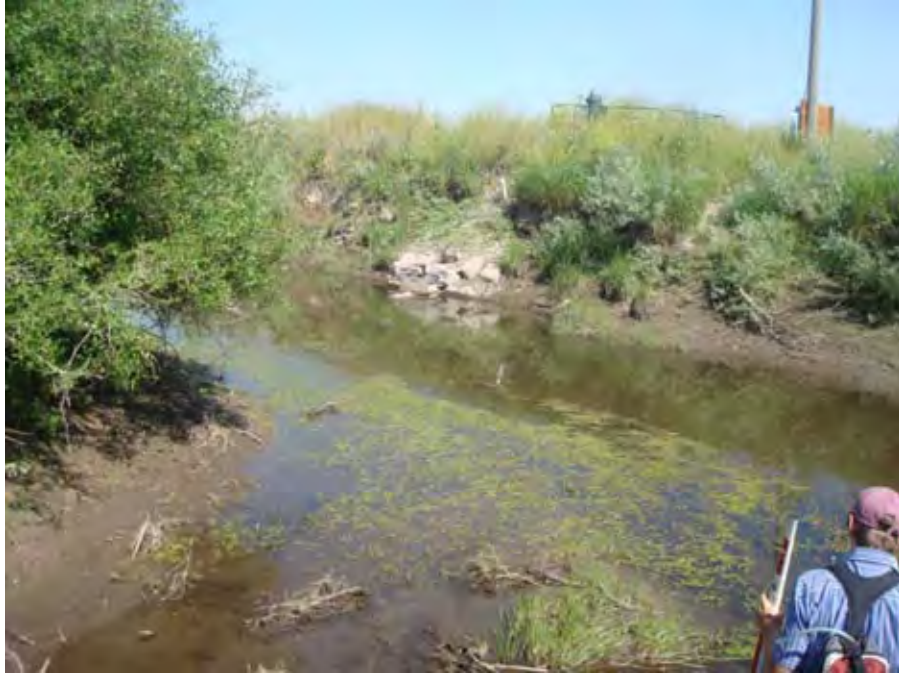
**Photograph 221. View from the right bank of riprap hardened points along both banks at river mile 27.72. Reach 2 – Catherine Creek, Grande Ronde Subbasin, Oregon – Bureau of Reclamation Photograph by R. McAfee, July 29, 2010.**

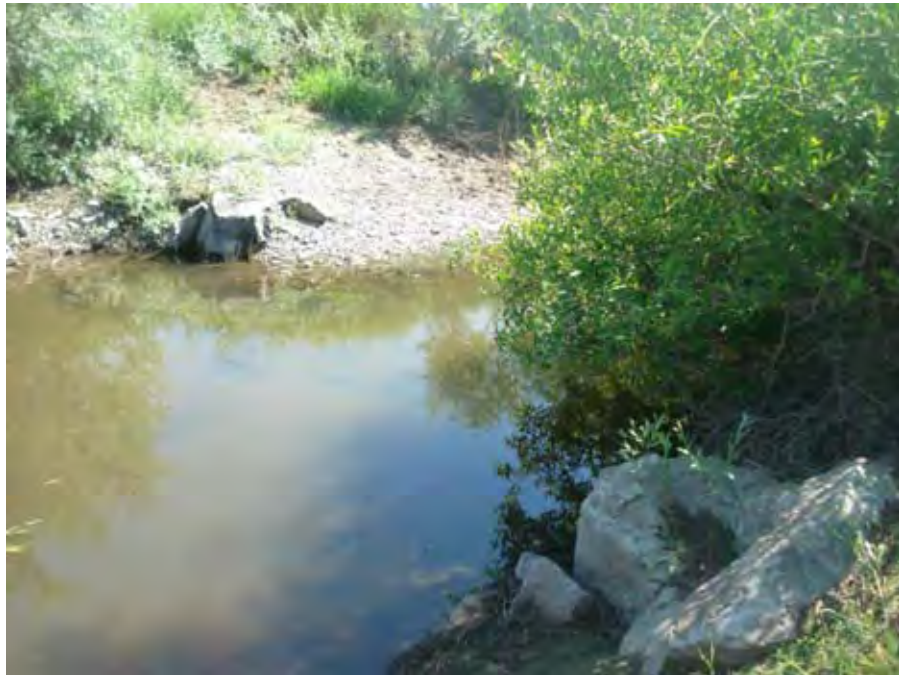
**Photograph 222. View from the right bank looking downstream at another exposure of thinly bedded clayey-silty sand material near river mile 27.59. The vertical and/or undercut ledge just beneath the water surface is up to 2 feet tall. Reach 2 – Catherine Creek, Grande Ronde Subbasin, Oregon – Bureau of Reclamation Photograph by R. McAfee, July 29, 2010.**

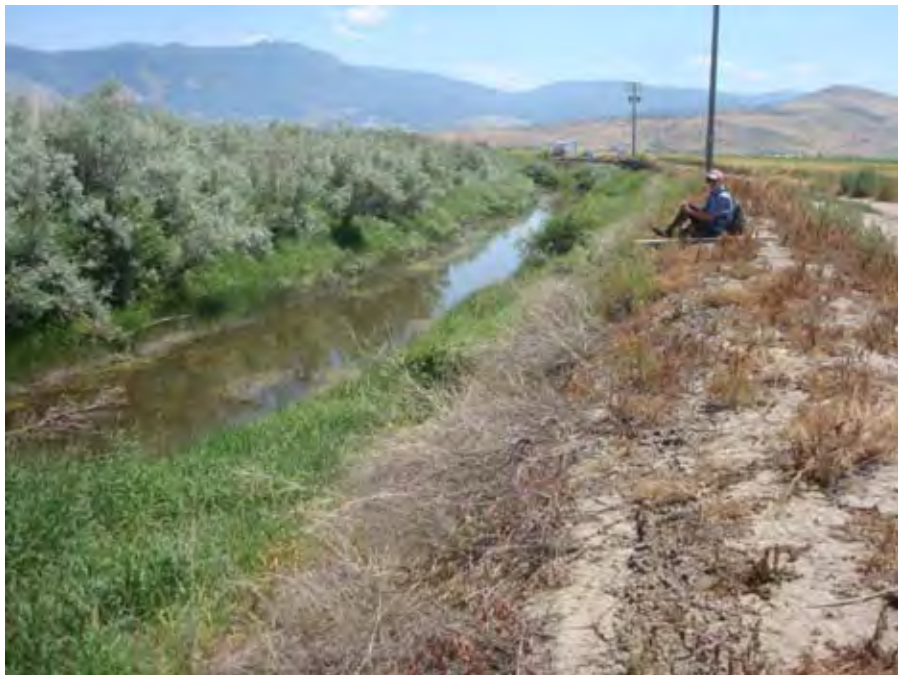
**Photograph 234. View from the right bank looking downstream at grass vegetated right bank and a grass/small tree vegetated right bank near river mile 26.34. Reach 2 – Catherine Creek, Grande Ronde Subbasin, Oregon – Bureau of Reclamation Photograph by R. McAfee, July 29, 2010.**

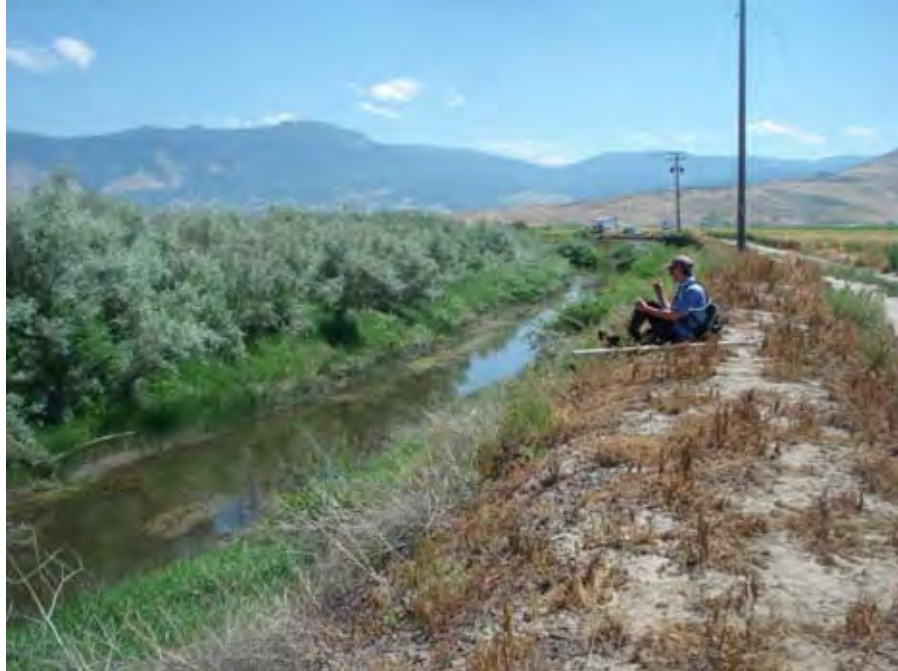
**Photograph 235. View from the left bank looking downstream at the top of grass vegetated left bank and a grass/small tree vegetated right bank near river mile 26.00. Note nearly vertical denuded left bank face and the hard indurated silty sand at the toe. Reach 2 – Catherine Creek, Grande Ronde Subbasin, Oregon – Bureau of Reclamation Photograph by R. McAfee, July 29, 2010.**

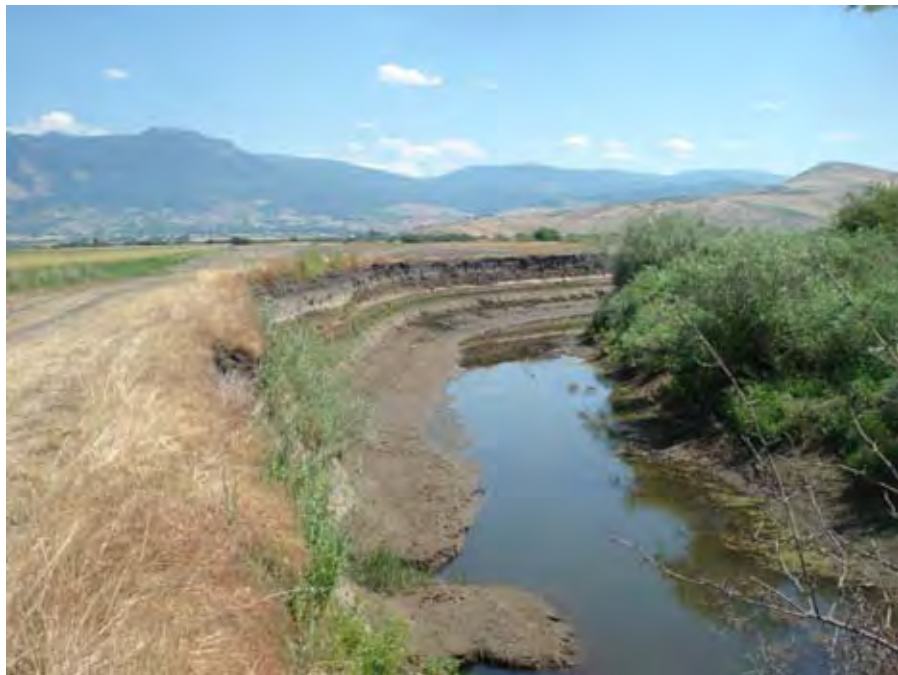
**Photograph 236. View looking downstream fine-grained alluvial sediments exposed along the left (north) bank of Catherine Creek near river mile 25.98. Reach 2 – Catherine Creek, Grande Ronde Subbasin, Oregon – Bureau of Reclamation Photograph by D. Stelma, July 29, 2010.**
