## **APPENDIX C – GEOLOGY AND GEOMORPHOLOGY**

## GEOLOGY AND GEOMORPHOLOGY REPORT FOR THE CATHERINE CREEK TRIBUTARY ASSESSMENT – GRANDE RONDE RIVER BASIN Tributary Habitat Program, Oregon

February 2012

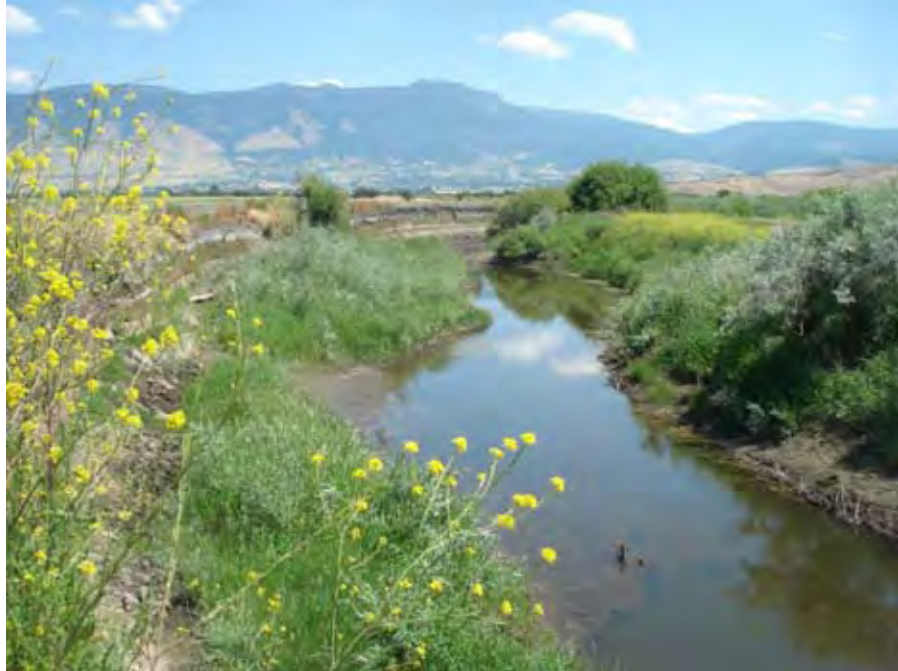
**Photograph 240. View from the left bank looking at a sand pulse in the channel at river mile 25.36. The pulse is lobe-shaped with secondary ripples along the length. Reach 2 – Catherine Creek, Grande Ronde Subbasin, Oregon – Bureau of Reclamation Photograph by R. McAfee, July 29, 2010.**

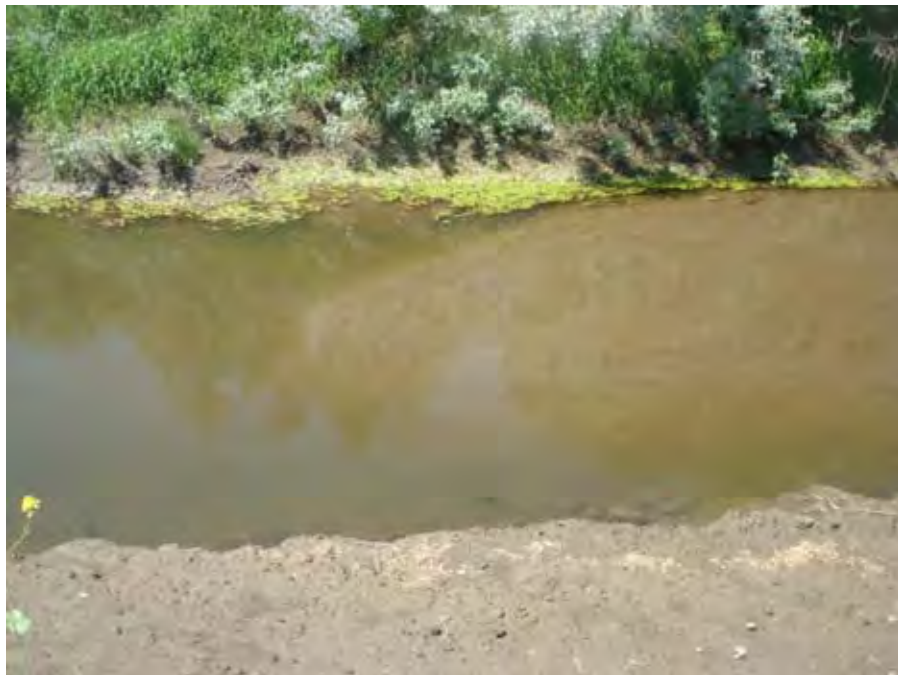
**Photograph 241. View looking downstream fine-grained alluvial sediments exposed along the left (north) bank of Catherine Creek (Phys Point at upper right of photo) near river mile 25.10. Reach 2 – Catherine Creek, Grande Ronde Subbasin, Oregon – Bureau of Reclamation Photograph by D. Stelma, July 29, 2010.**

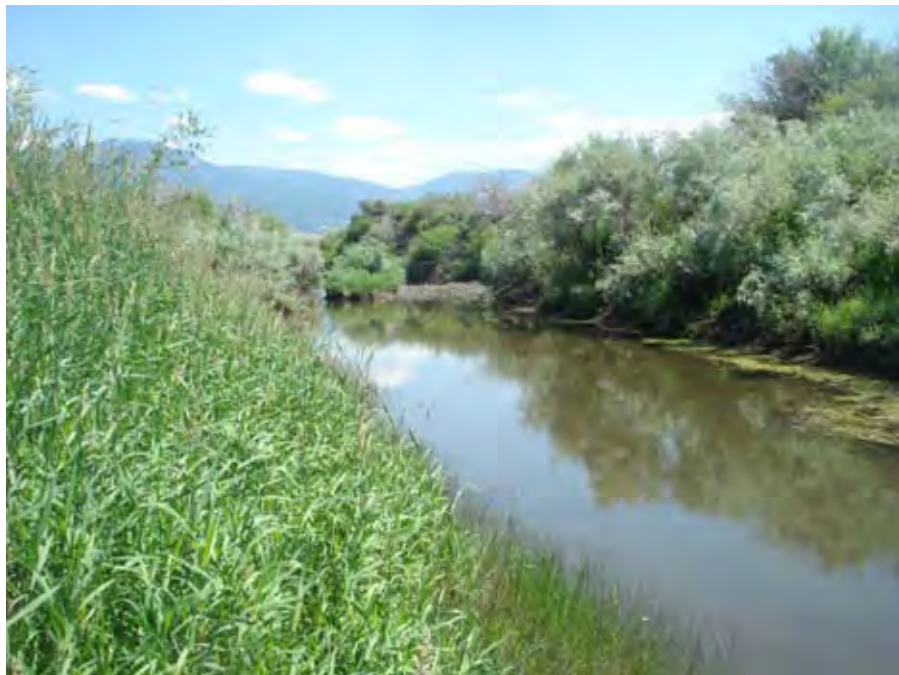
**Photograph 243. View from the left bank looking upstream of grass and small tree vegetation along the banks, with a firm, indurated sand in the bottom of the wetted channel near river mile 24.96. Reach 2 – Catherine Creek, Grande Ronde Subbasin, Oregon – Bureau of Reclamation Photograph by R. McAfee, July 29, 2010.**

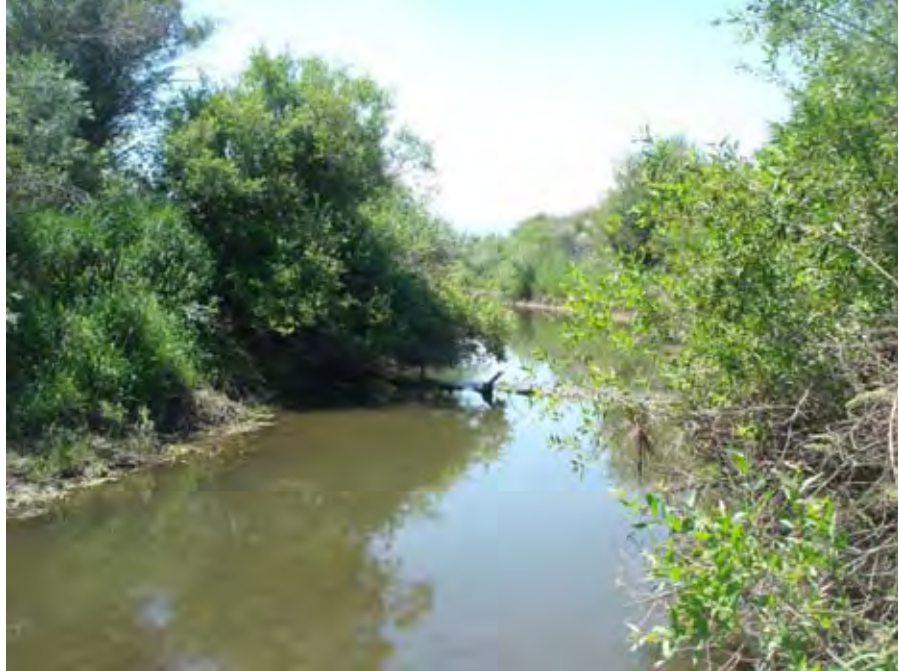
**Photograph 244. View from the top of the left bank looking at a historic oxbow in the left (north) floodplain near river mile 24.88. Reach 2 – Catherine Creek, Grande Ronde Subbasin, Oregon – Bureau of Reclamation Photograph by R. McAfee, July 29, 2010.**

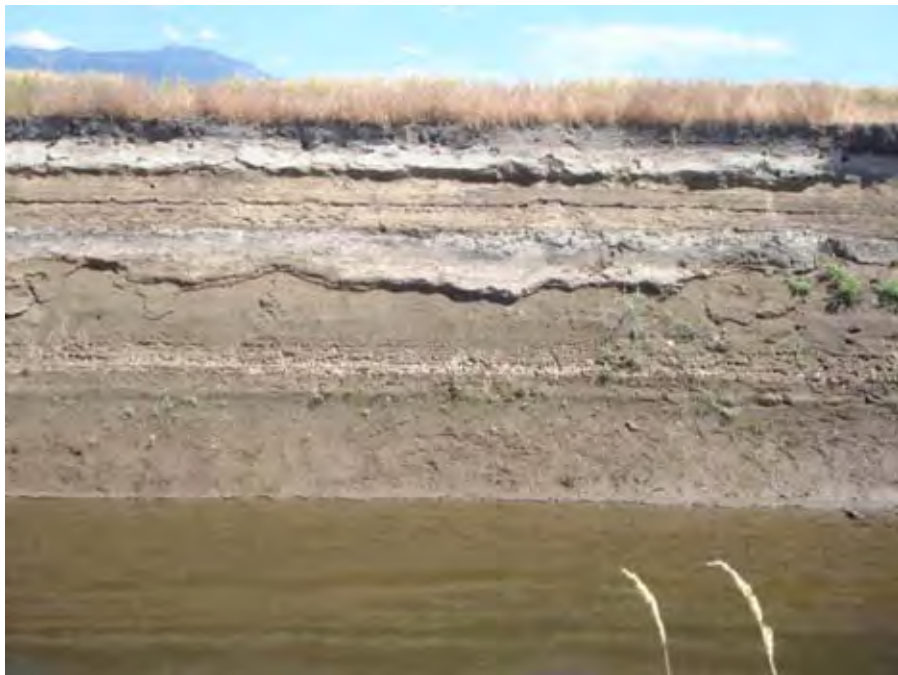
**Photograph 246. View of fine-grained fluvial lacustrine sediments exposed on the right (south) bank of Catherine Creek (near east end of artificial channel) near river mile 24.65. Reach 2 – Catherine Creek, Grande Ronde Subbasin, Oregon – Bureau of Reclamation Photograph by D. Stelma, July 29, 2010.**

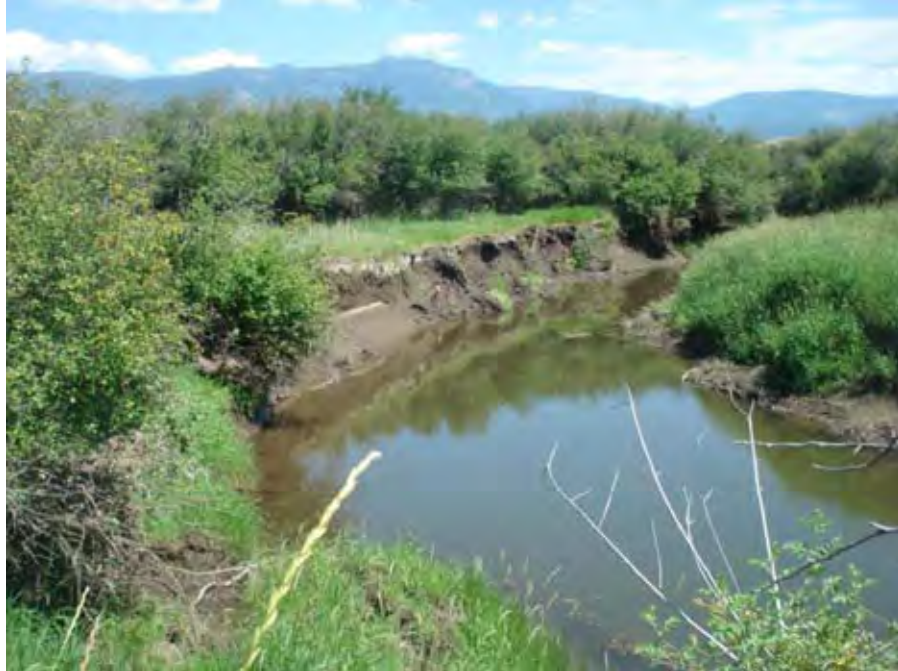
**Photograph 247. View from the left bank looking downstream at bank slumps and denudation of the bank indicates, which can indicate local fine sediment input at this site at river mile 24.54. Reach 2 – Catherine Creek, Grande Ronde Subbasin, Oregon – Bureau of Reclamation Photograph by R. McAfee, July 29, 2010.**

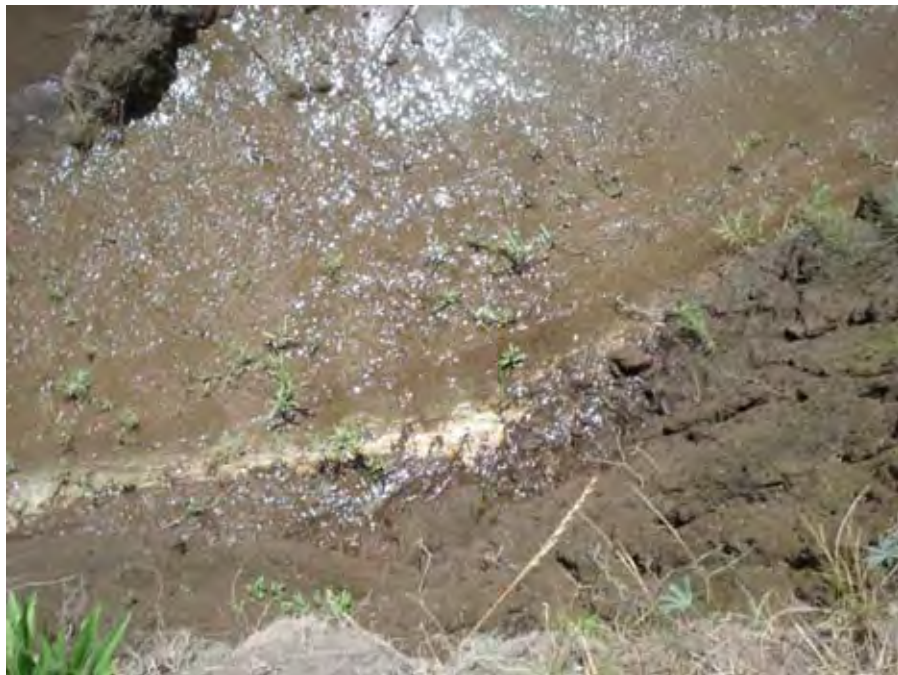
**Photograph 248. View from the top of the left bank looking down at a bank seep along the toe at river mile 24.54. Reach 2 – Catherine Creek, Grande Ronde Subbasin, Oregon – Bureau of Reclamation Photograph by R. McAfee, July 29, 2010.**

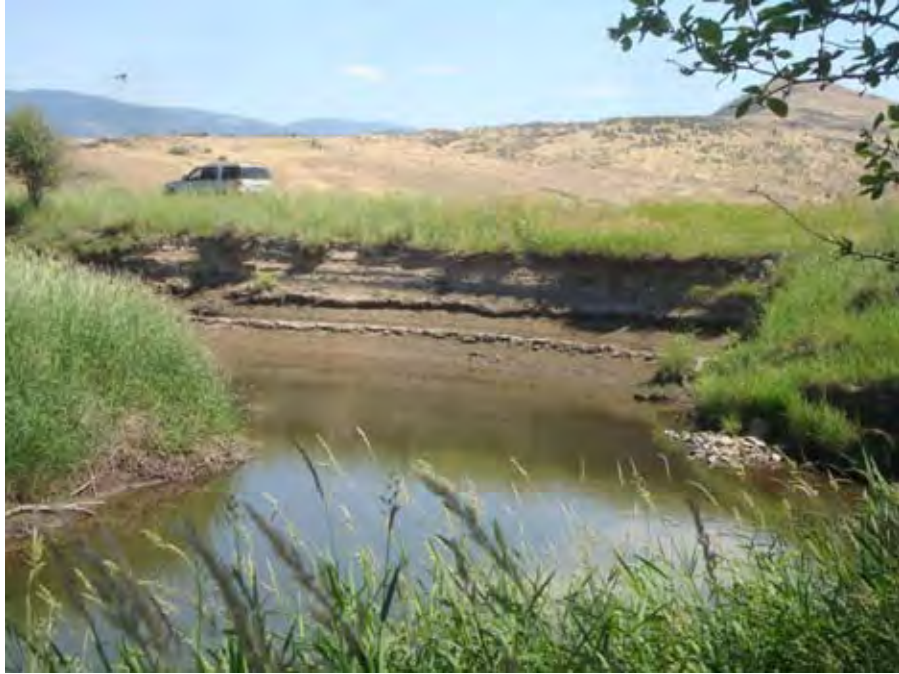
**Photograph 249. View of fine-grained fluvial lacustrine sediments exposed on the left (west) bank of Catherine Creek (Phys Point in background) near river mile 24.30. Reach 2 – Catherine Creek, Grande Ronde Subbasin, Oregon – Bureau of Reclamation Photograph by D. Stelma, July 29, 2010.**

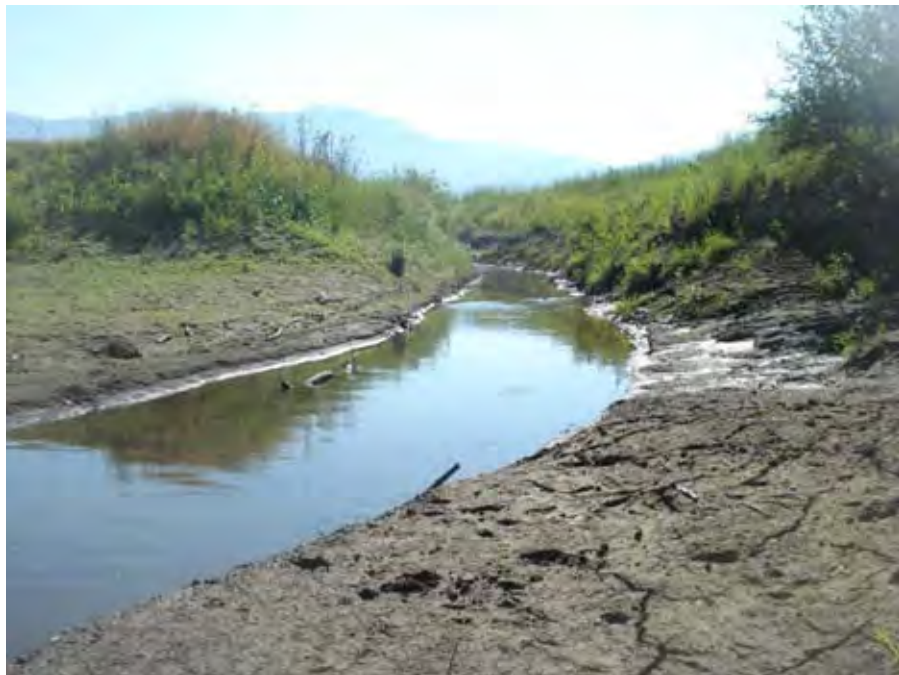
**Photograph 250. View right bank looking up into Mill Creek near river mile 24.11. Note the amount of apparent incision on Mill Creek. Catherine Creek reflects the same amount of incision. Reach 2 – Catherine Creek, Grande Ronde Subbasin, Oregon – Bureau of Reclamation Photograph by R. McAfee, July 30, 2010.**

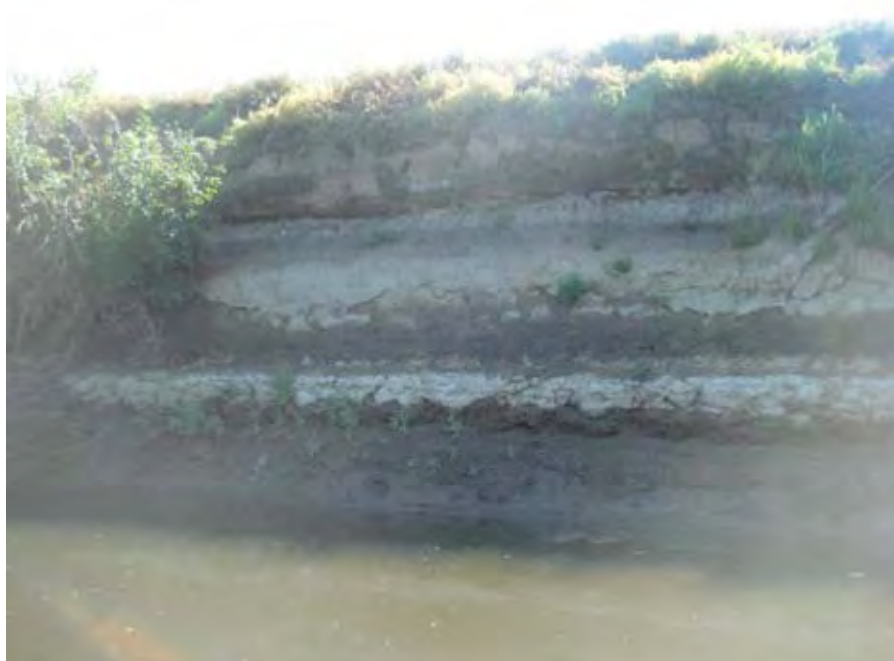
**Photograph 251. View looking at exposed sedimentary sequence along the right bank near river mile 24.09. Reach 2 – Catherine Creek, Grande Ronde Subbasin, Oregon – Bureau of Reclamation Photograph by R. McAfee, July 30, 2010.**

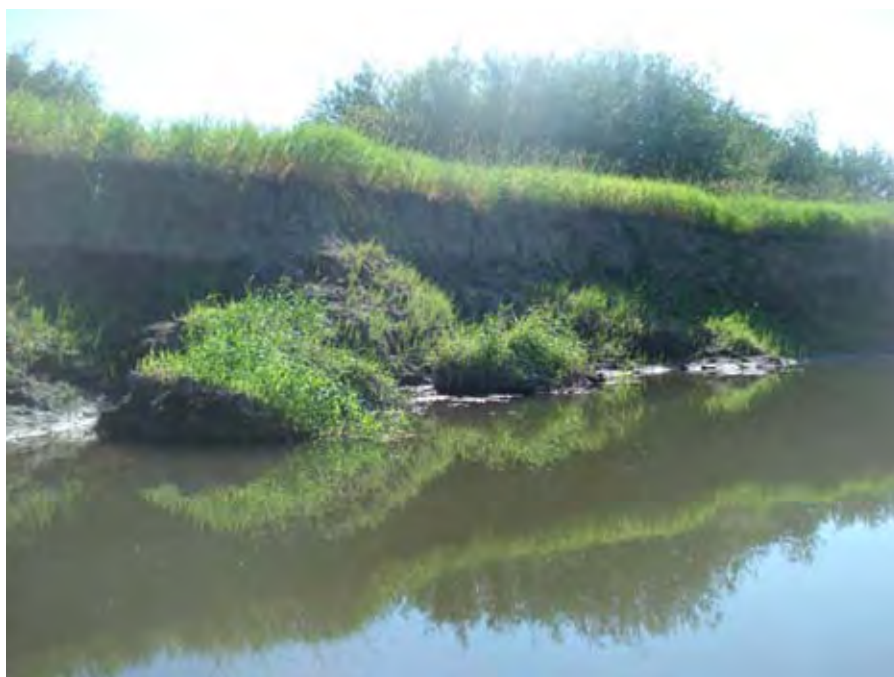
**Photograph 252. View looking at block-sized bank slumps along the right bank near river 23.92. Reach 2 – Catherine Creek, Grande Ronde Subbasin, Oregon – Bureau of Reclamation Photograph by R. McAfee, July 30, 2010.**

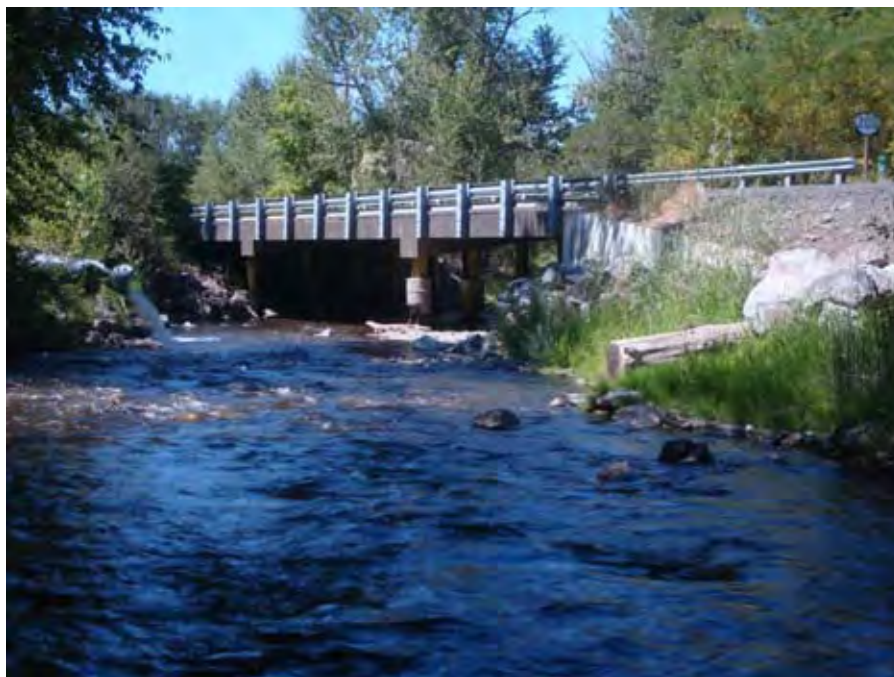
**Photograph 1. View looking downstream at the Oregon State (Medical Springs) Highway 203 Bridge over Catherine Creek at Union, OR near river mile 40.65, note return flow from CMP on left side of channel. Reach 3 – Catherine Creek, Grande Ronde Subbasin, Oregon – Bureau of Reclamation Photograph by D. Stelma, August 16, 2010.**

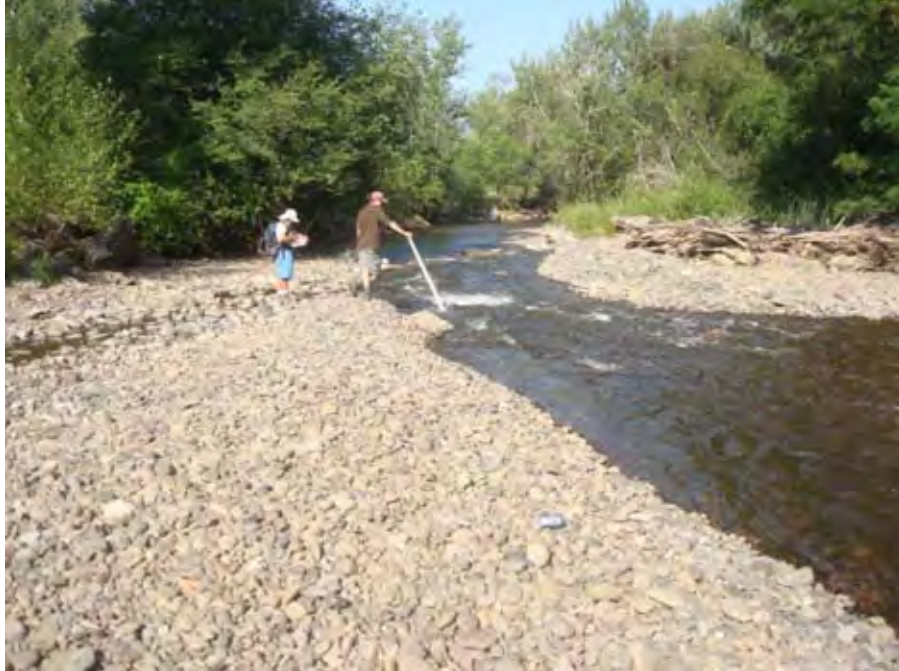
**Photograph 5. View looking downstream at the Catherine Creek channel below Schwackhammer diversion dam near river mile 40.56, note abundance of gravel and cobble size material in bars on both sides of the creek. Reach 3 – Catherine Creek, Grande Ronde Subbasin, Oregon – Bureau of Reclamation Photograph by D. Stelma, August 2, 2010.**

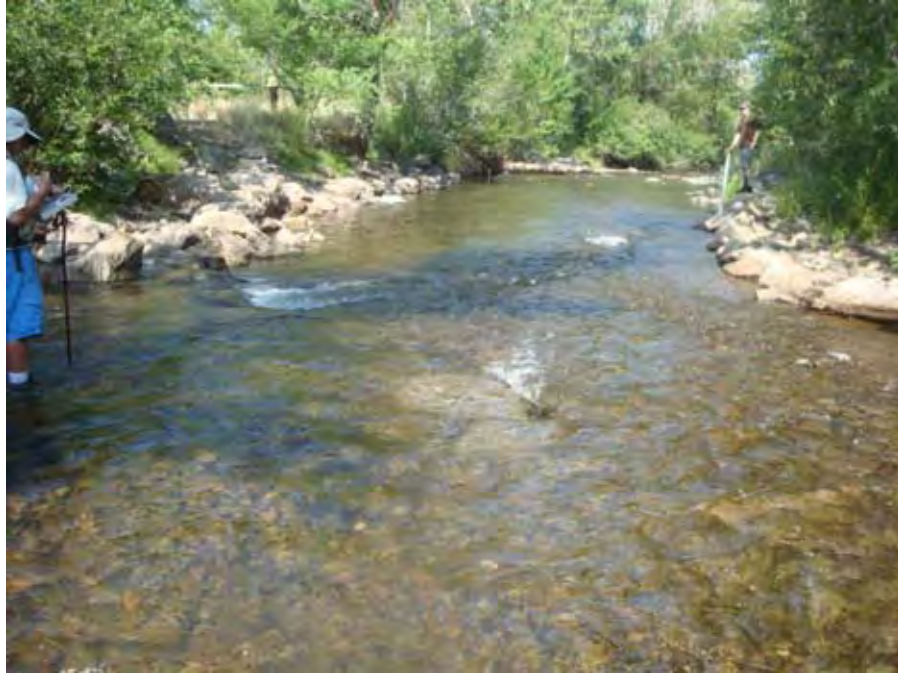
**Photograph 7. View looking downstream at the Catherine Creek channel in Union, OR near river mile 40.53, note rip rap erosion protection on both banks, Oregon State (Medical Springs) Highway 203 is near the left side of the photo. Reach 3 – Catherine Creek, Grande Ronde Subbasin, Oregon – Bureau of Reclamation Photograph by D. Stelma, August 2, 2010.**

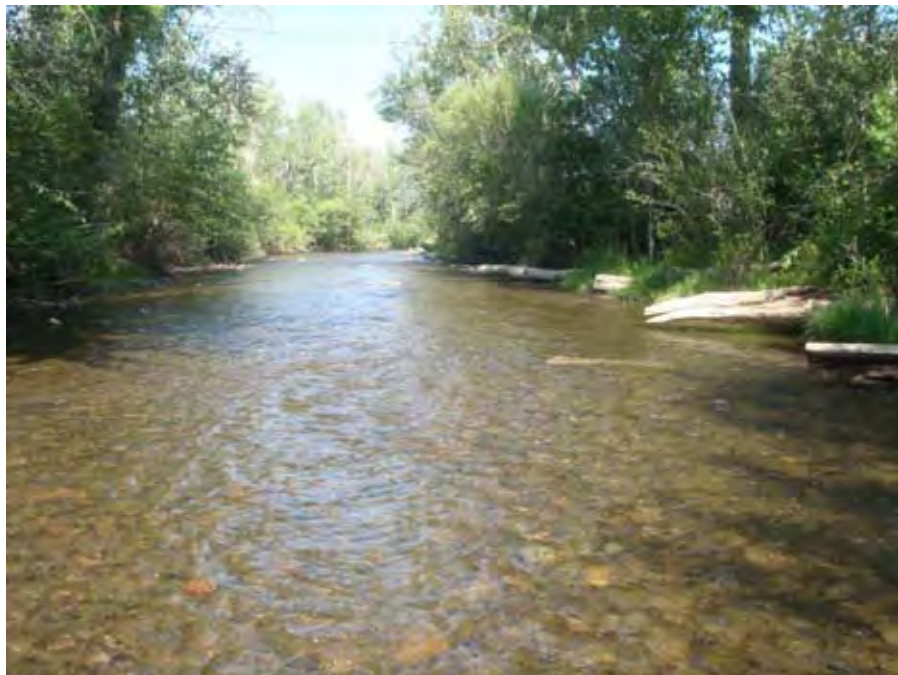
**Photograph 8. View looking downstream at the Catherine Creek channel in Union, OR near river mile 40.50, note log placed along banks to deflect flows. Reach 3 – Catherine Creek, Grande Ronde Subbasin, Oregon – Bureau of Reclamation Photograph by D. Stelma, August 2, 2010.**

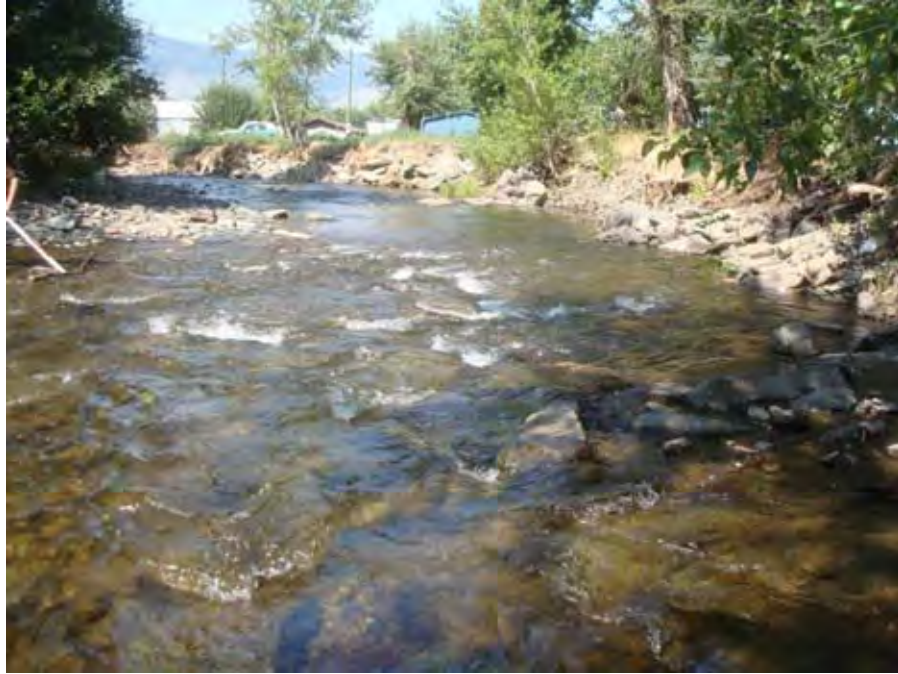
**Photograph 15. View looking downstream at the Catherine Creek channel in Union, OR near river mile 40.28, note rip rap erosion protection on right bank and bed. Reach 3 – Catherine Creek, Grande Ronde Subbasin, Oregon – Bureau of Reclamation Photograph by D. Stelma, August 2, 2010.**

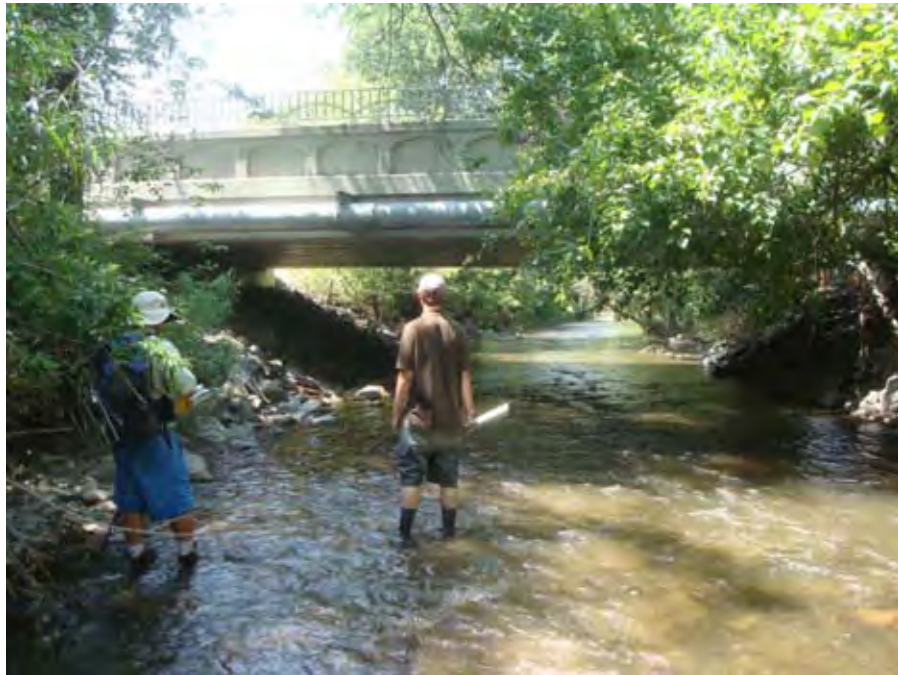
**Photograph 27. View looking upstream at diversion dam work on Catherine Creek in Union, OR near river mile 39.84. Reach 3 – Catherine Creek, Grande Ronde Subbasin, Oregon – Bureau of Reclamation Photograph by D. Stelma, August 2, 2010.**

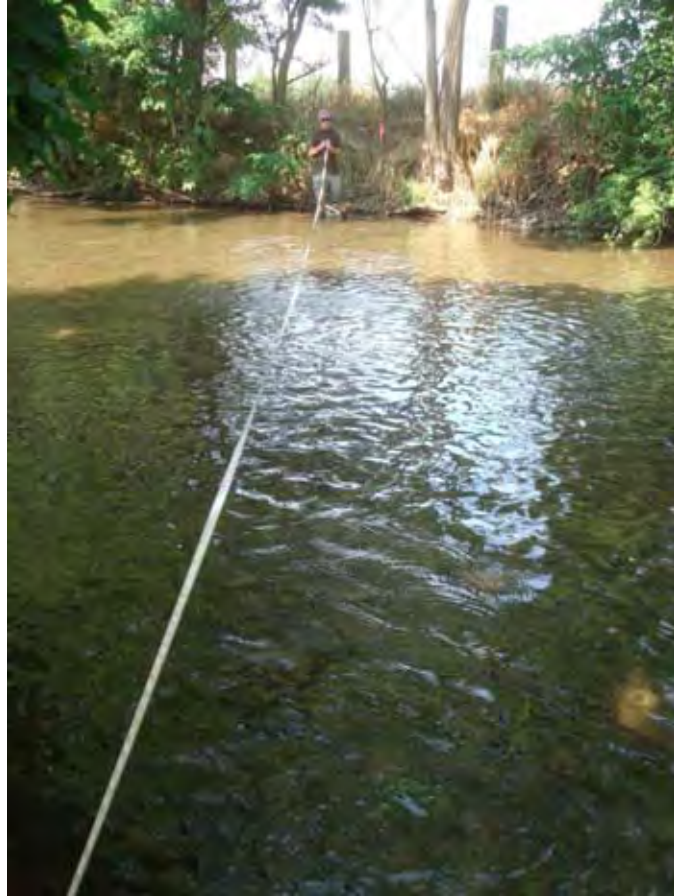
**Photograph 31. View looking downstream at the Catherine Creek channel and concrete diversion dam within the city of Union, OR near river mile 39.63, note ditch/canal intake on the upstream right side of the structure. Reach 3 – Catherine Creek, Grande Ronde Subbasin, Oregon – Bureau of Reclamation Photograph by D. Stelma, August 2, 2010.**

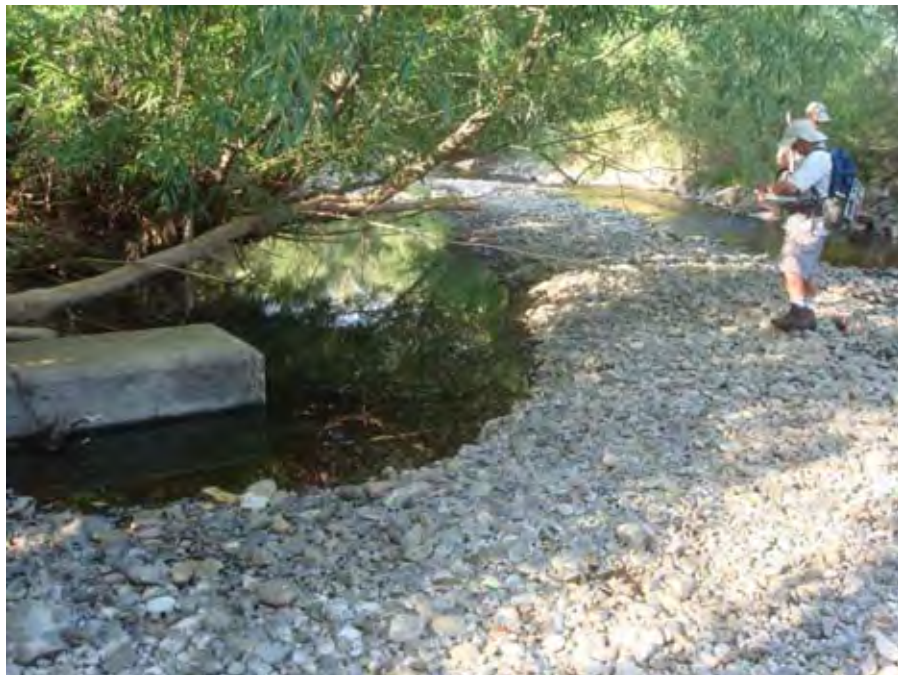
**Photograph 41. View looking toward the left bank of Catherine Creek at a concrete encased discharge pipe at waste water treatment plant near river mile 39.00. Reach 3 – Catherine Creek, Grande Ronde Subbasin, Oregon – Bureau of Reclamation Photograph by D. Stelma, August 3, 2010.**

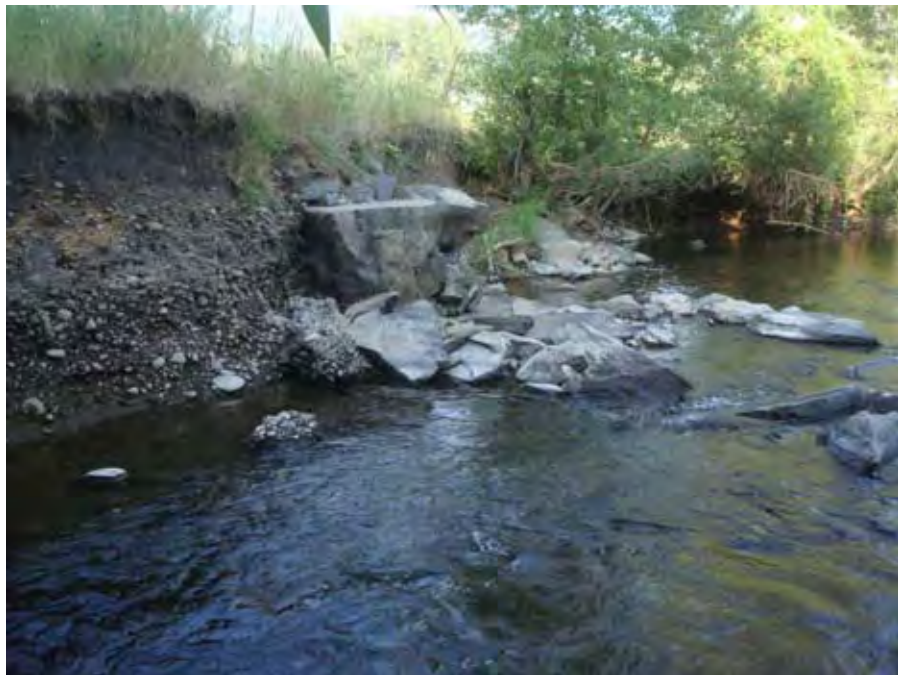
**Photograph 43. View looking downstream at Catherine Creek channel near the waste water treatment plant near river mile 38.99, note rock weir and logs placed for erosion protection. Reach 3 – Catherine Creek, Grande Ronde Subbasin, Oregon – Bureau of Reclamation Photograph by D. Stelma, August 3, 2010.**

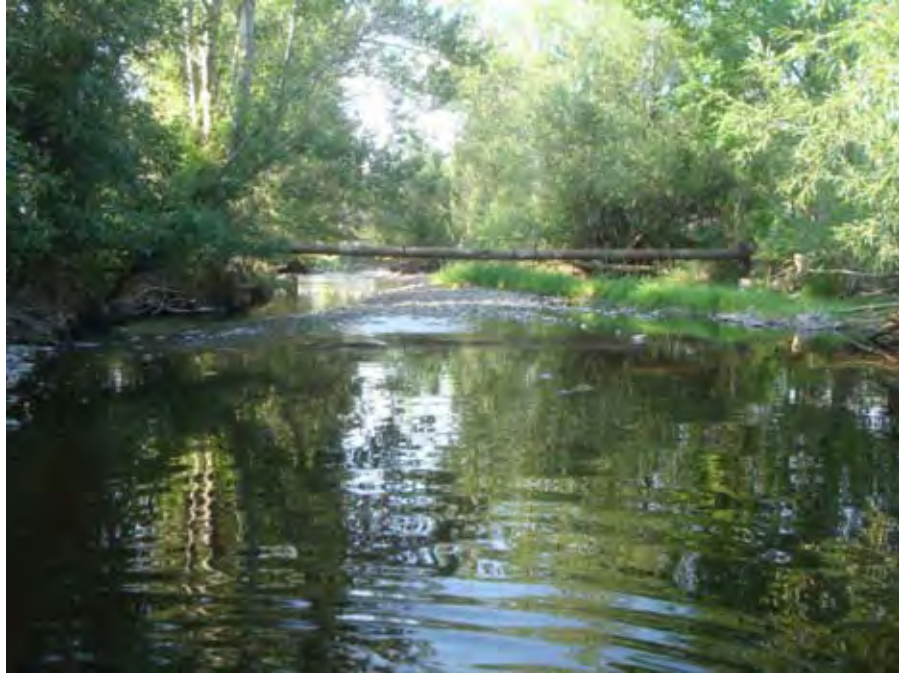
**Photograph 44. View looking downstream at Catherine Creek channel near waste water treatment plant near river mile 38.90, note rip rap erosion protection along left bank. Reach 3 – Catherine Creek, Grande Ronde Subbasin, Oregon – Bureau of Reclamation Photograph by D. Stelma, August 3, 2010.**

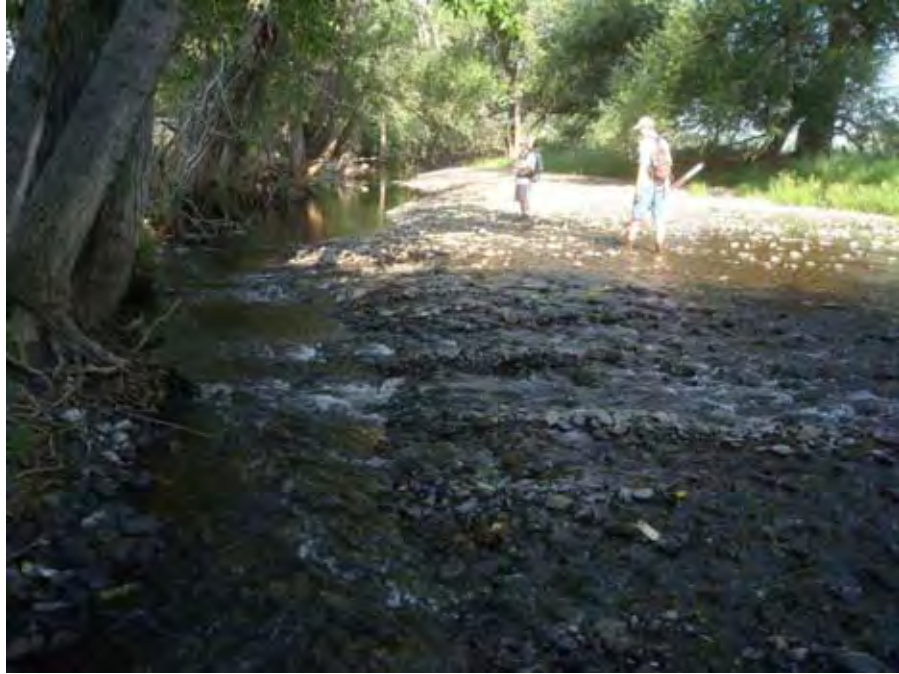
**Photograph 48. View looking at right bank of Catherine Creek near river mile 38.66, note coarse-grained alluvium overlying fine-grained sediments (dense silt). Reach 3 – Catherine Creek, Grande Ronde Subbasin, Oregon – Bureau of Reclamation Photograph by D. Stelma, August 3, 2010.**

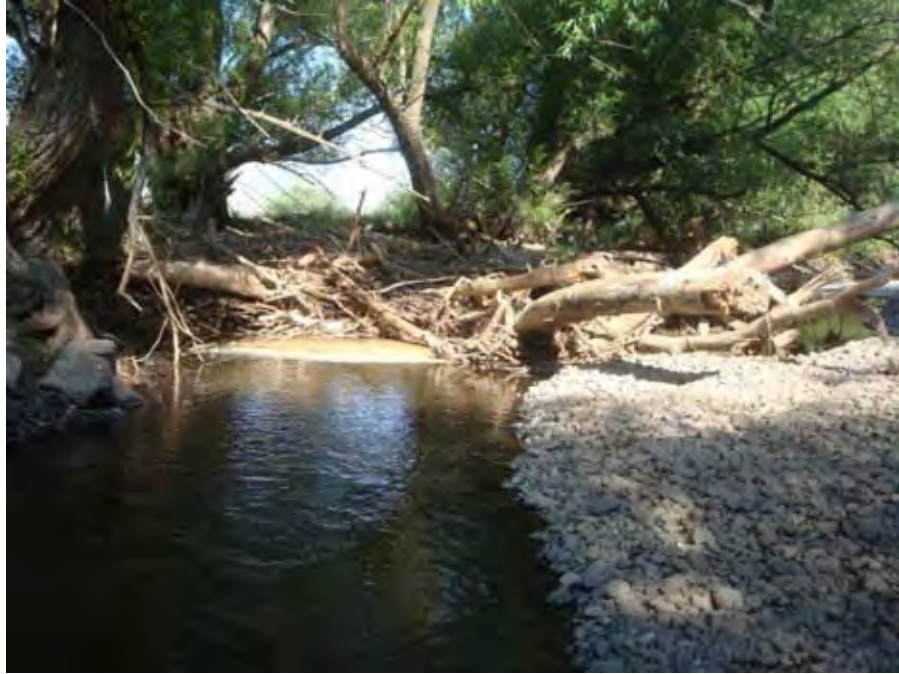
**Photograph 50. View looking downstream at Catherine Creek channel near river mile 38.25, note gravel bar and ponderosa pine log for erosion protection on left. Reach 3 – Catherine Creek, Grande Ronde Subbasin, Oregon – Bureau of Reclamation Photograph by D. Stelma, August 3, 2010.**

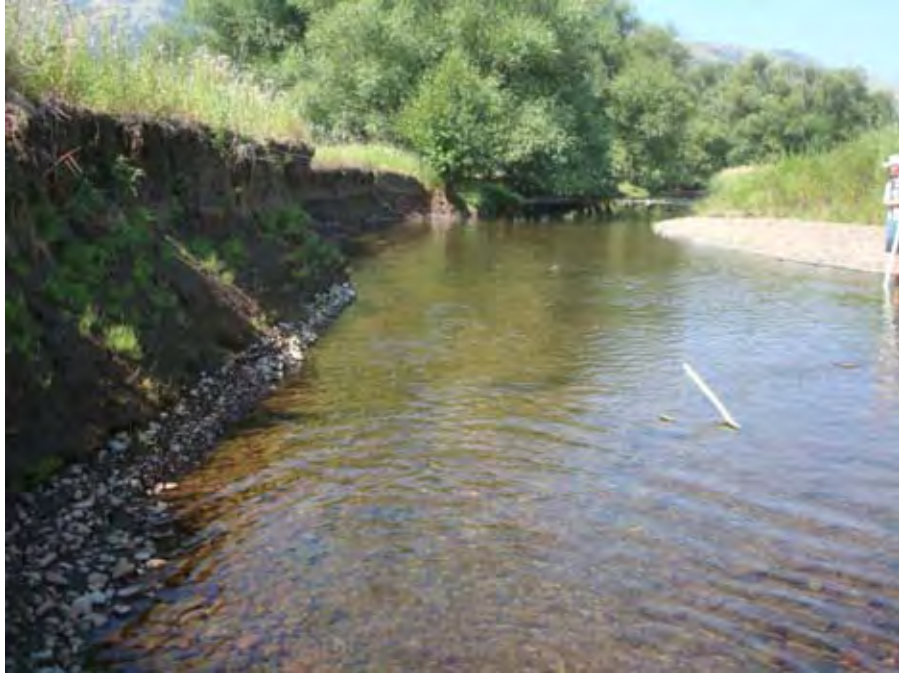
**Photograph 57. Close-up of left bank fine-grained sediments mixed with sandy silt and gravelly sediments at transition zone between Reaches 2 and 3 near river mile 37.95. Reach 3 – Catherine Creek, Grande Ronde Subbasin, Oregon – Bureau of Reclamation Photograph by D. Stelma, August 3, 2010.**

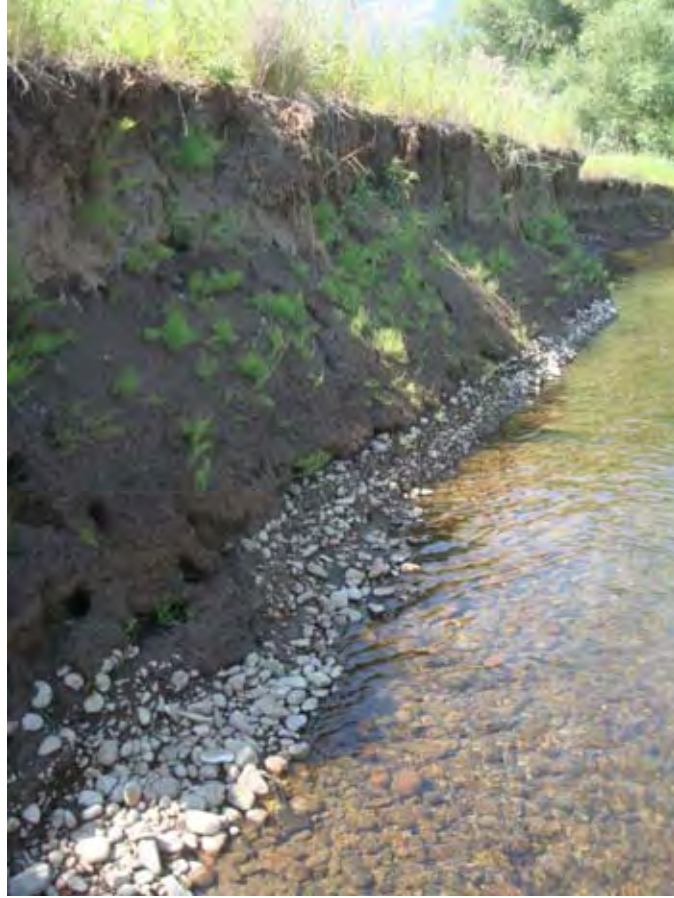
**Photograph 58. View looking downstream at Catherine Creek channel, note fine-grained deposits (fill or topsoil) over gravelly alluvium in left bank exposure near river mile 37.77. Reach 3 – Catherine Creek, Grande Ronde Subbasin, Oregon – Bureau of Reclamation Photograph by D. Stelma, August 3, 2010.**

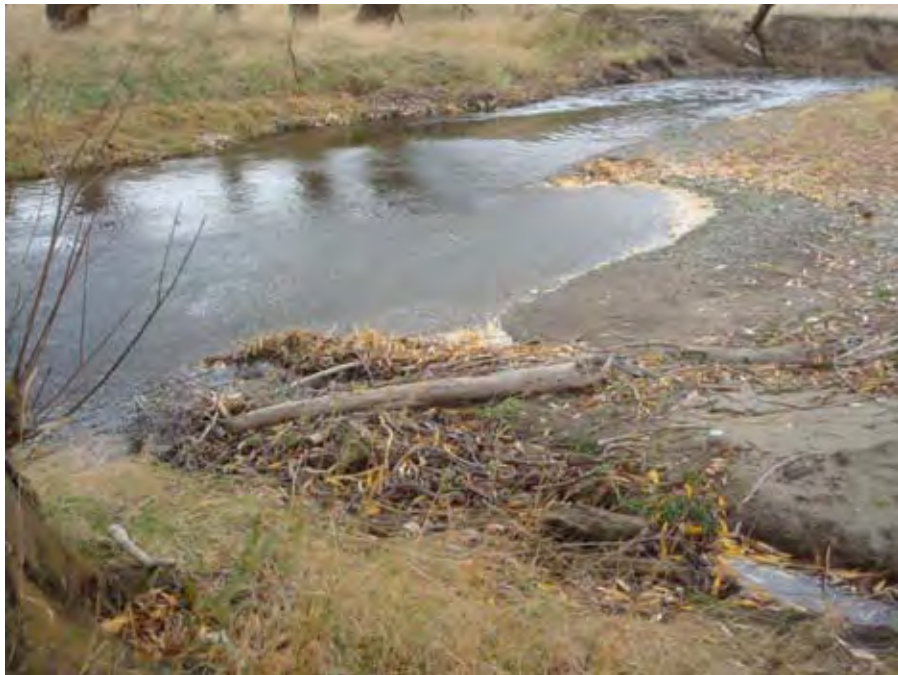
**Photograph 66. View looking downstream Catherine Creek channel; note gravel bar and wood debris accumulation under large tree branch near river mile 37.30. Reach 3 – Catherine Creek, Grande Ronde Subbasin, Oregon – Bureau of Reclamation Photograph by D. Stelma, November 9, 2010.**

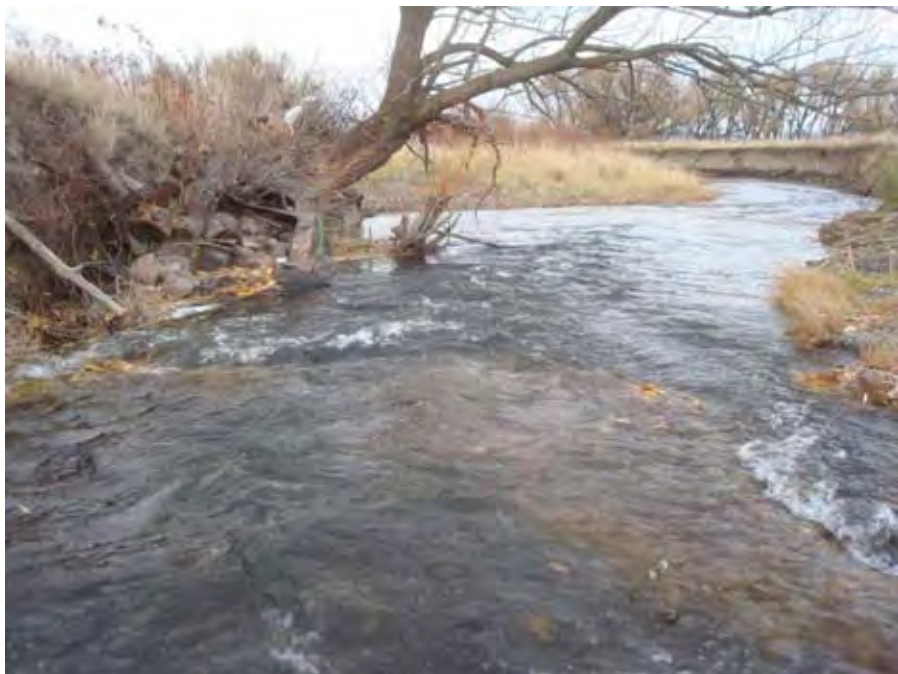
**Photograph 69. View looking downstream Catherine Creek channel and head-cut area, not rock-filled automobile for erosion protection on the left bank near river mile 37.26. Reach 3 – Catherine Creek, Grande Ronde Subbasin, Oregon – Bureau of Reclamation Photograph by D. Stelma, November 9, 2010.**

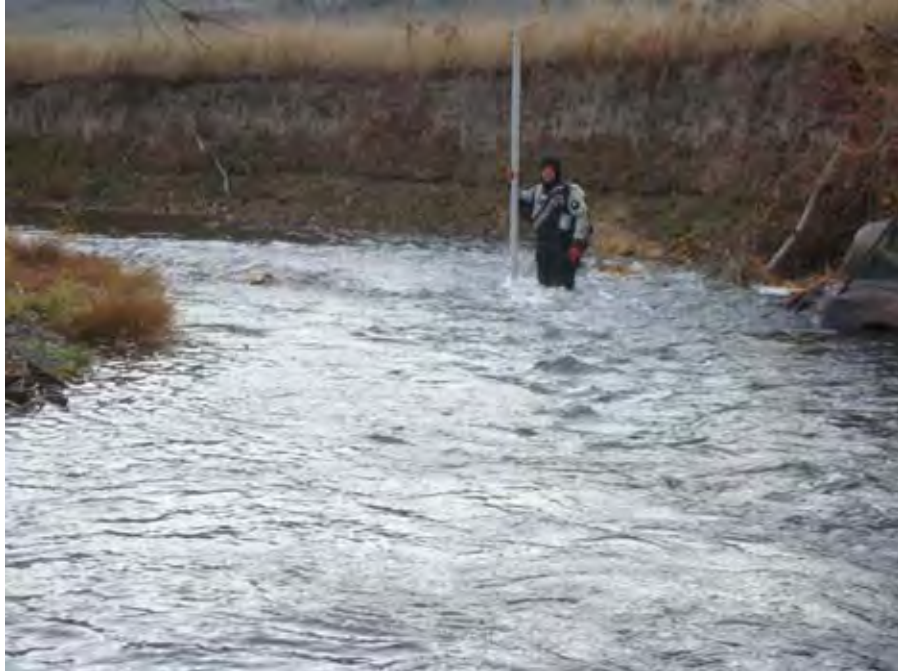
**Photograph 70. View looking upstream Catherine Creek channel and head-cut area, not rock-filled automobile for erosion protection on the left bank near river mile 37.26. Reach 3 – Catherine Creek, Grande Ronde Subbasin, Oregon – Bureau of Reclamation Photograph by D. Stelma, November 9, 2010.**

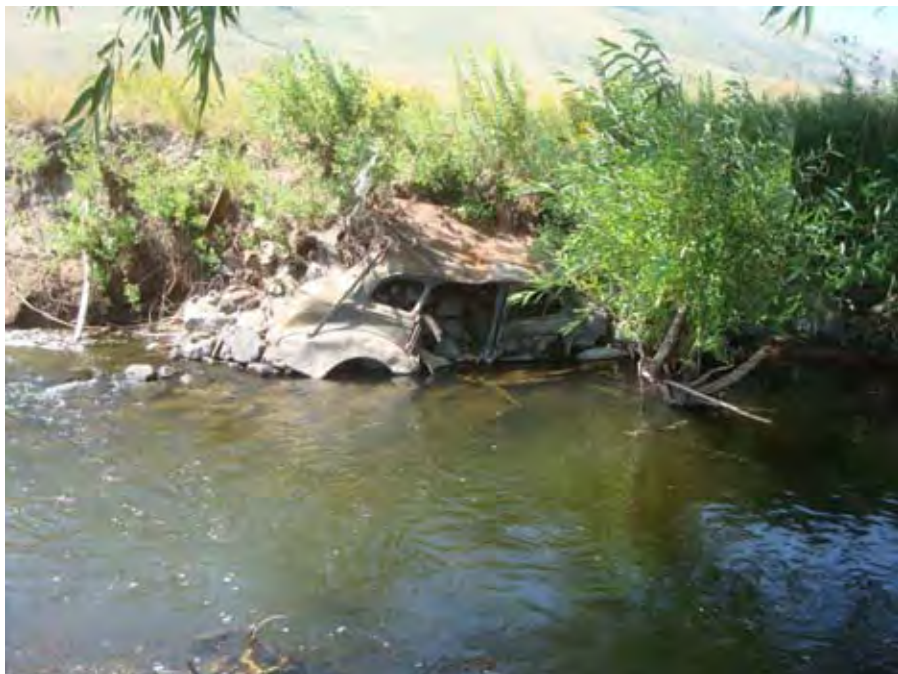
**Photograph 71. Rock-filled automobile used for erosion protection on the left bank of Catherine Creek near river mile 37.26. Reach – Catherine Creek, Grande Ronde Subbasin, Oregon – Bureau of Reclamation Photograph by D. Stelma, August 3, 2010.**

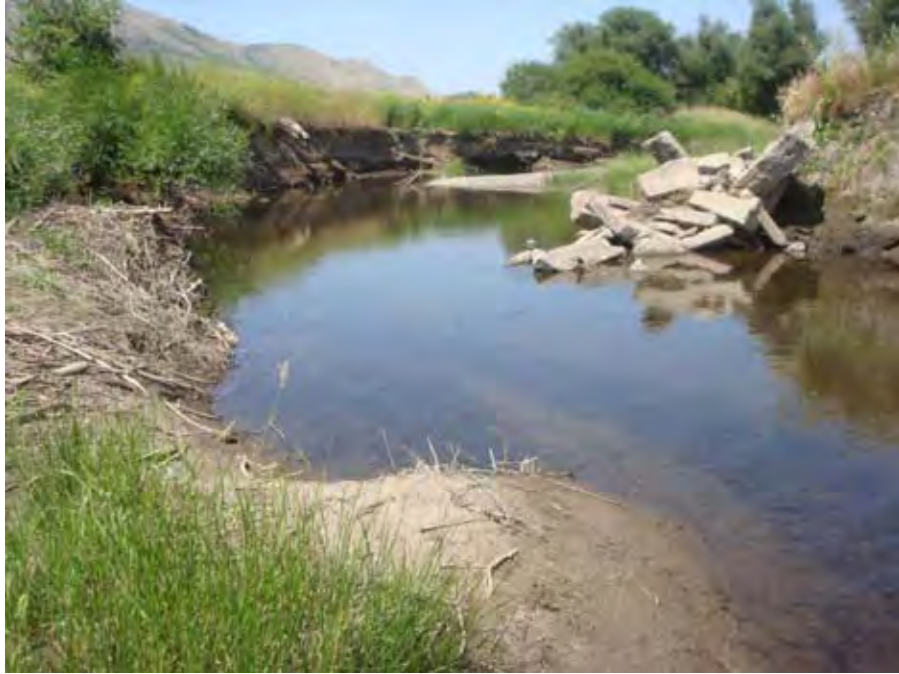
**Photograph 72. View looking downstream at concrete blocks and wood debris on the banks of Catherine Creek near river mile 37.20. Reach 2 – Catherine Creek, Grande Ronde Subbasin, Oregon – Bureau of Reclamation Photograph by D. Stelma, August 3, 2010.**

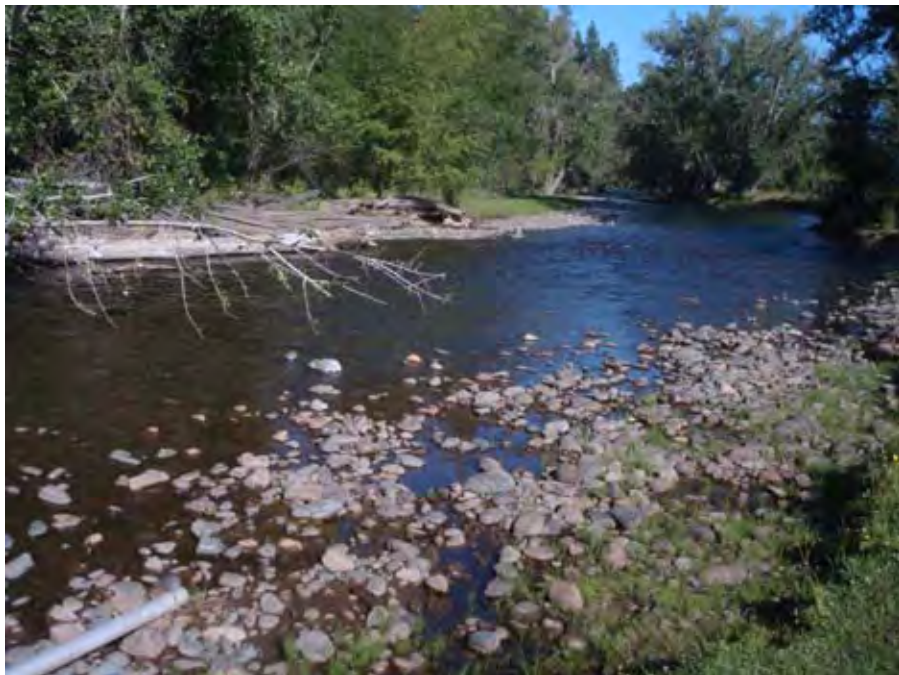
**Photograph 20. View looking downstream at Catherine Creek channel near river mile 42.96, note left bank erosion. Reach 4 – Catherine Creek, Grande Ronde Subbasin, Oregon – Bureau of Reclamation Photograph by D. Stelma, August 19, 2010.**

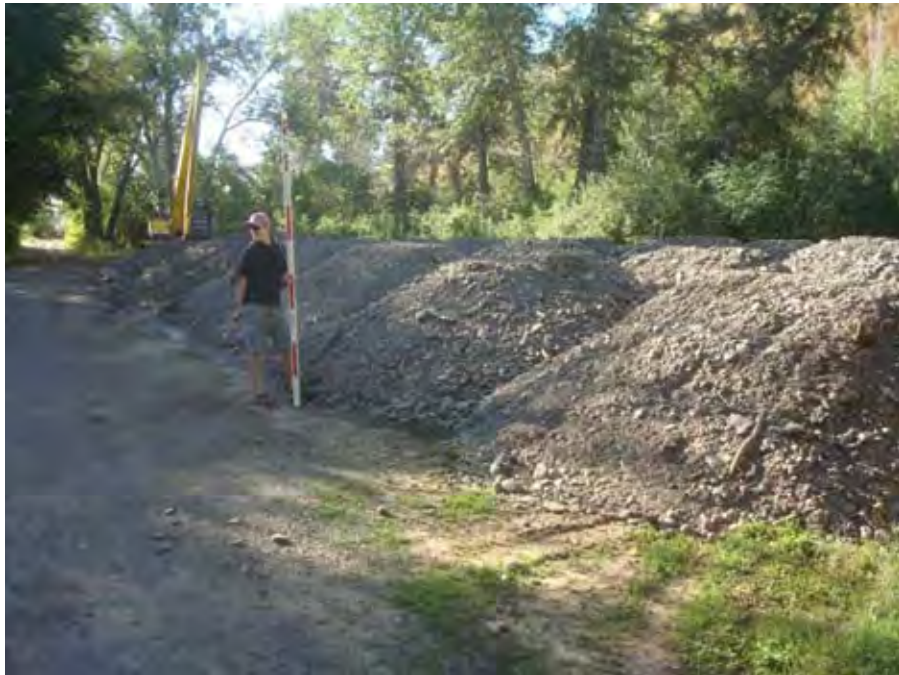
**Photograph 34. Sediment excavated from the bed of Catherine Creek upstream and within the concrete fish trap structure near river mile 42.49. Reach 4 – Catherine Creek, Grande Ronde Subbasin, Oregon – Bureau of Reclamation Photograph by D. Stelma, August 16, 2010.**

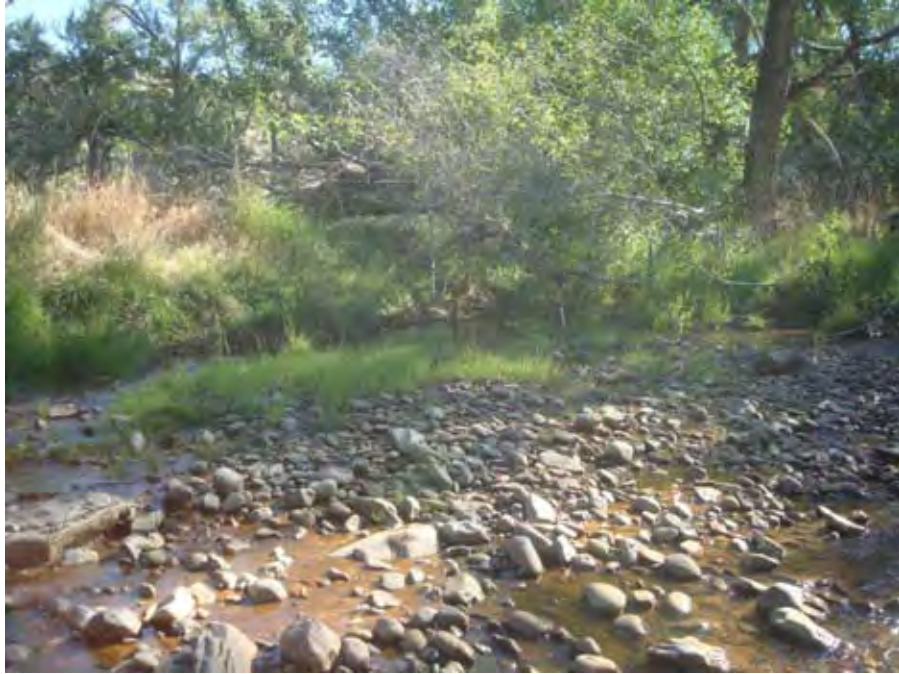
**Photograph 36. View looking north at fish trap return flow entering Catherine Creek on the right bank near river mile 42.40. Reach 4 – Catherine Creek, Grande Ronde Subbasin, Oregon – Bureau of Reclamation Photograph by D. Stelma, August 16, 2010.**
