## **APPENDIX C – GEOLOGY AND GEOMORPHOLOGY**

## GEOLOGY AND GEOMORPHOLOGY REPORT FOR THE CATHERINE CREEK TRIBUTARY ASSESSMENT – GRANDE RONDE RIVER BASIN Tributary Habitat Program, Oregon

February 2012

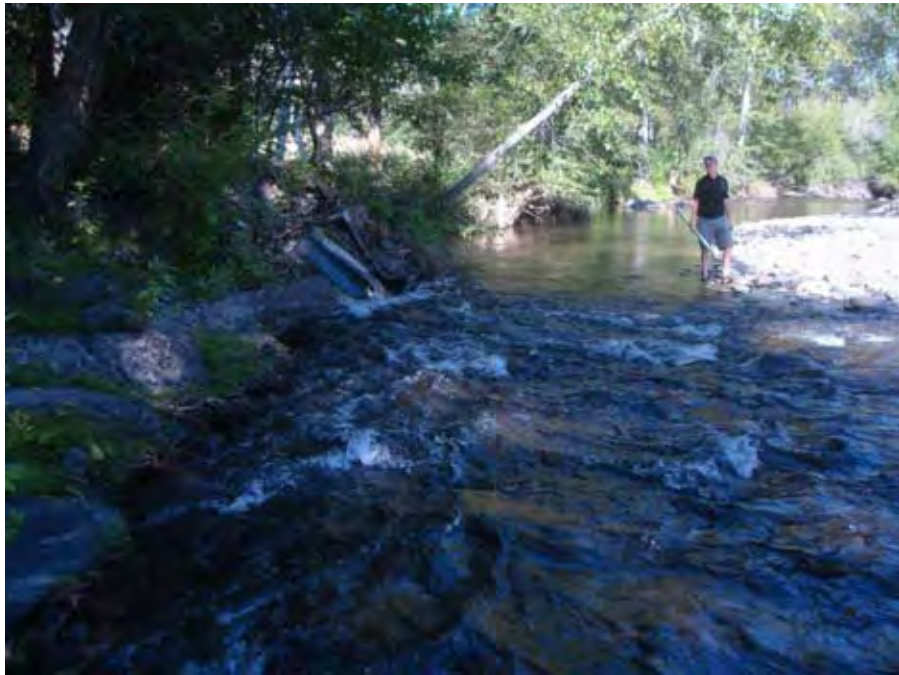
**Photograph 41. View looking downstream at Catherine Creek channel near river mile 42.24, note concrete blocks and automobile for erosion protection on left side creek. Reach 4 – Catherine Creek, Grande Ronde Subbasin, Oregon – Bureau of Reclamation Photograph by D. Stelma, August 16, 2010.**

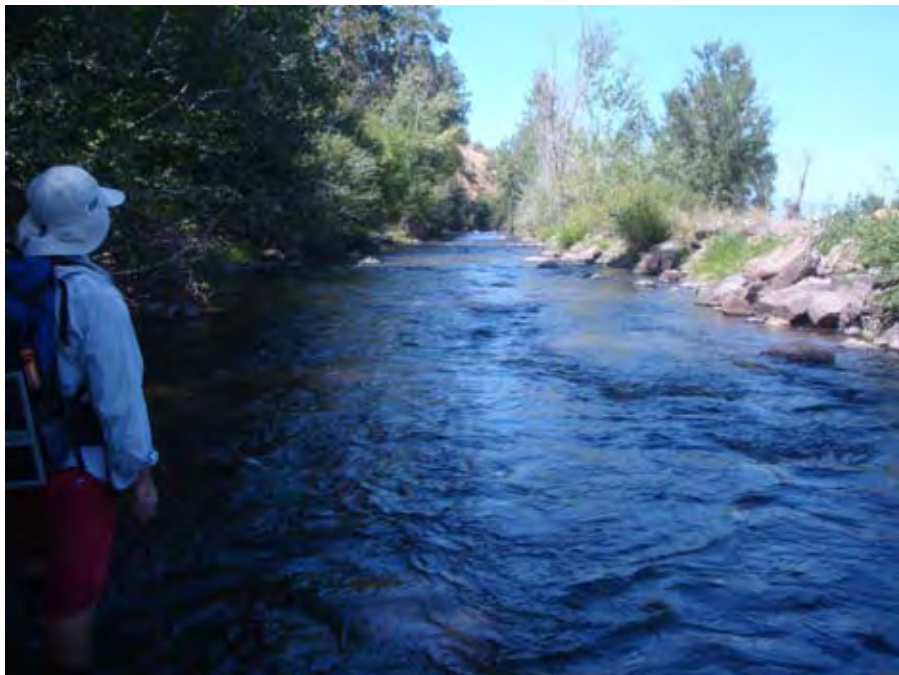
**Photograph 54. View looking downstream at the Catherine Creek channel near river mile 41.35, note Oregon State (Medical Springs) Highway 203 forms the right bank, bank material consists primarily of road fill and rip rap. Reach 4 – Catherine Creek, Grande Ronde Subbasin, Oregon – Bureau of Reclamation Photograph by D. Stelma, August 16, 2010.**

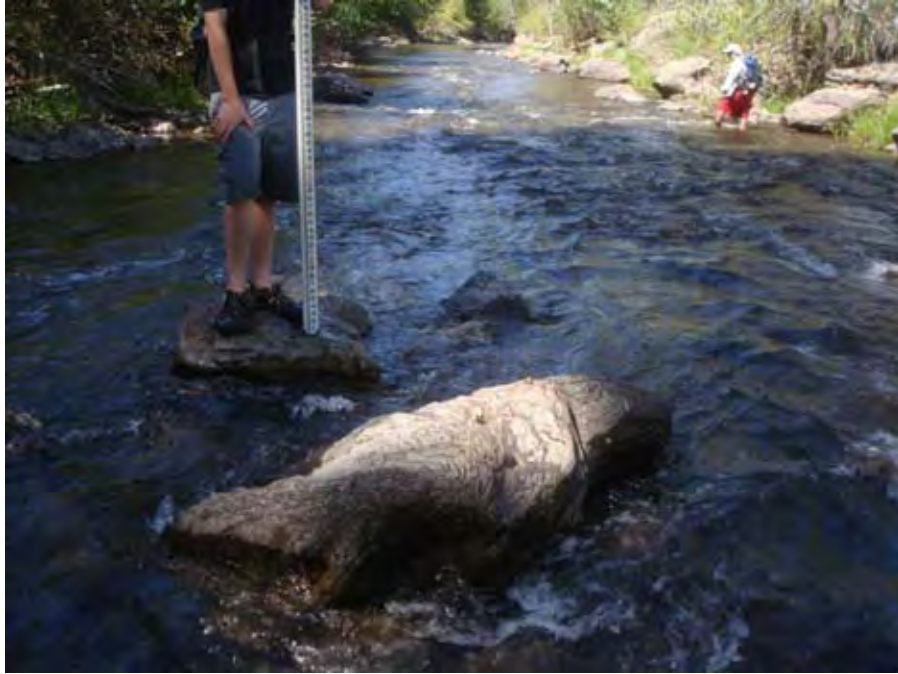
**Photograph 55. View looking downstream at the Catherine Creek channel near river mile 41.30, note boulders scattered along creek bed derived from road construction, and from the steep hillside to the south. Reach 4 – Catherine Creek, Grande Ronde Subbasin, Oregon – Bureau of Reclamation Photograph by D. Stelma, August 16, 2010.**

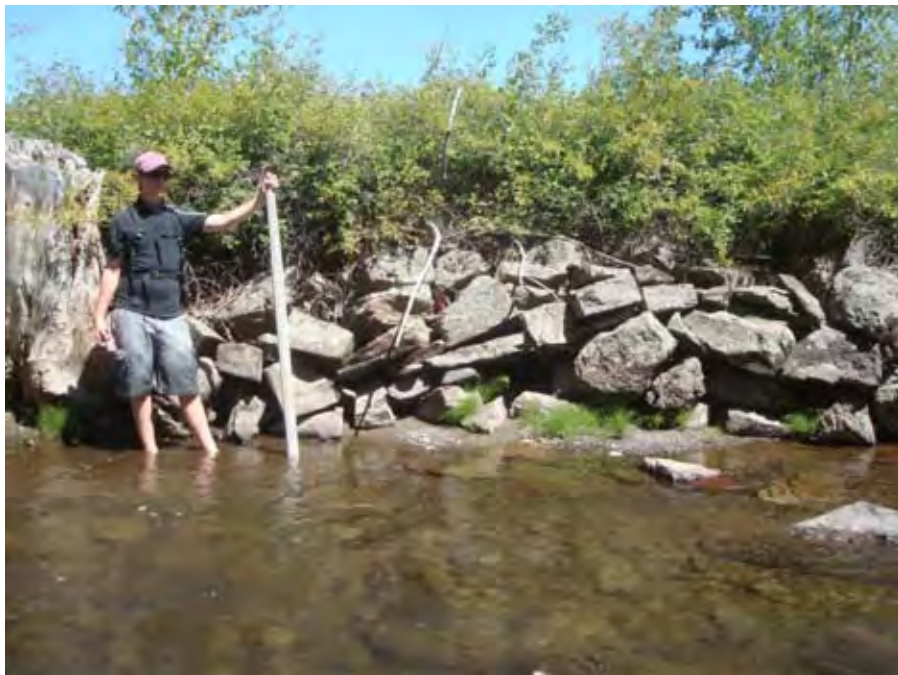
**Photograph 56. View looking toward the right bank of Catherine Creek near river mile 41.26, note Oregon State (Medical Springs) Highway 203 in background, bank material consists primarily of road fill and rip rap. Reach 4 – Catherine Creek, Grande Ronde Subbasin, Oregon – Bureau of Reclamation Photograph by D. Stelma, August 16, 2010.**

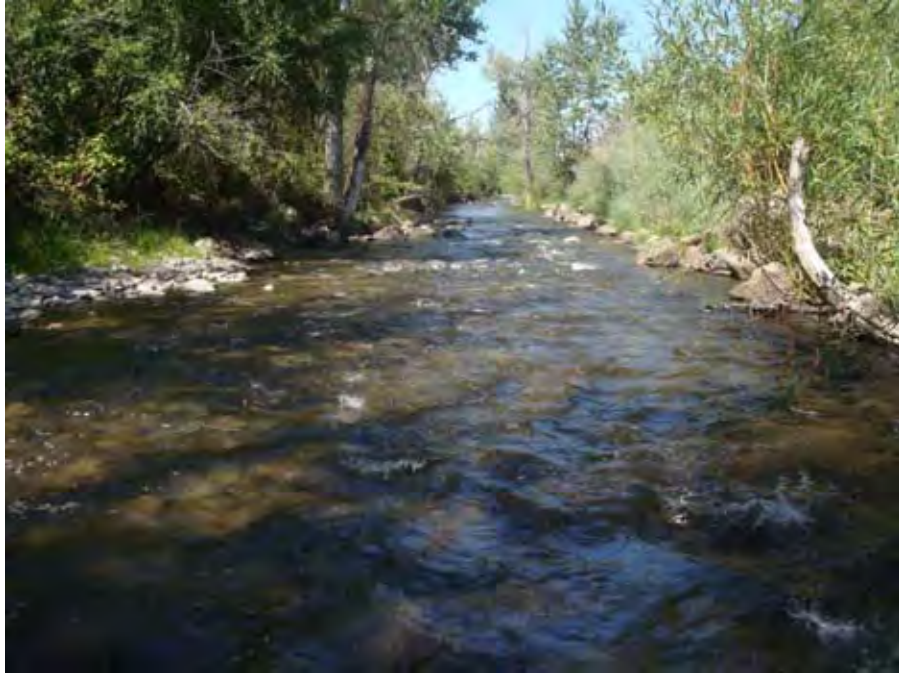
**Photograph 63. View looking downstream at the Catherine Creek channel adjacent to Oregon State (Medical Springs) Highway 203, located to the right, near river mile 41.05, note rip rap erosion protection on right bank. Reach 4 – Catherine Creek, Grande Ronde Subbasin, Oregon – Bureau of Reclamation Photograph by D. Stelma, August 16, 2010.**

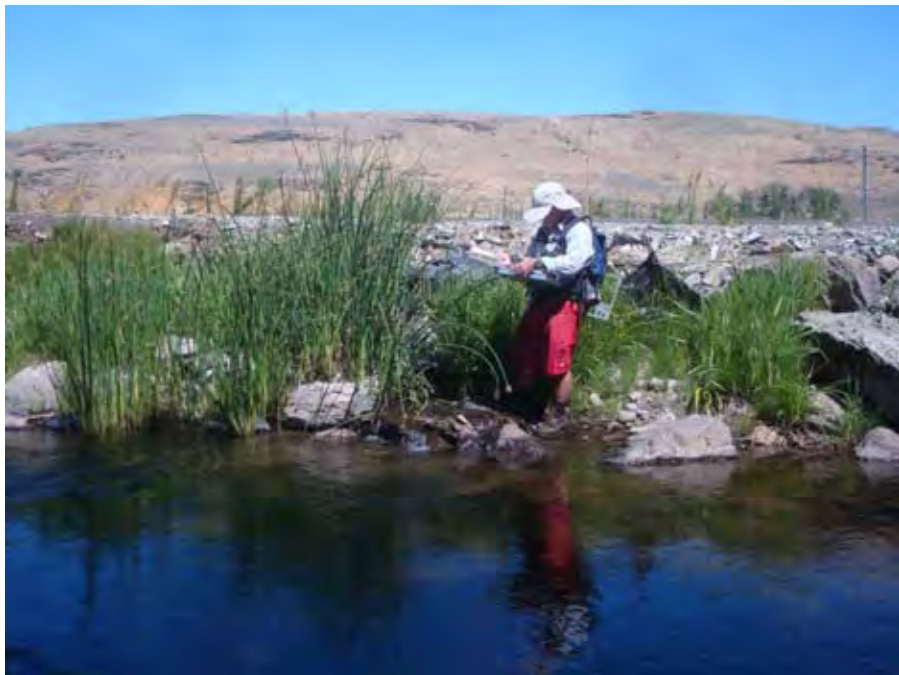
**Photograph 64. View looking toward the right bank of Catherine Creek near river mile 40.97, note Oregon State (Medical Springs) Highway 203 in background, bank material consists primarily of road fill and rip rap. Reach 4 – Catherine Creek, Grande Ronde Subbasin, Oregon – Bureau of Reclamation Photograph by D. Stelma, August 16, 2010.**

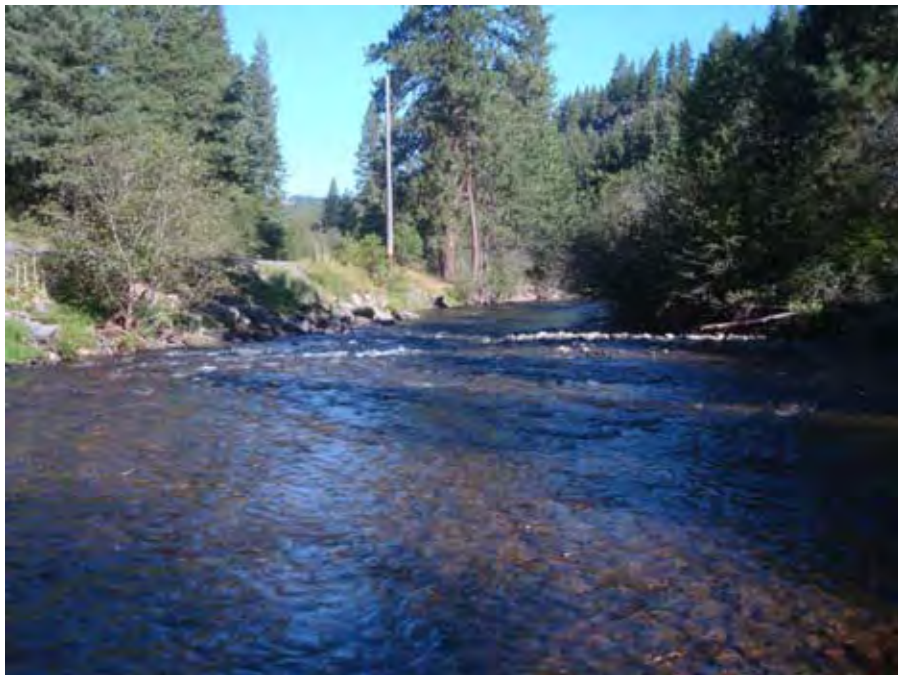
**Photograph 2. View looking downstream at Catherine Creek channel near river mile 50.00, Oregon State Highway (Medical Spring) 203 fill and rip rap erosion protection forms the left bank of the creek in this section. Reach 5 - Catherine Creek, Grande Ronde Subbasin, Oregon – Bureau of Reclamation Photograph by D. Stelma, August 17, 2010.**

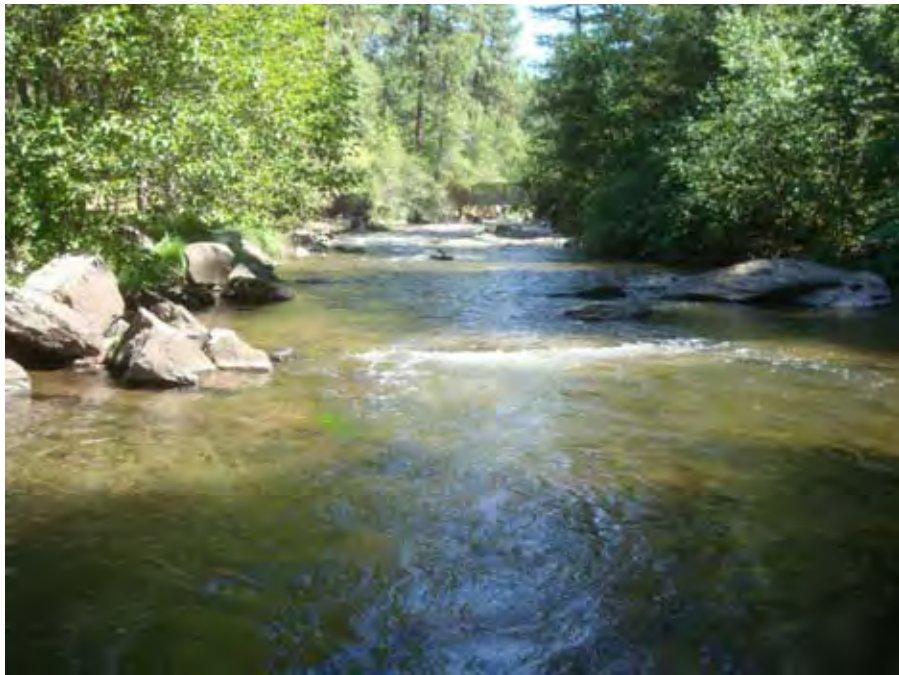
**Photograph 22. View looking downstream at wood debris along the left bed and bank of Catherine Creek within Catherine Creek State Park near river mile 48.63, note left abutment of foot-bridge at upper right side of photo. Reach 5 – Catherine Creek, Grande Ronde Subbasin, Oregon – Bureau of Reclamation Photograph by D. Stelma, August 17, 2010.**

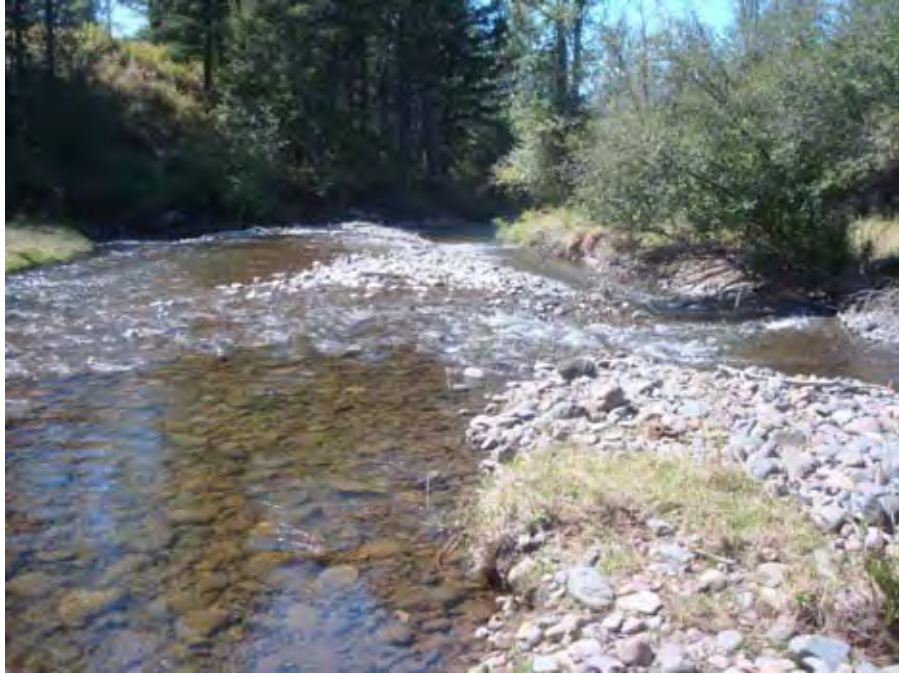
**Photograph 27. View looking downstream at eroded left bank of Catherine Creek near river mile 48.31. Reach 5 – Catherine Creek, Grande Ronde Subbasin, Oregon – Bureau of Reclamation Photograph by D. Stelma, August 17, 2010.**

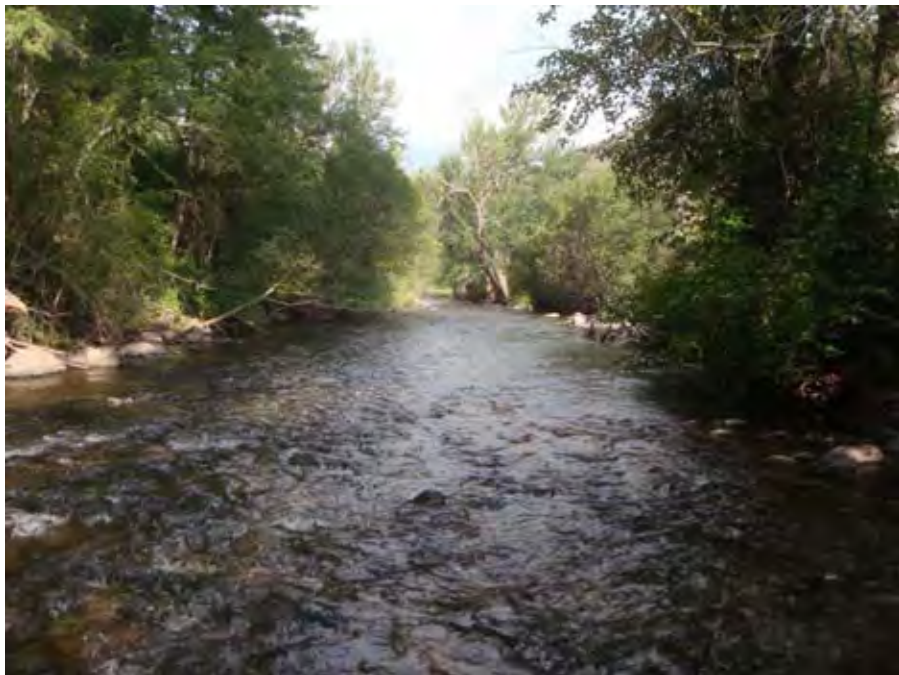
**Photograph 37. View looking downstream at Catherine Creek channel, Oregon State (Medical Springs) Highway 203 in background near river mile 47.51, note rip rap erosion protection along road embankment. Reach 5 – Catherine Creek, Grande Ronde Subbasin, Oregon – Bureau of Reclamation Photograph by D. Stelma, August 18, 2010.**

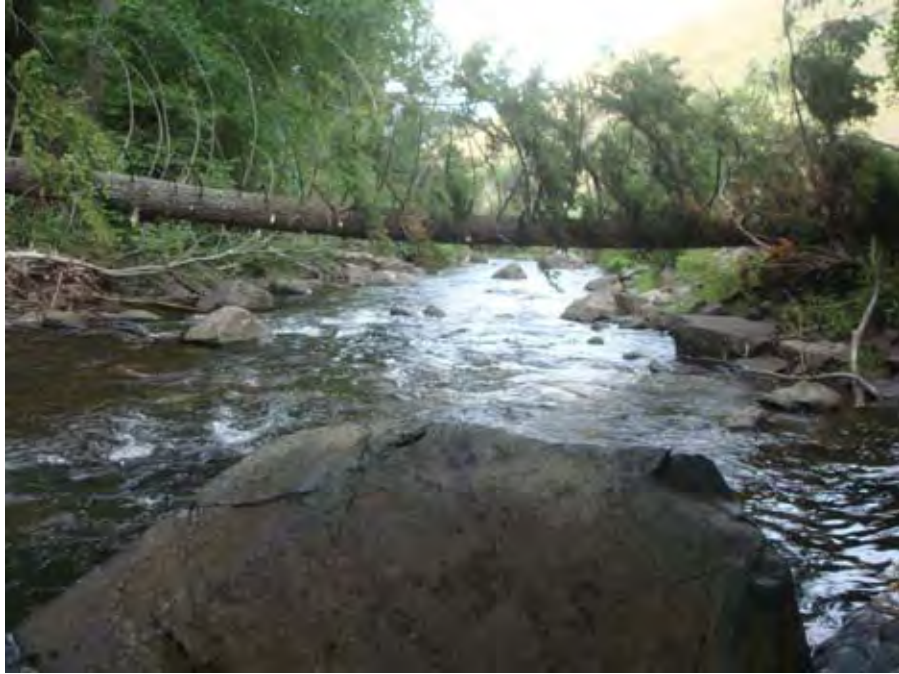
**Photograph 50. View looking downstream at Catherine Creek channel near river mile 46.85, note recently fallen tree across creek. Reach 5 – Catherine Creek, Grande Ronde Subbasin, Oregon – Bureau of Reclamation Photograph by D. Stelma, August 18, 2010.**

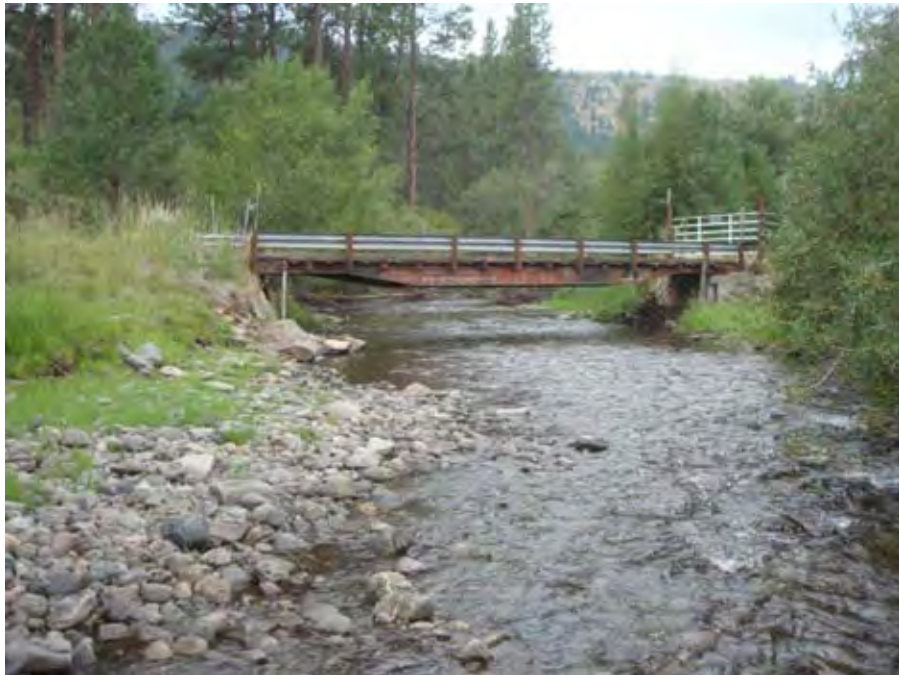
**Photograph 56. Remnant of bridge abutment on the left bank of Catherine Creek near river mile 46.57. Reach 5 – Catherine Creek, Grande Ronde Subbasin, Oregon – Bureau of Reclamation Photograph by D. Stelma, August 18, 2010.**

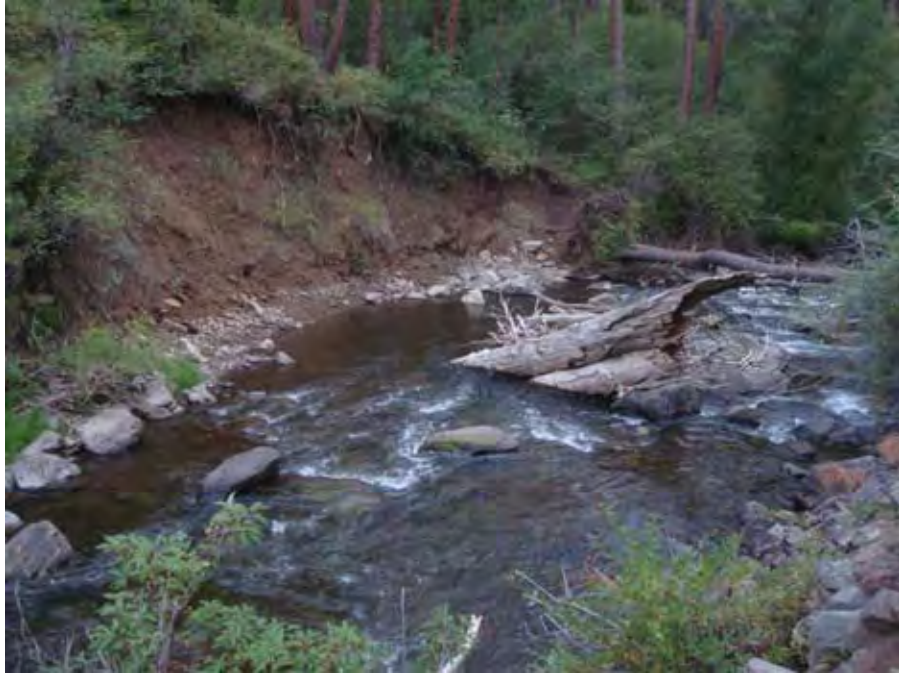
**Photograph 62. View looking downstream at Catherine Creek channel in the canyon section, Oregon State (Medical Springs) Highway 203 is to the right near river mile 46.22, note abundance of boulders derived from landslide debris (left bank) and road construction (right bank). Reach 5 – Catherine Creek, Grande Ronde Subbasin, Oregon – Bureau of Reclamation Photograph by D. Stelma, August 18, 2010.**

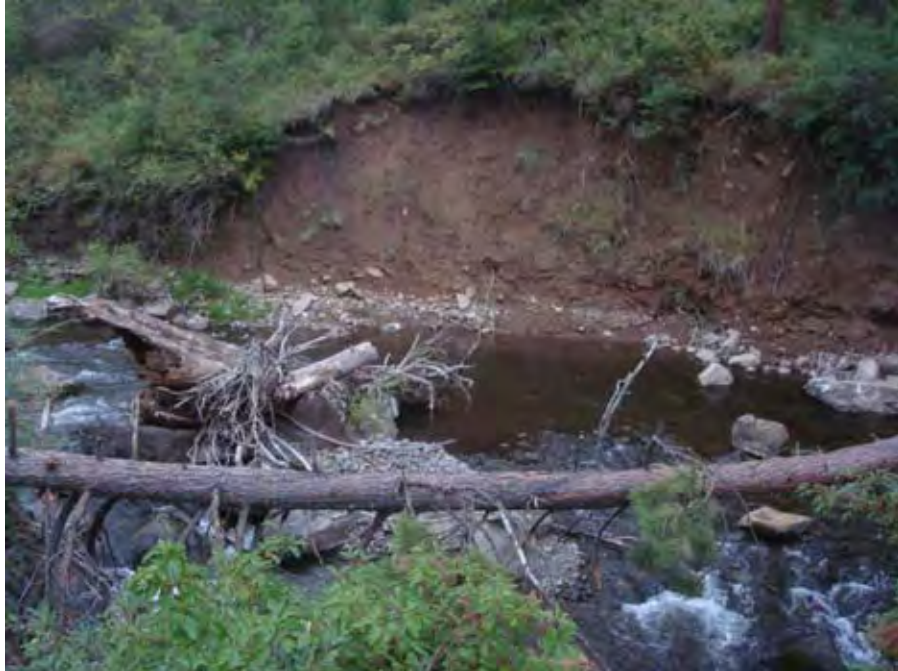
**Photograph 63. View looking downstream at Catherine Creek channel in the canyon section near river mile 46.21, note under-cut bank and fallen trees on the left side of the channel. Reach 5 – Catherine Creek, Grande Ronde Subbasin, Oregon – Bureau of Reclamation Photograph by D. Stelma, August 18, 2010.**

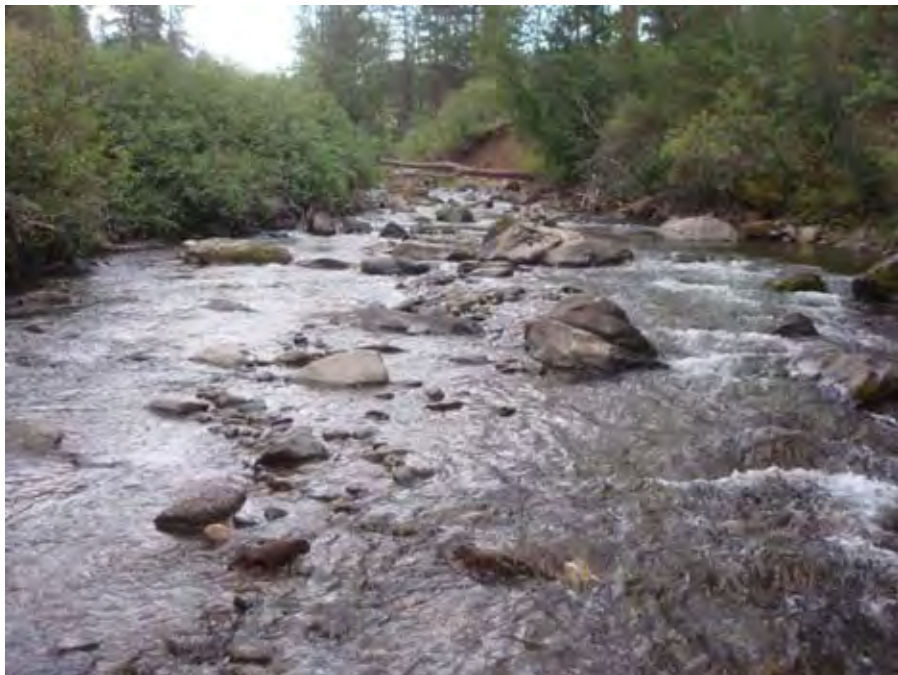
**Photograph 64. View looking toward left bank of Catherine Creek from Oregon State (Medical Springs) Highway 203 in the canyon section near river mile 46.21, note under-cut bank and fallen trees. Reach 5 – Catherine Creek, Grande Ronde Subbasin, Oregon – Bureau of Reclamation Photograph by D. Stelma, August 18, 2010.**

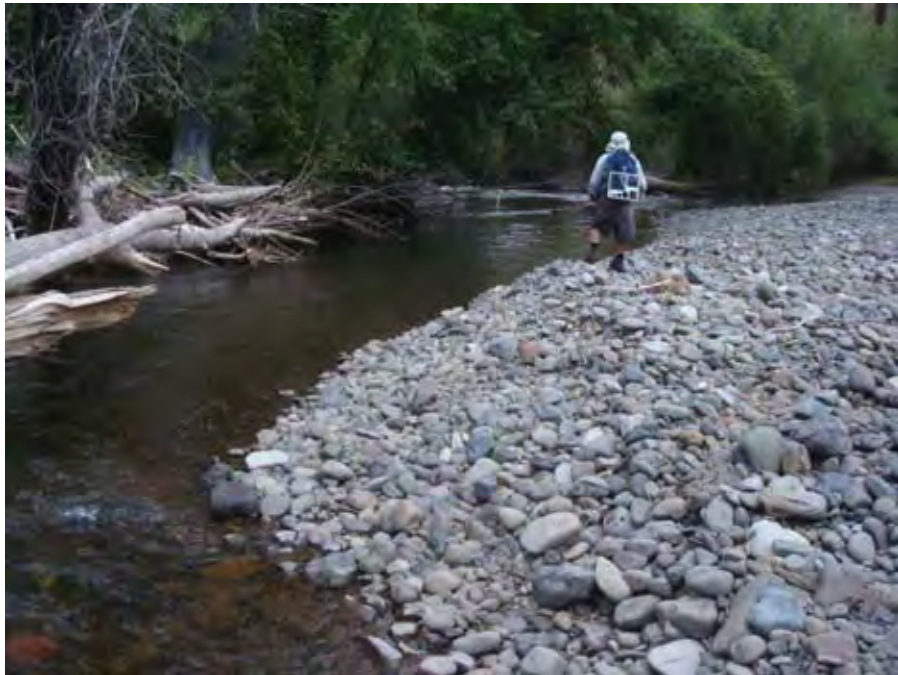
**Photograph 66. View looking downstream at log jam within the Catherine Creek channel near river mile 46.09. Reach 5 – Catherine Creek, Grande Ronde Subbasin, Oregon – Bureau of Reclamation Photograph by D. Stelma, August 18, 2010.**

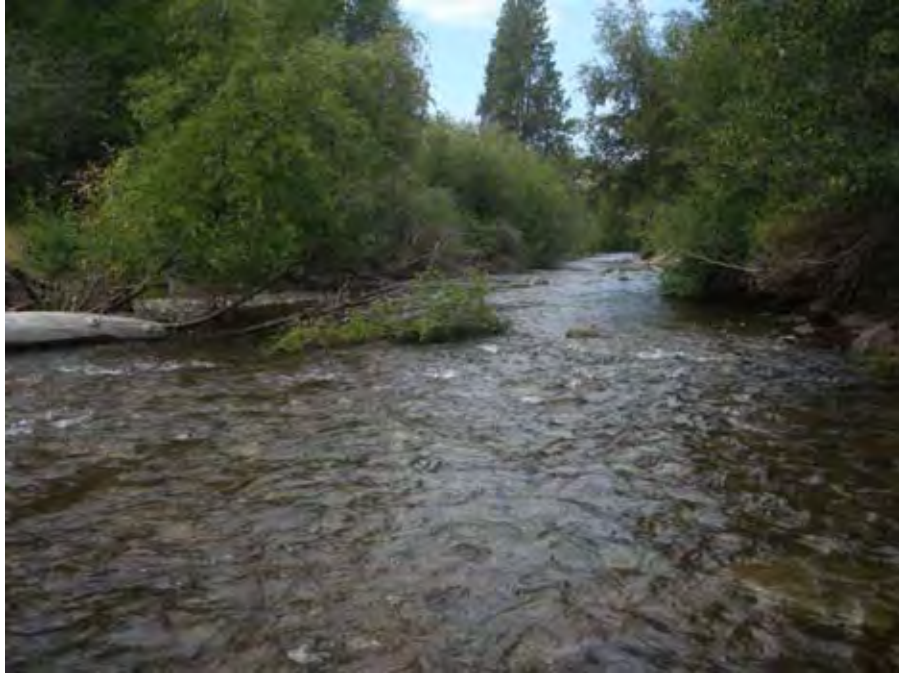
**Photograph 70. View looking downstream at Catherine Creek channel adjacent to Oregon State (Medical Springs) Highway 203 (upper right in photo) near river mile 45.99, note rip rap erosion protection on right bank. Reach 5 – Catherine Creek, Grande Ronde Subbasin, Oregon – Bureau of Reclamation Photograph by D. Stelma, August 18, 2010.**

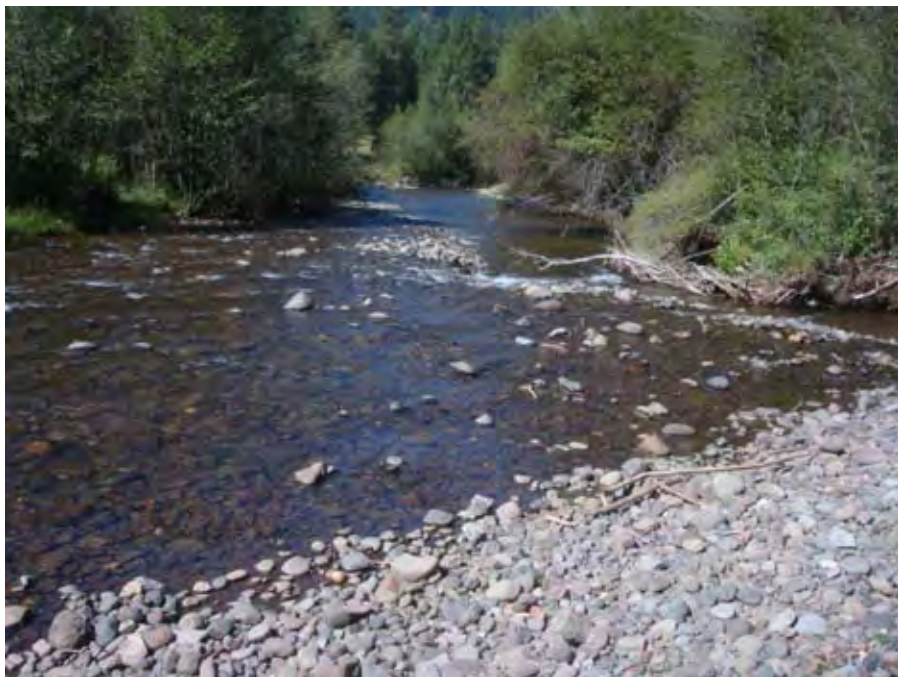
**Photograph 3. View looking downstream at Catherine Creek channel near river mile 52.00, note repaired erosion protection (concrete blocks, rip rap and log) along U.S.F.S. Road 7785 in background. Reach 6 – Catherine Creek, Grande Ronde Subbasin, Oregon – Bureau of Reclamation Photograph by D. Stelma, November 10, 2010.**

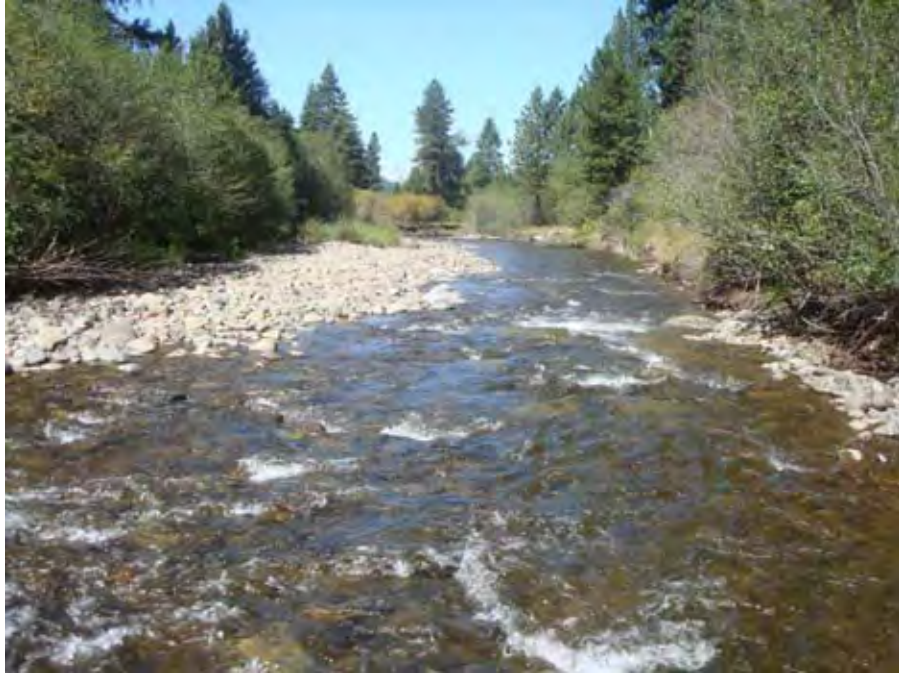
**Photograph 21. View looking downstream at Catherine Creek channel near river mile 51.40, note boulders in bed of creek. Reach 6 – Catherine Creek, Grande Ronde Subbasin, Oregon – Bureau of Reclamation Photograph by D. Stelma, August 19, 2010.**

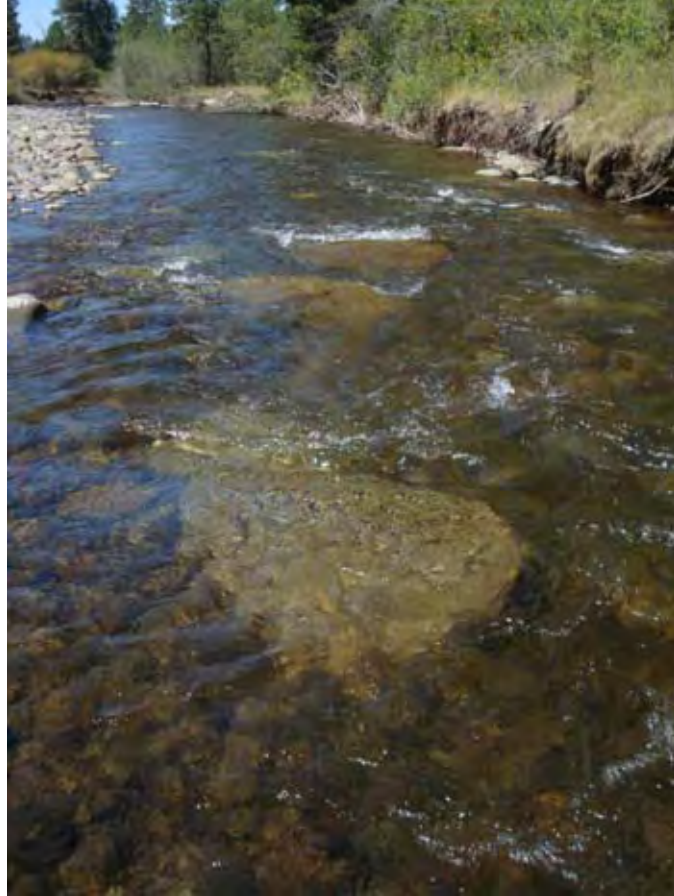
**Photograph 22. View looking north toward the right bank of Catherine Creek near river mile 51.40, note boulders on slope, and in creek bed. Reach 6 – Catherine Creek, Grande Ronde Subbasin, Oregon – Bureau of Reclamation Photograph by D. Stelma, August 19, 2010.**

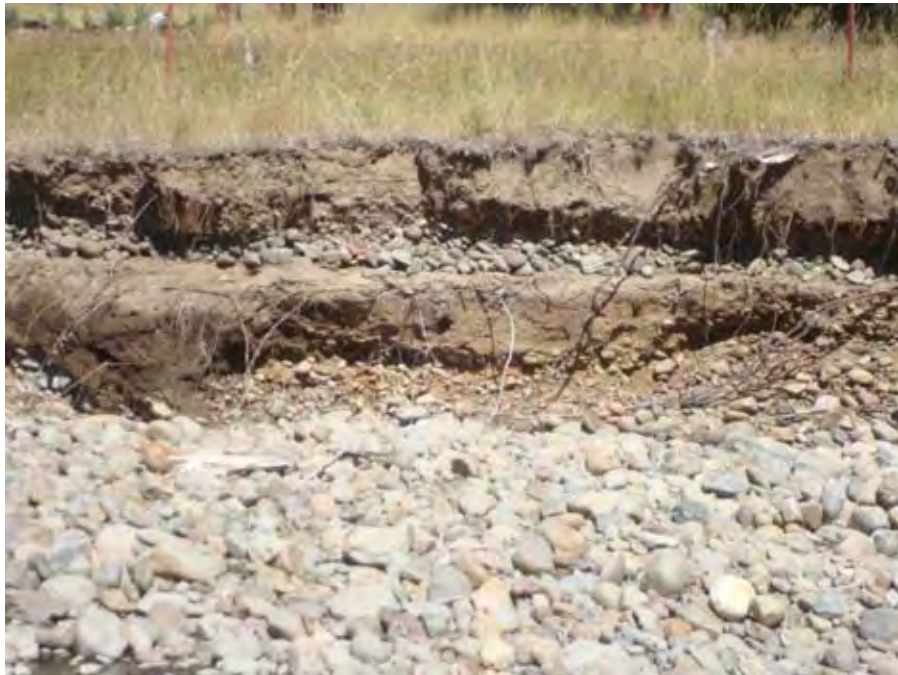
**Photograph 28. View looking toward the right bank of Catherine Creek at inter-bedded alluvium, glacial outwash and soil deposits near river mile 51.02. Reach 6 – Catherine Creek, Grande Ronde Subbasin, Oregon – Bureau of Reclamation Photograph by D. Stelma, August 19, 2010.**

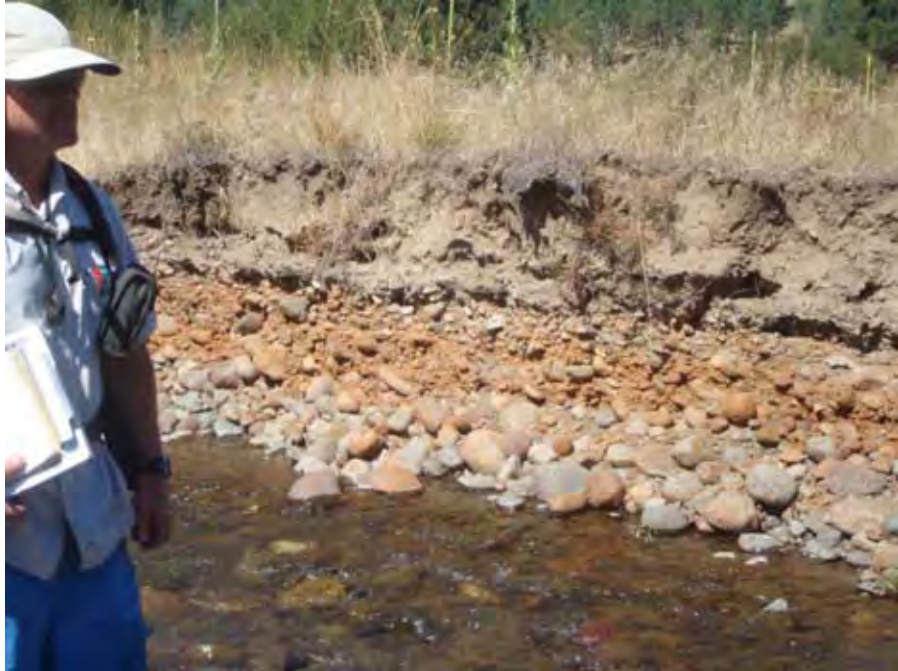
**Photograph 37. View looking at alluvium and glacial outwash deposits overlain by soil exposed along the right bank of Catherine Creek near river mile 50.45. Reach 6 – Catherine Creek, Grande Ronde Subbasin, Oregon – Bureau of Reclamation Photograph by D. Stelma, August 19, 2010.**
