Kahler Reach Assessment

Nason Creek

Chelan County, Washington

March 2009

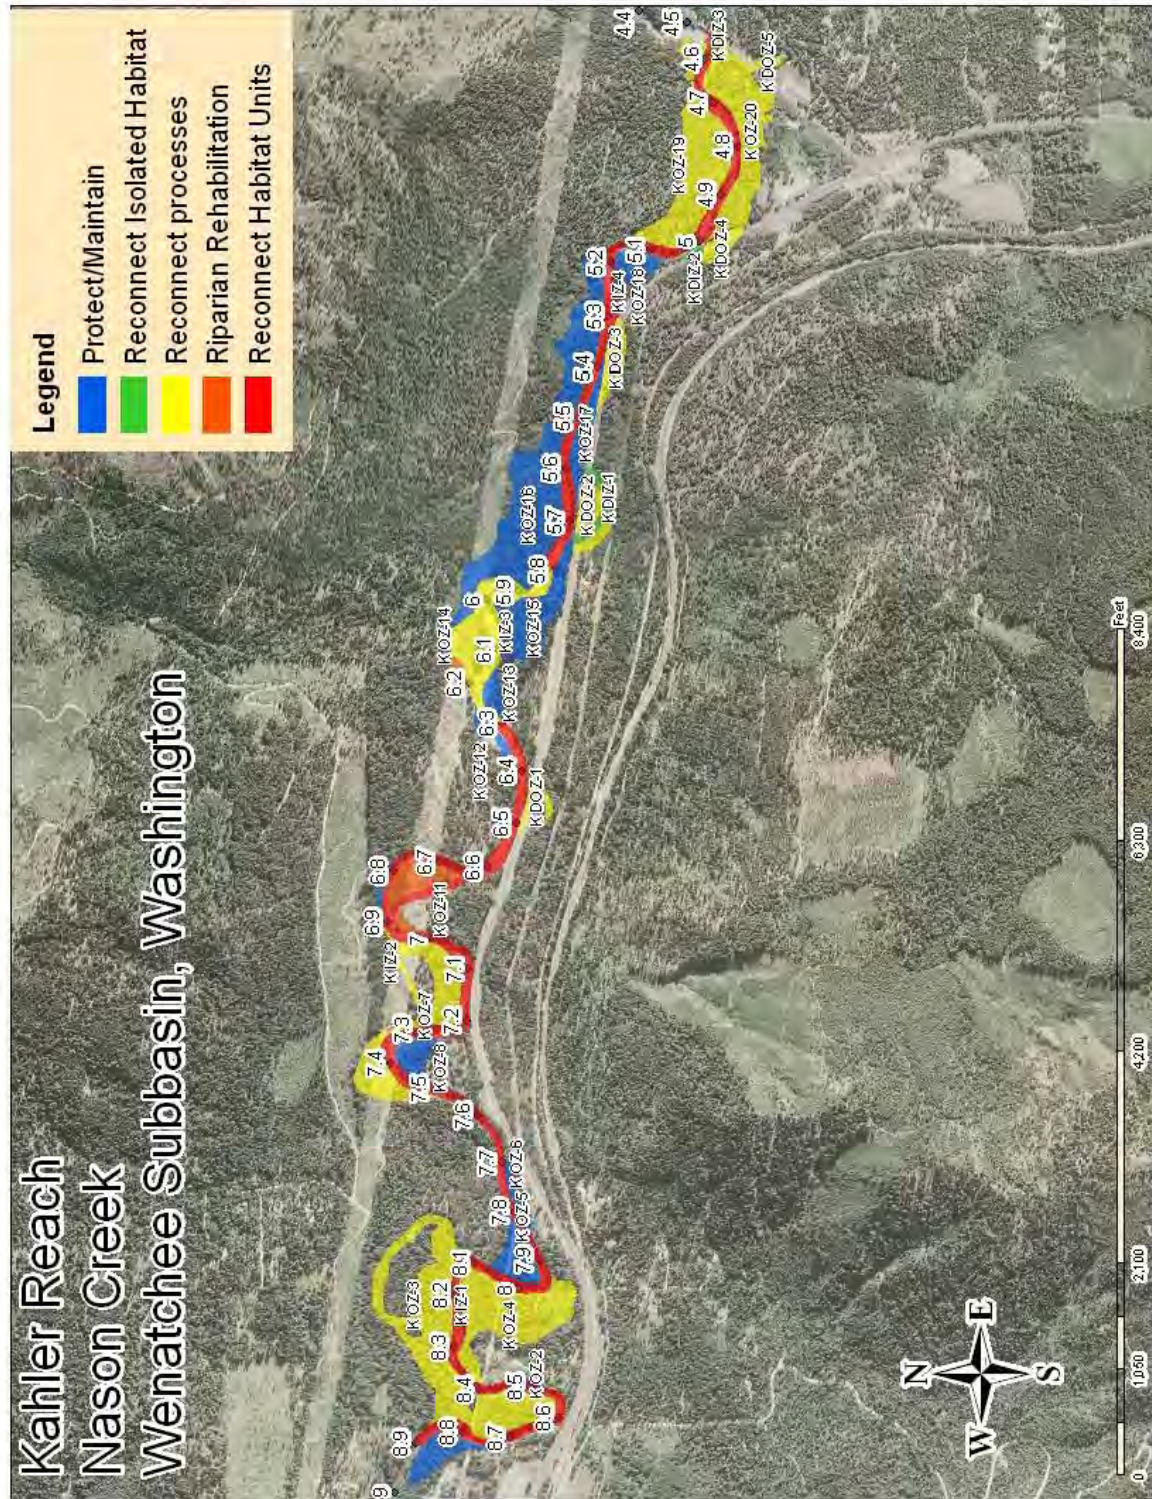
Figure 3 - A spatial representation of a prioritized rehabilitation approach for the Kahler reach by subreach unit.

Over 5 percent of the Kahler reach does not contribute to habitat-forming processes through the interaction of hydrologic, riparian, and geomorphic regimes. Figure 3 shows a prioritization of each subreach unit for the Kahler reach. A dual focus approach would concentrate on both protection and rehabilitation goals necessary for reestablishment of geomorphic potential and healthy stream conditions (Table 3). The rehabilitation goals would address two types of subreaches. The first type addressed by rehabilitation actions are those subreaches that are currently disconnected by the highways or other human features. Subreaches of particular interest include DIZ-1 and DIZ-2, along with historic outer zone areas of DOZ-1, DOZ-2, DOZ-3, DOZ-4, and DOZ-5. The second type of subreach addressed by rehabilitation actions are the outer zones that have impacted habitat units and include subreaches OZ-1 through OZ-19. This cooperative effort could be executed in conjunction with the protection goals that will complement reconnection of the disconnected subreaches and the connected subreaches that lack habitat. Potential habitat actions are identified and prioritized based on several key parameters established in the reach assessment.

A dual focus approach is expected to run in parallel with a measured difference in timing for implementation. Protection goals are a series of potential habitat actions that will complement the reconnection of the disconnected subreaches. Potential protection actions necessary in the short term include land acquisition or lease and stream bank and wetland protection. The rehabilitation goals covering the disconnected subreaches is a long-term enterprise requiring the full cooperation of the State of Washington Department of

Transportation as well as local landowners. Potential rehabilitation actions should be considered as components of a comprehensive strategy to reinitiate habitat-forming processes and include relocation or modification of the highway and/or culverts; unimproved road relocations or removals; small bridge placements; culvert removals, modifications, or replacements; riparian plantings and noxious weed eradication; and instream structures.

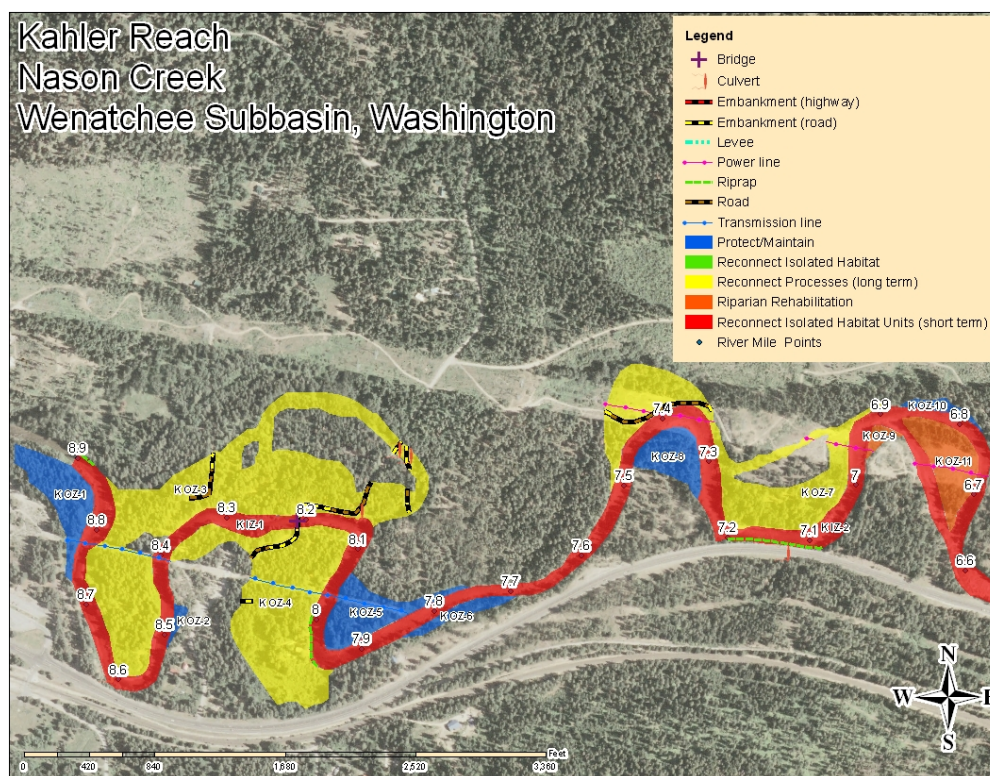
Figure 16 - K OZ-5 and adjacent subreaches in the Kahler reach.

Subreach K OZ-5 is located in the upstream section of the Kahler reach in the left floodplain from RM 7.75 to 8.06 (Figure 16). The subreach is considered to be functioning at greater than 80 percent efficiency which makes the subreach protection-oriented. Riparian rehabilitation actions can be implemented in tandem with protection strategies to address the low percentage of disturbed vegetation.

The subreach is about 4 acres in size. Natural lateral controls for the subreach are terraces. There are no anthropogenic features that disconnect the subreach from the active channel. Disturbances to vegetation associated with the power line are about one-half of an acre or about 13 percent of the total area of the subreach.

The potential to increase the area of inundation is low. When comparing 5,000 cfs stream flow for existing conditions versus potential conditions (i.e., with anthropogenic features removed), the 2D-hydraulic model results show little change in area of inundation. Most of the subreach is inundated at both modeled flows. Rehabilitation options are listed in Table 8 and are prioritized to maximize the geomorphic potential of the subreach through the reconnection and re-establishment of both long-term and short-term processes at the subreach scale. Rehabilitation actions in this subreach should be considered collectively with rehabilitation actions recommended in other adjacent subreaches to achieve a holistic reconnection and reestablishment of processes at the reach scale.

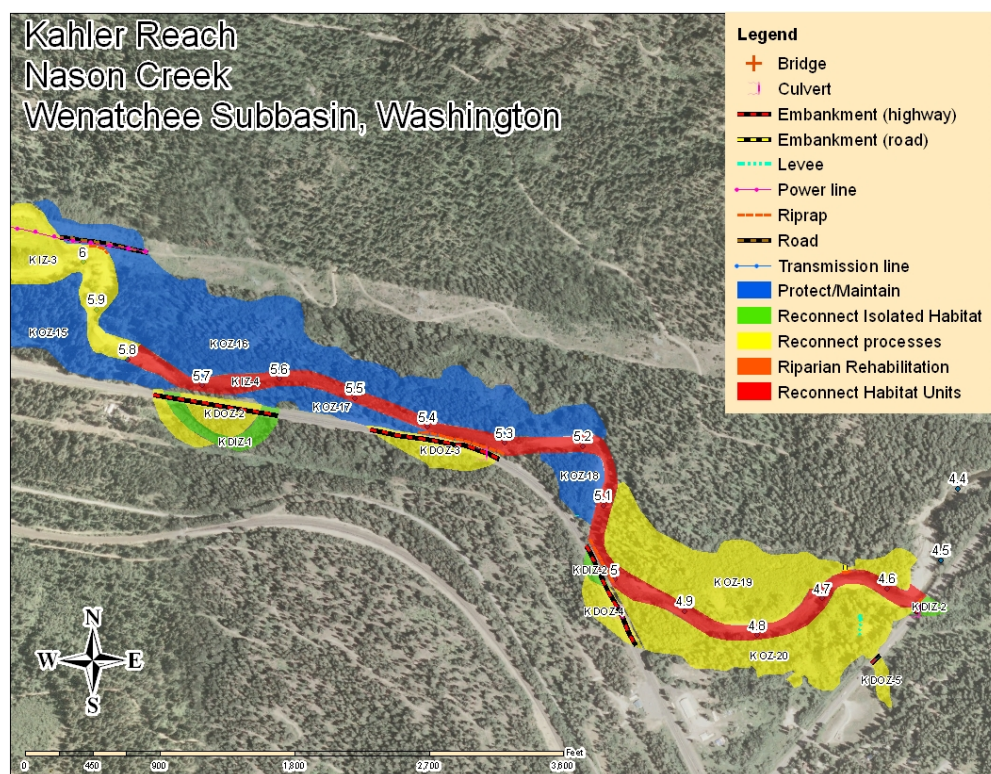
Figure 18 - K OZ-17 and adjacent subreaches in the Kahler reach.

Subreach K OZ-17 is located in the downstream section of the Kahler reach in the right floodplain from RM 5.4 to 5.67 (Figure 18). The subreach is considered to be functioning at greater than 80 percent efficiency which makes the subreach protection-oriented.

The subreach is slightly less than 3 acres in size. Natural lateral controls for the subreach are terraces and alluvial fans. There are no anthropogenic features that disconnect the subreach from the active channel or disturbances to vegetation.

The potential to increase the area of inundation is low. When comparing 5,000 cfs stream flow for existing conditions versus potential conditions (i.e., with anthropogenic features removed), the 2D-hydraulic model results show little change in area of inundation. Most of the subreach is inundated at both modeled flows. Rehabilitation options are listed in Table 10. Options are prioritized to maximize geomorphic potential of the subreach through the reconnection and reestablishment of both long-term and short-term processes at the subreach scale. Rehabilitation actions in this subreach should be considered collectively with rehabilitation actions recommended in other subreaches to achieve a holistic reconnection and reestablishment of processes at the reach scale.

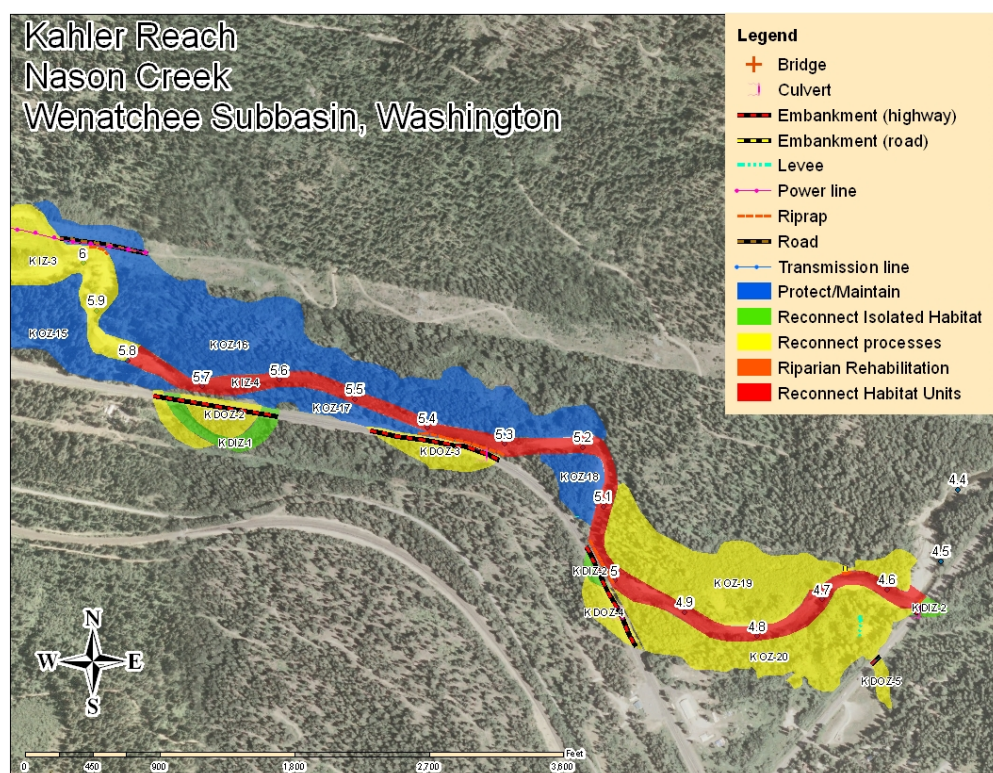
Figure 19 - K OZ-18 and adjacent subreaches in the Kahler reach.

The subreach is slightly less than 3 acres in size. Natural lateral controls for the subreach are terraces and alluvial fans. There are no anthropogenic features that disconnect the subreach from the active channel or disturbances to vegetation.

The potential to increase the area of inundation is low. When comparing 5,000 cfs stream flow for existing conditions versus potential conditions (i.e., with anthropogenic features removed), the 2D-hydraulic model results show little change in area of inundation. Most of the subreach is inundated at both modeled flows. Rehabilitation options are listed in Table 11 and are prioritized to maximize the geomorphic potential of the subreach through the reconnection and re-establishment of both long-term and short-term processes at the subreach scale. Rehabilitation actions in this subreach should be considered collectively with rehabilitation actions recommended in other adjacent subreaches to achieve a holistic reconnection and reestablishment of processes at the reach scale.

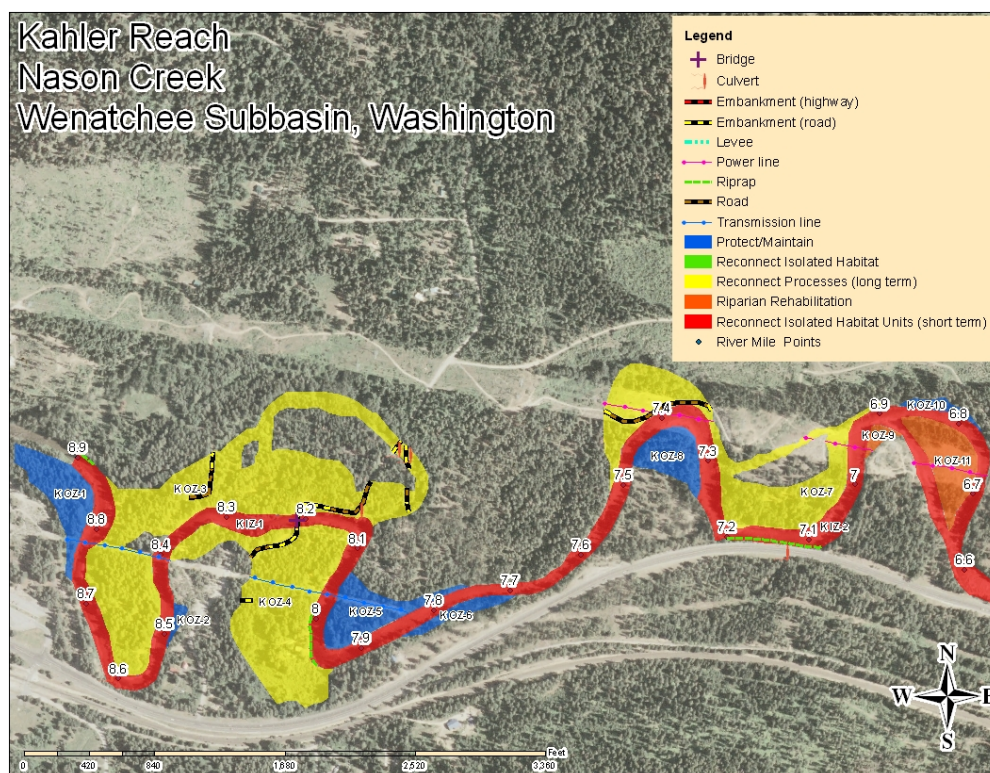
Figure 20 - K OZ-8 and adjacent subreaches in the Kahler reach.

The subreach is about 3 acres in size. Natural lateral controls for the subreach are terraces. There are no anthropogenic features that disconnect the subreach from the active channel. Disturbances to vegetation associated with the powerline total one-tenth of an acre or 3 percent of the total subreach.

The potential to increase the area of inundation is low. When comparing 5,000 cfs stream flow for existing conditions versus potential conditions (i.e., with anthropogenic features removed), the 2D-hydraulic model results show little change in area of inundation. Most of the subreach is inundated at both modeled flows. Rehabilitation options are listed in Table 12. Options are prioritized to maximize geomorphic potential of the subreach through the reconnection and reestablishment of both long-term and short-term processes at the subreach scale. Rehabilitation actions in this subreach should be considered collectively with rehabilitation actions recommended in other subreaches to achieve a holistic reconnection and reestablishment of processes at the reach scale.

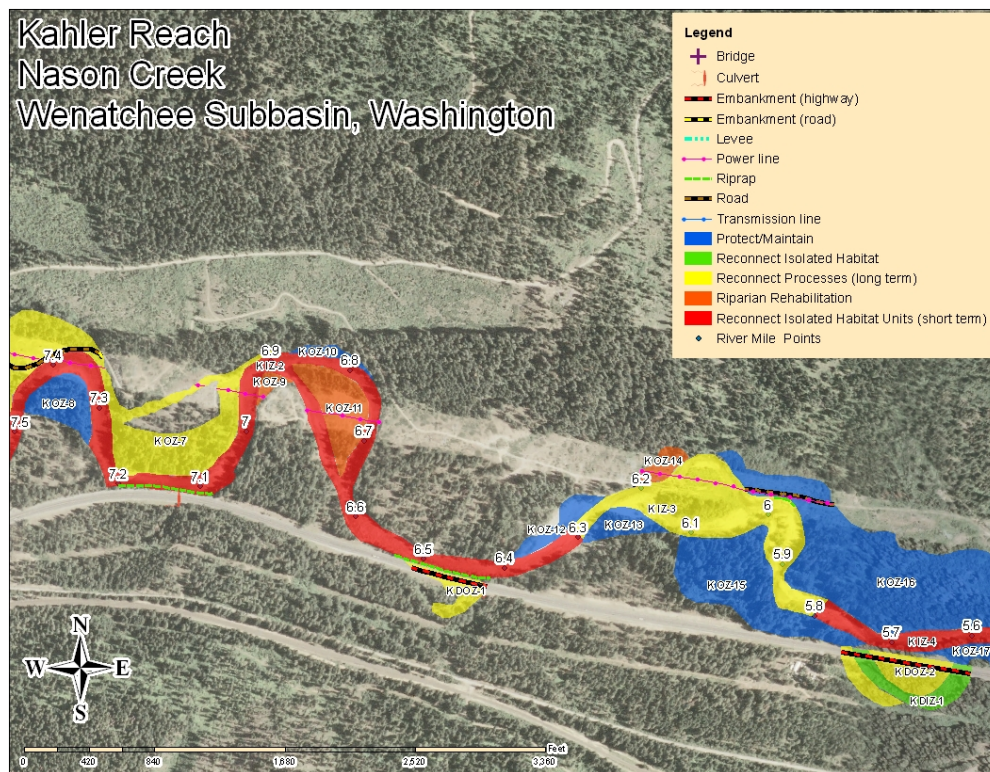
Figure 21 - K OZ-12 and adjacent subreaches in the Kahler reach.

The subreach is about 2 acres in size. Natural lateral controls are terraces and coarse substrate. There are no anthropogenic features that disconnect the subreach from the active channel. Although there are no human disturbances to vegetation proactive planting should be utilized to prevent noxious weed development.

The potential to increase the area of inundation is low. When comparing 5,000 cfs stream flow for existing conditions versus potential conditions (i.e., with anthropogenic features removed), the 2D-hydraulic model results show little change in area of inundation. Most of the subreach is inundated at both modeled flows. Rehabilitation options are listed in Table 13. Options are prioritized to maximize geomorphic potential of the subreach through the reconnection and reestablishment of both long-term and short-term processes at the subreach scale. Rehabilitation actions in this subreach should be considered collectively with rehabilitation actions recommended in other subreaches to achieve a holistic reconnection and reestablishment of processes at the reach scale.

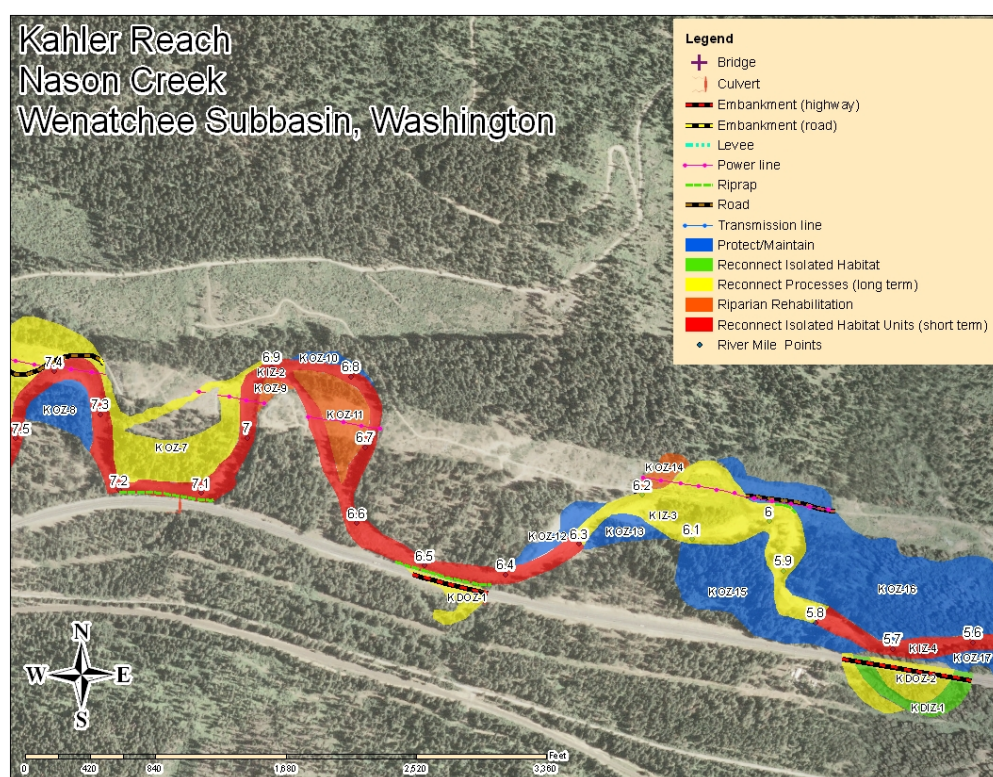
Figure 22 - K OZ-13 and adjacent subreaches in the Kahler reach.

Subreach K OZ-13 is located in the mid-section of the Kahler reach in the right floodplain from RM 6.12 to 6.3 (Figure 22). The subreach is considered to be functioning at greater than 80 percent efficiency which makes the subreach protection-oriented.

The subreach is about 2 acres in size. Natural lateral controls for the subreach are terraces and alluvial fans. There are no anthropogenic features that disconnect the subreach from the active channel or disturbances to vegetation.

The potential to increase the area of inundation is low. When comparing 5,000 cfs stream flow for existing conditions versus potential conditions (i.e., with anthropogenic features removed), the 2D-hydraulic model results show little change in area of inundation. Most of the subreach is inundated at both modeled flows. Rehabilitation options are listed in Table 14. Options are prioritized to maximize geomorphic potential of the subreach through the reconnection and reestablishment of both long-term and short-term processes at the subreach scale. Rehabilitation actions in this subreach should be considered collectively with rehabilitation actions recommended in other subreaches to achieve a holistic reconnection and reestablishment of processes at the reach scale.

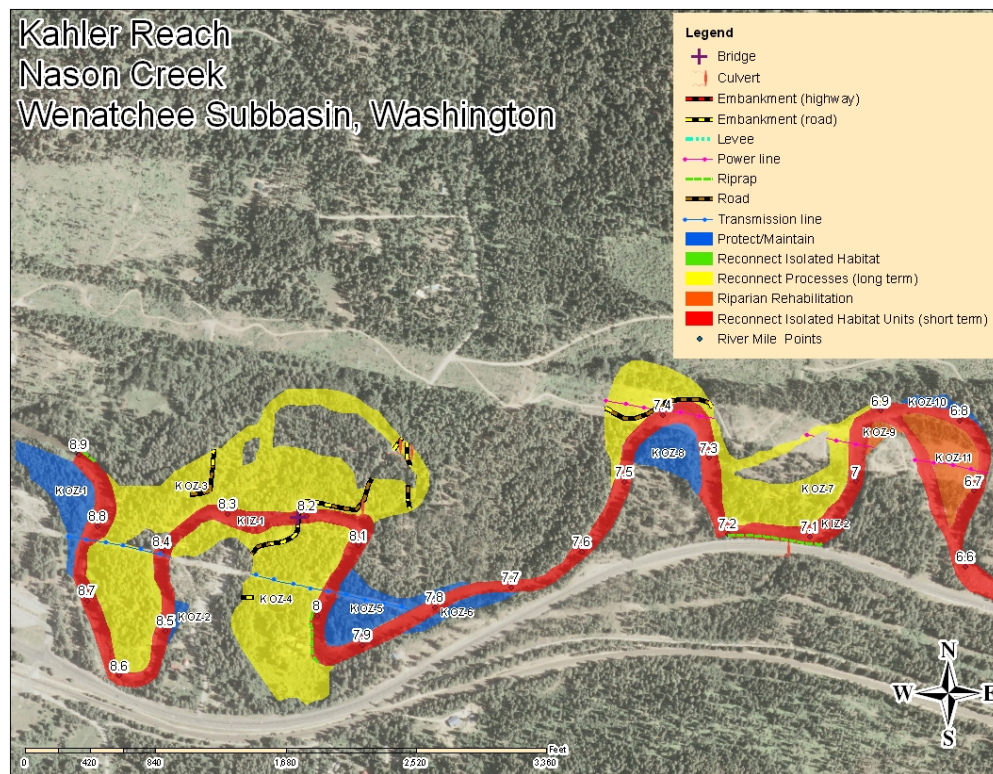
Figure 23 - K OZ-6 and adjacent subreaches in the Kahler reach.

Subreach K OZ-6 is located in the upstream section of the Kahler reach in the right floodplain from RM 7.7 to 7.86 (Figure 23). The subreach is considered to be functioning at greater than 80 percent efficiency which makes the subreach protection-oriented.

The subreach is about 1 acre in size. Natural lateral controls for the subreach are terraces. There are no anthropogenic features that disconnect the subreach from the active channel or disturbances to vegetation.

The potential to increase the area of inundation is low. When comparing 5,000 cfs stream flow for existing conditions versus potential conditions (i.e., with anthropogenic features removed), the 2D-hydraulic model results show little change in area of inundation. Most of the subreach is inundated at both modeled flows. Rehabilitation options are listed in Table 15. Options are prioritized to maximize geomorphic potential of the subreach through the reconnection and reestablishment of both long-term and short-term processes at the subreach scale. Rehabilitation actions in this subreach should be considered collectively with rehabilitation actions recommended in other subreaches to achieve a holistic reconnection and reestablishment of processes at the reach scale.

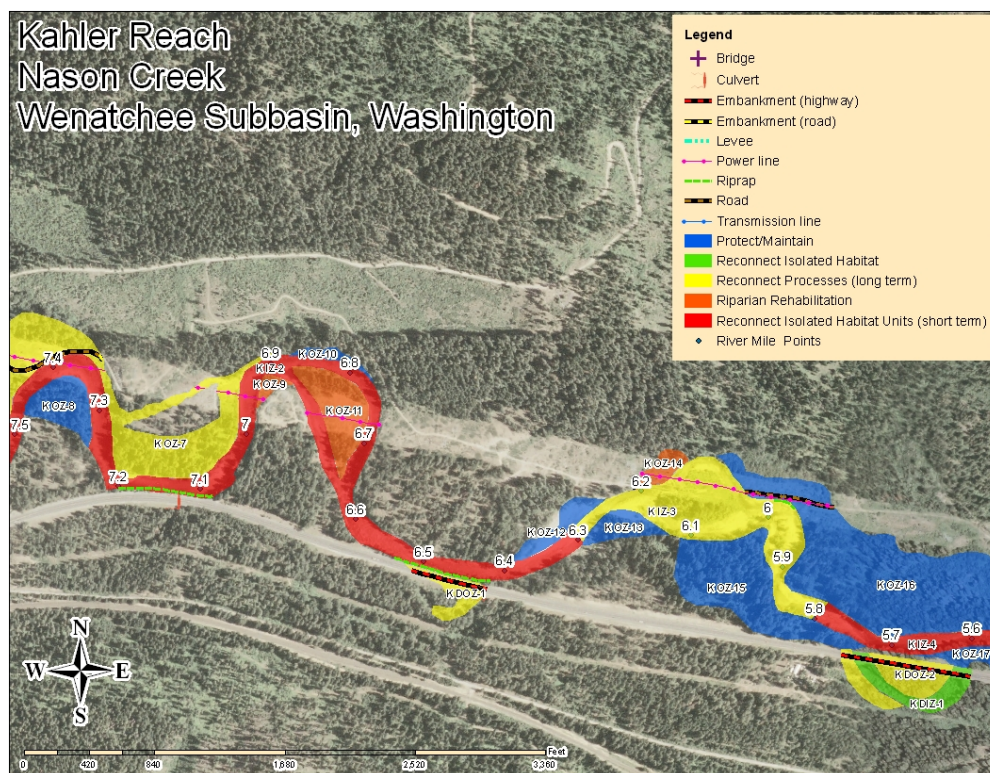
Figure 24 - K OZ-10 and adjacent subreaches in the Kahler reach.

Subreach K OZ-10 is located in the mid-section of the Kahler reach in the left floodplain from RM 6.78 to 6.89 (Figure 24). The subreach is considered to be functioning at greater than 80 percent efficiency which makes the subreach protection-oriented.

The subreach is about 1 acre in size. Natural lateral controls for the subreach are terraces alluvial fans. There are no anthropogenic features that disconnect the subreach from the active channel or disturbances to vegetation.

The potential to increase the area of inundation is low. When comparing 5,000 cfs stream flow for existing conditions versus potential conditions (i.e., with anthropogenic features removed), the 2D-hydraulic model results show little change in area of inundation. Most of the subreach is inundated at both modeled flows. Rehabilitation options are listed in Table 16. Options are prioritized to maximize geomorphic potential of the subreach through the reconnection and reestablishment of both long-term and short-term processes at the subreach scale. Rehabilitation actions in this subreach should be considered collectively with rehabilitation actions recommended in other subreaches to achieve a holistic reconnection and reestablishment of processes at the reach scale.

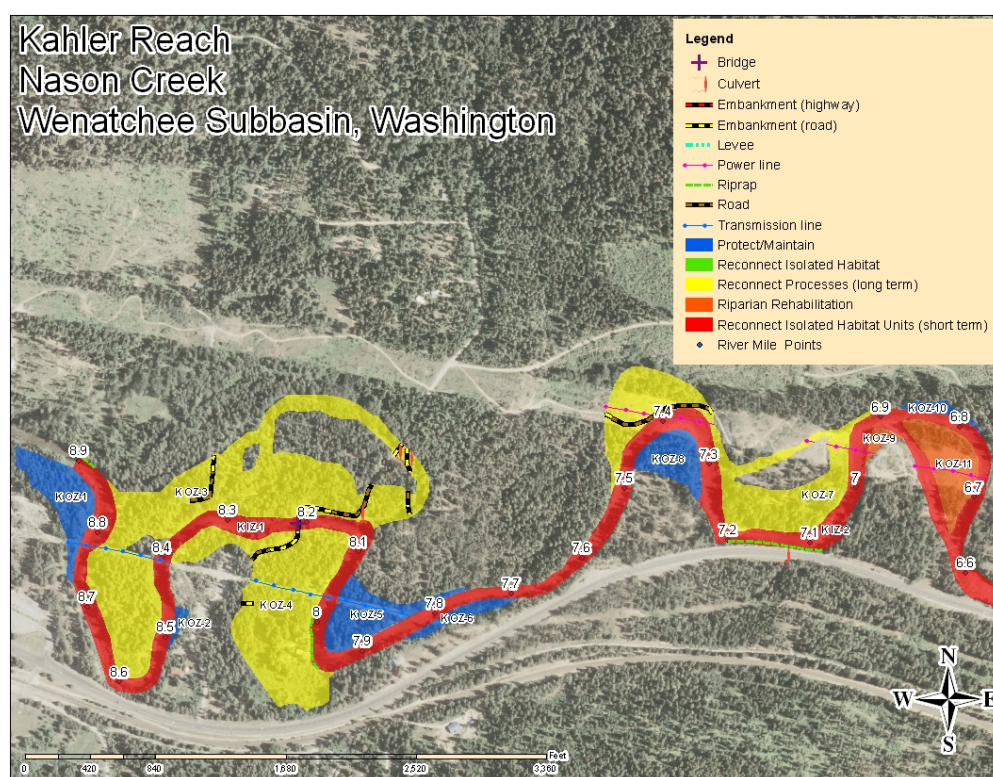
Figure 25 - K OZ-2 and adjacent subreaches in the Kahler reach.

The subreach K OZ-2 is located in the right floodplain in the up-stream section of the Kahler reach at RM 8.5 (Figure 25). The subreach is considered to be functioning at greater than 80 percent efficiency which makes the subreach protection-oriented.

The subreach is slightly less than 1 acre in size. Natural lateral controls for the subreach are terraces and alluvial fans. There are no anthropogenic features that disconnect the subreach from the active channel.

The potential to increase the area of inundation is low. When comparing 5,000 cfs stream flow for existing conditions versus potential conditions (i.e., with anthropogenic features removed), the 2D-hydraulic model results show little change in area of inundation. Most of the subreach is inundated at both modeled flows. Rehabilitation options are listed in Table 17. Options are prioritized to maximize geomorphic potential of the subreach through the reconnection and reestablishment of both long-term and short-term processes at the subreach scale. Rehabilitation actions in this subreach should be considered collectively with rehabilitation actions recommended in other subreaches to achieve a holistic reconnection and reestablishment of processes at the reach scale.

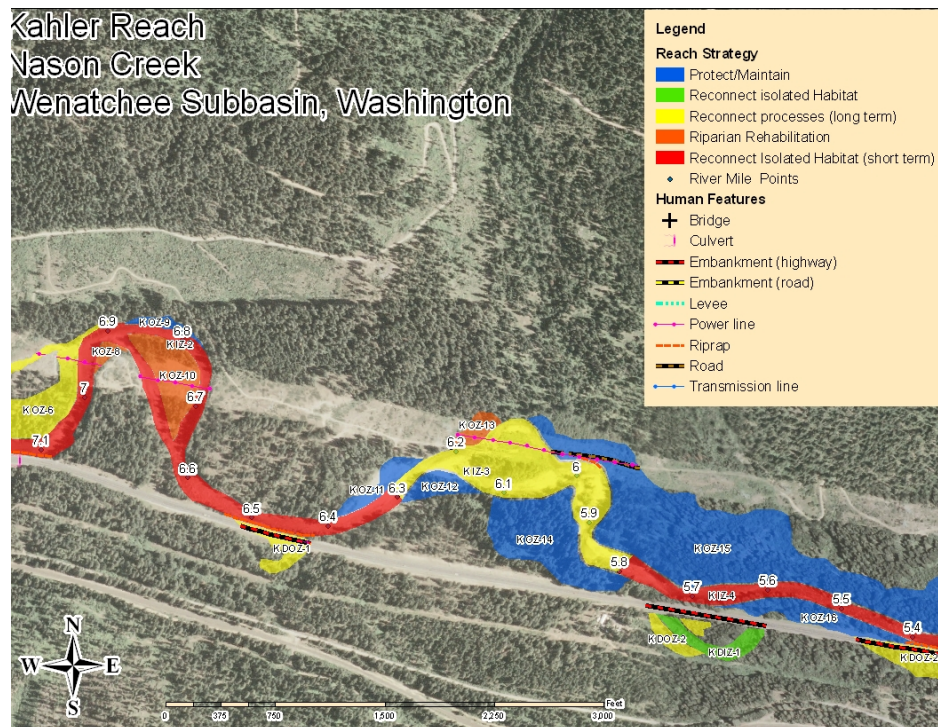
Figure 26 - K DIZ-1 and adjacent subreaches in the Kahler reach.

Subreach K DIZ-1 is located in the mid-section of the Kahler reach to the south of Highway 2 at RM 5.7 (Figure 26). This subreach is rehabilitation oriented due to impacts to the riparian vegetation.

The subreach is just less than 2 acres in size and contains wetlands. Human features include about 250 feet of Highway 2 that disconnects the historic channel bed from the active channel and floodplain. Impacts to the vegetation associated with the highway total just over 1 acre or about 30 percent of the total area of the subreach.

The 2-D hydraulic model did not predict any inundation with the human features removed at 5,000 cfs and the wetlands may be inundated by ground water and/or a small seasonal tributary. However, by improving the connection at a minimum, a cold water source may be utilized. Rehabilitation options are listed in Table 18. Options are prioritized to maximize geomorphic potential of the subreach through the reconnection and reestablishment of both long-term and short-term processes at the subreach scale. Rehabilitation actions in this subreach should be considered collectively with rehabilitation actions recommended in other subreaches to achieve a holistic reconnection and reestablishment of processes at the reach scale.

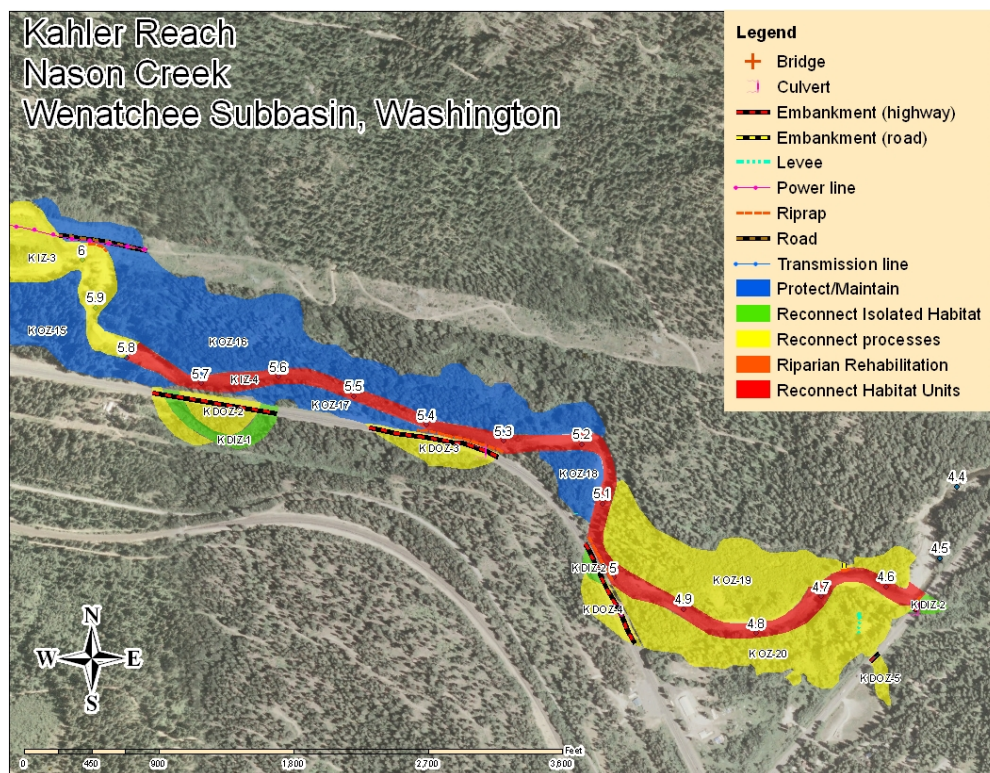
Figure 27 - K DIZ-2 and adjacent subreaches in the Kahler reach.

Subreach K DIZ-2 is located in the downstream end of the Kahler reach to the east of Highway 2 at RM 5.0 (Figure 27). This subreach is rehabilitation oriented due to the disconnection of floodplain and riverine processes.

The subreach is about a half an acre in size. Human features include about 290 feet of Highway 2 that disconnects the historic channel from the current active channel. Culverts are present but were observed to not provide passage at base flow. Impacts to the vegetation associated with the highway total about 0.4 acres or about 87 percent of the subreach.

The 2-D hydraulic model did not predict any inundation with the human features removed at 5000 cfs and the wetlands may be inundated by ground water and/or a small seasonal tributary. However, by improving the connection at a minimum, a cold water source may be

utilized. Rehabilitation options are listed in Table 19. Options are prioritized to maximize geomorphic potential of the subreach through the reconnection and reestablishment of both long-term and short-term processes at the subreach scale. Rehabilitation actions in this subreach should be considered collectively with rehabilitation actions recommended in other subreaches to achieve a holistic reconnection and reestablishment of processes at the reach scale.

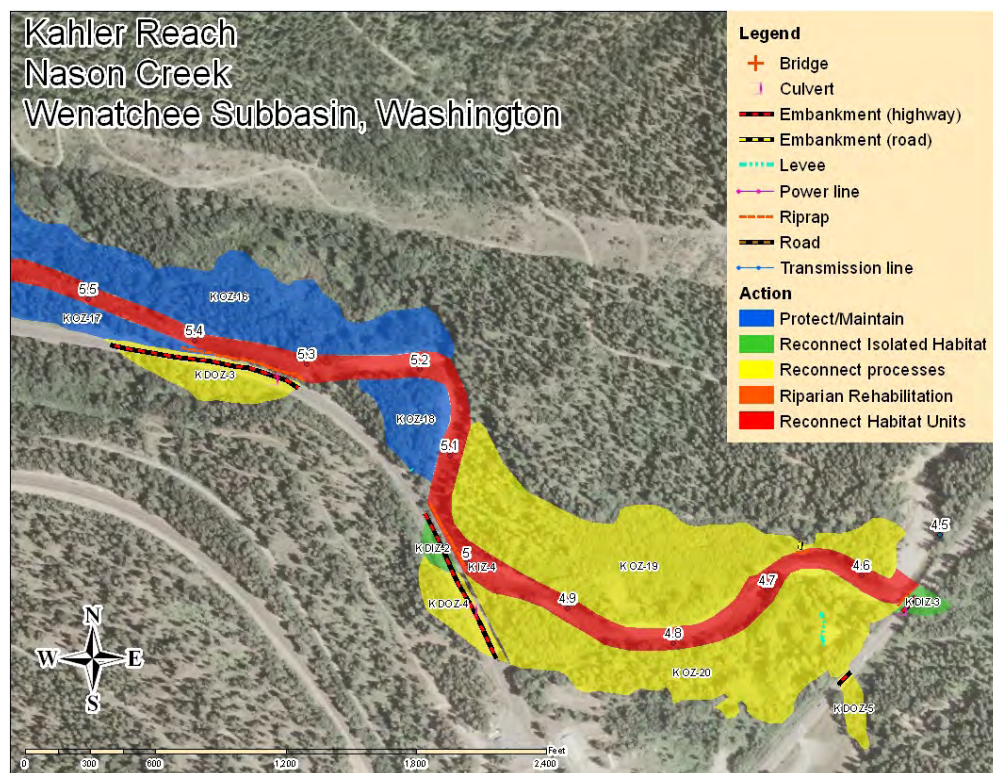
Figure 28 - K DIZ-3 and adjacent subreaches in the Kahler reach.

Subreach K DIZ-3 is located at the downstream end of the Kahler reach to the west of Highway 207 at RM 4.55 (Figure 28). This subreach is rehabilitation-oriented due to the impacts on the riparian vegetation.

The subreach, as mapped, is about a half of an acre in size; however this represents the agreed on end point of the reach assessment. The subreach is actually the upstream end of a disconnected inner and outer zone that is nearly 3 acres in size. The subreach is disconnected from the floodplain and active riverine system by a total of 1,232 feet of Highway 207.

The inundation potential is about 3 acres. Rehabilitation options are listed in Table 20. Options are prioritized to maximize geomorphic potential of the subreach through the reconnection and reestablishment of both long-term and short-term processes at the subreach scale. Rehabilitation actions in this subreach should be considered collectively with rehabilitation actions recommended in other subreaches to achieve a holistic reconnection and reestablishment of processes at the reach scale.

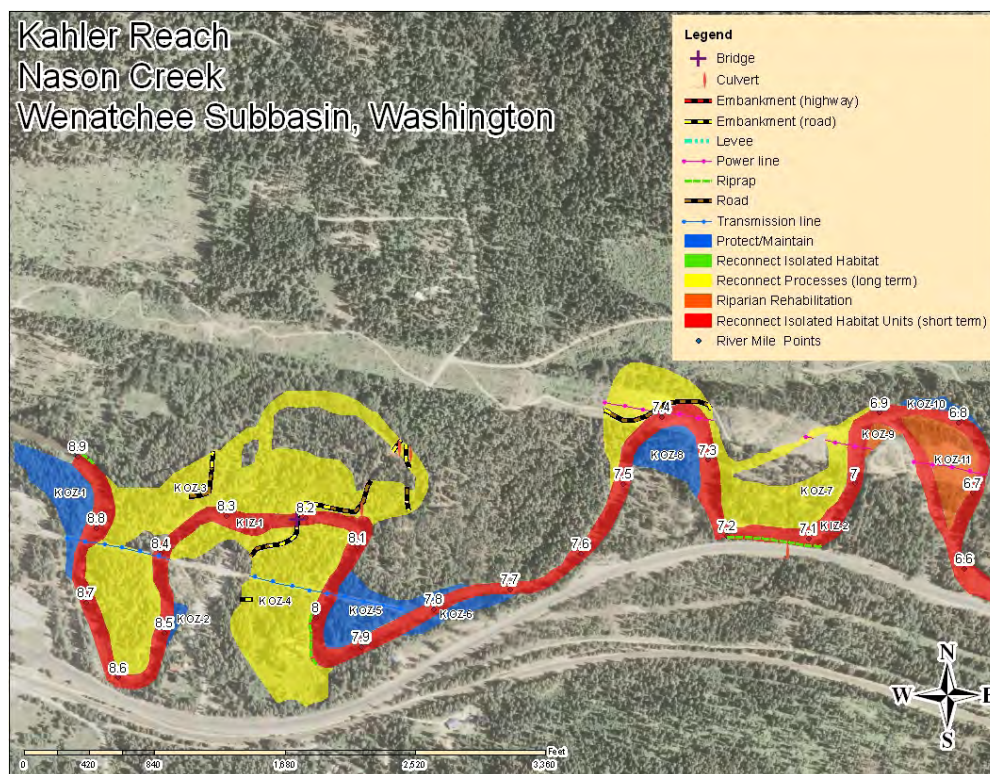
Figure 29 - K OZ-3 and adjacent subreaches in the Kahler reach.

Subreach K OZ-3 is located in the upstream section of the Kahler reach in the left floodplain from RM 8.87 – 8.11 (Figure 29). This subreach is rehabilitation-oriented due to disconnections within the floodplain.

The subreach is about 14 acres in size. Human features include 670 feet of road embankment and 770 feet of unimproved road. A bridge abutment is also present in the center of the reach at RM 8.2. Natural lateral controls are terraces and alluvial fans. Impacts to the vegetation associated with the unimproved road and bridge abutment are just over 1 acre, or about 9% of the total subreach.

The potential to increase the area of inundation is low. When comparing 5,000 cfs stream flow for existing conditions versus potential conditions (i.e., with anthropogenic features removed), the 2D-hydraulic model results show little change in area of inundation. Most of the subreach is inundated at both modeled flows. Rehabilitation options are listed in Table 21. Options are prioritized to maximize geomorphic potential of the subreach through the reconnection and reestablishment of both long-term and short-term processes at the subreach scale. Rehabilitation actions in this subreach should be considered collectively with rehabilitation actions recommended in other subreaches to achieve a holistic reconnection and reestablishment of processes at the reach scale.

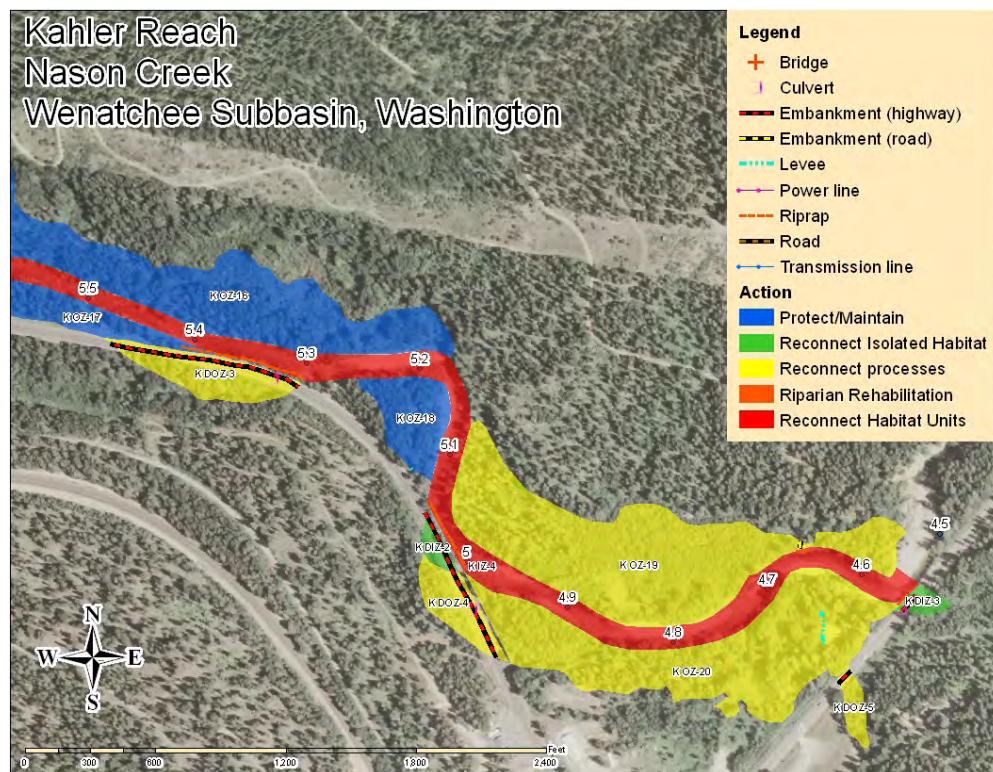
Figure 30 - K OZ-19 and adjacent subreaches in Kahler reach.

Subreach K OZ-19 is located in the downstream section of the Kahler reach in the left floodplain from RM 4.55 to 5.13 (Figure 30). This subreach is rehabilitation-oriented due to disconnections within the floodplain.

The subreach is about 16 acres in size and contains 3 acres of wetlands. Human features include 35 feet of unimproved road embankment and a bridge abutment that disconnect the downstream end of the subreach from the adjacent floodplain and active channel. Natural lateral controls are terraces and alluvial fans. Impacts to the vegetation associated with the unimproved road and bridge abutment are less than 1 acre.

The potential to increase the area of inundation is low. When comparing 5,000 cfs stream flow for existing conditions versus potential conditions (i.e., with anthropogenic features removed), the 2D-hydraulic model results show little change in area of inundation. Most of the subreach is inundated at both modeled flows. Rehabilitation options are listed in Table 22 and are prioritized to maximize the geomorphic potential of the subreach through the reconnection and re-establishment of both long-term and short-term processes at the subreach scale. Rehabilitation actions in this subreach should be considered collectively with rehabilitation actions recommended in other adjacent subreaches to achieve a holistic reconnection and reestablishment of processes at the reach scale.

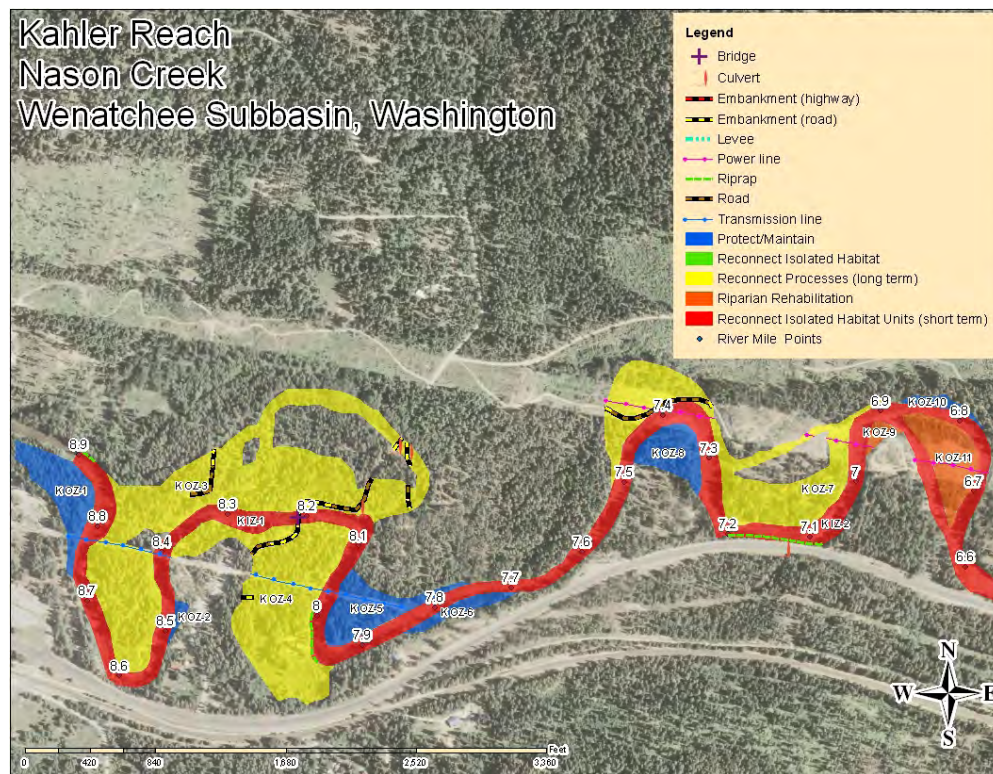
Figure 31 - K OZ-4 and adjacent subreaches in Kahler reach.

K OZ-4 is located in the up-stream section of the Kahler reach in the right floodplain from RM 7.94 to 8.4 (Figure 31). This subreach is rehabilitation-oriented due to disconnections within the floodplain.

The subreach is about 14 acres in size. Anthropogenic features include 337 feet of road embankment, 146 feet of unimproved road, and 384 feet of power lines. The subreach also includes developed areas. Natural lateral controls are terraces. Impacts of anthropogenic features to the vegetation total about 1 acre or about 7 percent of the subreach.

The potential to increase the area of inundation is low. When comparing 5,000 cfs stream flow for existing conditions versus potential conditions (i.e., with anthropogenic features removed), the 2D-hydraulic model results show little change in area of inundation. Most of the subreach is inundated at both modeled flows. Rehabilitation options are listed in Table 23 and are prioritized to maximize the geomorphic potential of the subreach through the reconnection and re-establishment of both long-term and short-term processes at the subreach scale. Rehabilitation actions in this subreach should be considered collectively with rehabilitation actions recommended in other adjacent subreaches to achieve a holistic reconnection and reestablishment of processes at the reach scale.

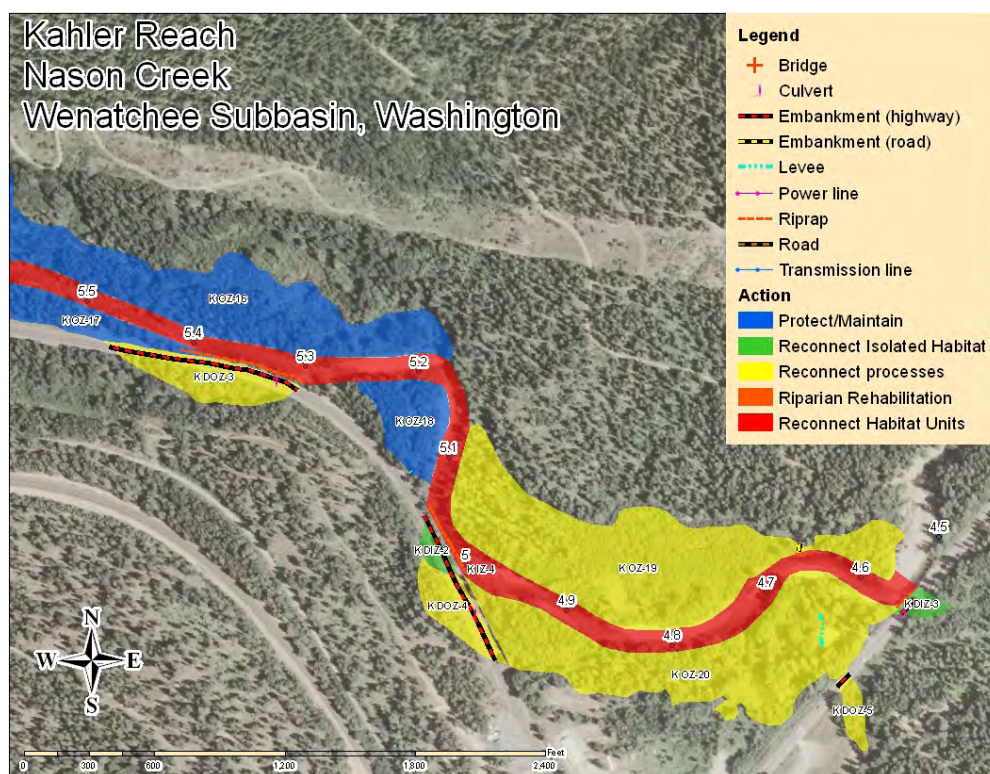
Figure 32 - K OZ-20 and adjacent subreaches in Kahler reach.

Subreach K OZ-20 is located in the downstream section of the Kahler reach in the right floodplain from RM 4.55 to 4.99 (Figure 32). This subreach is rehabilitation-oriented due to disconnections within the floodplain.

The subreach is about 14 acres in size and contains 6 acres of wetlands. Human features include 160 feet of levee that protects an elevated parking area and 20 feet of riprap. The riprap serves as bank protection and is addressed in the K IZ-4 profile. Impacts to the vegetation from the parking area and other disturbances total about a quarter of an acre or about 2 percent of the subreach.

The potential to increase the area of inundation is low. When comparing 5,000 cfs stream flow for existing conditions versus potential conditions (i.e., with anthropogenic features removed), the 2D-hydraulic model results show little change in area of inundation. Most of the subreach is inundated at both modeled flows. Rehabilitation options are listed in Table 24. Options are prioritized to maximize geomorphic potential of the subreach through the reconnection and reestablishment of both long-term and short-term processes at the subreach scale. Rehabilitation actions in this subreach should be considered collectively with rehabilitation actions recommended in other adjacent subreaches to achieve a holistic reconnection and reestablishment of processes at the reach scale.

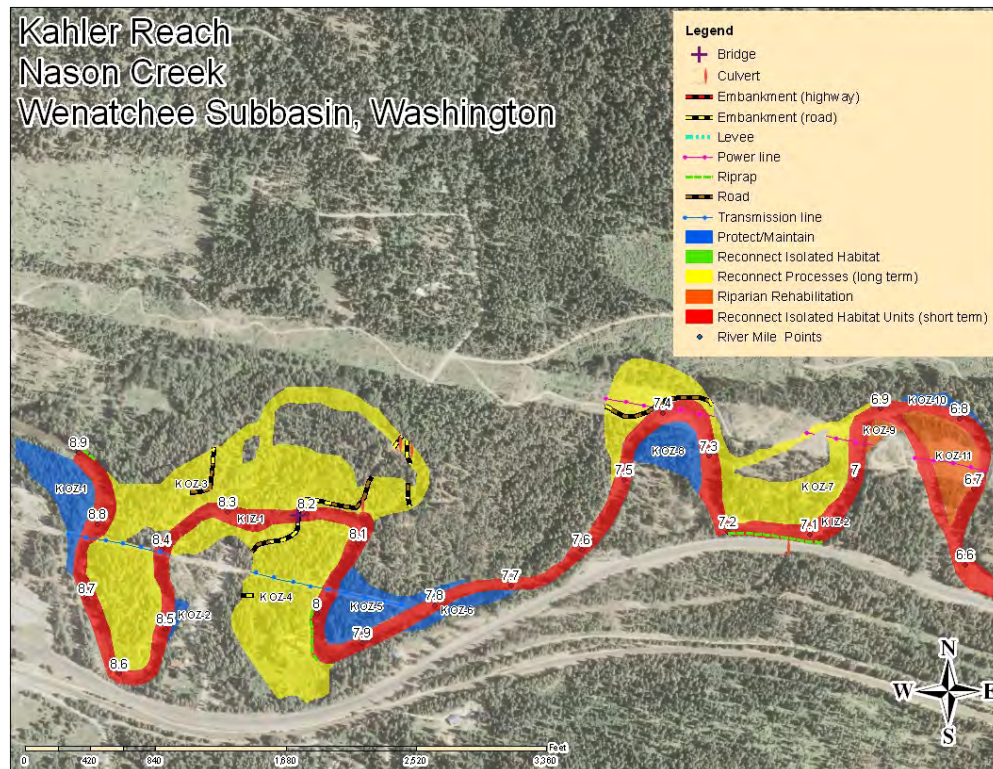
Figure 33 - K OZ-7 and adjacent subreaches in Kahler reach.

Subreach K OZ-7 is located in the upstream section of the Kahler reach in the left floodplain at RM 6.9 to 7.5 (Figure 33). This subreach is rehabilitation-oriented due to the disconnection from the floodplain and riverine system.

The subreach is about 13 acres in size and contains 1 acre of wetlands. Anthropogenic features include 75 feet of road embankment, 680 feet of unimproved road, and 580 feet of powerline. Natural lateral controls are alluvial fans and terraces. Impacts to the vegetation total just over 3 acres or about 27 percent of the subreach.

The potential to increase the area of inundation is low. When comparing 5,000 cfs stream flow for existing conditions versus potential conditions (i.e., with anthropogenic features removed), the 2D-hydraulic model results show little change in area of inundation. Most of the subreach is inundated at both modeled flows. Rehabilitation options are listed in Table 25. Options are prioritized to maximize geomorphic potential of the subreach through the reconnection and reestablishment of both long-term and short-term processes at the subreach scale. Rehabilitation actions in this subreach should be considered collectively with rehabilitation actions recommended in other subreaches to achieve a holistic reconnection and reestablishment of processes at the reach scale.
