Kahler Reach Assessment

Nason Creek

Chelan County, Washington

March 2009

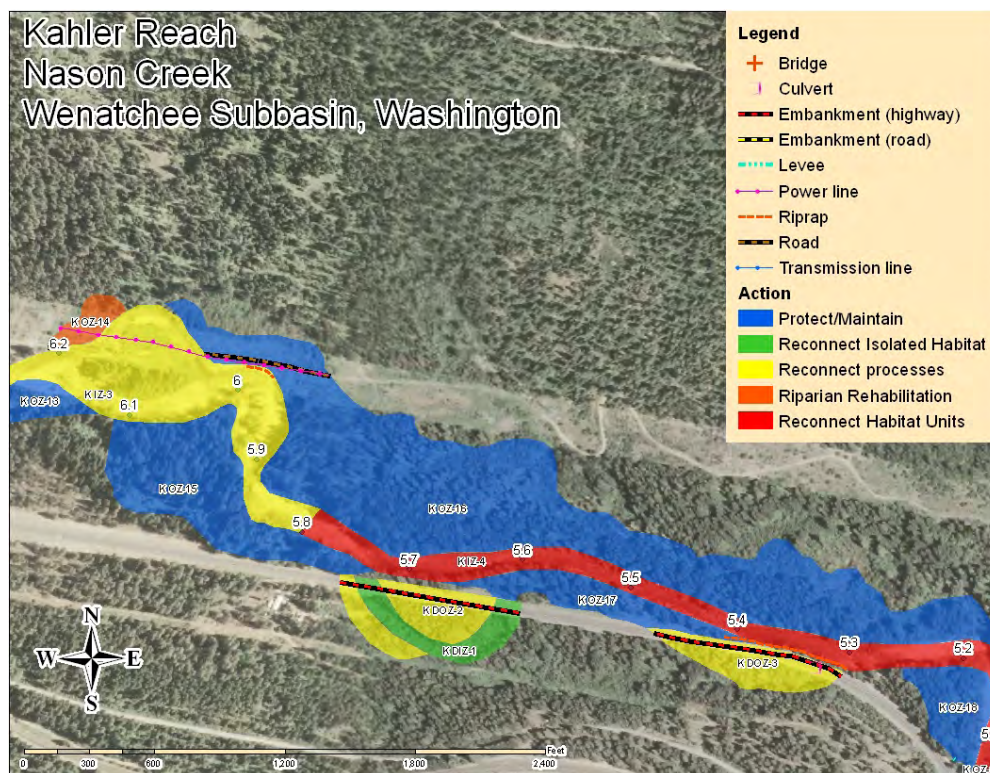
Figure 34 - K IZ-3 and adjacent subreaches in Kahler reach.

Subreach K IZ-3 is just over 11 acres and comprises a section of the current active channel from RM 5.8 to 6.3 in the Kahler reach (Figure 34). The dominant process is transition to deposition, as noted by the increase in sinuosity, gravel substrate and increase in the diversity of channel units. The subreach composition is 57 percent runs, 25 percent riffles, and 18 percent pools.

Anthropogenic features included one cabled log, one boulder cluster, and riprap. The biggest impact comes from two sections of riprap for a total of 390 linear feet along the left bank at the upstream and downstream boundaries of the subreach. Other anthropogenic impacts include two powerline crossings in the downstream end of the subreach.

Rehabilitation options are listed in Table 26. Options are prioritized to maximize geomorphic potential of the subreach through the reconnection and reestablishment of both long-term and short-term processes at the subreach scale. Rehabilitation actions in this subreach should be considered collectively with rehabilitation actions recommended in other subreaches to achieve a holistic reconnection and reestablishment of processes at the reach scale.

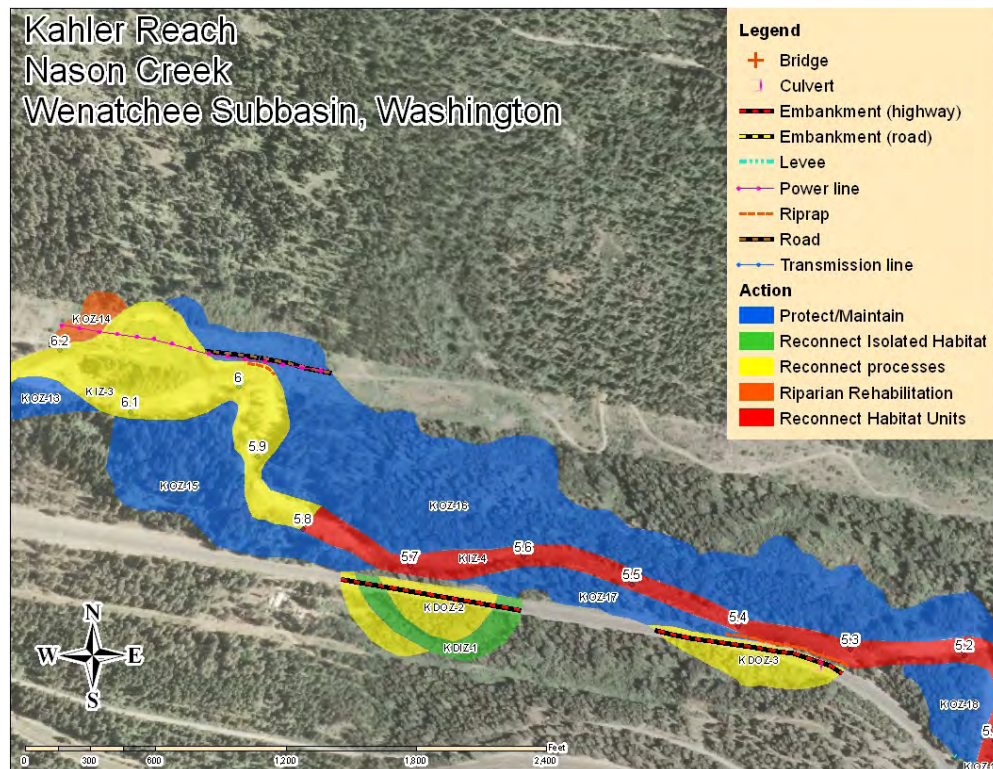
Figure 35 - K DOZ-3 and adjacent subreaches in Kahler reach.

K DOZ-3 is located in the downstream section of the Kahler reach in the right floodplain to the west of Highway 2 from RM 5.4 to 5.3 (Figure 35). This subreach is rehabilitation-oriented due to disconnections from the adjacent active floodplain and riverine system.

The subreach is just less than 3 acres in size. Human features include 884 feet of Highway 2. The highway disconnects the subreach from the adjacent floodplain and riverine system. There is a culvert at the downstream end, but it is believed to allow run-off water to enter the system rather than fish passage. Disturbance to the riparian vegetation associated with the highway totals just over 1 acre or about 44 percent of the subreach.

The inundation potential is about 1.4 acres or 1.4 percent of the inundation potential of the Kahler reach. Rehabilitation options are listed in Table 27 and are prioritized to maximize the geomorphic potential of the subreach through the reconnection and re-establishment of both long-term and short-term processes at the subreach scale. Rehabilitation actions in this subreach should be considered collectively with rehabilitation actions recommended in other adjacent subreaches to achieve a holistic reconnection and reestablishment of processes at the reach scale.

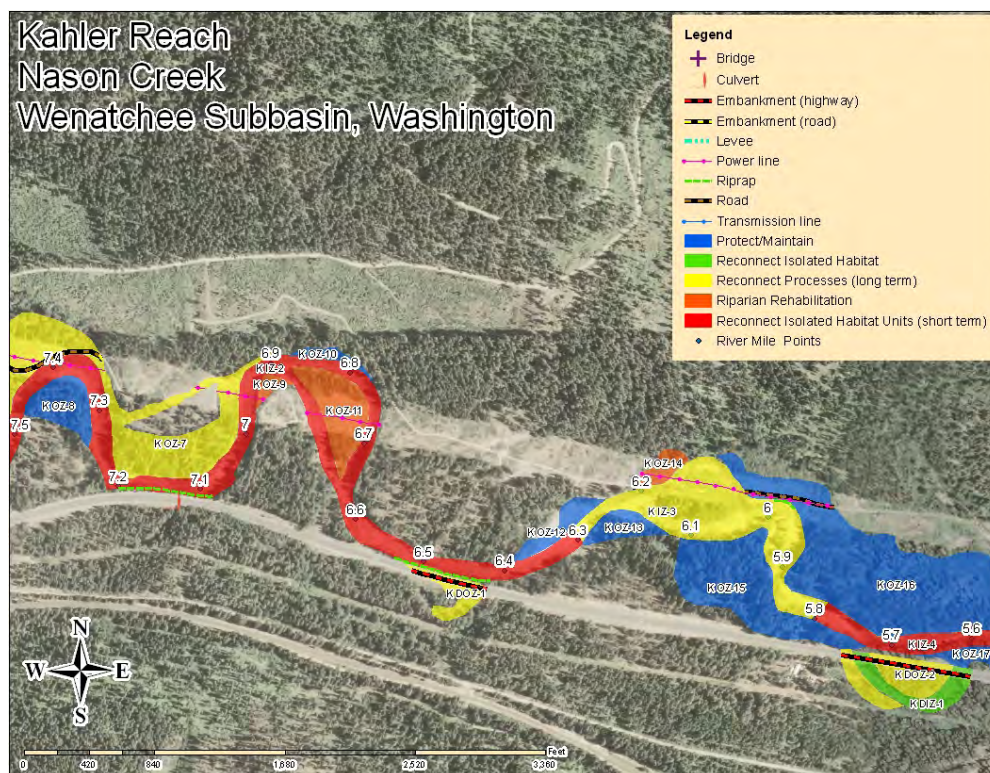
Figure 36 - K DOZ-2 and adjacent subreaches in Kahler reach.

The subreach K DOZ-2 is located in the mid-section of the Kahler reach to the south of Highway 2 at RM 5.7 (Figure 36). This subreach is rehabilitation-oriented due to the impacts on the riparian vegetation.

The subreach is about 3 acres in size and is the complimentary outer zone to DIZ-1. Human features include about 588 feet of Highway 2. Impacts to the vegetation associated with the highway total nearly 1 acre or about 30 percent of the subreach.

The 2-D hydraulic model did not predict any inundation with the human features removed at 5,000 cfs, although the wetlands may be inundated by ground water and/or a small seasonal tributary. By improving the connection as a minimum, a cold water source may be utilized. Rehabilitation options are listed in Table 28. Options are prioritized to maximize geomorphic potential of the subreach through the reconnection and re-establishment of both long-term and short-term processes at the subreach scale. Rehabilitation actions in this subreach should be considered collectively with rehabilitation actions recommended in other subreaches to achieve a holistic reconnection and reestablishment of processes at the reach scale

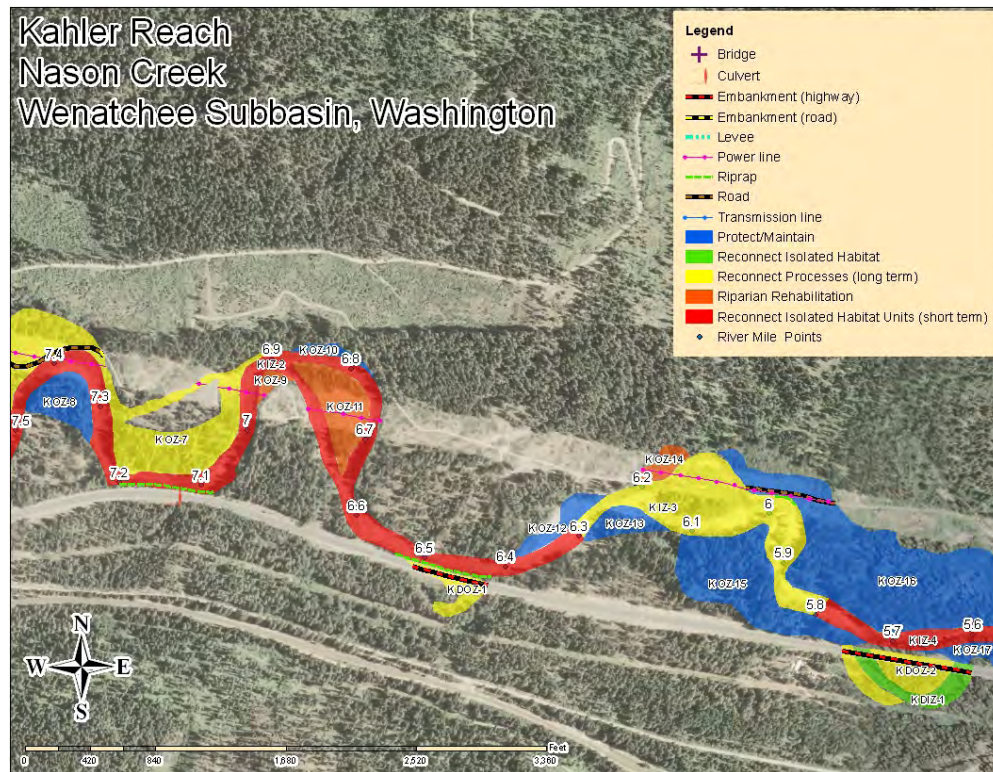
Figure 38 - K DOZ-1 and adjacent subreaches in Kahler reach.

Subreach K DOZ-1 is located in the mid-section of Kahler reach to the south of the right floodplain and Highway 2 from RM 6.42 to 6.53 (Figure 38). This subreach is rehabilitation-oriented due to disconnections within the floodplain and active channel.

The inundation potential is about 1 acre, which is about 1 percent of the inundation potential for the entire Kahler reach. Rehabilitation options are listed in Table 30. The options are prioritized to maximize the geomorphic potential of the subreach through the reconnection and re-establishment of both long-term and short-term processes at the subreach scale.

Rehabilitation actions in this subreach should be considered collectively with rehabilitation actions recommended in other adjacent subreaches to achieve a holistic reconnection and reestablishment of processes at the reach scale.

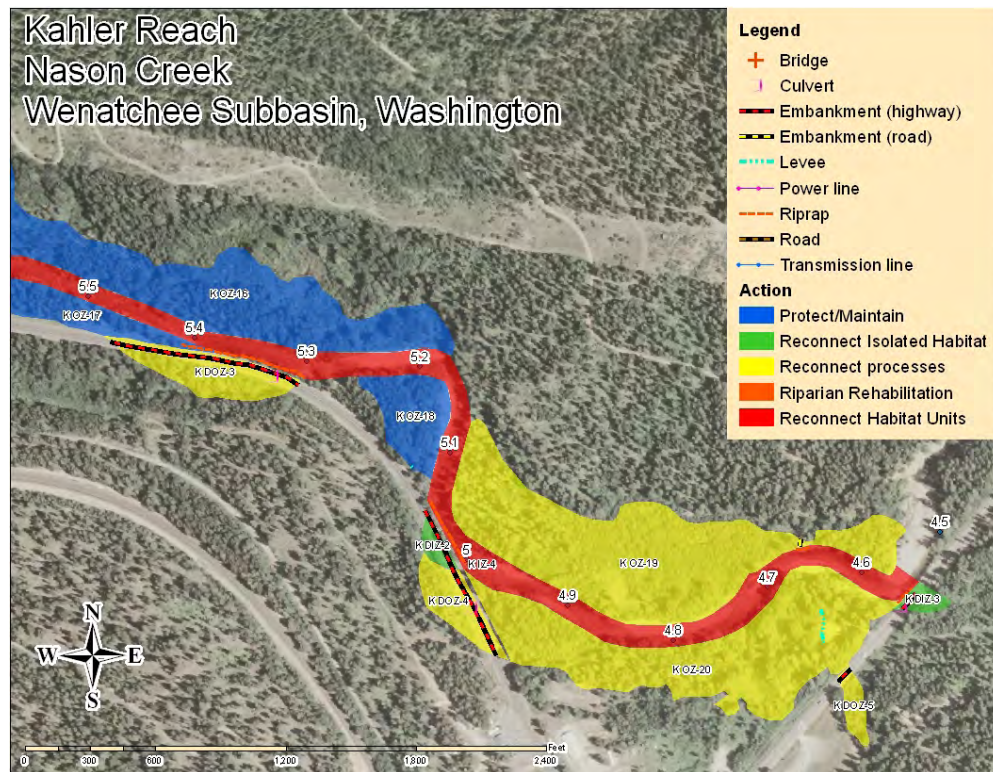
Figure 39 - K DOZ-5 and adjacent subreaches in Kahler reach.

Subreach K DOZ-5 is located in the downstream section of Kahler reach to the west of Washington State Highway 207 near RM 4.7 (Figure 39). This subreach is rehabilitation-oriented due to disconnections within the floodplain and active channel.

The subreach is less than 1 acre in size. Anthropogenic features include 78 feet of highway embankment that disconnects the subreach from the adjacent floodplain. Additional human impacts include the adding of fill material to the south. Natural lateral controls are terraces. Impacts to the vegetation associated with the highway total just less than 1 acre or about 30 percent of the subreach.

The inundation potential is about 1 acre, which is about 1 percent of the inundation potential for the entire Kahler reach. Rehabilitation options are listed in Table 31. The options are prioritized to maximize the geomorphic potential of the subreach through the reconnection and re-establishment of both long-term and short-term processes at the subreach scale. Rehabilitation actions in this subreach should be considered collectively with rehabilitation actions recommended in other adjacent subreaches to achieve a holistic reconnection and reestablishment of processes at the reach scale.

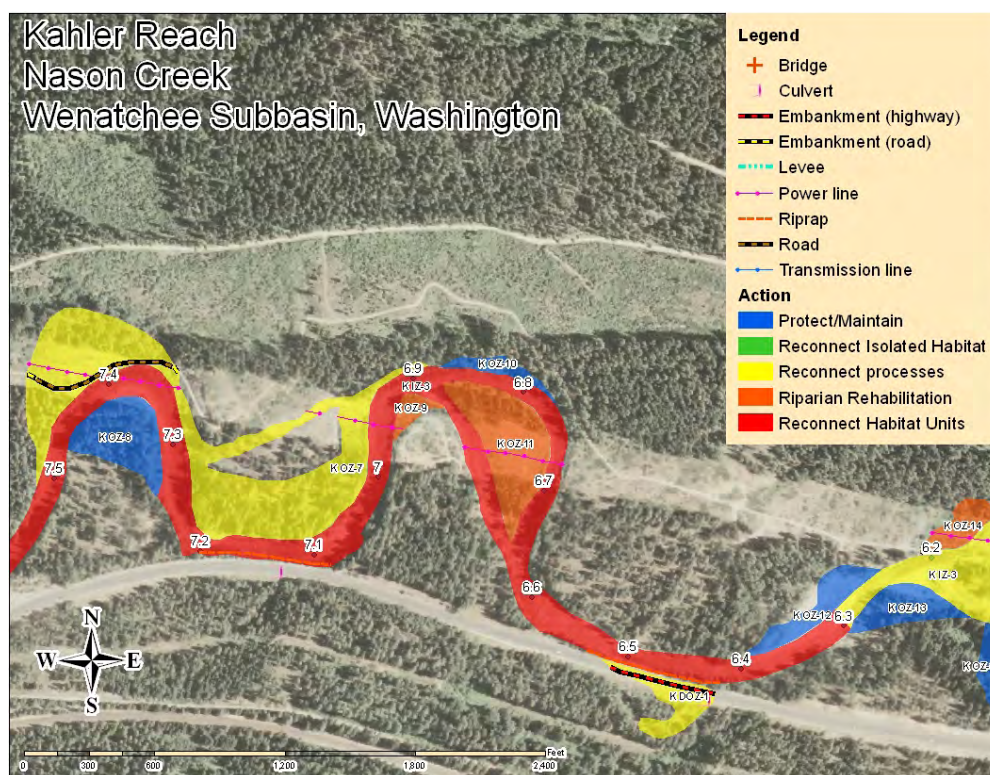
Figure 40 - K OZ-11 and adjacent subreaches in Kahler reach.

Subreach K OZ-11 is located in the mid-section of the Kahler reach as a vegetated island at RM 6.85 to 6.95 (Figure 40). This subreach is rehabilitation-oriented due to impacts to the riparian vegetation.

The subreach is about 4 acres in size. Human features include about 300 feet of power lines. Impacts to the vegetation associated with the power line total about 2 acres or about 50 percent of the subreach.

The potential to increase the area of inundation is low. When comparing 5,000 cfs stream flow for existing conditions versus potential conditions (i.e., with anthropogenic features removed), the 2D-hydraulic model results show little change in area of inundation. Most of the subreach is inundated at both modeled flows. Rehabilitation options are listed in Table 32. Options are prioritized to maximize geomorphic potential of the subreach through the reconnection and reestablishment of both long-term and short-term processes at the subreach scale. Rehabilitation actions in this subreach should be considered collectively with rehabilitation actions recommended in other subreaches to achieve a holistic reconnection and reestablishment of processes at the reach scale.

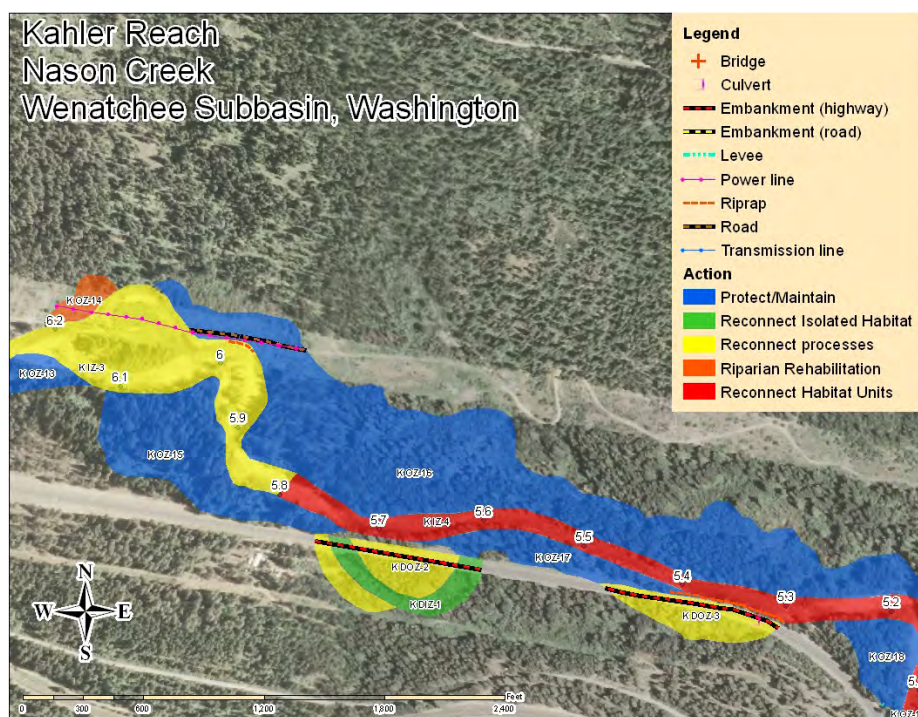
Figure 41 - K OZ-14 and adjacent subreaches in Kahler reach.

The subreach K OZ-14 is located in the mid-section of the Kahler reach in the left floodplain at RM 6.2 (Figure 41). This subreach is rehabilitation-oriented due to the impacts on the riparian vegetation.

The subreach is about 1 acre in size. Human features include about 185 feet of power lines and about 20 feet of access road that is utilized for recreation. Impacts to the vegetation associated with the power line total just under 1 acre or about 72 percent of the subreach.

The potential to increase the area of inundation is low. When comparing 5,000 cfs stream flow for existing conditions versus potential conditions (i.e., with anthropogenic features removed), the 2D-hydraulic model results show little change in area of inundation. Most of the subreach is inundated at both modeled flows. Rehabilitation options are listed Table 33. Options are prioritized to maximize geomorphic potential of the subreach through the reconnection and reestablishment of both long-term and short-term processes at the subreach scale. Rehabilitation actions in this subreach should be considered collectively with rehabilitation actions recommended in other subreaches to achieve a holistic reconnection and reestablishment of processes at the reach scale.

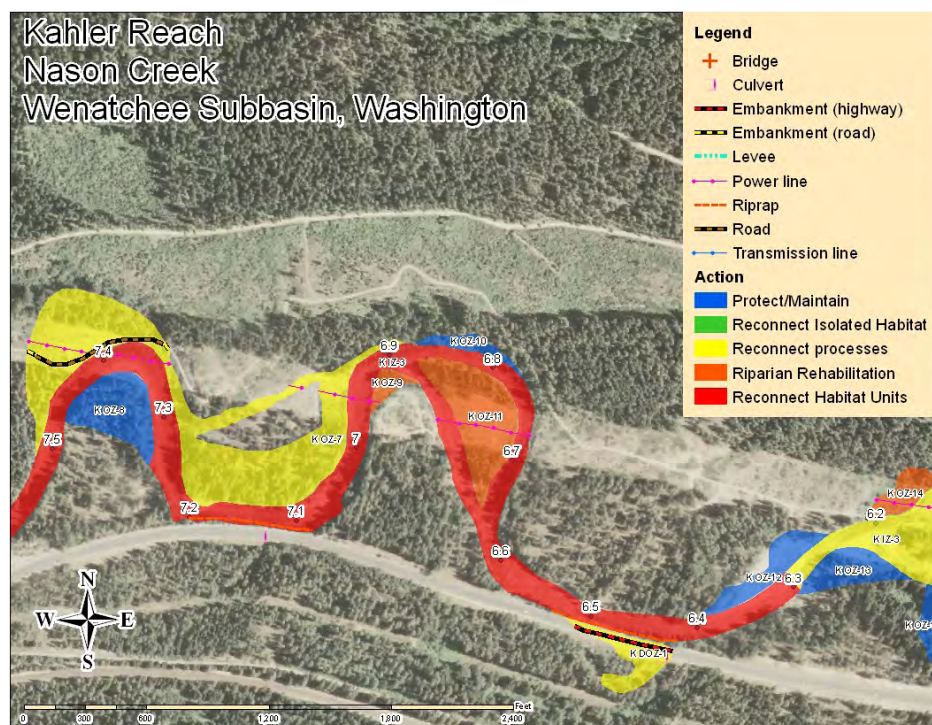
Figure 42 - K OZ-9 and adjacent subreaches in Kahler reach.

Subreach K OZ-9 is located in the mid-section of the Kahler reach in the right floodplain at RM 6.85 to 6.95 (Figure 42). This subreach is rehabilitation-oriented due to the impacts on the riparian vegetation.

The subreach is about one half of an acre in size. Human features include about 44 feet of power lines. Impacts to the vegetation associated with the power lines total about two-tenths of an acre or about 40 percent of the subreach.

The potential to increase the area of inundation is low. When comparing 5,000 cfs stream flow for existing conditions versus potential conditions (i.e., with anthropogenic features removed), the 2D-hydraulic model results show little change in area of inundation. Most of the subreach is inundated at both modeled flows. Rehabilitation options are listed in Table 34. Options are prioritized to maximize geomorphic potential of the subreach through the reconnection and reestablishment of both long-term and short-term processes at the subreach scale. Rehabilitation actions in this subreach should be considered collectively with rehabilitation actions recommended in other subreaches to achieve a holistic reconnection and reestablishment of processes at the reach scale.

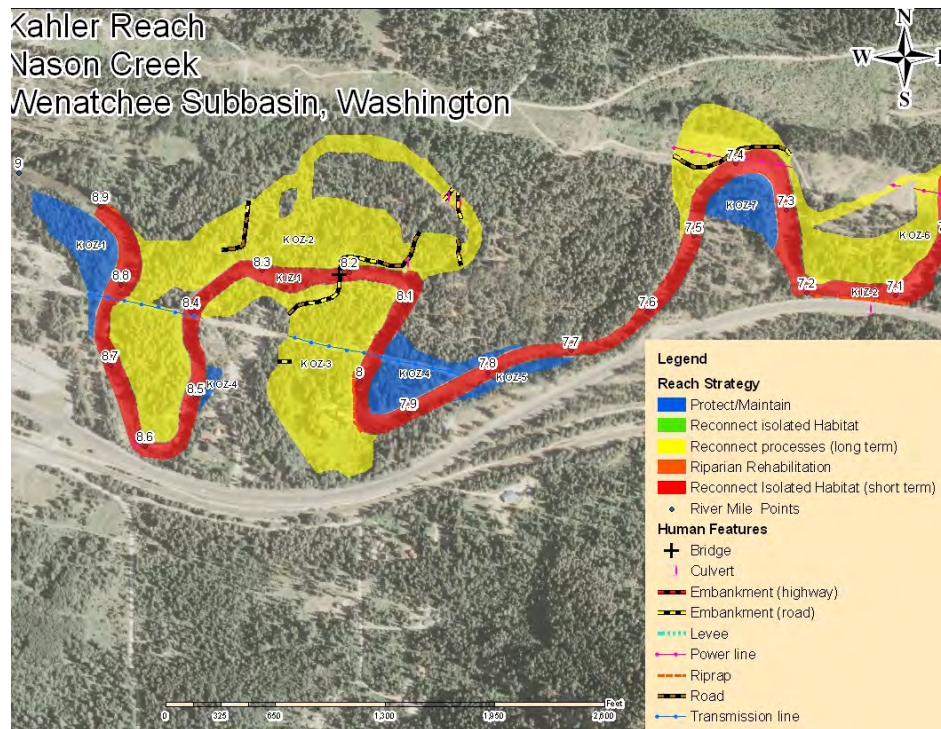
Figure 43 - K IZ-2 and adjacent subreaches in Kahler reach.

Subreach K IZ-2 is about 19 acres in size and comprises a section of the current active channel and bars from RM 6.3 to 7.7 (Figure 43). The dominant process is transition-to-deposition. The dominant substrate is gravel and cobble. The subreach channel unit composition is 41 percent runs, 7 percent pools, 33 percent riffles, and 19 percent rapids. Due to the existing functioning conditions of this subreach, it is restoration-oriented.

Anthropogenic features in the subreach include about 1,250 feet of riprap that protects Highway 2 along the right bank at RM 7.15 and 6.5. There are also four power line crossings throughout the reach. Natural lateral control for the subreach is alluvial fan and terraces with coarse substrate. Large woody debris is concentrated in three large wood complexes at RM 7.0 and two complexes at RM 6.2.

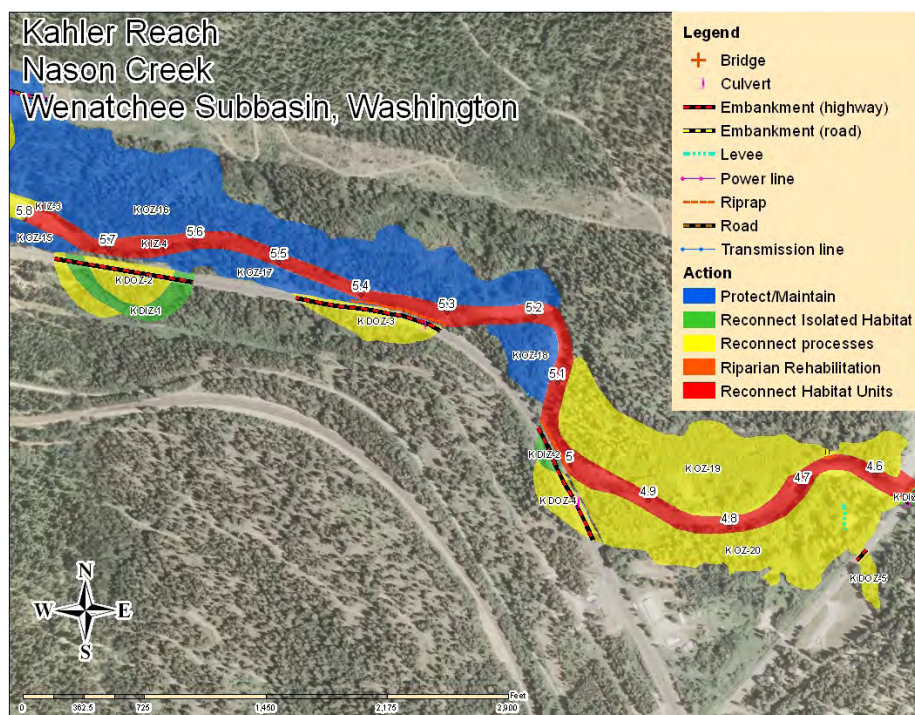
Figure 44 - K IZ-4 and adjacent subreaches in Kahler reach.

Subreach K IZ-4 is about 16 acres in size and comprises a section of the current active channel and bars from RM 4.65 to 5.8 (Figure 44). The dominant process is transition-to-transport. The dominant substrate is gravel and cobble. The subreach channel unit composition is 38 percent runs, 4 percent pools, 3 percent riffles, and 55 percent rapids. Due to the existing functioning conditions of this subreach, it is restoration-oriented.

Anthropogenic features in the subreach include about 950 feet of riprap. The riprap protects Highway 2 and State Highway 207 along the right bank of the active channel. Natural lateral control for the subreach is alluvial fan, terraces with coarse substrate, and bedrock. Large woody debris is concentrated in a large wood complex at RM 5.3.

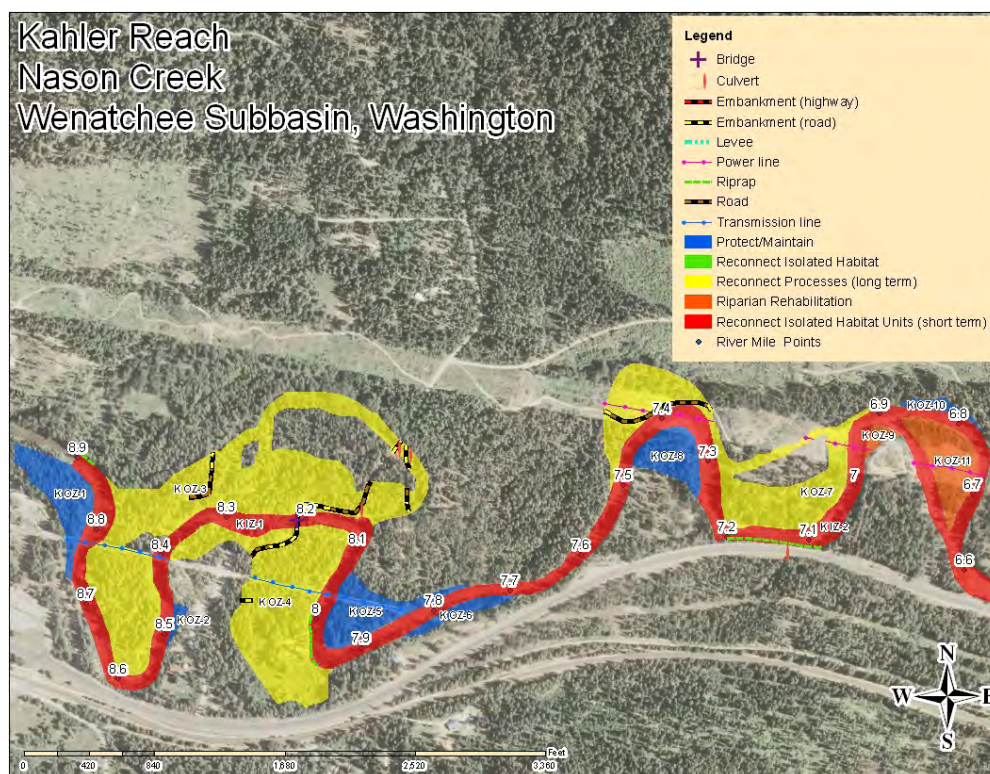
Figure 45 - K IZ-1 and adjacent subreaches in Kahler reach.

Subreach K IZ-1 is slightly less than 14 acres and comprises a section of the current active channel and bars in the Kahler reach from RM 7.7 to 8.9 (Figure 45). The dominant process is transition-to-deposition. The dominant substrate is gravel and cobble. The subreach channel unit composition is 58 percent runs, 10 percent pools, 30 percent riffles, and 2 percent rapids. Due to the existing functioning conditions of this subreach, it is restoration-oriented.

Natural lateral controls for the subreach are higher terraces that confine this subreach to a moderate extent. The existence of riprap and the higher terraces reduce the amount of lateral migration. The result is a decrease in diversity of channel units and reduced instream habitat complexity. Large woody debris counts are low which hinders the creation of complexity at higher flows. It is hypothesized that material begins to deposit during low flow.

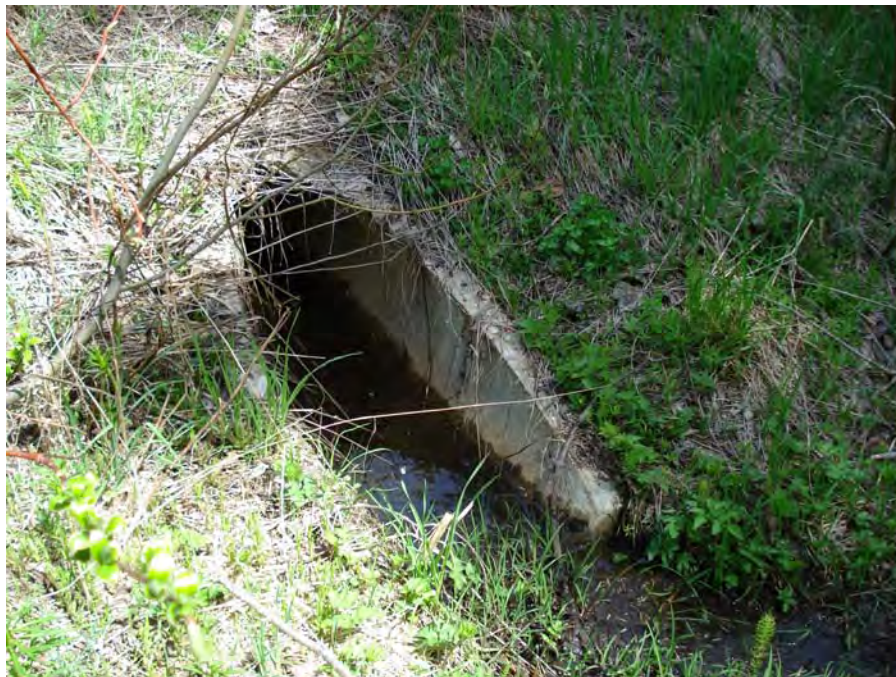
Photograph No. 1. Concrete culvert at the upstream end of a historic oxbow located to the south of U.S. Highway 2.. Kahler Reach; Subreach DIZ-1, Nason Creek - Wenatchee Subbasin, Washington. Bureau of Reclamation Photograph by R. McAfee, May 7, 2007.

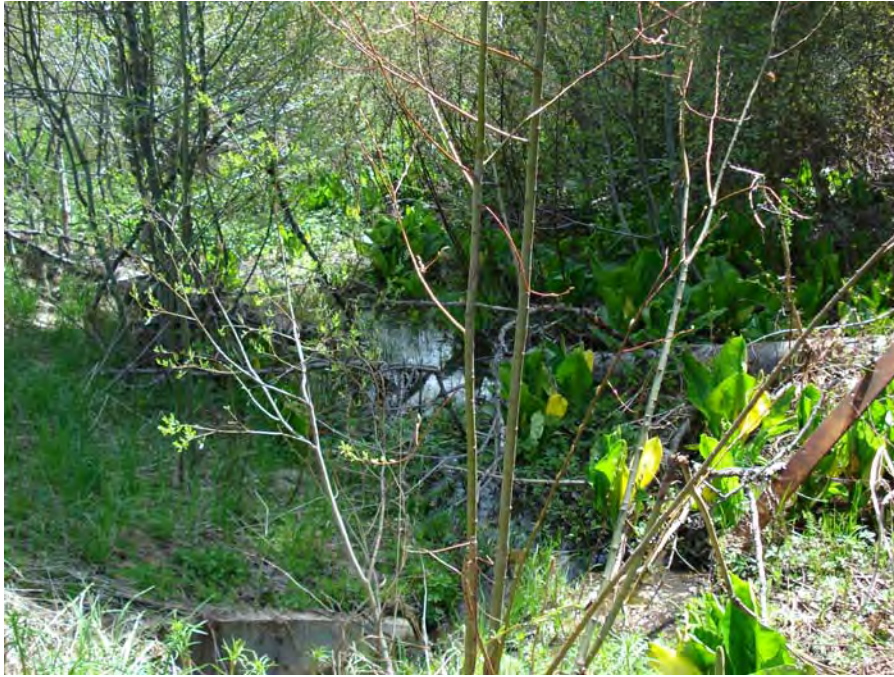
Photograph No. 2. Wetlands in the lower section of a historic oxbow located to the south of U.S. Highway 2.. Kahler Reach; Subreach DIZ-1, Nason Creek - Wenatchee Subbasin, Washington. Bureau of Reclamation Photograph by R. McAfee, May 7, 2007.

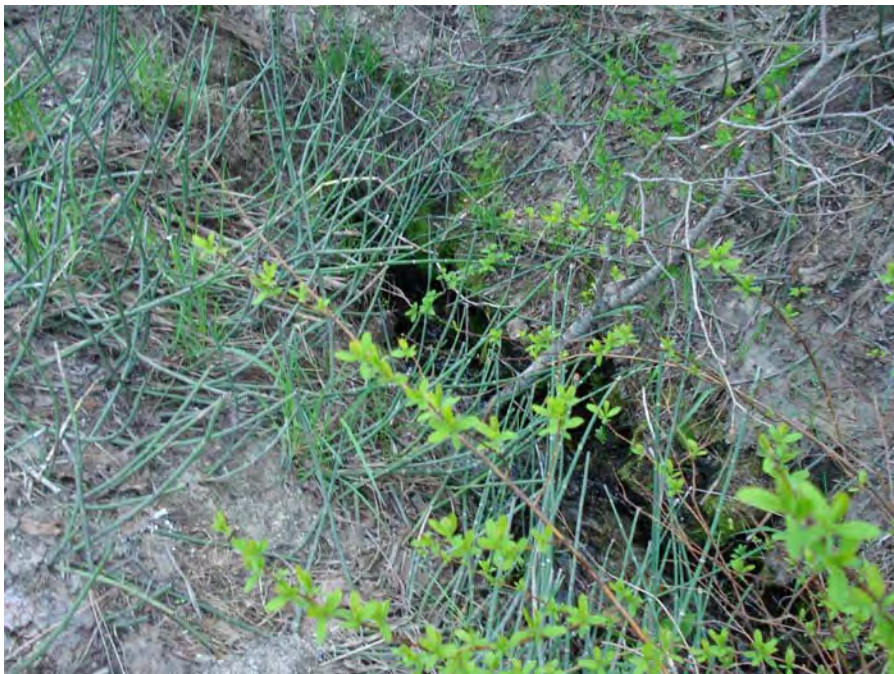
Photograph No. 3. Intake of culvert that drains wetlands in the lower section of historic oxbow located to the south of U.S. Highway 2. Kahler Reach; Subreach DIZ-1, Nason Creek - Wenatchee Subbasin, Washington. Bureau of Reclamation Photograph by R. McAfee, May 7, 2007.

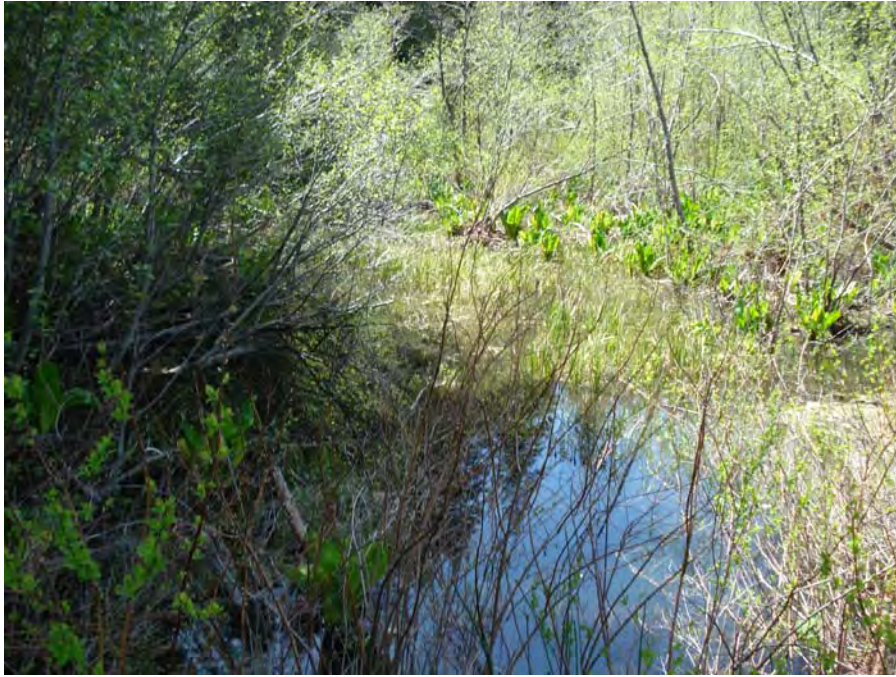
Photograph No. 4. Wetlands in the lower section of historic oxbow located to the south of U.S. Highway 2. Kahler Reach; Subreach DIZ-1, Nason Creek - Wenatchee Subbasin, Washington. Bureau of Reclamation Photograph by R. McAfee, May 7, 2007.

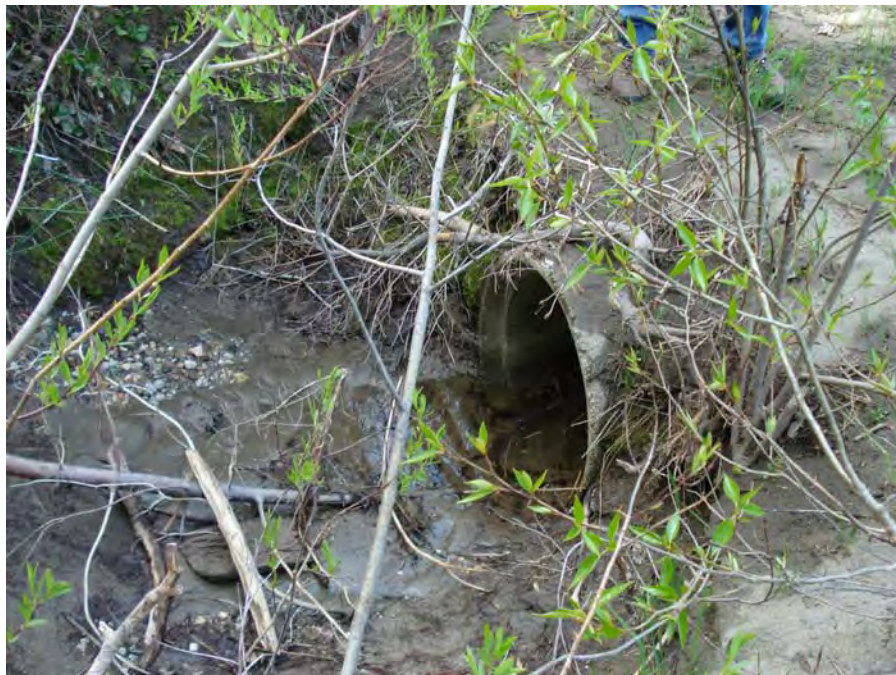
Photograph No. 1. View of the east (wetland) side of a culvert. Kahler Reach; Subreach DIZ-2, Nason Creek - Wenatchee Subbasin, Washington. Bureau of Reclamation Photograph by R. McAfee, May 5, 2007.

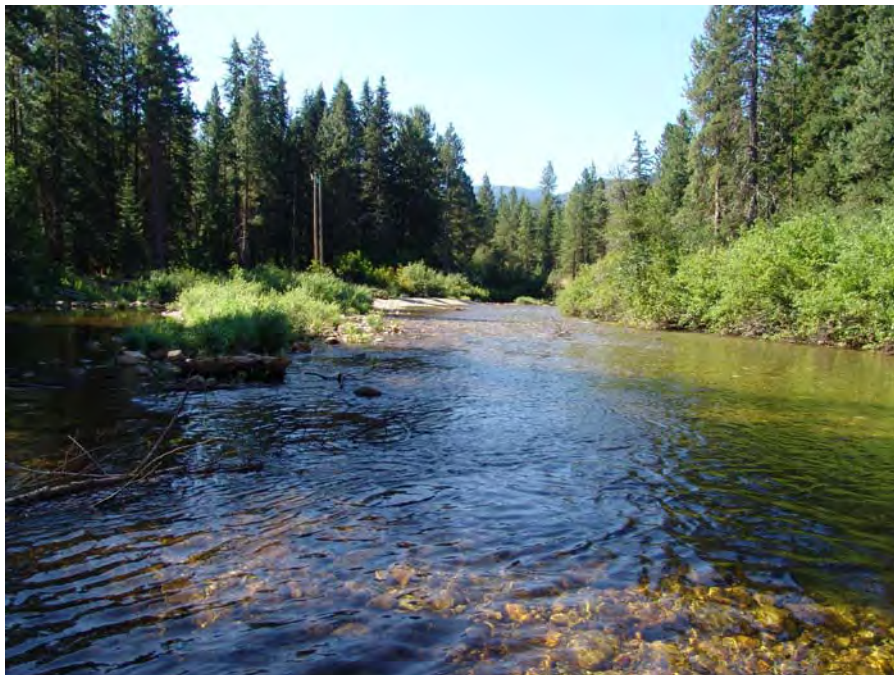
Photograph No.1. View is to the south looking downstream showing a channel unit sequence of glide-riffle-glide and brushy vegetation along both banks. Kahler Reach; Subreach IZ-1, Nason Creek - Wenatchee Subbasin, Washington. Bureau of Reclamation Photograph by D. Bennett 8/9/07.

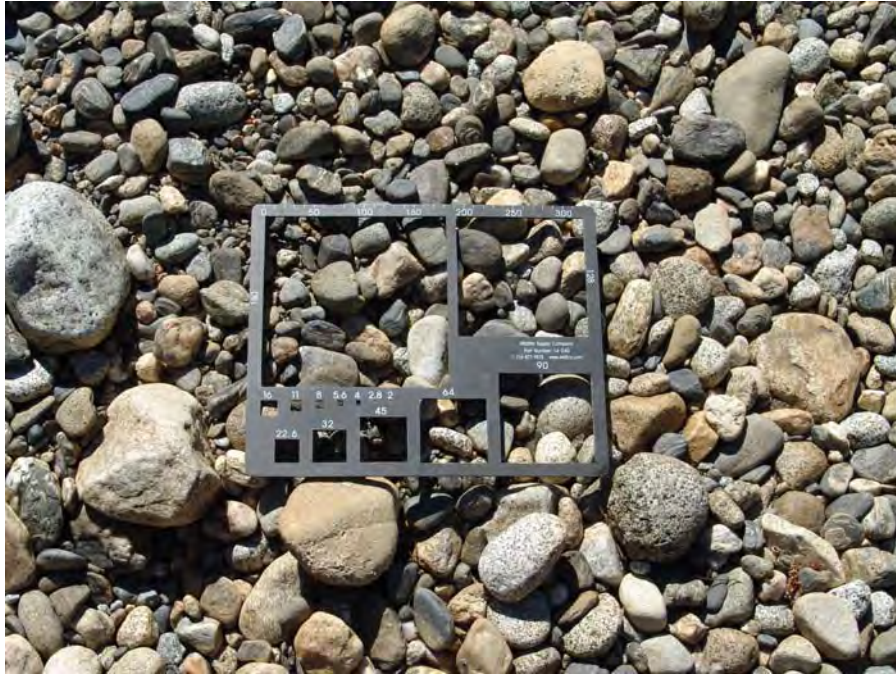
Photograph No.2. View of material located on bar with gravelometer for scale. Kahler Reach; Subreach IZ-1, Nason Creek - Wenatchee Subbasin, Washington. Bureau of Reclamation Photograph by D. Bennett 8/9/07.

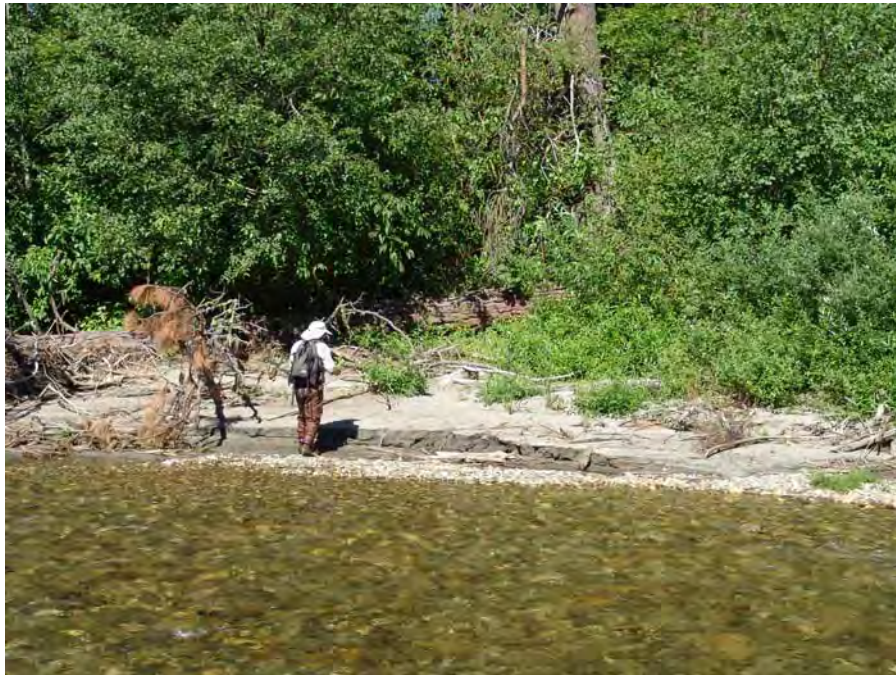
Photograph No.3. View to the west looking at sand deposits along the right bank. Kahler Reach; Subreach IZ-1, Nason Creek - Wenatchee Subbasin, Washington. Bureau of Reclamation Photograph by D. Bennett 8/9/07.

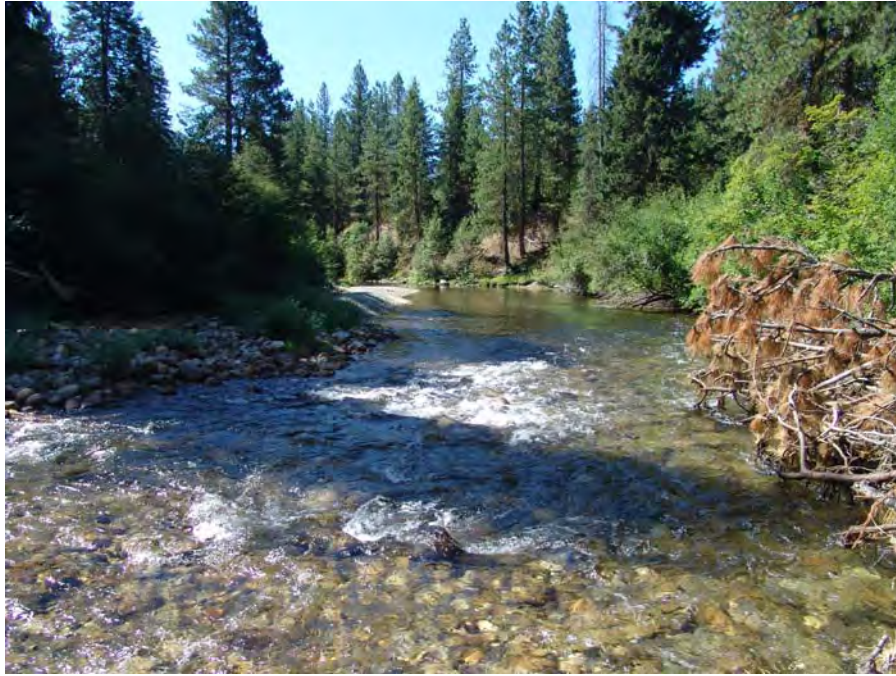
Photograph No.4. View is to the south looking downstream showing a channel unit sequence of riffle-pool and a cobble point bar along the left bank. Kahler Reach; Subreach IZ-1, Nason Creek - Wenatchee Subbasin, Washington. Bureau of Reclamation Photograph by D. Bennett 8/9/07.

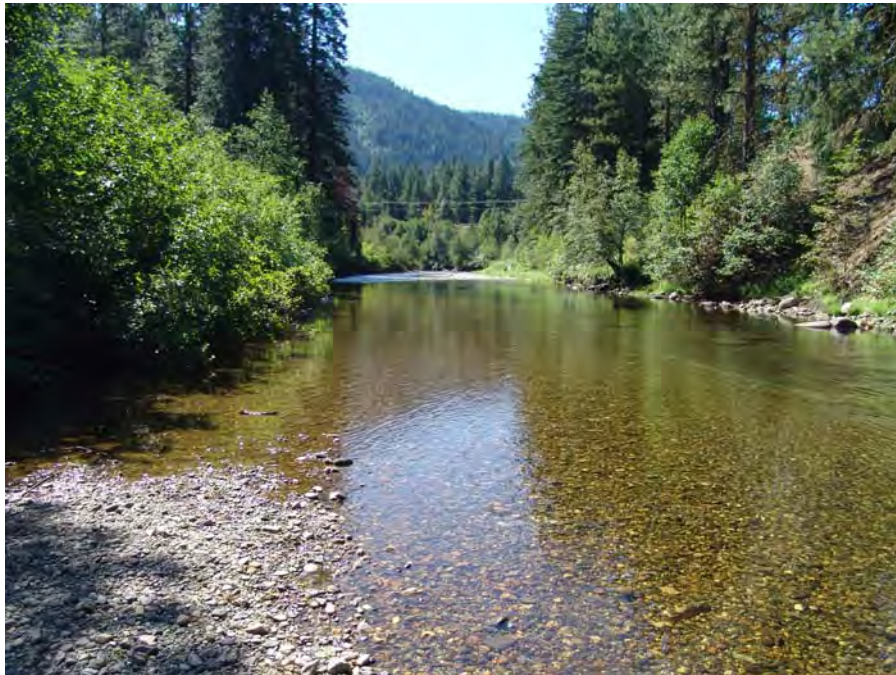
Photograph No.5. View is to the south looking downstream showing a long run and riffle sequence and a tall terrace along the right bank. Kahler Reach; Subreach IZ-1, Nason Creek - Wenatchee Subbasin, Washington. Bureau of Reclamation Photograph by D. Bennett 8/9/07.

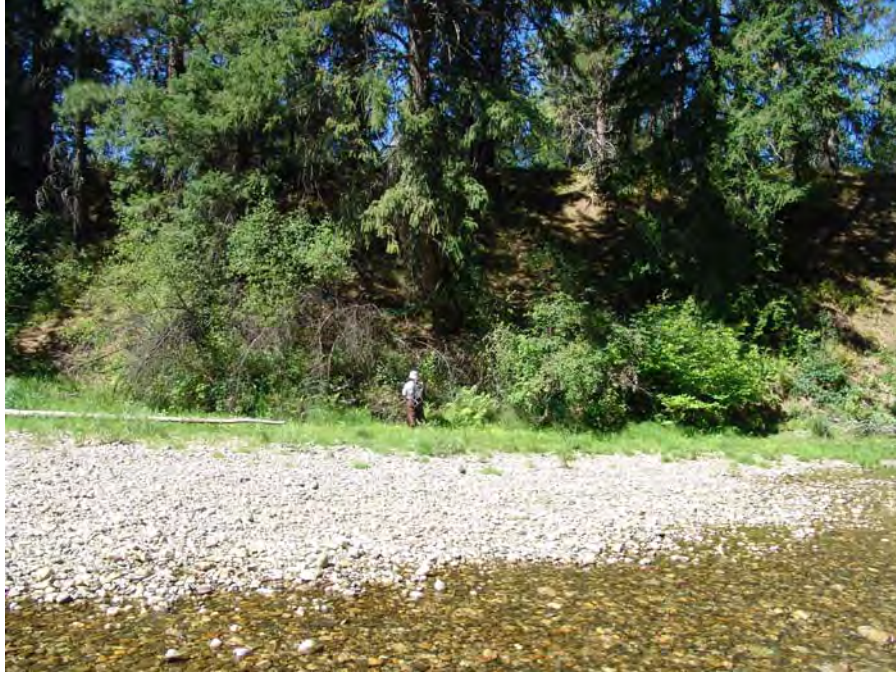
Photograph No. 6. View to the west looking at a gravel and cobble point bar and tall terrace along the right bank. Kahler Reach; Subreach IZ-1, Nason Creek - Wenatchee Subbasin, Washington. Bureau of Reclamation Photograph by D. Bennett 8/9/07.

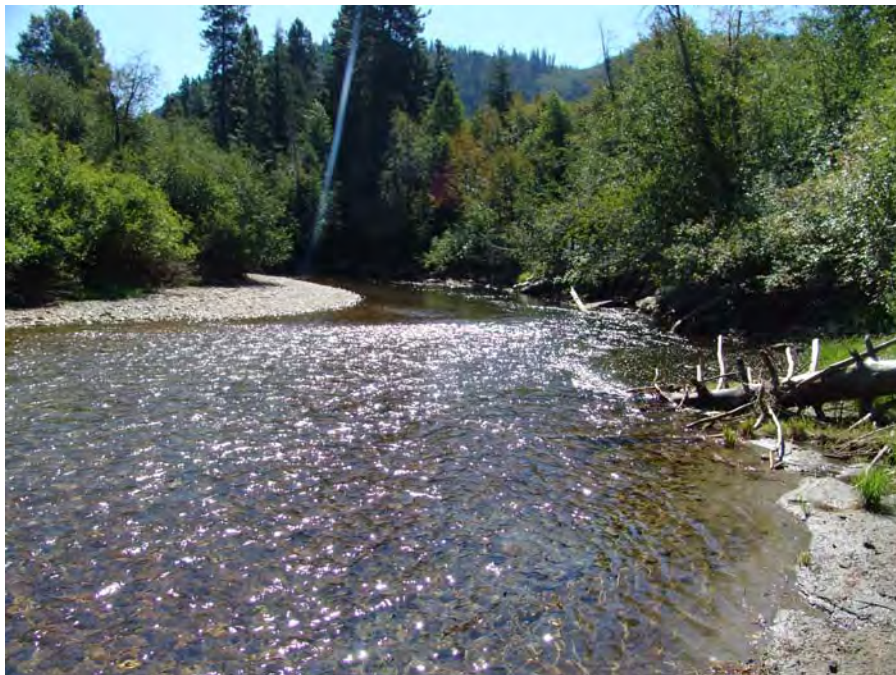
Photograph No. 7. View is to the southeast looking downstream showing a channel unit sequence of riffle-pool and varying vegetation along both banks. Kahler Reach; Subreach IZ-1, Nason Creek - Wenatchee Subbasin, Washington. Bureau of Reclamation Photograph by D. Bennett 8/9/07.

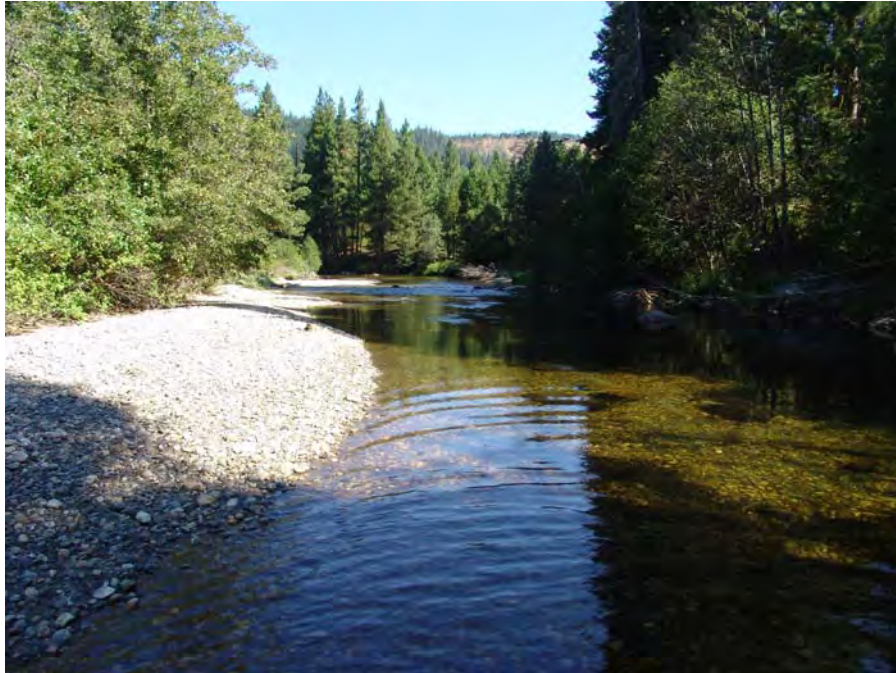
Photograph No. 8. View is to the north looking downstream showing a channel unit sequence of run-riffle-run and a gravel point bar along the left bank. Kahler Reach; Subreach IZ-1, Nason Creek - Wenatchee Subbasin, Washington. Bureau of Reclamation Photograph by D. Bennett 8/9/07.

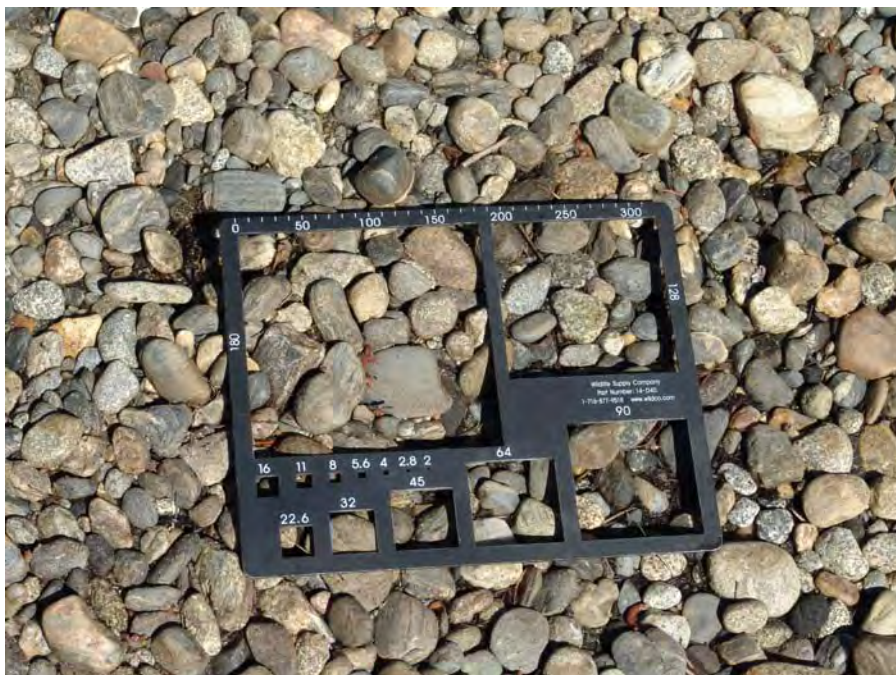
Photograph No. 9. View of gravel-sized material on a bar with gravelometer for scale. Kahler Reach; Subreach IZ-1, Nason Creek - Wenatchee Subbasin, Washington. Bureau of Reclamation Photograph by D. Bennett 8/9/07.

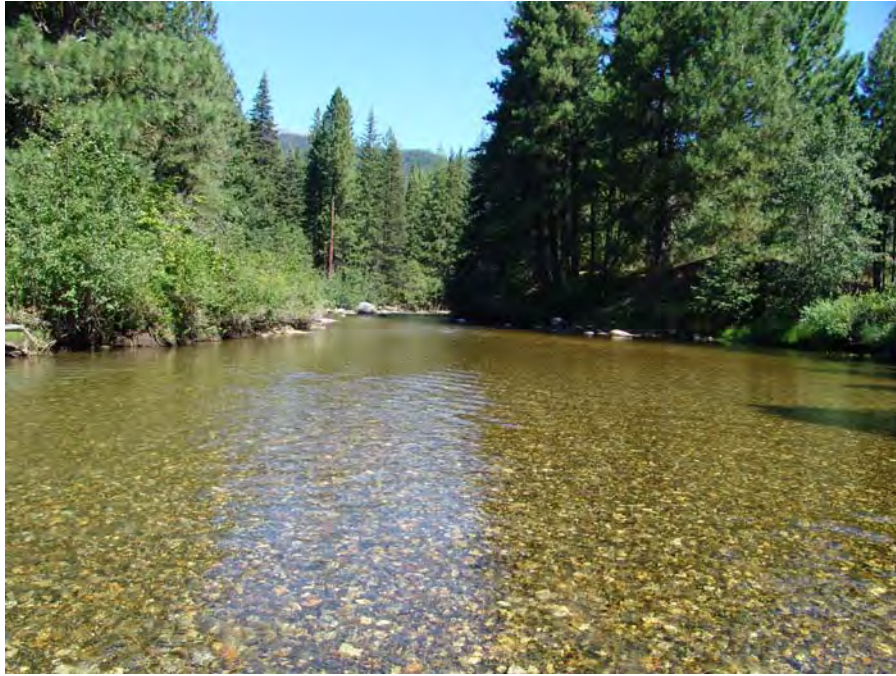
Photograph No.10. View is to the north looking downstream showing a channel unit of a long run, with varying vegetation along both banks. Kahler Reach; Subreach IZ-1, Nason Creek - Wenatchee Subbasin, Washington. Bureau of Reclamation Photograph by D. Bennett 8/9/07.

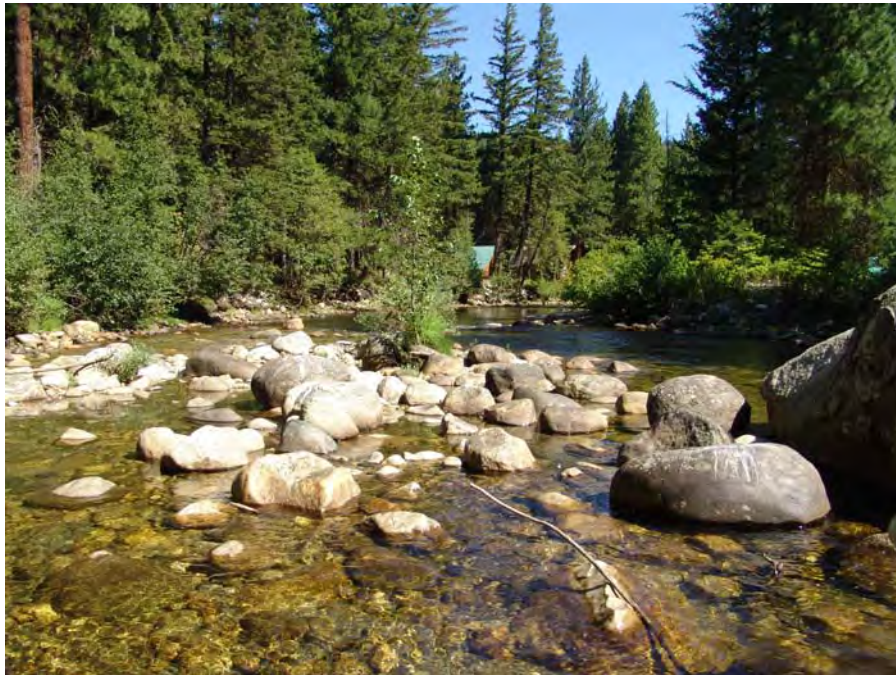
Photograph No. 11. View is to the north looking downstream showing boulder substrate and mixed vegetation along both banks. Kahler Reach; Subreach IZ-1, Nason Creek - Wenatchee Subbasin, Washington. Bureau of Reclamation Photograph by D. Bennett 8/9/07.
