Kahler Reach Assessment

Nason Creek

Chelan County, Washington

March 2009

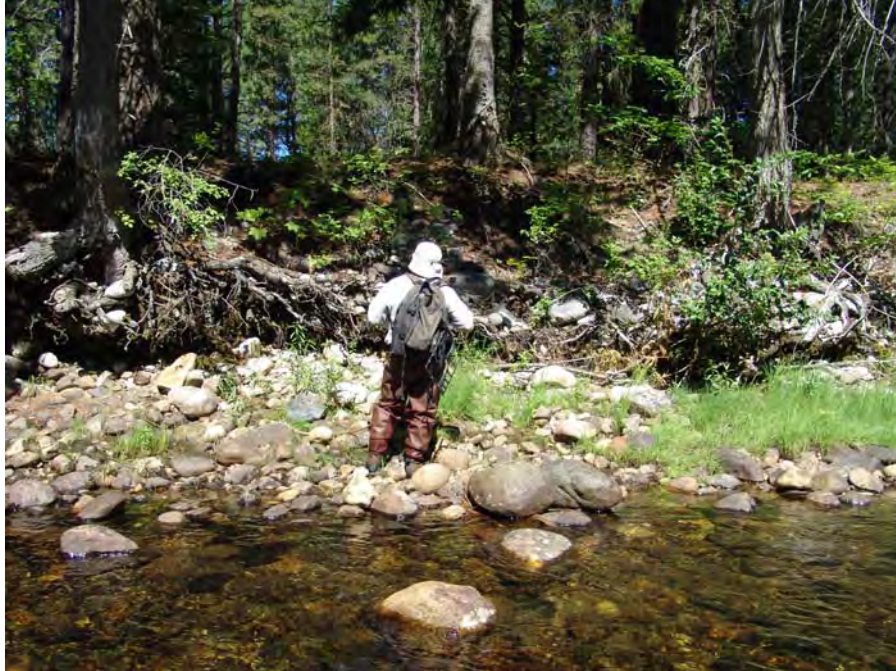
Photograph No. 12. View to the northwest showing cobble and boulder substrate and a 2 meter tall left bank. Kahler Reach; Subreach IZ-1, Nason Creek - Wenatchee Subbasin, Washington. Bureau of Reclamation Photograph by D. Bennett 8/9/07.

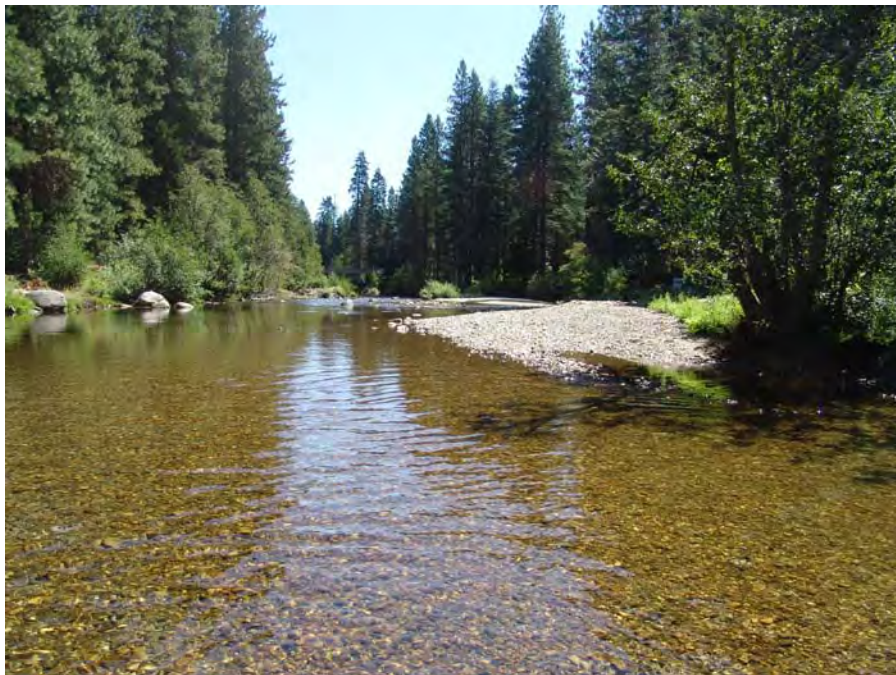
Photograph No. 13. View is to the east looking downstream showing a channel unit sequence of run to riffle and a gravel point bar along the right bank. Kahler Reach; Subreach IZ-1, Nason Creek - Wenatchee Subbasin, Washington. Bureau of Reclamation Photograph by D. Bennett 8/9/07.

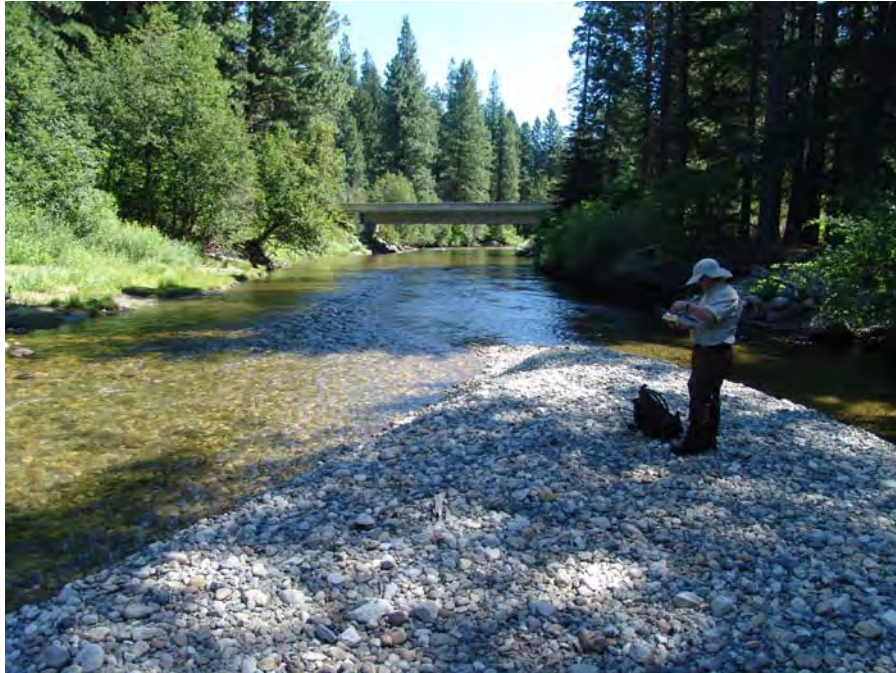
Photograph No.14. View is to the east looking downstream showing a gravel and cobble island a bridge and mixed vegetation along both banks. Kahler Reach; Subreach IZ-1, Nason Creek - Wenatchee Subbasin, Washington. Bureau of Reclamation Photograph by D. Bennett 8/9/07.

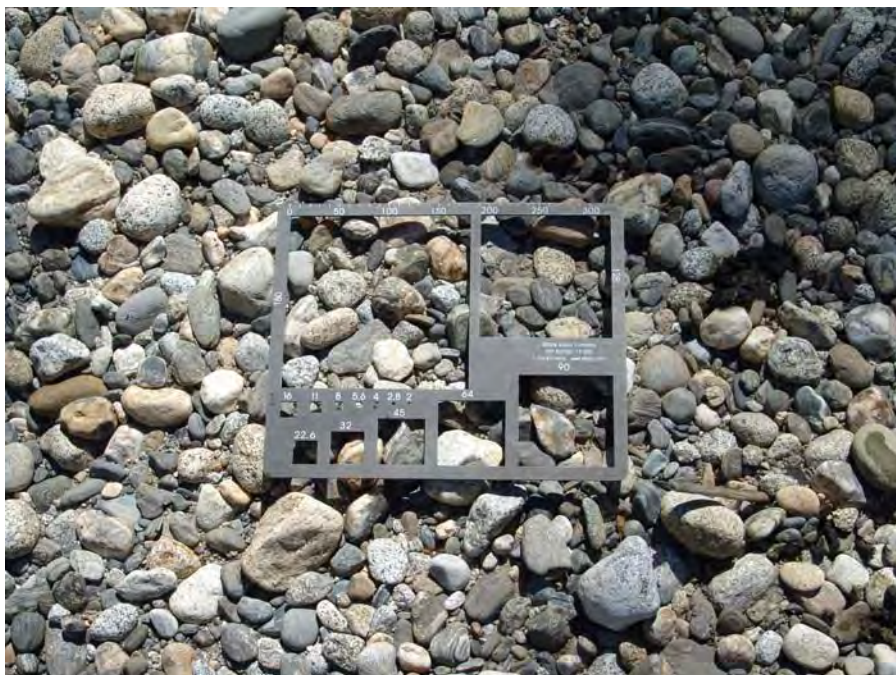
Photograph No. 15. View of gravel sized material on the bar with gravelometer for scale. Kahler Reach; Subreach IZ-1, Nason Creek - Wenatchee Subbasin, Washington. Bureau of Reclamation Photograph by D. Bennett 8/9/07.

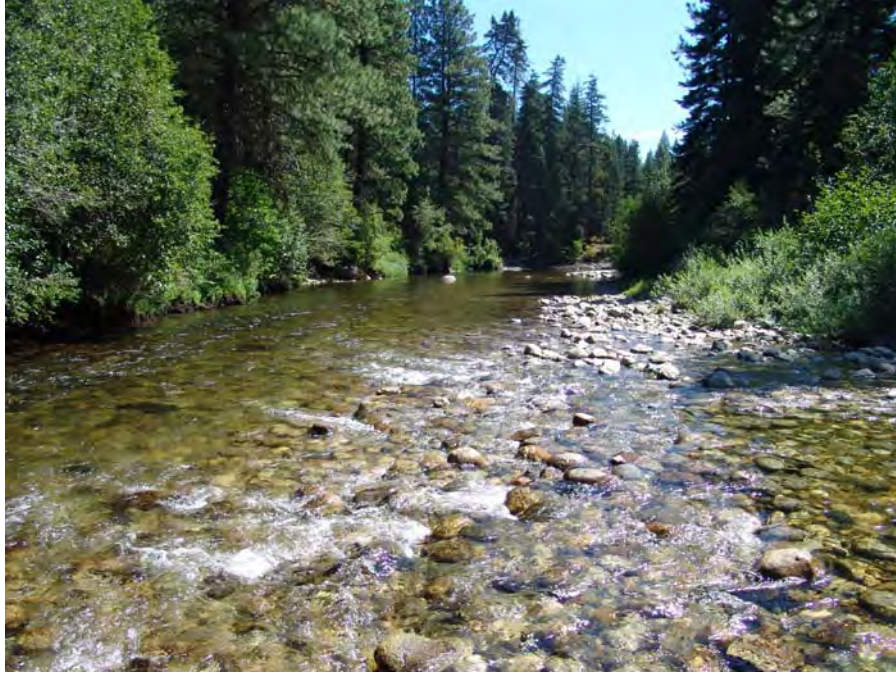
Photograph No. 16. View is to the east looking downstream showing a channel unit sequence of raping to run and mixed vegetation along both banks. Kahler Reach; Subreach IZ-1, Nason Creek - Wenatchee Subbasin, Washington. Bureau of Reclamation Photograph by D. Bennett 8/9/07.

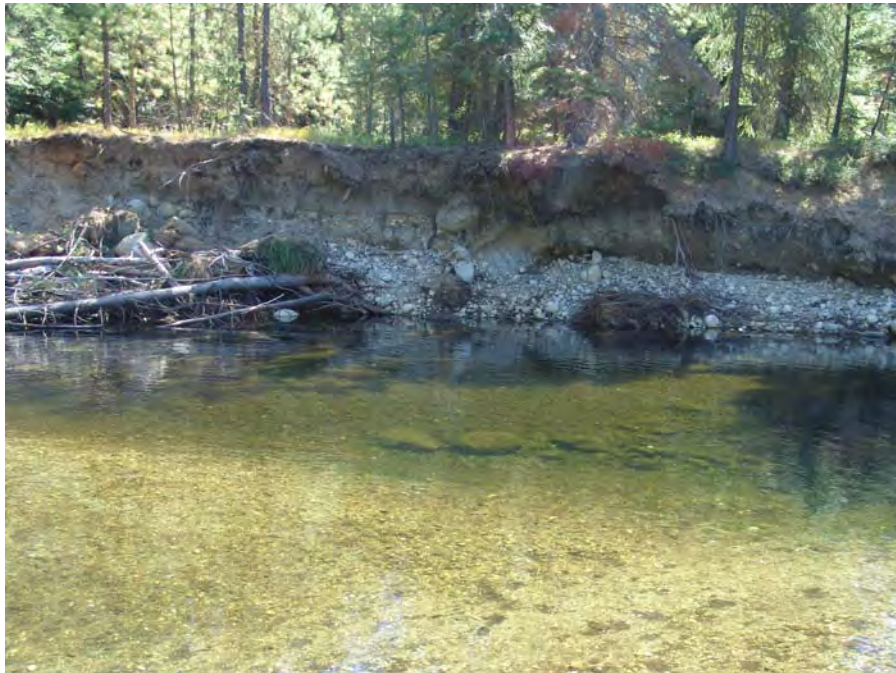
Photograph No. 17. View is to the east looking at a scour pool and local erosion along the left bank. Kahler Reach; Subreach IZ-1, Nason Creek - Wenatchee Subbasin, Washington. Bureau of Reclamation Photograph by D. Bennett 8/9/07.

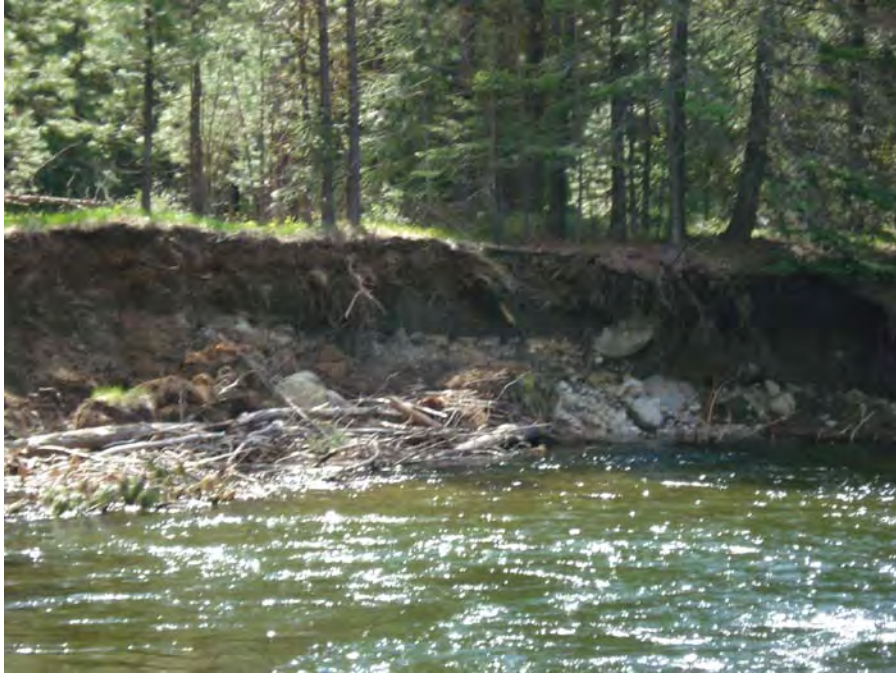
Photograph No.18. View looking to the southeast showing the eroding left bank comprised of cobbles and gravels overlain by silt and sands. Kahler Reach; Subreach IZ-1, Nason Creek - Wenatchee Subbasin, Washington. Bureau of Reclamation Photograph by R. McAfee, May 4, 2007.

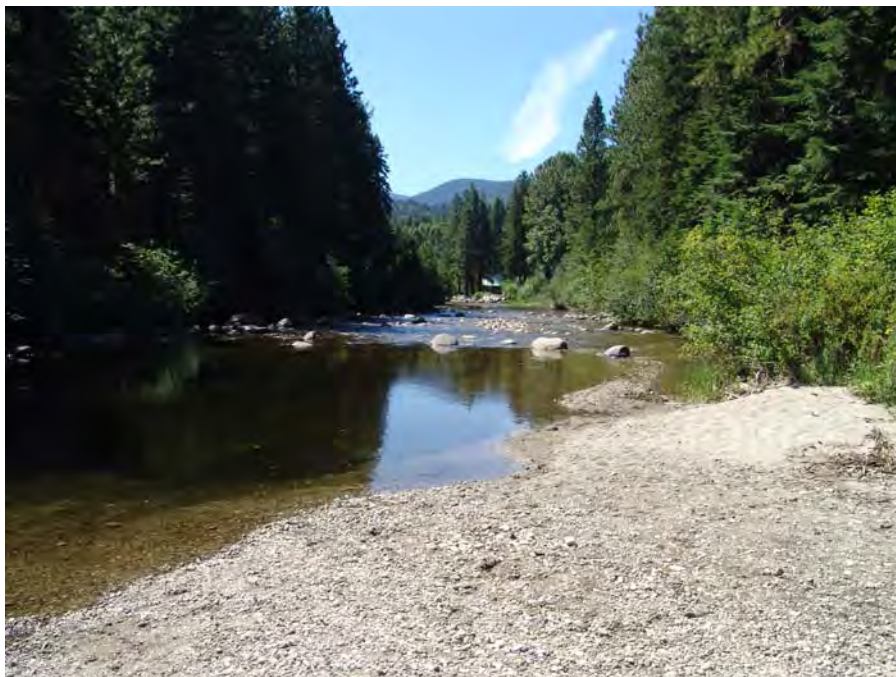
Photograph No. 19. View is to the south looking downstream showing a gravel point bar along the right bank, a channel unit sequence of run to riffle and mixed vegetation along both banks. Kahler Reach; Subreach IZ-1, Nason Creek - Wenatchee Subbasin, Washington. Bureau of Reclamation Photograph by D. Bennett 8/9/07.

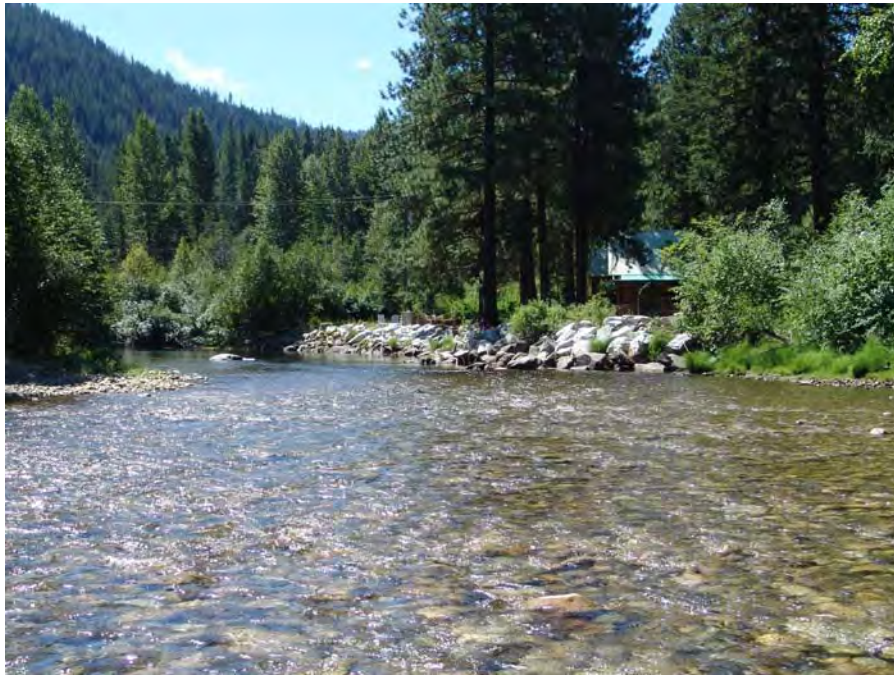
Photograph No. 20. View is to the south looking downstream showing a channel unit sequence of rifle to run and riprap protection along right bank. Kahler Reach; Subreach IZ-1, Nason Creek - Wenatchee Subbasin, Washington. Bureau of Reclamation Photograph by D. Bennett 8/9/07.

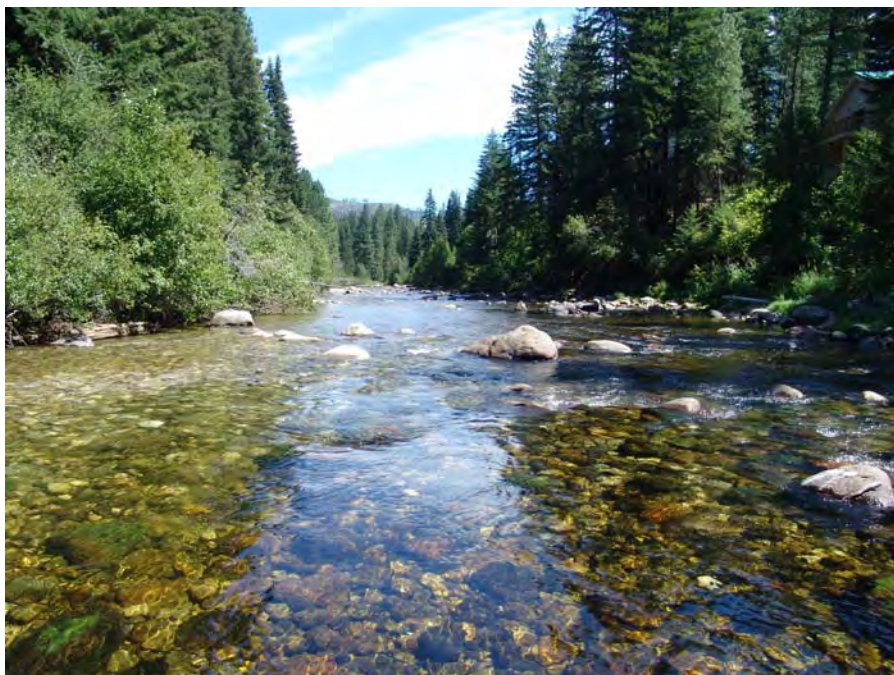
Photograph No. 21. View is to the northeast looking downstream showing cobble and boulder substrate and a tall terrace along the right bank. Kahler Reach; Subreach IZ-1, Nason Creek - Wenatchee Subbasin, Washington. Bureau of Reclamation Photograph by D. Bennett 8/9/07.

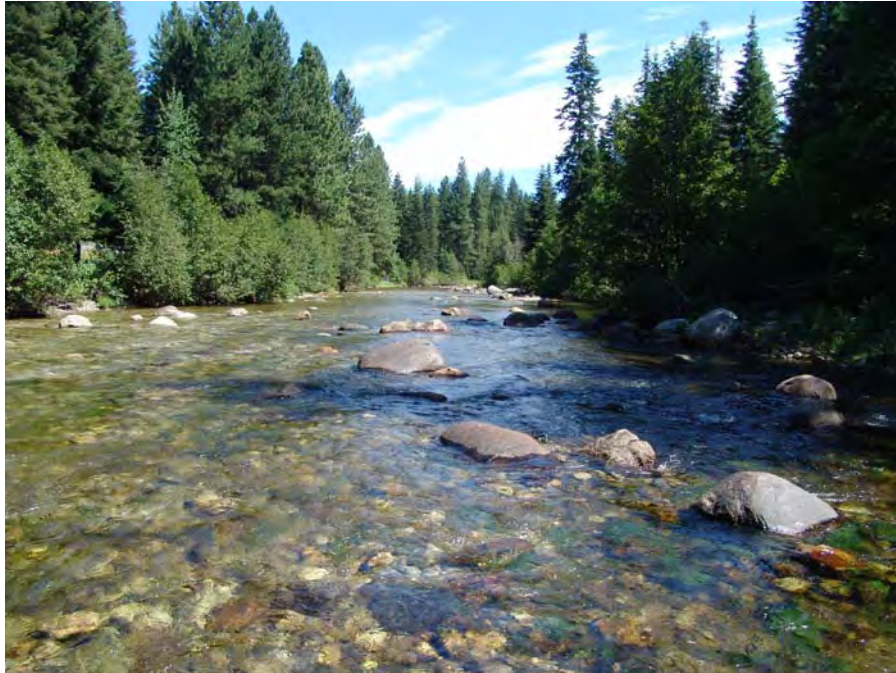
Photograph No. 22. View is to the northeast looking downstream showing cobble and boulder substrate with a channel unit of riffle. Kahler Reach; Subreach IZ-1, Nason Creek - Wenatchee Subbasin, Washington. Bureau of Reclamation Photograph by D. Bennett 8/9/07.

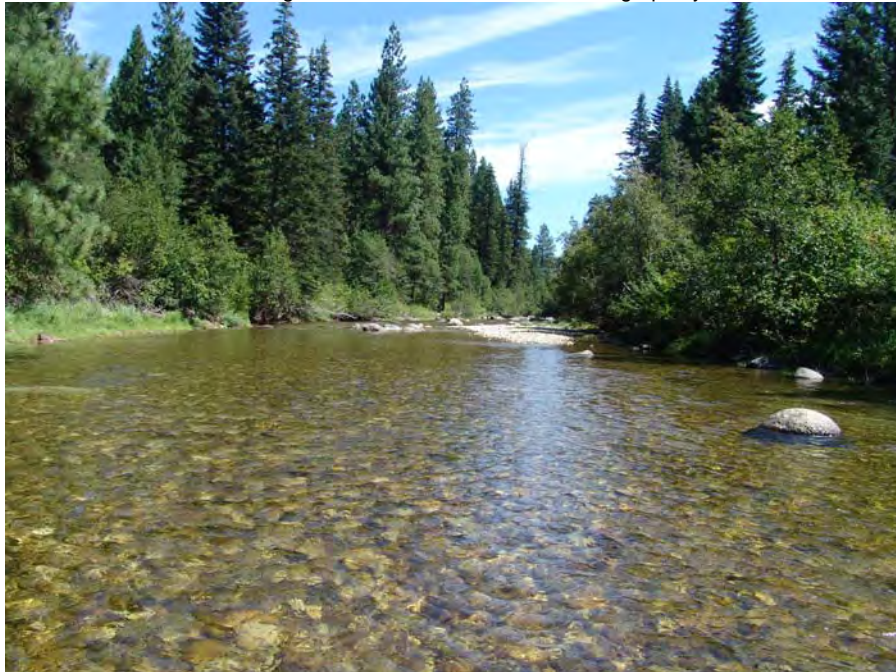
Photograph No. 23. View is to the northeast looking downstream showing a channel unit of riffle, a small cobble island and mixed vegetation along both banks. Kahler Reach; Subreach IZ-1, Nason Creek - Wenatchee Subbasin, Washington. Bureau of Reclamation Photograph by D. Bennett 8/9/07.

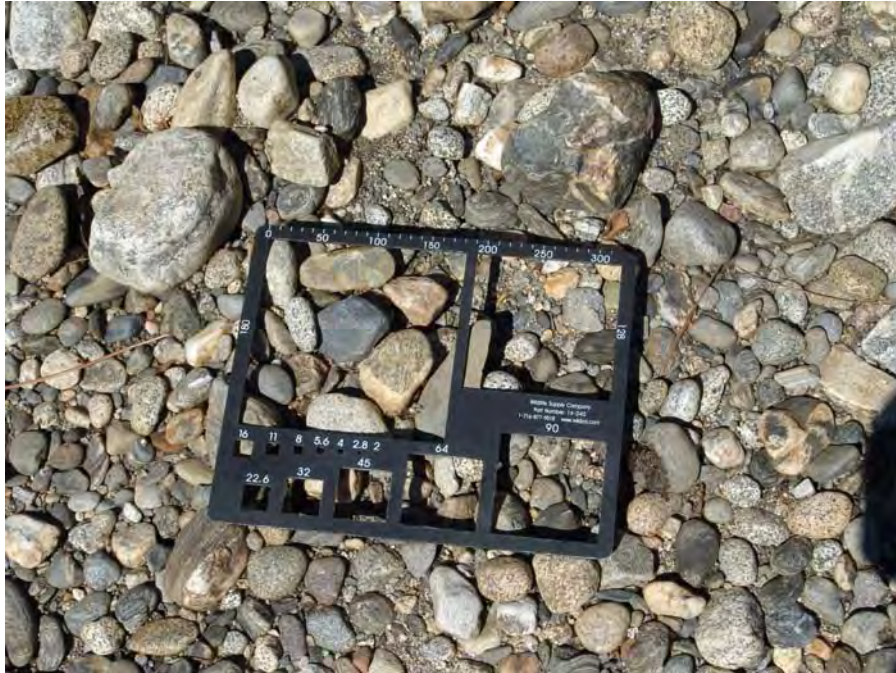
Photograph No.24. View of gravel and cobble sized material on a bar with gravelometer for scale. Kahler Reach; Subreach IZ-1, Nason Creek - Wenatchee Subbasin, Washington. Bureau of Reclamation Photograph by D. Bennett 8/9/07.

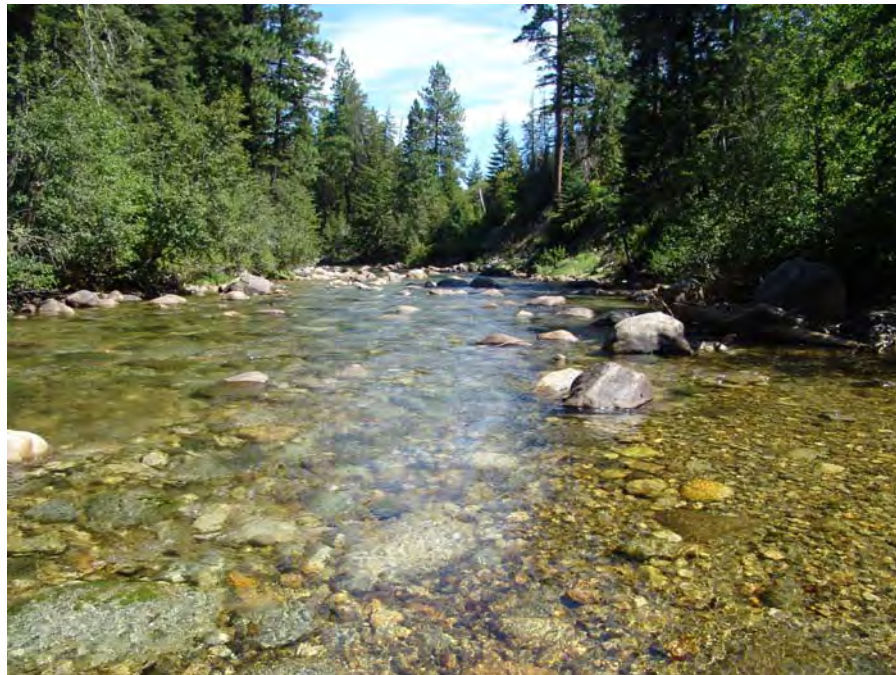
Photograph No. 1. View is to the northeast looking downstream showing gravel, cobble and boulder substrate and mixed vegetation along both banks. Kahler Reach; Subreach IZ-2, Nason Creek - Wenatchee Subbasin, Washington. Bureau of Reclamation Photograph by D. Bennett 8/9/07.

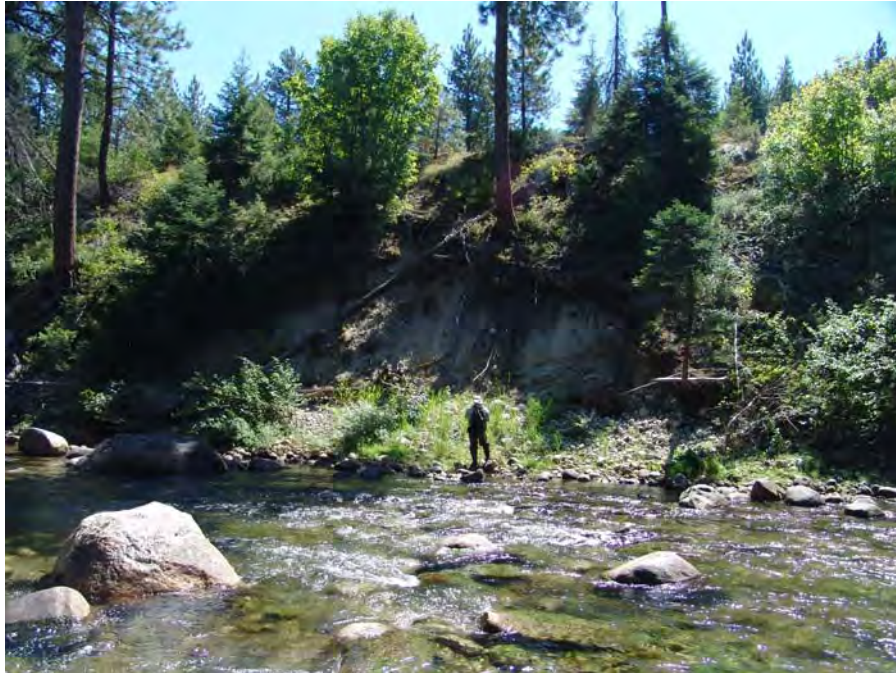
- Substrate is a mixture of gravel and cobbles with boulders (Photographs 1-25).
- Sediment input from local bank erosion was noted (Photographs 2, 6, 8, 13, 19, 22, 23 and 25).
- The power line crosses the active channel a total of four times throughout the reach (Photographs 10, 11 and 24)
- 1,250' Riprap exists within the reach (Photograph 16).

Photograph No. 2. View is to the east showing erosion along a tall terrace that forms the right bank. Kahler Reach; Subreach IZ-2, Nason Creek - Wenatchee Subbasin, Washington. Bureau of Reclamation Photograph by D. Bennett 8/9/07.

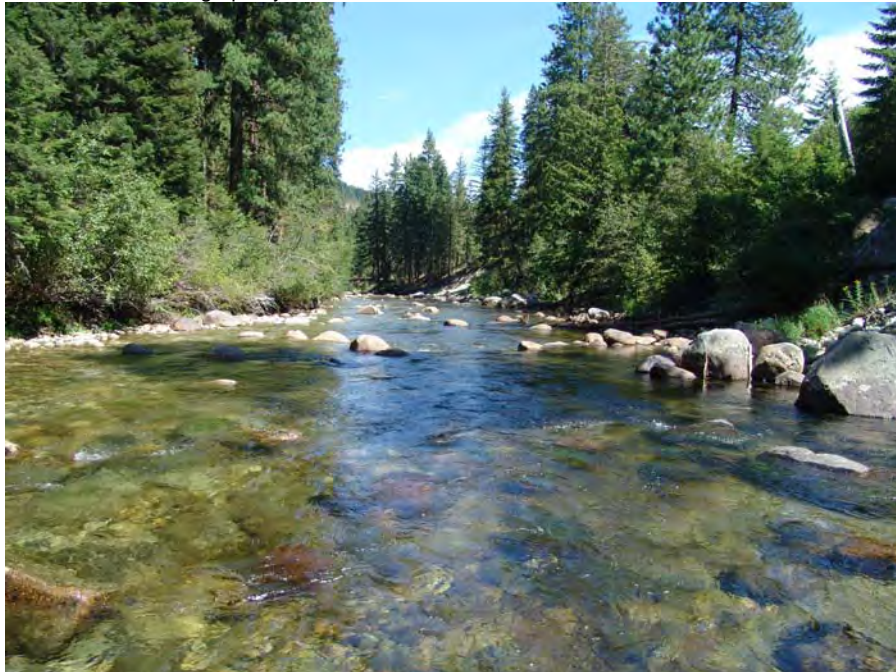
Photograph No. 3. View is to the northeast looking downstream showing cobble and boulder substrate and mixed vegetation along both banks. Kahler Reach; Subreach IZ-2, Nason Creek - Wenatchee Subbasin, Washington. Bureau of Reclamation Photograph by D. Bennett 8/9/07.

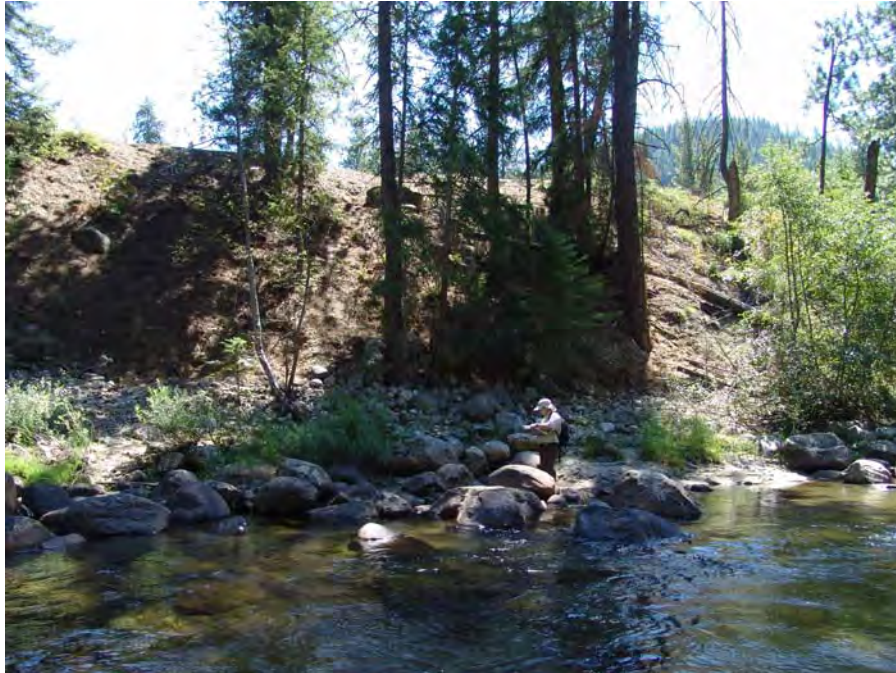
Photograph No. 4. View is to the east showing boulder substrate and a tall terrace along the right bank. Kahler Reach; Subreach IZ-2, Nason Creek - Wenatchee Subbasin, Washington. Bureau of Reclamation Photograph by D. Bennett 8/9/07.

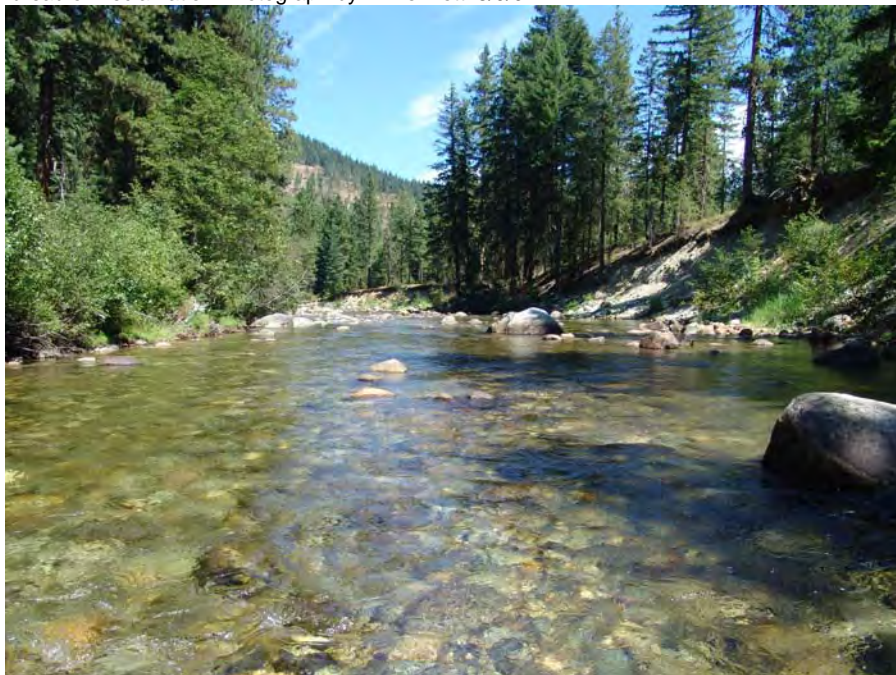
Photograph No. 5. View is to the northeast looking downstream showing cobble and boulder substrate and mixed vegetation along both banks. Kahler Reach; Subreach IZ-2, Nason Creek - Wenatchee Subbasin, Washington. Bureau of Reclamation Photograph by D. Bennett 8/9/07.

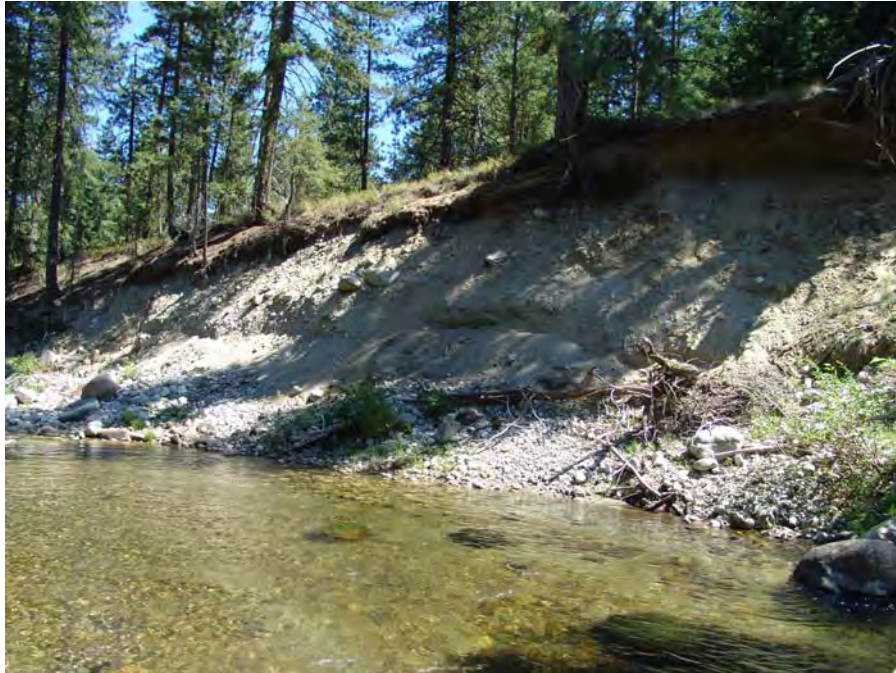
Photograph No. 6. View is to the northeast looking downstream showing erosion of the tall terrace along the right bank. Composition is a mixture of sand and gravel with cobbles. Kahler Reach; Subreach IZ-2, Nason Creek - Wenatchee Subbasin, Washington. Bureau of Reclamation Photograph by D. Bennett 8/9/07.

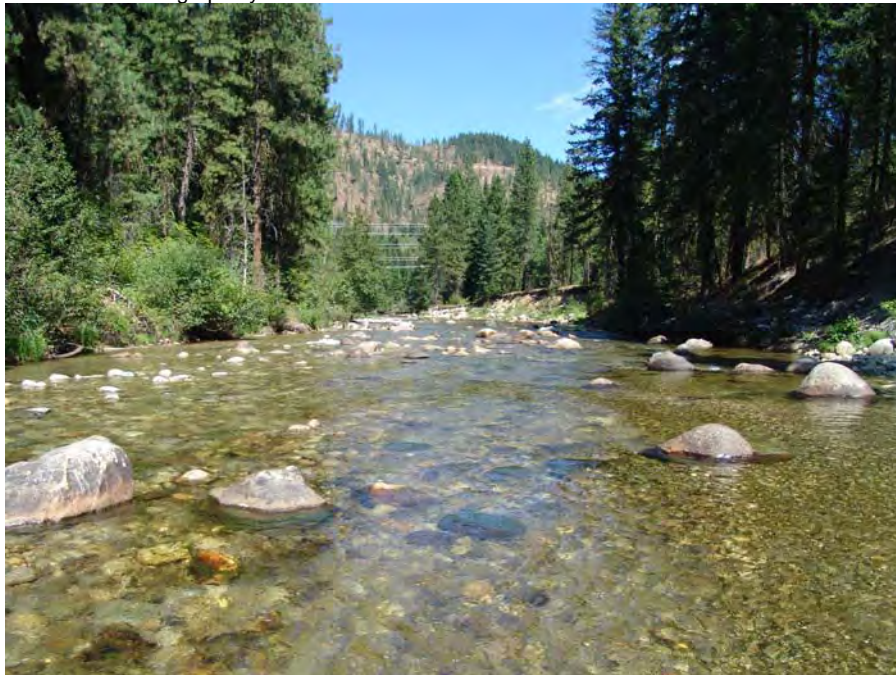
Photograph No. 7. View is to the north looking downstream showing gravel to boulder sized substrate with mixed vegetation along both banks. Kahler Reach; Subreach IZ-2, Nason Creek - Wenatchee Subbasin, Washington. Bureau of Reclamation Photograph by D. Bennett 8/9/07.

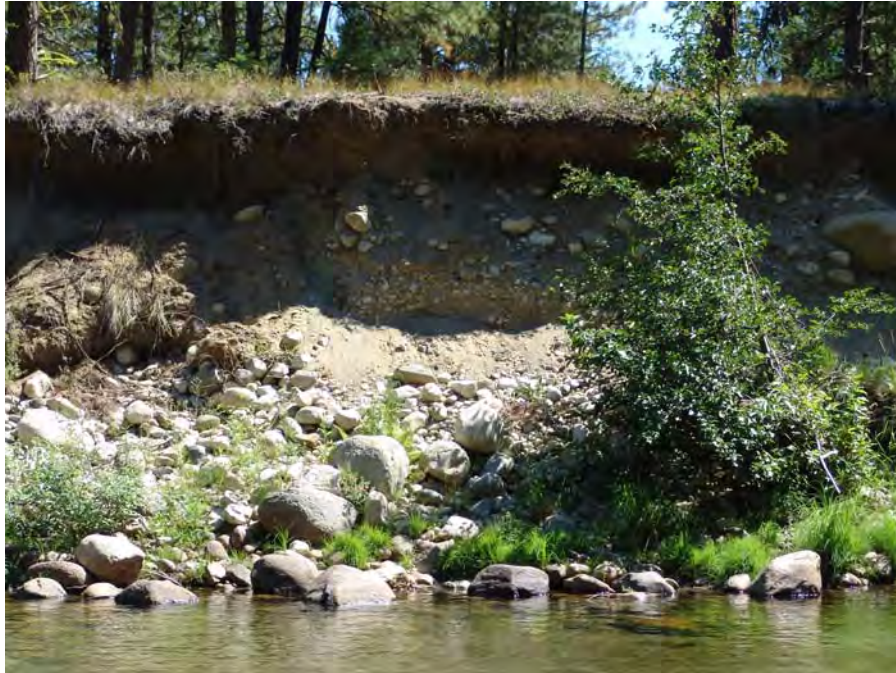
Photograph No. 8. View is to the east showing local erosion of the terrace along the right bank. Composition is a mixture of sand with gravels cobbles and boulders. Kahler Reach; Subreach IZ-2, Nason Creek - Wenatchee Subbasin, Washington. Bureau of Reclamation Photograph by D. Bennett 8/9/07.

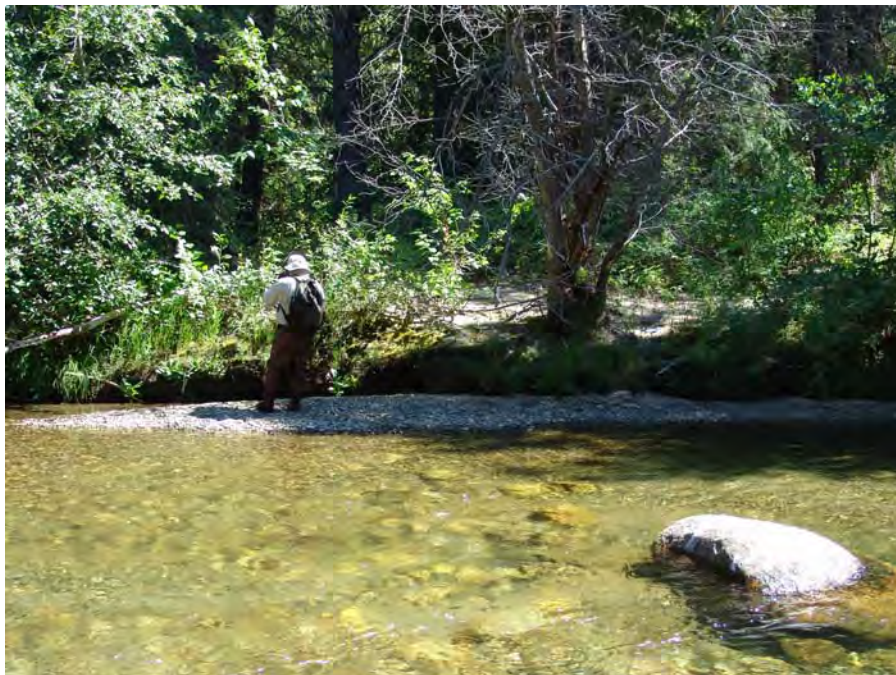
Photograph No. 9. View is to the east showing predominantly gravel substrate with mixed vegetation along the right bank. Kahler Reach; Subreach IZ-2, Nason Creek - Wenatchee Subbasin, Washington. Bureau of Reclamation Photograph by D. Bennett 8/9/07.

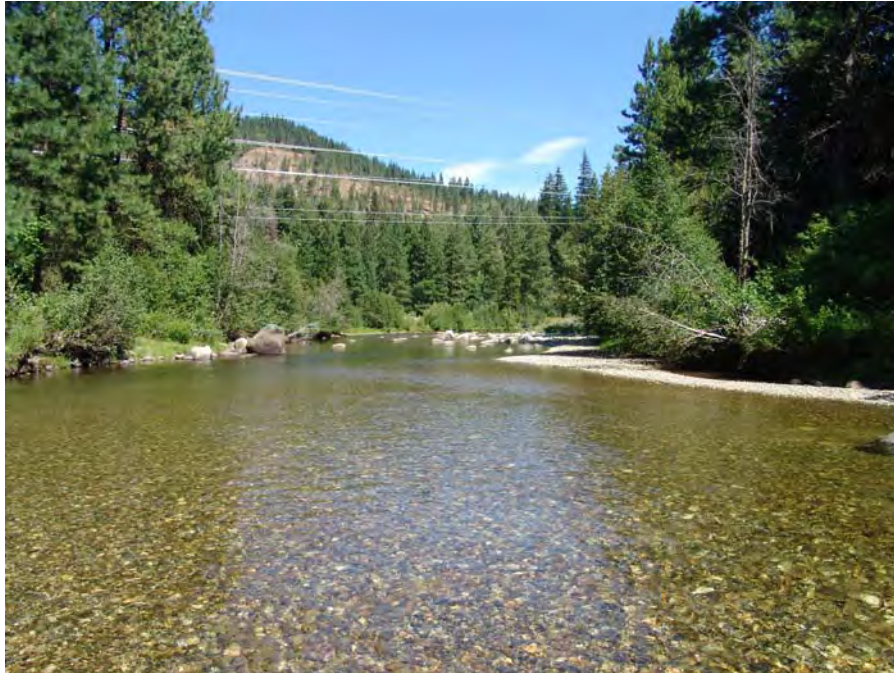
Photograph No. 10. View is to the northeast looking downstream showing a channel unit of a long run, with a small gravel point bar along the right bank. Note the powerline crossing the active channel. Kahler Reach; Subreach IZ-2, Nason Creek - Wenatchee Subbasin, Washington. Bureau of Reclamation Photograph by D. Bennett 8/9/07.

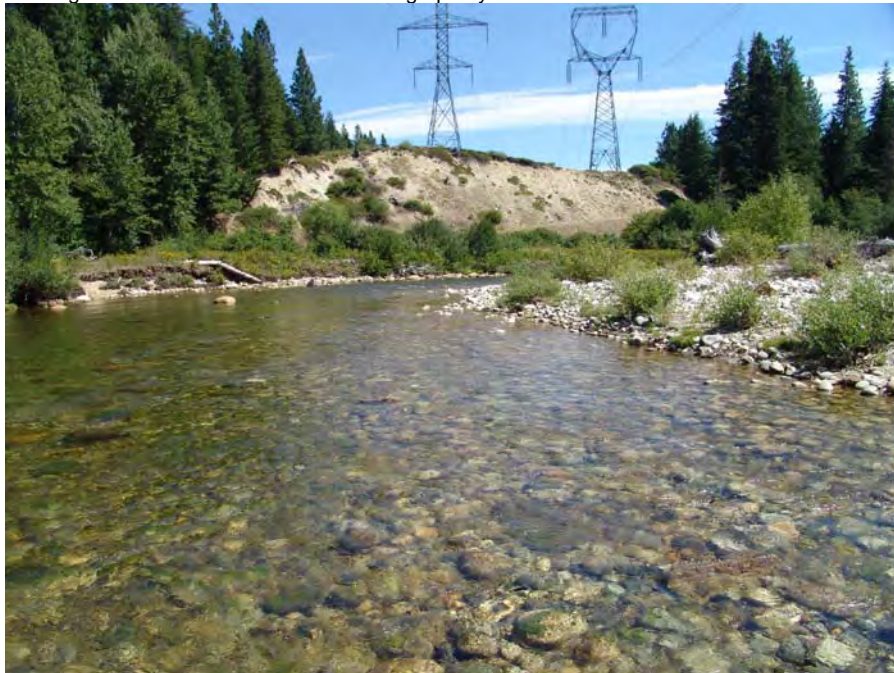
Photograph No. 11. View is to the east looking downstream showing cobble sized substrate and a gravel and cobble point bar along the right bank. Note the powerlines above the active channel. Kahler Reach; Subreach IZ-2, Nason Creek - Wenatchee Subbasin, Washington. Bureau of Reclamation Photograph by D. Bennett 8/9/07.

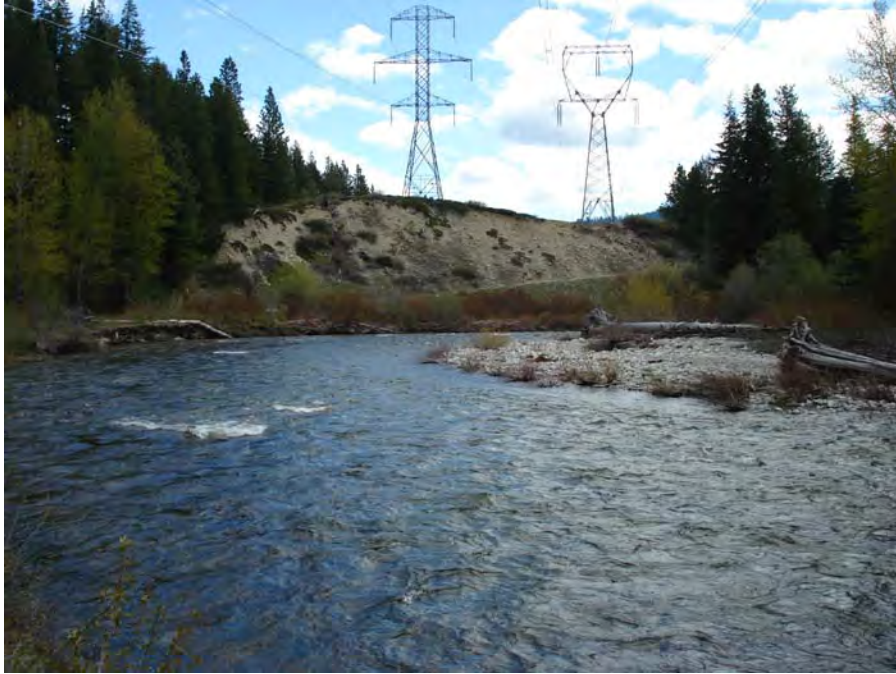
Photograph No.12. View is to the east looking downstream showing cobble sized substrate and a gravel and cobble point bar along the right bank. Kahler Reach; Subreach IZ-2, Nason Creek - Wenatchee Subbasin, Washington. Bureau of Reclamation Photograph by R. McAfee, May 4, 2007.

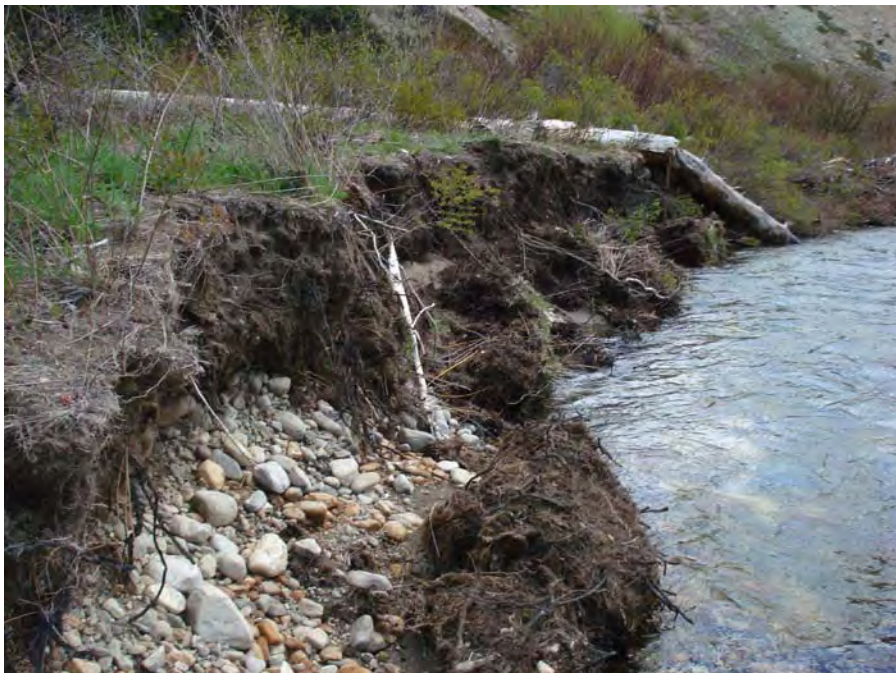
Photograph No. 13. View to the southeast showing local erosion along the left bank. Composition is a mixture of sand with gravel and cobble. Kahler Reach; Subreach IZ-2, Nason Creek - Wenatchee Subbasin, Washington. Bureau of Reclamation Photograph by R. McAfee, May 4, 2007.

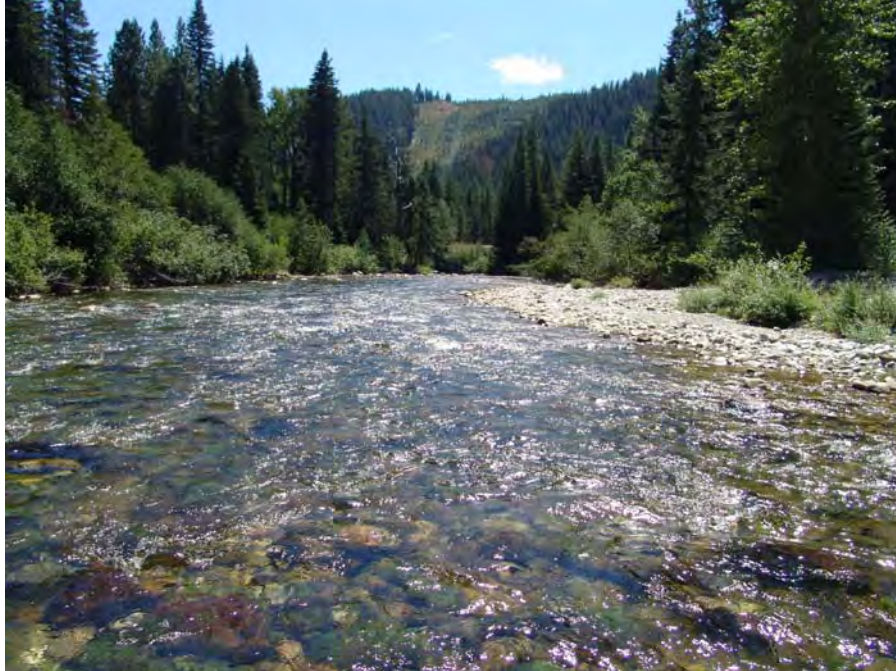
Photograph No. 14. View is to the south looking downstream showing a channel unit of riffle, a small gravel and cobble point bar along the right bank, and mixed vegetation along both banks. Kahler Reach; Subreach IZ-2, Nason Creek - Wenatchee Subbasin, Washington. Bureau of Reclamation Photograph by D. Bennett 8/9/07.

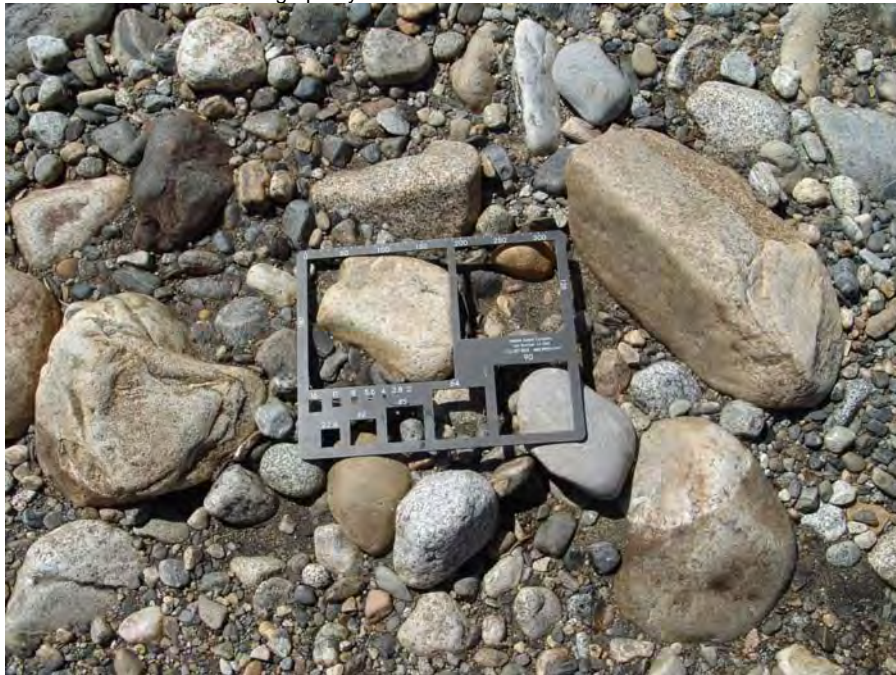
Photograph No. 15. View of gravel to boulder sized material located on a bar with gravelometer for scale. Kahler Reach; Subreach IZ-2, Nason Creek - Wenatchee Subbasin, Washington. Bureau of Reclamation Photograph by D. Bennett 8/9/07.

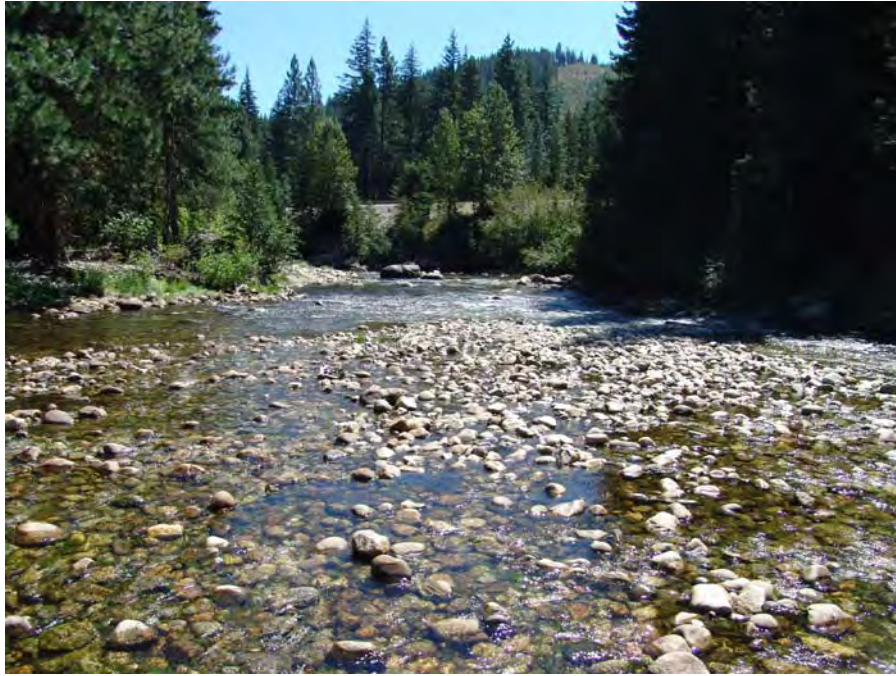
Photograph No. 16. View is to the south looking downstream showing a channel unit of rapid. Note the highway that is protected by riprap in the back ground. Kahler Reach; Subreach IZ-2, Nason Creek - Wenatchee Subbasin, Washington. Bureau of Reclamation Photograph by D. Bennett 8/9/07.

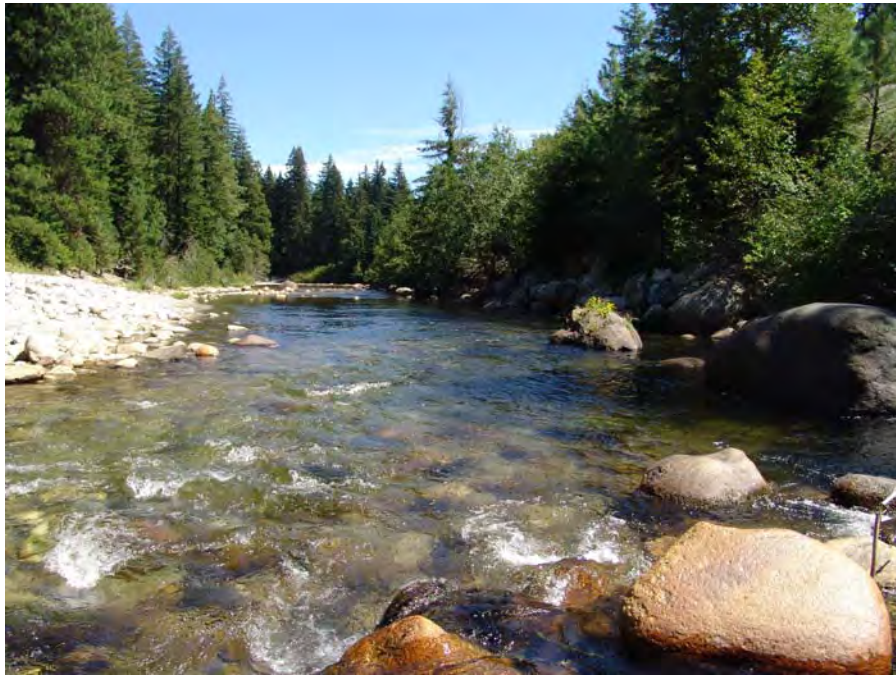
Photograph No. 17. View is to the east looking downstream showing boulder substrate and cobble point bar along the left bank. Kahler Reach; Subreach IZ-2, Nason Creek - Wenatchee Subbasin, Washington. Bureau of Reclamation Photograph by D. Bennett 8/9/07.

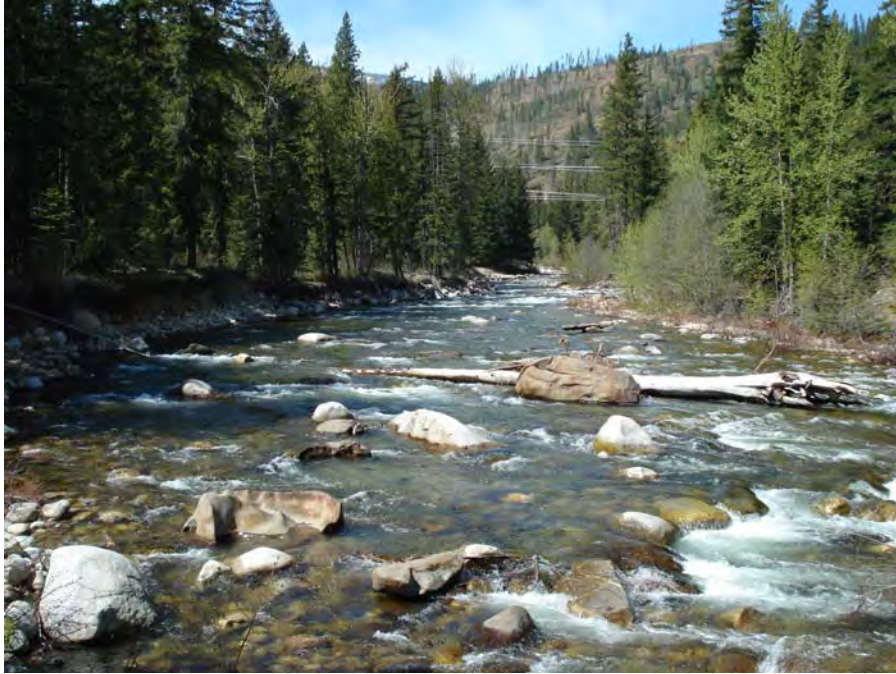
Photograph No. 18. View is to the northwest (upstream) showing a channel unit of rapid with cobble and boulder substrate. Kahler Reach; Subreach IZ-2, Nason Creek - Wenatchee Subbasin, Washington. Bureau of Reclamation Photograph by R. McAfee, May 5, 2007.

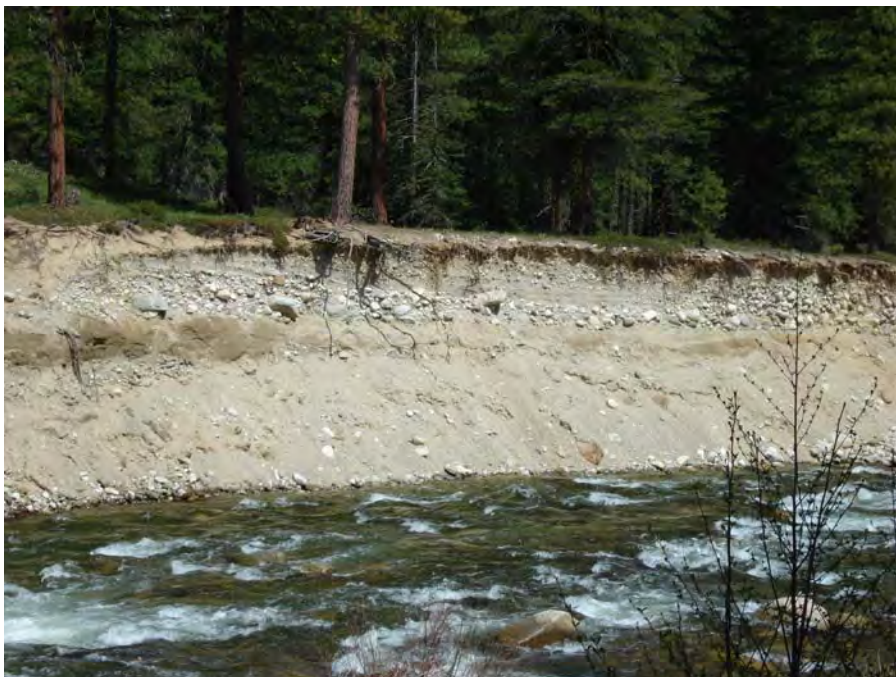
Photograph No. 19. View to northeast showing a glacially deposited bluff as the left bank. Kahler Reach; Subreach IZ-2, Nason Creek - Wenatchee Subbasin, Washington. Bureau of Reclamation Photograph by R. McAfee, May 5, 2007.

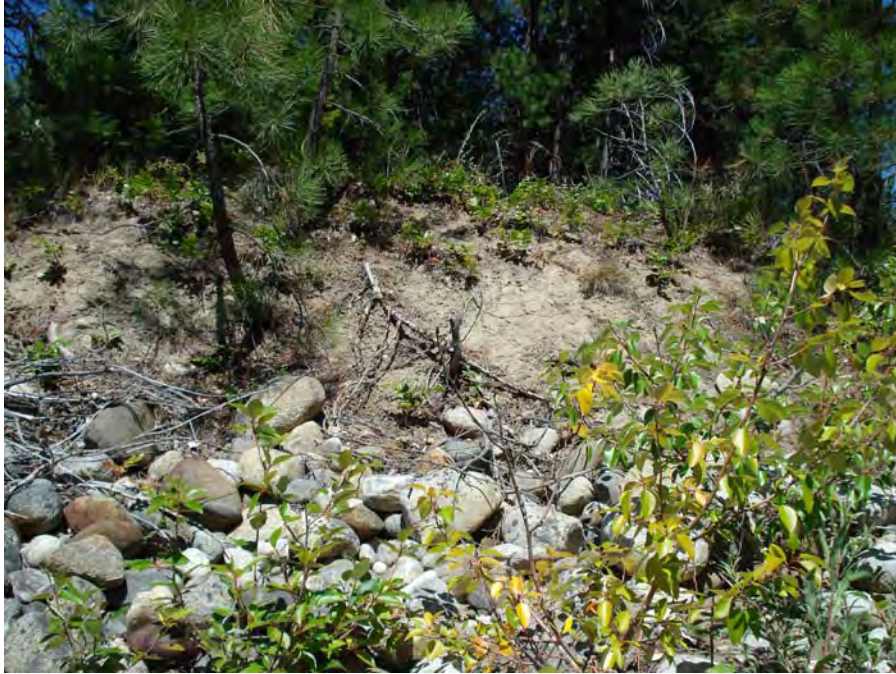
Photograph No. 20. View to the north showing the middle surface in a succession of terraces along the left bank of the river. Kahler Reach; Subreach IZ-2, Nason Creek - Wenatchee Subbasin, Washington. Bureau of Reclamation Photograph by R. M^oAffee, August 10, 2007.
