Kahler Reach Assessment

Nason Creek

Chelan County, Washington

March 2009

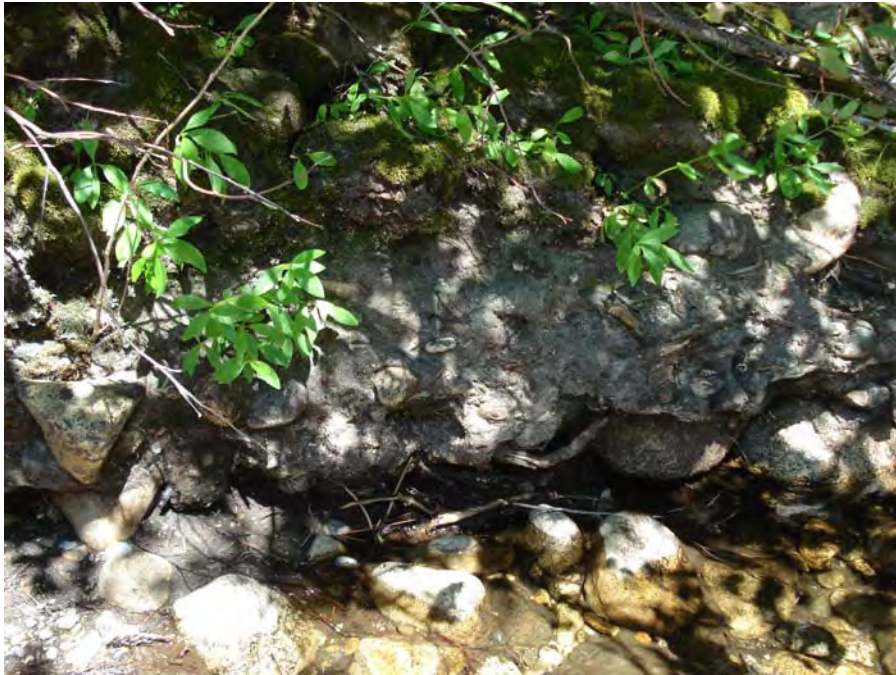
Photograph No. 21. View to the north showing minor undercutting of the lowest surface in a succession of terraces along the left bank of the river. Kahler Reach; Subreach IZ-2, Nason Creek - Wenatchee Subbasin, Washington. Bureau of Reclamation Photograph by R. M^oAffee, August 10, 2007.

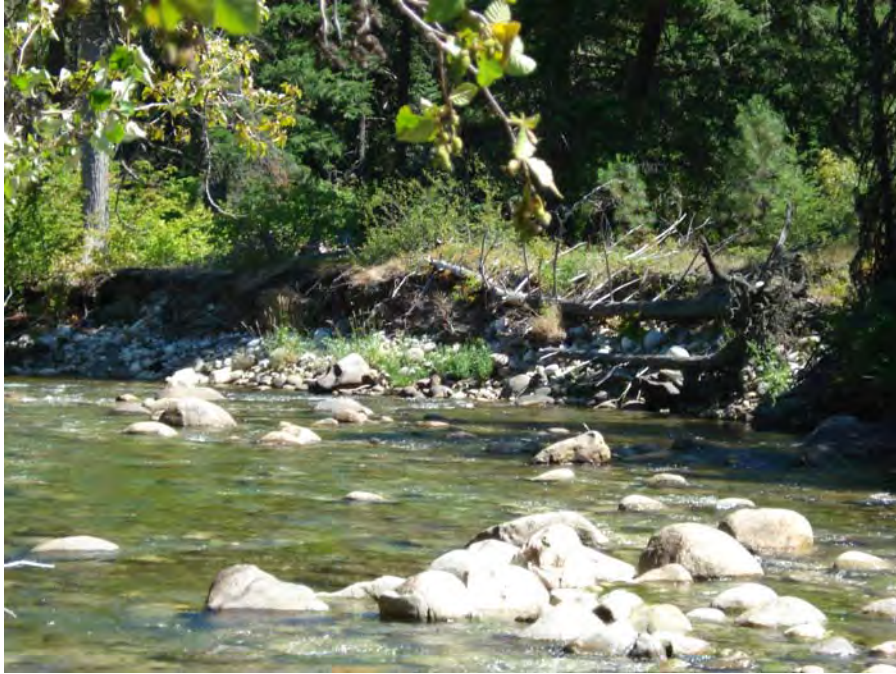
- Substrate is a mixture of gravel and cobbles with boulders (Photographs 1-25).
- Sediment input from local bank erosion was noted (Photographs 2, 6, 8, 13, 19, 22, 23 and 25).
- The power line crosses the active channel a total of four times throughout the reach (Photographs 10, 11 and 24)
- 1,250' Riprap exists within the reach (Photograph 16).

Photograph No. 22. A view to the east showing cobble and boulder substrate and local erosion along the right bank which is comprised of finer material over cobbles and boulders. Kahler Reach; Subreach IZ-2, Nason Creek - Wenatchee Subbasin, Washington. Bureau of Reclamation Photograph by R. McAfee, August 10, 2007.

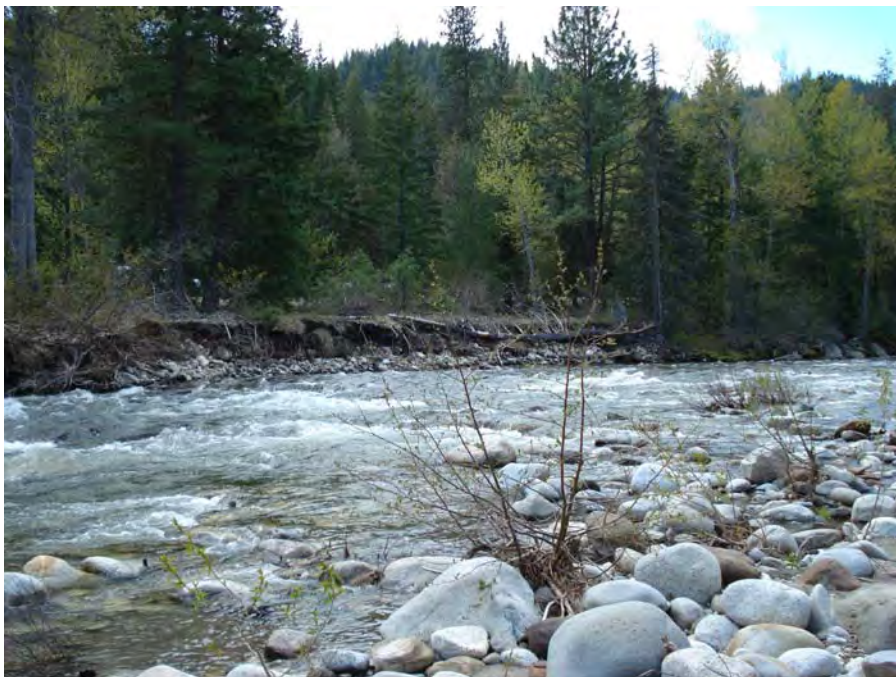
Photograph No. 23. View to the southwest from the top of the gravel bar on the left bank showing a channel unit of rapid with boulder substrate. Note the erosion of the right bank. Kahler Reach; Subreach IZ-2, Nason Creek - Wenatchee Subbasin, Washington. Bureau of Reclamation Photograph by R. McAfee, May 4, 2007.

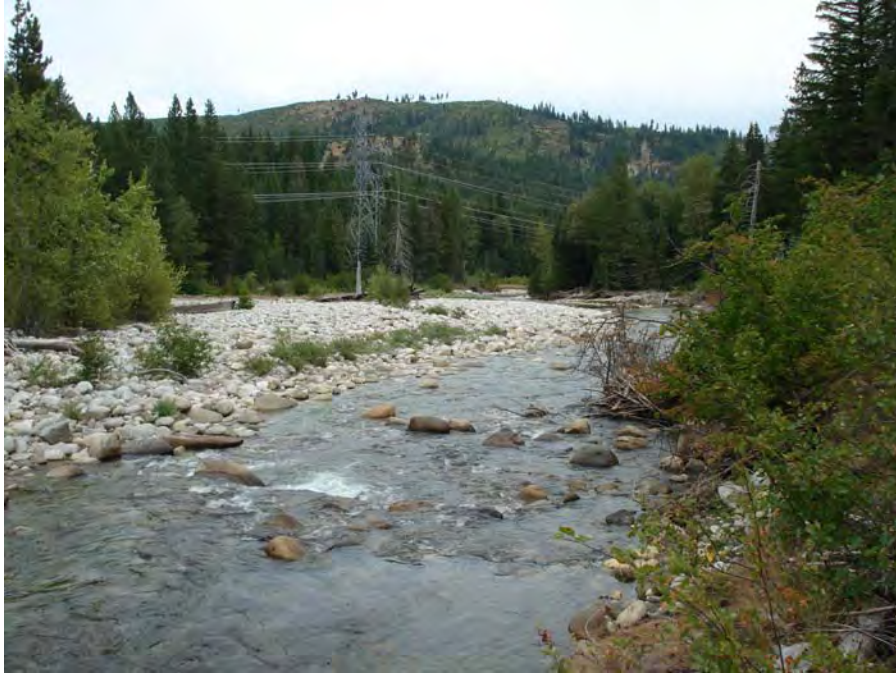
Photograph No. 24. View from the right bank looking downstream to the northeast showing a cobble point bar on the left bank of the river. Note the powerline crossing the active channel. Kahler Reach; Subreach IZ-2, Nason Creek - Wenatchee Subbasin, Washington. Bureau of Reclamation Photograph by R. M^cAfee, August 12, 2007.

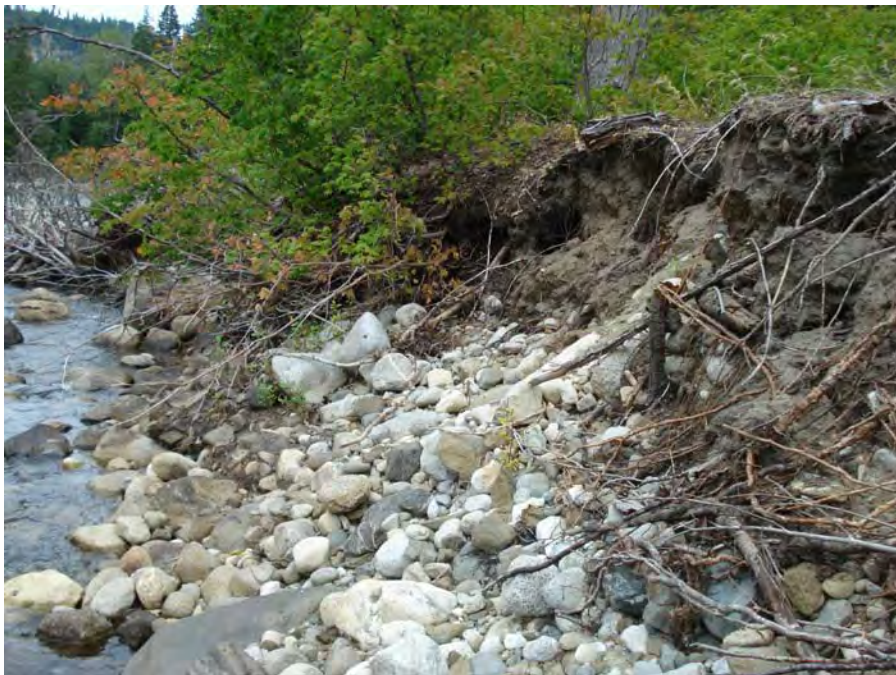
Photograph No. 25. A view showing the right bank which is comprised of sand gravel and cobbles, with finer material deposited on top. Kahler Reach; Subreach IZ-2, Nason Creek - Wenatchee Subbasin, Washington. Bureau of Reclamation Photograph by R. M^cAfee, August 12, 2007.

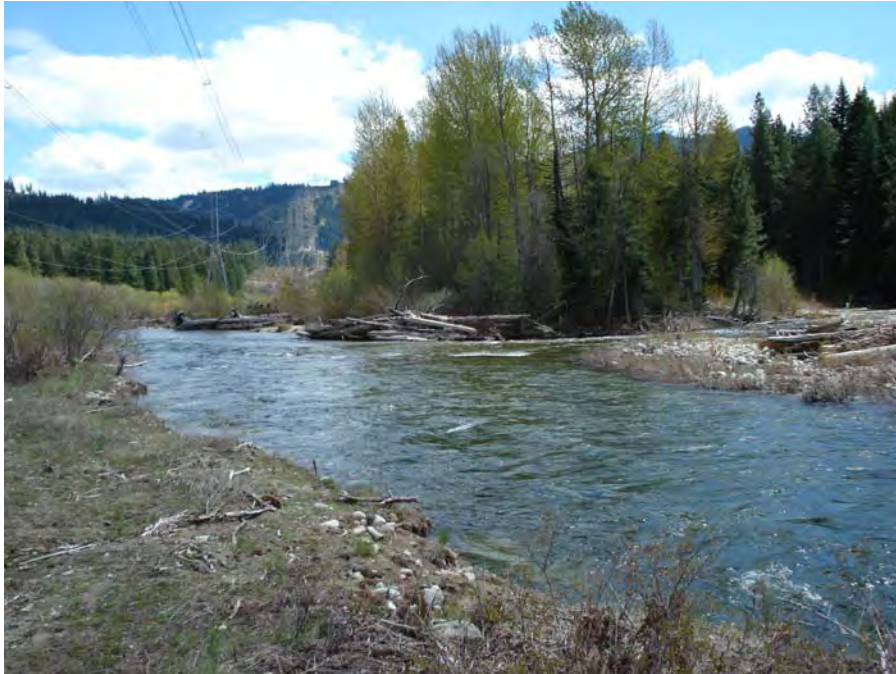
Photograph No. 2. View to the east showing the removal of riparian vegetation from along the left bank, multiple large wood complexes with split flow. Kahler Reach; Subreach IZ-3, Nason Creek - Wenatchee Subbasin, Washington. Bureau of Reclamation Photograph by R. McAfee, May 4, 2007.

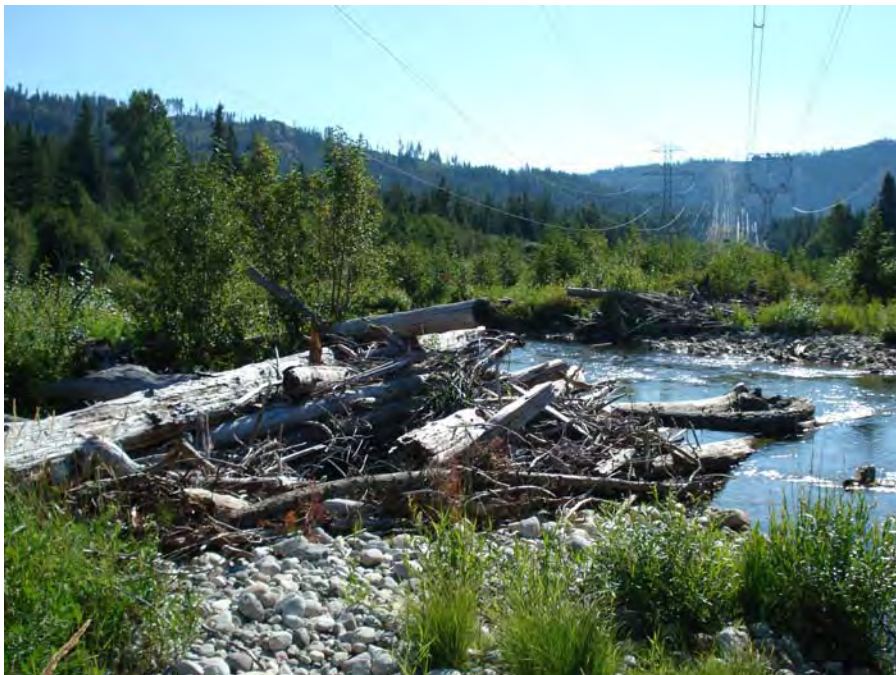
Photograph No. 3. View from the left bank to the east showing cobble substrate, and large wood complexes on both sides of the river. Kahler Reach; Subreach IZ-3, Nason Creek - Wenatchee Subbasin, Washington. Bureau of Reclamation Photograph by R. McAfee, August 11, 2007.

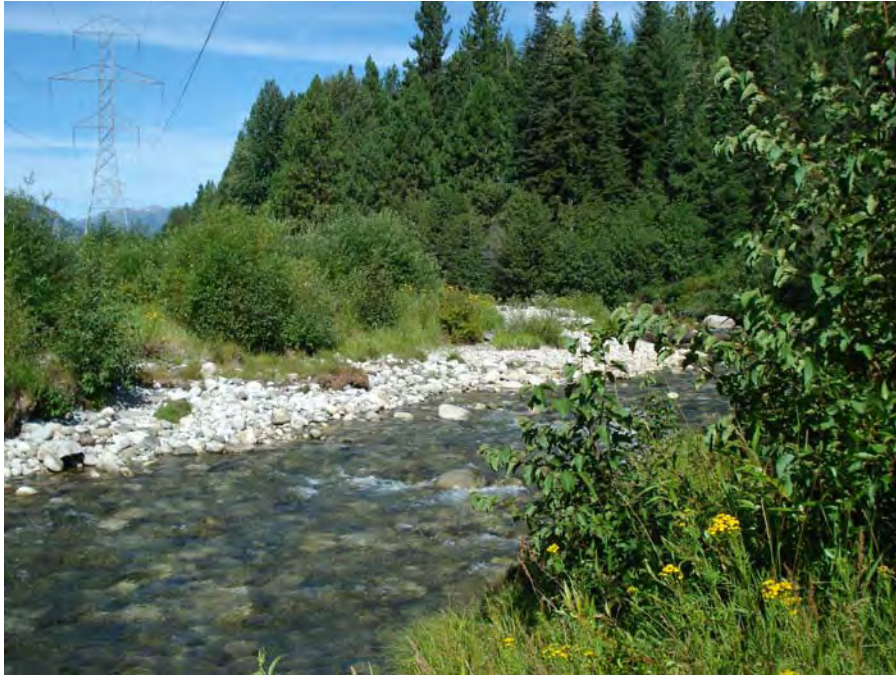
Photograph No. 4. View from the left bank looking upstream to the northwest, showing a vegetated cobble point bar along the right bank. Kahler Reach; Subreach IZ-3, Nason Creek - Wenatchee Subbasin, Washington. Bureau of Reclamation Photograph by R. M^eAffee, August 11, 2007.

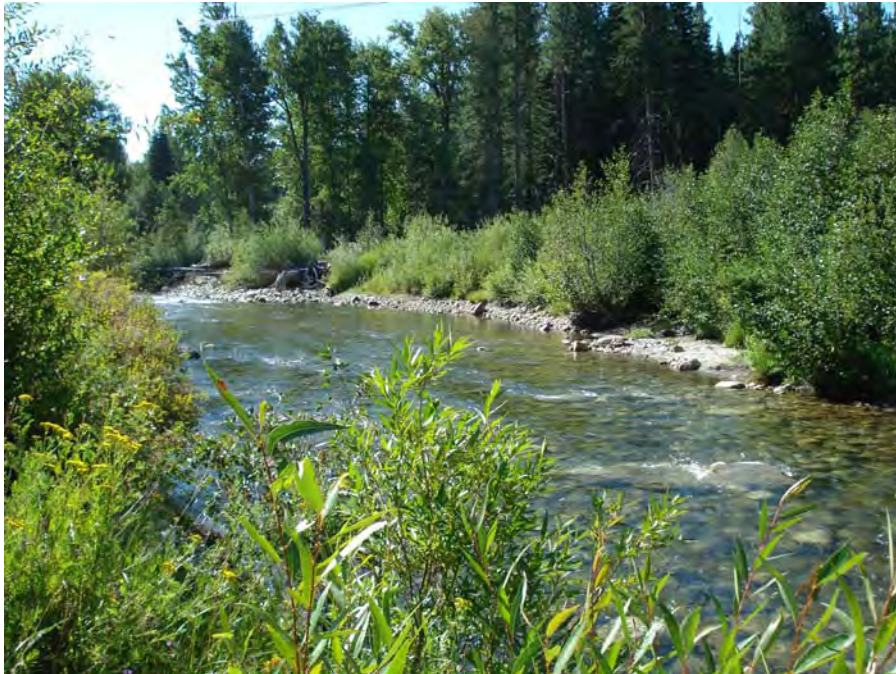
Photograph No. 5. View from the left bank looking to the southeast showing a channel unit of a run, cobble substrate, and brushy vegetation along both banks. Kahler Reach; Subreach IZ-3, Nason Creek - Wenatchee Subbasin, Washington. Bureau of Reclamation Photograph by R. M^eAffee, August 11, 2007.

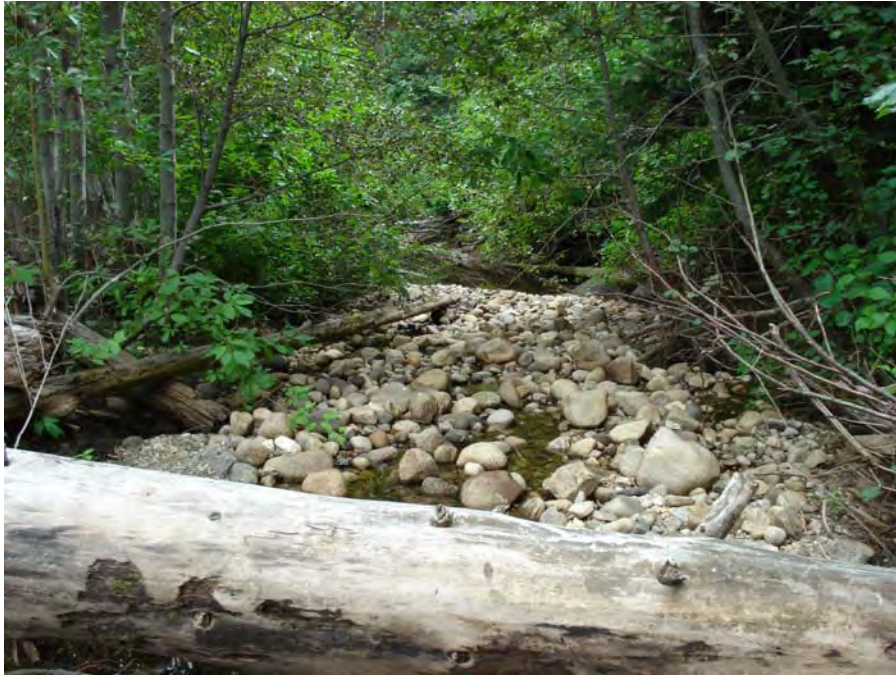
Photograph No. 6. View from the right bank looking to the south at the head of a functioning side channel off the right bank of the river. Kahler Reach; Subreach IZ-3, Nason Creek - Wenatchee Subbasin, Washington. Bureau of Reclamation Photograph by R. M^oAffee, August 12, 2007.

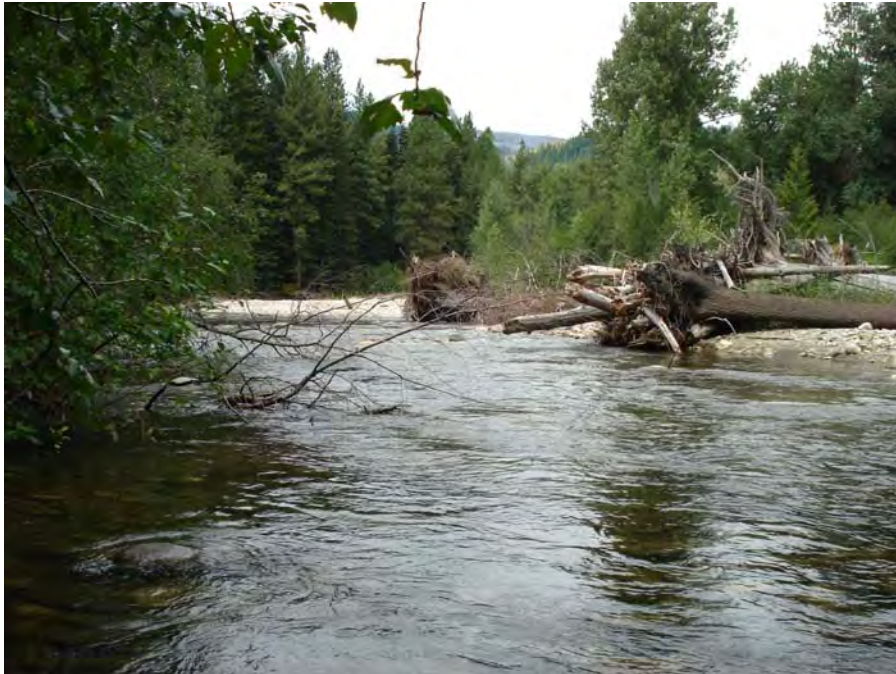
Photograph No. 7. View from the right bank looking upstream, to the northwest showing large wood accumulation along the left bank. Kahler Reach; Subreach IZ-3, Nason Creek - Wenatchee Subbasin, Washington. Bureau of Reclamation Photograph by R. M^oAffee, August 12, 2007.

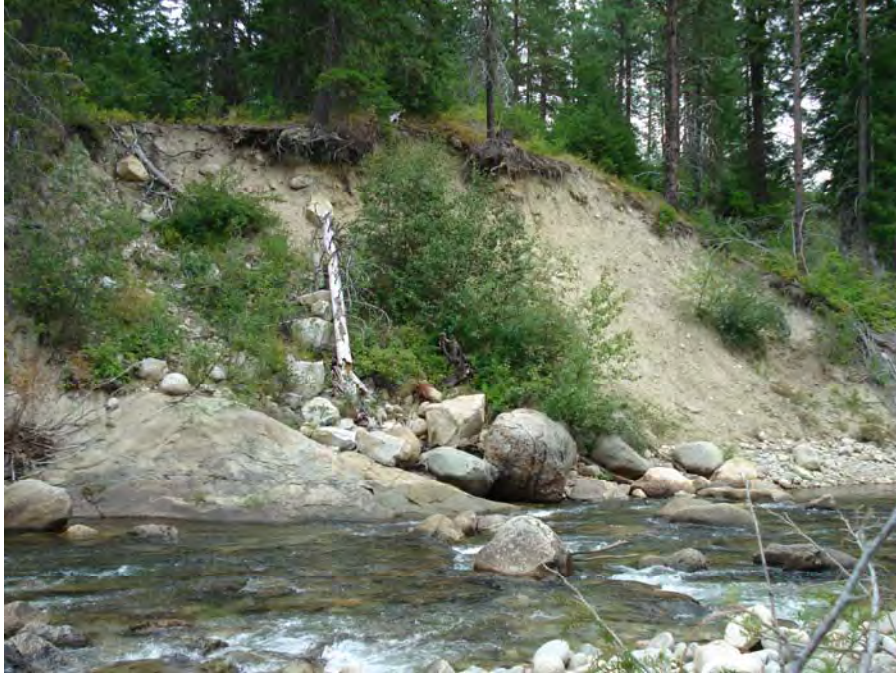
- Substrate is a mixture of cobbles and boulders (Photographs 1-8, 11-16 and 18, 19)
- Bedrock acts as local vertical and lateral control (Photograph 5)
- 950' Riprap exists within the reach (Photographs 10 and 17).

Photograph No. 5. View from the right bank looking to the southeast showing a bedrock outcrop, boulders and landslide along the left bank of the river. Kahler Reach; Subreach IZ-4, Nason Creek - Wenatchee Subbasin, Washington. Bureau of Reclamation Photograph by R. M^cAffee, August 12, 2007.

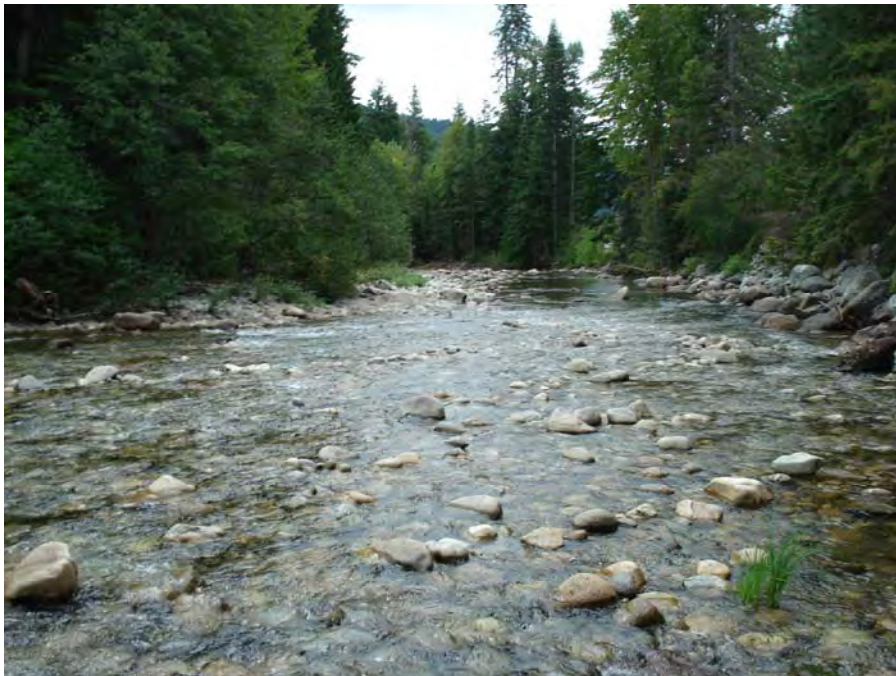
Photograph No. 8. View from the right bank looking downstream to the south showing an armored right bank and a cobble boulder bar along the left bank. Kahler Reach; Subreach IZ-4, Nason Creek - Wenatchee Subbasin, Washington. Bureau of Reclamation Photograph by R. M^cAfee, August 12, 2007.

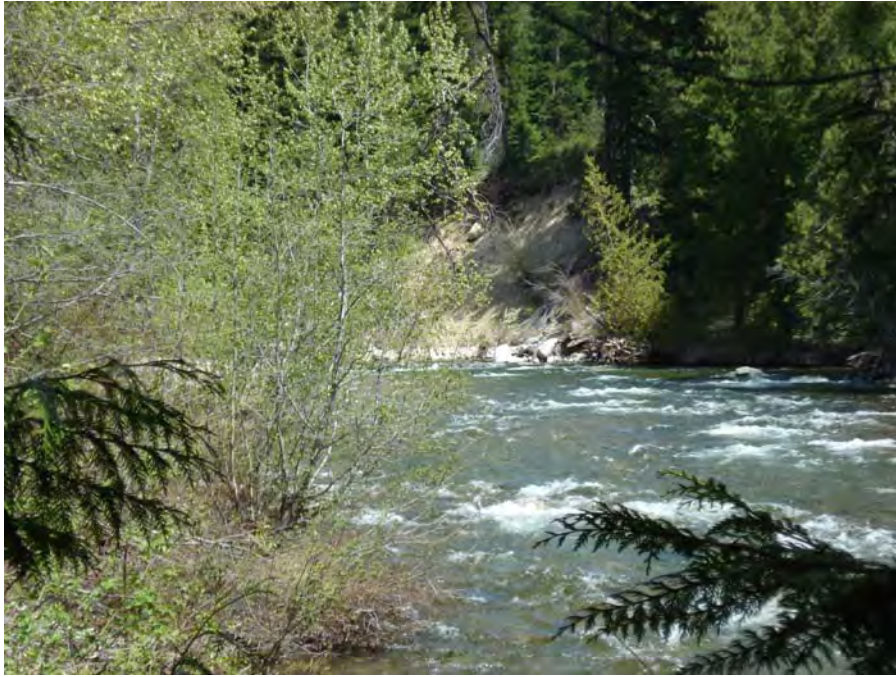
Photograph No. 9. View looking upstream to the northwest of a mass wasting site on the left bank. Kahler Reach; Subreach IZ-4, Nason Creek - Wenatchee Subbasin, Washington. Bureau of Reclamation Photograph by R. McAfee, May 7, 2007.

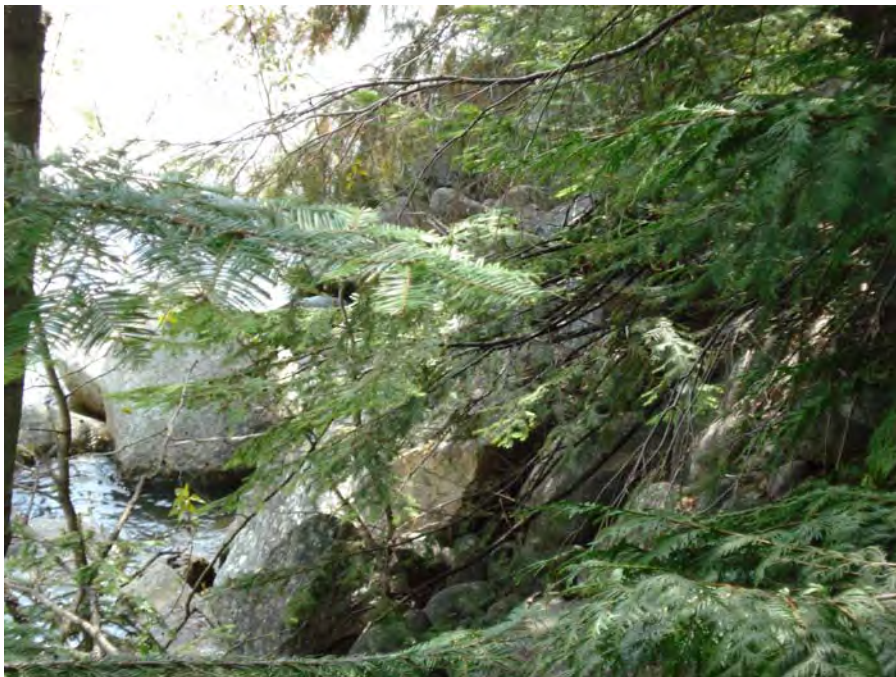
Photograph No. 10. View to the east of riprap along the toe of the road base on the right bank. Kahler Reach; Subreach IZ-4, Nason Creek - Wenatchee Subbasin, Washington. Bureau of Reclamation Photograph by R. McAfee, May 7, 2007.

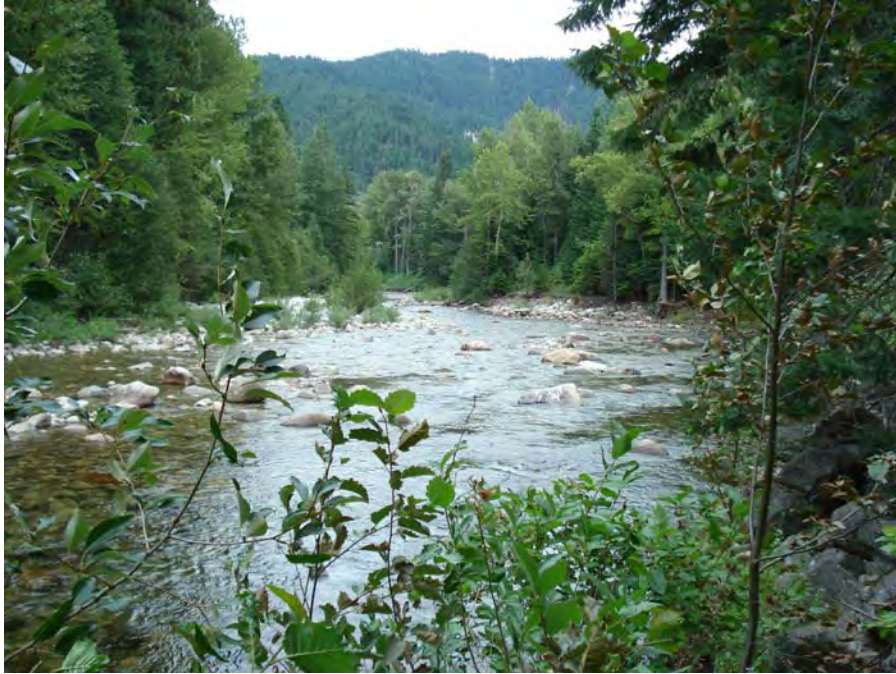
Photograph No. 11. View from the right bank looking downstream to the south east at in-channel boulders and riprap along the right bank. Kahler Reach; Subreach IZ-4, Nason Creek - Wenatchee Subbasin, Washington. Bureau of Reclamation Photograph by R. M^cAfee, August 12, 2007.

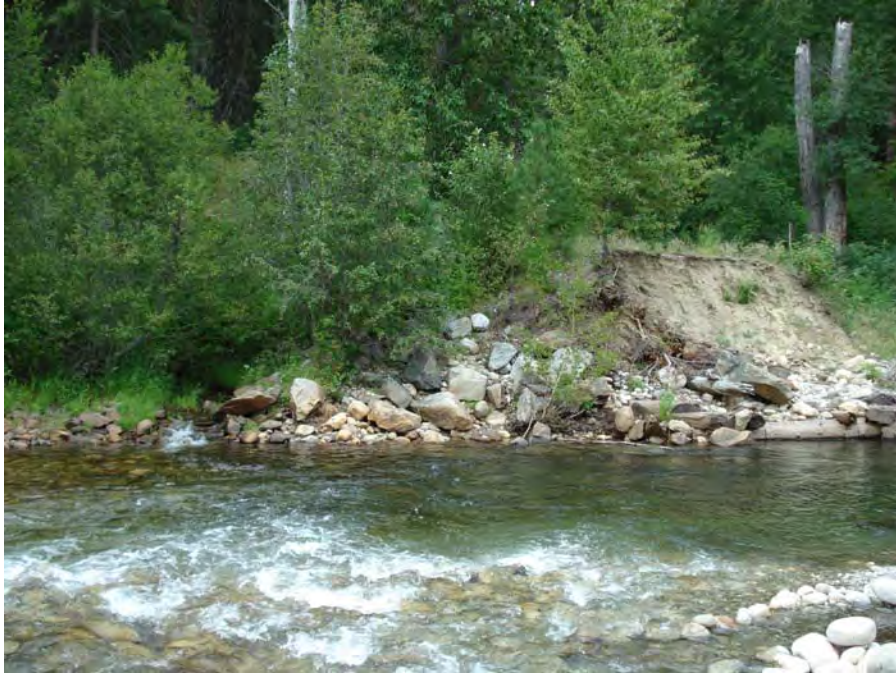
Photograph No. 151. View from the right bank looking to the north showing a channel unit sequence of rapid to scour pool with an old bridge abutment and stream/wetland inlet along the left bank of the river. Kahler Reach; Subreach IZ-4, Nason Creek - Wenatchee Subbasin, Washington. Bureau of Reclamation Photograph by R. M^oAffee, August 12, 2007.

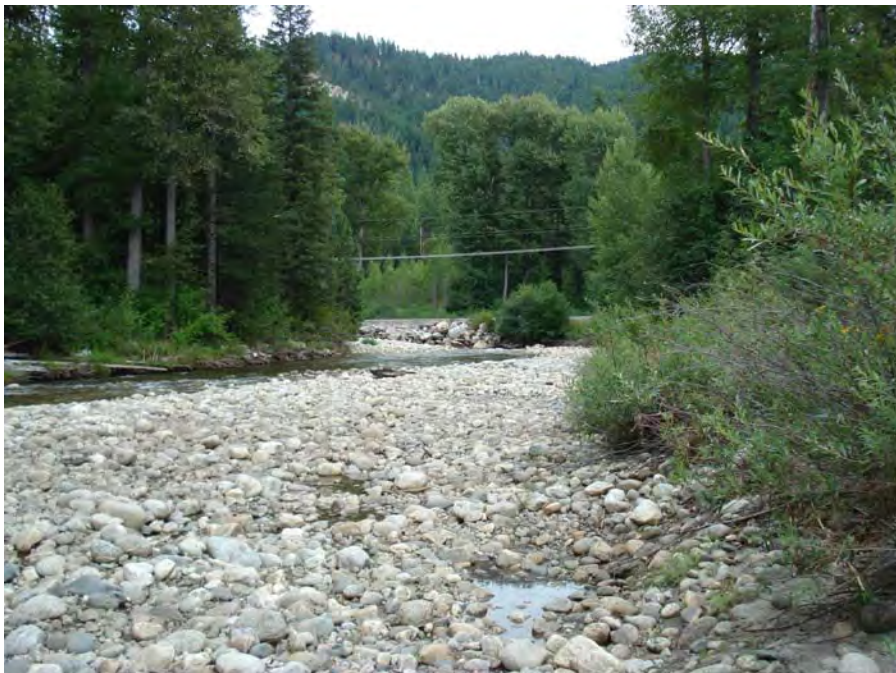
Photograph No. 16. View from the right bank to the east showing a cobble point bar along the right bank and riprap along the highway in the distance. Kahler Reach; Subreach IZ-4, Nason Creek - Wenatchee Subbasin, Washington. Bureau of Reclamation Photograph by R. M^oAffee, August 12, 2007.

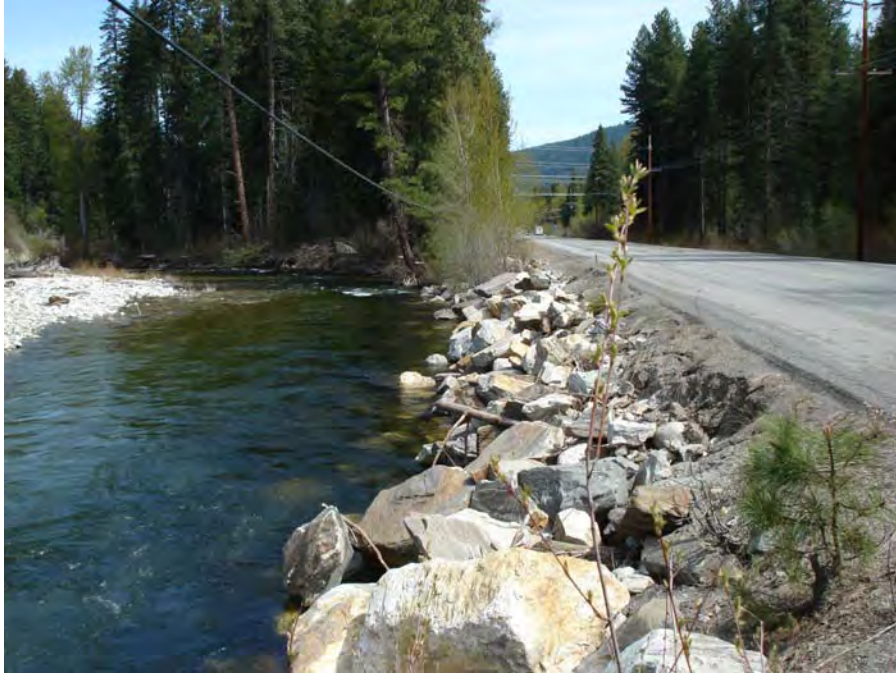
Photograph No. 17. View to the north of a scour pool associated with riprap along the base of the highway. Kahler Reach; Subreach IZ-4, Nason Creek - Wenatchee Subbasin, Washington. Bureau of Reclamation Photograph by R. McAfee, May 5, 2007.

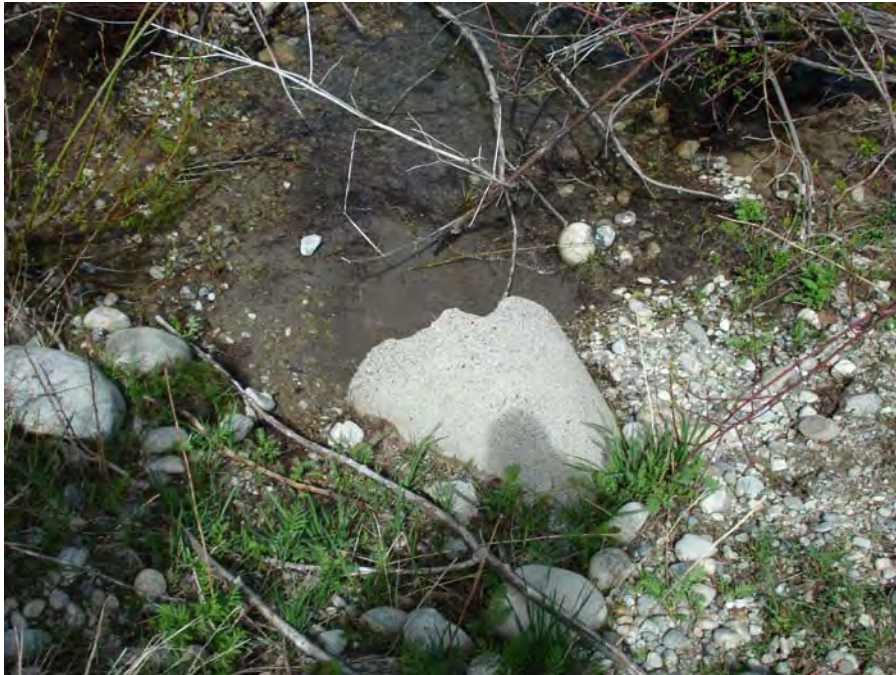
Photograph No. 20. View of the west (river) side of a culvert. Kahler Reach; Subreach IZ-4, Nason Creek - Wenatchee Subbasin, Washington. Bureau of Reclamation Photograph by R. McAfee, May 5, 2007.

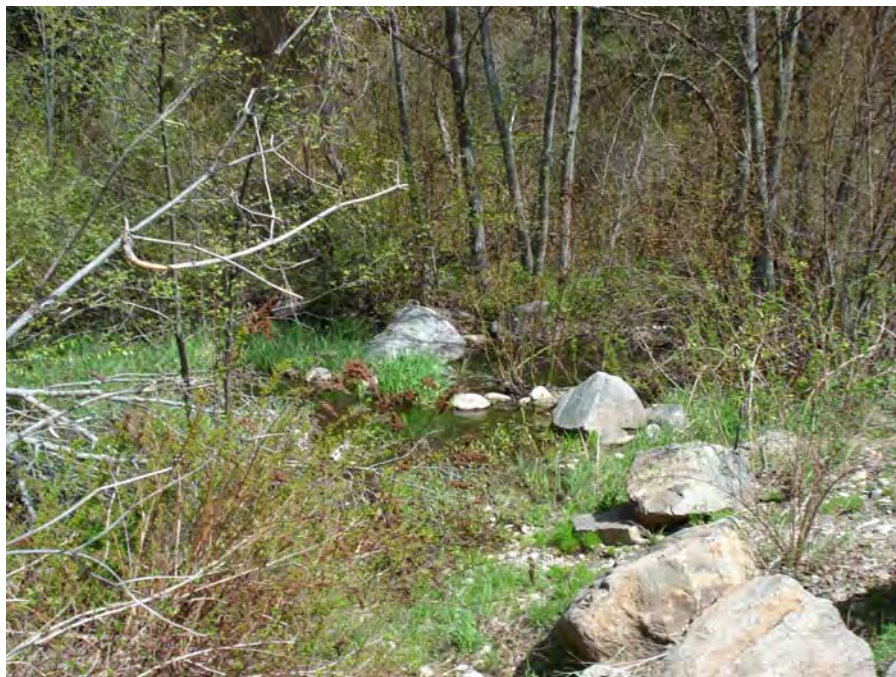
- 160 feet of pushup levee with loose riprap protects a parking area (Photograph 1).
- About 2 % of the vegetation for the subreach has been altered for the powerline.

Photograph No. 1. View to the northwest of overland flow behind a levee with scattered riprap. Kahler Reach; Subreach OZ-19, Nason Creek - Wenatchee Subbasin, Washington. Bureau of Reclamation Photograph by R. McAfee, May 5, 2007.

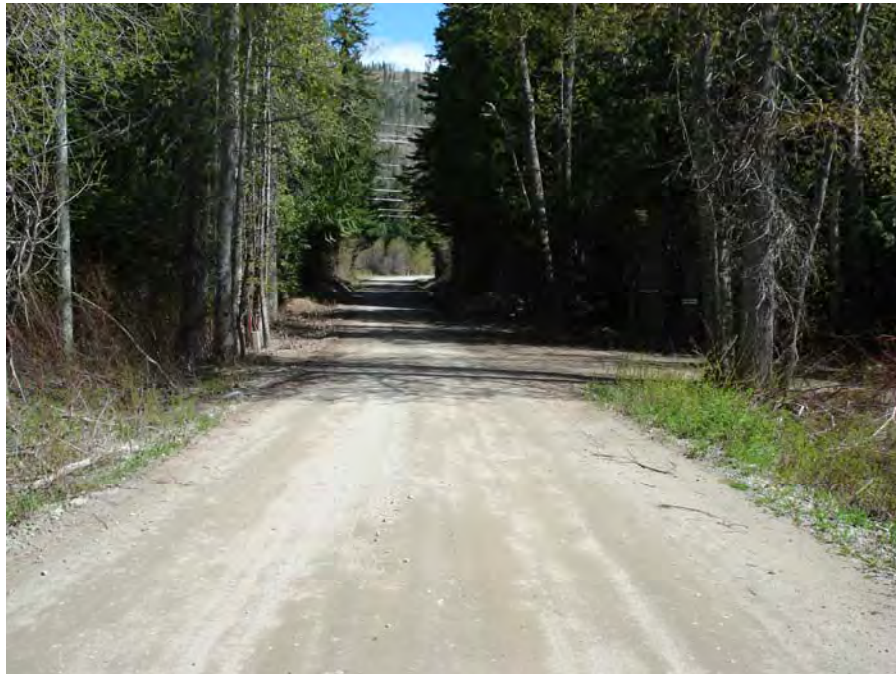
Photograph No. 1. View to the north showing a step-up to a higher surface. Kahler Reach; Subreach OZ-3, Nason Creek - Wenatchee Subbasin, Washington. Bureau of Reclamation. Photograph by R. McAfee, May 4, 2007.

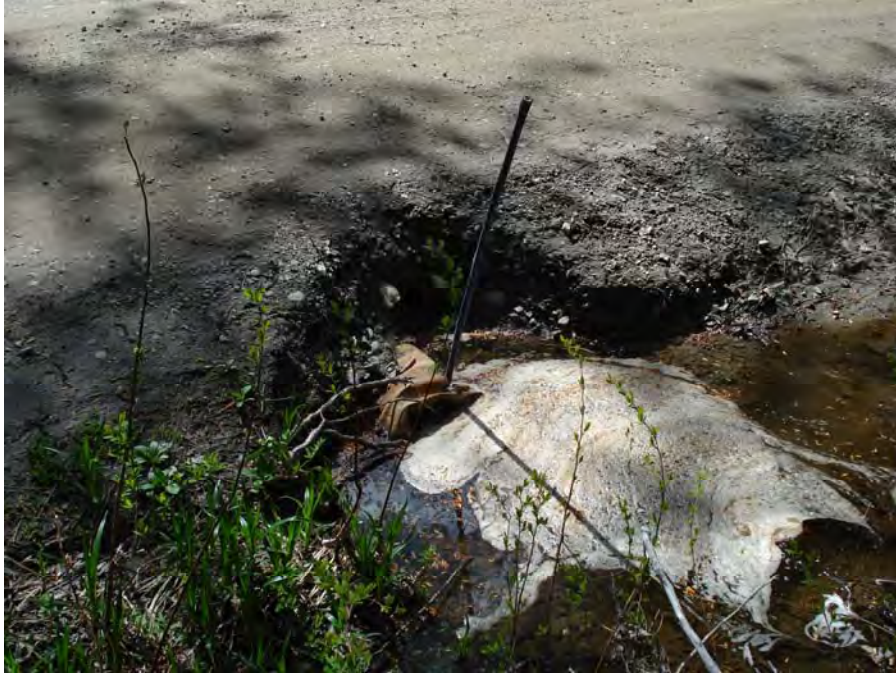
Photograph No. 2. View showing the top end of a culvert that drains a wetland area. Kahler Reach; Subreach OZ-3, Nason Creek - Wenatchee Subbasin, Washington. Bureau of Reclamation
Photograph by R. McAfee, May 4, 2007.

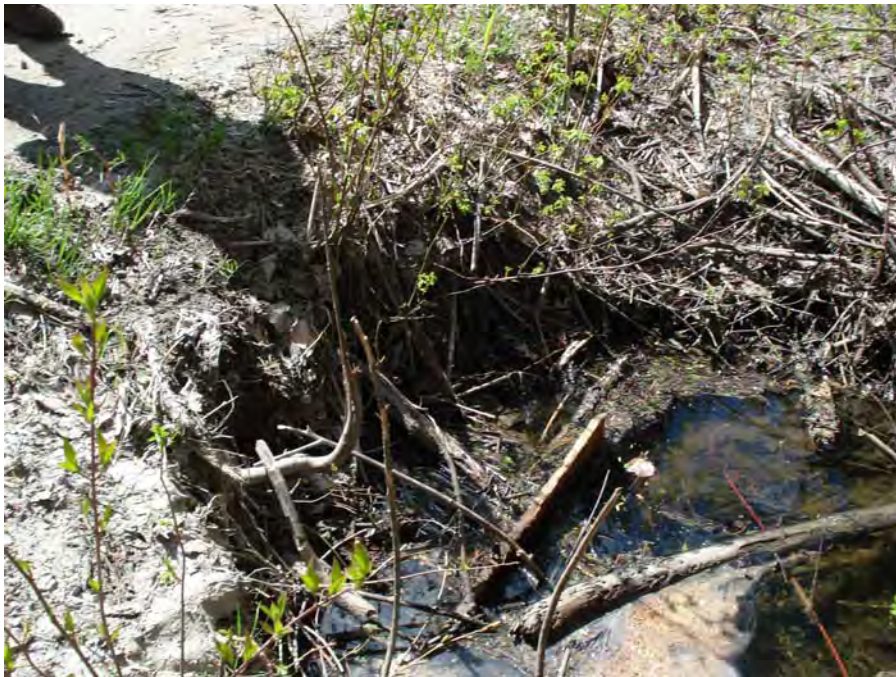
Photograph No. 3. View of the intake of a culvert that drains a wetland area. Kahler Reach; Subreach OZ-3, Nason Creek - Wenatchee Subbasin, Washington. Bureau of Reclamation
Photograph by R. McAfee, May 4, 2007.

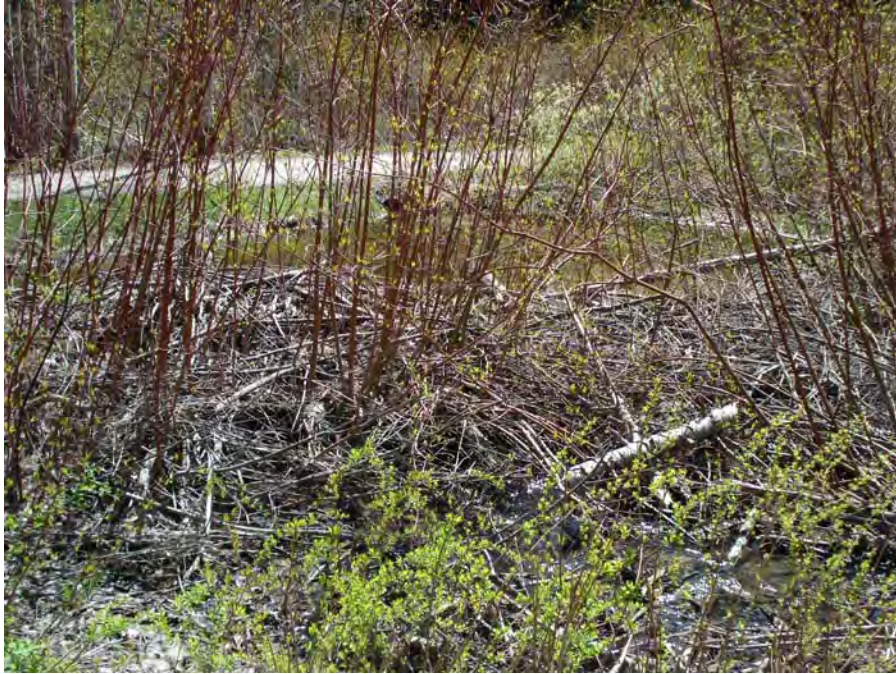
Photograph No. 4. View showing the outfall of the culvert and wetlands, with another culvert in the road embankment in the back ground. Kahler Reach; Subreach OZ-3, Nason Creek - Wenatchee Subbasin, Washington. Bureau of Reclamation Photograph by R. McAfee, May 4, 2007.

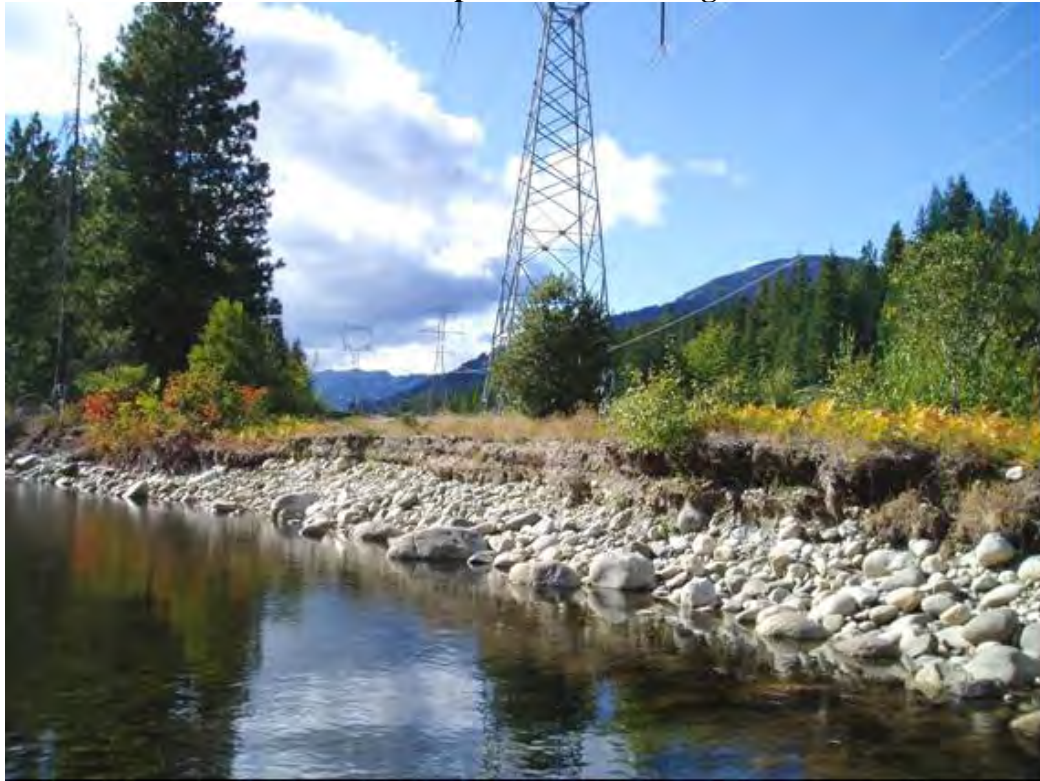
Bank erosion from power line crossing at RM 6.2

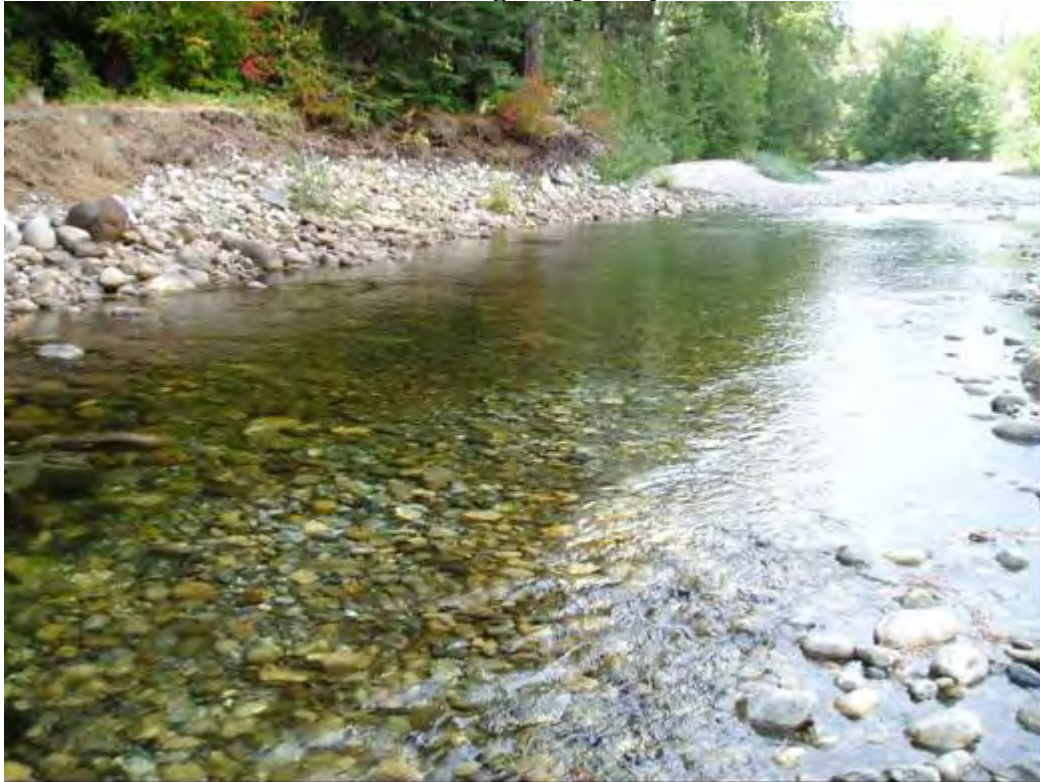
Pool habitat lacking complexity in Reach 1

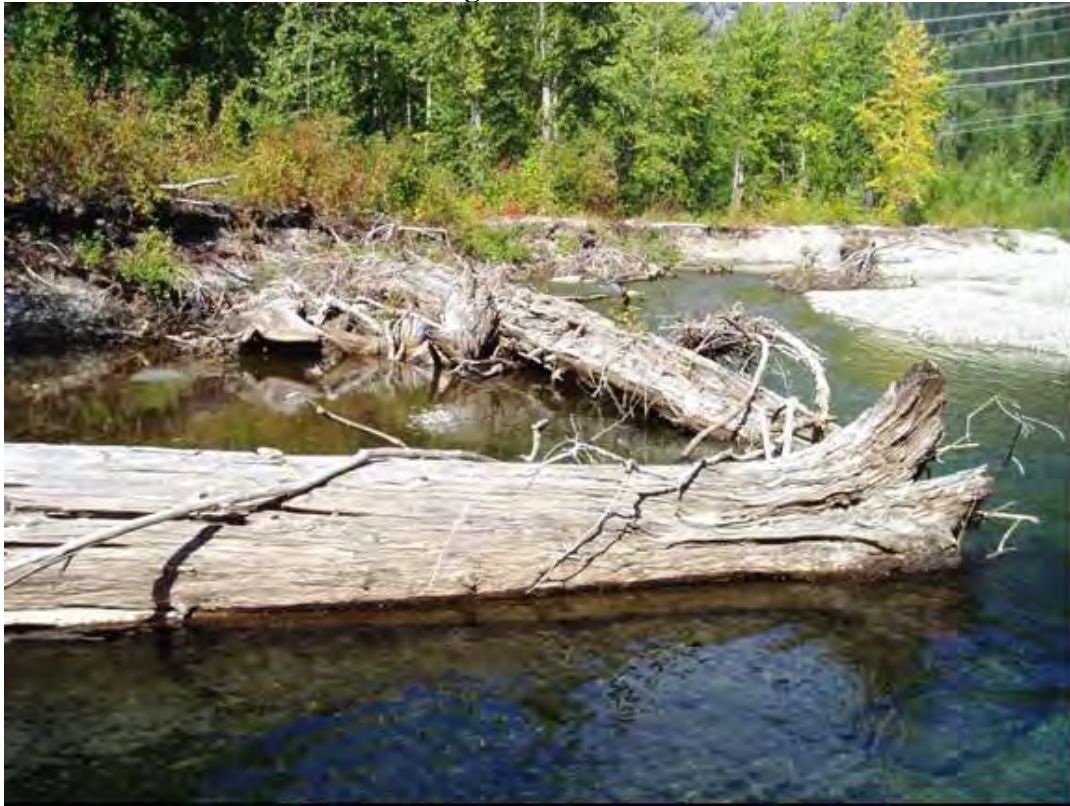
Cabled Logs in Pool at RM 10.3

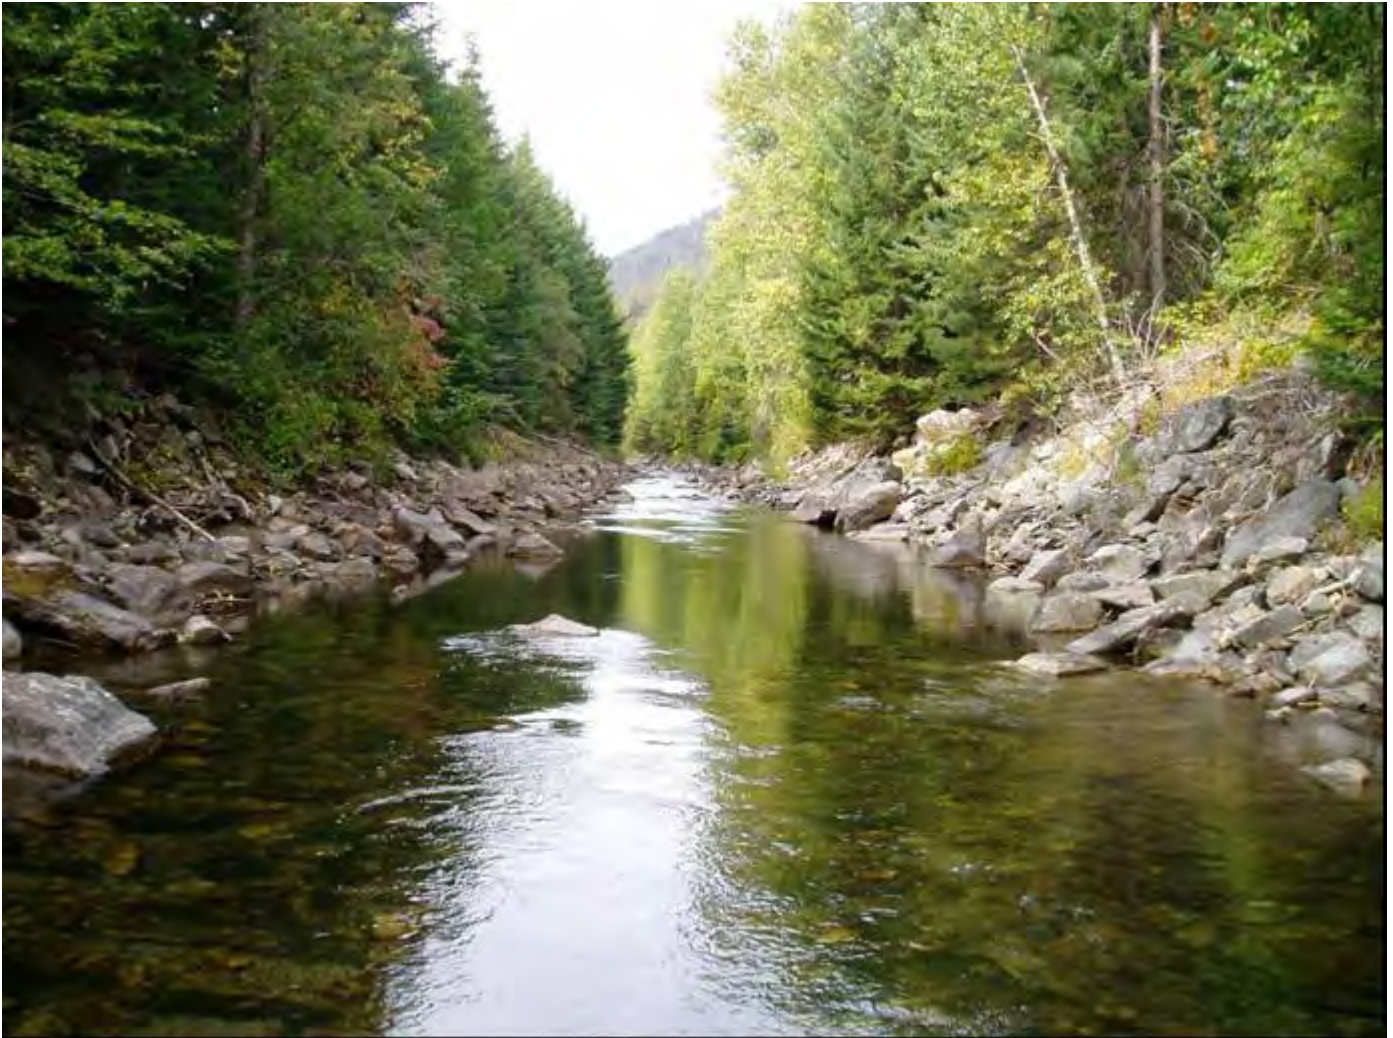
Nason Creek in channelized Reach 5
