Lower Nason

Assessment of Geomorphic and Ecologic Indicators
Nason Creek, Wenatchee Subbasin

Chelan County, Washington

April 2011

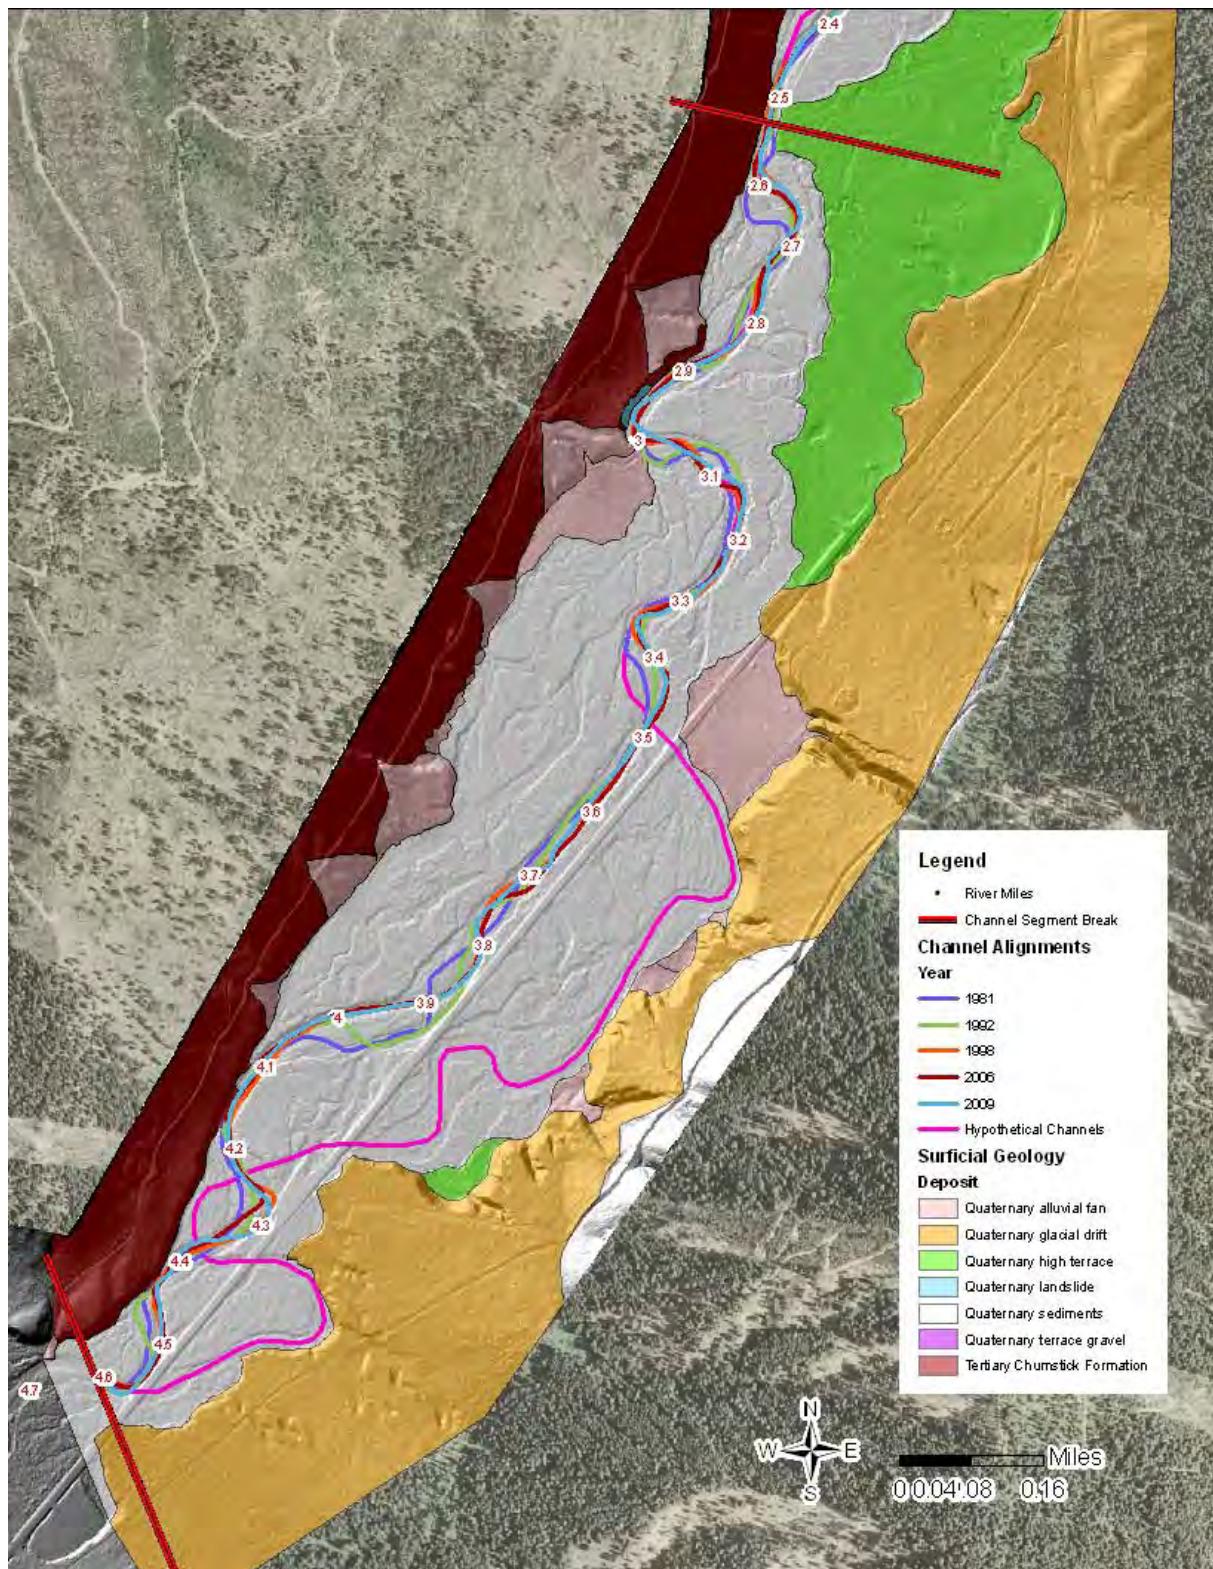
Figure 9. Channel Segment A: Historical channel alignments and hypothetical channel alignment interpreted from 2006 LiDAR hillshade

Aerial photographs were used to evaluate channel alignments for a period of about thirty-years. This channel alignment time series was after the re-routing of the channel during the construction of an improved road (State Route 207). To understand historic channel alignments and lateral migration prior to the road construction, a channel alignment was interpreted and traced from the 2006 LiDAR hillshade elevation model (Figure 9). Based on these channel alignments the following geomorphic channel changes are estimated to have

occurred: (1) the channel length has been reduced by about 2,000 feet, (2) the channel gradient has been increased by about 17 percent, and (3) the channel sinuosity has decreased about 17 percent (Table 12).

Channelization and constraints on lateral channel migration have changed the geomorphology of the channel and have resulted in increased streampower and increased sediment transport capacity. These channel changes have reduced channel-floodplain interactions and may have degraded the long-term physical and ecological processes that create and sustain appropriate habitat complexity, connectivity, and variability.

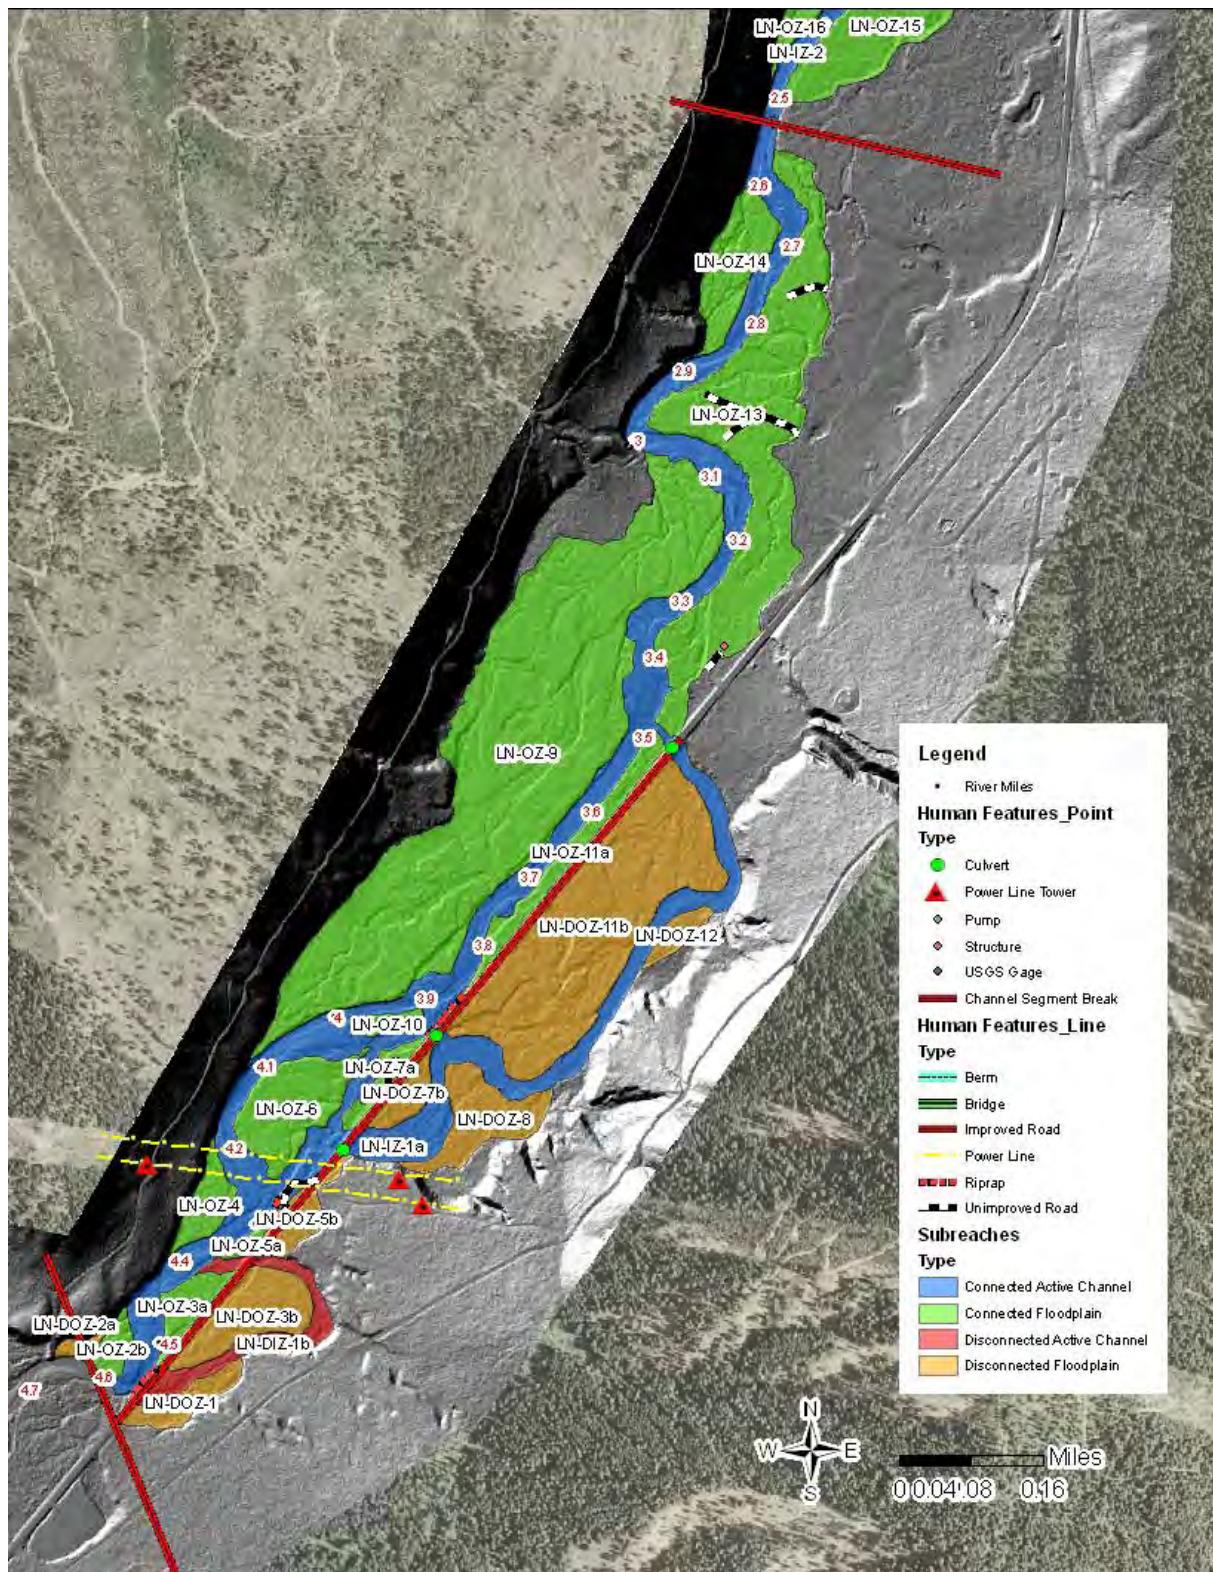
Figure 10. Channel Segment A: Active channel and floodplain connectivity and anthropogenic features

Other anthropogenic features such as unimproved roads, riprap, and powerline right-of-way impact physical processes to a lesser degree. Along the powerline right-of-way, vegetation near RM 4.25 has been cleared which reduces bank stability and channel boundary roughness, but otherwise does not affect floodplain connectivity. Unimproved roads in subreach LN-OZ-13 are not elevated and do not impede floodplain connectivity. Riprap placed along the State Route 207 may affect channel hydraulics and geometry, strempower, and lateral channel migration. In general, the relatively smooth hydraulic surface created by riprap decreases channel boundary roughness and maintains or increases strempower and can result in localized scour and downstream impacts. Anthropogenic features identified in this assessment are categorized by feature type and assigned a metric (i.e., measured or tabulated). A summary of the anthropogenic features and metrics are provided in Table 15 and their locations are shown in Figure 10.

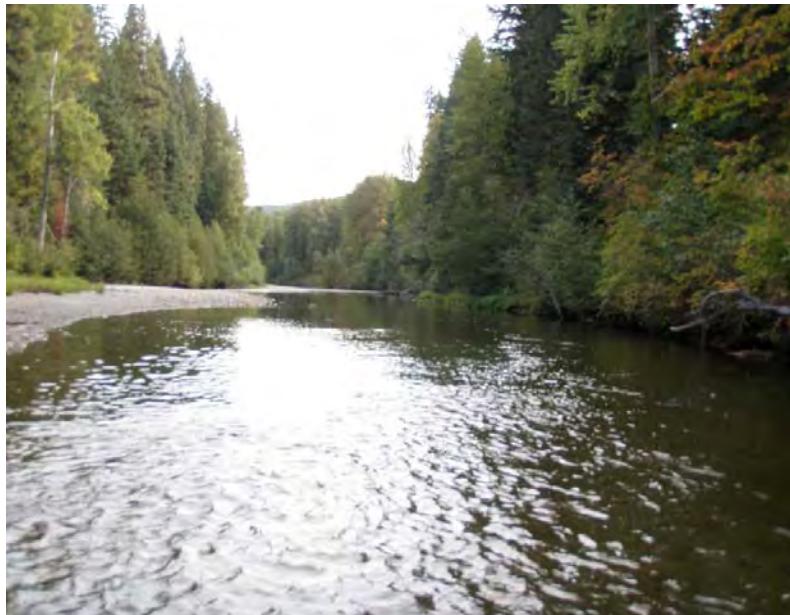
Most of the floodplain within the channel segment is in a Large Trees Condition and compositions of individual stands are coniferous deciduous or mixed, dependent on their location and elevation with respect to the active channel (Figure 11). Areas that are in a Shrub/Pole or Small Trees Condition are typically along the margins of the active channel or along side channels where ground disturbing flows occur. Most of the areas in a Grass/Forb Condition or with no vegetation are associated with anthropogenic disturbances. These disturbances include clearing along the powerline right-of-way, State Route 207, and residential and agriculture development (Figure 12).

Figure 11. Channel Segment A: View looking downstream at riparian buffer zone near RM 3.70. Lower Nason Creek, Wenatchee Subbasin, Washington – Bureau of Reclamation Photograph by E. Lyon, September 15, 2010.

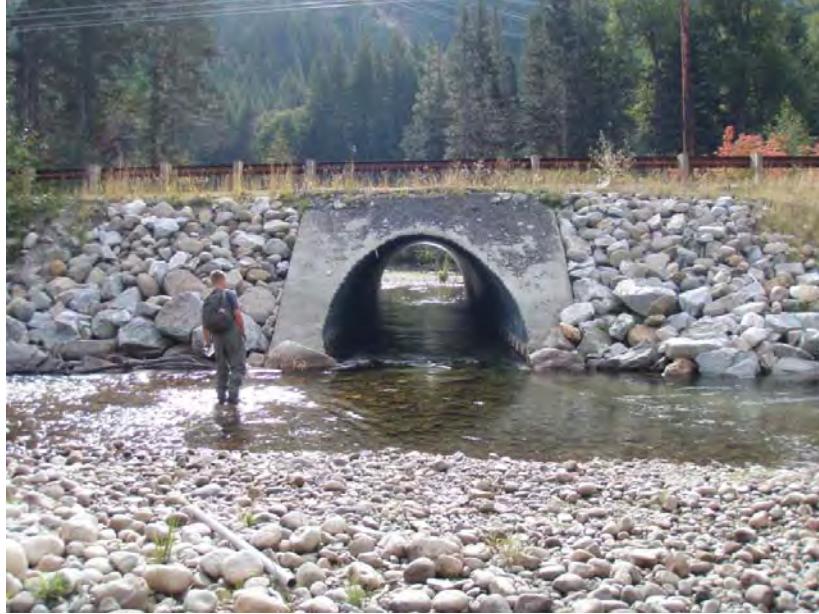
By reconnecting the historic channel path that was isolated by State Route 207 (Figure 16), available off-channel habitat was increased (Figure 17) and sediment transport capacity in the mainstem may have been reduced as flows are distributed over a larger cross sectional area. However, lateral channel migration remains restricted and most of the floodplain remains disconnected due to the road grade.

Figure 16. Channel Segment A: View looking at culvert placed through State Route 207 near RM 3.90 that reconnects historic channel path (side channel SC_3.48_R). Lower Nason Creek, Wenatchee Subbasin, Washington – Bureau of Reclamation Photograph by E. Lyon, September 15, 2010.

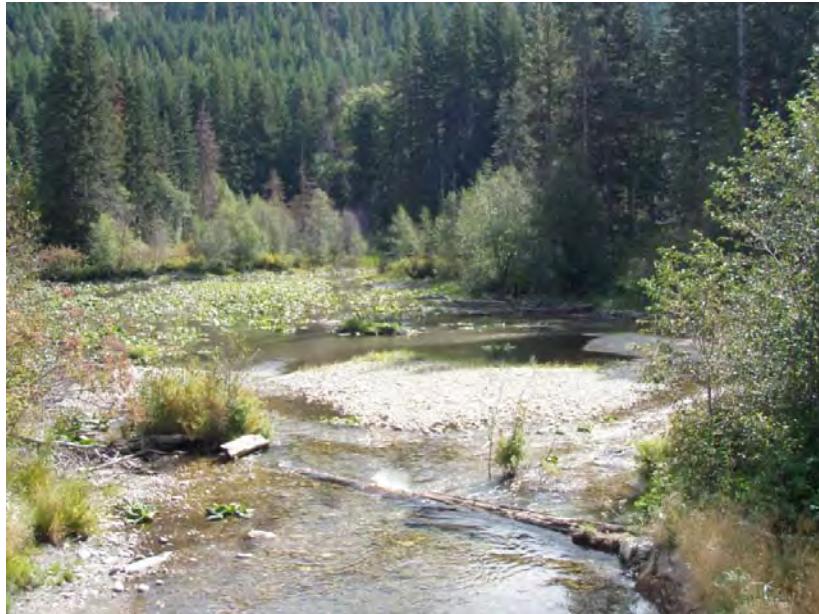
Figure 17. Channel Segment A: View looking downstream at reconnected historic channel path near RM 3.90 (side channel SC_3.48_R). Lower Nason Creek, Wenatchee Subbasin, Washington – Bureau of Reclamation Photograph by E. Lyon, September 16, 2010.

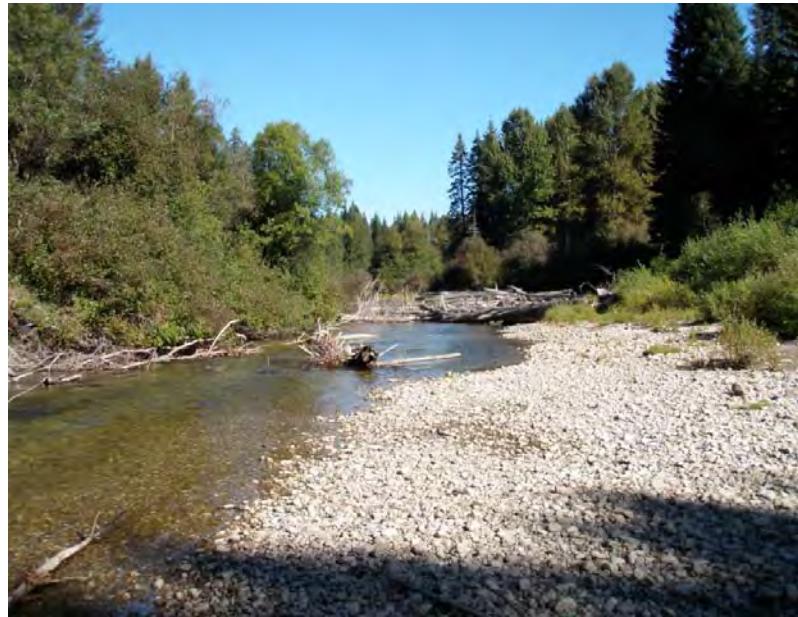
Floodplain vegetation was predominantly in a Large Trees Condition and a majority of stands had a mixed coniferous and deciduous composition (Figure 20). Vegetation structure was a mosaic comprised of individual stands in a Grass/Forbs to Small Trees Condition where the channel has reworked the floodplain and where some vegetation clearing has occurred (presumed for livestock grazing). There were a couple of areas with no vegetation that were associated with State Route 207 and an impoundment pond (Figure 21).

Figure 20. Channel Segment B: View looking downstream at riparian buffer zone and wood complex near RM 2.25. Lower Nason Creek, Wenatchee Subbasin, Washington – Bureau of Reclamation Photograph by E. Lyon, September 14, 2010.

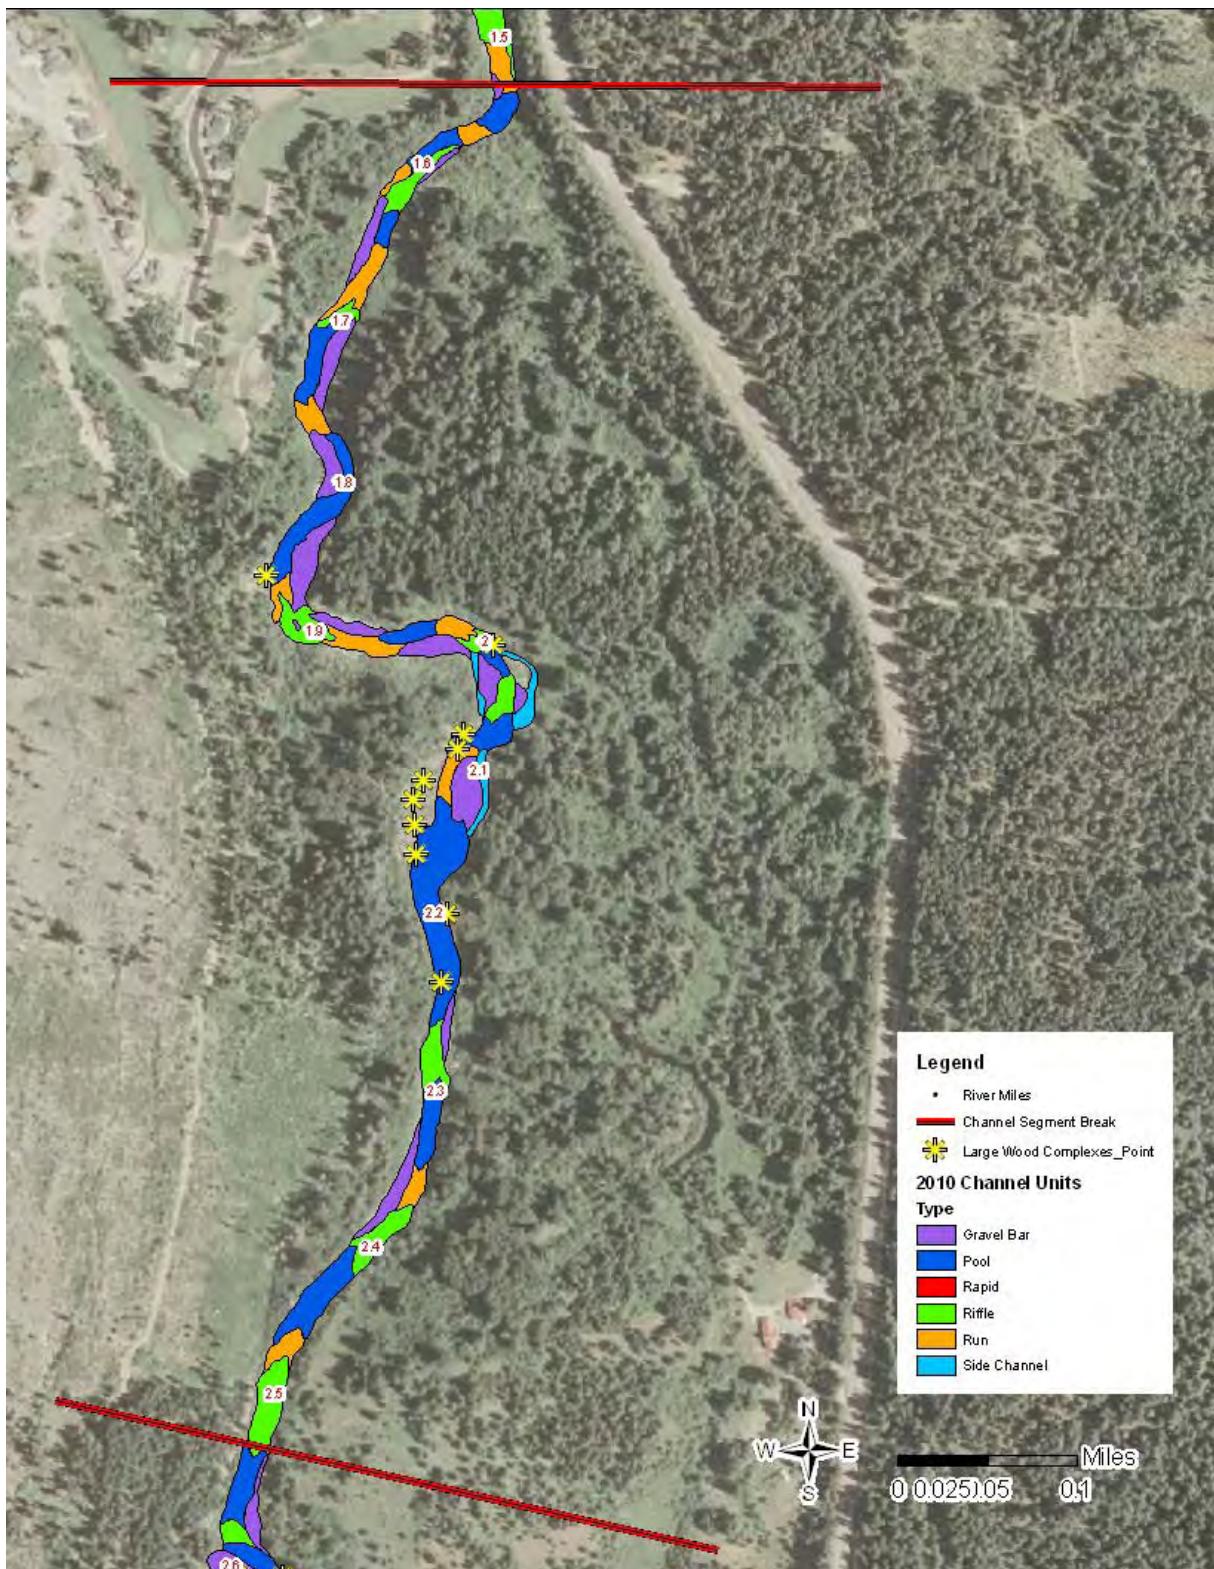
The intact physical and ecological processes may represent the appropriate type and quality of habitat that was present in the other geologically unconfined channel segments in this reach (Table 21 and graphically illustrated in Figure 22). Large wood was readily available for recruitment, and once incorporated into the channel contributes to the creation of in-stream complexity and diverse hydraulic habitats (Figure 23).

Figure 23. Channel Segment B: Visual representation of channel units and their association with large wood complexes

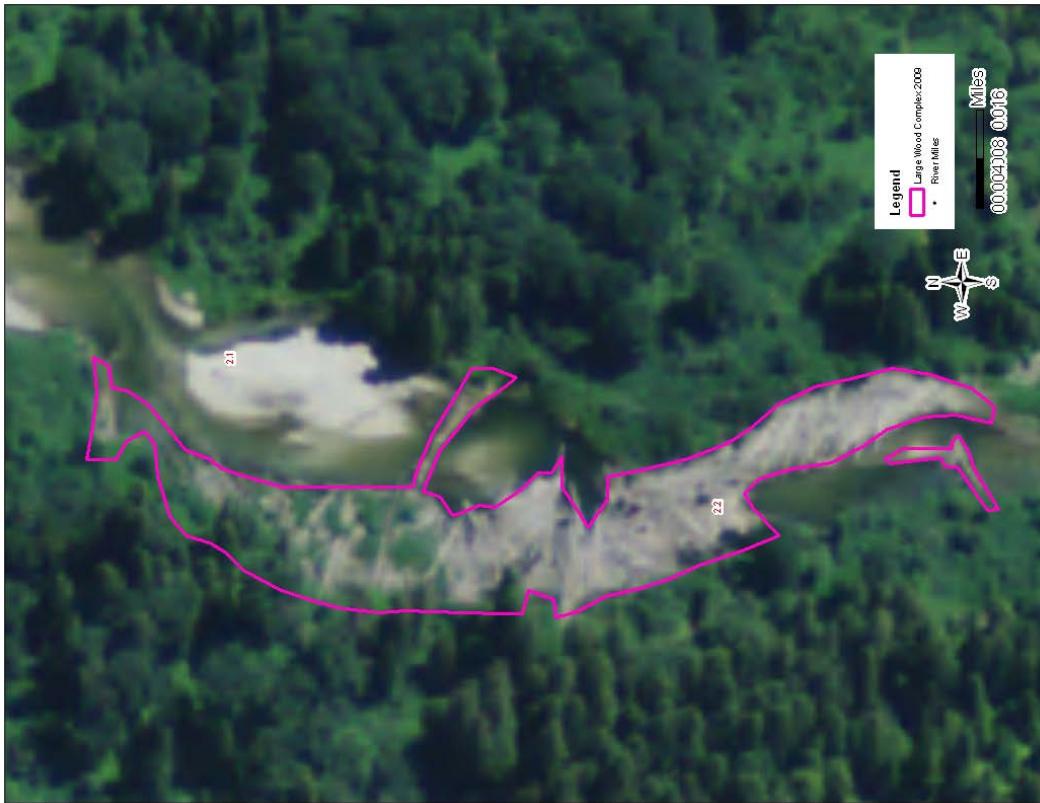
The channel spanning log jam near RM 2.2 covered about 0.85 acres in 2006, and by 2009 had increased to about 1.48 acres based on interpretation of aerial photographs (Figure 25 and Figure 26). A backwater (or debris dam) pool was created by the log jam and a middle channel scour pool has formed beneath the jam as flows scour underneath the jam. The log jam has contributed to the creation of macro-habitat in the form of large, deep pools and a mosaic of micro-habitats within the jam and along its margins.

Figure 25. Channel Segment B: 2009 aerial photograph of large wood complex near RM 2.2

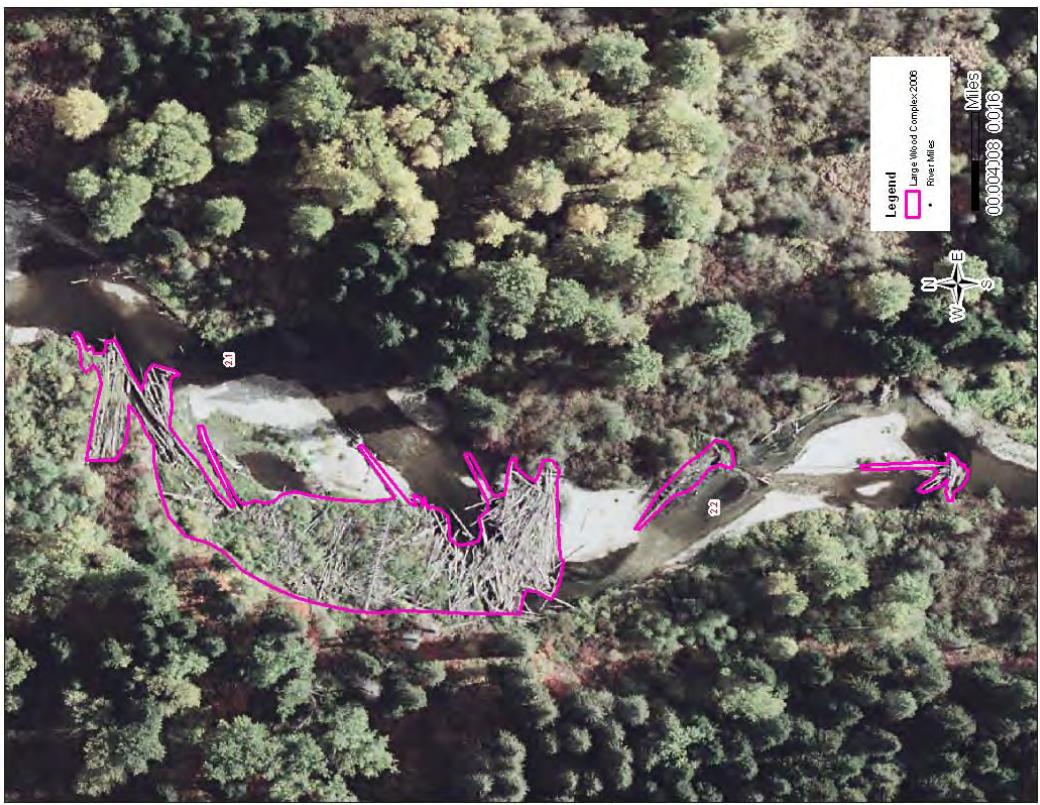
Figure 26. Channel Segment B: 2006 aerial photograph of large wood complex near RM 2.2

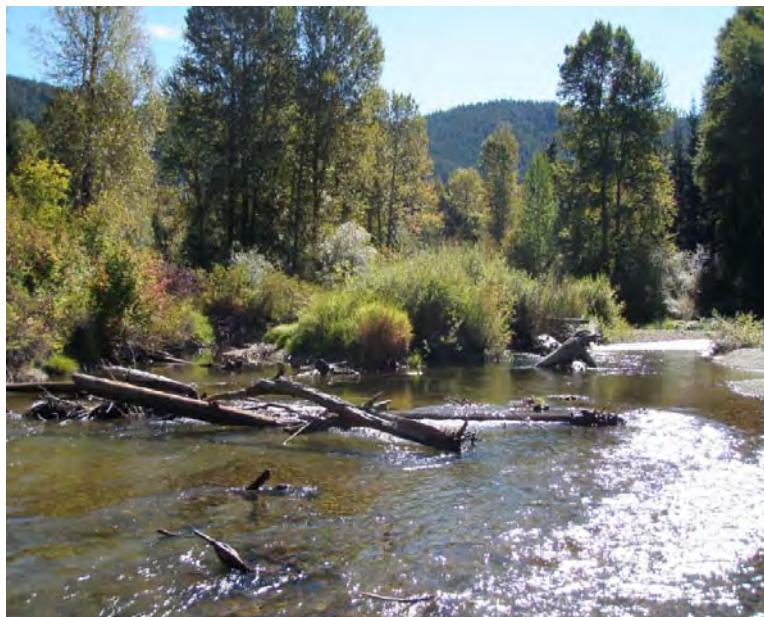
Three side channels were mapped totaling about 0.35 acres (Table 22). About 0.18 acres (51 percent) were classified as gravel bar-type side channels and about 0.17 acres (49 percent) were classified as floodplain-type side channels (Figure 27).

Figure 27. Channel Segment B: View looking upstream at a floodplain type side channel (SC_2.01_R) along river right near RM 2.00. Lower Nason Creek, Wenatchee Subbasin, Washington – Bureau of Reclamation Photograph by E. Lyon, September 14, 2010.

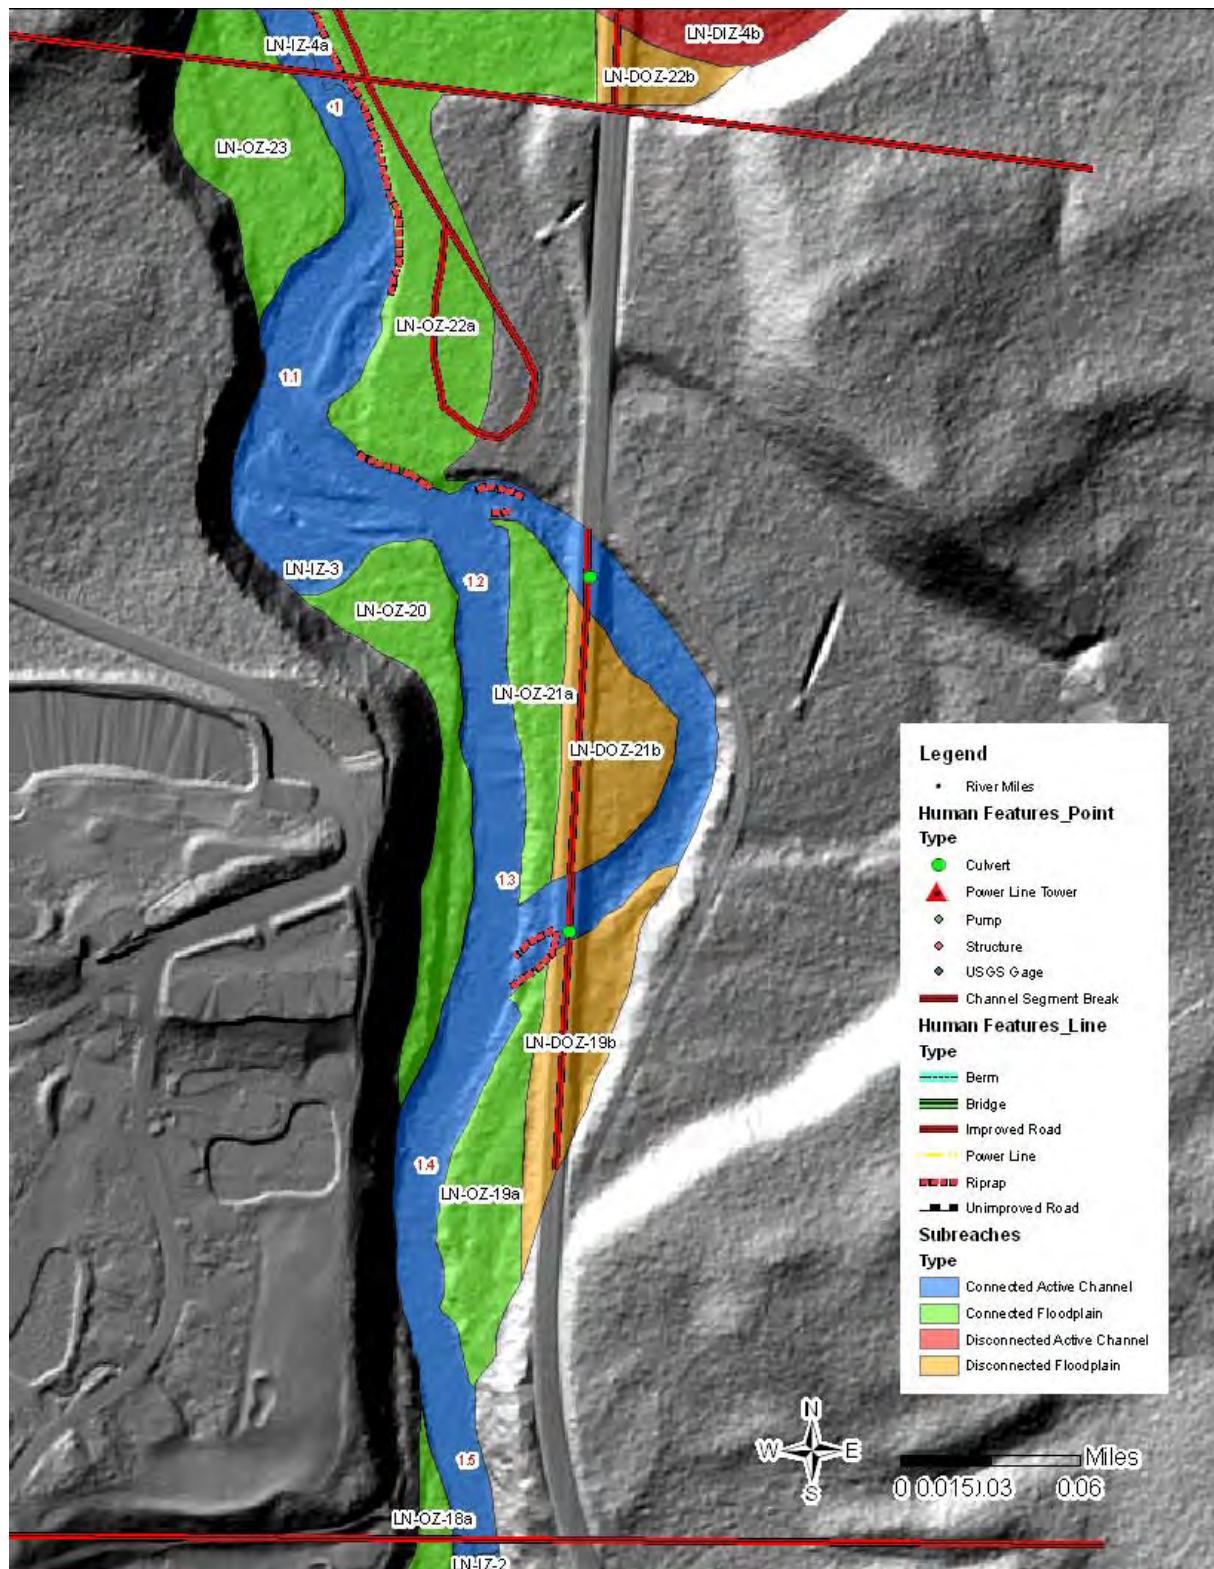
Improved roads in the campground area (LN-OZ-22a) do not have elevated road grades and don't impede floodplain connectivity (Table 26). Riprap placed along the streambank to protect the campground area may be affecting channel hydraulics and geometry, strempower, and lateral channel migration. The riprap decreases channel boundary roughness and maintains or increases strempower that can result in localized scour downstream impacts (Figure 29).

Figure 29. Channel Segment C: Subbreaches and subbreach complexes

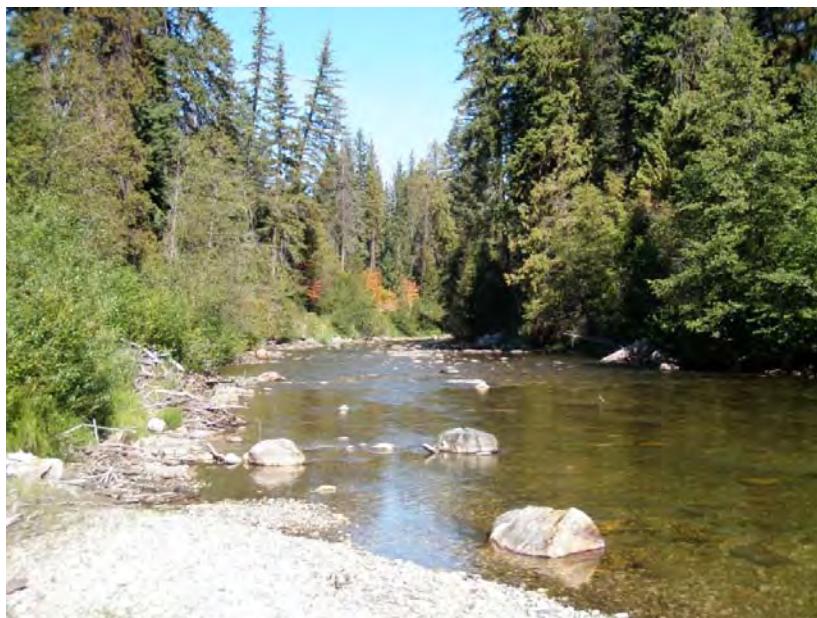
Much of the floodplain is in a Large Trees Condition and the predominant compositions of individual stands are mixed deciduous and coniferous species (Figure 30). Areas that are in a Shrub/Pole to Small Trees Condition are typically along the margins of the active channel and along side channels where ground disturbing flows occur. Anthropogenic disturbances associated with the campground and State Route 207 are in a Grass/Forbs Condition or have no vegetation (Figure 31).

Figure 30. Channel Segment C: View to the north looking downstream at riparian buffer zone near RM 1.52 that is in a large trees condition.
Lower Nason Creek, Wenatchee Subbasin, Washington – Bureau of Reclamation Photograph by E. Lyon, September 14, 2010.

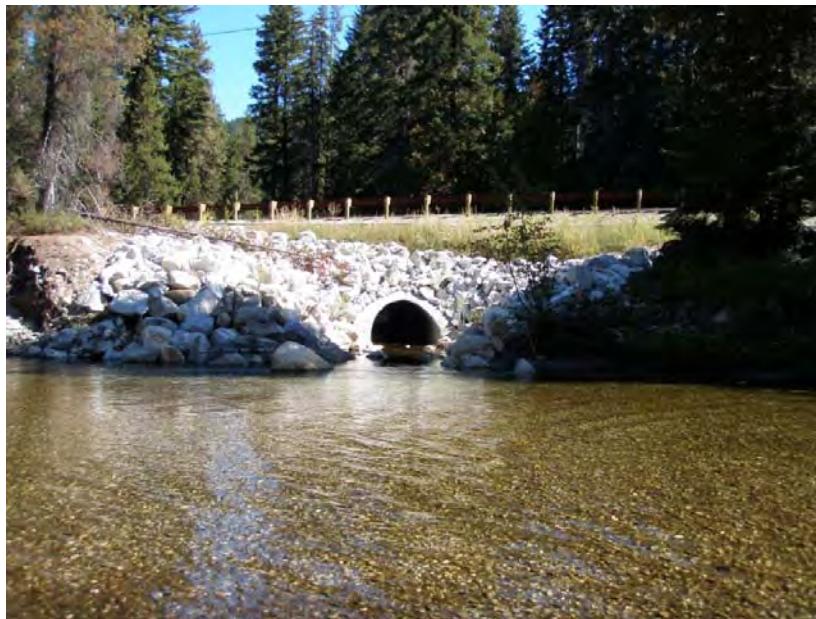
Two side channels were mapped totaling about 1.11 acres. One side channel about 0.85 acres or 77 percent of off-channel habitat was classified as a floodplain-type side channel (Table 28). The stream was re-routed for construction of State Route 207 and disconnected a historic channel path. In 2009, CCNRD reconnected the historic channel path using culverts that created a floodplain-type side channel (SC_1.17_R) to provide additional off-channel habitat and potentially reduce sediment transport capacity during floods (Figure 34). However the road grade still restricts lateral channel migration and floodplain processes. The other side channel was a gravel bar-type side channel that covered about 0.26 acres or 23 percent of available off-channel habitat and provides spawning and rearing habitat.

Figure 34. Channel Segment C: View looking at a culvert placed through the embankment of State Route 207 that reconnects a historic channel path (SC_1.17_R) near RM 1.30. Lower Nason Creek, Wenatchee Subbasin, Washington – Bureau of Reclamation Photograph by E. Lyon, September 14, 2010.

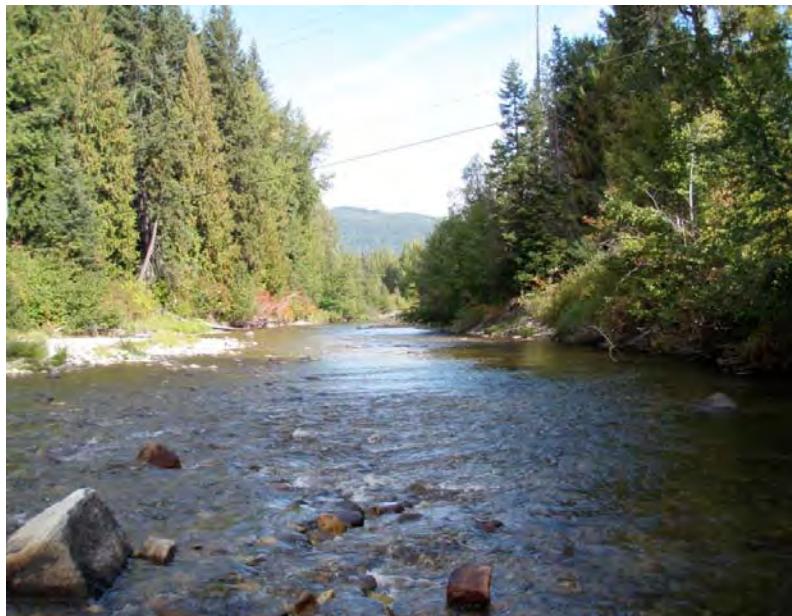
Channelization and constraints on lateral channel migration have changed the geomorphology of the channel and have resulted in increased streampower and increased sediment transport capacity (Figure 36). These channel changes have reduced channel-floodplain interactions and may have degraded the long-term physical and ecological processes that create and sustain appropriate habitat complexity, connectivity, and variability.

Figure 36. Channel Segment D: View looking downstream where the channel has been re-routed and confined by State Route 207 near RM 0.50. Lower Nason Creek, Wenatchee Subbasin, Washington – Bureau of Reclamation Photograph by E. Lyon, September 16, 2010.

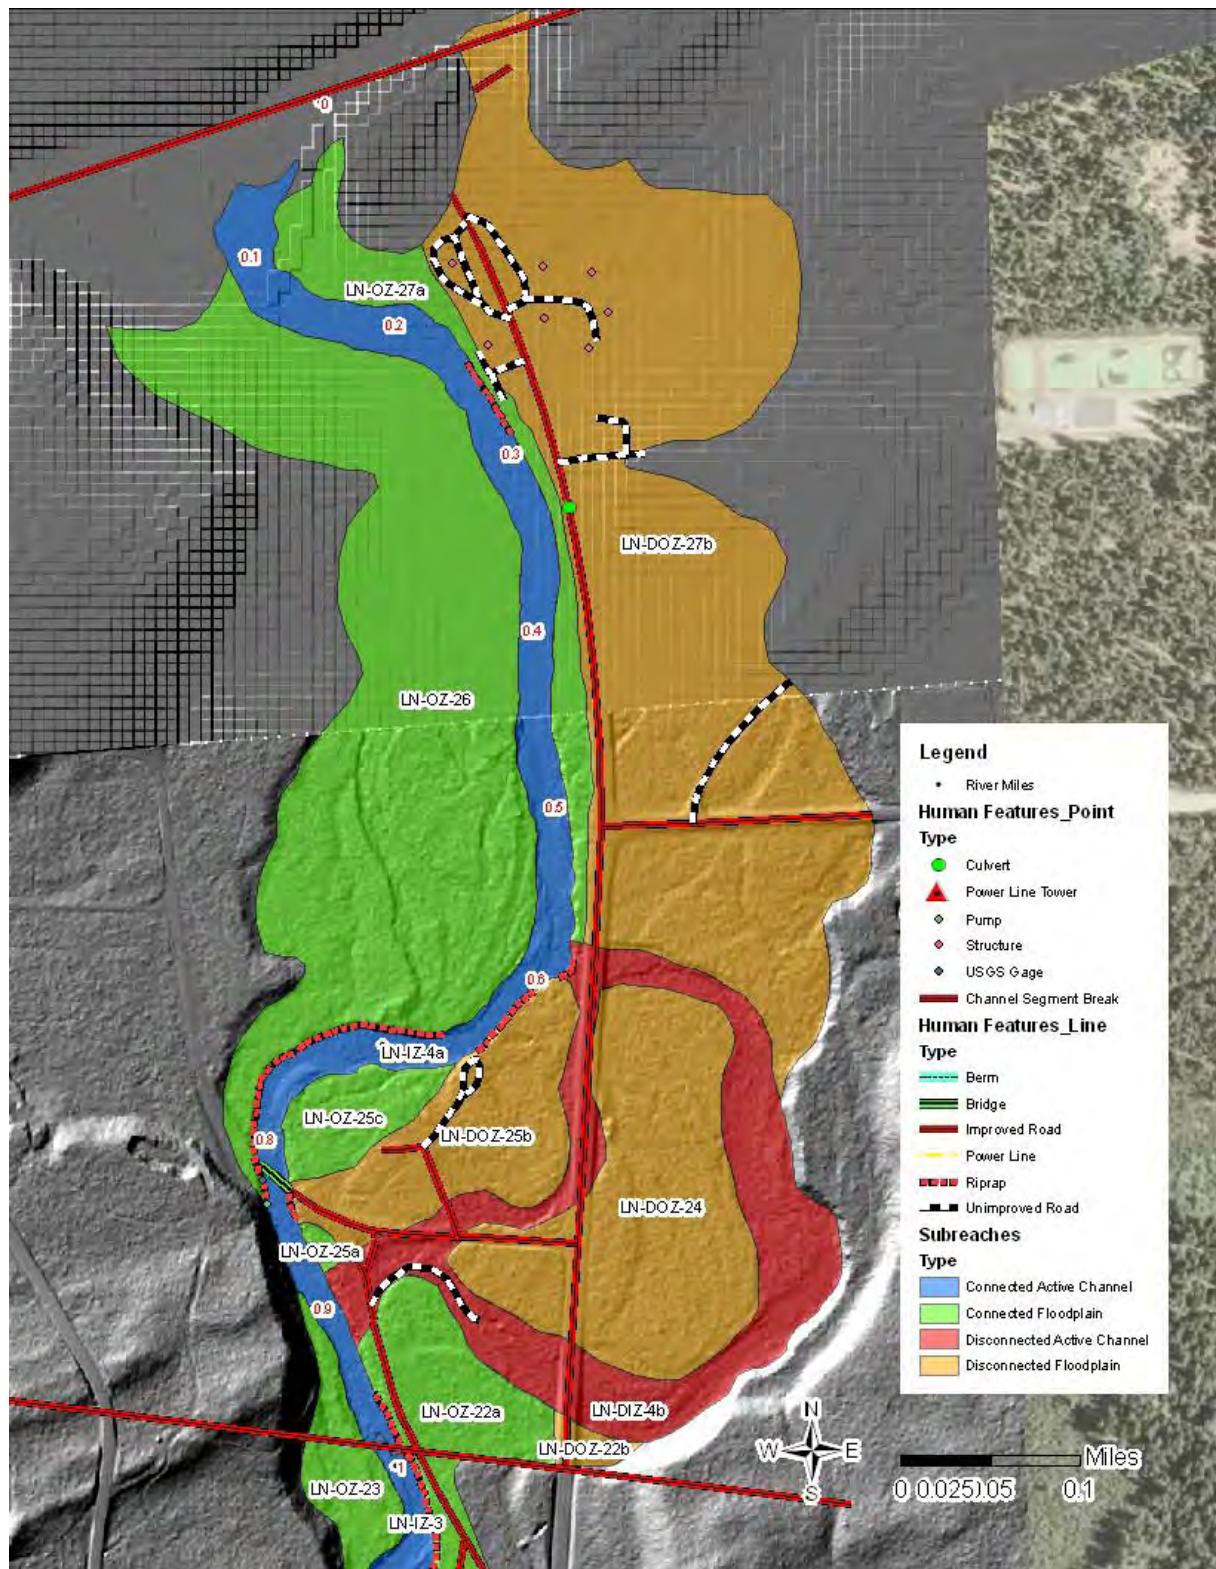
Other anthropogenic features that may affect physical processes include local utility lines, commercial and residential structures, unimproved roads, and riprap (Table 32; Figure 37). The utility lines provide electricity to commercial and residential structures, and may have impacts on floodplain roughness and vegetation structure. For the most part, unimproved roads do not have elevated grades and do not impede floodplain connectivity, but do have impacts on vegetation structure. Riprap placed along the streambank does not impede floodplain connectivity, but does affect lateral channel migration and may affect channel hydraulics and geometry, and strempower. In general, riprap does not provide appropriate channel boundary roughness and maintains or increases strempower than can result in localized scour and downstream effects (Figure 38).

Figure 37. Channel Segment D: Active channel and floodplain connectivity and anthropogenic features

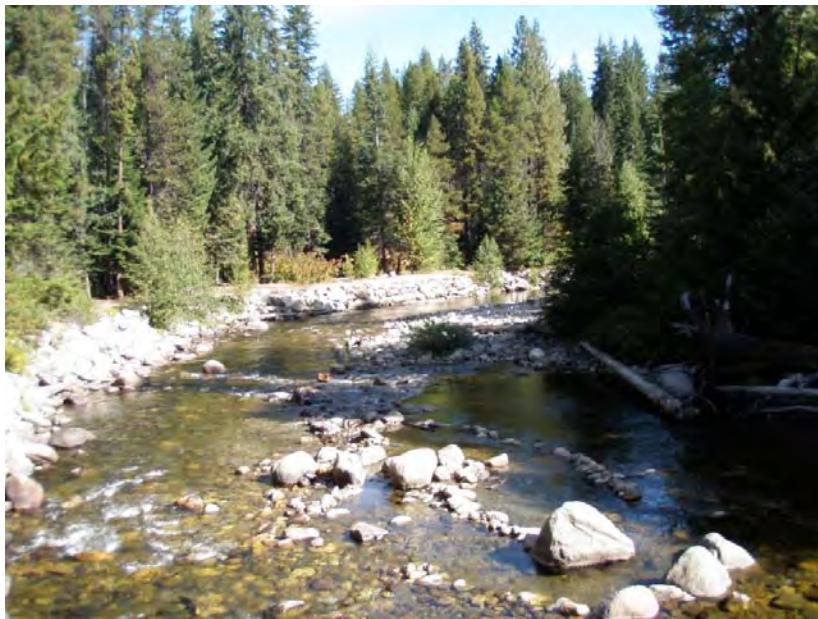
Figure 38. Channel Segment D: View looking from Nason Creek Campground Road bridge at riprap protecting campground along river left near RM 0.80. Lower Nason Creek, Wenatchee Subbasin, Washington – Bureau of Reclamation Photograph by E. Lyon, September 13, 2010.

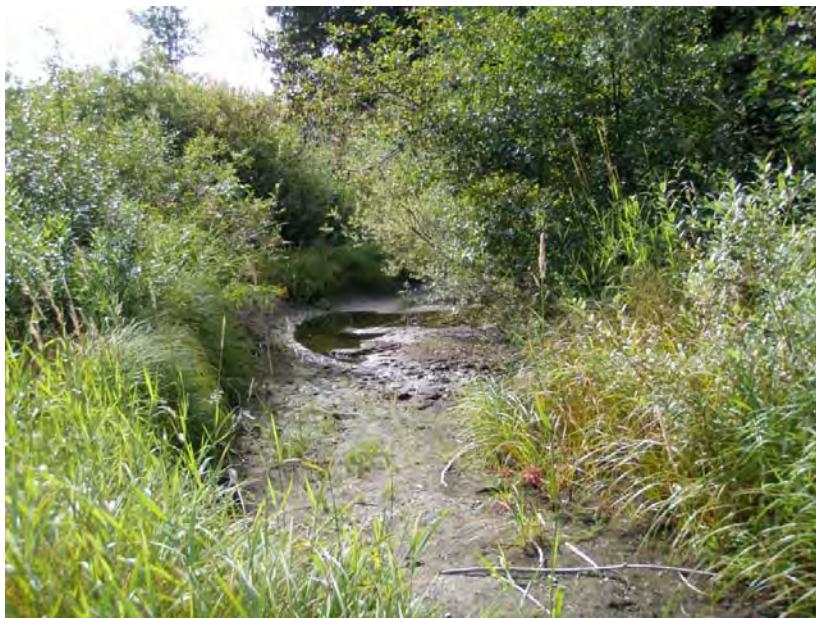
Four side channels were mapped totaling about 0.53 acres. Three of the side channels were gravel bar-type side channels that covered about 0.44 acres or 83 percent of available off-channel habitat (Table 34). The other side channel was classified as a floodplain-type side channel and covered about 0.09 acres or 17 percent of available off-channel habitat. This side channel (SC_0.13_L) was a spring-fed system where signs of beaver activity (i.e., chewed willows) were observed (Figure 42).

Figure 42. Channel Segment D: View looking upstream at spring-fed floodplain type side channel (SC_0.13_L) near RM 0.13. Lower Nason Creek, Wenatchee Subbasin, Washington – Bureau of Reclamation
Photograph by E. Lyon, September 16, 2010.

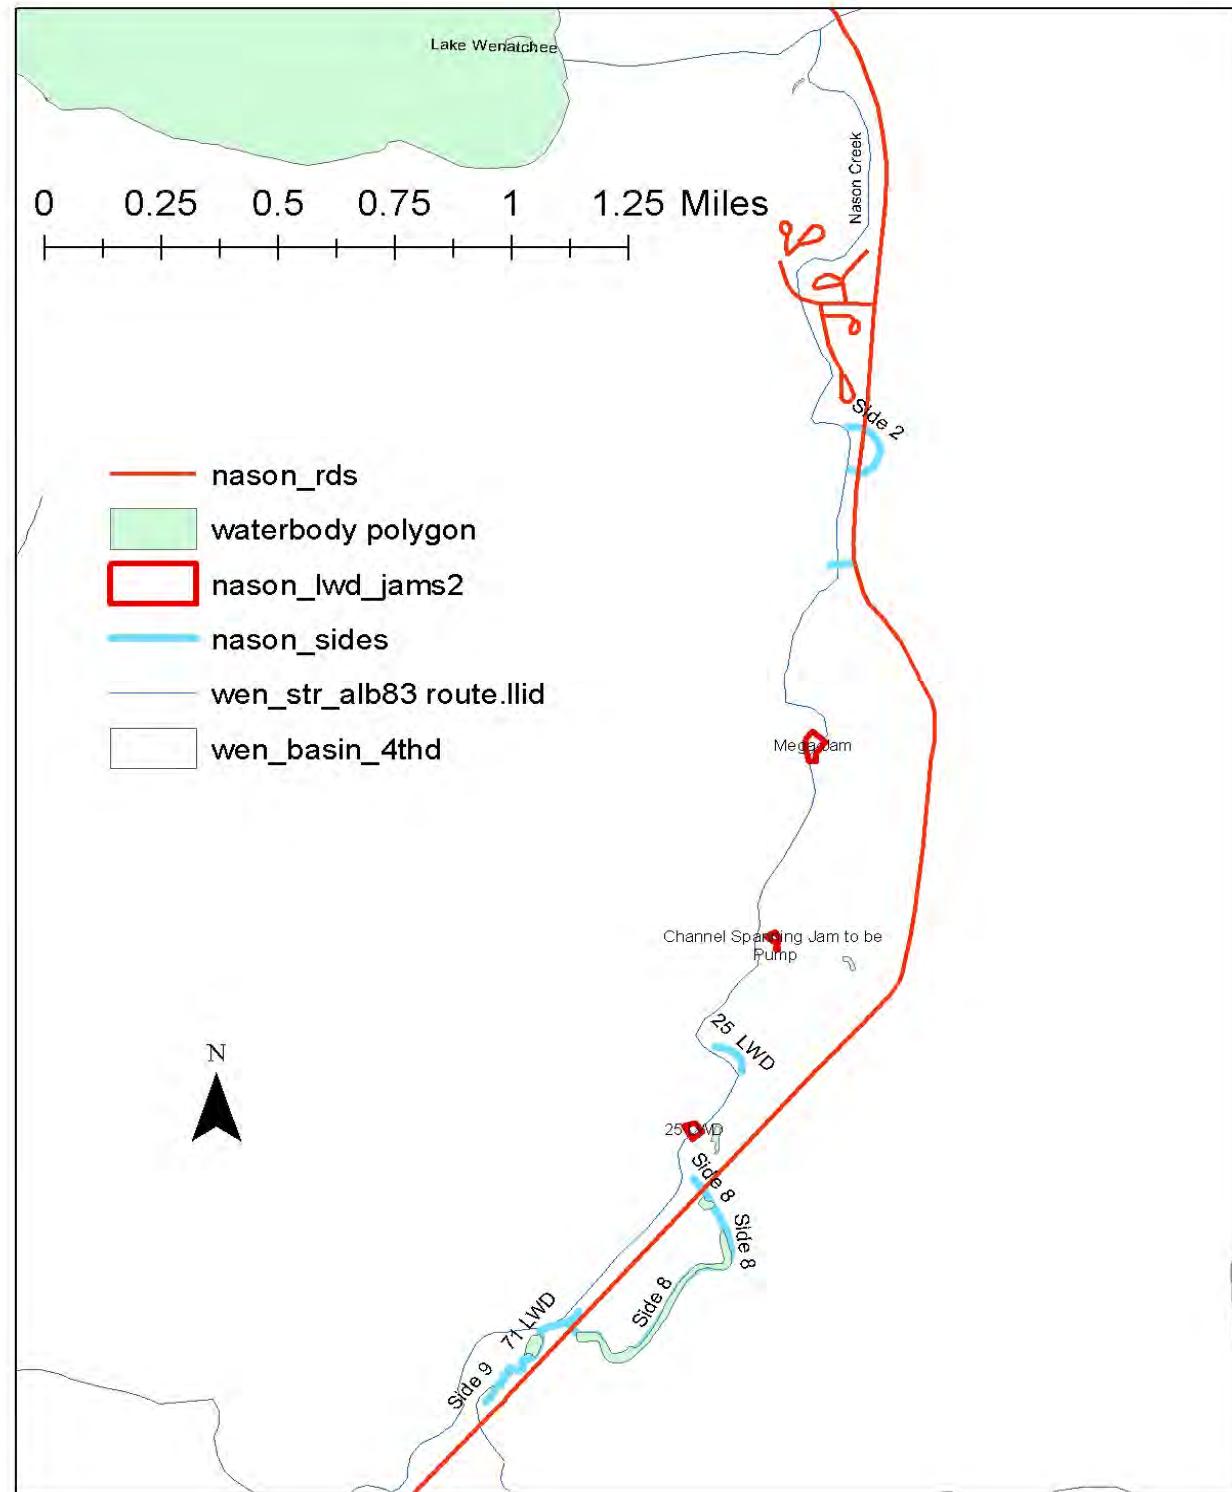
Note: The property owner of the land bordering the lwd jam labeled “Channel spanning jam to be” in Figure 1 (also labeled in the Arcmap project) should be contacted. There is an irrigation pump (labeled “Pump” in Figure 1 and Arcmap project) immediately upstream of the tangle of large channel spanning trees and many of the branches of the downed trees have already been trimmed off. We assume the property owner may be trimming branches to prevent pump damage or further property loss. Since the trees span the channel at a stream bend, further lwd accumulation and channel avulsion are likely to occur in the future if the downed trees remain in place. There may be an opportunity for the habitat committee to meet with the landowner and develop solutions that meet the landowner needs and maintain lwd function.

Figure 1. Map of 2010 surveyed portion of Nason Creek showing lwd accumulations, side channels and streamside roads.

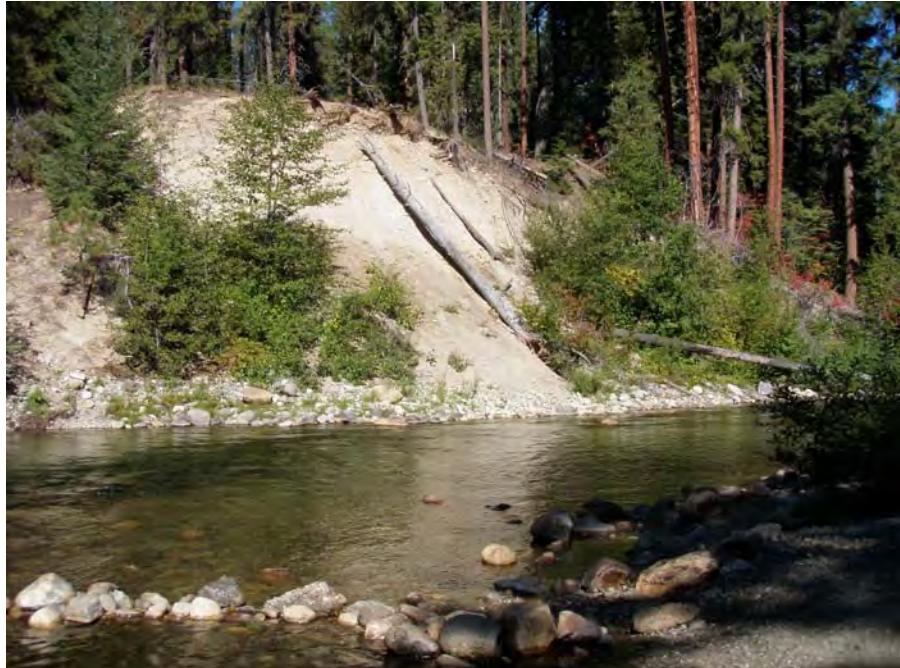
Photograph No. 1. View to the northwest looking downstream at a slide contributing sand and gravel.
Lower Nason Creek, Wenatchee Subbasin, Washington – Bureau of Reclamation Photograph by E. Lyon,
September 13, 2010.

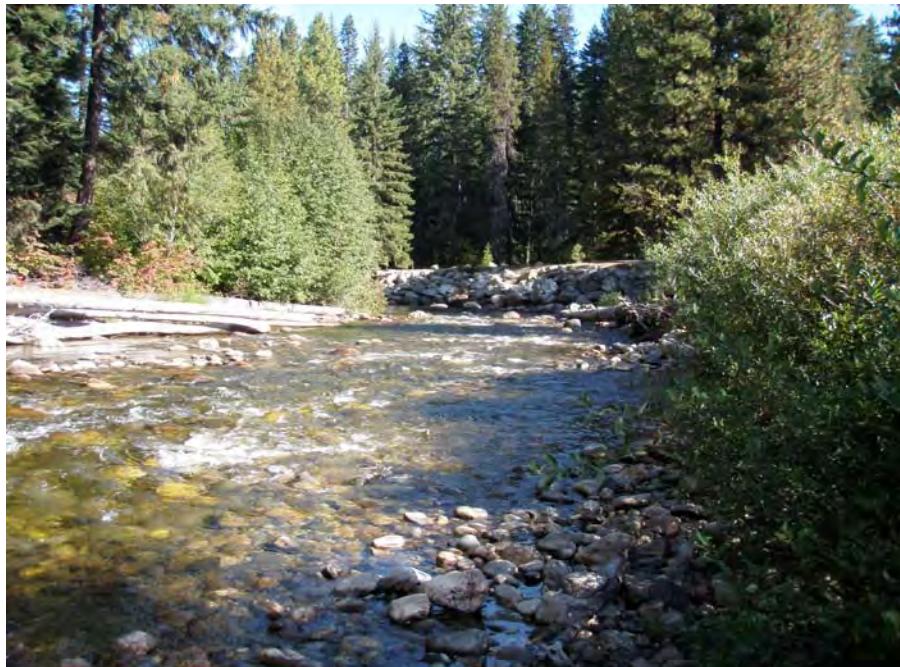
Photograph No. 2. View to the northeast looking downstream at riprap placed along river right. Lower Nason Creek, Wenatchee Subbasin, Washington – Bureau of Reclamation Photograph by E. Lyon, September 13, 2010.
