Lower Nason

Assessment of Geomorphic and Ecologic Indicators
Nason Creek, Wenatchee Subbasin

Chelan County, Washington

April 2011

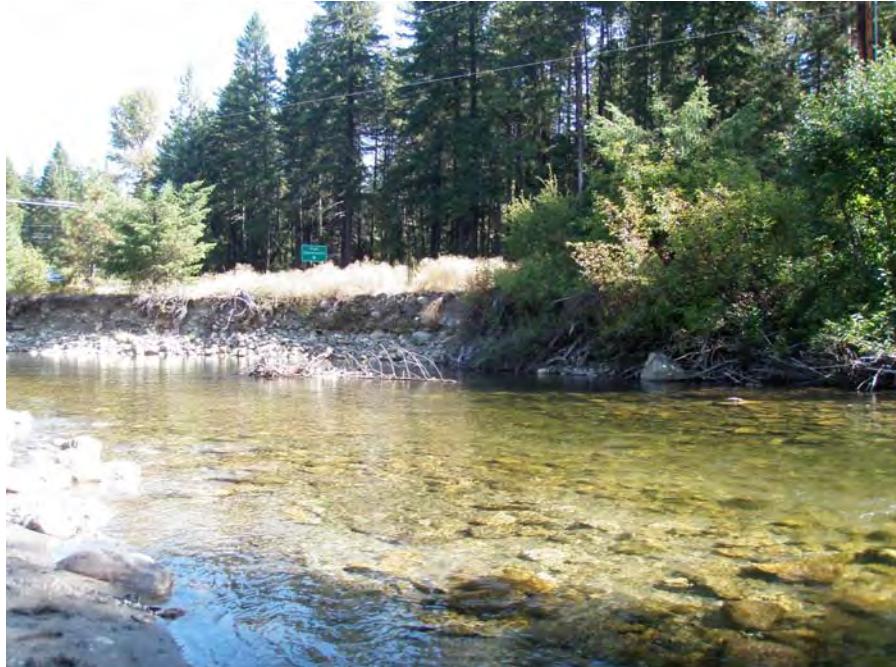
Photograph No. 5. View to the northeast looking at bank erosion along river right that could threaten improved road. Lower Nason Creek, Wenatchee Subbasin, Washington – Bureau of Reclamation Photograph by E. Lyon, September 13, 2010.

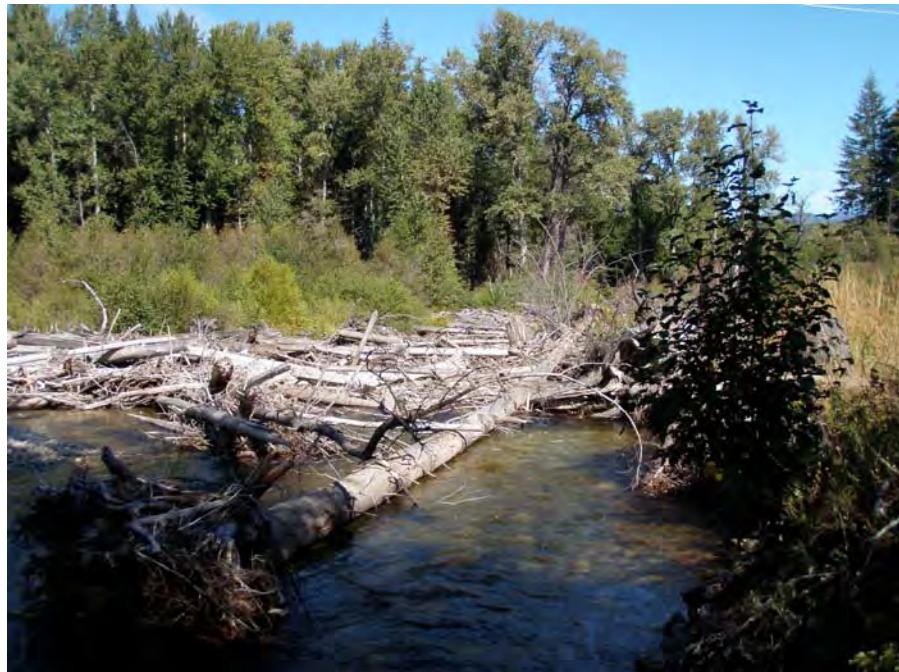
Photograph No. 9. View to the northeast looking downstream at large wood accumulating in side channel along river right. Lower Nason Creek, Wenatchee Subbasin, Washington – Bureau of Reclamation Photograph by E. Lyon, September 13, 2010.

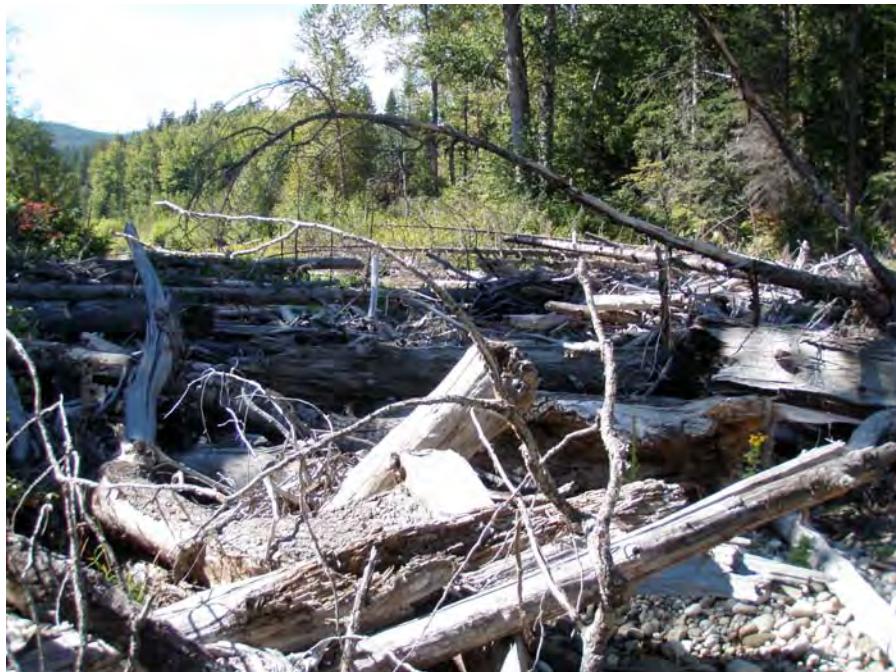
Photograph No. 11. View to the southwest looking upstream at large wood accumulation in a side channel along river right. Lower Nason Creek, Wenatchee Subbasin, Washington – Bureau of Reclamation Photograph by E. Lyon, September 13, 2010.

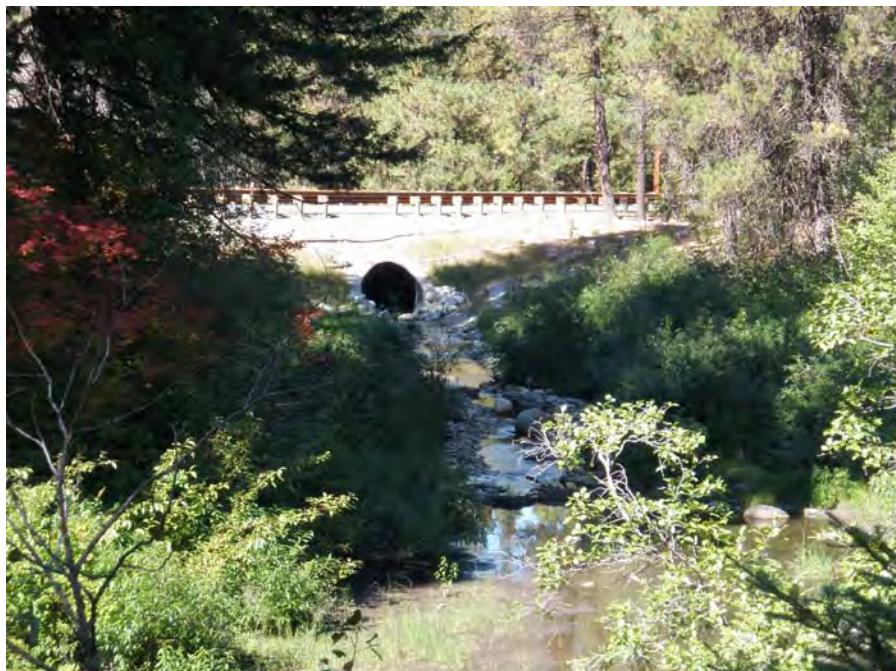
Photograph No. 12. View to the northwest looking downstream at a reconnected side channel through an improved road embankment along river right. Lower Nason Creek, Wenatchee Subbasin, Washington – Bureau of Reclamation Photograph by E. Lyon, September 13, 2010.

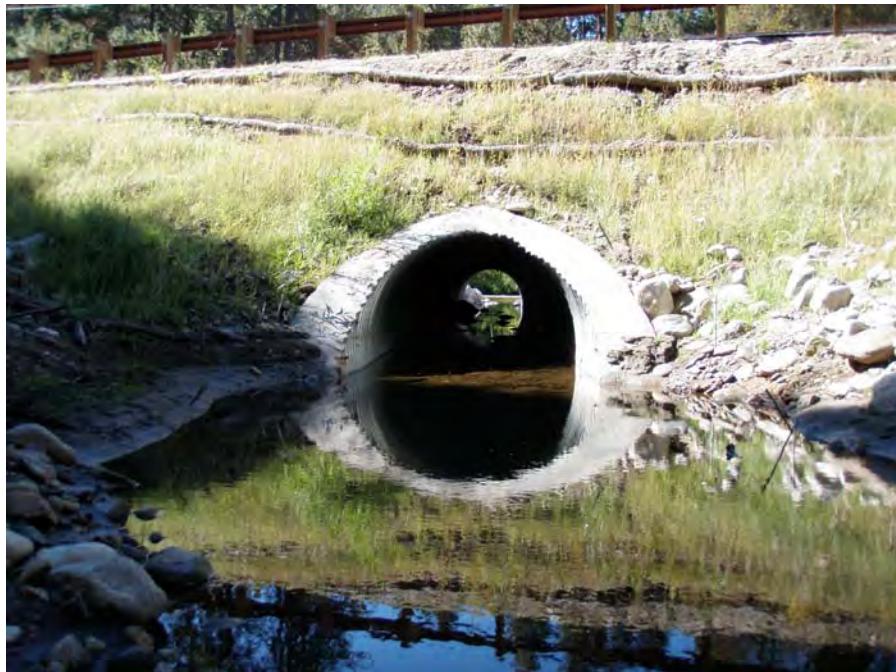
Photograph No. 13. View to the west looking upstream at a culvert placed through improved road embankment to reconnect side channel along river right. Lower Nason Creek, Wenatchee Subbasin, Washington – Bureau of Reclamation Photograph by E. Lyon, September 13, 2010.

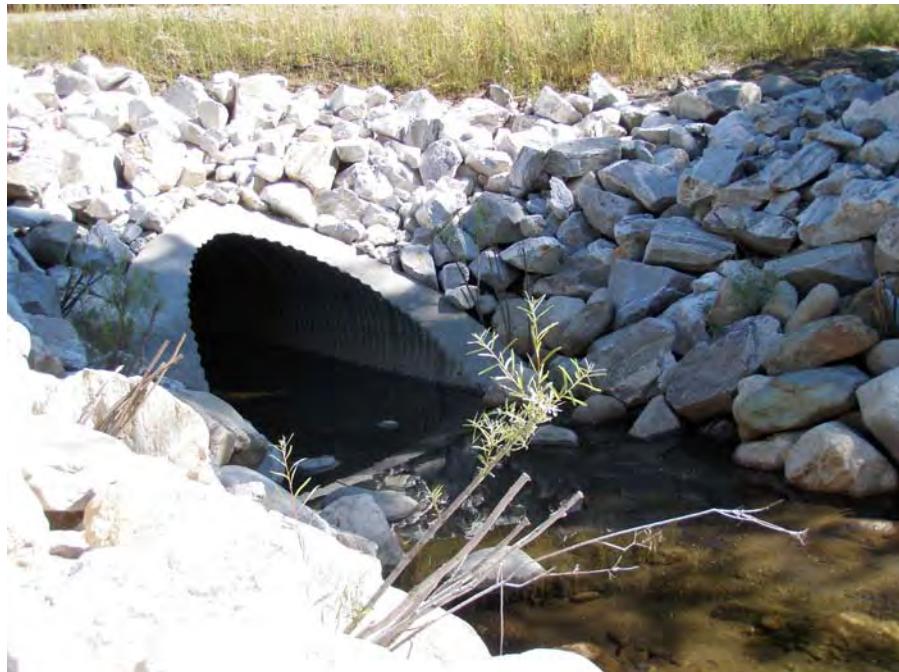
Photograph No. 15. View to the east looking downstream at culvert placed through improved road embankment that reconnects side channel. Lower Nason Creek, Wenatchee Subbasin, Washington – Bureau of Reclamation Photograph by E. Lyon, September 13, 2010.

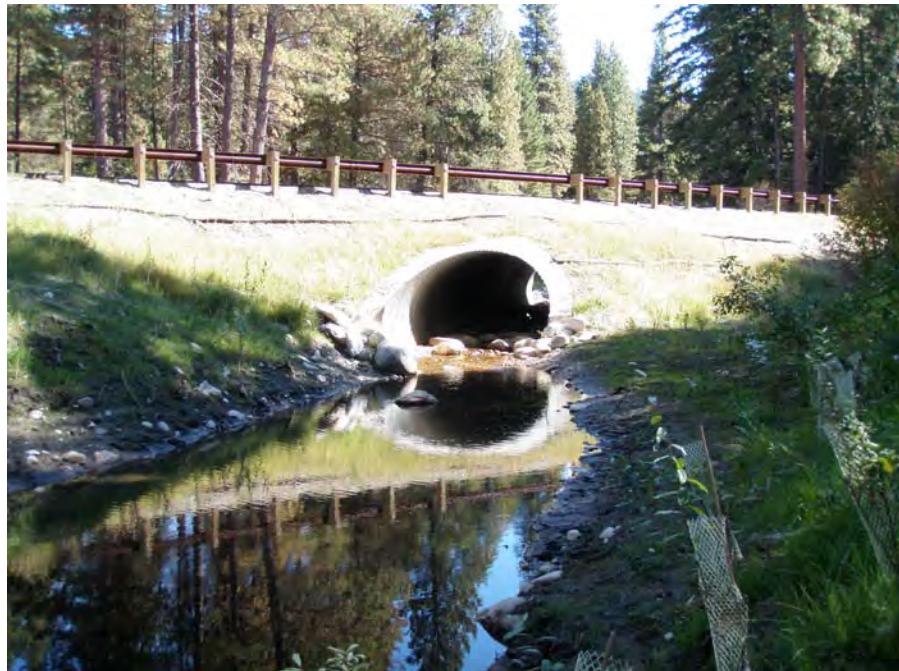
Photograph No. 16. View to the southeast looking upstream at culvert placed through improved road embankment that reconnects side channel. Lower Nason Creek, Wenatchee Subbasin, Washington – Bureau of Reclamation Photograph by E. Lyon, September 13, 2010.

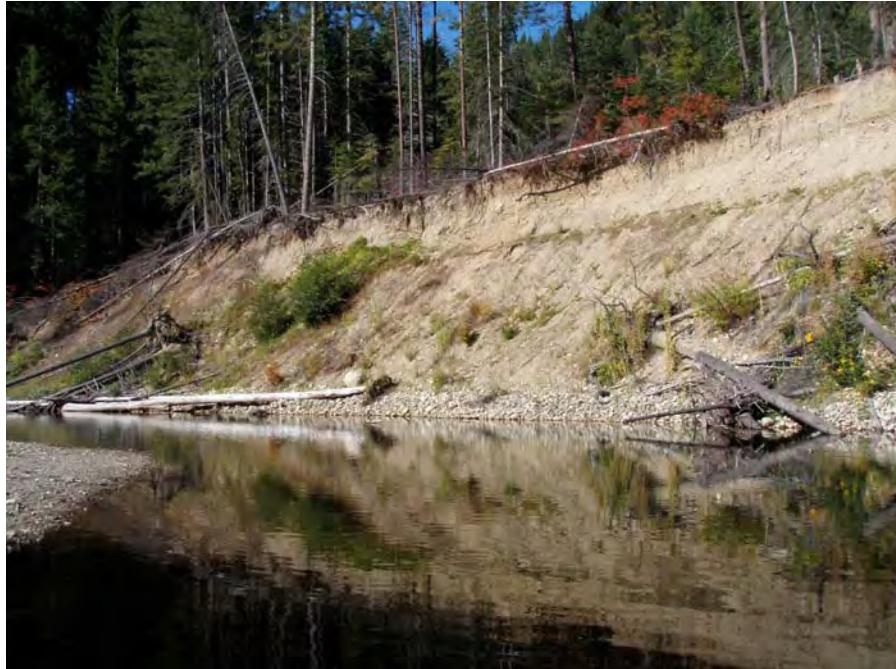
Photograph No. 23. View to the southwest looking upstream at an eroding glacial deposit overlying the Chumstick Formation along river left. Lower Nason Creek, Wenatchee Subbasin, Washington – Bureau of Reclamation Photograph by E. Lyon, September 14, 2010.

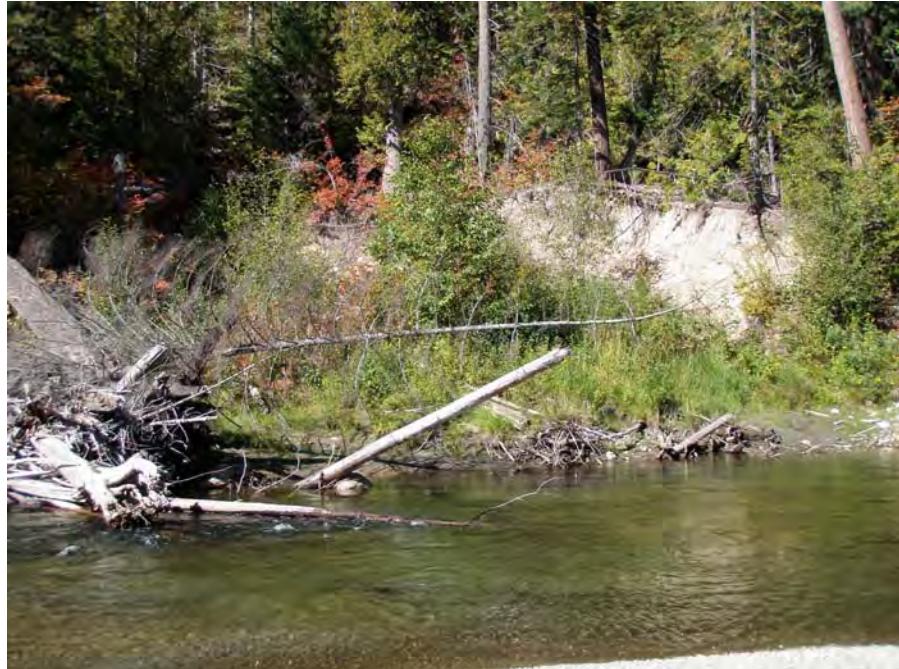
Photograph No. 29. View to the west looking at a landslide in glacial drift along river left. Lower Nason Creek, Wenatchee Subbasin, Washington – Bureau of Reclamation Photograph by E. Lyon, September 14, 2010.

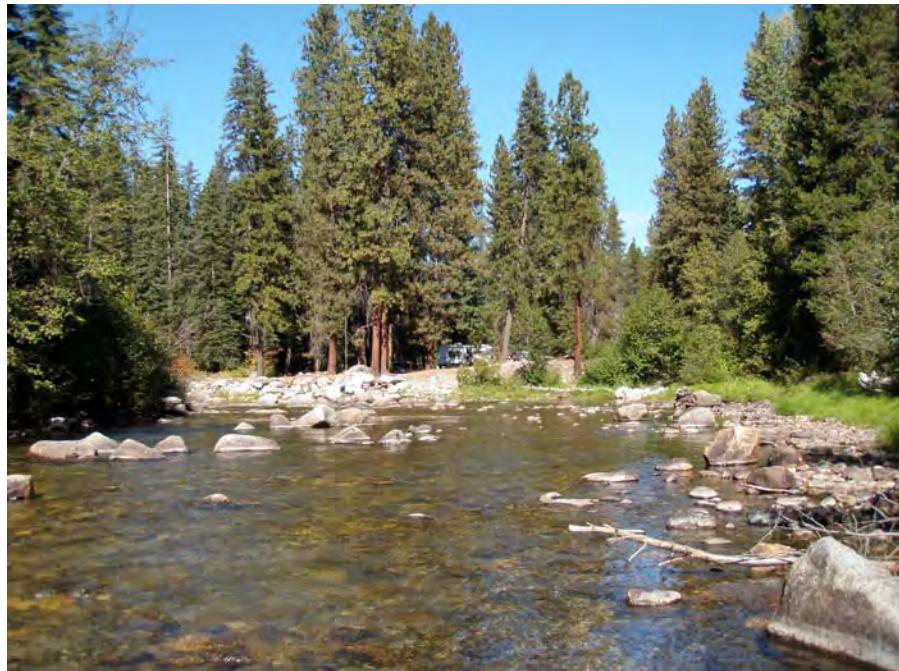
Photograph No. 34. View to the north looking downstream at pocket-pool habitat created by boulders. Also note riprap placed on the outside bend along river right in the distance. Lower Nason Creek, Wenatchee Subbasin, Washington – Bureau of Reclamation Photograph by E. Lyon, September 14, 2010.

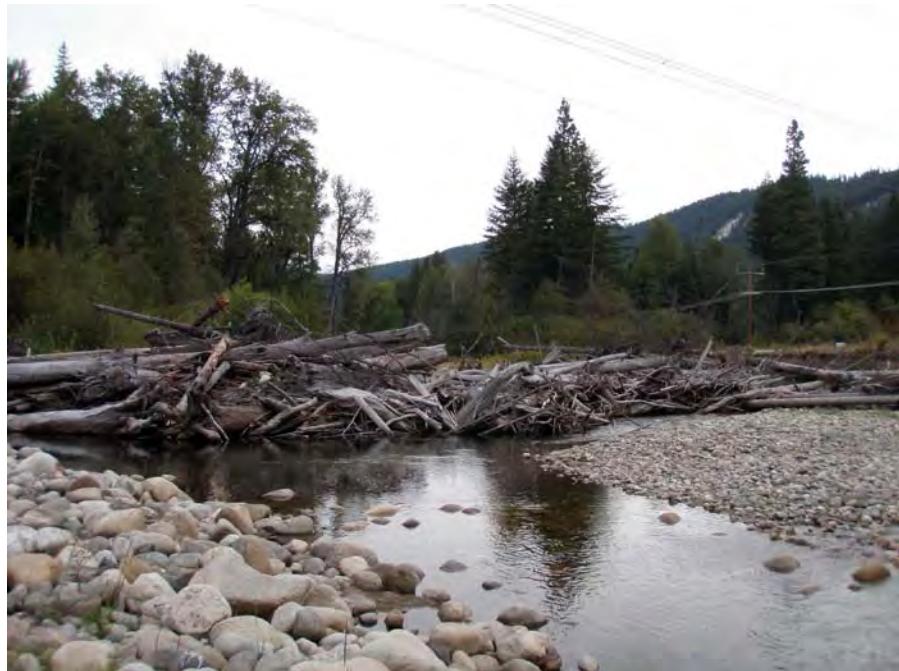
Photograph No. 36. View to the northeast looking downstream at large wood complex at head of side channel that may be contributing to bank erosion along river right. Lower Nason Creek, Wenatchee Subbasin, Washington – Bureau of Reclamation Photograph by E. Lyon, September 15, 2010.

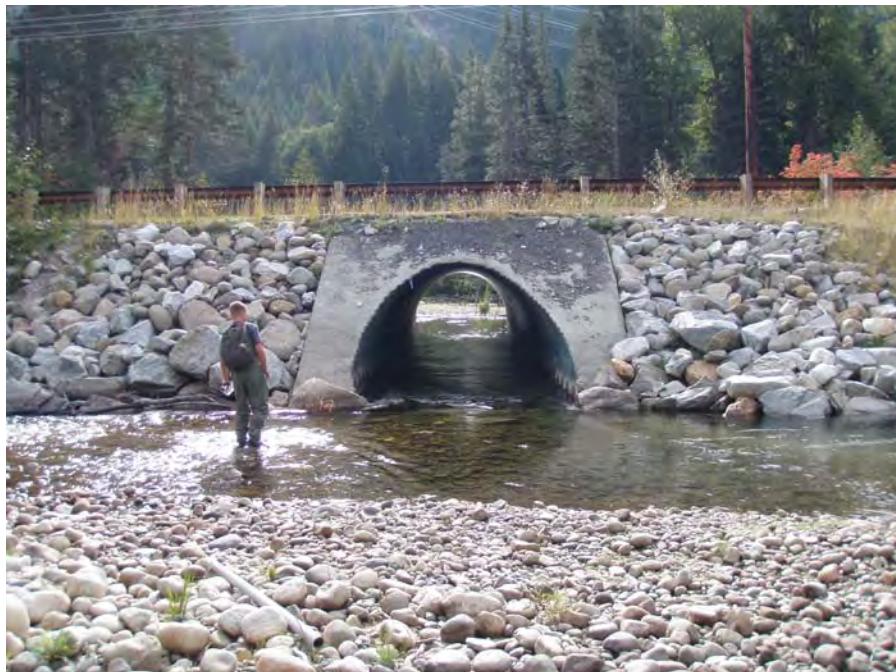
Photograph No. 42. View to the east looking at culvert through improved road embankment that reconnects historic channel path. Lower Nason Creek, Wenatchee Subbasin, Washington – Bureau of Reclamation Photograph by E. Lyon, September 15, 2010.

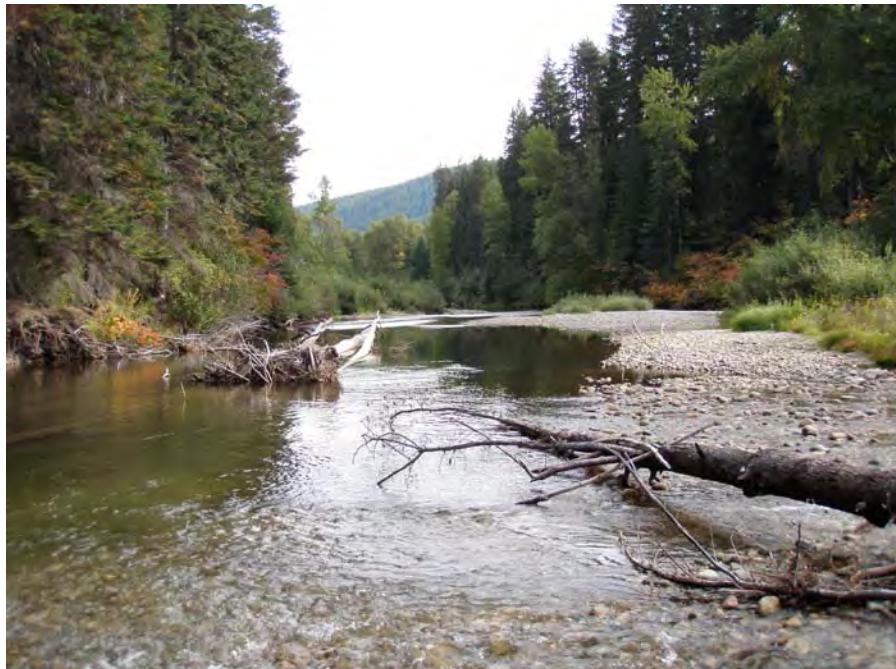
Photograph No. 44. View to the north looking at middle channel scour pool forced by large wood. Lower Nason Creek, Wenatchee Subbasin, Washington – Bureau of Reclamation Photograph by E. Lyon, September 15, 2010.

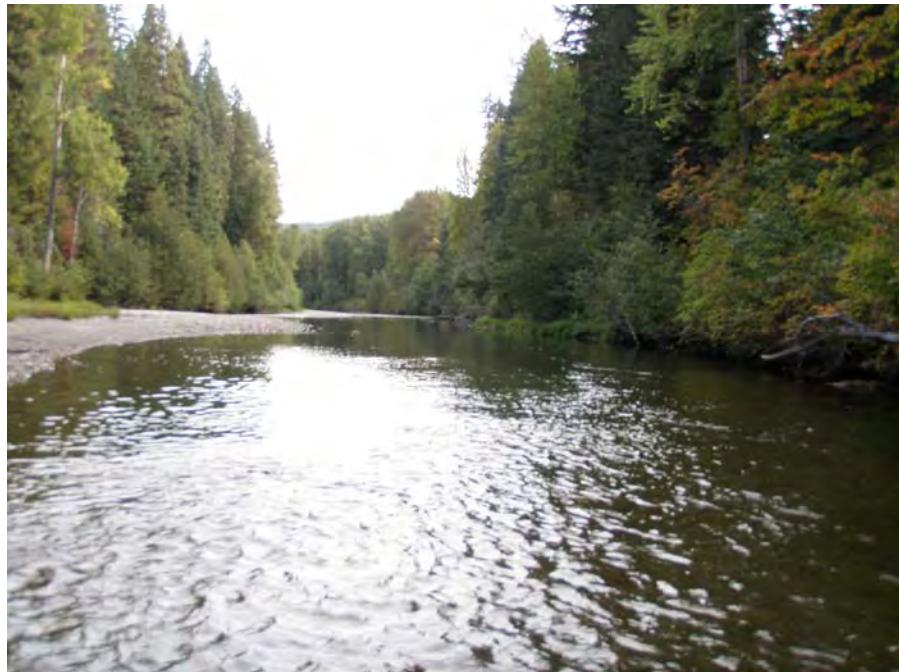
Photograph No. 45. View to the northeast looking at middle channel scour pool. Lower Nason Creek, Wenatchee Subbasin, Washington – Bureau of Reclamation Photograph by E. Lyon, September 15, 2010.

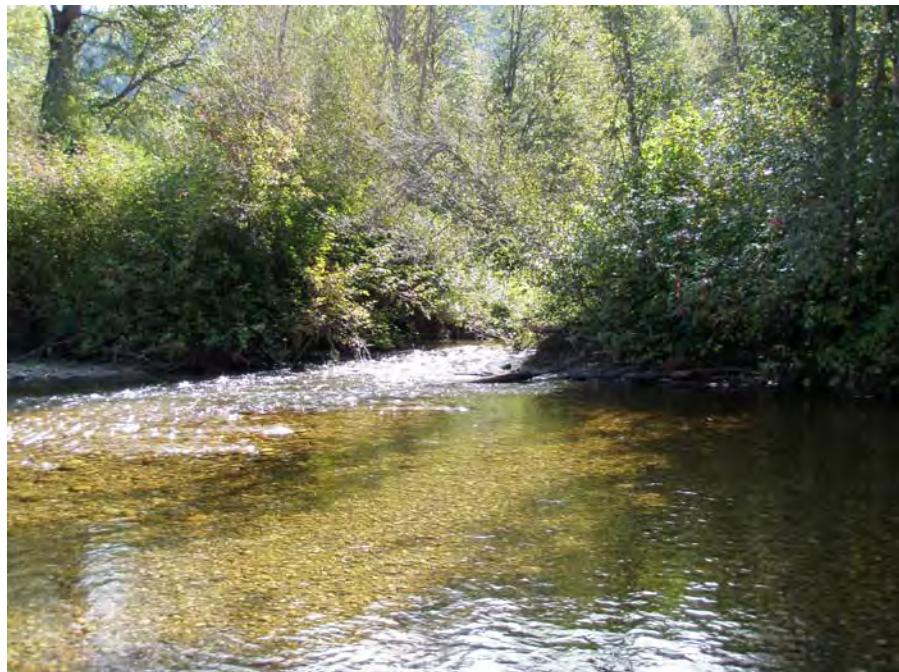
Photograph No. 46. View to the east looking at outlet of reconnected side channel. Lower Nason Creek, Wenatchee Subbasin, Washington – Bureau of Reclamation Photograph by E. Lyon, September 15, 2010.

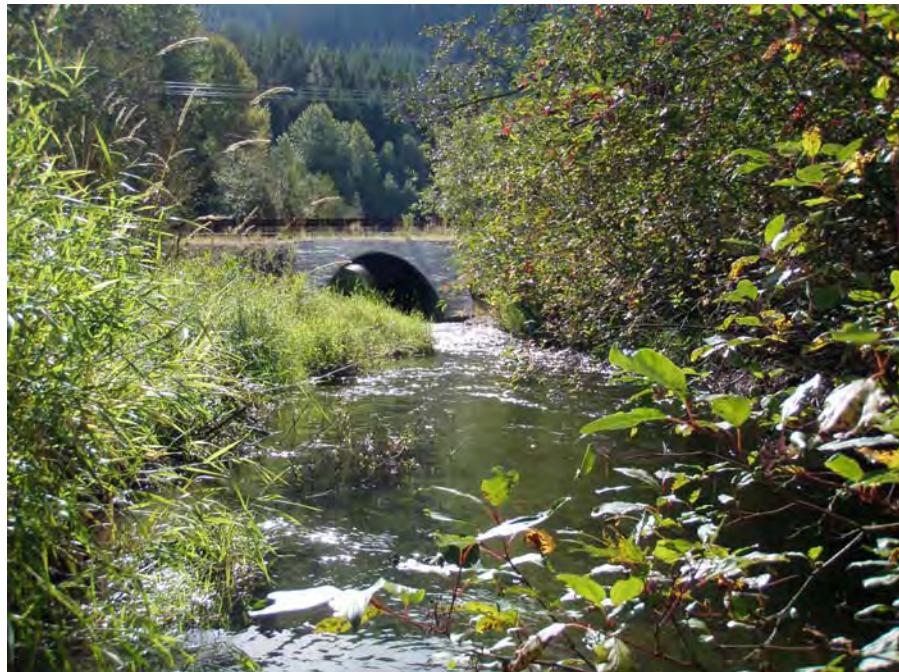
Photograph No. 47. View to the east looking upstream at culvert through improved road embankment that reconnects historic channel path. Lower Nason Creek, Wenatchee Subbasin, Washington – Bureau of Reclamation Photograph by E. Lyon, September 15, 2010.

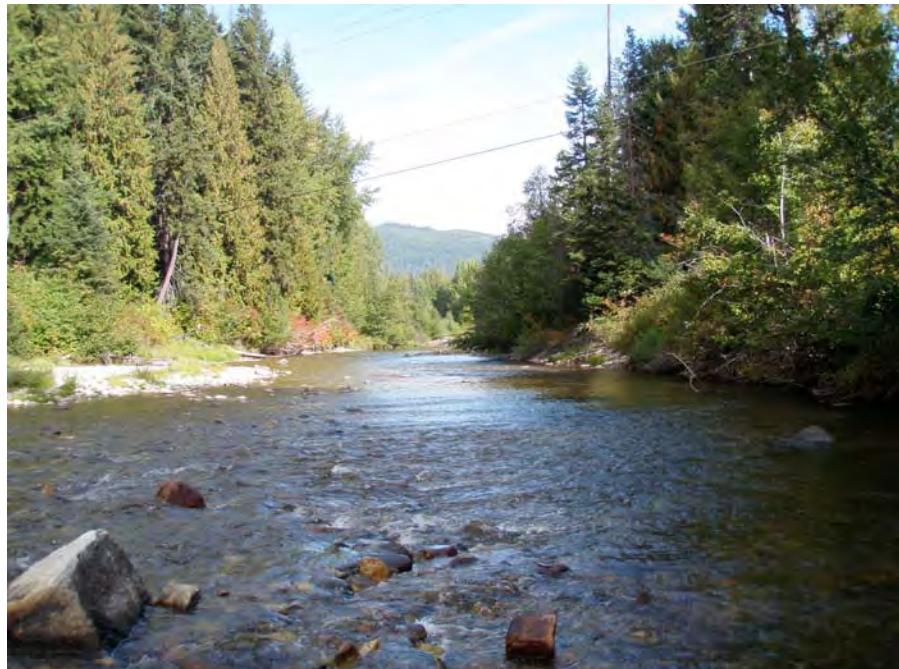
Photograph No. 48. View to the north looking downstream at riffle/pool sequence. Lower Nason Creek, Wenatchee Subbasin, Washington – Bureau of Reclamation Photograph by E. Lyon, September 16, 2010.

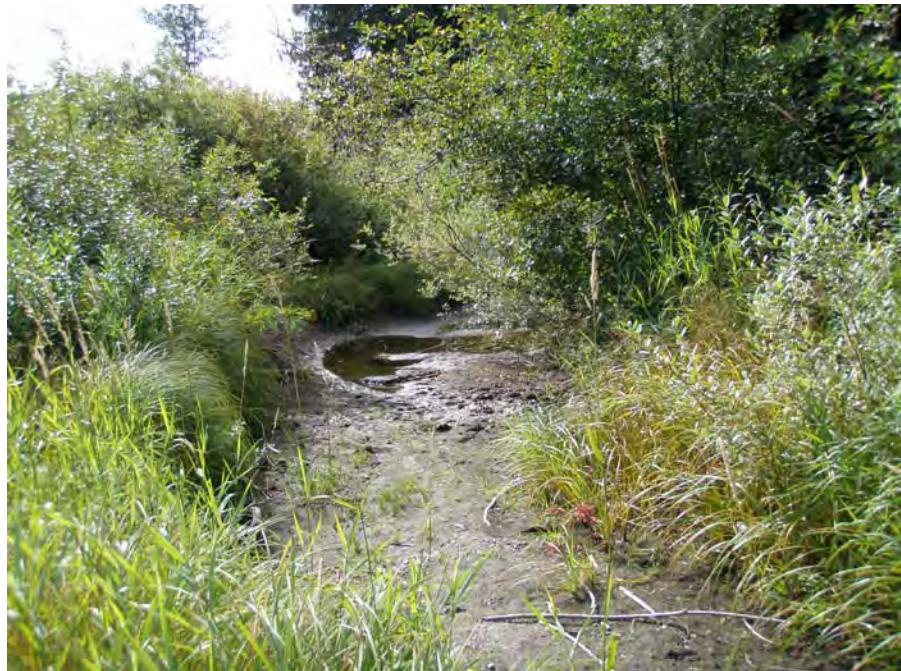
Photograph No. 50. View to the south looking upstream at developing floodplain-type side channel. Lower Nason Creek, Wenatchee Subbasin, Washington – Bureau of Reclamation Photograph by E. Lyon, September 16, 2010.

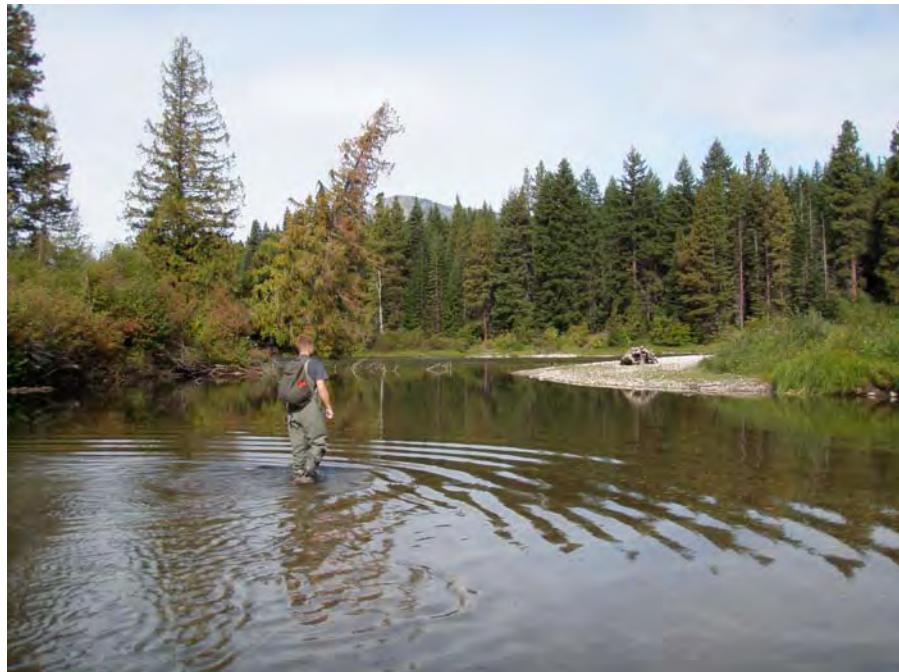
Photograph No. 51. View to the north looking downstream at the confluence with the Wenatchee River.
Lower Nason Creek, Wenatchee Subbasin, Washington – Bureau of Reclamation Photograph by E. Lyon,
September 16, 2010.

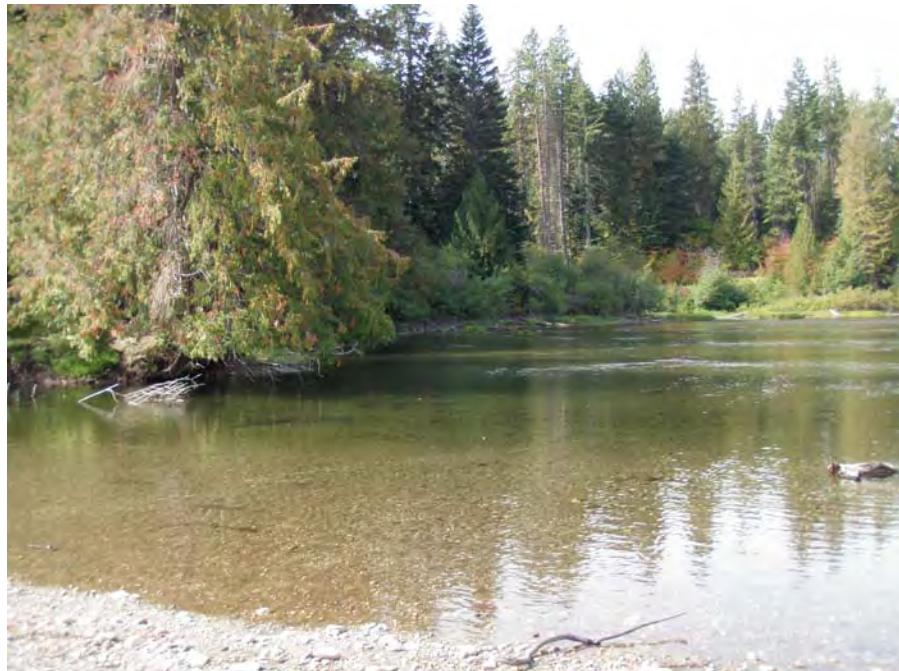
Photograph No. 52. View to the west looking upstream along the Wenatchee River at the confluence with Nason Creek. Lower Nason Creek, Wenatchee Subbasin, Washington – Bureau of Reclamation Photograph by E. Lyon, September 16, 2010.

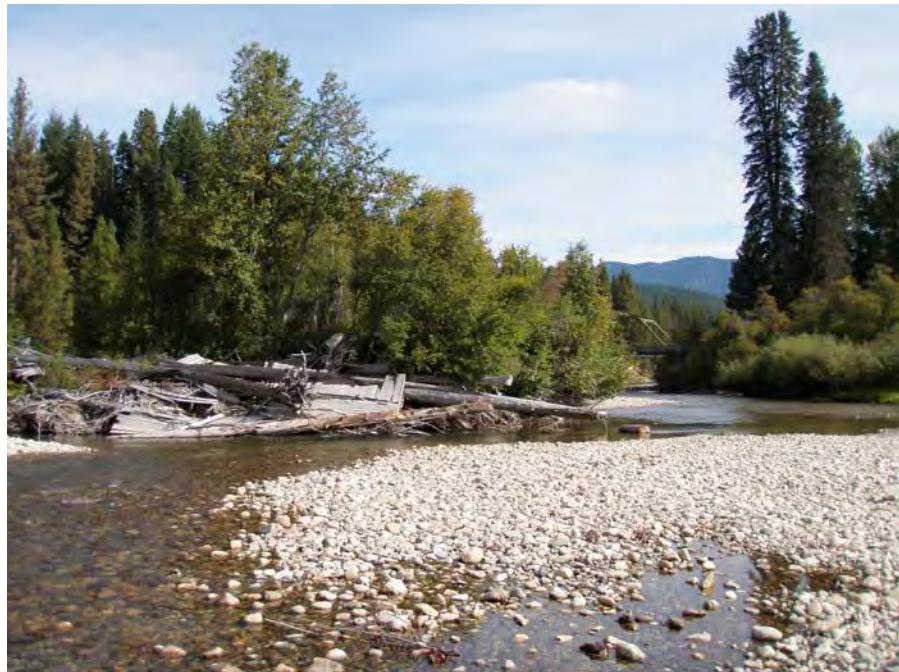
Photograph No. 53. View to the northeast looking at large wood complex along the Wenatchee River near the confluence with Nason Creek. Lower Nason Creek, Wenatchee Subbasin, Washington – Bureau of Reclamation Photograph by E. Lyon, September 16, 2010.

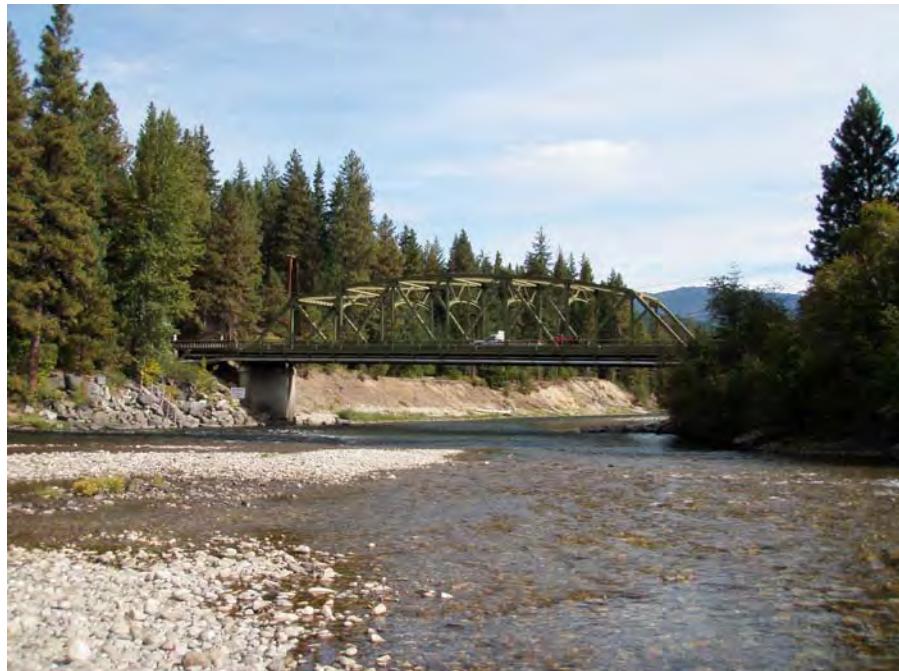
Photograph No. 54. View to the northeast looking at bridge crossing over the Wenatchee River downstream of the confluence with Nason Creek. Lower Nason Creek, Wenatchee Subbasin, Washington – Bureau of Reclamation Photograph by E. Lyon, September 16, 2010.

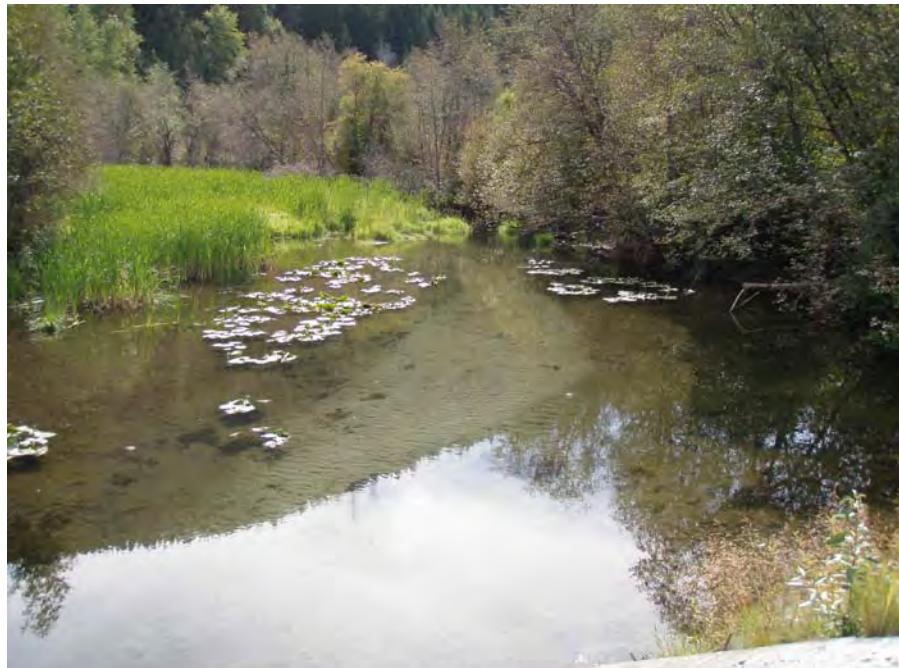
Photograph No. 55. View to the southeast looking upstream at reconnected historic channel path. Lower Nason Creek, Wenatchee Subbasin, Washington – Bureau of Reclamation Photograph by E. Lyon, September 16, 2010.

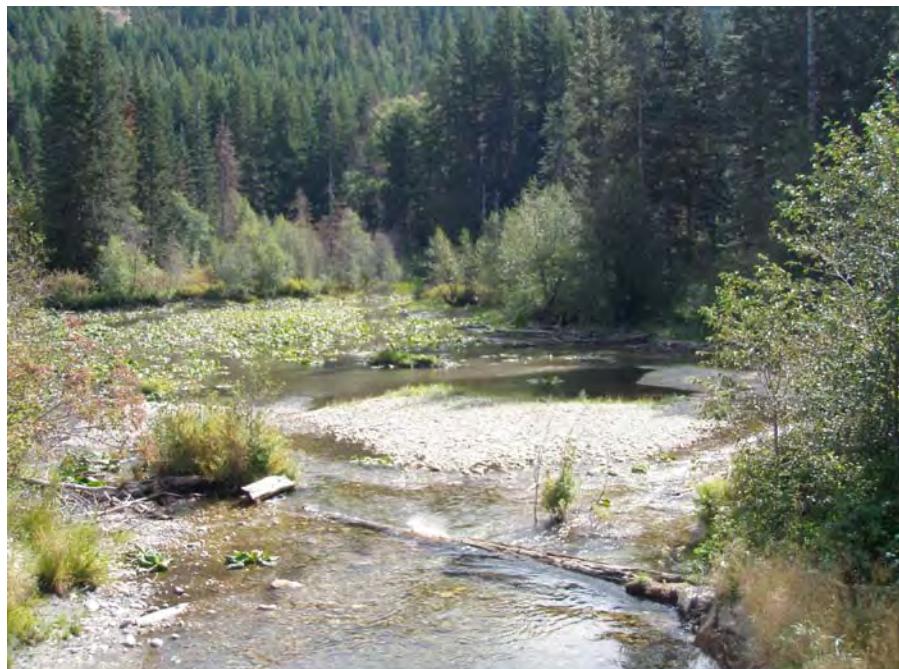
Photograph No. 56. View to the east looking downstream at reconnected historic channel path. Lower Nason Creek, Wenatchee Subbasin, Washington – Bureau of Reclamation Photograph by E. Lyon, September 16, 2010.

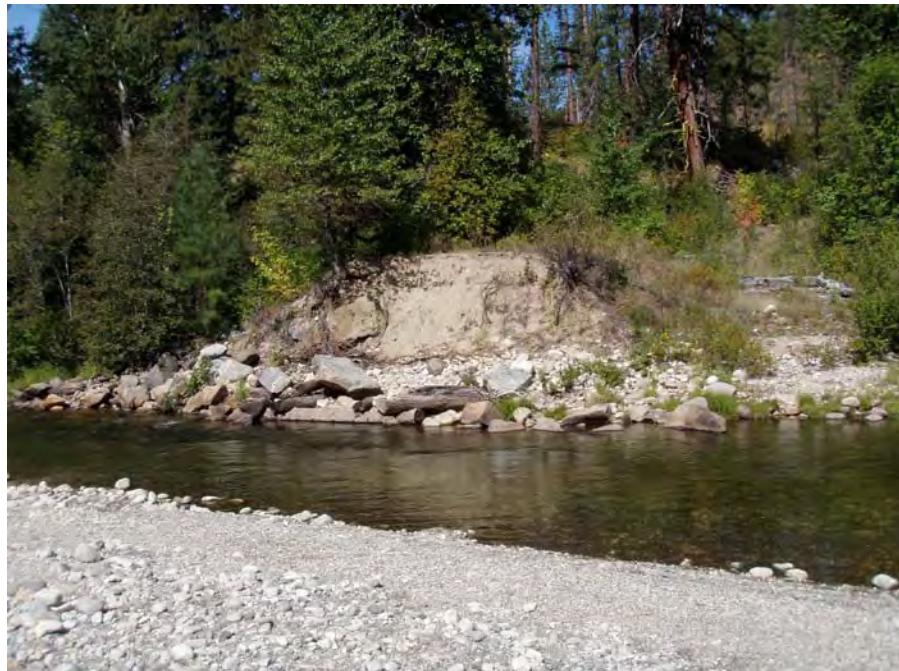
Photograph No. 58. View to the northwest looking at historic bridge abutment along river left. Lower Nason Creek, Wenatchee Subbasin, Washington – Bureau of Reclamation Photograph by E. Lyon, September 16, 2010.

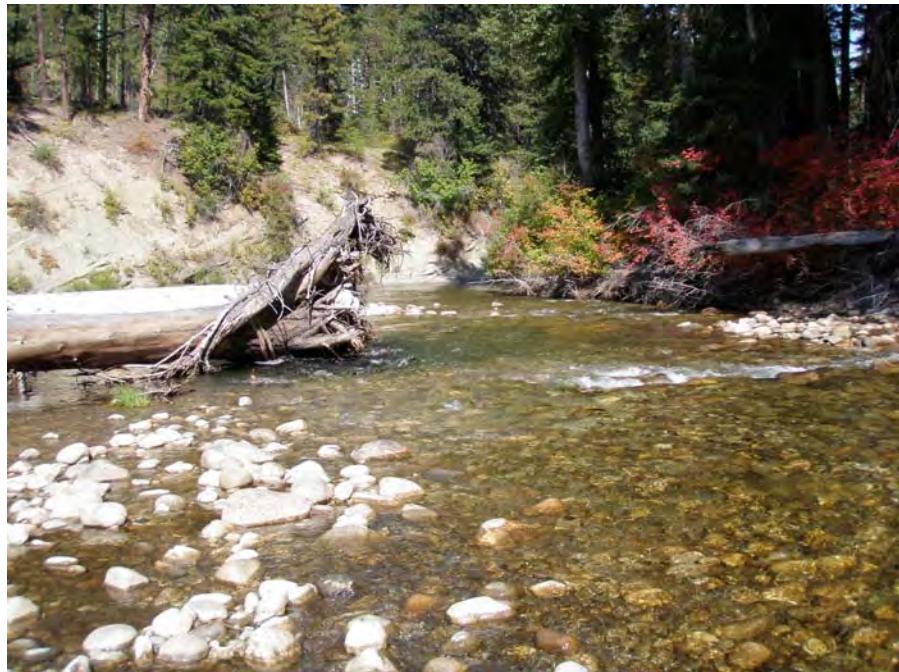
Photograph No. 59. View to the north looking downstream at large wood and riffle. Lower Nason Creek, Wenatchee Subbasin, Washington – Bureau of Reclamation Photograph by E. Lyon, September 16, 2010.

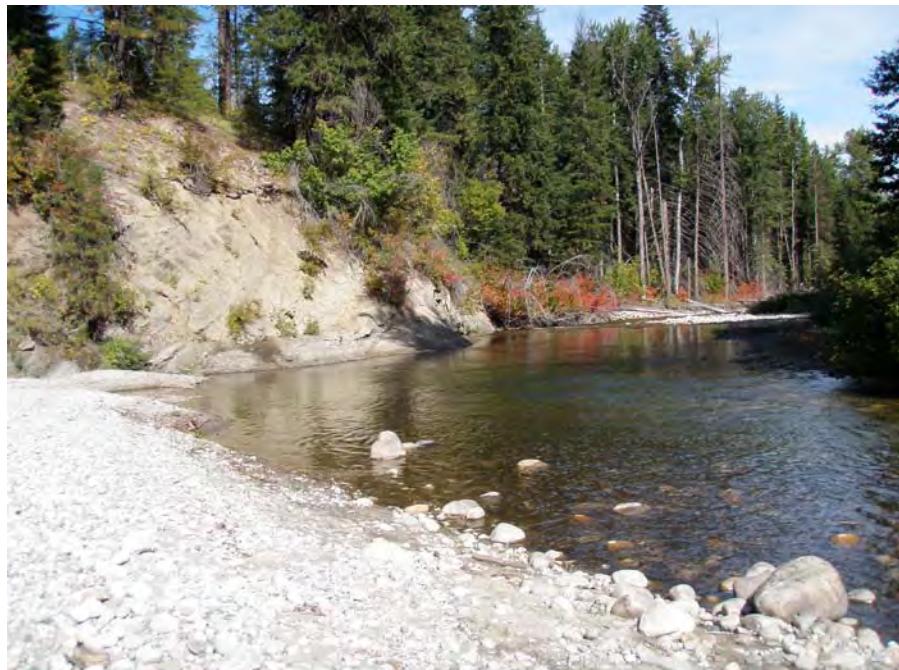
Photograph No. 60. View to the north looking downstream at bedrock (Chumstick Formation (Tc)) that restricts both lateral and vertical channel migration. Lower Nason Creek, Wenatchee Subbasin, Washington – Bureau of Reclamation Photograph by E. Lyon, September 16, 2010.

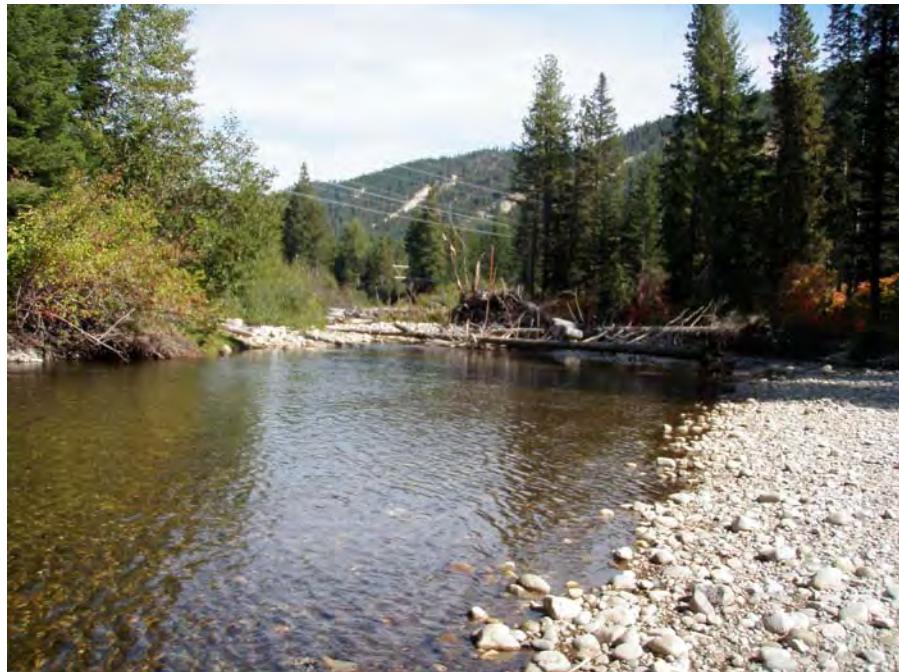
Photograph No. 61. View to the northeast looking downstream at large wood complex in the distance.
Lower Nason Creek, Wenatchee Subbasin, Washington – Bureau of Reclamation Photograph by E. Lyon,
September 16, 2010.

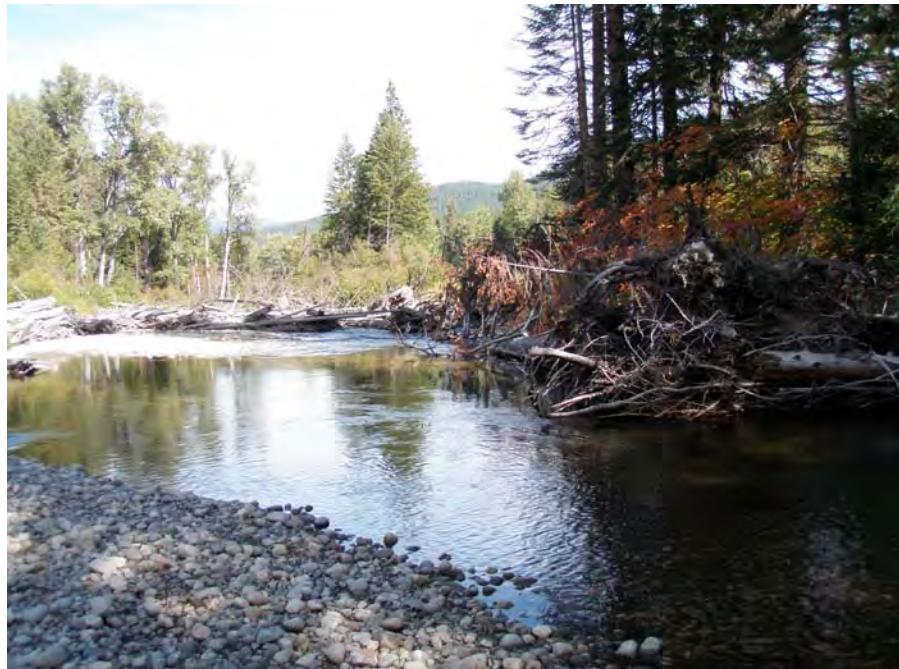
Photograph No. 62. View to the northeast looking downstream at lateral scour pool along river right and
large wood complex. Lower Nason Creek, Wenatchee Subbasin, Washington – Bureau of Reclamation
Photograph by E. Lyon, September 16, 2010.
