Upper Methow River Reach Assessment

River Miles 61 - 80

SUBMITTED TO
Yakama Nation Fisheries

FINAL - DECEMBER 2015

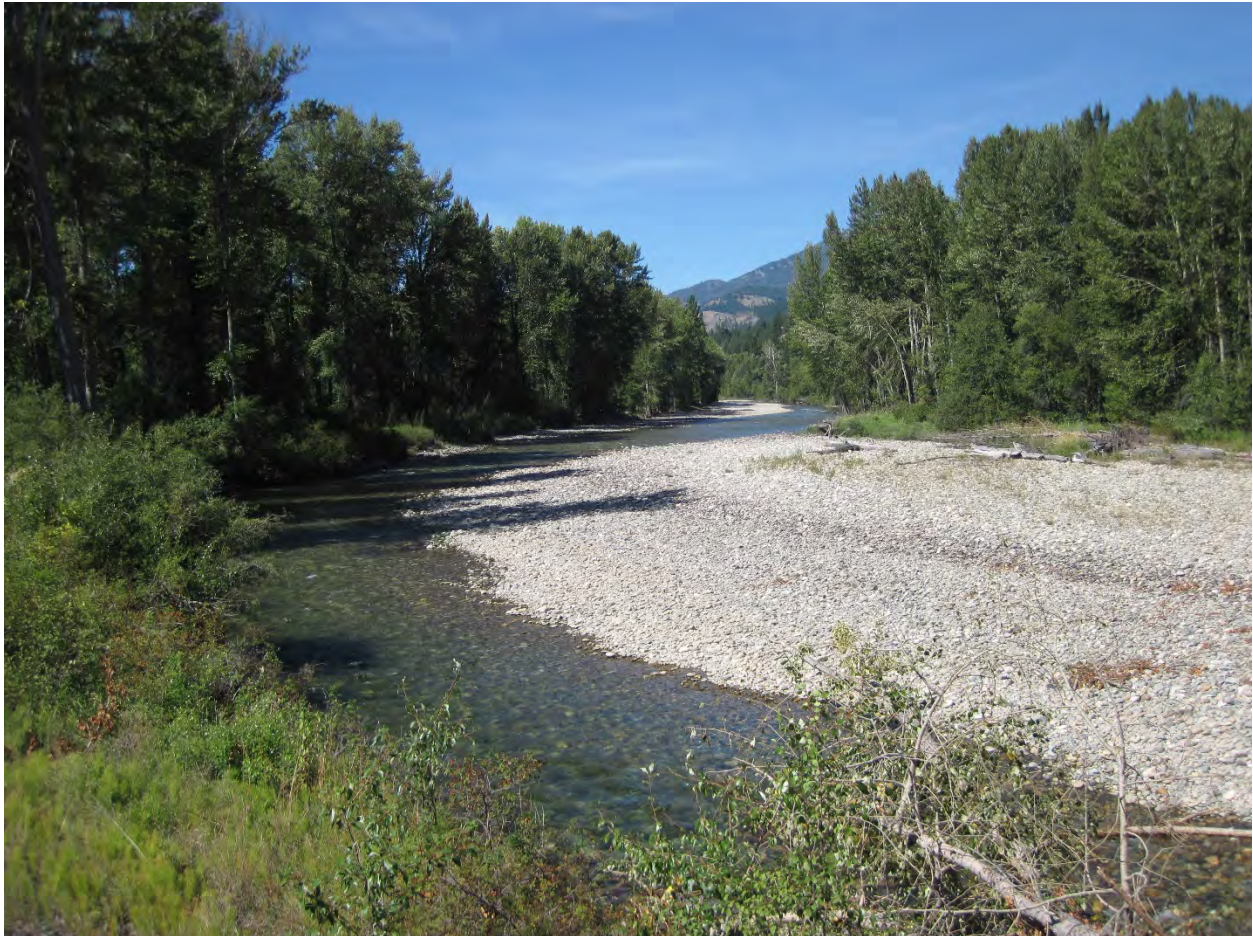
The banks of the channel in Reach 1 are vegetated except at riprapped banks and at the cleared residential site at RM 61.35. All floodplain surfaces host maturing forests (contains trees that are 50 years or older) composed primarily of a mix of cottonwood, aspen, fir, pine, and cedar (Figure 29). These surfaces have an understory dominated by grasses and forbs. Along the banks of the channel, mature trees offer shade and nutrients where they have established. However, the width of the channel limits the percent of water surface that receives shade. The presence of sparse tree stumps and the reduced complexity in the understory vegetation suggest that the west side floodplain was thinned or logged and cleared of underbrush within the last 100 years (Figure 30). A few pine trees have established within the other vegetation on the higher alluvial terrace surfaces adjacent to the channel. Sparse patches of willow and dogwood have taken root between the angular boulders near the channel along the riprapped embankments at the road and bridge.

Figure 29. Photo of channel and varied vegetation in Reach 1 – looking upstream from RM 61.2. (9/5/2014)

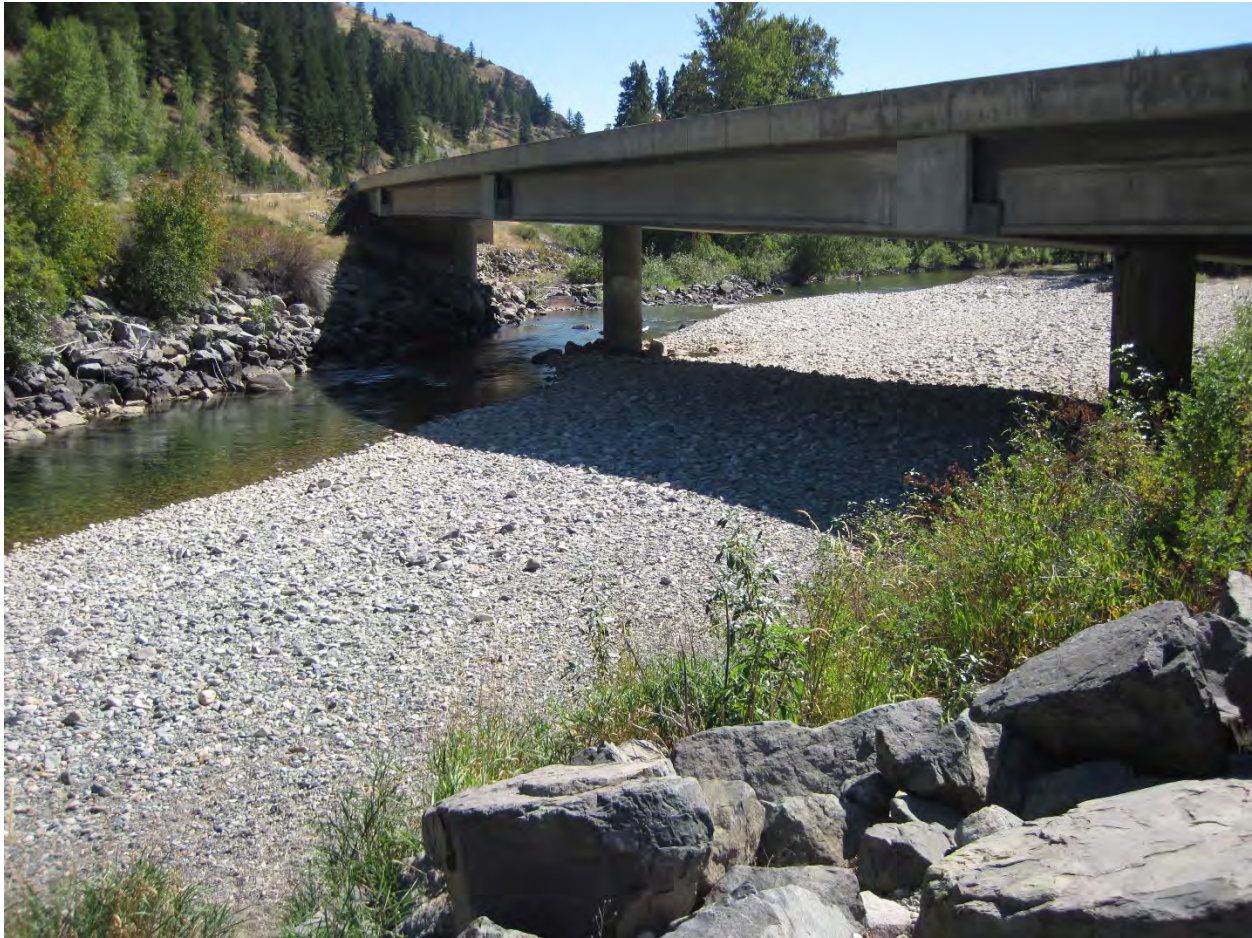
Loss of floodplain function has occurred in the lower portion of Reach 1. The construction of Highway 20 and the Weeman Bridge crossing has resulted in unnatural constriction of the floodplain at the downstream border of the reach. Floodplain scarring and the raised road grade of Highway 20 indicate that approximately 1,000 feet of historical floodplain upstream of the bridge and approximately 2,000 feet of historical floodplain downstream of the bridge has been disconnected. This amounts to approximately 55 acres of disconnected floodplain habitat. These impacts reduce floodplain inundation, induce channel incision, and reduce the formation and long-term availability of off-channel rearing habitats that are created by channel migration processes (e.g. side-channels, alcoves, and oxbow wetlands). The right bank – immediately upstream and at the bridge crossing – has been raised. Large, angular boulder riprap that reinforces both banks was placed to restrict lateral channel migration and to protect the bridge and its abutments (Figure 32). The bridge crossing locks the channel in place along the naturally confining hillslopes on river-left. The bridge's two middle piers interact with channel flow that today results in scour on channel left and bar development on river-right.

Figure 32. Weeman Bridge and the associated riprapped banks at RM 61.15. (9/5/2014)

Recommended actions in Reach 1 are focused primarily on increasing mainstem channel complexity as well as mitigating for the impacts of bank armoring and the effects of the Weeman Bridge and Highway 20 road fill on floodplain connectivity and off-channel habitat. Main channel complexity can be addressed by adding log jams to mid-channel locations at the upstream end of the reach to encourage split flow conditions, and adding large wood to channel margins to enhance complexity along existing bank protection features (i.e. riprap that is currently protecting infrastructure). Channel margin jams are suggested along river-right upstream from the Weeman Bridge to reduce the need for additional bank hardening measures for bridge protection. Restoration objectives also include addressing, or at least mitigating for, the floodplain disconnection associated with the Weeman Bridge and the associated Highway 20 road fill. This may include measures to enhance flood flow through the road prism (e.g. adding culverts or bridges) and/or off-channel habitat enhancement in the river-right floodplain upstream and downstream of the crossing to create floodplain rearing habitat that does not exist due to floodplain disconnection.

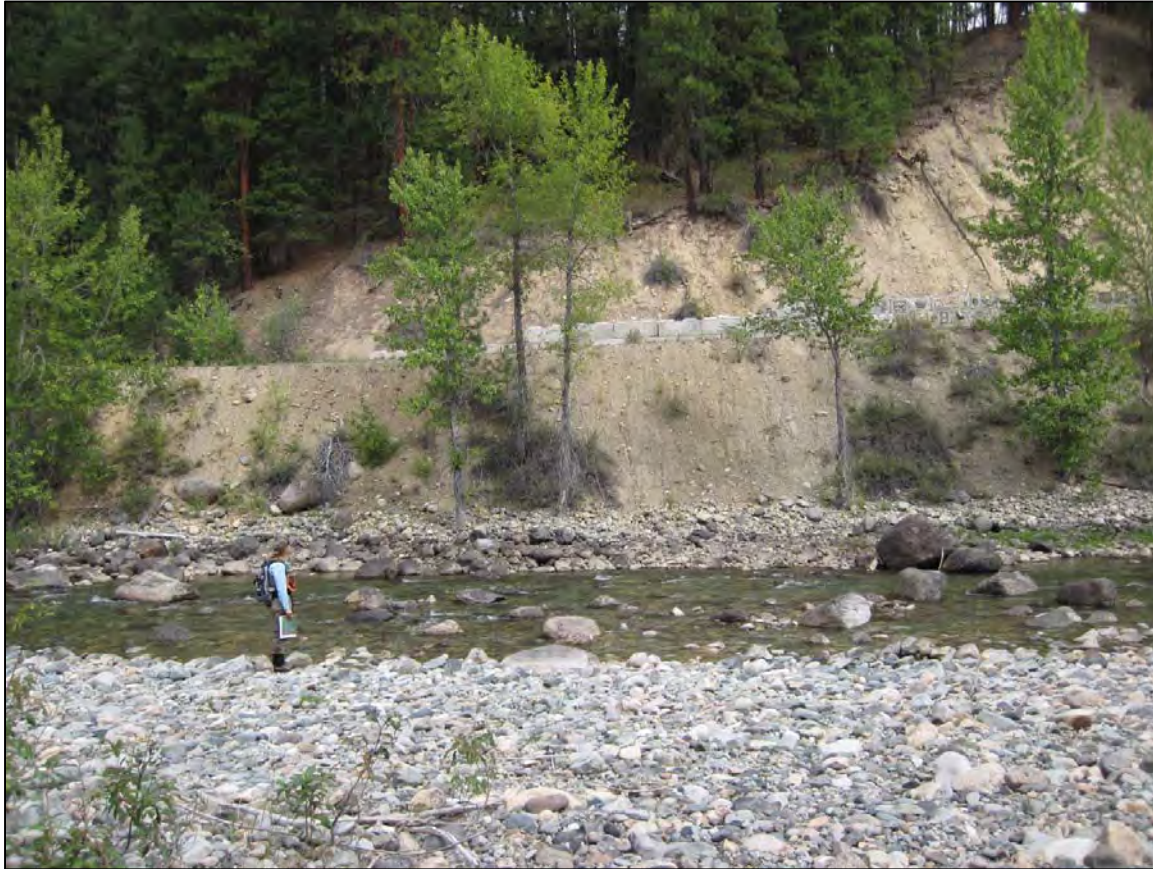
more difficult and slower to erode than the low-lying modern floodplain (Figure 41). Today, the mainstem channel has high cut-banks along glacial terraces on river-left from RM 62.2 to 62.25 and from RM 64.45 to 64.65. Cut-banks composed of alluvial fans contact the channel on river-right at Little Boulder Creek (RM 64.15) and on river-left at Fawn Creek (RM 62.9 to 63.1). The high bank at the Fawn Creek alluvial fan is riprapped with large, angular boulders and large constructed wood vanes; these features armor the bank and now unnaturally confine the channel here. The bank protection constructed along the Fawn Creek alluvial fan at RM 63 was constructed after a high-flow event in 2002 eroded the high bank and a private home was lost (State of Washington 2010).

Figure 41. Cut bank of glacial outwash terrace on river-left at RM 64.55. Old road grade cut into the bank with cement retaining wall for preserving community trail access. (9/3/2014)

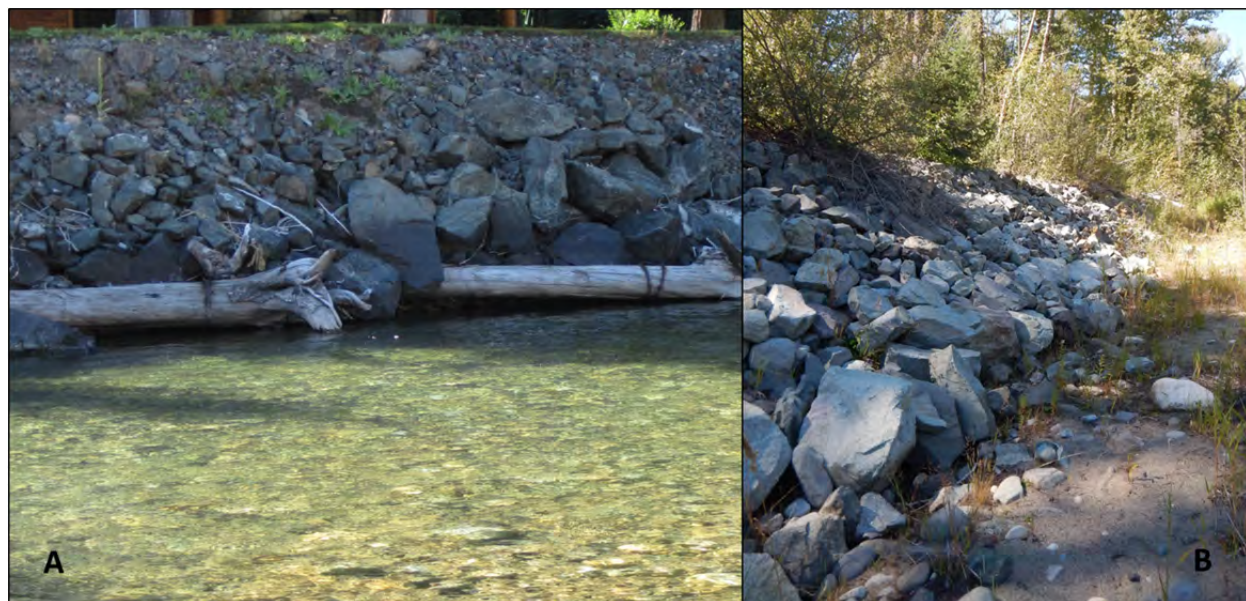
Levees and riprap have reduced the channel migration zone of Reach 2 (Figure 46). The channel width and location in the downstream portion of Reach 2 is largely locked in place. Lateral migration is limited by large-boulder riprapped banks topped with push-up levees on river-right from RM 61.7 to 61.85, RM 62.4 to 62.45, and RM 62.7 to 62.8. Riprap is used for bank protection on river-left from RM 61.7 to 61.75, RM 62.8 to 63.1, RM 63.15, and RM 64.6 to 64.65. Large wood has been attached to the riprapped banks at RM 62.7 (on river-right) and at RM 63 (on river-left).

Figure 46. Examples of confining features constructed of large angular riprap in Reach 2, (A) riprapped bank with cabled and anchored logs on river-right at RM 62.7; (B) section of the levee composed of riprap on river-right at RM 63.5. (9/4/2014)

Recommended actions in Reach 2 are focused on increasing channel complexity and lateral channel dynamics as well as improving connectivity to side-channels and floodplains. Complexity and lateral dynamics can be addressed by adding large wood jams to the main channel to enhance and create bar and island development and enhance split flow dynamics. Channel margin jams are suggested to create local pool development and enhance existing features. Side channel and floodplain connectivity can be addressed by removing unnecessary riprap, push-up levees, check dams, and sediment accumulations in off-channel habitat areas. Removal or breaching of levees at RM 63.35-63.7 has the potential to reconnect the largest off-channel impairment in the study area – but further evaluation and planning is needed to address the human-based function that the levees currently serve. Reach 2 also offers good opportunity to take advantage of public-access and recreation that occurs here by adding educational signage at restoration sites. Native riparian vegetation restoration where clearing has occurred is also recommended. Restoration recommendations recognize the importance of maintaining connectivity of the mainstem channel to perennial or groundwater fed tributaries and side-channels. This has been identified as a critical component for fish survival in a system with the potential to seasonally dewater.

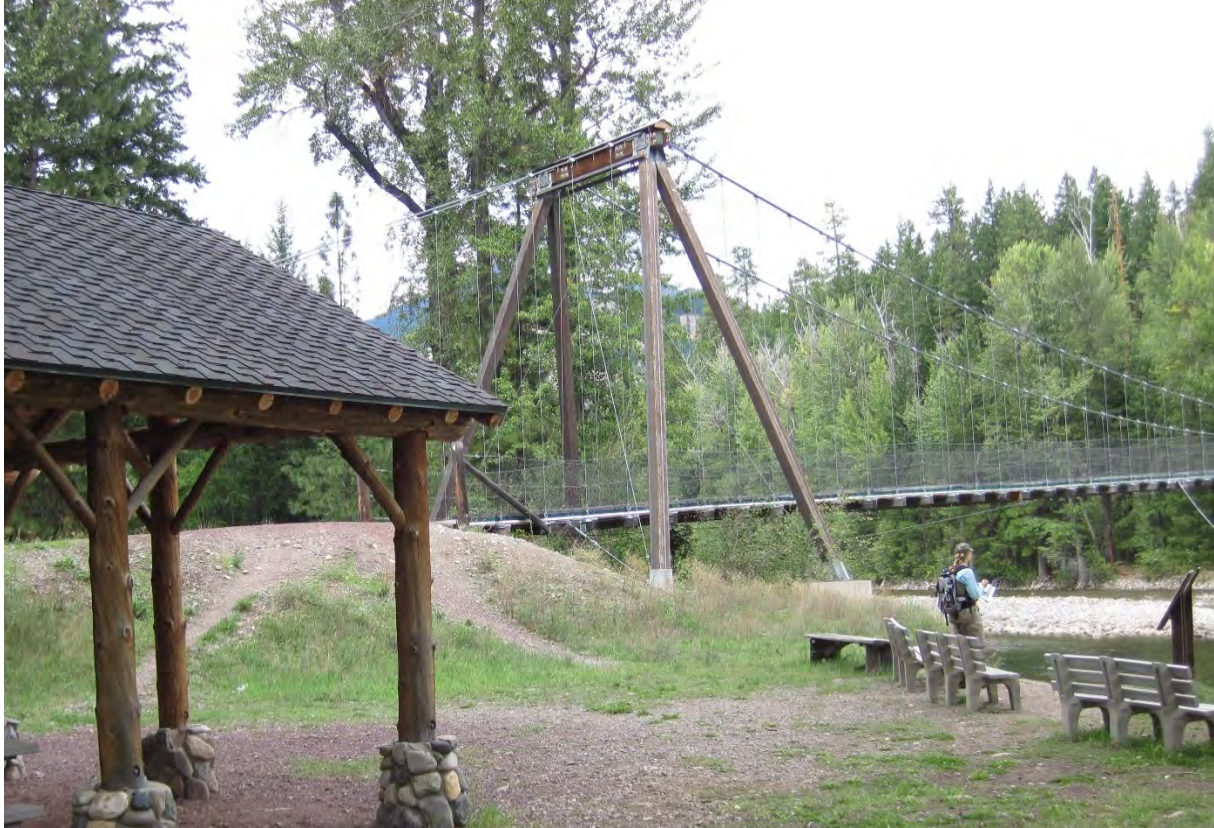
Additional loss of floodplain function occurs at the suspension bridge abutments at RM 64.35 and at an armored bank at the downstream end of the reach on river-right. The suspension bridge abutments are composed of boulders, cobbles and soil (similar to push-up levees). The abutments constrict the channel between them and alter normal floodplain inundation downstream on river-right (Figure 47). At the downstream end of the reach on river-right from RM 61.7 to 61.8, a riprapped bank topped with a push-up levee also confines channel width and location. Floodplain connectivity is reduced behind and downstream from this bank and levee in Reach 2 and Reach 1. Additional floodplain levees in Reach 2 alter localized floodplain inundation processes.

Figure 47. Suspension footbridge abutment and public area on downstream side of bridge on disconnected floodplain at RM 64.35. (9/3/2014)

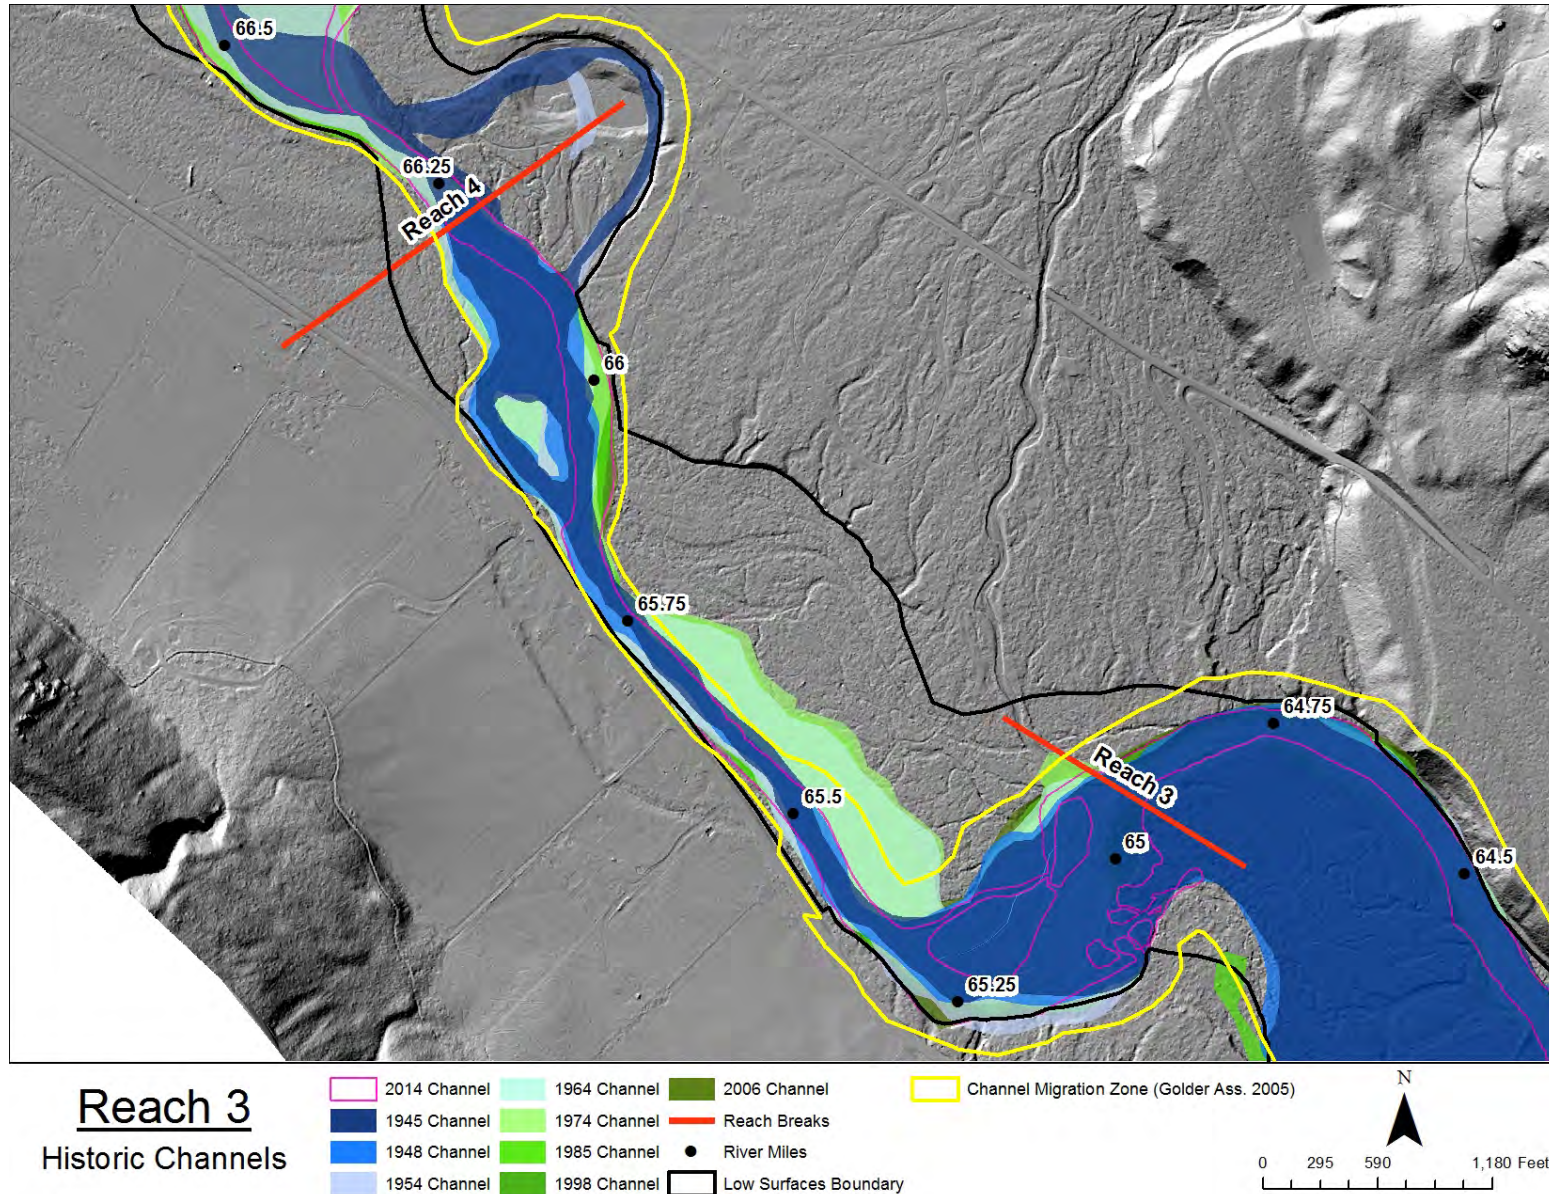
Fluvial scarring indicates that the modern floodplains in Reach 3 are inundated by high-flow events every two to ten years. However, historical aerial imagery and field observation of overbank deposition patterns indicate that the constructed levees and riprap in Reach 3 have reduced active-channel width and normal floodplain inundation. This is most evident from RM 65.35 to 66.75 along river-left, and on river-right from RM 65.4 to 65.6. As a result, the floodplains behind the levees and armored banks have been classified as disconnected. Channel migration has been limited since the construction of the levees and riprap (Figure 55).

Figure 55. Historical channel locations in Reach 3.

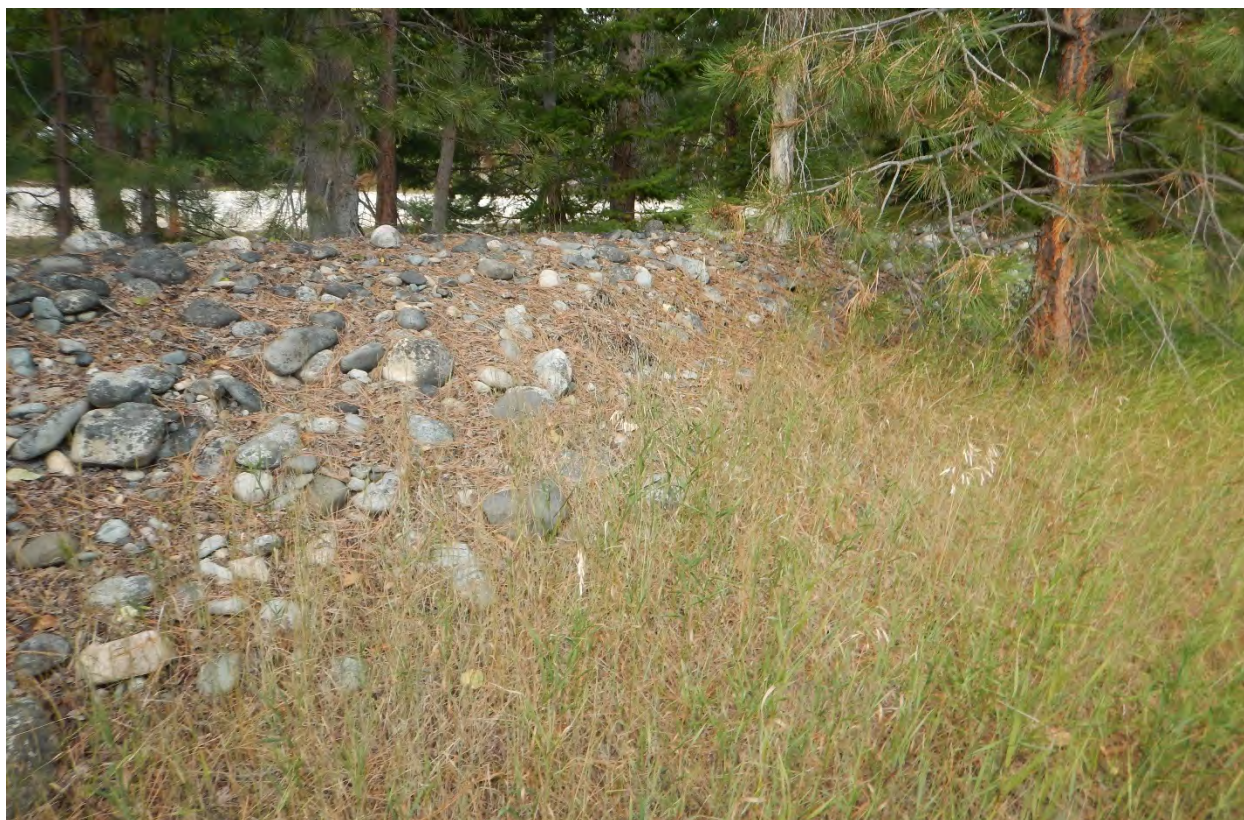
Floodplain function and channel migration have been reduced in Reach 3 as a result of constructed levees and boulder riprap. Approximately one-third of the available floodplain surfaces in Reach 3 have been disconnected from the channel by the construction of push-up levees. The levees have been built on river-right from RM 65.45 to 65.55, and on river-left from RM 65.35 to 65.55, at RM 65.85 (230 feet long), and at RM 65.9 (170 feet long). The most upstream bank protection is a boulder riprap reinforced levee at RM 65.9 on river-left. This levee aids in diverting the channel away from the alluvial fan toe and floodplain surfaces on this side of the reach. In general, the levees range from approximately two to four feet high and are composed of local boulders, cobbles, and soil (Figure 59). From RM 65.35 to 65.55, the channel is straight and basically locked in place due to the levees constructed on both sides of the channel. Here, the channel migration zone has been reduced from approximately 1,000 feet to the width of the channel (approximately 160 feet). Large boulder riprap armors the banks of the channel on river-right at RM 65.15 (100 feet long), at RM 65.35 (175 feet long), from RM 65.25 to 65.3, and from RM 65.75 to 65.8. The riprap between RM 65.15 and 65.35 is installed at the base of a high cut-bank where private homes are located. From RM 65.75 to 65.8, the riprap was installed to reduce bank erosion and protect the infrastructure of Hwy 20 (which lies approximately twenty feet behind the bank). The levees and riprap throughout Reach 3 restrict lateral channel migration and disconnect floodplain surfaces by stabilizing the banks and reducing the frequency and extent of inundation.

Figure 59. Push-up levee from land-ward side in Reach 3 on river-left at RM 65.35. (9/3/2014)

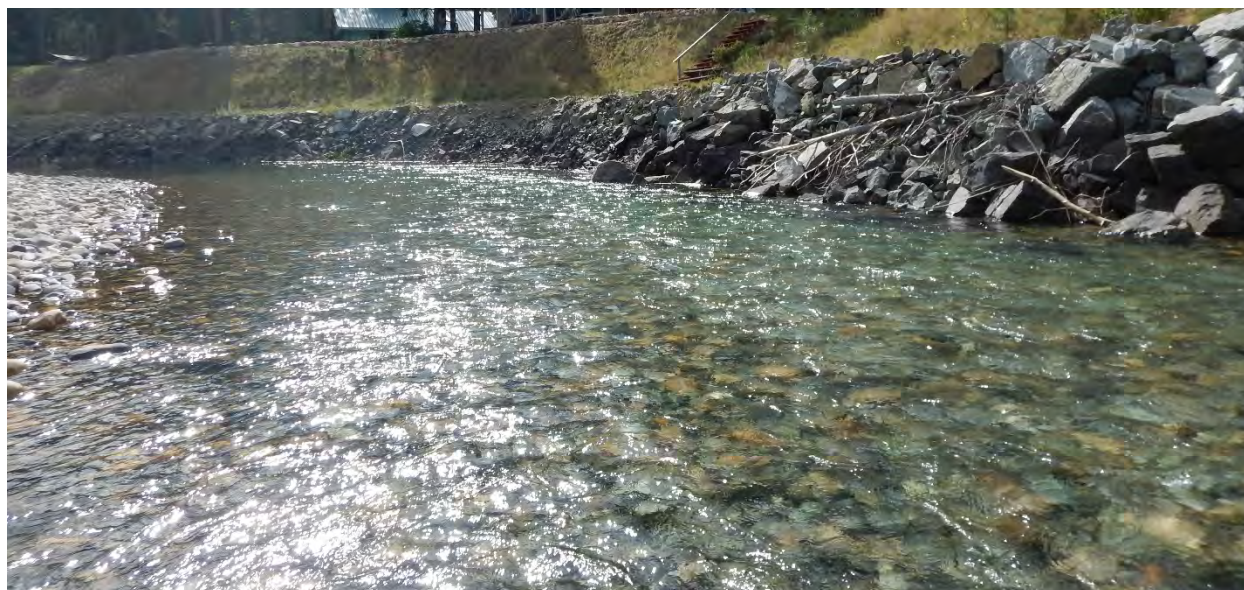
Streambank complexity and riparian vegetation in Reach 3 have been reduced along the riprapped banks. The riprap inhibits bank erosion, and thus alters localized sediment inputs into the system. This is particularly evident along the riprapped cut-bank on river-right from RM 65.25 to 65.3 and from RM 65.75 to 65.8 (Figure 60). The riprap also reduces the complexity of the riparian vegetation community and notably decreases the potential for the establishment of mature stands of trees along these banks. Additionally, this reduces localized shade to the channel and removes the potential for large wood recruitment in these areas. At the private residence on river-right (RM 65.15 to 65.35) and between the channel and Hwy 20 (RM 65.35 to 65.8), vegetation clearing and thinning near the channel bank further reduces the complexity of riparian vegetation and its corresponding benefits to channel function. Historical logging practices at the turn of the century cleared vegetation and utilized the river to transport cut logs to mill sites downstream (Devin 1997). This has likely reduced riparian function and channel complexity over the last century.

Figure 60. Riprap protected cut bank toe in Reach 3 on river-right at RM 65.30. (9/3/2014)

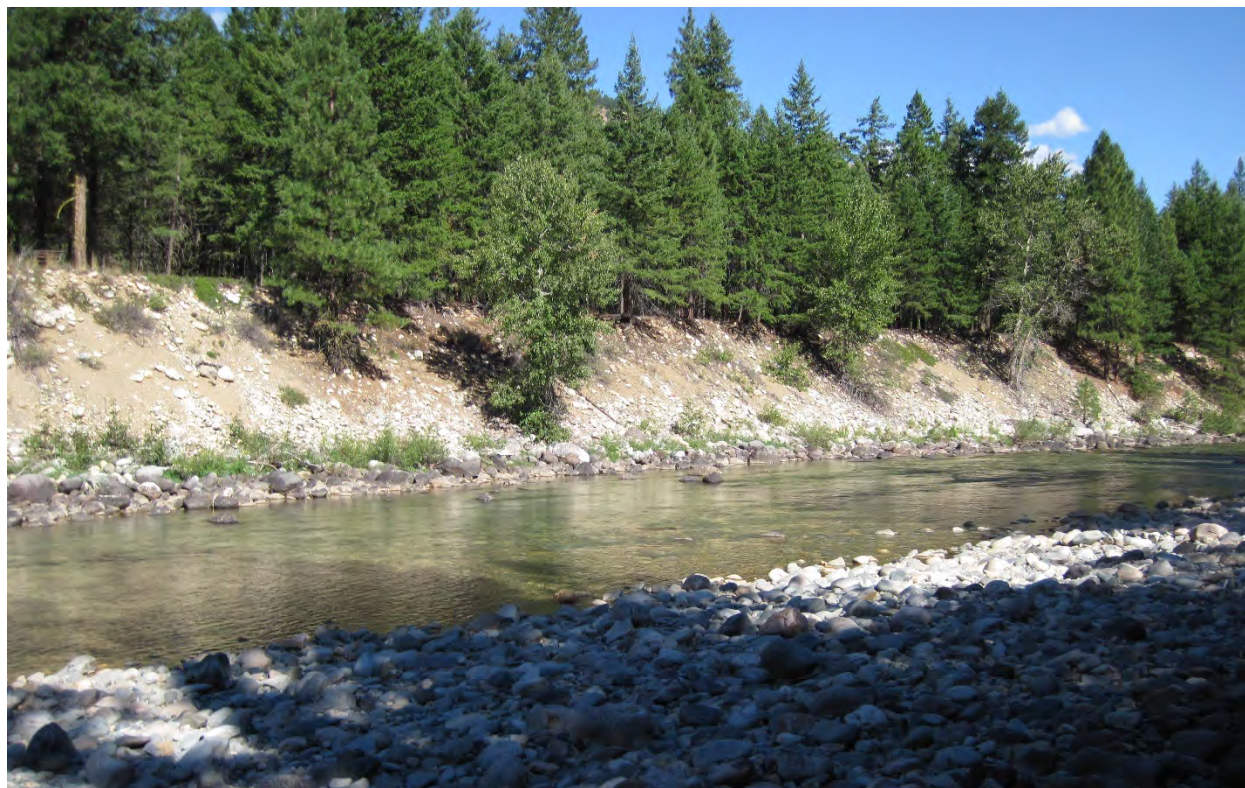
Figure 67. Glacial outwash terrace cut bank on river-left; looking downstream at RM 67.75. (8/27/2014)

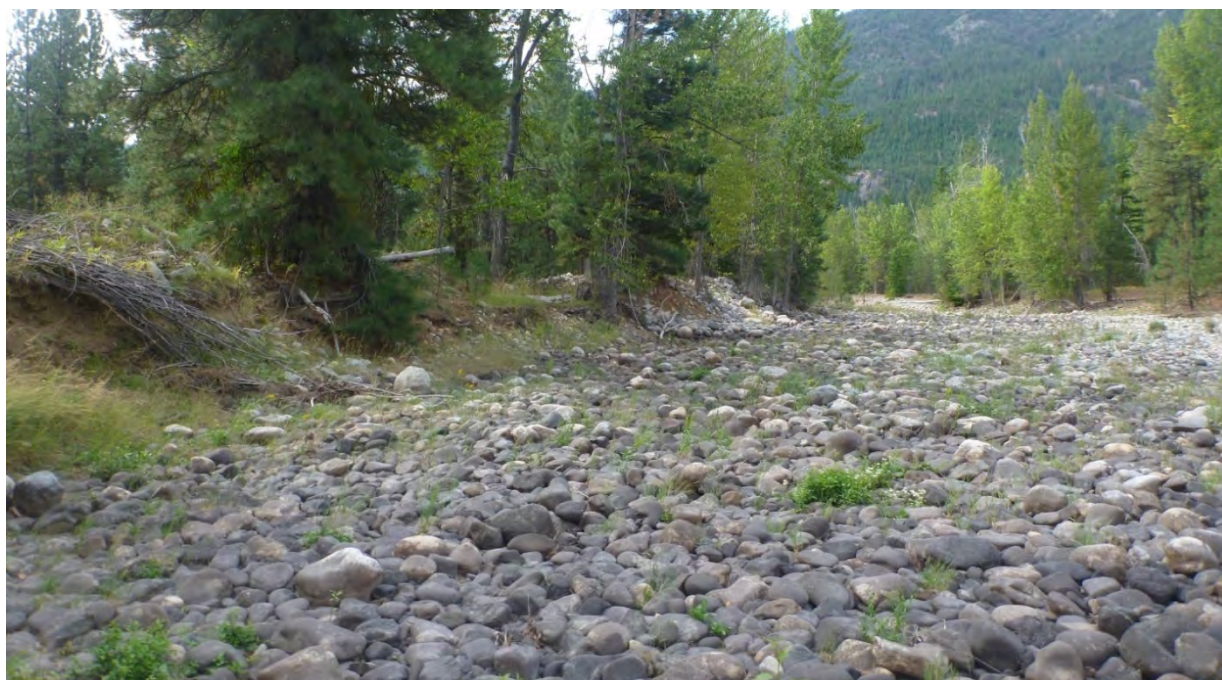
Two side-channels that are activated during high flow locally reduce incision potential by providing additional channel area for flow transmission. A side-channel that runs from RM 66.35 to 66.75 on river-left is over 700 yards long (2,100 feet) (Figure 69). The other side-channel runs from RM 68.25 to 68.35 on river-right (west side of the channel). It is only 225 yards long (675 feet) but it offers a backwater feature during low flows that, if maintained, could provide perennial off-channel habitat. Both side channel features have been scoured and then filled with large cobbles and gravel during high flow events.

Figure 69. High flow side-channel (dry) on river-left near RM 67.75; looking upstream. (8/27/2014).

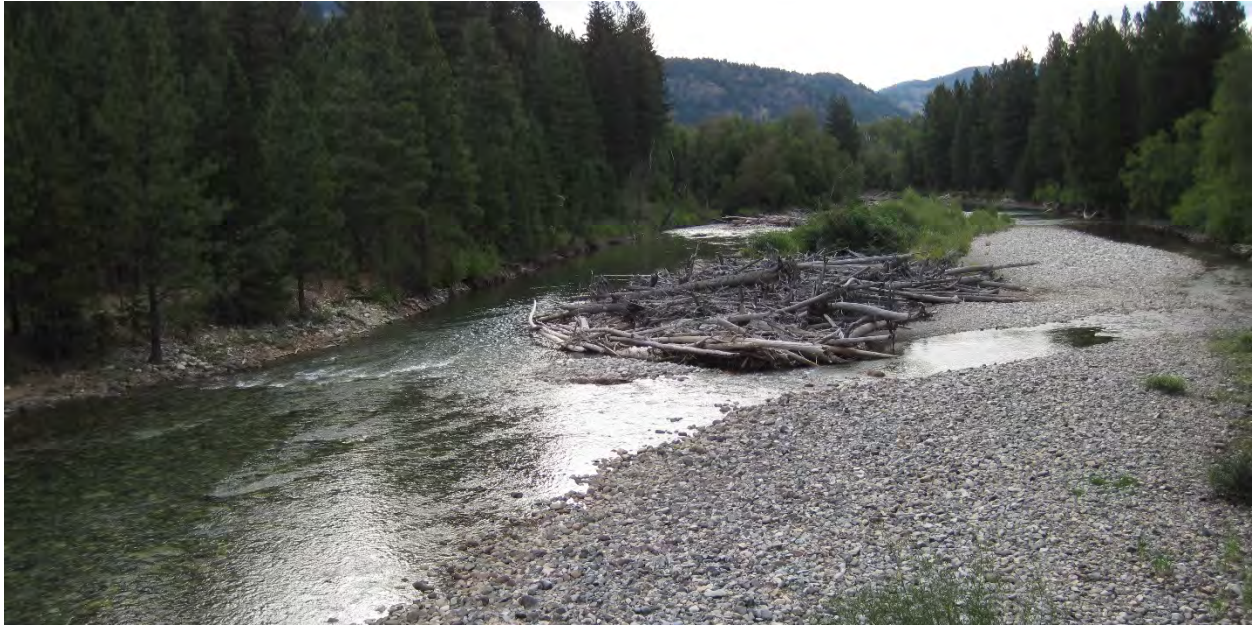
Throughout Reach 4, the river's path gradually meanders with a sinuosity of 1.09. Fairly stable banks and minimal channel complexity confirm that this reach is relatively stable laterally. The primary channel units are extended riffles and glides with a low frequency of pools. There is a scour pool downstream from the confluence with Early Winters Creek. The series of large pools downstream from the Mazama Bridge correlate with the localized increase in channel complexity. The localized complexity is induced by accumulations of sediment and wood that create large, mid-channel bars with extensive log jams from RM 66.85 to 67.15 (Figure 70). The average bankfull width of the channel in Reach 4 is 129 feet with its widest point (approximately 230 feet) occurring in the section with the large wood jams and bars. Channel complexity increases in proximity to the large jams and bars, while lateral channel processes only slightly increase.

Figure 70. Large wood accumulations on cobble bars; looking downstream from the Mazama Bridge (RM 67.2). (8/28/2014)

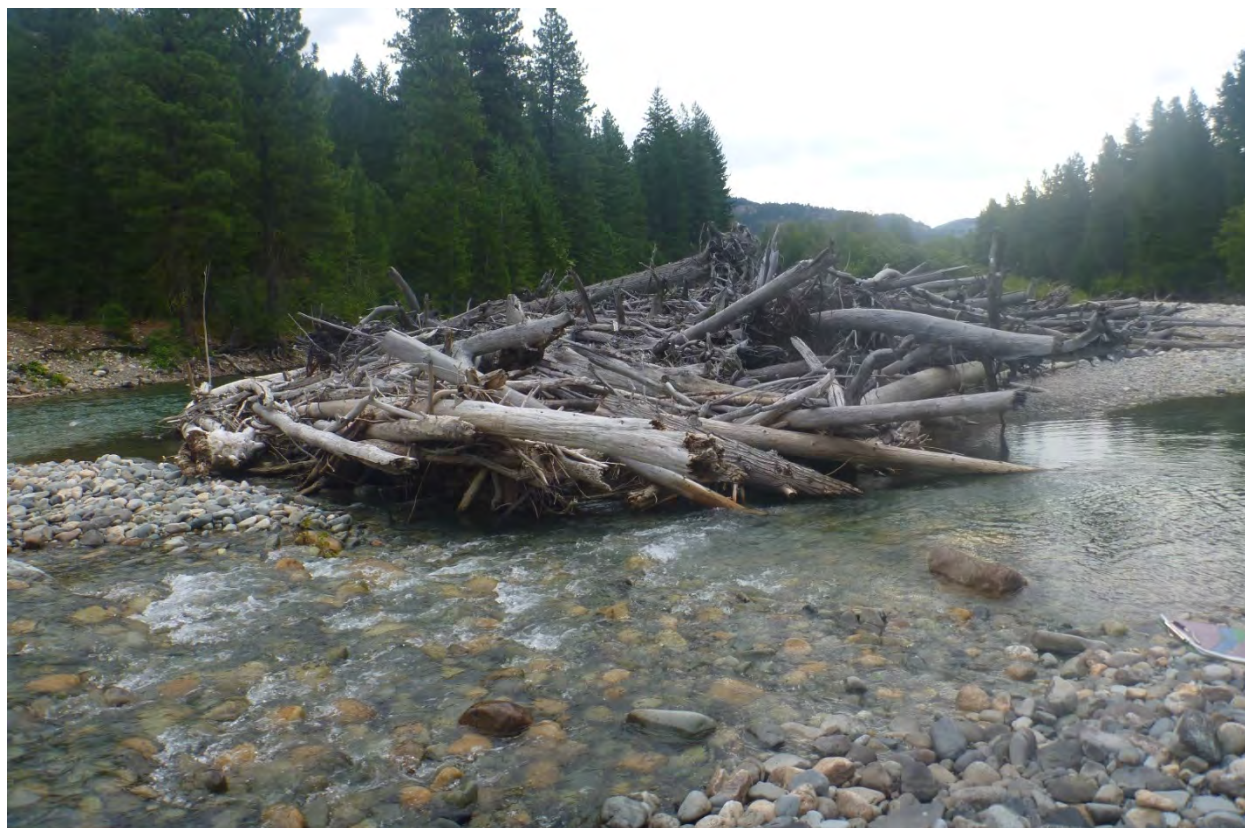
Figure 75. Large wood jam at apex of a cobble bar (RM 67.15). (8/28/2014)

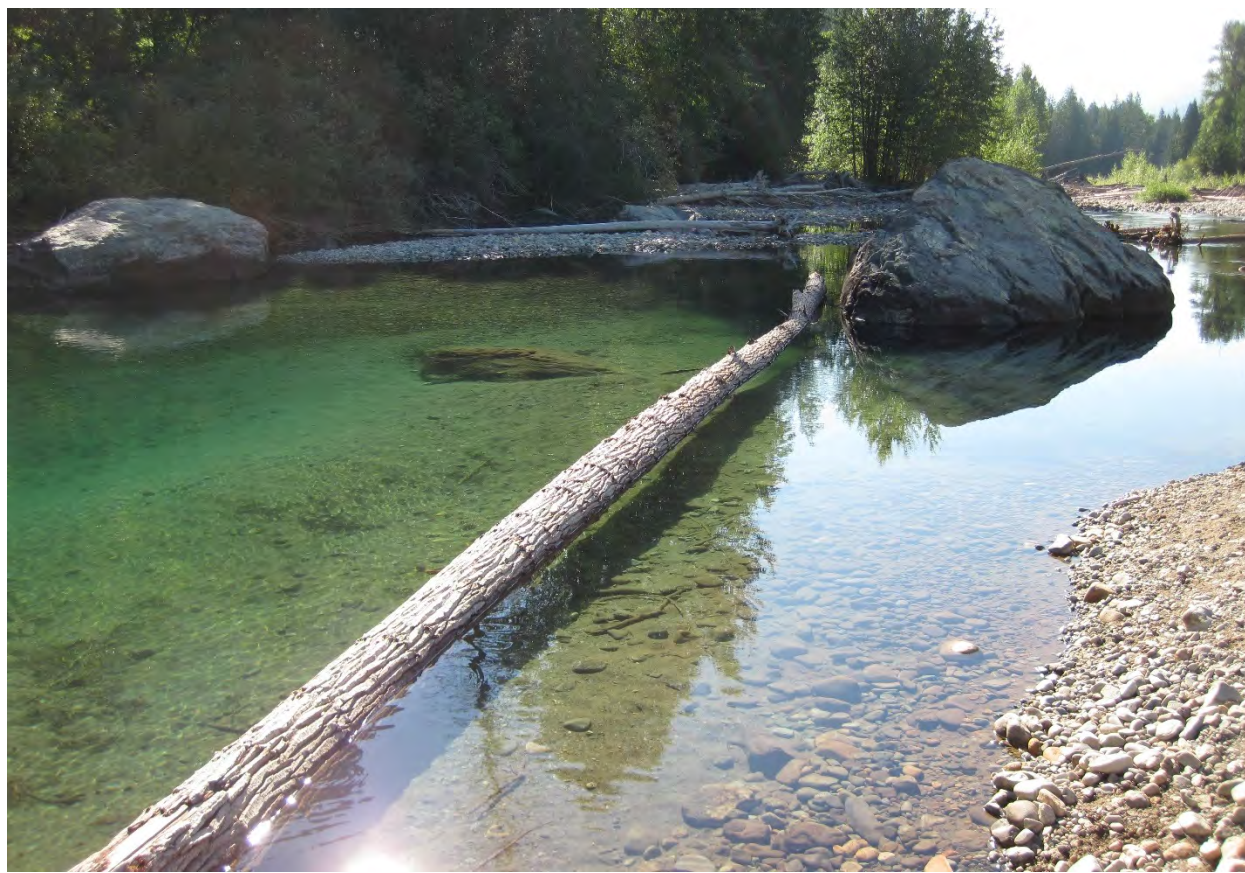
Figure 83. Pool with large boulders at RM 71.2. (8/26/2014)

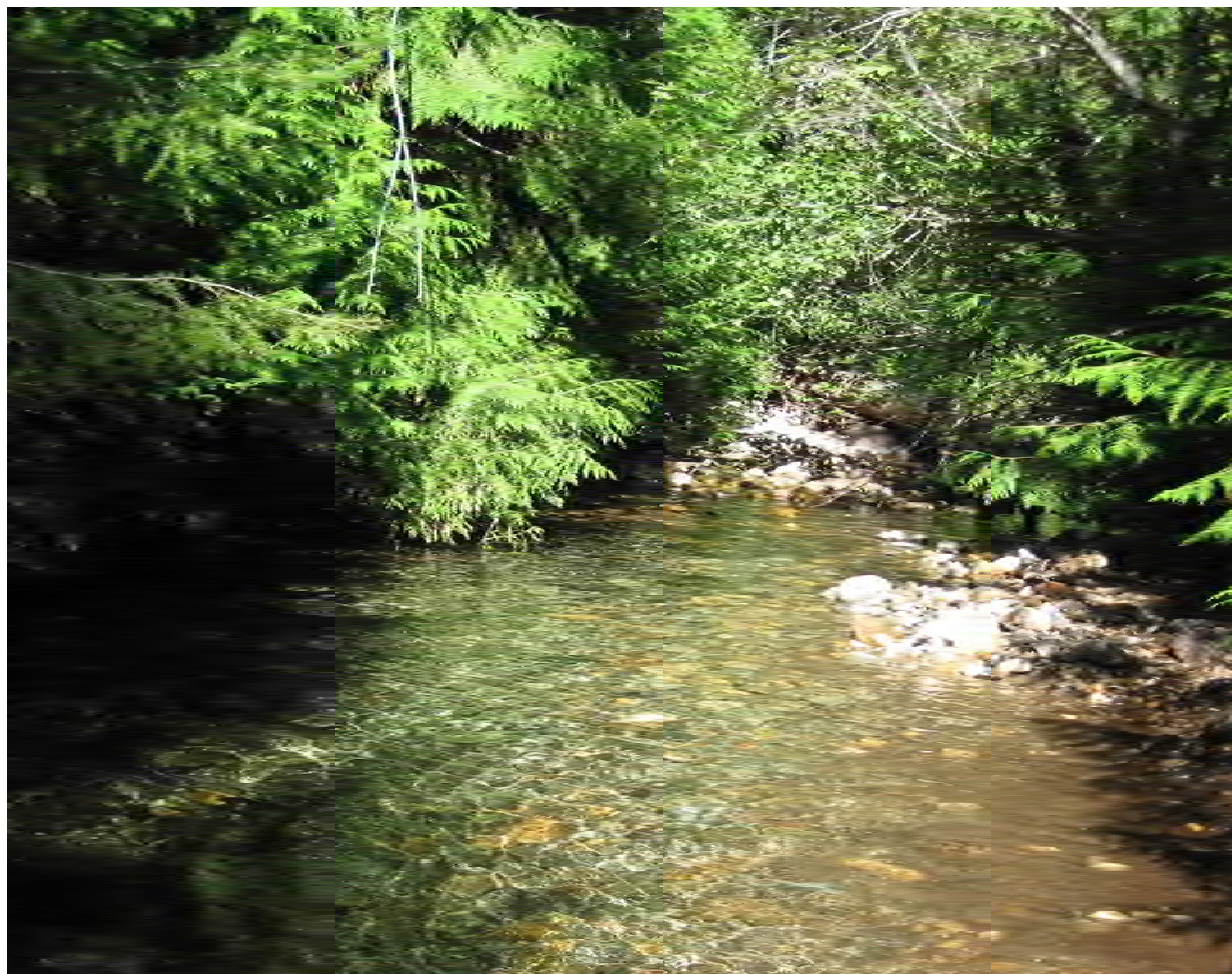
Figure 84. Groundwater-fed tributary near RM 70.4; at downstream end looking upstream. (8/26/2014)

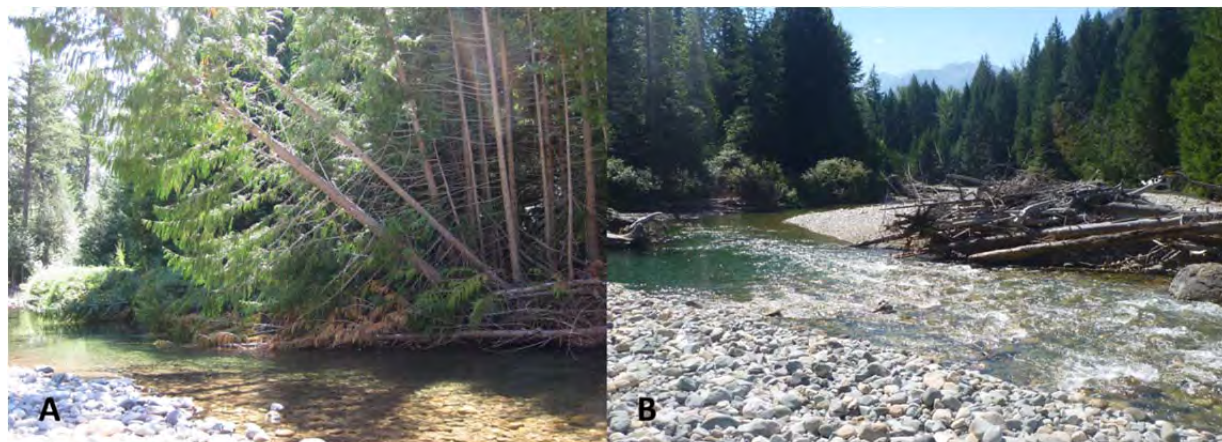
Large wood retention and recruitment is fairly good in Reach 5 with the exception of the riprapped and/or cleared banks. Even in the downstream section of the reach where the channel is confined and less complex, wood retention on the active bar surfaces appears only slightly reduced compared to the more complex middle section of the reach. Retention of wood is high in the upper section of the reach where channel complexity is greatest. Most of the wood in Reach 5 appears to be recruited from local banks or from immediately upstream of the reach boundary. The well-vegetated floodplain and alluvial surfaces adjacent to the channel offer high recruitment potential. Past and current lateral channel migrations resulted in local wood inputs to the channel. In August 2014, fresh wood inputs were observed from eroding banks (Figure 90).

Figure 90. A) Active large wood recruitment through bank erosion (RM 70.7); B) Large wood accumulations on bars. (8/27/2014)

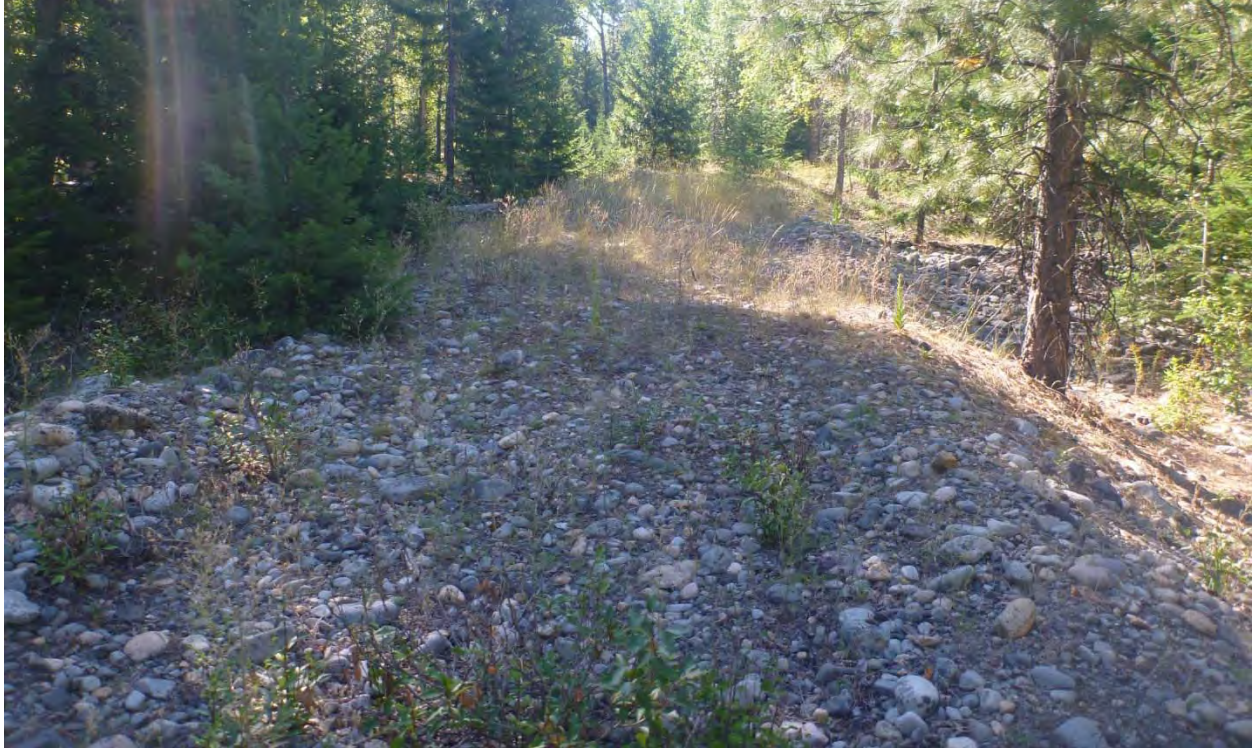
The push-up levee at the edge of the high floodplain surface on river-right at RM 70.75 disconnects floodplain processes. This levee is approximately 400 feet long and diverts channel flow away from the banks of this surface. It is likely that this levee is partially responsible for the disconnection of this surface from the channel. Remnant sections of another push-up levee are located on the floodplain on river-right between RM 71 and 71.25. This levee has been breached by flood waters leaving only an upstream section that is approximately 350 feet long and three feet tall and a downstream section approximately 250 feet long, four feet tall, and 15 feet wide. The downstream section of this levee has a flat road prism on top (Figure 93). It appears this levee was originally built along the 1945 channel boundary, which would have affected floodplain connectivity until the levees were finally breached and eroded. Although the levees have been breached, their presence continues to influence flood inundation patterns and possibly the location of the main channel and side-channels.

Figure 93. Section of the breached push-up levee on the floodplain near RM 71.1. (8/26/2014)

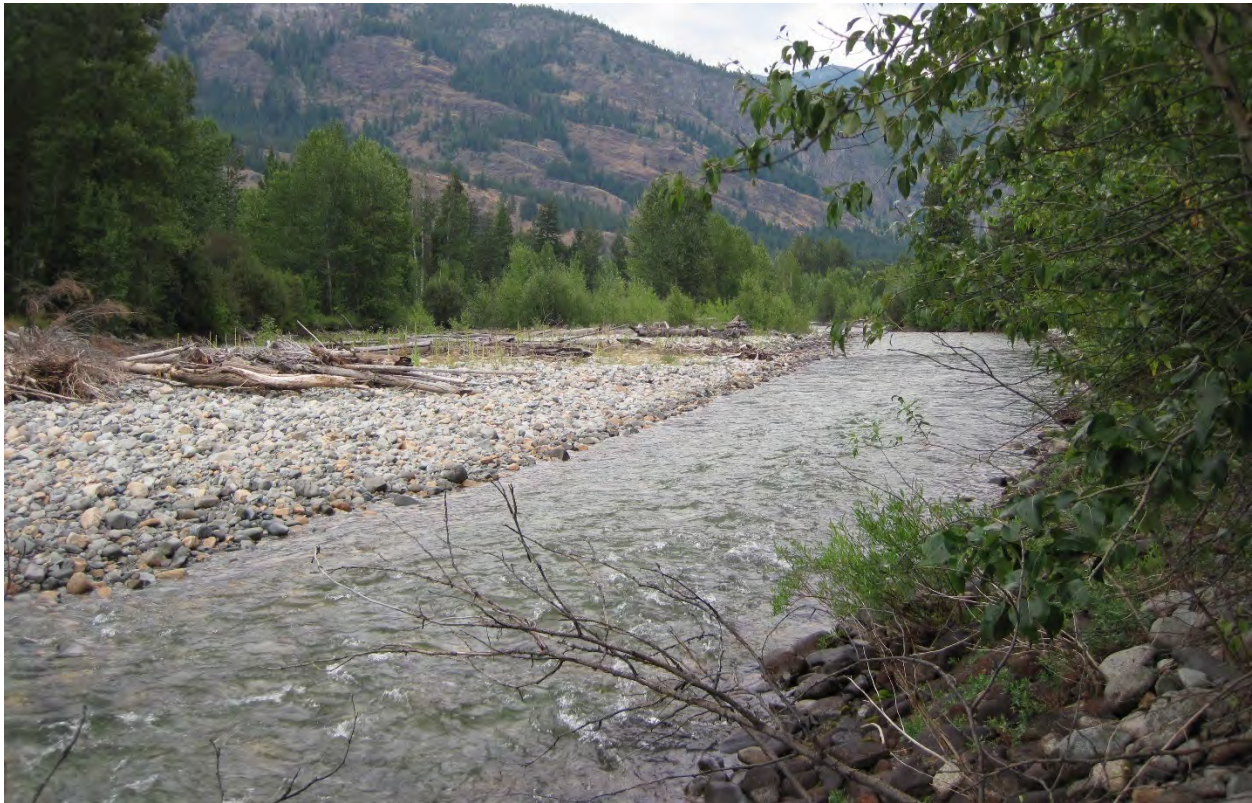
Figure 95. Representative photo of Reach 6; looking downstream at RM 74.25. (8/14/2014)
