Upper Methow River Reach Assessment

River Miles 61 - 80

SUBMITTED TO
Yakama Nation Fisheries

FINAL - DECEMBER 2015

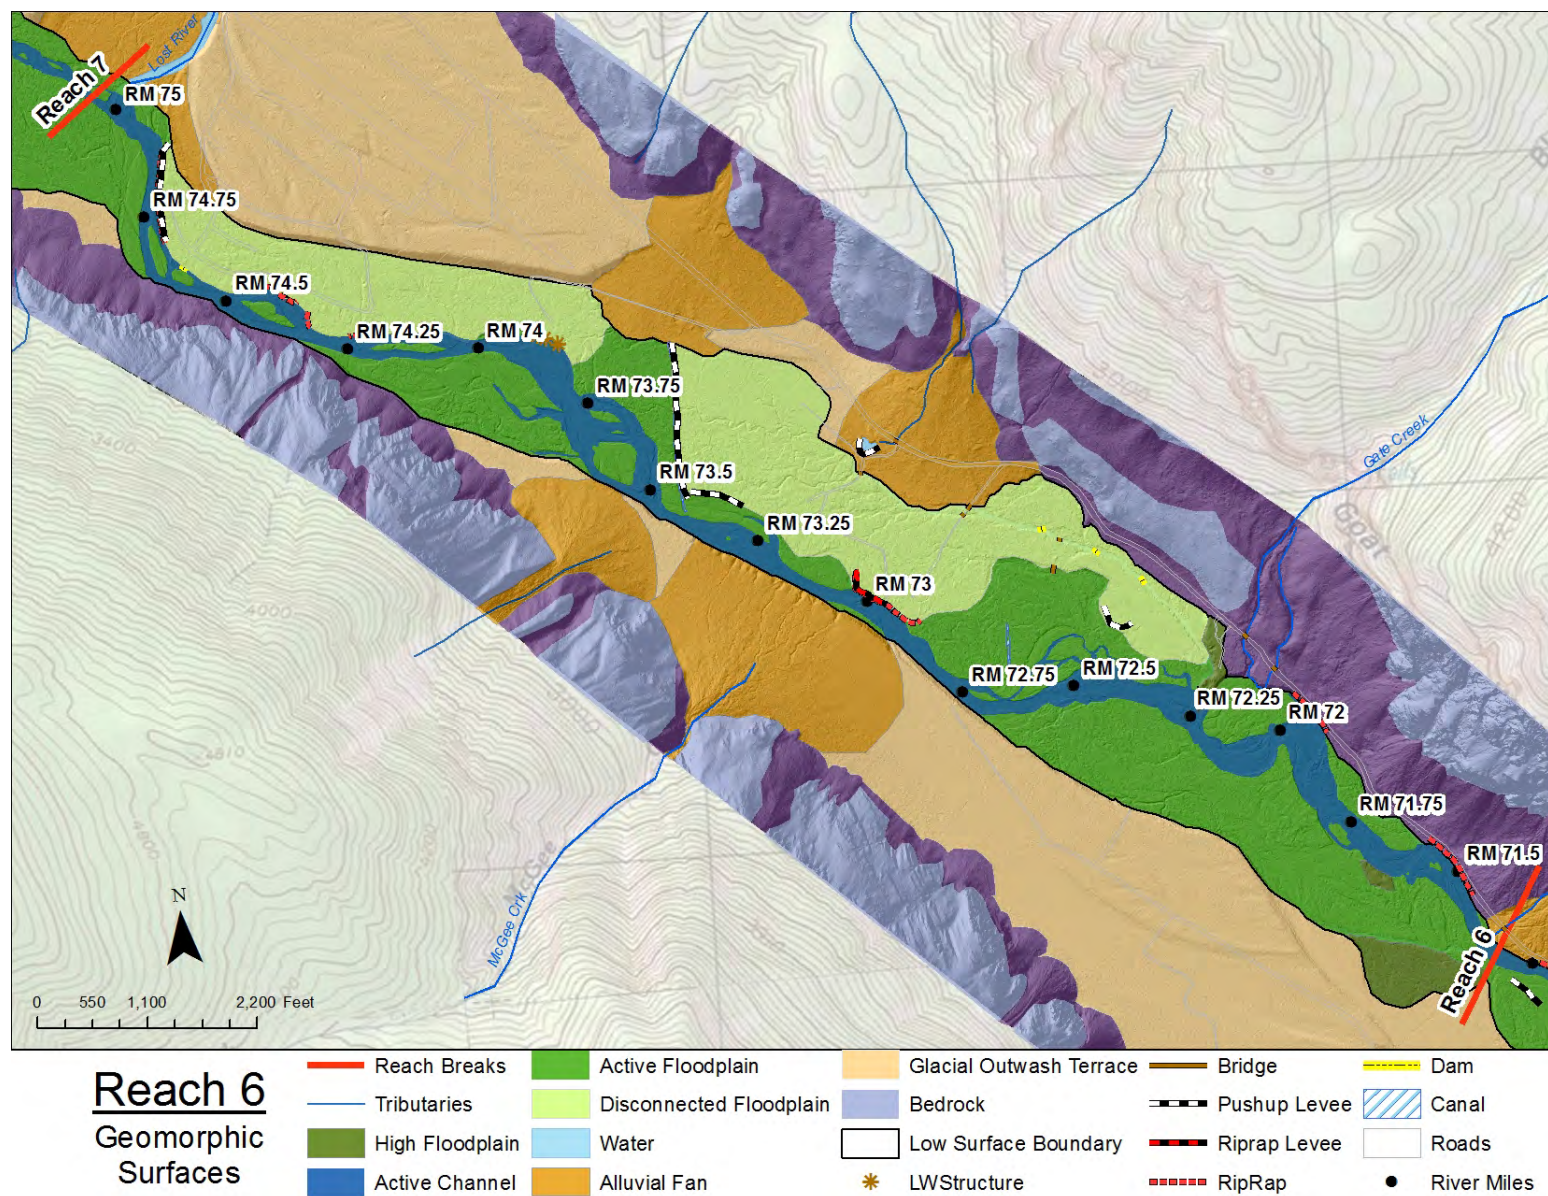
Reach 6 is located in a wide, glacially-carved, U-shaped valley. Increased discharge and sediment regimes during early Holocene periods of glacial retreat resulted in a thick layer of glacial outwash deposits filling the valley floor (Figure 97). The modern channel and floodplain in Reach 6 are inset into the outwash deposits that today form terraces along the edges of the valley. In the upper portion of the reach, glacial outwash terraces are located along river-left (the northeast side of the valley). In the lower portion, they are located along river-right (the southwest side of the valley). The Lost River drainage, also carved by glaciers, is now inset below its historical floodplain and alluvial fan deposits. Lost River's notable contribution of sediment and discharge to the Methow River influences geomorphic features and processes downstream. Discharge contributions from Lost River more than double the flow in the Methow River and the abundant sediment contributions influence bar development in the upper portion of the reach.

Figure 97. Geomorphic surfaces of Reach 6 with selected human-built features (log structures, levees, riprap, check dams, canals, bridges, and roads).

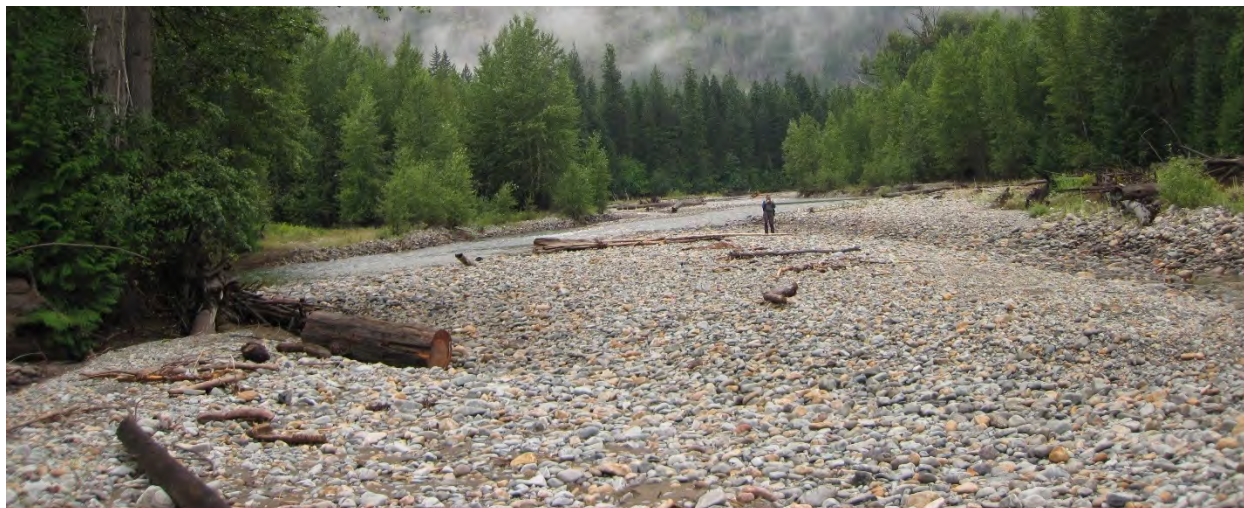
Figure 98. Cobble-gravel filled side-channel near RM 72.5.

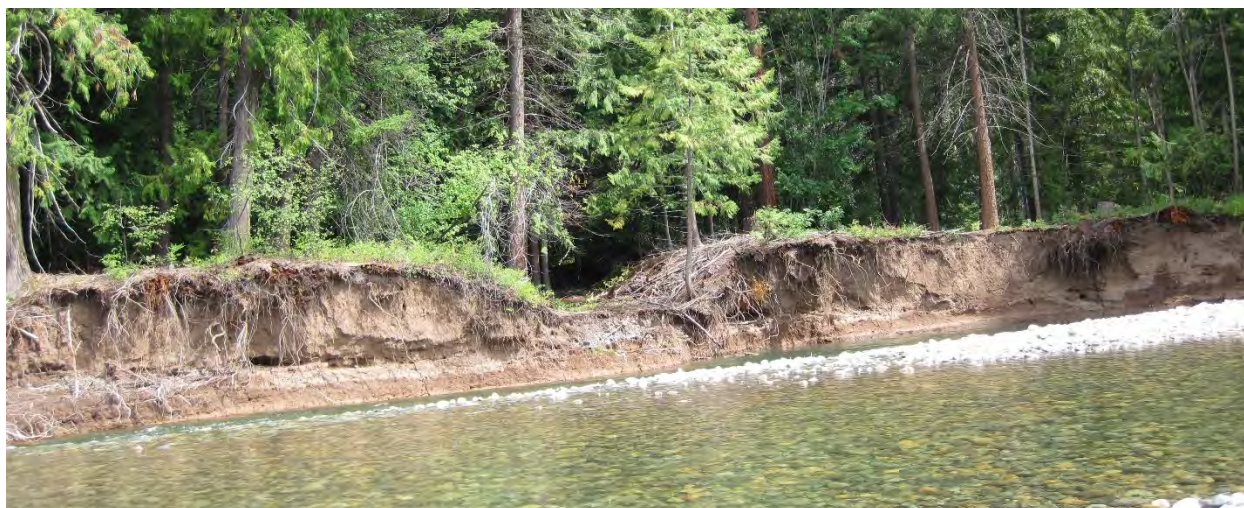
Small high floodplain surfaces in the most downstream portion of the reach on river-right have remnant scroll bar features and developing soil. These alluvial surfaces are the result of channel bed incision, which is likely being amplified by the modern artificial confinement of the channel at RM 71.3 (the downstream border of Reach 6). There is a unique cut-bank feature located at RM 72.2 on river-left where the active channel is eroding into alluvial deposits comprised primarily of fines (silts, sands, and clays). The stratigraphy in the cut-bank reveals a complex layering that includes former locations of a tributary channel, evidenced by gravel lenses and surface depressions (Figure 99).

Figure 99. Cut-bank located at RM 72.2 on river-left -- composed of alluvium (silts, sands, and clays with gravel lenses), with a paleo-channel notch. (8/15/2014)

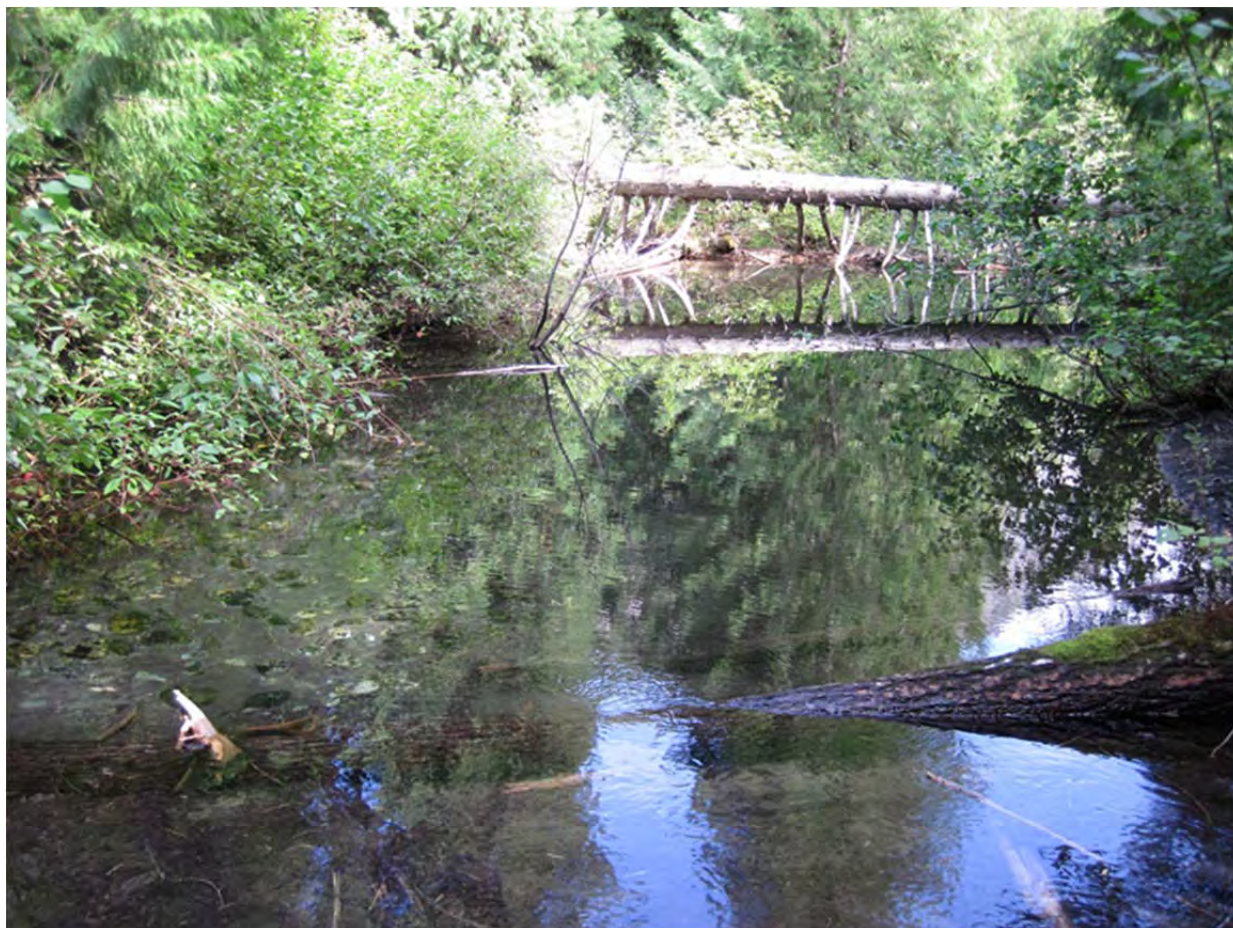
An important hydrologic feature in Reach 6 is the side-channel that traverses the floodplain on river-left from RM 73.8 to 72.3. The feature is now disconnected from the mainstem at the upstream end by a constructed canal that crosses its path. The canal blocks surface flow from entering the side-channel, and instead diverts it off the floodplain. Today, downstream from the canal, this side-channel still has surface flow but it is fed by groundwater inputs alone. The groundwater is generated upstream and from the adjacent terraces and alluvial fans. Where the side-channel borders the toe of a large alluvial fan, notable upslope groundwater inputs lower the temperature of its surface water. This side-channel traverses the edge of the floodplain along the north side of the valley and eventually delivers the collected groundwater to the mainstem as surface flow at RM 72.3. Three large beaver dams and a few log jams create pools that impose natural grade control on the stream and facilitate the local accumulation of fines and nutrients (Figure 102).

Figure 102. Ground-water wetted side-channel, disconnected from mainstem at upstream end by canal. Located on river-left between RM 73.8 and 72.3. (8/24/2014).

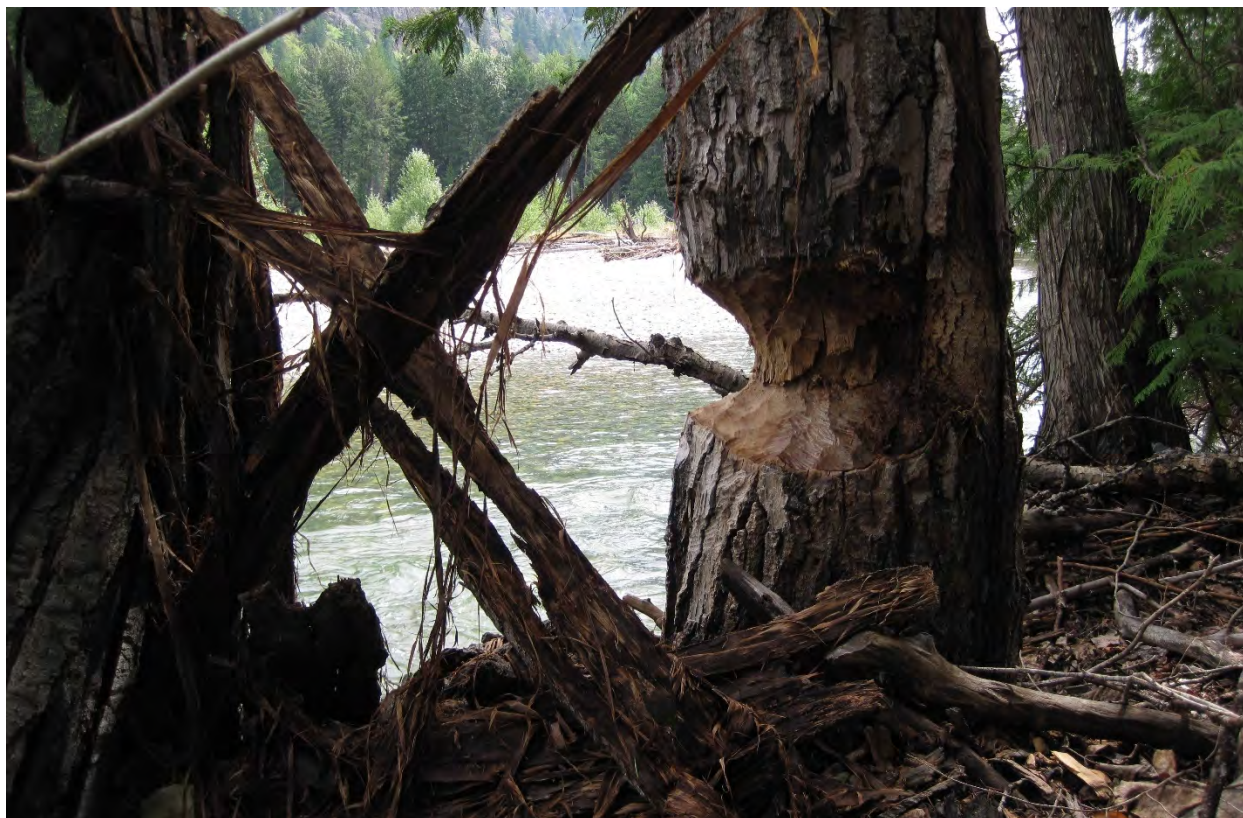
Figure 105. Beaver chew on a large cotton adjacent to the mainstem in Reach 6. (8/15/2014)

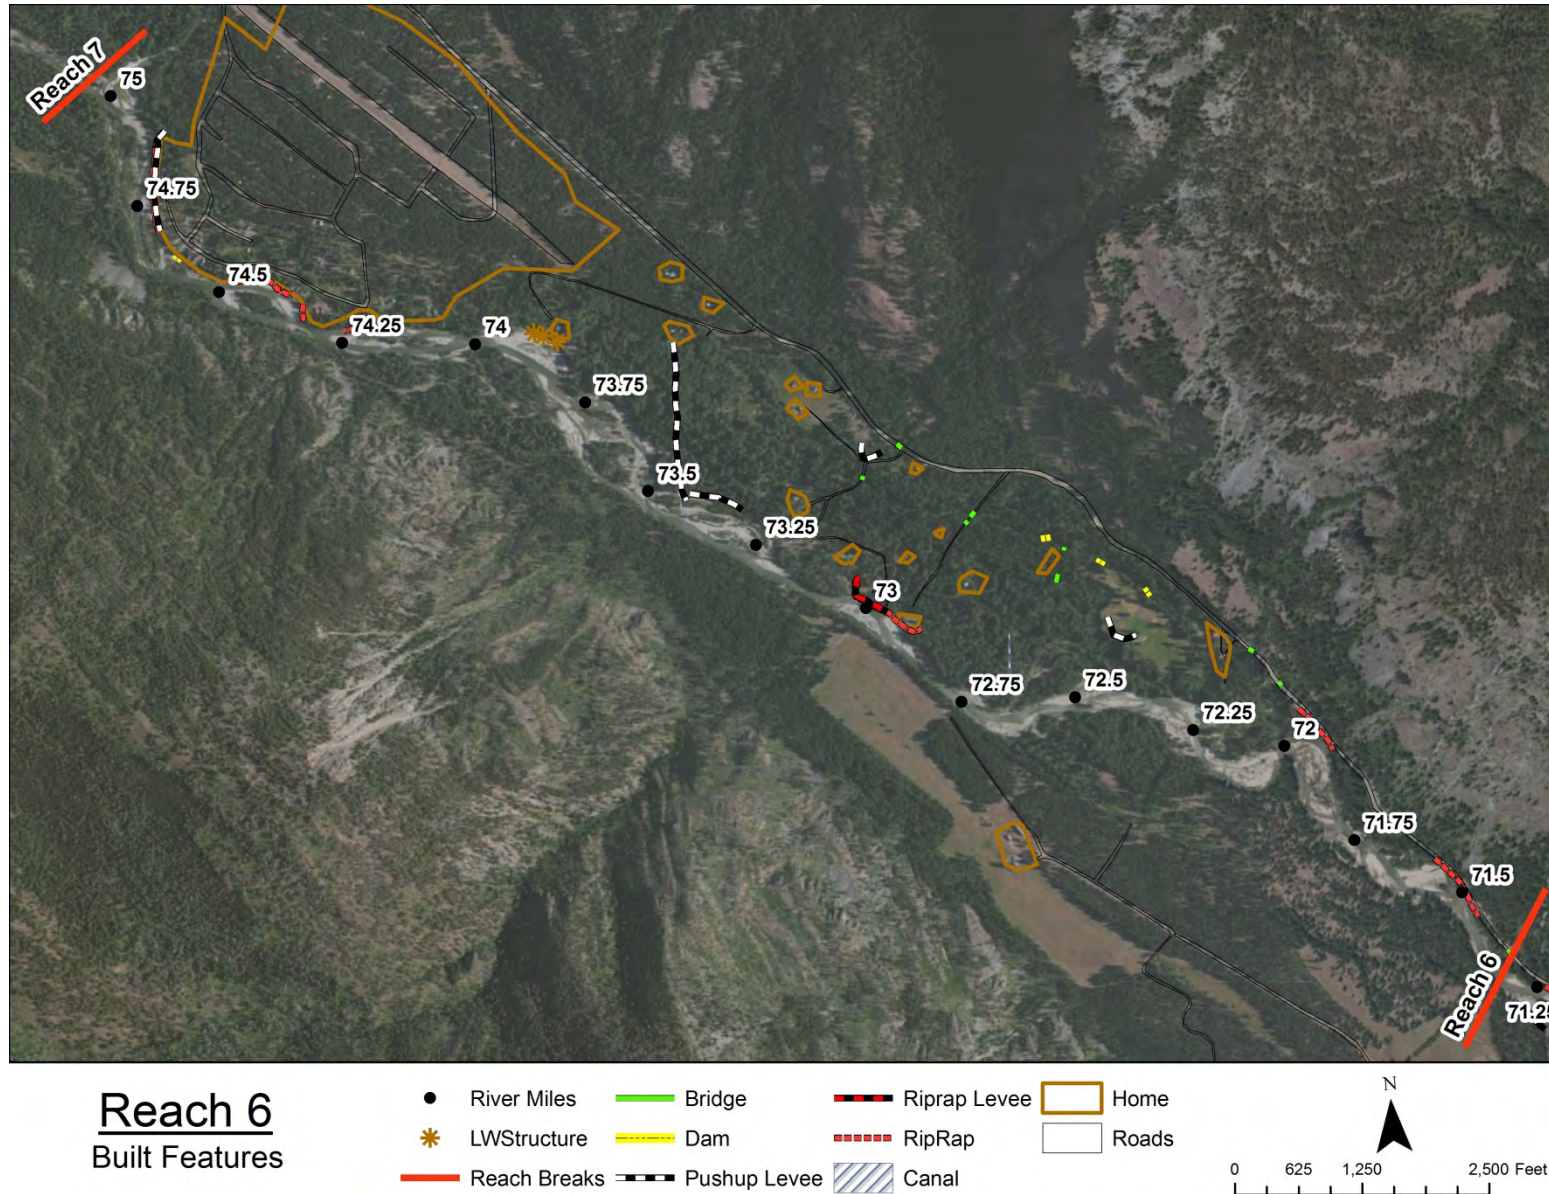
Figure 107. Primary human features in Reach 6.

Human features are mapped in Figure 107. The primary human alterations in the reach include the following, and are described further in the subsections below.

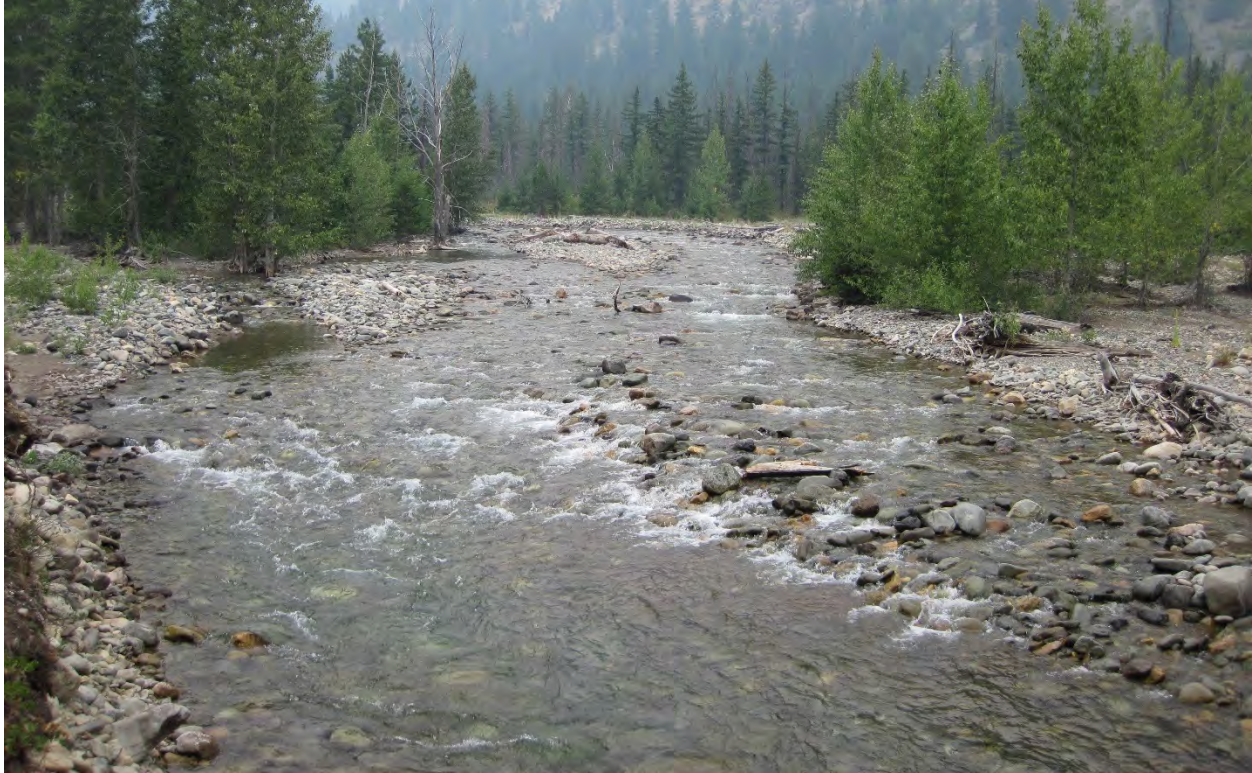
Figure 110. Representative photo of Reach 17 looking upstream at RM 76.15. (8/15/2014)

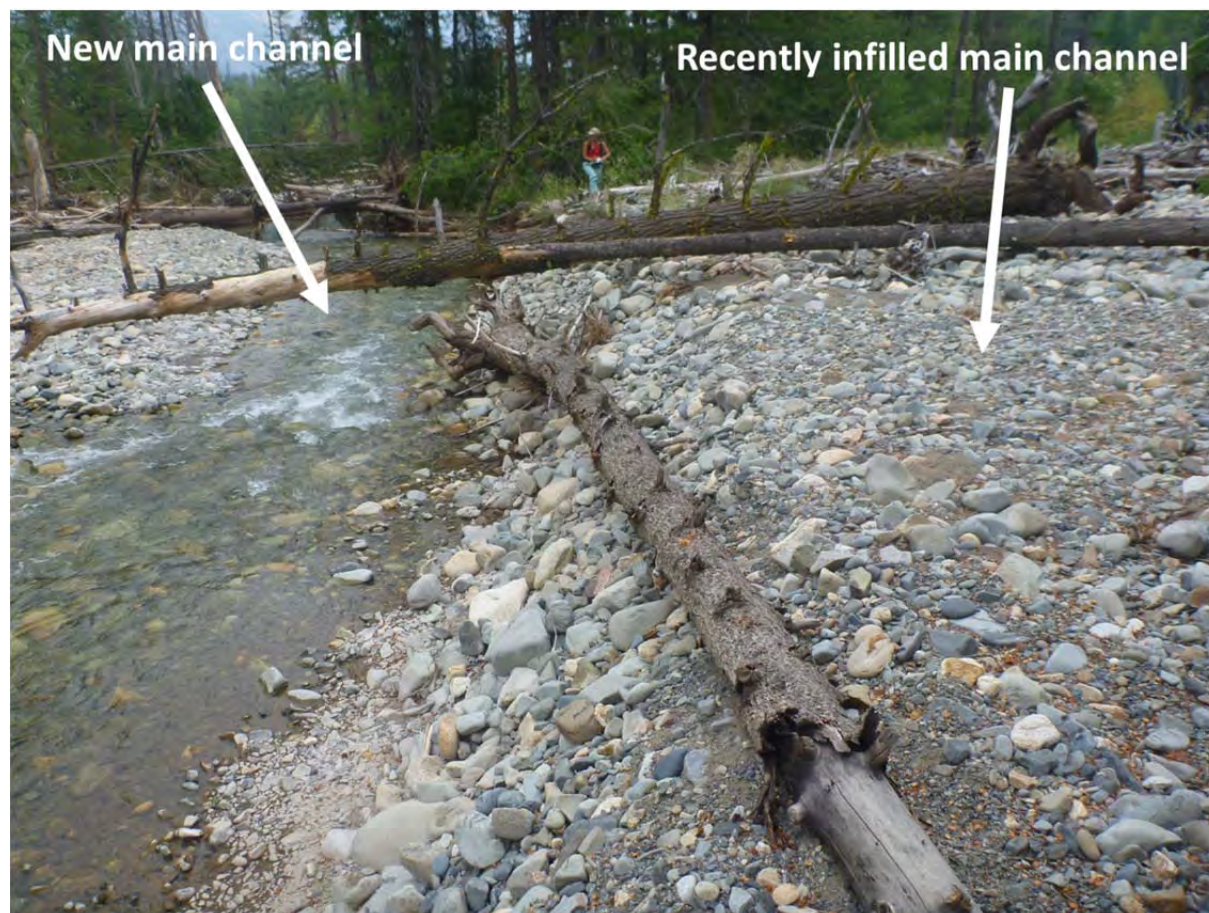
In Reach 7, the floodplain features are inundated at different rates due to the range in surface elevations relative to the channel bed [low (1-2 feet), medium (2-4 feet) and high (4-5 feet)]. Through processes of bed erosion or deposition, the rate of inundation for a particular floodplain surface can change if the channel bed elevation changes. Accumulations of sediment and/or large log jams that force changes in the river's hydraulics at a site can instigate lateral migration, channel avulsions, or the creation of multiple channels. High flow events can result in scour and/or fill of channel beds. A good example of this can be seen at the recently filled and abandoned channel on the south side of the channel at RM 75.75 (Figure 116).

Figure 116. Change in channel location through infilling (instigated by wood accumulations during high flow) and avulsion at RM 75.75.

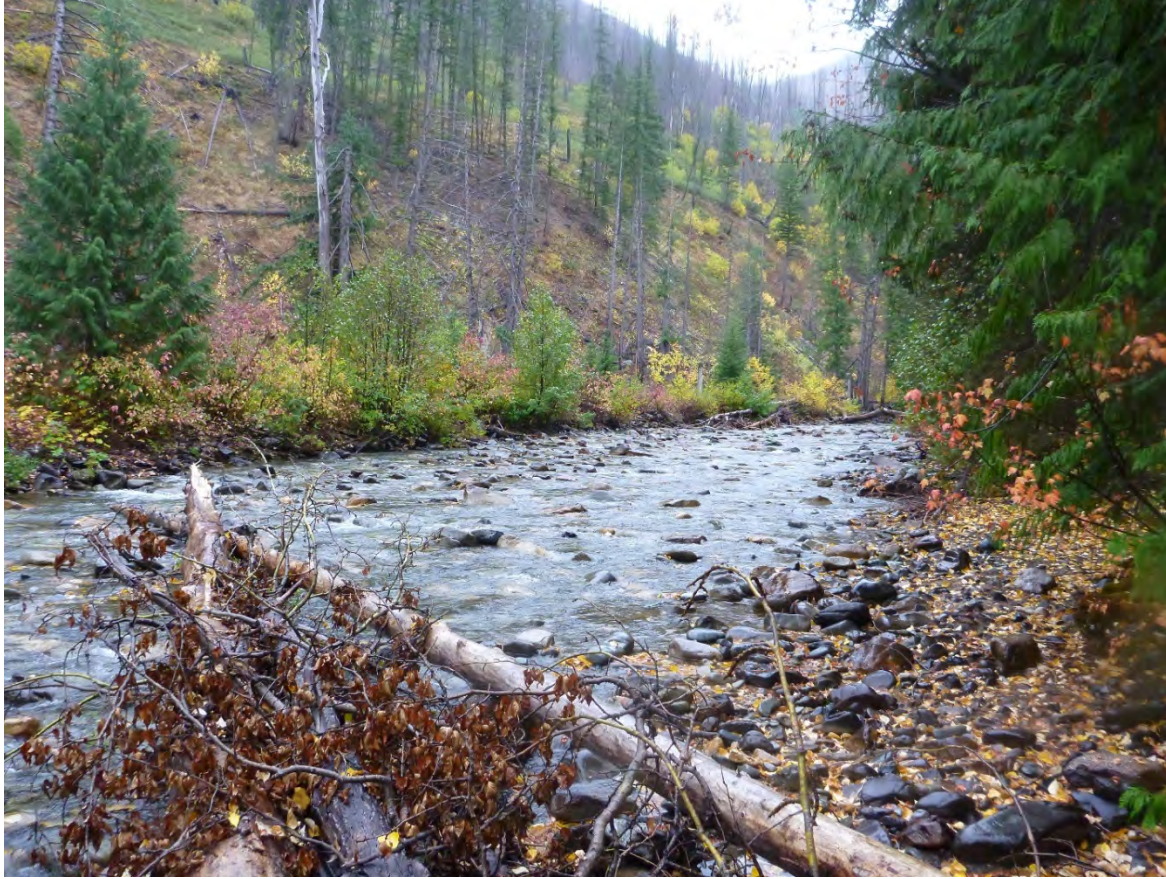
The channel in Reach 8 is a single-thread, riffle-pool stream with extended riffles and short pools (Figure 122). Many of the pools are maintained with boulder steps. There are three side-channels from RM 76.6 to 76.9, where aggradation is occurring due to local sediment inputs and large wood accumulation. The channel bed and active floodplains are composed of materials ranging in size from gravels to boulders, but large cobbles dominate the substrate. Hillslope inputs include weathered bedrock debris, glacial lag, and glacial terraces (rounded sand to boulders). Alluvial fan inputs from river-left (north side of the channel) also contribute sand- to boulder-sized material to the channel. Coarse sand and gravels are efficiently transported through the channel except where they are temporarily stored on floodplains or in localized deposition zones such as bar tops or eddies. The reach is vegetated with maturing forests except where forest fires recently burned most of the vegetation. The forest fire in 2003 left standing snags from RM 77.9 to 78.6; this section now has an establishing understory of shrubs and saplings. The remaining snags are now a plentiful source of large wood to the channel. This wood is influencing and will continue to influence geomorphic processes in Reach 8, and downstream reaches, for a decade or more.

Figure 122. Representative photo of Reach 8; looking downstream at RM 78.25. (10/15/2014)
