Qualitative Evaluation of Rock Weir Field Performance and Failure Mechanisms

U.S. Department of the Interior
Bureau of Reclamation
Technical Service Center
Denver, Colorado

September 2007

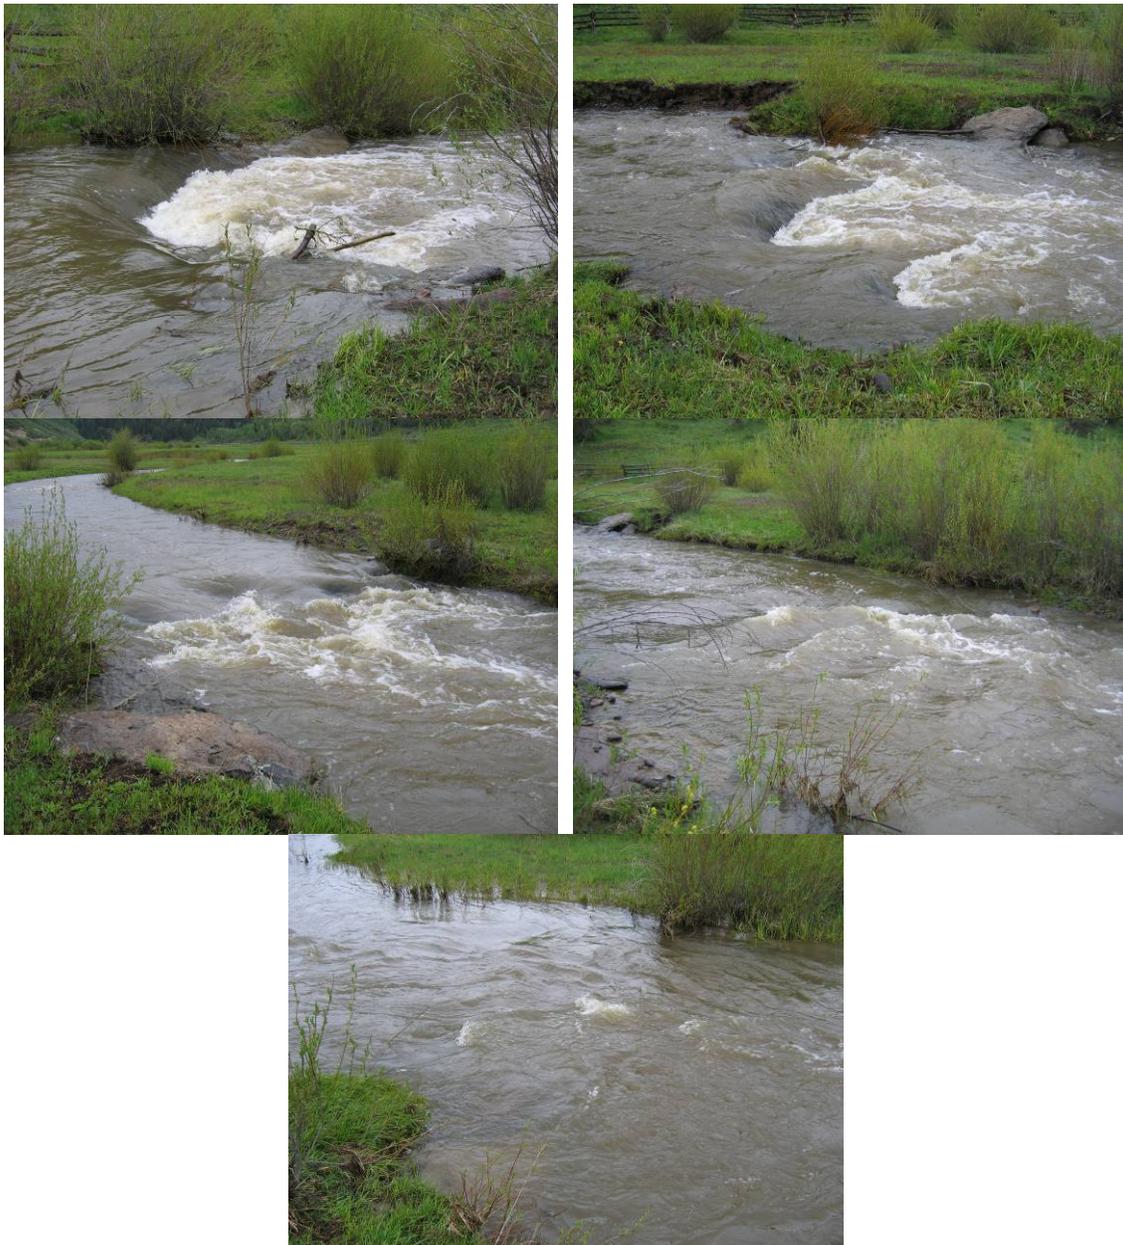
Maintaining a given water surface elevation difference across the structure is necessary for diversion purposes or for grade control. The elevation difference depends, in part, on flow rate. At high flows, the structure may become submerged and no longer alter water surface elevations (Figure 3). Site visits primarily occurred during low flow conditions and on structures designed to maintain a water surface elevation for irrigation diversions. Maintenance of a downstream pool provides depth diversity for habitat and entrance conditions for fish passage over a structure. Sedimentation filling the downstream pool can be deleterious to fish habitat and passage. Bank stabilization in the vicinity of the structure may be necessary for proper structure performance in addition to proper structure tie-in with the floodplain so that flow passing over the structure and the river do not flank it, as shown in Figure 4.

Figure 3. Examples of submergence conditions at high flow. Little Snake River, CO.

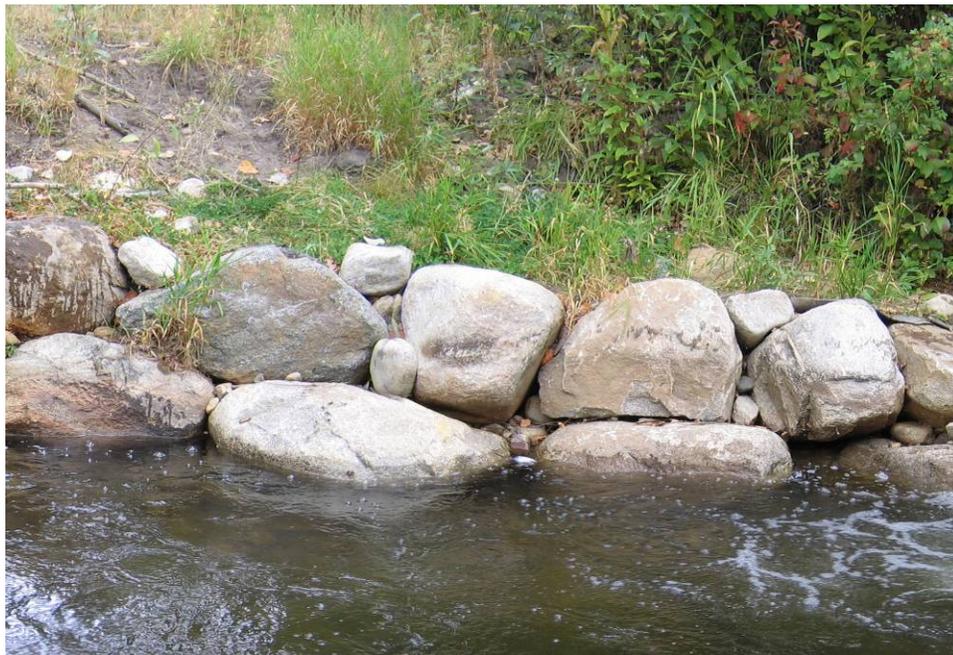
Figure 10. Staggering of header and footer rocks. Beaver Creek, WA.

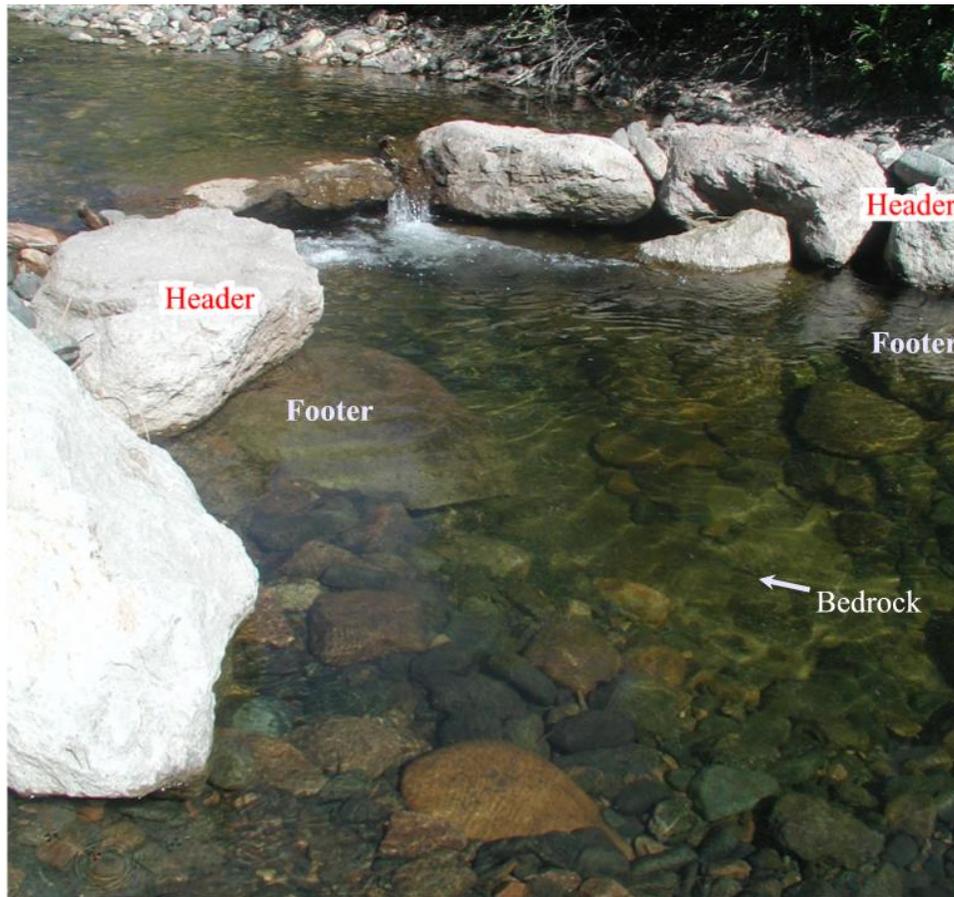
Foundation observations examined whether the rocks rested on bedrock or alluvium and estimated the depth of header and footer stacks. Figure 11 depicts a typical header-footer foundation configuration and the presence of bedrock in the scour pool.

Figure 11. Header-Footer configuration with exposed bedrock in scour pool. Little Snake River, CO.

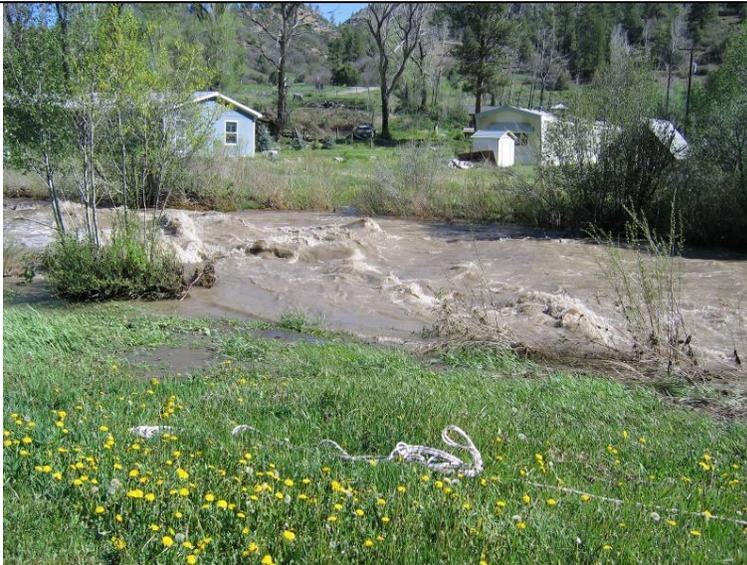
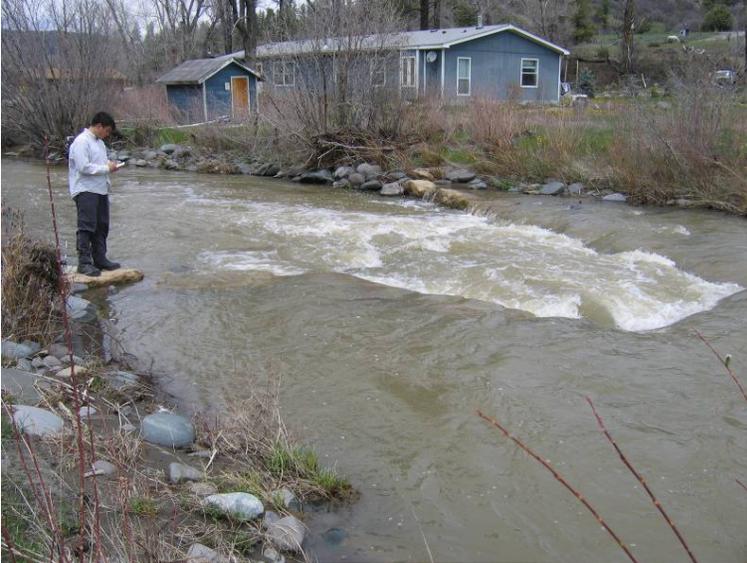
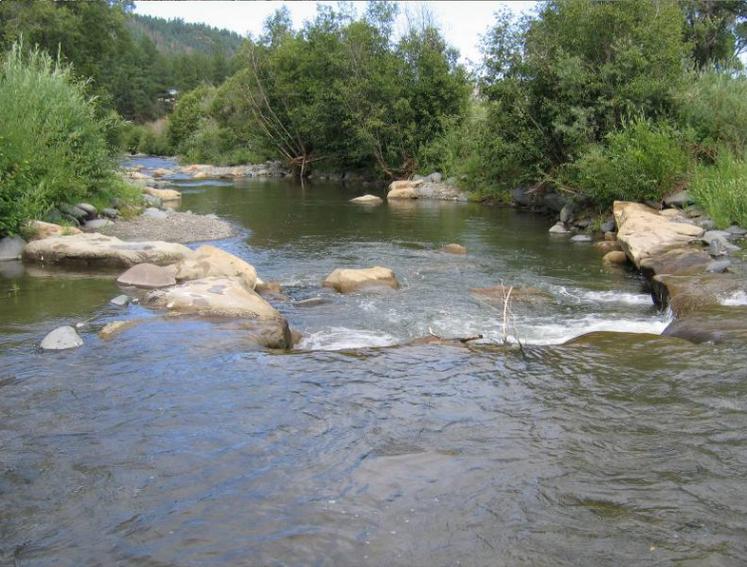
An increased velocity jet was visible downstream of the crest, extending 3 to 4 times the length of the structure. Backwater effects caused by flow constrictions of the structure created the energy head that caused the noted velocity jets through the structure. Low flow observations nearly always showed some level of water surface drop over the structure, except in locations where the structure and downstream pool had completely filled with sediment. High flow observations indicated a variety of submerged, free flow, and mixed conditions. In free flow conditions, changes to the water surface below the structures do not influence the upstream water depths. Submerged conditions were defined as the downstream water surface elevation influencing the elevation upstream of the structure. Determination of this condition was subjective. Rollers are frequently present even under submerged conditions. Several structures appeared completely drowned out during higher flows with no visible water surface disturbance. Figure 15 shows examples of submerged and free-flowing conditions at a single structure on the Rio Blanco.

In general, backwater effects on the Little Snake River during low flows appeared to extend the entire length between structures. If sediment buried the structure, this backwater effect was not evident. On the Rio Blanco, flow depths between structures appear to return to normal depth in most cases. The sites that did not appear to have one structure's backwater affecting the hydraulics of the upstream structure had larger spacing between the structures. Structures with voids still created a significant backwater effect.

Figure 15. Backwater Effects of (a) Submerged, (b) transitional, and (c) Free-Flow Conditions. Rio Blanco, CO.

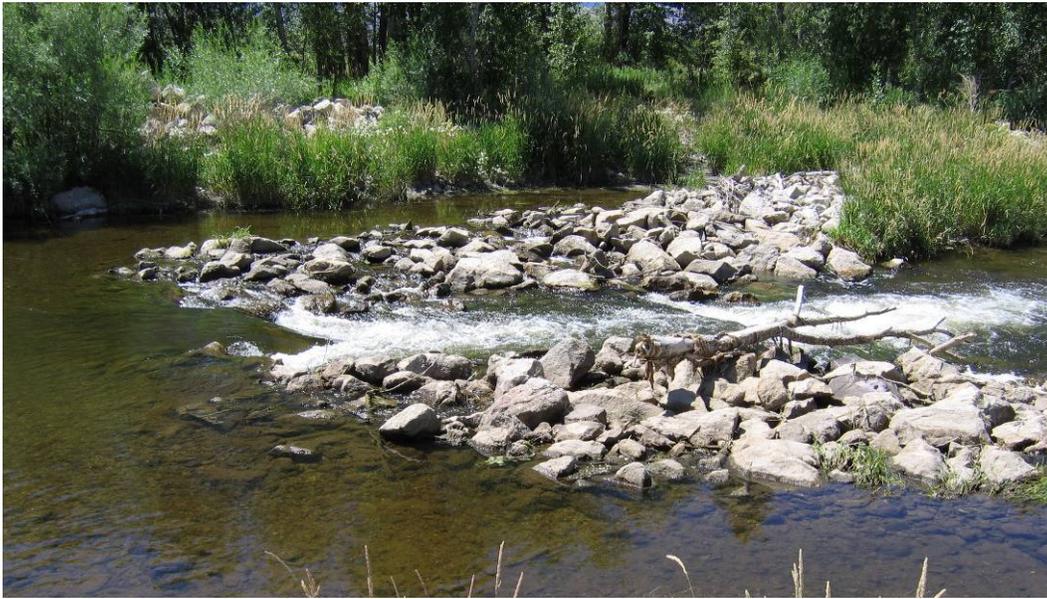
- Of all structures evaluated, PN region tended to use more rocks of smaller diameter and a more regular shape with multiple stone widths forming a crest.
- PN structures typically had steep sloped ramps of multiple rocks (Figure 19) and used a geomembrane in some instances to create a notch. Footers appeared staggered in some instances and not in others.
- Typical Rosgen designs were observed to be constructed out of fewer elongated rocks, resulting in the crest being defined by a single rock width (Figure 20).

Figure 19. Steep sloped ramps frequently used in PN Regional Designs. Lemhi River, ID

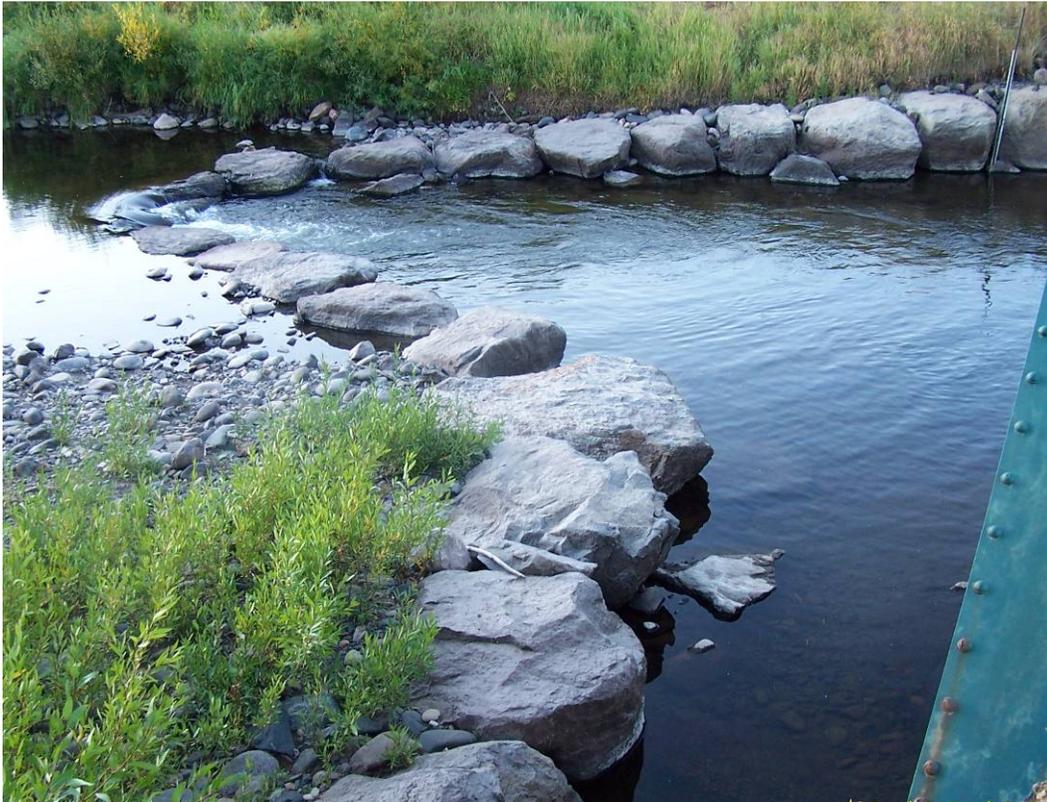
Figure 20. Typical Rosgen design with a single rock width of rocks defining structure. Little Snake River, CO

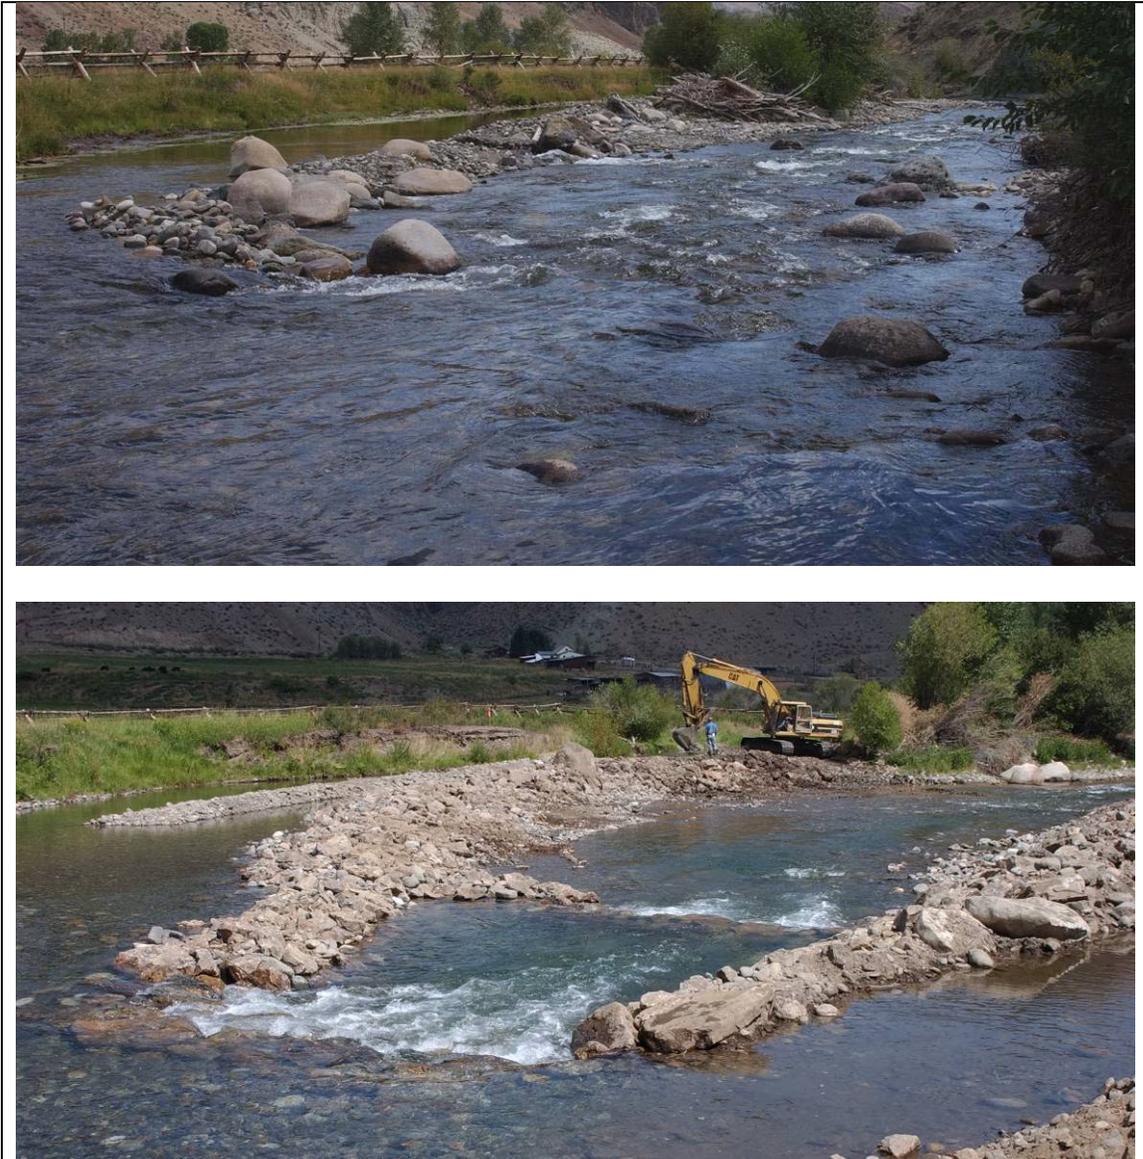
All structures appeared to successfully modify river flow patterns even under partial failure conditions. Observed influences of the structures included higher velocity flow jets through the center of structures, breaks in water surface profiles during low flow events, and presence of scour pools in numerous incidences (Figure 21). High flow events reduced the influence of the structures on the water surface elevation.

Figure 21. Pre- and Post- construction photos on the East Salmon River. Note changes in velocities and water surface profiles. East Fork Salmon River, ID

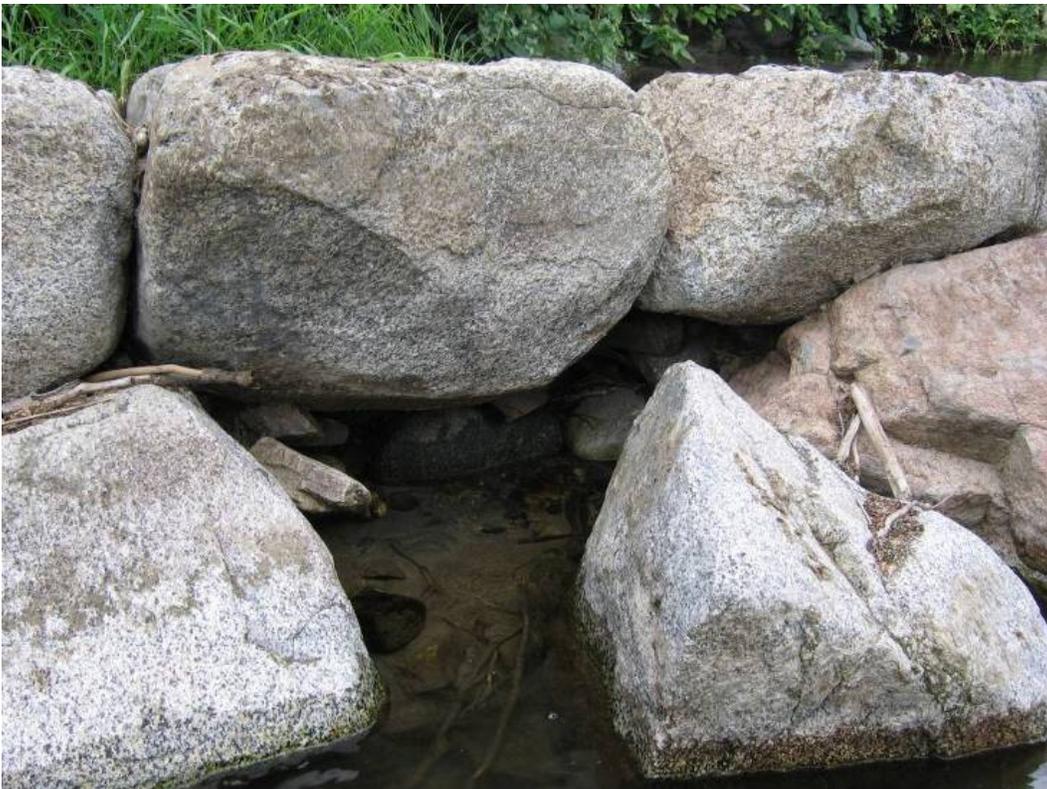
Interlocking structures appeared to resist sliding into a scour pool following the geotechnical slumping of footer rocks. Interlocking structures are characterized by the staggering of the header and footer rocks, in which the header rocks are placed over the seams of the footer rocks, and by the ability of the structure to remain intact if one of the footer rocks becomes dislodged (Figure 28). Although structures may still maintain some degree of functionality after rock dislodgement, the interlocking temporarily provides support and most-likely only delays failure.

Figure 28. Interlocking of rocks providing additional structure support.
