Technical Memorandum No. MERL-2014-67

## **Foul Release Coatings Scale-Up Testing – Parker Dam Trashrack: Fiscal Year 2014 Report**

U.S. Department of the Interior  
Bureau of Reclamation  
Technical Service Center  
Denver, Colorado

July 2014

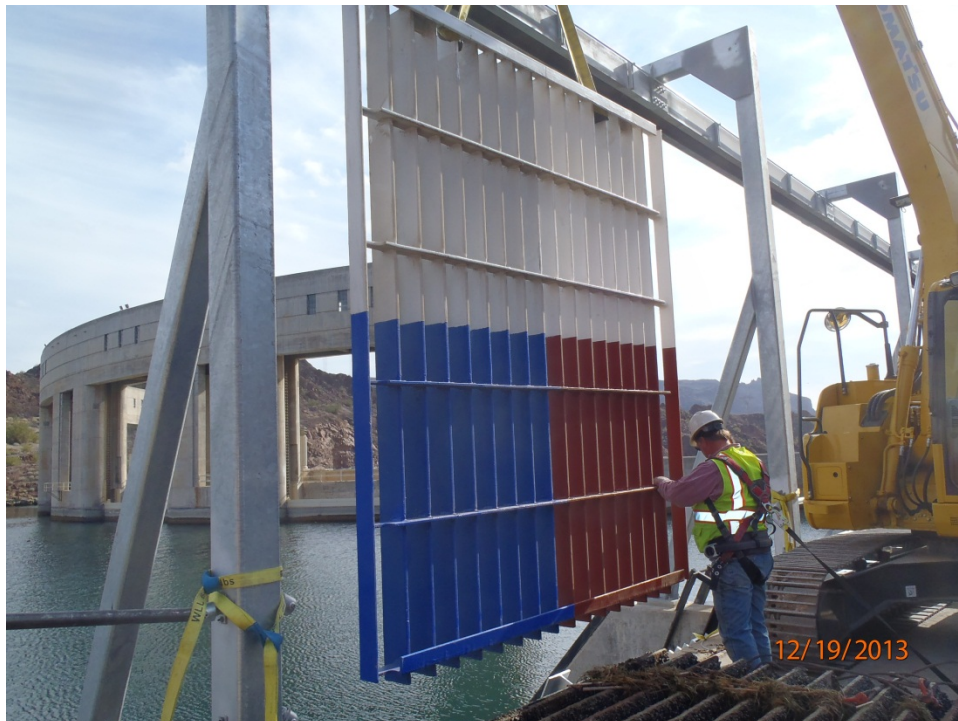
The experimental trashrack installation was completed on December 19, 2013. It was installed in Bay 9 right side (facing downstream). There were no problems extracting the existing trashrack, and it appeared to be in good condition, with no major rusting. Note that despite the presence of an automated trash rake, significant mussel buildup was present on the existing panel (figures 1–3). Figures 4–6 show the rack being installed in Bay 9.

Figure 4.—Installation of the new trashrack panel.

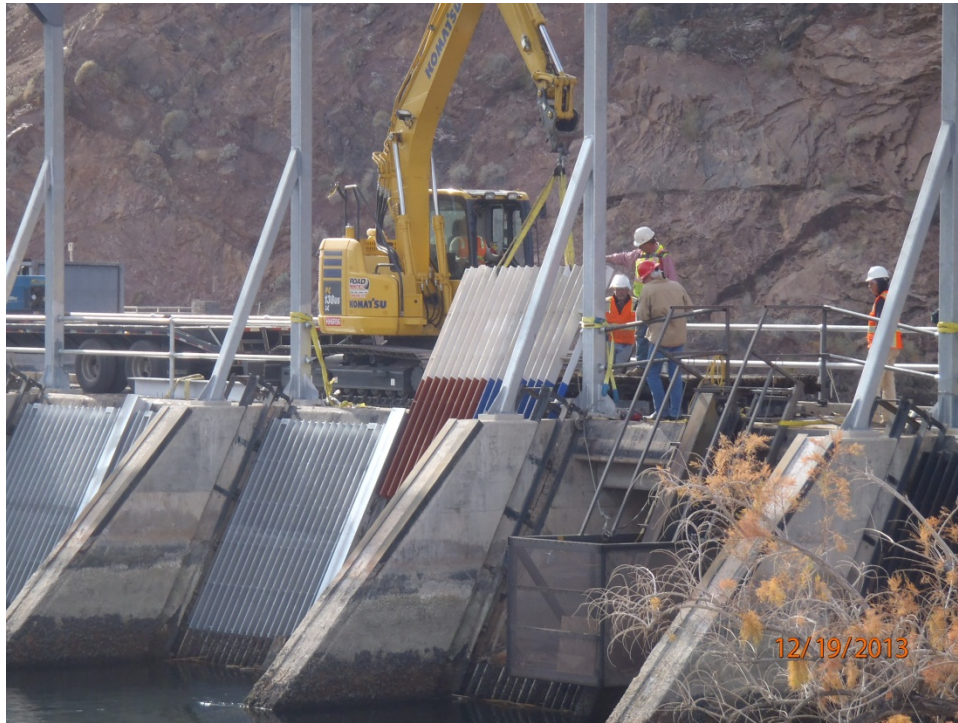
Figure 5.—Installation of the new foul release coated panel.

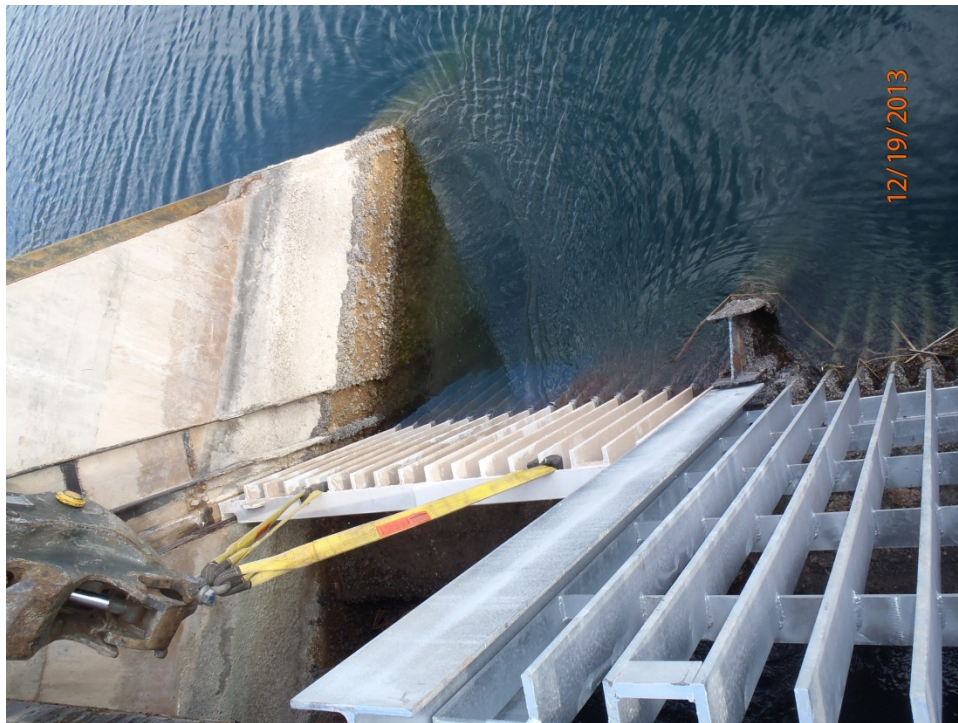
Figure 6.—Installation of the new trashrack panel.

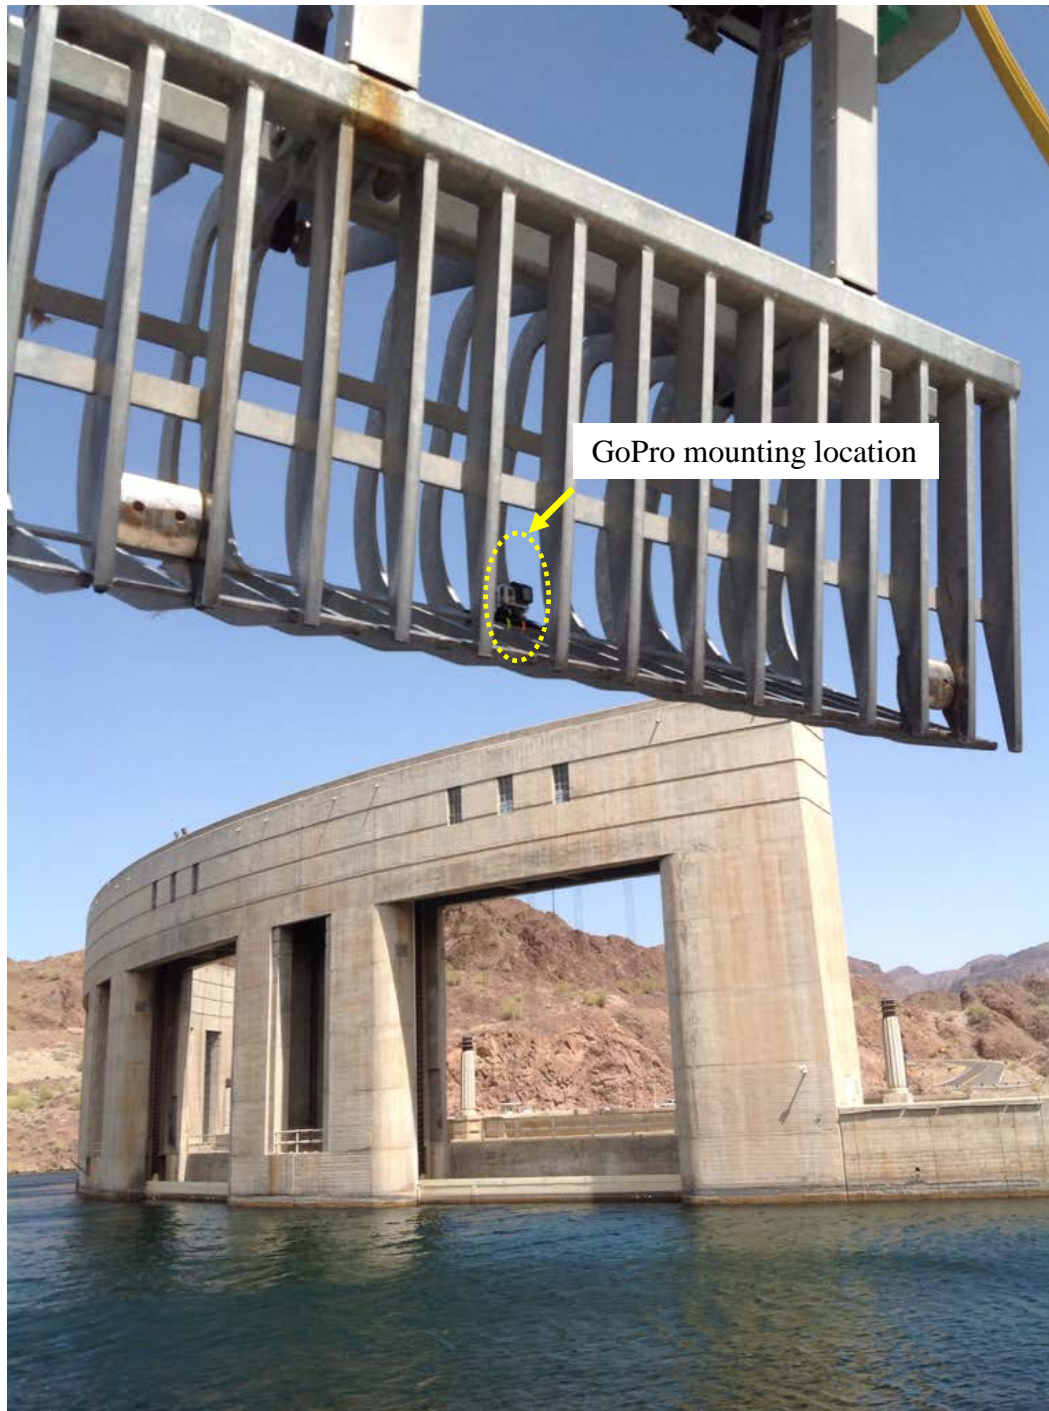
A scheduled inspection was performed May 23–24, 2014. A submersible camera was deployed to evaluate the degree of fouling and damage on the existing structure. This was accomplished by attaching a GoPro camera to the bars of the trashrack cleaner (see figure 7 for the mounting location). Opening the trash rake jaws tilted the camera downward and gave a broad perspective of the fouling

Figure 7.—Trashrack cleaner with GoPro camera mounted.
