Foul-Release Coatings Scale-Up Testing—Parker Dam Trashrack

Research and Development Office
Science and Technology Program
Final Report ST-2015-5270-1

September 2015

Foul-Release Coatings Scale-Up Testing—Parker Dam Trashrack: FY 2015 Final Report

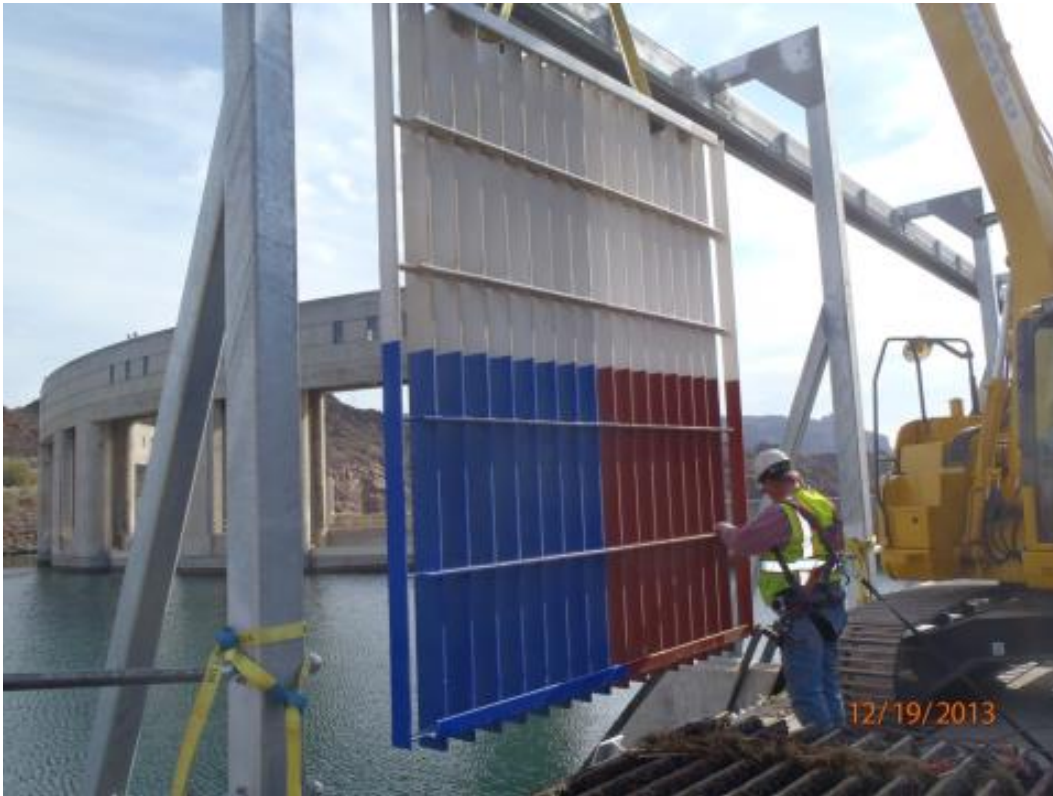
Figure 4.—Installation of the new trashrack panel.

The experimental trashrack installation was completed on December 19, 2013. It was installed in Bay 9 right side (facing downstream). There were no problems extracting the existing trashrack, and it appeared to be in good condition, with no major rusting. Significant mussel buildup was present on the existing panel (figures 1–3). Figures 4–6 show the foul-release coated trashrack panel being installed in Bay 9.

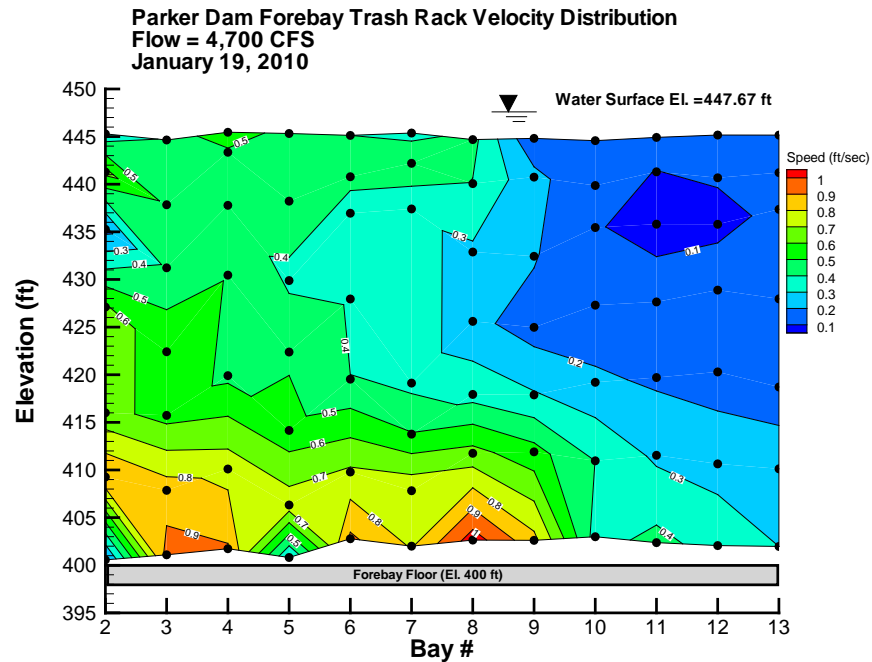
The top of the foul-release coated trashrack panel is approximately 3 to 5 ft below the water surface at elevation 445 ft, and is 10-ft-long. Figure 7 shows measured velocities during the lowest flow rate of 4,700 ft^3/s , figure 8 shows velocities at 9,800 ft^3/s , and figure 9 shows velocities at 15,000 ft^3/sec . The variability in

measurement elevation was caused by strong currents moving the probe downstream and upward in the water column. At $4,700 \text{ ft}^3/\text{s}$ the velocities were 0.2 to 0.3 ft/s. At $9,800 \text{ ft}^3/\text{s}$ the velocities were 0.6 to 0.7 ft/s. At $15,000 \text{ ft}^3/\text{s}$, the velocities were 1.2 to 1.3 ft/s.

Figure 7.—Isovel plot of the velocity magnitudes passing through trashrack bays 2 to 13. The foul-release coated panel is located at 435-445 ft.

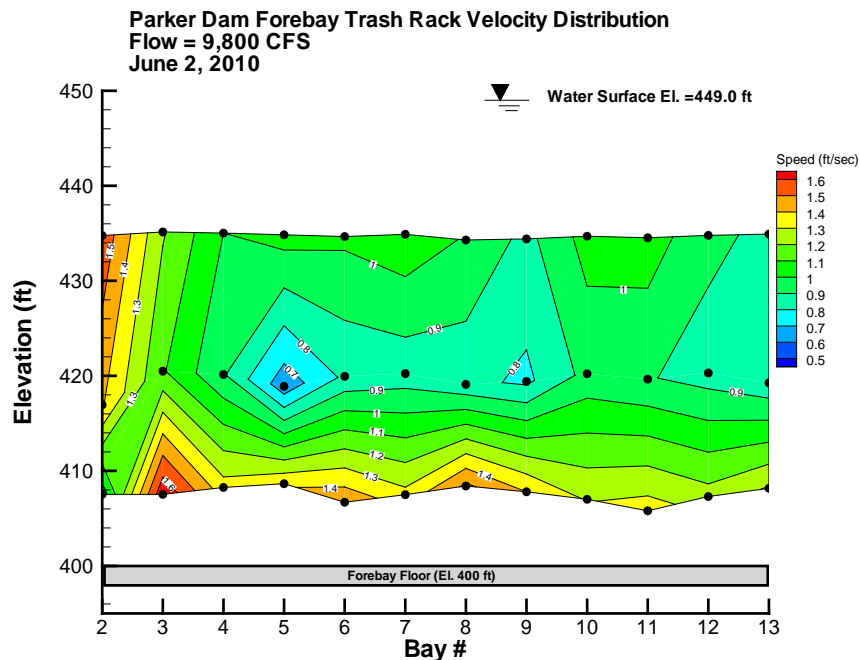
Figure 8.—Isovel plot of the velocity magnitude passing through trashrack bays 2 to 13. The foul-release coated panel is located at 435-445 ft.

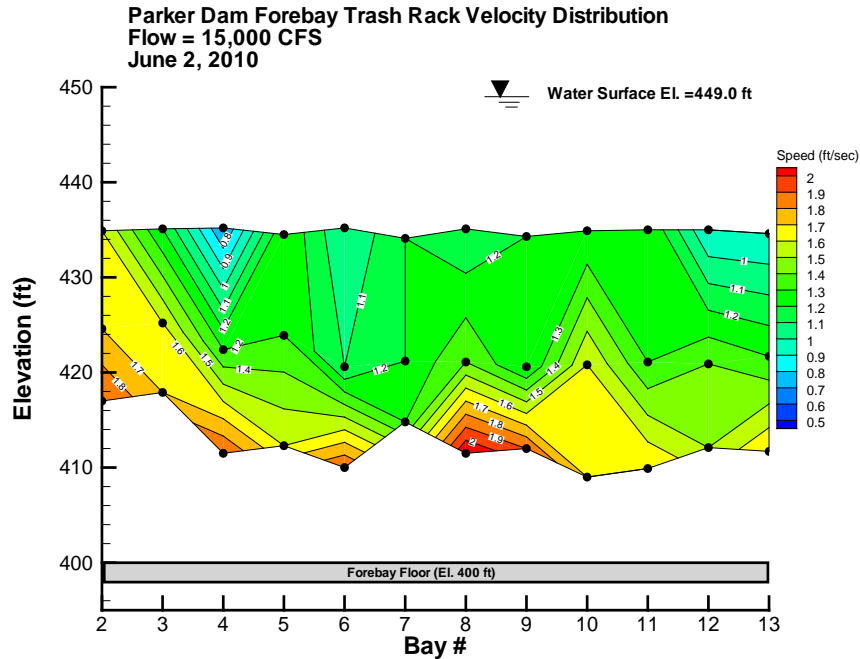
Figure 9.—Isovel plot of the velocity magnitude passing through trashrack bays 2 to 13. The foul-release coated panel is located at 435-445 ft.

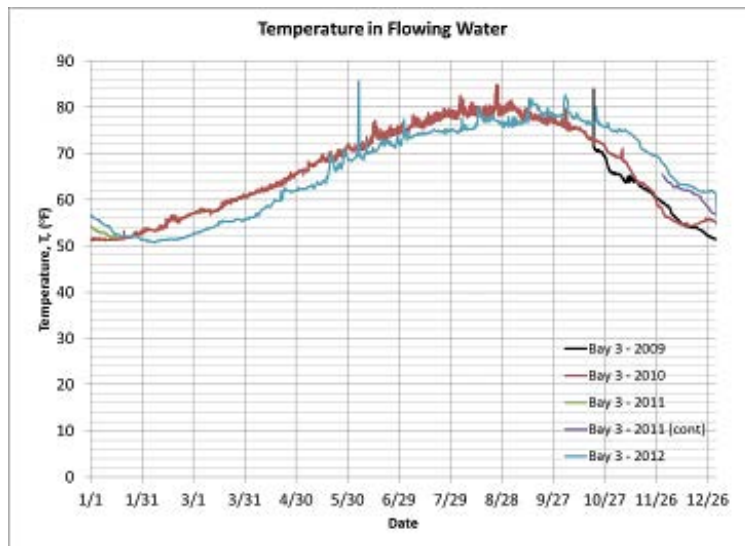
Water temperature data were recorded between October 20, 2009, through December 2012, at 15-minute intervals. Figure 10 shows temperature data at elevation 410 ft, 40 ft below the water surface. Quagga mussels are capable of reproducing as low as 48°F. Temperature data shows that at this facility the water temperatures would allow mussels to reproduce year round.

Figure 10.—Temperature data from 2009-2012 in bay 3 of trashrack, 40 ft below the water surface.

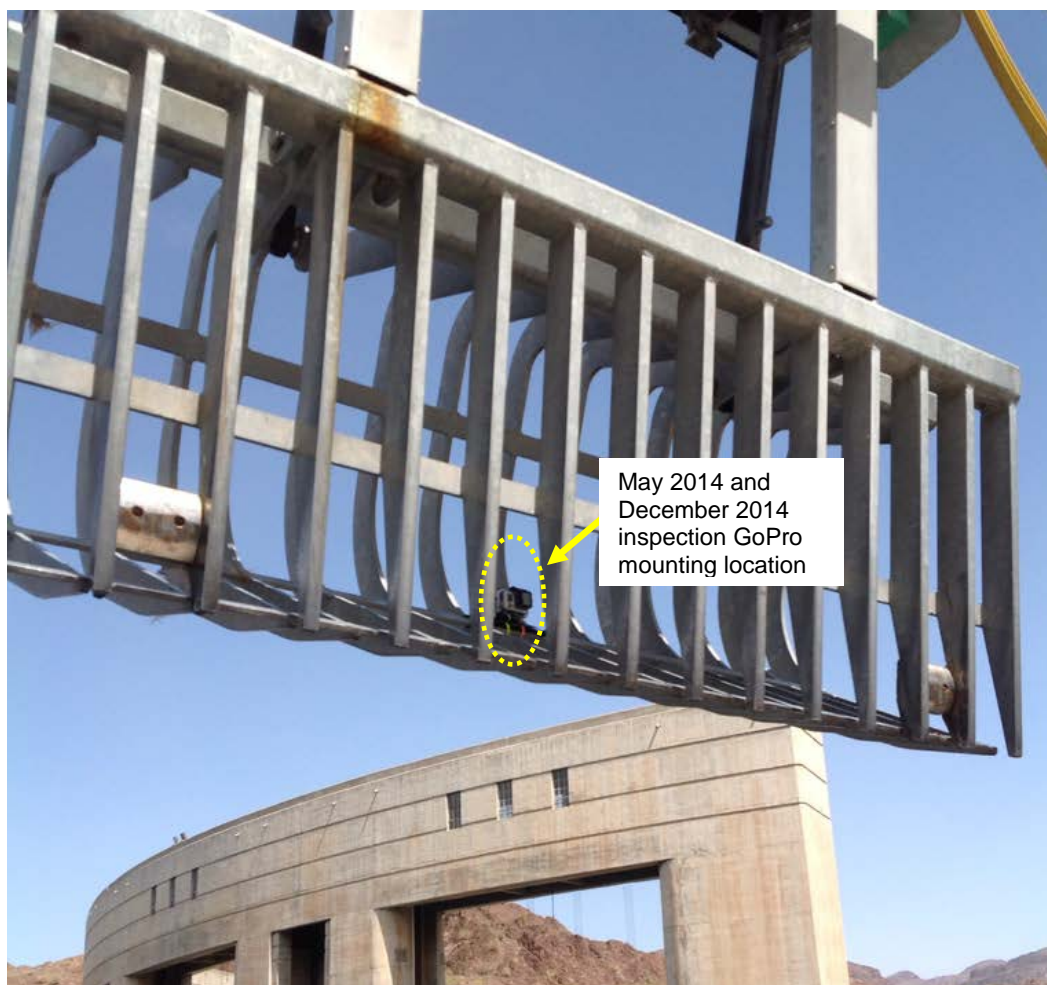
Figure 11.—Trashrack cleaner with GoPro camera mounted.

Scheduled inspections were performed May 20, 2014, December 1, 2014, and May 19, 2015. A submersible camera was deployed to document the degree of fouling and damage on the existing structure. This was accomplished by attaching a GoPro camera to the bars of the trashrack cleaner (see figure 11 for the mounting location for May and December 2014 inspections). Opening the trash rake jaws tilted the camera downward and gave a broad perspective of the fouling conditions. Closing the jaws produced a closer picture, revealing the coating condition with 3 visible bars. During the May 2015 inspection, the camera was mounted further to one side initially and then shifted to the other side for a more complete inspection.

The trash rake has three points of contact, the bottom has two guides that are in contact with the trash bars (figure 11) and a roller at the top (figure 12).

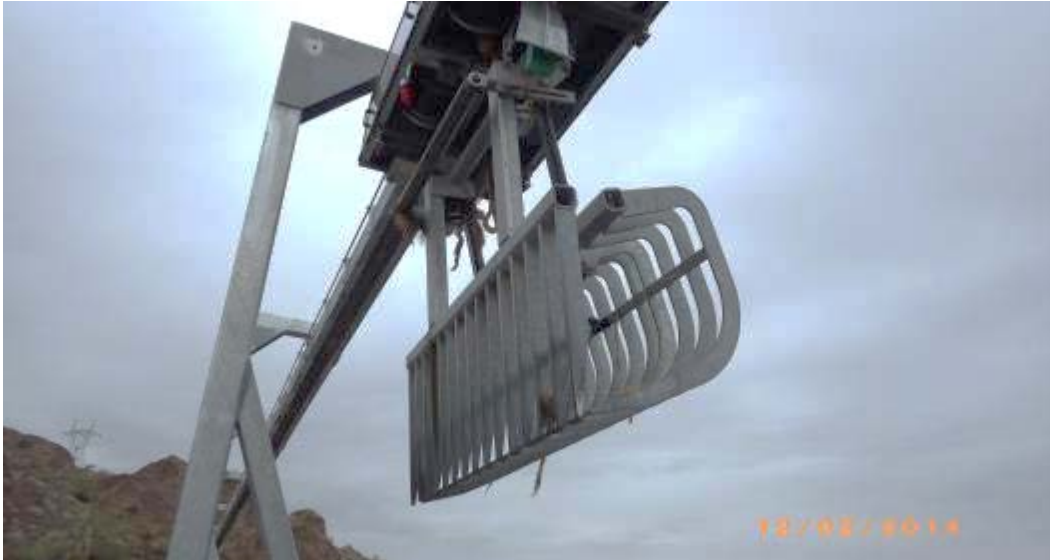
Figure 12.—Trash rake has a roller in the back and two guides on the bottom of the rake.
