Foul-Release Coatings Scale-Up Testing—Parker Dam Trashrack: FY 2015 Final Report

Research and Development Office
Final Report ST-2015-5270-1 / MERL-2015-75

September 2015

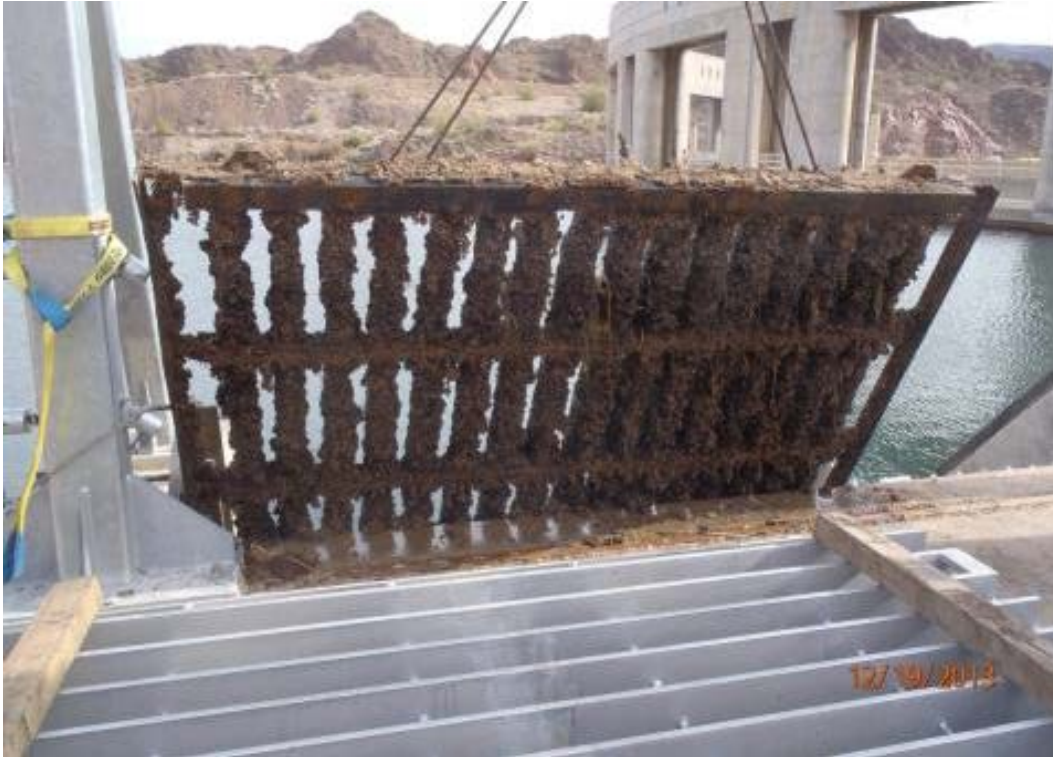
The experimental trashrack installation was completed on December 19, 2013. It was installed in Bay 9 right side (facing downstream). There were no problems extracting the existing trashrack, and it appeared to be in good condition, with no major rusting. Significant mussel buildup was present on the existing panel (figures 1–3). Figures 4–6 show the foul-release coated trashrack panel being installed in Bay 9.

Figure 2.—Existing trashrack, view looking east.

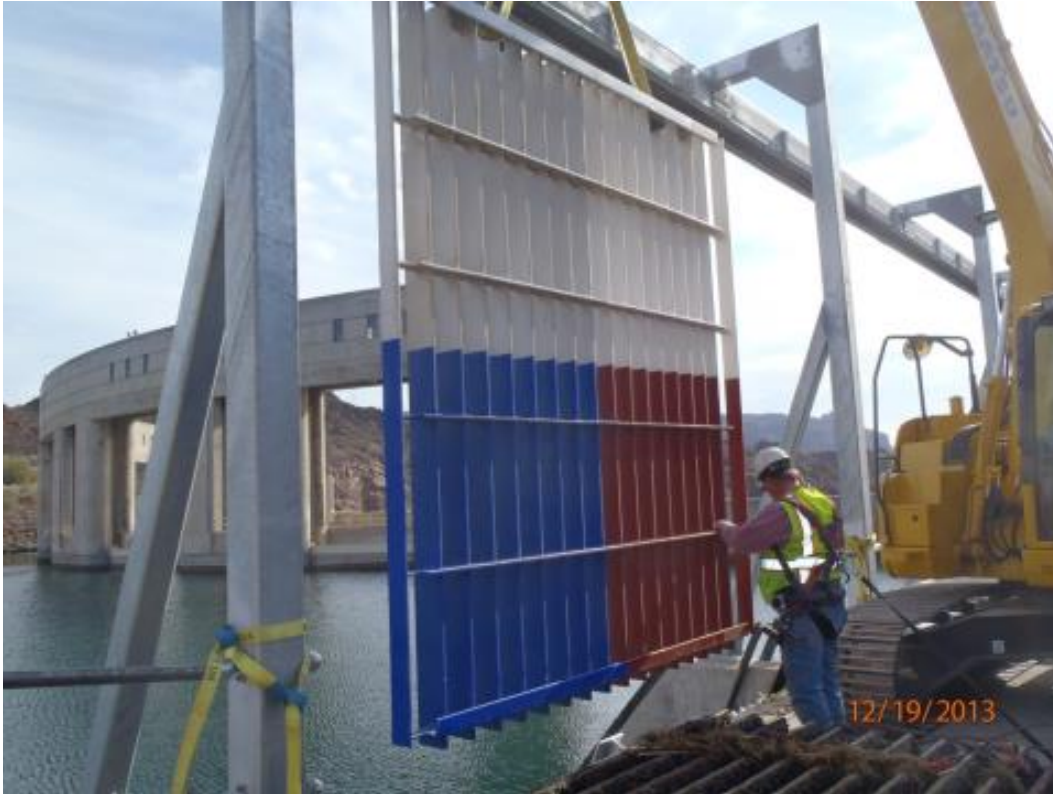
Figure 4.—Installation of the new trashrack panel.

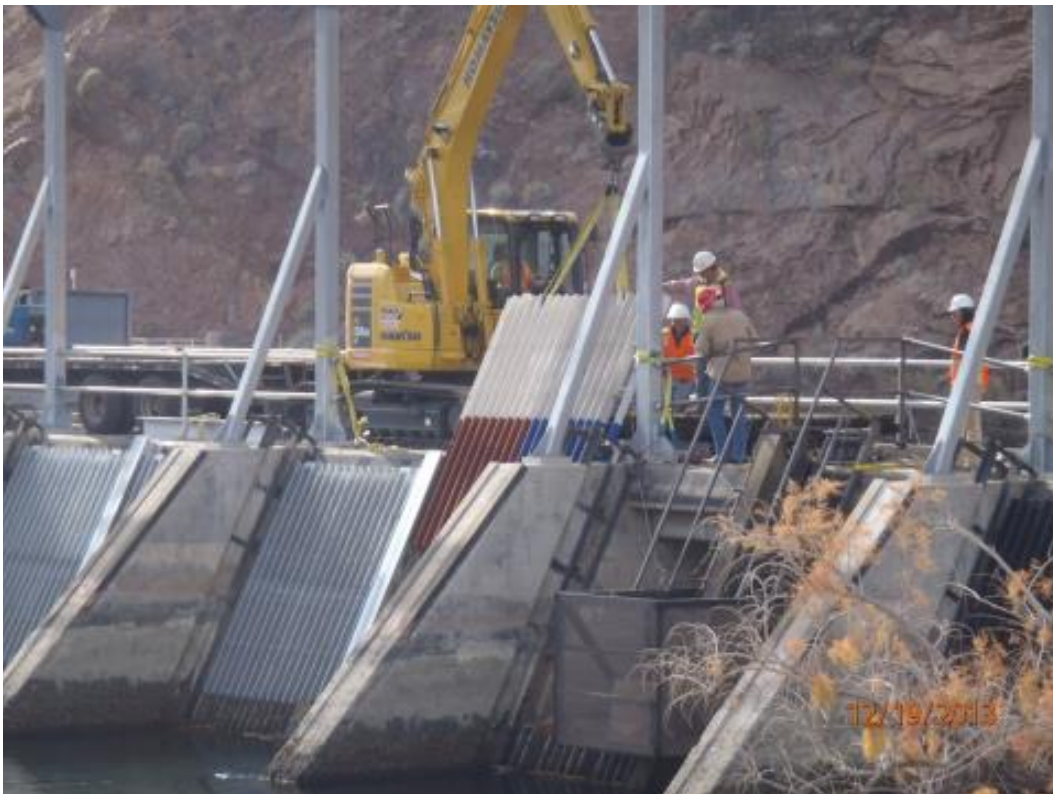
Figure 5.—Installation of the new foul-release coated panel.

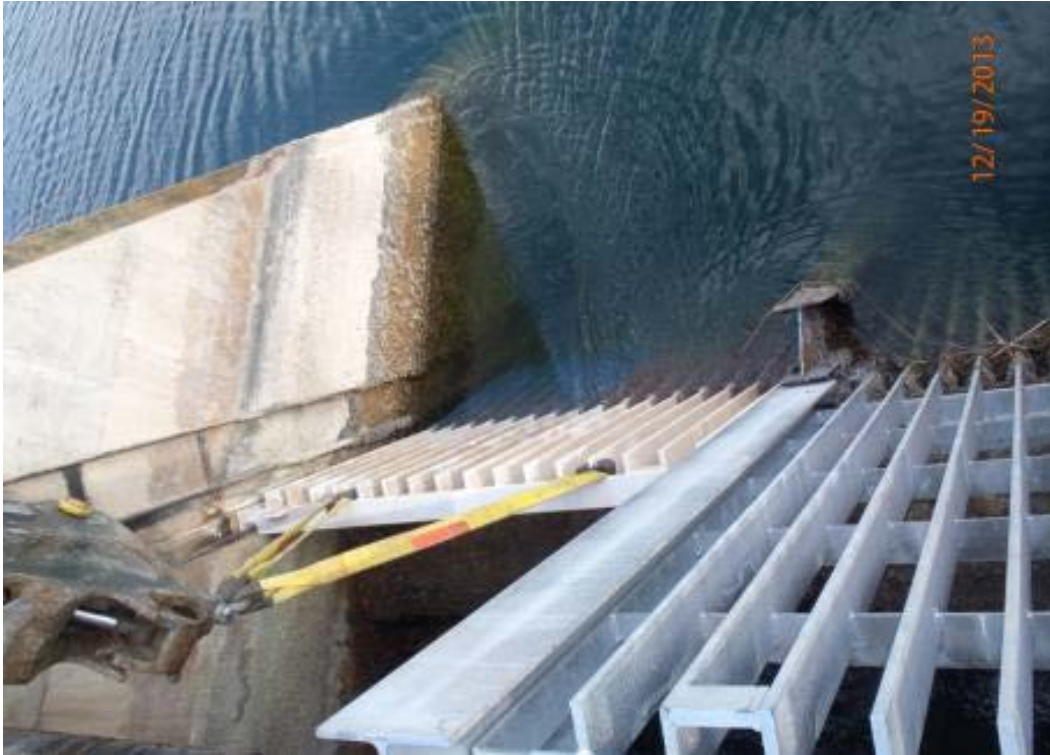
Figure 6.—Installation of the new trashrack panel.

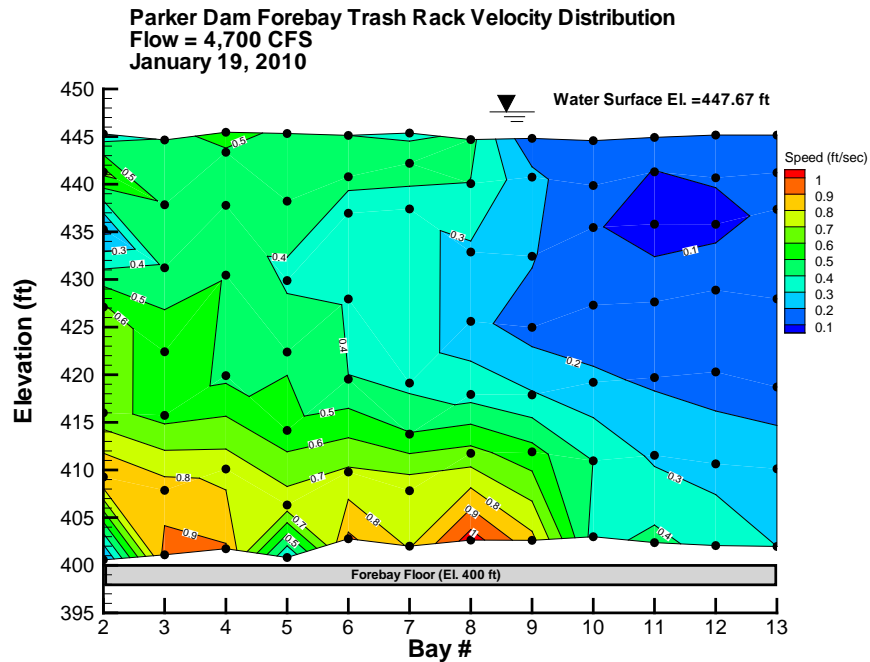
measurement elevation was caused by strong currents moving the probe downstream and upward in the water column. At 4,700 ft³/s the velocities were 0.2 to 0.3 ft/s. At 9,800 ft³/s the velocities were 0.6 to 0.7 ft/s. At 15,000 ft³/s, the velocities were 1.2 to 1.3 ft/s.

Figure 7.—Isovel plot of the velocity magnitudes passing through trashrack bays 2 to 13. The foul-release coated panel is located at 435-445 ft.

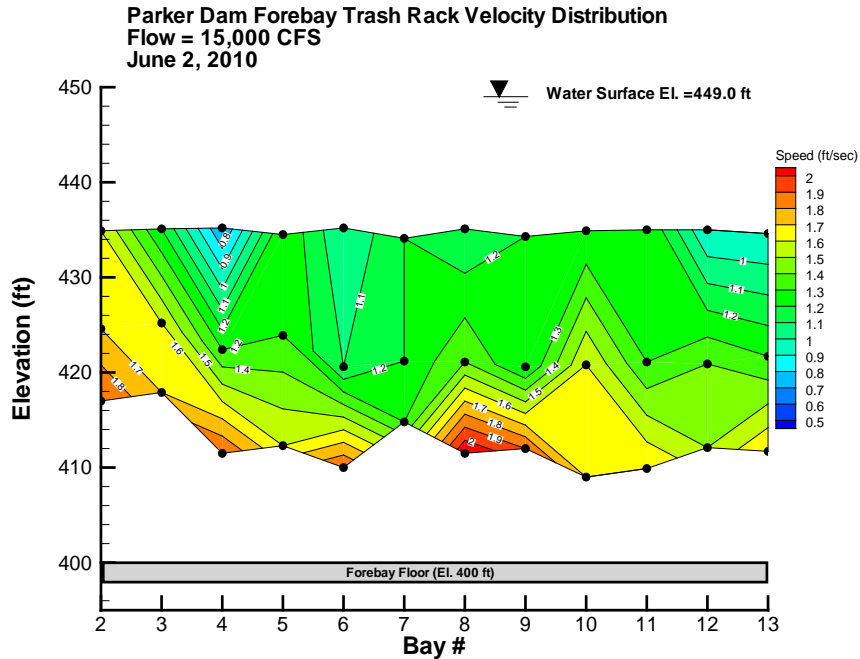
Figure 9.—Isovel plot of the velocity magnitude passing through trashrack bays 2 to 13. The foul-release coated panel is located at 435-445 ft.

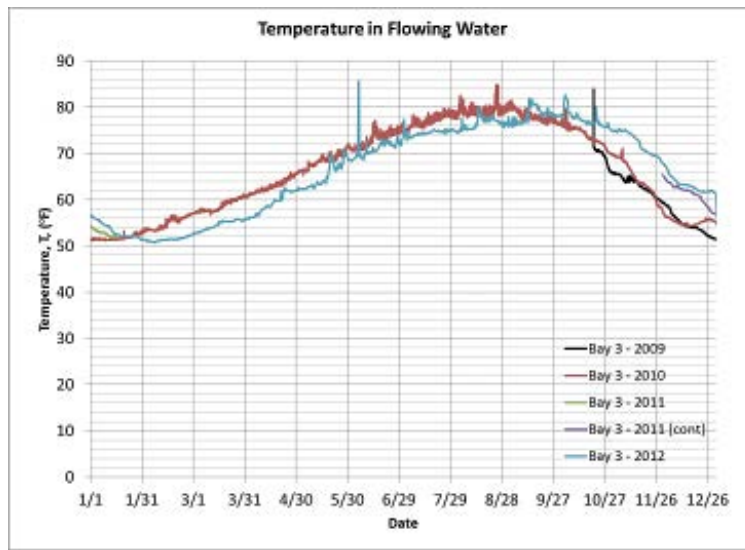
Water temperature data were recorded between October 20, 2009, through December 2012, at 15-minute intervals. Figure 10 shows temperature data at elevation 410 ft, 40 ft below the water surface. Quagga mussels are capable of reproducing as low as 48°F. Temperature data shows that at this facility the water temperatures would allow mussels to reproduce year round.

Figure 10.—Temperature data from 2009-2012 in bay 3 of trashrack, 40 ft below the water surface.

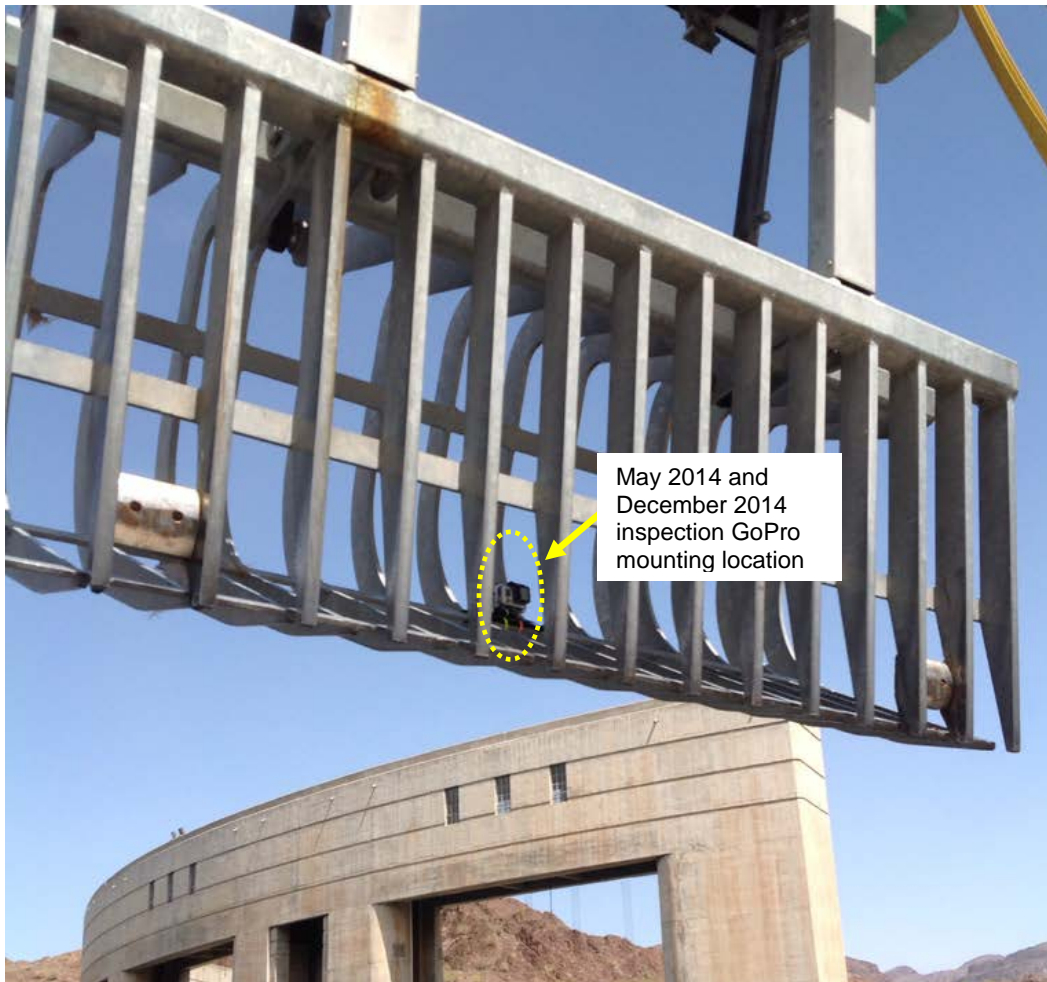
Figure 11.—Trashrack cleaner with GoPro camera mounted.

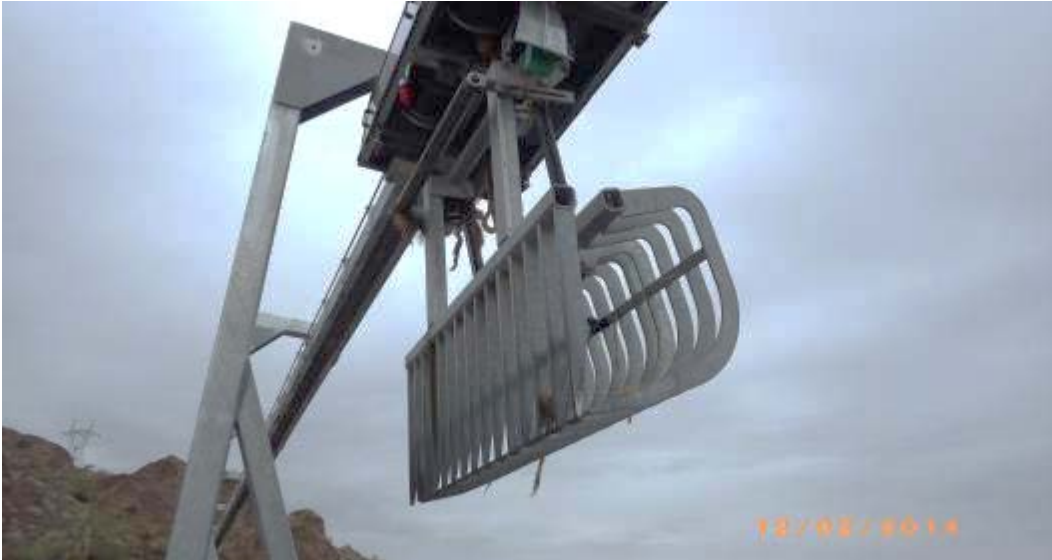
The trash rake has three points of contact, the bottom has two guides that are in contact with the trash bars (figure 11) and a roller at the top (figure 12).

Figure 12.—Trash rake has a roller in the back and two guides on the bottom of the rake.
