Corrosion Protection of Steel Structures by Coal Tar Enamel: 80 Years of Performance

Research and Development Office
Science and Technology Program
Final Report ST-2017-1546-01, 8540-2017-45

August 2017

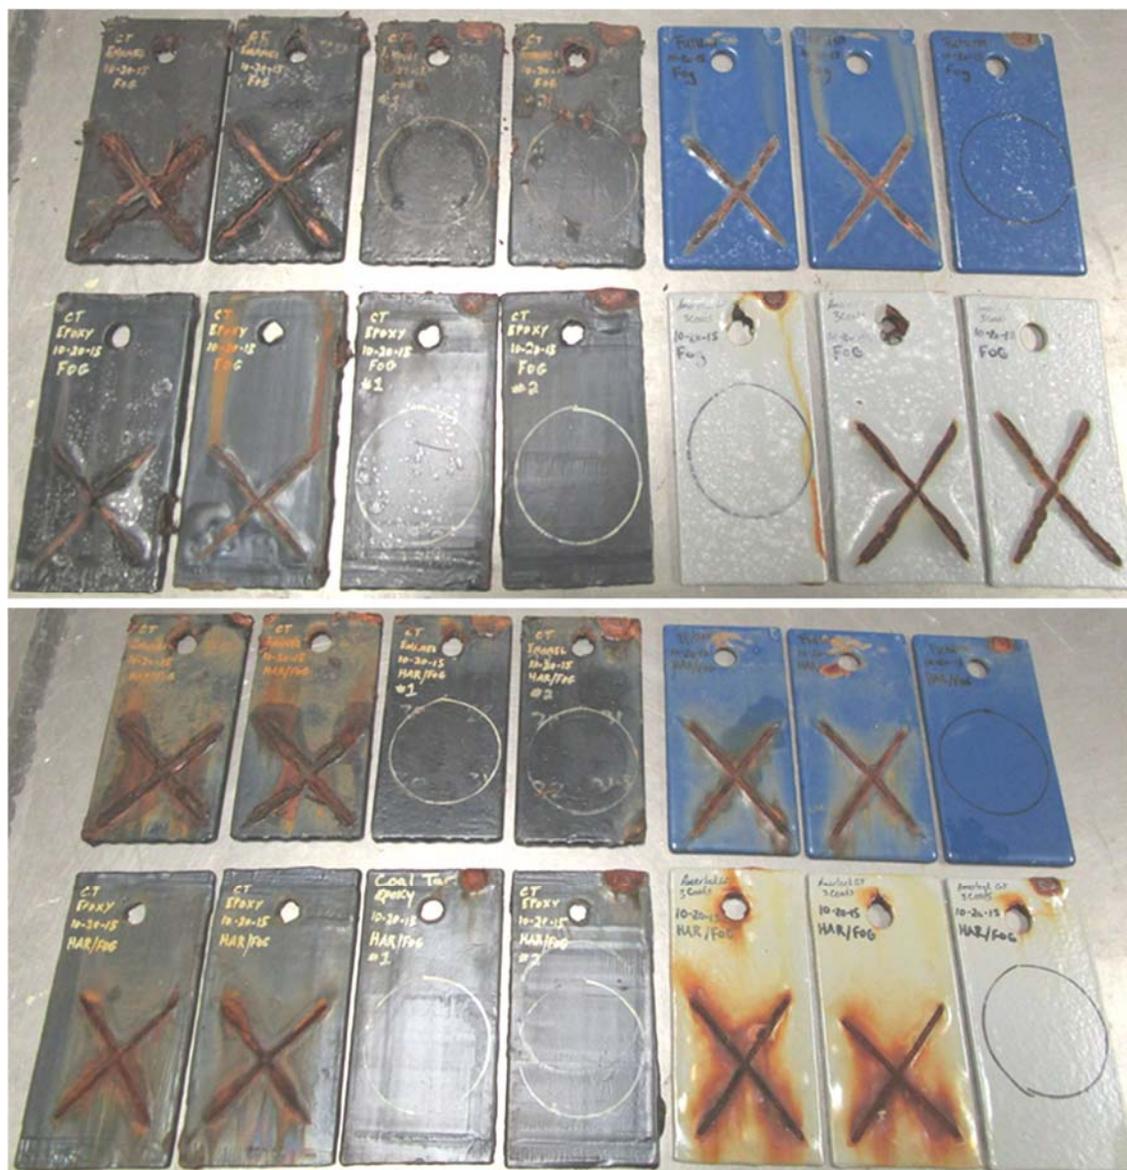
All panels received testing following 5000 hours in laboratory weathering exposures. Figure 5 documents the coatings’ visual appearance following testing for the FOG and HAR/FOG exposure, which generally provided the most severe material degradation.

Figure 5. Full sample sets of FOG, at top, and HAR/FOG, at bottom, after completing six months of exposure: coal tar enamel (top-left), coal tar epoxy (bottom-left), polyurethane (top-right), and epoxy (bottom-right).

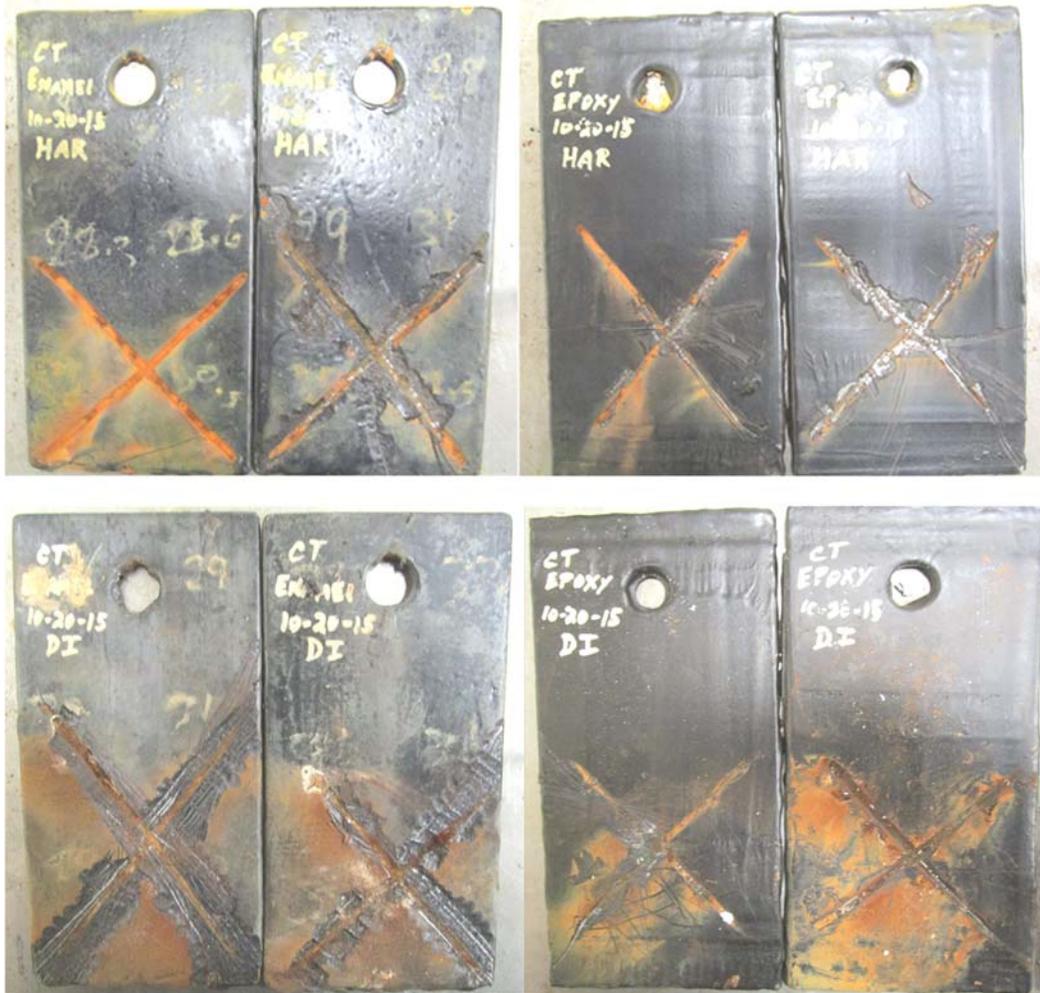
In both the HAR and DI immersion exposures, no undercutting occurred for the coal tar enamel and the coal tar epoxy. The coating could not be removed past the scribe, as shown in Figure 7. This result supports field observations that coatings with coal tar pitch have excellent performance in immersion exposures when temperature and humidity fluctuations are limited.

Figure 7. Corrosion undercutting of coal tar enamel panels after HAR (top-left) and DI (bottom-left) exposures; coal tar epoxy after HAR (top-right) and DI (bottom-right) exposures.

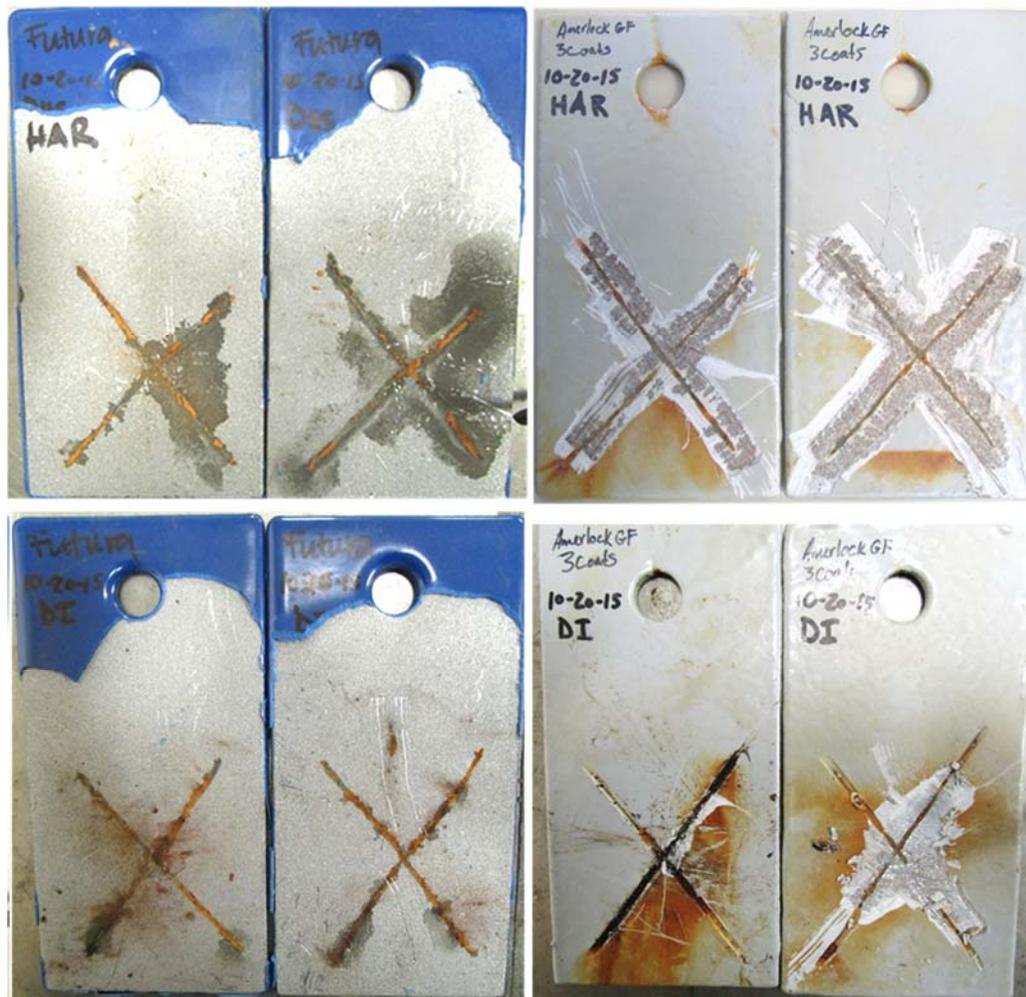
The polyurethane coating easily peeled from the entire surface of the panel in both immersion exposures. Corrosion staining as a result of undercutting occurred only in the area adjacent to the scribe, see Figure 8. The undercutting for the HAR exposure was more severe than for DI. The results indicate a severe loss of adhesion for the polyurethane coating in immersion, despite some protection from corrosion undercutting.

The epoxy had minimal corrosion creep in HAR and DI exposures. In addition, a small band of coating could be removed adjacent to the scribe in both HAR panels and in only one DI panel. The removal of this small section of coating is similar to the polyurethane in that no corrosion undercutting was observed; however, this reduced coating adhesion is much less severe and fails in a more brittle in nature.

Figure 8. Corrosion undercutting of polyurethane panels after HAR (top-left) and DI (bottom-left), and epoxy after HAR (top-right) and DI (bottom-right).

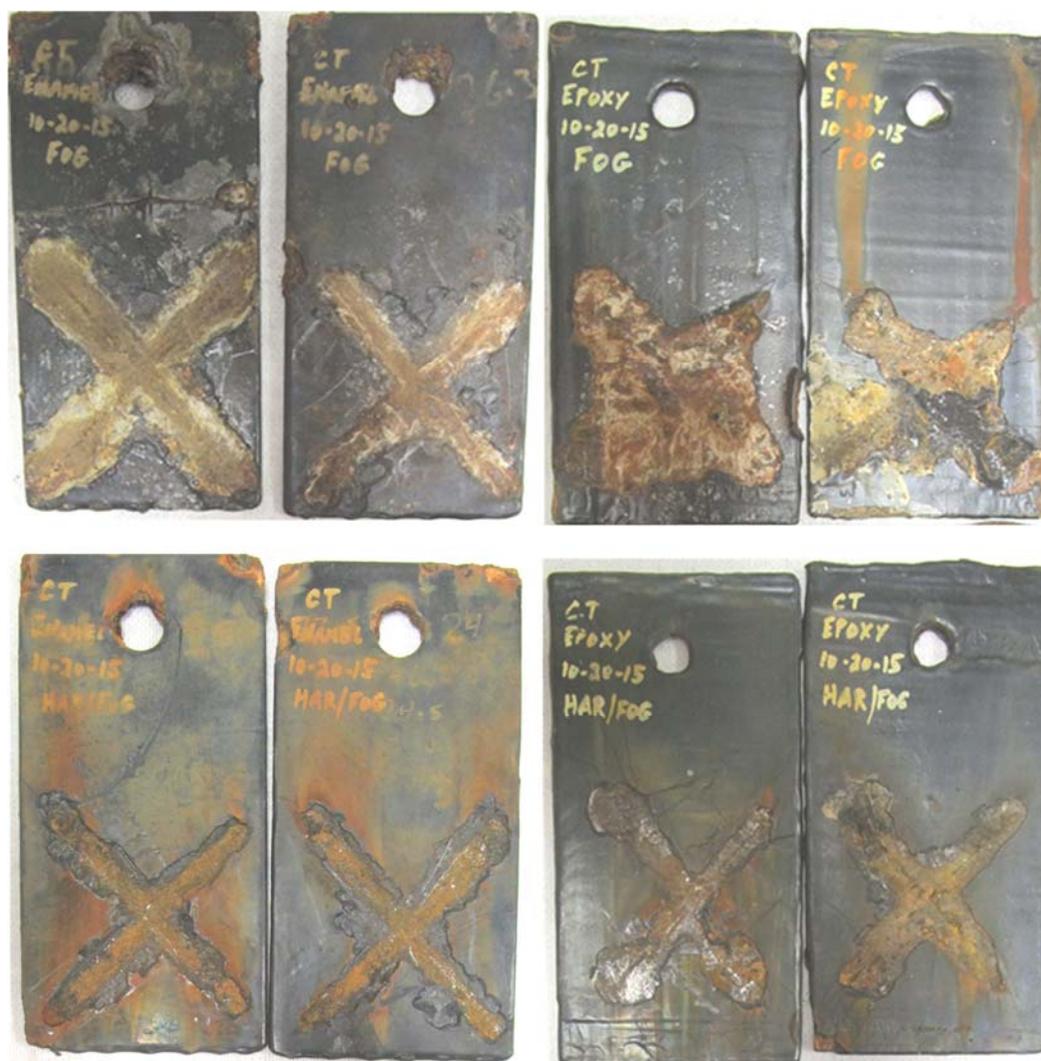
Figure 9 shows the coal tar enamel and coal tar epoxy panels after exposure. The FOG exposure provided the poorest performance for both coal tar coatings and had a higher variability than seen on other samples. The corrosion undercut area lifted and peeled coating from the substrate. Additional coating is easily removed beyond undercut, but a residue remains adhered to the substrate, which is likely coal tar pitch.

The top layer of the coal tar enamel coating in FOG exposure was easily removed by scraping. This suggests that the outer layers of the material degrade as a result of the cycling.

FOG exposure caused extensive blistering and undercutting on the coal tar epoxy coating as a result of induced cracks and fractures. However, the coating remained strongly adhered beyond the corrosion undercutting area.

Figure 9. Corrosion undercutting of coal tar enamel panels after FOG (top-left) and HAR/FOG (bottom-left), and coal tar epoxy after FOG (top-right) and HAR/FOG (bottom-right).

The coal tar enamel coating exposure to HAR/FOG produced less corrosion undercutting than observed for the other three coating systems. However, both coal tar enamel and coal tar epoxy were very brittle after HAR/FOG exposure and chipped from the substrate easily. Coating was easily removed from the area adjacent to the scribe, but a coating residue remained adhered to the substrate.

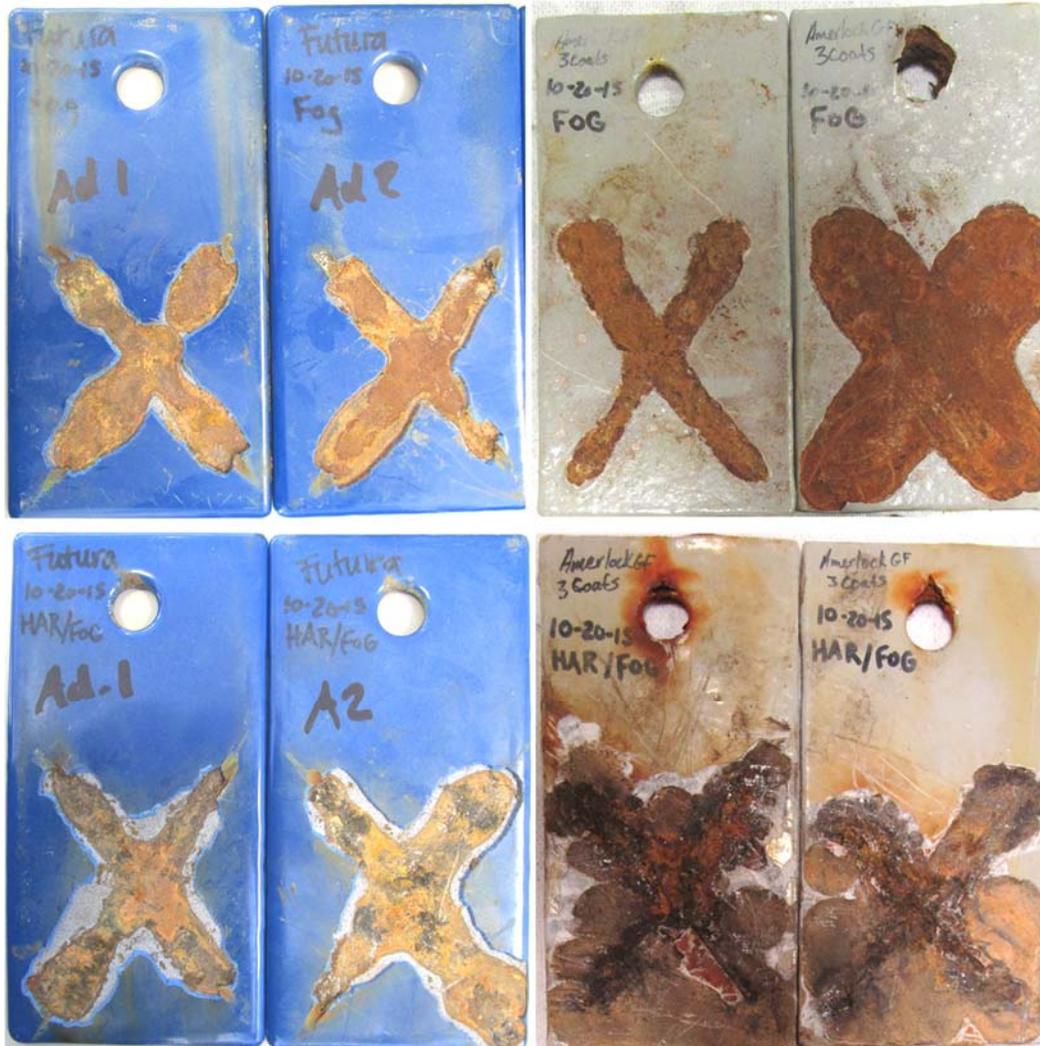
The polyurethane had moderate corrosion undercutting at the scribe for both the FOG and HAR/FOG exposures, see Figure 10. For FOG testing, the coating could be removed minimally from the area adjacent to the scribe. It could be removed more significantly in the HAR/FOG exposure but not nearly as far as observed in polyurethane's immersion exposures.

The epoxy coating FOG exposure produced undercutting that lifted and peeled the coating from the area adjacent to the scribe. The undercutting did not extend beyond the lifted area. Significant blistering also

occurred in the epoxy coating during HAR/FOG exposure that extended to the nearest edges of the panel. Both epoxy exposures had significant undercutting, with very high variability occurring in the FOG test.

Figure 10. Corrosion undercutting of polyurethane panels after FOG (top-left) and HAR/FOG (bottom-left), and epoxy after FOG (top-right) and HAR/FOG (bottom-right).

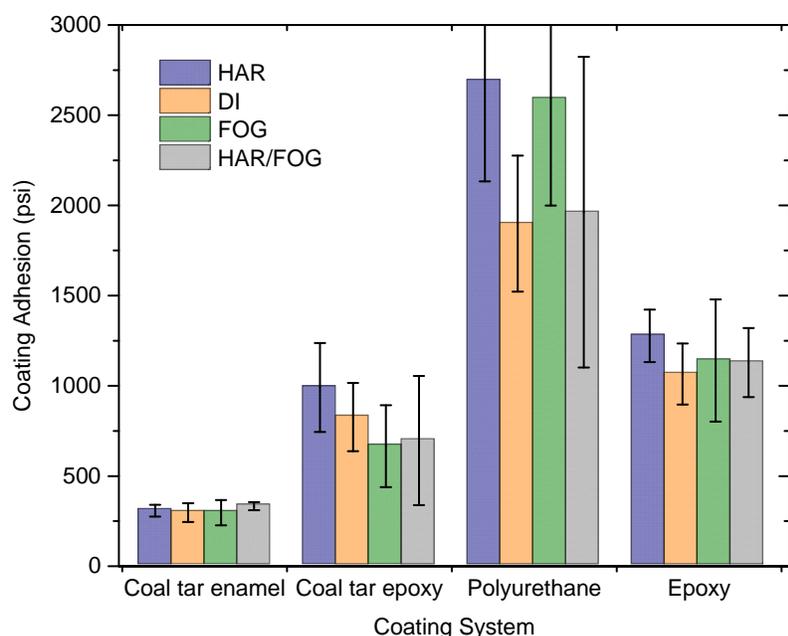
Figure 15. Adhesion testing results following completion of accelerated weathering exposure

The coal tar enamel coating had a significantly lower adhesion than the other coating systems. The average adhesion values for coal tar enamel following all exposures was 300 to 350 pounds per square inch (psi). All of these measurements failed at or just beneath the glue and were considered to be cohesive failures. Coal tar epoxy also has low adhesion values, 650 to 1000 psi, but mostly failed at the glue.

Both coal tar materials left a light brown color on the underside of many of the dollies, likely due to coal tar pitch and other lower molecular weight compounds diffusing into the glue before it cured. The coal tar enamel pull-off locations also contained distinct smooth shapes that are unlike the brittle fracture surfaces observed in pull-off testing of the other three coatings. Figure 16 shows the pull-off surfaces for coal tar enamel following testing. McManus [8] showed that coal tar enamel deforms in the direction of applied force; a blunt rod pressure test showed that 25 psi causes significant deformation for the plasticized coating. The water pressure in penstock service exposures may improve the barrier properties by slight compression of the film.

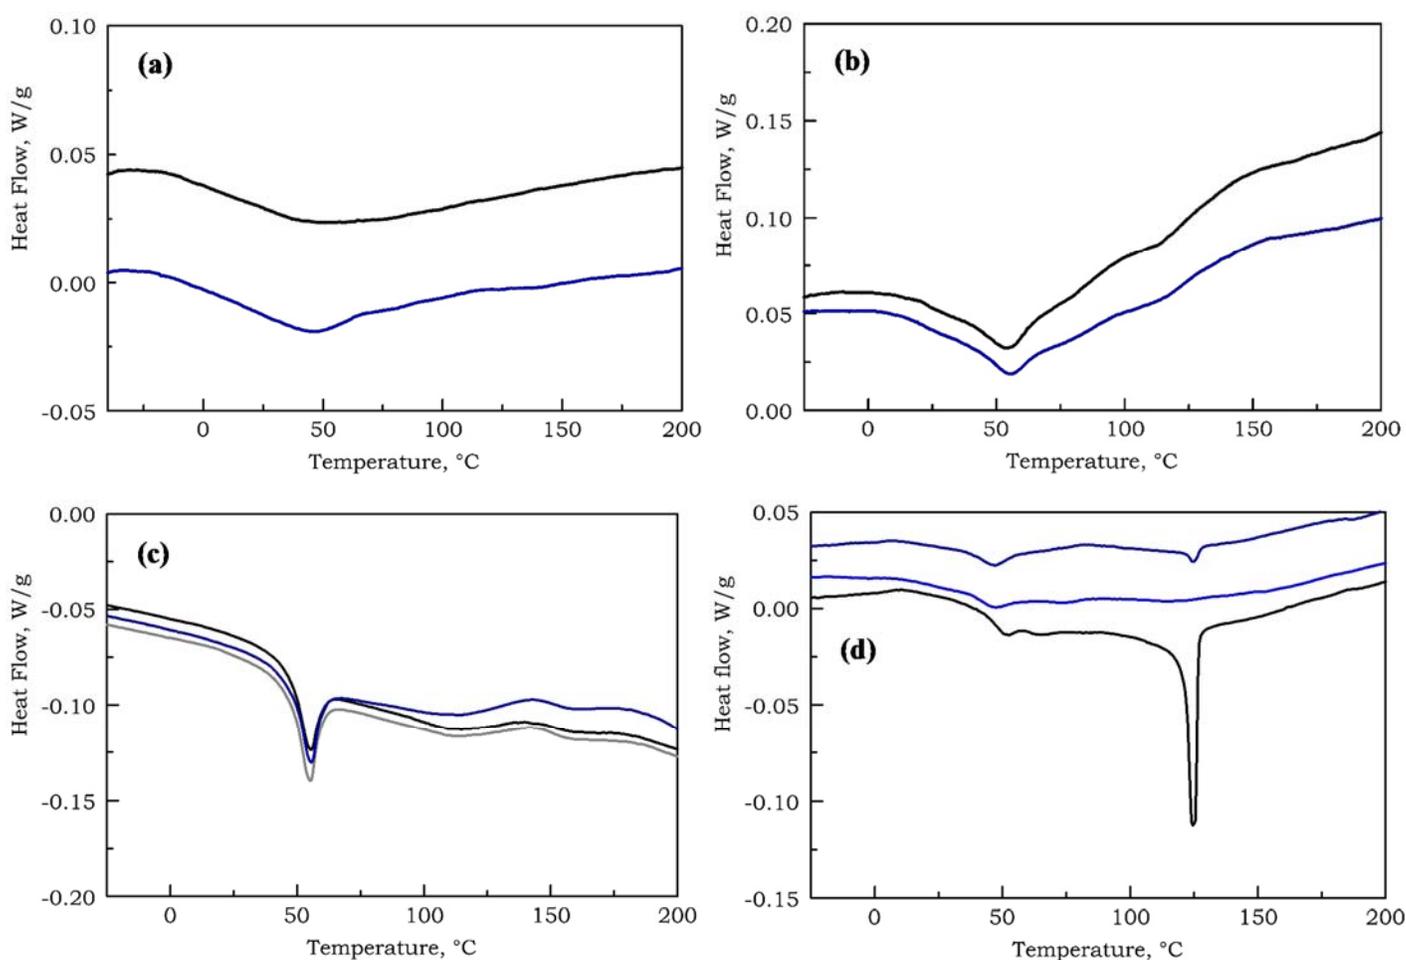
Table 6 reports a T_g of 10 °C for coal tar enamel, but its curve does not have distinct features as is typically seen by homogeneous materials. Figure 17 reproduces the DSC plots provided in the NDSU-CPM report for coal tar enamel and the three thermoset coatings evaluated. Coal tar enamel is a heterogeneous material, and the broad T_g curve is a result of the lowest molecular weight materials becoming mobile at small additions of heat or stress. The plasticizer in coal tar enamel contributes to the broad T_g curve and is critical to ensuring that the material is not brittle in service. The measured T_g for coal tar pitch was reported as ranging from -58 to 42 °C [51]. Identifying the T_g for coal tar enamel is challenging and has little value. The coal tar enamel polymeric components may also be able to restructure or self-heal during service, as is proposed for the solution vinyl coatings.

Figure 17. DSC curves used to derive T_g reproduced from NDSU-CPM report for (a) coal tar enamel, (b) coal tar epoxy, (c) polyurethane, and (d) epoxy.

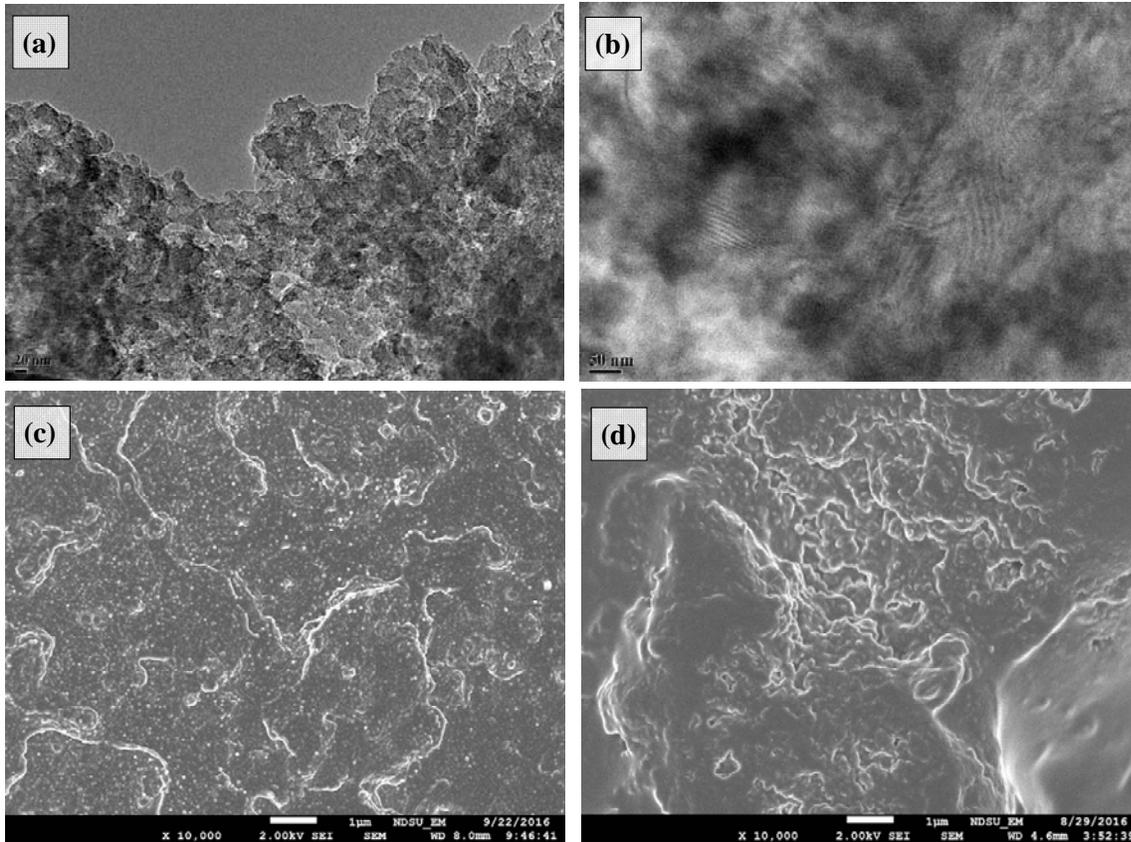
XRD and TEM testing for the thermoplastic materials failed to show distinct crystallinity in the films. Figure 18 shows TEM images for coal tar enamel at top; the scale bars in the lower left-hand corner are 20 nanometers (nm) and 50 nm for (a) and (b), respectively. The ordered lines in Figure 18(b) reveal organized regions of the material that could provide superior barrier properties. The very close spacing in solution vinyl coatings and coal tar enamel likely contribute to strong physical barrier to the permeation of water and ions. Ring spacings observed within the coal tar enamel samples were in the range of 3.5 to 4.5 Å. The smaller spacing is near that of graphite [5]. The heterocyclic ringed compounds and polynuclear aromatic hydrocarbons in coal tar enamel possibly organize in planar layers at the 4.5 Å spacing [16].

Figure 18. Micrograph images reproduced from NDSU-CPM report showing TEM of coal tar enamel at (a) high magnification and (b) with electron diffraction pattern as well as an SEM cross section of (c) vinyl and (d) coal tar enamel.

The two bottom images in Figure 18 are SEM cross sections of solution vinyl coating and coal tar enamel. Both materials have very good continuity between the binder and pigments, which is essential to good corrosion protection. The scale bars for both images are 1 micron.

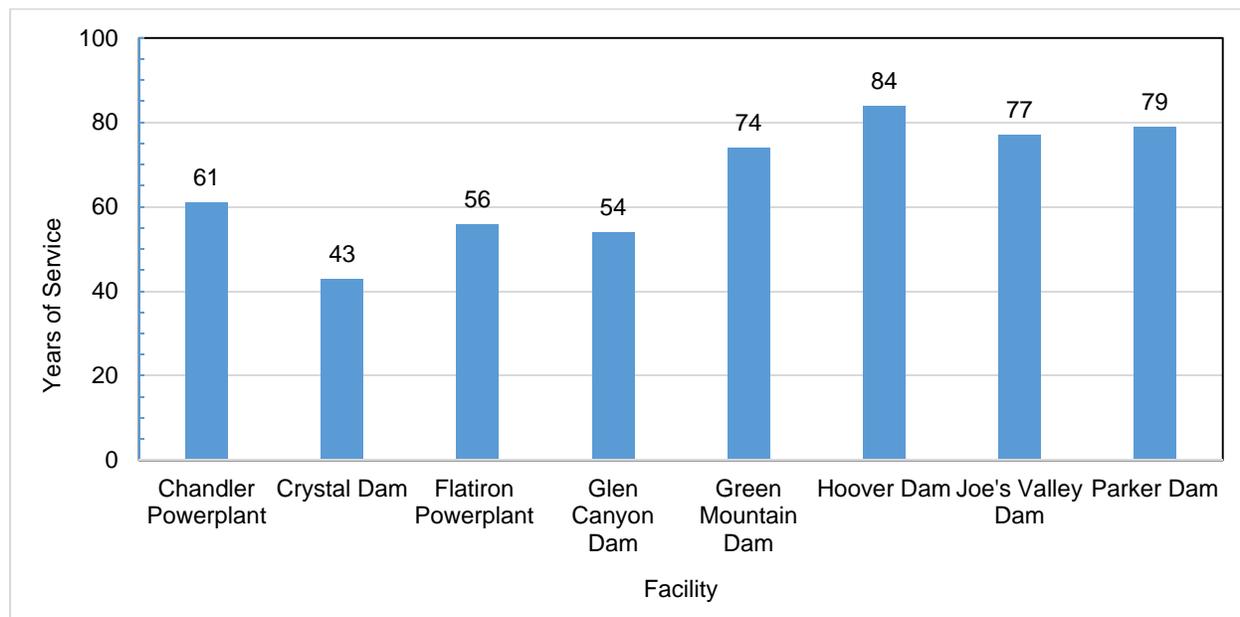
Figure 24 provides information on the age of coal tar enamel linings at several Reclamation facilities. Most of these linings are still in service and may have received spot repairs. For example, Reclamation file information suggests that Hoover and Joe's Valley received spot repairs in 2005 and 1998, respectively. Glen Canyon also received repairs or possibly recoated entire units in 2001. Flatiron

penstocks were relined entirely in 2010; the low achieved service life is attributed to the pipes being above ground and subjected to wide temperature fluctuations.

Figure 24. Age of coal tar enamel lined penstocks at several Reclamation facilities.
