Contraction Joint Leak Repair Collaboration

Research and Development Office
Science and Technology Program
Final Report ST-2018-7139-01 (8530-2018-60)

Subject: Travel to Dardanelle Lock and Dam, Arkansas to observe installation of retrofit waterstop through a contraction joint on dam.

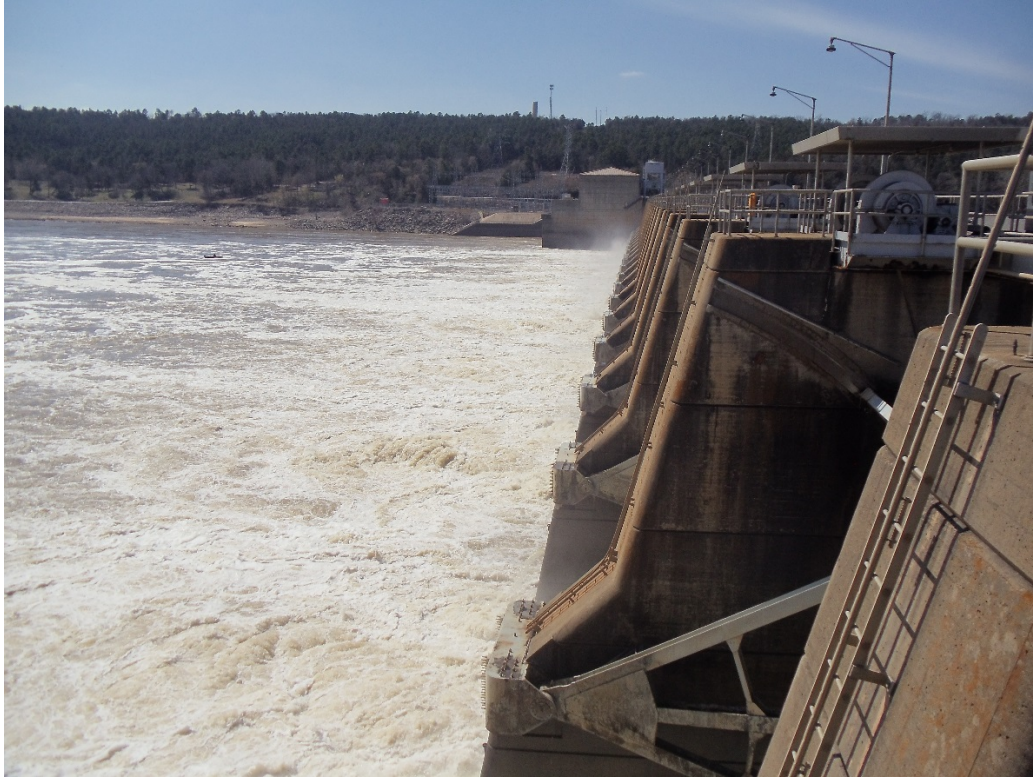
and testing. When we arrived, the contractor was preparing to install one of several waterstops on the Lock side of the dam (see Figure 3). The waterstops are a retro-fit type of waterstop that consists of a reinforced vulcanized rubber tube, custom made to a length to fit the core drilled hole. These rubber tubes can be fabricated to fit the core hole, but are typically fabricated in 8-inch or 10-inch diameters. The rubber durometer is between 30 and 40. The length can also be customized based on field requirements. Similar to car tires, the waterstop tubes are reinforced with special fiber strands. However, the tubes are only reinforced longitudinally as opposed to circumferentially (car tire). This allows the tube to expand circumferentially, while providing enough strength longitudinally such that the tubes do not tear while being installed. According to the contractor, these tubes have been fabricated up to 200 feet in length. At Dardanelle Dam, the tubes were on average about 110 feet in length, and the drilled holes were 98 feet deep. The tubes weigh about 700 lbs.

Figure 3 – Typical view of Dardanelle Dam and radial gates.
