## Leaking Crack Repair Using Chemical Grouts

U.S. Department of the Interior  
Bureau of Reclamation  
Technical Service Center  
Civil Engineering Services Division  
Materials Engineering and Research Laboratory  
Denver, Colorado

September 2005

# Leaking Crack Repair Using Chemical Grouts

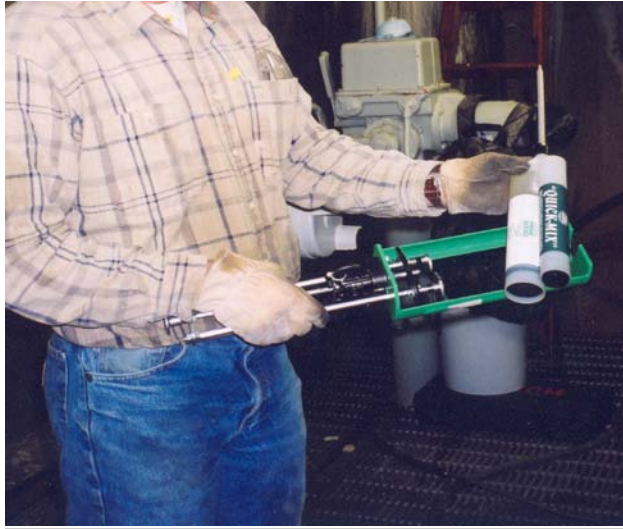
**Figure 2. - Hand held, caulk gun injection system.**

- 4) The hand operated caulk gun type injectors were only effective on relatively large, shallow cracks that required little pressure to inject. With narrower, deeper cracks, the units were not able to create enough pressure to inject resin, and frequently malfunctioned. With longer cracks, operators had trouble operating the gun for sufficient time to seal the cracks.

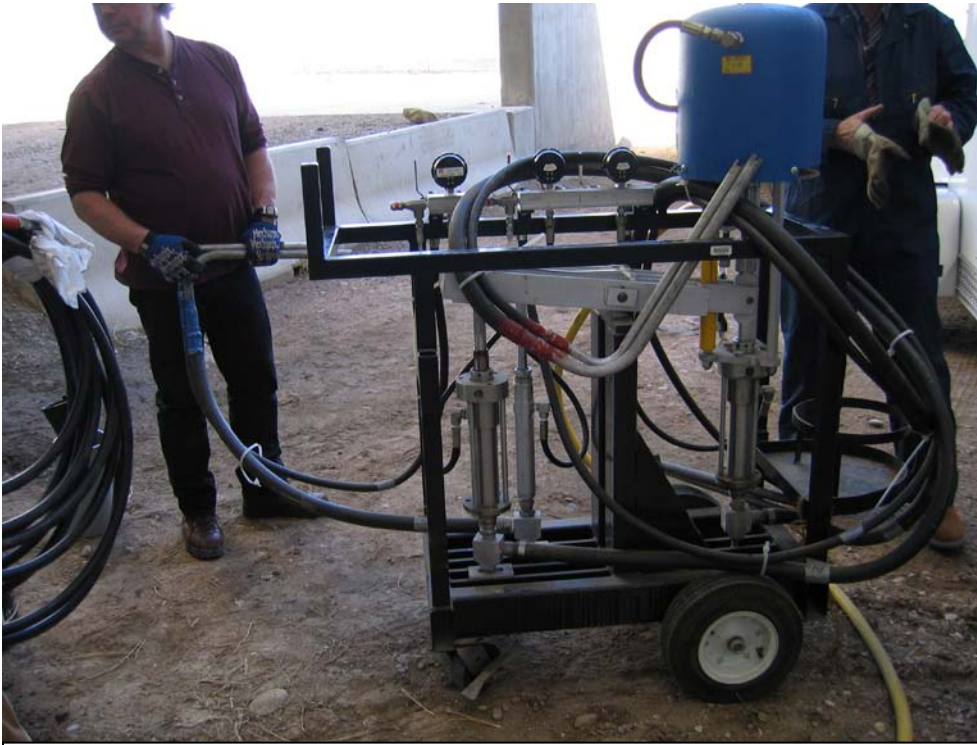
**Figure 4. - Multi component, variable ratio, rocker pump.**

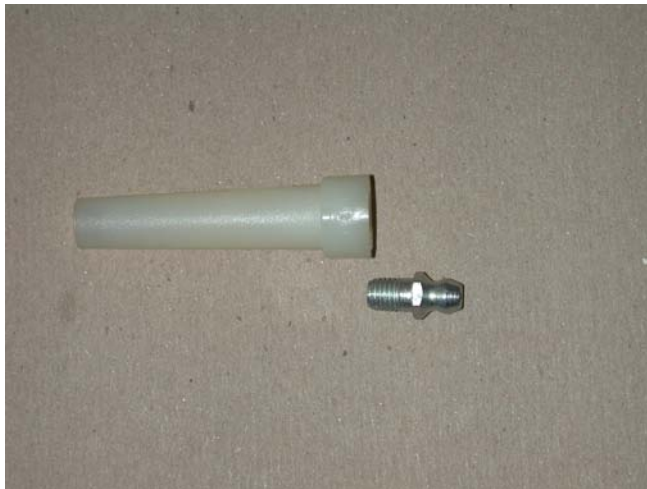
**Figure 3. - Example of a bang-in packer with the zirc fitting removed.**

6) The bang-in packers were very easy to install, but were only effective for small, localized crack repairs that utilized lower pressures. With higher pressures, and depending on the quality of the concrete, grout would begin to leak around the ports, or the ports would be dislodged.

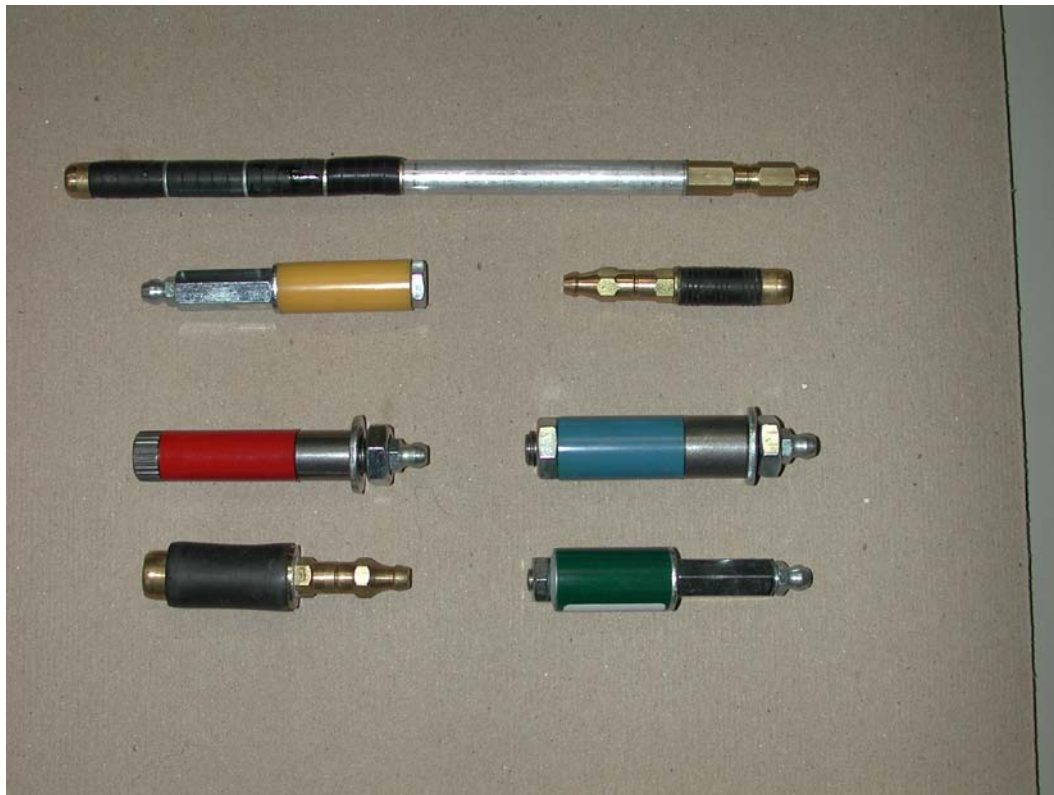
**Figure 6. - Examples of mechanical packers. Typically, a nut near the top of the packer is tightened, compressing and expanding the rubber sleeve(s), locking the packer into the hole. Grout can be injected through the zirc fitting.**

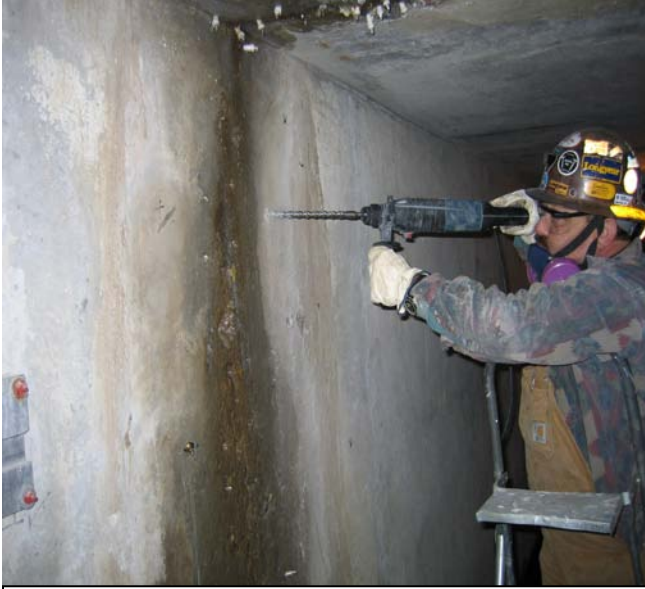
**Figure 9. - Drilling holes for mechanical packers.**

After the crack opening was exposed, injection ports were drilled into the concrete. For the bang-in ports, 3/8-inch diameter holes were drilled into the concrete. For the mechanical packers, 5/8-inch diameter ports were drilled into the concrete (Figure 9). Figure 10 shows a combination of bang-in and mechanical ports. All the ports we evaluated used either 3/8 or 5/8-inch port sizes. We determined these sizes were appropriate since all the cracks we were injecting were small. Larger cracks requiring higher flows of grouts would need larger ports. There are many different sizes of packers and ports that can be used.

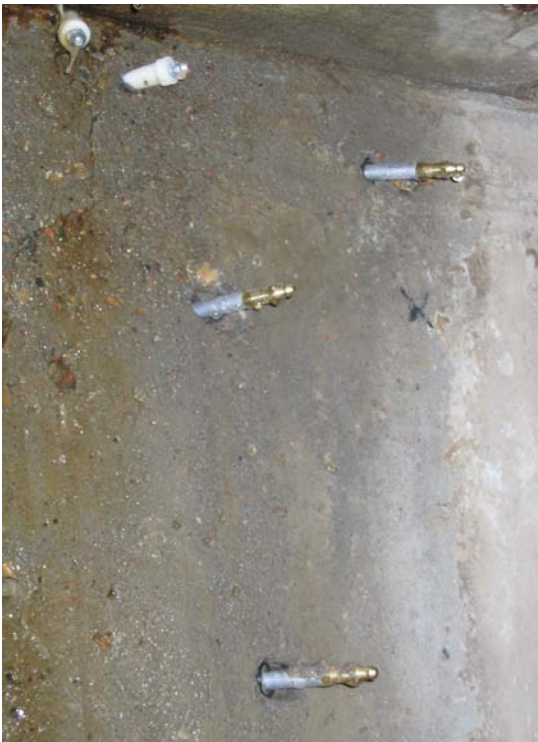
**Figure 10. - In several locations, combinations of bang-in and mechanical packers were used to assist with grout injection.**

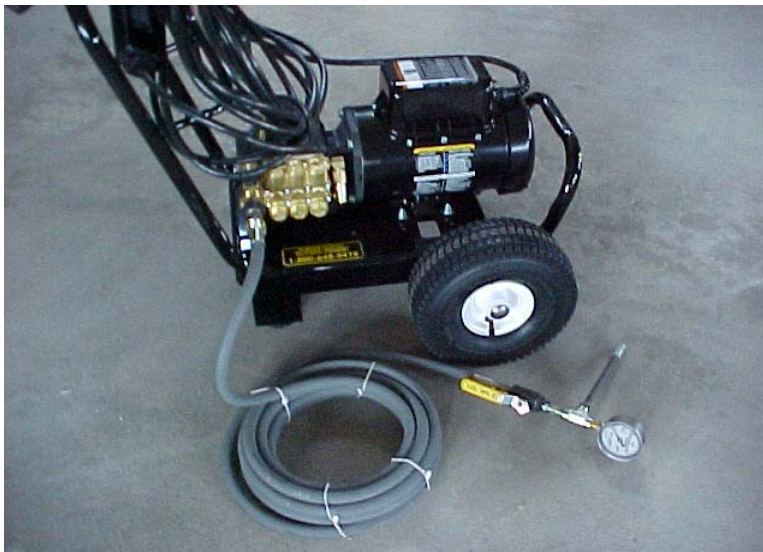
**Figure 11. - Pressure washer used to water test cracks.**

Once ports were installed, water testing could start. Water testing was performed to ensure that grout could be injected into the crack by attempting to inject water into the crack first. Several methods were tried for this. In one method, used for larger cracks, house water at about 80 lbs/in<sup>2</sup> was attached to the port. For another method, a pressure washer was attached to the port (Figure 11) for the water test. Finally, when the rocker pump was used, the water line from that could be attached to the port for water testing.

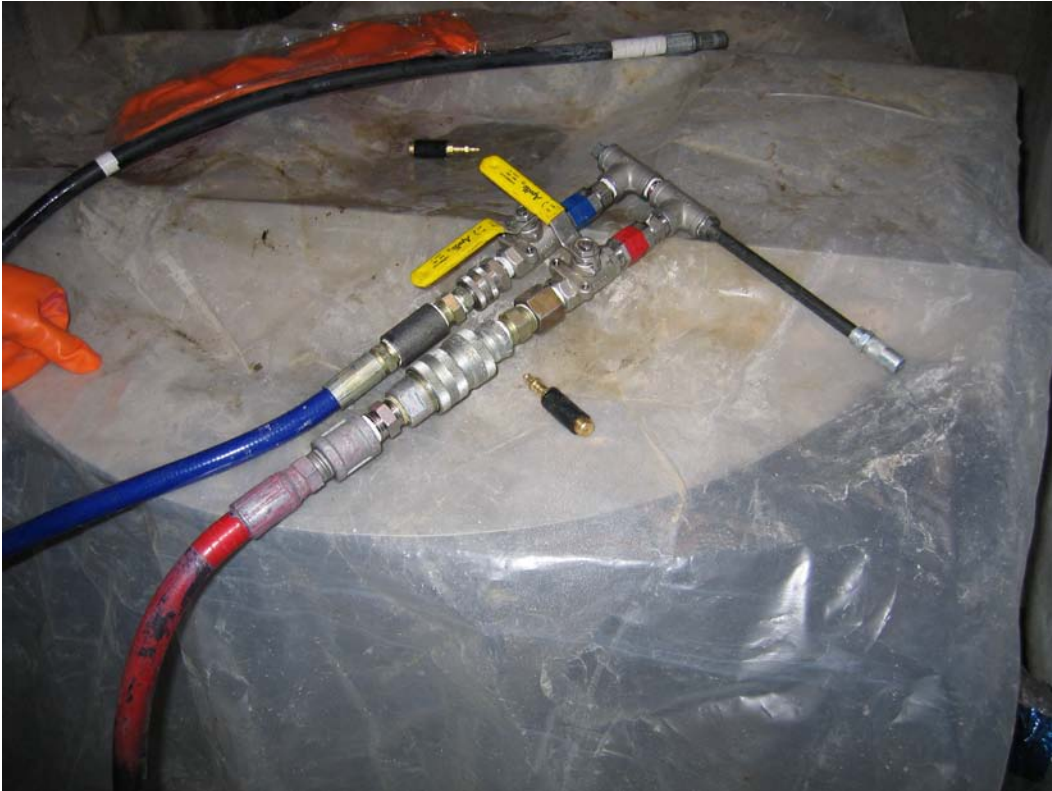
**Figure 12. - Assembly used to connect grout lines to injection ports for higher pressure injection. Note provision for 2 material lines, which allows for keeping reacting materials separate until close to the point of injection. A small chain or mixer in the small tube provides for mixing just prior to injection.**

After all the ports were water tested, and re-drilled/re-installed as necessary, grouting was started. Grouting would generally start at one end of the crack to be injected, and proceed from port to port to the terminating end. When higher pressure injection equipment was used, an assembly as shown in Figure 12 would be used to attach to the grout port and inject the grout. With 2 incoming lines, reacting components can be kept separate until just before the point of injection.

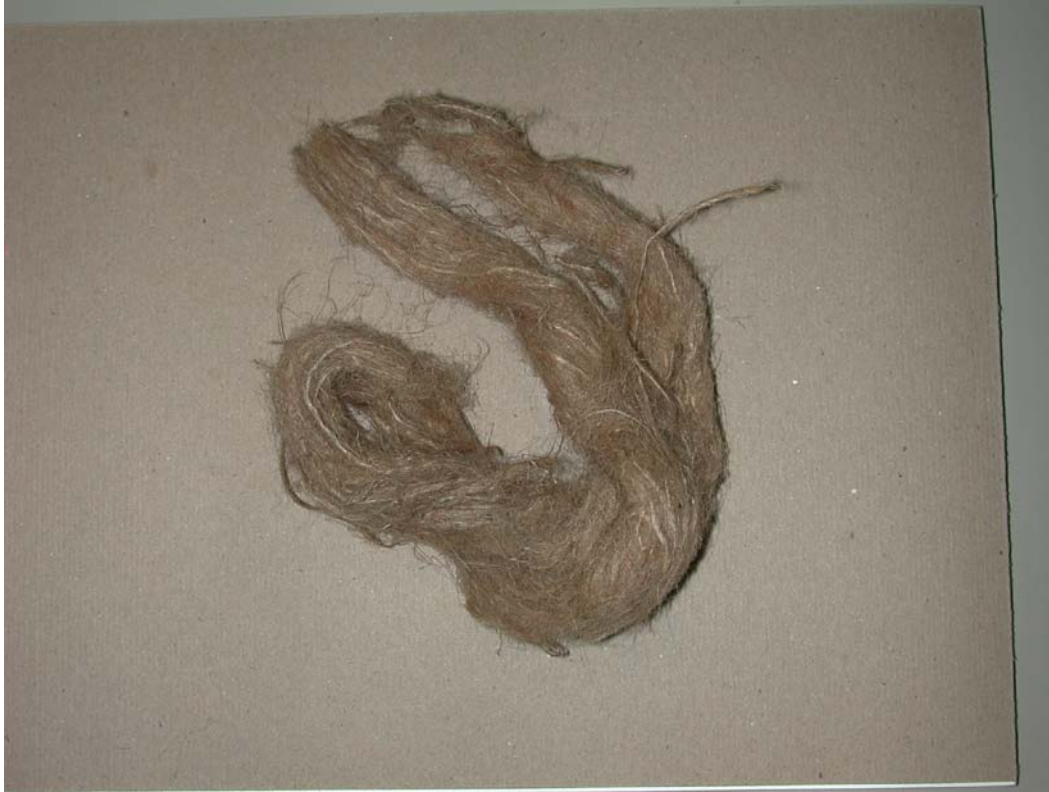
**Figure 13. – Jute used to seal crack faces. The jute can be soaked with resin, or resin and water depending on the system, then pounded into the crack opening.**

After the components combine, a small chain or mixer in the small tube can be used to mix the components. The crack face would be monitored for grout leakage as an indication of grout flow. If grout appeared quickly at a crack face, the crack face would be closed up by hitting with a hammer, or pounding in jute (Figure 13), wood, or cloth. For this program, since we did not want the grout to travel far, the crack faces were generally not sealed unless a large amount of water or grout was leaking from them.

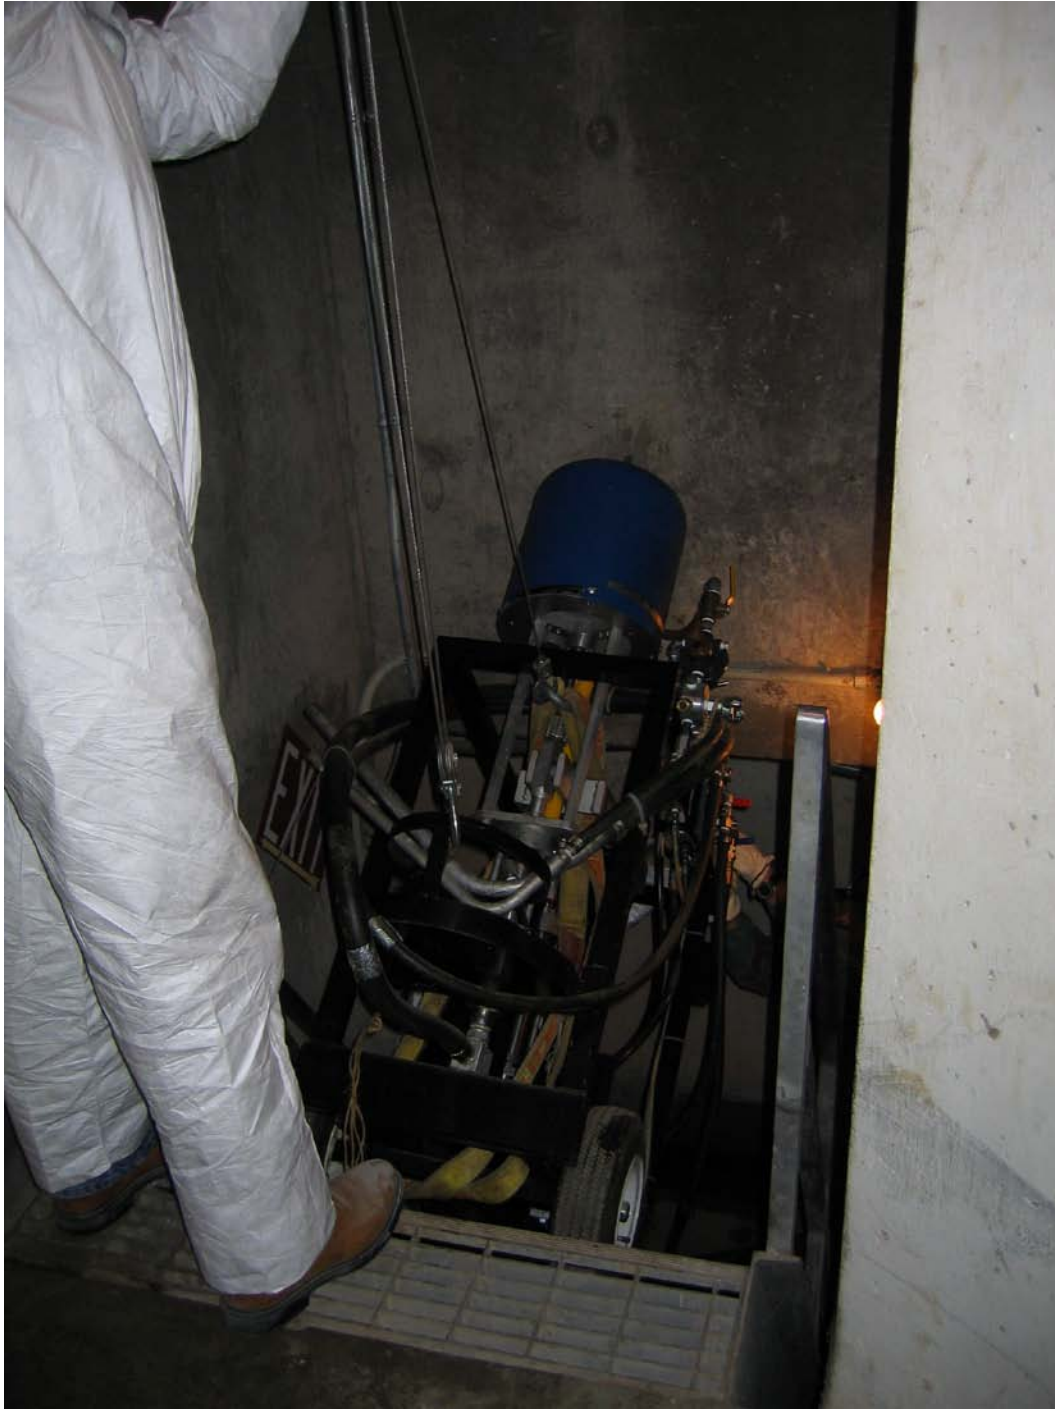
- 2) The rocker pump worked best in most situations, had the most flexibility for various chemical grouts and greatest control of pressure. However, due to its size and operating requirements, it is much harder to transport and set-up (Figure 14).

**Figure 14. - Lowering the rocker pump into a gallery.**
