Memorandum Number MERL 2011-34

Evaluation of New Concrete Shrinkage Reducing Additive for Glen Elder Dam Spillway Inlet Slab Repair

**Missouri River Basin Project –
Solomon Division – Glen Elder Unit - Kansas
Great Plains Region**

Glen Elder Dam

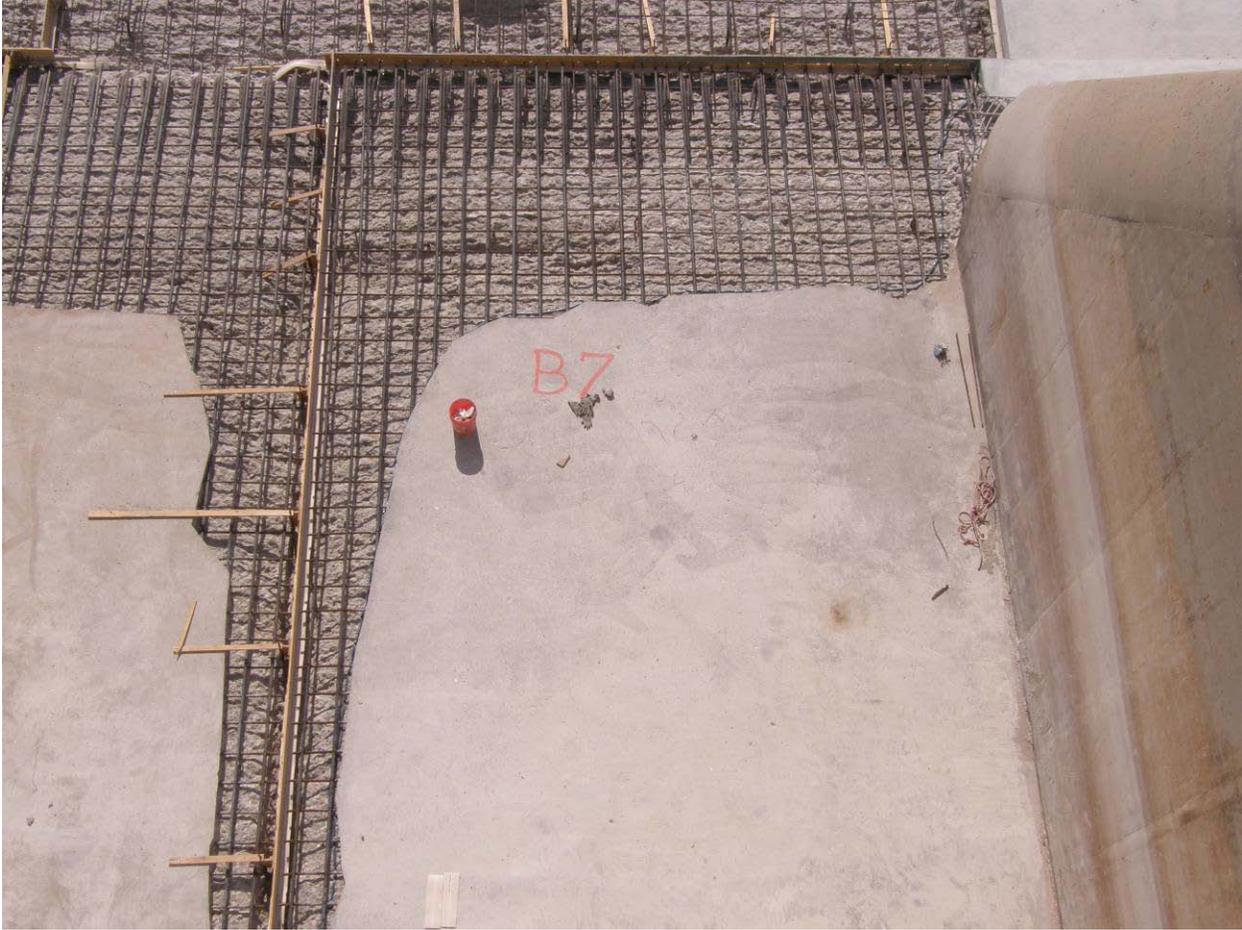
The trial placements occurred in early May. Initially, 2 areas were approved for trials with the Premier additive – one bay area placement (B7, Figure 8) and one approach slab placement (S10,

Figure 8. Bay 7 ready for trial concrete placement using concrete containing the Premier Magnesia additive.

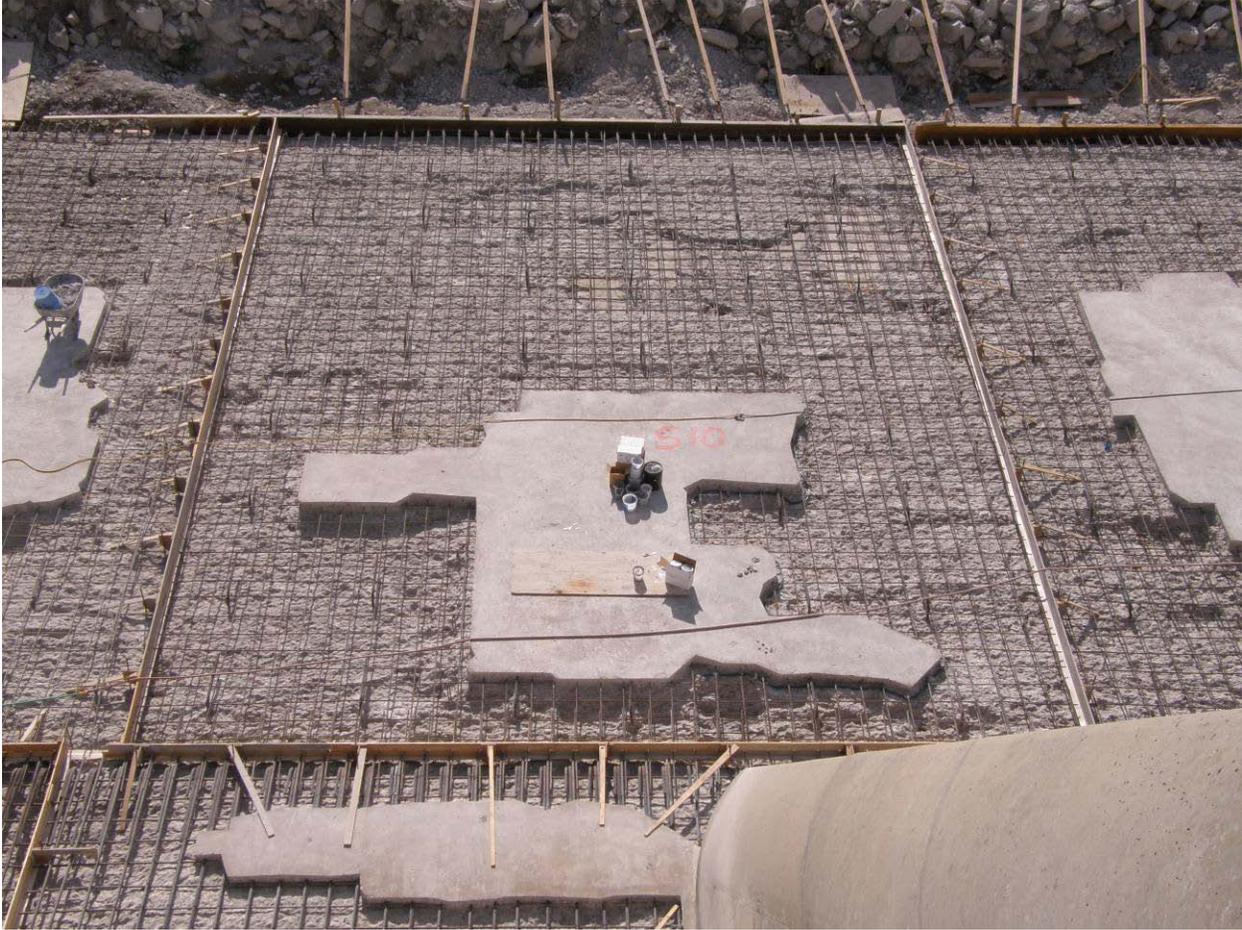
Figure 9). For the comparison crack mapping, two similar areas with about the same shape were selected to map cracks (B3, Figure 10 and S3 Figure 11). One bay area placement (B8 and 9, Figures 12, shown after concrete placement) was added to the trial since material was available and the contractor had time to place additional concrete.

Figure 9. – Slab 10 ready for trial concrete placement using concrete containing the Premier Magnesia additive.

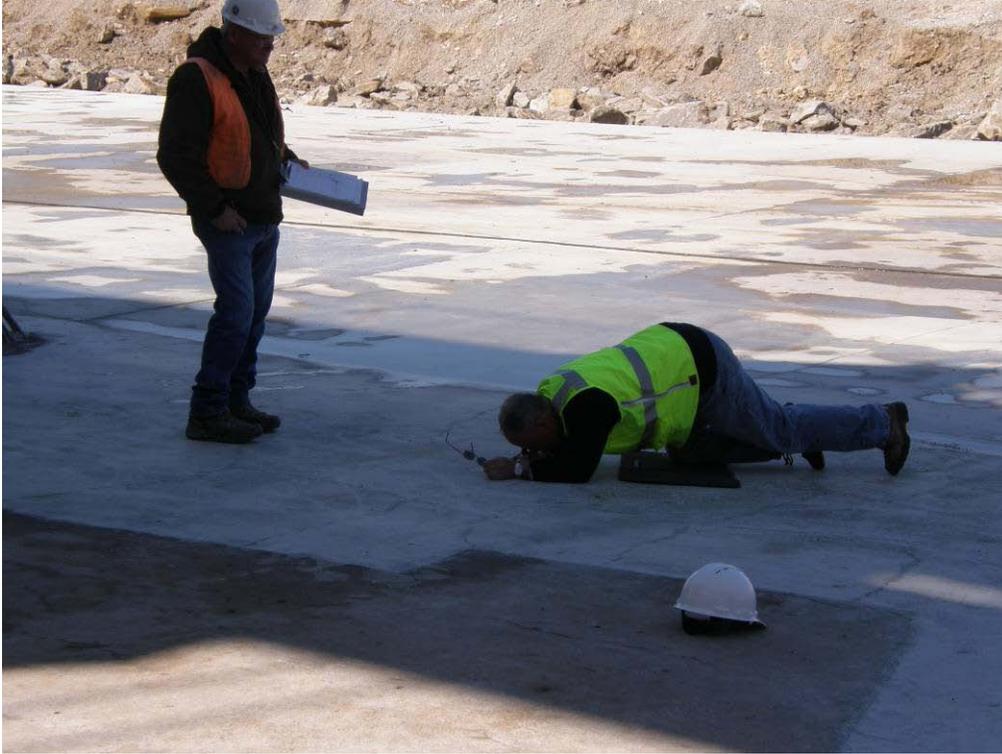
MERL personnel traveled to the site just prior to the placements to map cracks from comparable placements made the fall before (Figures 13 and 14).

Figure 14. – Measuring crack openings.

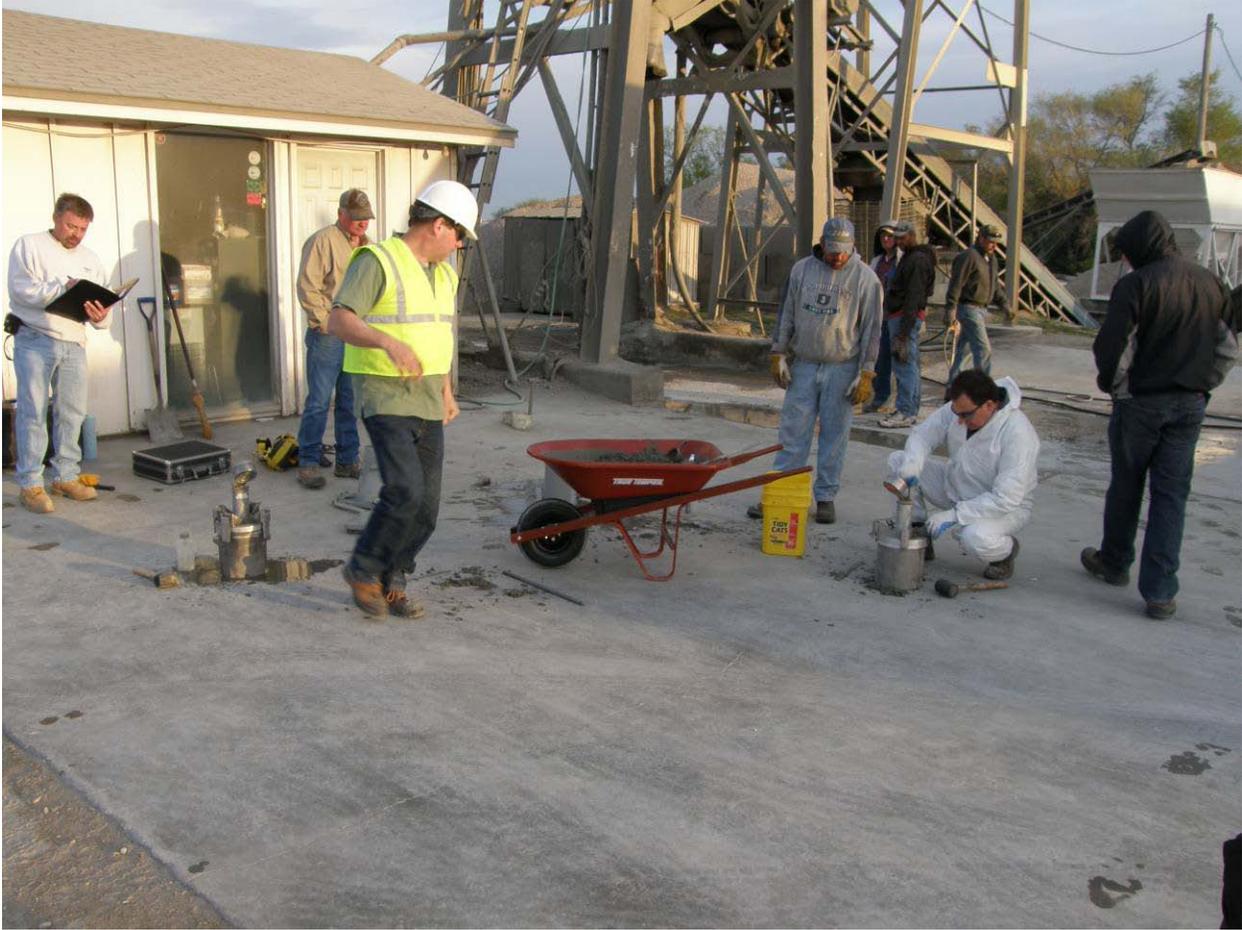
Figure 15. – Measuring fresh properties of the concrete after addition of the Premier Magnesia additive.

The Premier product was manually added to the mixture by personnel from their lab. Each truck was loaded with about half the concrete batch, then the Premier products, comprised of a liquid component and a dry powder, were added by hand. The rest of the concrete ingredients were added to the truck, it was brought to mixing speed for the appropriate time, and fresh properties were measured (Figure 15). After that, trucks drove to the site, fresh properties were measured again, any adjustments were made as appropriate, and then the concrete was placed using a conveyor system (Figure 16).

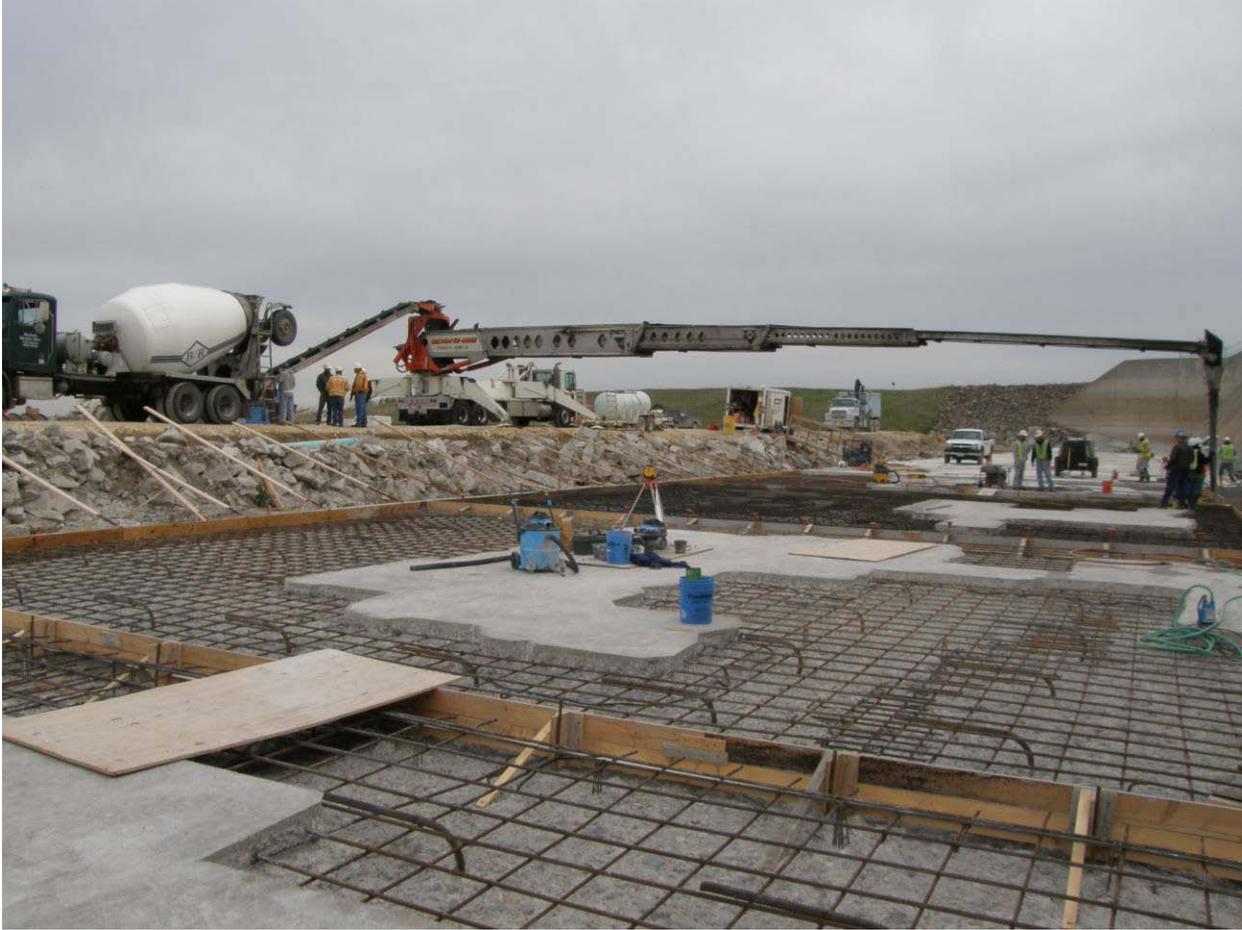
Figure 16. – Placement of the trial concrete.
