Memorandum Number MERL 2011-34

Evaluation of New Concrete Shrinkage Reducing Additive for Glen Elder Dam Spillway Inlet Slab Repair

**Missouri River Basin Project –
Solomon Division – Glen Elder Unit - Kansas
Great Plains Region**

Glen Elder Dam

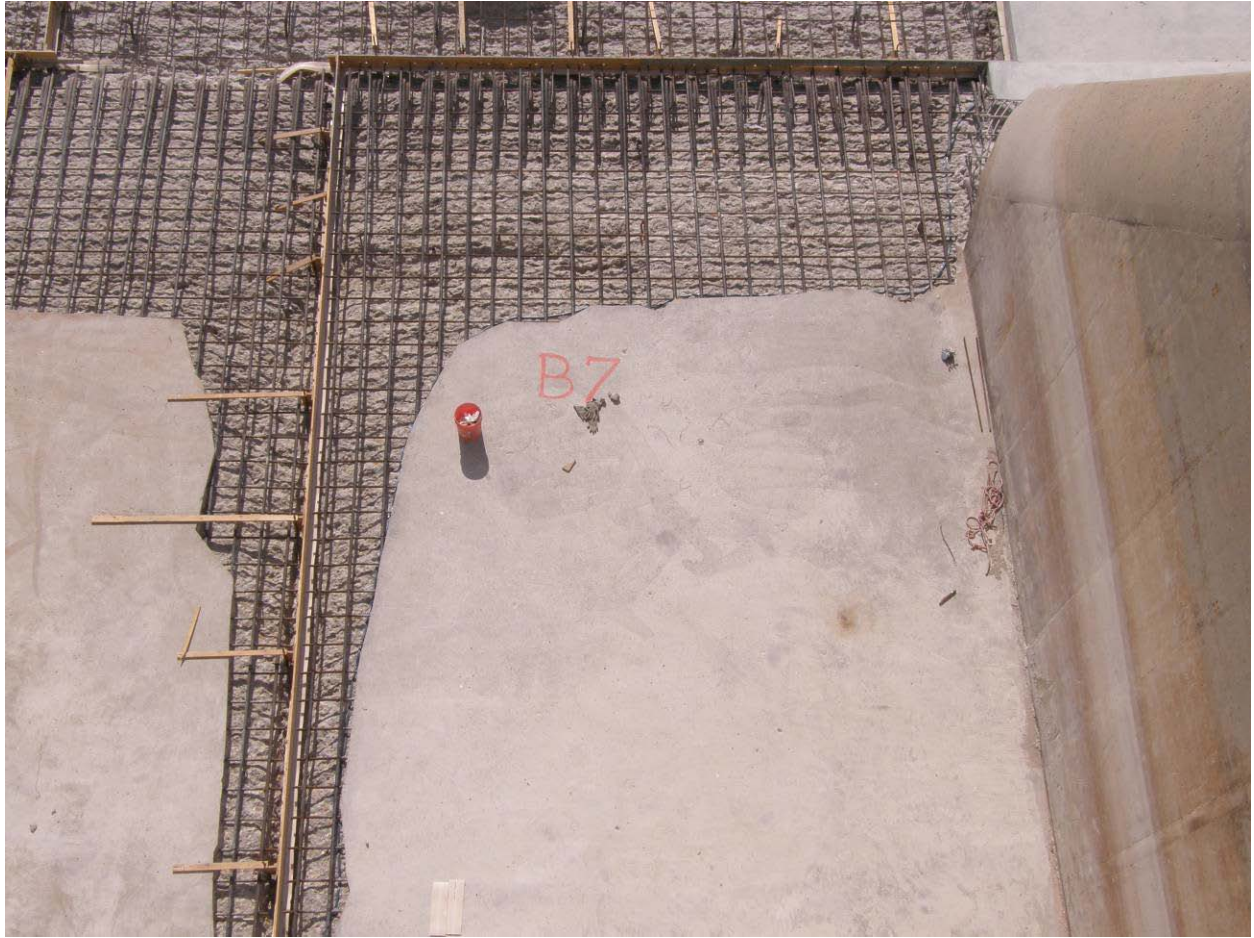
The trial placements occurred in early May. Initially, 2 areas were approved for trials with the Premier additive – one bay area placement (B7, Figure 8) and one approach slab placement (S10,

Figure 8. Bay 7 ready for trial concrete placement using concrete containing the Premier Magnesia additive.

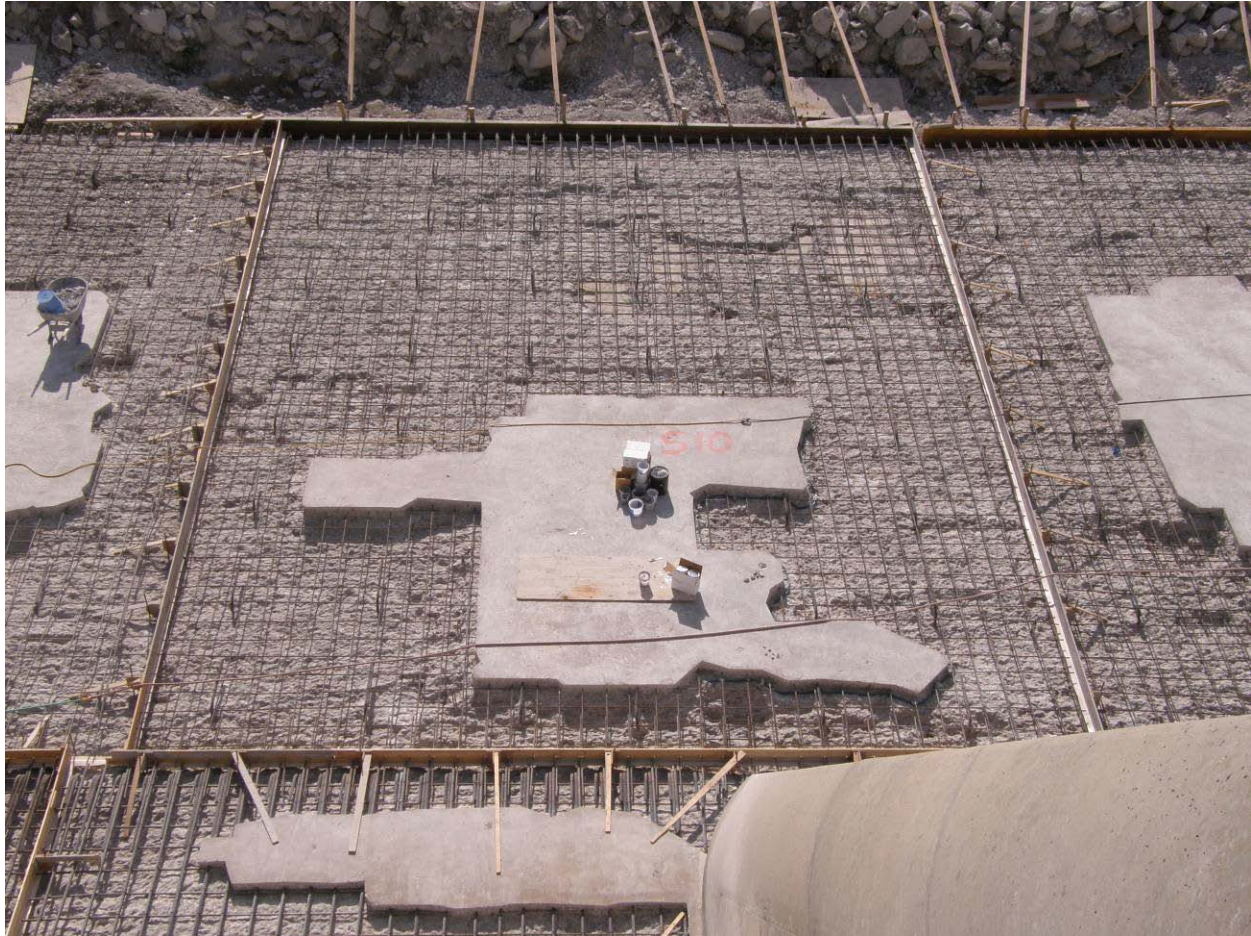
Figure 9). For the comparison crack mapping, two similar areas with about the same shape were selected to map cracks (B3, Figure 10 and S3 Figure 11). One bay area placement (B8 and 9, Figures 12, shown after concrete placement) was added to the trial since material was available and the contractor had time to place additional concrete.

Figure 9. – Slab 10 ready for trial concrete placement using concrete containing the Premier Magnesia additive.

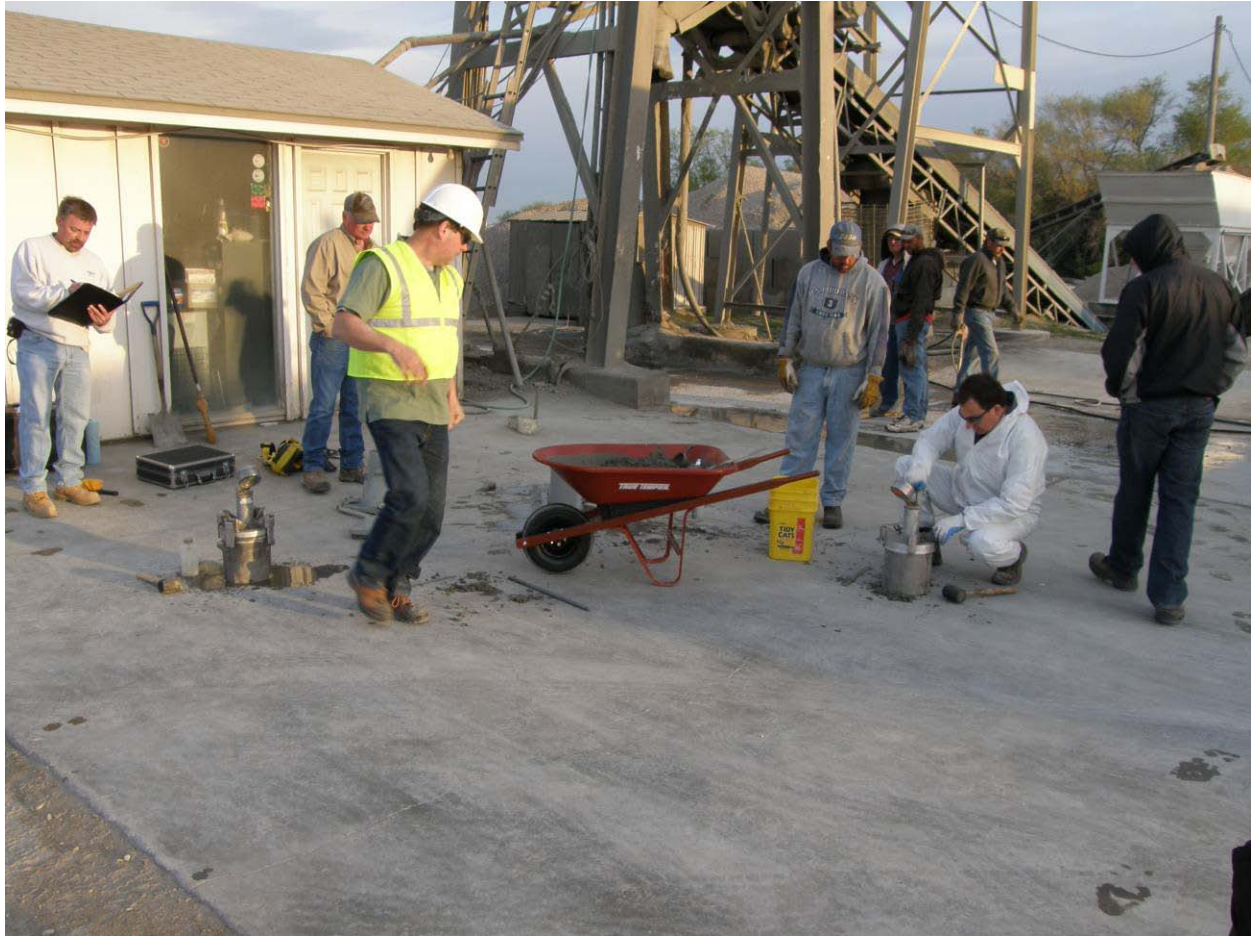
Figure 15. – Measuring fresh properties of the concrete after addition of the Premier Magnesia additive.

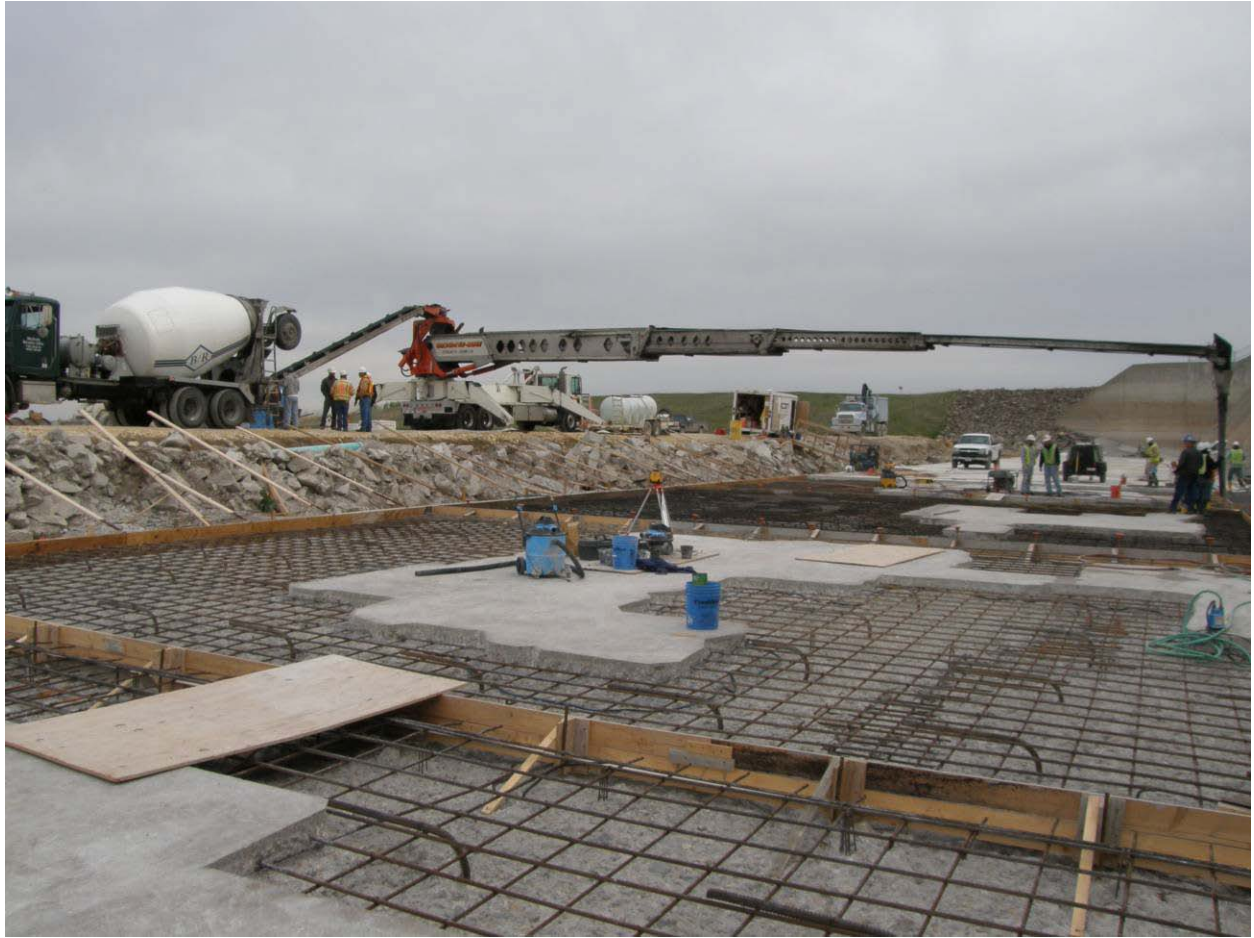
The Premier product was manually added to the mixture by personnel from their lab. Each truck was loaded with about half the concrete batch, then the Premier products, comprised of a liquid component and a dry powder, were added by hand. The rest of the concrete ingredients were added to the truck, it was brought to mixing speed for the appropriate time, and fresh properties were measured (Figure 15). After that, trucks drove to the site, fresh properties were measured again, any adjustments were made as appropriate, and then the concrete was placed using a conveyor system (Figure 16).

Figure 16. – Placement of the trial concrete.
