Technical Report No. SRH-2010-1

Bighorn River Side Channel Investigation: Geomorphic Analysis

**U.S. Department of the Interior
Bureau of Reclamation
Technical Services Center
Denver, CO**

February 2010

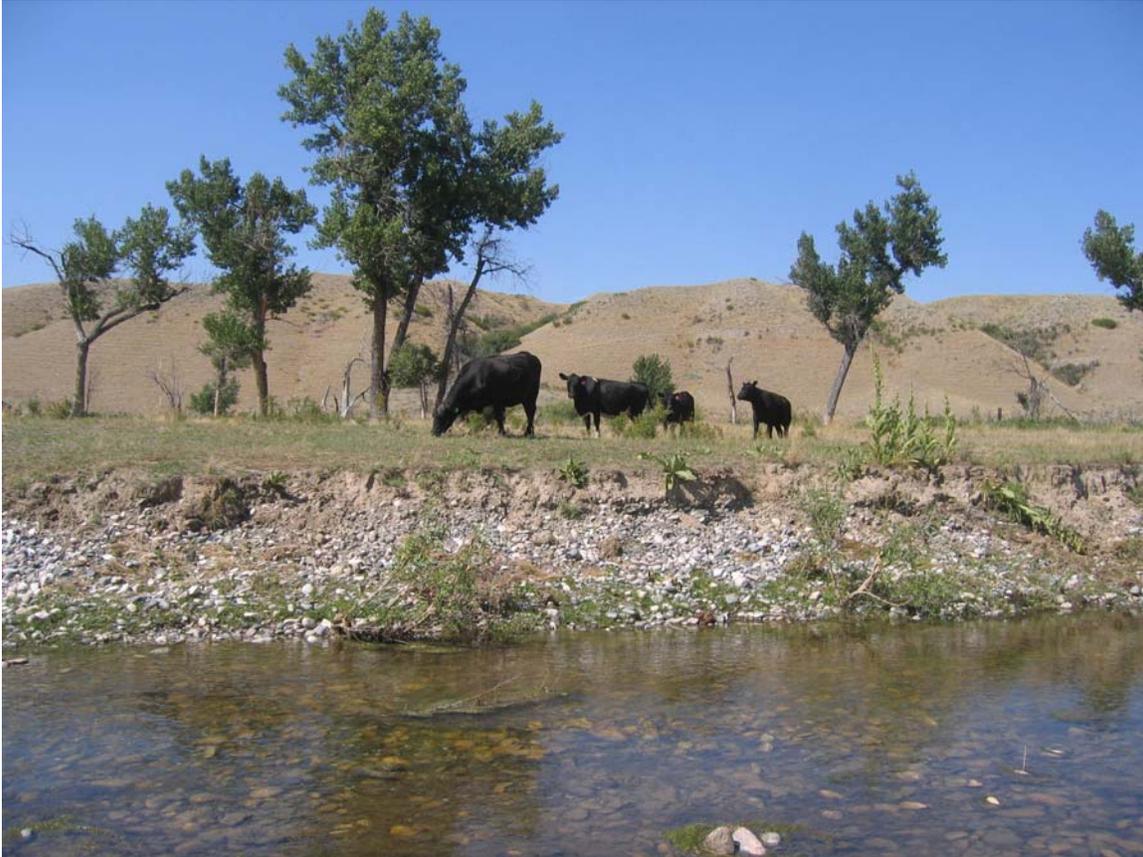
Descriptions of materials in streambanks for other type 5 anabranching rivers are also generally consistent with Bighorn River bank materials in which a cap of sandy alluvium overlies gravelly substrate (Figure 4). Vertical accretion rates in these systems are

Figure 4. Example of bank materials showing fine-grained overbank sediment capping gravelly alluvium.

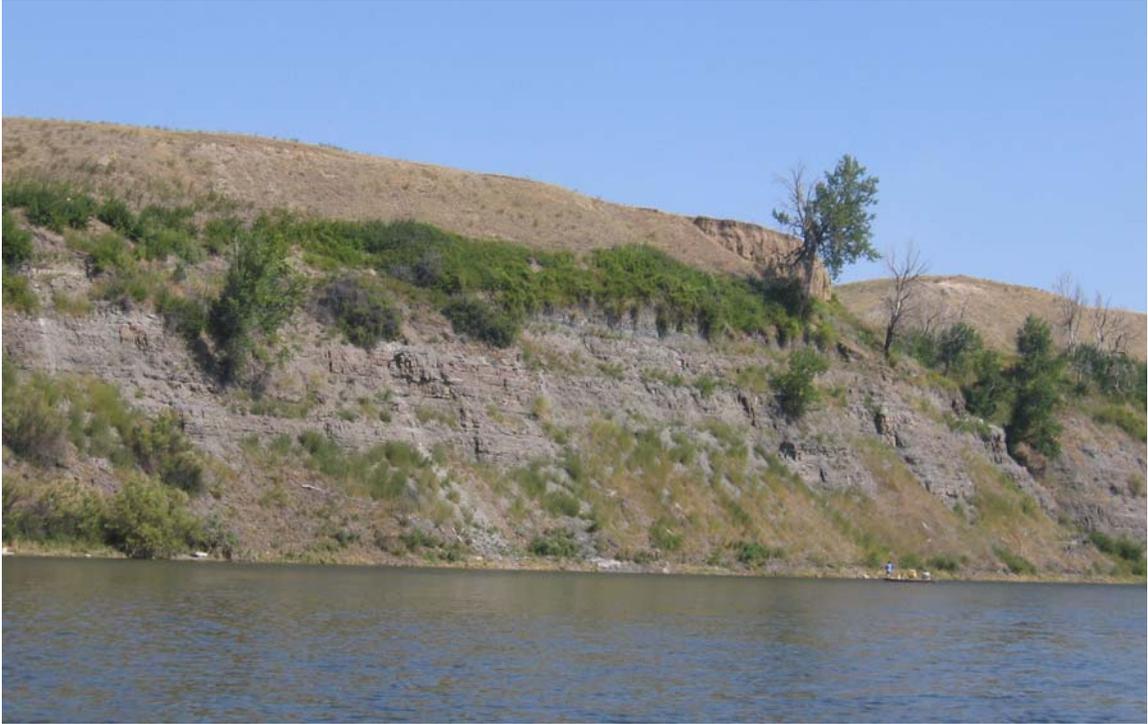
Figure 12. Example of a bedrock outcrop along the study reach.

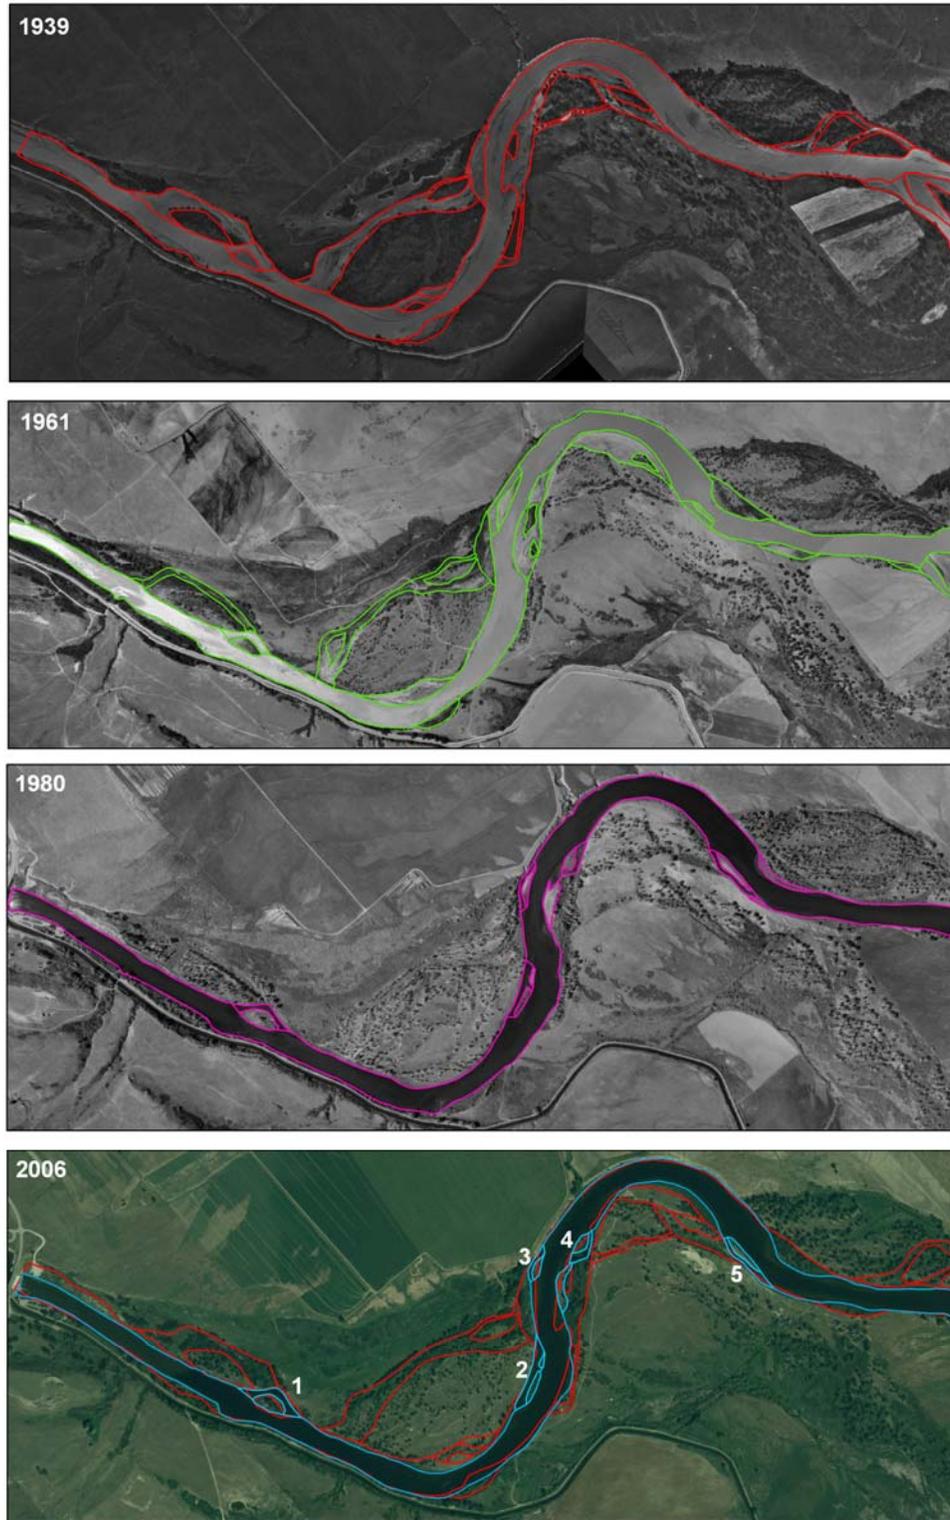
Side channel 1 has been in almost the same position since the earliest aerial photography available (Figure 16). In 1939, the channel flowed around an unvegetated bar and received additional flow during large discharges from an overflow channel that entered at its abrupt bend to the east. By 1961, the overflow channel began to fill in with vegetation and the unvegetated bar separating the side channel from the main channel also began to stabilize with vegetation. By 1970, the overflow channel appeared to be inactive, being cut off by a lateral bar along the main channel margin at the entrance to the overflow channel. Vegetation density continued to increase and mature on both the overflow channel and island. However, the downstream end of the overflow channel appears to have maintained a downstream connection with the side channel and serves as a backwater environment. It appears that the entrance to the overflow channel was utilized as a right-of-way for power lines and is kept cleared for this reason. Side channel 1 exists currently as a high velocity channel with cobble substrate. Bedrock was observed at the downstream end of the overflow channel and also at the downstream end of the side channel.

The present configuration of side channel 3 was established in 1980 (Figure 16). In 1939, unvegetated bars existed in the area, but no side channel was present. By 1954, the general configuration for side channel 3 was established, with a side channel formed around an unvegetated bar in the area. This general pattern was maintained with minor variations in channel and bar position until 1980, when the side channel stabilized into a form that has not changed considerably for the past several decades. Vegetation encroachment along an extensive lateral bar on the right bank from 1954 to 1980 aided in the stabilization of side channel 3. Observations from April 2009 indicated that this was a low velocity channel with a mucky bottom of fine sediment over a gravelly substrate. However, observations following the high flow during July 2009 revealed that some of this sediment had been scoured, leaving remnant benches of fine-grained sediment along the channel margins.

In 1939, the area near side channel 4 was occupied by a small vegetated island in the center of the main channel with an unvegetated lateral bar between the island and streambank (Figure 16). Downstream, several narrow overflow channels cut across vegetated portions of the large point bar on the right bank. In 1954, the general geometry of the channel was established but not well defined. Vegetation encroachment onto the lateral channel bar helped to establish a stable position for the side channel by 1970; this area has continued to vegetate through the present time. This side channel was marginally inundated during field observations and consisted of a silty sand deposit over cobbly substrate and young willows along the channel margins at its entrance. Several mucky backwaters existed at the downstream connection with the main channel and within the sharp bend to the northwest.

Figure 16. Historical channel mapping for complexes 1 through 5 showing changes from 1939, 1961, 1980 and 2006. The 1939 mapping is overlaid in the 2006 imagery for comparison.

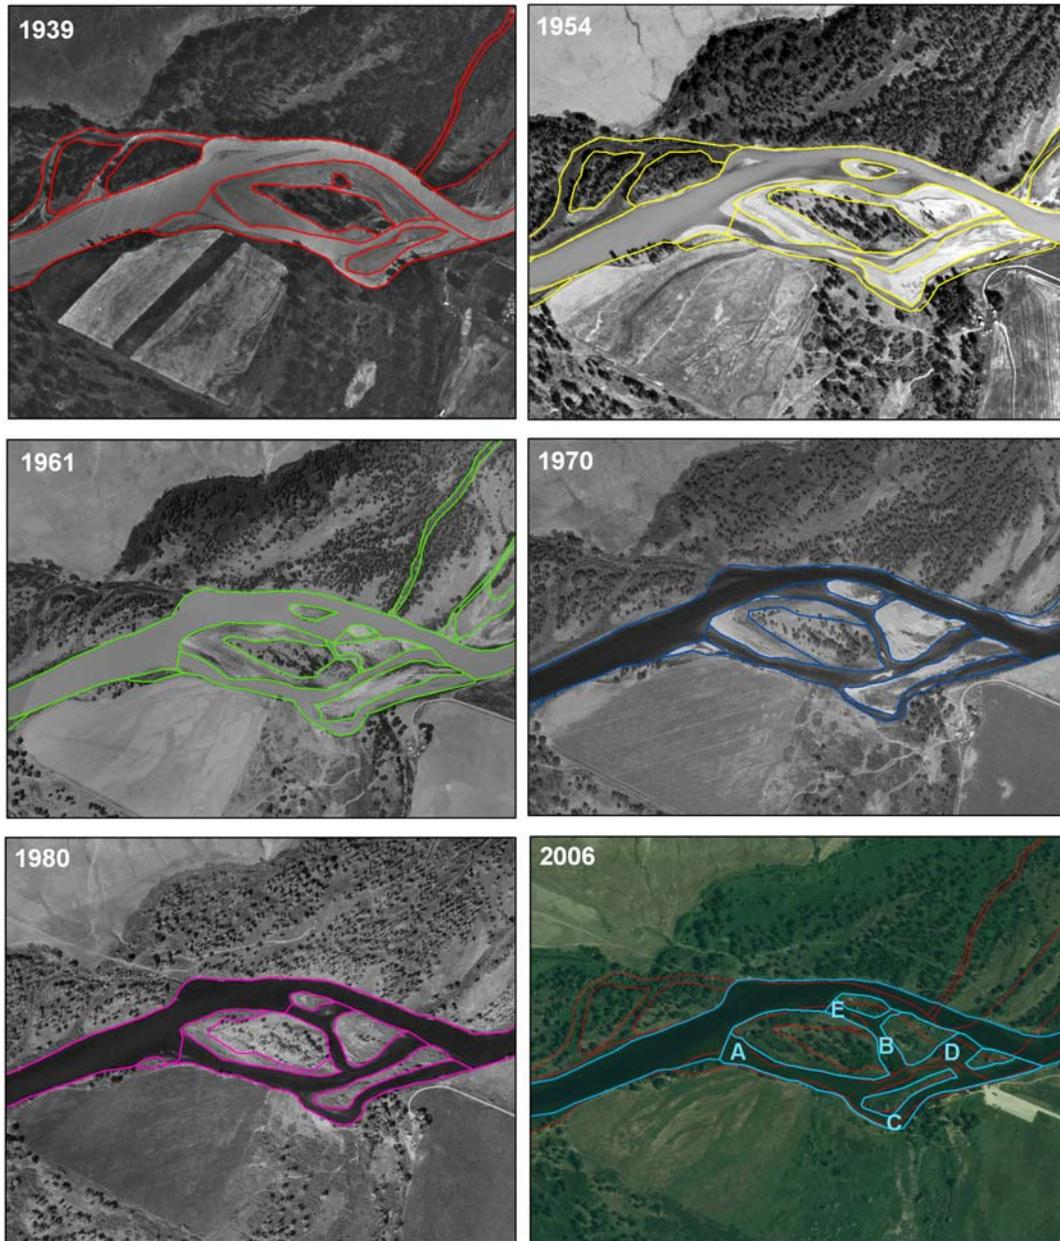
Channel complex 6 is located just upstream of the 3-mile (Lind) boat access and consists of multiple channels with pebble-cobble substrates (labeled A through E; Figure 17) and moderate velocities. Minor areas of fine sediment exist where secondary flow currents create low velocity eddies, but the majority of the channel has fast flowing confluences within the multiple branches and with the main channel. 1939 aerial photography shows that several of the channels, including 6A, 6C, and 6D are in similar locations to the present configuration (Figure 17). Additional channels are located upstream on the left bank in 1939, one designated as a side channel and the other as an overflow channel. By 1954, side channel 6E is formed and more vegetation is observed on the mid-channel bar. Between 1954 and 1961, side channel 6B developed and the channels along the left bank have been abandoned. These were probably utilized during the 1935 flood have not been accessed since that time. The present configuration of channels was developed by 1970 and vegetation has continued to increase on the islands through 2006.

Figure 17. Historical channel mapping of complex 6.

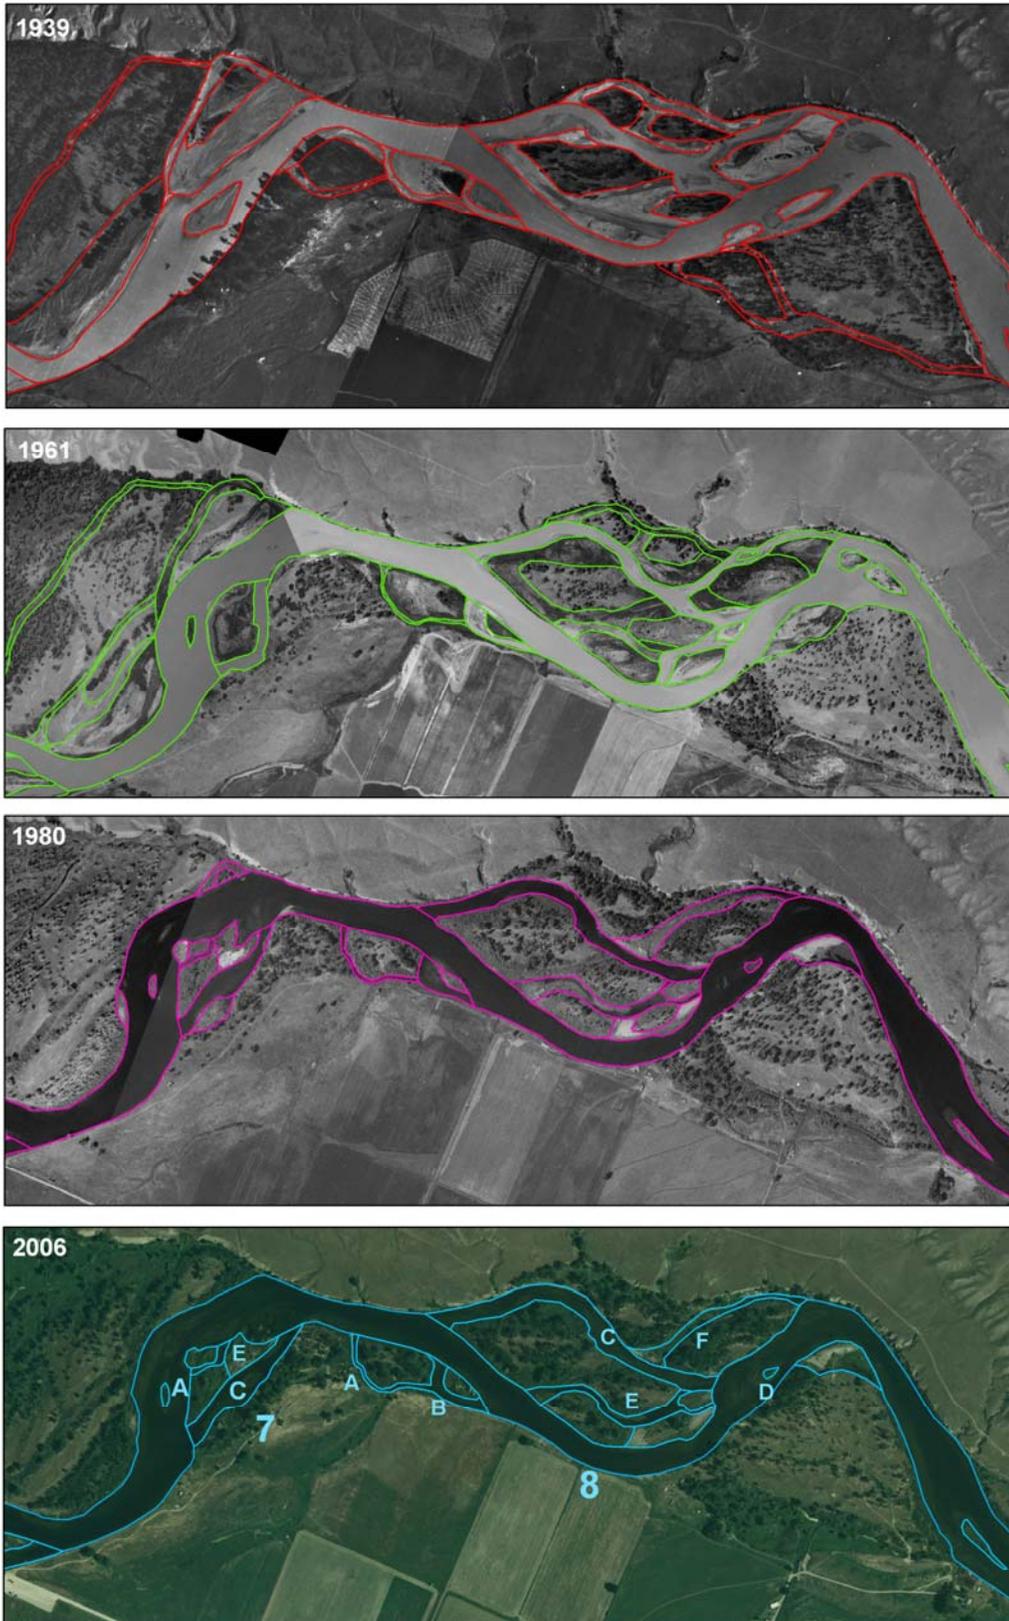
The 1939 channel pattern in the vicinity of complex 7 consisted of main channel split flow around an unvegetated mid-channel bar with an extensive lateral unvegetated bar and overflow channel along the left bank (Figure 18). Several narrow overflow channels are also mapped in the left bank and right bank floodplain areas. The change in channel configuration began to develop in 1954, in which the right branch of split flow developed into a distinct side channel separate from the main channel and vegetation began to establish on the mid-channel bar. The overflow channel along the left bank was progressively abandoned. Erosion along the right bank between 1961 and 1970 elongated the side channel and lengthened the mid-channel bar into an unvegetated and vegetated component. This channel pattern continued to stabilize through 2006 with further vegetation establishment in the unvegetated bar areas. The overflow channels present in the 1939 aerial photography were abandoned by 1970, at which point the vegetation was large enough to infer that these were not being regularly utilized by the river in the post-dam construction. The side channels within channel complex 7 can be described currently as moderate to high velocity with a pebble-cobble substrate. The only exception to this is side channel 7E, which was not previously mapped by FWP, but exists as a low velocity channel with shallow flow. In April 2009, a beaver dam existed at the downstream end of the side channel, which backed up flow to the sharp bend in the channel and encouraged the deposition of fine sediment in the ponded area. In August 2009, the beaver dam had been significantly eroded by the flood in July and much of the fine sediment had been eroded, leaving a patchy gravelly substrate in the channel bottom.

Figure 18. Historical channel mapping for complexes 7 and 8.

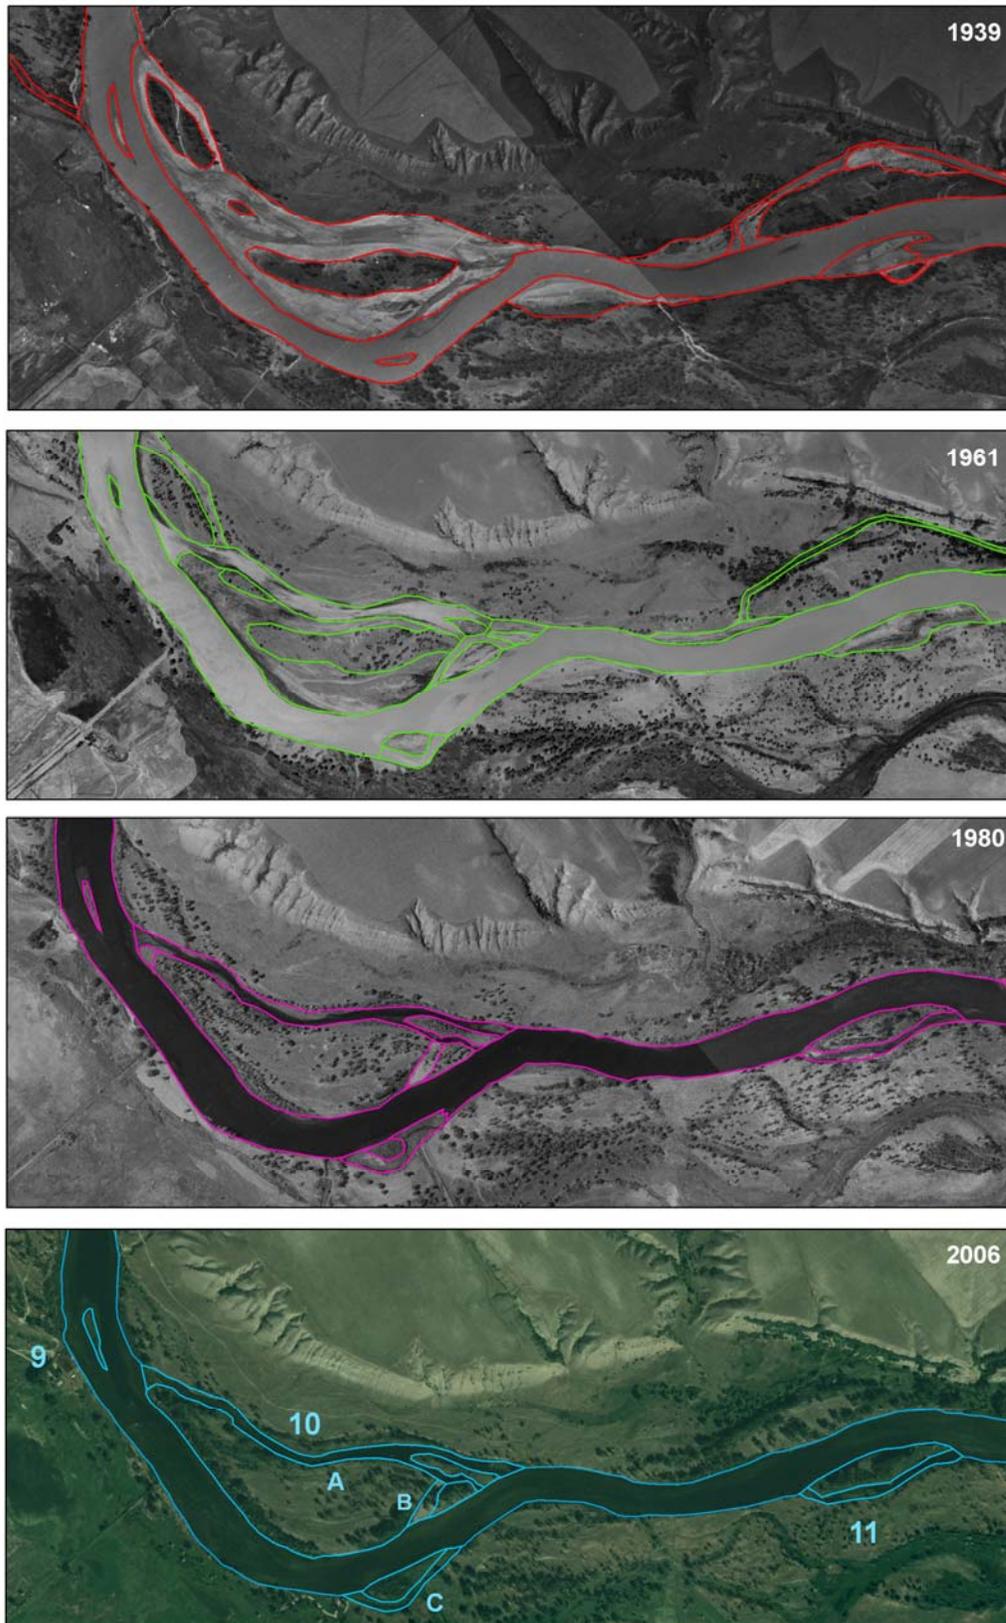
The mid-channel bar that exists at channel complex 9 has been present in this general location since 1939 and has remained relatively unvegetated throughout the historical period (Figure 19). This suggests that the bar is relatively low elevation and has received significant flow to destabilize sediment and vegetation on a regular basis. It should be noted that the mapping scheme in this study did not designate a side channel in the area due to the similar width of the channel on both sides of the mid-channel bar. Both channels are relatively deep with moderate to high velocities.

In 1939, the area of channel complex 10 existed as an extensive lateral bar with several vegetated islands (Figure 19). The main channel was in a similar position as that mapped in 2006. Vegetation establishment between 1939 and 1954 created several distinct channels including side channel 10A and smaller side channels 10B and 10C, separated from the main channel by unvegetated mid-channel bars. An overflow channel was also present at the upstream end of the complex. By 1980, the side channels had transitioned to overflow channels; 10B exists currently as an unvegetated, gravelly overflow channel while 10C is filled with cattails and fine-grained sediment over gravel and received some minor flow at lower discharges. The overflow channel at the upstream end filled in with vegetation by 1980. Vegetation encroachment of many of the bars can be observed between 1961 and 2006. Channel 10A is the only remaining active side channel in this complex and the entrance contains pebble-cobble bed material. Some scour pools along its length are partially filled with a thin layer of silt. Downstream connections of the split flow channel form low velocity or backwater areas.

Figure 19. Historical channel mapping for complexes 9, 10 and 11.

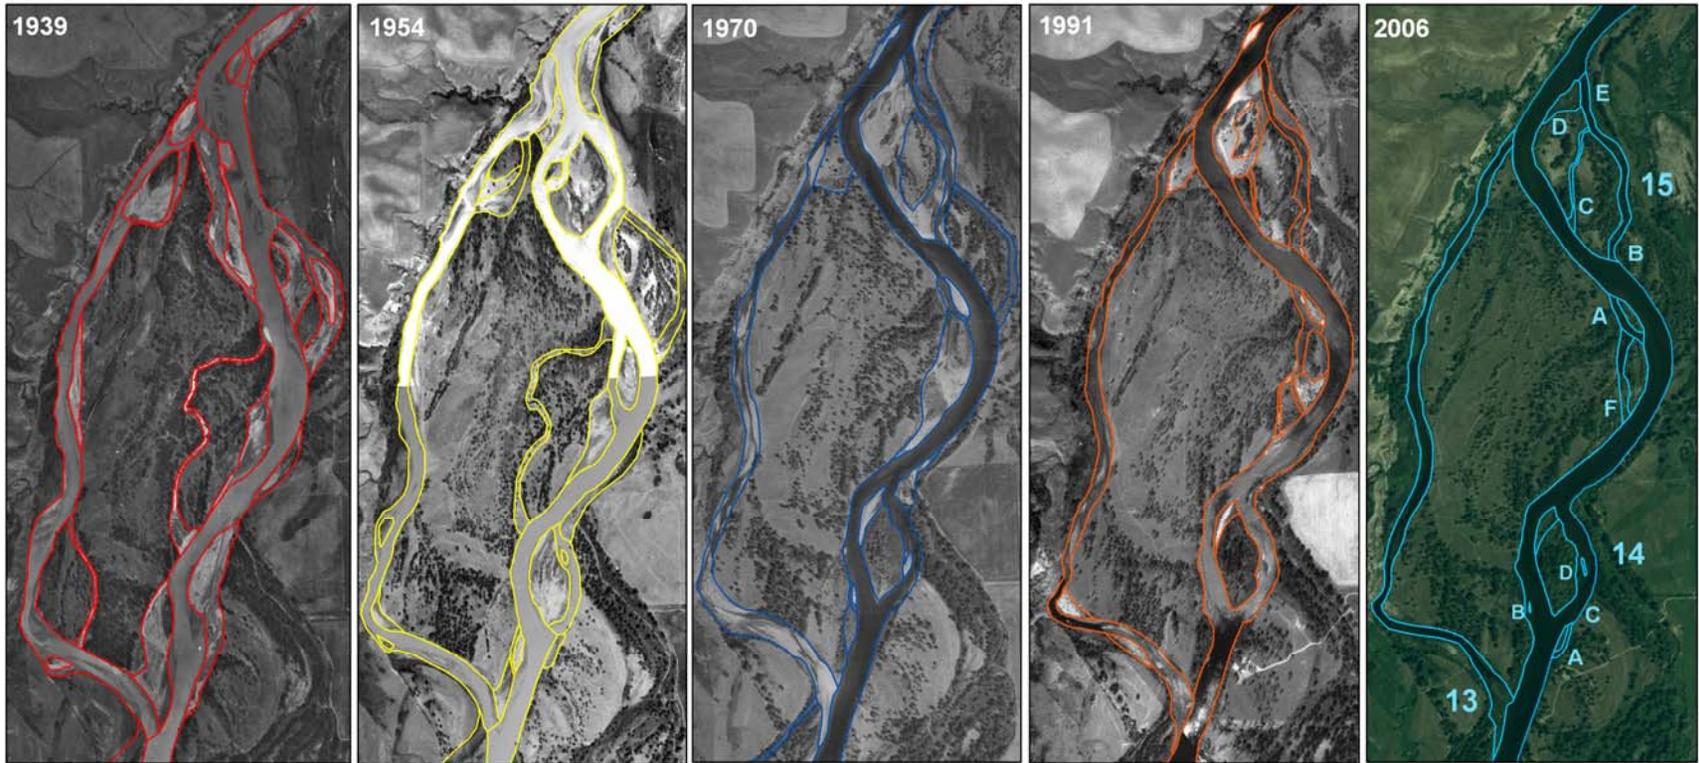
In 1939, side channel 13, also known as Glines channel, was a large side channel with a greater width and number of unvegetated bars than in 2006 (Figure 21). Two flow paths diverged at the downstream end around an unvegetated bar. In 1970, flow was disconnected at the upstream end with water visible in parts of the channel. The right branch of split flow appeared to be filling in with sediment. From 1970 to 1991, a gradual increase in vegetation can be seen with a few bushes or trees visible at the upstream connection with the main channel. By 2006, a significant increase in vegetation at the side channel entrance is visible. This channel was observed to have shallow flow during 2009 field work with grass, willows and cattails growing in the channel entrance. Fine sediment was also noted in the channel entrance and downstream from the entrance, which covered the gravel bed in most locations.

Figure 21. Historical channel mapping for complexes 13, 14 and 15.

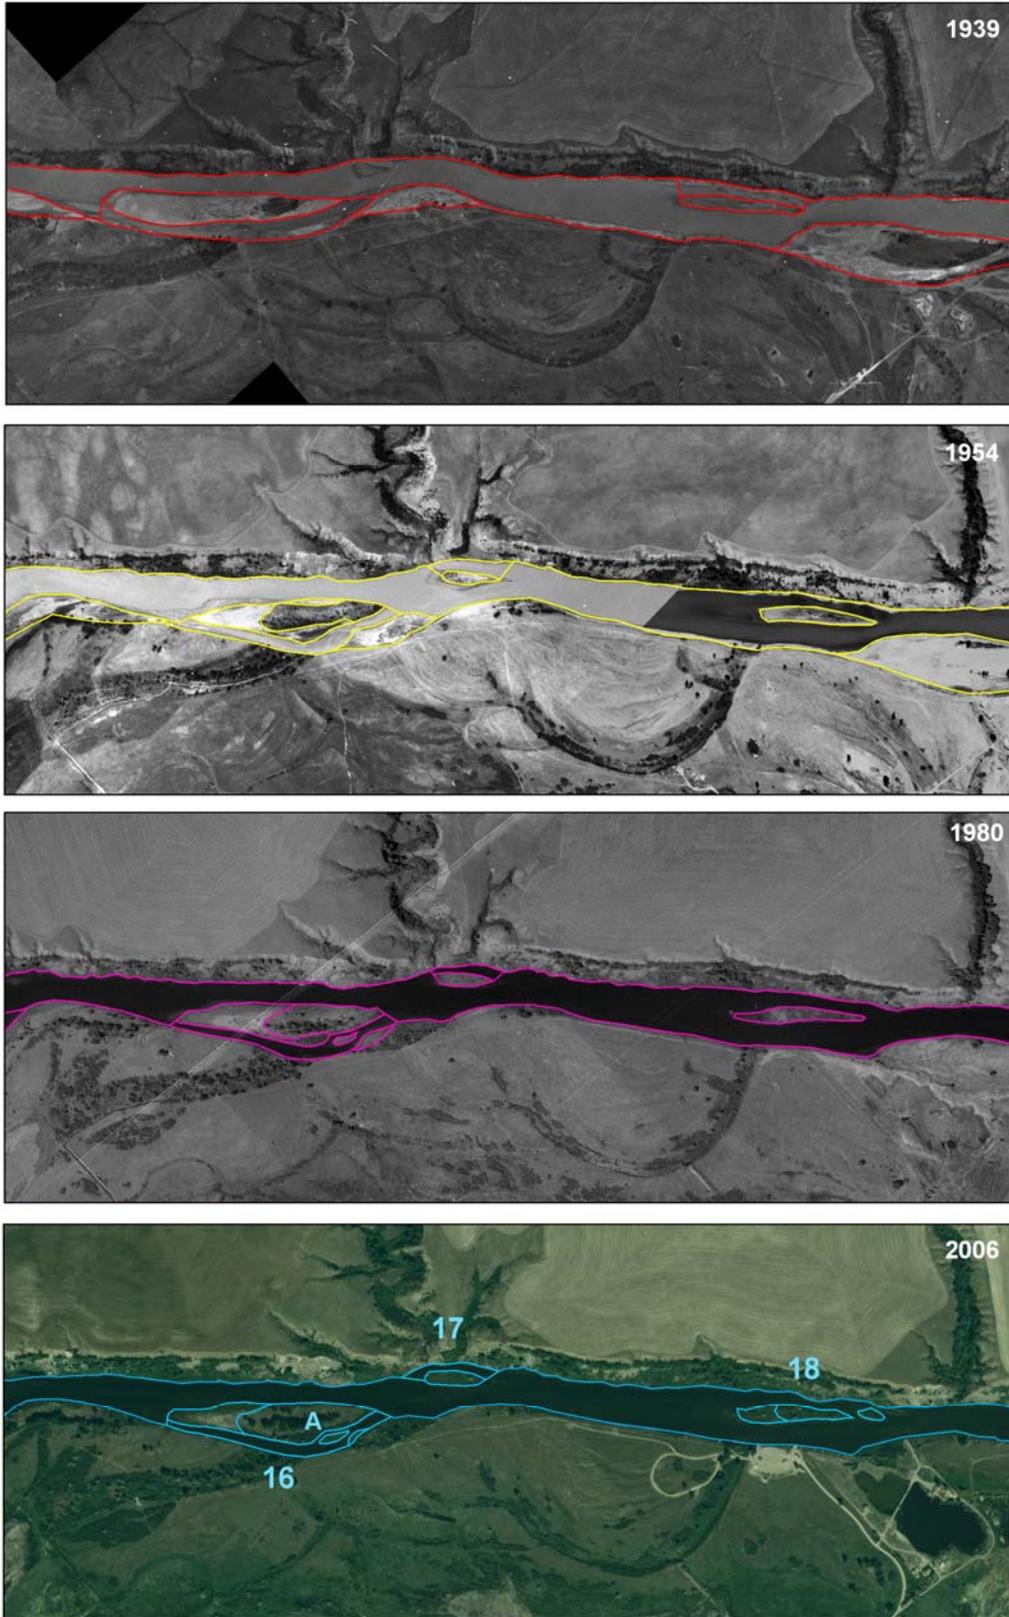
Channel complex 17 is located at the entrance of an unnamed gulch. The history for complex 17 is similar to complex 16. In 1939, the side channel was in its present location, but shorter in length (Figure 22). By 1954, the configuration was very close to the present configuration.

Figure 22. Historical channel mapping for complexes 16, 17 and 18.
