Future Utilization of Electro-Osmotic Pulse Technology on Concrete Structures

Science and Technology Program

Final Report No. ST-2020-1764-01, 8540-2020-13

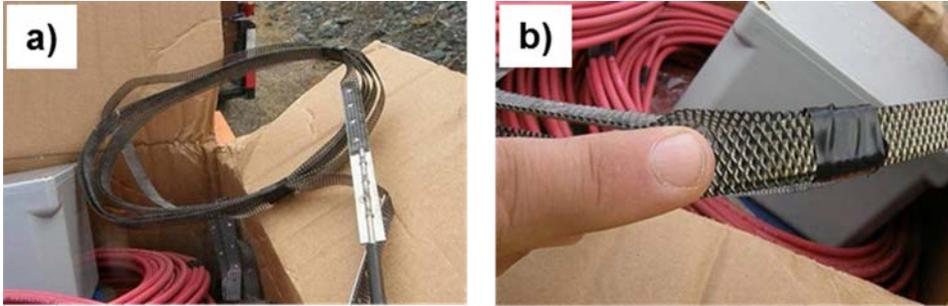
Image 3. Mixed metal oxide coated titanium mesh strip type anodes (a and b) and cathodes (c and d) installed in the concrete wall [1].

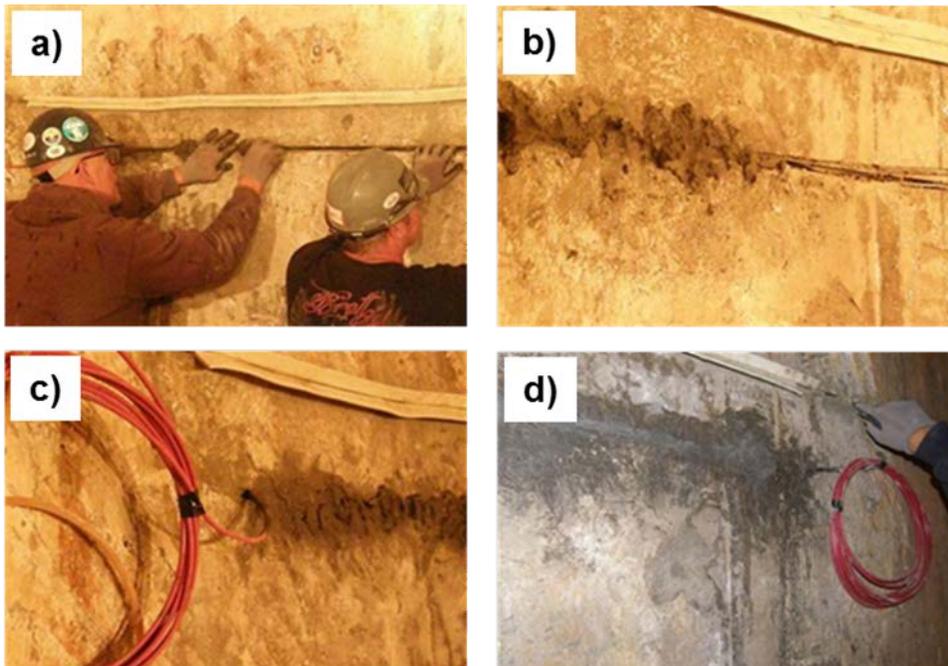
Image 4. Installation of upper strip anode and hand packing of Portland cement grout into the groove shown in photos a), b) and c). Photo d) shows finished installation of upper anode strips and cable [1].

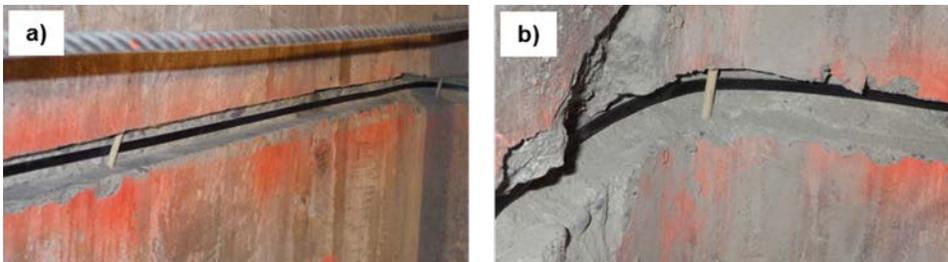
Image 5. MMO anode ribbons installed in grooves and held in place using wooden dowels [2].

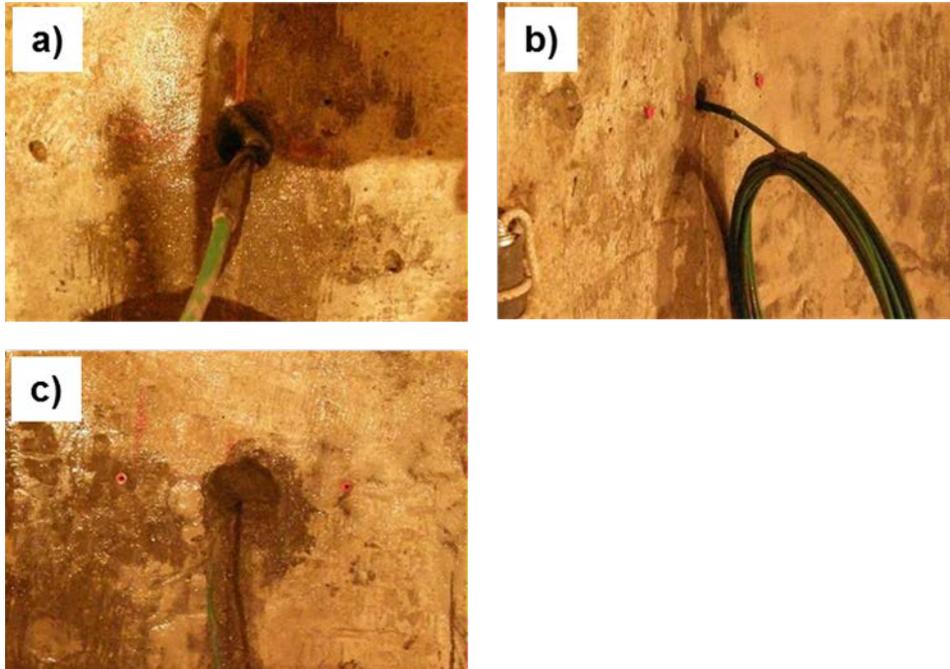
Image 6. Installation of strip cathodes into holes drill to a depth of ~18 inches shown in a) and b). Portland cement grout was poured in the holes around the cathodes, and the cathodes and cables were grouted in as shown in c) [1].

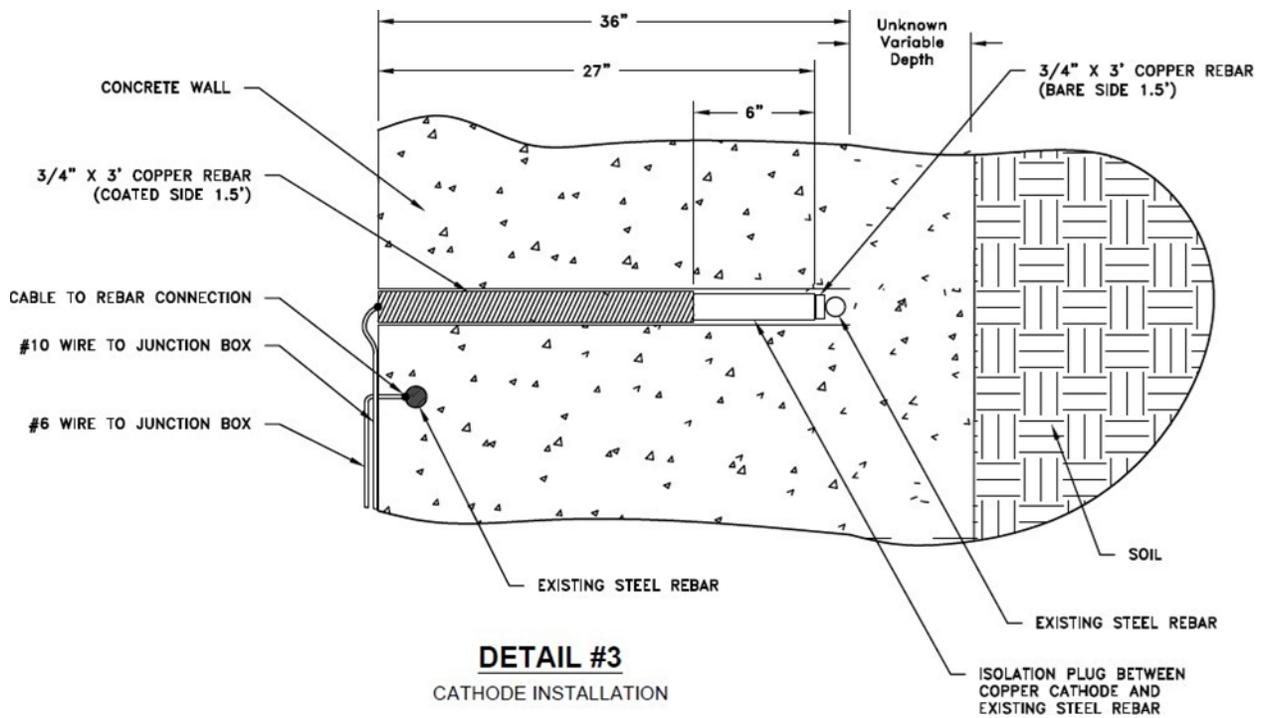
Figure 3. Schematic of cathode installation for isolation from rebar [2].

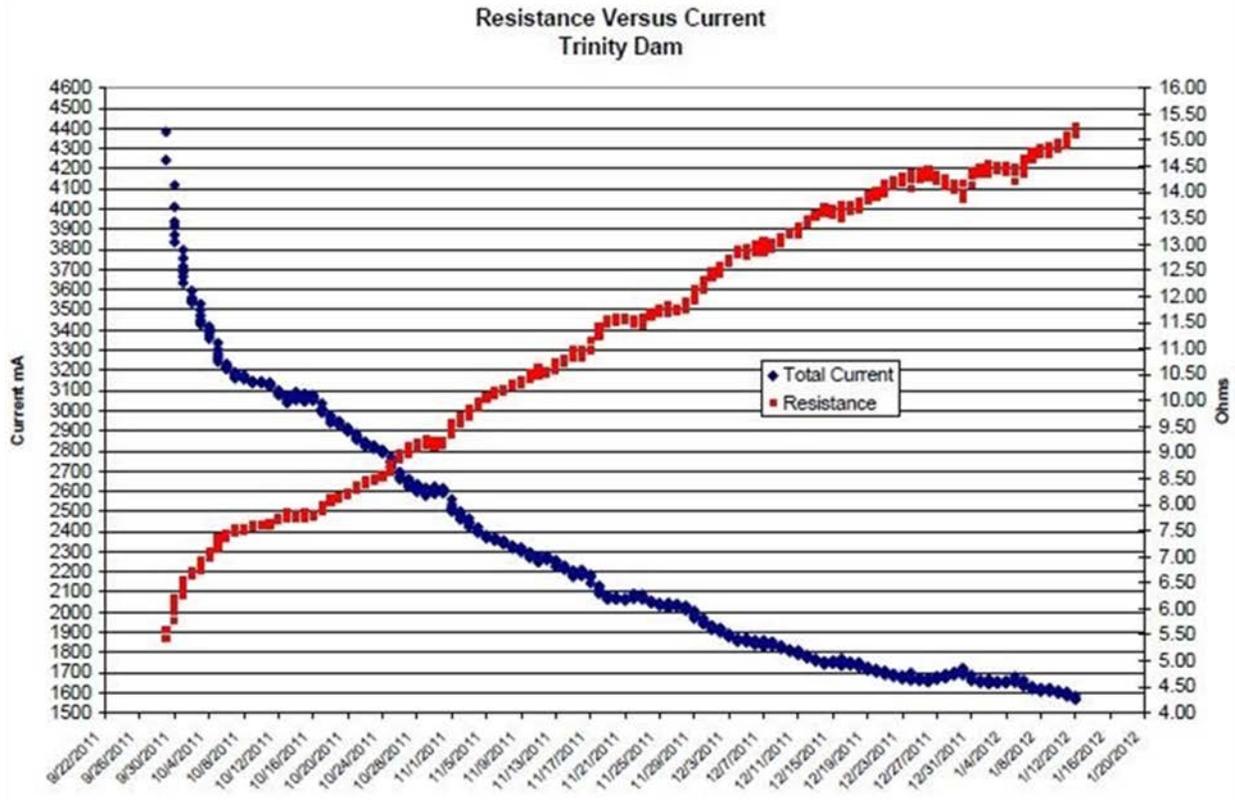
Data Results Data is analyzed using Ohm's law $E = IR$, where E is the potential (Voltage), I is the current (Amperage), and the R is resistance (ohms). The data presented in MERL-2012-10 [1] and ST-2018-4553 [2] show that at a constant applied potential, as the moisture level in the concrete decreases in the wall, the current will decrease and the resistance will increase. Figure 4 shows the analyzed data for total current output and resistance from Phase 2 after 15 weeks of operation. The increase in resistance indicates that the system is operating and moving water through the concrete towards the cathodes.

Figure 4. Data from the first 15 weeks of the Phase 2 system operation showing the current and resistance over time. The data shows that the moisture content in the concrete is decreasing [1].

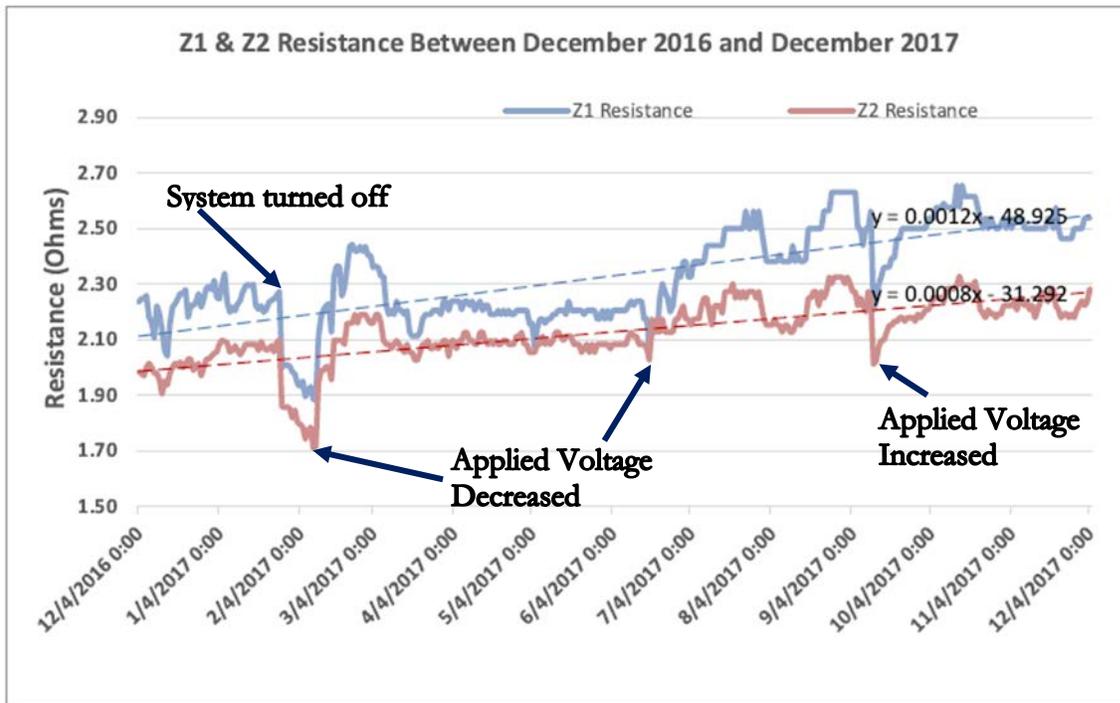
Phase 3 data also showed increased resistance values over the first 12 months of operation as shown from the graph in Figure 5. The data indicate the effect of moisture leaving the structure. As the electrolyte (water) decreases in the concrete, it makes it more difficult for electrical current to flow, resulting in increasing resistance.

Figure 5. Graph of the first 12 months of data collected after energizing the Phase 3 EOP system. The resistance for each zone is increasing over time indicating that the water is moving away from the surface and the system is still operating as designed [2].

The applied voltage was decreased twice and increased once during the initial 12-month operational period. Adjustments to the applied voltage are required occasionally to establish an electric field gradient between the anode and cathode to maintain a force against the flow of water. As the system operates over time, a steady state or equilibrium will eventually be achieved; the system will stop driving the water and the resistance will stop changing. This change in the applied voltage essentially “jump-starts” the effect of the system by changing the electric field and the resistance increases again as desired. Since the forces due to pressure and electro-osmosis are generally the dominant components regarding the movement of water in concrete, the force due to electro-osmosis must balance or exceed that of the pressure force to prevent water seepage [1]. A minimum current density is required to create enough electric field strength in the concrete in order to overcome the force exerted on the water molecules by the hydraulic gradient [1]. The applied voltage when the system was energized was set at 40 V. The decrease in the resistance in January was the result of the system accidentally being switched off allowing water to migrate towards the anodes. The voltage was then decreased to 15 V in February, based on the initial steady state resistance measured prior to the system being off. Since after the voltage was decreased in February the resistance of the concrete started increasing again indicating that an equilibrium had not been obtained. The voltage was decreased again to 10 V in June due to the steady state measured by the controller which “jump-started” the system’s ability of the system to drive more water out of the concrete. In September, the voltage was increased to 17 V to determine if an equilibrium had been reached and the resultant steady state resistance measured indicated that this was indeed the case.
