## **RCEM – Reclamation Consequence Estimating Methodology**

### **Dam Failure and Flood Event Case History Compilation**

**U.S. Department of the Interior  
Bureau of Reclamation**

**June 2015**

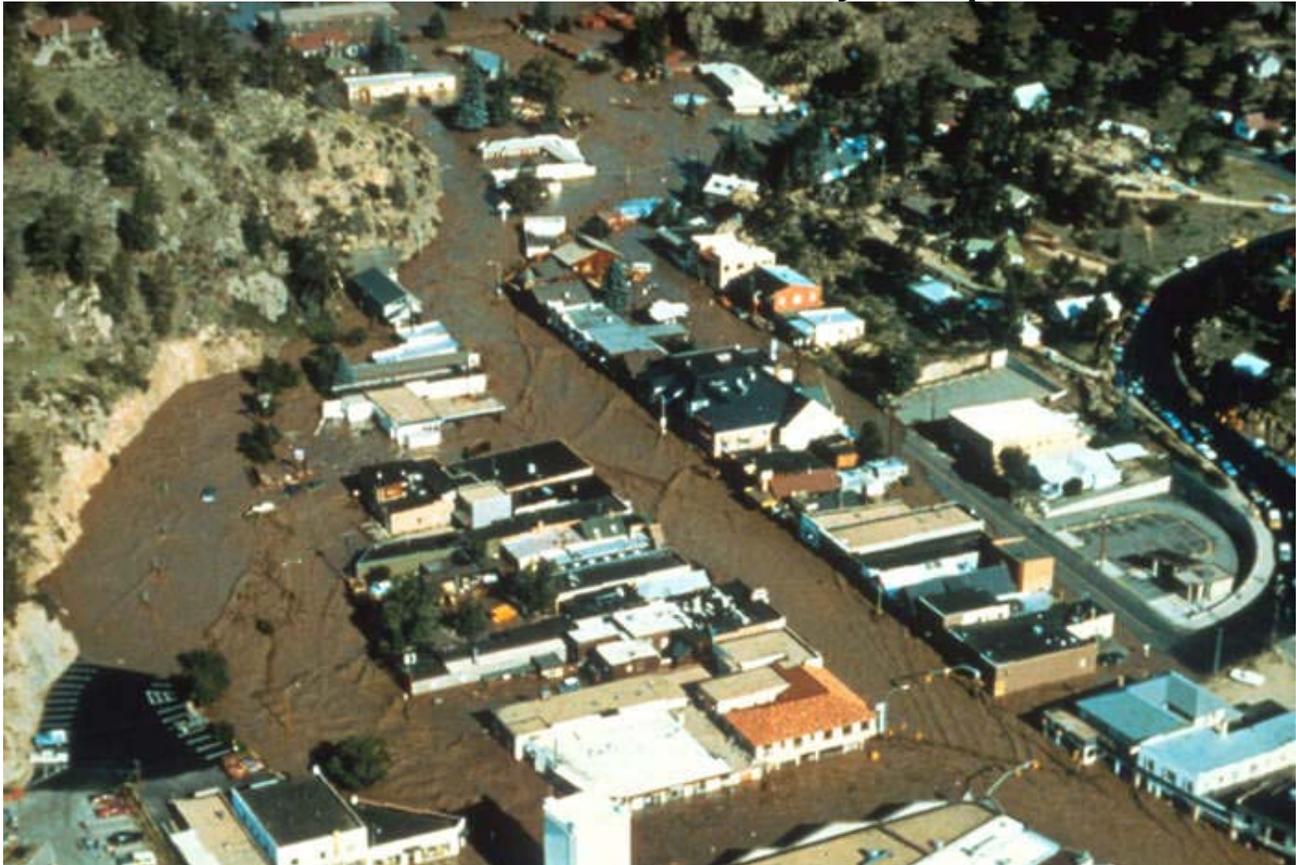
Lawn Lake Dam failure flood in 1982 at Estes Park, CO (Reclamation photograph)

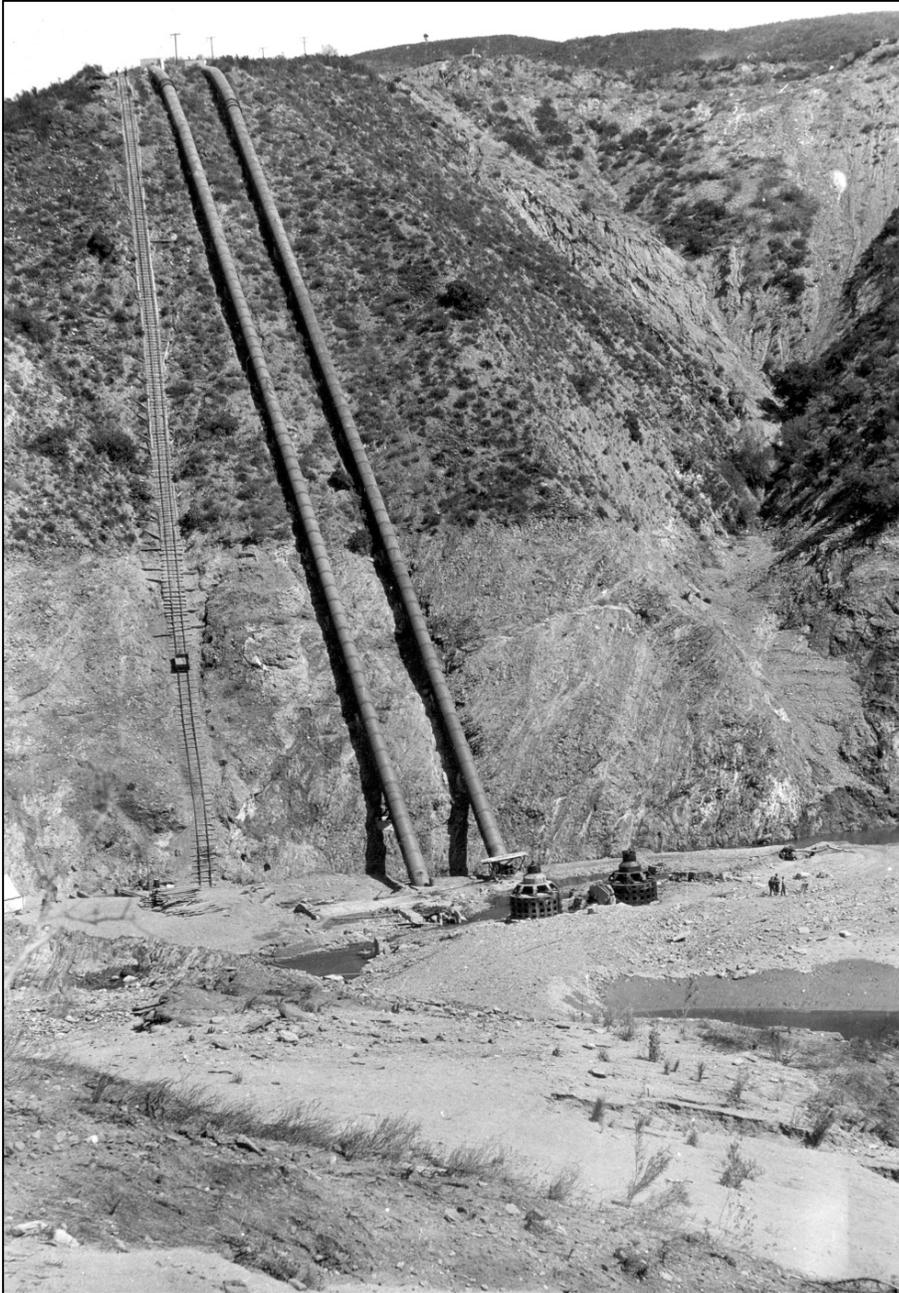
Two downstream areas are of particular interest. Powerhouse No. 2 was located in the San Francisquito Canyon, about 1.4 miles downstream from the dam. The flood arrived at this location as a wall of water, about five minutes after the dam had failed. This was the classic example of high

**Figure 5. Location of Powerhouse No. 2, area swept clean after flooding**  
Source: U.S. Geological Survey/photo by H.T. Stearns  
<http://libraryphoto.cr.usgs.gov/htmlorg/lpb212/land/sht00685.jpg>

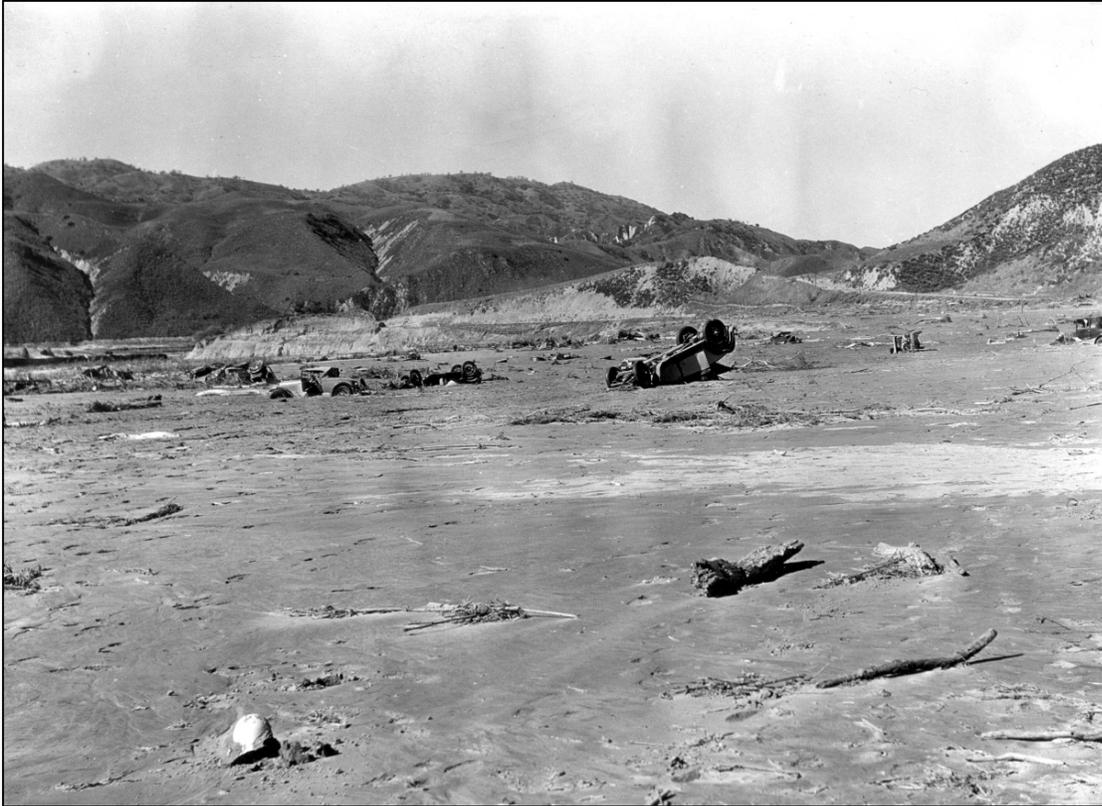
Another area of interest was the Edison Construction Camp located 18.5 miles downstream where 150 men slept in tents along the banks of the river. The flooding at this location was described as a 60-foot wall of water. An effort to issue advance warning to the site was unsuccessful. As the flood approached, a night watchman became alerted and attempted to wake the sleeping men, but it was mostly too late. An estimated eighty-four fatalities occurred at this site.

**Figure 6** Aftermath of flooding at the Edison Construction Camp

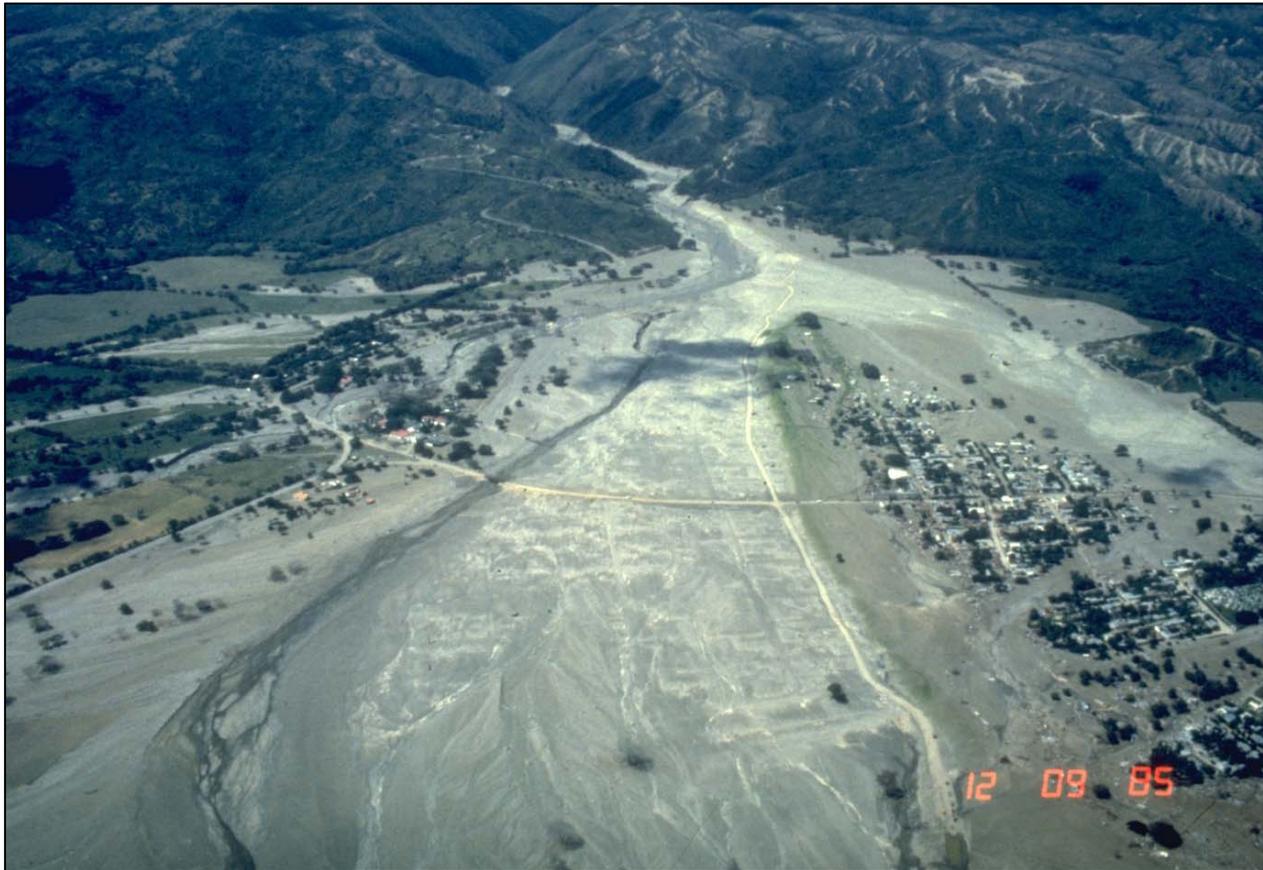
**Figure 8. The town of Armero, Columbia and the aftermath of the Nevado del Ruiz Lahar mudflow**  
Source: U.S. Geological Survey, <http://volcanoes.usgs.gov/vdap/images/ruiz/armero85.jpg>

On November 13, 1985, the Nevado del Ruiz Volcano erupted causing a small portion of its icecap to melt, and setting off a massive mudflow (lahar flow) which resulted in the deaths of about 22,000 people at the town of Armero, Columbia.

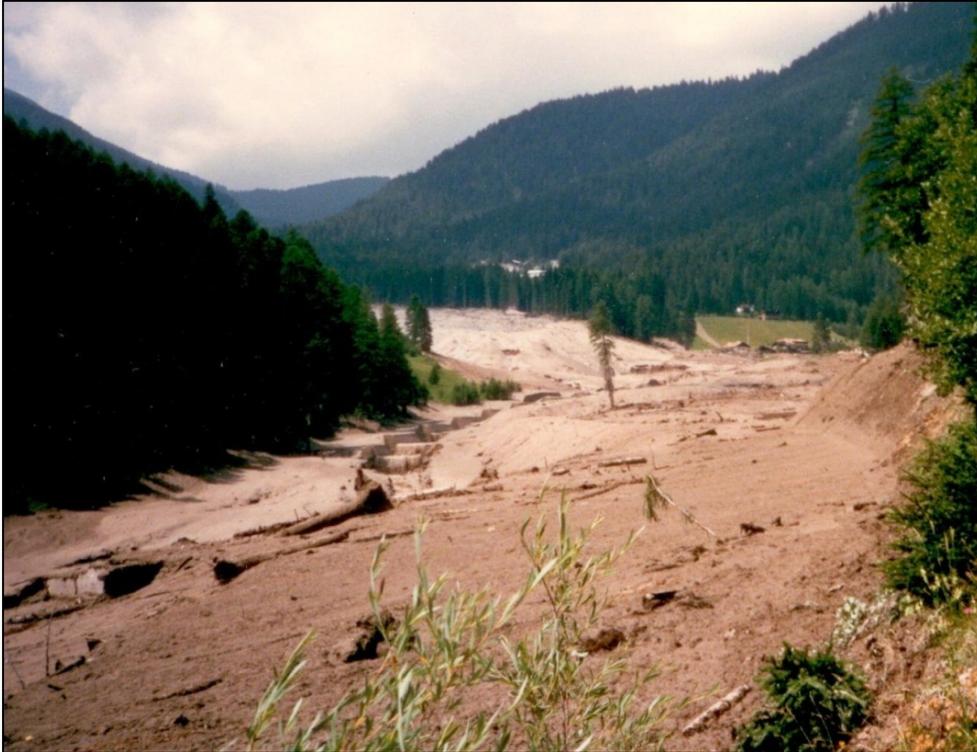
**Figure 10. Destruction in the valley, downstream from Stava Tailings Dam**  
Source: Fondazione Stava 1985 Archives, <http://www.stava1985.it/>

The failure of Stava Tailings Dam is considered to have been high severity flooding due to the rapid failure of the embankments which resulted in very fast flood flow velocities and the complete destruction of the downstream community. Maximum flooding depths appear to be unavailable, but the river valley at the community of Stava was “swept clean” and this is another classic example of high severity flooding.

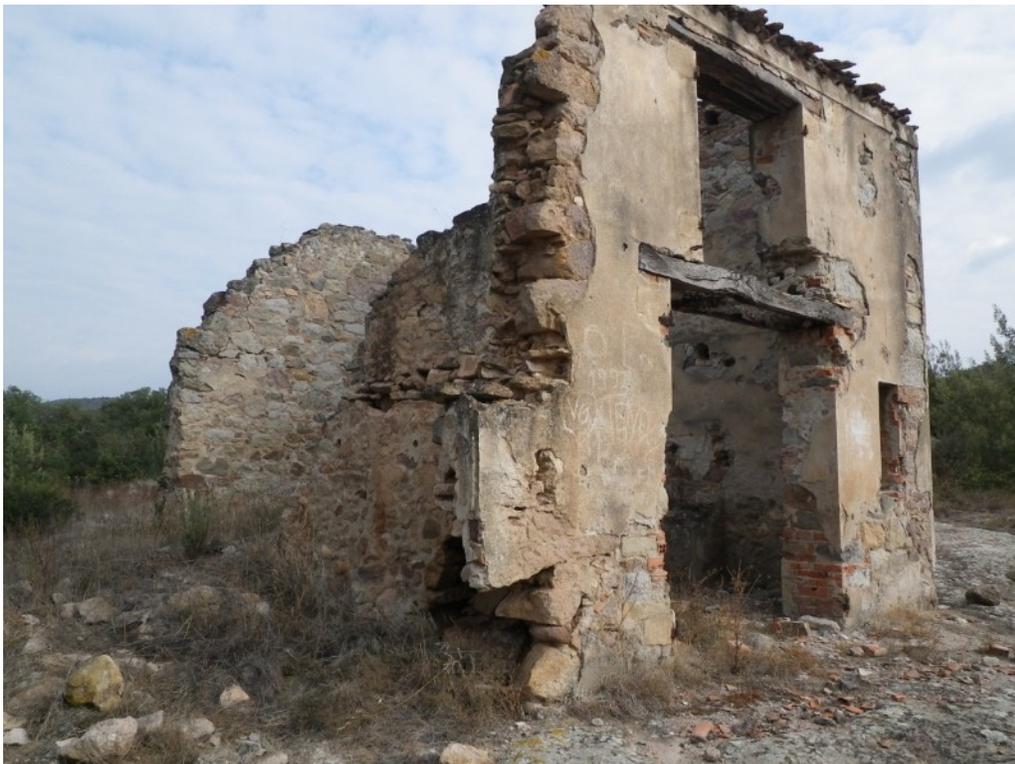
**Figure 17. Remains of destroyed home, upstream of Frejus**  
Source: Photo courtesy of Derek Sakamoto

High severity flooding is thought to have occurred in the reach of the Reyran River from the dam to the upstream outskirts of Frejus. A highway construction camp was located several hundred yards downstream of the dam which contained more than 30 workers. Most of the workers were reported to have been killed by the flood. The flooding at Frejus was probably a combination of high and medium severity, based on a B.C. Hydro hydraulic re-creation of the flood which indicated DV lower than 160 ft<sup>2</sup>/s for much of the community. Many homes at Frejus collapsed when subjected to the flooding, including houses located in the zone of medium flood severity.

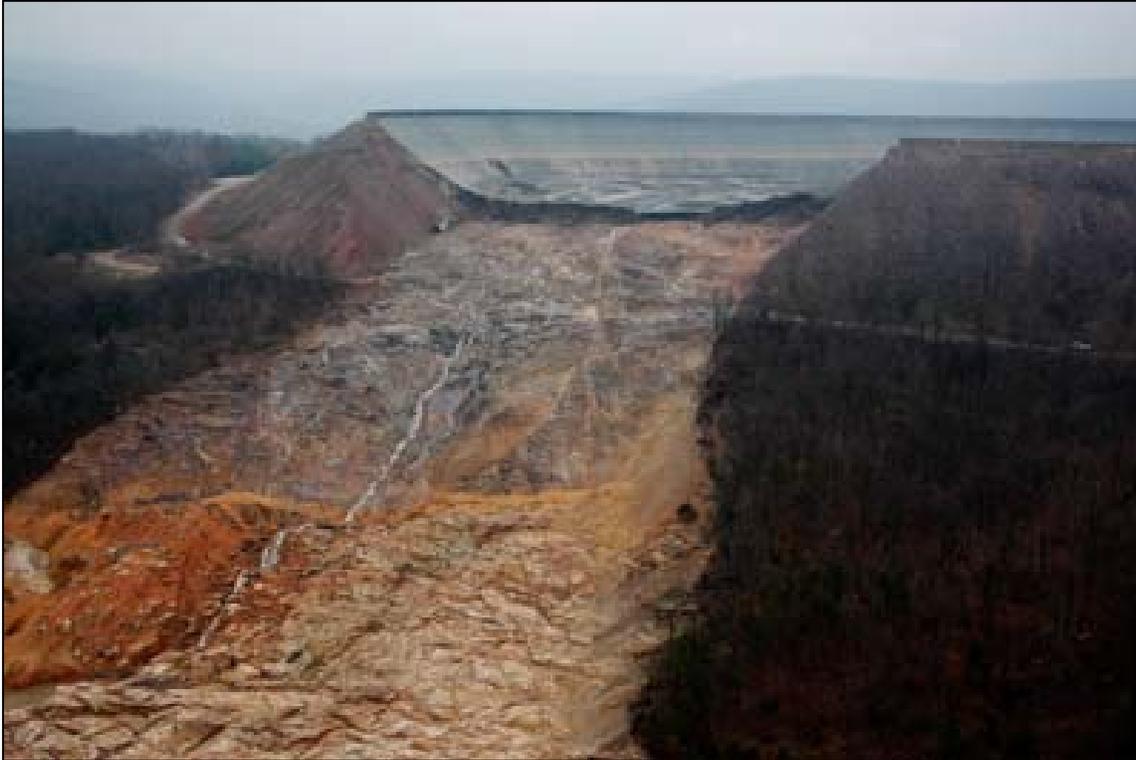
**Figure 22. Swath of flood zone, downstream of Taum Sauk Upper Dam**

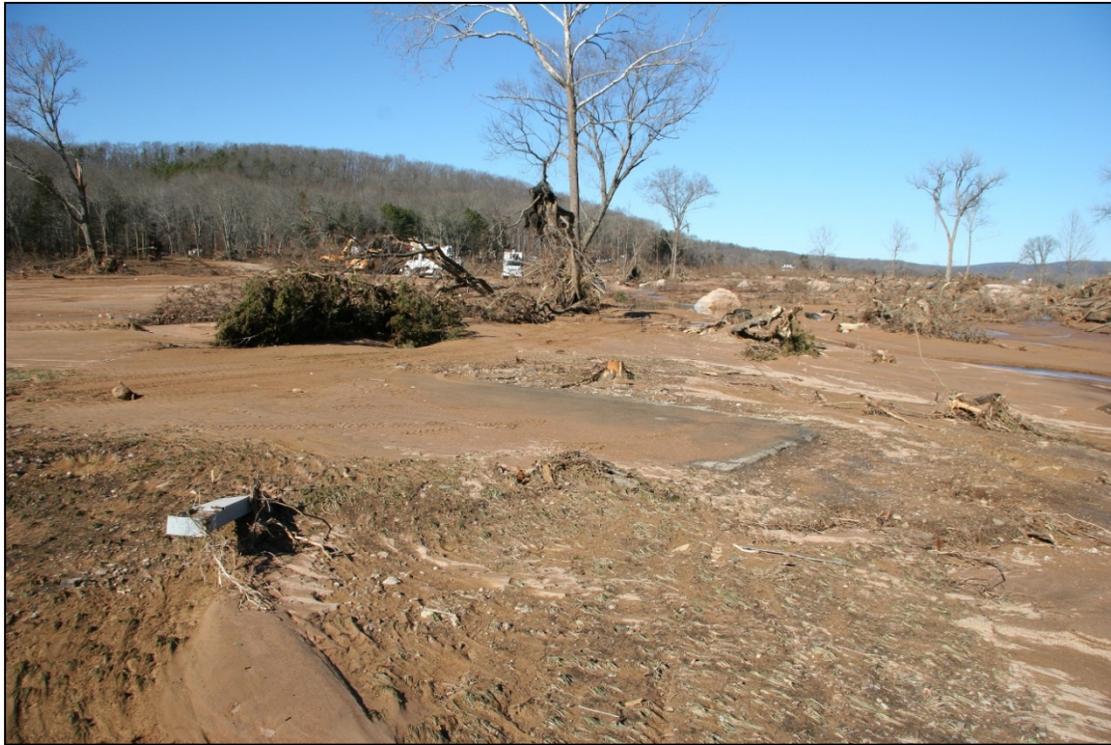
Figure 23. Flooding in the vicinity Johnsons Shut-Ins State Park

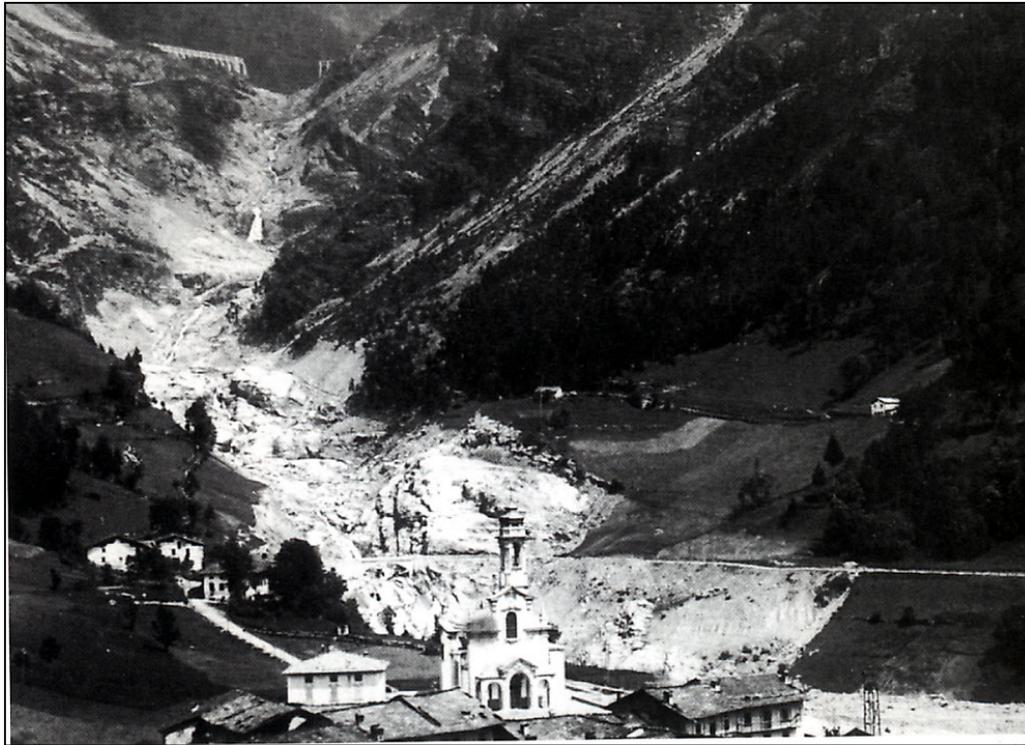
The flood wave took 45 minutes to reach Darfo. Total fatalities were estimated to be at least 356. Along with the death toll, the flood destroyed three villages, five power stations, and finally a high number of isolated buildings and factories. (Case Study and Numerical Modeling)

Figure 25. Aftermath of flooding, downstream of Gleno Dam  
Source: Newspaper Eco di Bergamo, www.scalve.it

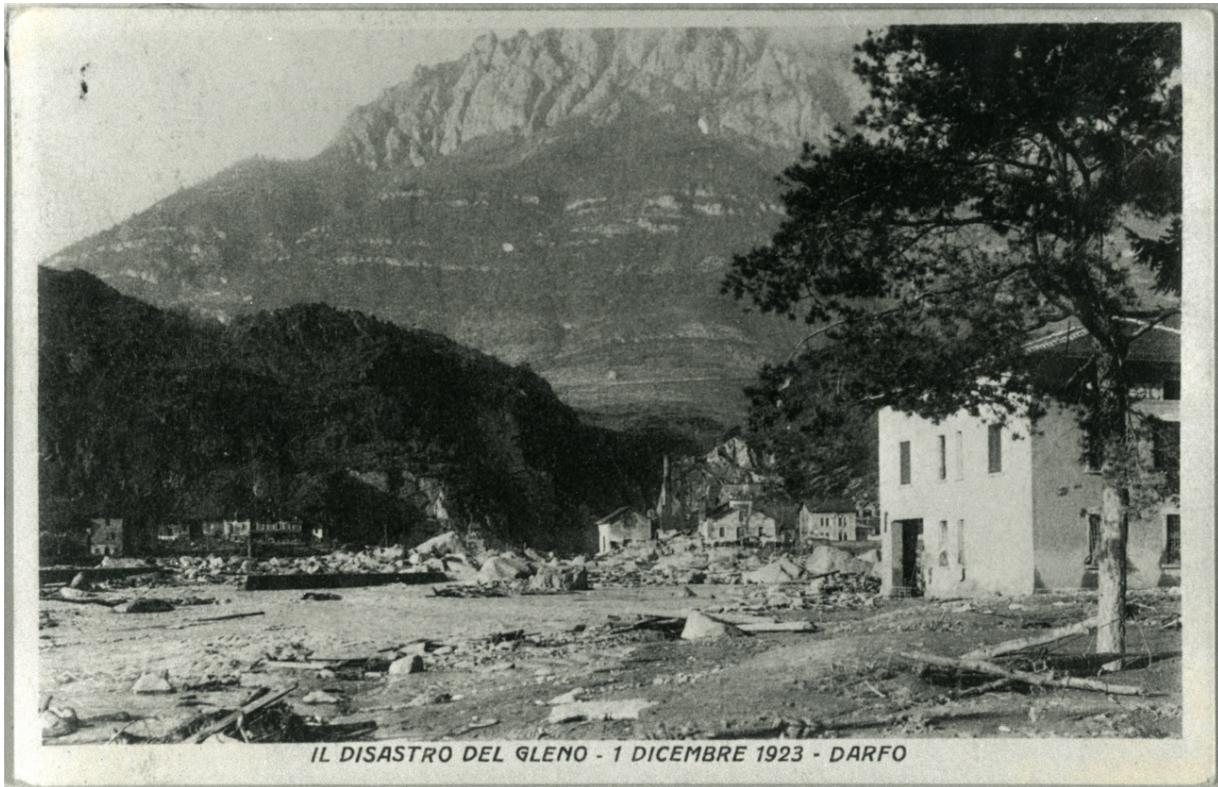
DV has been calculated to be in the range of high severity. Rate of rise is not known, but photographs of the flood aftermath indicate that the flood zone was “swept clean”. Considering also the steep narrow channel, and the high DV values it seems reasonable to assume that the flooding was high severity.

**Figure 26. Flooding Aftermath at Darfo**  
Source: Newspaper Eco di Bergamo, [www.scalve.it](http://www.scalve.it)

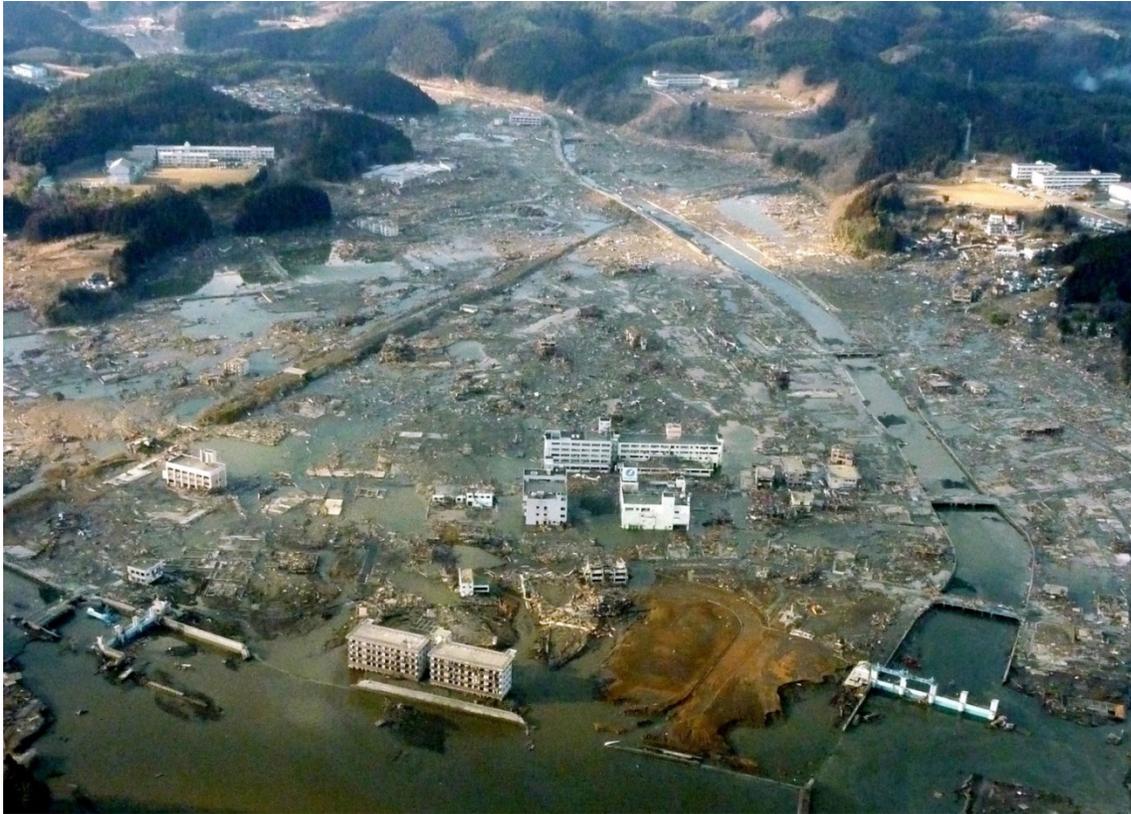
Figure 27. Tsunami flooding aftermath at Minami Sanriku  
Source: Licensed by the Associated Press

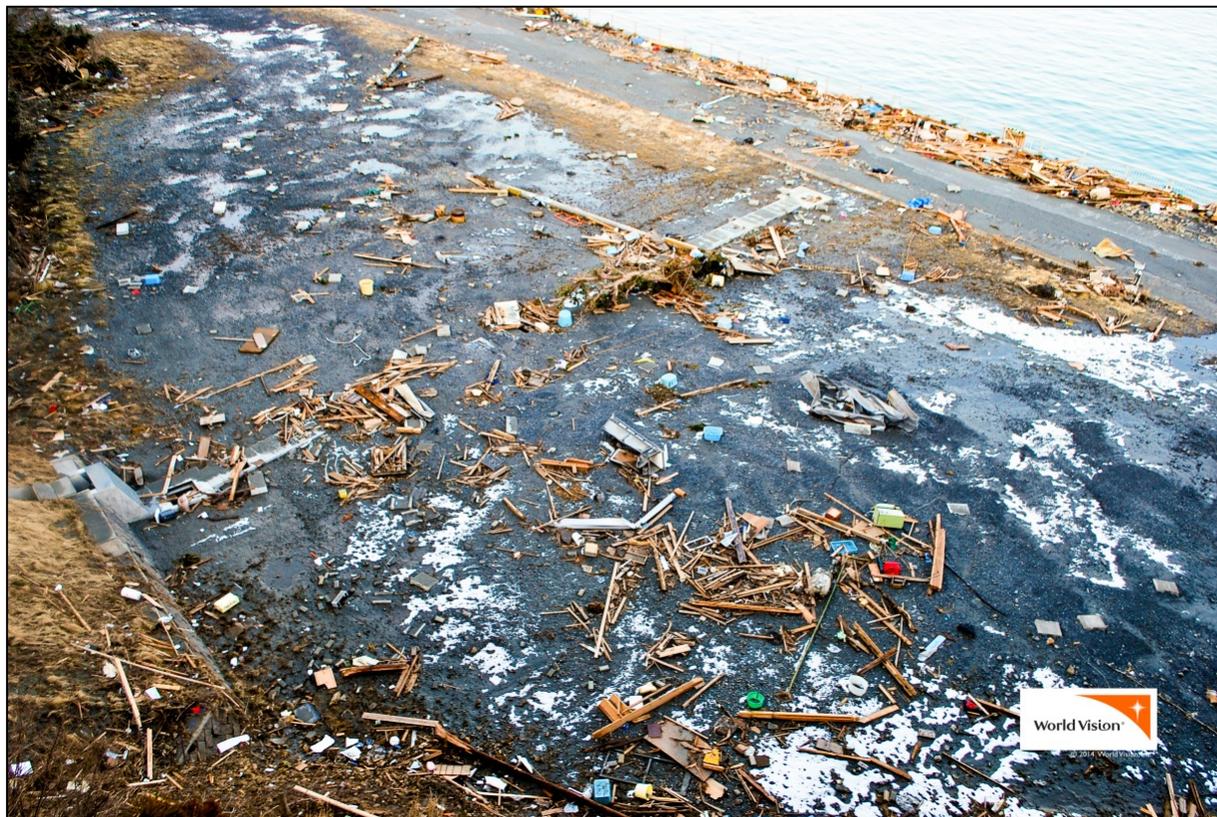
Figure 28. Flooding aftermath, Minami Sanriku  
Source: Courtesy Image ©2014 World Vision, Inc. All Rights Reserved.

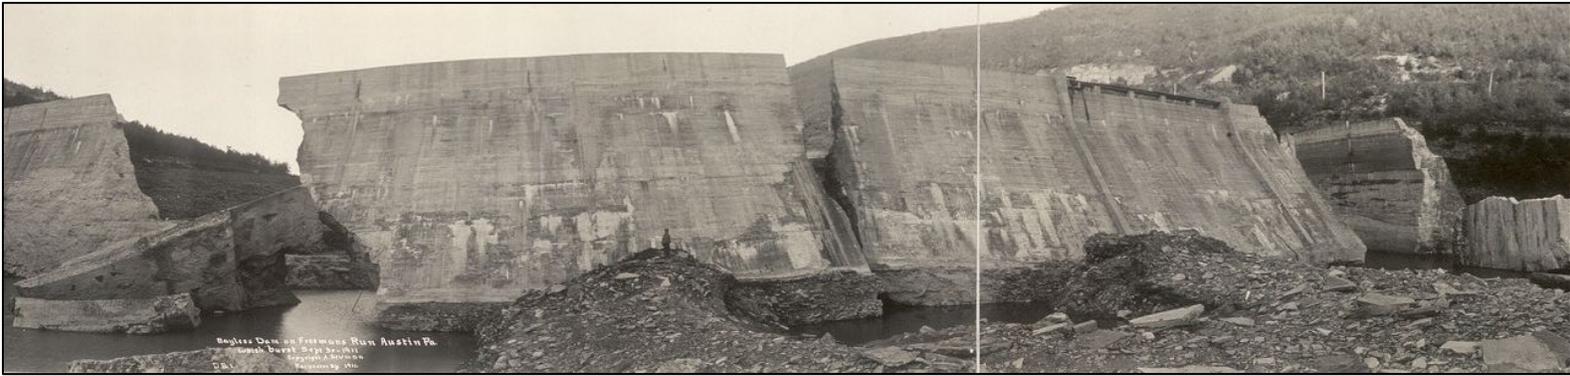
The concrete gravity dam on a stream known as Freeman's Run near Austin, Pennsylvania, failed suddenly on September 30, 1911, with the loss of at least 78 human lives. The dam was 50 feet high, 30 feet thick at the base, 2.5 feet thick at the top, and had a crest length of 544 feet. The structure, completed in 1909 was composed of cyclopean concrete buttressed by a rolled earthfill. The foundation consisted of interbedded shale and sandstone. The initial trouble occurred during the dam's first year of operation. In January 1910, when the reservoir had reached full capacity for the first time, the dam began to slide downstream. Disaster was reportedly averted by blasting holes in the structure. Evidently, during the initial introduction of water into the reservoir, the dam was loaded before the concrete had set sufficiently. This caused the opening of cracks and the development of excessive pressures under the dam. As a consequence, in the 1910 incident the dam settled about 6 inches at the toe and slid out on the foundation, a distance of about 18 inches at the spillway. The paper company which owned the dam allegedly did not strengthen the structure, and allowed the reservoir to fill again. Presumably, the holes in the dam were plugged, but adequate repairs were not made; and the structure remained in this hazardous condition until its sliding collapse on September 30, 1911. There was about 40 feet of head on the dam at the time of failure.

**Figure 30. Austin Dam, after failure (1911)**

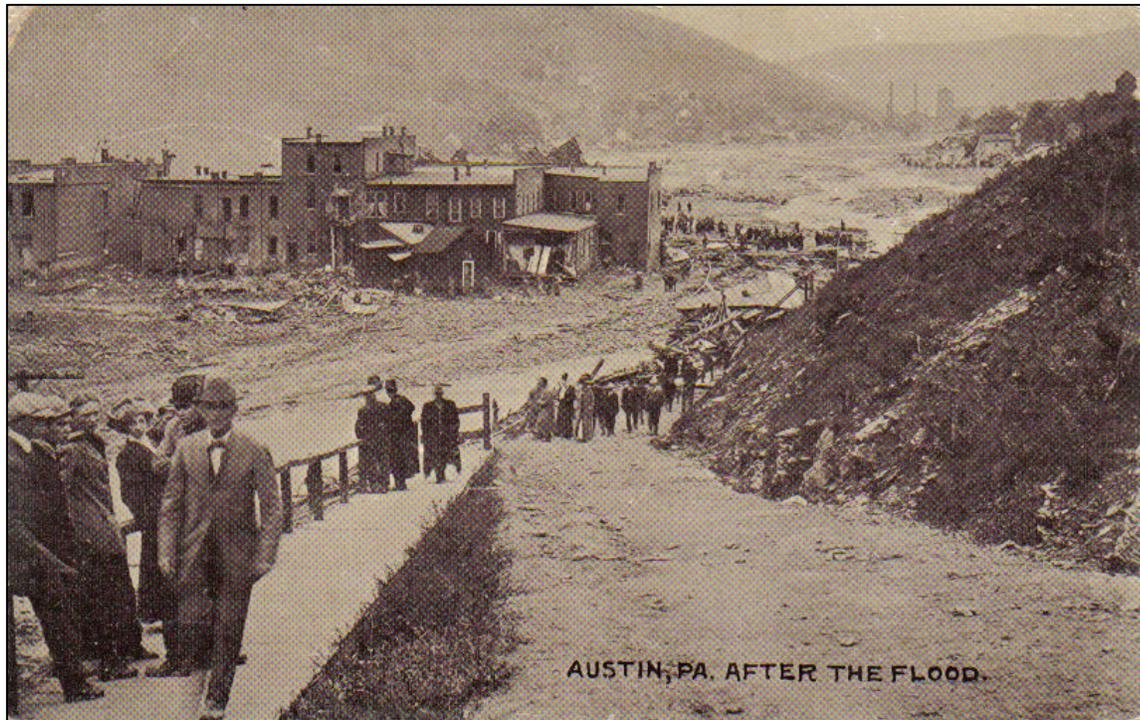
Figure 31. Remains of flooding at Austin, note the proximity to high ground  
Source: Austin Dam Memorial Association, <http://austindam.net/>

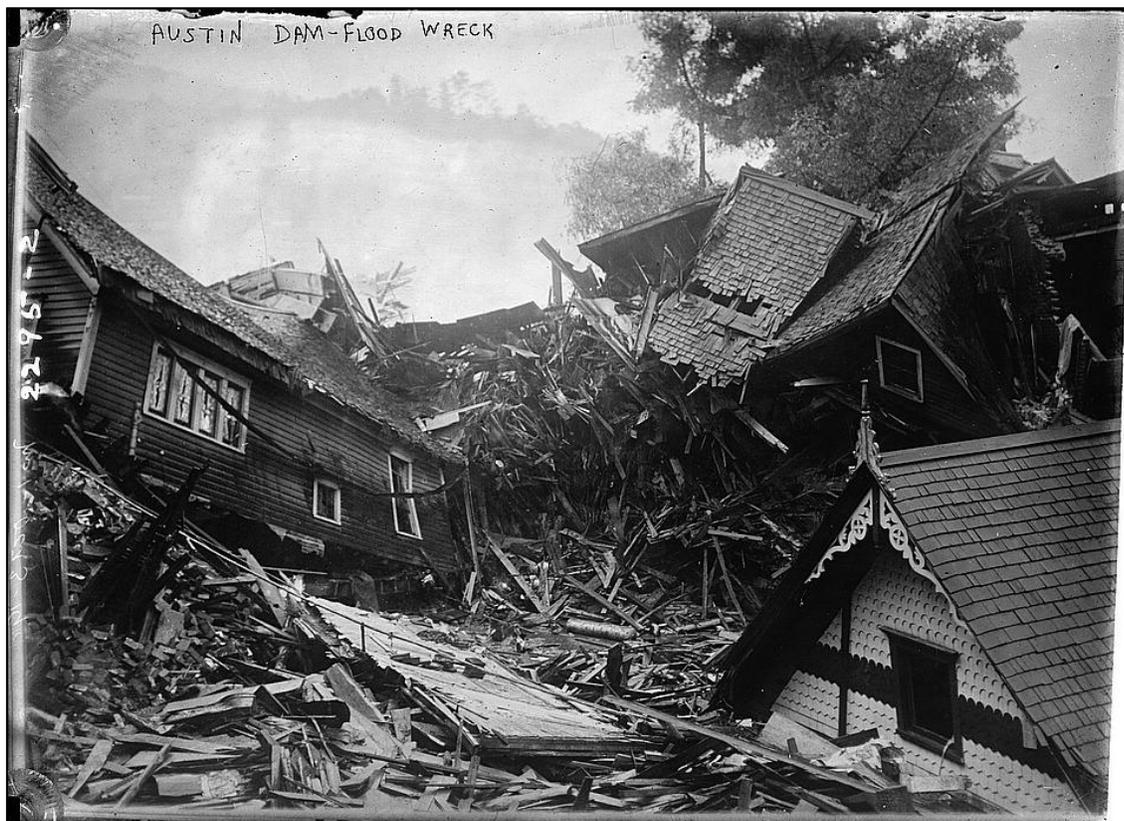
Figure 32. Remains of flooding at Austin  
Source: Library of Congress/George Grantham Bain Collection, <http://www.loc.gov/pictures/resource/ggbain.09763/>

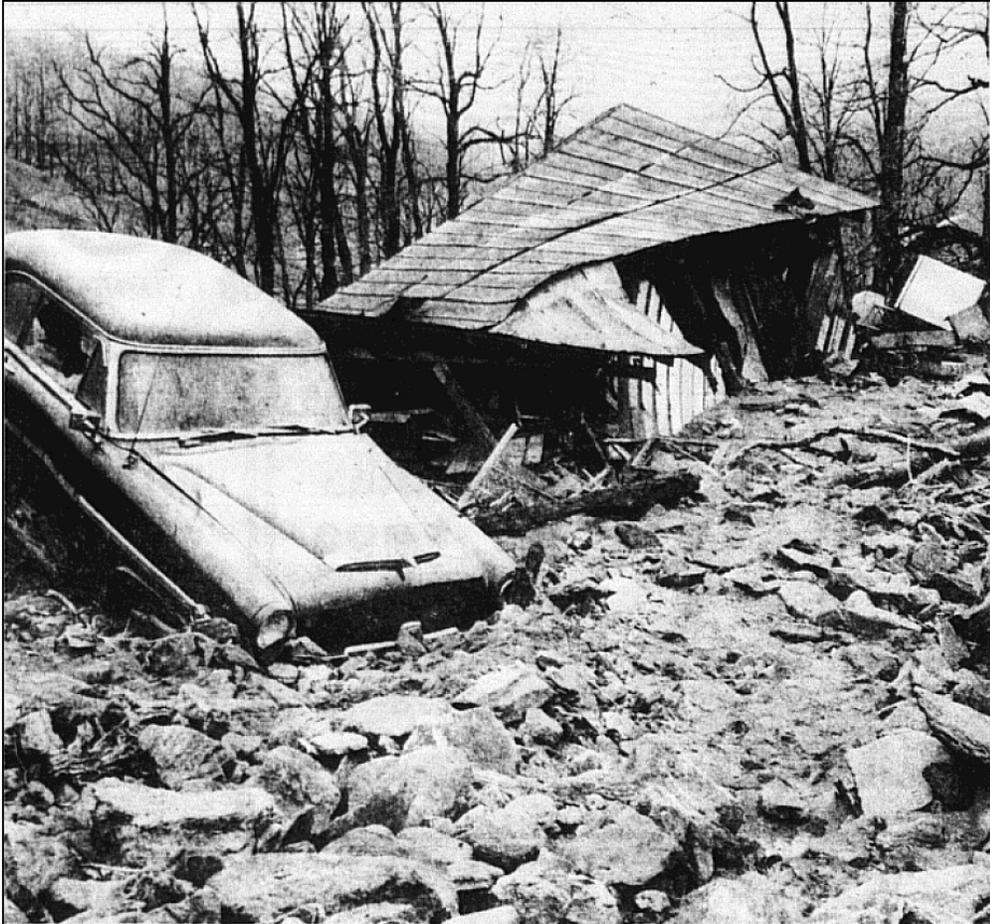
DV and rate of rise are unknown, but this dam failure flood event is considered to have been medium severity. The downstream channel contained the very steep slopes and there was a reported wall of water. However, based on photos of the aftermath, the destruction of houses and other property downstream was not complete and the area was not “swept clean”. Remains of damaged structures and cars were present.

**FOUR MEMBERS OF THE LEDBETTER FAMILY WERE SWEEPED AWAY FROM THIS NEWFOUND COMMUNITY HOME.**

**Figure 33. Bear Wallow Dam, remains of house where fatalities occurred**  
Source: The Asheville Citizen, February 23, 1976

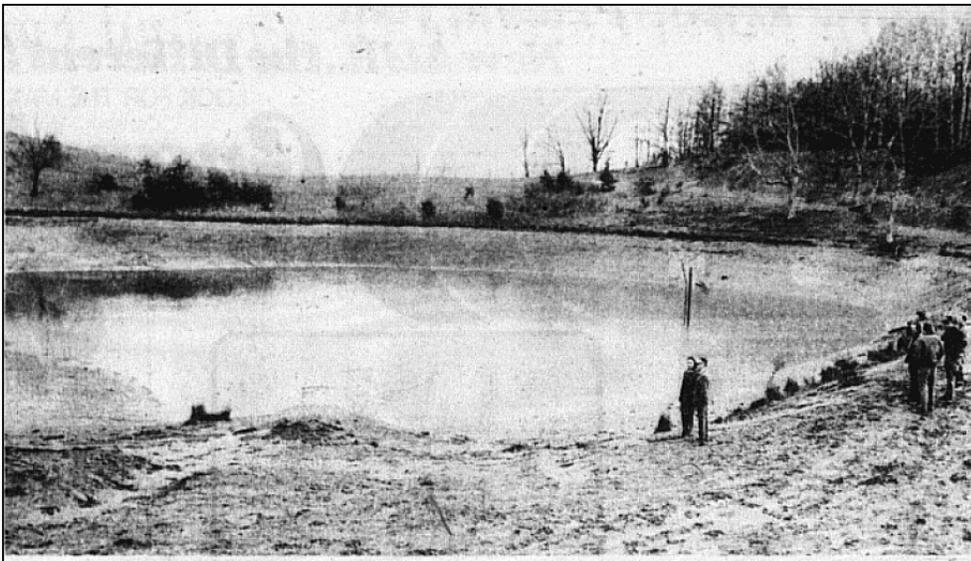
**COMMISSIONERS OWEN AND TRANTHAM INSPECT HALF-EMPTY LAKE. DAM BREAK IS BEHIND GROUP ON RIGHT**

**Figure 34. Bear Wallow Reservoir after failure**  
Source: The Asheville Citizen, February 23, 1976

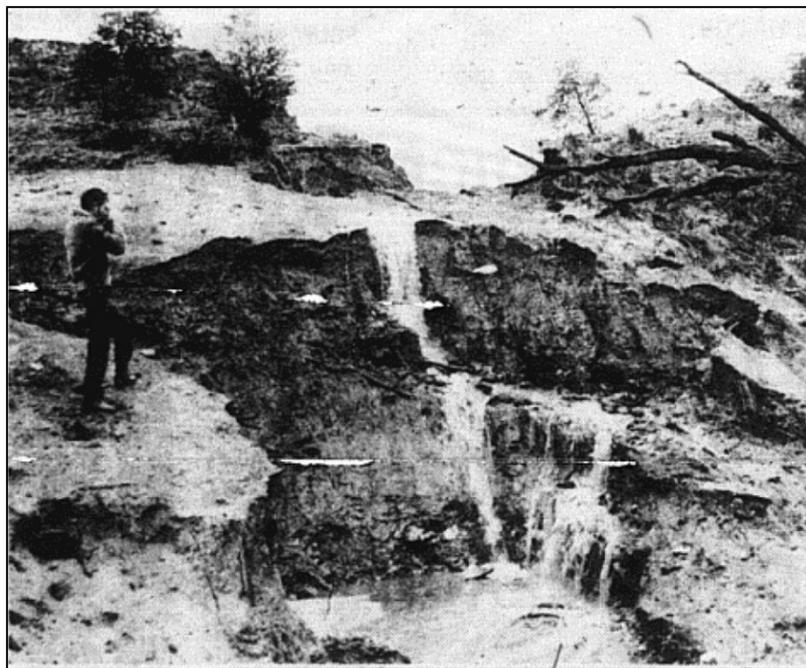
Rainfall had been occurring and the reservoir had risen to about 0.2 feet below the emergency spillway crest which was 1.2 feet below the crest of the dam. The embankment was reported to have been saturated and the failure may have been by a combination of dam crest slumping and internal erosion. A 25-foot wide chunk of the dam “broke out” and the reservoir “dropped 15 feet in minutes”.

**Figure 36. Bear Wallow Dam, photo showing dam breach**  
Source: The Asheville Citizen, February 21, 1976

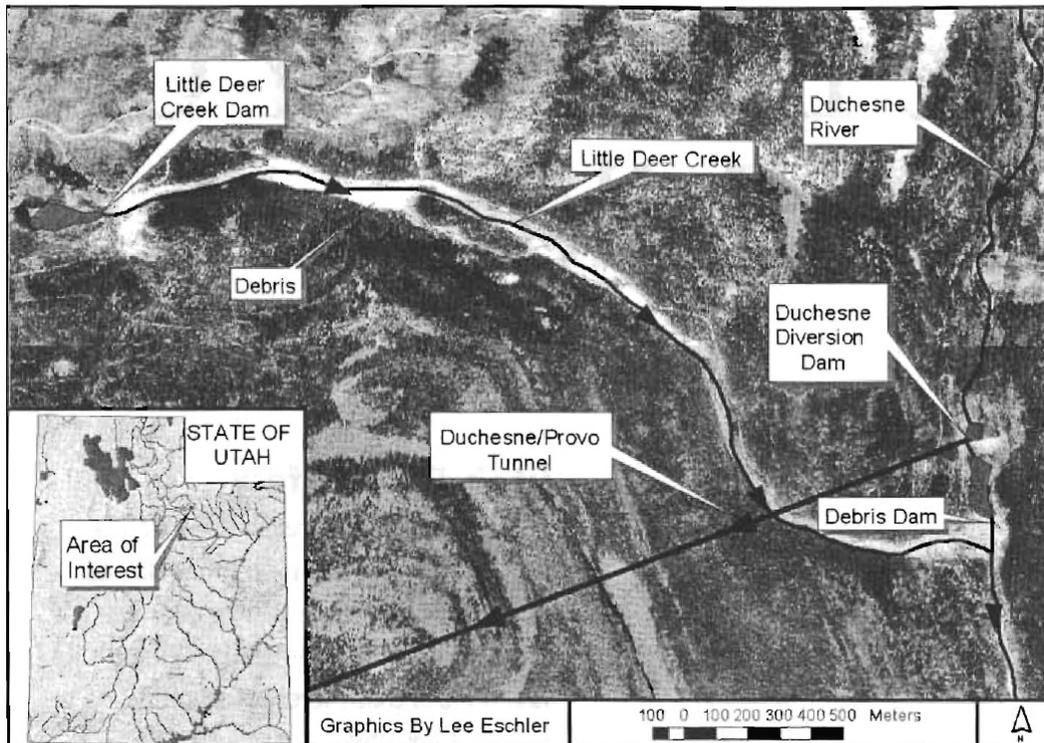
This flood is considered to have been medium severity due to the high breach discharge and the relatively steep, confined downstream channel.

Figure 37. Overview of Downstream Area

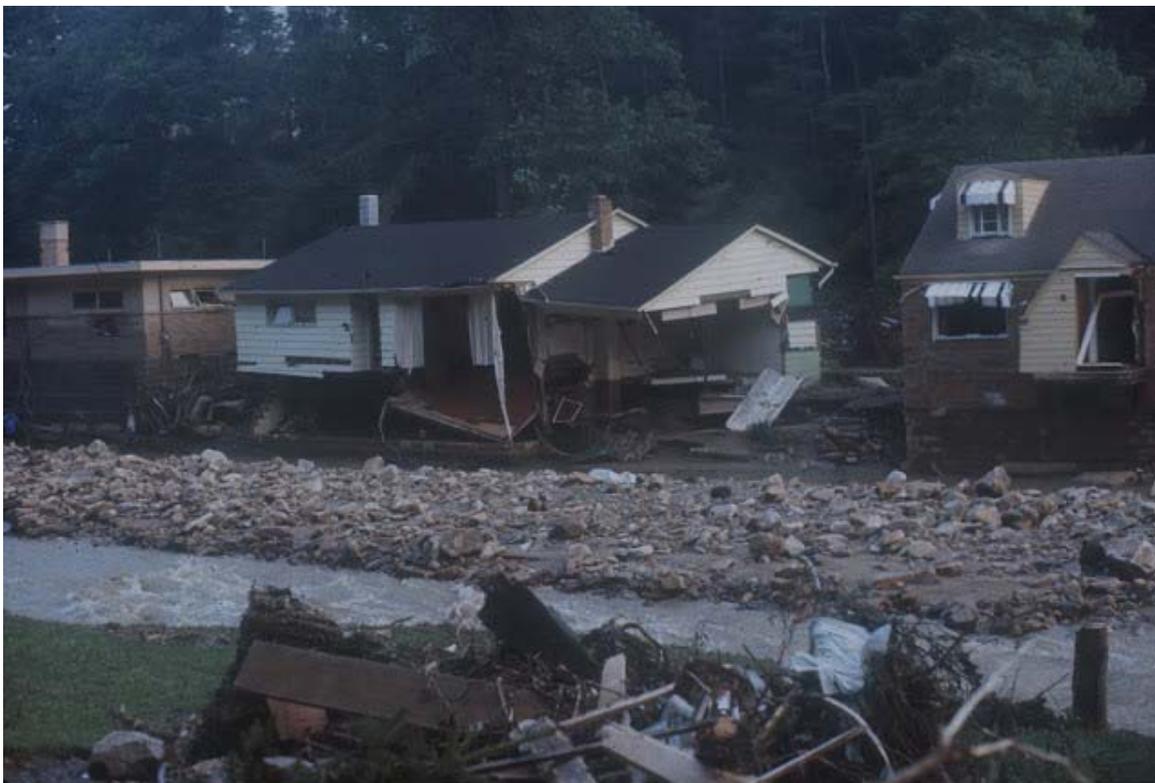
This dam failure flood is considered to have been medium severity due to the fact that buildings were destroyed, but the area was not completely swept clean. Maximum breach discharge was estimated by a hydraulic re-creation to be about 56,000 ft<sup>3</sup>/s, but this flow rapidly attenuated to 37,000 ft<sup>3</sup>/s near the town of Coopersdale and the confluence with the Conemaugh River. Flood velocity along Laurel Run was estimated, but there are no depths available and precise DV values are unknown. Some information is available in a USGS report which cites maximum stage at various locations along Laurel Run, but it is difficult to establish estimates of actual flood depths due to limited ground surface elevation data along the Laurel Run stream.

Figure 41. Flooding aftermath at Tanneryville  
Source: Vintage Johnstown, <http://johnstownhistory.blogspot.com/2012/02/tannerville-1977.html>

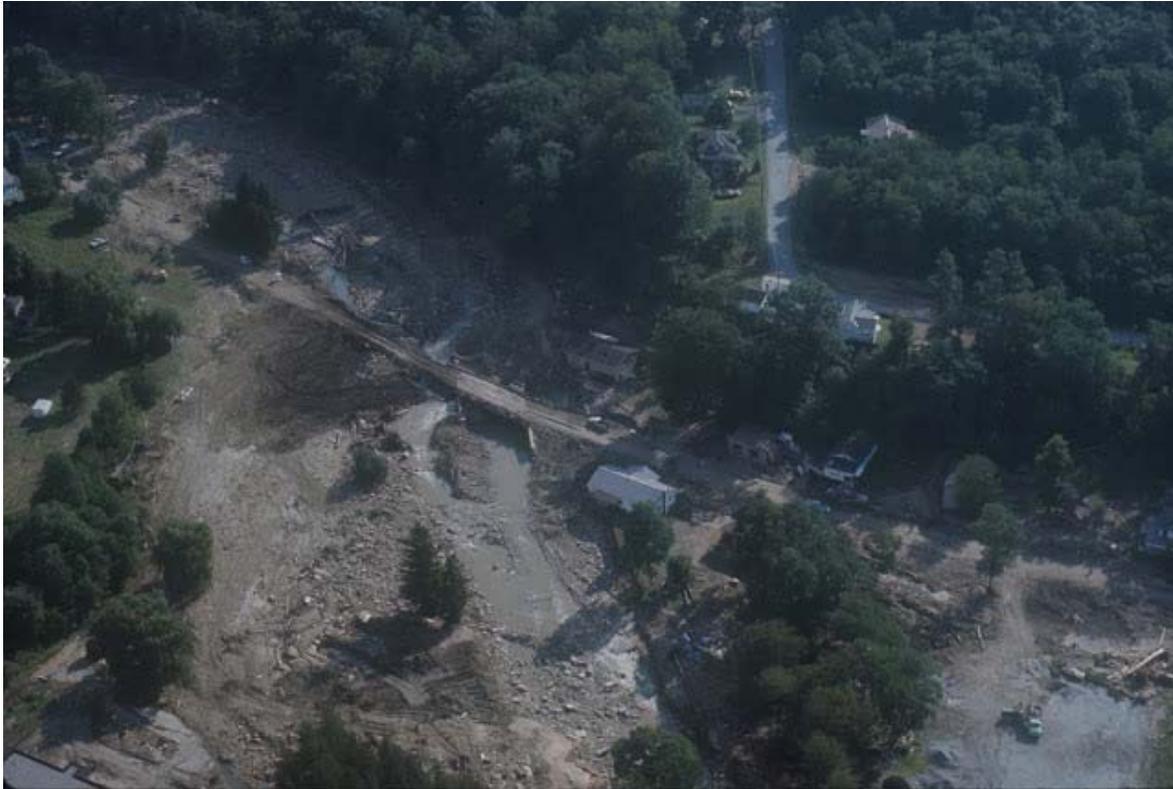
Figure 42. Aerial view of flooding aftermath at Tanneryville

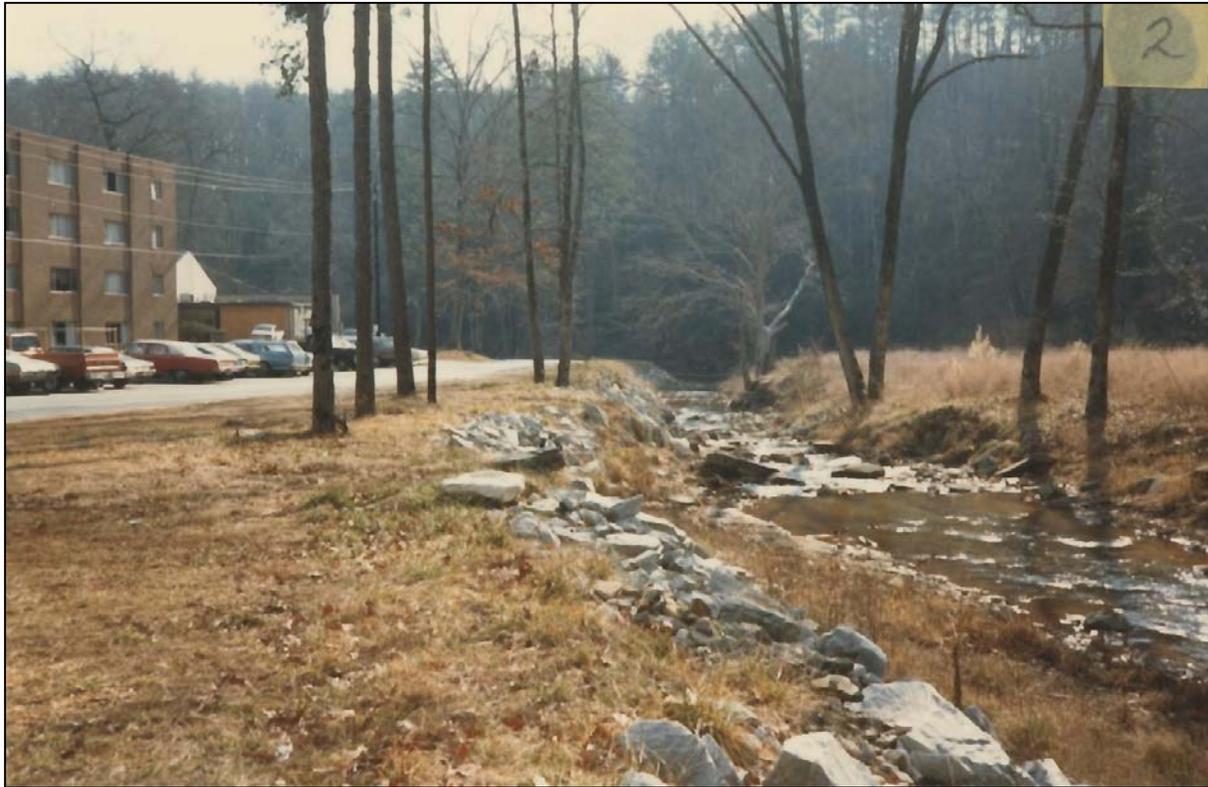
The Forest Hall dormitory building was partially in the flood plain. The flood wave reached a height of about eight feet in the ground floor. Three of the students occupying this floor were drowned; others were able to swim or scramble to safety. The upper floors were not damaged. Forest Hall dormitory was about 0.8 miles below the dam. Flooding width was maybe 200 feet wide (USGS hydrologic investigations). Using the flood width method suggested in DSO-99-06 with maximum discharge equal to 24,000 ft<sup>3</sup>/s, the maximum DV is estimated to be 120 ft<sup>2</sup>/s. This would be considered medium severity flooding.

**Figure 45. Forest Hall Dormitory on left, Toccoa Creek on right**  
Source: Wayne Graham, Bureau of Reclamation

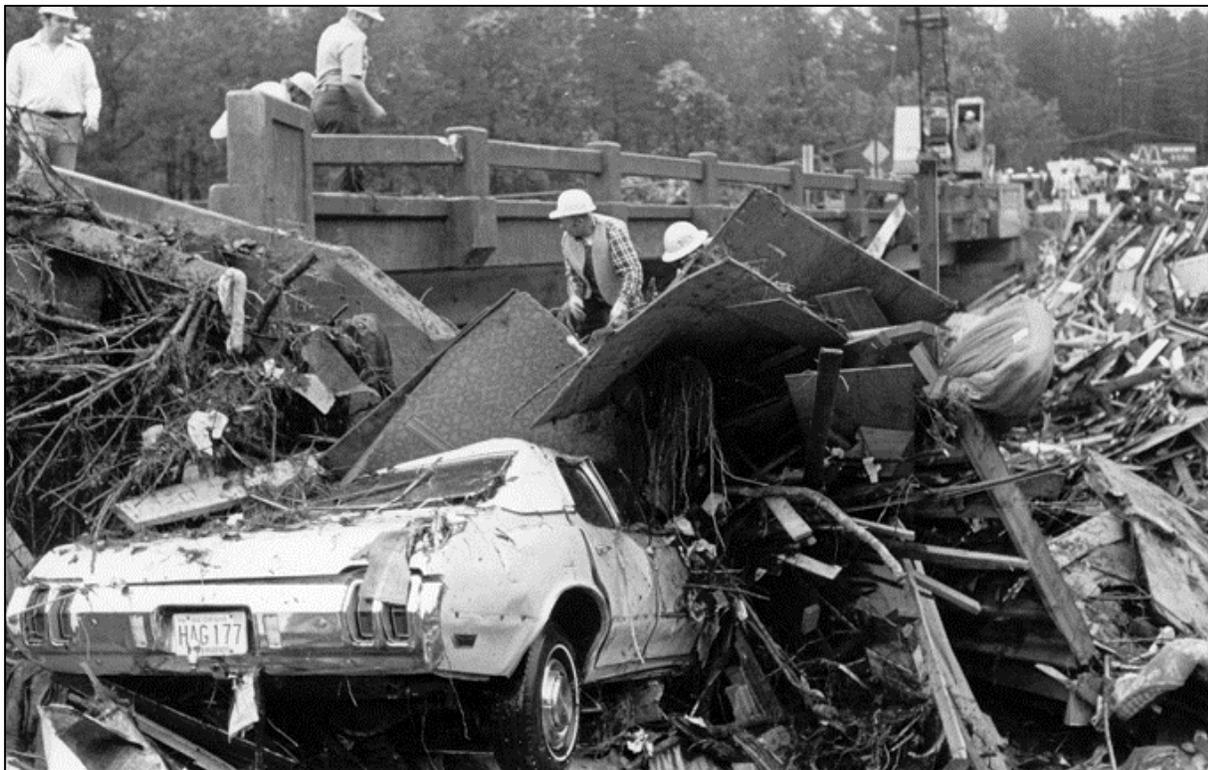
**Figure 46. Flooding debris at bridge, downstream of Kelly Barnes Dam**  
Source: *Dam Break in Georgia* by K. Neil Foster

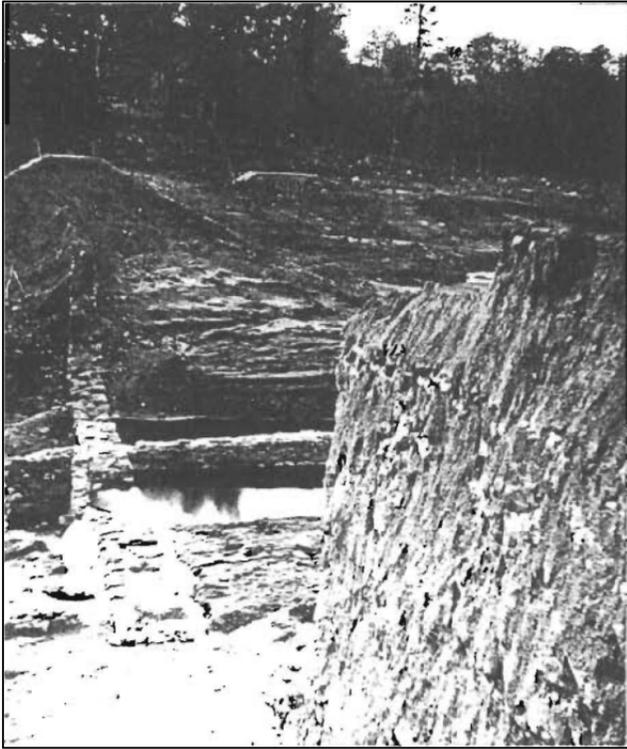
**Figure 47. Remains of Mill River Dam**  
Source: Knowlton Brothers Photographers, Northampton, MA
