## **RCEM – Reclamation Consequence Estimating Methodology**

### **Dam Failure and Flood Event Case History Compilation**

**U.S. Department of the Interior  
Bureau of Reclamation**

**June 2015**

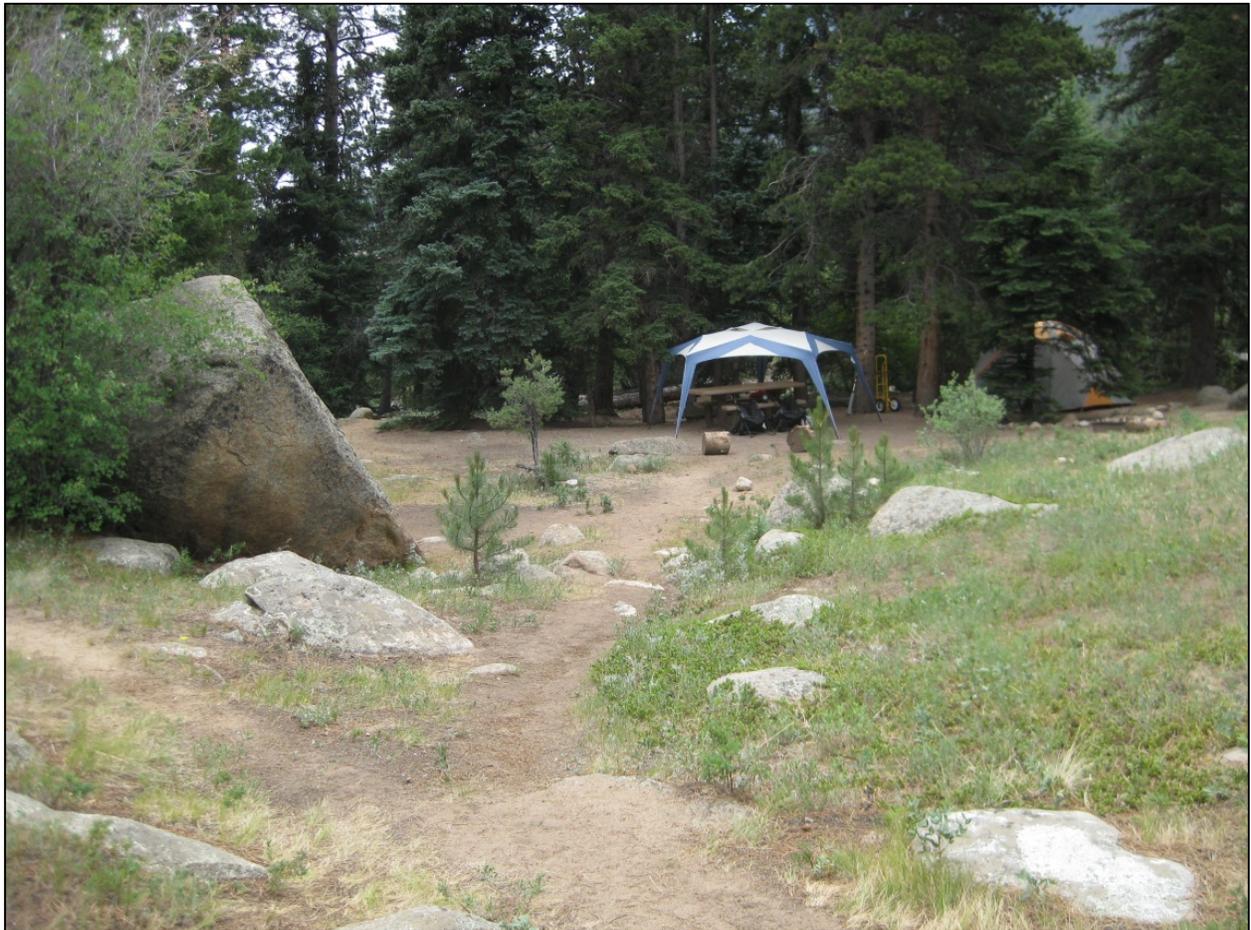
**Figure 50. Aspenglen Campground site near where two fatalities occurred.  
Source: Bruce Feinberg, Bureau of Reclamation, taken July 2012**

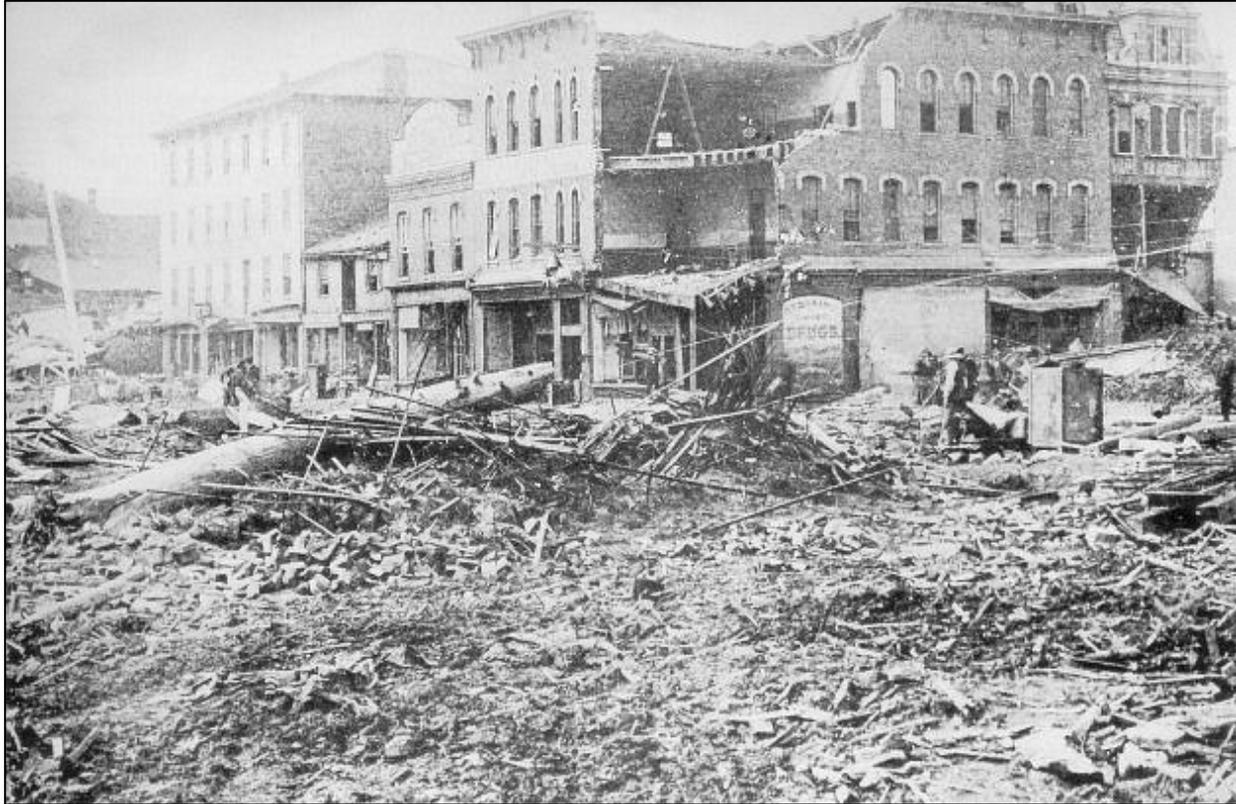
At 5.2 miles downstream from South Fork Dam, the Conemaugh Viaduct, a 78 foot high railroad bridge ([www.wikipedia.org](http://www.wikipedia.org)), became clogged with debris. Flood water built up behind the viaduct and its collapse created an intensified, secondary surge of flooding.

**Figure 53. Aftermath of the South Fork Dam failure flood**  
Source: *A Photographic Story of the 1889 Johnstown Flood* by Harold H. Strayer and Irving L. London,  
<http://www.swartzentover.com/cotor/e-books/misc/JTF/6as.jpg>

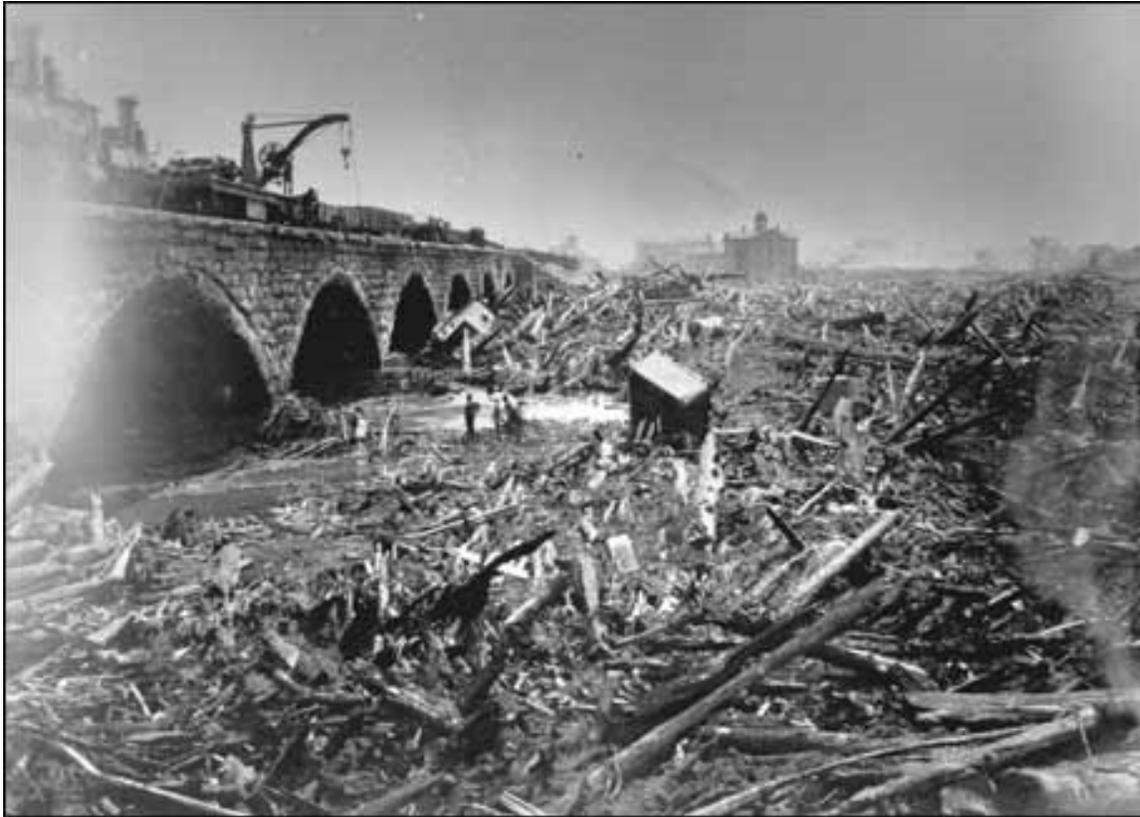
Figure 55. Debris piled up at the “Stone Bridge”  
Source: National Park Service

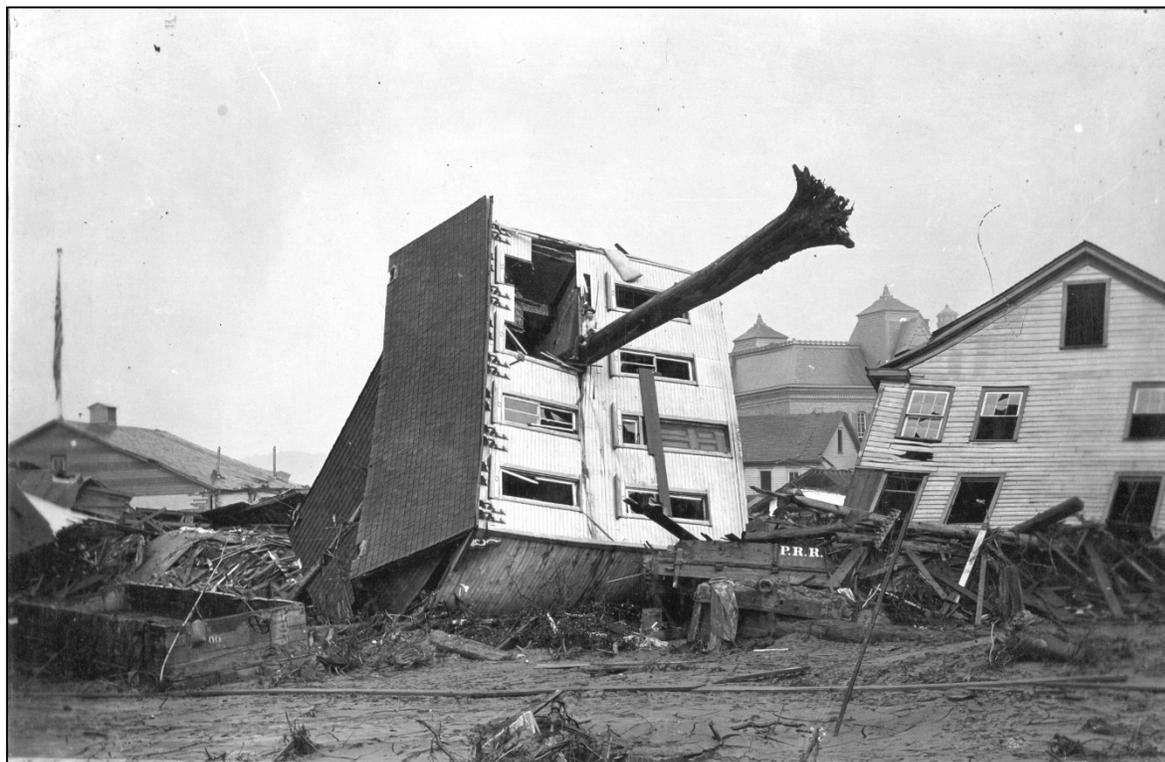
Figure 56. Destroyed houses and the flooding aftermath  
Source: Copyright © 2012 Commonwealth of Pennsylvania, Pennsylvania Historical and Museum Commission  
<http://www.phmc.state.pa.us/bah/dam/rg/di/LindaRiesPhotoGuide/PhotographGuideArchives.htm>

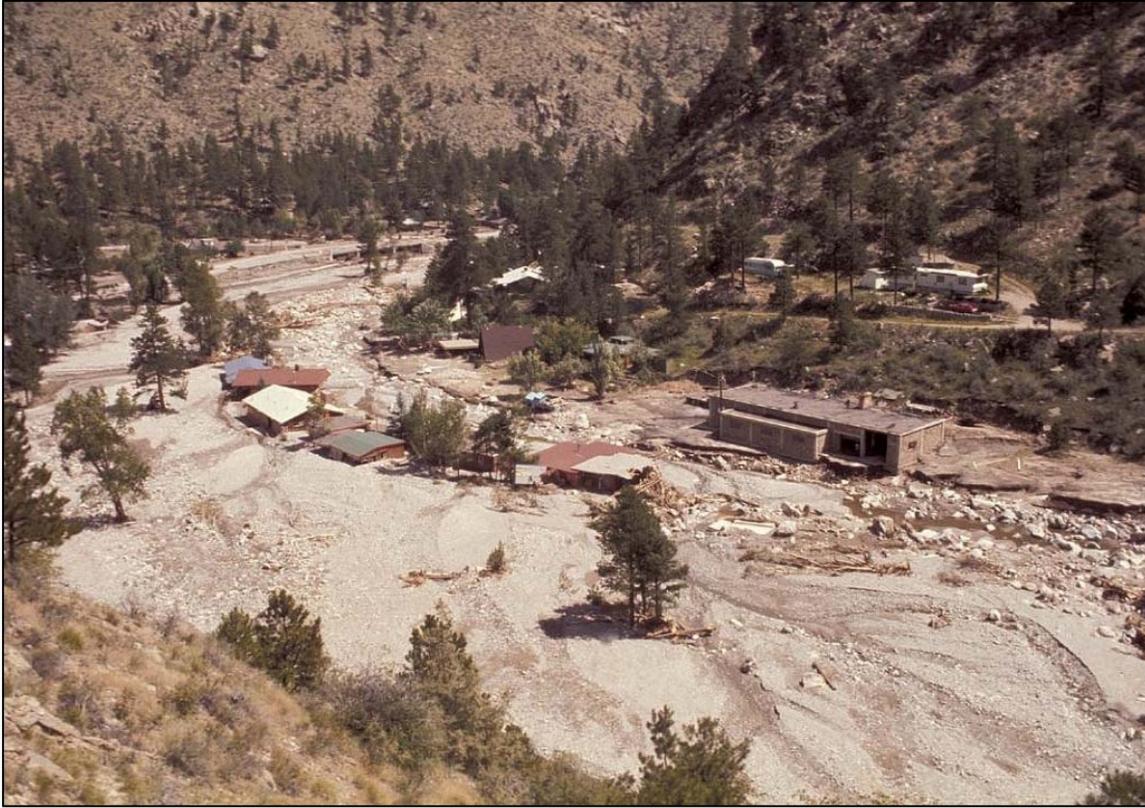
Figure 57. Flooded homes in the Big Thompson Canyon

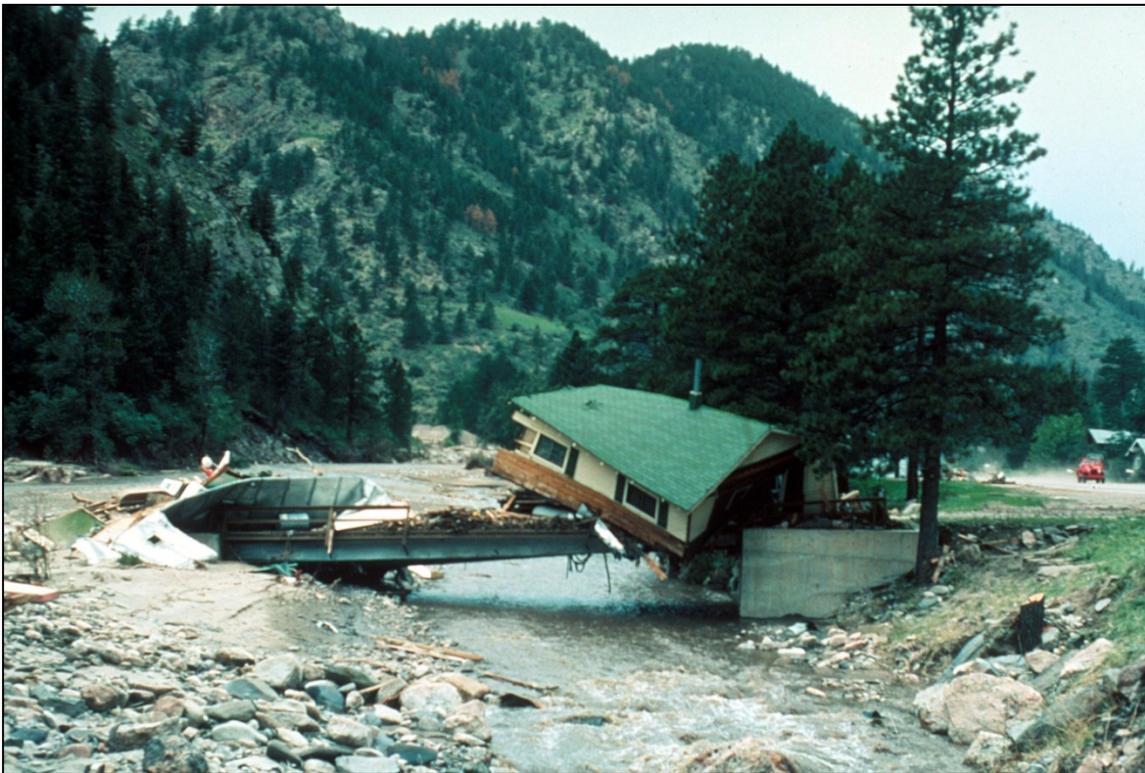
Figure 58. Destroyed house and mobile home remains at private bridge crossing in the Big Thompson Canyon  
Source: U.S. Geological Survey, <https://www.sciencebase.gov/catalog/item/51dc1c75e4b0f81004b7839e>

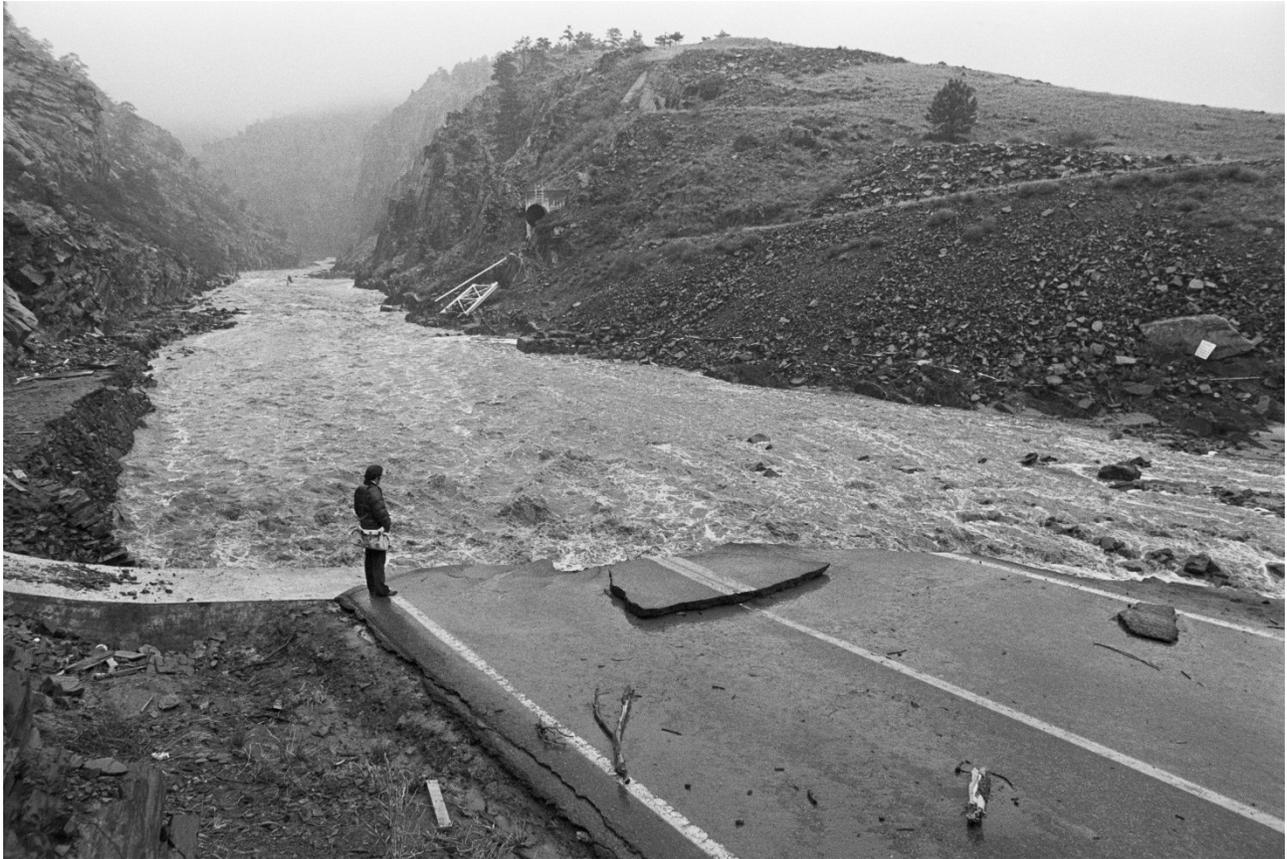
U.S. Highway 34, a two-lane paved road which runs through the canyon, was completely washed out along multiple reaches of the flood areas.

**Figure 59. Destroyed portion of Highway 34 in the Big Thompson Canyon**  
Source: Licensed by Corbis Images

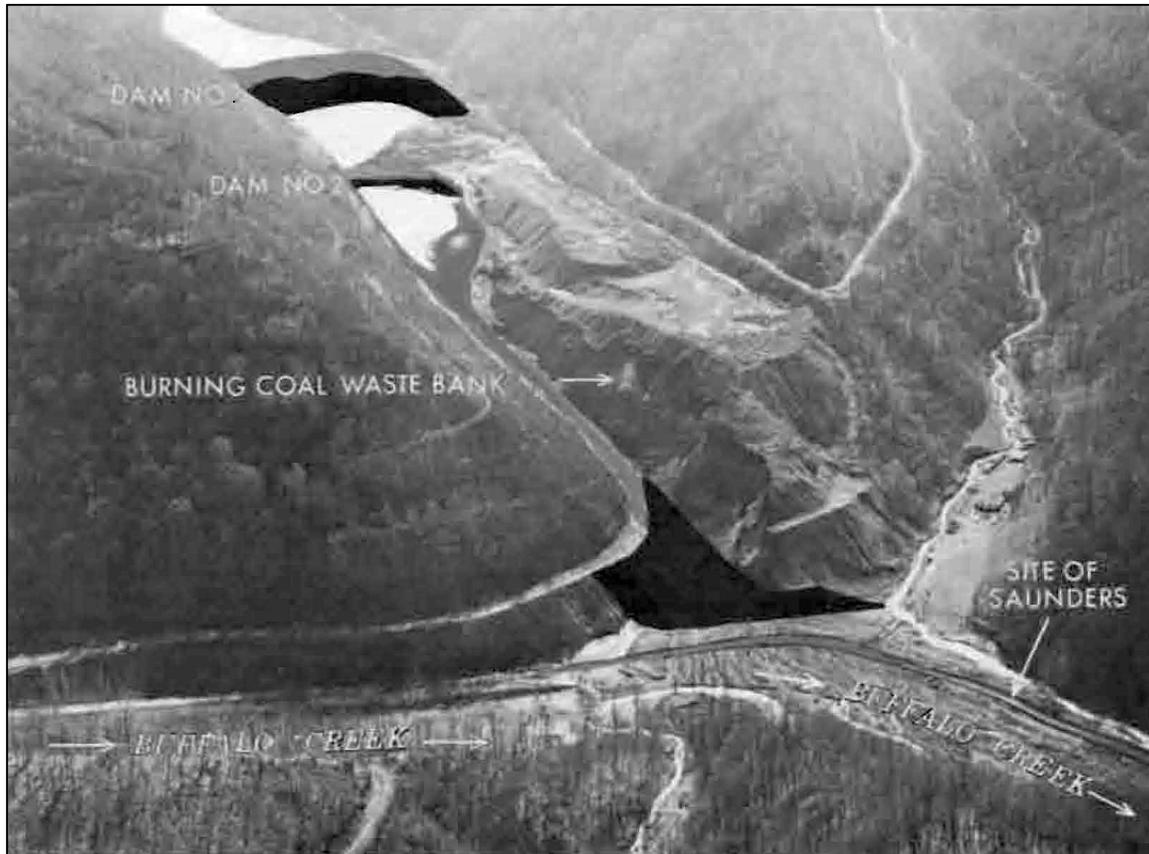
Figure 61. Reconstructed view of the damsite.  
Source: U.S. Geological Survey, Circular 667

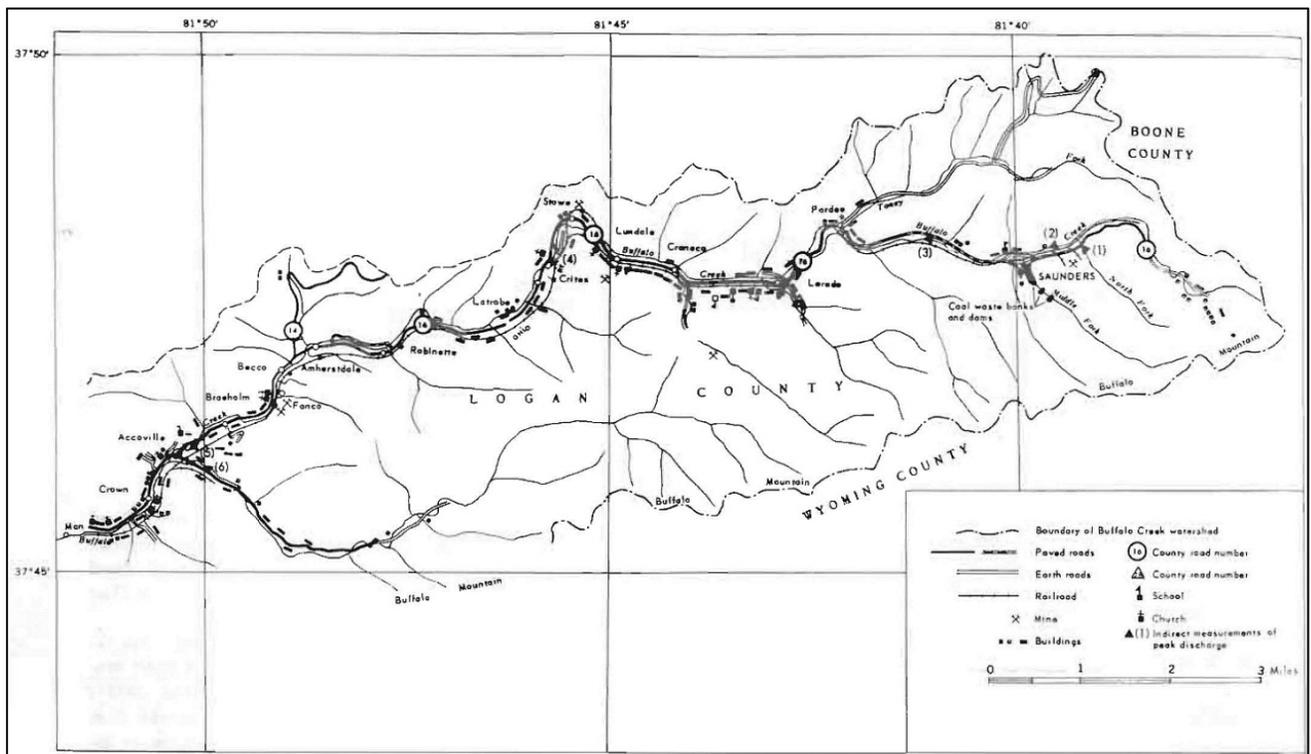
Figure 62. Overview of affected area  
Source: U.S. Geological Survey, Circular 667

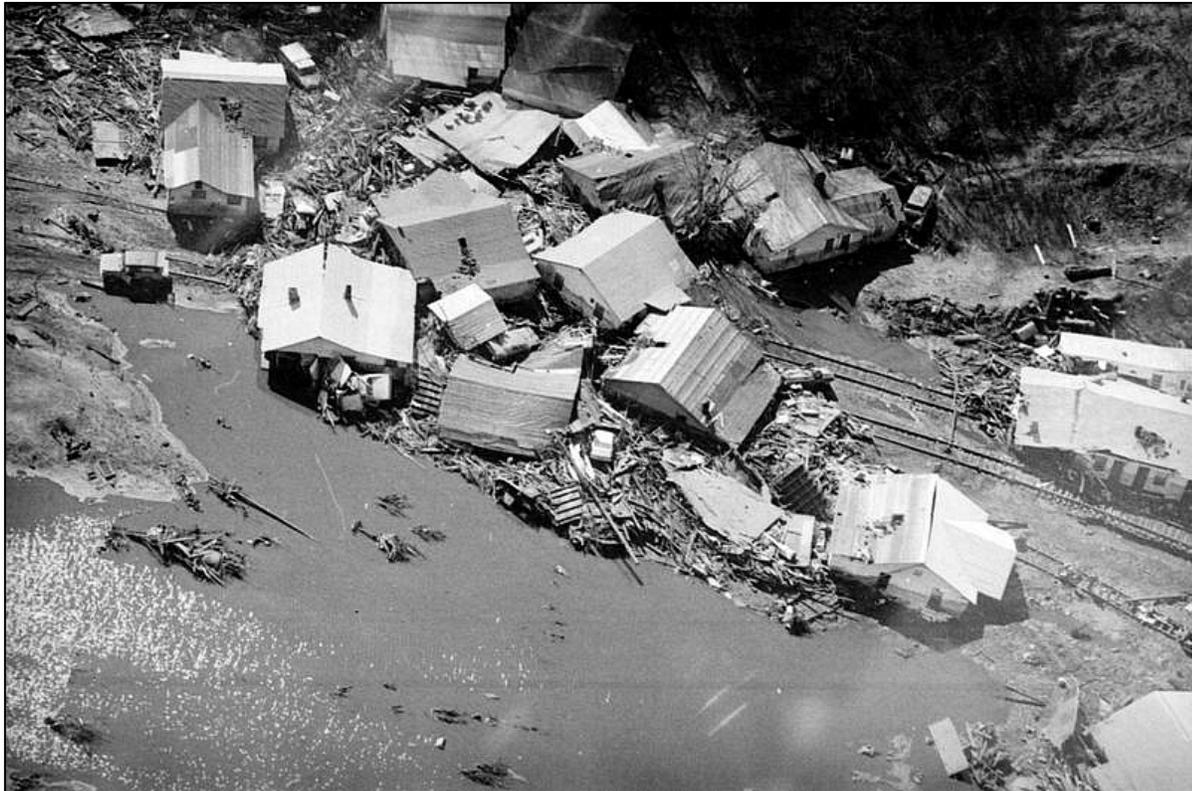
Figure 63. Aftermath of the Buffalo Creek Dam failure flood

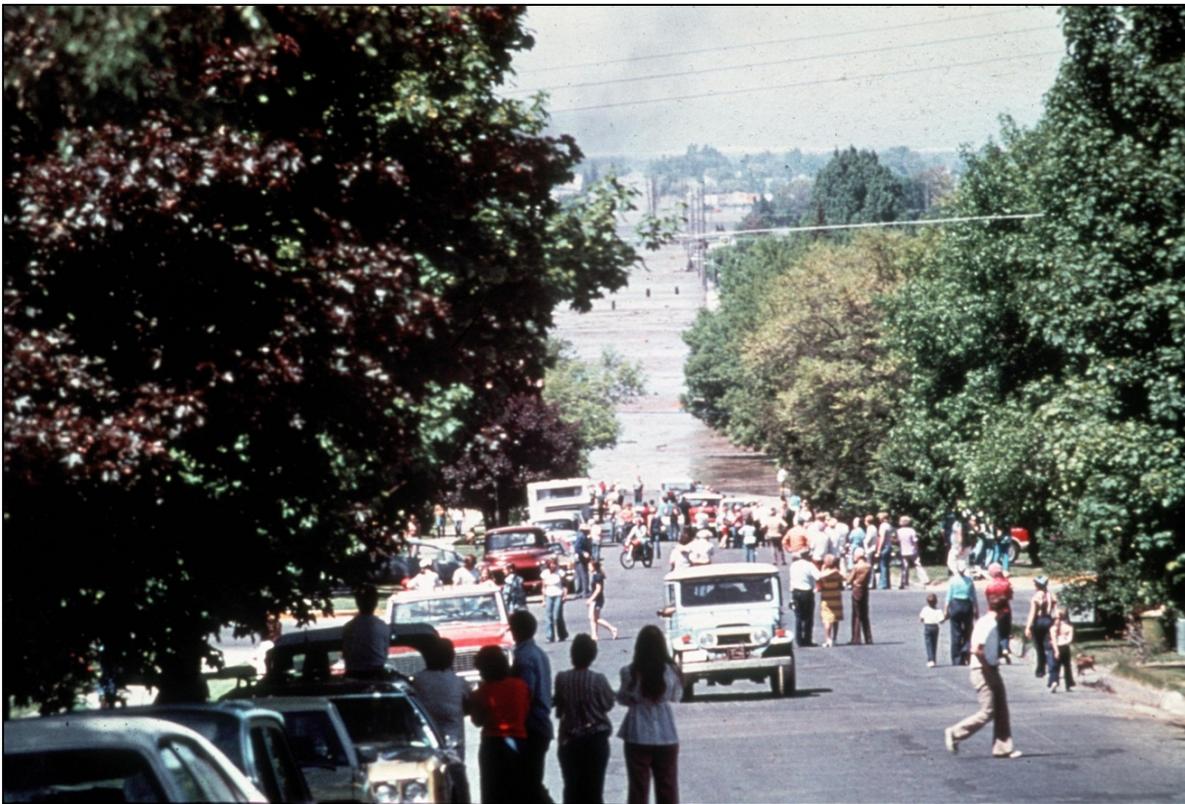
Figure 65. Flooding and evacuation at Rexburg, Idaho  
Source: ID-L-0022, WaterArchives.org

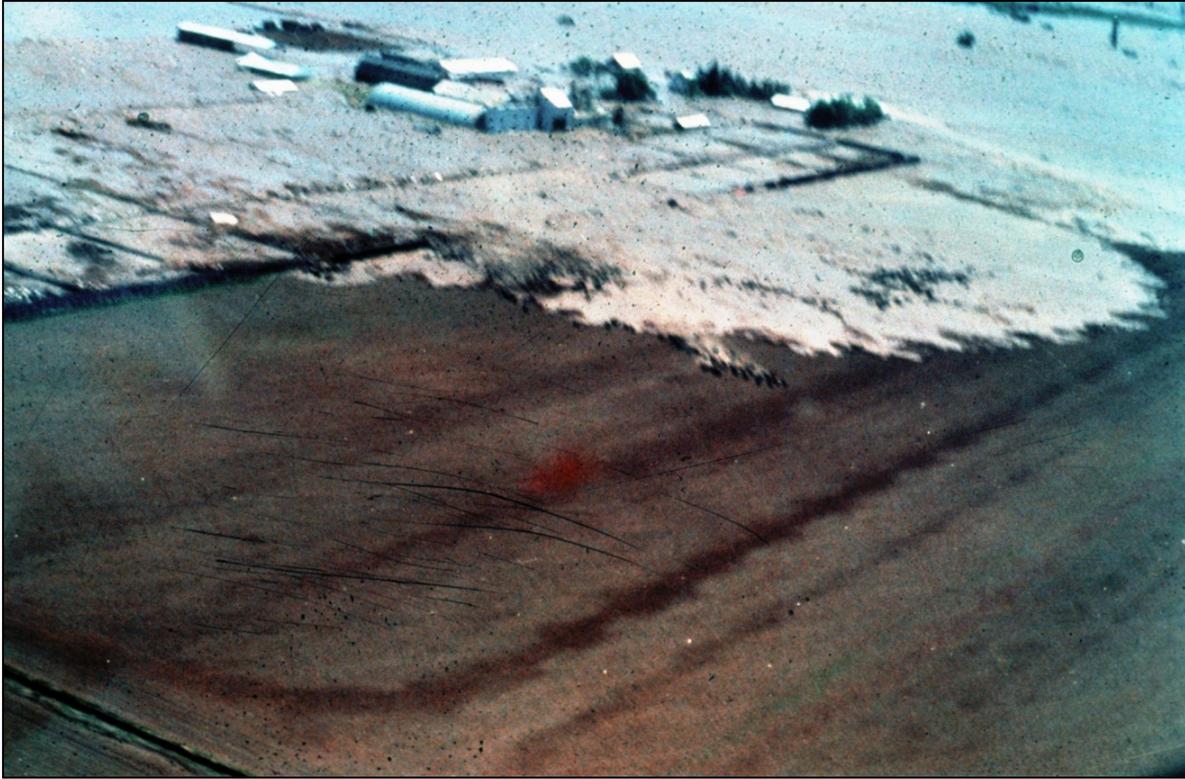
**Figure 66. Flood wave propagation across farmland in Wilford**  
Source: ID-L-0020, WaterArchives.org

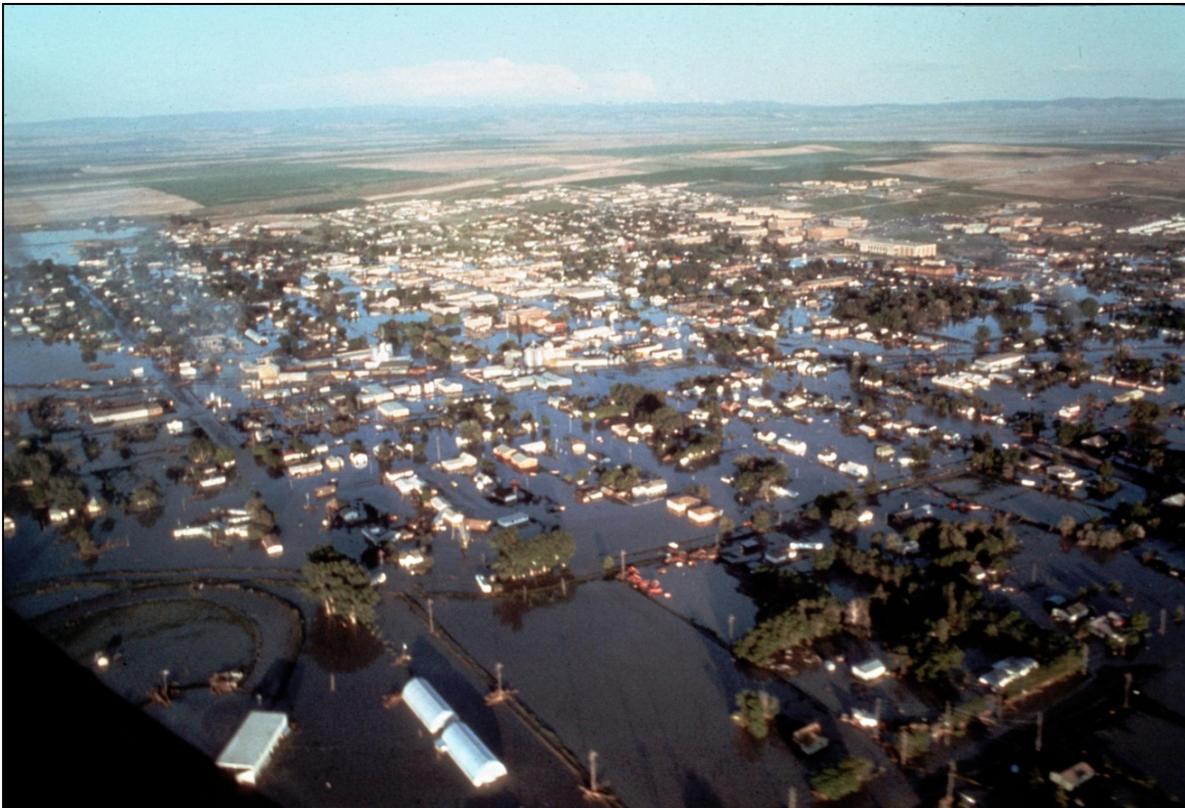
**Figure 67. Flooding aftermath at Rexburg**  
Source: ID-L-0043, WaterArchives.org

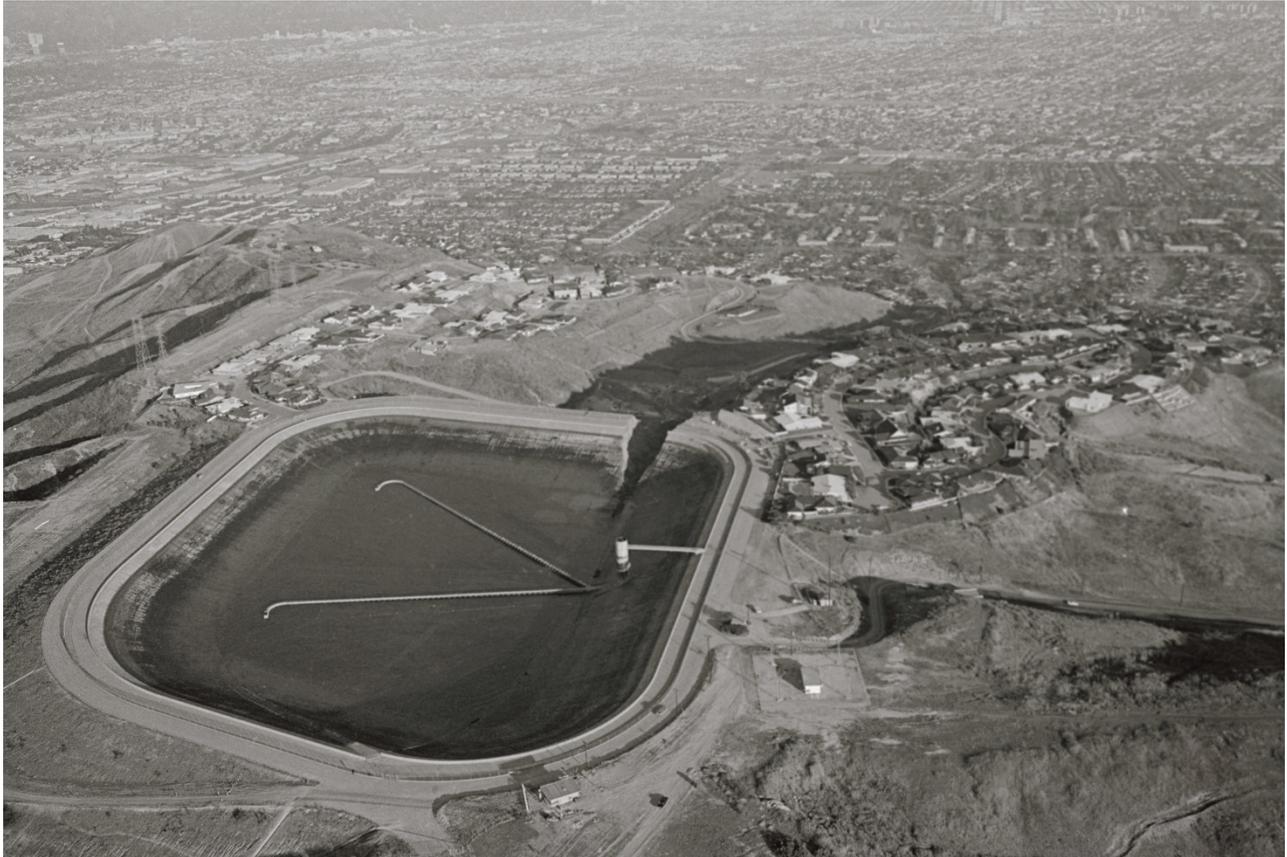
Baldwin Hills Dam was an embankment structure which consisted of the main dam and three interconnected dikes, which formed a “ring” that enclosed the reservoir. The dam, situated on a hilltop in Los Angeles, California, stored municipal water. Baldwin Hills Dam had a 65.5 foot structural height with a crest length of 650 feet. Failure occurred on Saturday December 14, 1963 due to subsidence, leading to internal erosion and piping. Baldwin Hills Dam was twelve years old at the time of its failure.

**Figure 68. Baldwin Hills Dam**  
Source: Photo licensed by Corbis Images

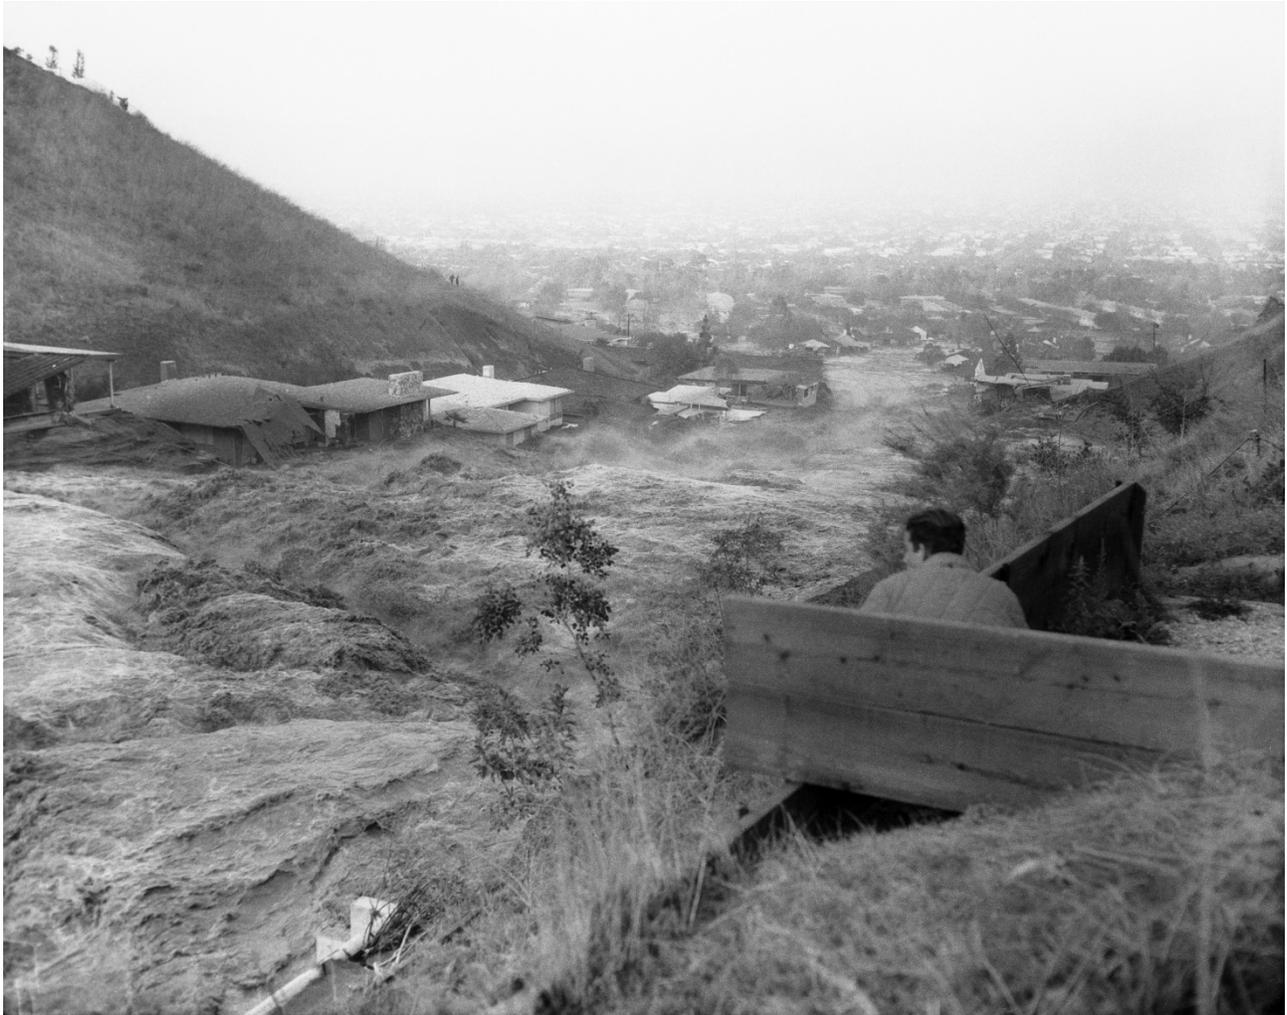
**Figure 69. Flooding directly below dam, upstream of Sanchez Drive, no fatalities in this area**  
Source: Photo licensed by Corbis Images

In general, this flood was considered to have been medium severity. Damage in the Village Green area was extensive, but many structures remained standing after the flood. The narrow flood channel immediately downstream of the dam may have experienced high severity flooding, although no fatalities occurred in this area.

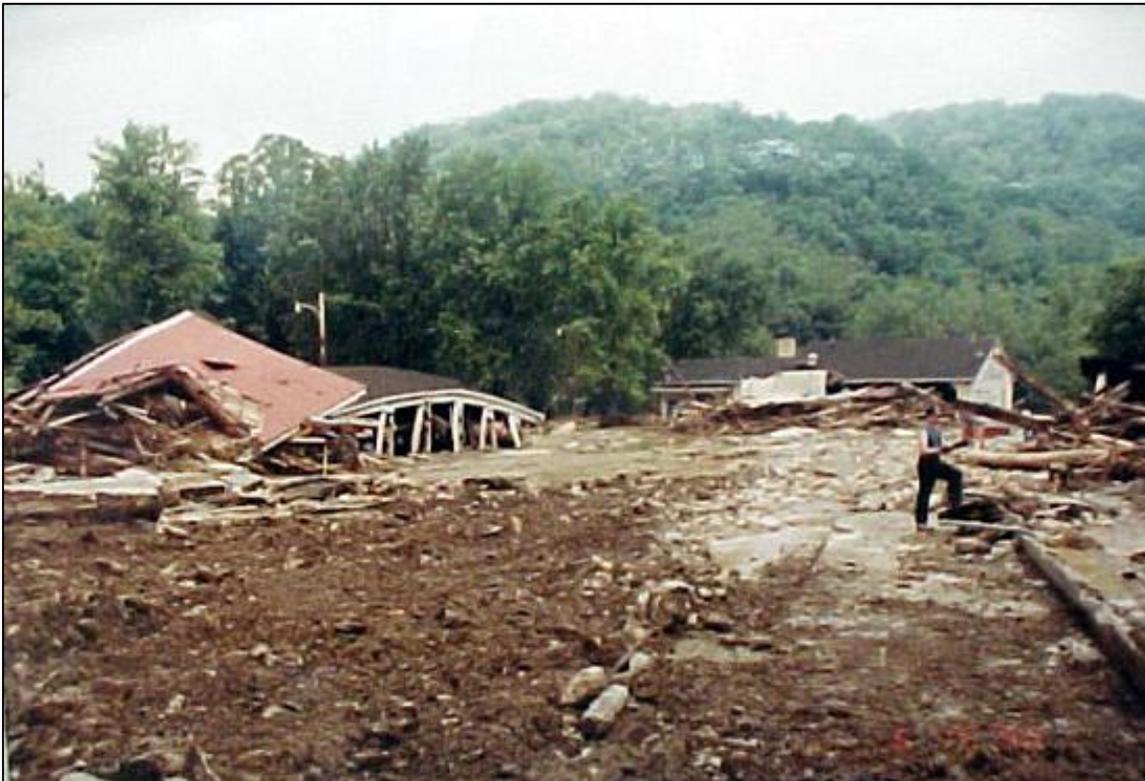
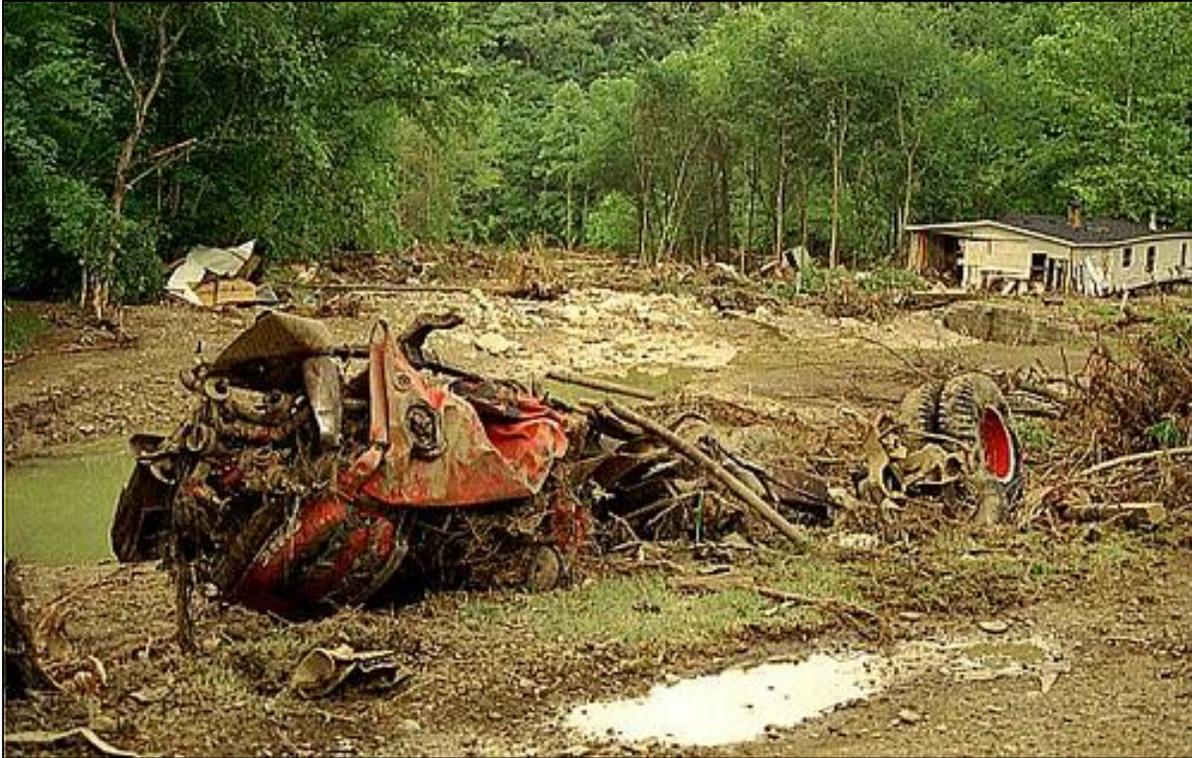
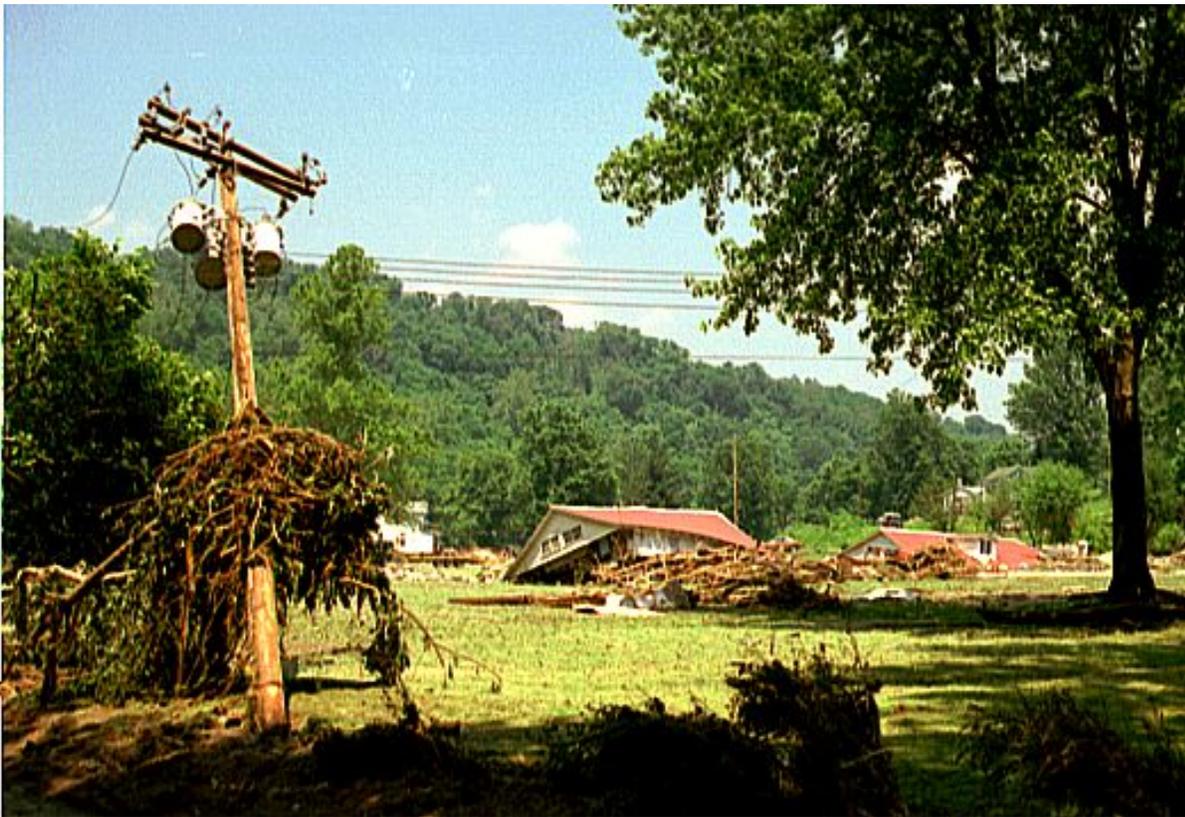
**Figure 70. Damage from the Shadyside flash flood**  
Source: Photo courtesy of the Belmont County Emergency Management Office

**Figure 71. Flooding aftermath, Shadyside flash flood**  
Source: NOAA National Severe Storms Laboratory/photo by M. Wyatt

**Figure 72. Destroyed homes, Shadyside Flash Flood**  
Source: Photo courtesy of the Belmont County Emergency Management Office

This flood is considered to have been medium severity. Flood damage was extensive, but the affected areas were not swept clean. The remains of destroyed and damaged structures were present in the flooded areas.

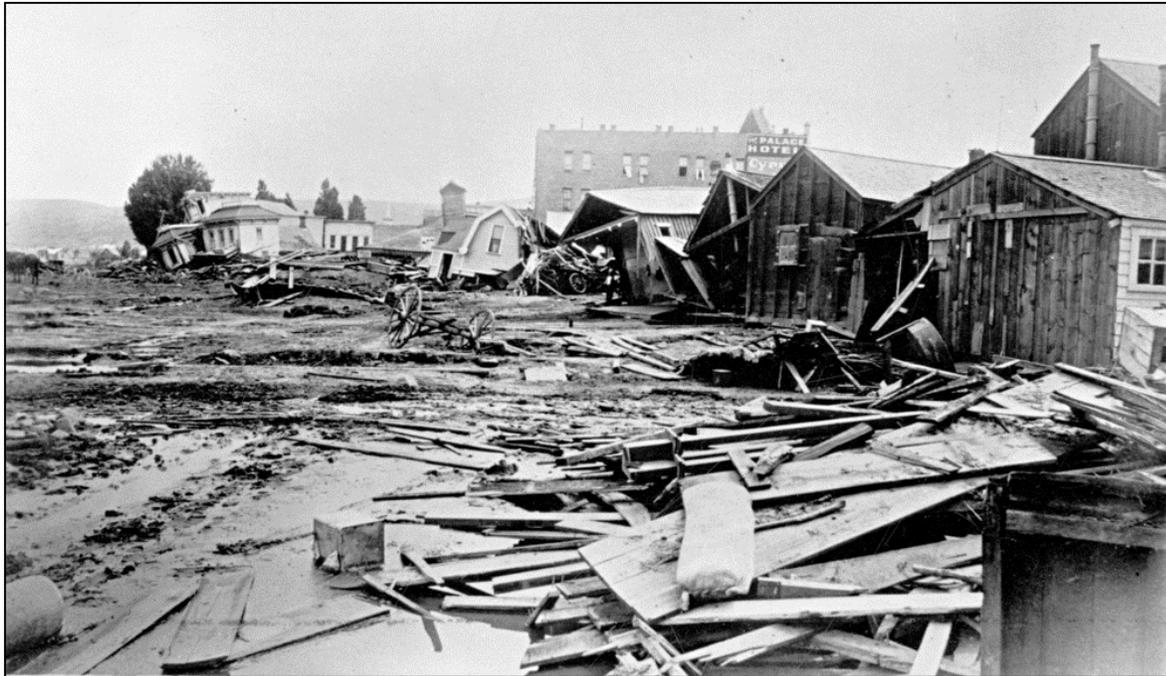
Figure 74. Aftermath of flooding at Heppner  
Source: Oregon Historical Society, #ba010628

DSO-99-06 considered this flood to have been medium severity. Building damage was extensive, but the area was not swept clean. Flood depths reportedly exceeded 10 feet at Heppner.

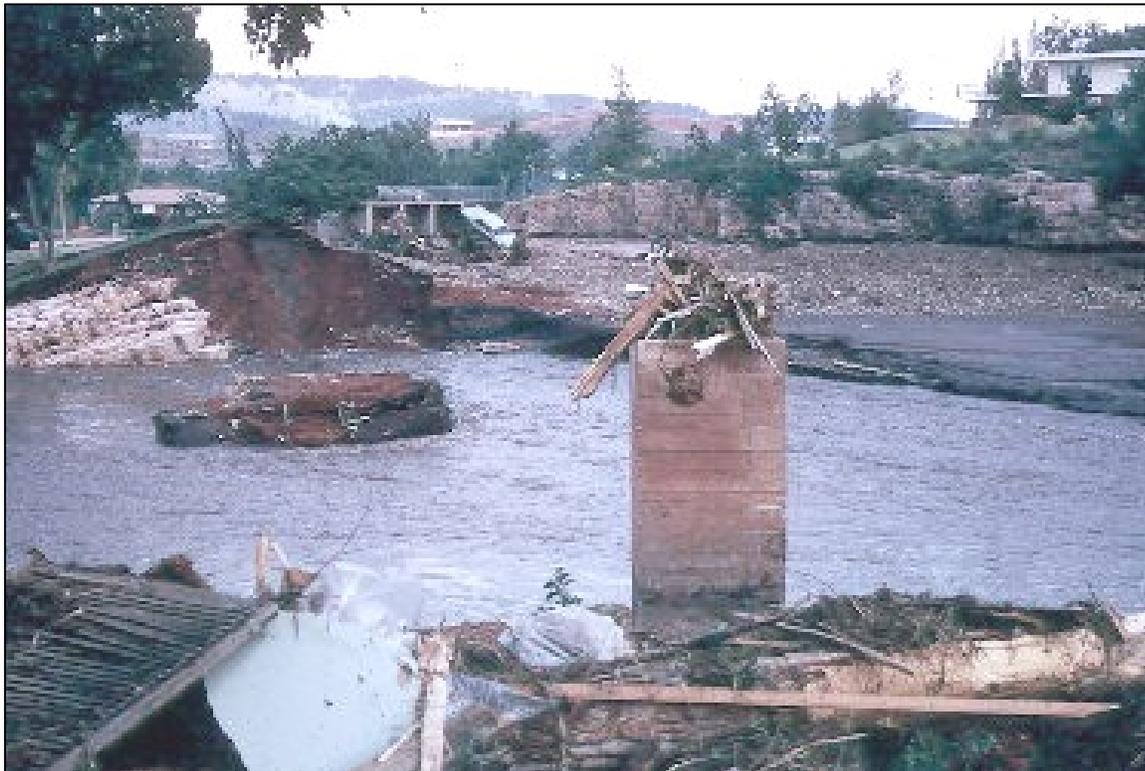
Canyon Lake Dam was an earthfill embankment that was 30 feet high and held a volume of 192 acre-feet at the spillway crest. Spillway capacity was 3,200 ft<sup>3</sup>/s. The dam failed when overtopping reached roughly three to four feet. The total volume released during the breach event is estimated to have been between 650 to 750 acre-feet. The peak discharge from the dam breach has been estimated at 60,000 ft<sup>3</sup>/s.

Figure 75. Remains of Canyon Lake Dam  
Source: U.S. Geological Survey, USGS Fact Sheet FS-037-02

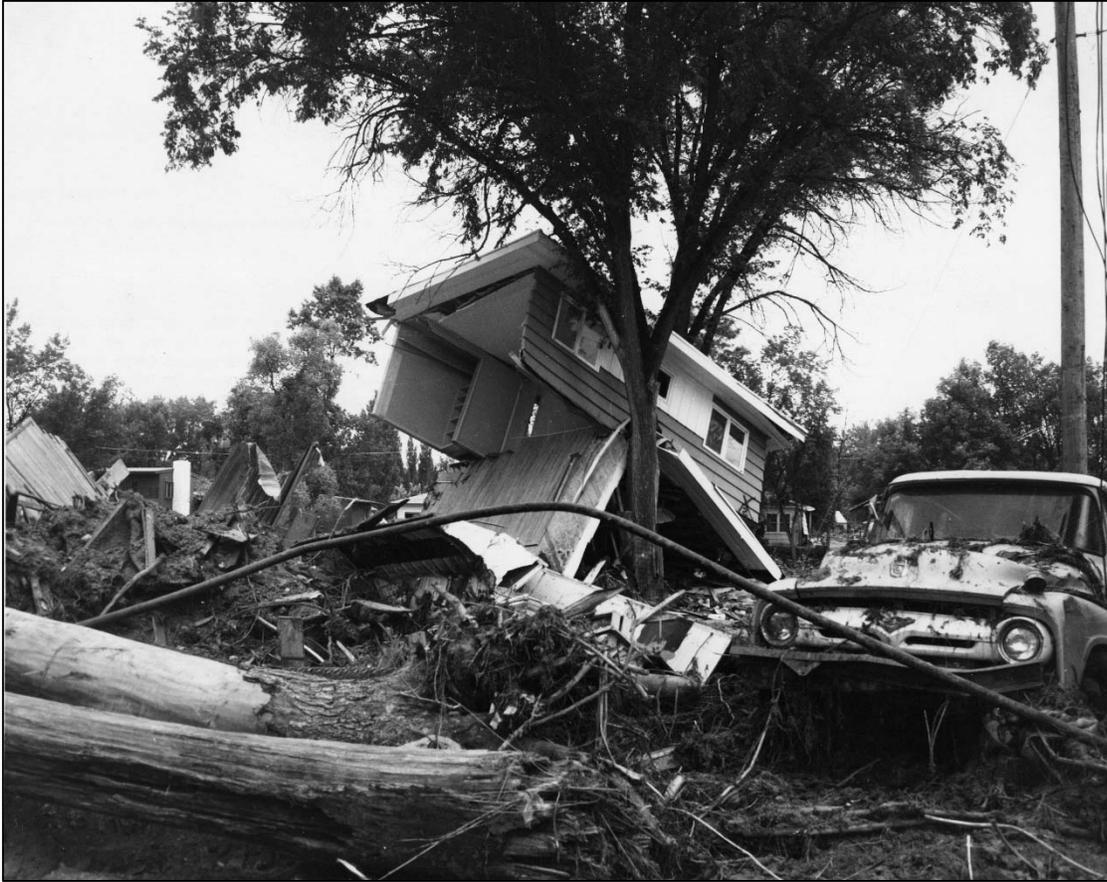
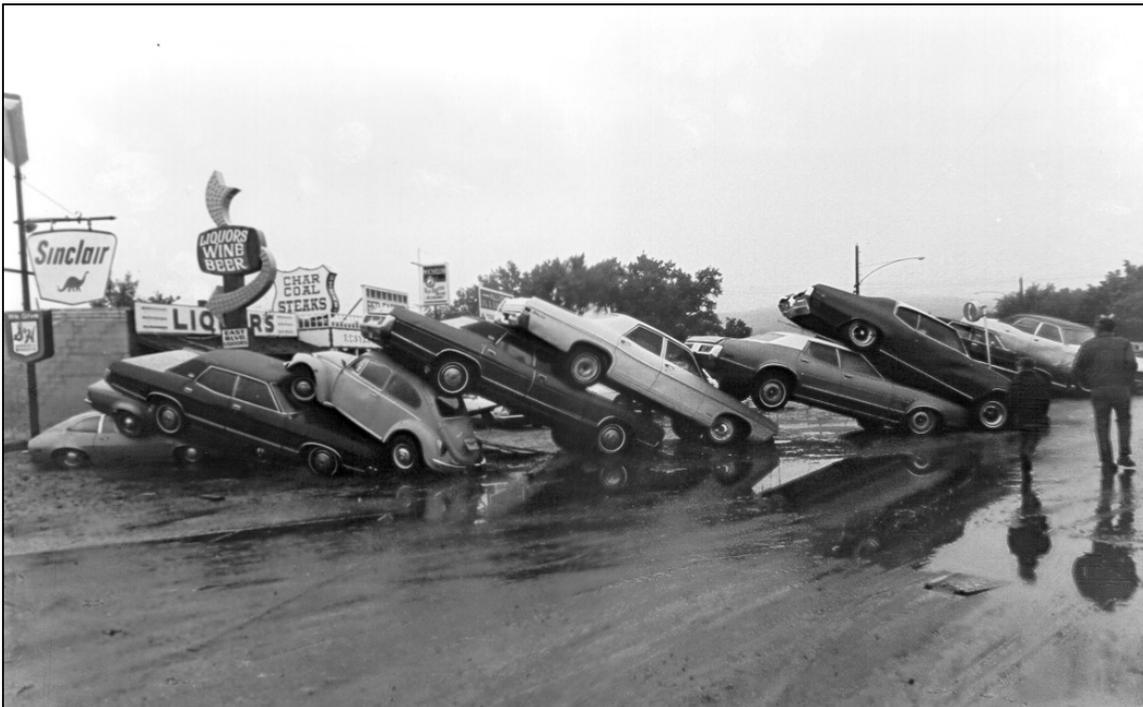
Figure 76. Aftermath of flooding, Rapid City, South Dakota  
Source: Photo courtesy of the U.S. Department of Agriculture

Figure 77. Flooding aftermath, Rapid City, South Dakota  
Source: NOAA National Weather Service, [http://www.crh.noaa.gov/images/unr/1972/frontier\\_motors.jpg](http://www.crh.noaa.gov/images/unr/1972/frontier_motors.jpg)

This flood was considered to have been medium severity. Analysis of the flood indicates that the DV was greater than 50 ft<sup>2</sup>/s. Structures were destroyed and damaged, but the flooded area was not swept clean.
