## **RCEM – Reclamation Consequence Estimating Methodology**

### **Dam Failure and Flood Event Case History Compilation**

**U.S. Department of the Interior  
Bureau of Reclamation**

**June 2015**

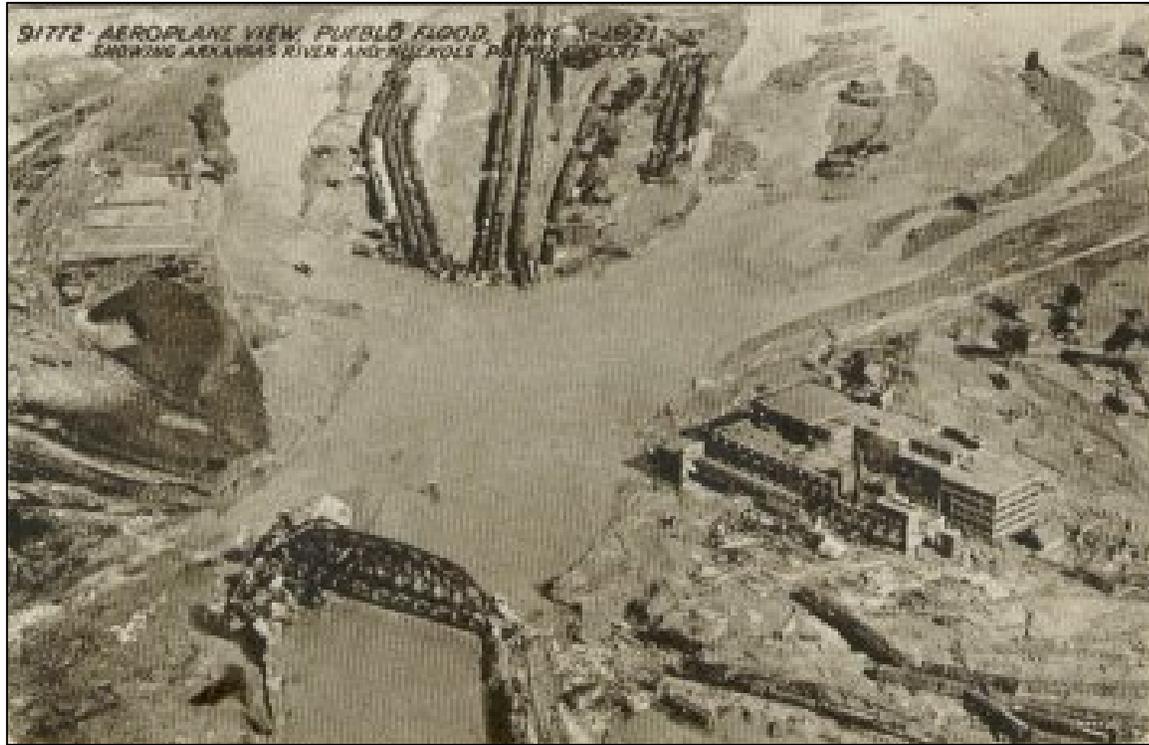
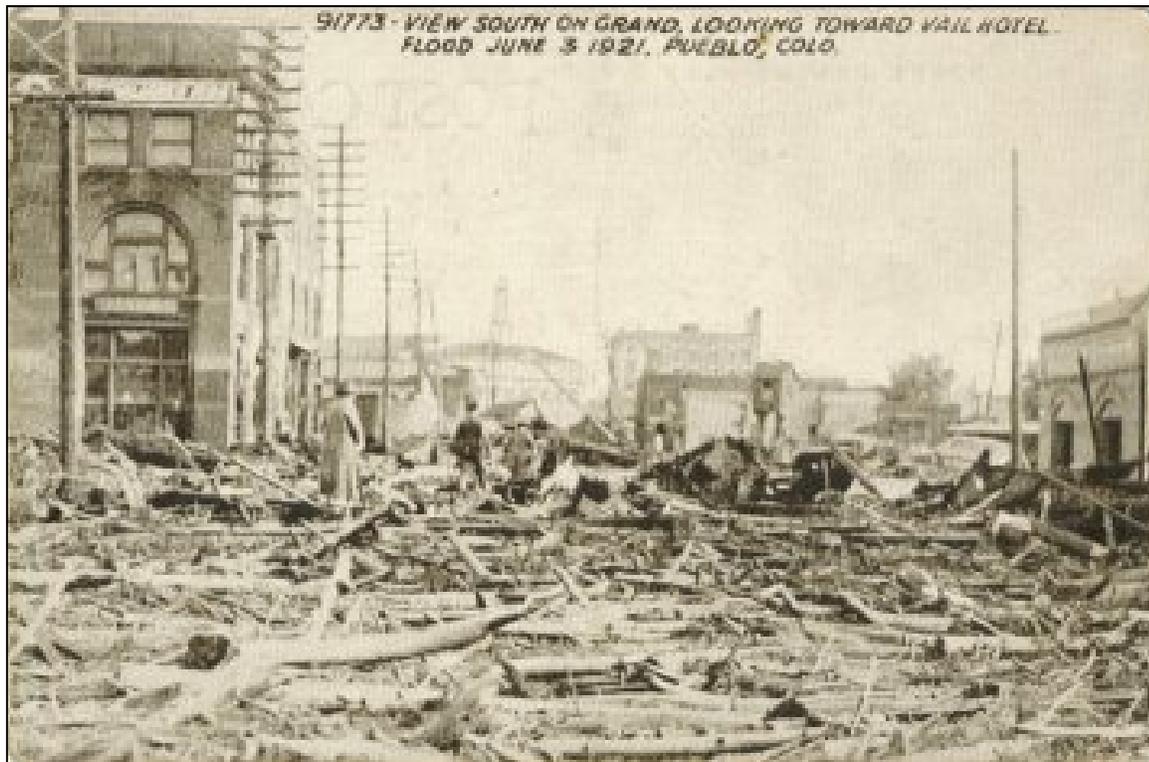
Figure 78. Aftermath of the 1921 Arkansas River Flood

Figure 79. Flooding at Pueblo, Colorado, 1921

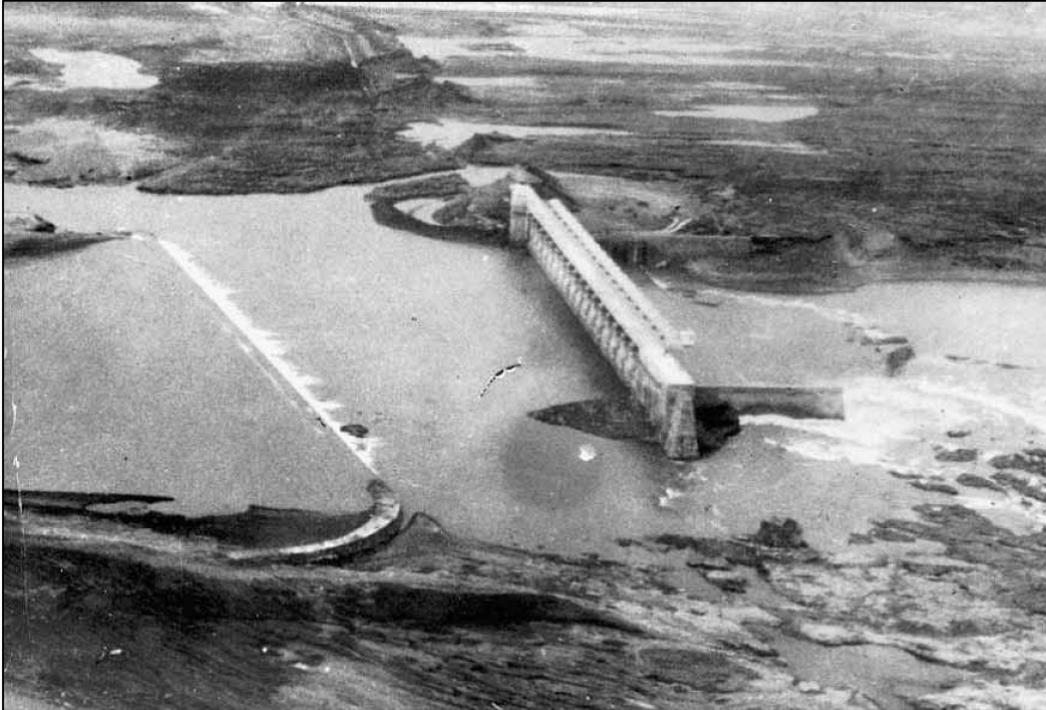
**Figure 82. Remains of the failed Machhu II Dam**

The Machhu II Dam has been rebuilt, with increased spillway capacity and is in operation today.

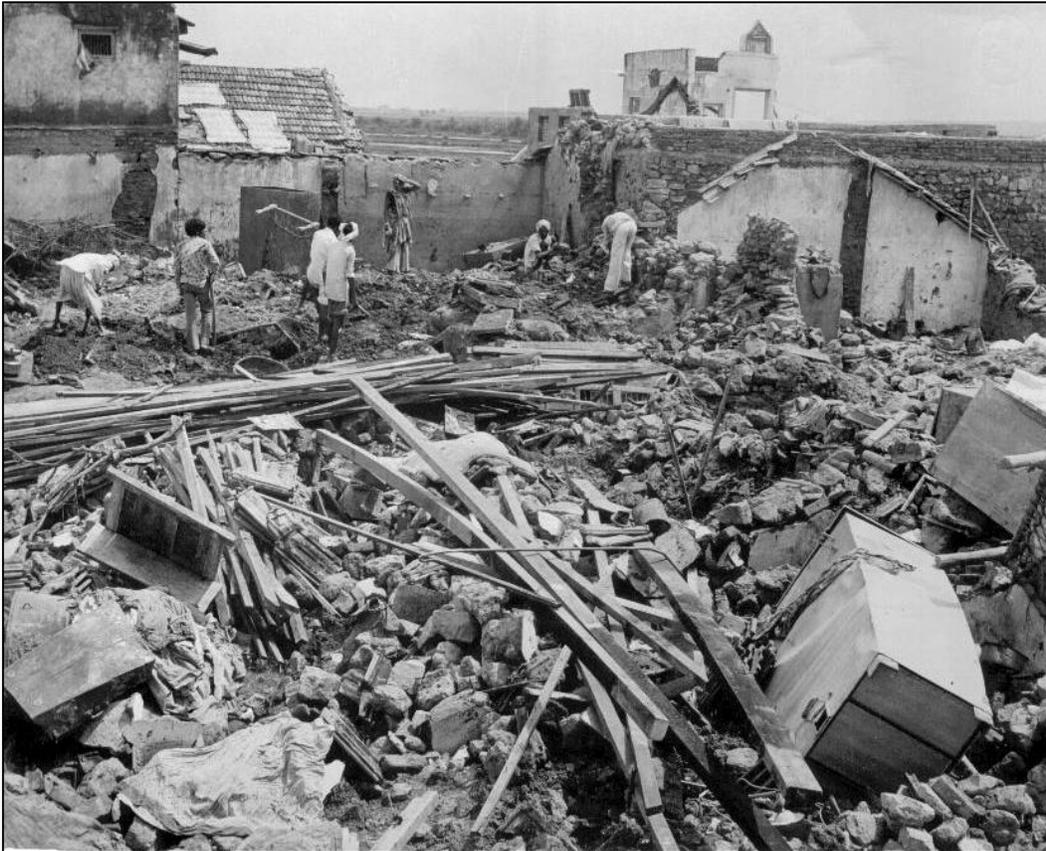
**Figure 83. Flooding aftermath at Morbi**

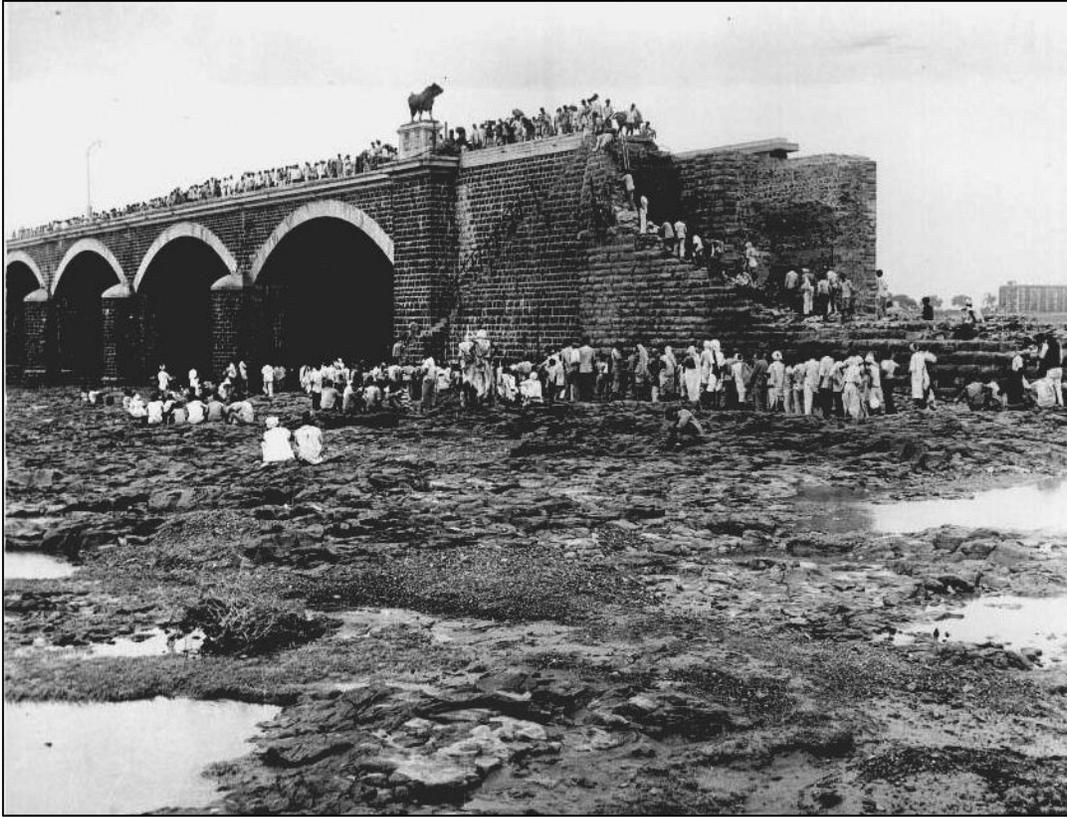
**Figure 84. Remains of the Buffalo Bridge at Morbi**

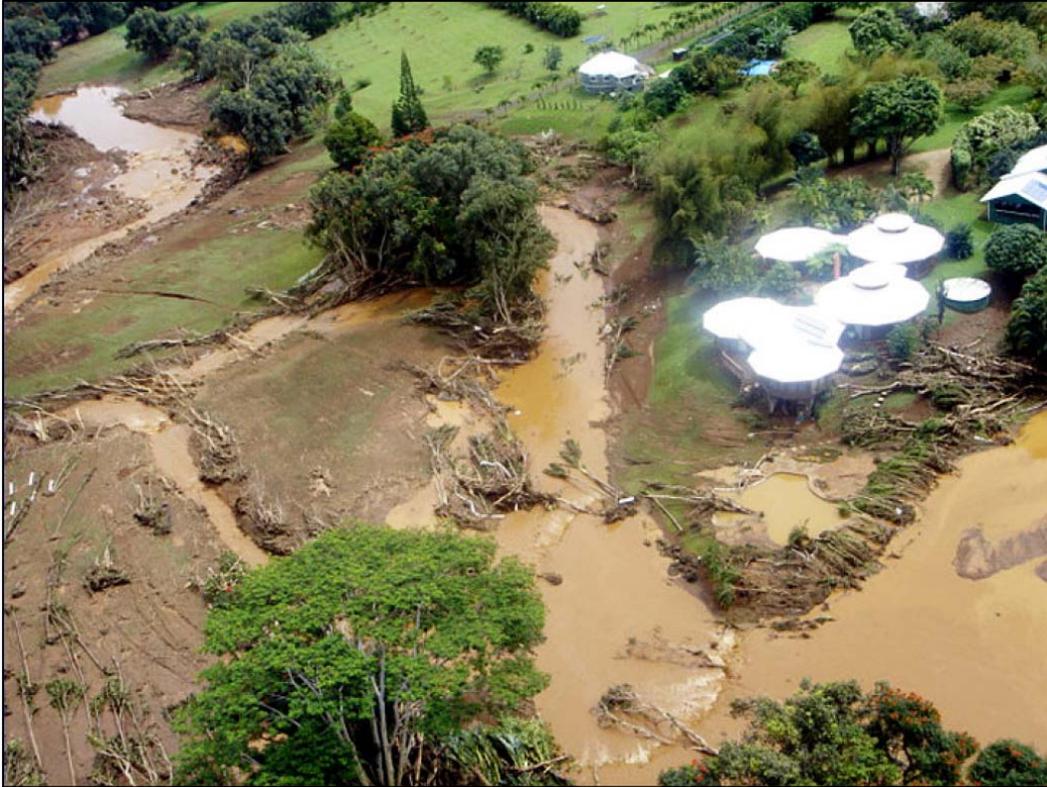
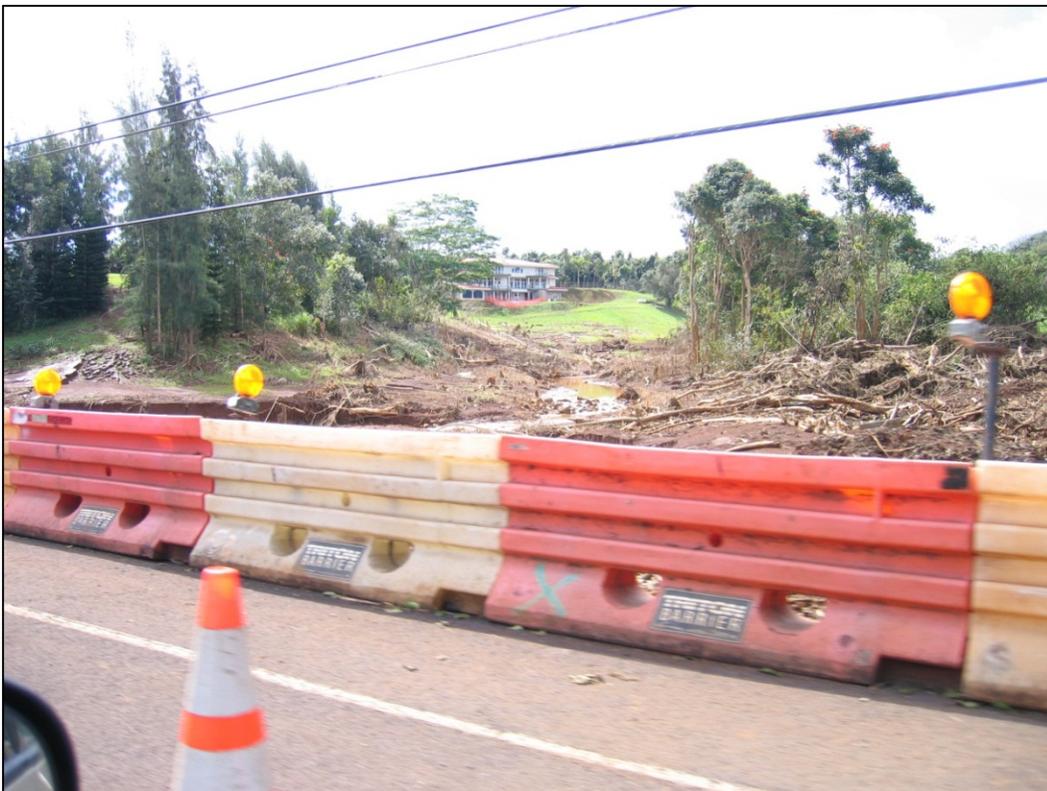
Figure 86. Location where two houses were destroyed and where the seven fatalities occurred  
Source: Photo courtesy of Hawaii State Department of Land and Natural Resources

Figure 87. Kuhio Highway crossing 2 miles downstream from Ka Loko Dam  
Source: Photo courtesy of Dave Hammond, National Park Service

The flood severity for this event is rated as medium. Examination of photographs of affected downstream regions shows areas swept clean and devoid of any vegetation. However, there is not much known about the steepness of the channel slope, the rate of rise, and the flow velocities. High severity flooding is typically seen with rapid failure of high dam structures and with steep downstream channel slopes. This event might be considered to have flood severity characteristics of the upper end of the range of medium severity.

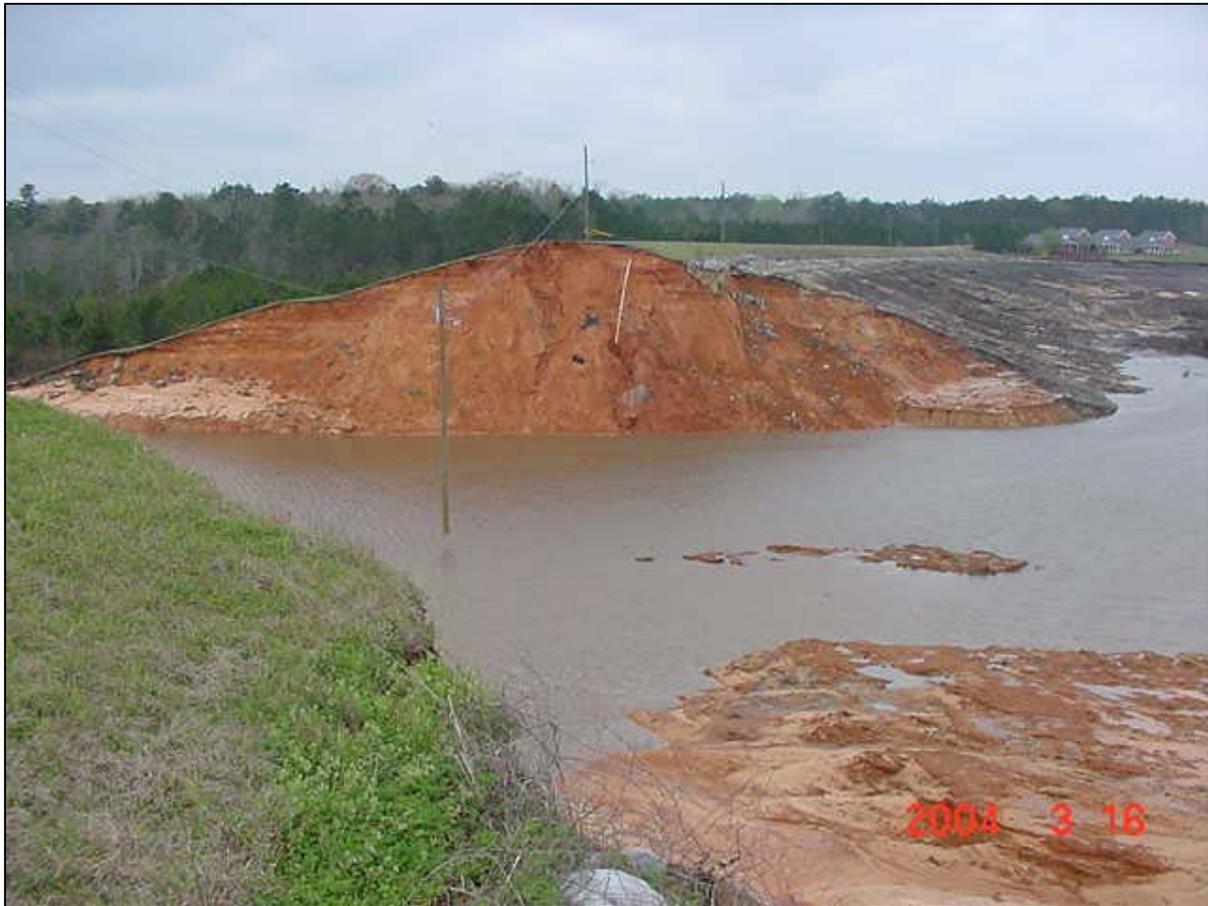
Figure 88. Big Bay Dam breach

flood zone does not appear to have been “swept clean”, which is a characteristic of very high intensity flooding. For this reason, the flood is characterized as medium severity.

Big Bay Dam was approved to be rebuilt. Re-construction of the dam began in 2007.

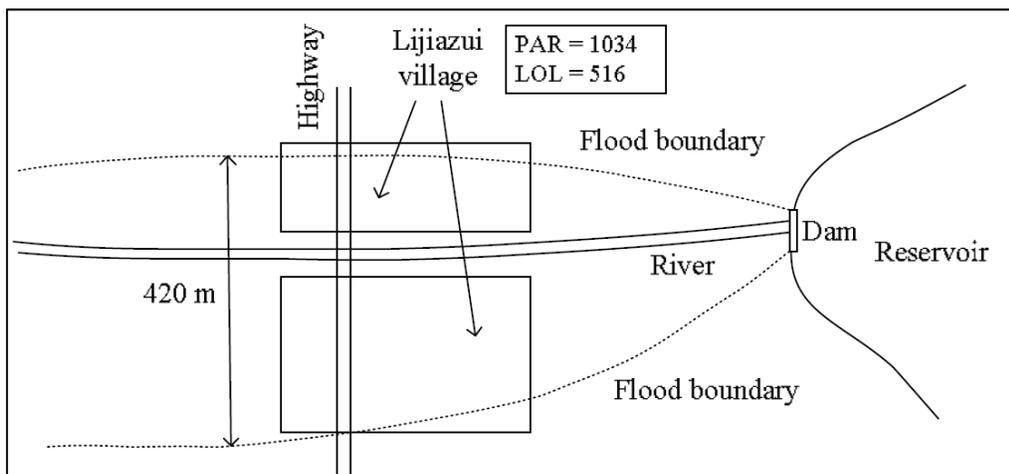
Figure 95. Area downstream of Lijiazui Dam  
Source: Photo courtesy of L.M. Zhang

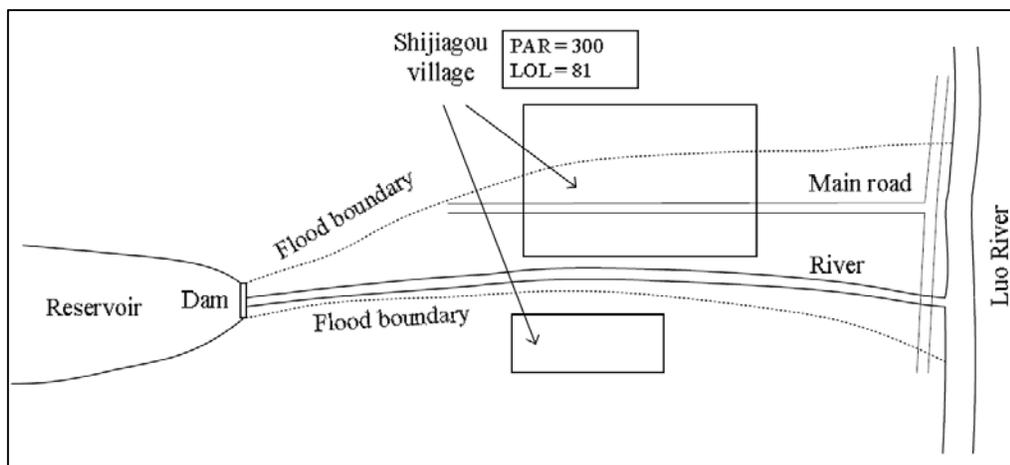
**Figure 96. Area downstream of Shijiagou Dam**  
Source: Photo courtesy of L.M. Zhang

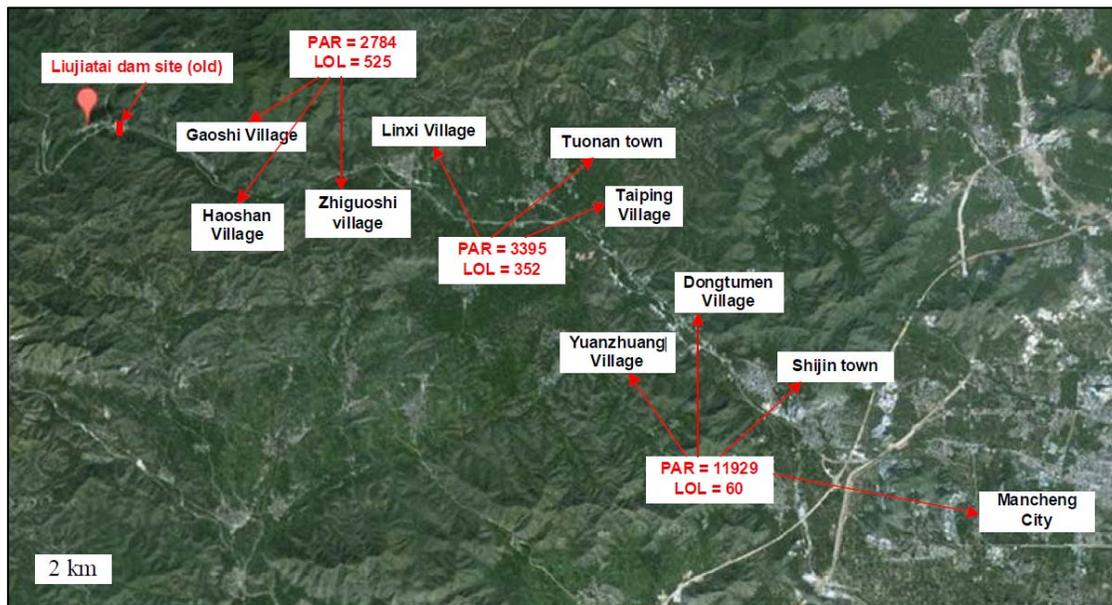
Figure 97. Liujiatai Dam and downstream areas  
Source: Photo courtesy of L.M. Zhang

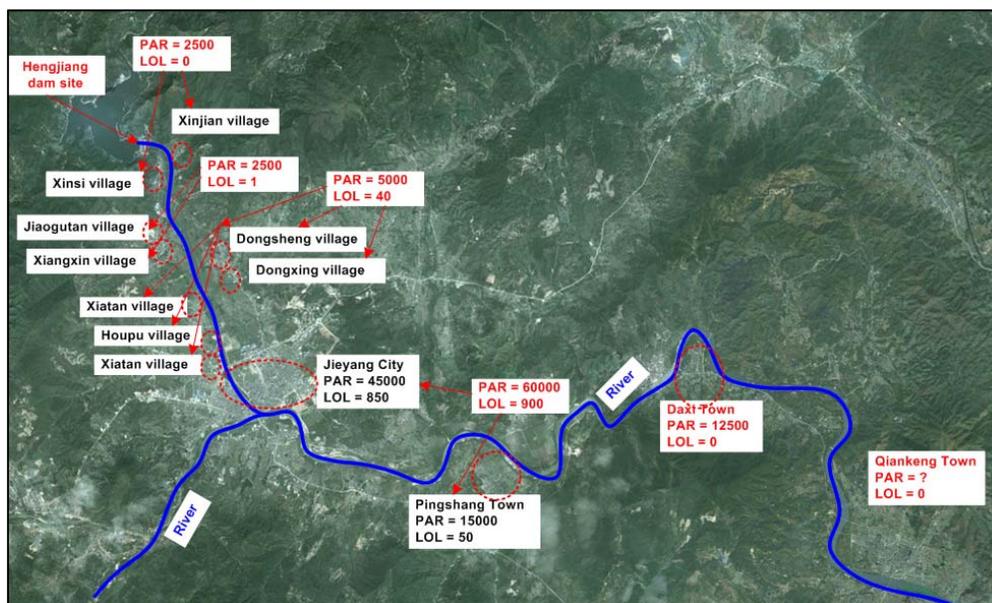
No warning was received at Jieyang City and the areas downstream. Many people were swept away by the sudden flood. 850 people were killed, out of a total PAR of 45,000. No warning was issued at Pingshang Town, which was another 2.4 miles downstream from Jieyang City. About 50 people out of 15,000 PAR were killed in this town. No fatalities occurred downstream of the Pingshang Town. This may have been due to the flood becoming more benign, with lower DV and a slower rate of rise.

Figure 98. Locations downstream of Hengjiang Dam  
Source: Photo courtesy of L.M. Zhang

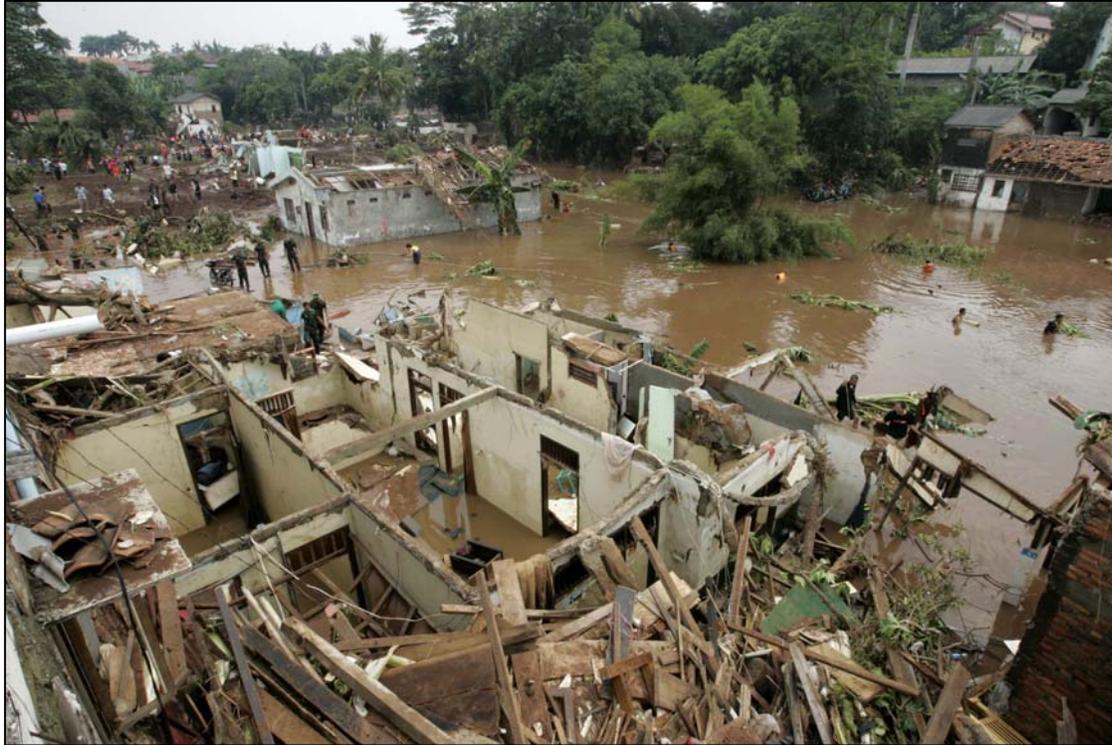
The area experienced several hours of heavy rain on the night of March 26/27, 2009 which caused the reservoir to rise. The dam was overtopped, eroding the dam surface and resulting in a breach 230 feet wide at around 2:00 am on March 27. Cracks were reportedly visible in the face of the dam's embankment from around midnight. The dam operators were reported to have sounded a warning siren shortly before the dam failed. A surge of water and debris, maybe 10 feet high was sent into the town of Cirendeudeu, washing away cars, houses and a brick-built bridge. The flood hit while most of the population was asleep and left standing water up to 8 feet deep. Many people were trapped in the town and many took to their rooftops to avoid the floodwaters. The flood killed 98 people, and 5 more were unaccounted for. The waters also inundated around 400 homes of which 250 were damaged or destroyed, displacing 171 people. Five power terminals became submerged, and the lack of power cut off drinking water supplies to the nearby suburb of Lebak Bulus.

**Figure 100. Aftermath of flooding downstream of Situ Gintung Dam**  
Source: REUTERS/Dadang Tri

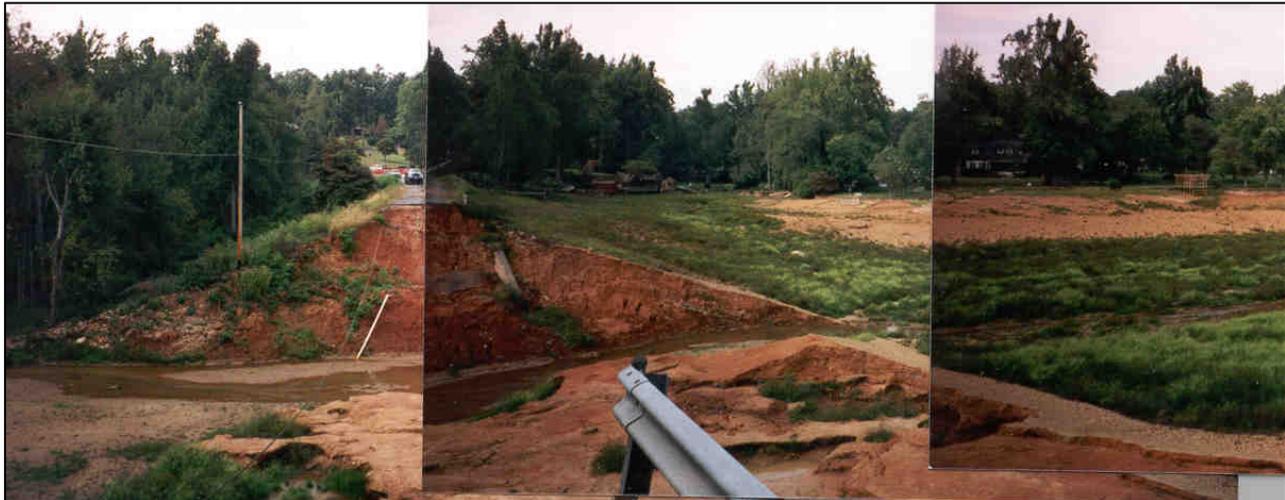
**Figure 101. The breached Timberlake Dam**  
Source: Photo by Wayne Graham, Bureau of Reclamation

Timberlake Dam was rebuilt about one year after its failure.

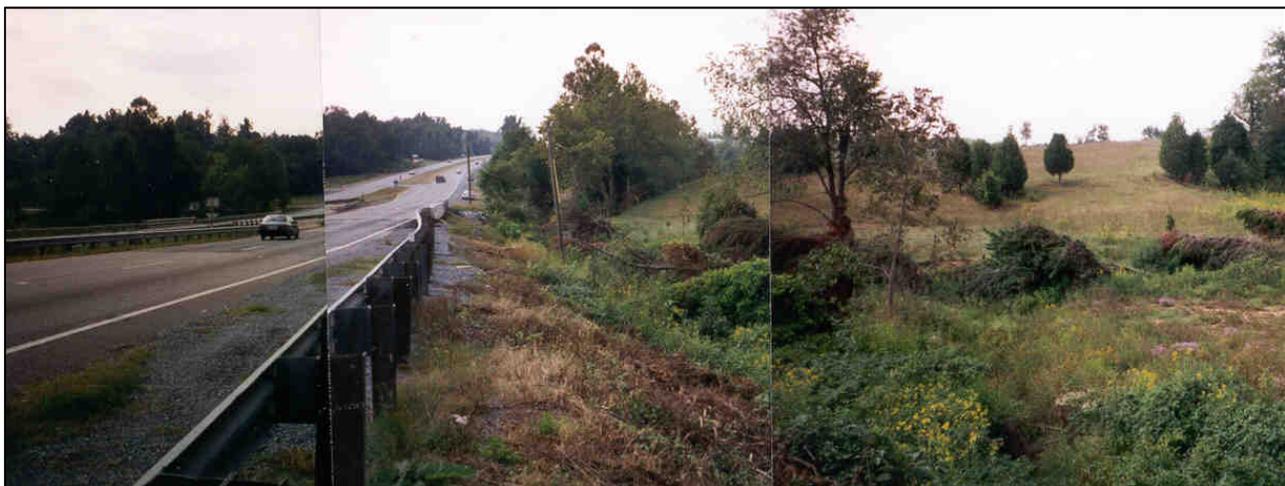
The failure of the Timberlake Dam caused two fatalities, and damage to local roads and residences. Downstream from the dam and prior to dam failure, flooding caused by heavy rainfall stranded three cars traveling on U.S. Highway 460 on the bridge crossing over Buffalo Creek. Rescue worker Carter Martin was trying to assist motorists stranded on the bridge. When the dam breach flows arrived, the water level rose more than 4 feet almost instantly, overcoming Martin. The second fatality involved Doris Stanley, who was driving home to Forest, Virginia from Richmond. She never made it home, however, as her car was washed away by the rising flood water. Her crumpled vehicle was found in Buffalo Creek on Saturday morning about 200 to 300 yards downstream from Turkey Foot Road. Her body was found Sunday morning about 200 or 300 yards from where her vehicle was found.

**Figure 102. Location where rescue worker was killed**  
Source: Photo by Wayne Graham, Bureau of Reclamation

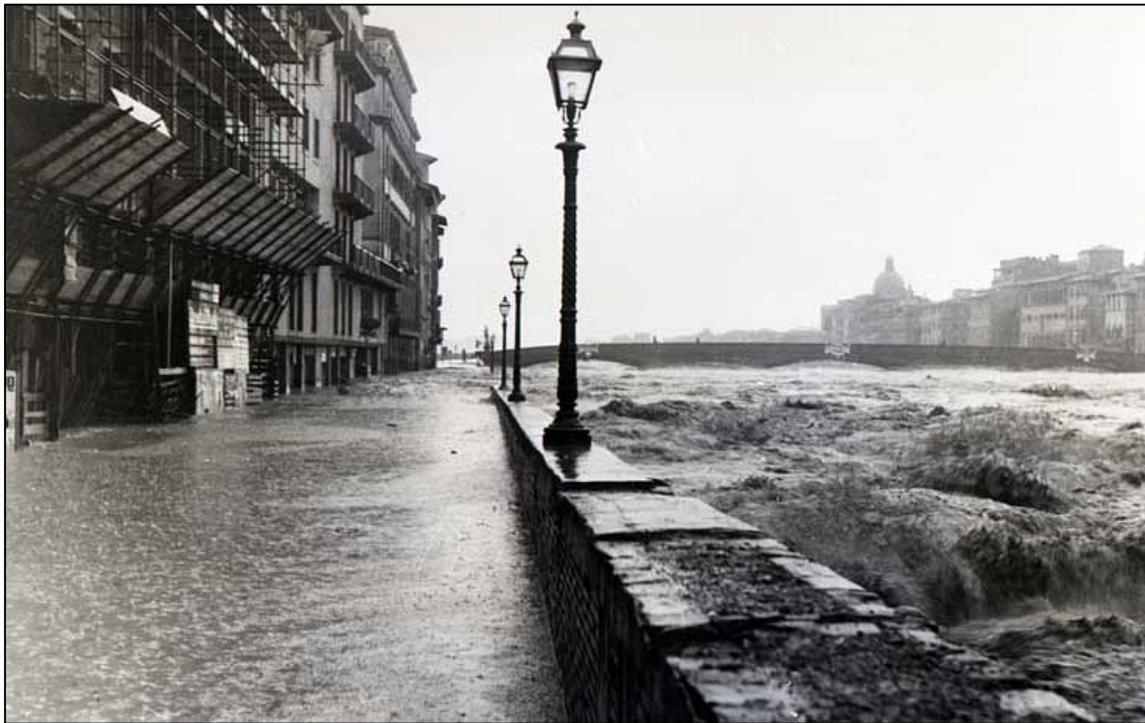
Figure 103. Arno River flooding at the city of Florence, Nov. 3, 1966

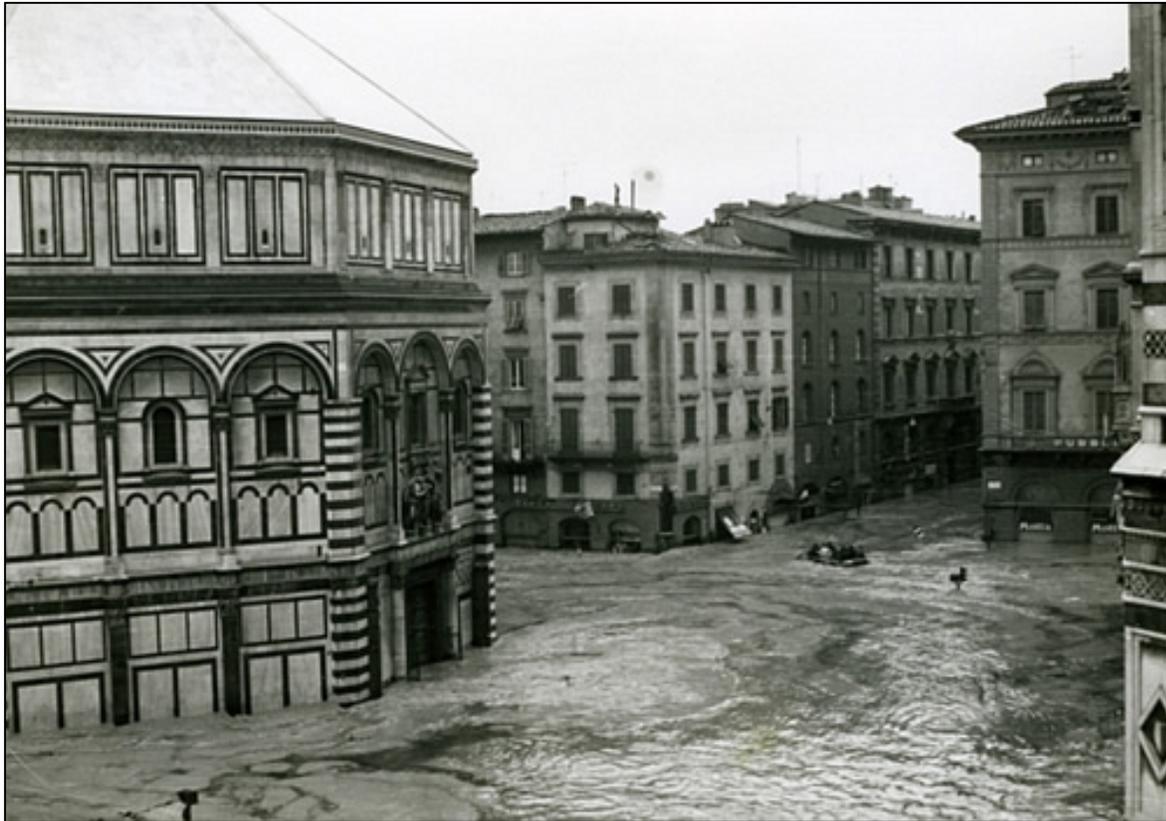
Figure 104. Flooding in the city of Florence  
Source: Armando Poggi, [www.apoggi.com](http://www.apoggi.com)

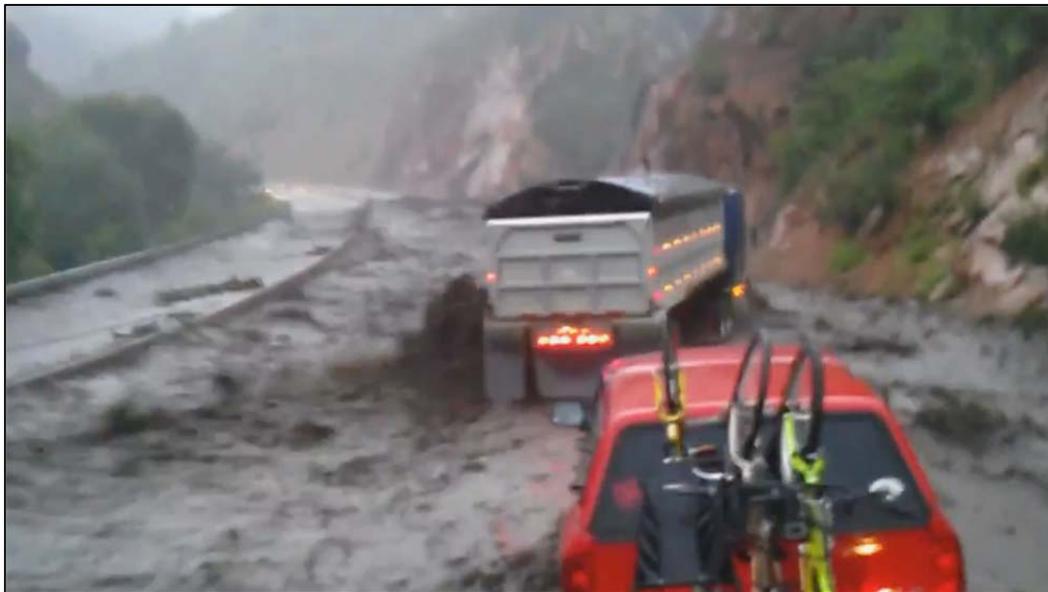
Hourly data from a USGS gage suggested the peak discharge of the flood to have been 1,500 ft<sup>3</sup>/s. However, calculations based on a field survey suggests a slightly higher peak discharge of 1,800 ft<sup>3</sup>/s. Flood depths along Highway 24 varied due to the formation of small debris dams which concentrated flow in some areas. In some locations, water flowed over the tops of the Jersey barrier median and moved down both sides of the highway. Maximum flood depths were about 5 feet, and were located along a ditch on the right side of the north-bound lane. Based on video footage of cars floating along this ditch, the maximum velocity is estimated to have been at least 10 ft./s.

**Figure 105. Flooding along Highway 24, looking north**  
Source: YouTube/Tj Omara

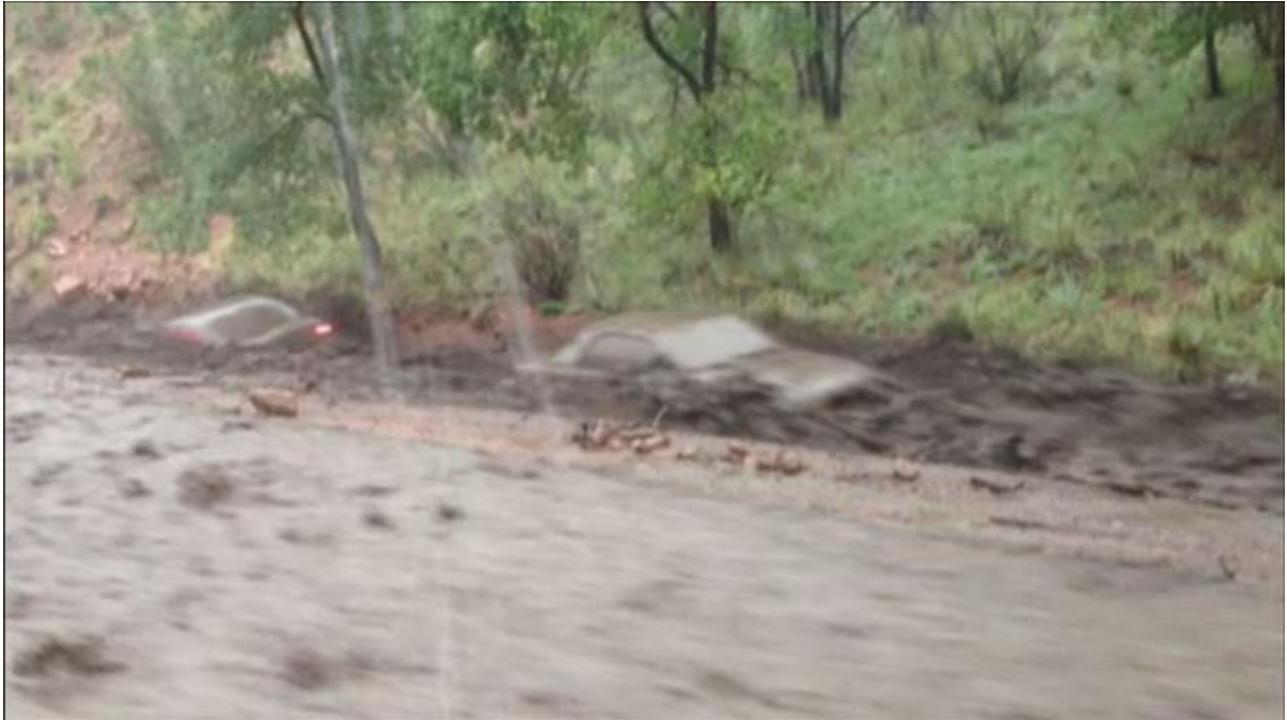
**Figure 106 Cars floating in the ditch along Highway 24**  
Source: Used by permission, [www.9news.com](http://www.9news.com)

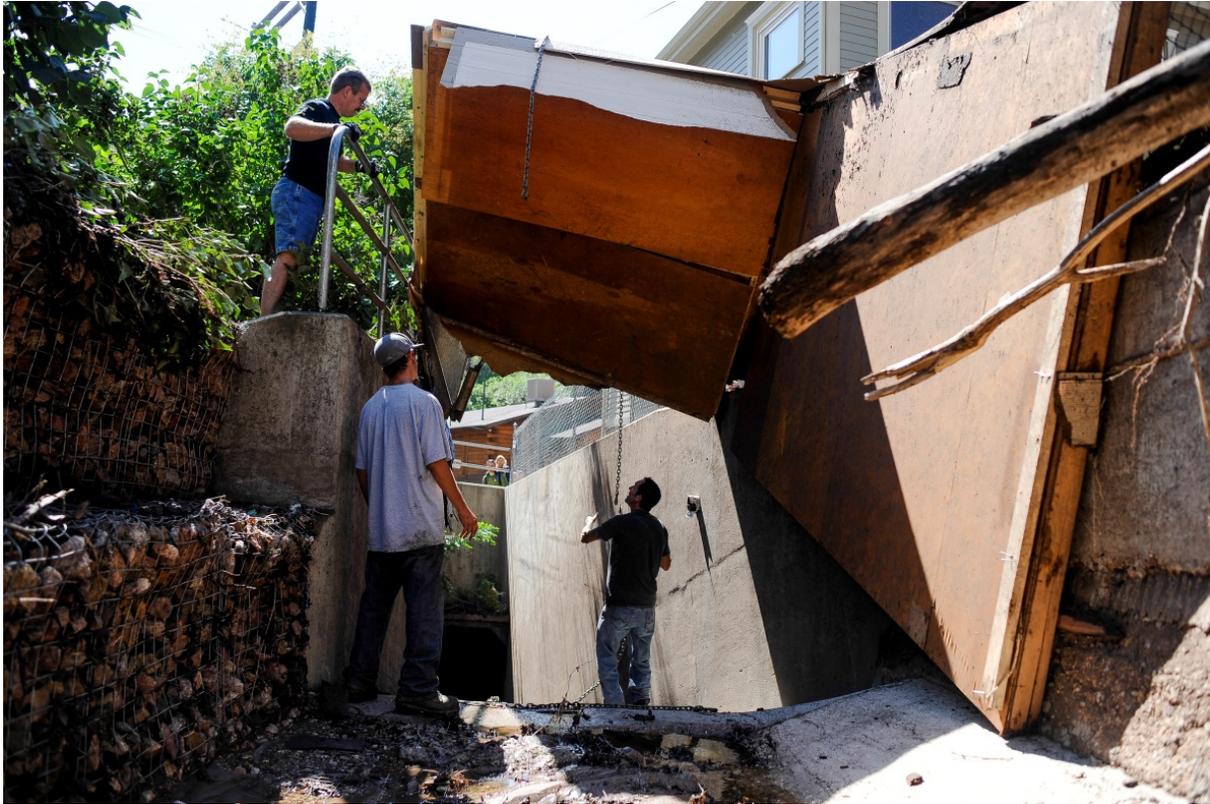
Flooding was severe further downstream at the town of Manitou Springs. Six homes were reported to have been destroyed including one residence, a small cottage was floated off of its foundation and deposited in a drainage channel. The occupant of the cottage escaped as water was gushing into the structure. This individual, who was hospitalized with injuries, reported fighting for her life while submerged in flood water and attempting to reach high ground. Numerous other structures sustained damage, and motor vehicles were swept away destroyed. Flood alert sirens along Fountain Creek were activated, but were too late to provide advance warning. No fatalities occurred at Manitou Springs, however the flooding there certainly had the potential to have been lethal.

Figure 107 Remnants of destroyed cottage at Manitou Springs  
Source: Used by permission of the Colorado Springs Gazette, [www.gazette.com](http://www.gazette.com)

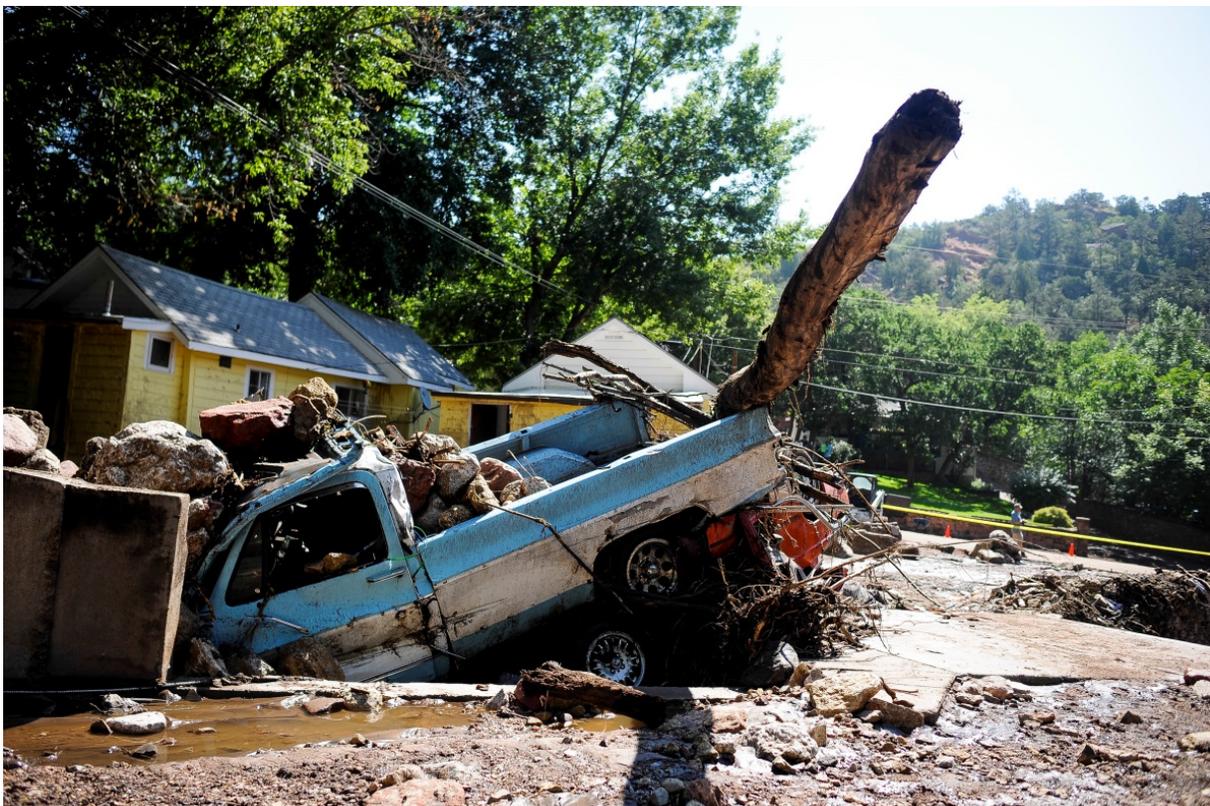
Figure 108 Aftermath of flooding, Manitou Springs  
Source: Used by permission of the Colorado Springs Gazette, [www.gazette.com](http://www.gazette.com)

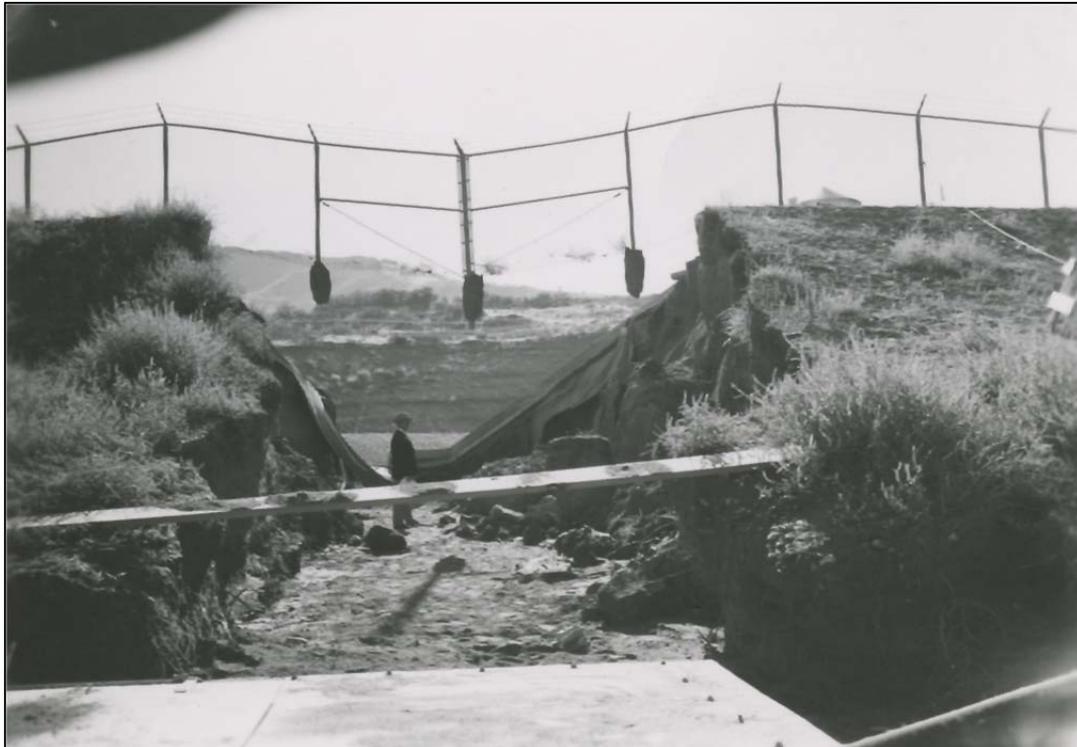
Reservoir No.1, located near Bountiful, Utah, failed on Sunday September 24, 1961 at 4:30 am. The earthen dam, which created a bathtub reservoir, was two years old when it failed from what was thought to have been internal erosion. The exact height of the dam is not known, but from examining photos of the breach, it appears that the dam height was in the range of about 15 feet. 4.4 acre-feet of storage was reportedly released from the breach and the reservoir emptied in less than fifteen minutes. Failure of the dam was not detected prior to its occurrence and no warning was issued. The flood resulted in damage to about twenty properties which were damaged, but not destroyed, and there was an affected population at risk (PAR) of maybe eighty people. This event did not result in any fatalities.

**Figure 110. Close up of breach, Reservoir No.1 Dam**  
Source: Bud Bay, Bureau of Reclamation, photo taken on September 25, 1961

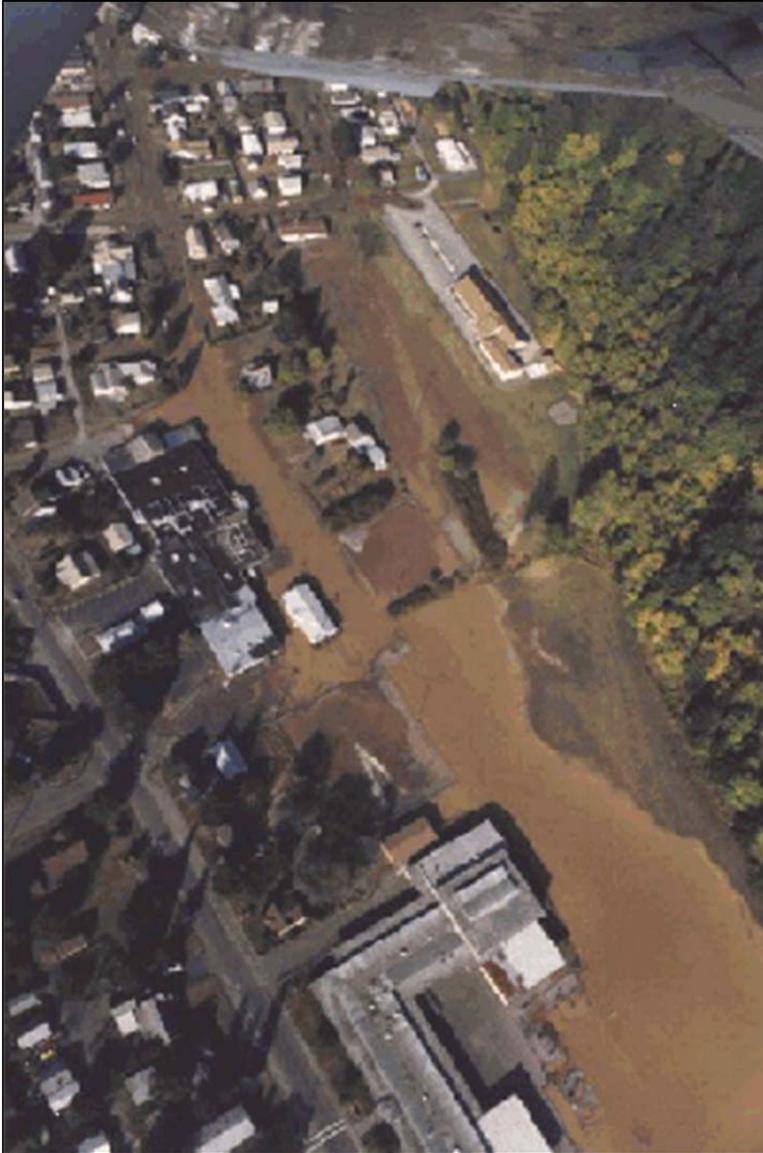
The flood flow moved down the steep hillside ravine and entered a residential neighborhood. Two homes were knocked off their foundations and destroyed. Several other homes were severely damaged by the water and mud flow. Many other homes had silt and mud deposited in their yards. (<http://www.ecy.wa.gov>)

**Figure 112. Aerial view of flooded areas downstream of dam**

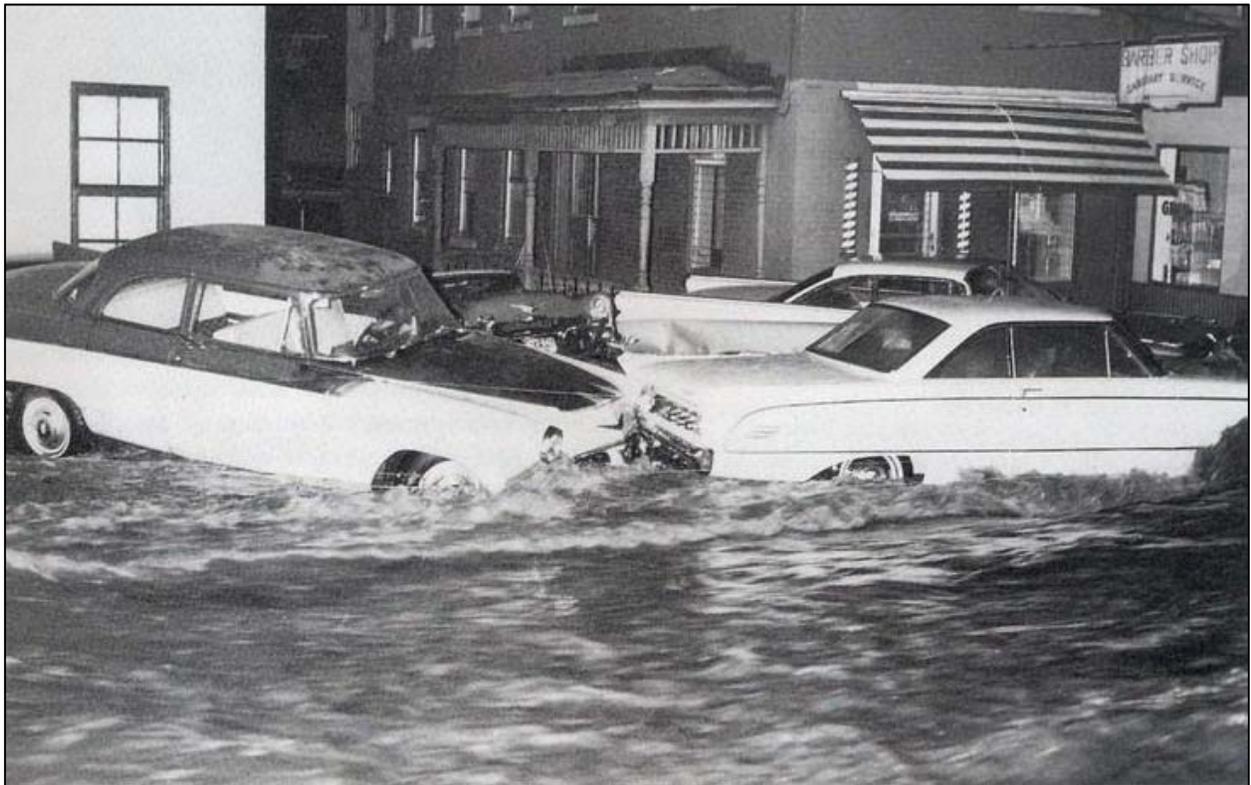
Figure 113. Flooding from failure of Mohegan Park Dam  
Source: Photo courtesy of Norwich Historical Society

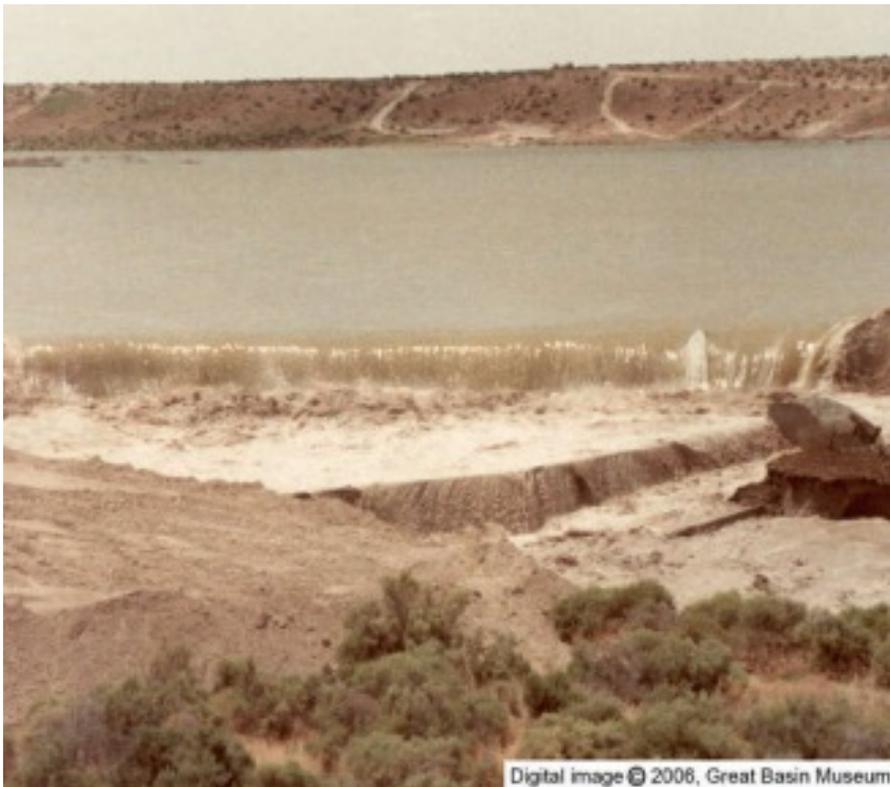
DMAD Dam was a 34-foot-high earthfill structure located five miles north east of Delta, Utah on the Sevier River. Breaching of the dam's spillway section occurred due to headcutting erosion into the foundation near the spillway. Peak discharge from the breach was estimated to have been 28,000 ft<sup>3</sup>/s.

**Figure 115. DMAD Dam, Breach in the spillway section**  
Source: Courtesy of the Great Basin Museum
