## **RCEM – Reclamation Consequence Estimating Methodology**

### **Dam Failure and Flood Event Case History Compilation**

**U.S. Department of the Interior  
Bureau of Reclamation**

**June 2015**

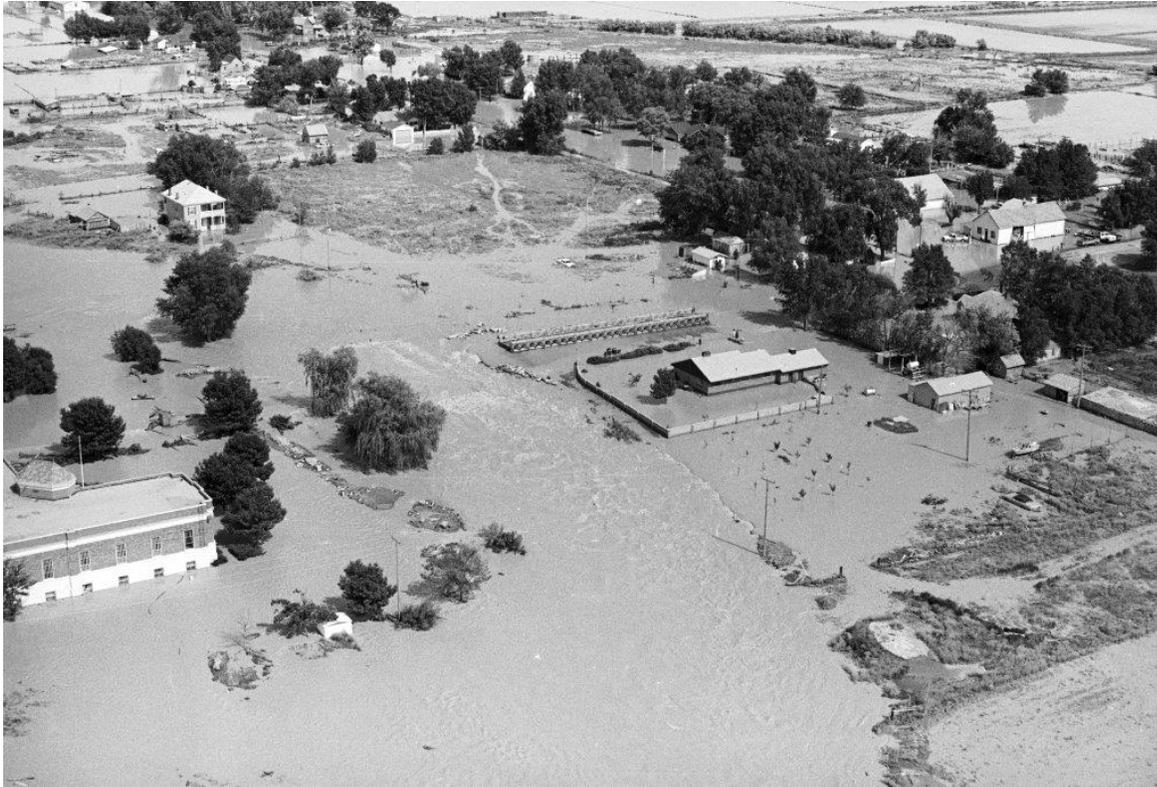
**Figure 116. Flooding downstream of DMAD Dam**  
**Source: Photo by Jane Beckwith from the Frank Beckwith Collection**

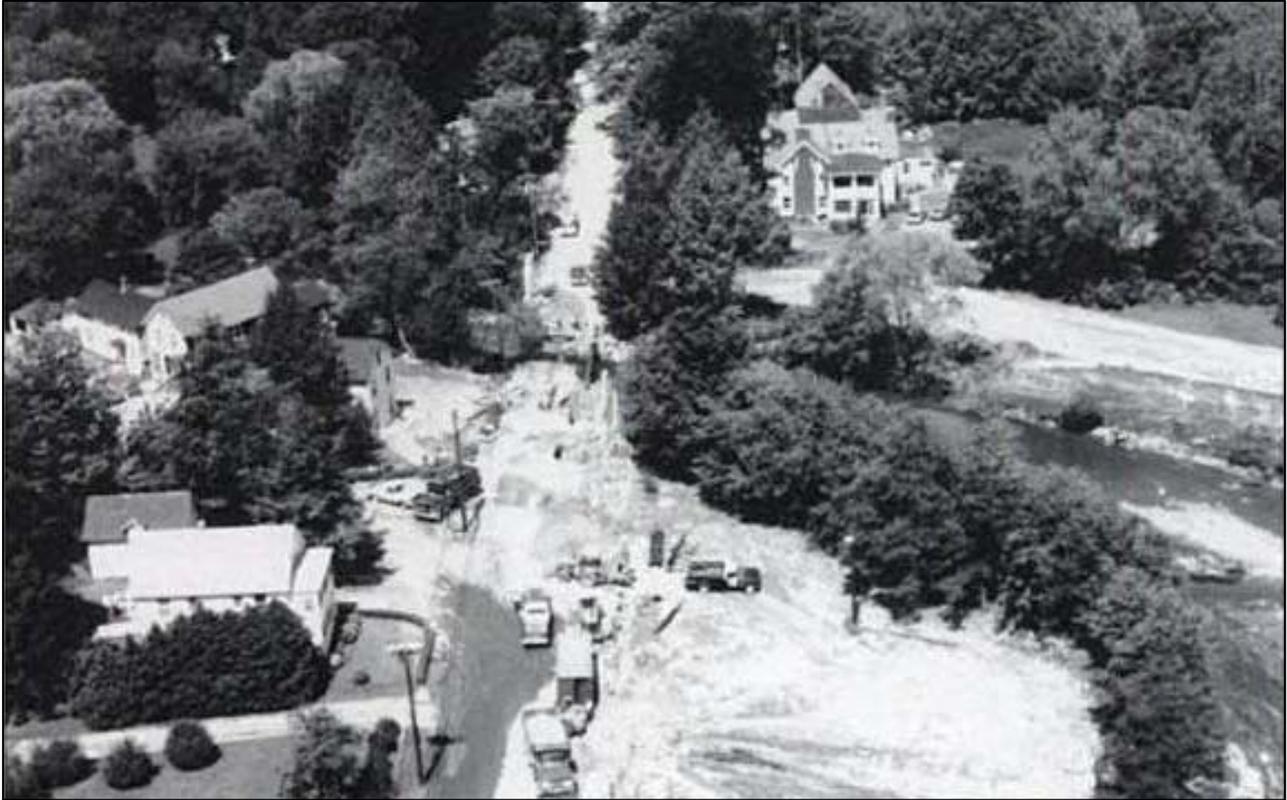
**Figure 118. Washed out bridge over Fall River, Ivoryton, CT**  
Source: Image courtesy of the Ivoryton Library Association

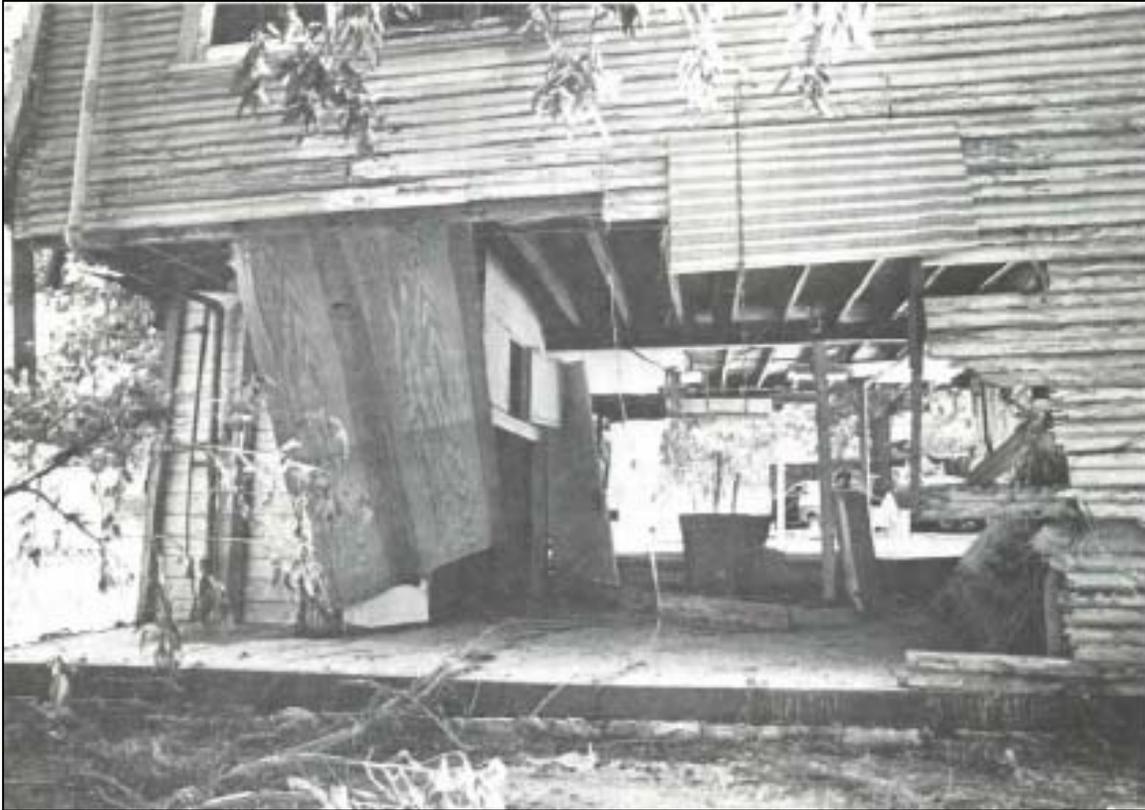
**Figure 119. Damaged home at Austin**  
Source: Photo courtesy of the Austin American-Statesman

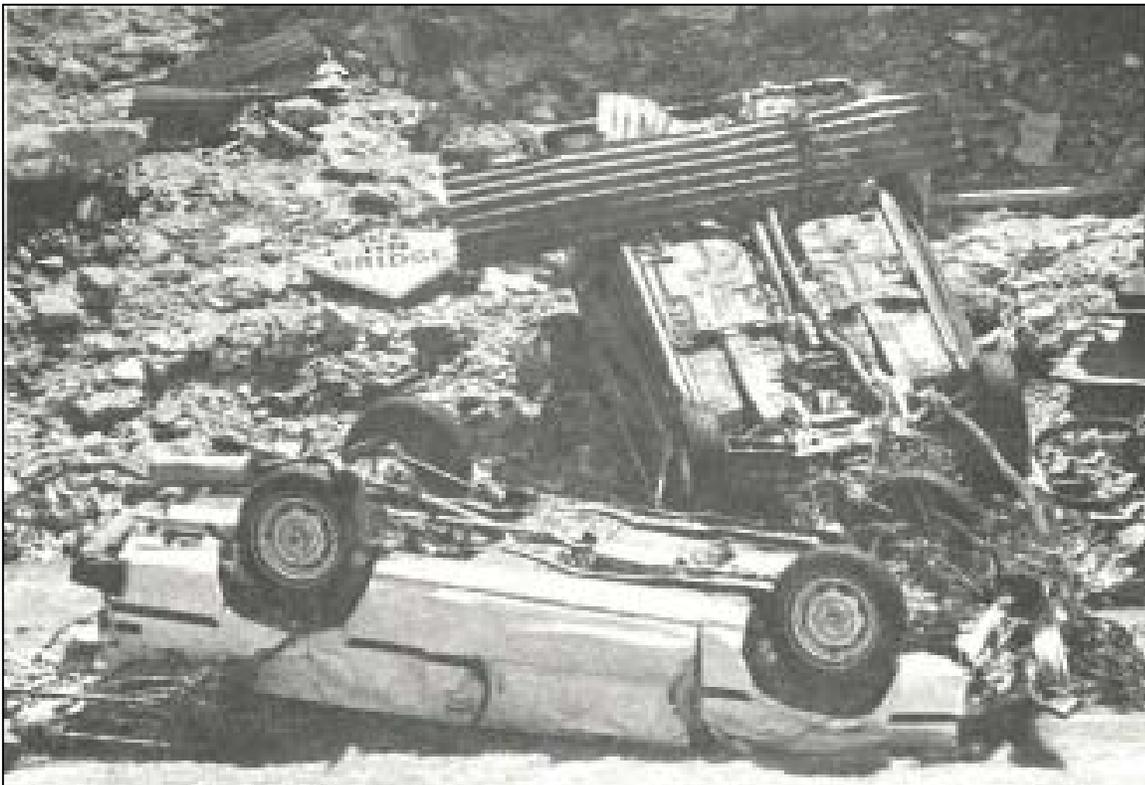
**Figure 120. Automobiles washed into the bed of Shoal Creek**  
Source: U.S. Geological Survey

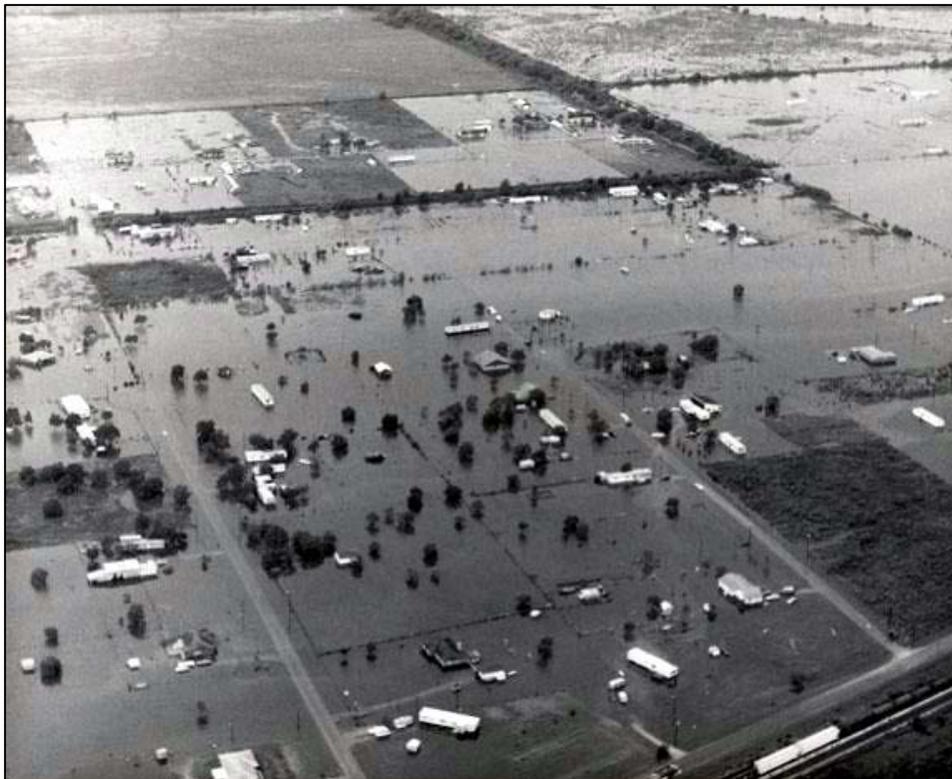
Figure 121. Texas Hill Country Flooding, 1978  
Source: U.S. Army Corps of Engineers

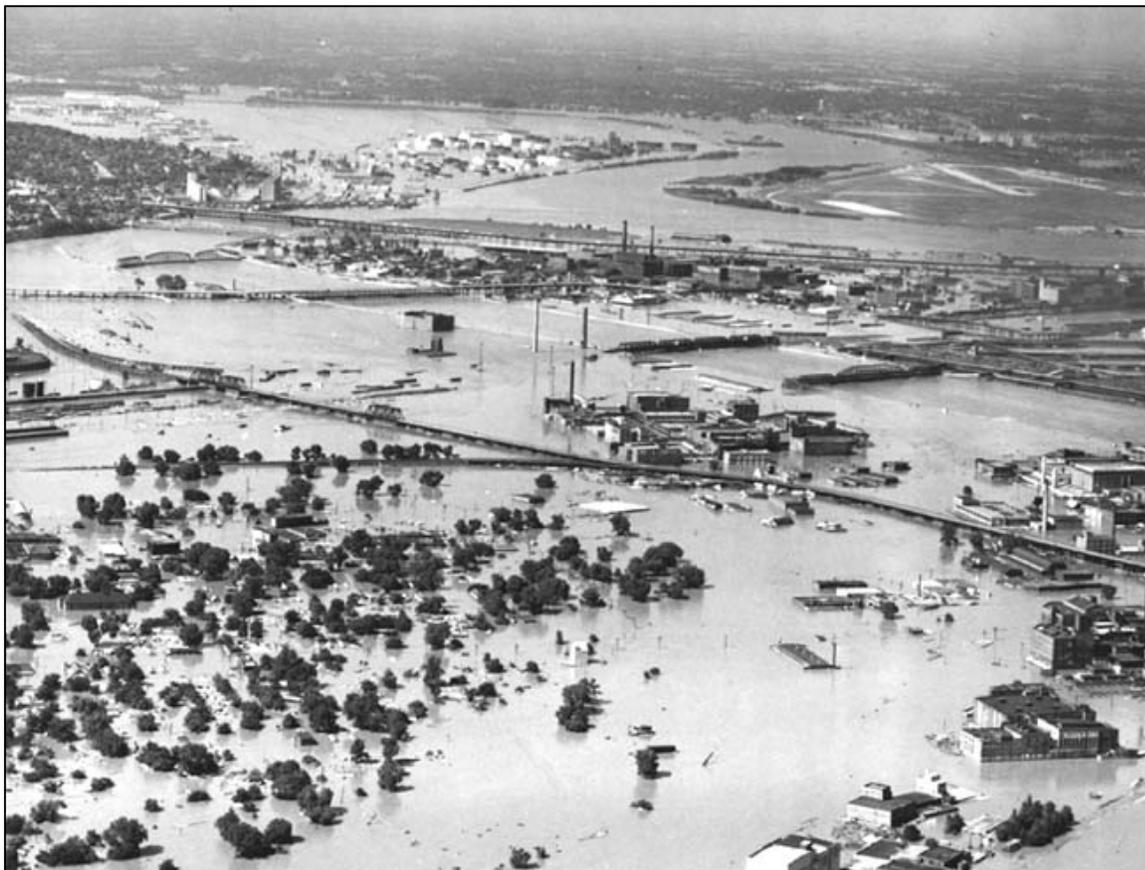
Figure 122. Aerial view of flooding at the confluence of the Kansas and Missouri Rivers in Kansas City looking northeast on July 13, 1951

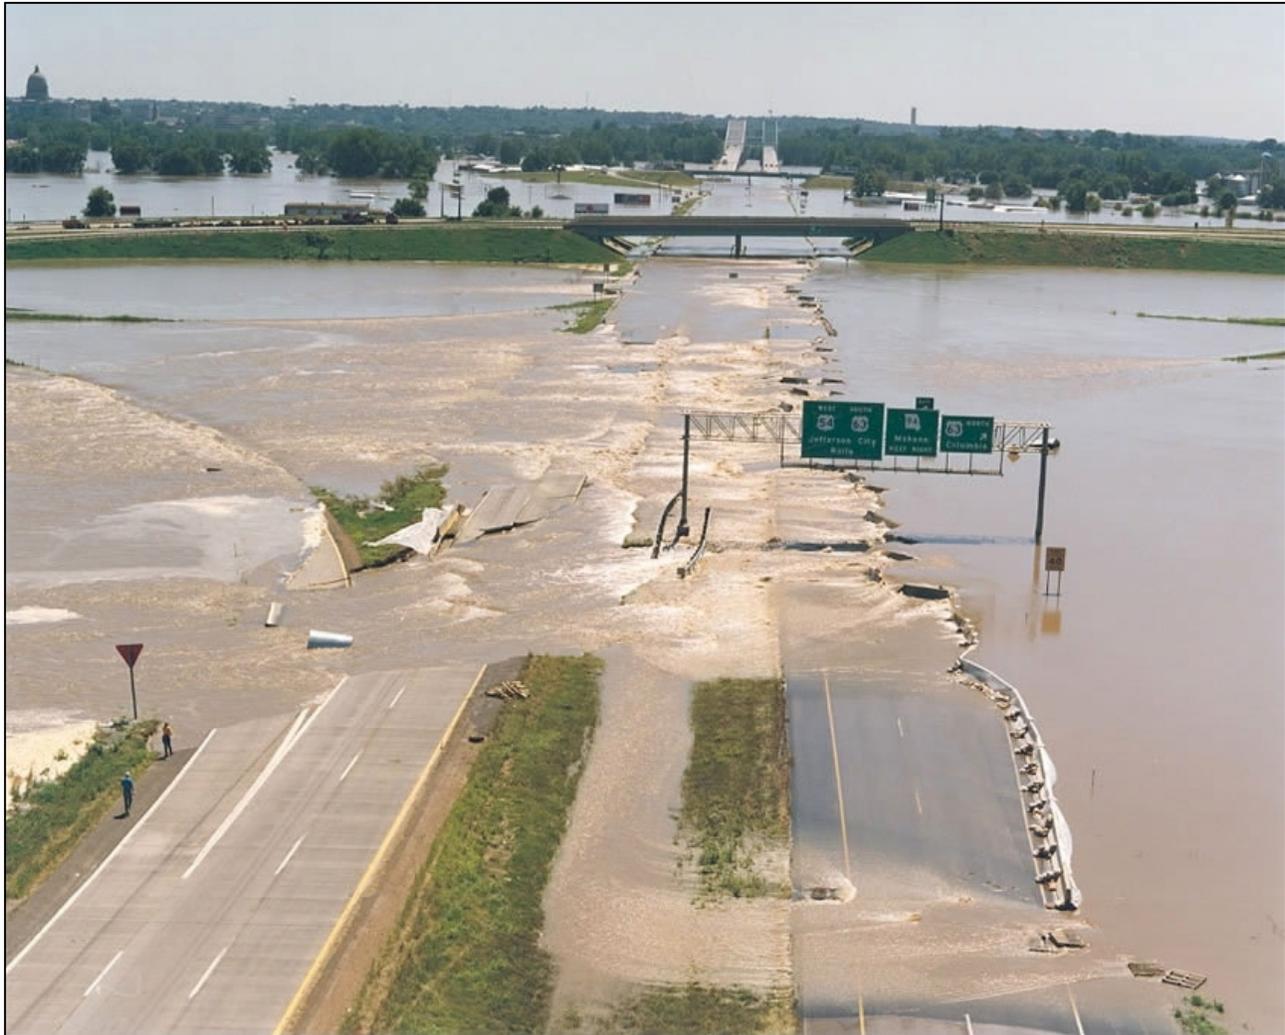
Figure 123. Great Flood of 1993

Aerial view of the Missouri River flooding on July 30, 1993, at U.S. Highway 54 just north of Jefferson City, Missouri, looking south (photograph from the Missouri Highway and Transportation Department).

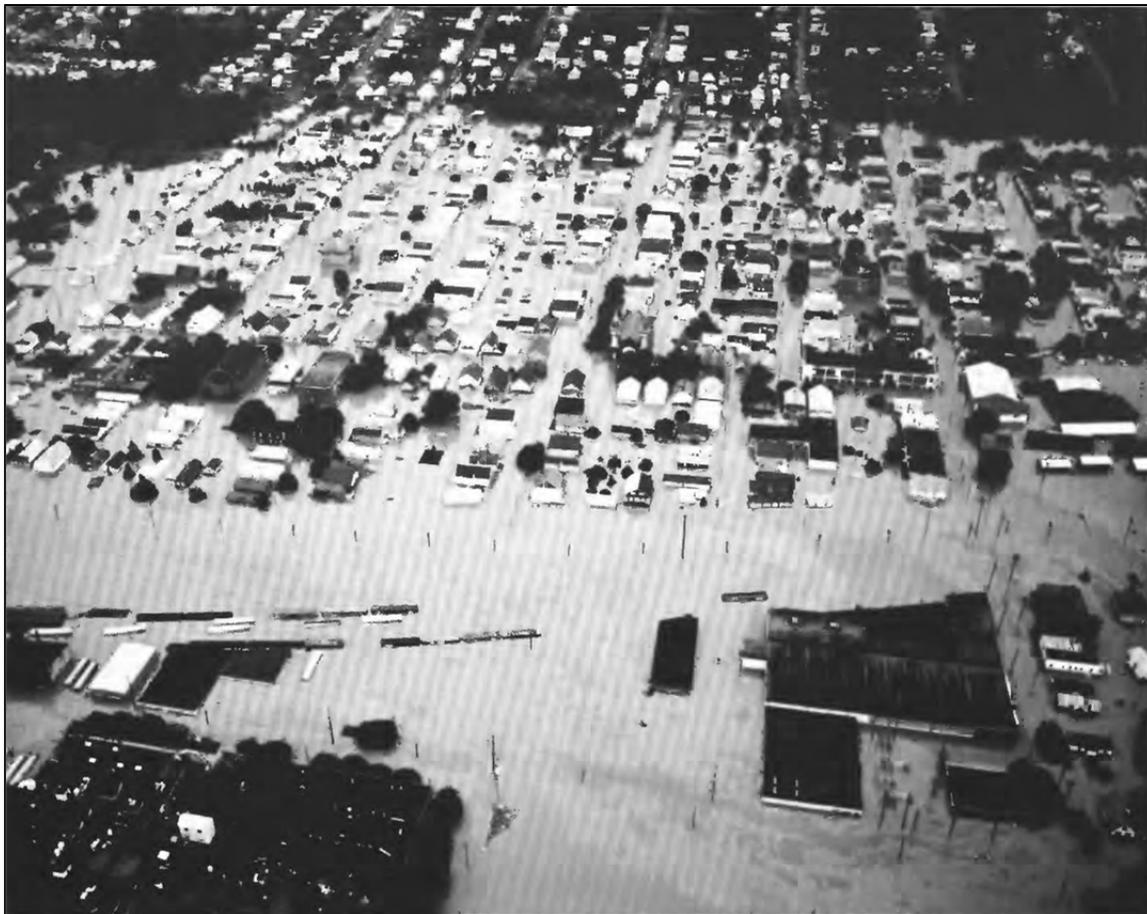
Figure 124. Hurricane Agnes, Susquehanna River at Wilkes-Barre, PA  
Source: U.S. Geological Survey

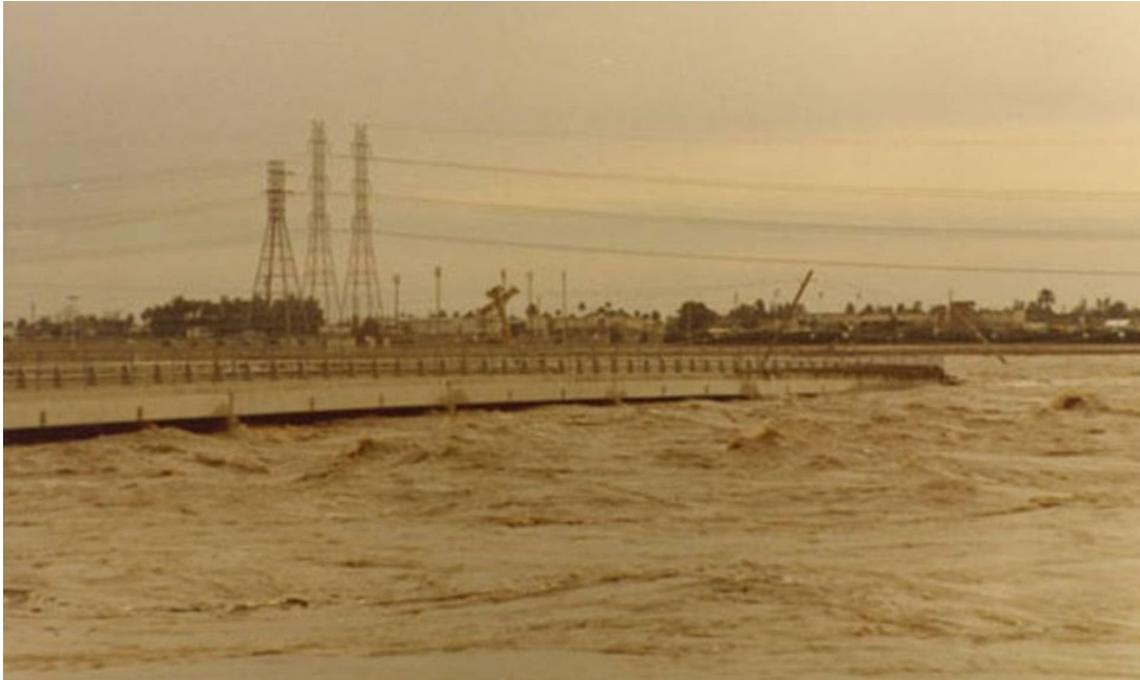
**Figure 126. Phoenix Area Flooding, 1980, Bridge Crossing on the Salt River**  
Source: Photo courtesy of State Historical Society of North Dakota from the William E. Shemorry Photograph Collection

DSO-99-06 considered this flooding to have been low severity. Flood discharge was high along the Salt, Verde and Agua Fria Rivers, but perhaps the flooding which occurred away from the main river channel was relatively benign.

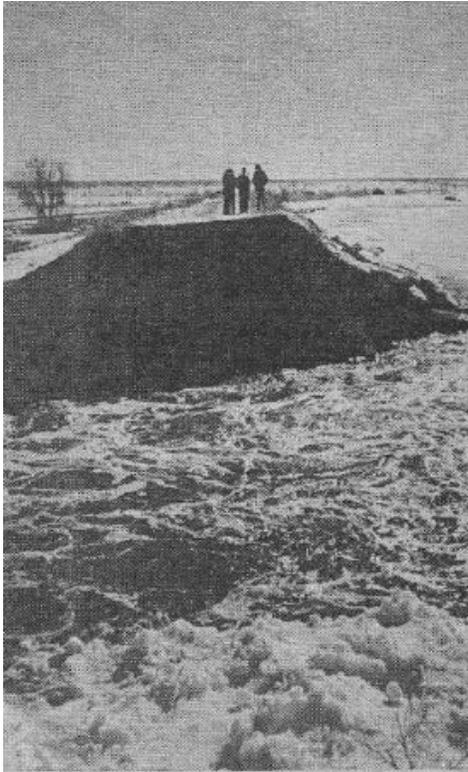
Prospect Dam was an embankment dam located on Lost Creek, near Keenesburg, Colorado. The 45 foot high embankment dam failed on Sunday, February 10, 1980 at about 9:00 am. The weather was clear at the time of failure and the cause of the breach was likely to have been internal erosion. Maximum operating capacity of the dam was 6,300 acre-feet, and the reservoir contained 5,850 acre-feet at the time of its breach.

A 10-foot diameter tunnel in the embankment was observed by a local farmer at about 9:30 am. By 9:55 am, the breach was estimated by an observer to have been 30 feet wide. As erosion continued, the gap spread at an average rate of 2.3 feet per hour to a final breach width of 83 feet. (CWCB report)

**Figure 127. The breached Prospect Dam**  
Source; Rocky Mountain News Archives, Courtesy of Denver Public Library

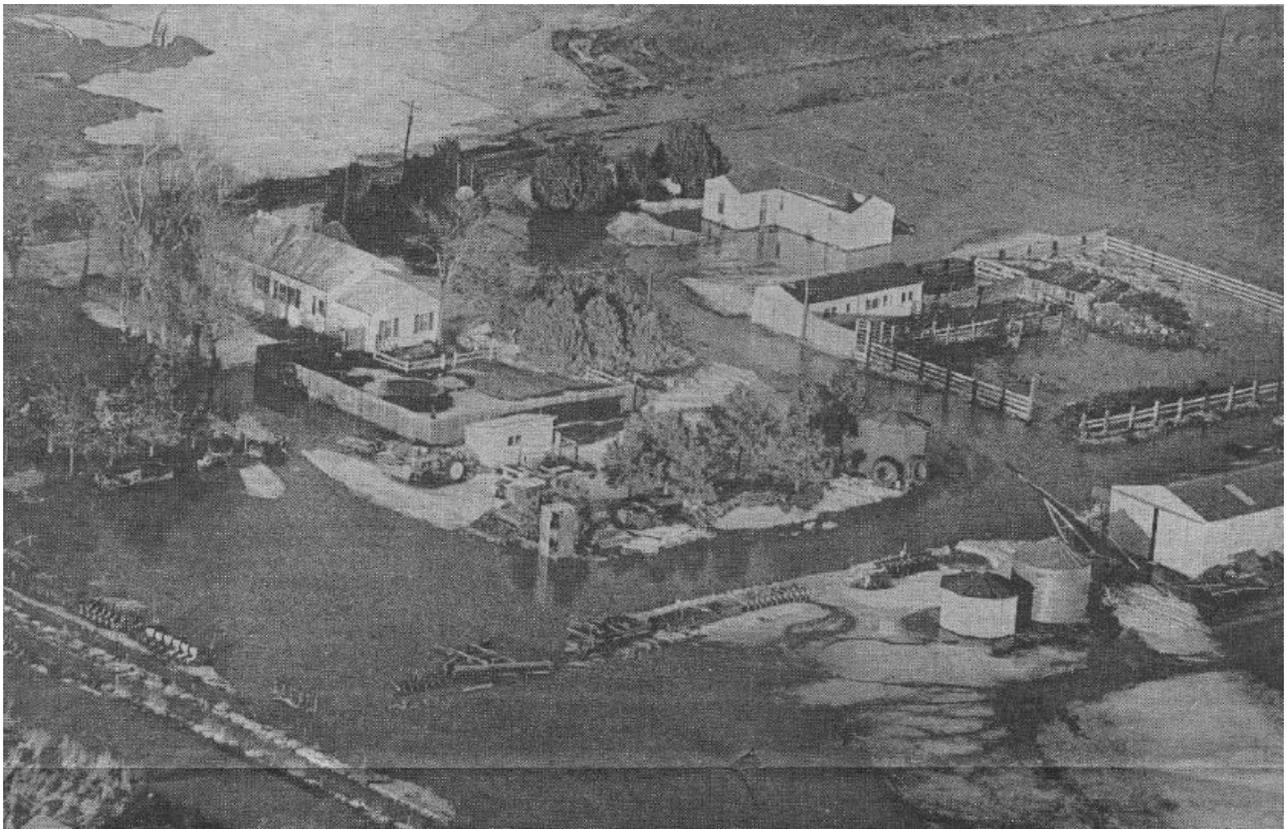
This flooding is considered to have been low severity. The DV was low and the downstream channel slopes were mild. As a result, the flooding was slow rising.

**Figure 128. Flooding downstream of the breached Prospect Dam**  
Source: Rocky Mountain News Archives, Courtesy of Denver Public Library

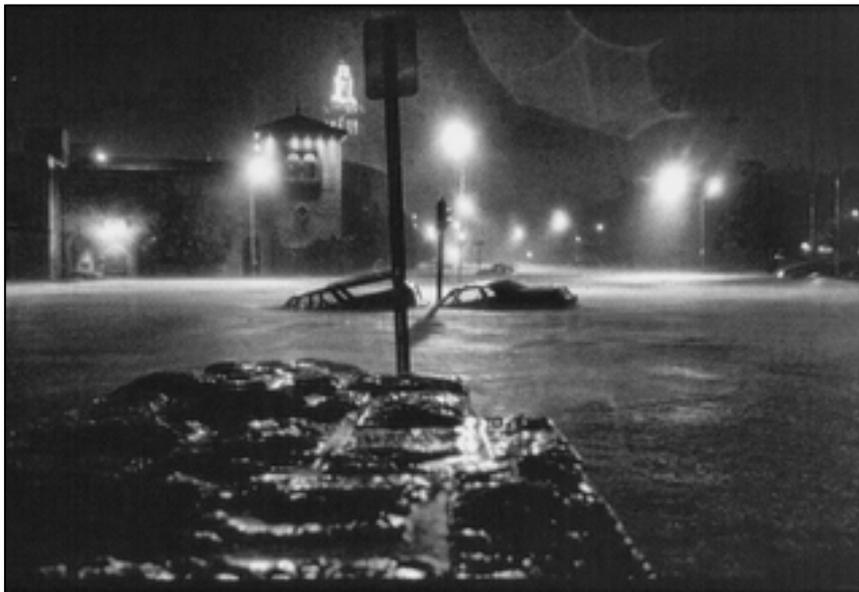
DSO-99-06 characterized this flood event as low severity. Flood velocities and depths may have been relatively low, although there is not a lot of information available.

**Figure 129. Brush Creek Flood, 1977, Ward Parkway, Kansas City, MO**  
Source: U.S. Geological Survey Professional Paper 1169

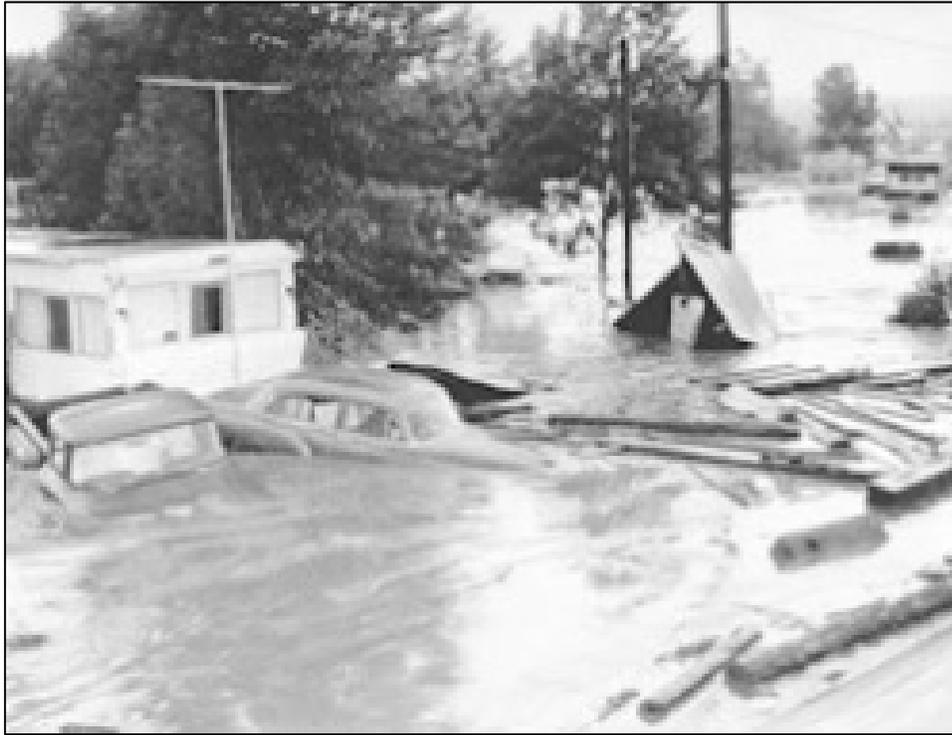
**Figure 130. South Platte River flood, 1965, mobile home park near Bowles and Santa Fe Avenues, Littleton, CO**  
Source: Colorado Water Conservation Board

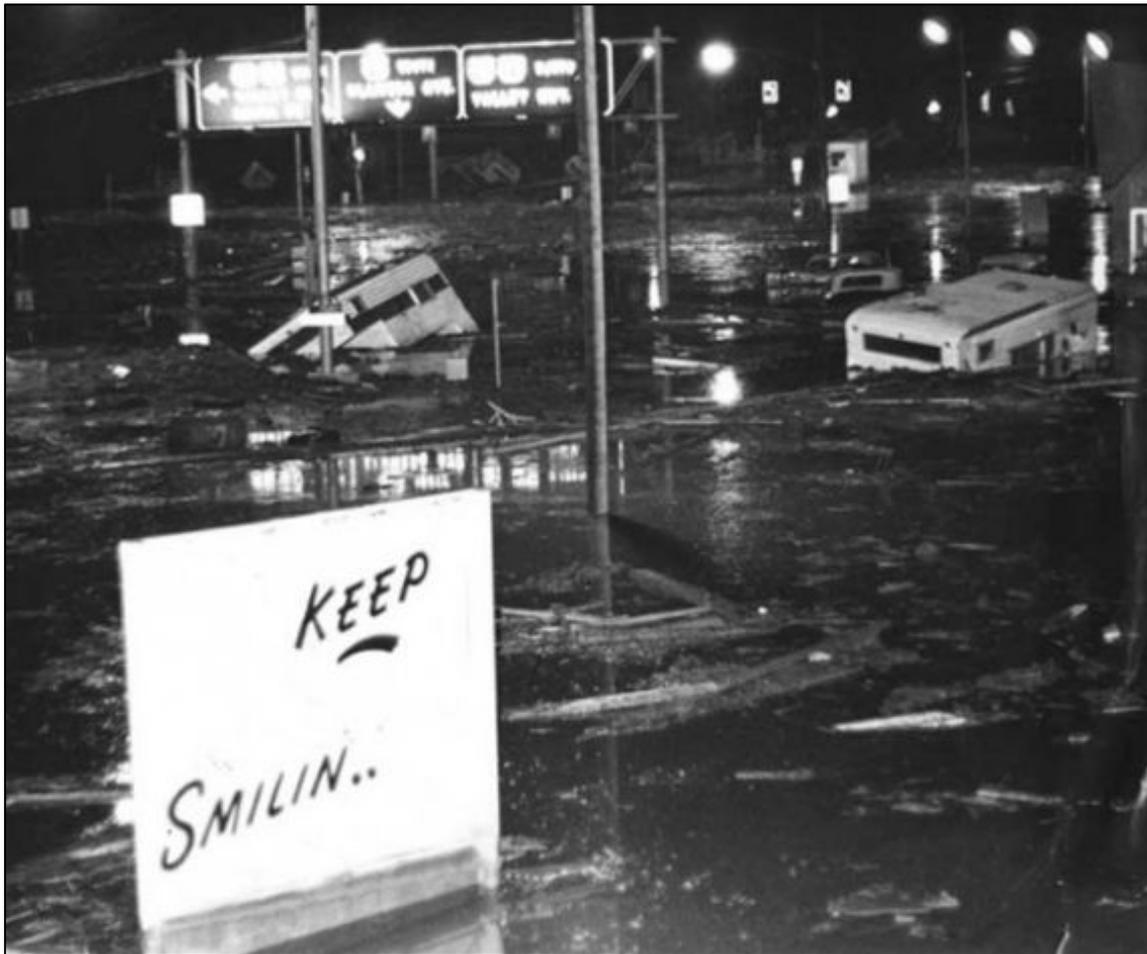
The Denver metropolitan area suffered extensive damage. The flood zone represented 67 percent of the industrial area in the city. Peak discharge on the South Platte River at Denver was reported to have been 40,300 ft<sup>3</sup>/s. (ucar.edu)

**Figure 131 .South Platte River Flood, 1965, flooding at Interstate 25, Denver, CO  
Source: U.S. Army Corps of Engineers**

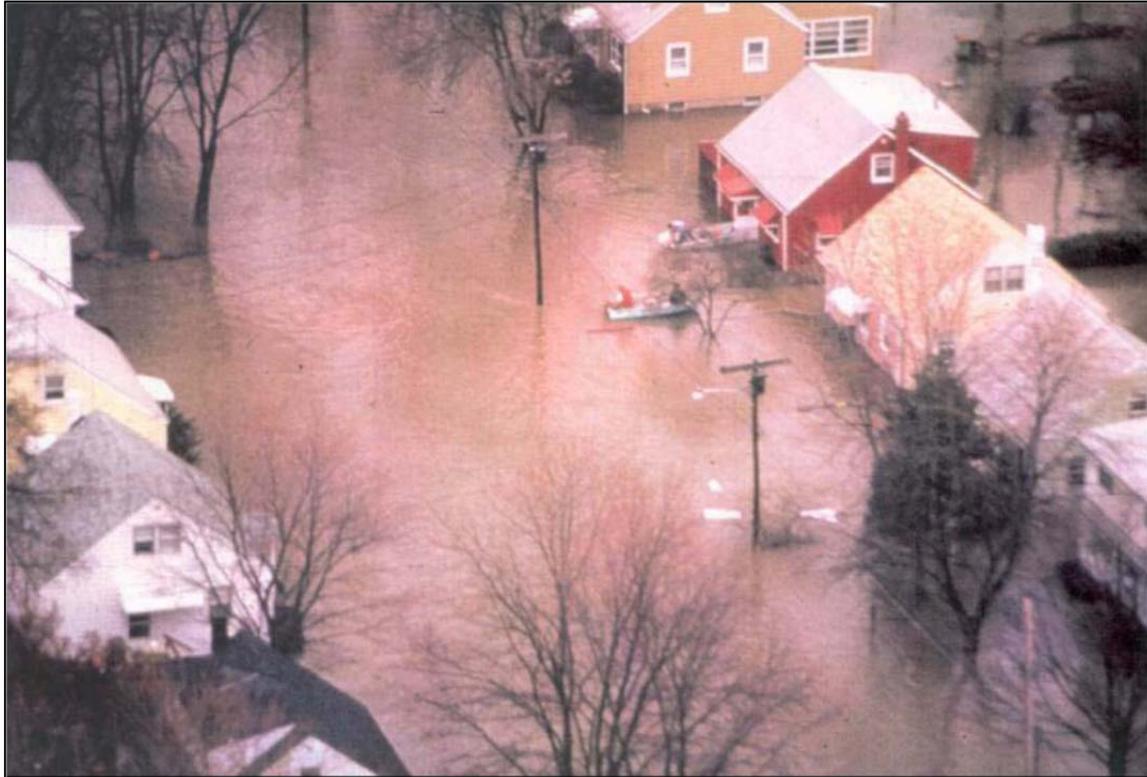
Figure 132. Passaic River Basin Flood, 1984, residential flooding  
Source: U.S. Army Corps of Engineers

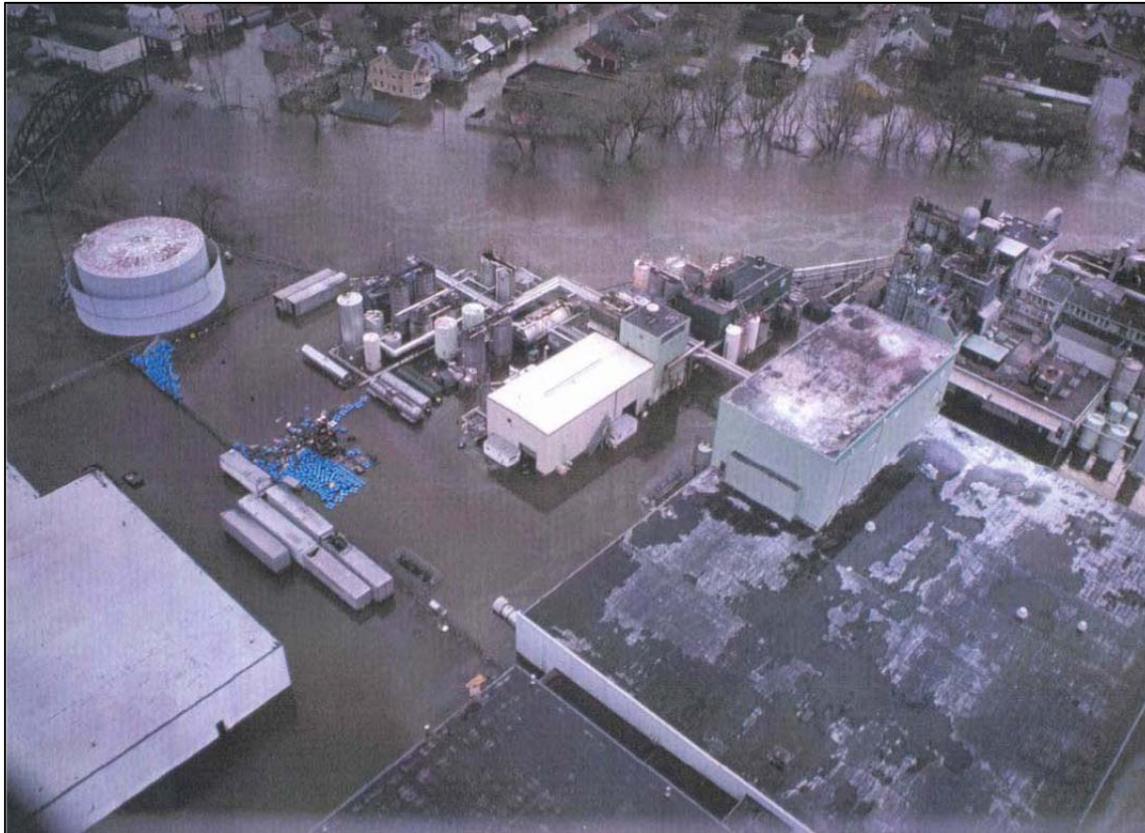
**Figure 133. Passaic River Basin Flood, 1984, Paterson City industrial facility**  
Source: U.S. Army Corps of Engineers

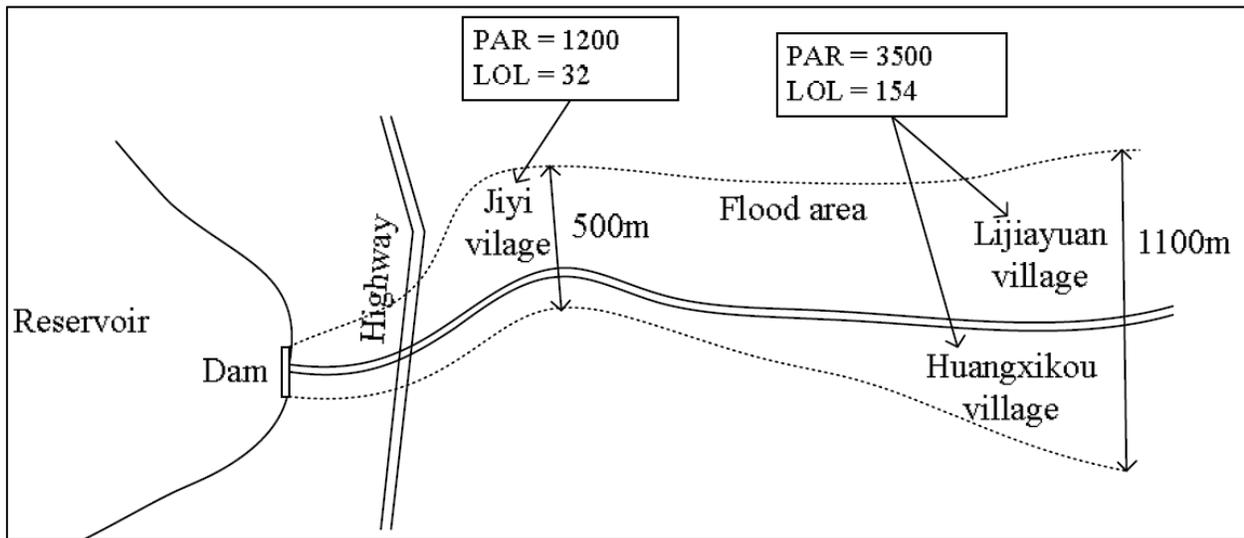
Dongkoumiao Dam located at Xidian Town, Ninghai County, Zhejiang Province, China. Construction of the dam was completed in 1959. The dam had a height of 71 feet, and a reservoir capacity of 2,067 acre-feet. Donkoumiao Dam failed at 5:50 to 5:55 am on June 2, 1971 due to internal erosion. The peak discharge at the dam site was estimated as 49,400 ft<sup>3</sup>/s. Three villages, Jiyi, Lijiayuan and Huangxikou, were located downstream of the dam. Jiyi village was 0.3 to 0.6 miles downstream and had a population of 1,200; Lijiayuan and Huangxikou village were 0.9 to 1.2 miles downstream from the dam and had a population of 3,500. The dam failed in the early morning, few signs were observed, and no warning was issued to the people downstream. Zhou (2006) performed dam break flood routing with FLDWAV; the hydraulic results have been used to estimate DV.

Figure 134. Areas downstream of Donkoumiao Dam  
Source: Image courtesy of L.M. Zhang

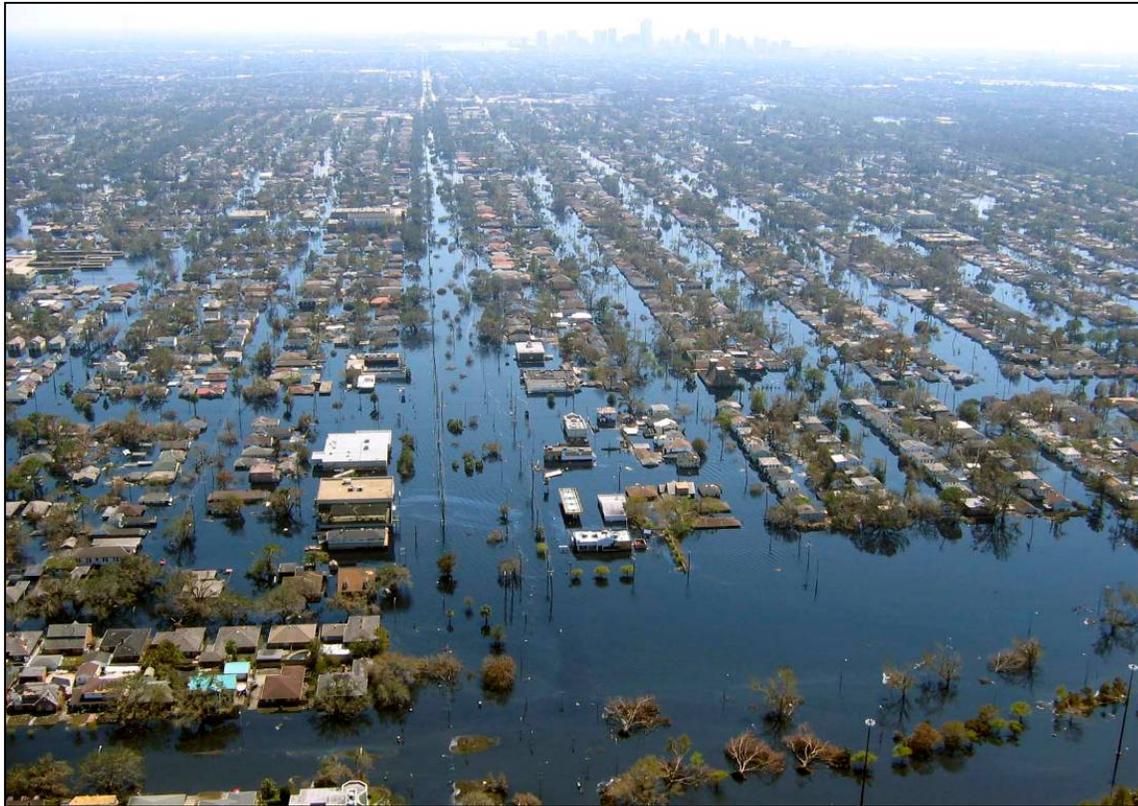
The highest fatality rates computed in the metropolitan area were in the St. Bernard bowl (Lower 9<sup>th</sup> Ward), which had rates of 5% to 7%. This is a low lying area that was near two large breaches in the levees. In the Lower 9<sup>th</sup> Ward, the two large breaches allowed water to enter the area with great force, causing many buildings to collapse.

**Figure 136. Flooding from Hurricane Katrina**  
Source: NOAA

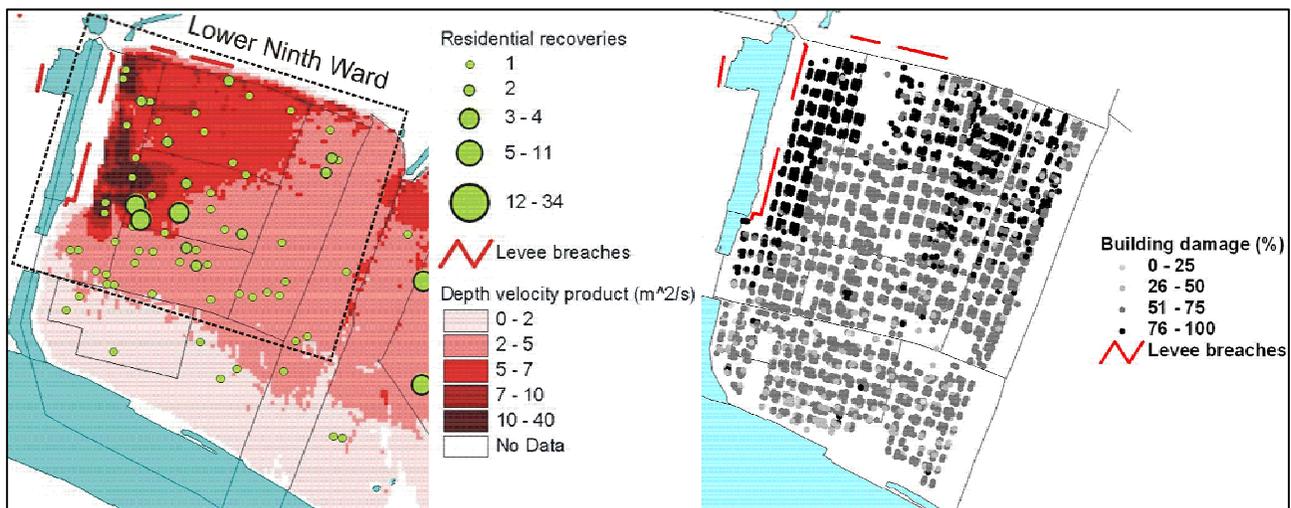
The paper: “Loss of Life Caused by the Flooding of New Orleans After Hurricane Katrina” performed hydraulic re-creation and examined life loss at three locations in New Orleans. These locations were: the Lower Ninth Ward, the Metro Bowl and the East Bowl. Information regarding these findings are presented in Table 63.

**Figure 137. DV, fatalities, and building damage in the Lower Ninth Ward (fatalities referred to as recoveries)**  
Source: Courtesy of Bas Jonkman

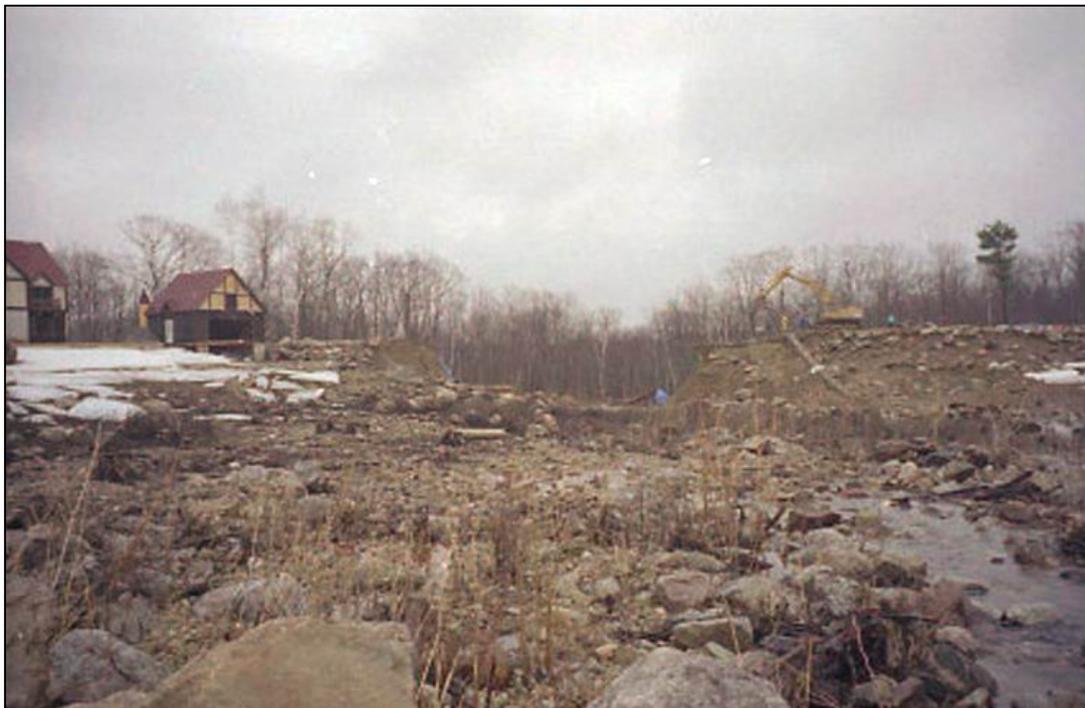
About a quarter-mile of Route 140 was damaged. The flooding also caused power outages in Gilmanton, Belmont, and Alton. Subsequent investigations by the state-appointed civil engineering firm, GEI Consultants indicated the failure was caused by a combination of design and construction deficiencies. The design did not adequately account for the cold weather conditions, and mistakes in construction greatly exacerbated the errors.

**Figure 138. Remains of Meadow Pond Dam**
