Failure of Radial (Tainter) Gates Under Normal Operational Conditions

Best Practices in Dam and Levee Safety Risk Analysis

Chapter G-1

Last modified June 2017, presented July 2019

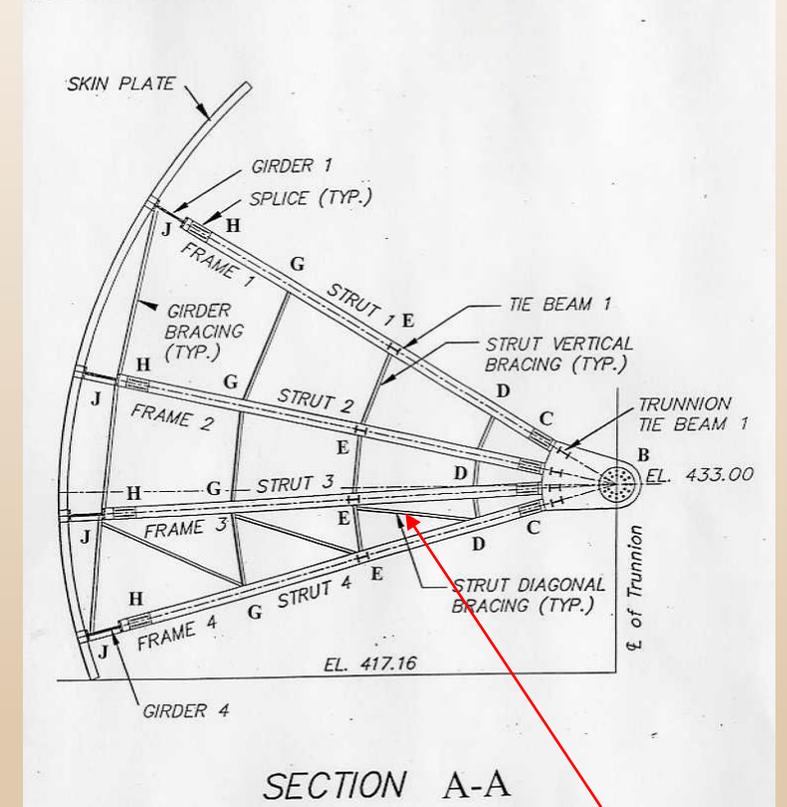
FORENSIC INVESTIGATION: IDENTIFICATION CODE FOR GATE CONNECTIONS

- Spillway has eight spillway Tainter gates (5 service, 3 emergency)
- Gate No. 3 failed suddenly on 7/17/95 with reservoir full
- Uncontrolled release peak – 40,000 ft³/s
- Failure started at lower strut brace, proceeded to adjacent braces and then arms buckled (determined to be trunnion pin friction)
- Contributing factors
 - Spillway gates weren't designed for trunnion friction loads
 - Large, hollow pin (32" diameter)
 - Reduced frequency of lubrication and lack of weather protection at ends of pin resulted in corrosion and increased friction over time
 - Struts 3 & 4 post failure evaluation led to conclusion about failure sequence

Initial Failure

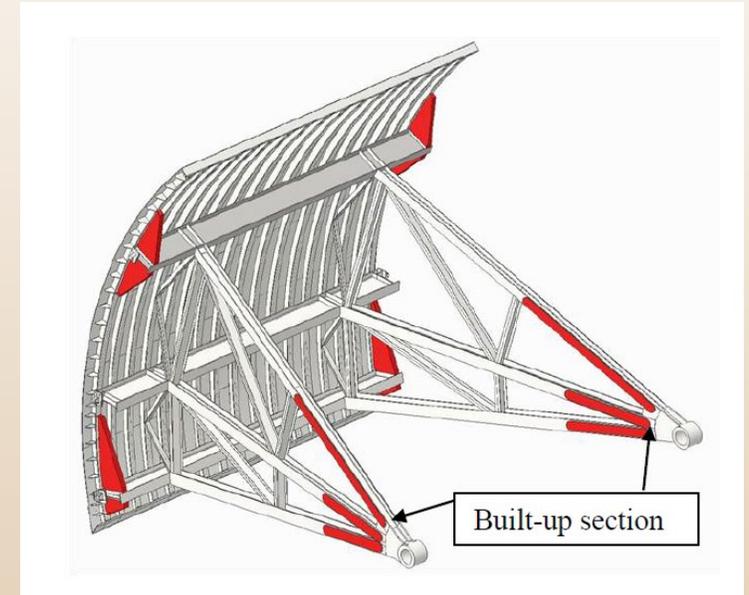
Strengthening (Red Highlights) of Fall Creek Dam Spillway Gates

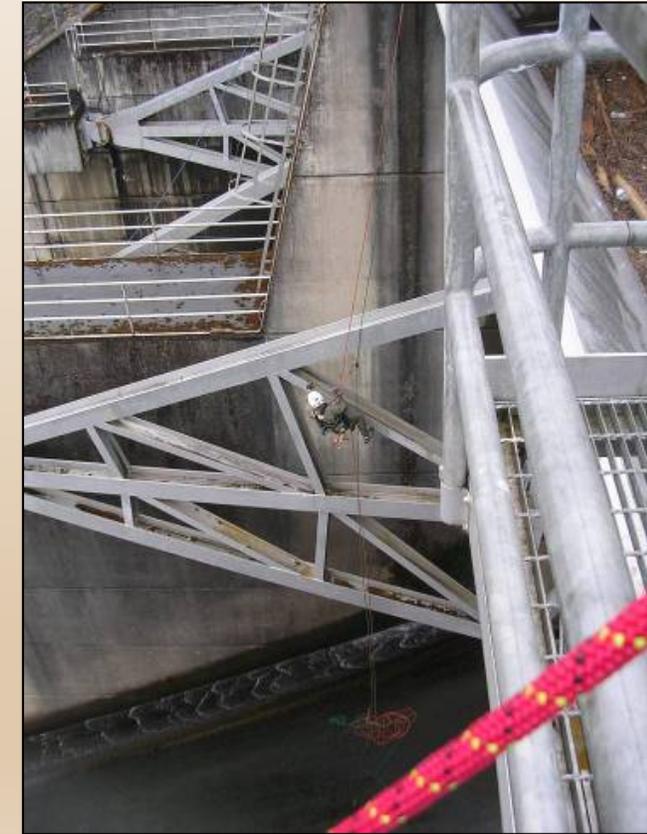
July 2008 – Climbing inspection of gates 3 & 4

- Top strut arms and diagonals showed signs of distress.

Evidence of Buckling of Strut Arms at Foster Dam

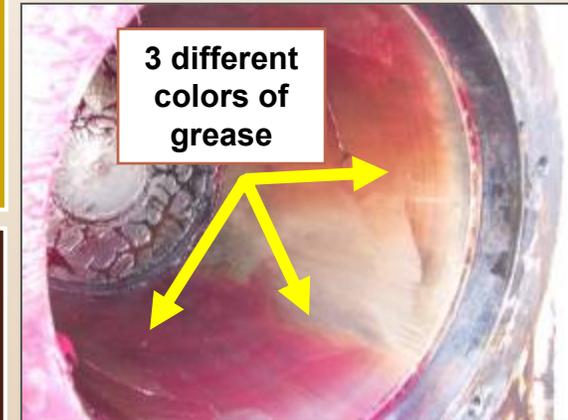
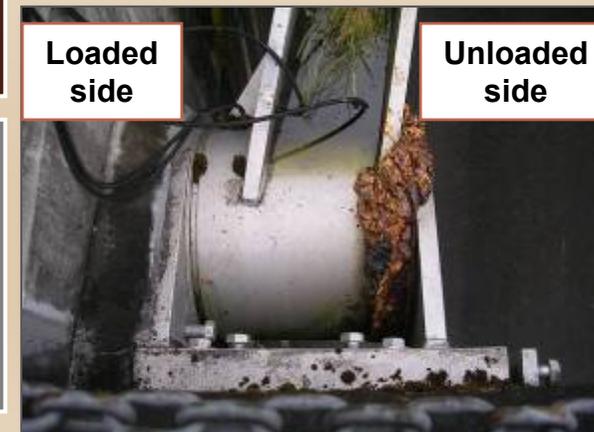
- Debris damage
- Gates have been operated at full pool for the last two years (powerhouse downtime prompted spill from Tainter gates).
- Deformations were load-induced

Foster Dam: Emergency – Change in Operation

Lower Pool to 622' (limit load on top strut)

Ranked gates according to condition for priority of use until repairs could be implemented

- Gate 3 – worst damage to struts – do not use
- Gate 1 – damage to struts – do not use
- Gate 2 – some damage to struts - restricted
- Gate 4 – some damage, restricted

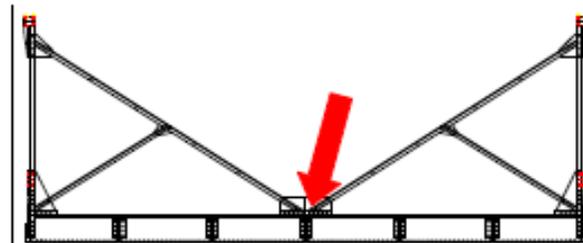
Photo 90: Gate 4 – Heavy corrosion of top horizontal center gusset plate. Up to 100% section loss on downstream edge of plate. Up to 100% section loss of rivets. Welded diagonal strut connections heavily corroded.

- The gates did not meet current criteria with regard to single sided hoisting operations, stall torque, trunnion friction, and/or impact.
- All gates replaced in 2014
