# Failure Thresholds of RCC Crest Caps

**Technology Development Program**  
**Dam Safety Office, Dam Safety and Infrastructure**  
**Final Report DSO-2023-01**

Umbarger Dam is a 13.2-m (43.3-ft) high dam on Tierra Blanca Creek in Randall County, Texas, about 16 km (10 miles) upstream and west from the city of Canyon, Texas, population 15,650 (Figure 1). The dam was originally constructed in 1938 by the Public Works Administration and Works Progress Administration as a homogeneous embankment with a height of 15.5 m (51 ft). Materials in the original dam are described as well-compacted sandy clays and lean clays with 75 to 85 percent medium plasticity fines and a plasticity index ranging from 12 to 19. The dam is now owned by the U.S. Dept. of the Interior, Fish & Wildlife Service (FWS) and is a principal feature of the Buffalo Lake National Wildlife Refuge. To address dam safety concerns, the dam was modified in 1993, reducing the crest elevation by 2.4 m (8 ft) and adding roller-compacted concrete (RCC) armoring to the crest and downstream slope (Figure 2). The existing spillway was abandoned and partially covered by the new overlay, since the modified dam was meant to serve as i

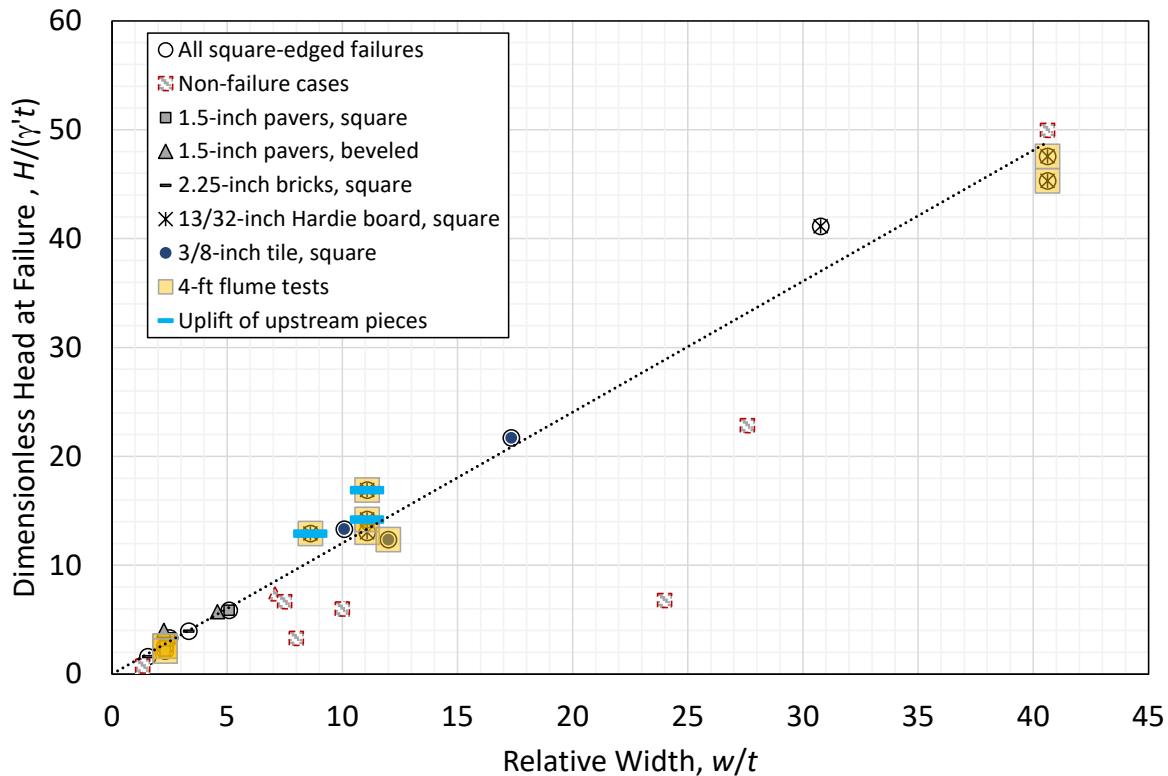
**Figure 10:** Relative failure head vs. relative width. Cross-hatched symbols with dashed red edges are cases that did not fail. (Dimensions in legend are material thickness in inches. 1 inch=25.4 mm)

A total of 25 tests were conducted with non-sealed downstream edges, and the results are plotted in Figure 10. Materials included 9.5-mm-thick ceramic tile, 10.3-mm Hardiebacker board, 38- and 40-

Flow capacity and tailwater control limits of the laboratory facilities prevented achieving failure in 8 tests. Failure occurred in 17 tests, with 3 of those tests involving crest caps that were composed of two separate pieces divided by a simulated longitudinal crack. For the 14 sliding failures, the dashed line in Figure 10 representing the failure threshold relationship is defined by the equation  $H/(\gamma t) = 1.19(w/t)$ . Although the initial failure mechanism was uplift, as shown in Figure 9, this occurred at a similar head threshold as predicted by the relation for sliding failures of complete blocks.

The tests performed with downstream edges sealed by duct tape are not included in Figure 10; the failure heads were very small, but this failure mode is not believed to realistically represent real-world conditions, since the downstream edge of the cap is never sealed.

Two of the tests included in Figure 10 used beveled-edge blocks cut to match the profile of the finished RCC lift faces at Umbarger Dam. These tests showed that the bevels had only a minor effect compared to square edges and tended to provide greater block stability.

The crest-width to lift-thickness ratio for Umbarger Dam is  $w/t = 25$ . Figure 10 suggests that an overtopping head of about 30 ft is needed to produce sliding of an intact top lift of the dam. This is a significantly higher failure threshold than predicted by previous analyses. As discussed, this is

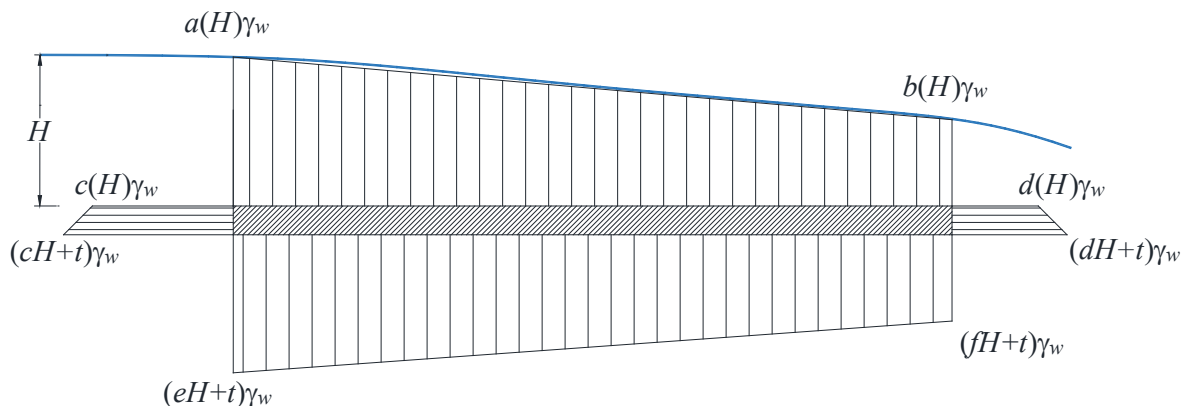
**Figure 11:** Sketch of pressure distributions applied to RCC crest cap lift. Coefficients  $a-f$  can each vary from 0.0-1.0. The blue line illustrates an approximate water surface profile.

To resolve this question the previous analyses were revisited by considering the forces on the top RCC lift as a free body, with the pressure distributions against all faces of the lift defined as linearly varying fractions of the upstream reservoir head (Figure 11). Coefficients defining the relevant fractions are indicated by the parameters  $a-f$  in Figure 11, which can each be varied from 0.0 to 1.0. Pressure forces against the upstream and downstream faces are assumed to be hydrostatic (coefficients  $c$  and  $d$ ), while the uplift pressure below the slab and the weight of water above the slab are each assumed to vary linearly from upstream to downstream, as defined by the variables  $a$ ,  $b$ ,  $e$ , and  $f$ . Tractive force (fluid drag) along the top surface of the slab is neglected, since rough estimates indicated such forces to be near zero.

Programming the equations for these pressure distributions into a spreadsheet model, the thresholds of sliding failure and uplift/rotation failure can be computed as the variables  $a-f$  are adjusted. The 2011 and 2016 analyses were based on assumptions of full reservoir uplift at the upstream bottom edge, and critical depth at the downstream bottom edge; full reservoir hydrostatic pressure on the upstream face; hydrostatic pressure equal to critical depth applied to the downstream face; and weight of water equal to critical depth over the full length of the top surface. Setting the values of  $a-f$  to match these assumptions ( $a, b, d, f = 0.667$ ;  $c, e = 1.0$ ) causes the uplift/overturning failure mode to control, with a low failure threshold of about  $H/(\gamma' t) = 6$ , independent of  $w/t$  for large values of  $w/t$ .

Observations of the tests suggested that head applied to the upstream edge of the crest cap was slightly less than full reservoir head, while head applied to the downstream edge was less than critical depth (i.e., supercritical flow at the downstream edge of the crest). A plausible set of coefficients consistent with these observations was constructed, with  $a = 0.95$ ,  $b, d, f = 0.6$ ,  $c = 0.98$ , and  $e = 0.96$ , and the sliding and uplift/overturning failure thresholds were recomputed (see Figure 12). With the adjusted coefficients, the uplift/overturning failure threshold increases dramatically, and the sliding failure mode controls for all but the smallest values of  $w/t$ . The predicted failure threshold curve exhibits a linear increase with the  $w/t$  ratio, similar to the results of the physical model tests. This result is very sensitive to the values of  $a$  and  $e$ , the coefficients defining the pressure distribution at the upstream bottom edge of the slab and the weight of water applied to the upstream top edge. These locations have the longest moment arms and thus have the most influence on the overturning failure mode. Specifically, the result is sensitive to the difference  $e-a$ , which must be positive for overturning failure to occur.

To represent the tests conducted with the duct-tape-sealed downstream edge, the value of  $f$  (pressure applied to bottom face at downstream corner) can be set to 0.96, matching the value of  $e$  (pressure at the upstream bottom corner). With only this one change, the uplift/overturning failure mode threshold is again quite low, approximately  $H/(\gamma't) = 10$ , almost independent of  $w/t$ . This is consistent with the results of the physical model tests.

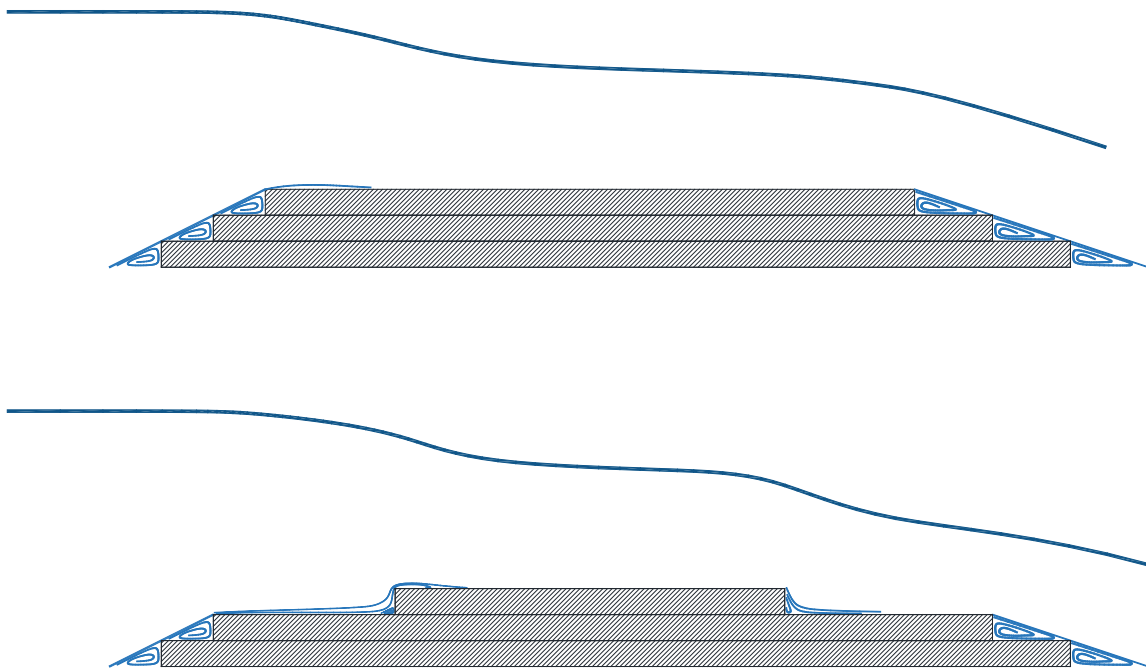
**Figure 13:** Illustration of changes in flow structure when crest cap lifts are aligned (top) or not aligned (bottom) with the upstream and downstream dam face slopes.

In the wider flume, limited tests were conducted of square-edged lifts that were intentionally made too narrow for the crest of the dam, so that either the upstream or downstream edge was not aligned with the prevailing slope of the lower body of the dam. Both situations led to failure by sliding at much lower overtopping heads. This is believed to be due to a change in the structure of the vortex that forms in the corner of the step, as illustrated in Figure 13. The vortex typical of the aligned-step condition apparently reduces the fraction of reservoir head that penetrates the upstream seam and may also increase the tendency for uplift pressure to be relieved at the downstream edge of the seam. When the top lift is narrower than the width that would maintain the prevailing slope (as shown in the bottom of Figure 13), the separated flow region in the step cavity is reduced or eliminated, with the result being higher pressure in the seam between the lifts, which reduces the stability of the top lift.
