Testing of Commonly used Fish Screens for Resistance to Invasive Mussel Fouling

Research and Development Office
Science and Technology Program
Final Report ST-2016-5740-1

HL-2016-03

September 2016

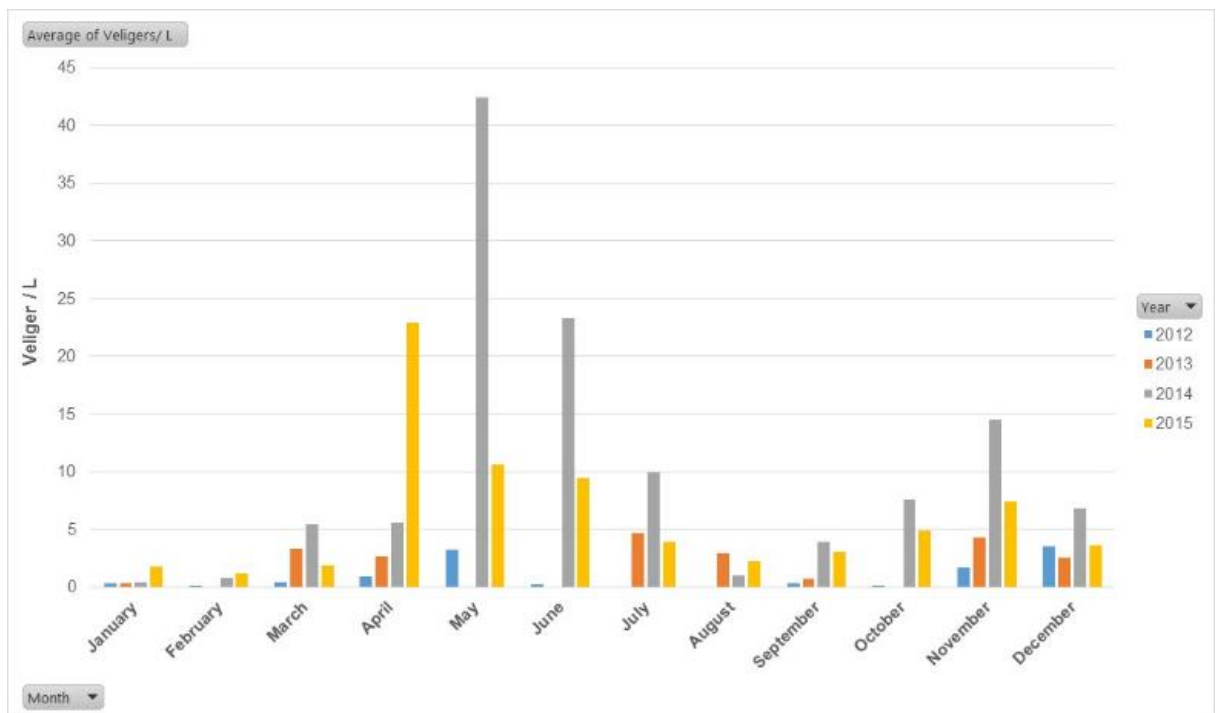
Testing was conducted over approximately 4 ½ years (Figure 13) to observe mussel impacts on each fish screen system over multiple reproduction cycles. Quagga mussel reproduction typically increases in spring and fall at Lake Mead (Holdren *et al*, 2012) and a similar trend was found throughout the test period of the current study (Figure 14). Water temperature was monitored throughout the entire test period as very warm temperatures (approximately 86°F) may prevent mussel settlement (Wong *et al*, 2012). Figure 13 shows daily average water temperatures at 10 ft below the surface which approached that threshold every summer in the 4 ½ year test period. The summer of 2012 was especially warm which may have contributed to a mussel die-off observed at the test facility during that time. This die-off was also indicated by the noticeable drop in veliger counts during June of 2012 (Figure 14).

Figure 14 Veliger count data from 2012 to 2015 taken at the buoy line at Hoover Dam, not far from the test location (Reclamation Detection Laboratory for Exotic Species, Denver, CO).

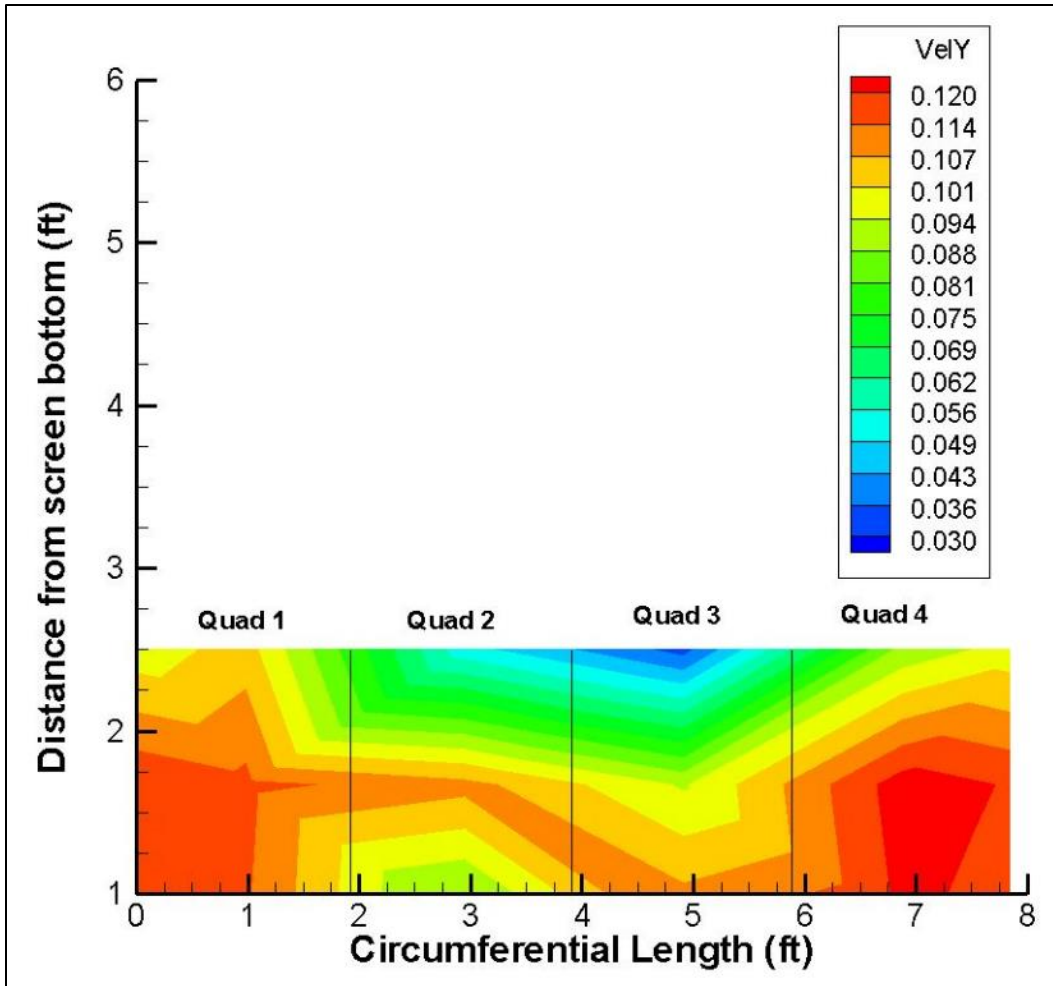
Acoustic Doppler Velocimetry (ADV) measurements were made around the outside circumference of the ISI screen to determine flow through the screen and identify areas that may have been clogged. Figure 23 shows approach velocities that were taken at four locations around the cylindrical screen in August 2014. The plot of the cylindrical screen is laid out linearly with four quadrants where measurements were made (circumferential length of 0 and 7.8 ft are the same location). While velocities were not perfectly uniform, they do show that the majority of the screen was not clogged as evidenced by approach velocities above 0.08 ft/s over the majority of the screen area. The average velocity was 0.096 ft/s which translates to a flowrate of approximately 1.9 ft³/s. Again, there are no baseline data without mussels for comparison.

Figure 23 Interpolated contour plot of approach velocity data of the ISI cylindrical screen. Measurements were taken at 4 locations around the screen (3 depths per location, 12 measurements total).

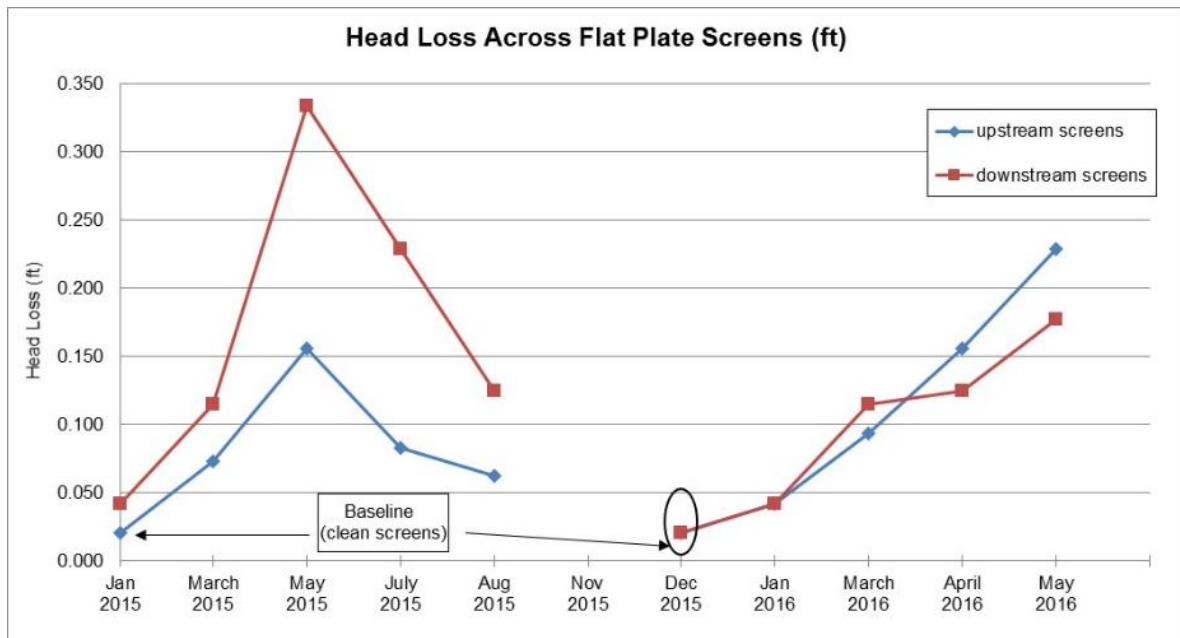
Flow depths in the channel were measured upstream and downstream of each row of screens to determine the change in screen head loss over time. Figure 30 shows minimal head loss at baseline conditions and then a steady increase in head loss for both rows of screens through May for testing in 2015 and 2016. This trend is consistent with increasing veliger counts (Figure 14) through the spring months as well as visual observations.

Figure 30 Head loss measurements across the 1st row (upstream) and 2nd row (downstream) of flat plate test screens from January 2015 through June 2016.

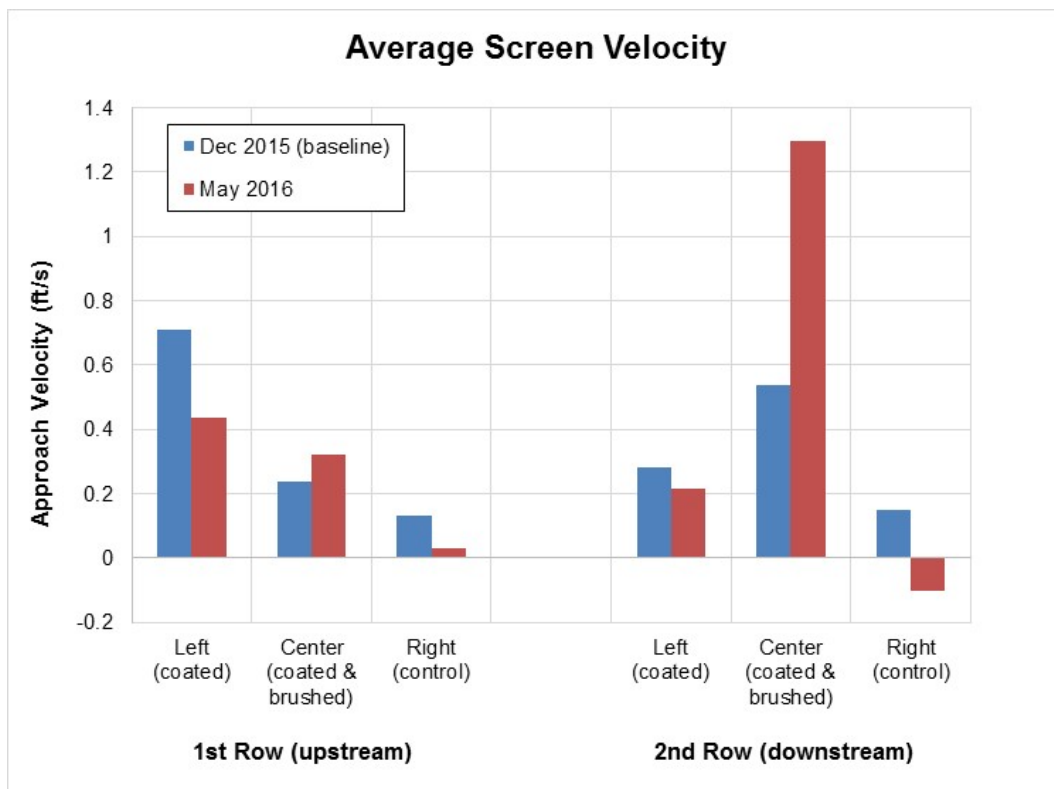
Figure 31 compares velocities with clogged screens to their baseline condition. Velocities were measured approximately 3 inches upstream of the 1st row of screens and 4 inches downstream of the 2nd row of screens (space limitations prevented measurements upstream of the 2nd row). Despite having a baffle in the upstream test channel to help provide uniform flow, baseline velocities were skewed to the left side. Velocities measured in May show a decrease through the screens that were not cleaned (especially the control) and an increase through the center screen that had been consistently brushed. The 2nd row produced similar results with decreases in flow through the unclogged screens and a significant increase through the brushed screen in the center. The flow reversal at the downstream control screen is likely a reverse eddy on the downstream side of the screen where the measurement was made and indicates that the screen was completely clogged.

Figure 31 Comparison of average approach velocity measurements through the flat plate test screens from Dec. 2015 (baseline) to May 2016. Screen layout is shown in Figure 12

Again, these results suggest that even in an environment of heavy biofilm and mussel fouling, screen operation can remain effective if the cleaning systems operate correctly and consistently as designed. However, screens will quickly become clogged and ineffective if cleaning is neglected.
