UNITED STATES
DEPARTMENT OF THE INTERIOR
BUREAU OF RECLAMATION

EROSION TESTS ON NARROWS DAMSITE FOUNDATION
SAMPLE NO. 9B-1040 TAKEN FROM TEST PIT NO. 3
AT AN ELEVATION OF 4373.7 FEET--EMERGENCY
SPILLWAY--NARROWS DAM--MISSOURI RIVER BASIN

Hydraulic Laboratory Report No. Hyd.-265

DECEMBER 2, 1949

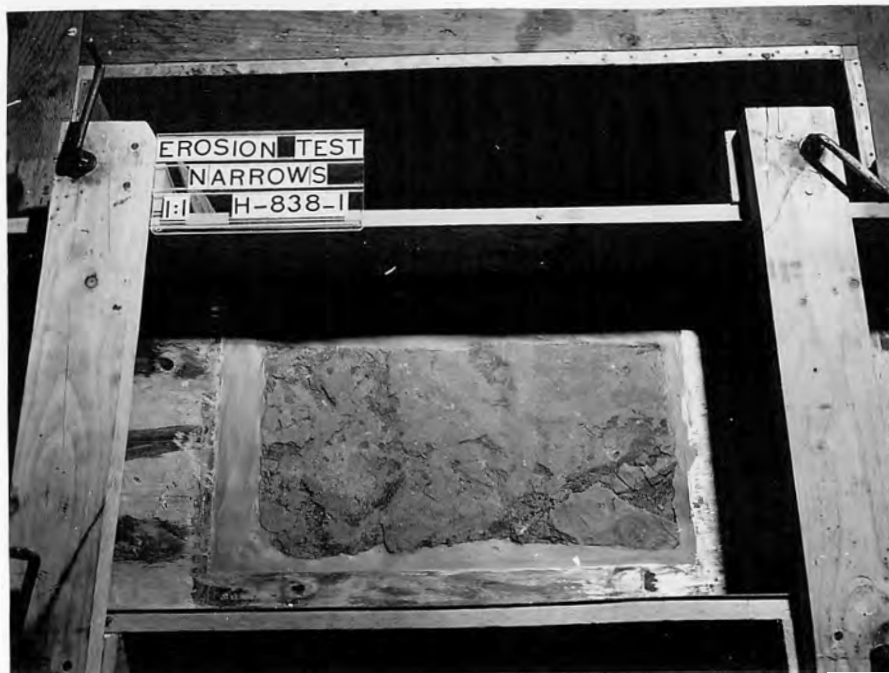
A. Appearance of Test Specimen No. 1 before start of erosion tests.

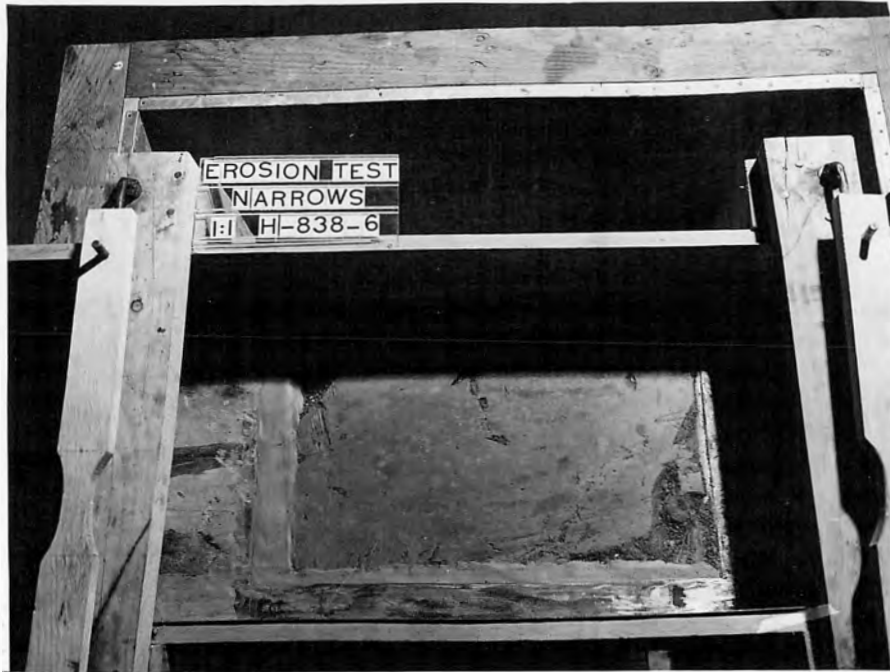
After completing the 8-foot per second test, the surface of the specimen was raised 2 inches above the chute floor and then cut and trimmed down to the floor level, thereby obtaining a smooth surface (Figure 5A). Water was passed over this new surface at velocities ranging from 12 to 16 feet per second for a total duration of 3 minutes. Considerable clay was dislodged from the specimen, most of it being in irregular pieces 2 to 3 cubic inches in volume. The maximum depth of erosion was 2-3/4 inches while the average depth was 1-1/4 inches. One portion of the specimen, however, remained unaffected by the flow (Figure 5B).

A. Appearance of Test Specimen No. 1 after being trimmed 2 inches to a new surface for high velocity tests.
