UNITED STATES DEPARTMENT OF THE INTERIOR BUREAU OF RECLAMATION

HYDRAULIC LABORATORY TESTS OF SEALS FOR HIGH-HEAD COASTER AND FIXED WHEEL STRUCTURAL STEEL GATES

Hydraulic Laboratory Report No. Hyd. -311

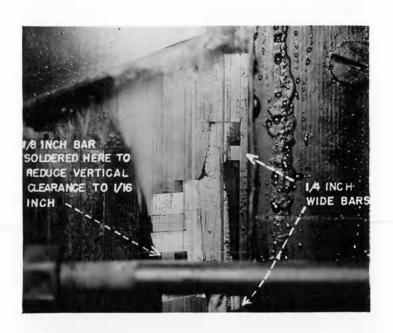
B. Seal in retracted position at 195 feet head with bars in place, intended to stop stem buckling.

Operation of Double Stem Seal without Stem Attaching Screws--**Design No.** 1; 1/8-inch Seal-to-Seat Gap.

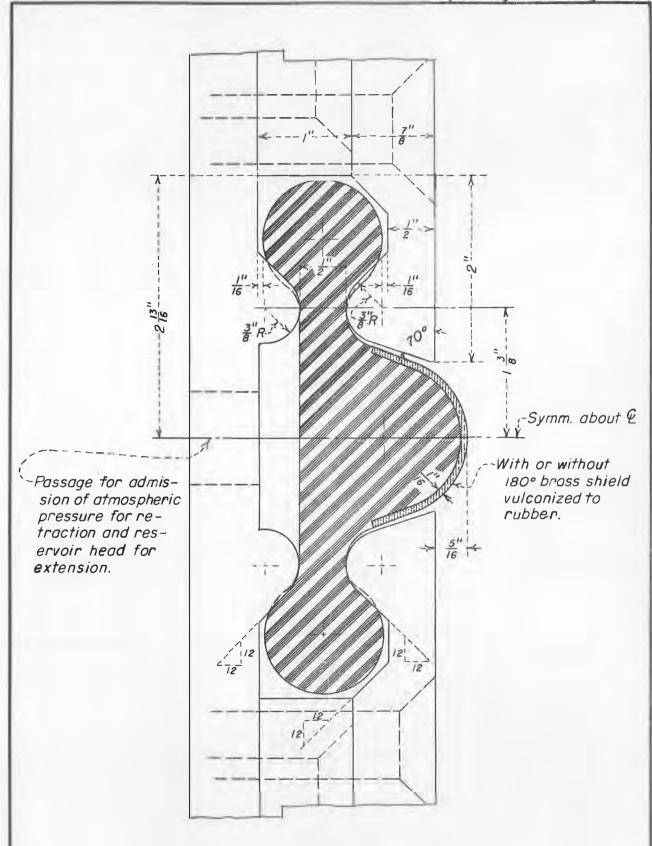
A preliminary design of this seal assembly is shown in Figure 42. As shown, the seal stem ends include an integral circular-shaped section that fits into a groove in the adjacent steel parts, and thus prevents the seal stem from buckling. The two grooves, one for each circular section, are separated sufficiently to put a small, initial tension stress in the seal stems. The maximum section dimension of this seal is somewhat less than the double-stem seal with stem-attaching screws (Figure 43). The bulb section of this seal is less of a half circle than the bulb section of the seal with stem-attaching screws which reduces the amount the bulb can extend. However, limited bulb extension is generally desired for seals operated with continuous extension of the bulb, because too much bulb extension will permit the bulb to become pinched more easily on the upper corner of the seat bevel.

DOUBLE STEM SEAL WITHOUT STEM ATTACHING SCREWS

DESIGN NO. 2 - PRELIMINARY

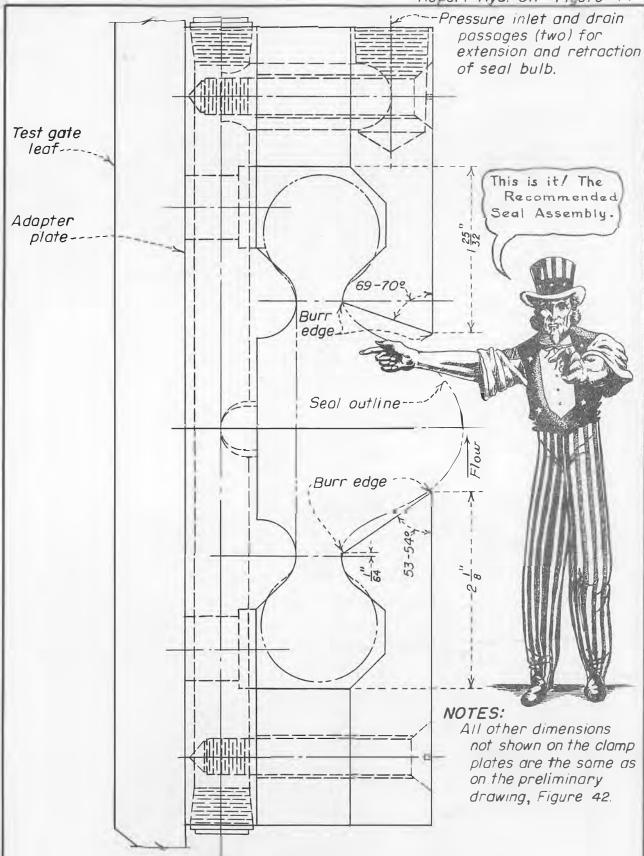
HIGH HEAD GATE SEAL STUDIES
DOUBLE STEM SEAL WITHOUT STEM ATTACHING SCREWS DESIGN NO. 2-TEST GATE ASSEMBLY - RECOMMENDED DESIGN

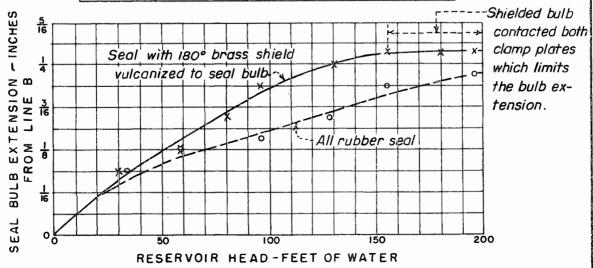
SEAL BULB EXTENSION VERSUS RESERVOIR HEAD
DOUBLE STEM SEAL WITHOUT STEM ATTACHING SCREWS - DESIGN No. 2

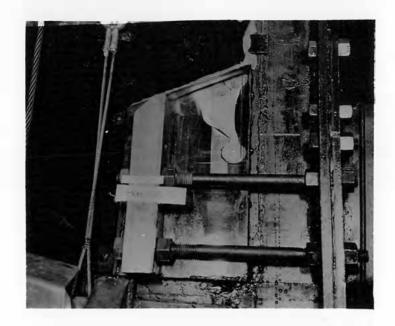
A. Seal with 180 degree brass shield, raised above seat. Bulb was wedged between clamp plates at 160 feet head or more when bulb was extended.

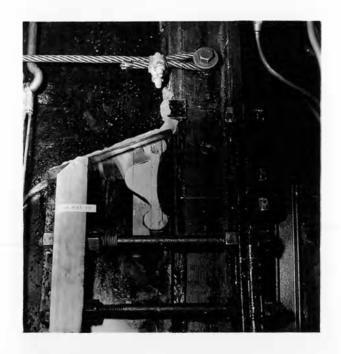
B. Seal without a brass shield and zero seal-to-seat gap. With bulb extended during gate closure, bulb was not pinched at 195 feet head.

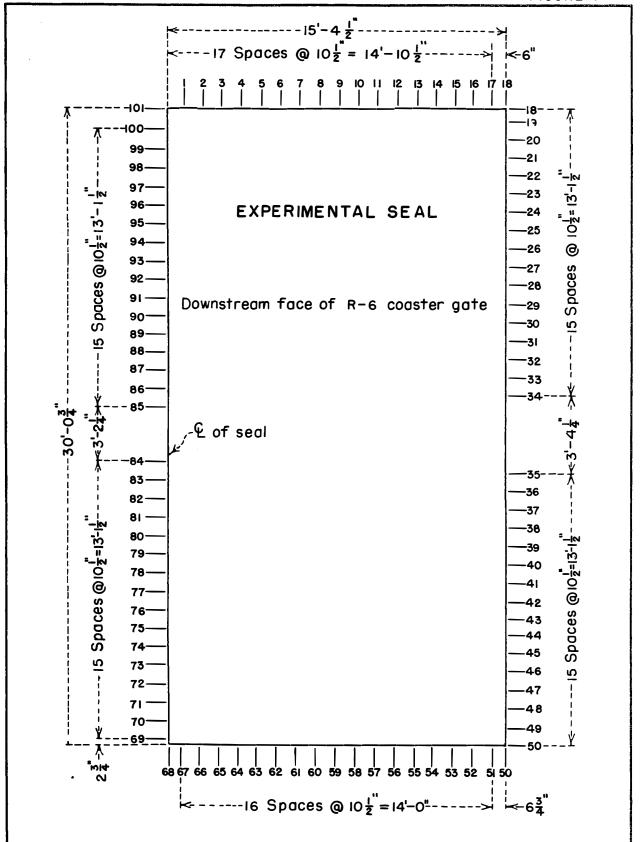
- 2. After the installation of the seal was completed, clearance readings were taken on the seals at the points indicated on Figure 1. Readings on the vertical seals were taken with a gage inserted between every other pair of rollers using the roller track for a reference plane as shown in photograph No. 3-22819. A wire was strung parallel to the top and bottom seals and the clearance readings taken between the seal and the brass seal seat on the dam is 1/16 inch (+0, -1/16") as shown on Drawing No. 222-D-9732, but this was not attained on all parts of the seals. See figures 3 and 4 for the readings obtained.

POSITIONS AT WHICH SEAL CLEARANCES WERE MEASURED

SEPTEMBER 14, 1950

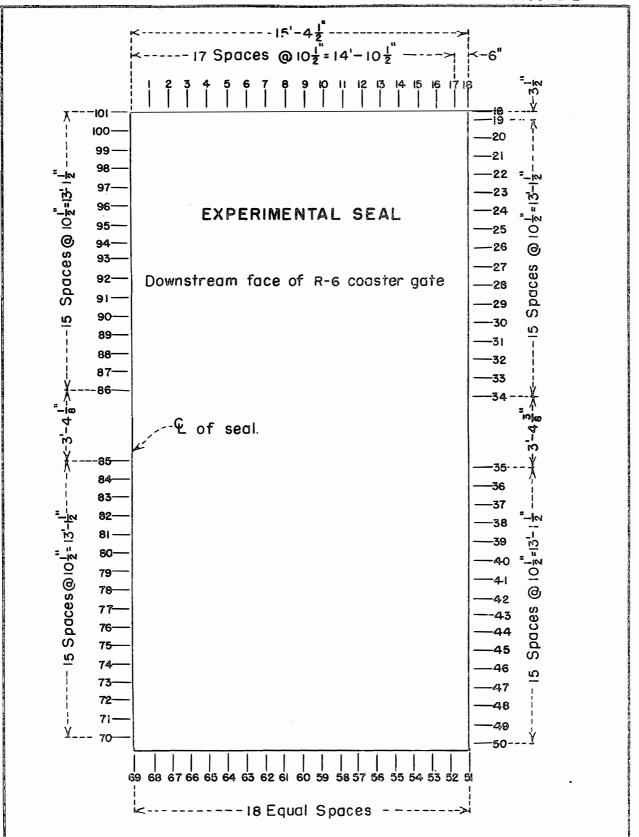
Figure 3

- 2. Another set of seal clearance readings, similar to those taken before installation of the gate, were taken. Using the gage inserted between a pair of rollers and using the roller track as a reference plane, readings (See Figures 3 and 4) to the vertical seals were taken but not at the same locations as previously, because the roller chains could not be rotated as was mentioned in paragraph A-2.
- 3. The average seal clearances both before and after the closure tests are shown below, also shown is the average change in the seal clearances during the tests. The normal recommended clearance between the seal and the seal seat on the dam is 1/16 inch (+0, -1/16-inch).

POSITIONS AT WHICH SEAL CLEARANCES WERE MEASURED OCTOBER 11, 1950

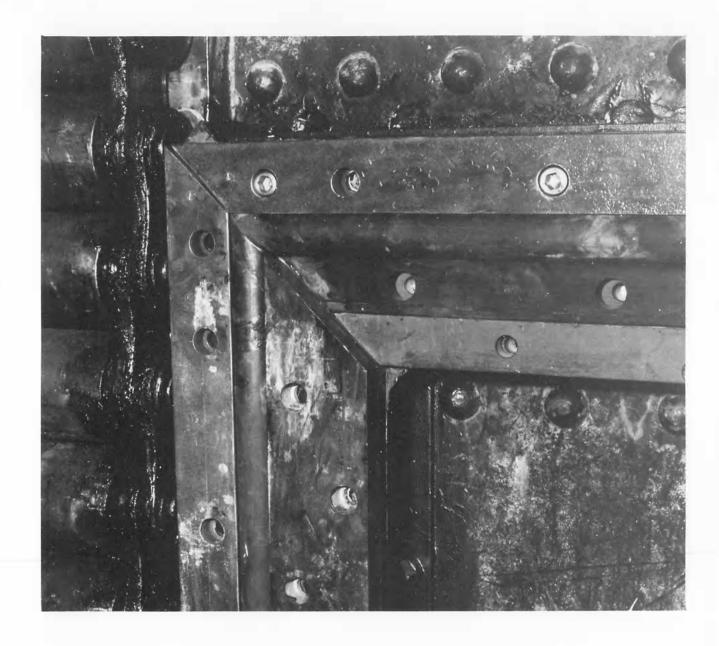
- 2. Removal of the coaster gate was accomplished on August 25, 1950. The seal bases were removed and then taken to the machine shop for alteration in accordance with Drawing No. 222-D-15067. The roller chains were noted to be in an inoperable condition at this time due to corrosion. (See photograph No. 3-22706.) The chains were removed from the gate,

The roller chains appeared to have functioned satisfactorily, however, this might not have been true if the chains had not been worked over prior to the test. It is felt that this vital portion of the gate should be made of corrosion resistant steel.

R-6 coaster gate (formerly L-3) lower right roller chain. Photo shows corrosion of the steel chain links. This gate was in service from June, 1941 until November, 1949, and from April, 1950 until August, 1950. The chains are in an inoperable condition, and it may be noted that their sliding action in operation has slightly flattened the contact surface. After removing the rust from the links, many pits were found to be in excess of 1/16 " in depth. August 30, 1950.

soaked in solvent, and worked by mechanical means until each roller and link was free to move. The links were treated with Texaco Type L rust preventive compound before the chains were reinstalled on the gate. After installing the chains on the gate, it was just possible to rotate them using an air tugger which exerted a 1-ton pull. After completion of the tests, the chains could not be rotated using the same pull. The probable reason for the high resistance to rotation is that this coaster gate was equipped with roller chains having unbalanced or double links, whereas subsequent coaster gate chains incorporated the balanced or triple type links.

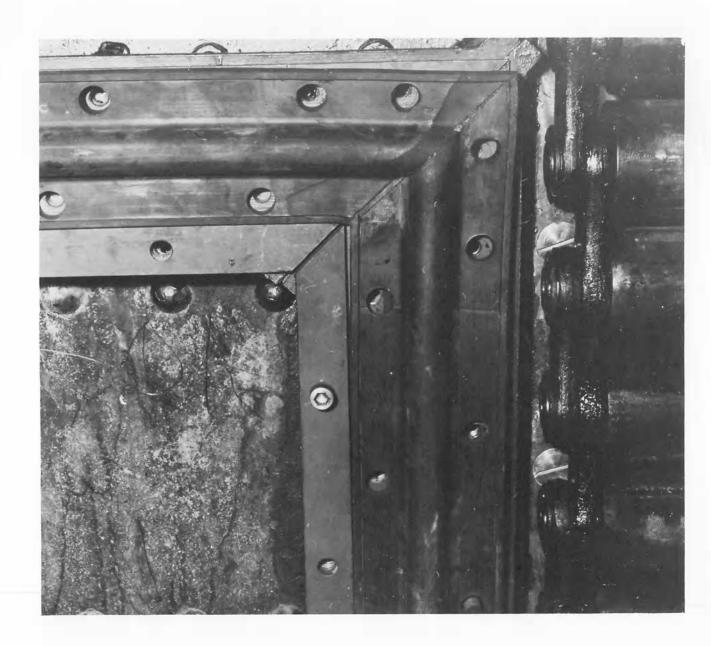
The R-6 coaster gate which was formerly installed in L-3 and furnished under Specifications No. 905, showing installation of the experimental seal (Reference Drawing No. 222-D-15067). This close-up shows the top left corner of the seal during installation of the clamp bars. September 13, 1950.

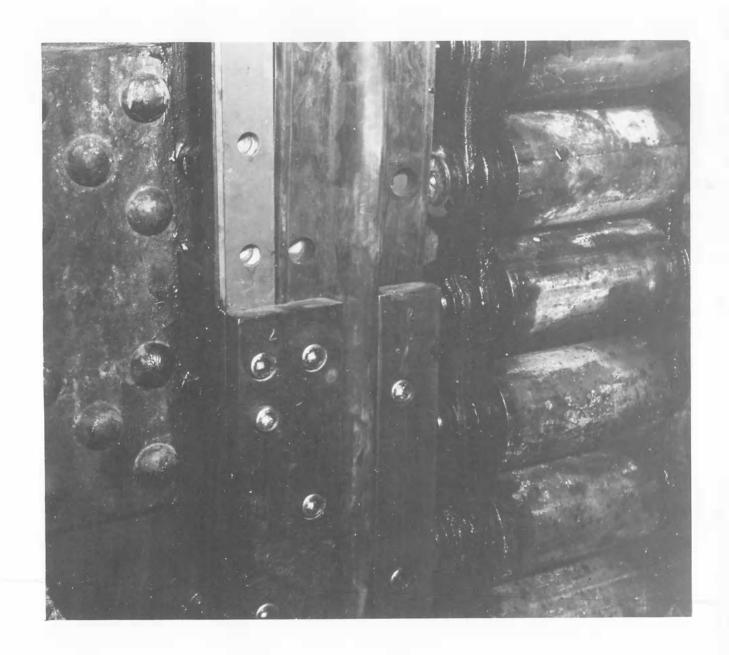
The R-6 coaster gate which was formerly installed in L-3 and was furnished under Specifications No. 905, showing installation of the experimental seal (Reference Drawing No. 222-D-15067). This close-up shows the top right corner after the completion of field vulcanizing. September 13, 1950.

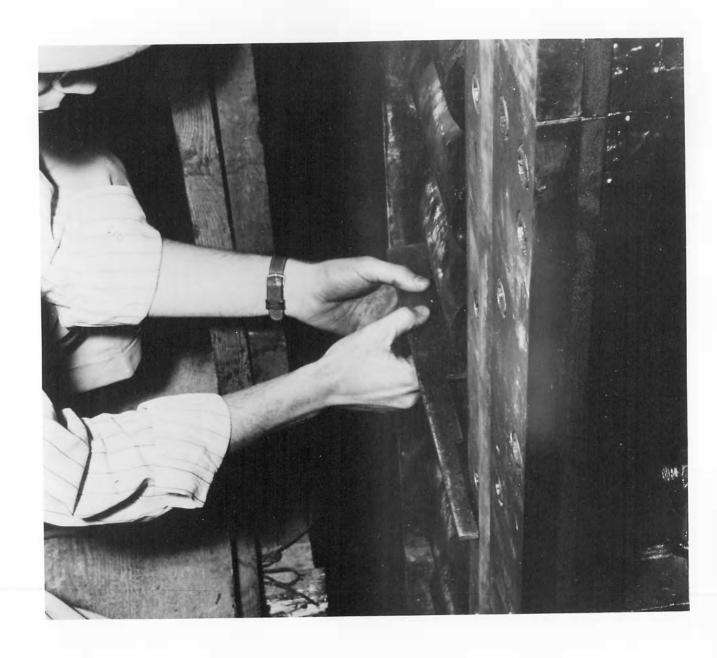
The R-6 coaster gate which was formerly installed in L-3 and was furnished under Specifications No. 905, showing installation of the experimental seal (Reference Drawing No. 222-D-15067). This view of the seal was taken of the upper right hand side of the gate. September 13, 1950.

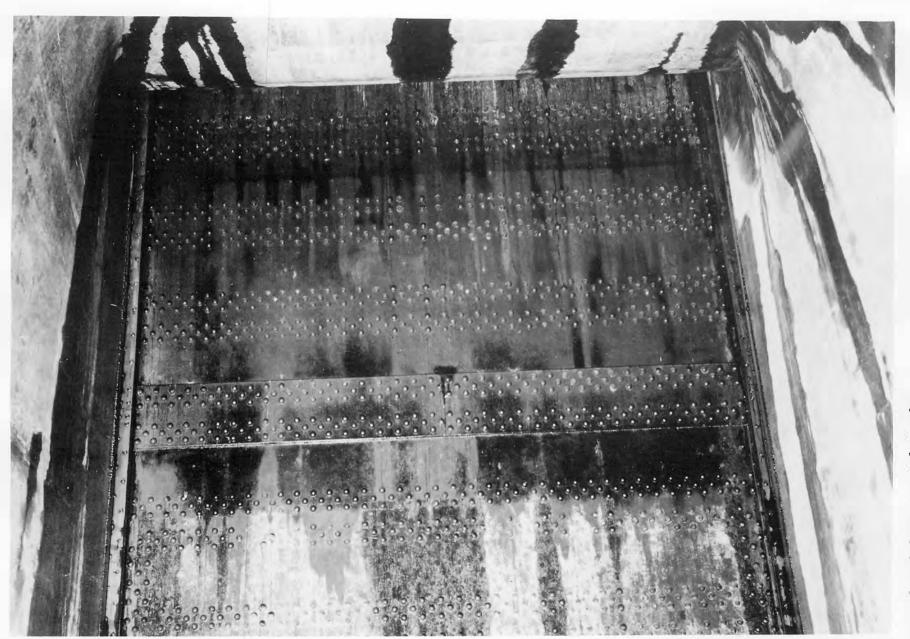
The R-6 coaster gate which was formerly installed in L-3 and was furnished under Specs. No. 905, showing installation of the experimental seal (Reference Drawing No. 222-D-15067). Use of the seal clearance gauge is shown. The gauge was inserted between the rollers and firmly seated against the roller track. A clearance of 1/16" between the seal and the gauge is the normal setting. September 13, 1950.

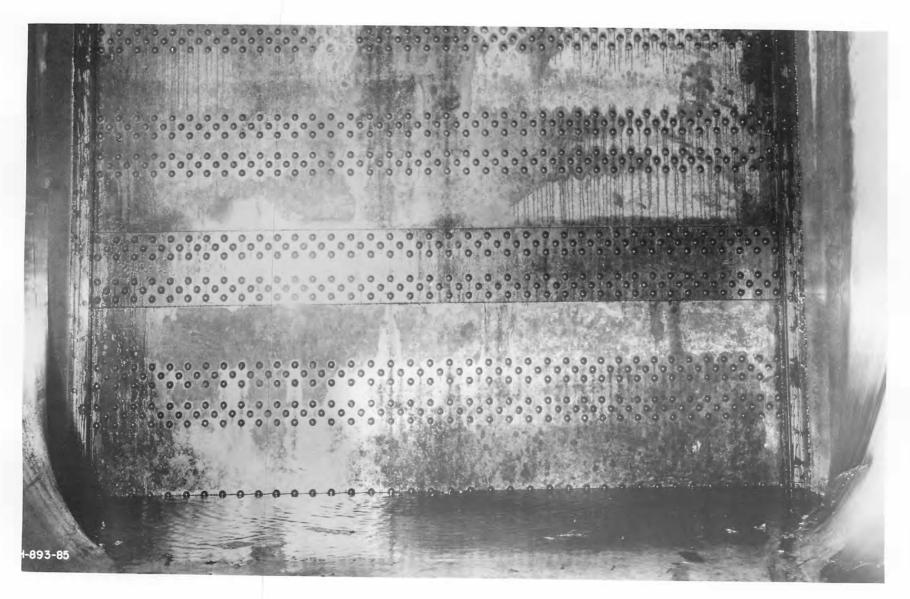
The coaster gate, formerly installed in Unit L-3, is shown installed in the R-6 penstock. The gate is equipped with the experimental seal (Reference Drawing No. 222-D-15067). Total leakage past the gate was estimated to be 25 gallons per minute. The top half of the gate is shown in the photo. September 20, 1950.
