HYDRAULIC LABORATORY REPORT NO. 37

REPORT ON INSPECTION TRIP TO CORRELATE PRESENT
HYDRAULIC DESIGN PRACTICE AND
THE OPERATIONS OF STRUCTURES IN THE FIELD

J. E. Warnock

August 8, 1938

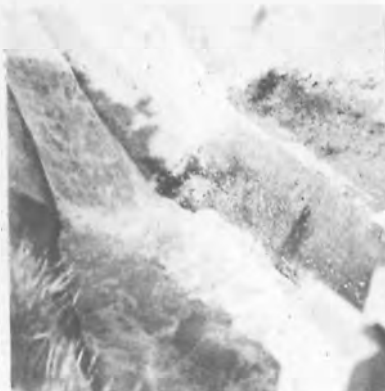
4 second-feet when inspected. The jet of water down the chute was shooting into the pool on the left side and a return whirl or eddy current which develops on the right, flows over the jet disrupting

FIGURE 14 - CHUTE POOL AT STA. 84+60 ON OWYHEE ADVANCEMENT LATERAL

the feeble attempts to form a hydraulic jump. The lower end of the chute should have been flared much more gradually so that the sides of the transition would be vertical. A photograph of the complete structure could not be obtained because of a wooden flume over it. Considering the second group of structures as a type, it appears that if the transition between the sloped paving in the chute and the vertical pool walls is correct, the combination is a good one.

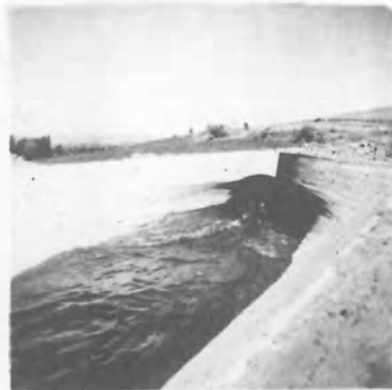
19. A siphon with a weed-swallower entrance has been used to replace metal flumes across low points on the Tieton division of the Yakima project. The entrance (figure 20) has been used on highway culverts where weeds are blown into the ditch in large quantities

Figure 20 - Entrance to Weed-Swallower Siphon on Tieton Canal

and are carried into the culvert. The shape of the entrance prevents the collection of the weeds by rolling them into the swift part of the stream and literally swallowing them. The action of the structure has been very satisfactory.

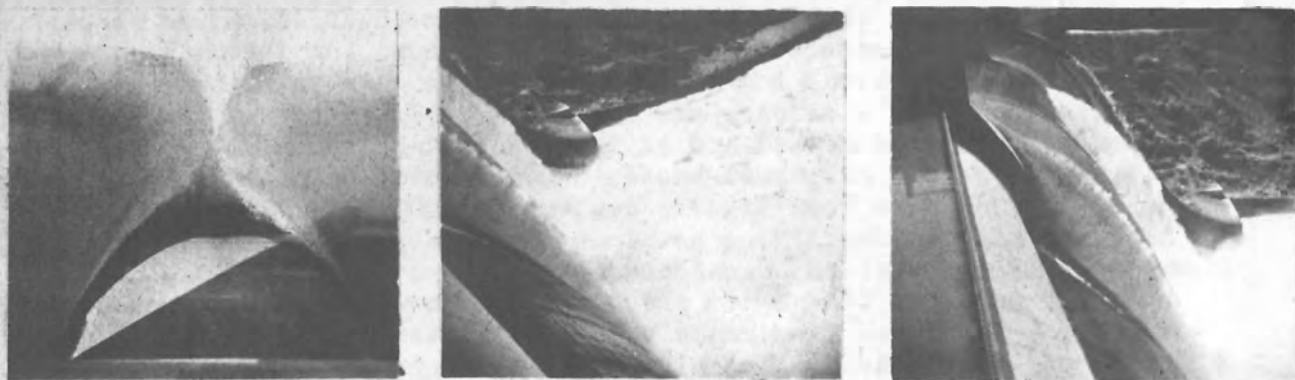
21. At Black Canyon Dam particular interest was paid to the question of vibration at certain gate-operating conditions. As described by Mr. George R. Larson, Assistant Engineer, the vibration occurs when about one foot of water is flowing over the gate. This vibration problem has been studied in the Fort Collins laboratory on the 1:40 model of the Grand Coulee and Shasta spillway crests and the cause is believed to be the lack of aeration at very low discharges. At certain flows the path of the sheet of water is practically vertical and of sufficient thickness to seal against the piers forming an air chamber between the downstream face of the drum gate and the sheet of falling water. The air is evacuated by the falling water and the pressure is lowered in this chamber. The sheet of water is pulled back toward the face of the drum gate until the surface tension of the water can no longer support this low pressure. The surface of the water is broken, air rushes in to relieve the low pressure, and the sheet of water springs quickly back to its true trajectory. The vibration evidently is caused by the latter. Since the air space is relatively small, this evacuation of air and relief occurs at short intervals. Mr. Larson could not estimate the frequency of this vibration but the intensity was sufficient to be felt in his home some distance below the dam. When the gate setting is such that the vibration occurs, a slight change of position by either raising or lowering eliminates it. Figure 22 shows the conditions at which vibration occurs on the model of the Grand Coulee and Shasta spillway crests. The vibration can be stopped by admitting air to replace that carried away by the overflow. On the model this could

FIGURE 23 - TWO LEFT DRUM GATES AT BLACK CANYON DAM HALF LOWERED

be done by breaking the water surface with a pipe or stick or by inserting vents through the piers. It is believed that a complete cure of the vibration at Black Canyon Dam could be obtained by air vents through the piers into the zone beneath the gate in its raised position. The flow conditions with the gate partly lowered are shown in figure 23.

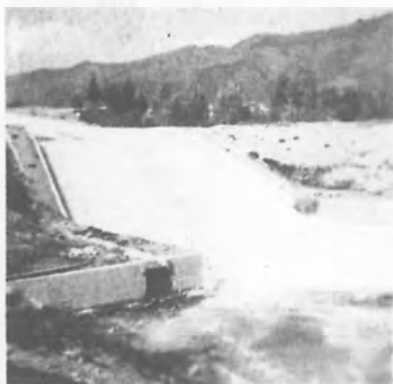
26. The flow conditions in the Kachess Dam spillway channel were very similar to those in the Cle Elum spillway except that there was only one control gate instead of five as at Cle Elum. This gate was raised to provide a flow of about 3,000 second-feet in the channel. The distribution of flow across the stilling pool was uniform and the severe disturbance due to energy absorption was confined to the pool. The outlet works were not in operation.

FIGURE 30 - FLOW IN KACHESS DAM SPILLWAY, DISCHARGE ABOUT 3,000 SECOND-FEET

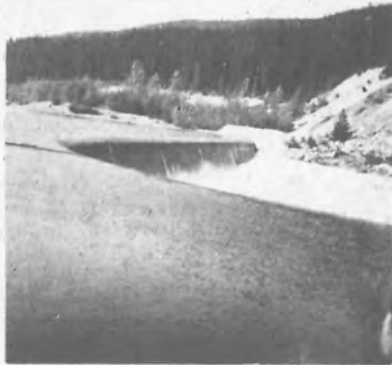
27. The flow over the spillway at Keechelus Dam was not sufficient to show the behavior with quantities approaching maximum. Photographs of the conditions are shown in figure 31.

Spillway as Seen From Top
of Dam

FIGURE 31 - KEECHLUS DAM SIDE-CHANNEL SPILLWAY

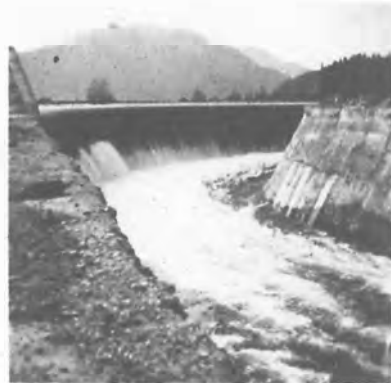
Spillway as Seen From Lower
End of Side Channel

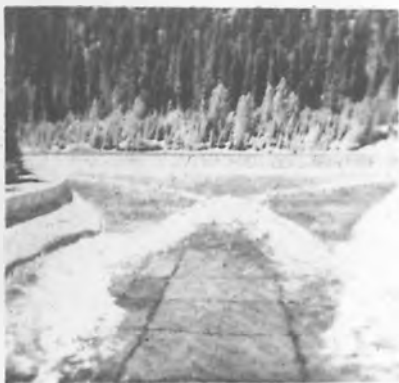
28. A small flow was passing through Bumping Lake spillway (figure 32) and one gate in the outlet works was opened completely to demonstrate the action of the discharge channel below. Although a previous flood filled the spillway channel to within 12 inches of the top of the frame channel, no damage was done and the natural

Flow in Spillway Channel

FIGURE 32 - BUMPING LAKE SPILLWAY AND OUTLET WORKS

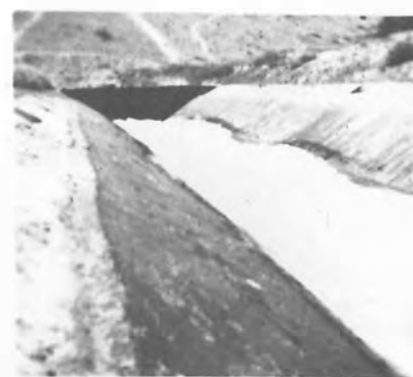
Flow Conditions in Out-
let Works Channel

stilling pool below functioned satisfactorily. The outlet-works tunnel now discharges into a trapezoidal-lined channel which extends about 1,000 feet to the old creek bed. The velocity in this channel is above critical and the conditions may be classed as good, as seen in figure 32. When the dam was first built, a series of baffles were built across the channel at a point below the tunnel to retard the velocity and allow the water to flow away with a low velocity and prevent scour of the channel. The seats for these baffles can be seen in the photograph. So much trouble was experienced with clogging that it was finally decided to pave the channel to the river and allow the high velocity to prevail. The conditions in the channel are now very satisfactory.

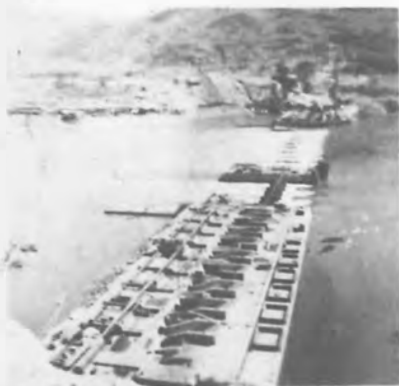
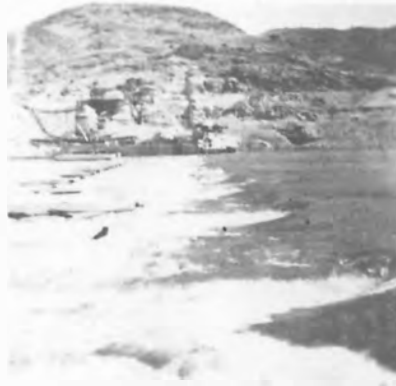
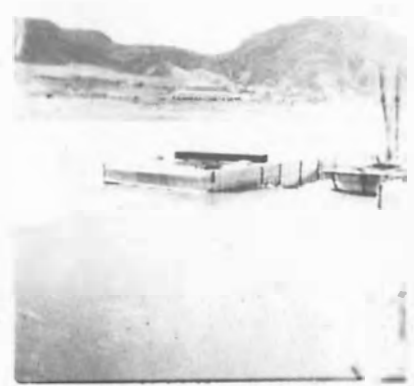
29. A stop was made at Grand Coulee Dam on the return trip. The river discharge was 361,700 second-feet and was increasing slightly. The similarity of the flow conditions to those in the model was very pronounced, the principal difference being the entrainment of large amounts of air in the prototype structure where the water surface is broken by flow over obstructions. The magnitude of the structure makes it difficult to get photographs comparable to those made on the model but three are included which show the conditions insofar as possible (figure 33).

FIGURE 33 - CONDITIONS AT GRAND COULEE DAM WITH FLOW OF 361,700 SECOND-FEET
(June 7, 1938)

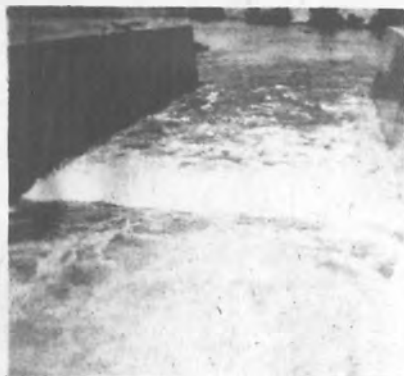
30. The outlet works at Bull Lake Dam (figure 34) were operated to demonstrate the behavior of the stilling pool. The reservoir was at elevation 5765.0, giving a head of 27 feet as compared to a maximum of 67 feet. The hump in the stilling pool de-

FIGURE 34 - CONDITIONS IN BULL LAKE DAM OUTLET WORKS - RESERVOIR ELEV. 5765.0

signed to spread the flow from the two conduits regardless of the number of gates operating functions as designed in the model giving a uniform distribution of flow across the pool with the hydraulic jump forming immediately downstream from the hump. The two gates in one conduit were fully opened presenting a very unbalanced flow condition. Although there was considerable disturbance near the portal of the conduit it did not carry over the hump.

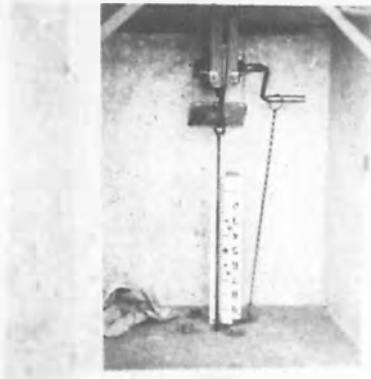
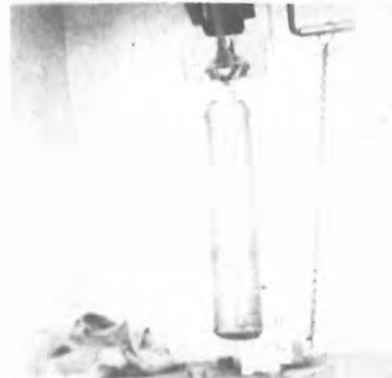
FIGURE 40 - RESERVOIR GAGE AT PATHFINDER DAM
