HYDRAULIC LABORATORY REPORT NO. 42

REPORT ON INSPECTION TRIP TO
STUDY OPERATIONS OF OUTLET
WORKS - ALCOVA DAM - KENDRICK
PROJECT

Denver, Colorado
November 16, 1938

Subject: Report on inspection trip to study operation of outlet works, Alcova Dam, Kendrick project, Wyoming.

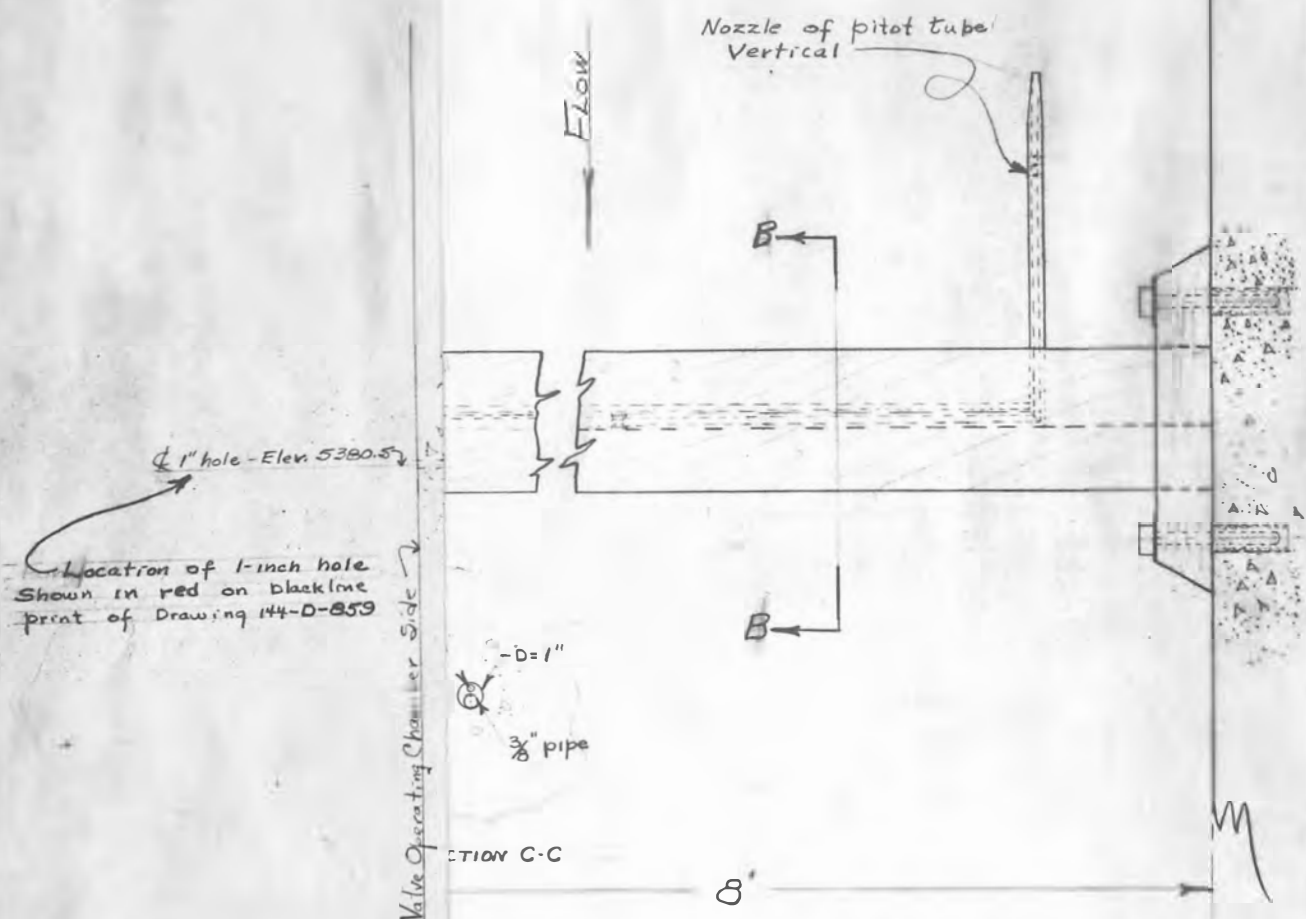
144-JEN-101

4. Previous to the operation of the needle valves for test purposes, the construction engineer had installed, in accordance with drawing no. 144-JEW-101 (figure 1), a pitot tube and supporting strut in the 6-foot by 8-foot air shaft (drawing no. 144-D-1292). A differential gage from the Denver hydraulic laboratory was used to determine the velocity head at the pitot tube. With ^{both} needle valves being opened simultaneously, complete pitot tube traverses were made in the 6-foot by 8-foot air shaft at 25, 50, 75, and 100 percent valve openings. These observations showed an excellent velocity distribution. Pitot-tube readings were taken only on the center line of the shaft for the tenth-point valve openings. These readings were corrected to average cross-sectional velocity by a constant derived from the complete traverses. The mean cross-sectional velocity plotted against valve opening is shown in figure 2. The quantity of air flowing into the discharge tunnel plotted against valve opening is also given in figure 2. A study of these curves and pressures taken in the discharge tunnel resulted in a decision to remove the louvers and grill installed at the entrance to the air shaft (drawing no. 144-D-1064). Pitot-tube investigations were repeated for this condition and the results are given in figure 2. Since there was no simple means of further augmenting the air supply to the tunnel, no further air-demand tests were made.

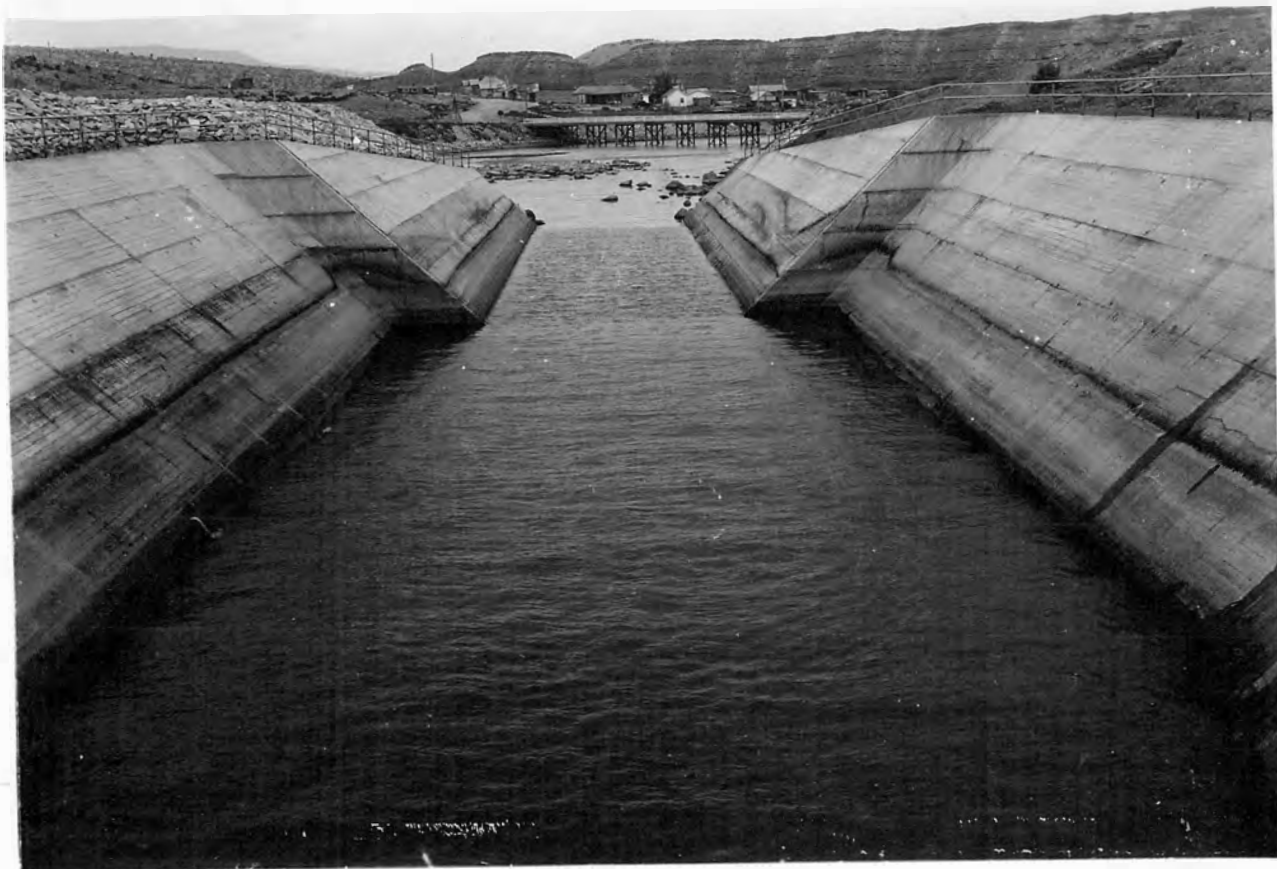
NO FLOW.

12. Flow conditions in the stilling pool for four valve settings are shown in figures 6, 7, 8, 9, and 10. The hydraulic jump occurs within the tunnel for discharges below approximately 2,000 cubic feet per second, and conditions in the pool are fair. At higher discharges, the pool is very rough and turbulent. At discharges above 2,000 second-feet, there is a return flow along the left pool wall near the tunnel portal that enters the hydraulic jump from the side, thus impairing the stability of this phenomenon, and waves are produced in the pool. These waves overtop the walls of the stilling basin for discharges above approximately 4,000 second-feet. The tunnel did not flow full at any discharge (figures 8, 9, and 10). The flow leaves the lined section of the pool at high velocity (figure 10). The boulder-strewn stream bed downstream from the pool (figure 11) is sufficient protection against erosion in the bed. However, erosion of the right bank at the end of the lining is quite severe and has exposed most of the cut-off wall (figure 11). In fact, some of the large riprap was moved during the relatively short time that the tests were being made. The riprap on this bank was dumped from the top. The left bank shows little or no tendency to erode (figure 11). The difference in stability is due to the fact that the riprap on the left bank was placed and swings back on a long arc from the end of the concrete. If the right bank is allowed to erode until it is similar in plan to the left bank, and then covered with placed riprap, the tendency for erosion in this area should be completely eliminated. The sharp offset in the walls and floor of the stilling pool at station 15+00, causes the flow to leave the walls, and possibly the floor, immediately downstream from the square corner. An expansion joint traverses

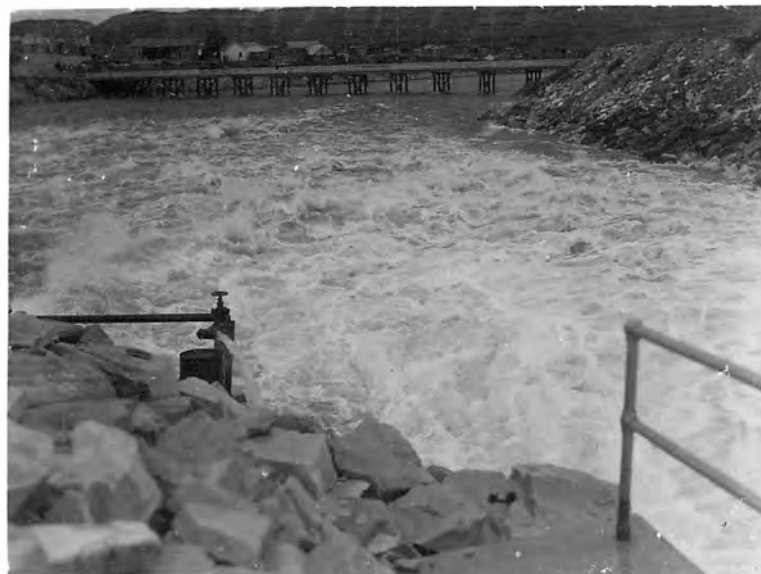
ALCOVA OUTLET WORKS - STILLING POOL.

the pool at this point (figure 11). The mastic in this joint had been removed to a depth of 2-1/2 feet due to the low pressure. The joint in the floor appeared to have suffered no damage. It is suggested that the remaining plastic be removed from this joint and the joint grouted to avoid possible damage to the walls.

riprap on the right bank at the end of the pool is repaired, no further maintenance should be necessary for some time.
