UNITED STATES  
DEPARTMENT OF THE INTERIOR  
BUREAU OF RECLAMATION

WHY CLOSE TOLERANCES ARE NECESSARY  
UNDER HIGH-VELOCITY FLOW

Hydraulic Laboratory Report No. Hyd-473

October 20, 1960

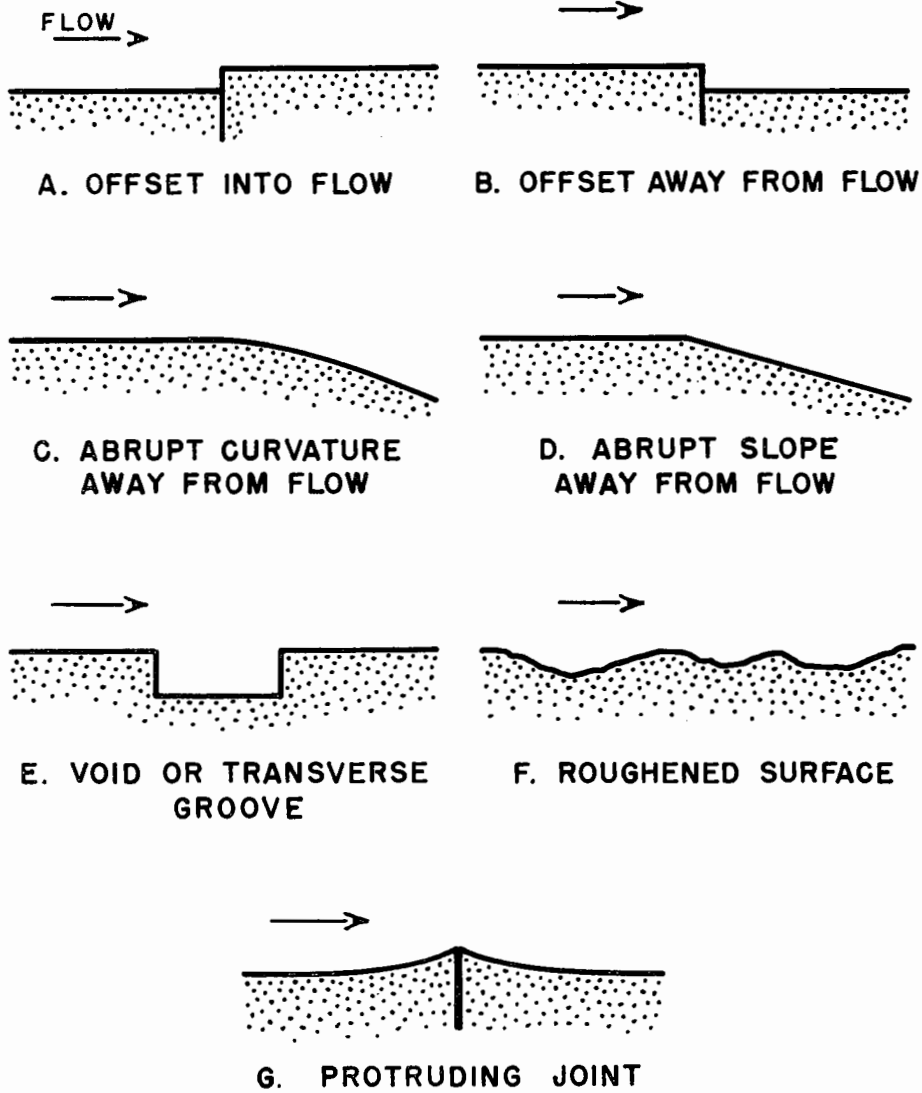
FIGURE 1. POSSIBLE CONSTRUCTION IRREGULARITIES ON FLOW SURFACES

Typical types of irregularities include abrupt offsets into the flow, abrupt offsets away from the flow, abrupt curvatures and slopes away from the flow, voids, roughened surfaces, and protrusions (Figure 1). Offsets occur frequently and are one of the most troublesome of the many types of irregularities. Offsets may lie at any angle with the flow, but are usually either parallel or perpendicular to it. The perpendicular, or transverse into-the-flow offsets are usually the most objectionable (Figure 1A). Offsets away from the flow, and protruding joints (Figure 1B and Figure 1G) are also objectionable. Offsets in joints parallel to the direction of flow are not objectionable in themselves, but irregularities in the joints may be troublesome. Surfaces that curve too abruptly away from the flow (Figure 1C) induce low pressures that cause cavitation. Appreciable changes in slope, or alinement, away from the flow (Figure 1D) are also bad. Voids in the surfaces, "bug holes," or plain grooves (Figure 1E) may also be culprits. Even surface roughnesses (Figure 1F) may cause trouble. All these irregularities will cause cavitation under certain conditions.

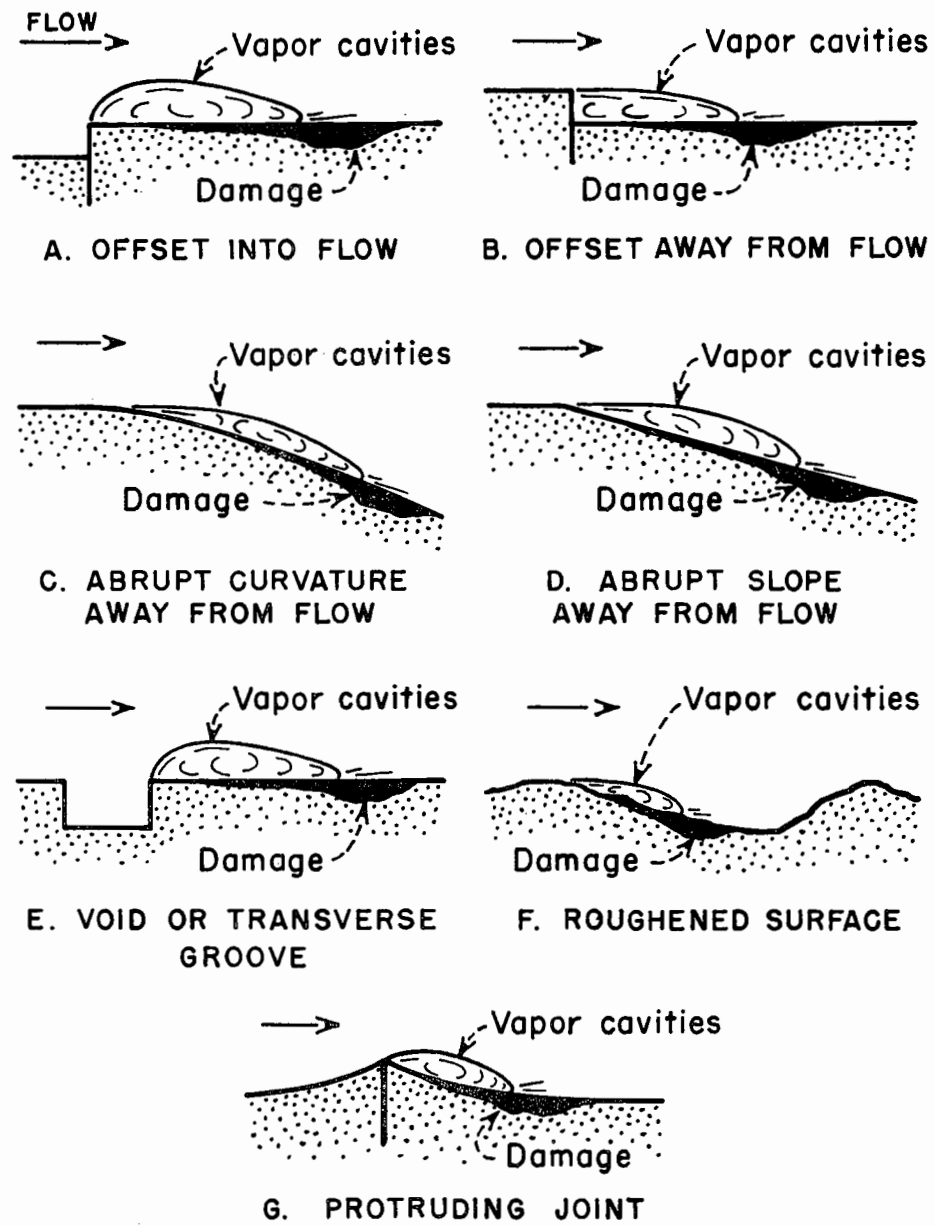
FIGURE 2. POSSIBLE OCCURRENCE OF  
 CAVITATION AT FLOW SURFACE  
 IRREGULARITIES

The formation of low pressure zones and the action of cavitation are illustrated in Figure 2. The irregularities tend to deflect the stream from the surface. Air cannot enter the area under the jet just downstream from the irregularity, and thus a low pressure zone must form to cause the flow to stay in contact with the surface. The higher the flow velocity, the more the tendency for the jet to leave the surface and the lower the pressures become. When the velocity is such that the pressure in the zone is equal to the vapor pressure, vapor cavities form, cavitation begins (incipient cavitation), and damage may result. Once vapor pressure is reached, the pressure can go no lower, and an increase in velocity only enlarges the vapor zone, increases the rate of damage, and moves the damage farther downstream. As a rule, the larger the irregularity the lower the velocity will be to give incipient cavitation. The shape of an irregularity will also influence the velocity at which incipient cavitation will occur. This illustrates the need for more strict tolerances as flow velocities increase and explains why tolerances are varied from point to point on a structure such as the Hungry Horse Dam spillway tunnel.

The first, and one of the most common, will be the offset joint. The joint may be offset either into or away from the flow (Figures 2A and 2B). The offset into the flow has the greater cavitation potential and also has the bad feature of subjecting the joint to extremely high pressures due to impact on the upstream face of the offset. Laboratory studies have established the velocity-pressure relationship for incipient cavitation for different sizes of square-edged offsets into the flow (Figure 3). With a known velocity and a known pressure, it is possible to determine the size of offset that can be tolerated. A field example of damage resulting from this type of offset is shown on Figure 4. The offset was in the concrete wall downstream from one of the outlet gates at Palisades Dam where the pressure in the water at the irregularity was nearly atmospheric. The velocity of the water was about 100 feet per second and the offset was about 1/8 inch. The chart of Figure 3 does not extend beyond velocities of 80 feet per second, but nevertheless definitely shows that cavitation will occur and that the damage should be expected. Rounding the corner will decrease the cavitation potential of the irregularity, but the influence is not known at this time.

Transverse grooves (Figure 1E), including gate slots, can be a source of much trouble. In this type of irregularity, the low pressure zone forms just downstream from the downstream corner (Figure 2E). A section through a void or "bug hole" is similar to that of a transverse groove. Damage by cavitation has been observed downstream from bug holes of about 1/2-inch diameter and larger (Figure 11). On this basis it is believed that bug holes and voids should be filled to form smooth continuous surfaces when flow velocities exceed about 50 feet per second. The hole depth and width, and the flow velocity will influence the cavitation potential of such irregularities. To date, there have been insufficient observations to establish any definite relationships. Some work on gate slots has been done in the laboratory <sup>2/</sup>, but considerable field data covering a wide range of the variables would be extremely useful.
