UNITED STATES
DEPARTMENT OF THE INTERIOR
BUREAU OF RECLAMATION

REDESIGN OF CHECK DROPS
SUNNYSIDE MAIN CANAL
YAKIMA PROJECT - WASHINGTON

H. G. DEWEY, JR., JUNIOR ENGINEER

February 28, 1939.

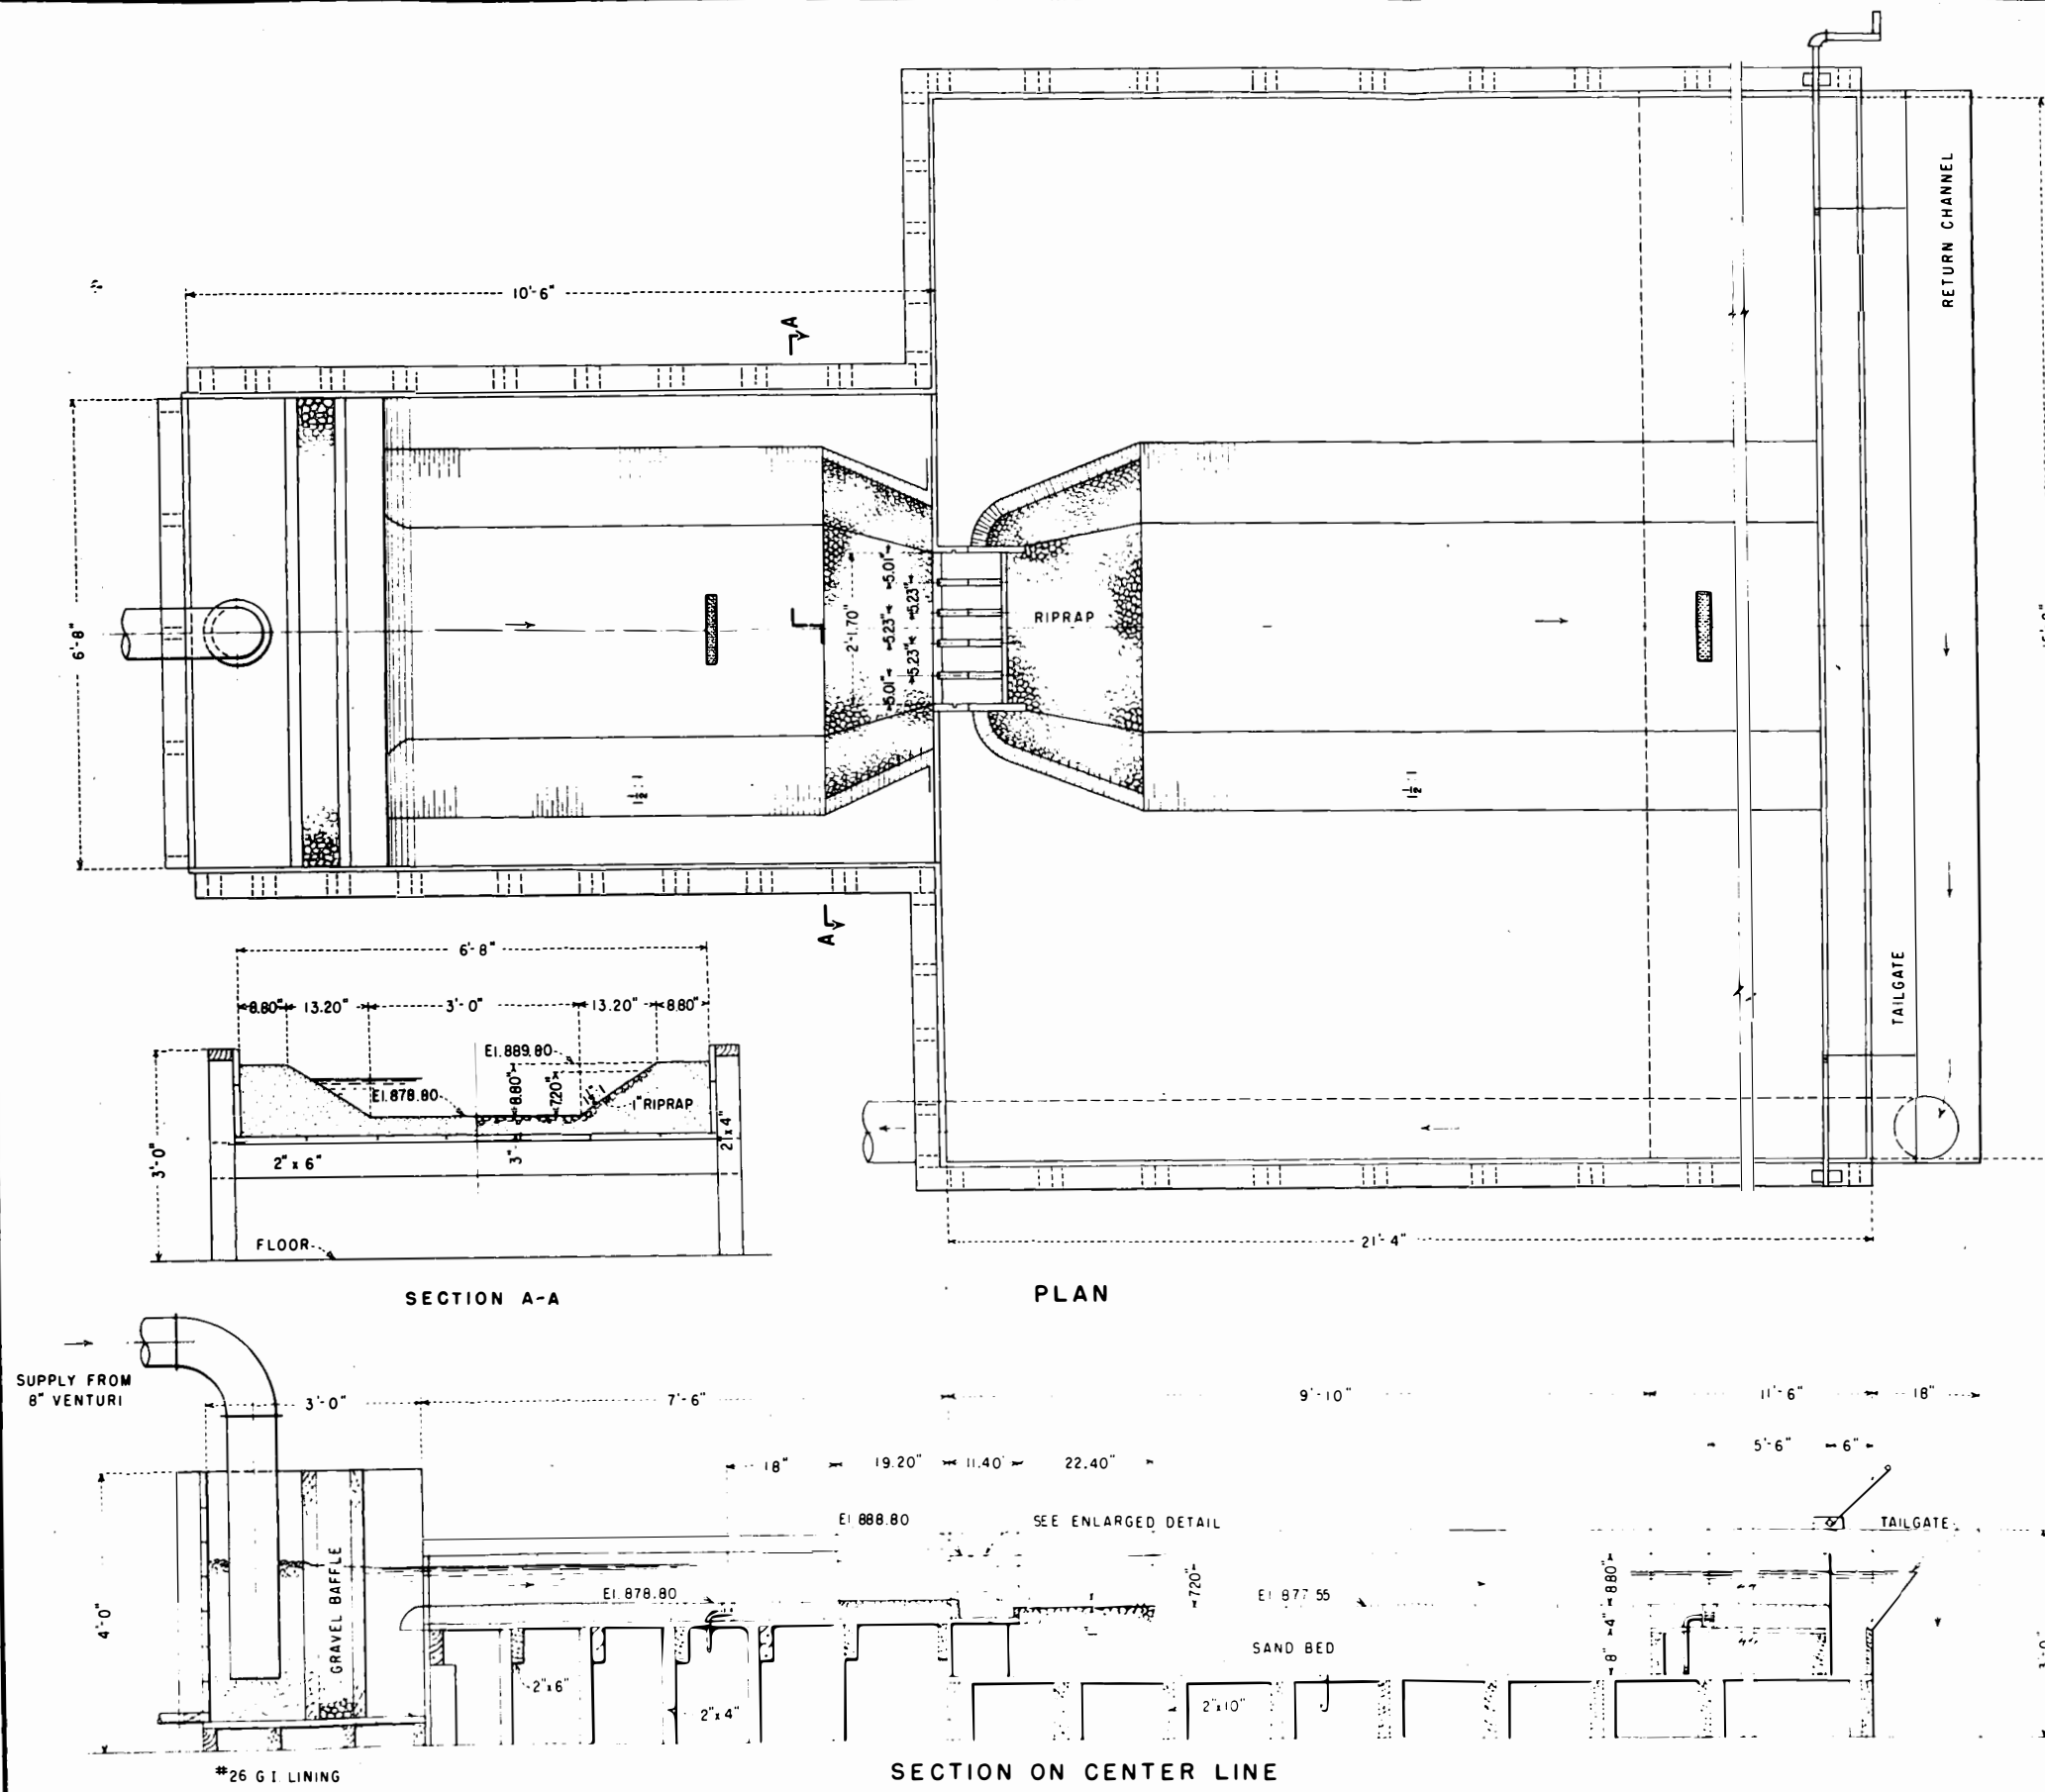
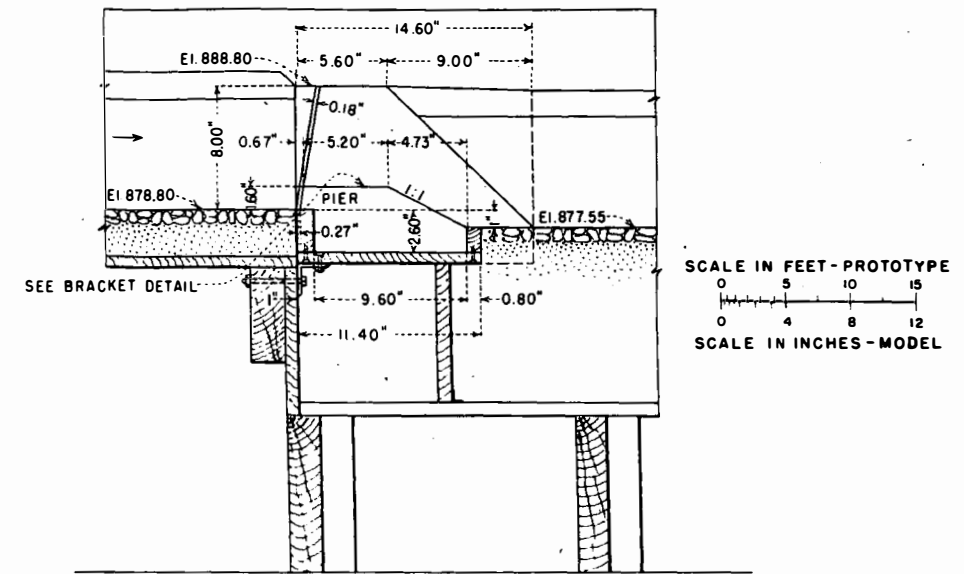
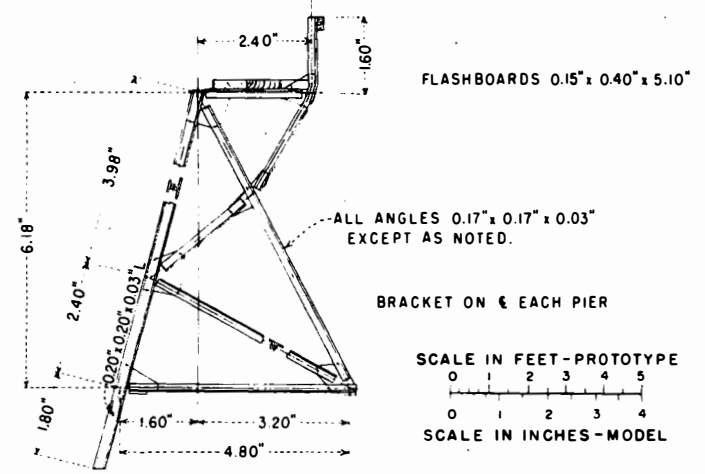
10. The model. The model of check drop no. 4 was built to a scale of 1 to 15 (figures 5 and 6). The drop structure was constructed of redwood, and the steel brackets were made of light-gage sheet metal. The drop structure was installed in a large, metal-lined box, which provided sufficient length of approach upstream from the drop and sufficient width

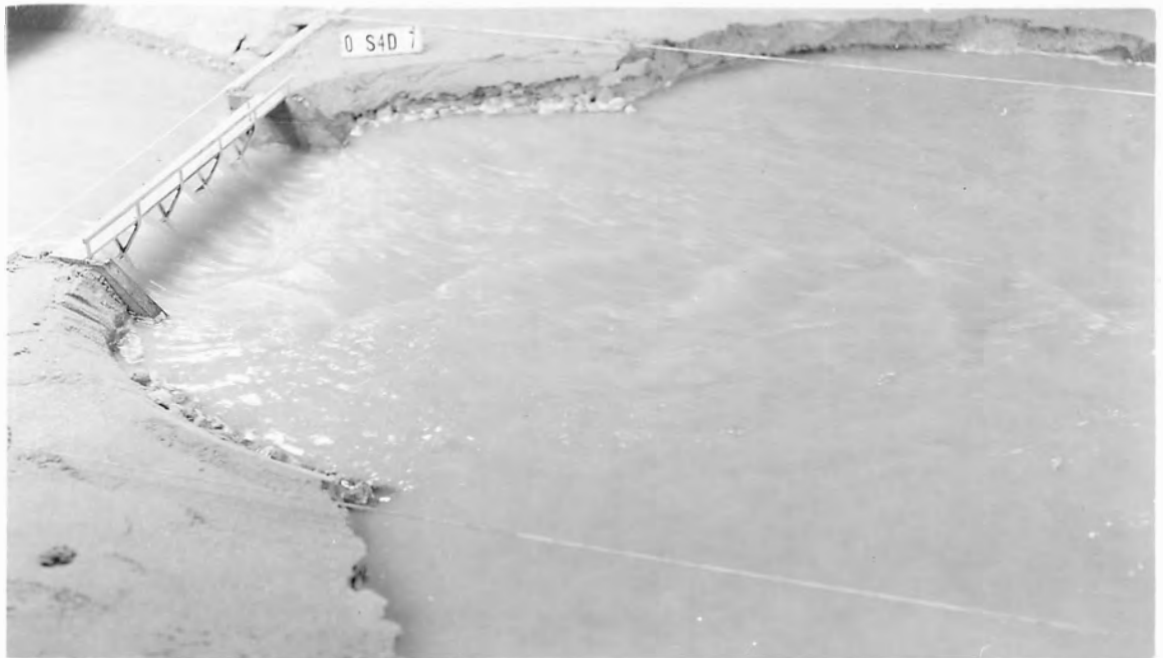
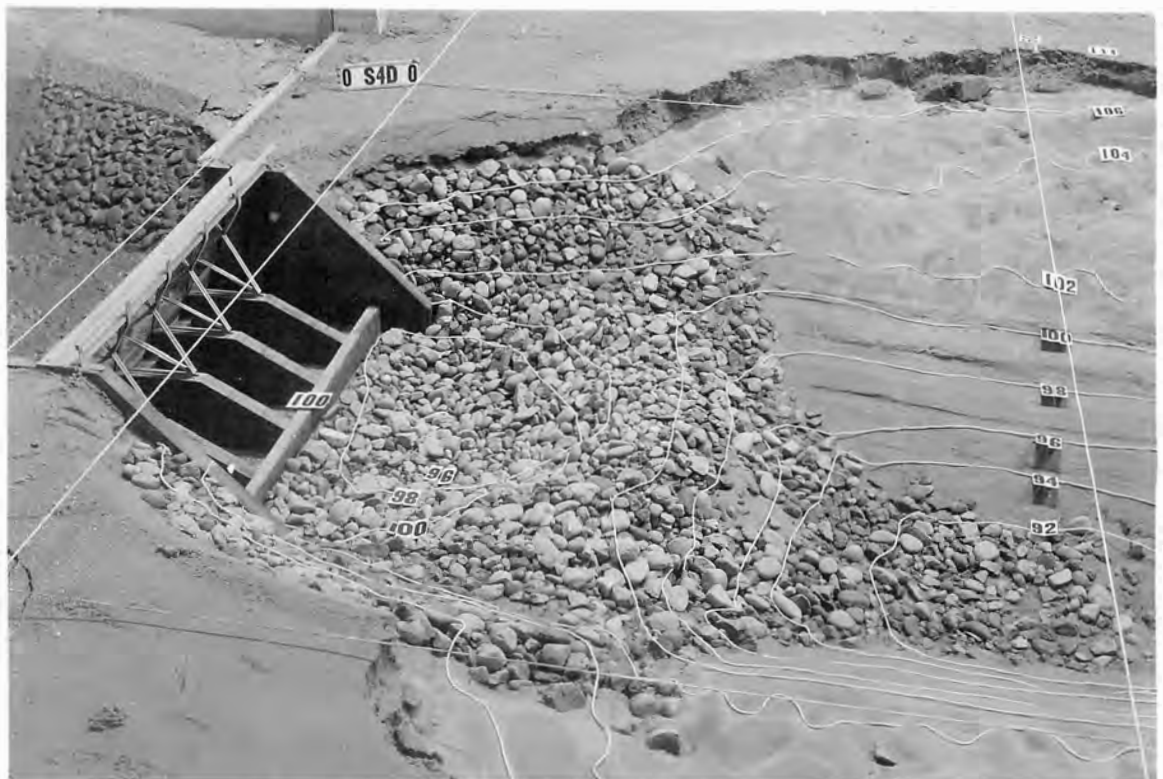
EXISTING STRUCTURE

A. SCOUR AFTER 21 HOURS - DISCHARGE 1300 SECOND-FOOT
 UPSTREAM WATER SURFACE ELEVATION 886.25 .
 DOWNSTREAM WATER SURFACE ELEVATION 884.55
 FOUR FLASHBOARDS PER PANEL

B. SCOUR AFTER 26 HOURS
 MODEL ELEVATION 100.0 EQUALS PROTOTYPE ELEVATION 877.55

The scour in the model appears to be more severe than in the prototype, as shown on figures 1, 10, and 11. This was expected since the sand in the model was more saturated and less compacted than the material in the field. The scour to the riprapped canal bottom for a distance of 20 feet downstream from the drop was not excessive, but, beyond this point, the canal bottom was heavily scoured. Observations on the model revealed that, as the flow passed over the flashboards, it was partially deflected upwards by the weir wall at the lower end of the check basin. This had a tendency to reduce the amount of scour just below the drop. But, as the flow passed downstream to the end of the riprapped transition, high velocities prevailed along the bottom of the canal, which scoured a large hole (figure 9B) into which the riprap near this region was deposited. This may explain the reason why the riprap at the prototype structure is continually washed into the pool below the drop.

It will be noted that the scour pattern in the model (figure 8) is symmetrical about the center line of the canal whereas the scour at the prototype (figure 1) is on the left side of the canal. This difference in scour pattern is due principally to the fact that there was no curvature in the canal alignment in the model above or below the drop structure whereas the canal curves to the left upstream from the prototype drop structure and to the right downstream. Another factor contributing to the prototype scour pattern has been the method of placing the flashboards. These have been placed unsymmetrically so as to divert the flow from the scoured section of the canal. The model showed definitely, however, that scour will be excessive below

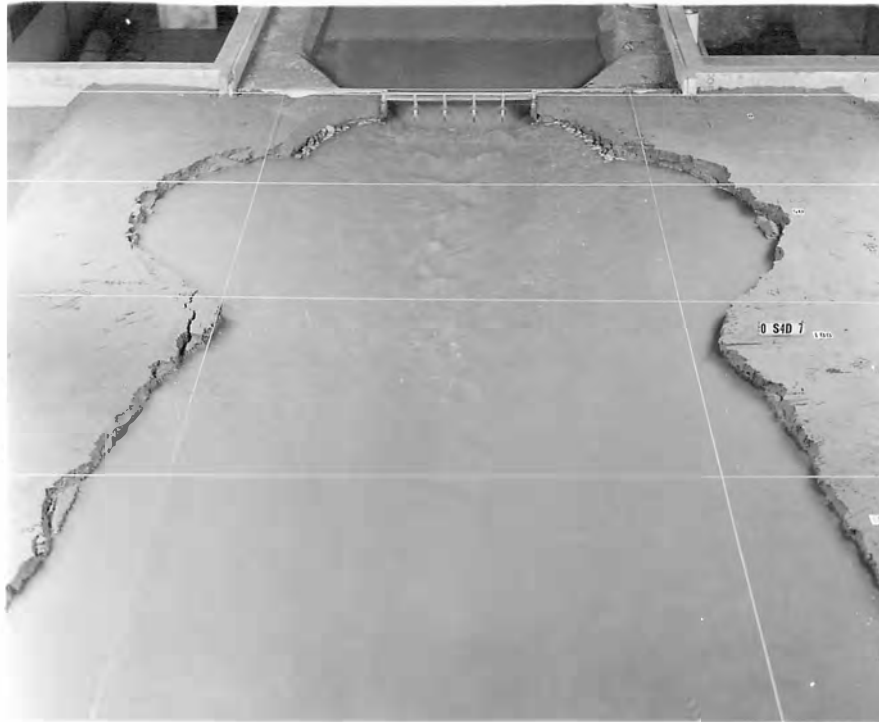
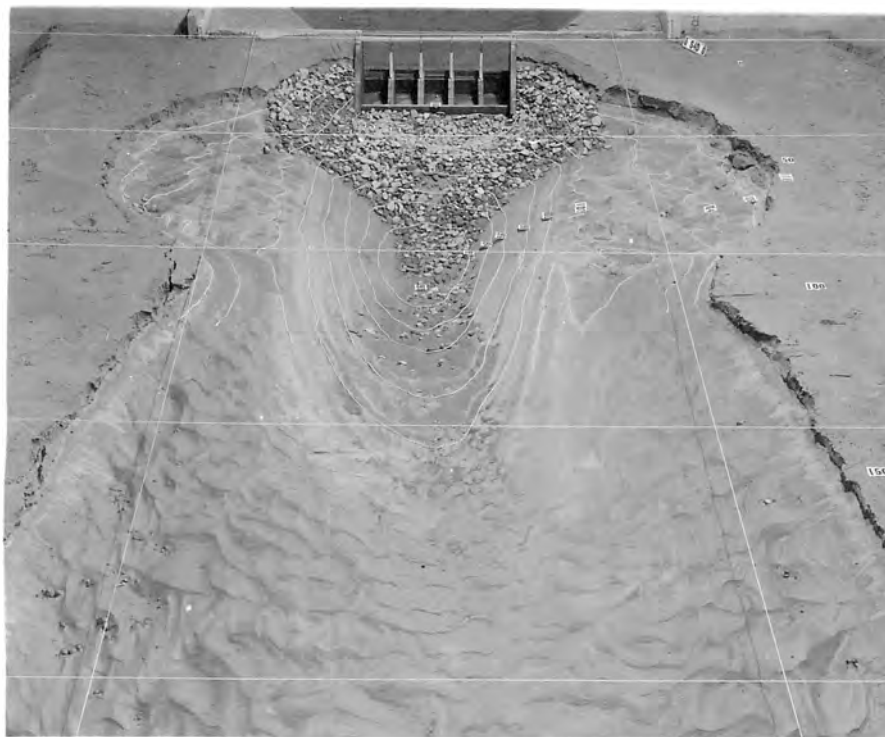
EXISTING STRUCTURE

A. SCOUR AFTER 21 HOURS - DISCHARGE 1300 SECOND-FEET
 UPSTREAM WATER SURFACE ELEVATION 886.25
 DOWNSTREAM WATER SURFACE ELEVATION 884.55
 FOUR FLASHBOARDS PER PANEL

B. SCOUR AFTER 26 HOURS
 MODEL ELEVATION 100.0 EQUALS PROTOTYPE ELEVATION 877.55

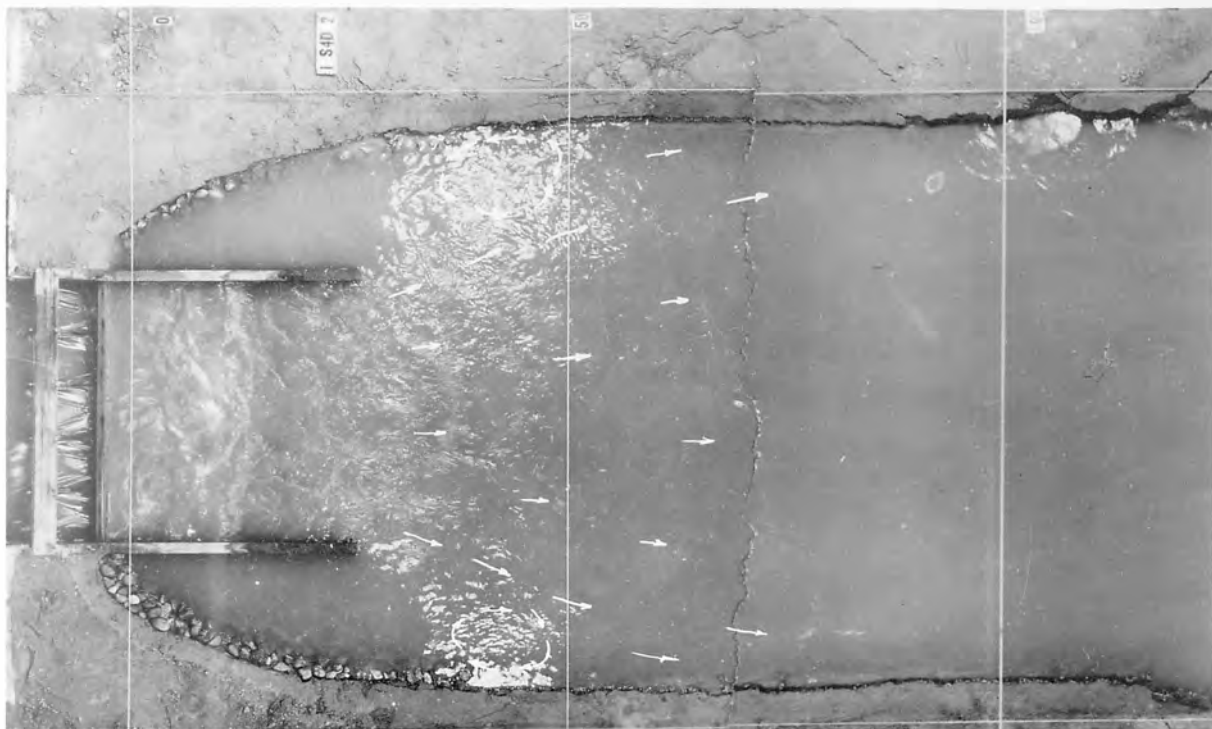
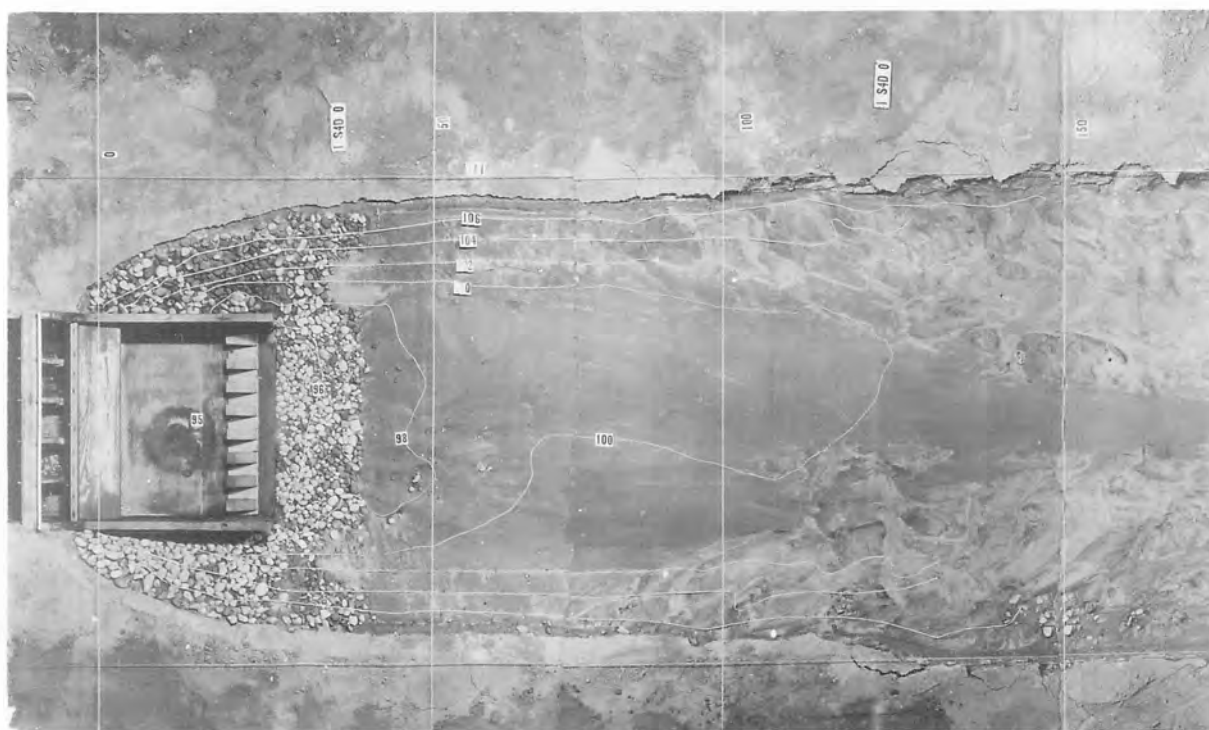
A scour test was made on this design similar to the one made on the model of the existing structure. At the end of 26 hours, the scour in the model was slight (figures 10C, 15B,

A. SCOUR AFTER 21 HOURS - DISCHARGE 1300 SECOND-FEET
 UPSTREAM WATER SURFACE ELEVATION 886.35
 DOWNSTREAM WATER SURFACE ELEVATION 884.55
 FOUR FLASHBOARDS PER PANEL

B. SCOUR AFTER 26 HOURS
 MODEL ELEVATION 100.0 EQUALS PROTOTYPE ELEVATION 877.55
