HYDRAULIC MODEL STUDIES OF THE BARTLETT DAM SPILLWAY SALT RIVER PROJECT, ARIZONA

Report No. Hyd-576

**by
G. L. Beichley**

October 2, 1967

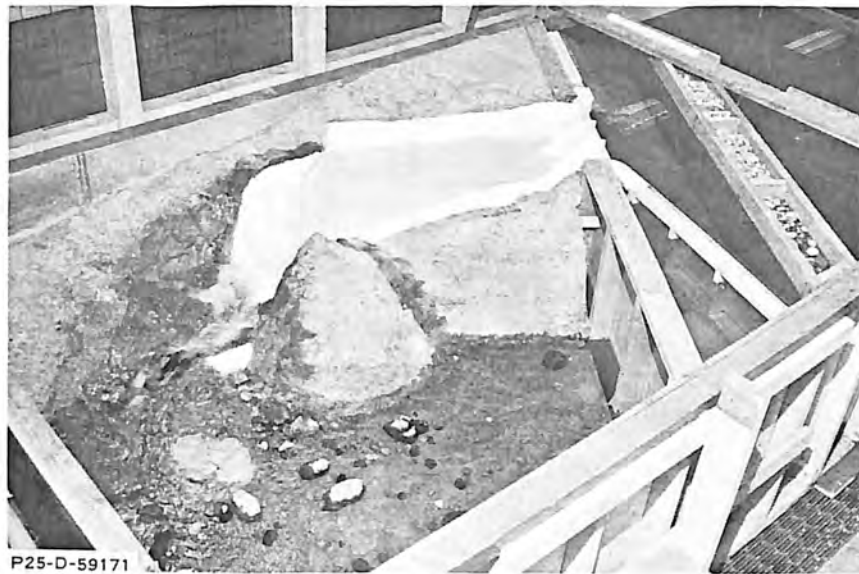
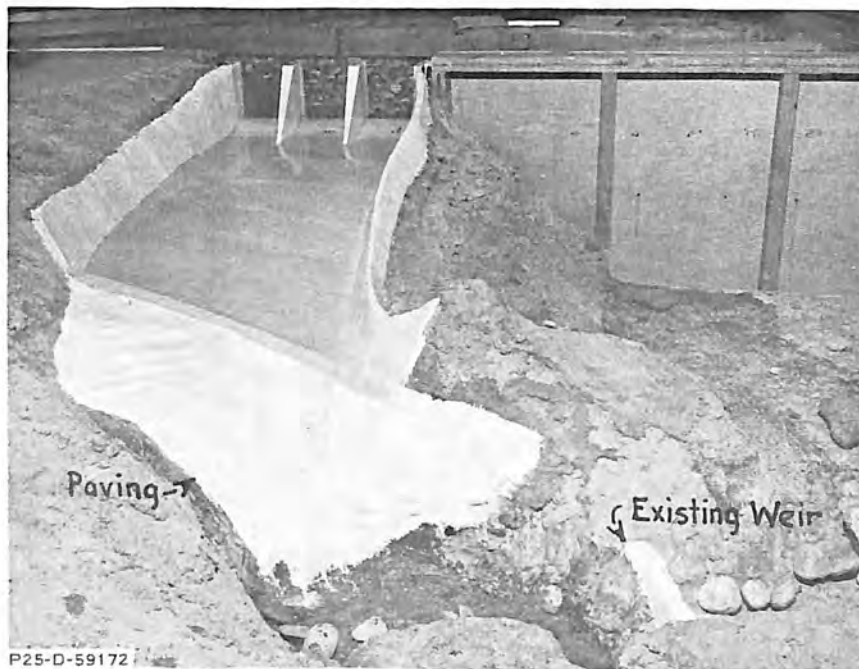
BARTLETT DAM SPILLWAY
Repairs to the Discharge Channel Following
the 1965-66 Flood

The extent of concrete paving placed
in discharge channel following the
1965-66 flood is painted white.

2. Repairs made after the 1965-66 floods appear to be well located for protection of the channel against further erosion, but the paving should be extended a little higher and farther downstream along the left bank (Figures 4, 9, and 11).

3. The deep erosion hole at the base of the steep slope should be filled with concrete (Figures 4, 7, and 11). This concrete fill should extend from the existing concrete on the upstream side of the hole to sound rock on the downstream side and should slope downward to the left in the direction of flow to flush loose rock from the channel.
