TEST OF PROTECTIVE COATINGS FOR NAVY

BUREAU OF RECLAMATION  
HYDRAULIC LABORATORY

Tests of Protective Coatings  
CONE CAVITATION APPARATUS

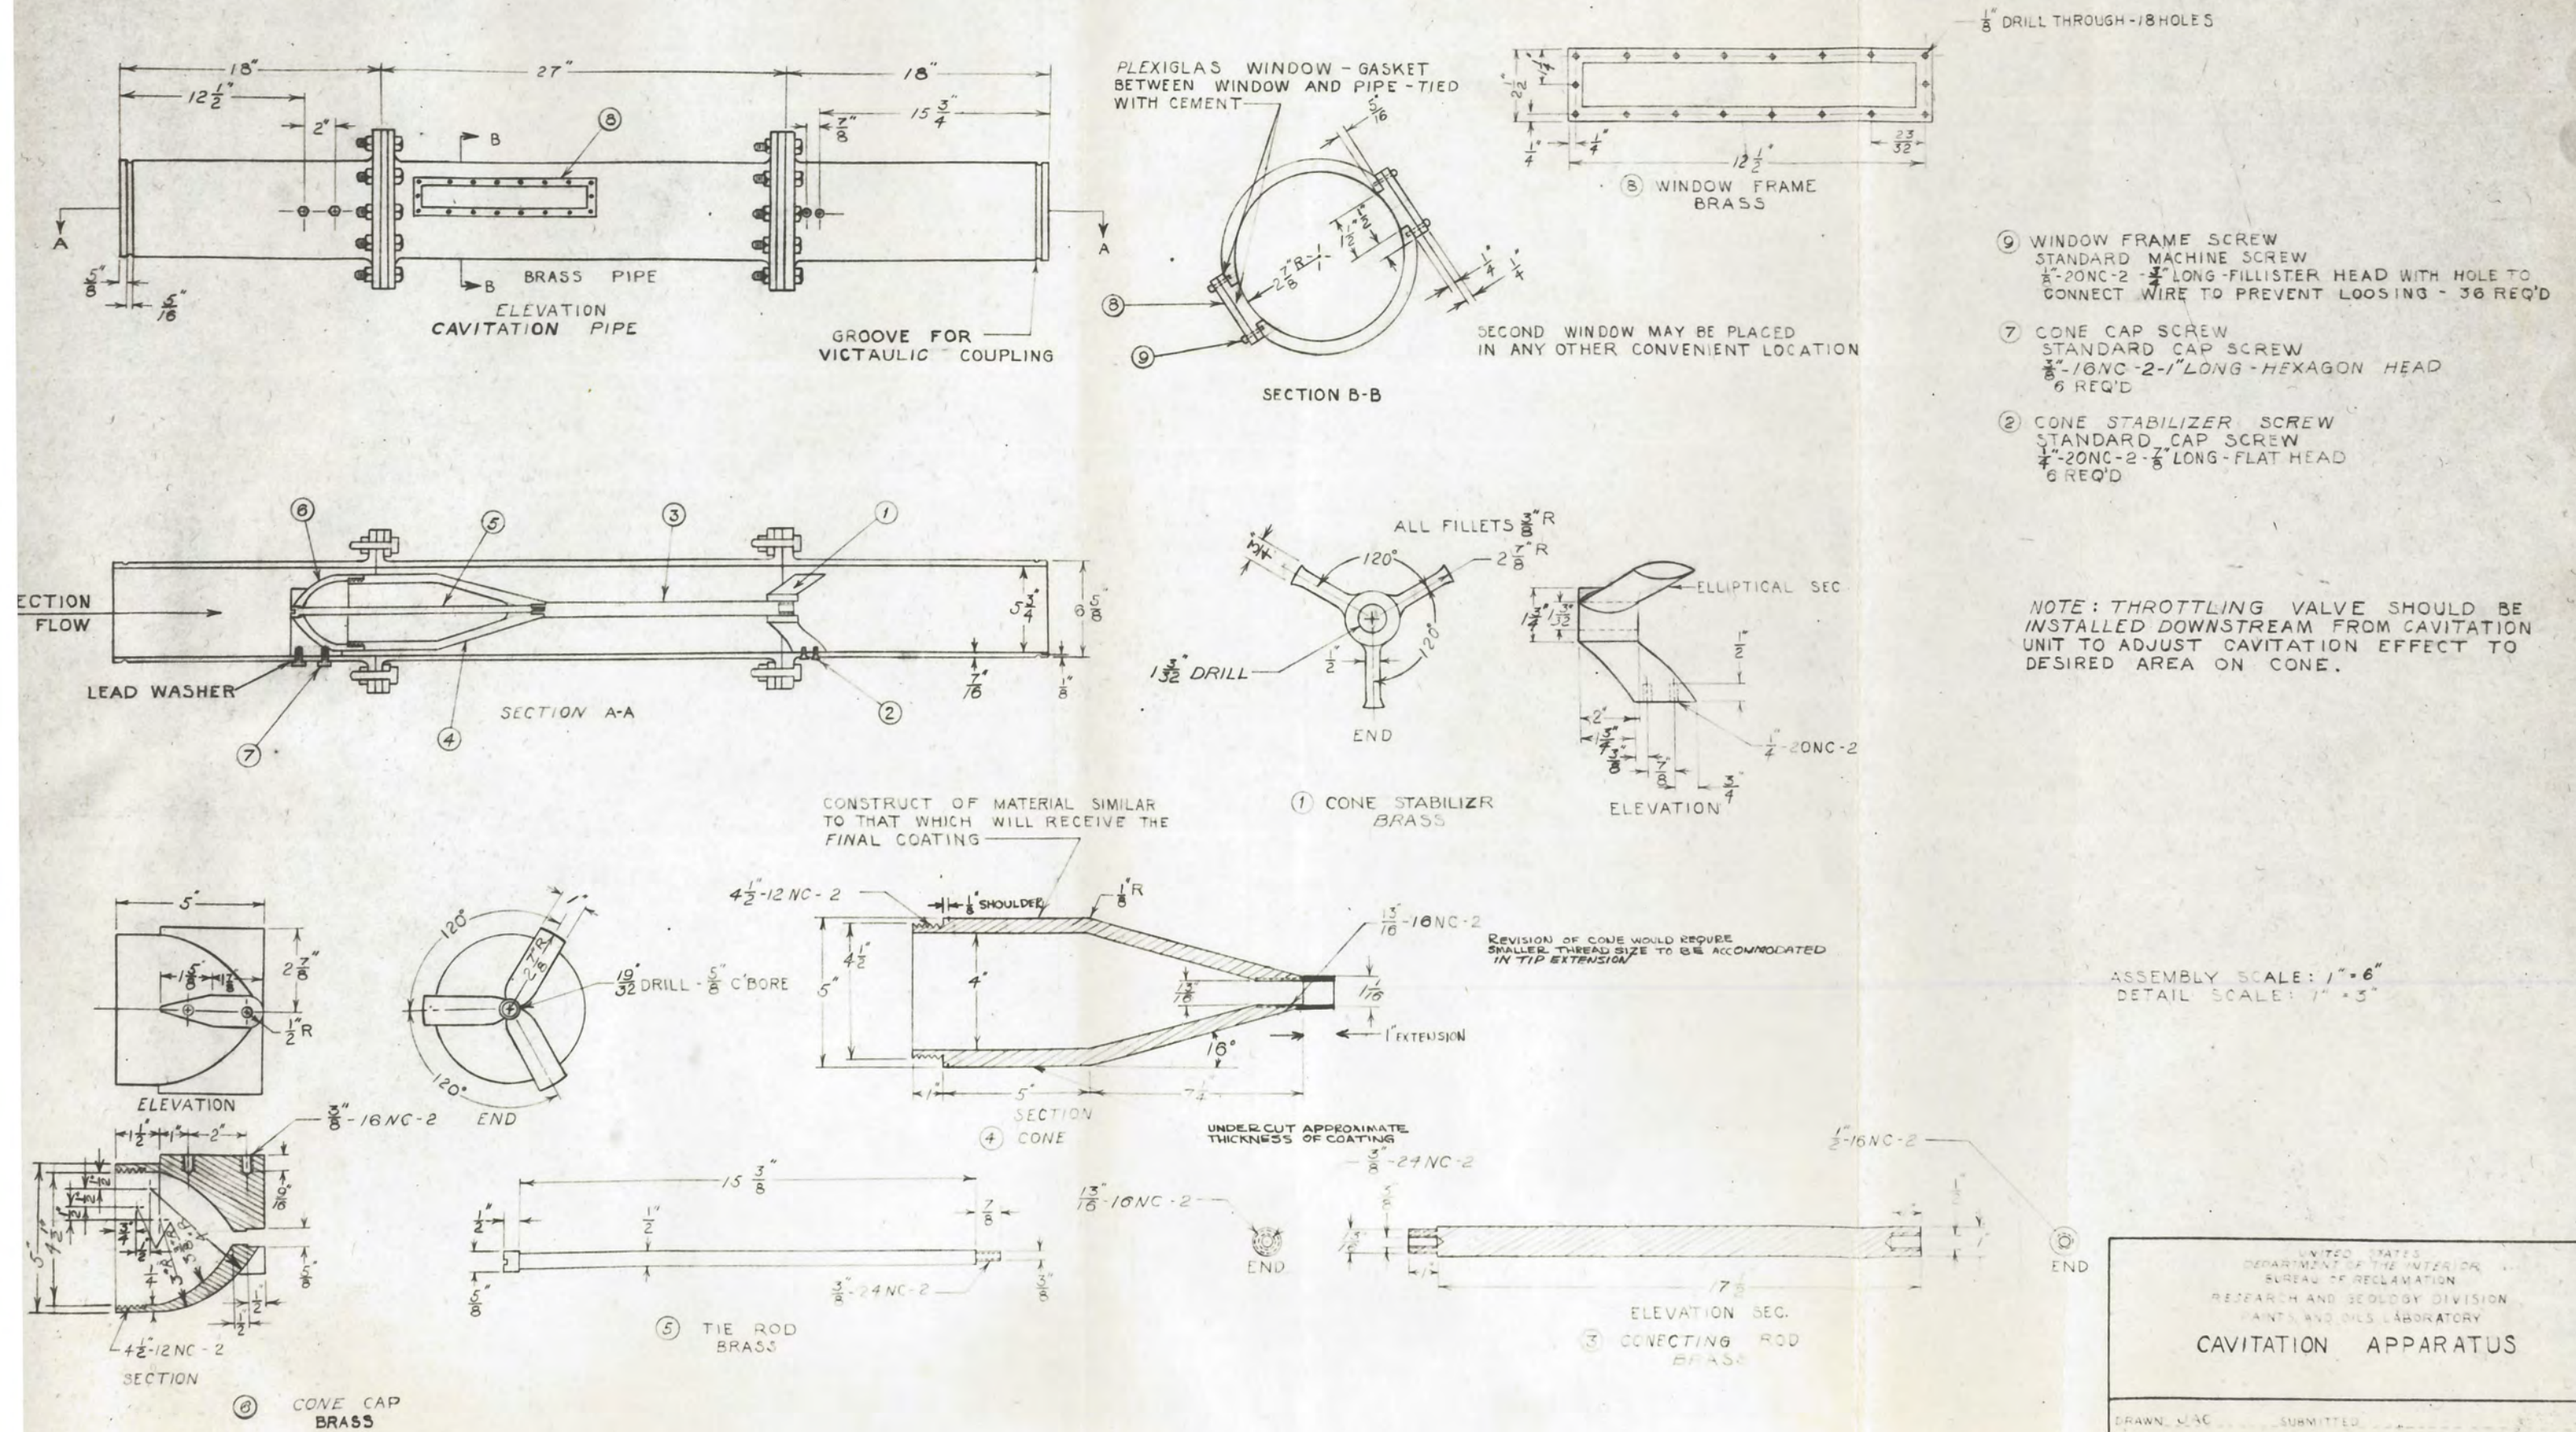
FIGURE 1

Damage near the base of the cone section of the specimens was by cavitation-erosion. This damage was noticeable on all except Specimens 9 and 10 (Figures 5, 7, 10, 15, 16, 19, and 21). This damage occurred at the upstream end of the cavitation envelop--an unusual location. It is believed that slight pressure surges at the cone base where the pressure gradient (throat pressure to vapor tension pressure) is practically vertical caused a collapse of some of the cavities almost as soon as they formed. This resulted in erosion of the surface at that location. This condition was not prevalent in our previous tests where the corner at the cone base was rounded as shown on Figure 1.

The tests prove that some special treatment of the coating at both upstream and downstream edges of the coating materials should be considered in future test programs. This treatment should be of a nature to prevent velocity and pressure acting on loosened edges of the coating to tear them and upset the test conditions. A special undercutting or extension of the specimen at both ends might do much to solve the problem. Some degree of success was obtained by slight alterations to the cone in some of our most recent tests (Figure 1).

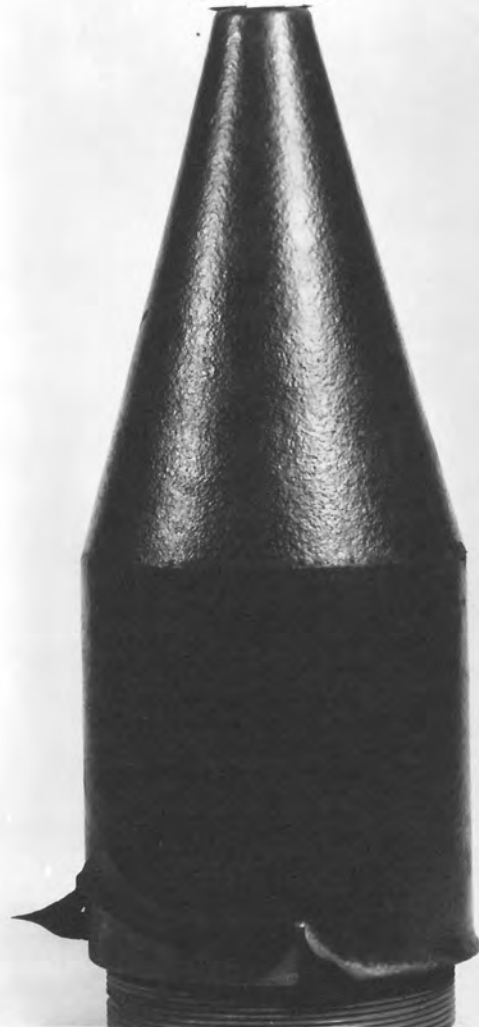
The coating of the second specimen (Number 2) became loosened and torn at the upstream edge of the coating in the throat section in 10-1/2 hours (Figure 6). The loosening and tearing of the coating at this location prevented continuing the test under controlled conditions, and the test was discontinued. There was cavitation-erosion at the base of the cone as in the case of Specimen 1, but a portion of the coating seemed to have been removed as a layer (Figure 7A). This damage seemed to be a result of cavitation and velocity on a thin layer of the coating.

NO 2, FLAME SPRAYED THIOKOL  
TESTED 10 1/2 HRS. AT 71.2 FT/SEC

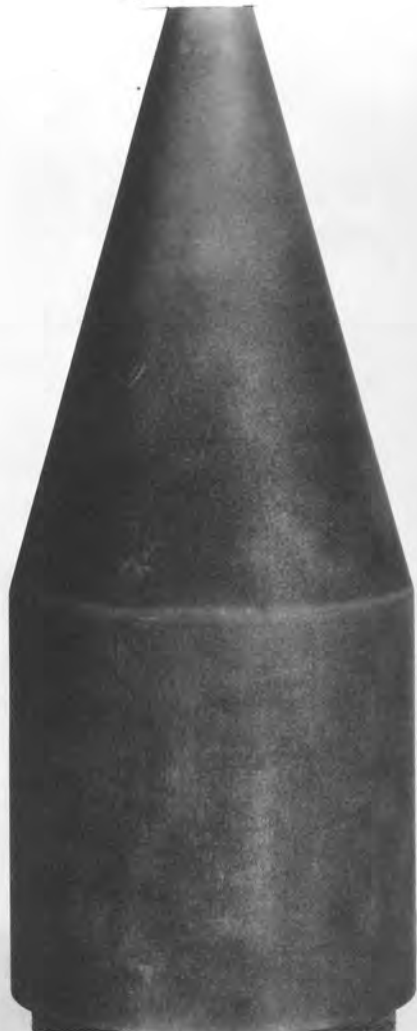
NO 3, UNCOATED SPECIMEN  
TESTED 11 1/4 HRS. AT 72.09 FT SEC  
A. METAL CONE SPECIMEN

B. SLIGHT PITTING NEAR CONE BASE - DARK SPOTS  
CAUSED BY RUSTING

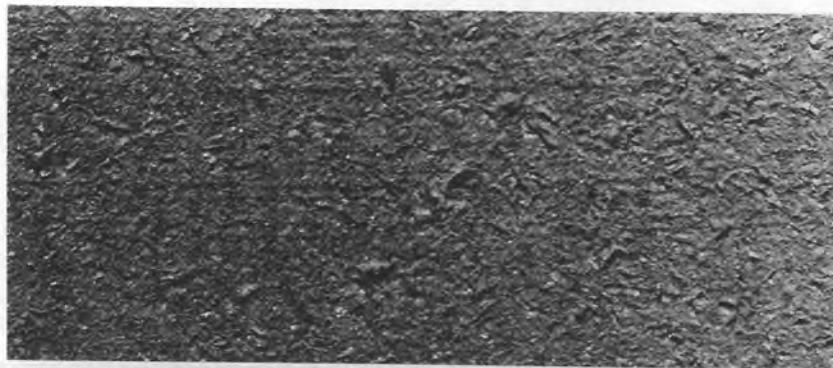
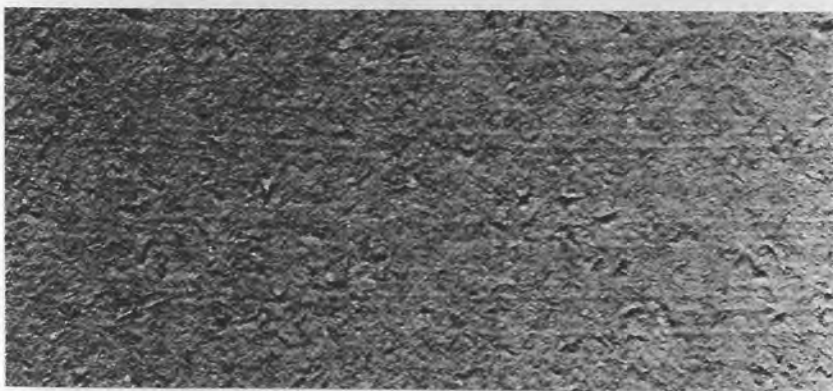
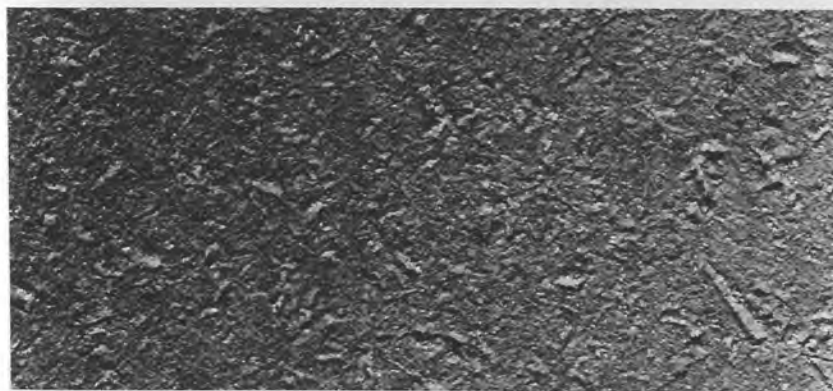
Figure 11

The two metal specimens (Numbers 3 and 4) were tested for different periods. Specimen 3 was tested for a period comparable to that for Specimen 1 (11-1/4 hours) while Specimen 4 was subjected to 40 hours' testing. The test on this specimen was continued in order to obtain sufficient damage for comparison with that obtained for the other coatings. The test was made after the tests on all other coatings were completed. A slight erosion at the base of the cone, characterized by a silvery appearance of the metal, was noted on Specimen 3 (Figure 9). No other damage could be detected. After 40 hours' testing of Specimen 4, there still seemed to be no damage other than that of the periphery at the cone base where the erosion was greater than that after 11-1/4 hours' testing of Specimen 3 (Figure 10). Photomicrographs of areas in the throat of the apparatus, at the base of the cone section, midway between the cone base and tip, and near the cone tip were taken at the end of the 40-hour test on Specimen 4. While erosion at the base of the cone is shown distinctly by the photomicrographs, there is no apparent damage in the other areas (Figure 11).

A. SURFACE AT TIP

B. SURFACE NEAR  
MIDDLE OF CONE

D. SURFACE IN THROAT

Tests of Protective Coatings  
PHOTO-MICROGRAPHS - MAGNIFICATION 12X  
SPECIMEN 4 AFTER 40 HRS At 71.6 FT/SEC.

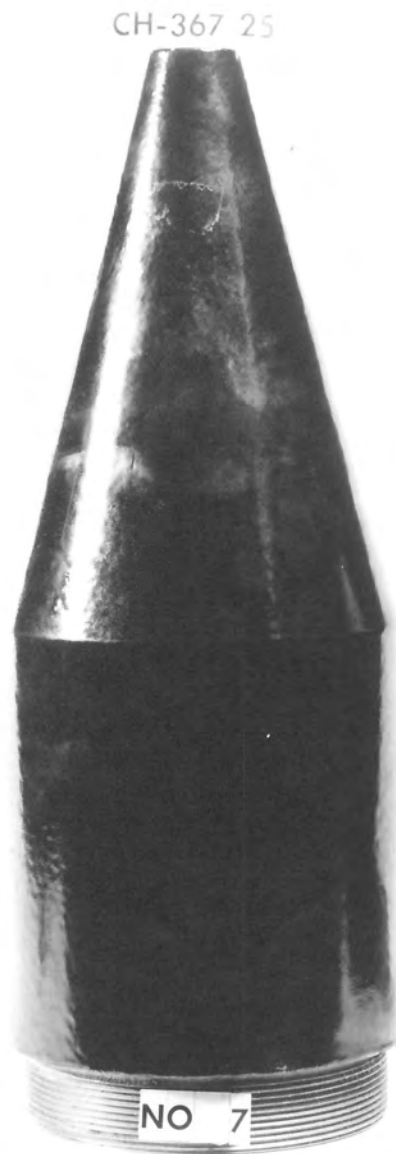
A. BEFORE TEST

B. PITTING AT BASE - TEARING AT TIP RESULTING FROM LOOSENING BY CAVITATION

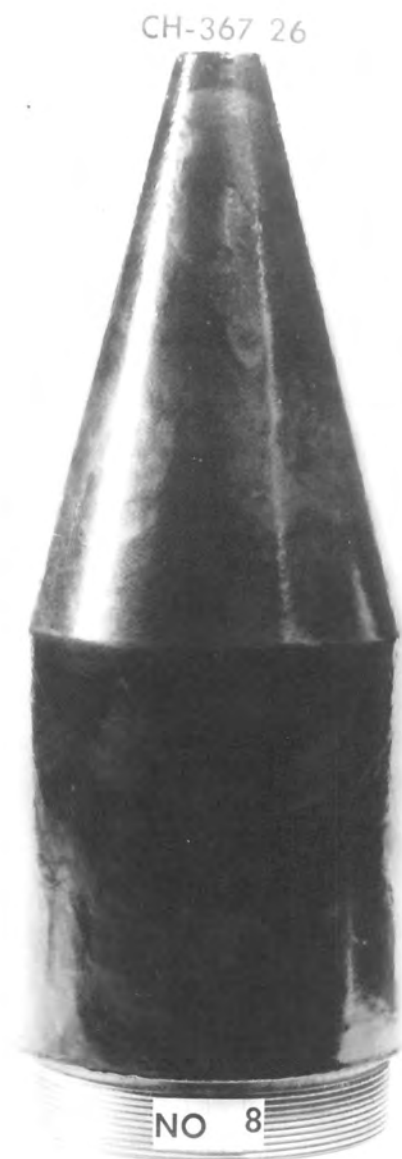
Metal was exposed near the cone base of Specimen 7 in 2-1/2 hours of testing. The coating on the upper half of the cone was loosened by cavitation and torn away in 8-1/2 hours (Figures 18 and 19). Failure similar to that on Specimen 7 was noted on Specimen 8 after 3-1/2 hours' testing. Bare metal exposed by cavitation-erosion was noted at the cone base in about 2 hours (Figures 20 and 21).

A. BEFORE TEST

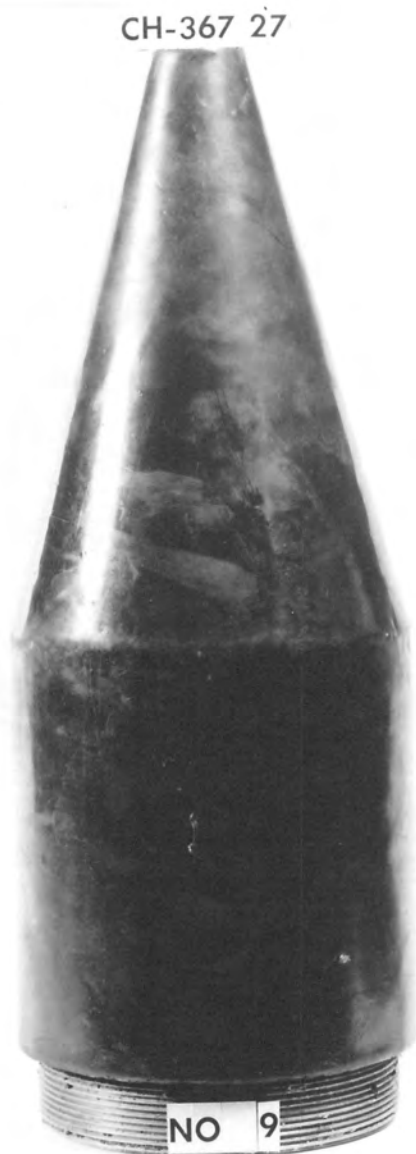
A. BEFORE TEST

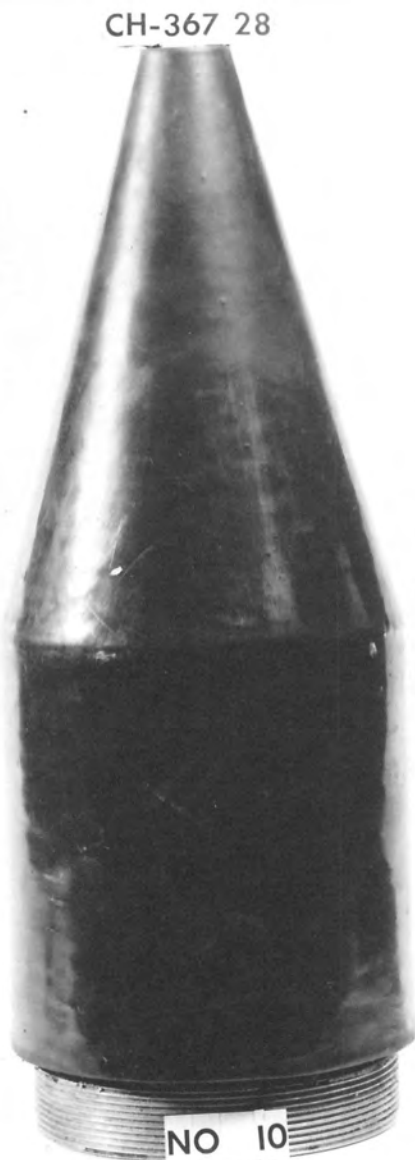
The coatings of both Specimens 9 and 10 became loosened and torn at the upstream edge of the coating in the throat section. The time in which this took place on both specimens was so short that no comparison as to cavitation-erosion resistance was possible (Figures 22 through 24). This gave further indication that a revision should be made to prevent pressure and velocity conditions damaging the coatings in this area so as to prevent further controlled cavitation studies.

A. BEFORE TEST
