# Performance of Glen Canyon Dam Diversion Tunnel Outlets

William E. Wagner, F. ASCE

ASCE Environmental  
Engineering Conference  
Dallas, Texas  
February 6-9, 1967/\$0.50

PERFORMANCE OF GLEN CANYON DAM  
DIVERSION TUNNEL OUTLETS

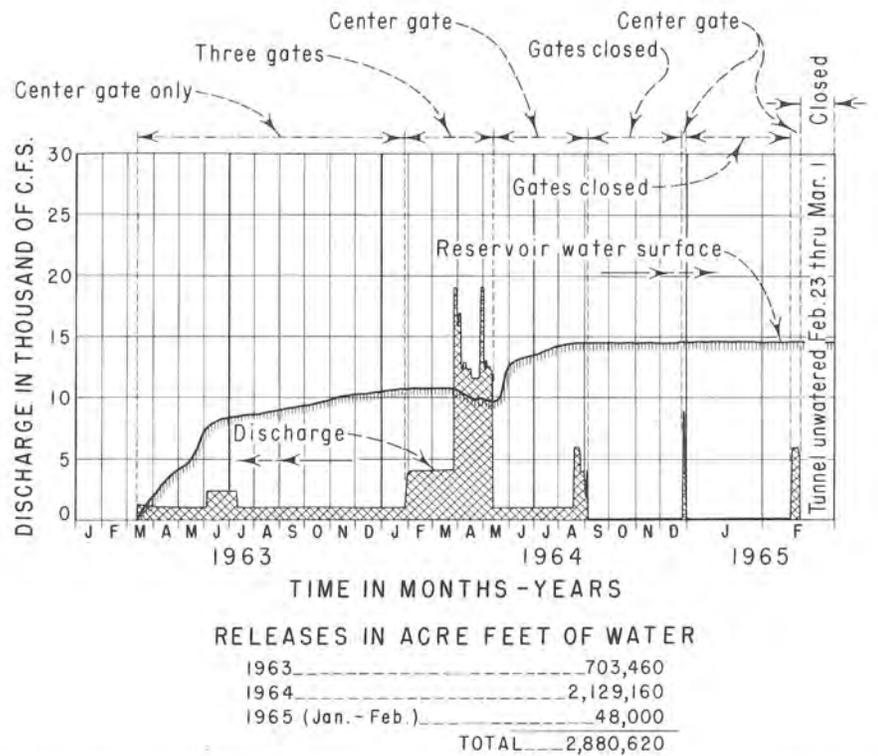
On March 13, 1963, the right diversion tunnel was permanently closed and releases through the left diversion tunnel outlets were started. Figure 5 charts the outlet discharges, number of gates operating, and the corresponding reservoir elevation for the period from March 13, 1963, to February 23, 1965, when the downstream tunnel was unwatered and inspected. In this period, nearly 2.9 million acre-feet of water were released at discharges up to 19,600 cfs and heads ranging from 43 feet to 336 feet. About 20 percent of these releases were made at heads less than 240 feet; 60 percent were made at heads ranging between 240 to 260 feet; and the remaining 20 percent of the releases were at heads from 260 to 336 feet. Gate openings at which

FIGURE 5 RELEASES THROUGH TUNNEL OUTLETS  
MARCH, 1963 - FEBRUARY, 1965

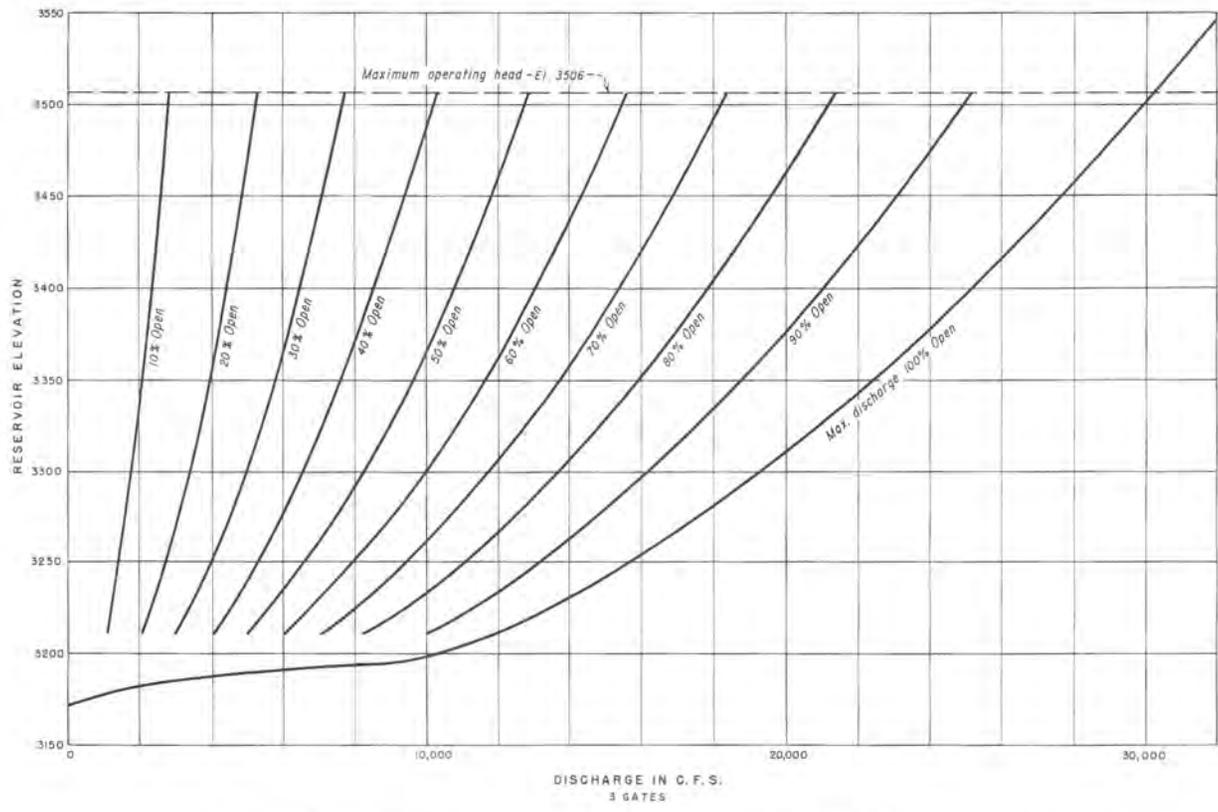
the outlets operated can be determined from the head-discharge curves shown in Figure 6. In September 1964, the reservoir reached the minimum level for power operation and, except for two short periods in December 1964 and February 1965, the outlets were closed and the inflow to the reservoir was passed through the power generating units.

FIGURE 6 HEAD - DISCHARGE CURVES, LEFT DIVERSION TUNNEL OUTLET WORKS

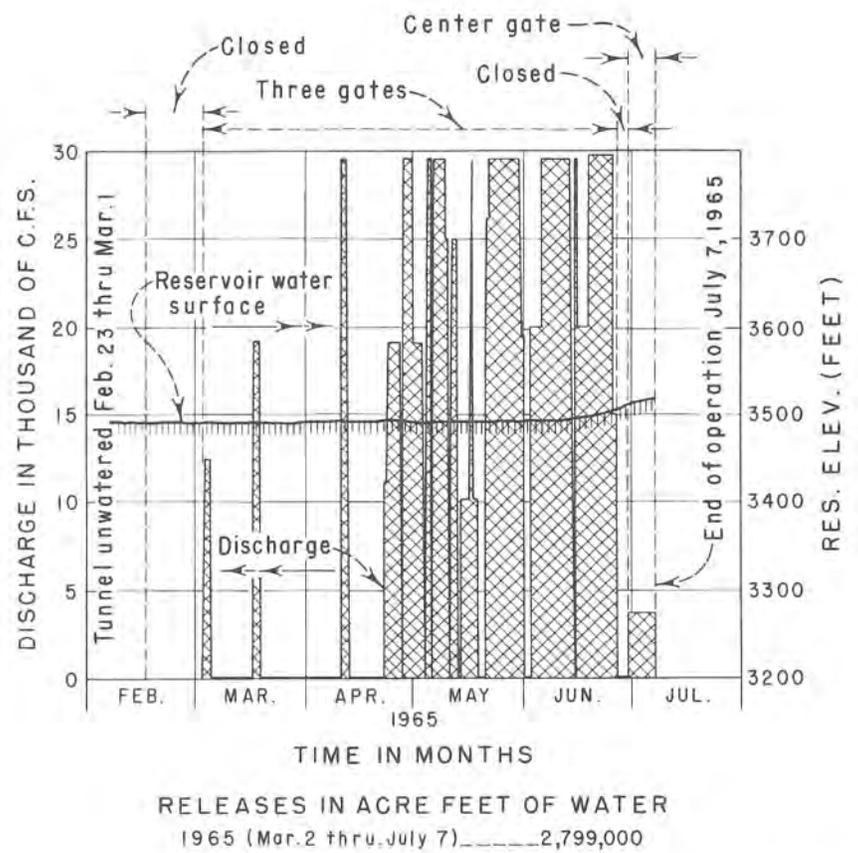
FIGURE II RELEASES THROUGH TUNNEL OUTLETS  
MARCH 2, 1965 - JULY 8, 1965

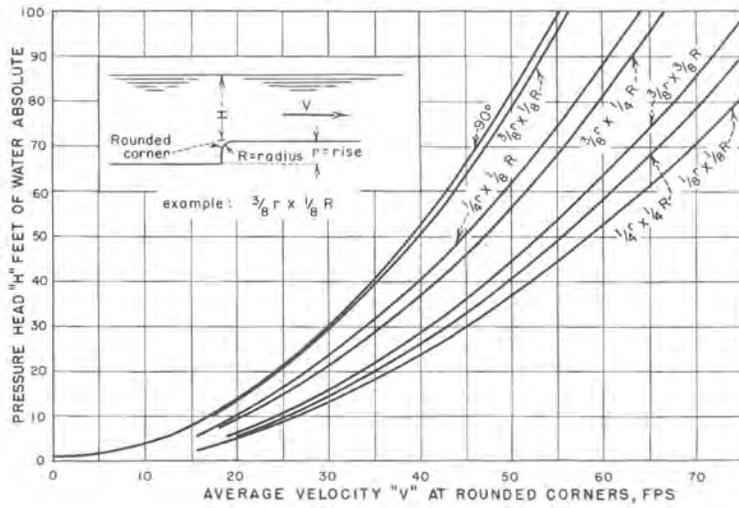
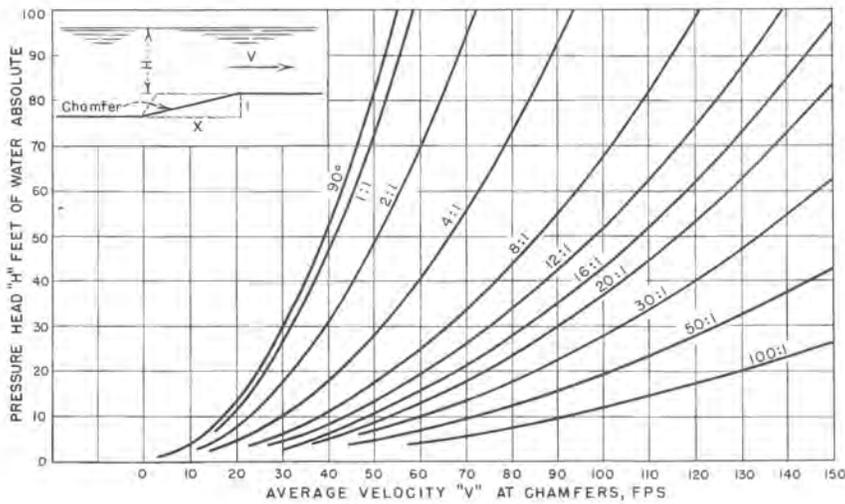
protrude into the flow<sup>1/</sup>. These relationships (Figure 20) may be used as guidelines for establishing tolerances for surface irregularities in fluidways and for specifying maximum slopes that may be permitted in removing irregularities by grinding. The experience at Glen Canyon Dam supports the validity of these curves for predicting the type of irregularity that may cause cavitation damage. For example, the 1/8-inch offset superimposed on the 65:1 slope in the left outlet (Figure 15) caused extensive damage to the gate body while no significant damage was experienced at the break in the 65:1 slope in the other two conduits. The average flow velocity through the tunnel outlets was about 135 feet per second for most of the March-July releases. Although the curves appear to be valid for carbon steel, more stringent tolerances may be required for less cavitation damage resistant materials, such as concrete.

FIGURE 20 VELOCITY-PRESSURE RELATIONSHIP FOR INCIPIENT CAVITATION AT ROUNDED AND SLOPED OFFSETS PROTRUDING INTO THE FLOW

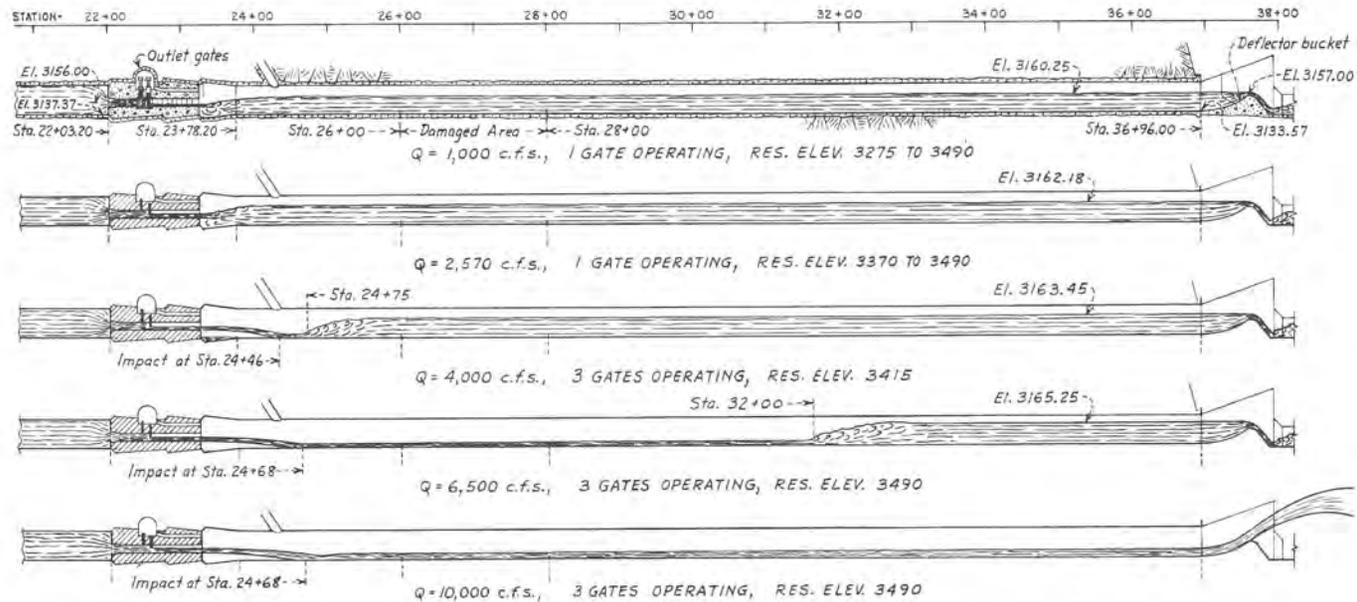
An analysis of the flow conditions in the tunnel for typical releases during the March 1963-February 1965 operation was made. This study (Figure 21) showed that for flows less than 3,000 cfs and reservoir elevations up to 3,490, a pool of water existed in the tunnel from the plug to the flip bucket. As the releases increased above 3,000 cfs, a hydraulic jump formed in the tunnel and moved downstream until it swept out at a discharge of about 10,000 cfs and reservoir elevation, 3,490. These computed flow conditions were verified later by a field test which showed that sweepout occurred at 9,400 cfs and reservoir elevation, 3,492.

tunnel downstream to about Station 25+00 probably occurred during the first 11 months of operation at 1,000 and 2,570 cfs (Figures 5 and 21). On February 1, 1964, the discharge was increased, and a constant discharge of 4,300 cfs was released until March 26, 1964. During this period, the reservoir elevation also remained constant at 3,415 and a hydraulic jump formed in the tunnel in the region of maximum damage. The "ball-mill" action of the foreign material in the hydraulic jump probably was the cause of the maximum damage to the tunnel lining between Stations 26+00 and 28+00. This conclusion is supported by the fact that damage was observed high on the sides of the tunnel (Figure 9). Also, laboratory model tests (Figure 22) showed that foreign material in a hydraulic jump would damage the surfaces of a circular tunnel in a manner similar to that experienced at Glen Canyon. No additional gravel was added during the 3-hour laboratory test, and the original gravel remained in the region of the hydraulic jump and was continuously circulated by the jump.

NOTES  
 Computations based on uniform velocity distribution at  $d_1$ , Manning's  $n$  of 0.011, estimated depth of flow over bucket lip, and side weir crest.  
 Field tests on March 2, 1965 showed sweepout occurred at 9,400 c.f.s. and Res. Elev. 3492.

FIGURE 21 COMPUTED FLOW CONDITIONS IN TUNNEL FOR TYPICAL RELEASES BETWEEN MARCH 13, 1963 AND FEBRUARY 15, 1965

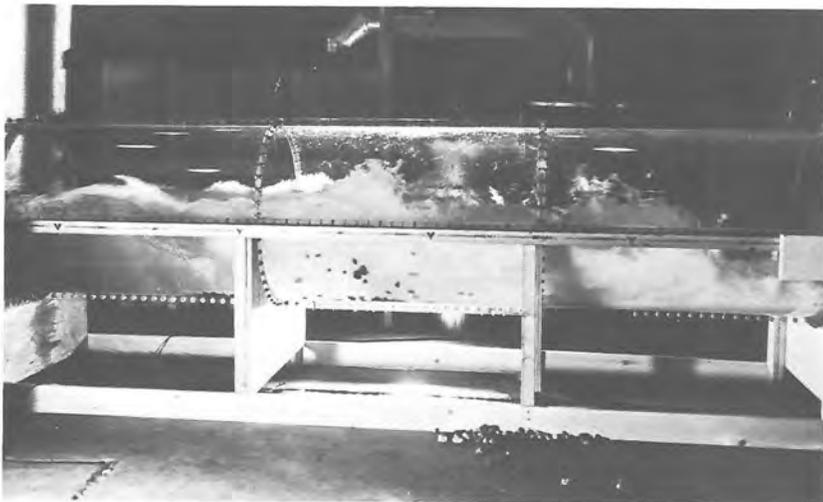
A. CIRCULATING ACTION OF 1/4- TO 1/2-INCH GRAVEL IN A HYDRAULIC JUMP IN A CIRCULAR TUNNEL

FIGURE 22 MOVEMENT OF MATERIAL IN A HYDRAULIC JUMP

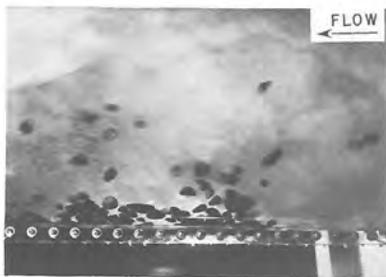
B. MOST OF THE GRAVEL CIRCULATED NEAR THE INVERT

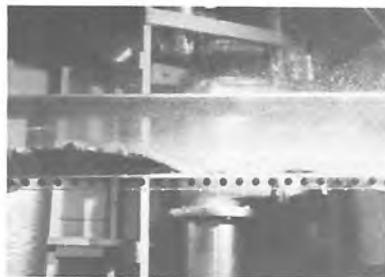
C. AFTER 3 HOURS OPERATION, THE PLASTIC TUNNEL WAS CLOUDED BY THE CIRCULATING GRAVEL
