LABORATORY TESTS AND INSPECTION OF TWO MEASURE-RITE  
OPEN-FLOW PROPELLER METERS

BUREAU OF RECLAMATION  
HYDRAULIC LABORATORY

October and November 1966

These studies were made to determine the accuracy of the flow rate indicated by two Measure-Rite meters that had been used for the "study of the use of water on Federal irrigation projects" in the Angostura Unit, Missouri River Basin Project, South Dakota.

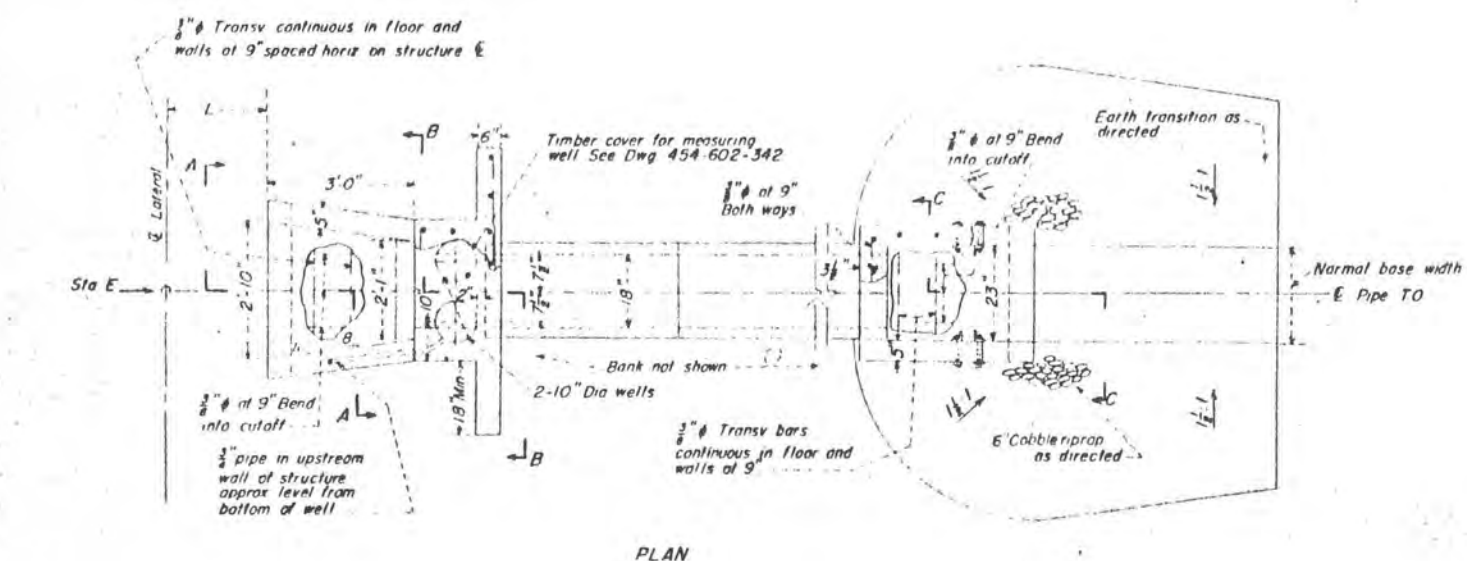
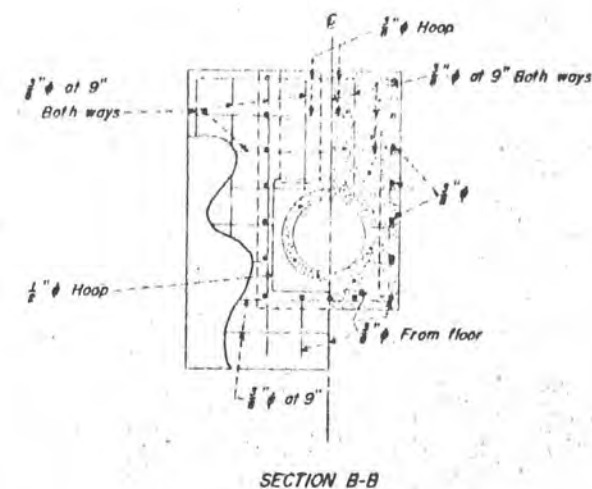
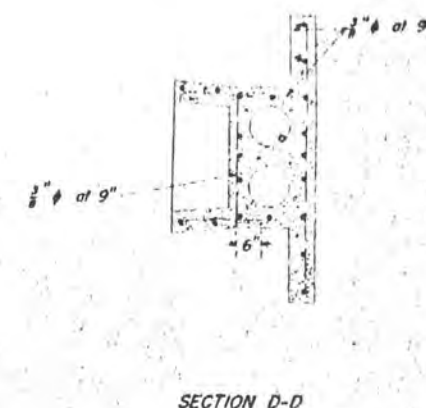
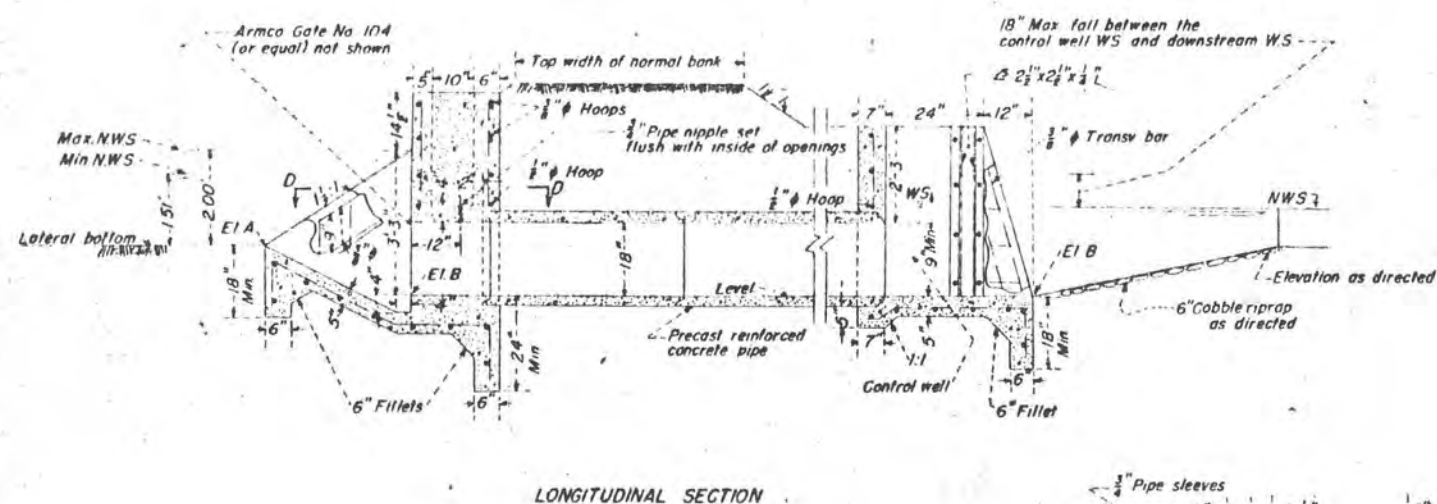
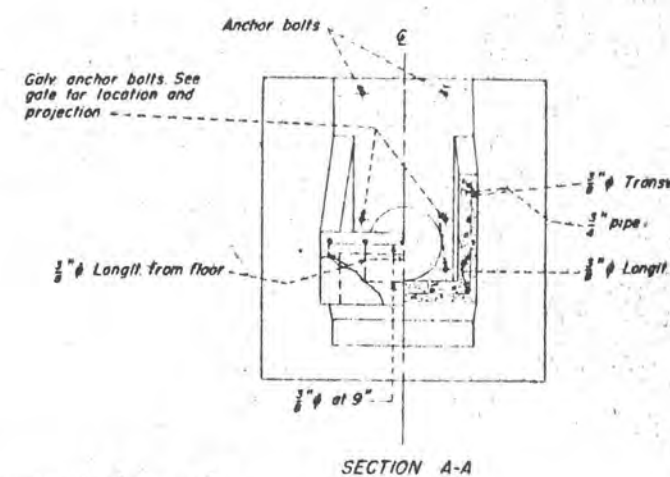
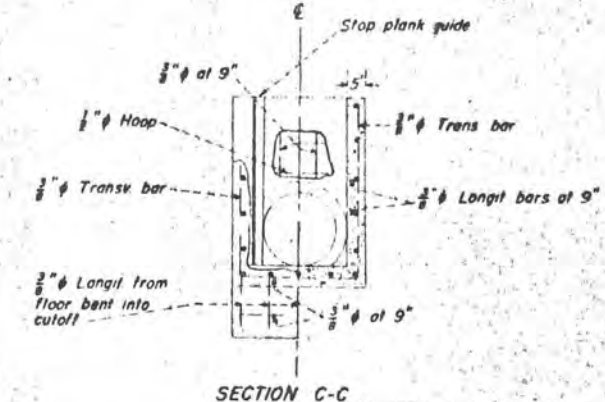
Figure 1

Laboratory installation.--In the laboratory the meters, one at a time, were installed in a typical Angostura 18-inch turnout, Figure 1.
