Preliminary report on hydraulic model studies, Bartlett Dam  
Spillway

This report summarizes the investigations on a 1:100 scale model of the Bartlett Dam spillway and discharge channel. Corrective measures as determined from the study are suggested. A formal report on the studies will be distributed as Laboratory Report No. Hyd-576.

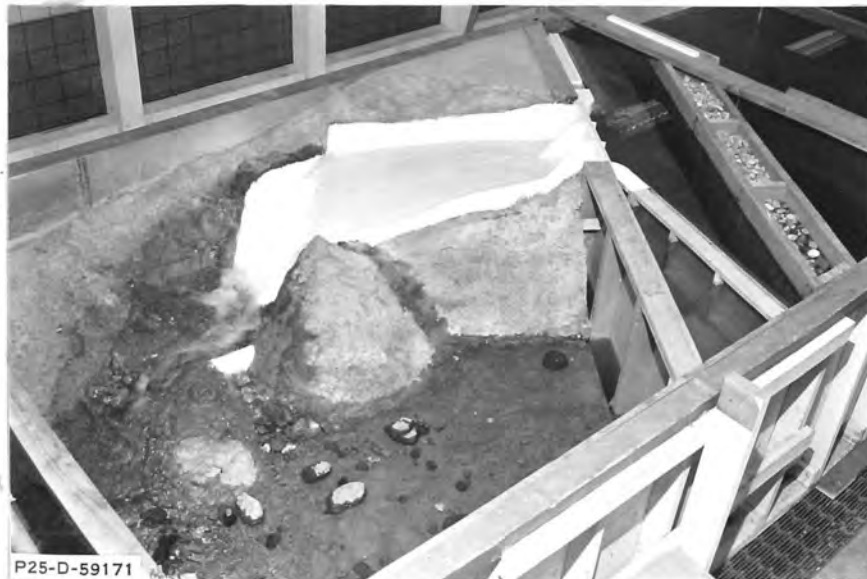
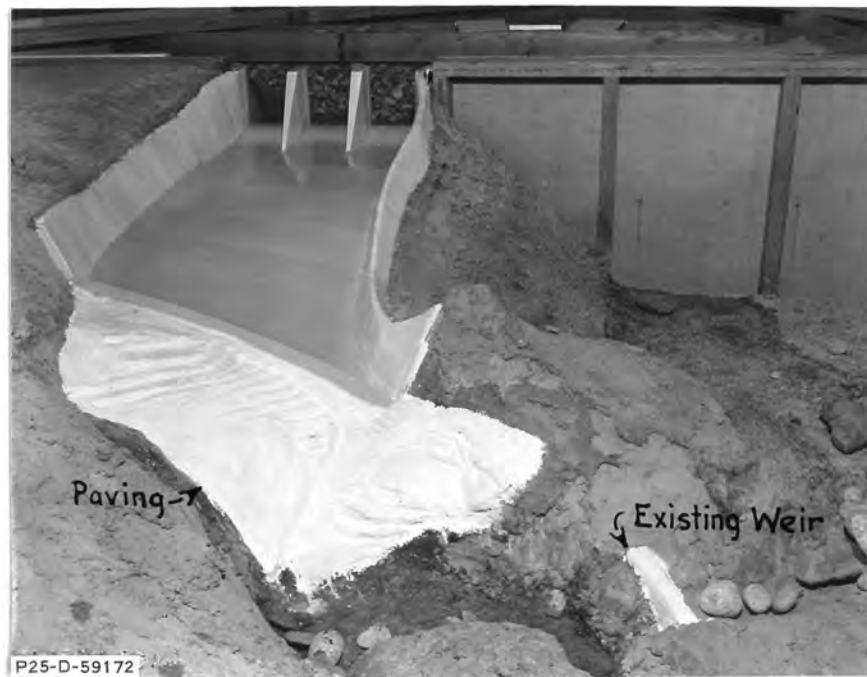
BARTLETT DAM SPILLWAY  
The 1:100 scale model

The extent of concrete paving placed  
in discharge channel following the  
1965-66 flood is painted white.
