ASCE National Water Resources
Engineering Meeting
January 24-28, 1972 • Atlanta, Georgia \$0.50

AERATION MITIGATES CAVITATION IN SPILLWAY TUNNEL

Donald Colgate, M. ASCE and
James Legas, M. ASCE

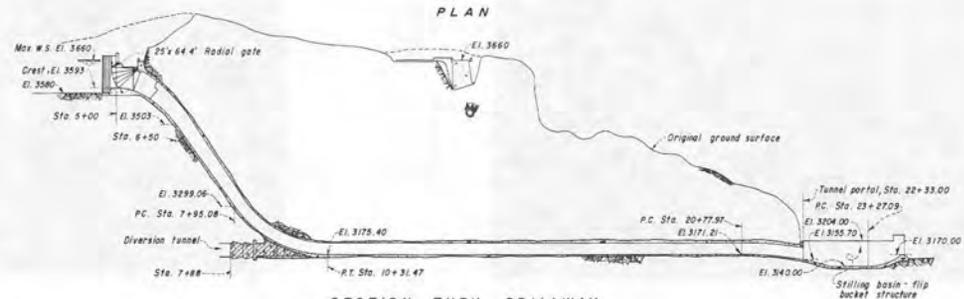
The condition of the stilling basin invert was excellent considering the amount of silt-laden materials passed during diversion. The surface was sufficiently eroded to expose aggregate, see Figure 3, but the texture of the eroded surfaces was generally smoother than similarly affected areas in the spillway tunnel. Depth of erosion was greatest at the basin centerline and decreased uniformly to the original surface in a distance of 6 to 8 feet from the centerline.
