EMERGENCY REDESIGN OF SILVER JACK SPILLWAY

G. W. Center

T. J. Rhone

Prepared for presentation at the American Society of Civil Engineers
Water Resources Engineering Conference in Washington, D.C.,

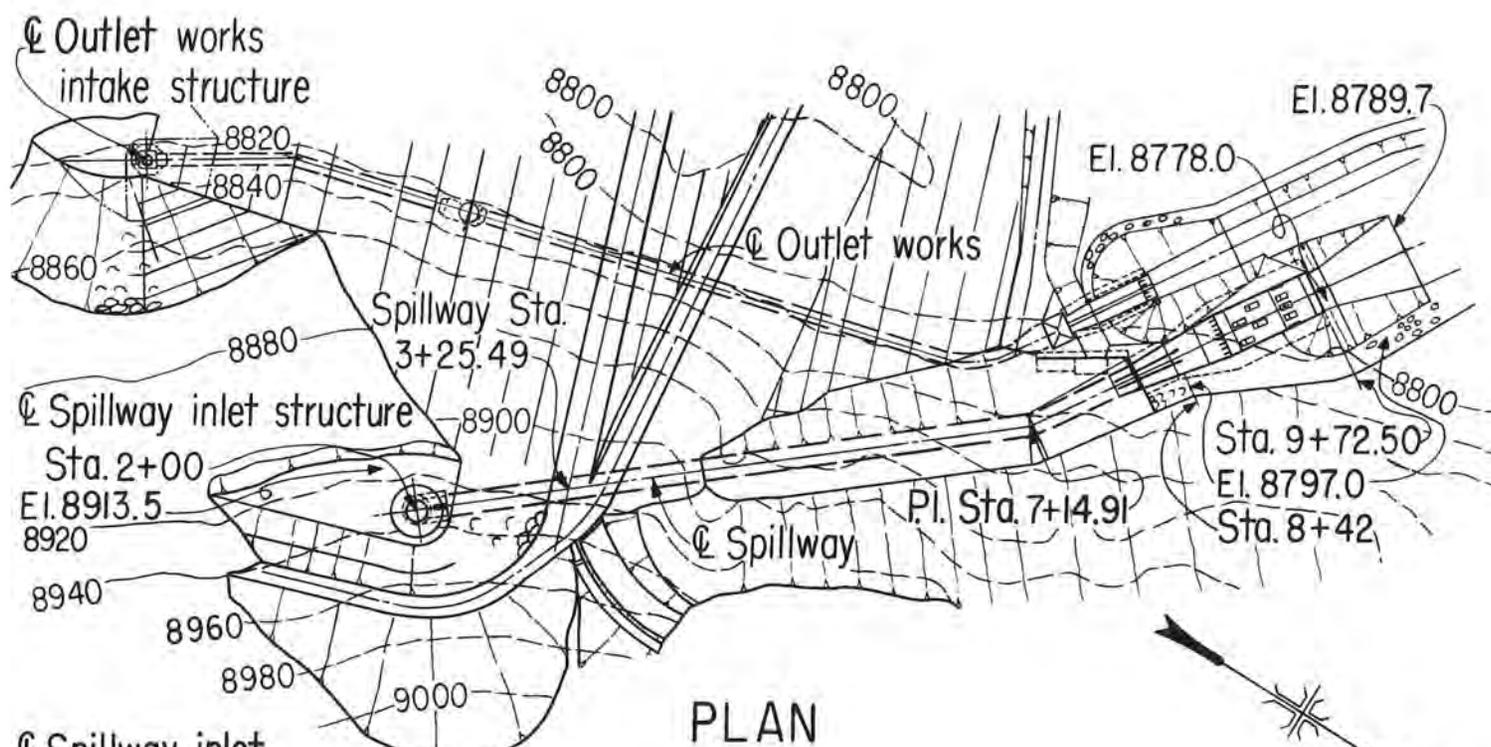
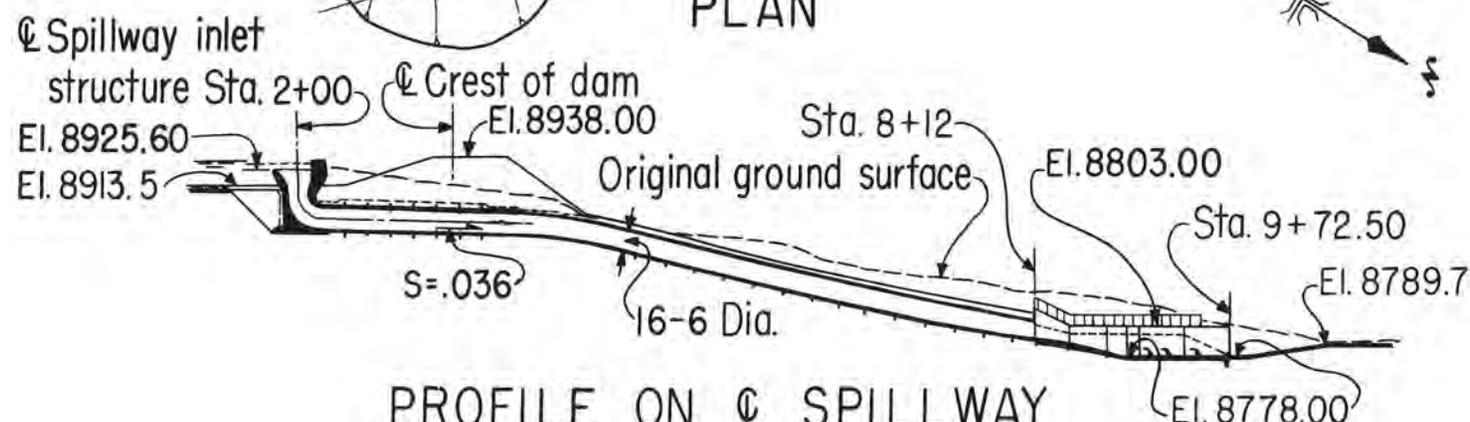
SILVER JACK DAM

The spillway is a 41-foot (12.48-m) diameter morning glory with its crest at elevation 8925.60 (2722.3 m), 136 feet (41.50 m) above the creek channel, Figure 1. Flow from the spillway crest falls about 44 feet (13.4 m) into a 16.5-foot (5.03 m) diameter circular conduit. The circular conduit is about 563 feet (171.5 m) long and connects to a diverging chute leading to the stilling basin. The stilling basin floor is about 147 feet (44.8 m) below the spillway crest.

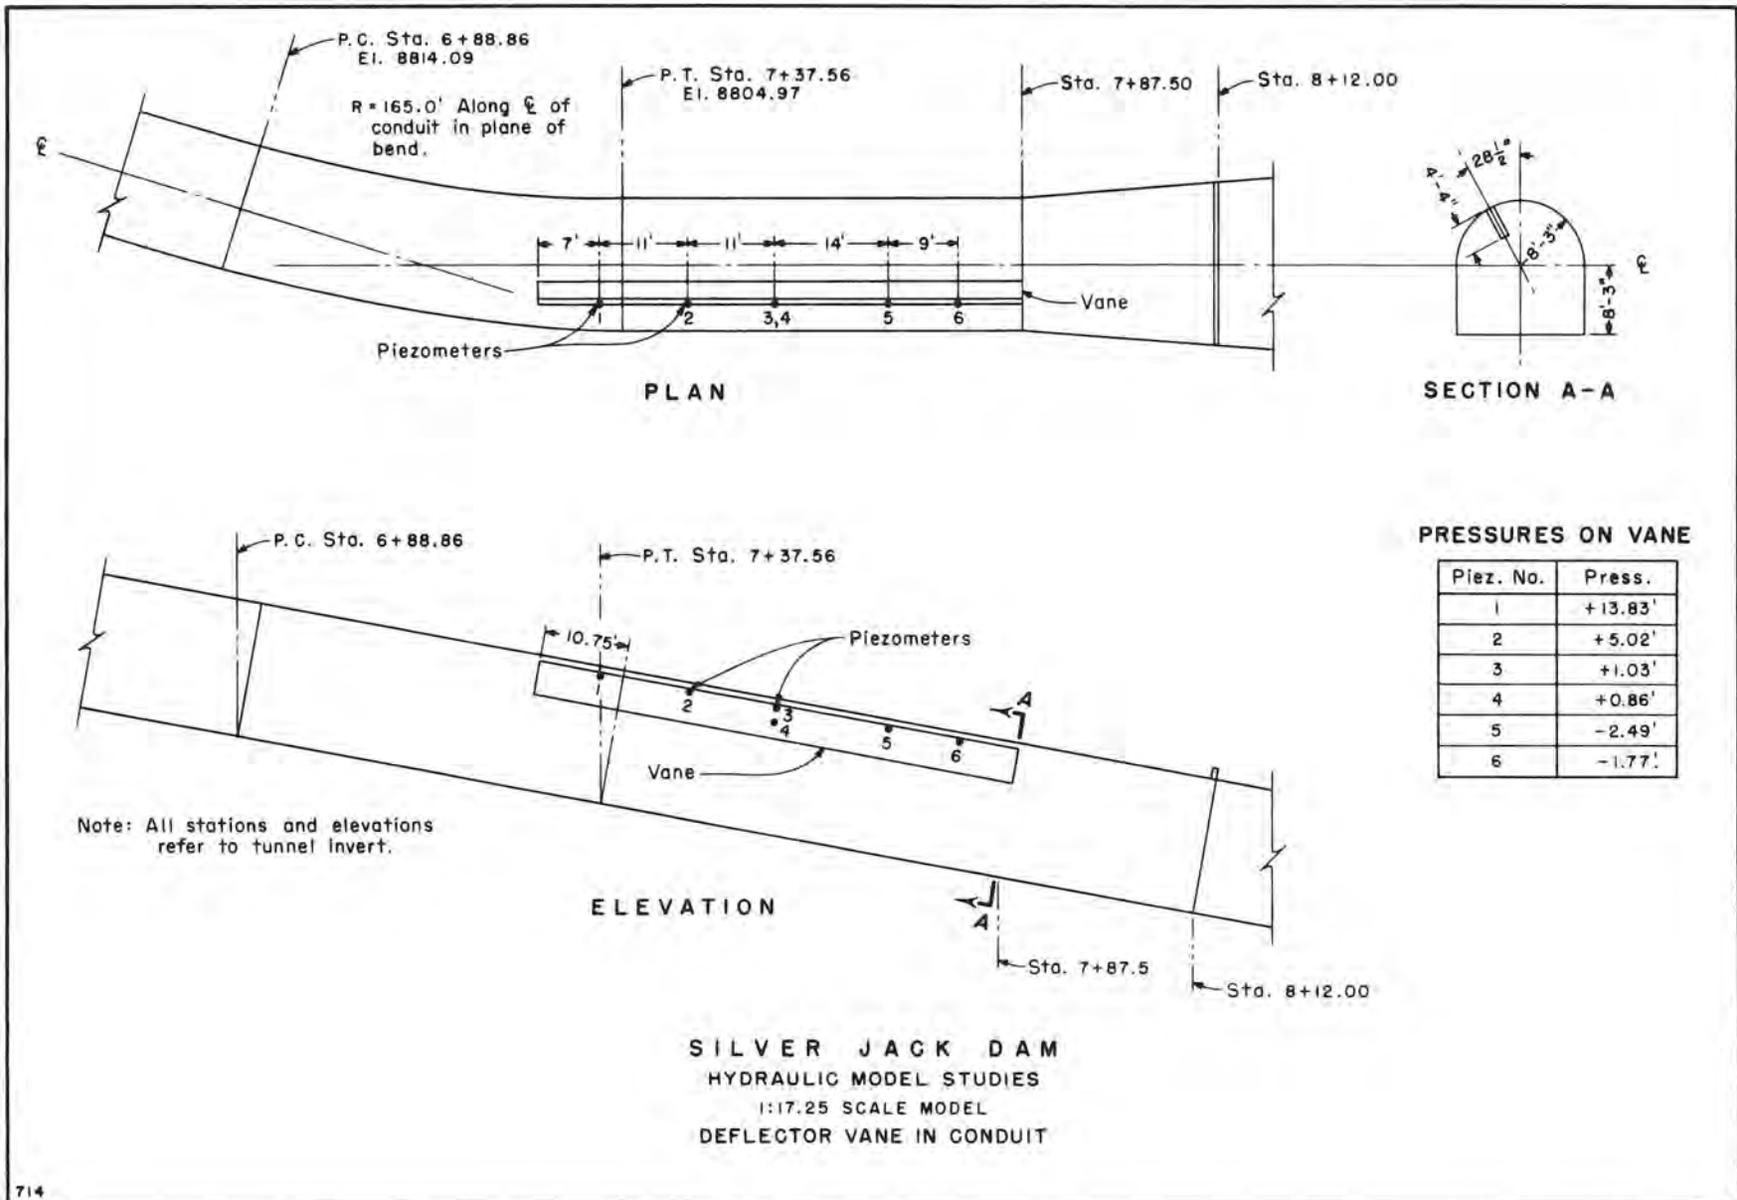
Figure 6

To prevent the direct impingement of the deflected flows, the wall was moved to the right of the crown. Three trials were made with the wall off center 15° , $28\text{-}1/2^\circ$, and 45° from vertical. All of the off-center locations reduced the splash and spray, but the $28\text{-}1/2^\circ$ location, Figure 6, caused the least disturbance and also improved the flow distribution at the tunnel portal.

Six piezometers were placed along the right side of the deflector wall near the roof. Pressure measurements at the maximum discharge indicated that at the upstream end where the wall intercepted most of the flow, the pressure would be equivalent to about 14 feet (4.27 m) of water, Figure 6. All of the other piezometers indicated pressures near atmospheric.

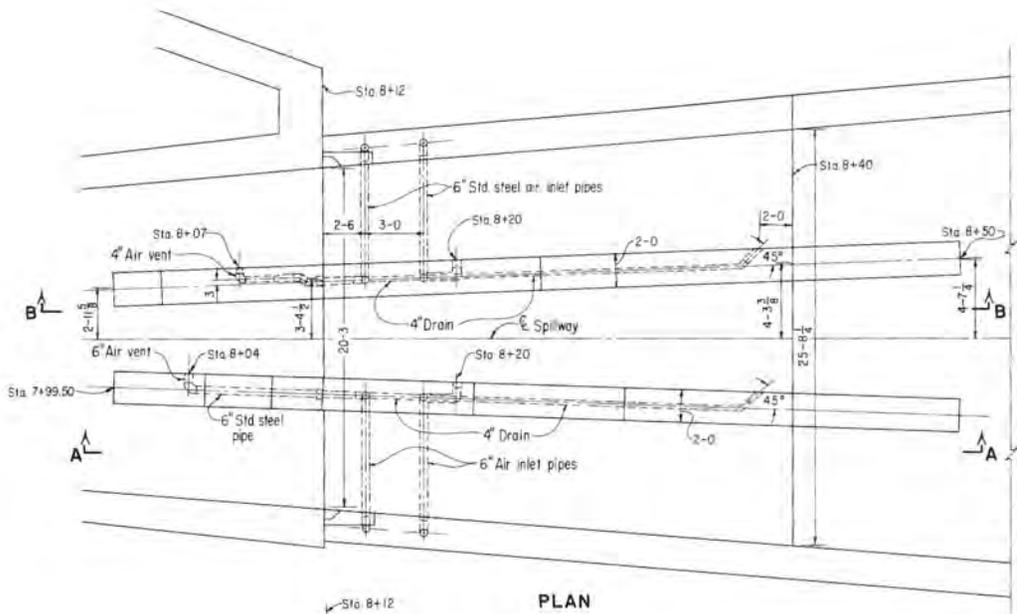
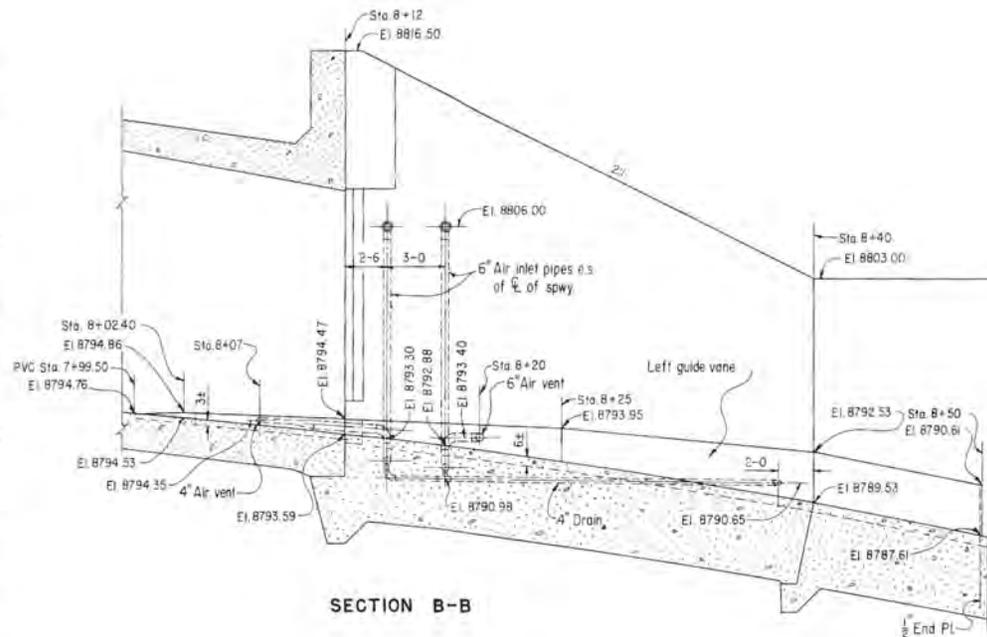
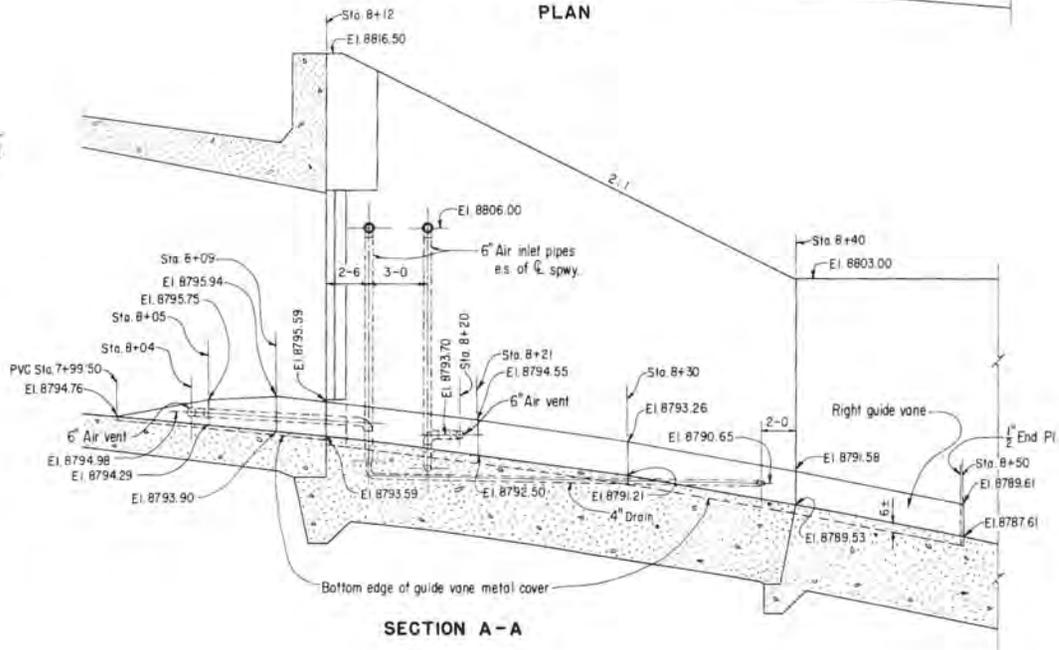
SILVER JACK DAM
 SPILLWAY
 CHUTE GUIDE VANES
 FIGURE 8

Flow entering the diverging chute leading to the stilling basin was very unsymmetrical, and the unequal distribution carried into the stilling basin. In the preliminary design, the flow was concentrated on the left side of the basin with the 1,650 cfs (46.75 cu m/sec) and 6,280 cfs (177.8 cu m/sec) discharges, but with the 3,140 cfs (89.0 cu m/sec) discharge, the flow was more concentrated on the right side, Figure 7. Longitudinal guide vanes dividing the chute in thirds were developed to provide symmetrical distribution of the flow entering the stilling basin. Both vanes are 2 feet (0.61 m) wide and extend between Station 7+99.50 (2+43.8 m) and Station 8+50.00 (2+59.2 m). The height of each vane and the configuration at the upstream end were developed by cut and fit until the optimum distribution of the flow entering the stilling basin and the minimum amount of disturbance near the upstream end of the vane were obtained for all three test discharges. The configurations of the vanes are shown on Figure 8, and the flow appearance in the basin is shown on Figure 9.

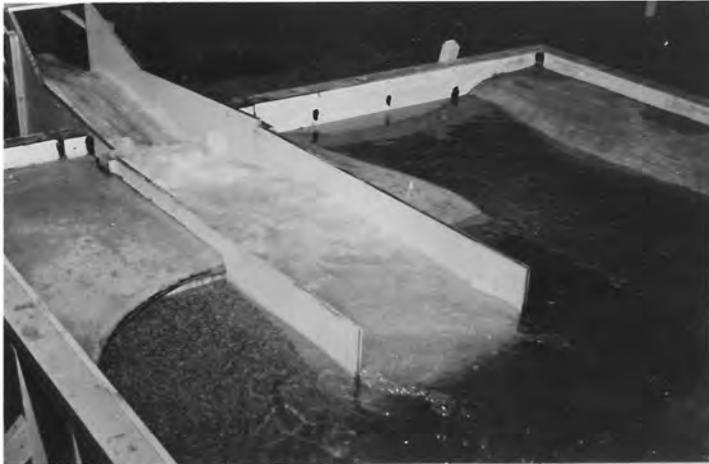
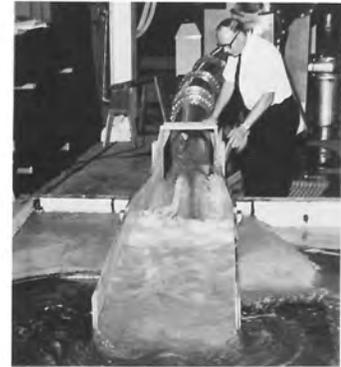
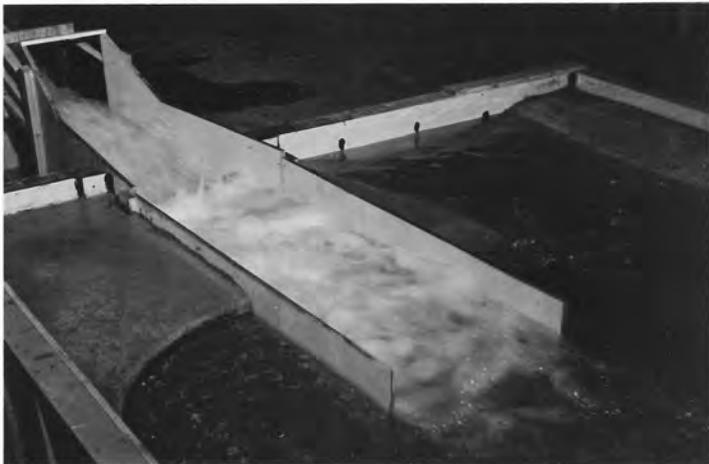
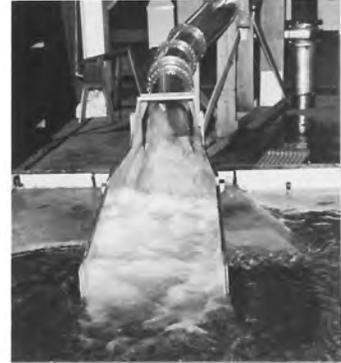
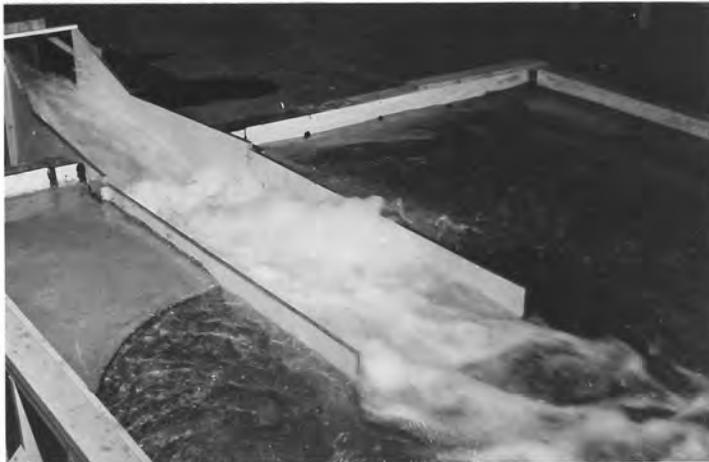
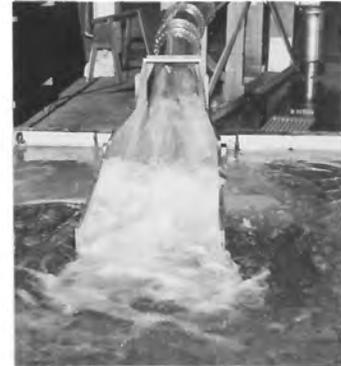
Figure 9

SILVER JACK DAM
Hydraulic Model Studies
1:17.25 Scale Model
Stilling Basin Performance
Recommended Vanes in Conduit and Chute-Preliminary
Baffle Block Arrangement

slope. The second row contained four 3-foot (0.91-m) wide blocks 14 feet (4.27 m) downstream from the first row. All blocks were 7 feet (2.13 m) high. This arrangement provided unsatisfactory stilling action in the basin. The lack of energy dissipation was evident whether or not the deflector vanes were installed on the approach chute, Figures 7 and 9. A similar block arrangement was tried with 5-foot (1.52 m) high blocks in both rows and with 5-foot (1.52 m) high blocks in the first row and 7-foot (2.13 m) high blocks in the second row. There was very little improvement in the energy dissipation with any of these symmetrical arrangements of blocks.

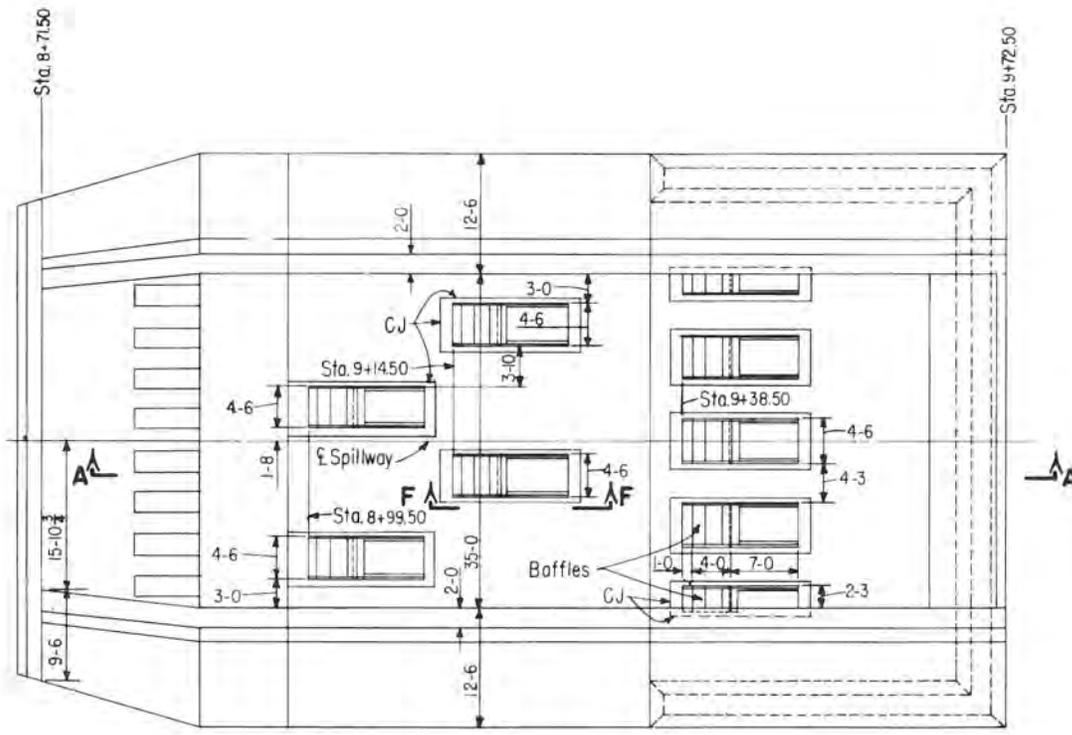
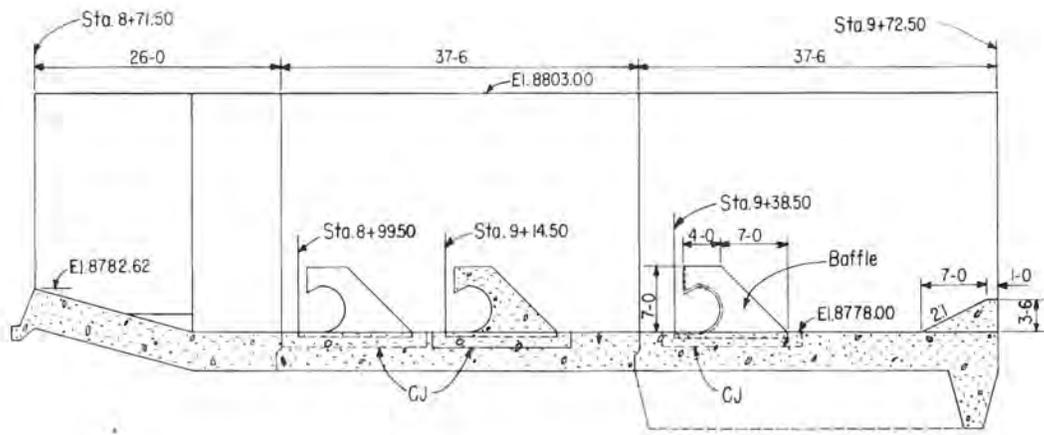
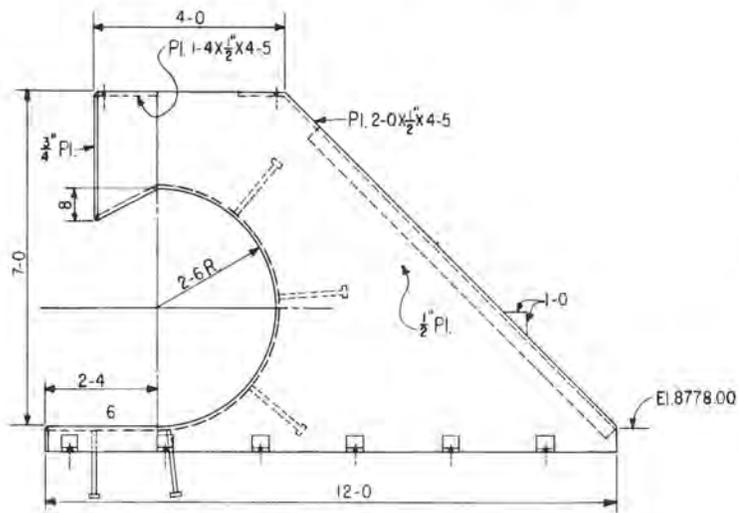
FIGURE II

STILLING BASIN-BAFFLES

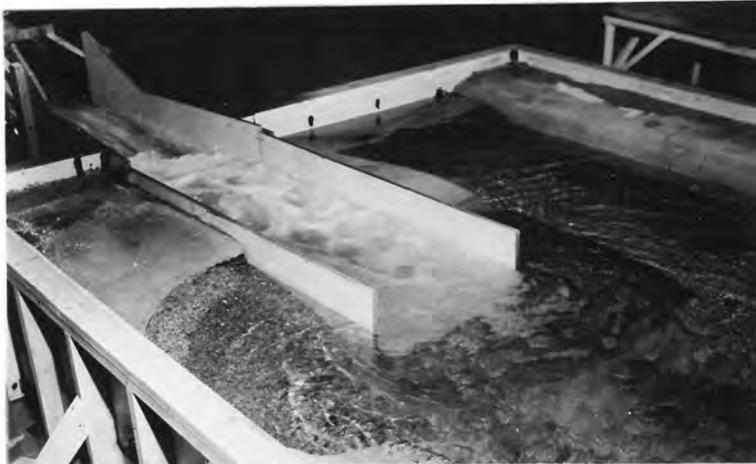
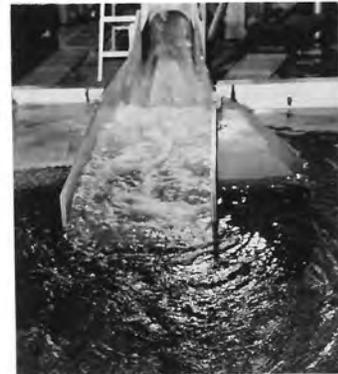
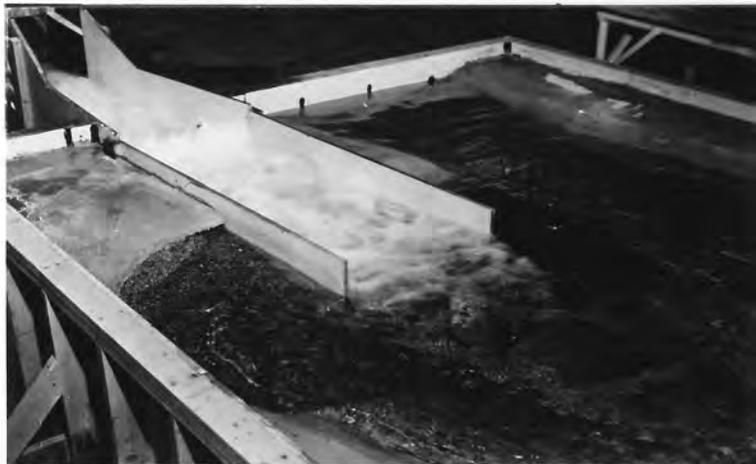
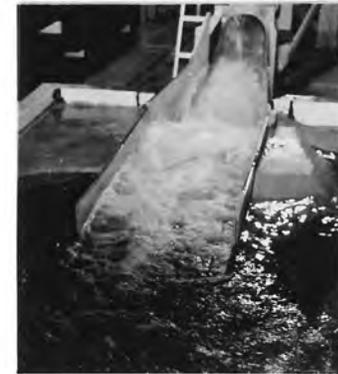
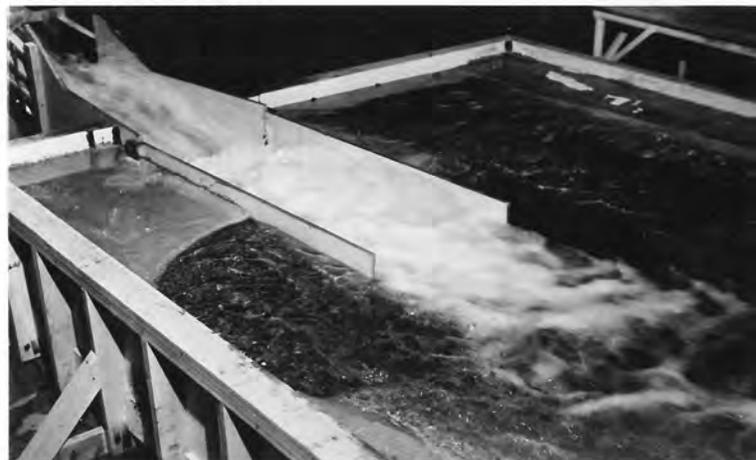
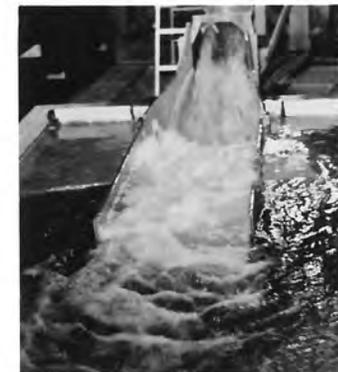
Figure 12

The flow entering the basin was not truly symmetrical, and the flow concentration changed from the left side to the right side and then back to the left side as the discharge increased. These flow conditions indicated that an unsymmetrical block arrangement might be necessary to obtain adequate energy dissipation. On this premise, the tests were continued on a "trial and error" basis to develop an effective block arrangement. The location of the rows and the spacing and location of individual blocks were adjusted and changed many times in arriving at the final arrangement with three rows of blocks as shown in Figure 11. The flow appearance with the final arrangement for the stilling basin is shown on Figure 12. The excellent flow conditions were prevalent for all discharges, and the tailwater could be lowered about 3 feet (0.92 m), at which point the model channel became the control without adversely affecting the basin efficiency.

SILVER JACK DAM
Hydraulic Model Studies
1:17.25 Scale Model
Stilling Basin Performance
Recommended Design

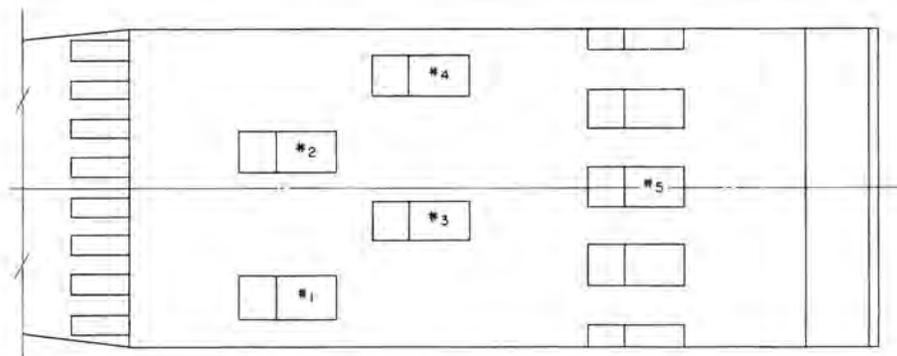
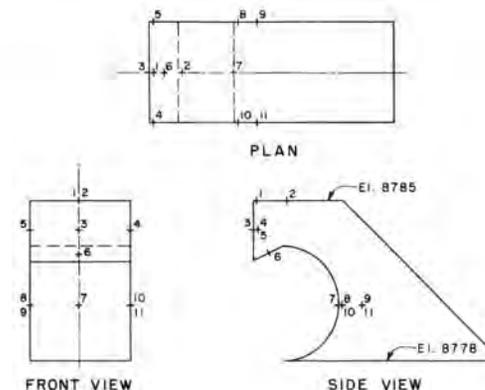
Figure 13

Eleven piezometers were installed in critical locations in one block to determine if dangerous subatmospheric pressures or exceptionally high impact pressures could be detected, Figure 13. Pressures were measured with the block in

The highest pressure was measured with the block in the two first row positions and the left second row position. These pressures, located in the center of the concave face, were equivalent to 70 to 75 feet (21.3 to 22.8 m) of water. The lowest observed pressure was equivalent to about 19 feet (5.79 m) of water below atmospheric. The low pressures occurred on the sides of the block near the top with the block in the left second row position. The pressure readings have been tabulated on Figure 13.

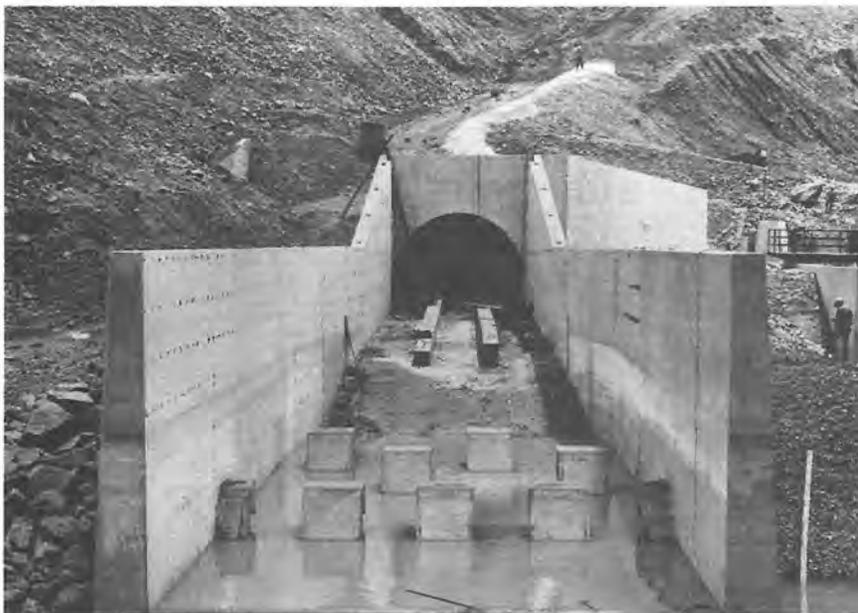
Melting snow saturated the slopes of the exposed cut in this area where the spillway cut crossed an old landslide. This 400-ft (120-m) wide slide destroyed the newly constructed stilling basin at Silver Jack Dam, Colo.

The shift in alignment of the stilling basin called for in the redesign created some additional engineering problems. The curve in the conduit created unsymmetrical approach flow. This was corrected mostly by installing guide vanes in the conduit. However, the large baffle blocks used to compensate for inadequate tailwater depth were staggered further correct the affects of uneven flow.
