PAP-304

BUTTERFLY VALVE TESTS

HYDRAULIC LABORATORY
DIVISION OF GENERAL RESEARCH
ENGINEERING AND RESEARCH CENTER
DENVER, COLORADO

February 1974

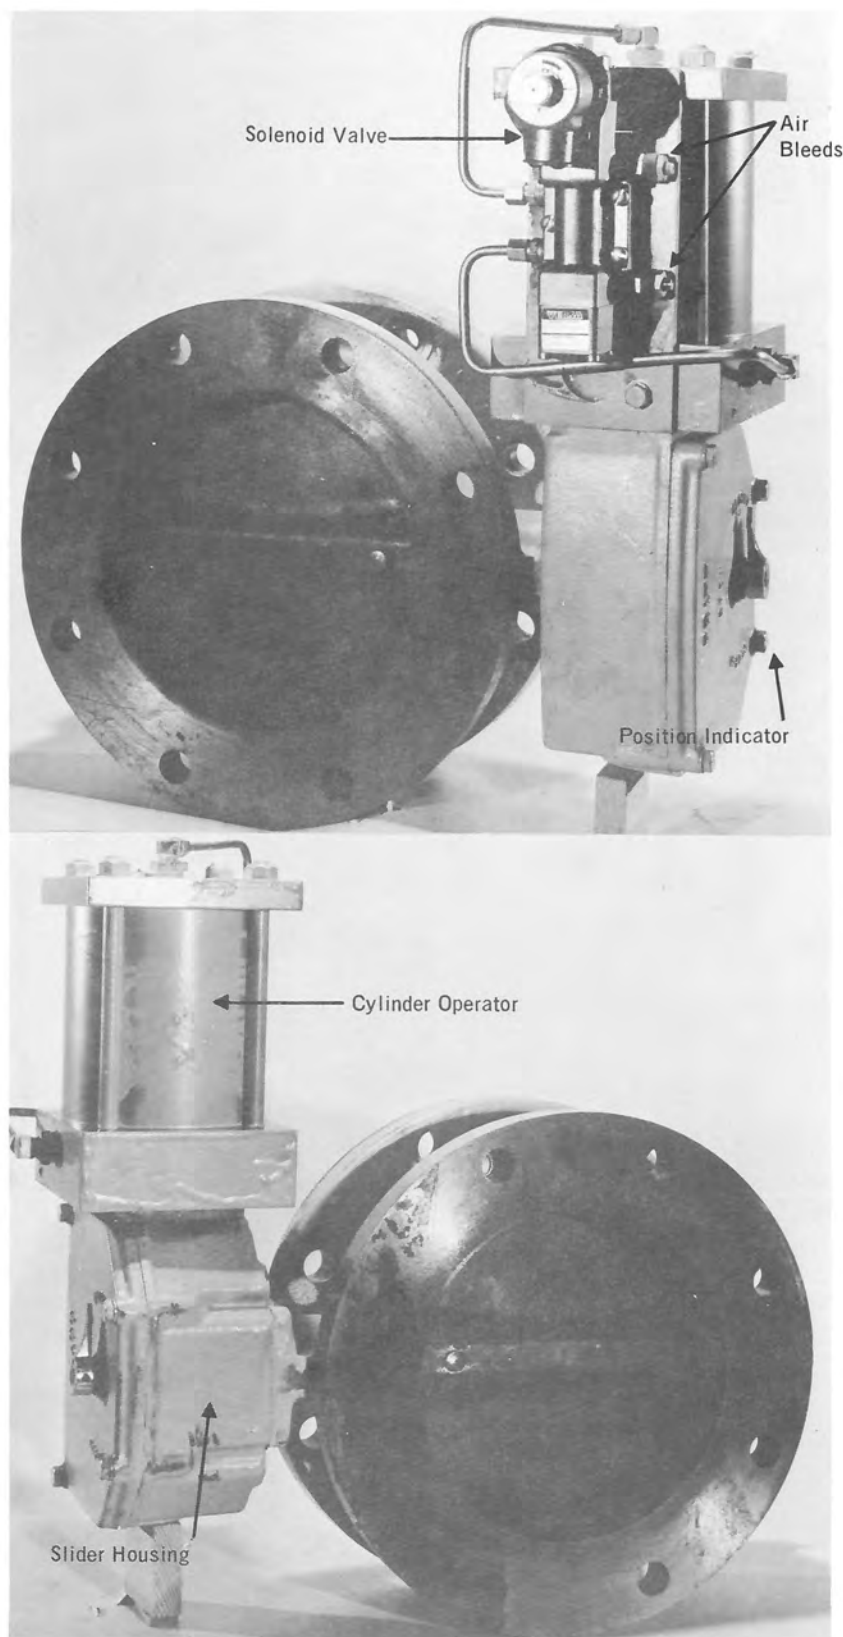
Figure 1P. Pratt valve with components labeled.
Photos P801-D-74498 (upper), P801-D-74497 (lower)

The Pratt valve (Figure 1-P) was a flanged design, quite compact, with no external moving parts to interfere with adjacent equipment. The butterfly leaf (disk) was a modified lenticular shape and sealed on a rubber seat. The seat was factory bonded to the inside of the valve body and could not be replaced in the field.

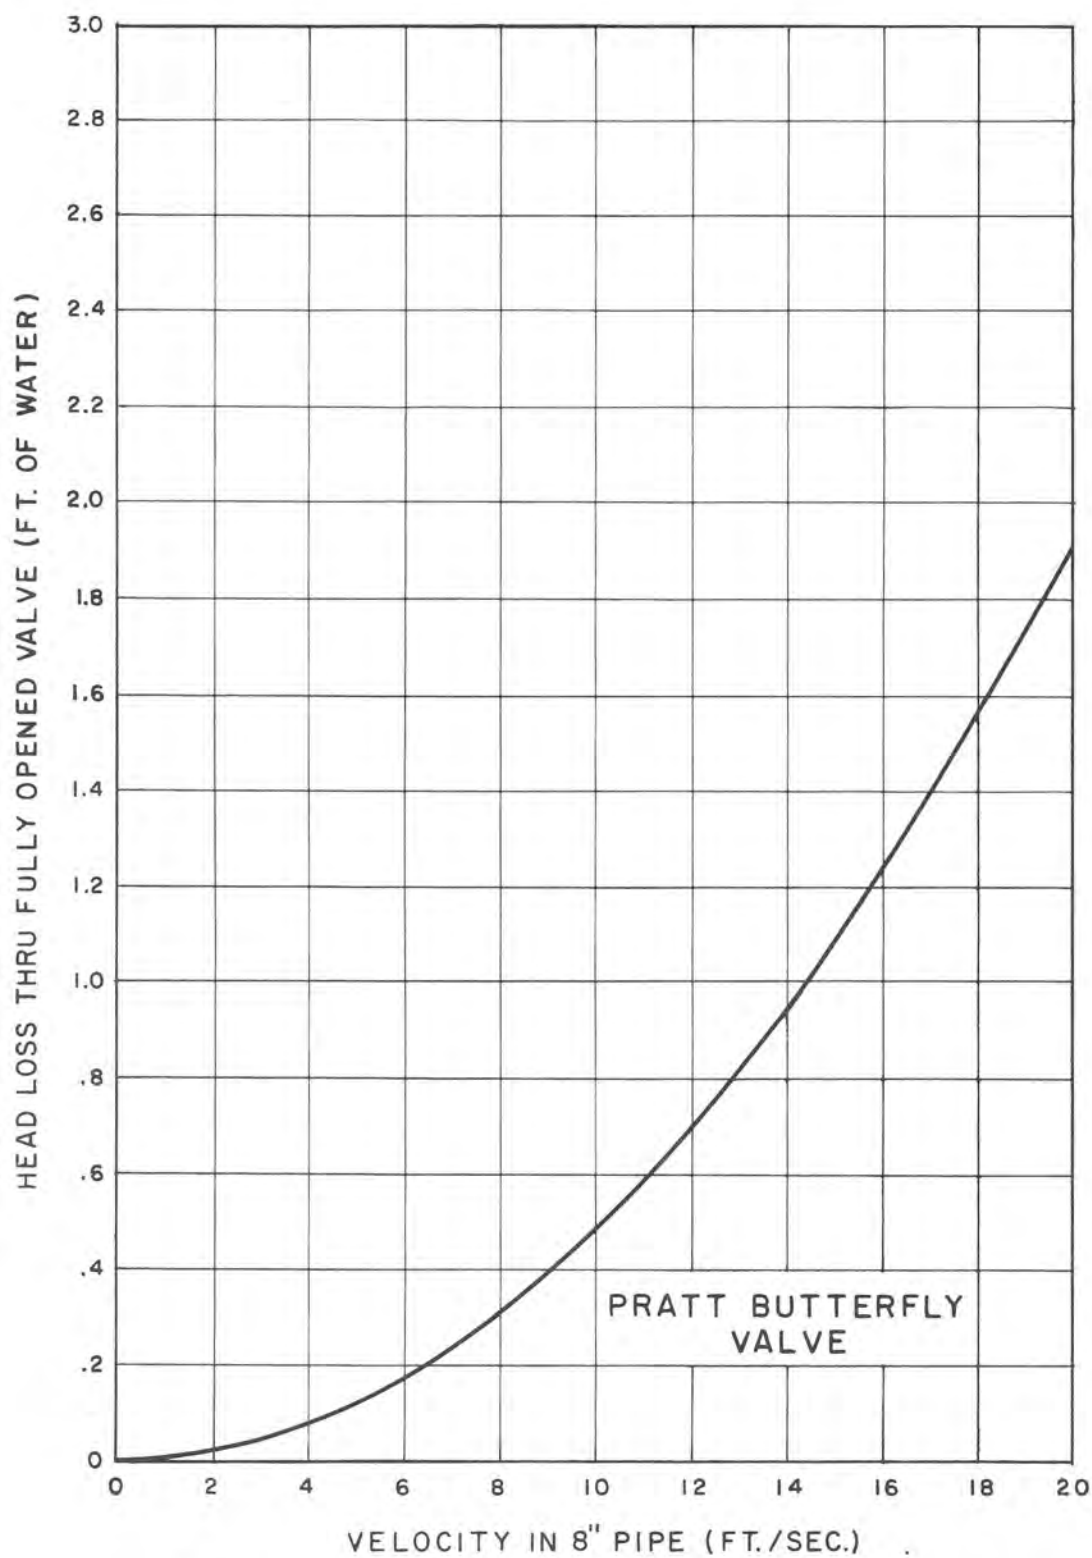
Figure 5P. Head loss through fully opened Pratt valve.

The Pratt valve possessed the smoothest action of all valves tested. The solenoid valve with air bleeds provided excellent control of valve opening and closing times. Head losses were lower for the Pratt valve than for any of the other valves tested. The factory bonded rubber seal developed cracks and was not bubble tight at 150 psig. Minor shaft seal leakage occurred on the side opposite the slider housing. No deviations from specifications AWWA C504-66 were listed by Henry Pratt Company for their valve.

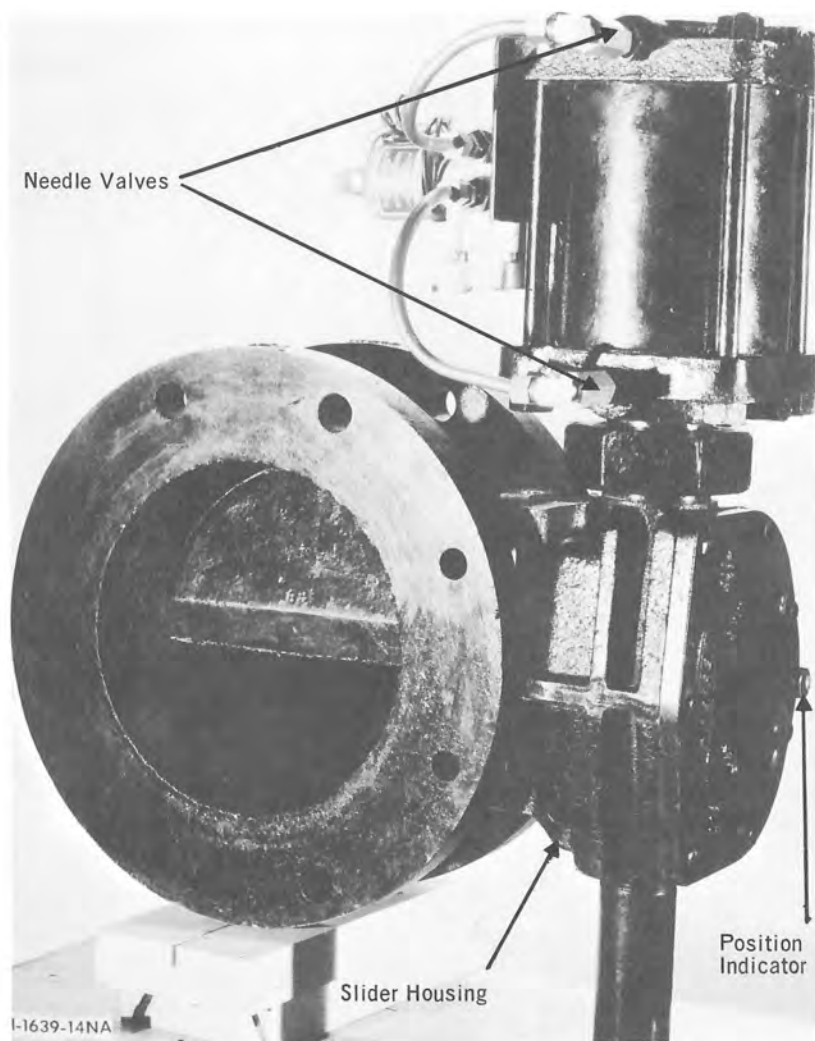
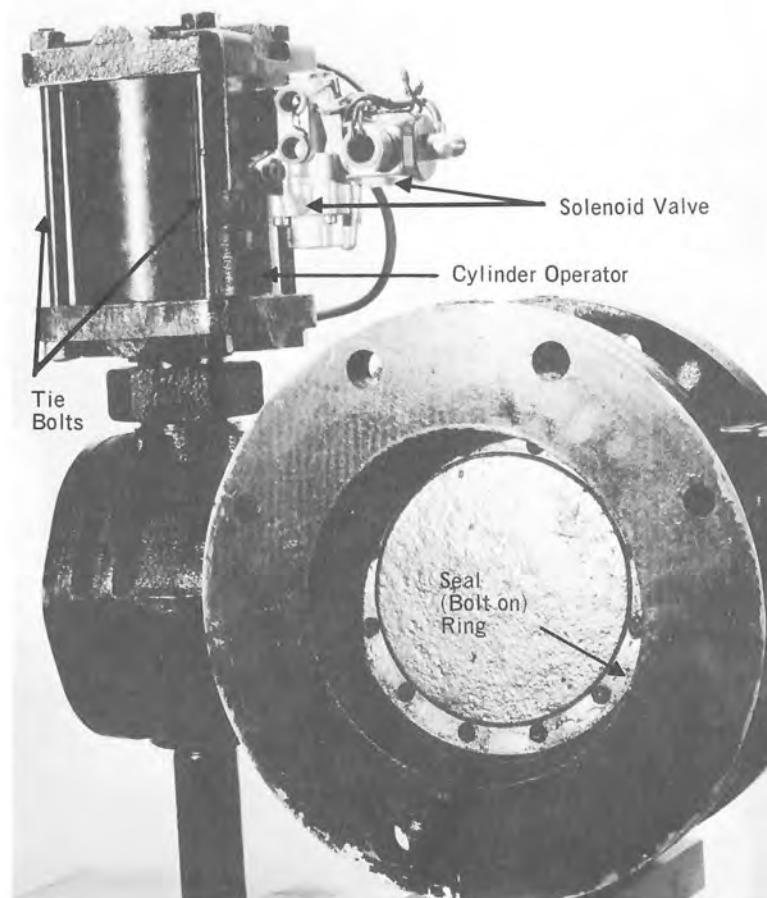
Figure 1D. Dresser valve with components labeled.

The Dresser valve (Figure 1-D) was a flanged design, compact, with no external moving parts to interfere with adjacent equipment. The butterfly leaf (disk) was an unsymmetrical shape with one side flat and the other raised over the shaft area (offset disk). The flat side contained the field renewable continuous rubber seal ring. The seal is composed of rubber vulcanized to a stainless steel ring. The ring was held in place by 12-1/4-inch (0.64-cm) button head cap screws (Figure 2-D). Once the valve was removed from the line, approximately 15 minutes was required to remove and replace the seal.

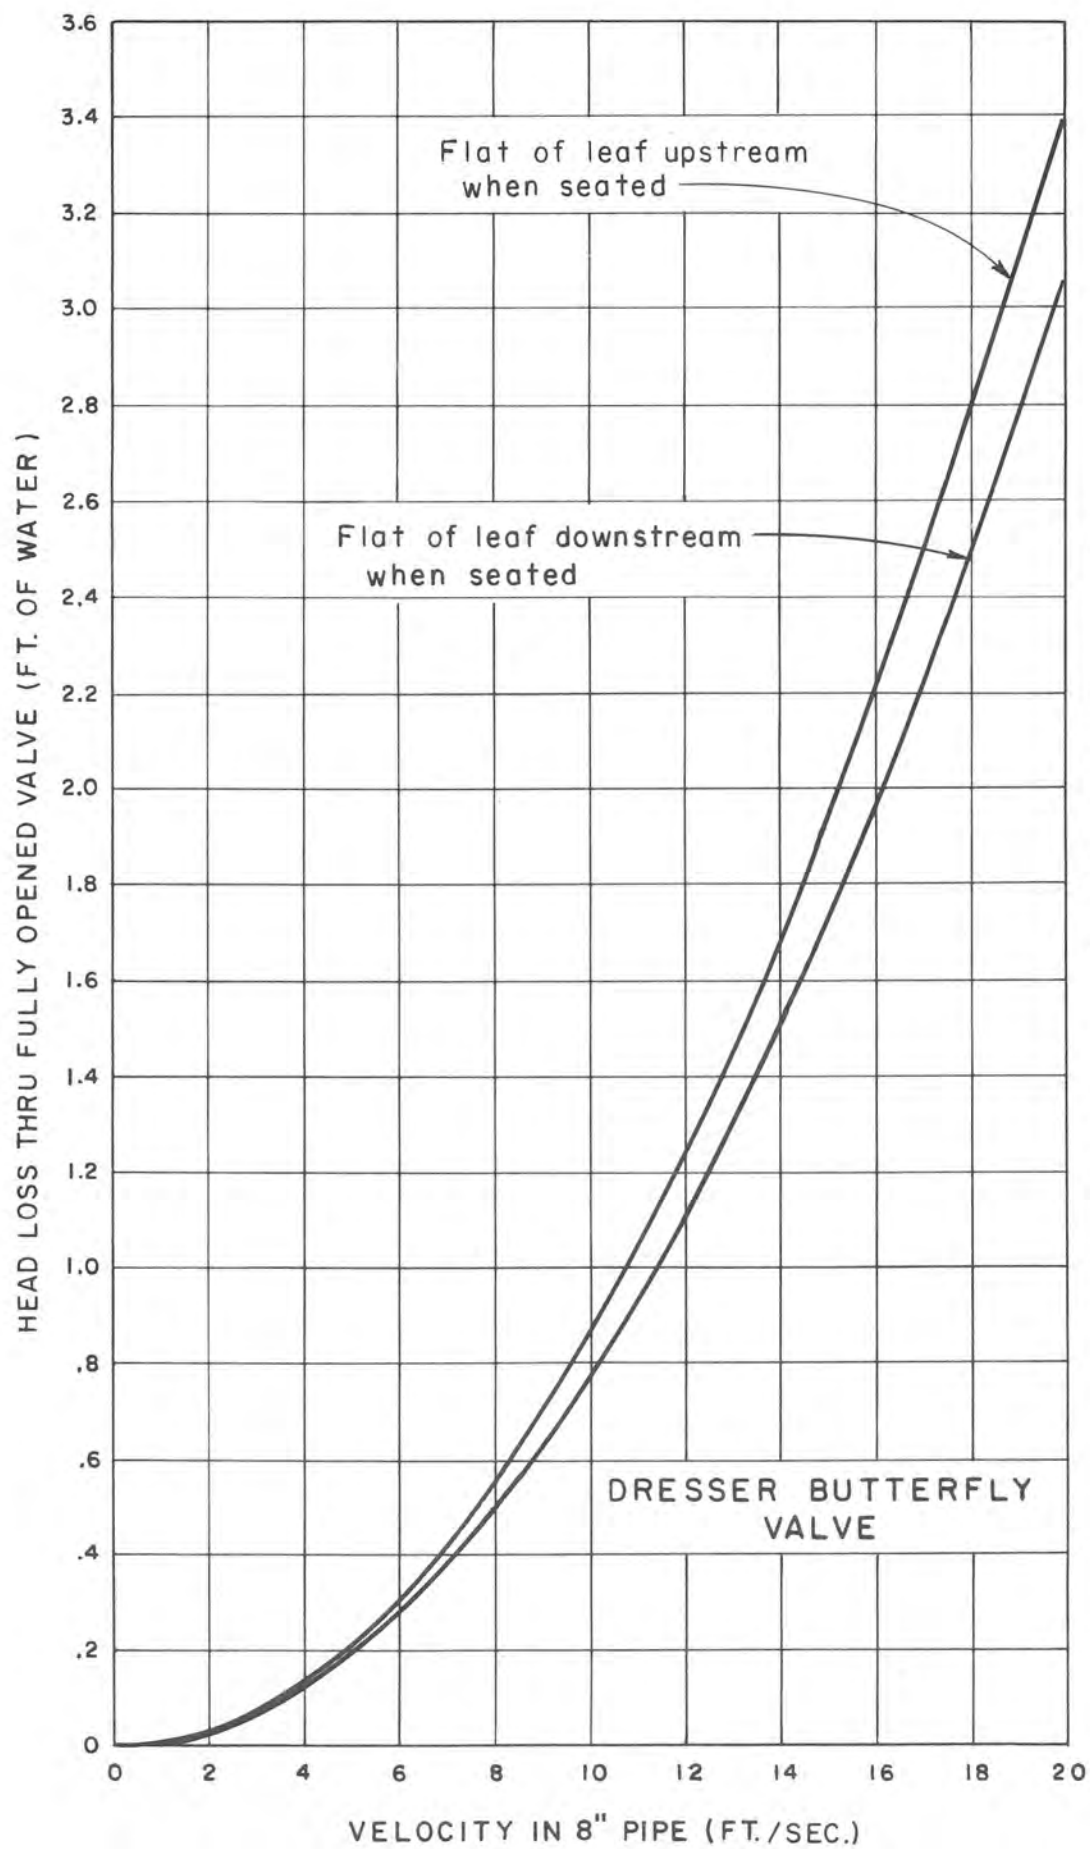
Figure 5D. Head loss through fully opened Dresser valve.

10. Head losses for the fully opened valve were obtained for a wide range of line velocities. These losses are shown in Figure 5-D. As mentioned earlier, these losses are comparative because of the short length of pipe between a Venturi meter upstream of the test valve and the valve. Curve A was obtained when the flat of the leaf (seal side) was facing downstream when closed. Curve B was obtained when the valve was turned end for end. In either case, the head losses are higher for the Dresser valve than for any of the other valves for which losses were measured.

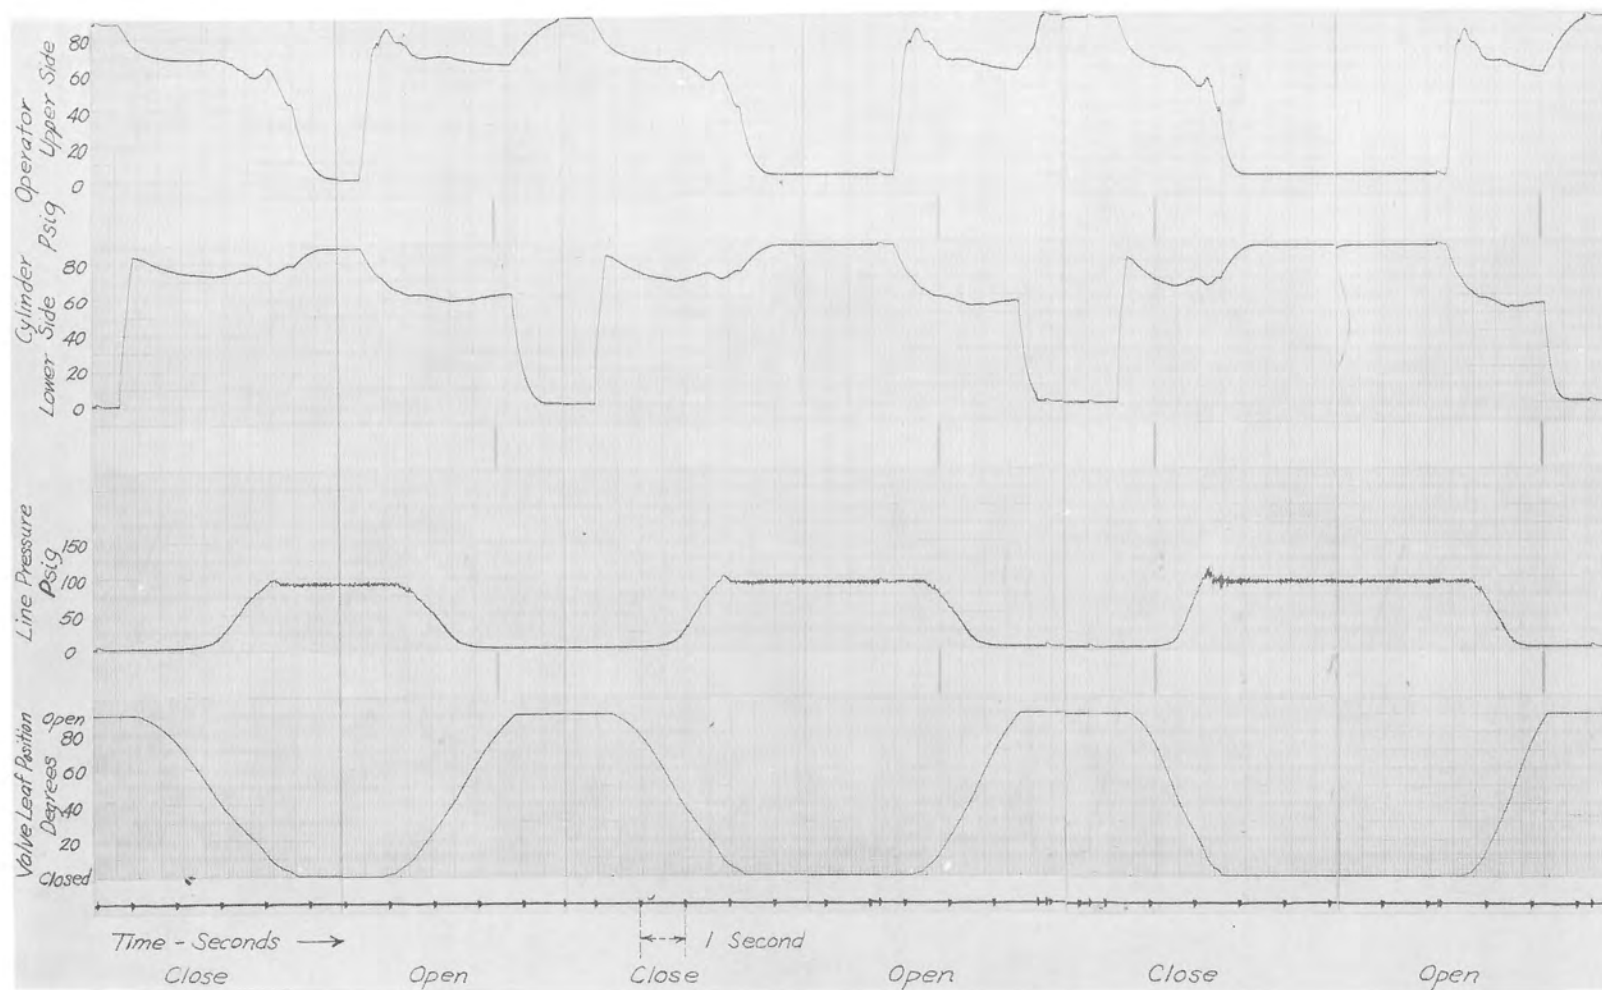
Figure 8D

At 150 psig the valve performed quite well. Smooth leaf travel still existed for opening cycles and only minor effects from hydraulic forces occurred during the closing cycle. These effects produced only slight variations in leaf closure speeds, however, at no time was leaf control affected (Figure 8-D). Also, a slight leak was observed in the slider box (Figure 9-D). This leak occurred only when the valve was in an intermediate position on an opening or closing cycle. The factory inspection after the valve was returned for modification revealed a metal shaving had damaged the shaft seal. The shaving apparently had been in the valve since the initial assembly.

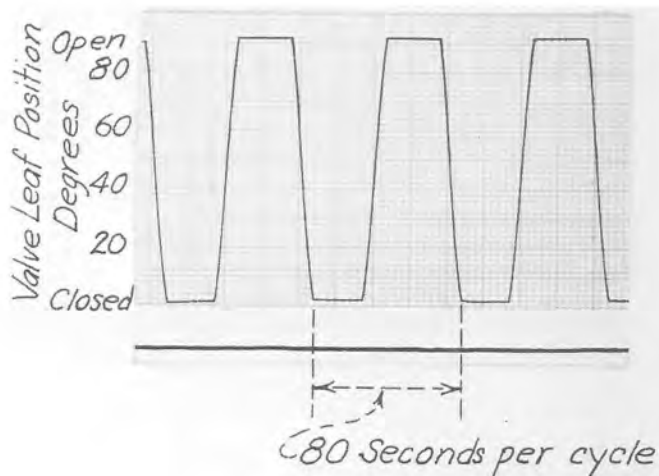
B. Leaf Flat Upstream

Note near constant leaf speed. Line pressure - 150 psig.

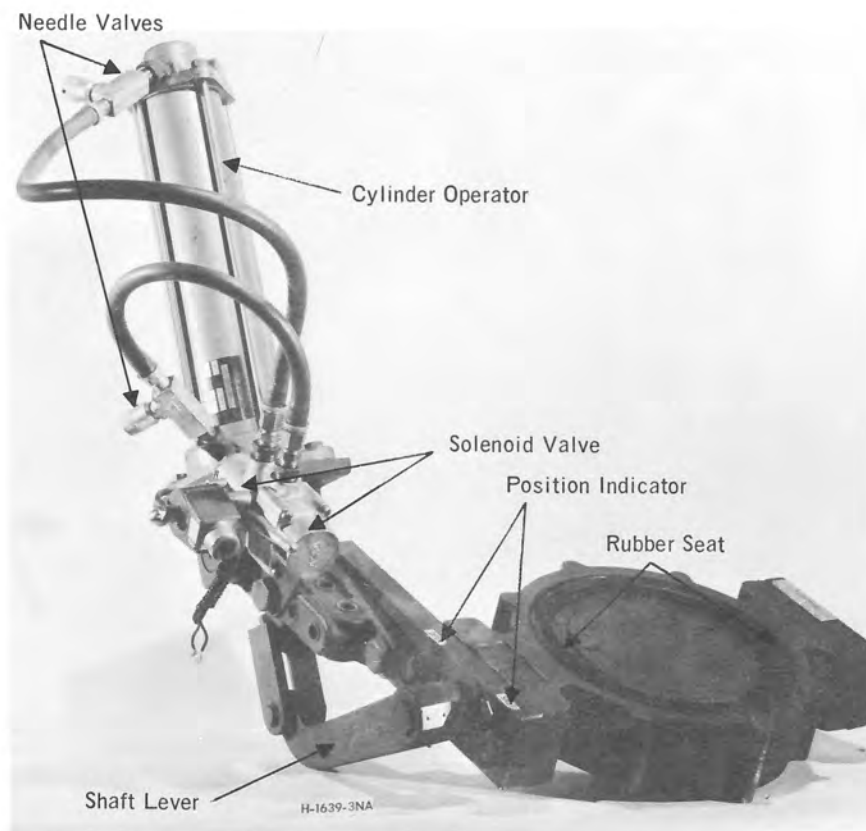
Figure 1AC. Allis-Chalmers wafer-type butterfly valve. Flat side of leaf is up. Photo P801-D-74509

The Allis-Chalmers valve (Figure 1-AC) was a wafer design with attached cylinder operator. The valve required mounting between 150-pound flanges. A continuous rubber seal seat was contained in the valve body. The butterfly leaf (disk) was an unsymmetrical shape, with one side flat and the other raised over the shaft area (offset disk) (Figure 2-AC). The operator was attached through a lever arm to the butterfly leaf shaft. During installation, care was required to insure adequate clearance between the valve and adjacent equipment for movement of the operator and shaft lever. A four-way ASCO solenoid valve and two micrometer adjustable needle valves controlled airflow for the 3 x 12-inch (7.6 x 30.5-cm) cylinder operator. A position indicator was indexed at open and shut positions. The valve was actuated by unbalanced pressure on the cylinder operator.

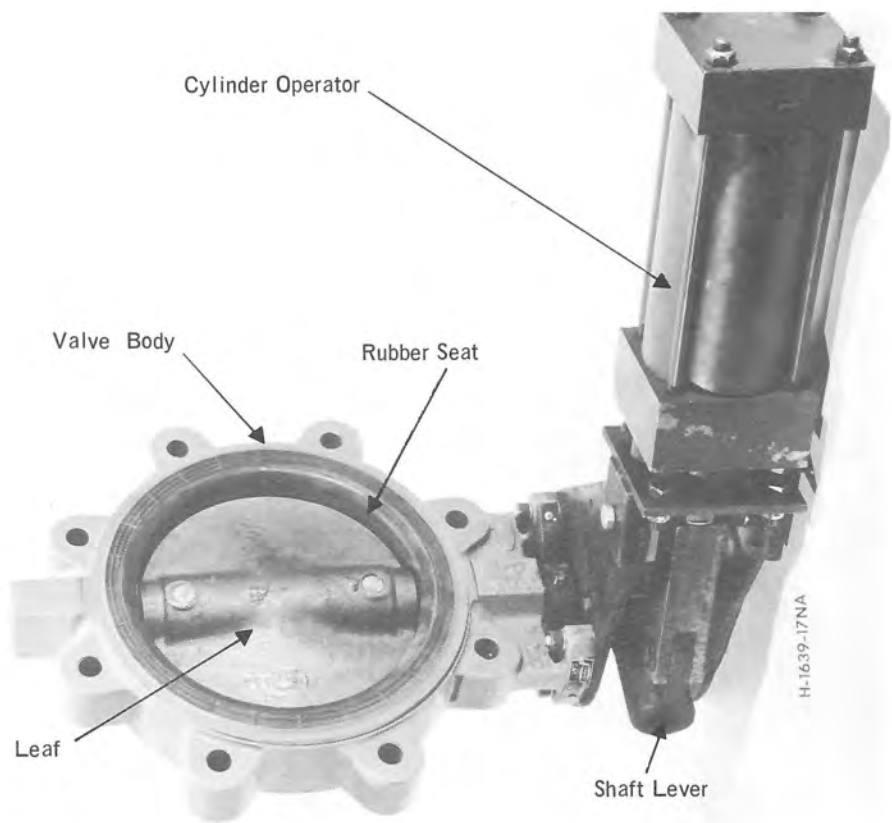
Figure 1CR. Crane wafer-type butterfly valve. Photo P801-D-74513

The Crane valve was a wafer design with attached cylinder operator (Figure 1-CR). The valve body was tapped for bolting between 150-pound flanges. The leaf (disk) was a modified lenticular shape and sealed on a continuous rubber seat bonded to the valve body.

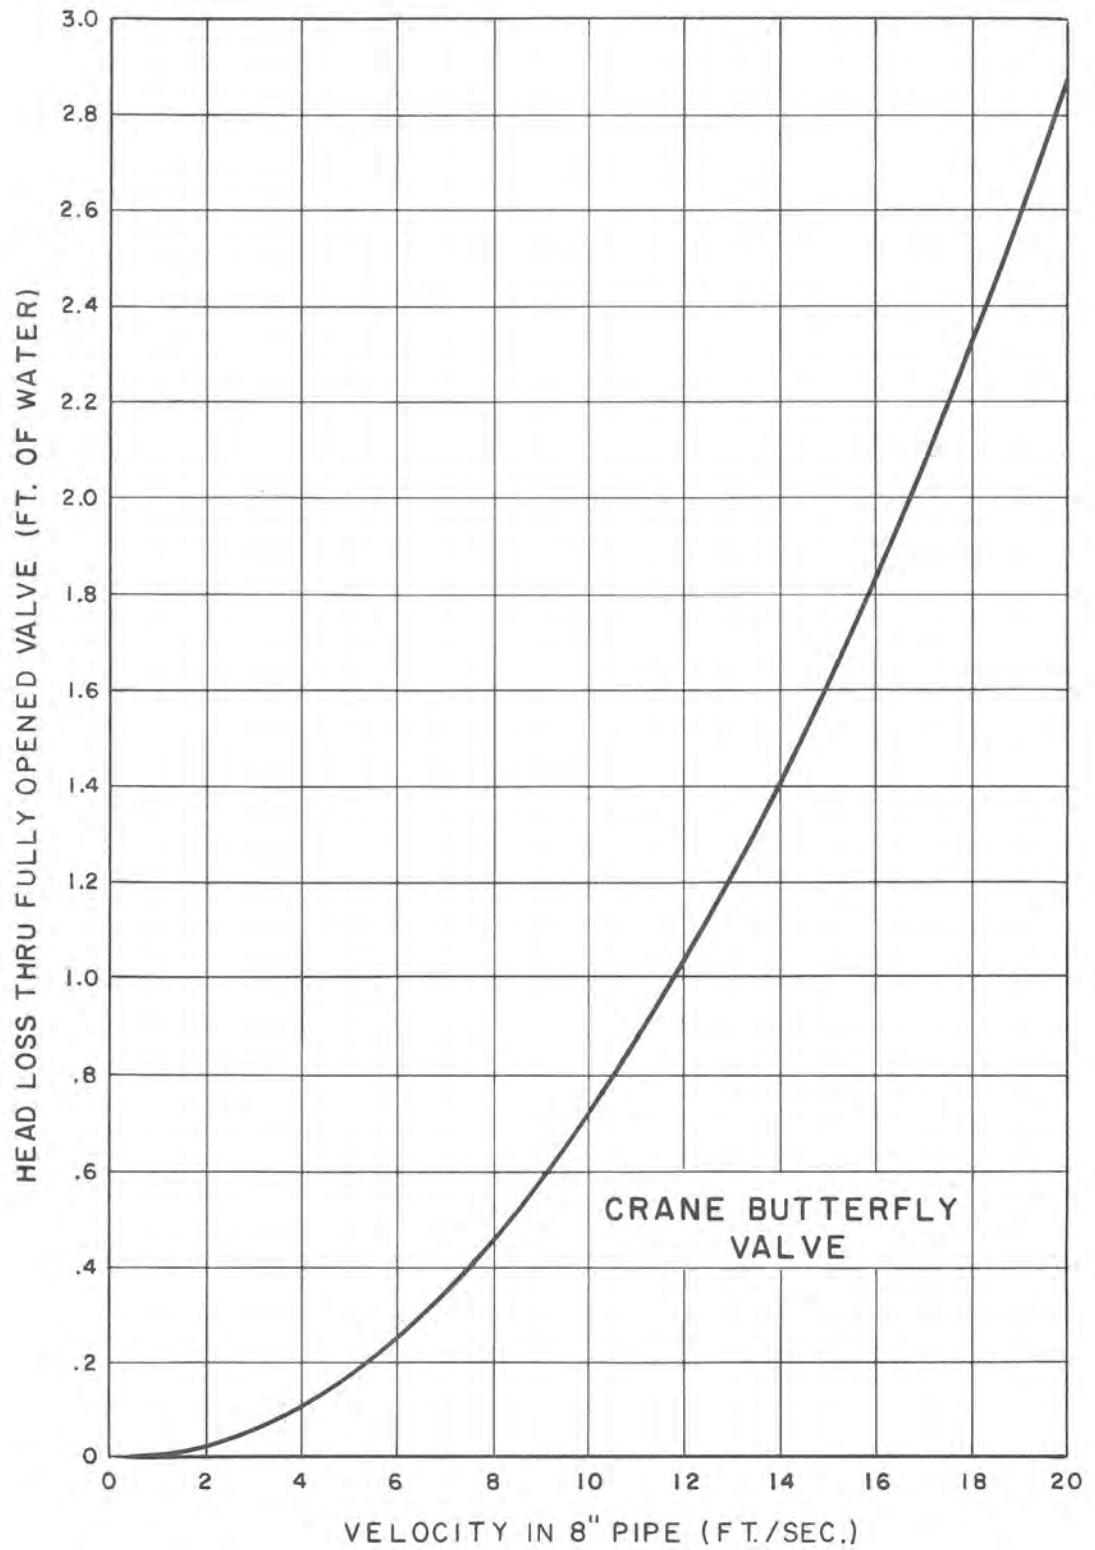
Figure 5CR. Head loss through fully opened Crane valve.

10. Head losses for the fully opened Crane valve were obtained for a wide range of line velocities. These losses are shown in Figure 5-CR.

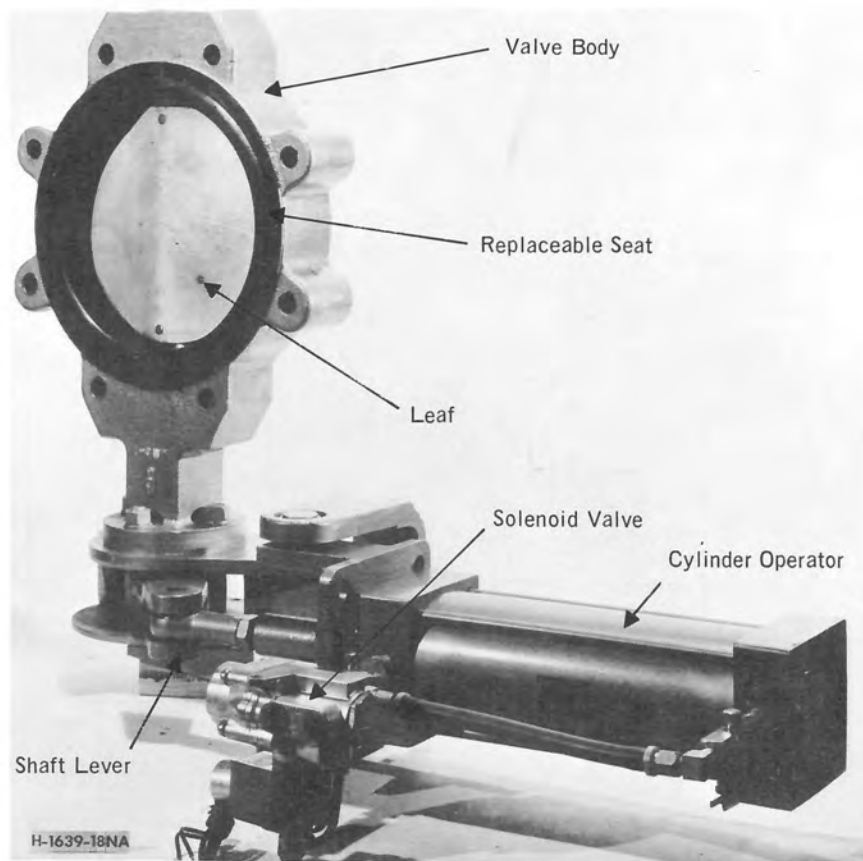
Figure 1CL. Centerline wafer-type butterfly valve, with replaceable seat. Photo P801-D-74518

The replaceable rubber seat of the Center Line valve appears to be an excellent idea, however, leakage from the seat and molded flat area must be eliminated before the design would be acceptable. The travel of the leaf which appeared quite smooth for rapid operation
