# SPILLWAY TESTS AT GLEN CANYON DAM

*July 1985*

*Engineering and Research Center*

Hydraulics Branch  
Division of Research and Laboratory Services  
Engineering and Research Center  
Denver, Colorado  
July 1985

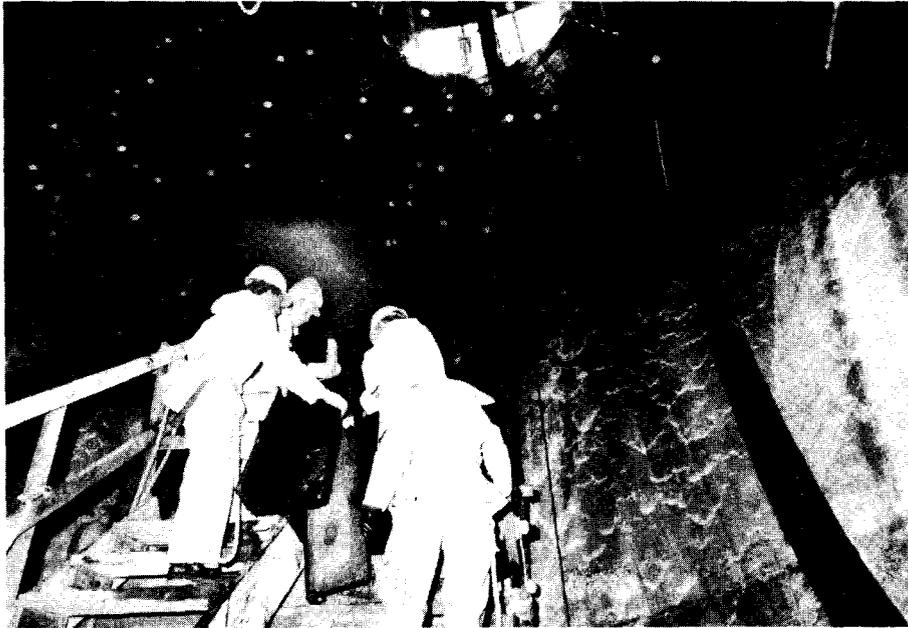
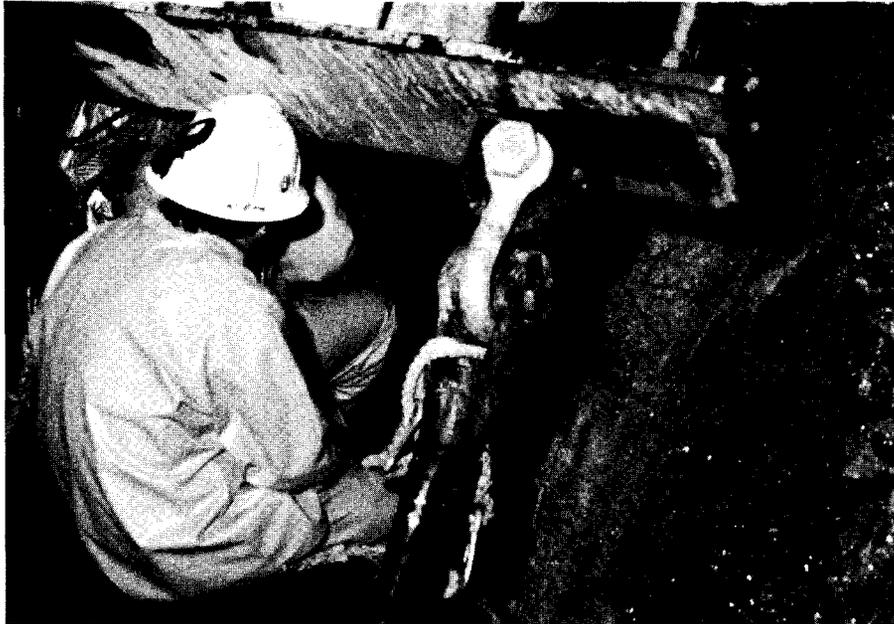
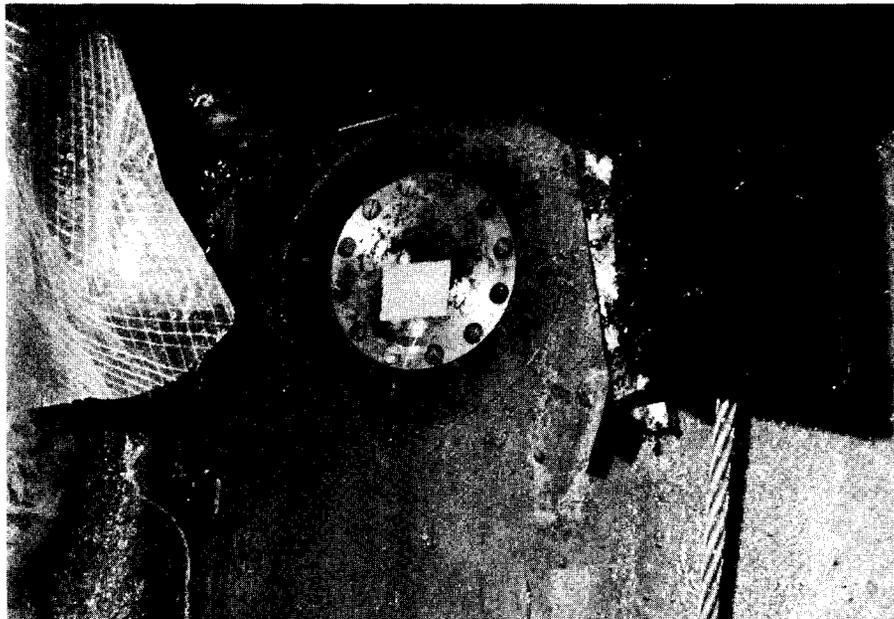
Figure 8. - Installation of static pressure transducer in box 8.

(a) Water diverter being placed for installation of box 8.

(b) Signal wire being connected to transducer, box 8.

(c) Tightening cover plate to box frame.

(d) View on finished installation, box 8.
